CRASH TESTING AND EVALUATION OF THE 12 FT PINNED F-SHAPE TEMPORARY BARRIER

Contract No. T4541-AB
Report/Test No. 405160-3-1/2a
Date of Test: 09-19-2006/11-15-2008

Sponsored by
**Roadside Safety Research Program Pooled Fund
Study No. TPF-5(114)**

**TEXAS TRANSPORTATION INSTITUTE
THE TEXAS A&M UNIVERSITY SYSTEM
COLLEGE STATION, TEXAS 77843**

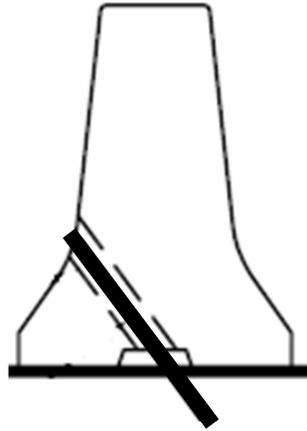
Figure 2.1. Initial configuration with 55-degree drop-pin angle.

On evaluating barrier cross-sections and reinforcement details of all participating states, the researchers was found that using same pin angle as the Texas design would require modifications to rebar details of TN, AK, LA and MN designs. These modifications would be required to ensure the drop-pins pass over at least one longitudinal rebar inside the barrier. To eliminate the need for barrier modification by the majority of participating states, the researchers increased the drop-pin angle to 55 degrees (see figure 2.1). Evaluating barrier cross-sections and rebar designs of participating states indicated that, except Minnesota, no state would require modification to its current rebar details. Even for Minnesota, the nature of the modification was minor. Figure 2.2 shows the scaled half-profile of each state's barrier and the position of the pin inside the barrier. The location of the longitudinal rebar is also shown in the figure. The

drop-pin angle of 55 degrees is currently being used by Oregon DOT and was also adopted by Alaska DOT. However, the impact performance of this practice has not been evaluated with full-scale crash testing.

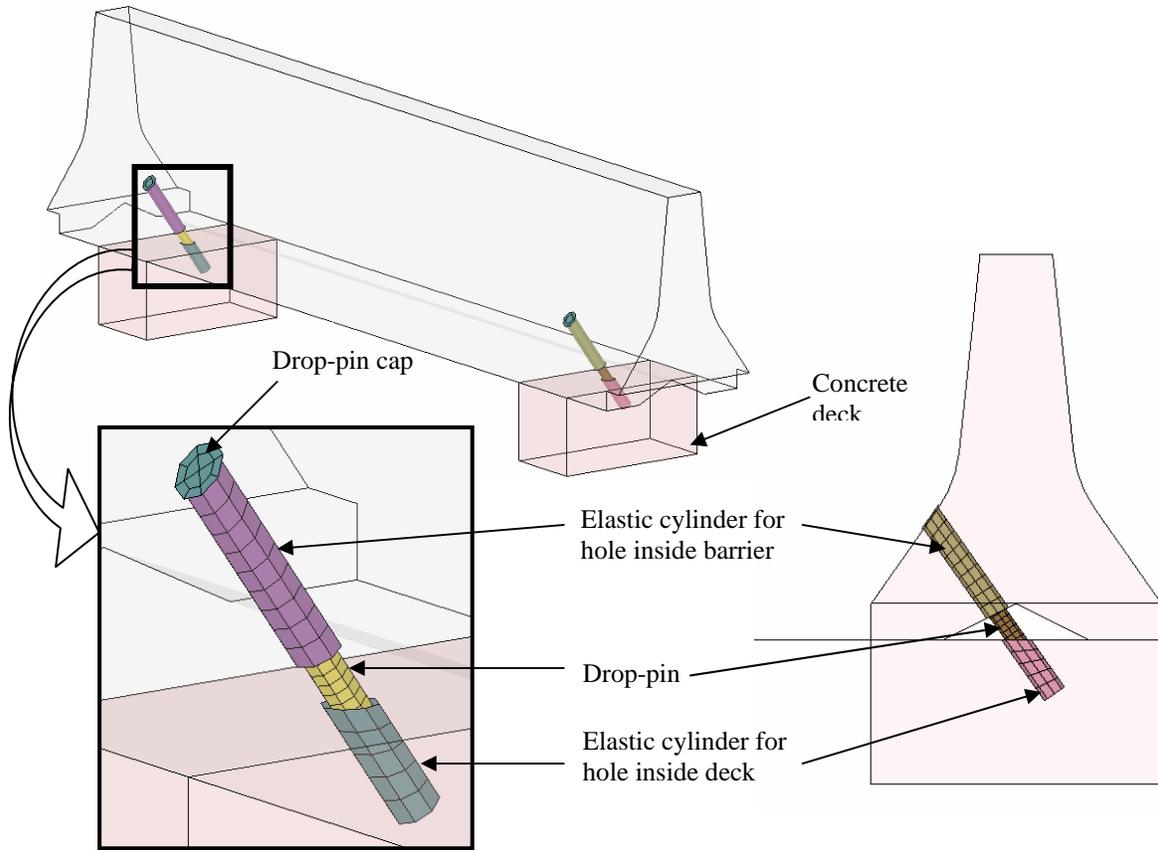
Figure 2.4. FE model of the drop-pins in the initial WSDOT pinned-barrier model.

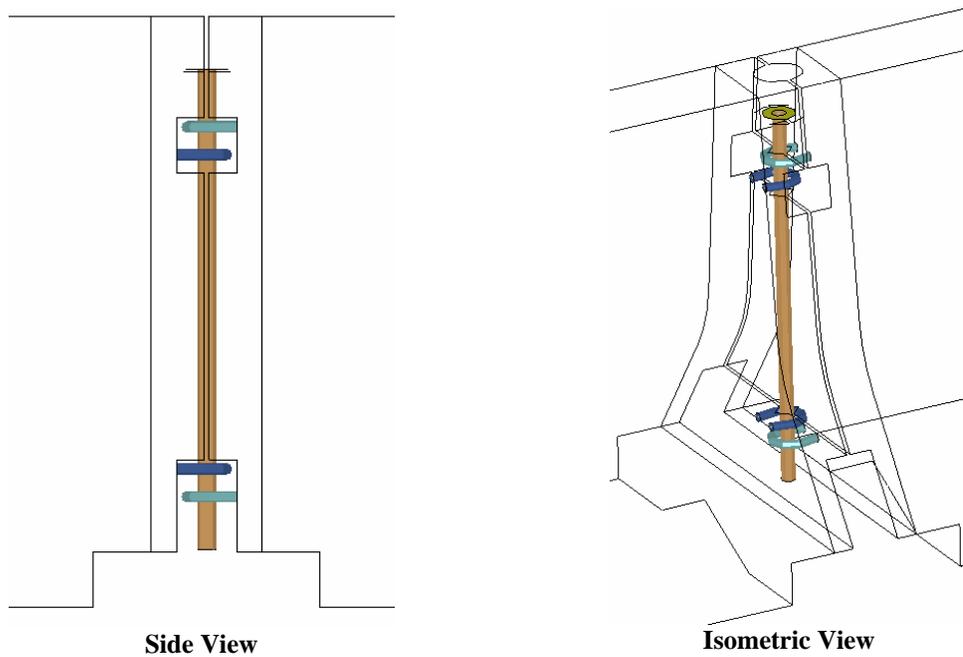
Figure 2.5. Pin-and-loop connection model in the initial WSDOT pinned barrier model.

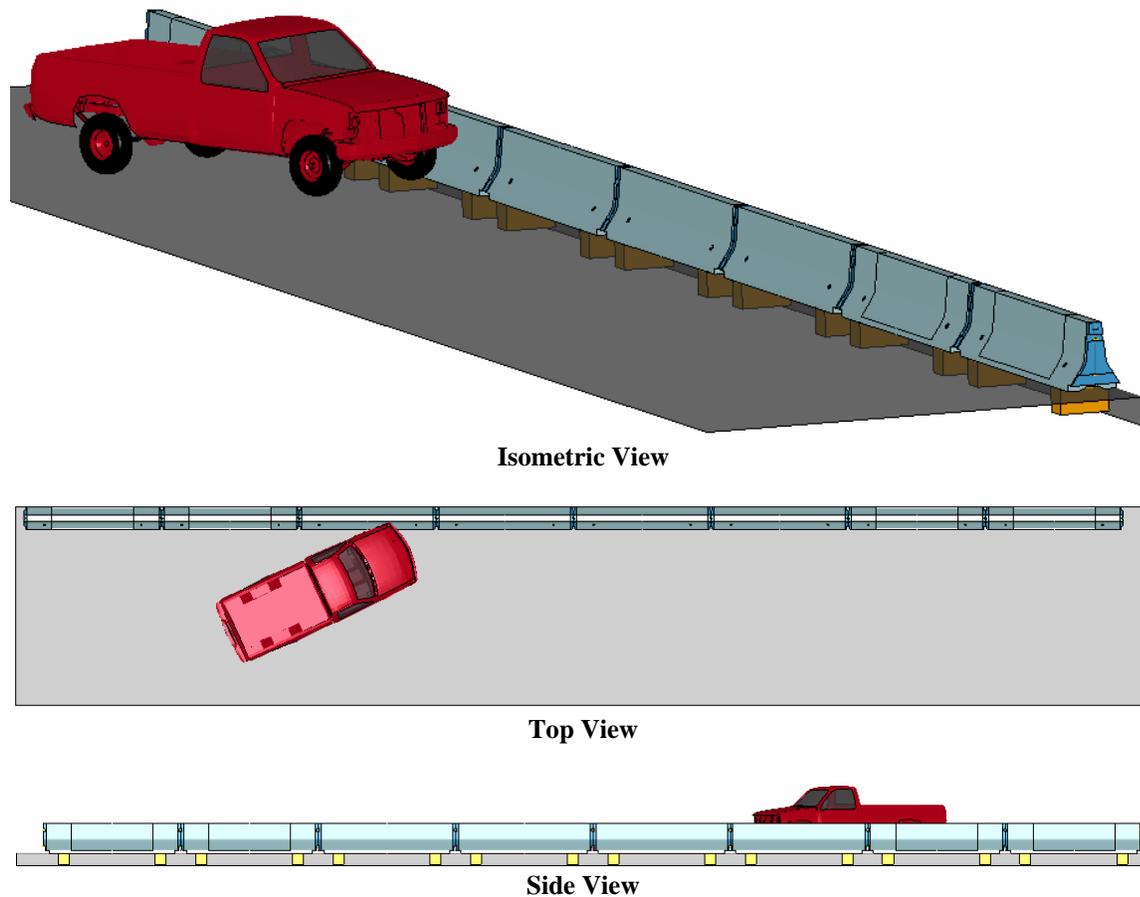
The full system model of the WSDOT pinned barrier is shown in figure 2.6. The simulation replicated Test Designation 3-11 of *NCHRP Report 350*. This test involves a 4409 lb (2000 kg) pickup truck impacting the barrier at a speed of 62.2 mi/h (100 km/h) and an angle of 25 degrees. This test is considered to be the critical test for evaluating the structural integrity of the drop-pin configuration and the maximum dynamic deflection of the barrier. A total of eight barrier segments were modeled to provide a barrier length of 100 ft. The vehicle model impacted the barrier system 4 ft upstream of the joint between the 3rd and the 4th barrier segment as shown in figure 2.6.

Figure 2.6. Initial FE system model of the WSDOT pinned barrier.

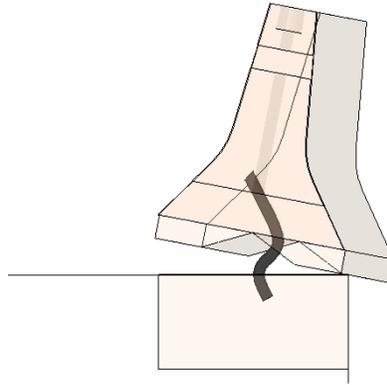
Figure 2.9. Barrier segment with maximum roll.

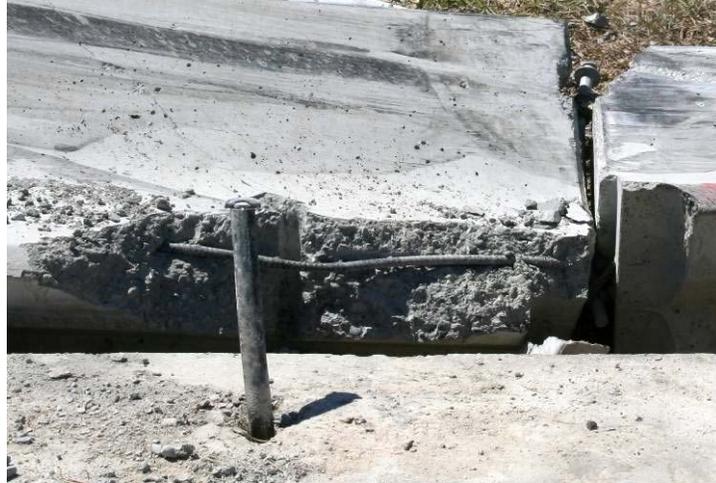
A crash test was subsequently performed with the above mentioned pinned configuration, but it failed to meet the *NCHRP Report 350* criteria. Concrete around one of the drop-pins failed catastrophically as shown in figure 2.10. The drop-pin initially caught on to the longitudinal rebar, but slipped off after bending the pin-cap, which resulted in high barrier roll and vehicle climb. The barrier then dropped off the edge of the deck and as it rotated, causing more rotation and lift in the adjacent upstream barriers, which also eventually dropped off the deck. Details of the crash testing are presented in Chapter 4.

Figure 2.10. Failure of the concrete around the drop-pin at the joint of impact.

Analysis of the crash test results also indicated that even though concrete damage at the ends of adjacent barrier segments was moderate, it was enough to reveal some portions of the wire-rope loops that ran into the barrier. Since the wire-rope loops do not have any significant torsional stiffness of their own, the exposed wire-rope resulted in additional rotation of the barrier segments relative to each other. Thus, it was noted that instead of using the wire-rope connection, the new design should incorporate connections with loops made of round stock steel.

It was also observed that once the barriers started to roll, the drop-pins pulled out of the concrete pavement without significant resistance. Reducing the drop-pin angle relative to the ground was expected to offer more resistance to the drop-pin pullout. Welding a thicker pin cap to the top of the drop-pins was also expected to help grab on to the longitudinal rebar in case of concrete failure in the vicinity of the drop-pins. It was also noted that further finite element analysis for the barrier design should incorporate concrete material failure as it can significantly affect the outcome of the crash test.

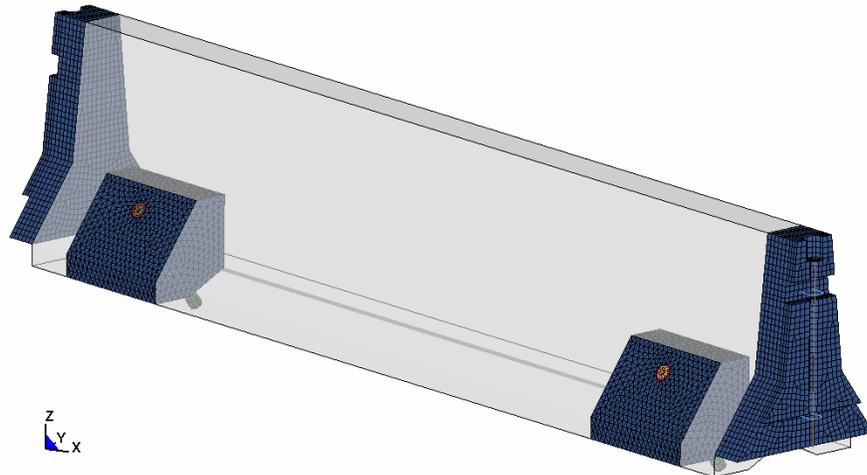
Modifications were made to capture some of the concrete failure that was observed in the test. The failure was incorporated using the Continuous Surface Cap Model (CSCM) (*MAT_CSCM) in LS-DYNA materials library. Inclusion of the concrete failure significantly increases the size of the model and the computational time required to complete the simulations. To reduce model size, concrete failure was only incorporated in regions that exhibited failure in the crash test. These regions were the ends of the adjacent barriers at two joints immediately downstream of the impact, and the concrete in the vicinity of the drop-pins. Figure 2.11 highlights the regions of the barriers that included concrete failure. The reinforcement of the barrier was also modeled in these regions as shown in figure 2.12. Portion of the rebar inside the concrete material was constrained using LAGRANGE_IN_SOLID constraints between the rebar and the concrete material.

Figure 2.11. Regions of the barrier that incorporate concrete failure.

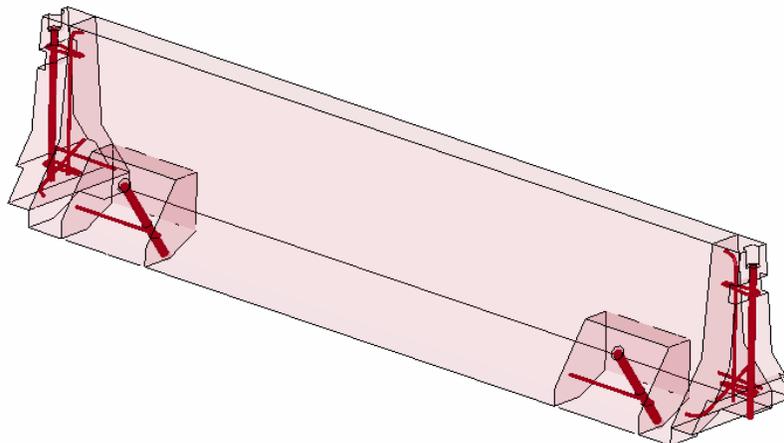
Figure 2.12. Barrier reinforcement modeled in regions with concrete material failure.

The wire-rope loops were comprised of beam elements that passed a certain distance inside the regions of the barrier where concrete material failure was incorporated (see figure 2.13). This was done to account for barrier rotation resulting from wire-rope loops that were exposed once the concrete failed in their vicinity. To allow for proper stress distribution in the concrete material around the drop-pins, the holes for passing the drop-pins were explicitly modeled as shown in figure 2.13.

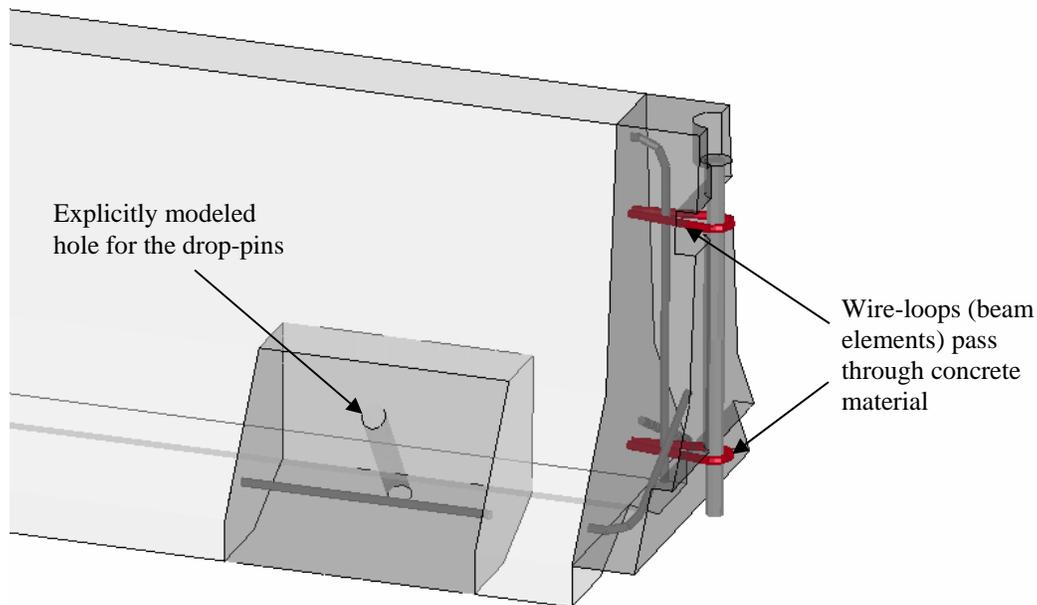
Figure 2.13. Changes to the barrier model.

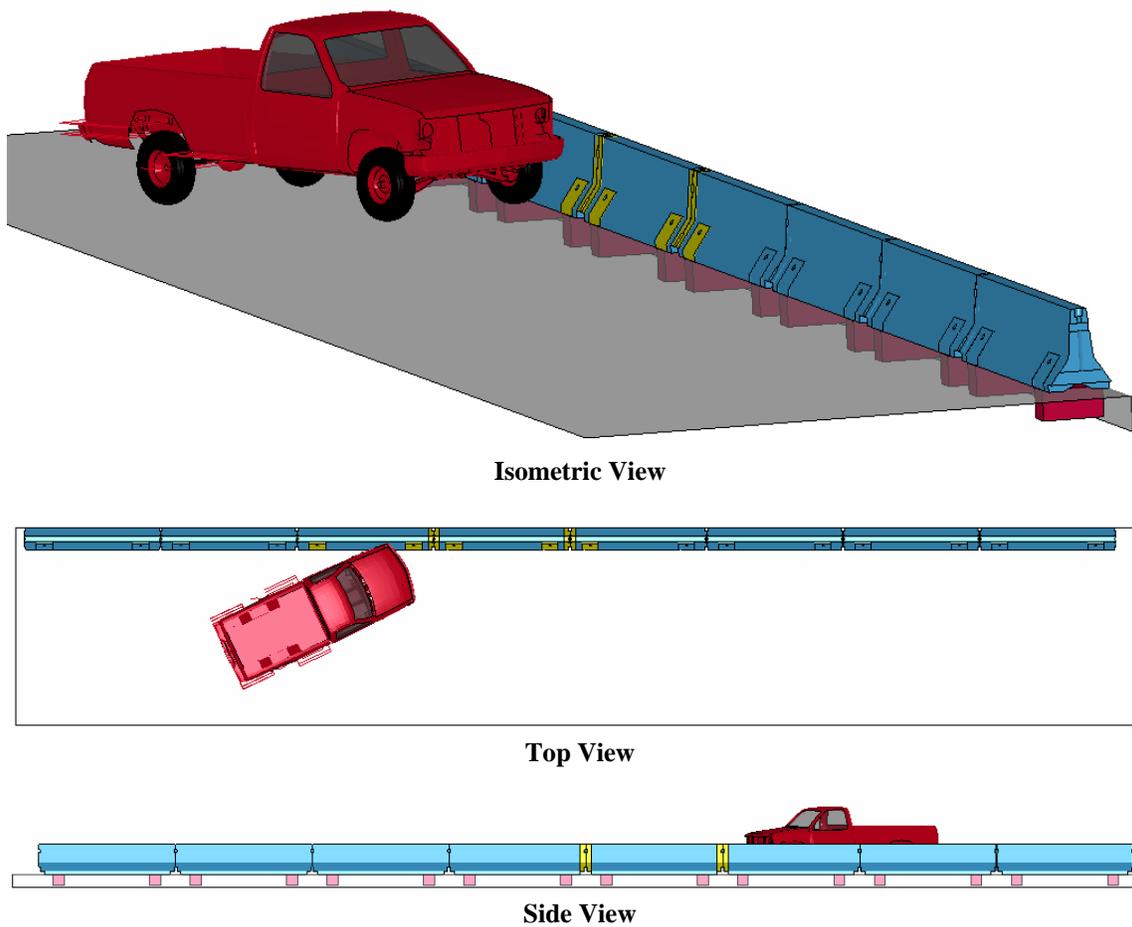
The modified full system model of the WSDOT pinned barrier is shown in figure 2.14. The simulation replicated Test Designation 3-11 of *NCHRP Report 350*, which involves a 4409 lb (2000 kg) pickup truck impacting the barrier at a speed of 62.2 mi/h (100 km/h) and an angle of 25 degrees. A total of eight barrier segments were modeled to provide a barrier length of 100 ft (30.48 m). The vehicle model impacted the barrier system 1.2 meters upstream of the joint between the 3rd and the 4th barrier as shown in figure 2.14.

Figure 2.14. Modified full-system model of the WSDOT barrier.

Several iterations were performed on the properties of the concrete material model to calibrate failure in the simulations to some of the failure observed in the test. The failure of concrete material in the finite element model occurred through erosion of elements that achieve a certain threshold of concrete damage and plastic strain. Thus the element erosion/material failure using the CSCM concrete material model is not completely independent of the mesh size used in the model. Several iterations of the erosion parameters were performed to improve correlation between simulation and test results.

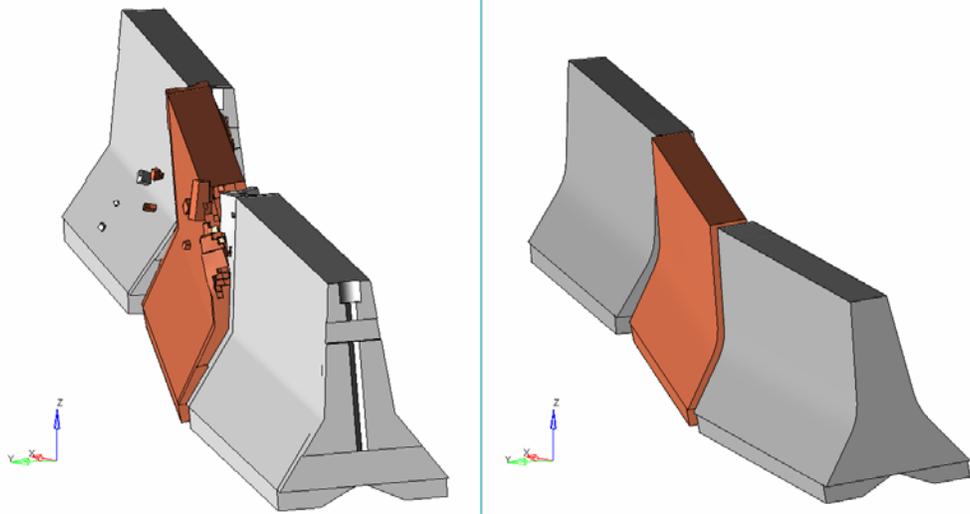
With the inclusion of concrete material failure at barrier faces and by modifying the properties wire-rope connection details, the relative rotation between adjacent barrier segments was improved compared to the previous model (see figure 2.15). In the crash test, the barriers upstream of the impact point showed a tendency to lift up without much resistance from the pins. This tendency was captured in the modified model as shown in figure 2.16). Similarly, the vehicle had significant climb in the test. The modified finite element model showed an increased climb of the vehicle compared to the previous model, as shown in figure 2.17.

Figure 2.15. Increased barrier rotation in modified WSDOT model (left) versus old model (right).

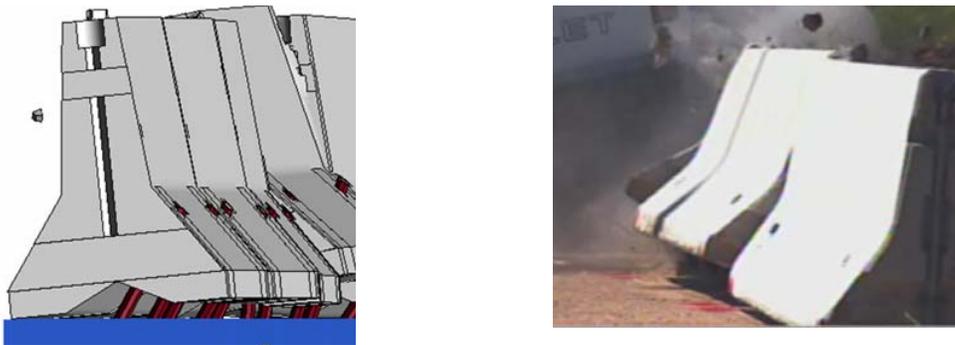
Figure 2.16. Lifting of the barrier observed in the test and simulation results.

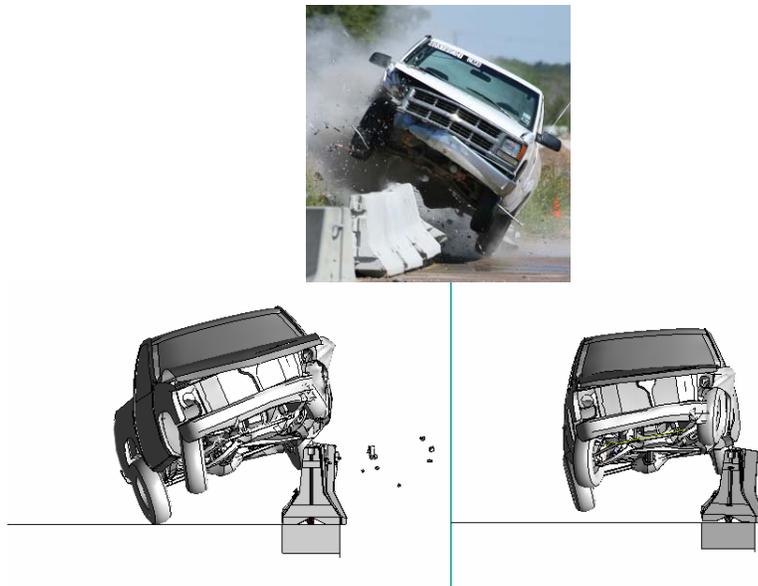
Figure 2.17. Vehicle climb comparison. Modified WSDOT simulation (left), old simulation (right), and crash test (top).

While significant improvements to the finite element model of the WSDOT pinned barrier were made, a complete agreement with crash test results was not achieved within the limited resources allocated for the effort. The simulation results showed some failure in the concrete region around the drop-pin, but the catastrophic failure observed in the test was not replicated. This, in turn, influenced the degree of barrier roll and vehicle climb. Nonetheless, the overall model behavior was significantly improved and provided higher confidence in the use of simulation for analysis of the new pinned-down barrier system.

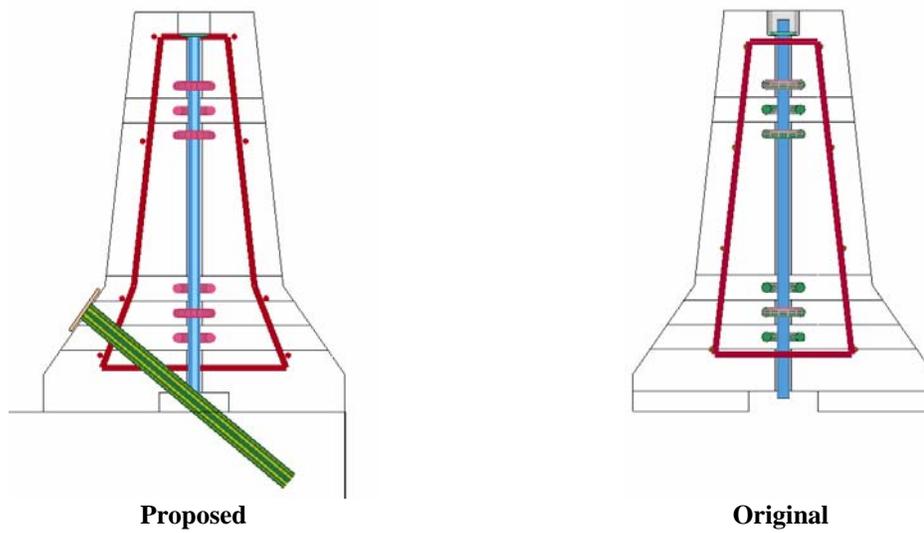
The design effort addressed factors that had a negative affect on barrier performance in the WSDOT pinned barrier crash test. The NJ profile of the barrier, which causes high vehicle climb, was changed to the more stable F-shape profile. After evaluating connection details of crash tested barrier designs, the researchers selected Oregon DOT's pin-and-loop concrete barrier as the basis for the new pinned-down configuration. This barrier design has been adopted by Alaska and Louisiana Departments of Transportation, both of whom are members of the pooled fund. The basic profile and connection details of Oregon DOT's F-shaped pin-and-loop barrier were retained. The barrier connection incorporates "two sets of the three loops" made of $\frac{3}{4}$ -inch diameter smooth bar steel. The connecting pin is 1-inch in diameter and the gap between adjacent barrier segments is also 1-inch. The length of the barrier segments is 12.5-ft.

The drop-pin design incorporated two drop-pins per barrier segment. To better resist barrier rotation under vehicle impact, the drop-pin angle relative to the ground was reduced to 40 degrees. Rebar details of the Oregon/Louisiana barrier were slightly modified to ensure that at least one longitudinal rebar passes below the drop-pins. This provides an opportunity for the drop-pin cap to catch onto the rebar in case of significant concrete failure around the pin. The thickness of the drop-pin cap was also increased to 1/2 inch as the thinner 1/4-inch cap was easily peeled off one of the pins in the WSDOT barrier test. Figure 2.18 shows the drop-pin orientation and a comparison of the changes made to the reinforcement. It should be noted that while the simulation analysis was performed using the reinforcement layout shown in figure 2.18, some modifications were made prior to crash testing as shown in figure 2.19. These included a slightly changed shape of the stirrups to provide adequate concrete cover for the longitudinal inset at the bottom of the barrier. A diagonal U-bar, which passed underneath the hole for the drop-pins, was also incorporated to act as a backup for engaging the drop-pins in case of catastrophic concrete failure around the pins.

Figure 2.18. Changes in barrier reinforcement.

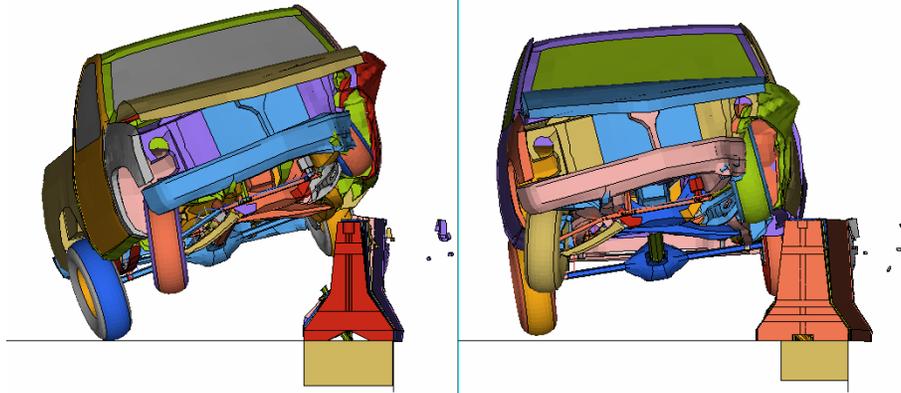
Figure 2.23. Vehicle climb observed in WSDOT barrier (left) and the new pinned-down barrier (right).

The roll angle of the barriers during impact was also significantly reduced between the new F-shaped barrier simulation and the modified WSDOT pinned barrier model. Figure 2.24 shows this difference for the barrier segment exhibiting maximum roll in both designs. The reduction in the angle of the drop-pins helped restrain barrier-roll and prevented the lifting of the barriers that was observed in the WSDOT test and simulation. Figure 2.25 shows the reduction in the barrier lift between the two designs.

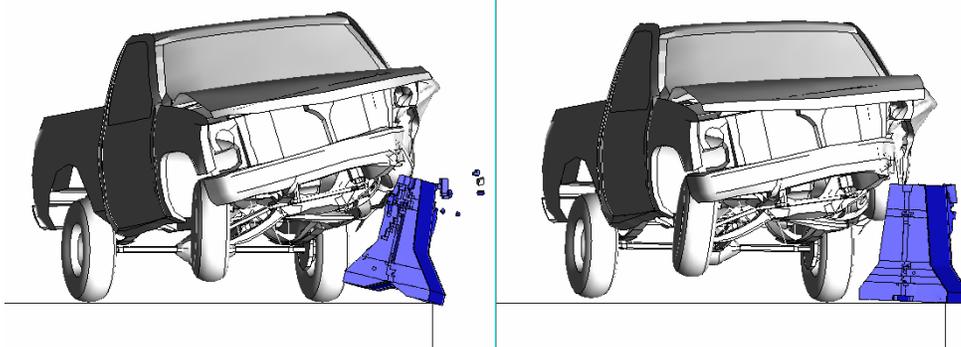
Figure 2.24. Maximum barrier roll in WSDOT barrier (left) and the new pinned-down barrier (right).

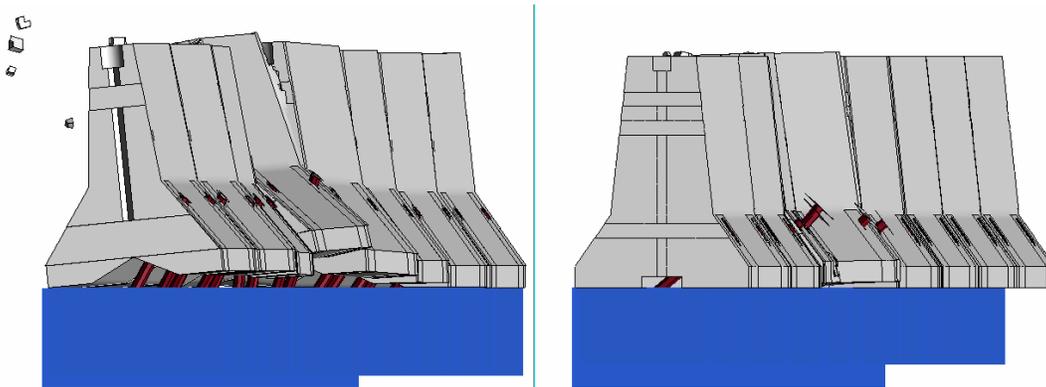
Figure 2.25. Barrier lift observed in the WSDOT simulation (left) is improved in new design (right). (Vehicle not shown).

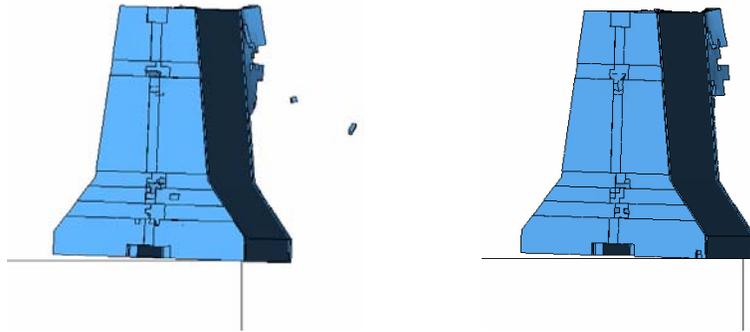
A simulation with the barrier placed at a 6-inch lateral offset from the edge of the deck drop-off was also performed. The objective of this simulation was to investigate if allowing lateral off-set behind the barrier would positively affect barrier performance by reducing barrier roll. Simulation results did not indicate any significant difference in the barrier roll as shown in figure 2.26.

Figure 2.26. Barrier rotation comparison with the barrier placed on edge (left) and barrier placed at a 6-inch offset (right).

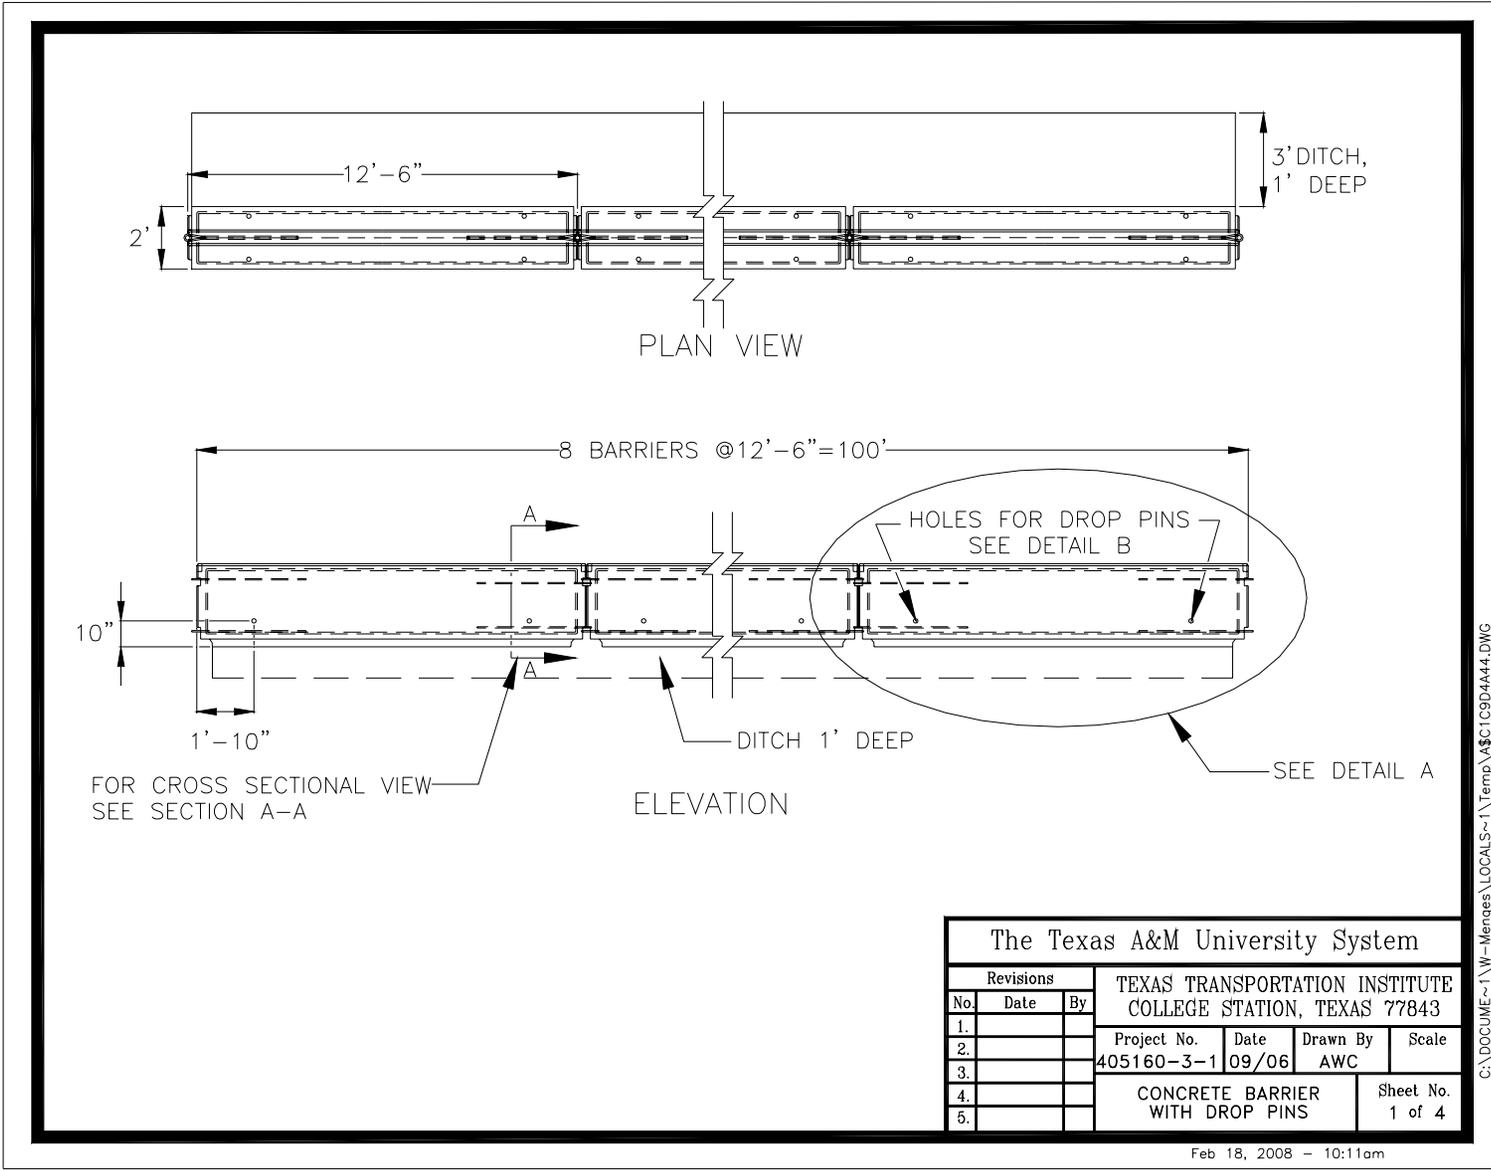
The completed test installation consisted of eight barrier segments connected together for a total length of approximately 100 ft (30.5 m). Details of the barrier and the pin-down restraint are shown in figures 4.1 through 4.4. Figure 4.5 shows photographs of the completed test installation.

Figure 4.1. Details of the pinned F-shape barrier – layout.

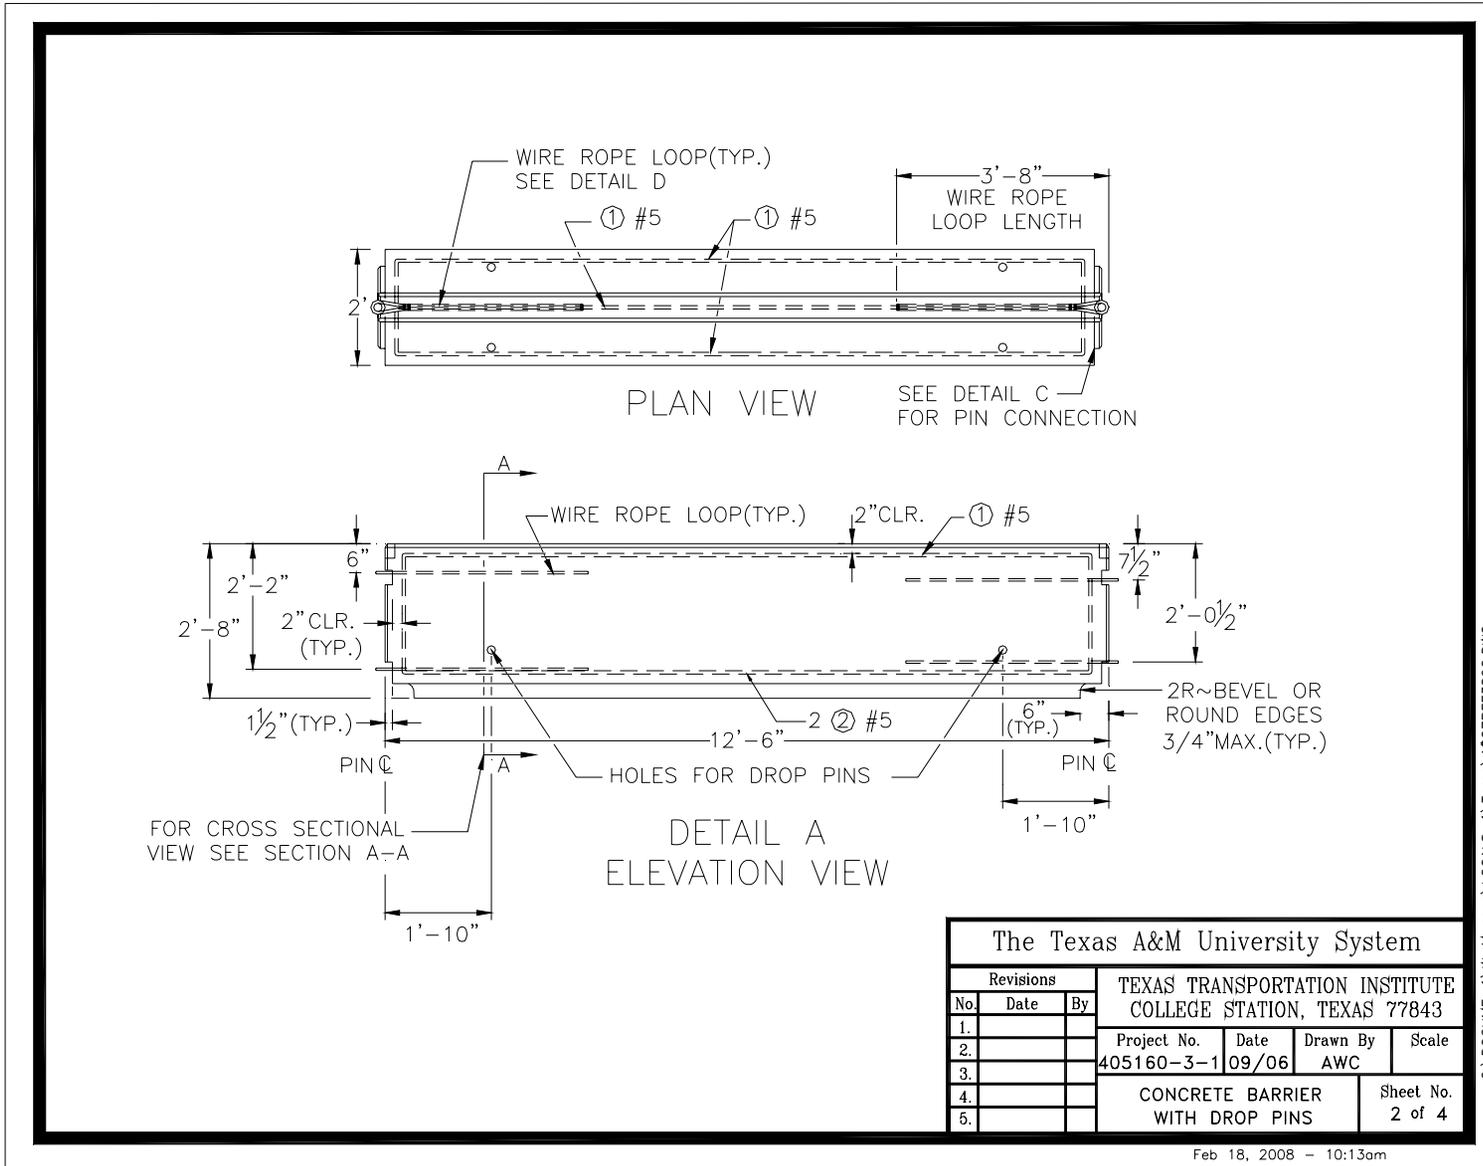
Figure 4.2. Details of the pinned F-shape barrier – detail A.

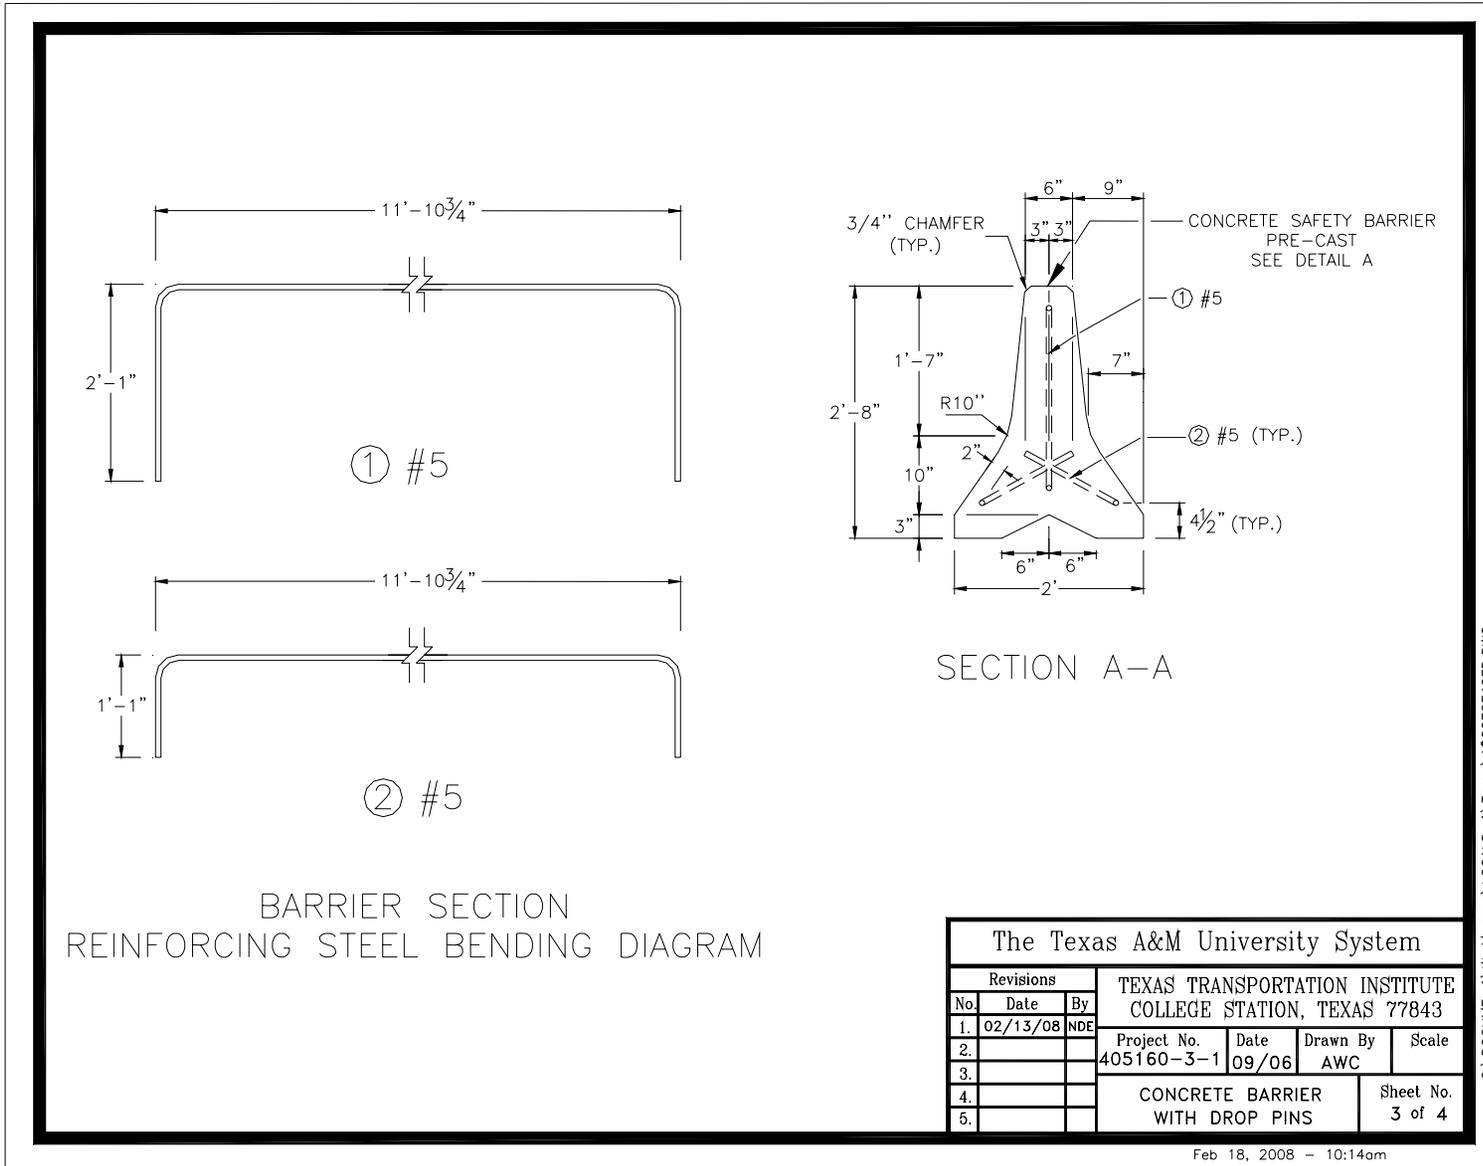
Figure 4.3. Details of the pinned F-shape barrier – cross section.

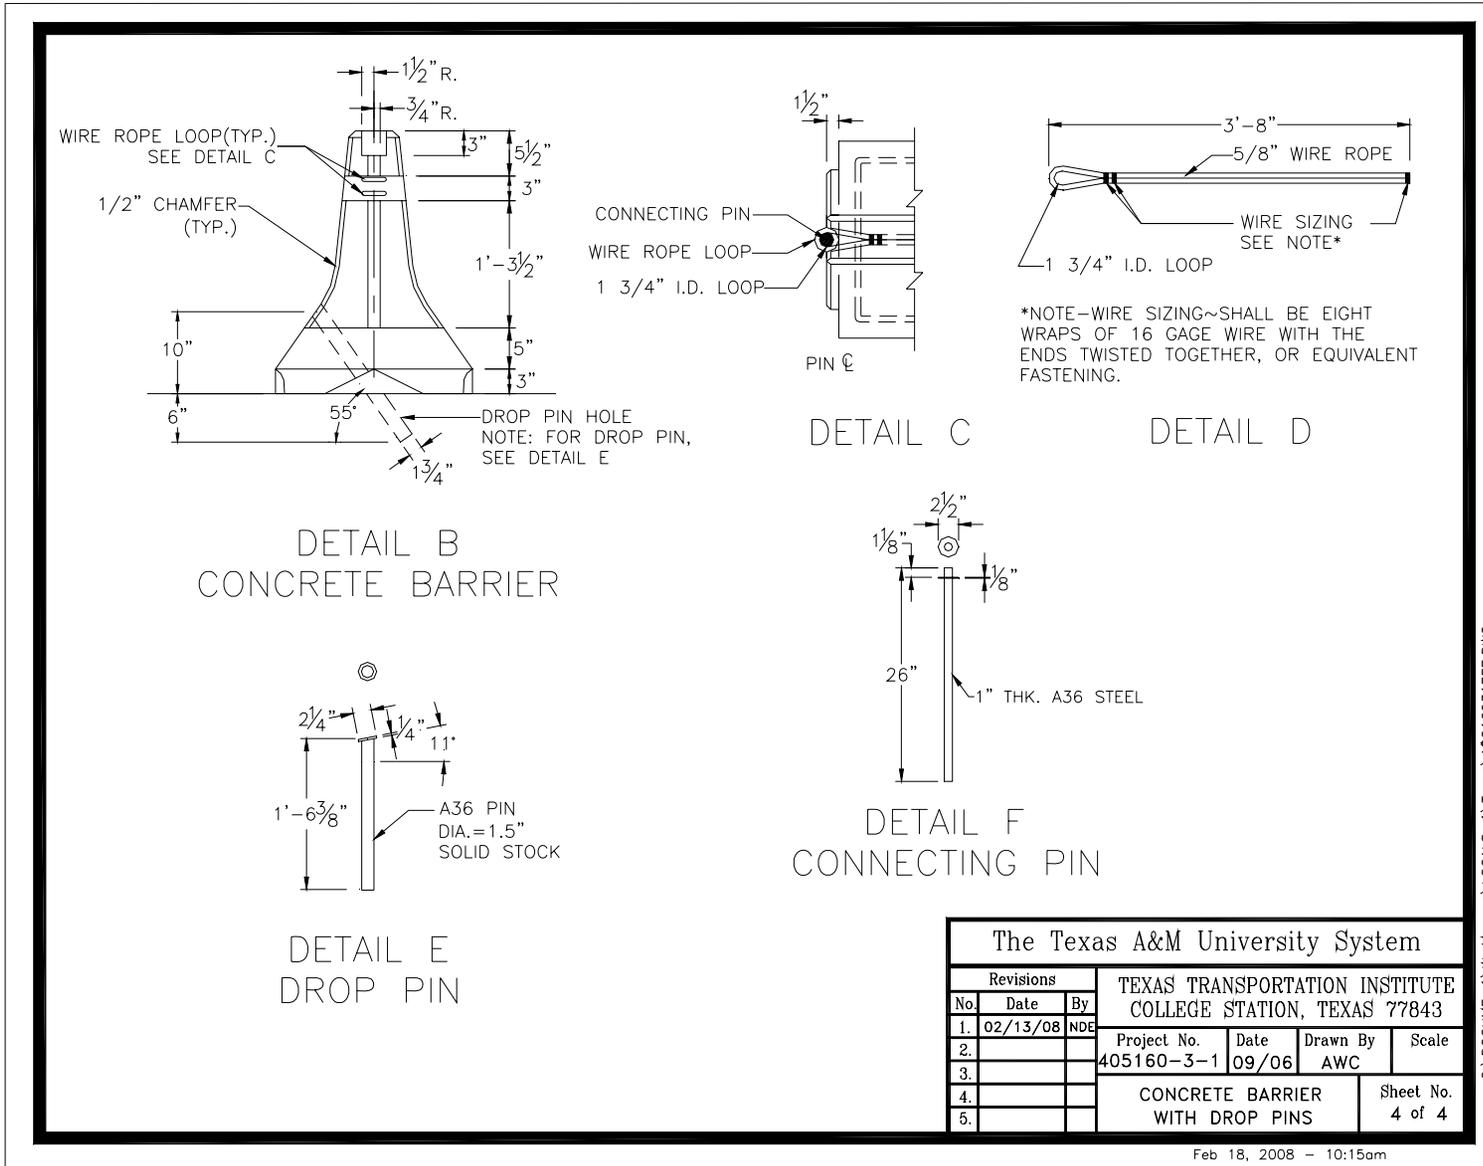
Figure 4.4. Details of the pinned F-shape barrier – rebar.

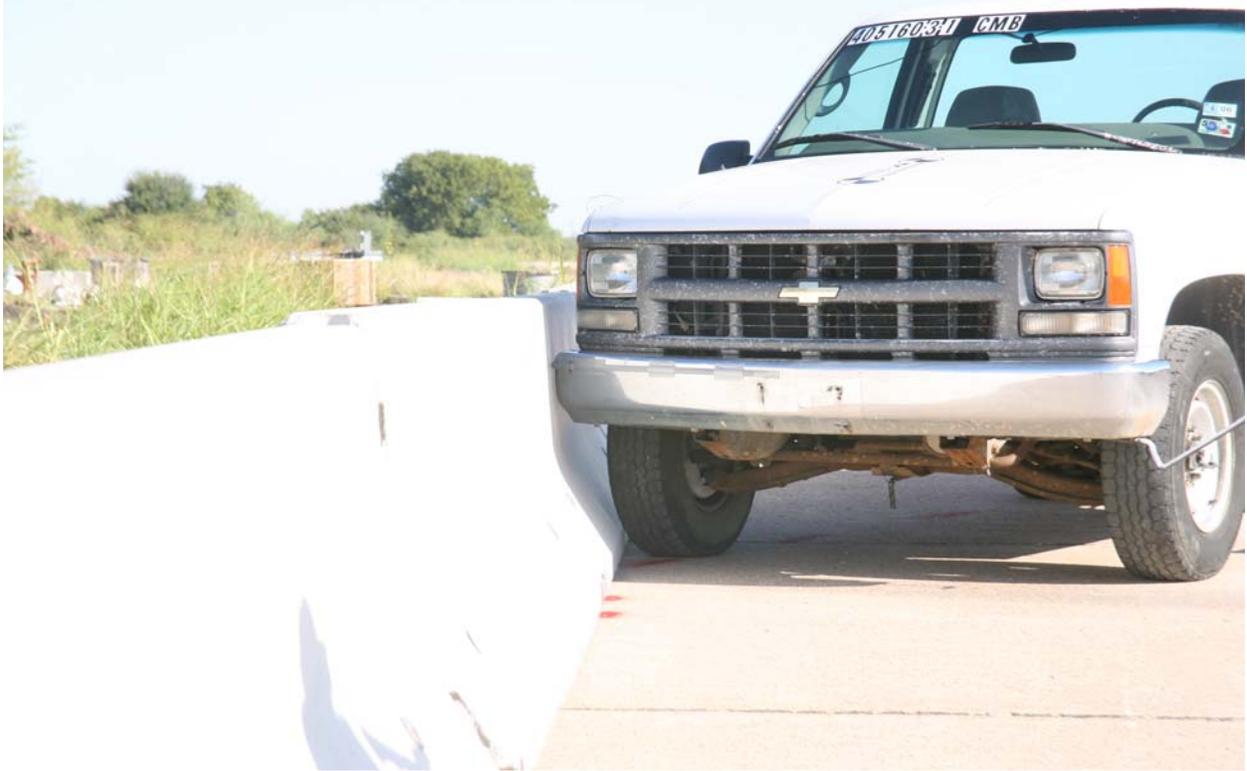
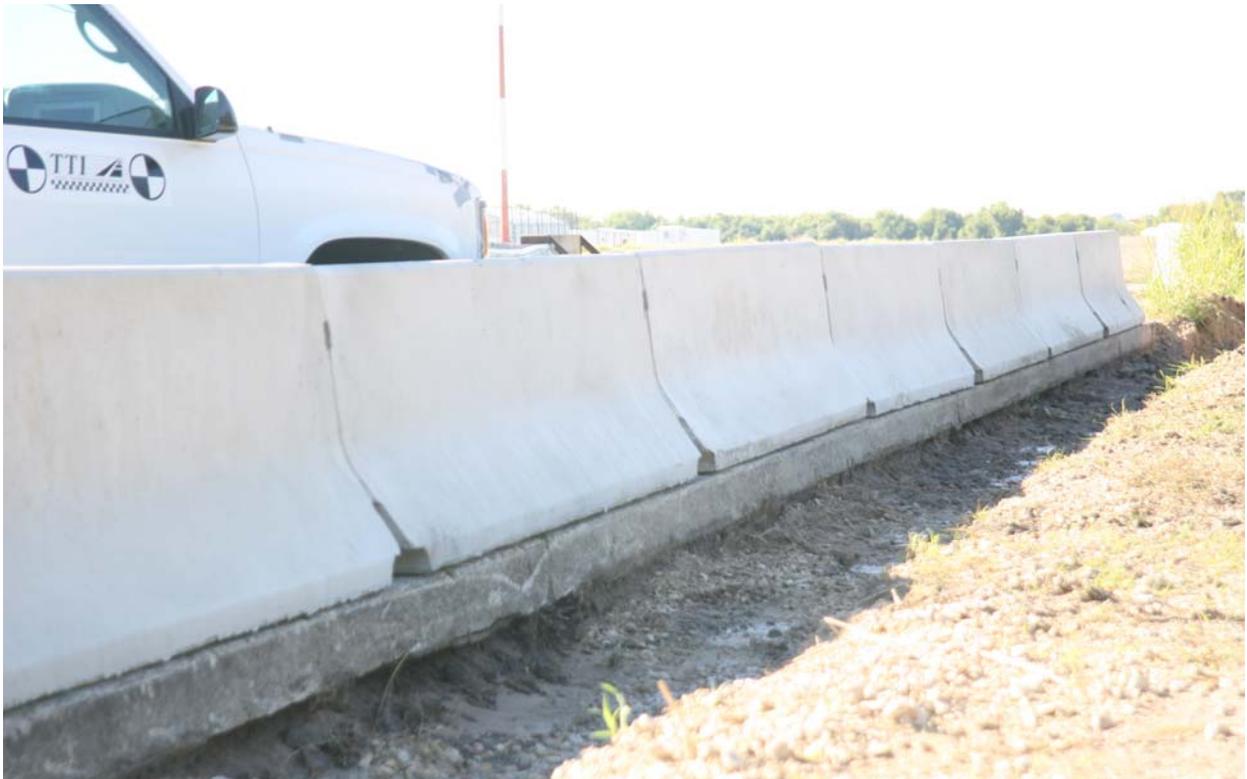
Figure 4.6. Vehicle/installation geometrics for test 405160-3-1.
