CRASH TESTING AND EVALUATION OF THE 12 FT PINNED F-SHAPE TEMPORARY BARRIER

Contract No. T4541-AB
Report/Test No. 405160-3-1/2a
Date of Test: 09-19-2006/11-15-2008

Sponsored by
**Roadside Safety Research Program Pooled Fund
Study No. TPF-5(114)**

**TEXAS TRANSPORTATION INSTITUTE
THE TEXAS A&M UNIVERSITY SYSTEM
COLLEGE STATION, TEXAS 77843**

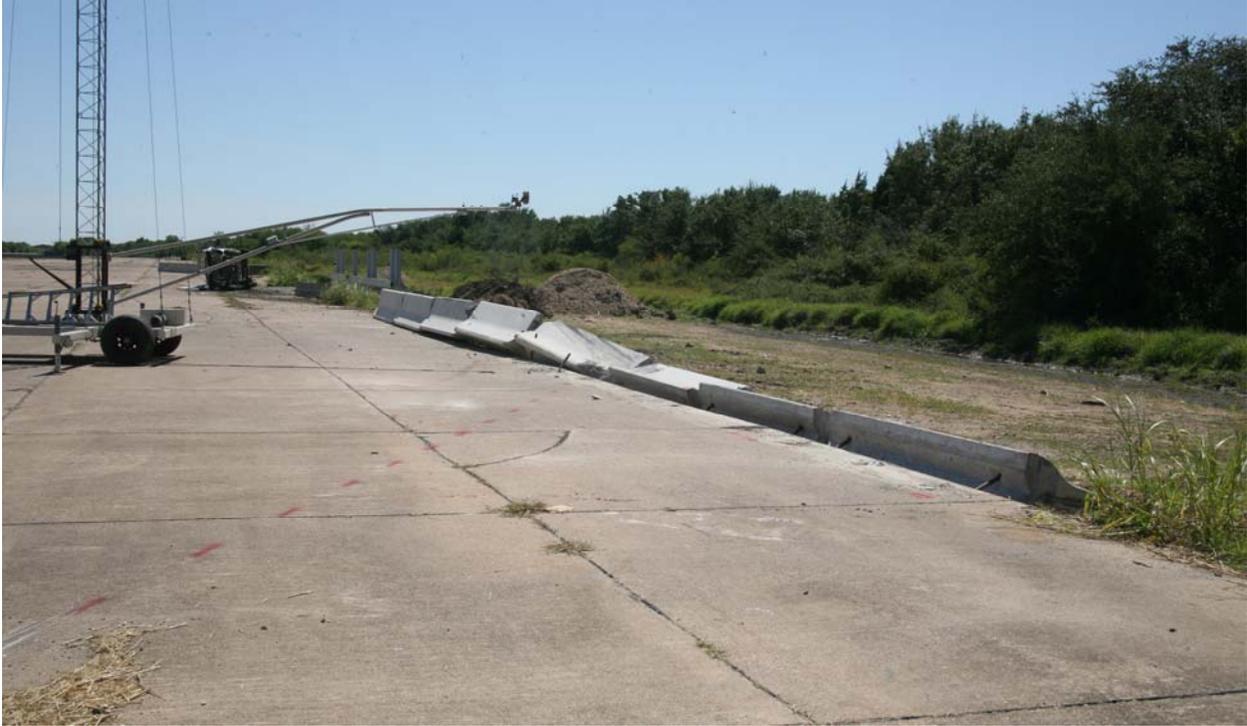
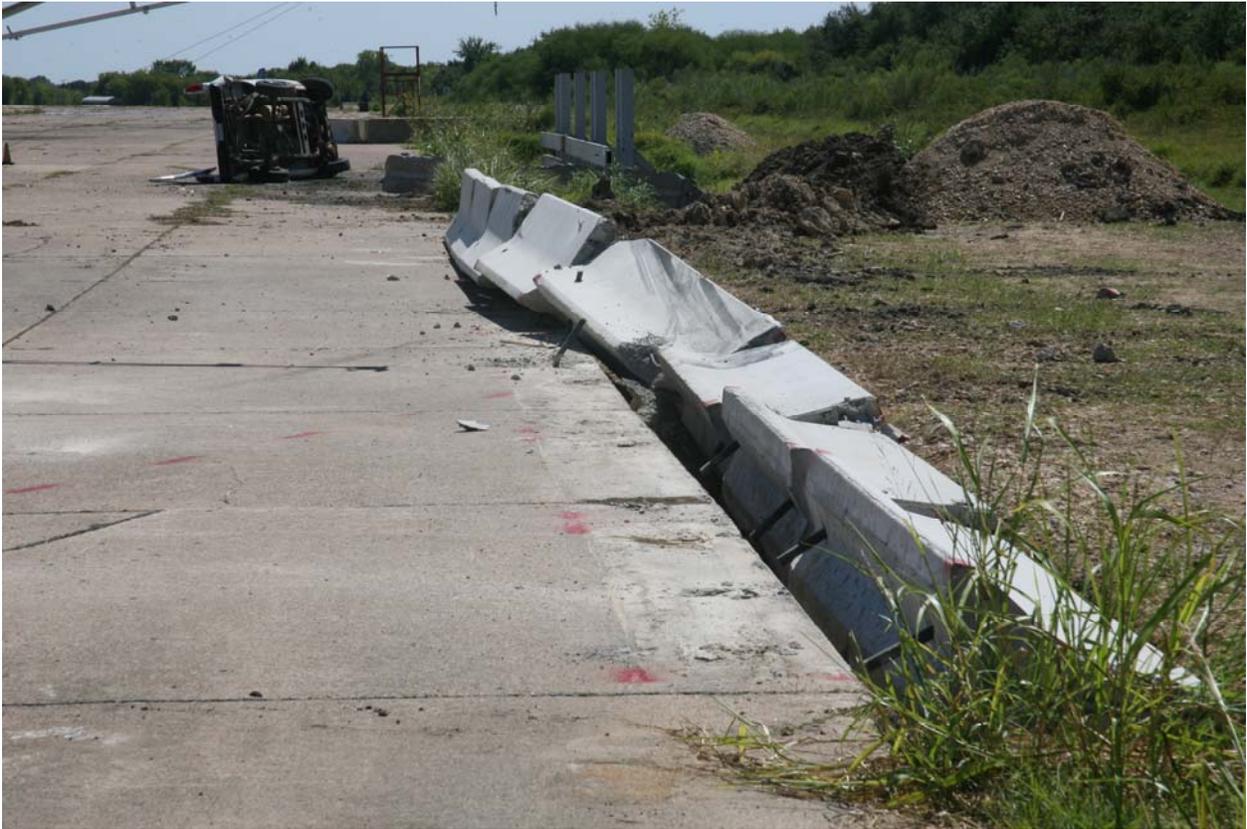
As shown in figures 4.8 and 4.9, the first three segments fell into the ditch to the field side of the barrier. Part of the fourth segment fell in the ditch with part remaining on the concrete surface. The remaining segments remained completely on the concrete surface. The vehicle contacted the installation 4.4 ft upstream of the joint between segments 3 and 4, and remained in contact to the end of the installation, for a total length of contact of 64.3 ft. Concrete around one of the drop-pins failed catastrophically, exposing the longitudinal rebar as shown in figure 4.10. This was the upstream pin of the fourth barrier. There was no concrete failure observed at other drop-pin locations. No significant failure was observed in the concrete pavement around the drop-pin holes.

Figure 4.8. Vehicle trajectory path after test 405160-3-1.

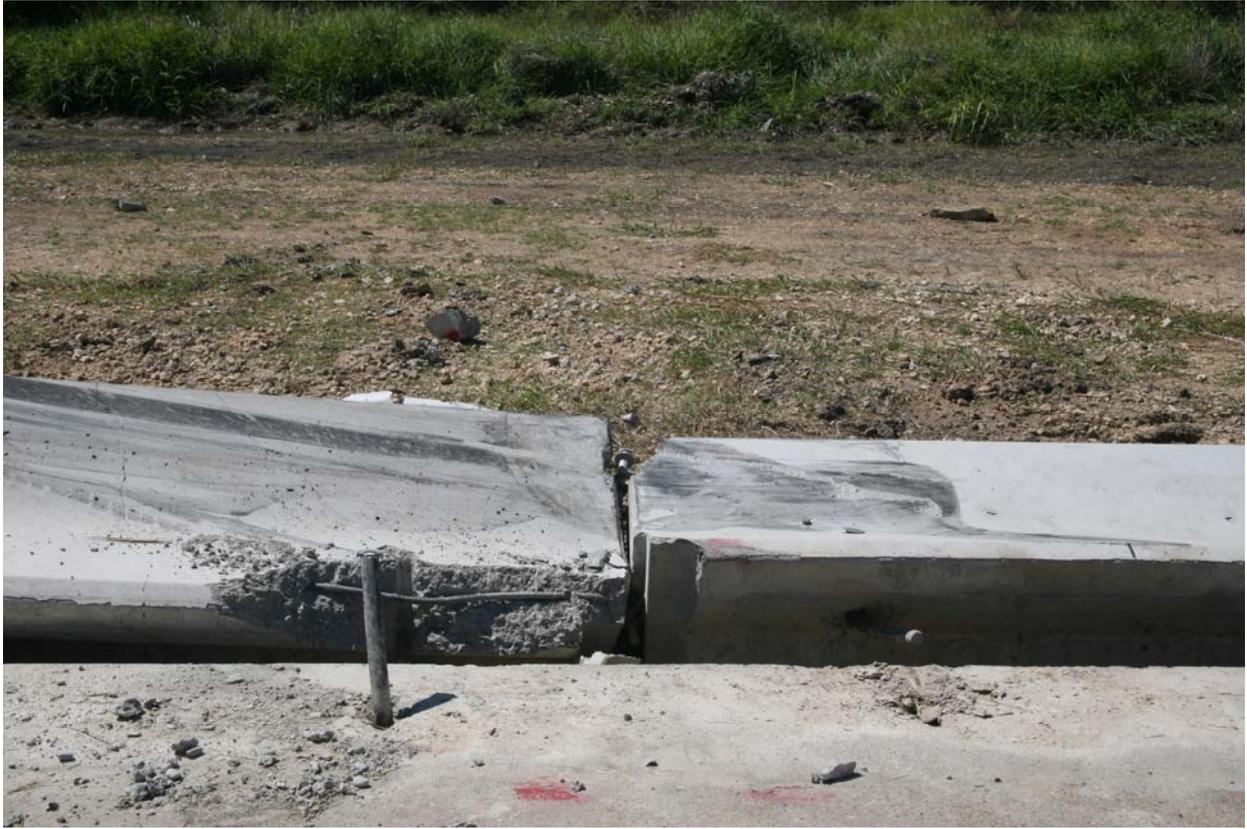
Figure 4.10. Concrete failure around the upstream drop-pin of the forth barrier segment after test 405160-3-1.

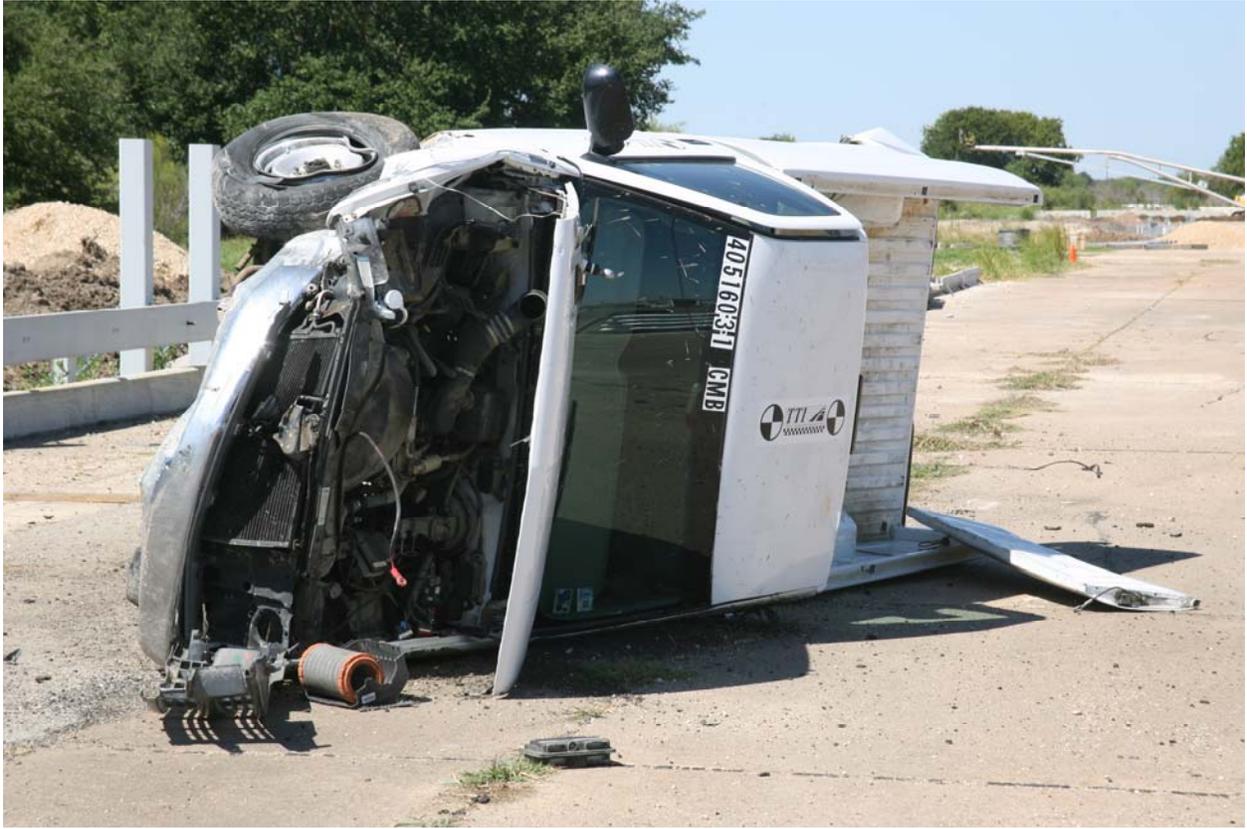
Damage to the vehicle is shown in figure 4.11. Structural damage included deformed right front frame rail, sway bar, right upper and lower A-arm, and right tie rod end; the right side rear U-bolts broke and the rear axle was pushed back. Also damaged were the front bumper, hood, grill, right and left front quarter panels, right front tire and wheel rim, right door, right rear exterior bed, and right rear tire and wheel rim. The windshield was cracked in the right lower corner. The left door, door glass, and left exterior bed were damaged due to the impact. Maximum exterior crush to the vehicle was 19.7 inches in the side plane at the right front corner at bumper height. Maximum occupant compartment deformation was 1.0 inch in the right side firewall area near the toe pan. Exterior vehicle crush and occupant compartment measurements are shown in appendix B, tables B1 and B2.

Figure 4.11. Vehicle after test 405160-3-1.

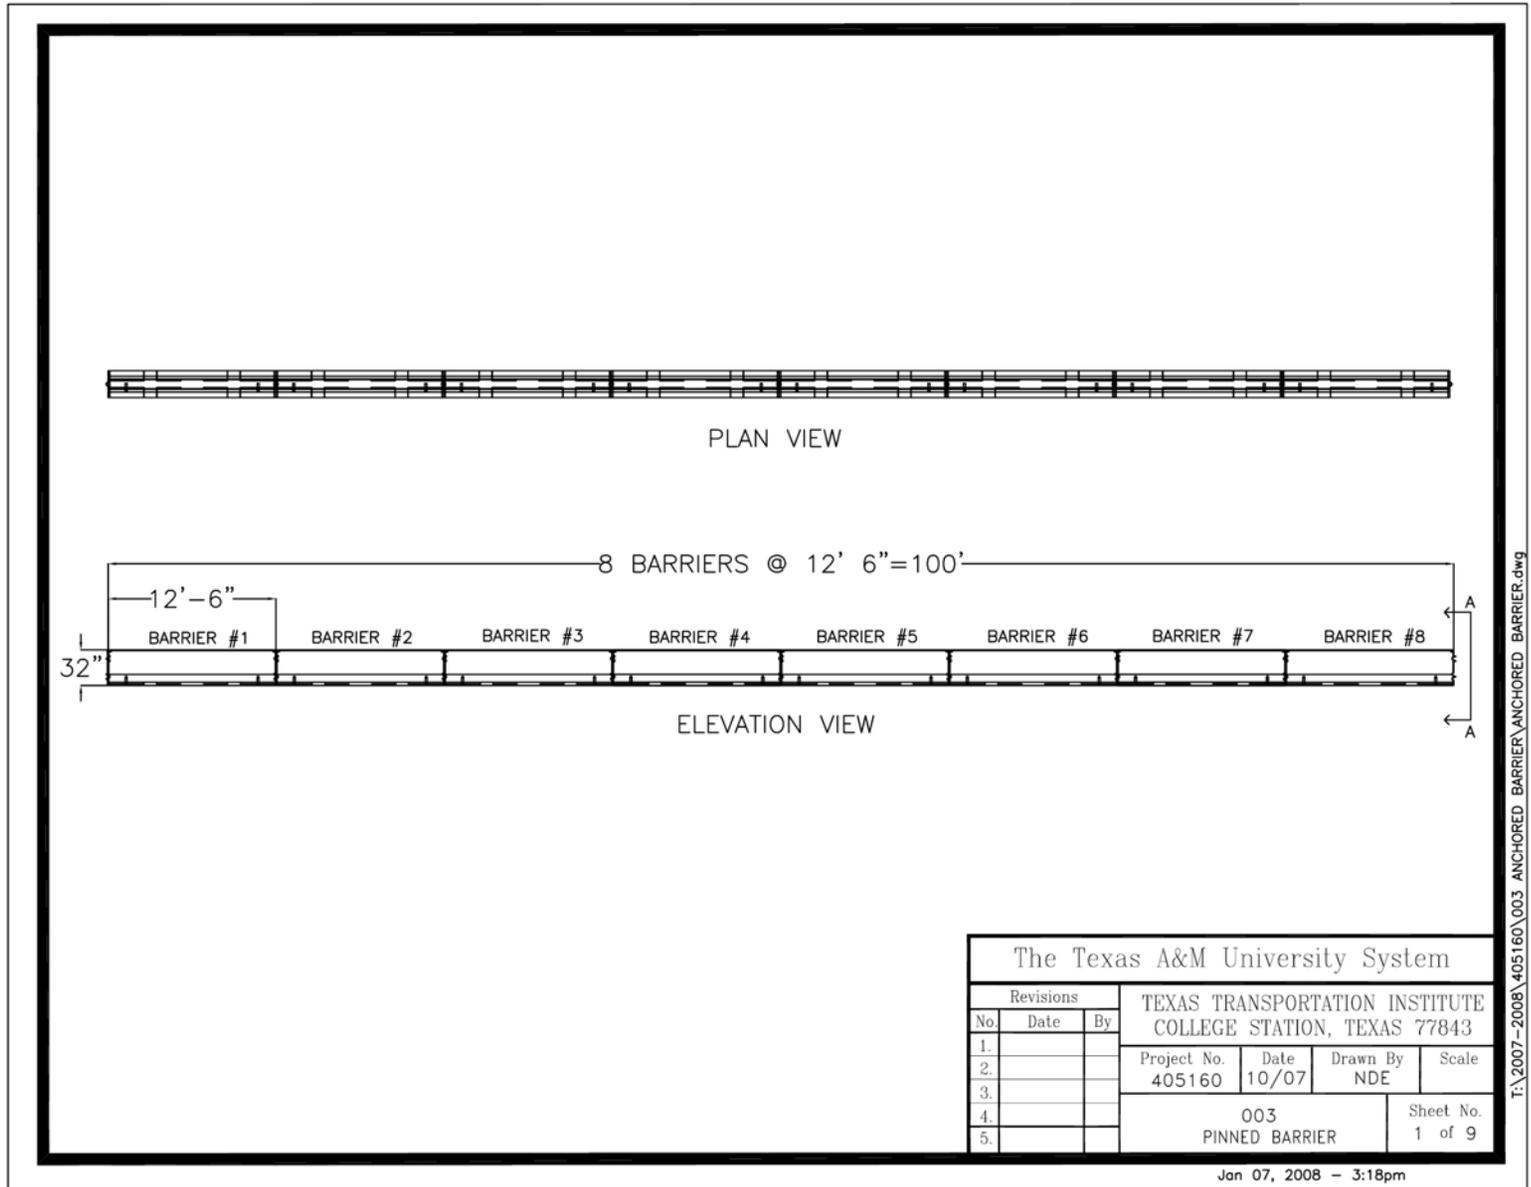
The completed test installation consisted of eight barrier segments connected together for a total length of approximately 100 ft. Details of the barrier and the pin-down restraint are shown in figures 5.1 through 5.9. Figure 5.10 shows photographs of the completed test installation.

Figure 5.1. Details of the pinned F-shape barrier – installation layout.

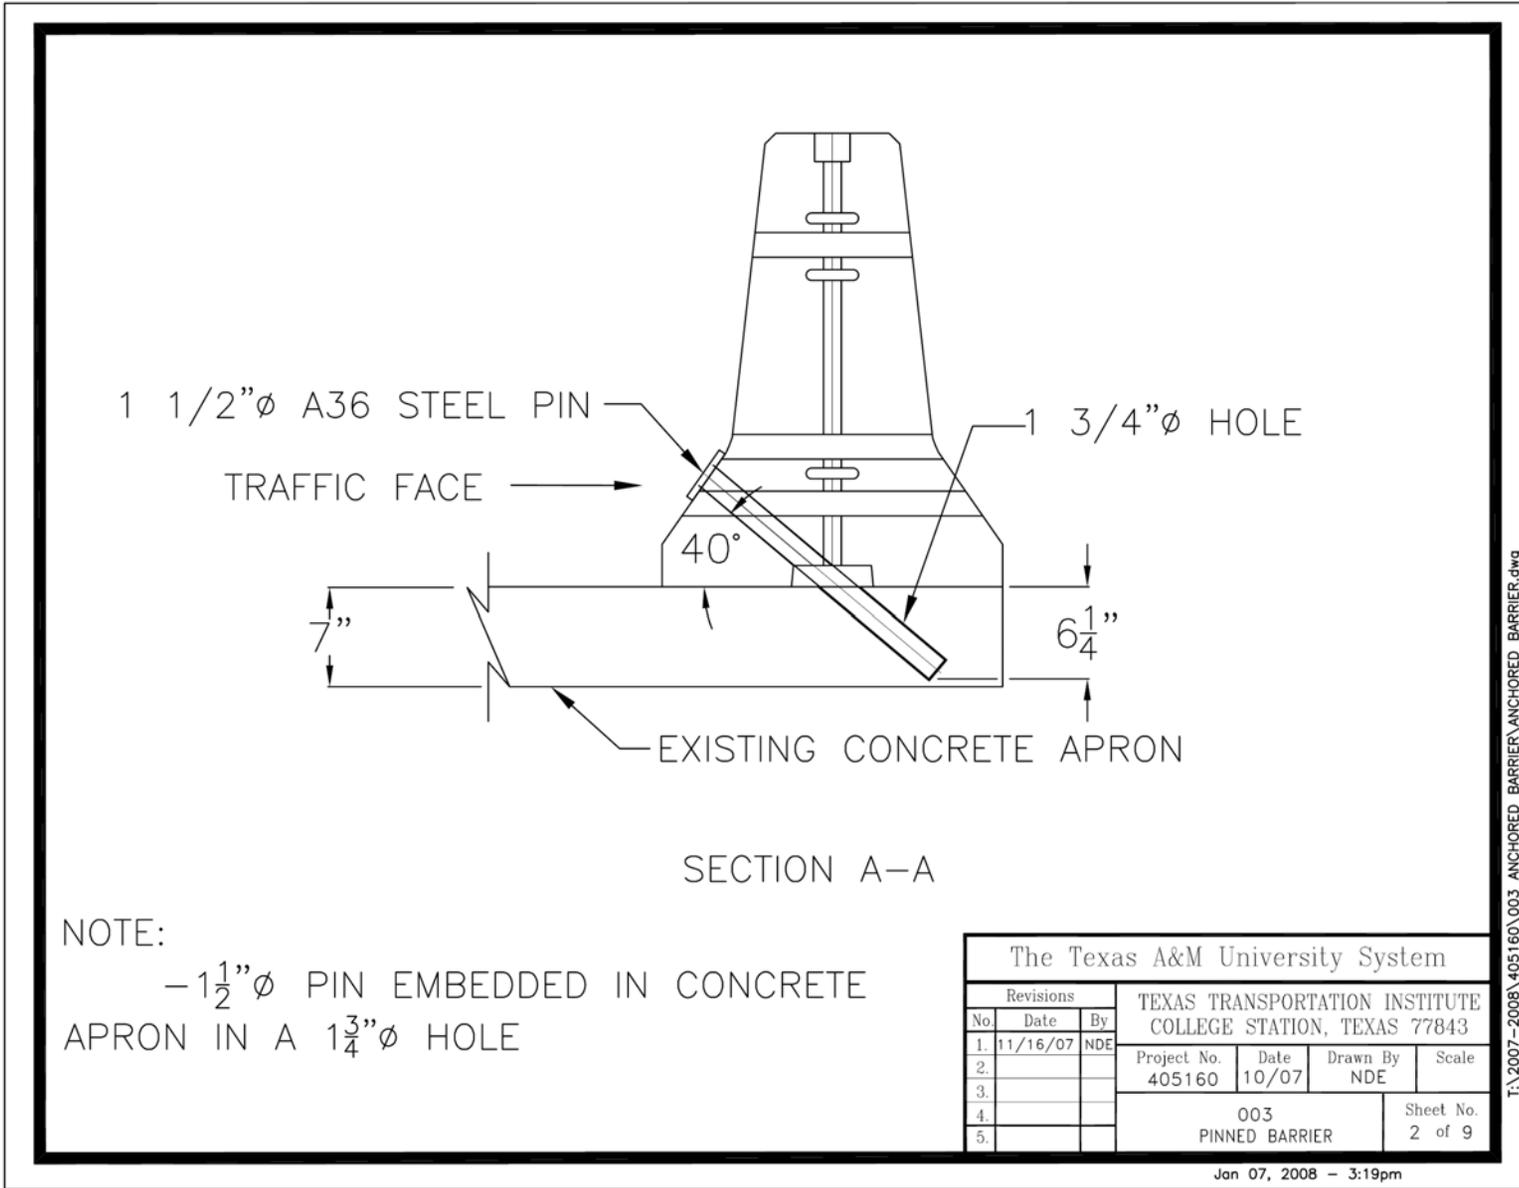
Figure 5.2. Details of the pinned F-shape barrier – Section A-A.

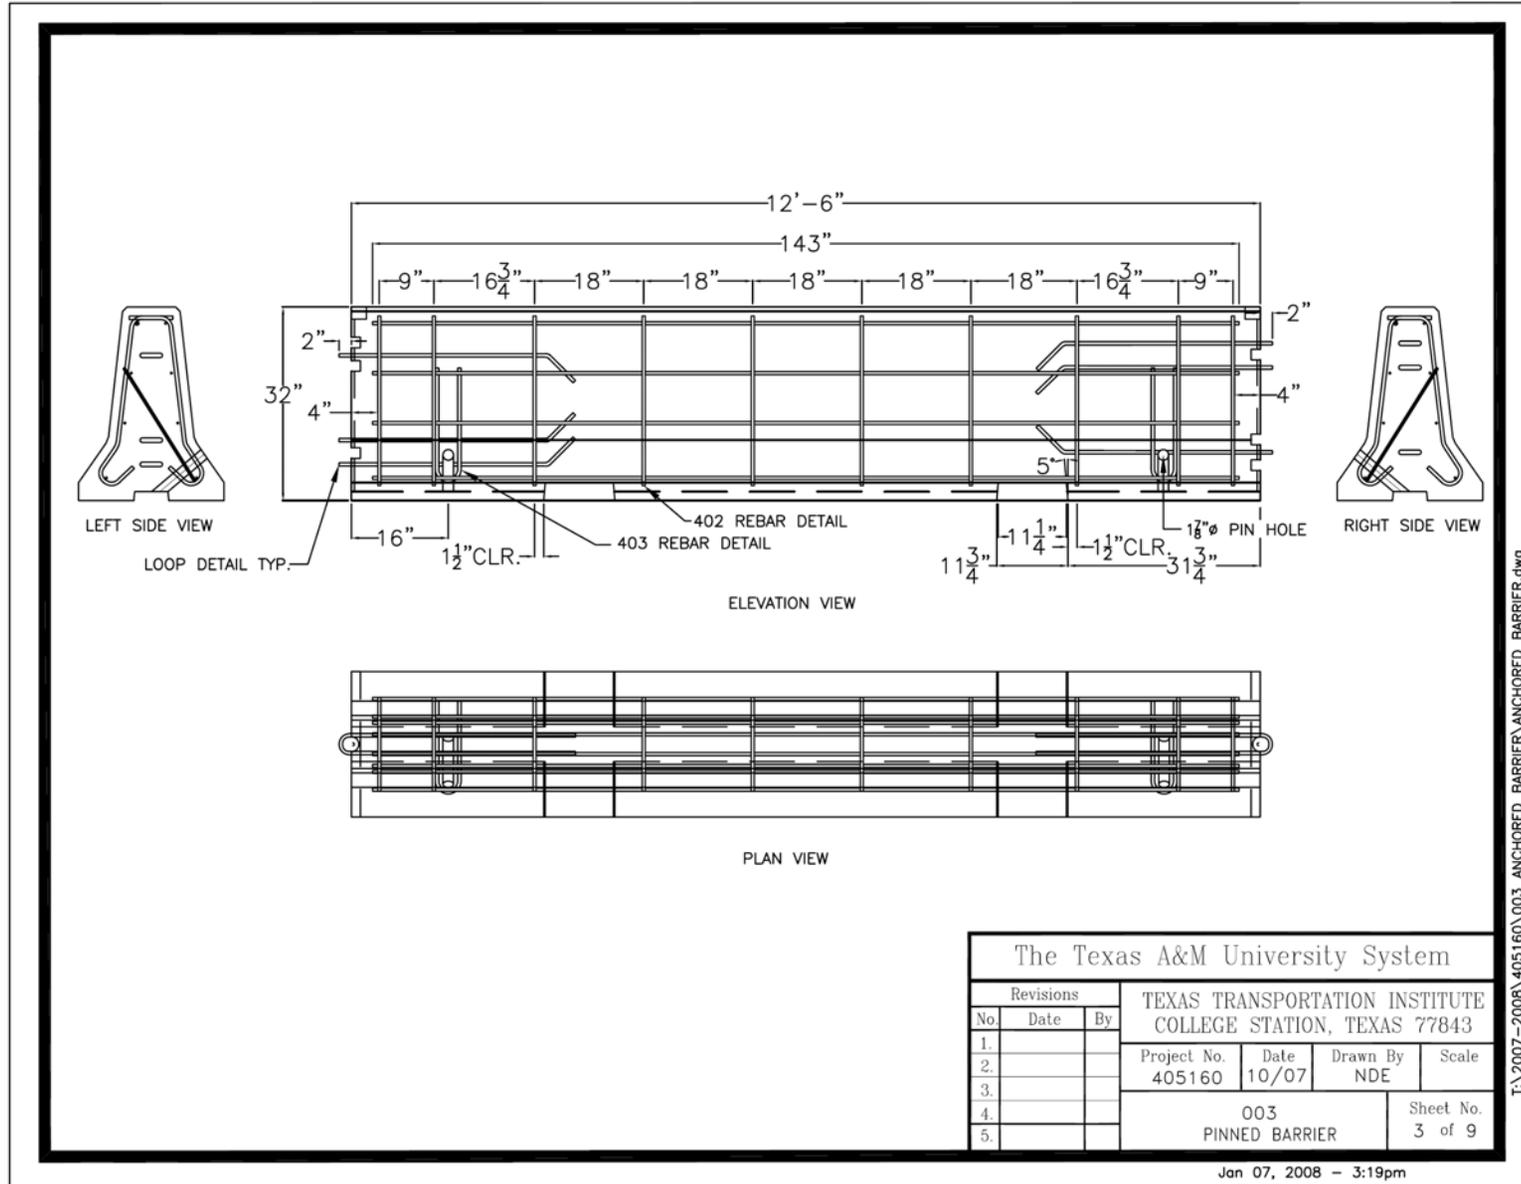
Figure 5.3. Details of the pinned F-shape barrier –segment detail.

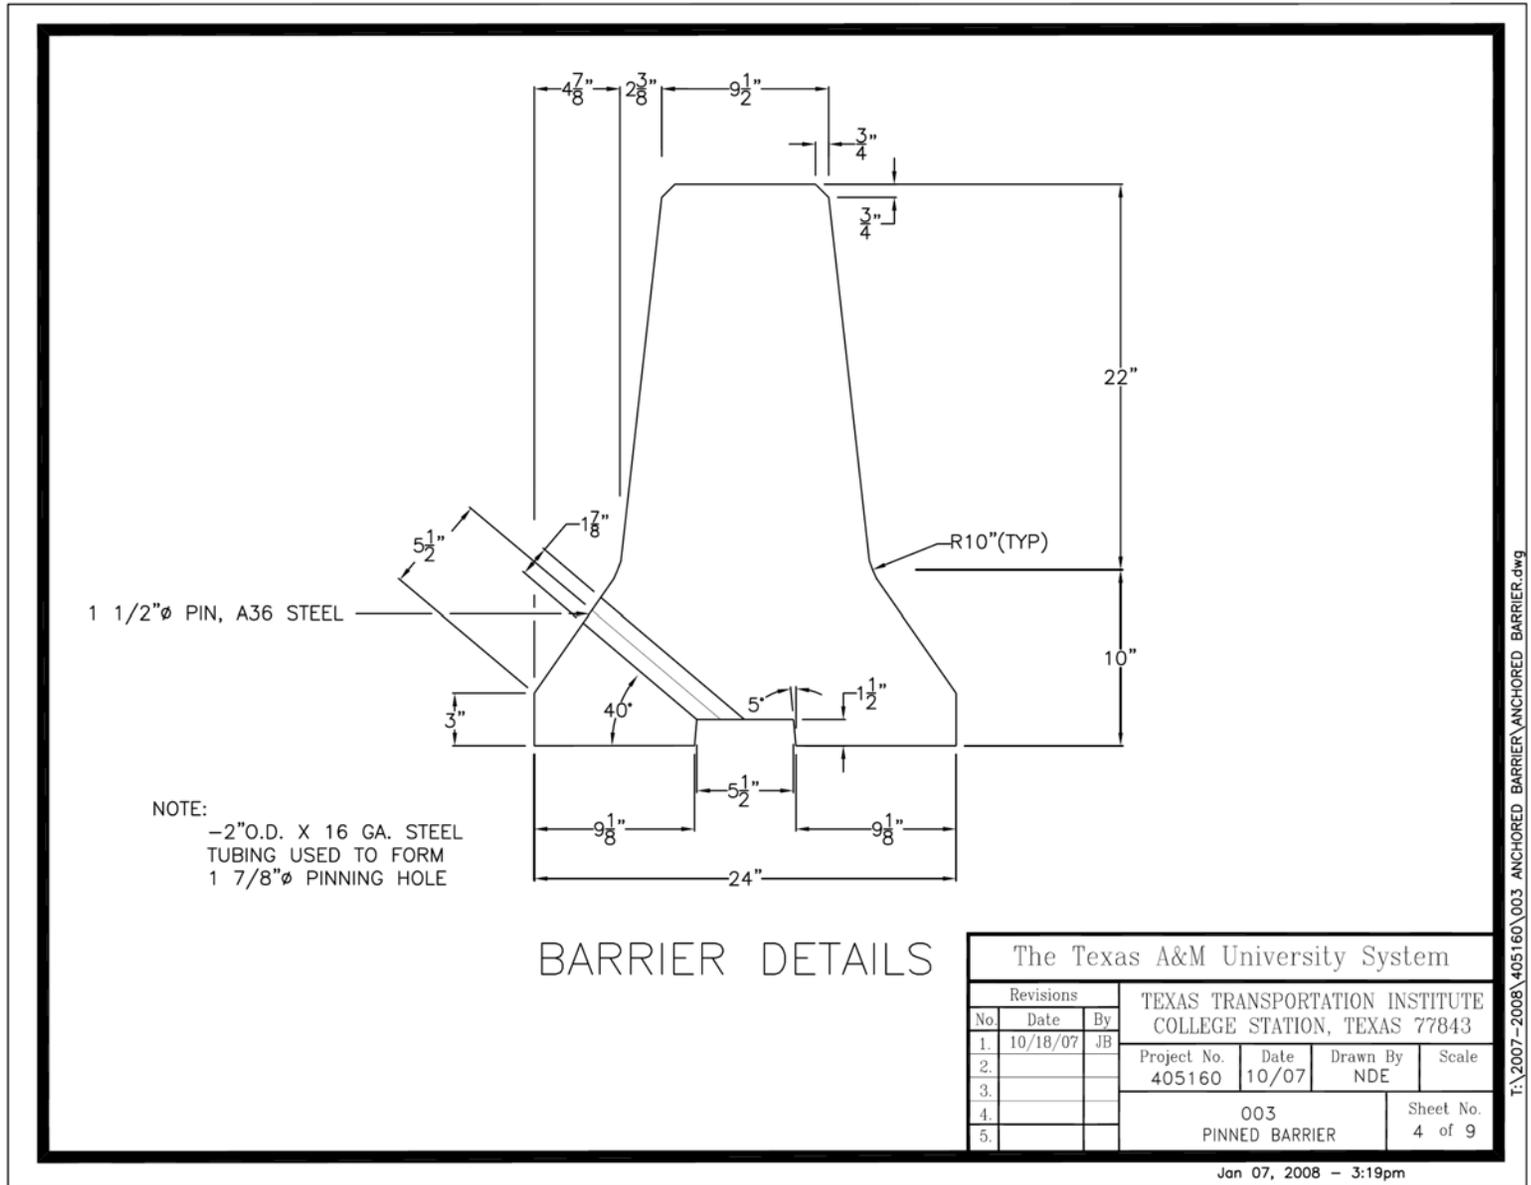
Figure 5.4. Details of the pinned F-shape barrier – cross section.

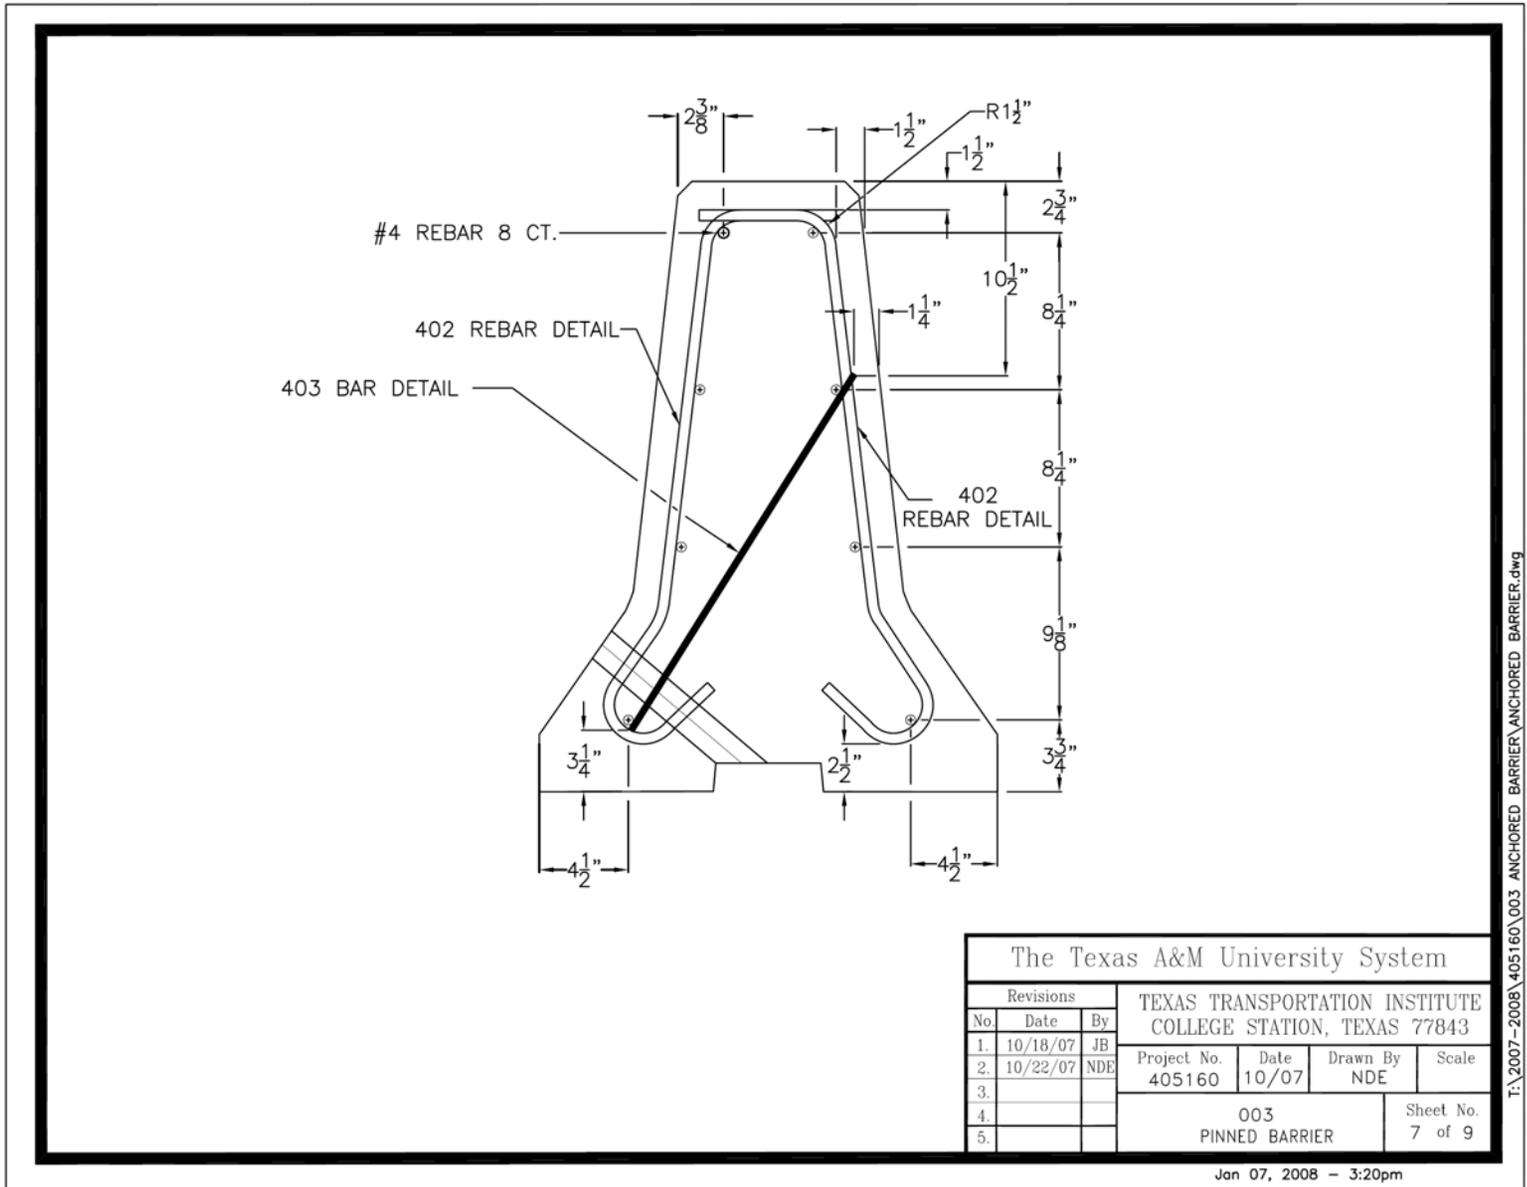
Inside the barrier segments, a 22-inch long U-shaped #4 bar was diagonally placed at the location of each drop-pin hole. The U-shaped bar was placed around the drop-pin hole to provide resistance to drop-pin pullout in the event of concrete failure in the vicinity of the hole.

Figure 5.7. Details of the pinned F-shape barrier – rebar placement.

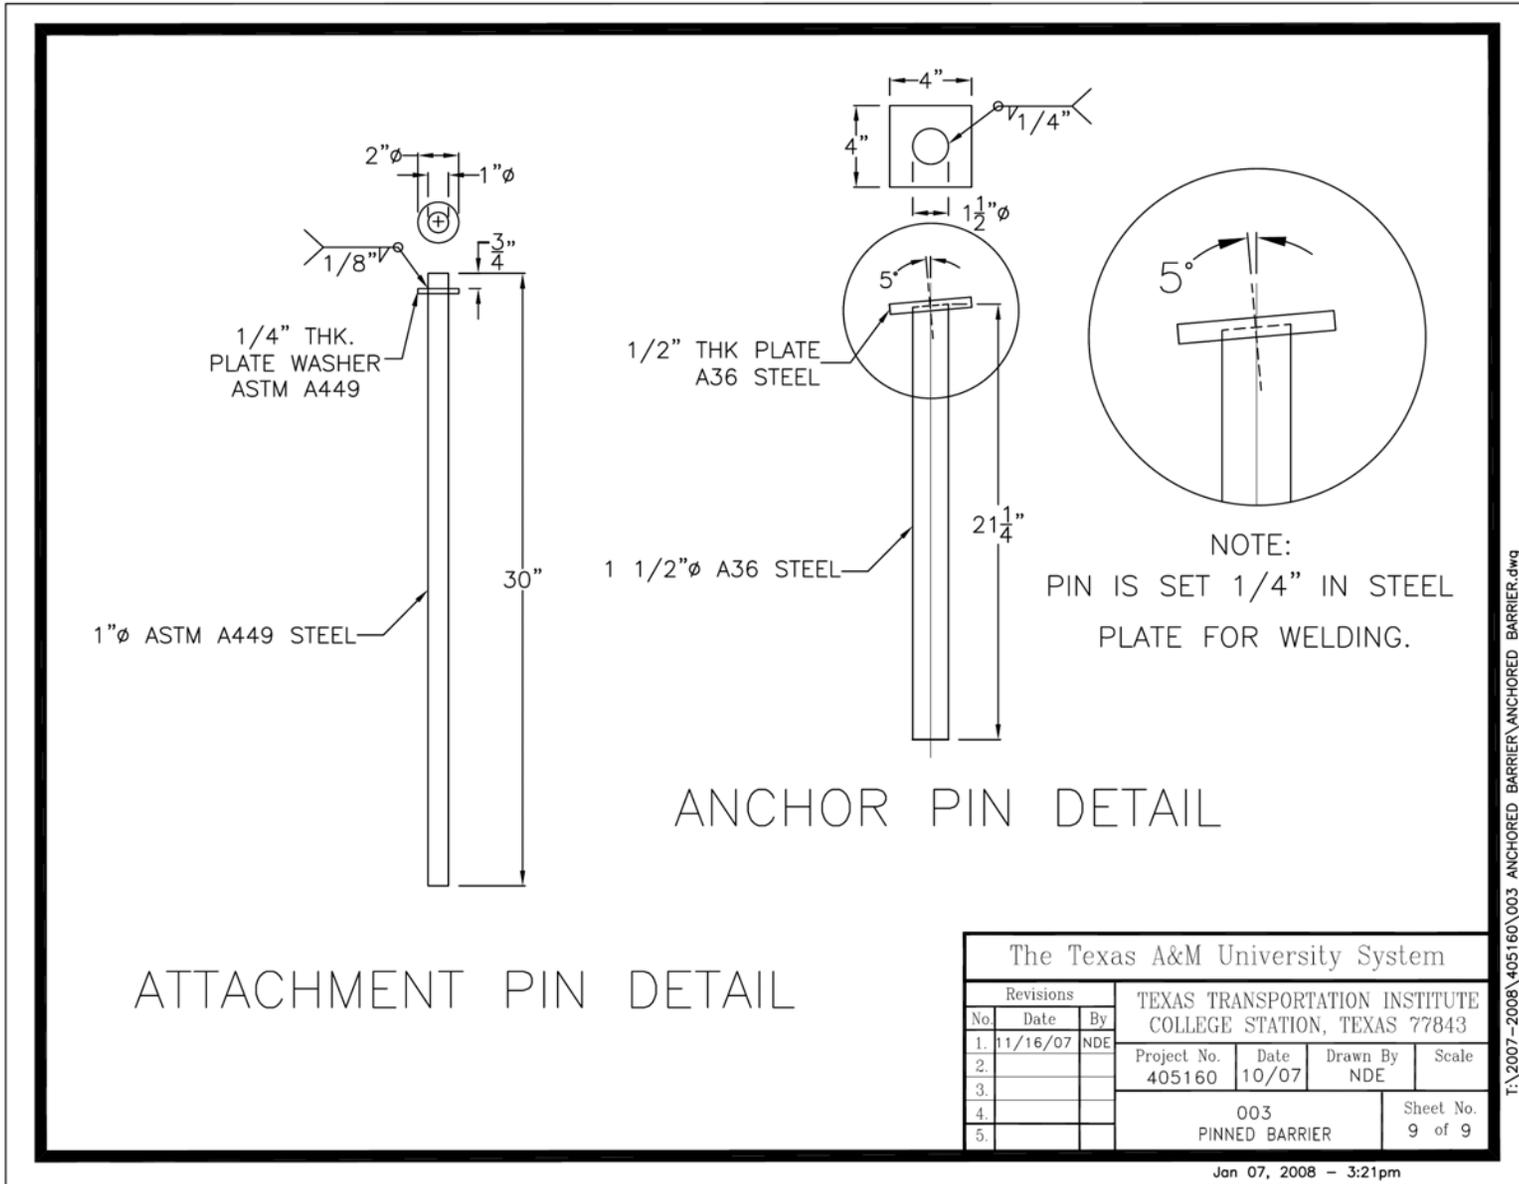
Figure 5.9. Details of the pinned F-shape barrier – pin details.

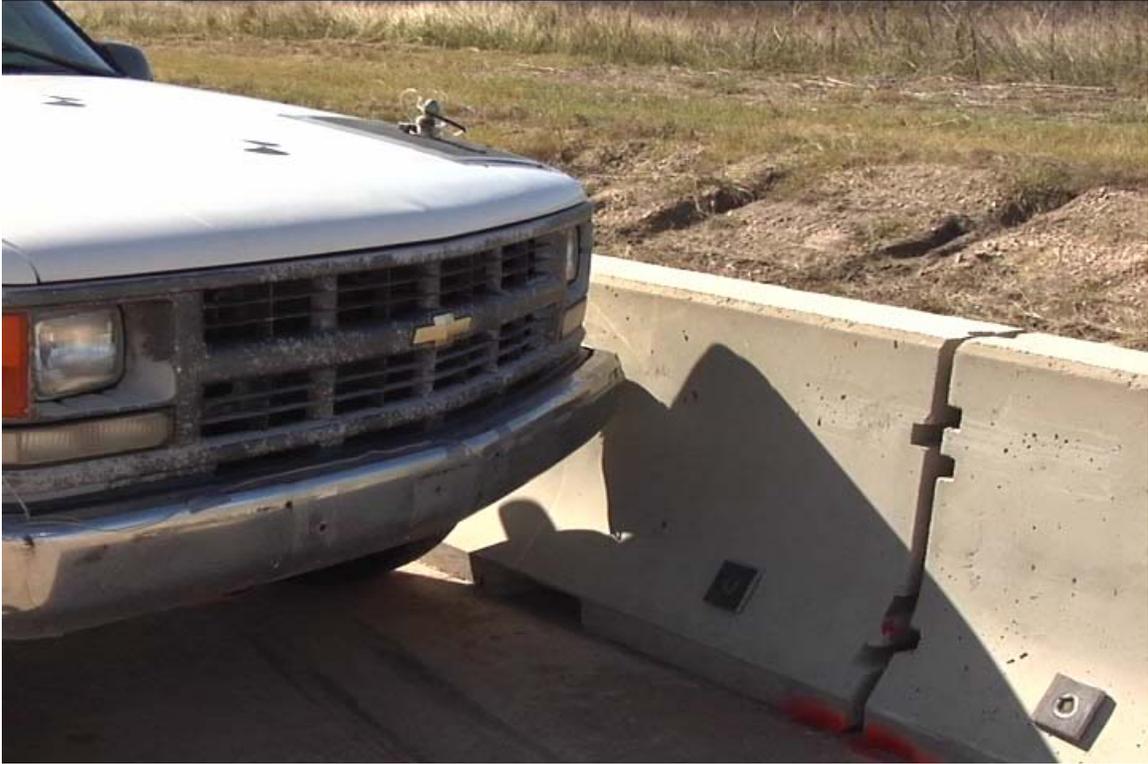
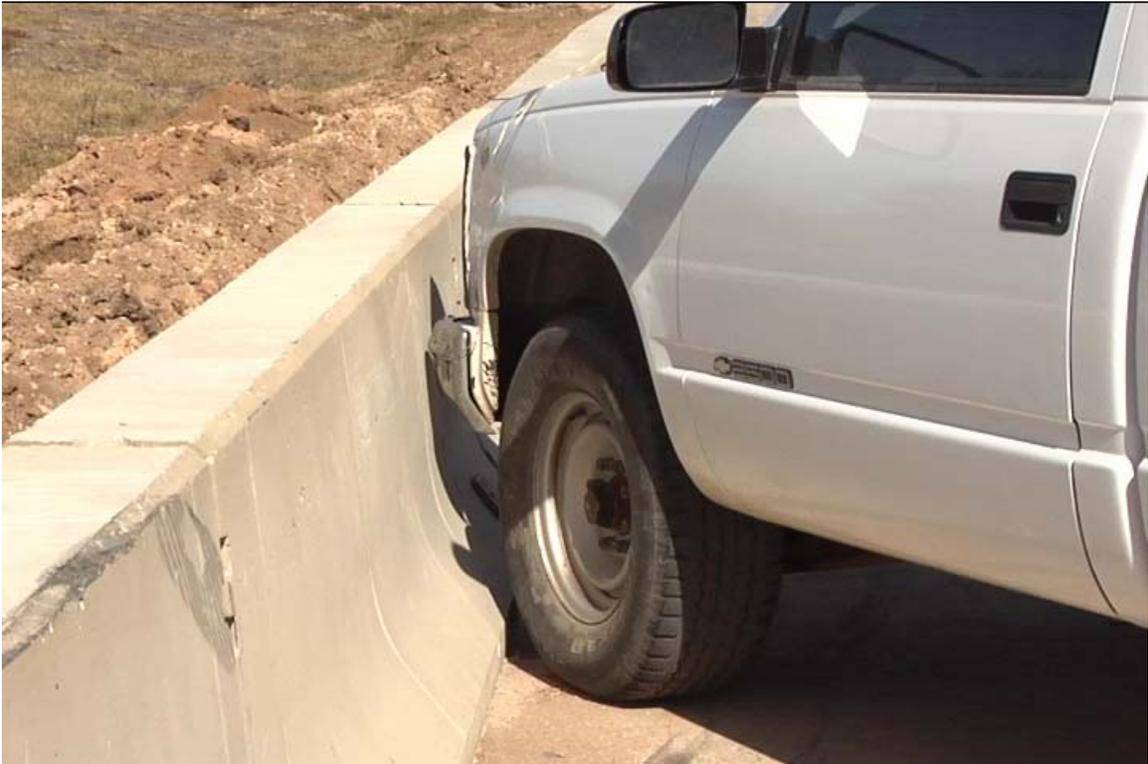
The 2000 Chevrolet C2500 pickup truck, traveling at an impact speed of 62.7 mi/h, impacted the installation 4.0 ft upstream of joint 3-4 at an impact angle of 25.4 degrees. Shortly after impact, segment 3 began to deflect toward the field side, and at 0.012 s, segment 3 began to rise and lose contact with the surface of the ground. At 0.015 s, the joint between segment 2 and 3 began to open up, and at 0.018 s, segment 4 began to deflect toward the field side. The vehicle began to redirect at 0.032 s, and the vehicle contacted the end of segment 4 at 0.034 s. The front edge of segments 2, 5, 1, 6, and 7 began to rise at 0.057 s, 0.066 s, 0.086 s, 0.095 s, and 0.111 s, respectively. By 0.121 s, the front bumper reached the top of the barrier, and at 0.170 s, the left rear tire contacted the toe of the barrier. At 0.181 s, the vehicle contacted the end of segment 5, and at 0.205 s, the left rear tire on the vehicle ruptured. At 0.283 s, the vehicle began to travel parallel with the barrier at a speed of 46.8 mi/h. The right rear tire contacted the barrier face at 0.387 s. Segment 1 and 2 re-contacted the ground at 0.479 s and 0.551 s, respectively. At 0.695 s, the left rear tire contacted the face of the rear of the barrier, and at 0.847 s, the vehicle lost contact with the end of the barrier. Exit speed and angle were not obtainable due to excessive dust. Brakes on the vehicle were applied, and the vehicle subsequently came to rest facing the installation 190 feet downstream of the impact point and aligned with the traffic face. Sequential photographs of the test period are shown in appendix C, figures C3 and C4.

Figure 5.11. Vehicle/installation geometrics for test 405160-3-1.

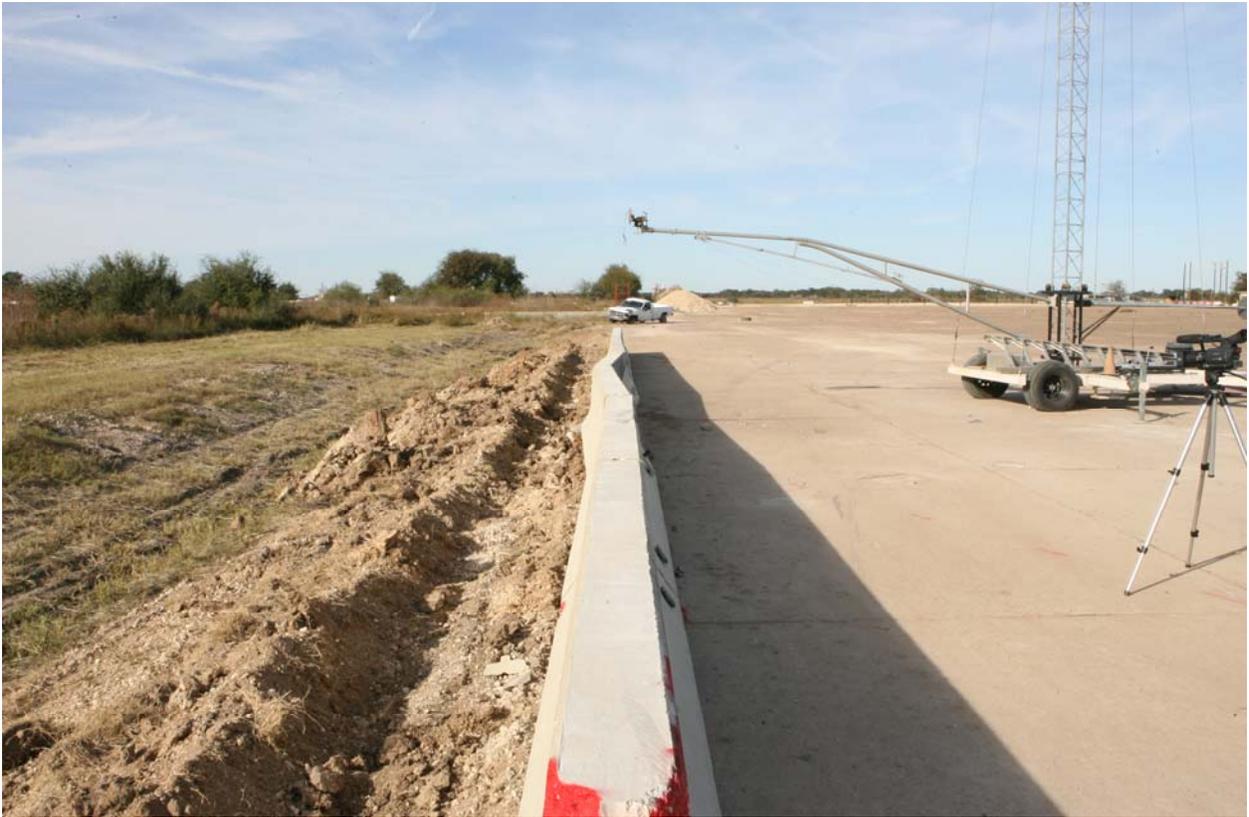
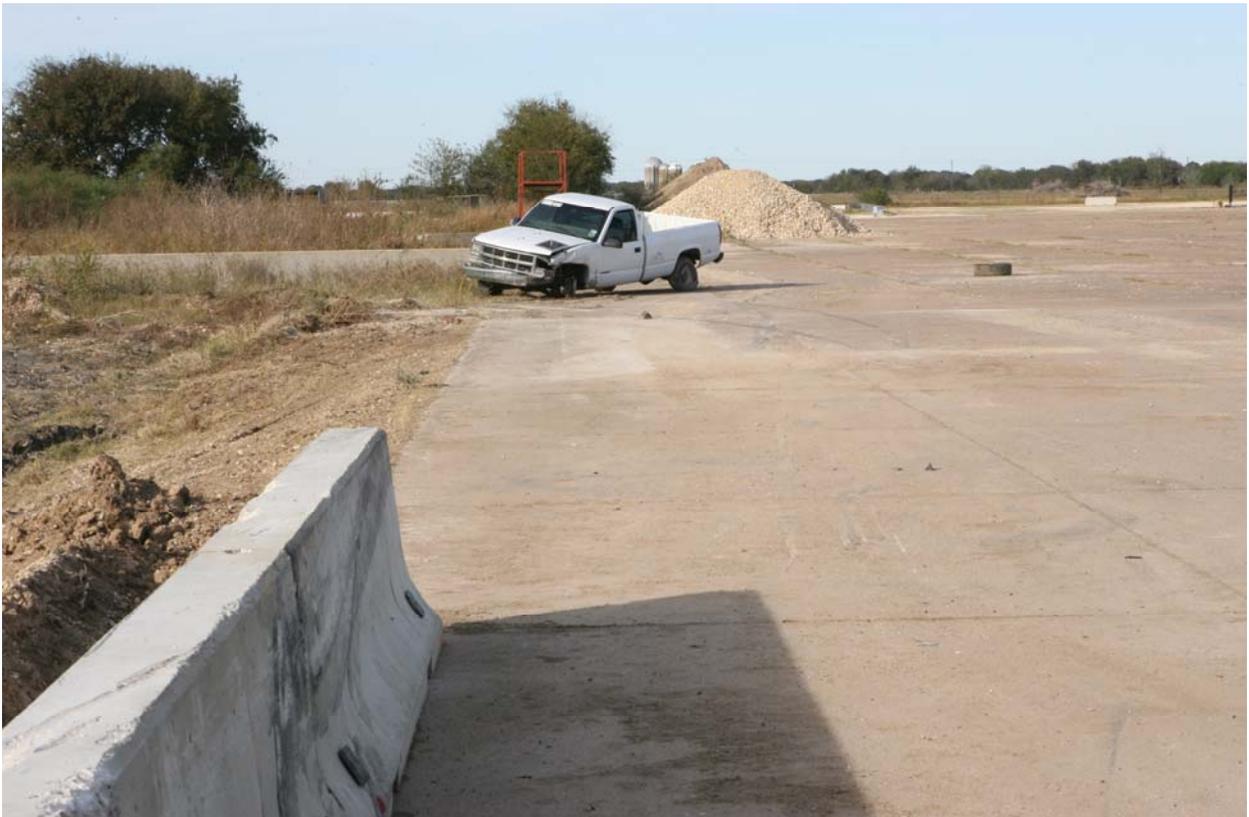
Figure 5.13. Vehicle trajectory path after test 405160-3-1.

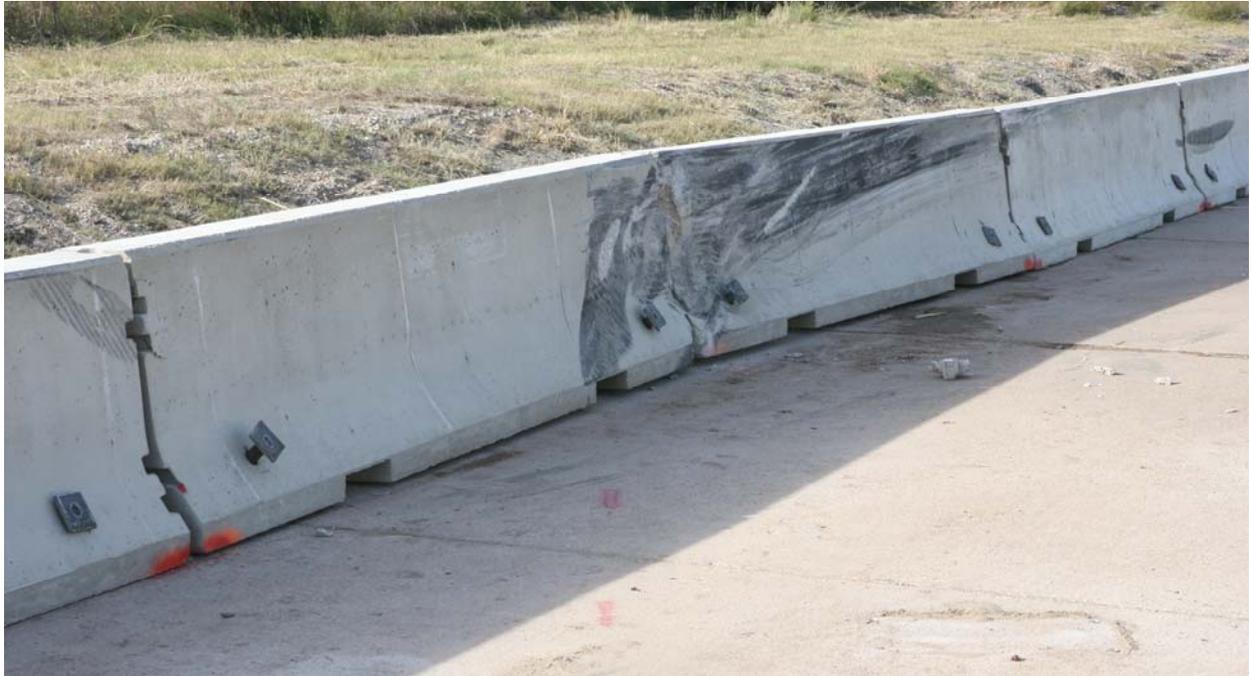
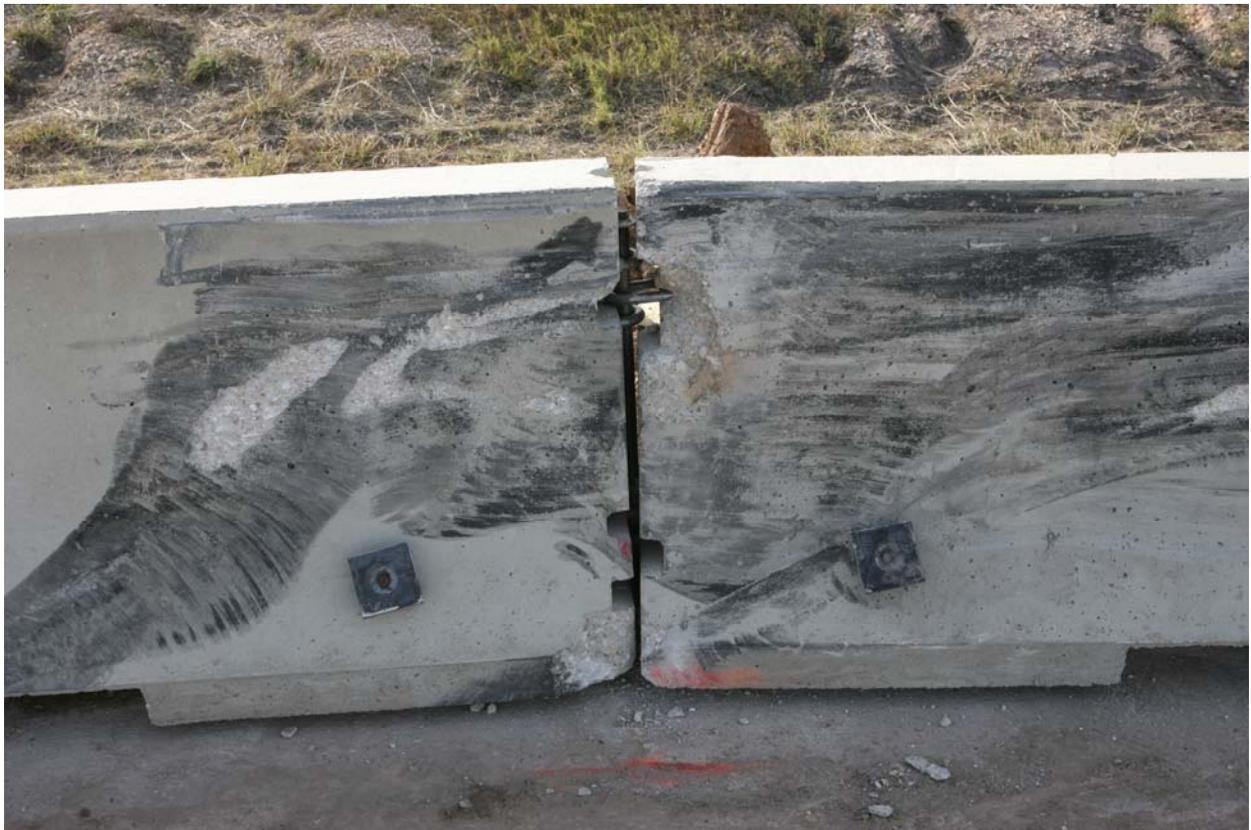
Figure 5.14. Installation after test 405160-3-1.
