CRASH TESTING AND EVALUATION OF THE 12 FT PINNED F-SHAPE TEMPORARY BARRIER

Contract No. T4541-AB
Report/Test No. 405160-3-1/2a
Date of Test: 09-19-2006/11-15-2008

Sponsored by
**Roadside Safety Research Program Pooled Fund
Study No. TPF-5(114)**

**TEXAS TRANSPORTATION INSTITUTE
THE TEXAS A&M UNIVERSITY SYSTEM
COLLEGE STATION, TEXAS 77843**

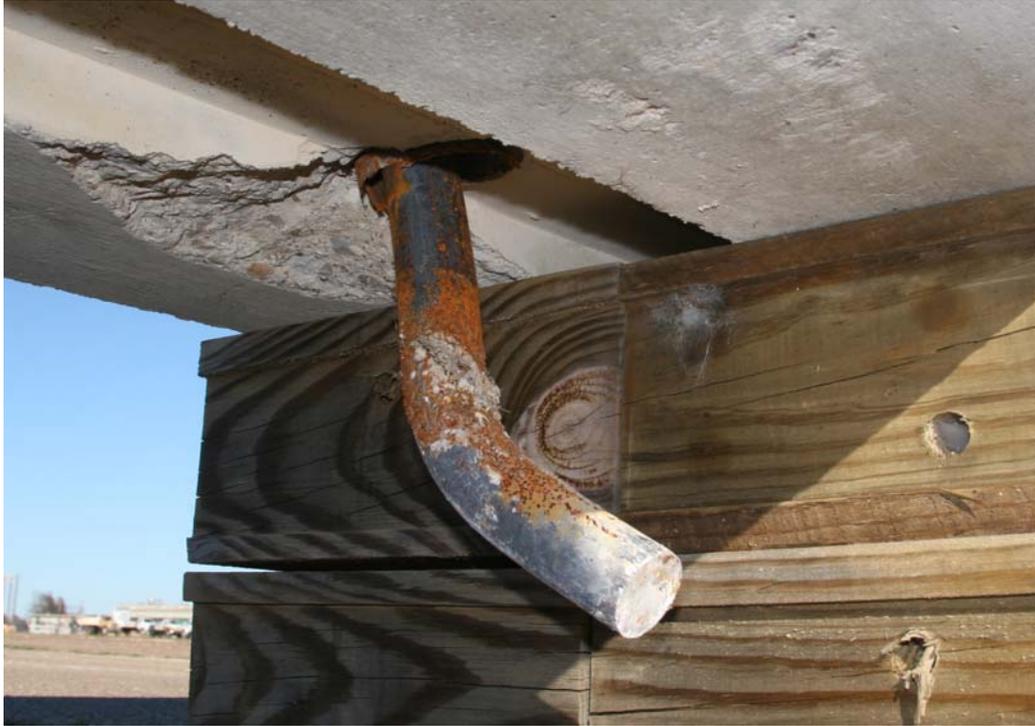
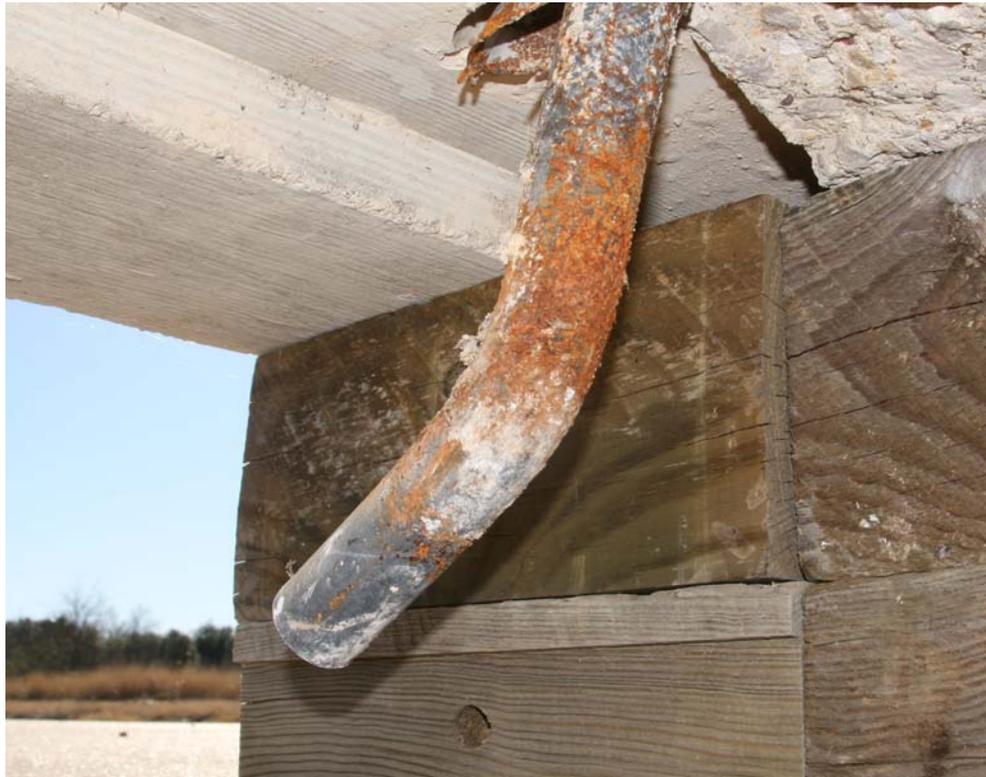
Figure 5.15. Deformed drop-pins after test 405160-3-1.

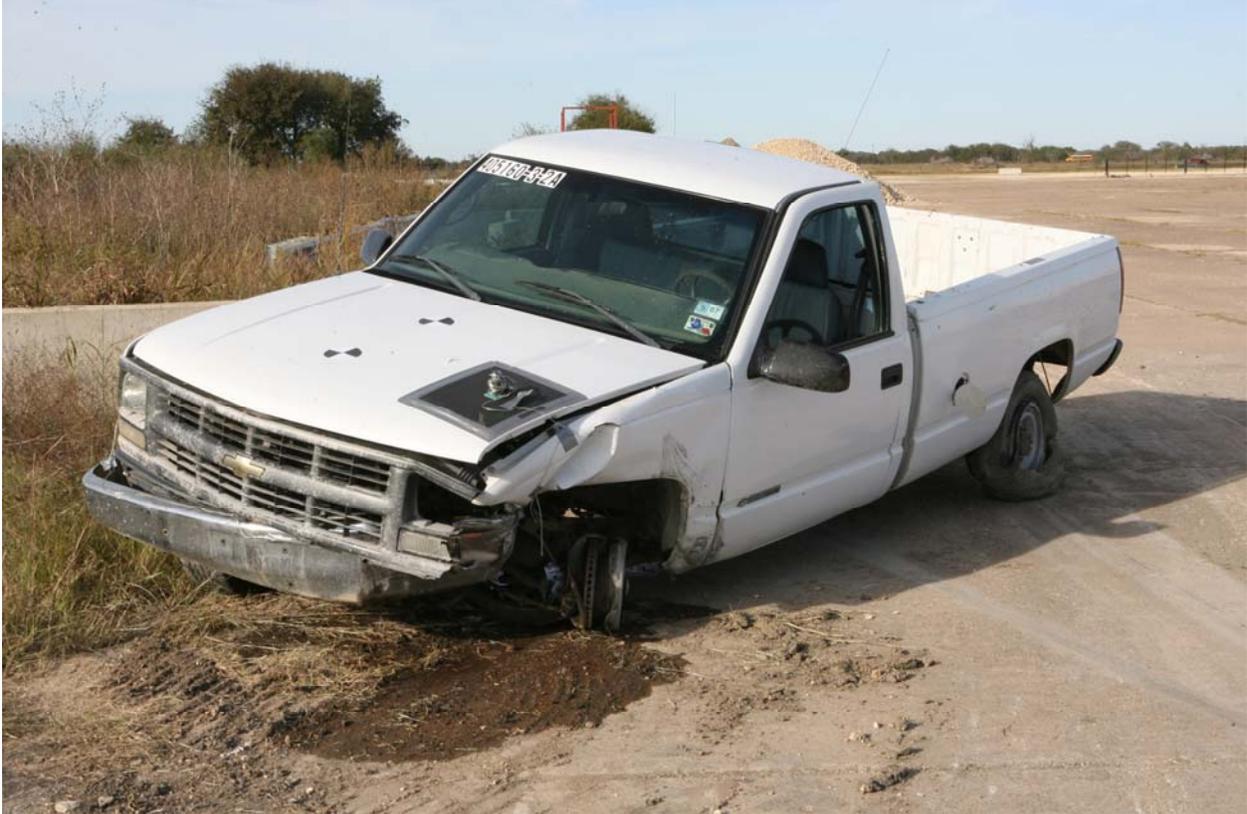
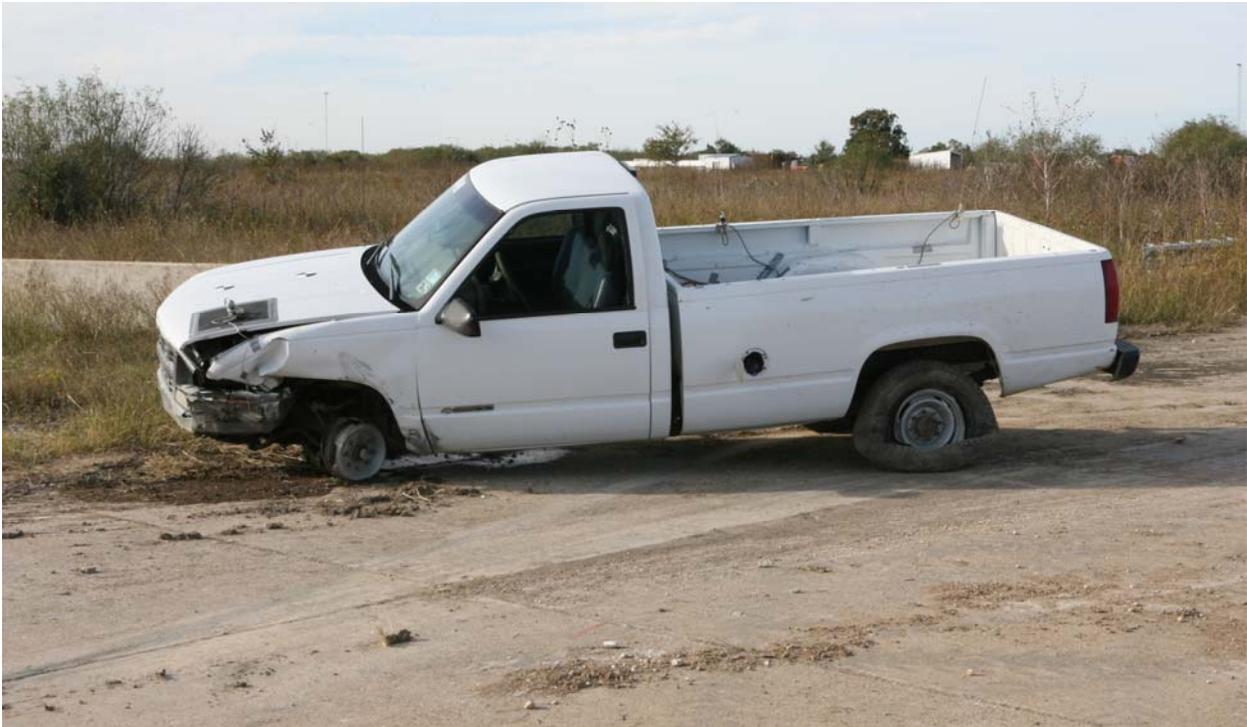
Figure 5.16. Vehicle after test 405160-3-1.

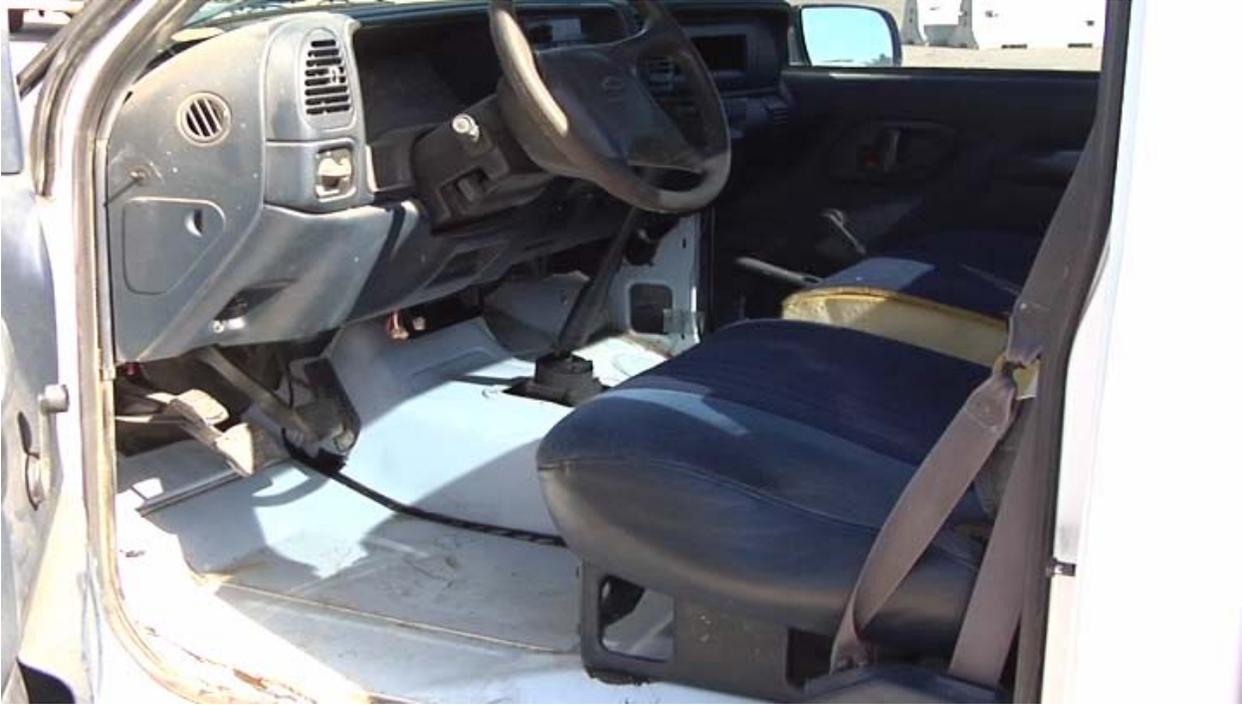
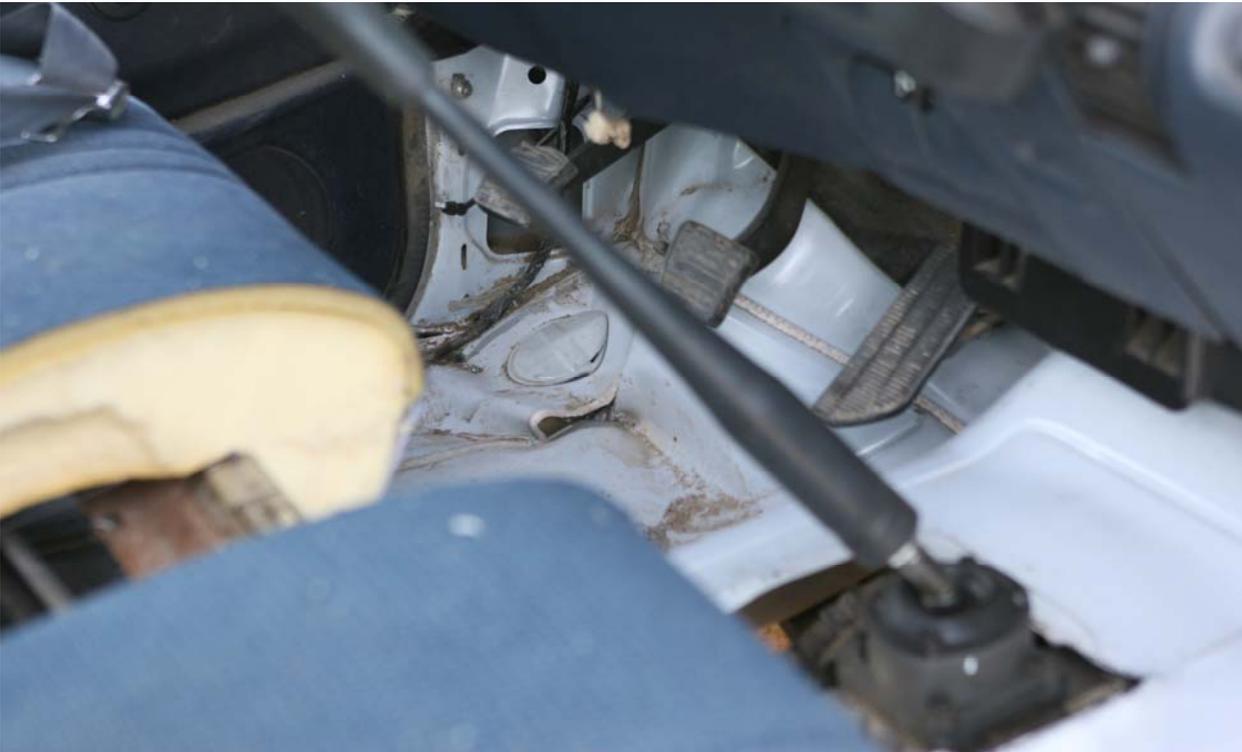
Figure 5.17. Interior of vehicle for test 405160-3-1.

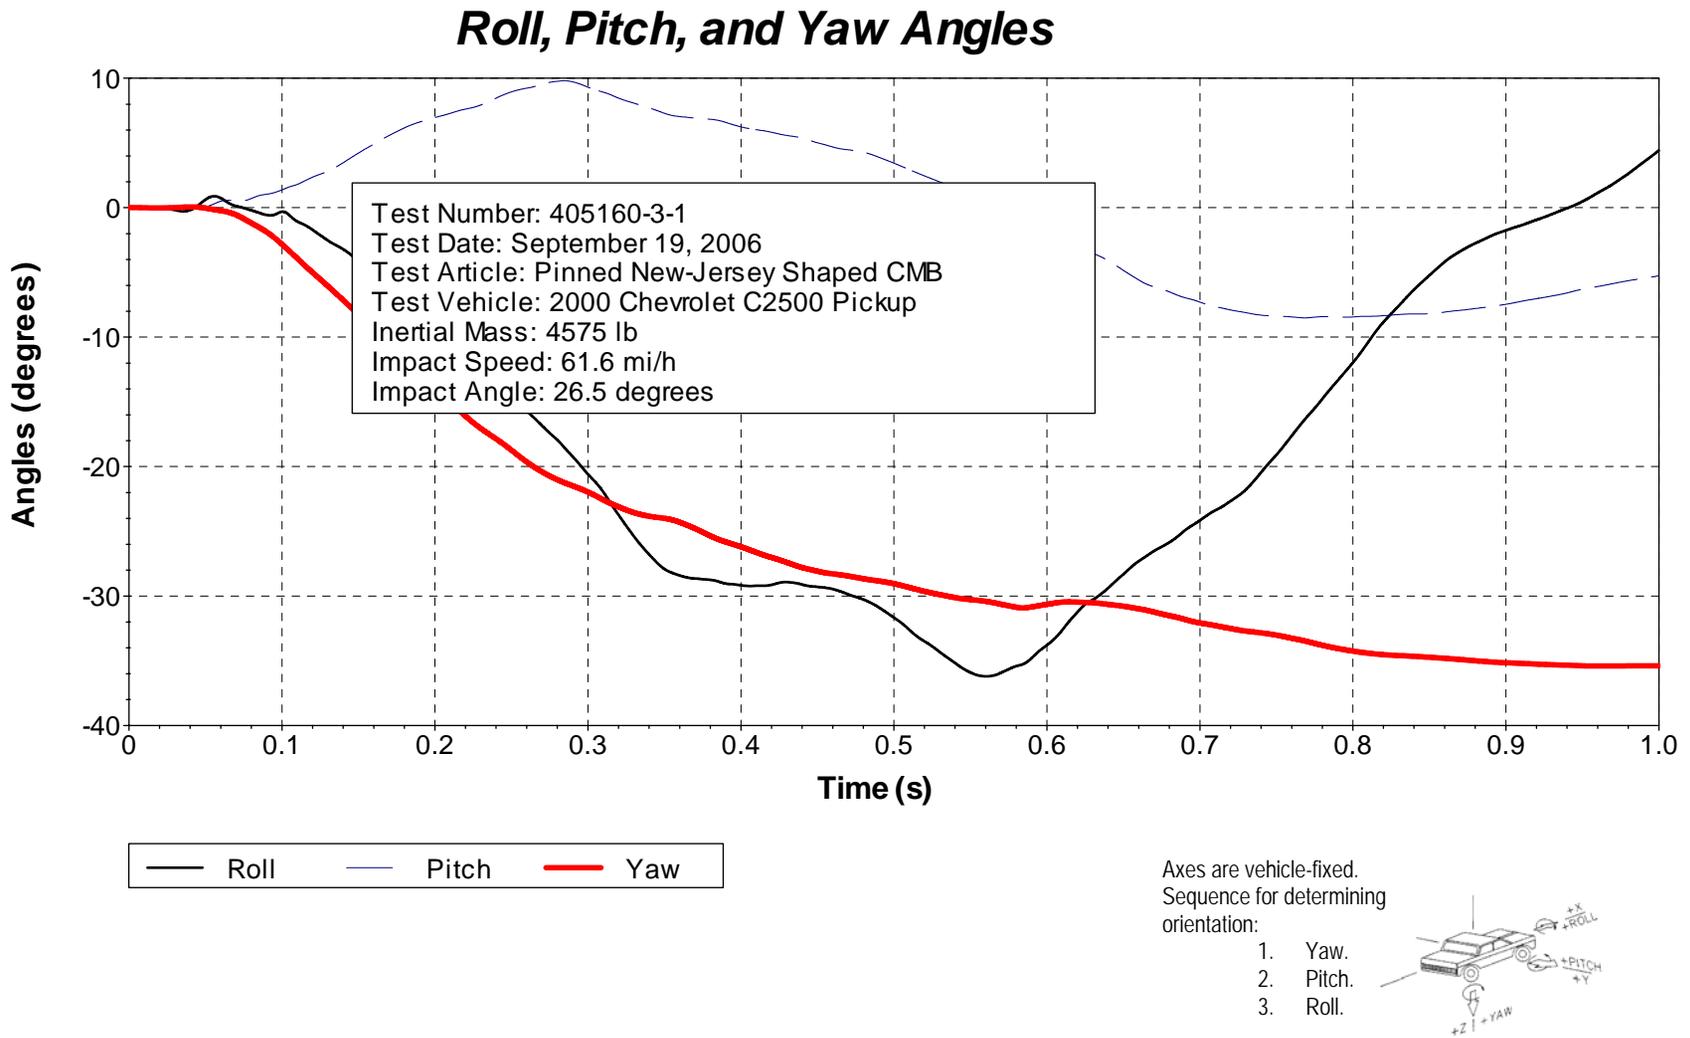
Figure D1. Vehicle angular displacements for test 405160-3-1.

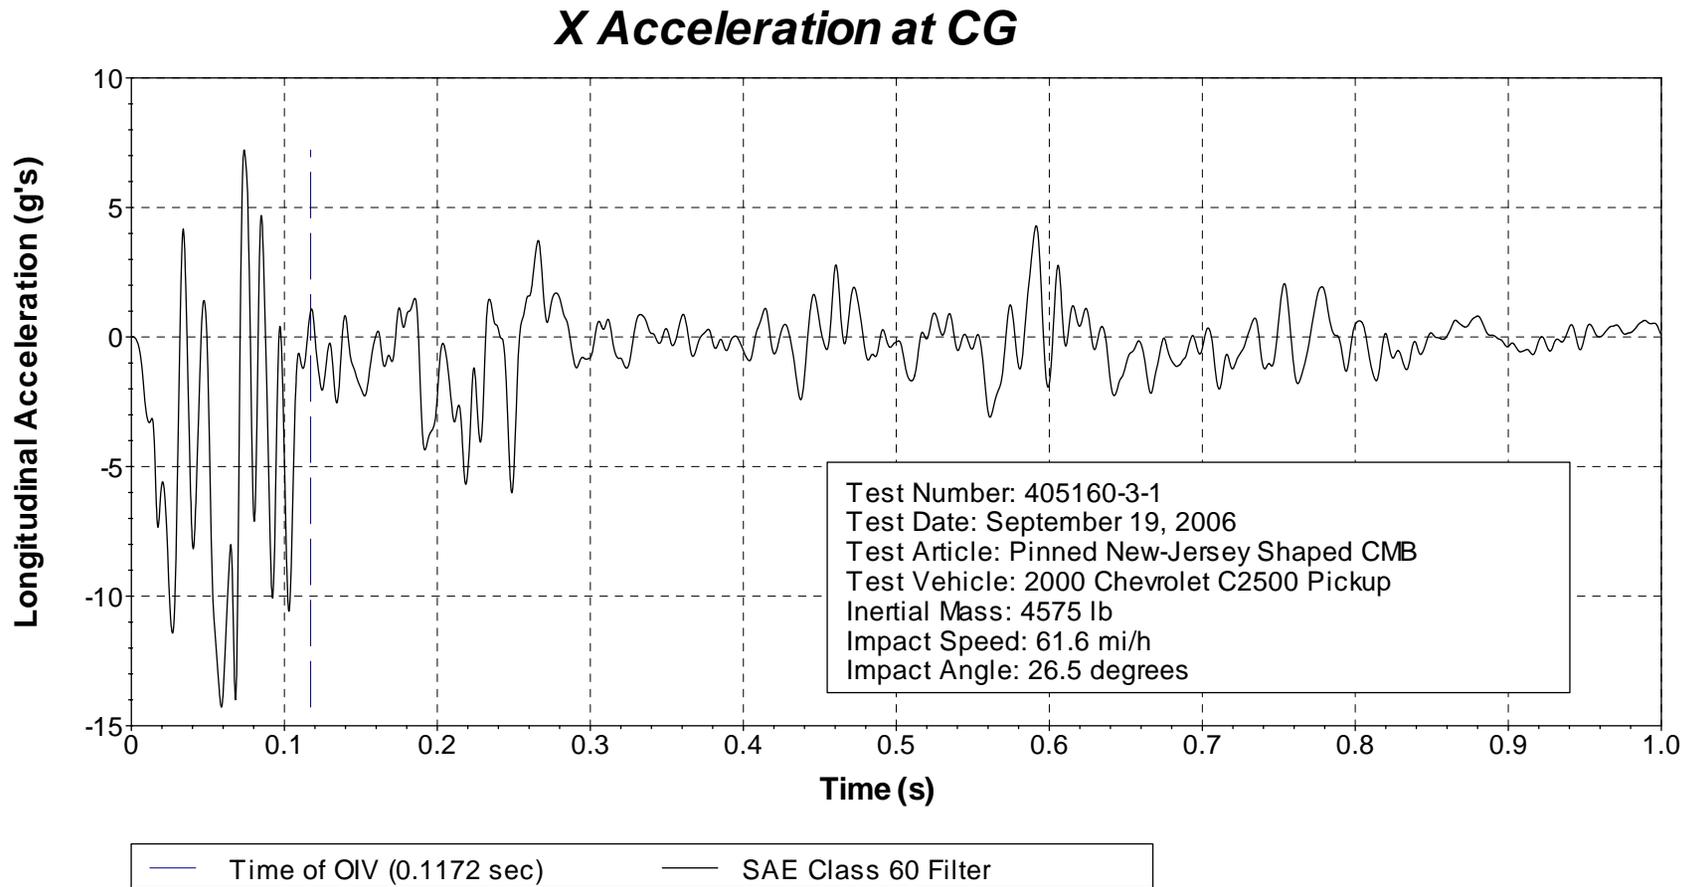
Figure D2. Vehicle longitudinal accelerometer trace for test 405160-3-1 (accelerometer located at center of gravity).

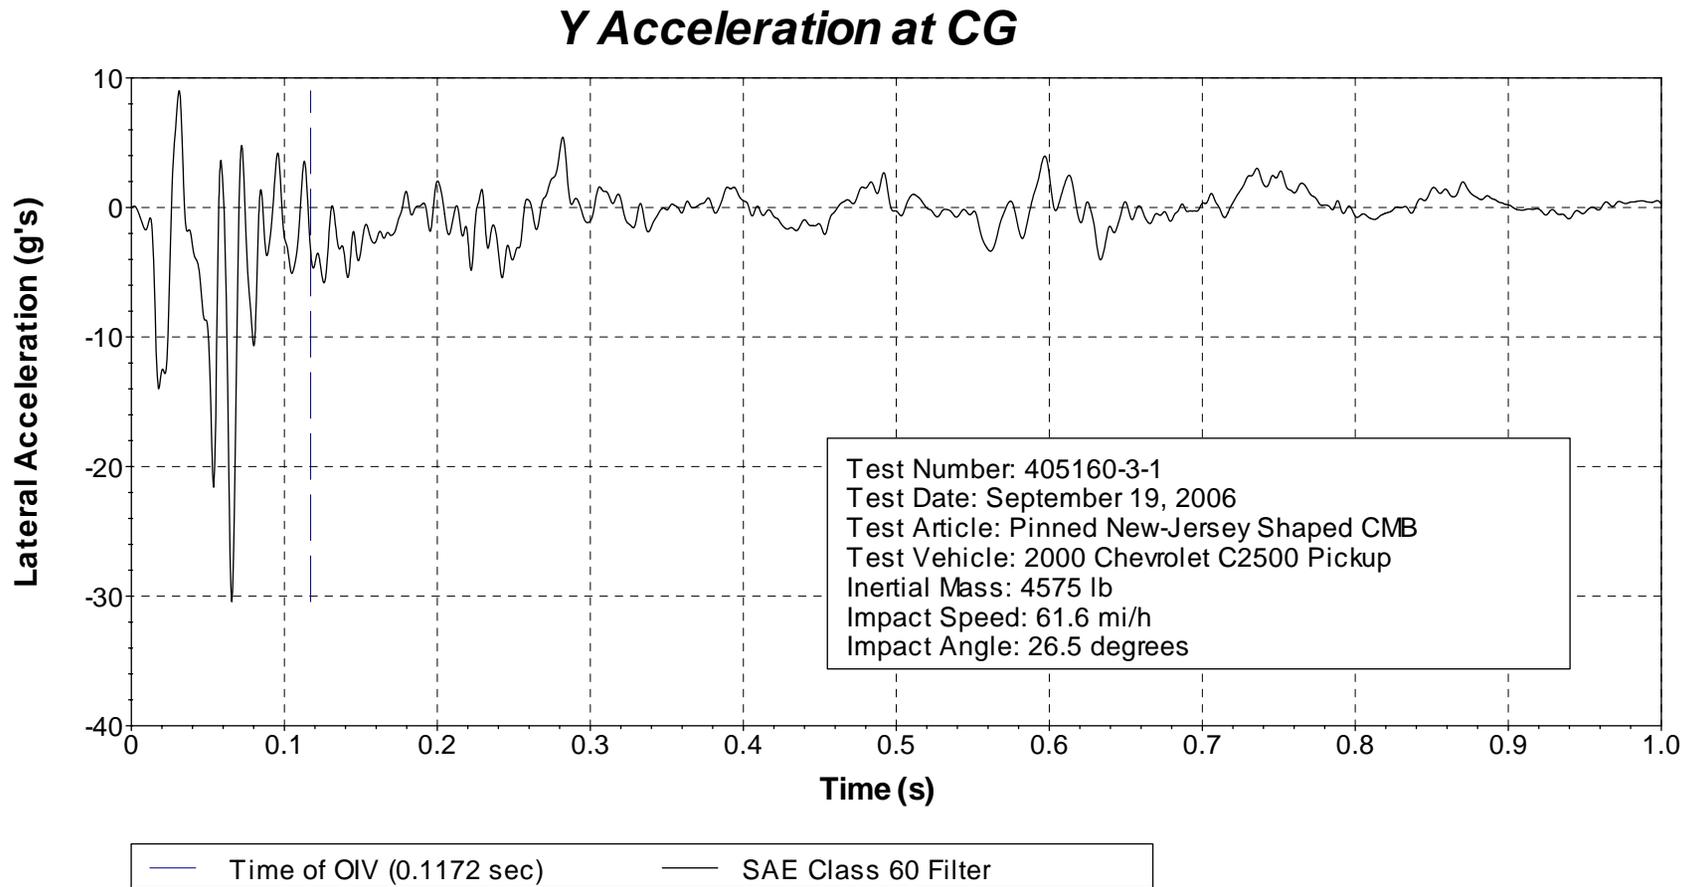
Figure D3. Vehicle lateral accelerometer trace for test 405160-3-1 (accelerometer located at center of gravity).

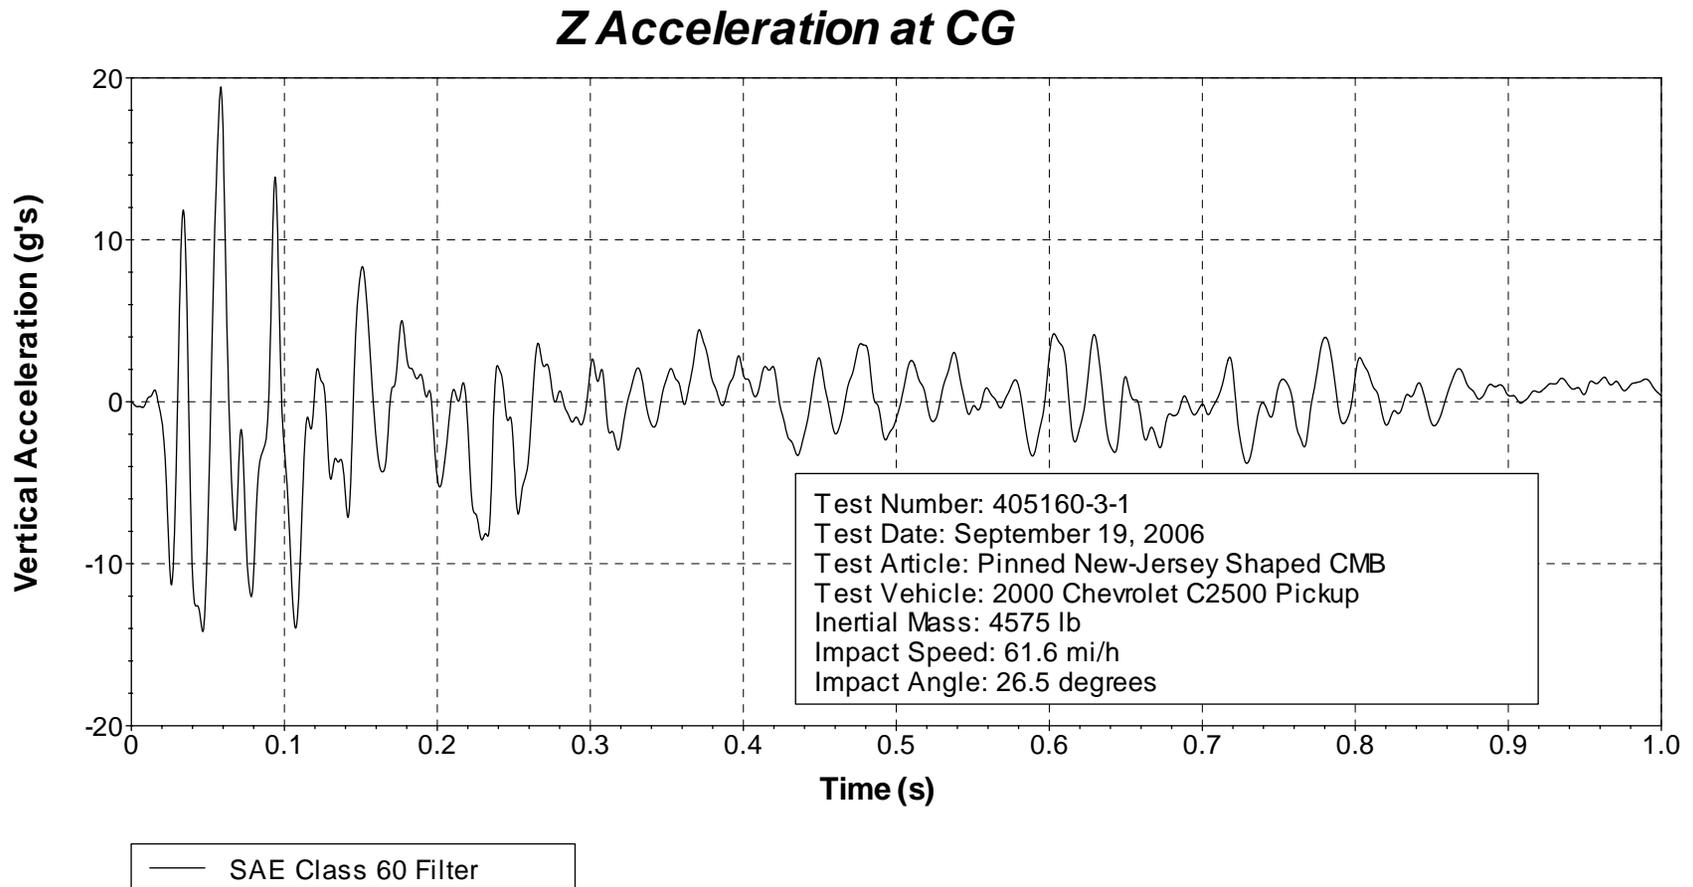
Figure D4. Vehicle vertical accelerometer trace for test 405160-3-1 (accelerometer located at center of gravity).

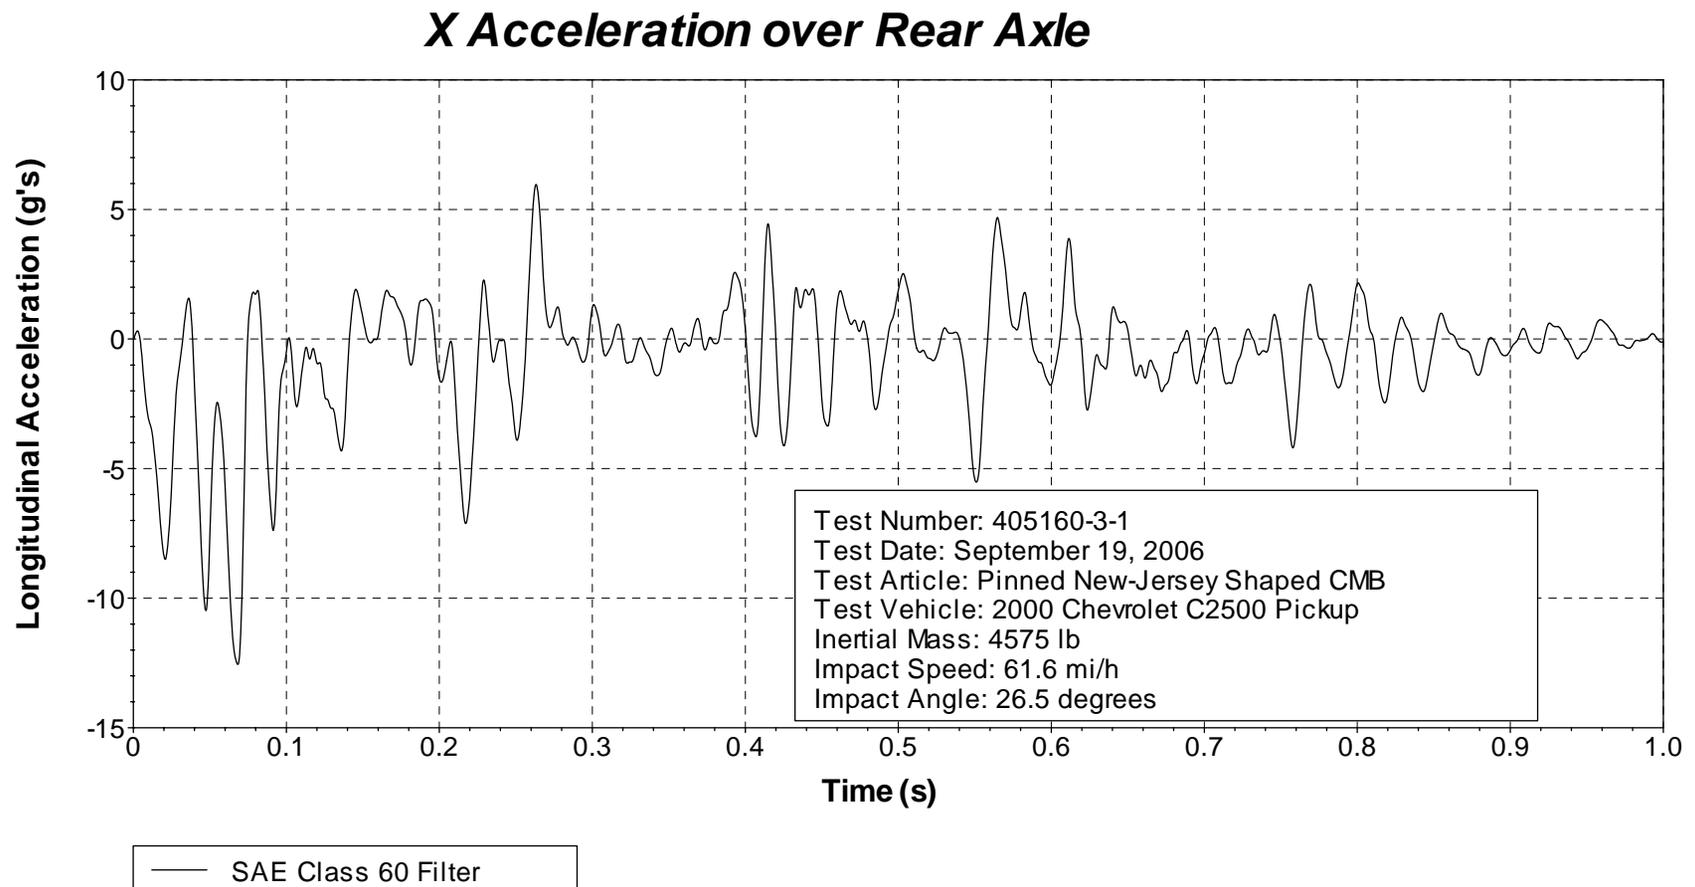
Figure D5. Vehicle longitudinal accelerometer trace for test 405160-3-1
(accelerometer located over rear axle).

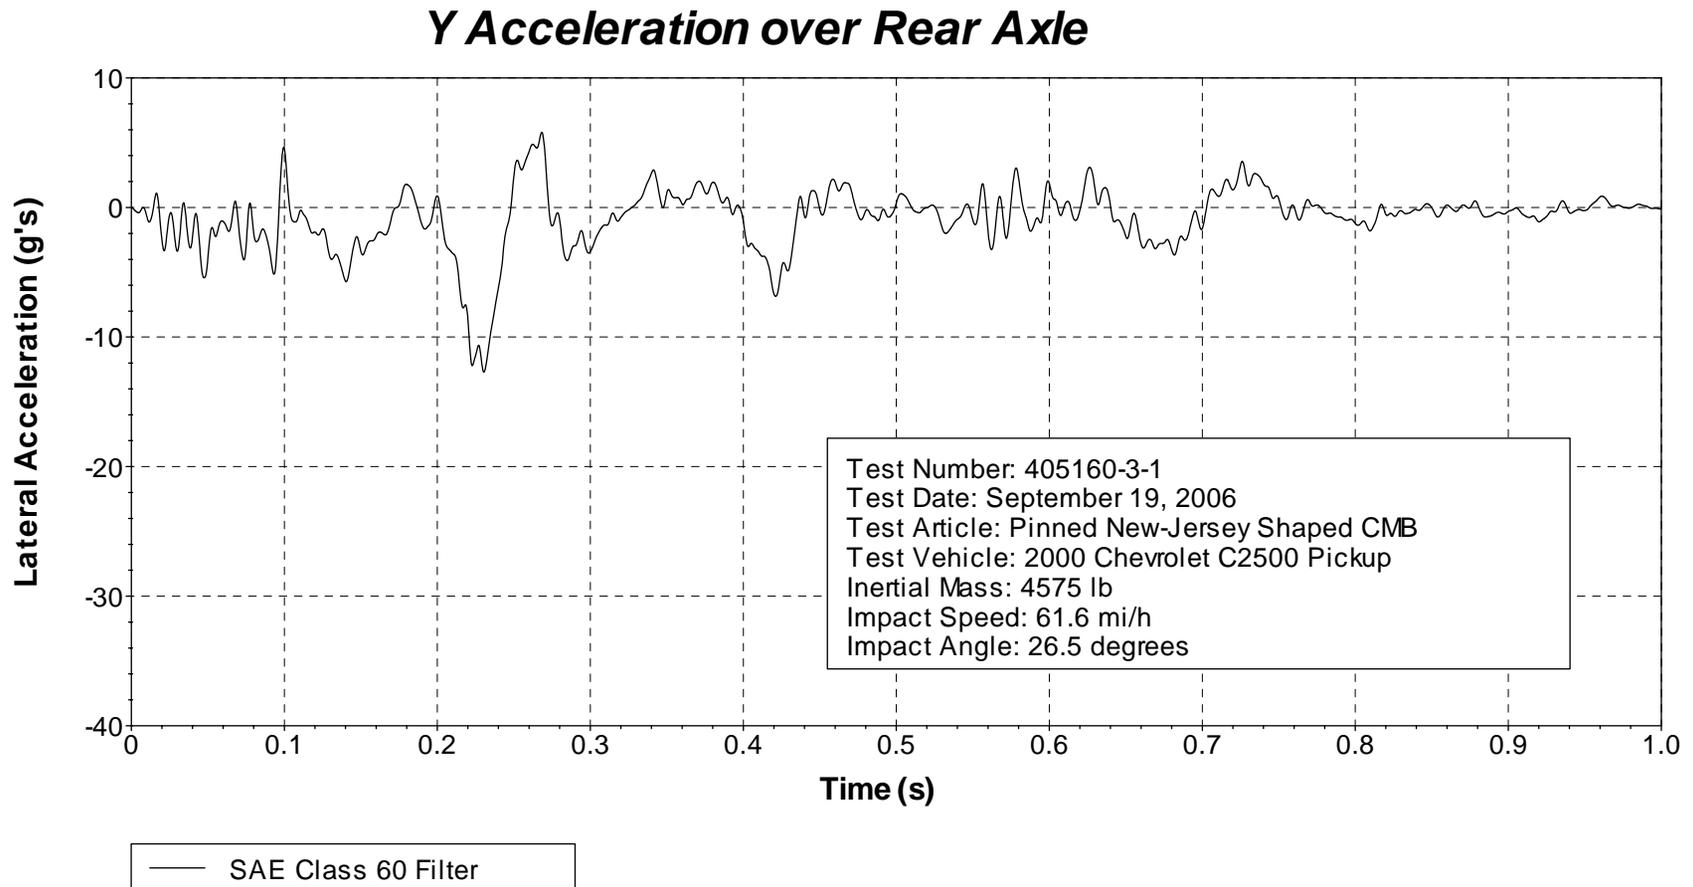
Figure D6. Vehicle lateral accelerometer trace for test 405160-3-1 (accelerometer located over rear axle).

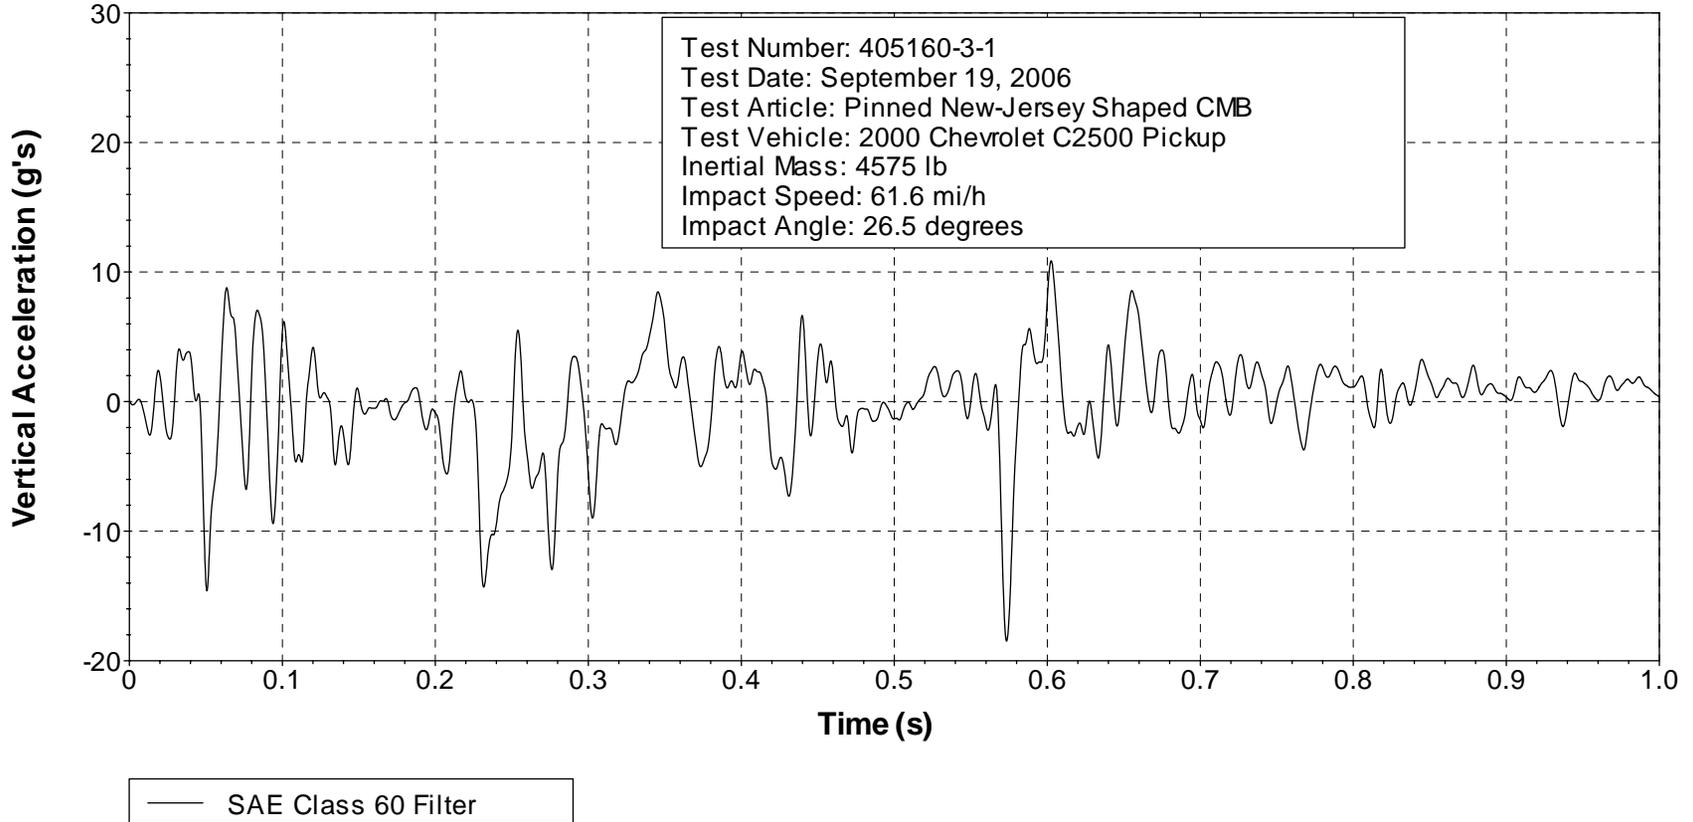
Figure D7. Vehicle vertical accelerometer trace for test 405160-3-1 (accelerometer located over rear axle).

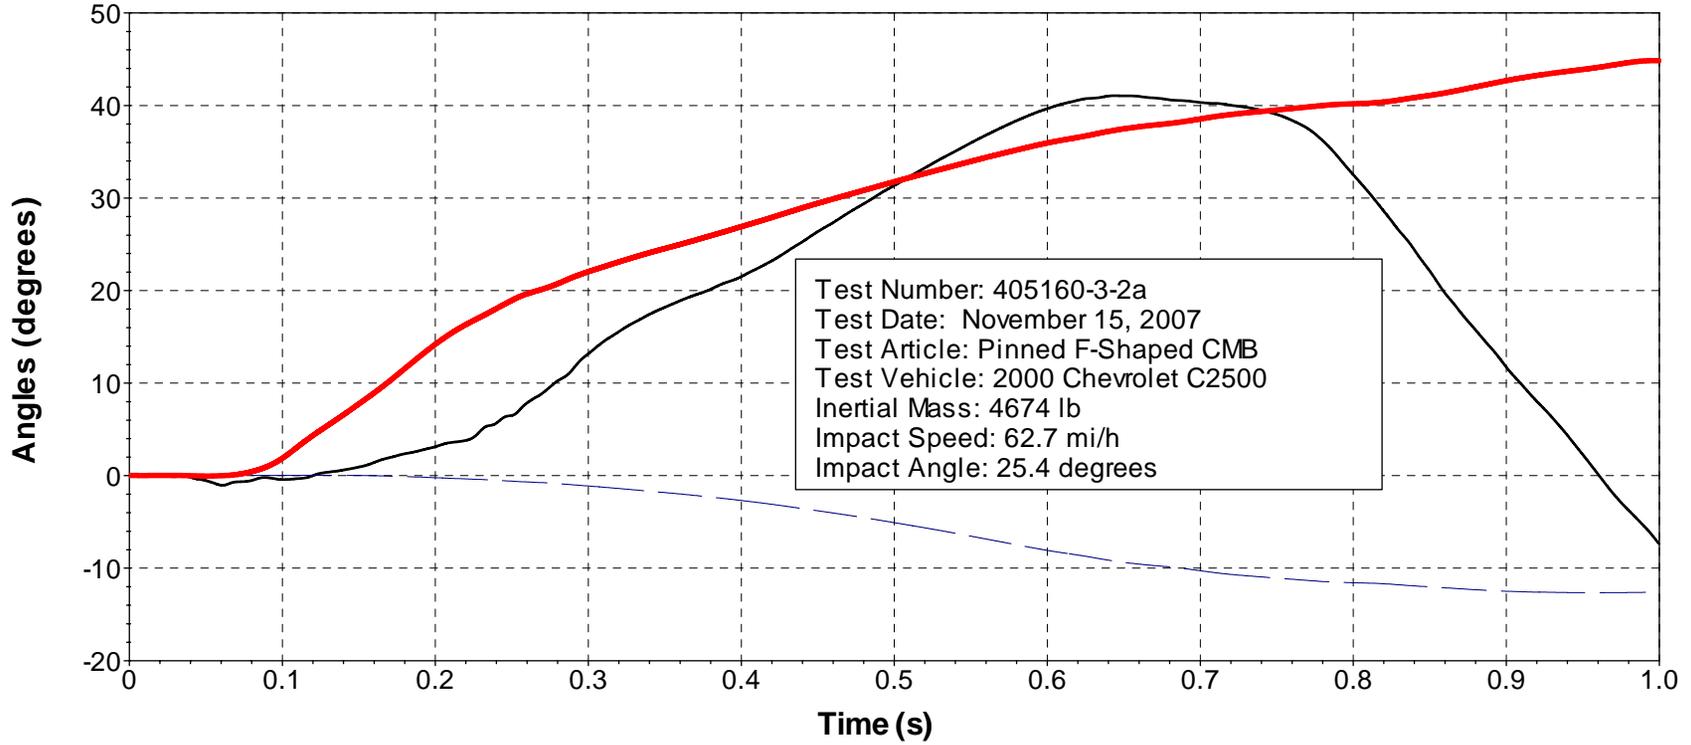
Test Number: 405160-3-2a
 Test Date: November 15, 2007
 Test Article: Pinned F-Shaped CMB
 Test Vehicle: 2000 Chevrolet C2500
 Inertial Mass: 4674 lb
 Impact Speed: 62.7 mi/h
 Impact Angle: 25.4 degrees

Figure D8. Vehicle angular displacements for test 405160-3-2a.

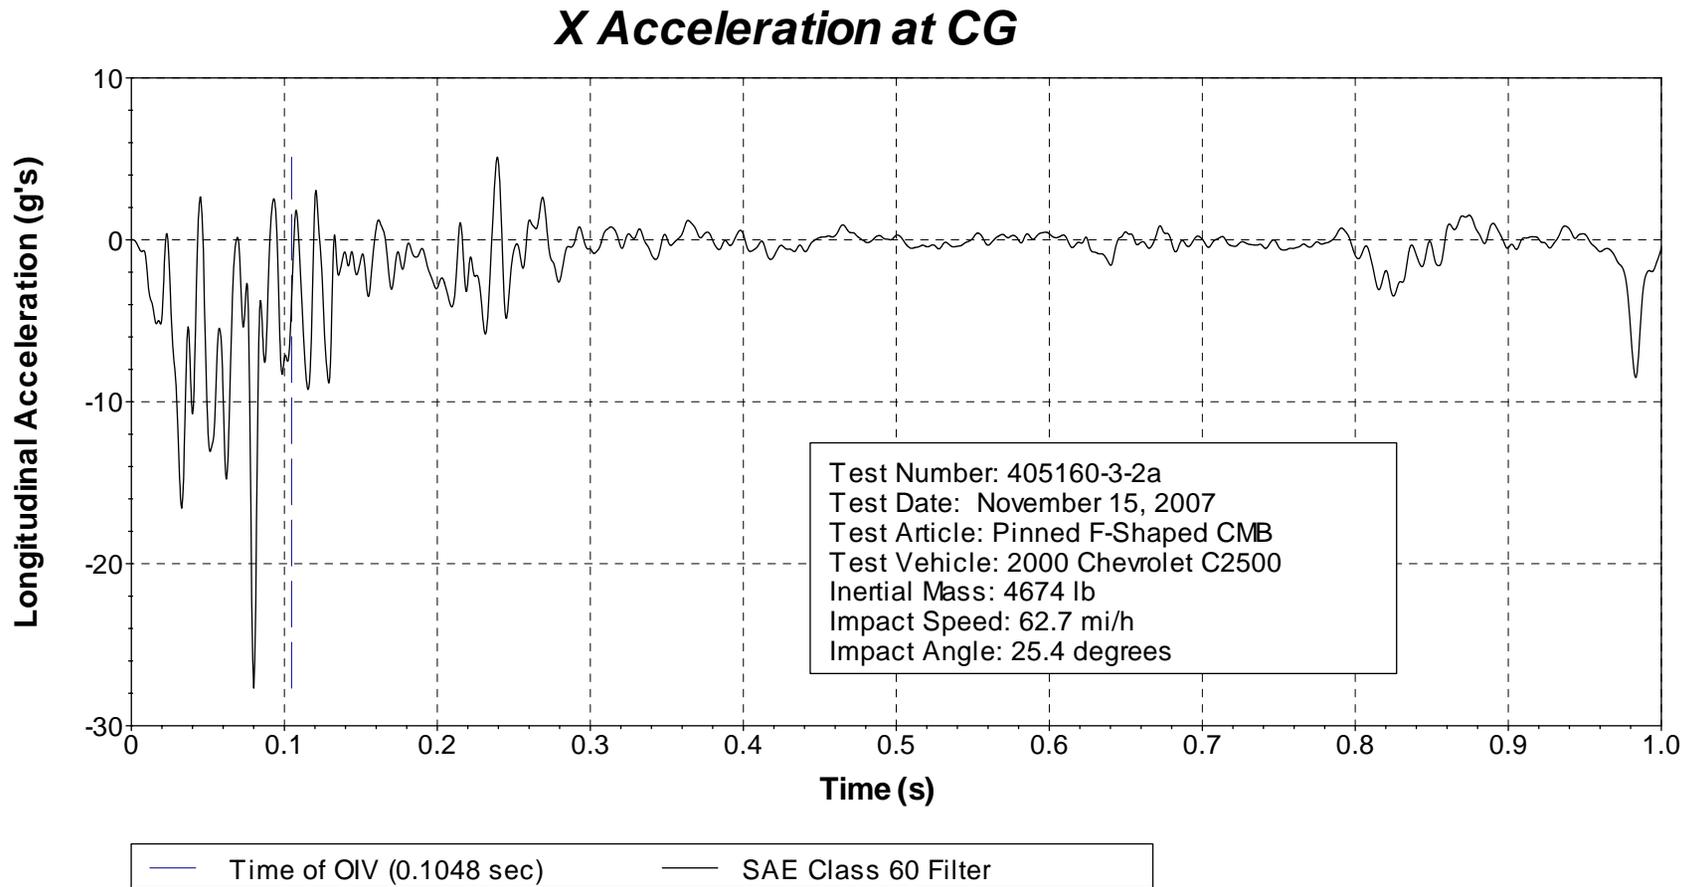
Figure D9. Vehicle longitudinal accelerometer trace for test 405160-3-2a (accelerometer located at center of gravity).

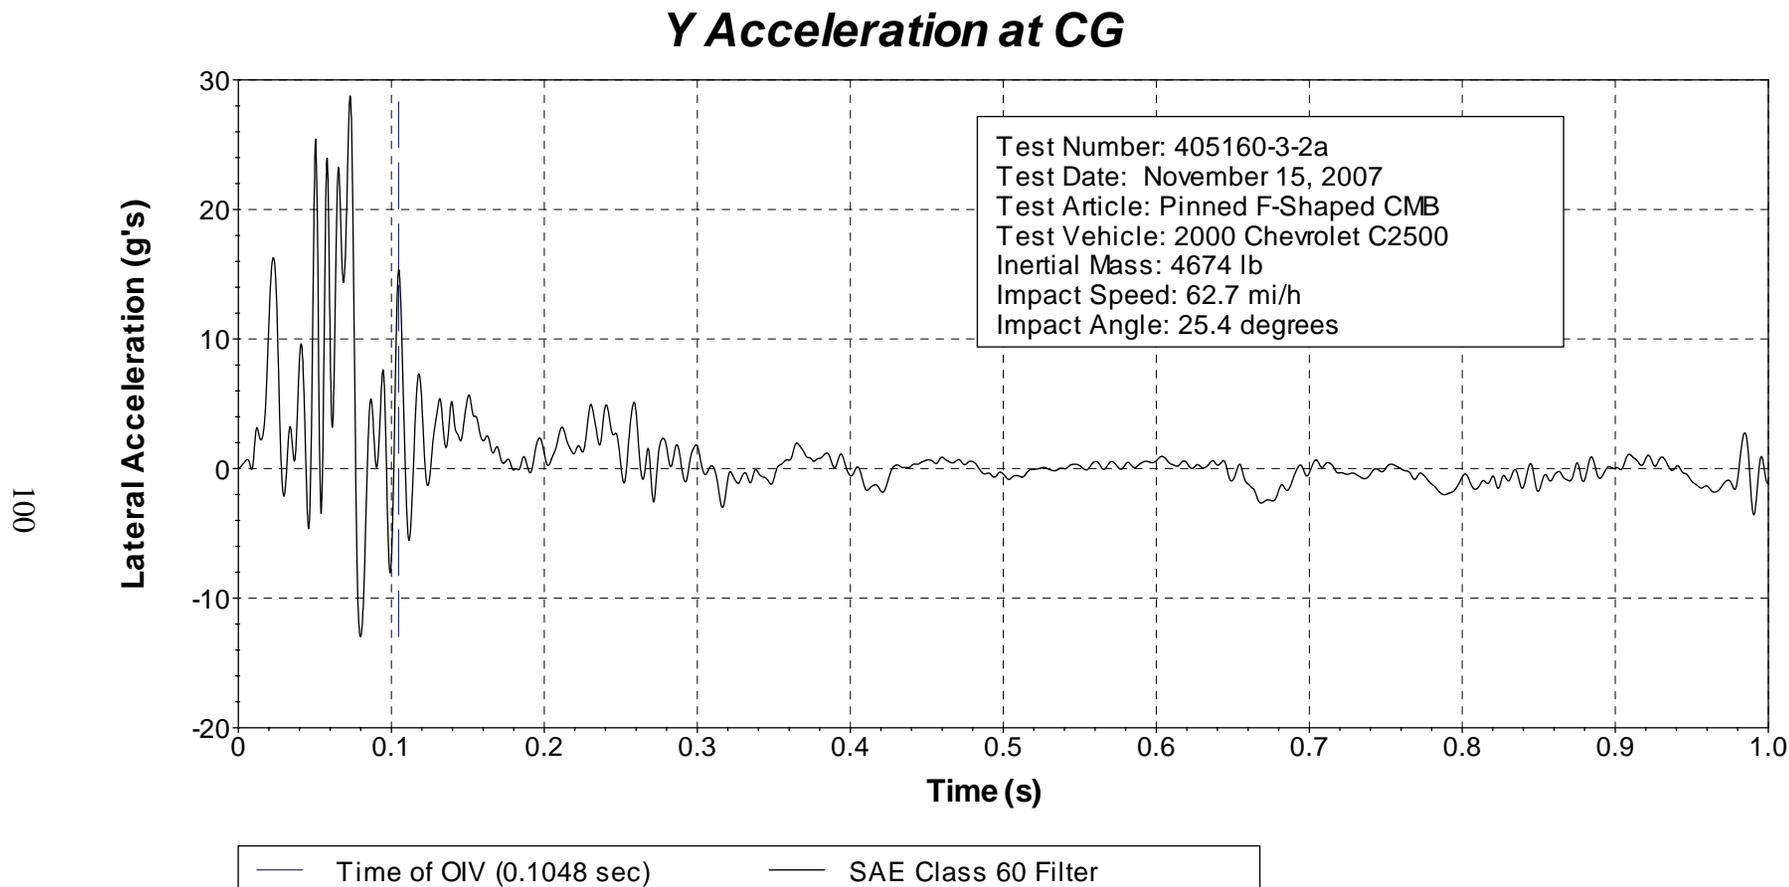
Figure D10. Vehicle lateral accelerometer trace for test 405160-3-2a (accelerometer located at center of gravity).

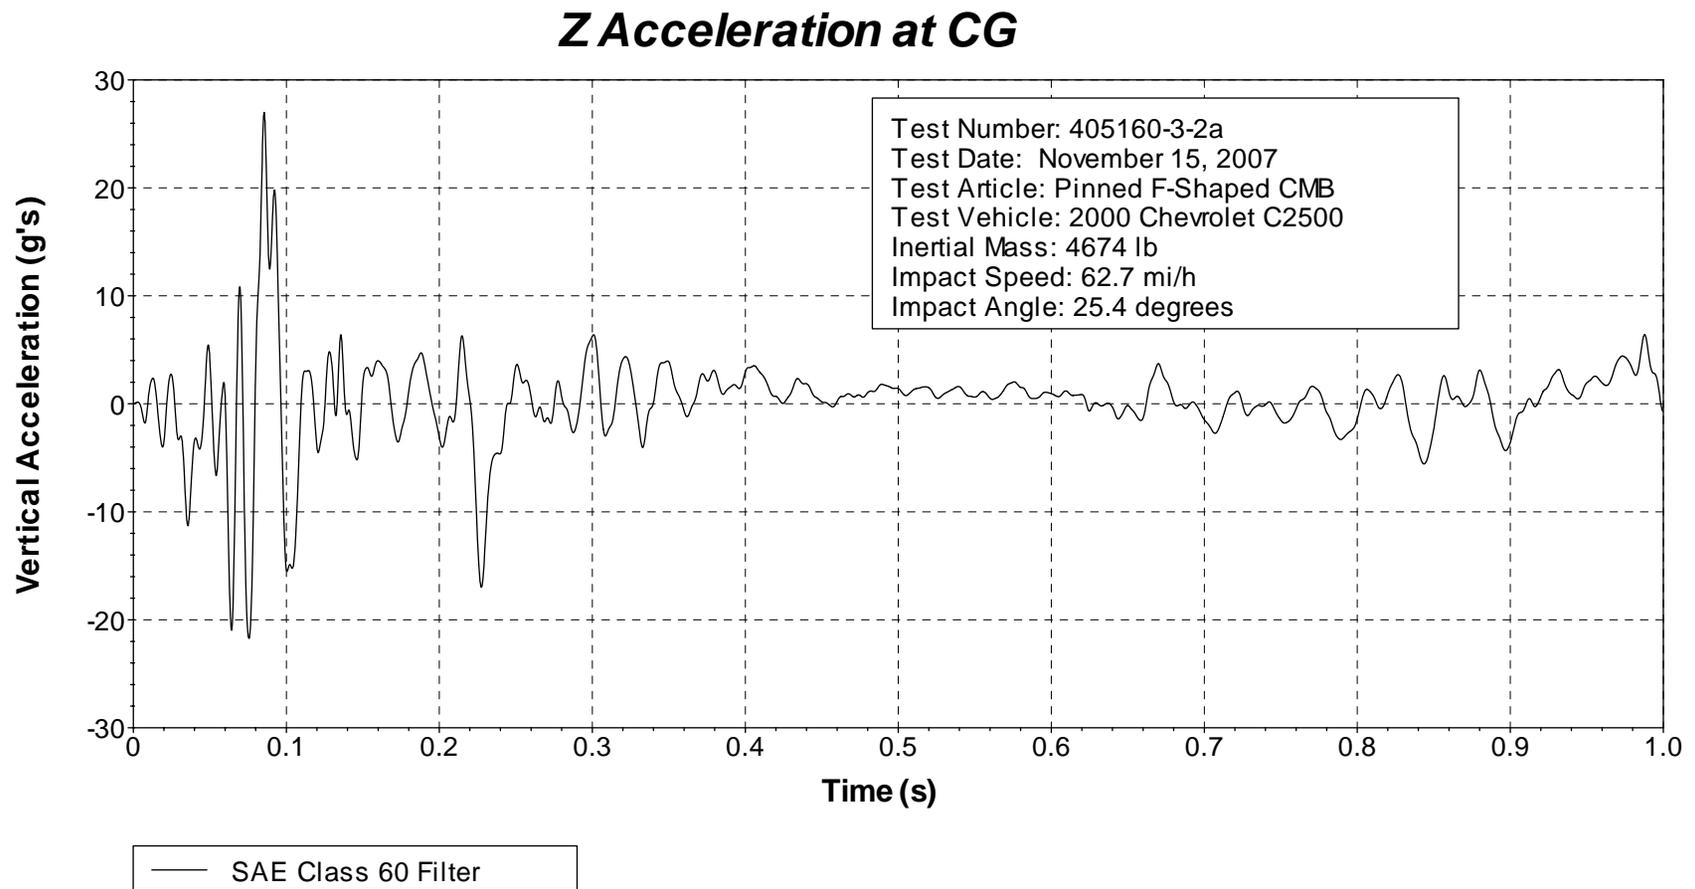
Figure D11. Vehicle vertical accelerometer trace for test 405160-3-2a (accelerometer located at center of gravity).
