CRASH TESTING AND EVALUATION OF THE 12 FT PINNED F-SHAPE TEMPORARY BARRIER

Contract No. T4541-AB
Report/Test No. 405160-3-1/2a
Date of Test: 09-19-2006/11-15-2008

Sponsored by
**Roadside Safety Research Program Pooled Fund
Study No. TPF-5(114)**

**TEXAS TRANSPORTATION INSTITUTE
THE TEXAS A&M UNIVERSITY SYSTEM
COLLEGE STATION, TEXAS 77843**

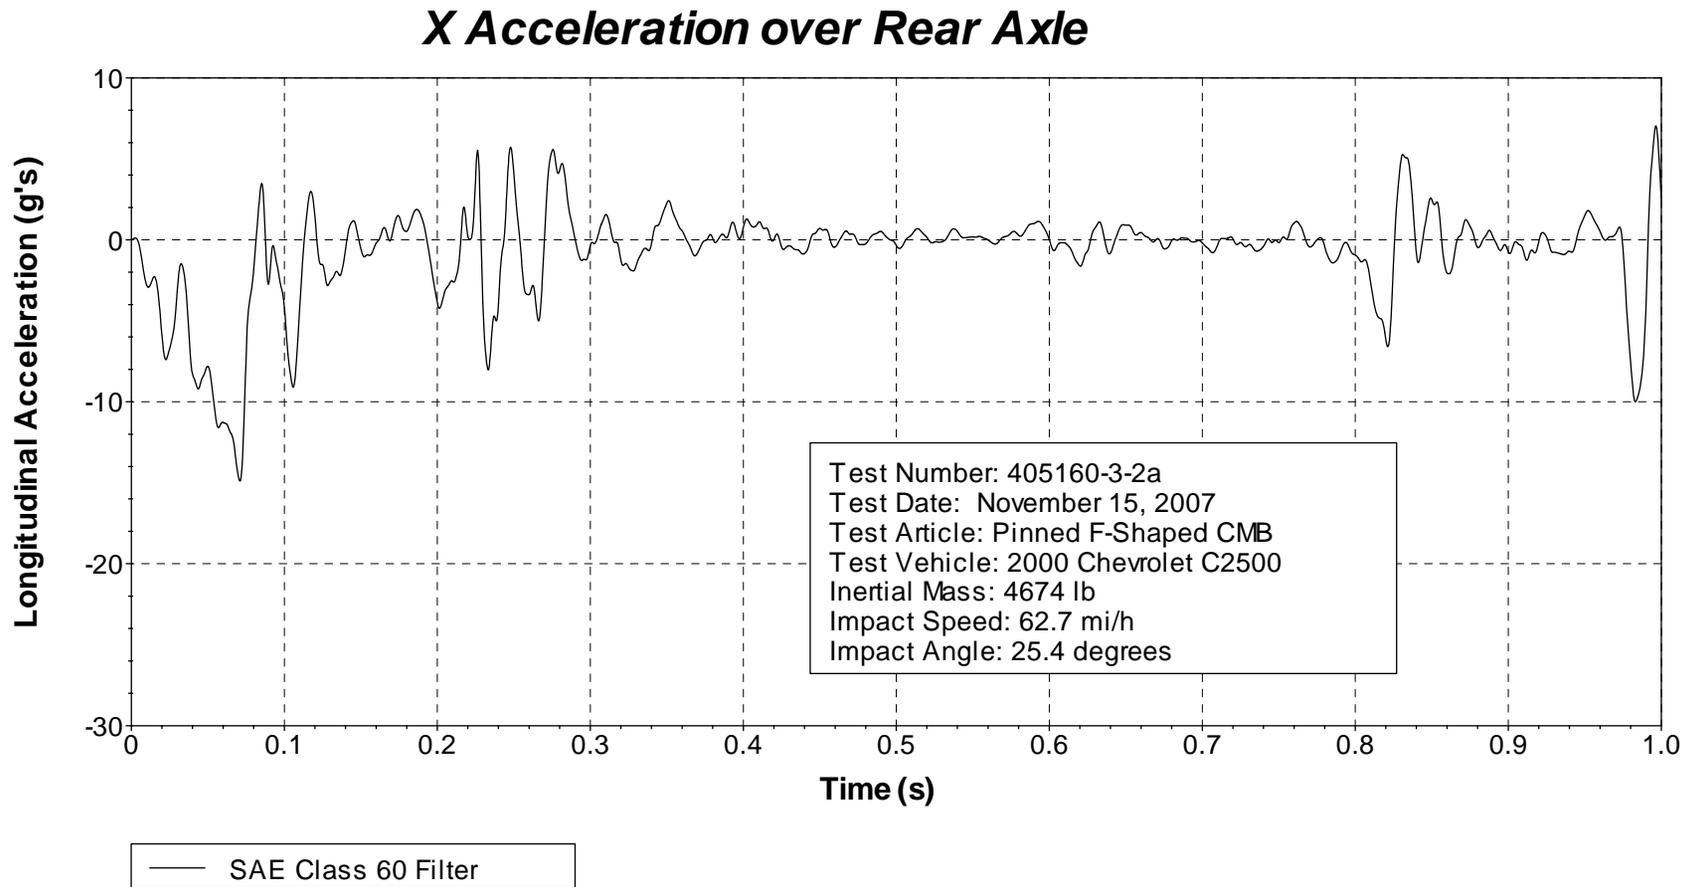
Figure D12. Vehicle longitudinal accelerometer trace for test 405160-3-2a
(accelerometer located over rear axle).

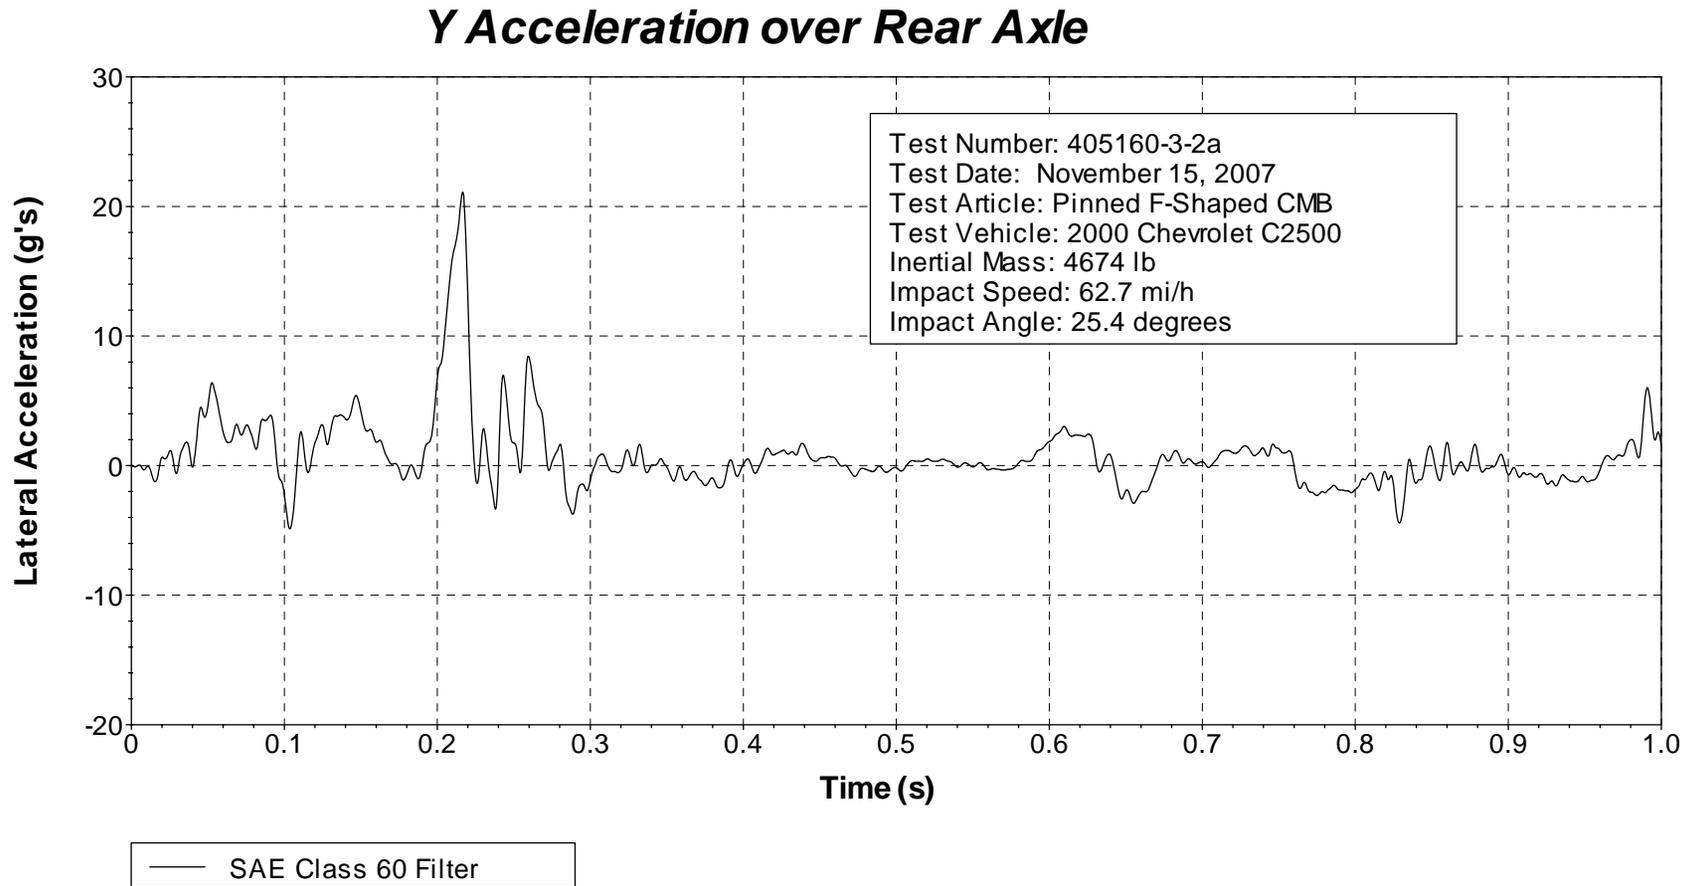
Figure D13. Vehicle lateral accelerometer trace for test 405160-3-2a (accelerometer located over rear axle).

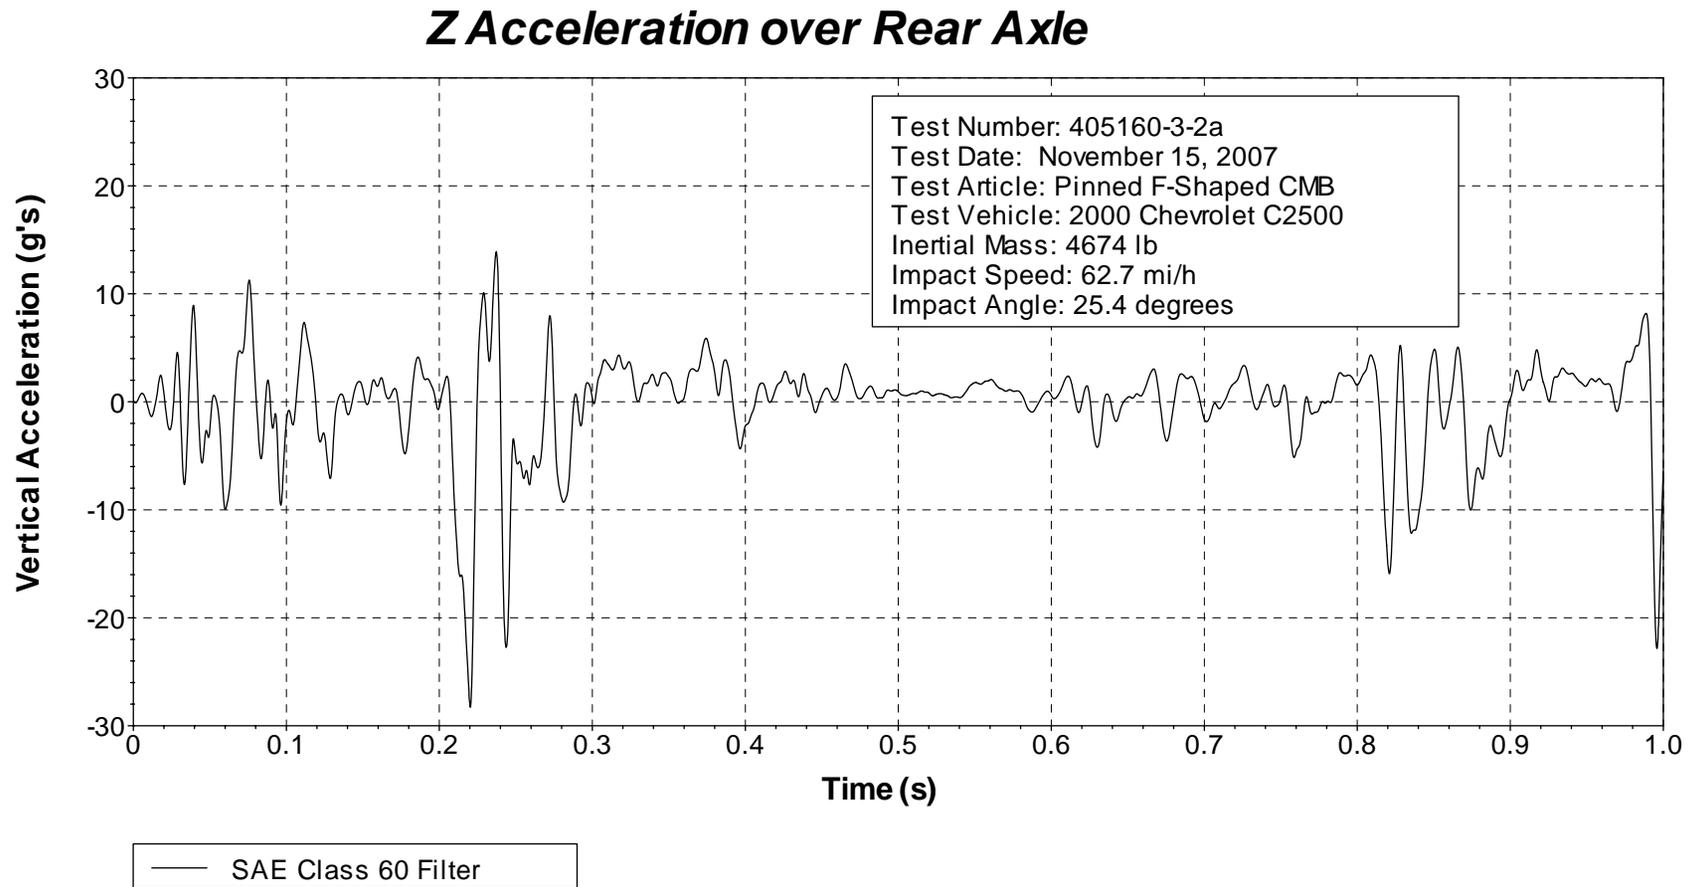
Figure D14. Vehicle vertical accelerometer trace for test 405160-3-2a (accelerometer located over rear axle).
