TECHNICAL MEMORANDUM

Contract No.: T4541-BT
Test Report No.: TM602371-P1-P4
Project Name: Guidance for Raising Beam Guardrail Block
Sponsor: Roadside Safety Pooled Fund

DATE: September 23, 2013

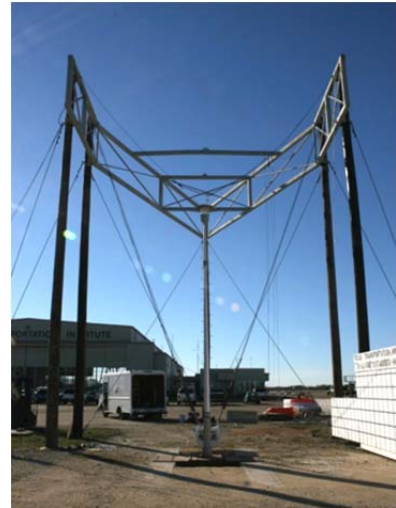
The raised 8-inch wood blockout on wood posts embedded in soil was tested at Texas A&M Transportation Institute (TTI) outdoor pendulum testing facility. The pendulum bogie, built according the specifications of the Federal Outdoor Impact Laboratory's (FOIL) pendulum, and the testing area are shown in the adjacent figure. A sweeper plate, constructed of steel angles and a steel plate, is attached to the body of the pendulum with a ground clearance of 6 inches to replicate roughly an automobile's undercarriage. The pendulum impacts the raised 8-inch wood blockout on wood posts embedded in soil at a target speed of 22 mi/h and at a height of 21-25 inches above the ground. A brief description of the procedures is presented in Appendix A.

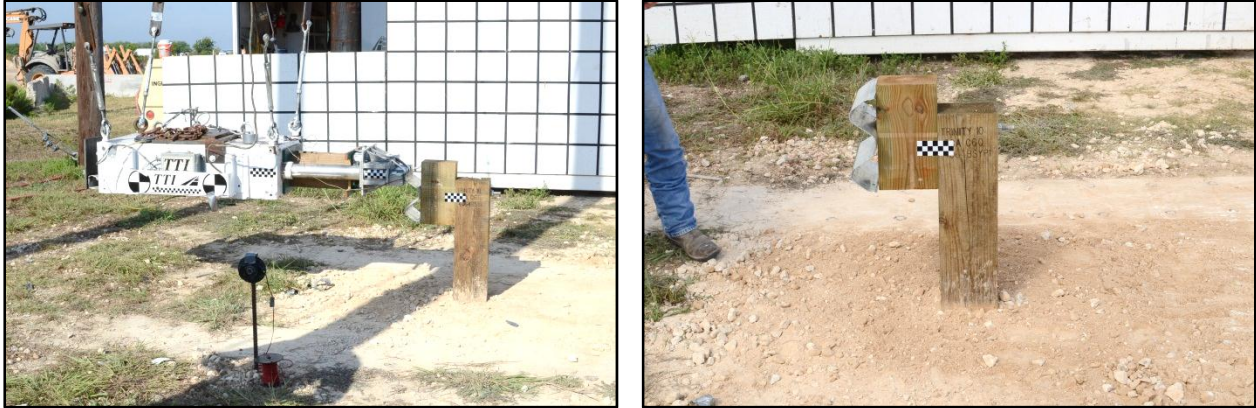
Figure 1. Test setup for Tests P1 and P2.

For Test P1, a 72-inch long modified wooden post (PDE02) with a blockout (PDB01a) was installed such that the top of the post was 28 inches above grade, and the top of the blockout was 32 inches above grade. The post was buried to a depth of 44 inches and secured with pneumatically tamped soil. A W-beam in the form of a W-beam back-up plate (RWB01a) was attached to the post and blockout with an 18-inch guardrail bolt with recessed nut and flat washer through a drilled ¾-inch diameter hole 3 inches below the top of the post (centerline at 25 inches above grade). Test P1 was designed such that the pendulum bogie impacted the face of the W-beam back-up plate at 90° (normal) to what would be the direction of travel, at a target speed of 20 mi/h, and at a height of 29½ inches above grade. Detailed drawings are provided in Attachment B and photographs are shown in Figure 1.

Test P2 was a repeat of Test P1, with the same test installation setup and same conditions.

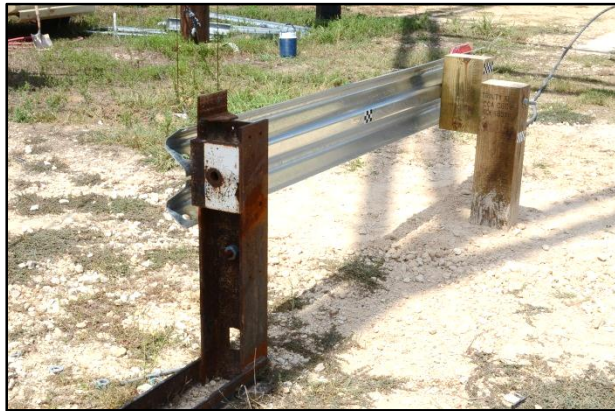
Figure 2. Test setup for Test P3.

Test P3 was a pull/jerk test in the longitudinal direction (in the direction of traffic) wherein the test article was yanked by the pendulum bogie at a height of 25 inches above grade. Similar to Test P1, a 72-inch long modified wooden post (PDE02) with a blockout (PDB01a) was installed such that the top of the post was 28 inches above grade, and the top of the blockout was 32 inches above grade. The post was buried to a depth of 44 inches and secured with pneumatically tamped soil.

An 8 ft-6 inch long standard 12 gauge W-beam guardrail was attached to the wooden post and blockout with an 18-inch guardrail bolt with recessed nut and flat washer through a drilled $\frac{3}{4}$ -inch diameter hole 3 inches below the top of the post (centerline at 25 inches above grade). Near the test post, the W-beam featured eight $\frac{3}{4}$ -inch diameter holes through which the pendulum cable jerk bracket was attached with $\frac{5}{8}$ -inch \times 2-inch bolts and recessed nuts.

The far end of the W-beam guardrail was supported by a W6 \times 9 anchor post installed in a 6-inch \times 8-inch \times 6-ft deep steel tubular sleeve embedded in tamped soil. Two 3 \times 3 \times $\frac{1}{2}$ -inch angle ground struts connected (welded) the post to a steel baseplate, which was bolted to a reinforced concrete foundation. The guardrail’s bolting slot on this end was cut such that it extended to the end of the rail forming a horizontal elongated “U”. A standard 1 $\frac{1}{4}$ -inch guardrail bolt and recessed nut were installed to simply support this end of the Guardrail.

Test P3 was designed such that the pendulum bogie jerked the guardrail and wooden post in a longitudinal direction and at a height of 25 inches above grade. Detailed drawings are provided in Attachment B, and photographs of the completed installation area shown Figure 2.

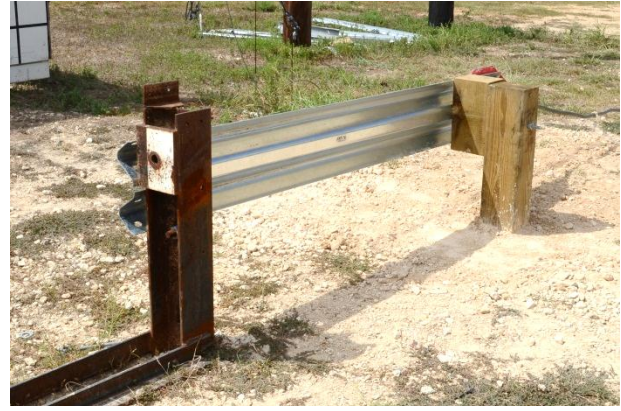
Figure 3. Test setup for Test P4.

Test P4 was a pull/jerk test in the longitudinal direction (in the direction of traffic) similar to Test P3 except that the test article was yanked by the pendulum bogie at a height of 21 inches above grade (vs. 25 inches). Similar to the previous tests, a 72-inch long modified wooden post (PDE02) with a blockout (PDB01a) was installed such that the top of the post was 28 inches above grade. The post was buried to a depth of 44 inches and secured with pneumatically tamped soil. However in Test P4, the top of the blockout was also 28 inches above grade and flush with the top of the post, and the guardrail and blockout were bolted to the post with an 18-inch guardrail bolt with recessed nut and flat washer through a drilled $\frac{3}{4}$ -inch diameter hole 7 inches below the top of the post (centerline at 21 inches above grade). Anchor post installation was similar to Test P3 except that the guardrail bolt was 4 inches lower to provide for a level

guardrail. Detailed drawings are provided in Attachment B, and photographs are shown in Figure 3.

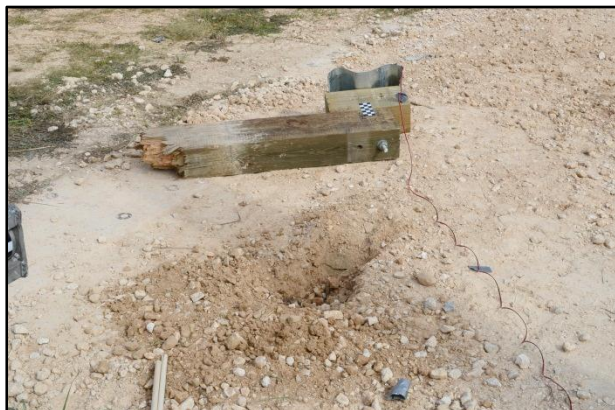
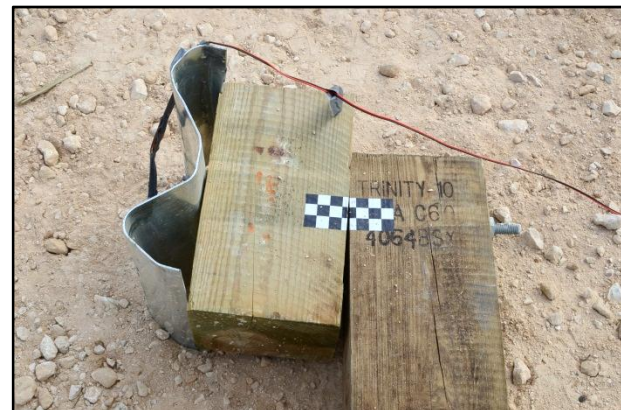
Figure 4. Post and Blockout after Test P1.

The wood post fractured approximately 12 inches below ground level and the upper section pulled out of the ground. The blockout remained attached to the post. A ½-inch gap was measured from the lower edge of the blockout to the post, as shown in Figure 4.

The pendulum bogie impacted the raised 8-inch wood blockout mounted at 32 inches on a wood post embedded in soil at an impact speed of 19.9 mi/h. At approximately 0.038 s, the W-beam backup plate compressed and the wood post began to deflect toward the field side. By 0.143 s, the post contacted the ground, and at 0.178 s, the pendulum lost contact with the blockout and post traveling at an exit speed of 14.7 mi/h. As the pendulum bogie continued forward, the bottom of the post rotated upward and contacted the rear of the pendulum bogie.

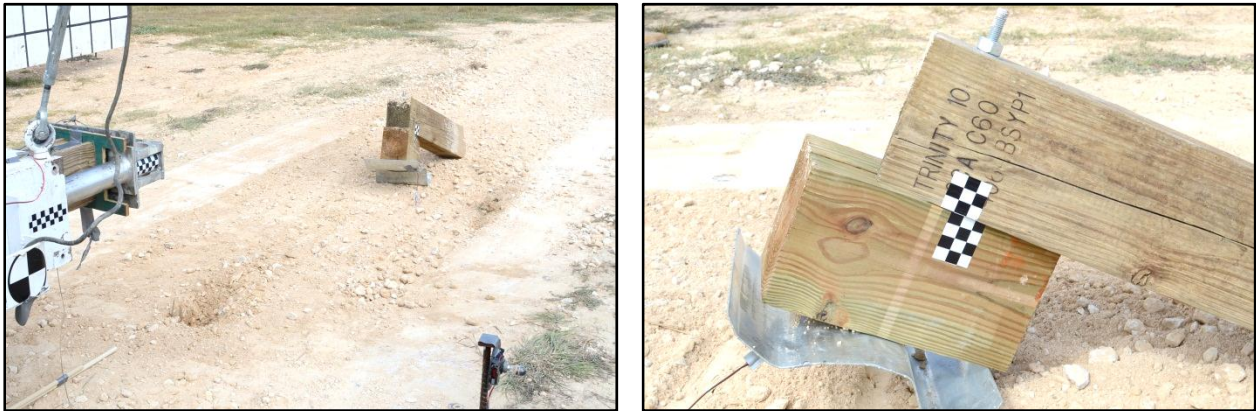
Figure 5. Post and Blockout after Test P2.

The wood post fractured approximately 7 inches below ground level and the upper section pulled out of the ground. The blockout remained attached to the post and rotated slightly on the post, as shown in Figure 5.

The pendulum bogie impacted the raised 8-inch wood blockout mounted at 32 inches on a wood post embedded in soil at an impact speed of 20.0 mi/h. At approximately 0.042 s, the W-beam backup plate compressed and the wood post began to deflect toward the field side. By 0.133 s, the post contacted the ground, and at 0.184 s, the pendulum lost contact with the blockout and post traveling at an exit speed of 16.9 mi/h. As the pendulum bogie continued forward, the bottom of the post rotated upward and contacted the rear of the pendulum bogie.

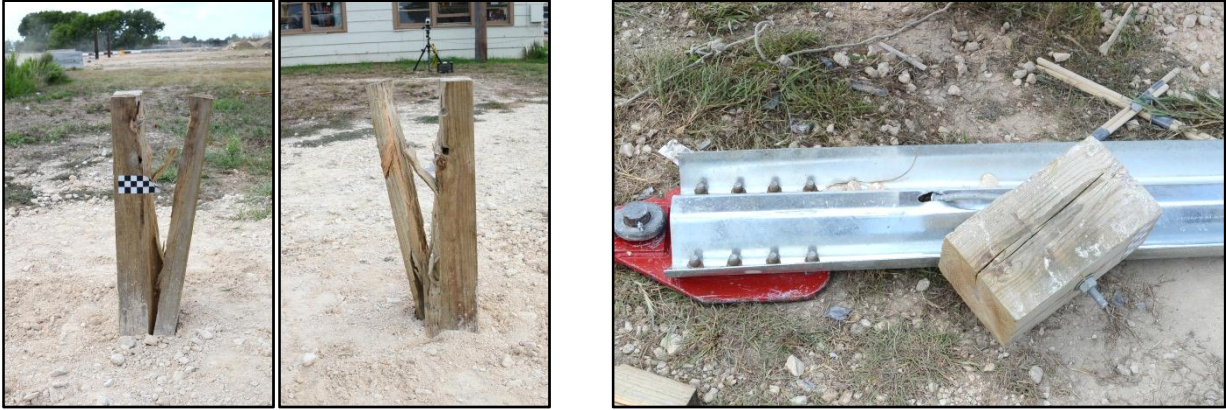
Figure 6. Post and Blockout after Test P3.

The wood post split longitudinally. The blockout remained attached to the rail, as shown in Figure 6.

The pendulum bogie pulled the raised 8-inch wood blockout mounted at 31 inches on a wood post embedded in soil at a speed of 14.8 mi/h. At approximately 0.033 s, the wood post began to split and at 0.041 s, the guardrail separated from the post. The wood blockout and rail separated from the post at 0.067 s, and by 0.123 s, the wood blockout and rail contacted the ground.

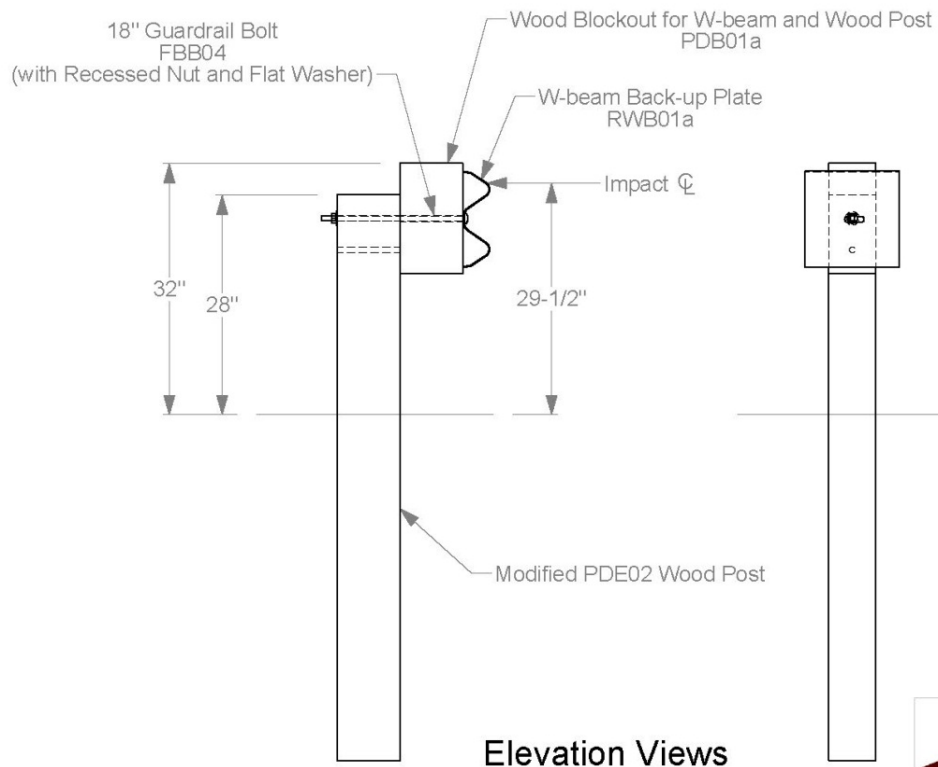
Roadside Safety and Physical Security Division Proving Ground -	
Project	602371-P	Raised Blockout	
Drawn By	GES	Scale	1:20 Sheet 1 of 5 First Installation
Approved:		Date:	2013-09-11
Chiara Dobrovoly:

Tests P1-P2

Elevation Views

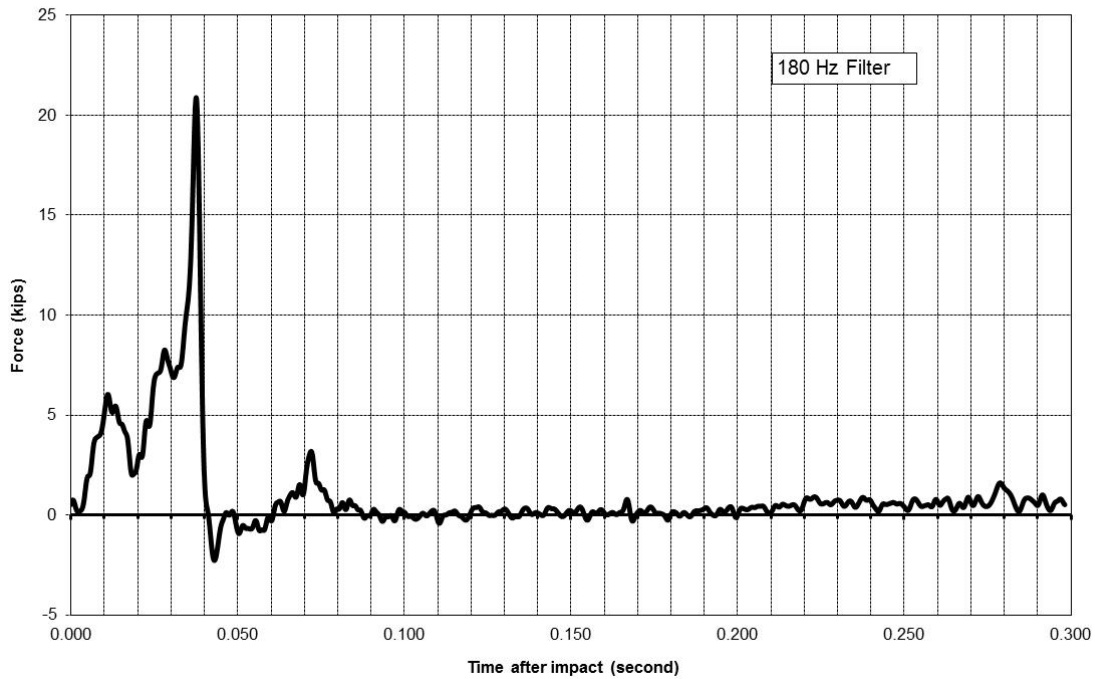
Figure D4. Force trace for test 602371-P2.

Pendulum Test No. 602371-P2

Longitudinal occupant impact velocity was 6.9 ft/s, and longitudinal ridedown acceleration was 0.9 G. The maximum longitudinal 50-msec average acceleration was -3.7 G. Maximum 10-ms average force was 11.0 kips, and maximum kinetic energy was 8.26 ft-kips. Maximum change in velocity was 4.5 ft/s. A summary of results is provided in Table C2, and accelerometer graphs are shown in Attachment D, Figures D3 and D4.
