Test Report No. 602191-1
Test Report Date: October 2013

**MASH TEST 3-11 ON THE WASHINGTON CONCRETE
TRAFFIC BARRIER WITH ACOUSTIC COATING**

TEXAS A&M TRANSPORTATION INSTITUTE PROVING GROUND

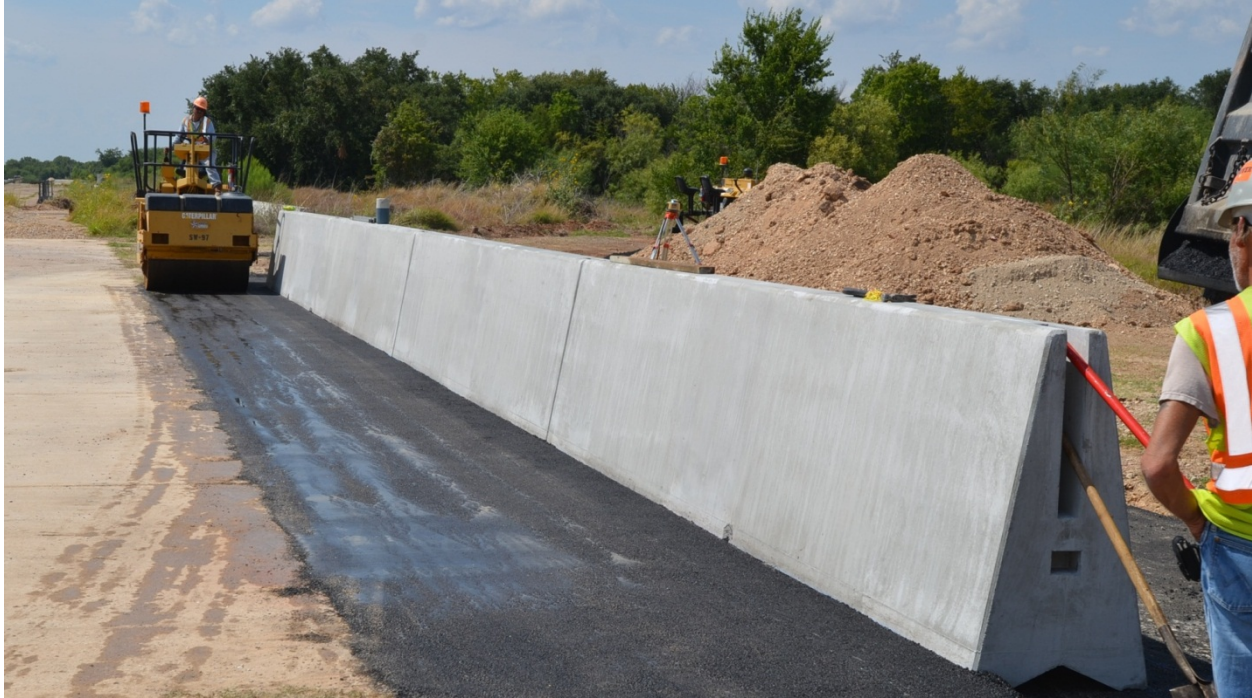
Figure 2.2. Compaction of 3-inch Asphalt Overlay/Key.

The barrier segments were placed along the centerline of a 14 ft- 4¼ inch wide × 82-ft long × 2-inch thick pad of HMAC Type D hotmix asphalt that was rolled and compacted on top of 6 inches of Type A, Grade 1 road base compacted to 95 percent of Standard Proctor Density. Once set, the barriers were secured in place with a 6-ft wide × 3-inch thick overlay of HMAC Type D hotmix asphalt on each side of the barrier (see Figure 2.1 and 2.2). No other methods were used to secure the barrier in place.

It should be noted that the test results verify that a 3-inch asphalt overlay/key is sufficient for anchorage of precast concrete median barrier with grouted rebar connections. The barrier used in the test had negligible movement and no structural damage.

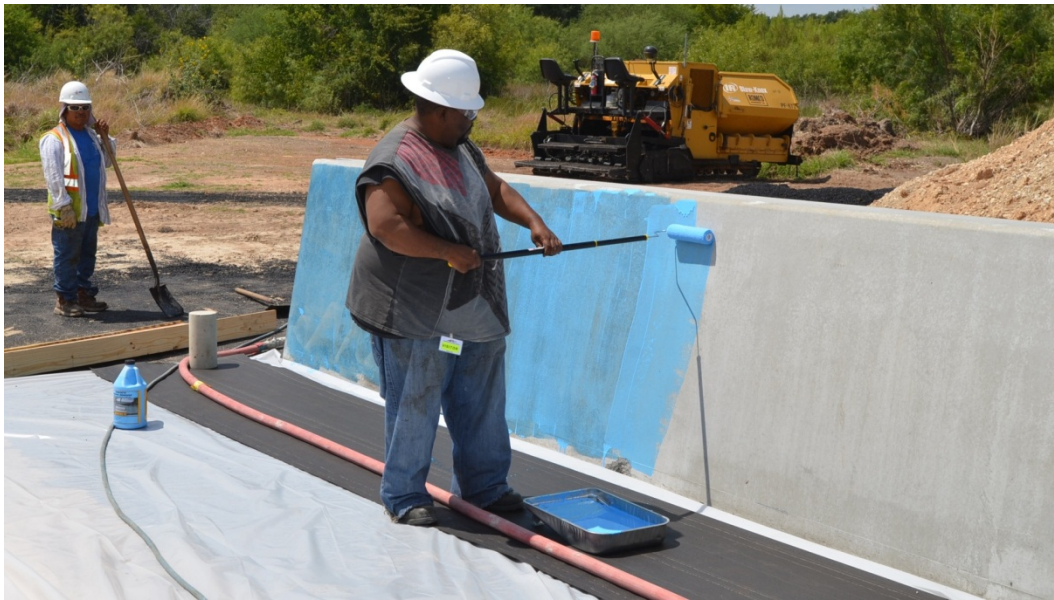
Figure 2.3. Application of Weld-Crete® Concrete Bonding Agent.

Once the barrier construction was complete, the sloped traffic surface of the barrier was coated with Acoustement[®] 40 manufactured by Pyrok, Inc. The manufacturer’s literature represents that “Acoustement[®] 40 is a 40 lb per cubic foot Portland cement formulation suitable for exterior applications to unpainted concrete and other substrates containing Portland cement.” Preparation of the barrier surface consisted of a rolled on application of Weld-Crete[®] Concrete Bonding Agent (Larsen Products, Jessup, MD) to enhance surface bonding by providing control of irregular moisture ‘suction’ into the concrete surface (see Figure 2.3). The Weld-Crete[®] application dried for at least one hour per the manufacturer’s instructions.

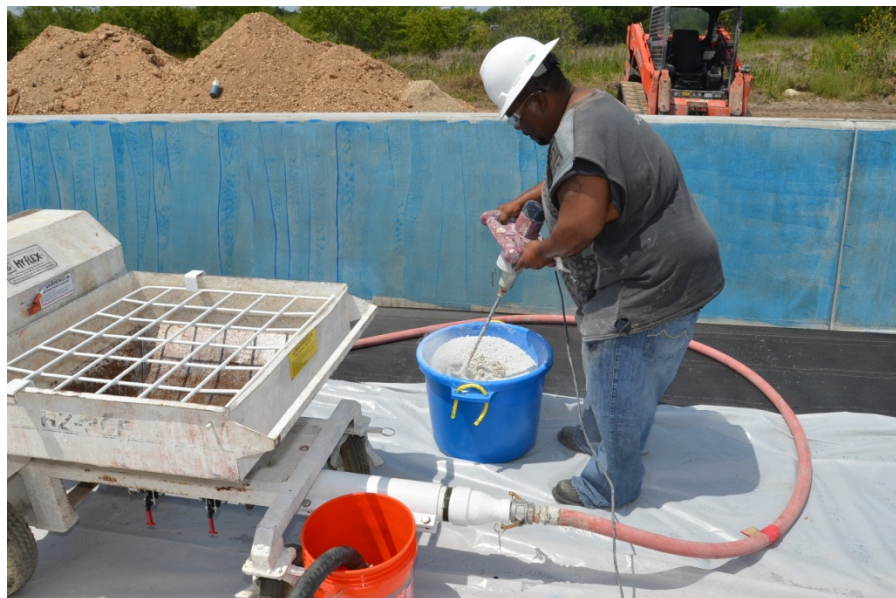
Figure 2.4. Mechanical Mixing of Acoustement® 40.

The Acoustement[®] 40 was applied via a Hy-Flex (New Castle, IN; <http://hyflexcorp.com>) HZ-30E fireproofing-stucco pumping and mixing rig that incorporated a 2L6 Rotor/Stator pump and a supplied Nathan Kimmel 1-inch mixing nozzle and hose with a ½-inch diameter orifice and rubber over cap (see Appendix B). Compressed air was supplied at 50 psi at approximately 6 cfm via a ¾-inch diameter hose. The dry Acoustement[®] 40 base material, supplied in 35 lb bags, was wetted at a mix ratio of 5 gallons of water to each 35 lb bag of dry material and mechanically mixed for approximately 2 minutes to form a pumpable slurry (see Figure 2.4). A “key” or “flock” coat (see-through sputter coat) was applied to establish an adhesion “tooth” on which to apply subsequent layers (see Figure 2.5). Plastic tarp and roofing felt were used to

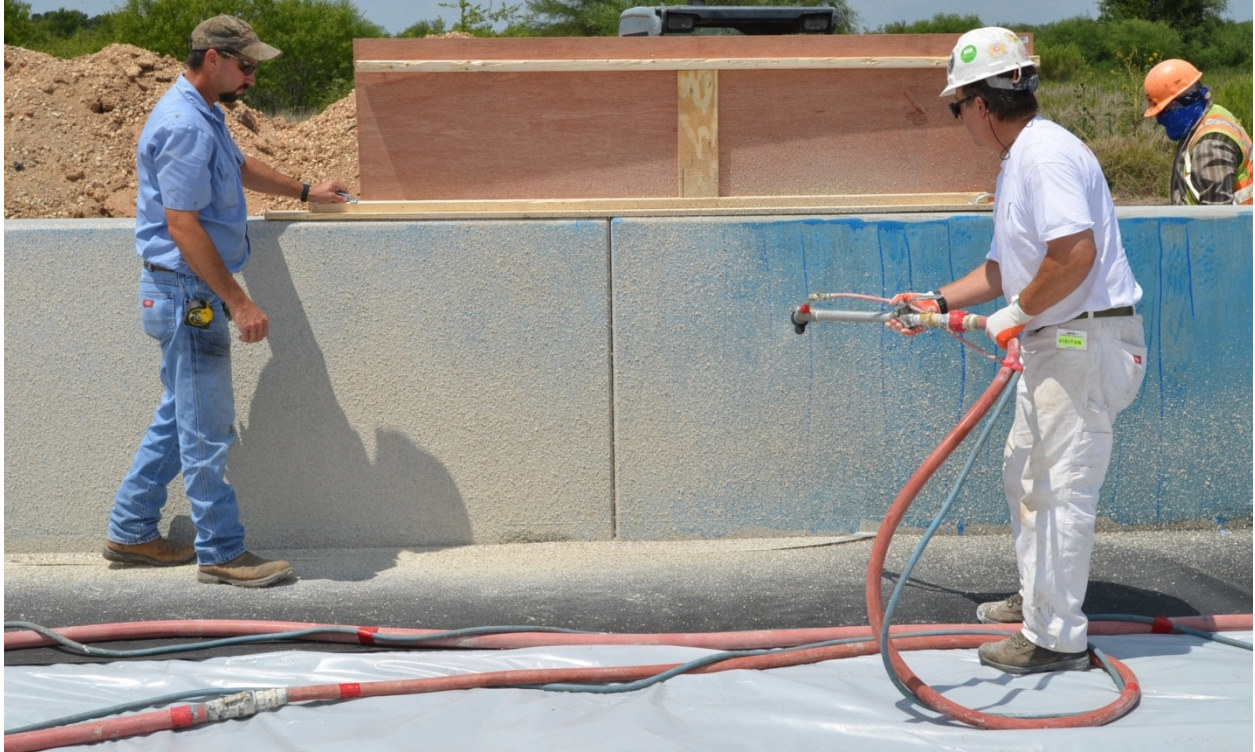
Figure 2.5. Application of First “Key” or “Flock” Coat of Acoustement® 40.

shield the pavement from the spray, and a plywood shield was moved along the barrier to prevent overspray. The next day, three additional coats of approximately 1/8-inch thick per pass were applied to a final built-up nominal thickness of 1/2 inch. The coating buildup is shown in Figure 2.6, and the application of the final coat is shown in Figure 2.7. After the final coat, the surface was lightly troweled by hand to knock down the peaks to the specified semi-smooth surface finish and thickness (see Figure 2.8). Photos of the finished coating surface are shown in Figure 2.9, and the completed test installation is shown in Figure 2.10. The Acoustement® 40 product sets overnight as a low density coating, and like most cementitious concrete, is considered fully cured in 28 days. Fifteen bags (525 lb) of Acoustement® 40 material were used to coat one side of the four barrier segments for the entire 80 foot length.

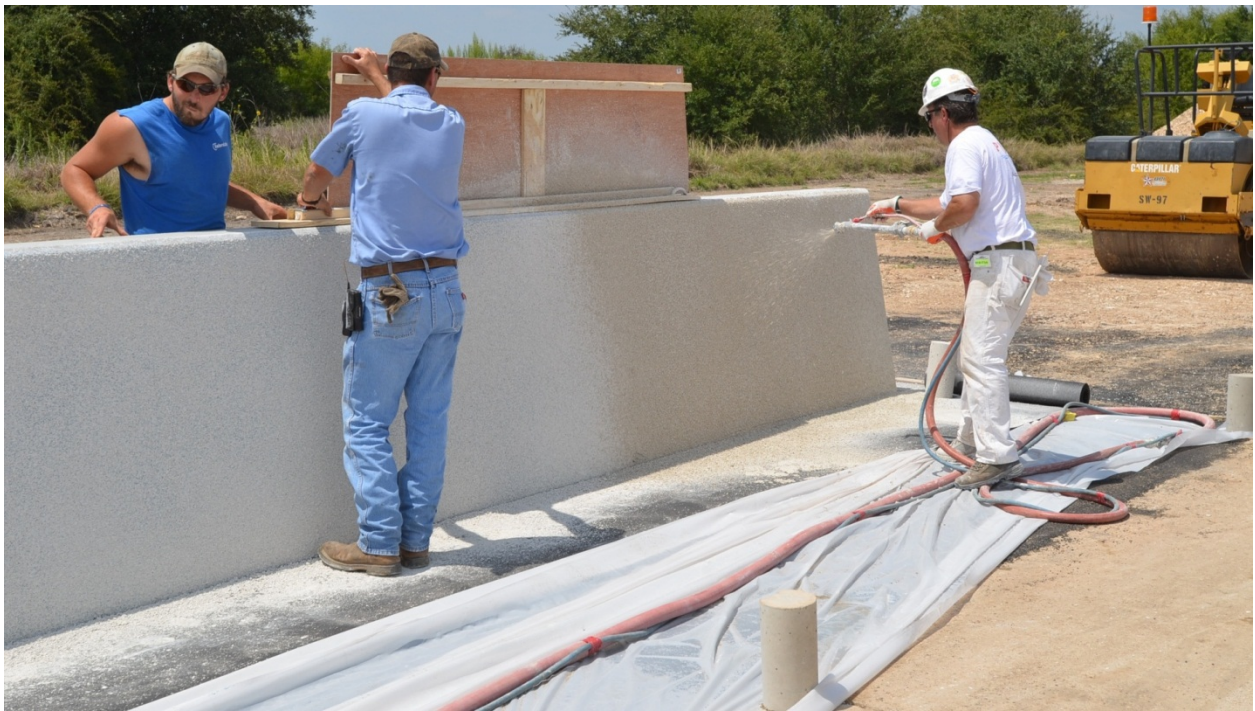
Figure 2.6. Coating Buildup of Acoustement® 40.

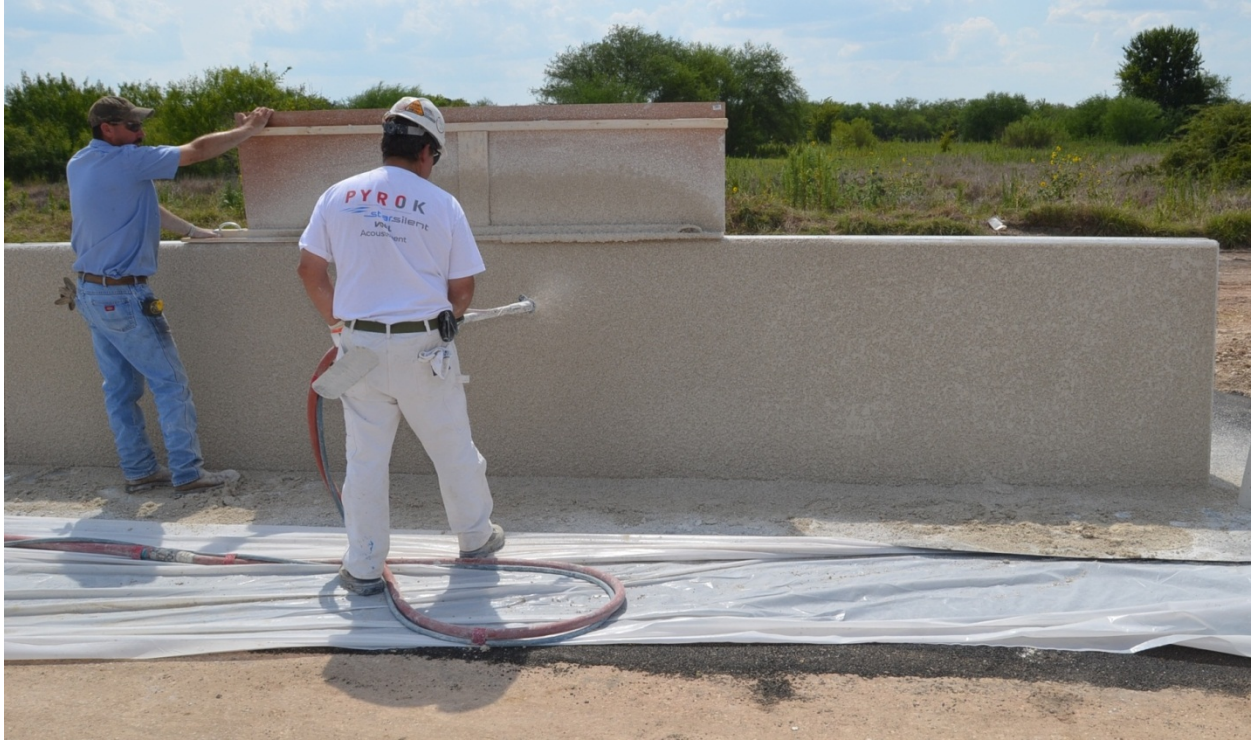
Figure 2.7. Application of Final Coat of Acoustement® 40.

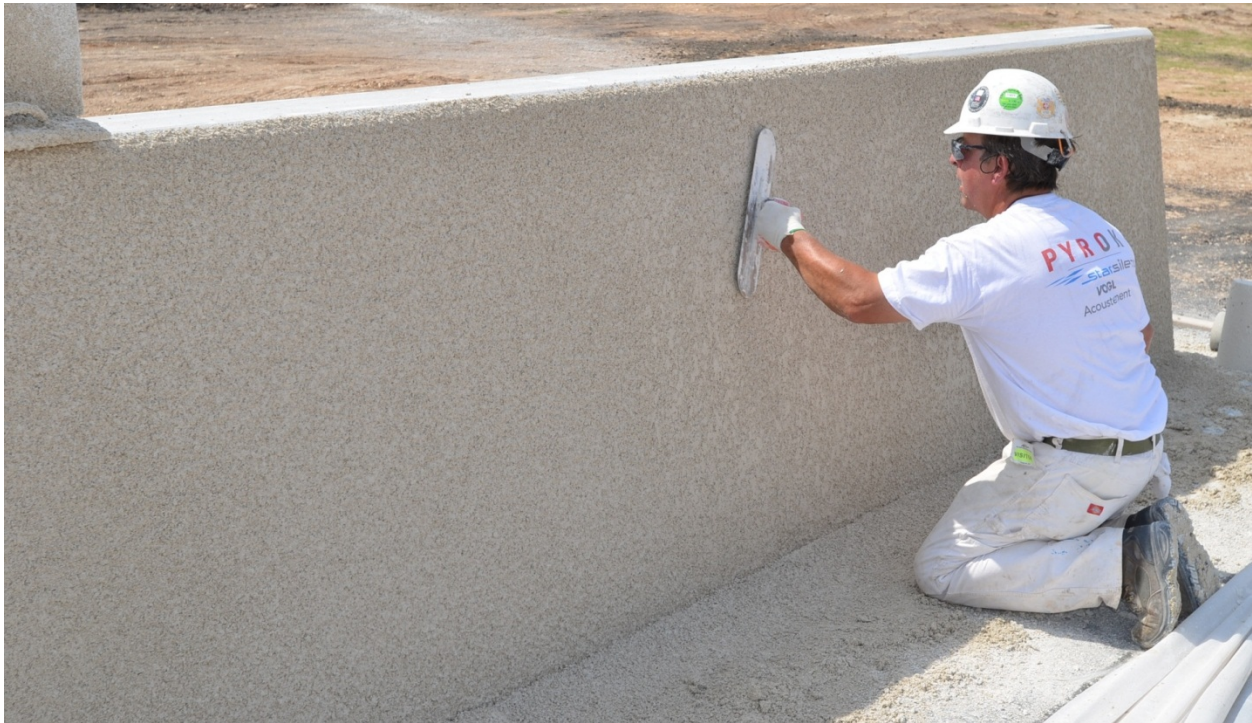
Figure 2.8. Light Hand Finishing of Acoustement® 40 coating.

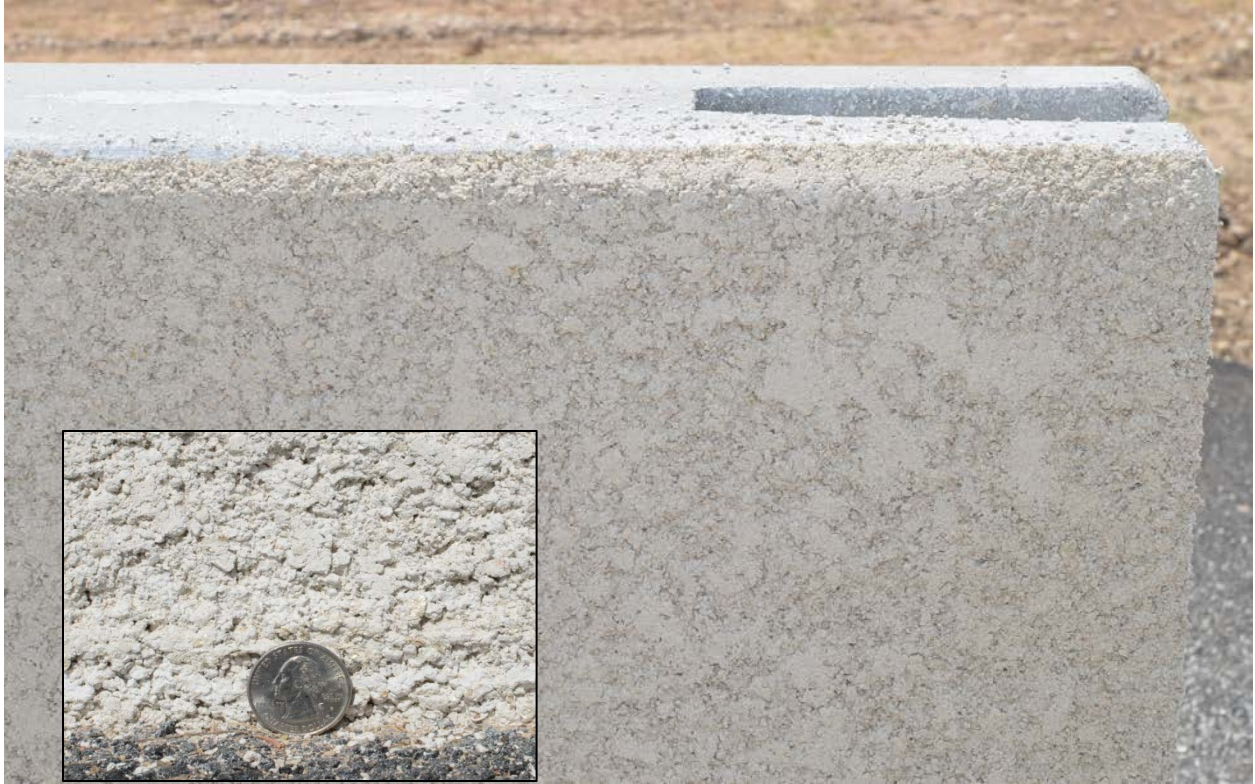
Figure 2.9. Finished Acoustement® 40 coating.

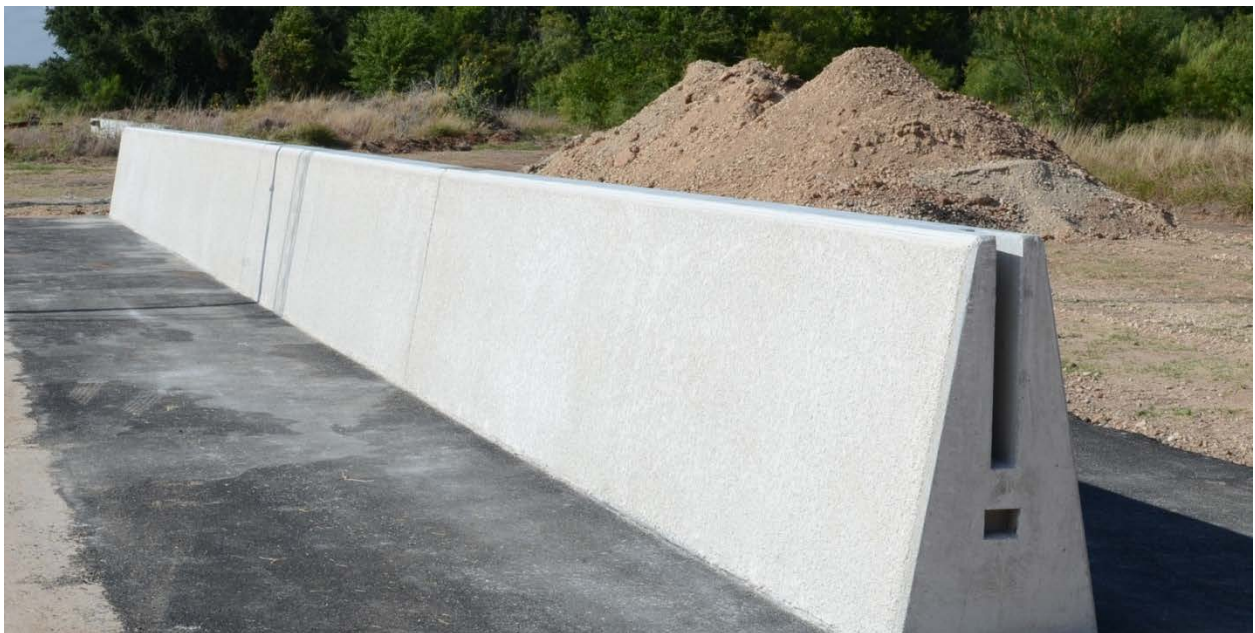
Figure 2.10. Completed test installation.

Photographs of the completed test installation are shown in Figure 2.10.

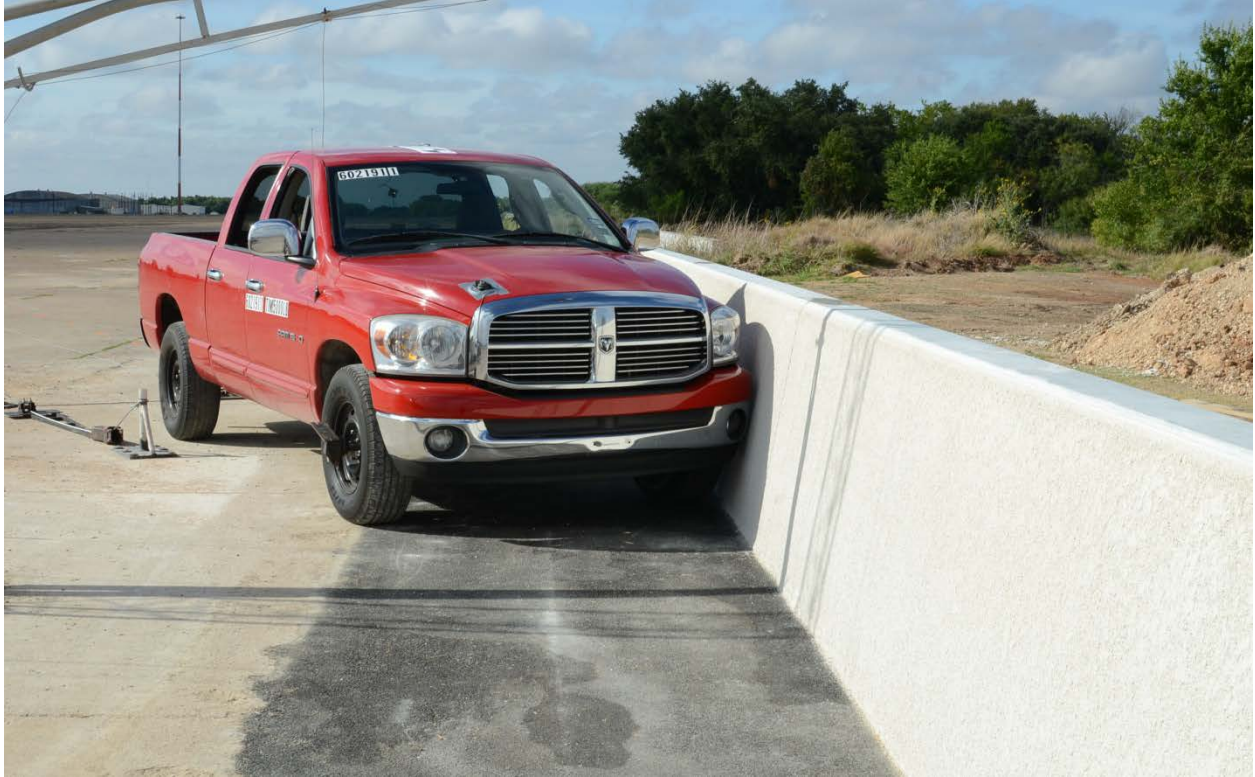
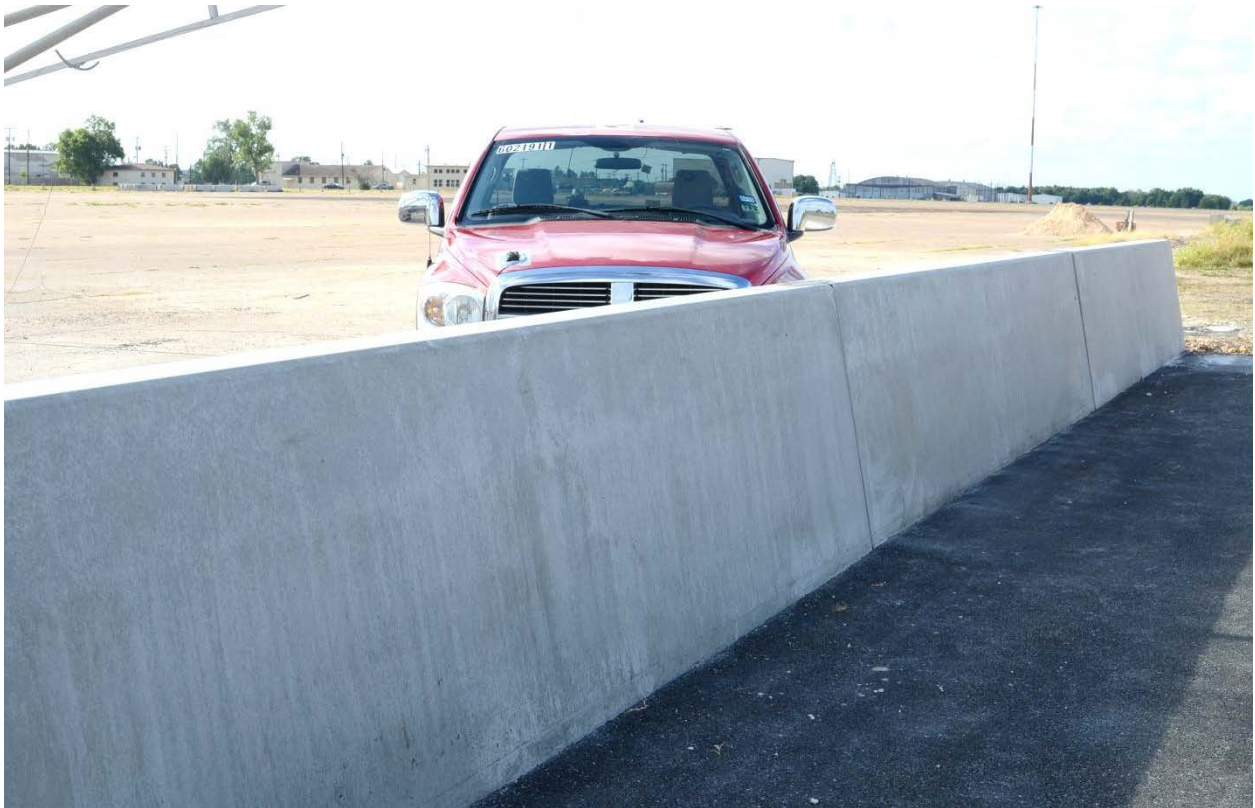
Figure 5.1. Vehicle/Installation Geometrics for Test No. 602191-1.

The 2007 Dodge Ram 1500 pickup truck, traveling at an impact speed of 63.2 mi/h, contacted the barrier 44 inches upstream of the joint between segments 2 and 3 at an impact angle of 24.8 degrees. At approximately 0.042 s, the 2270P vehicle began to redirect, and the vehicle yawed to be parallel with the barrier at 0.216 s. As the vehicle traveled forward, a dust cloud from the acoustic coating blocked much of the high-speed camera views. It is estimated that the vehicle lost contact with the barrier at 0.312 s, traveling at an exit speed and angle of 46.5 mi/h and 1.6 degrees, respectively. Brakes on the vehicle were applied 1.3 s after impact, and the vehicle came to rest 150.7 ft downstream of impact, with the centerline of the vehicle aligned with the centerline of the barrier. Appendix D.2, Figure D.1 and Figure D.2 present sequential photographs of the test.

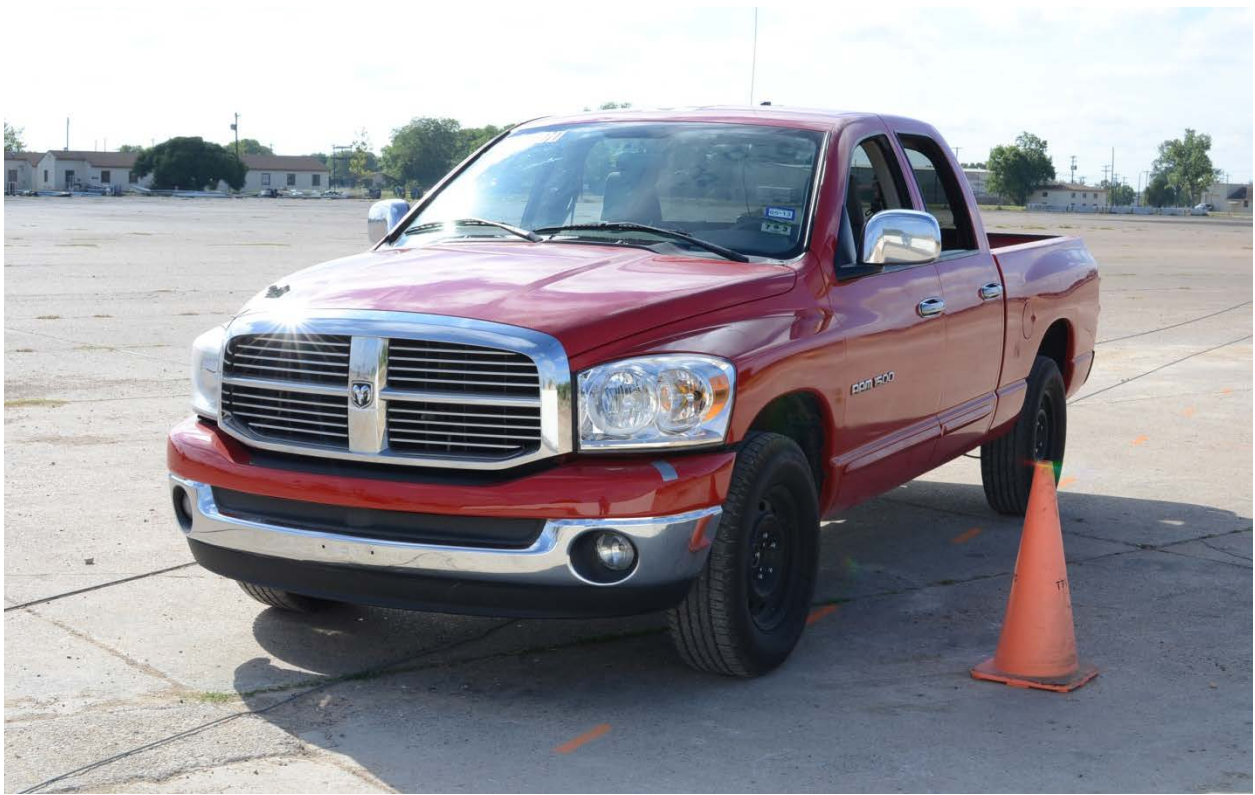
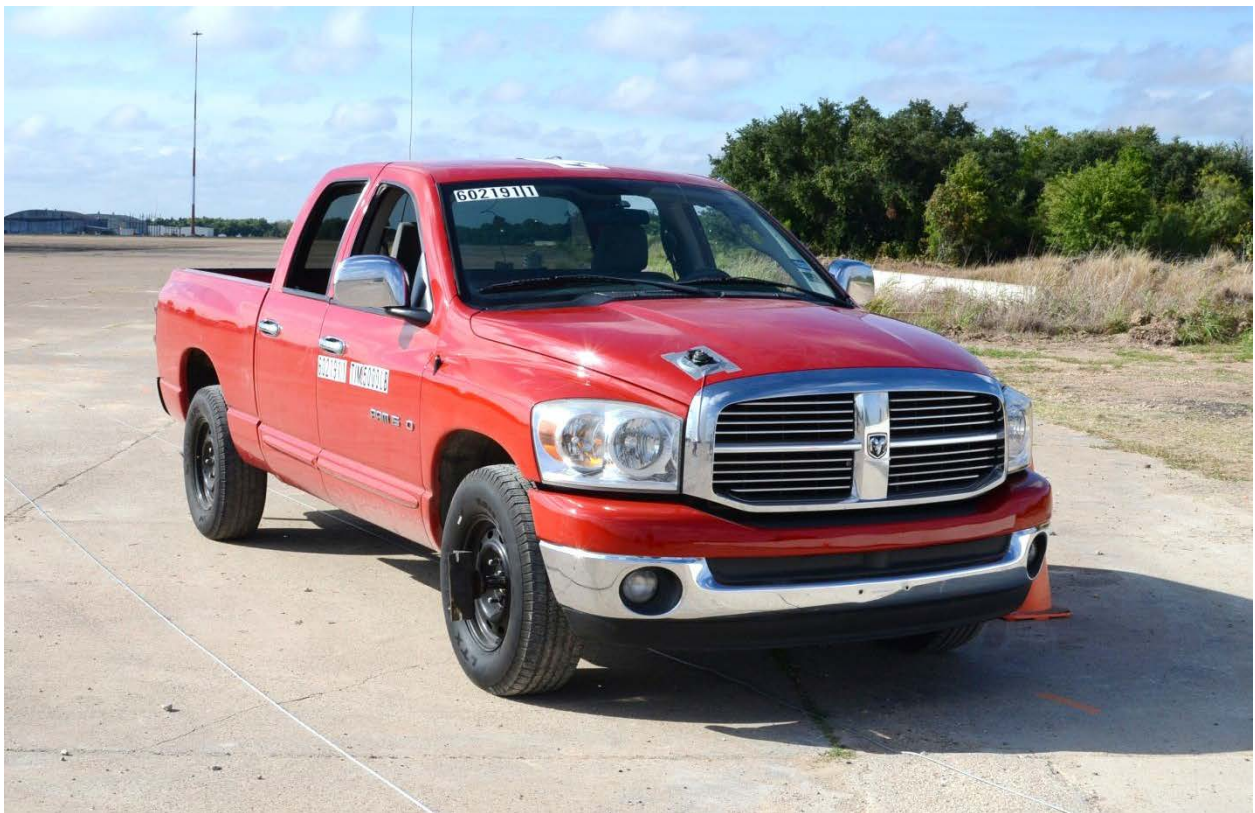
Figure 5.2. Vehicle before Test No. 602191-1.

Figure 5.1 and Figure 5.2 show the 2007 Dodge Ram 1500 pickup truck used in the crash test. Test inertia weight of the vehicle was 5031 lb, and its gross static weight was 5031 lb. The height to the lower edge of the vehicle front bumper was 15.25 inches, and the height to the upper edge of the front bumper was 27.00 inches. The height to the center of gravity was 28.25 inches. Additional dimensions and information on the vehicle are given in Appendix D.1, Table D.1 and Table D.2. The vehicle was directed into the installation using a cable reverse tow and guidance system, and was released to be freewheeling and unrestrained just prior to impact.

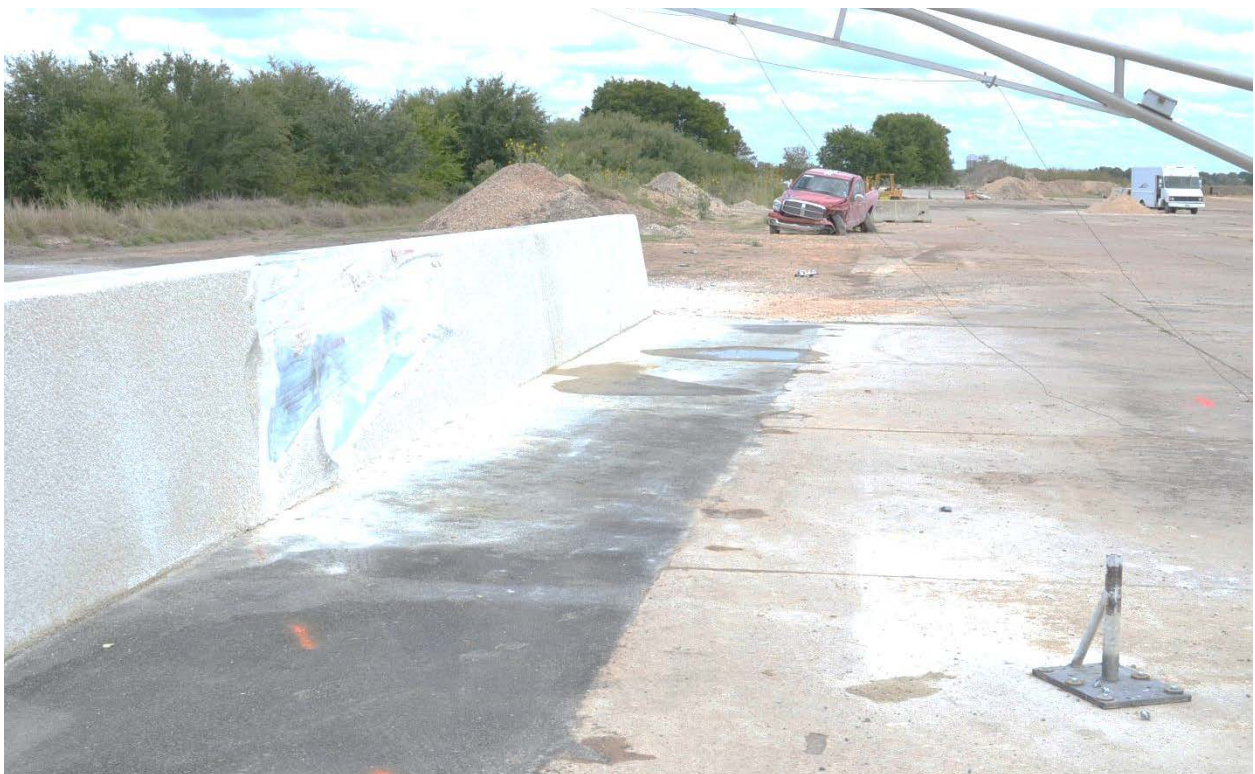
Figure 5.3. Vehicle/Washington Concrete Traffic Barrier with Acoustic Coating Positions after Test No. 602191-1.

Figure 5.3 and Figure 5.4 show damage to the Washington concrete traffic barrier with acoustic coating. The acoustic coating material was scraped off the surface of the barrier exposing the blue undercoat, and the barrier sustained scuff marks. There was no discernible movement of the barrier and no structural cracking noted. Length of contact of the vehicle with the barrier was 13.7 ft. No measurable dynamic deflection or permanent deformation was noted. Working width was 9.2 inches, and vehicle penetration was 10.3 inches.

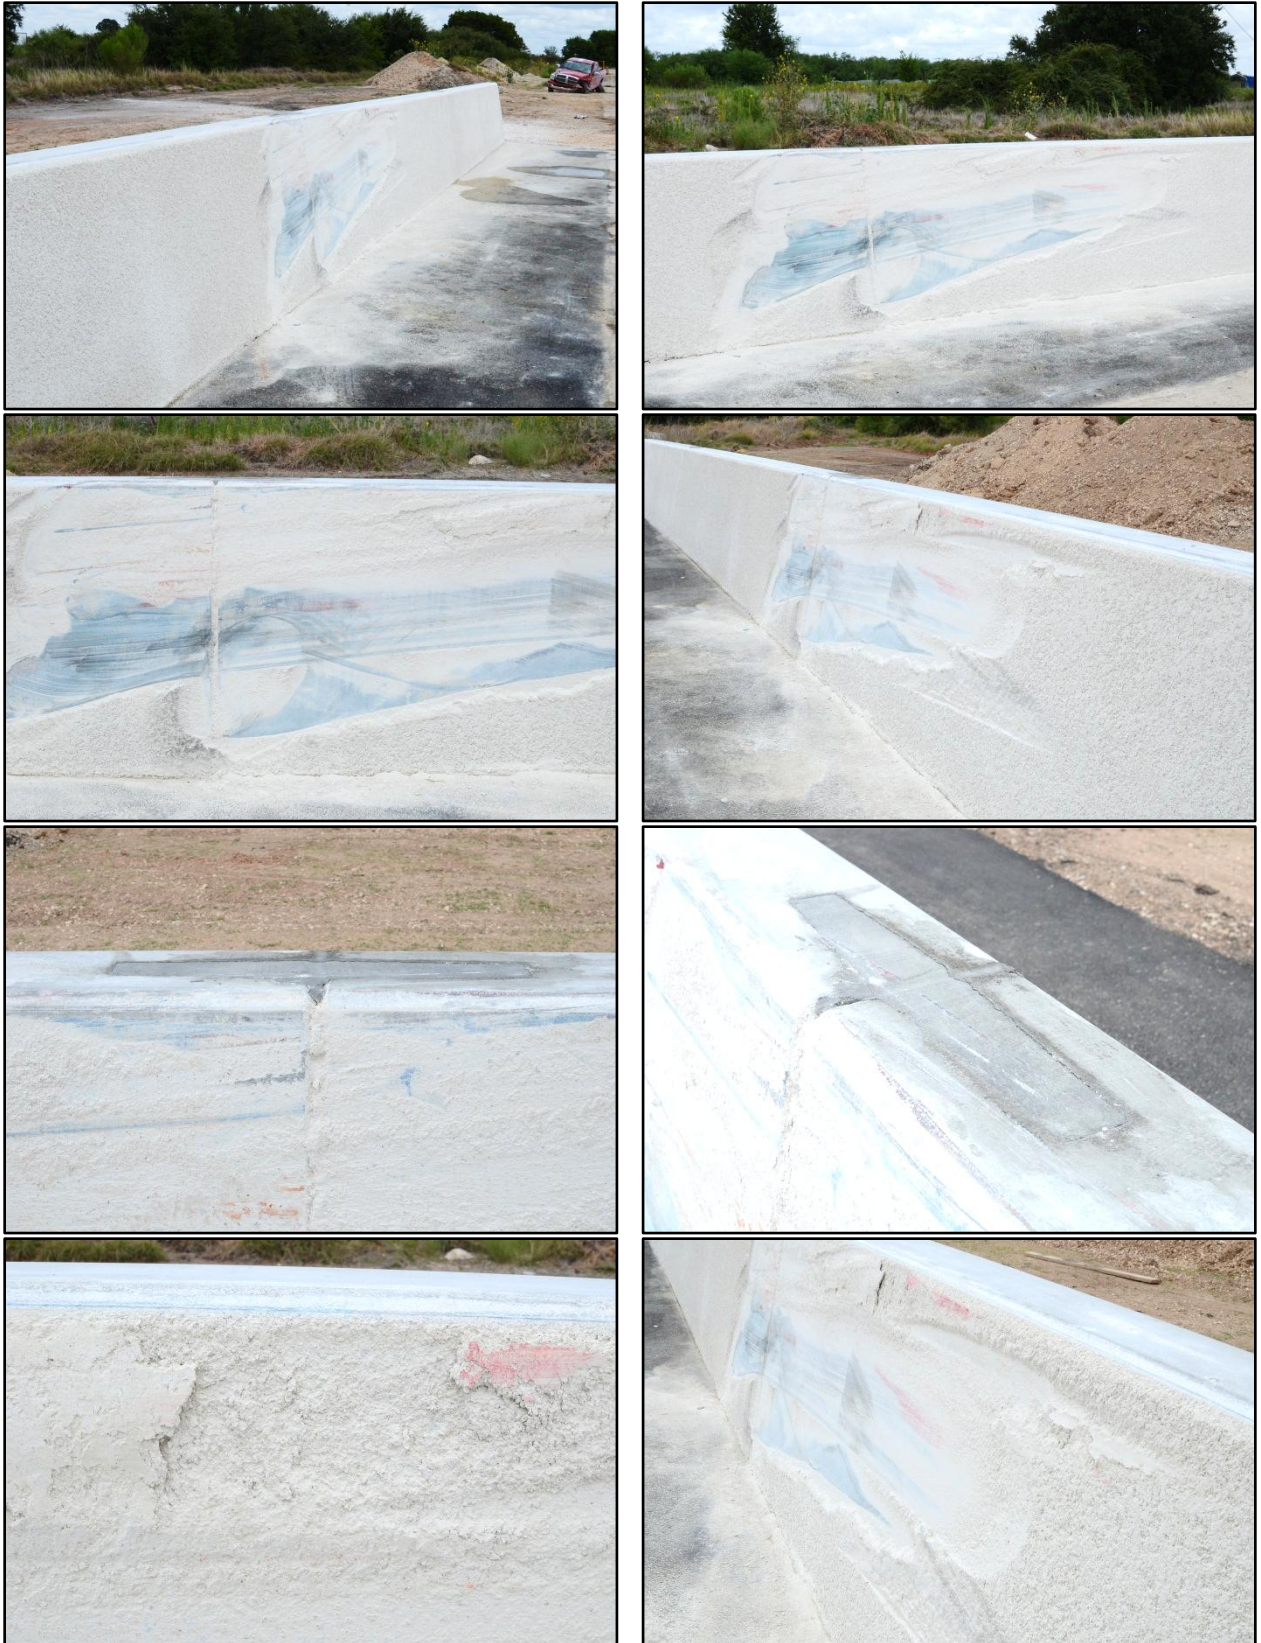
Figure 5.4. Installation after Test No. 602191-1.

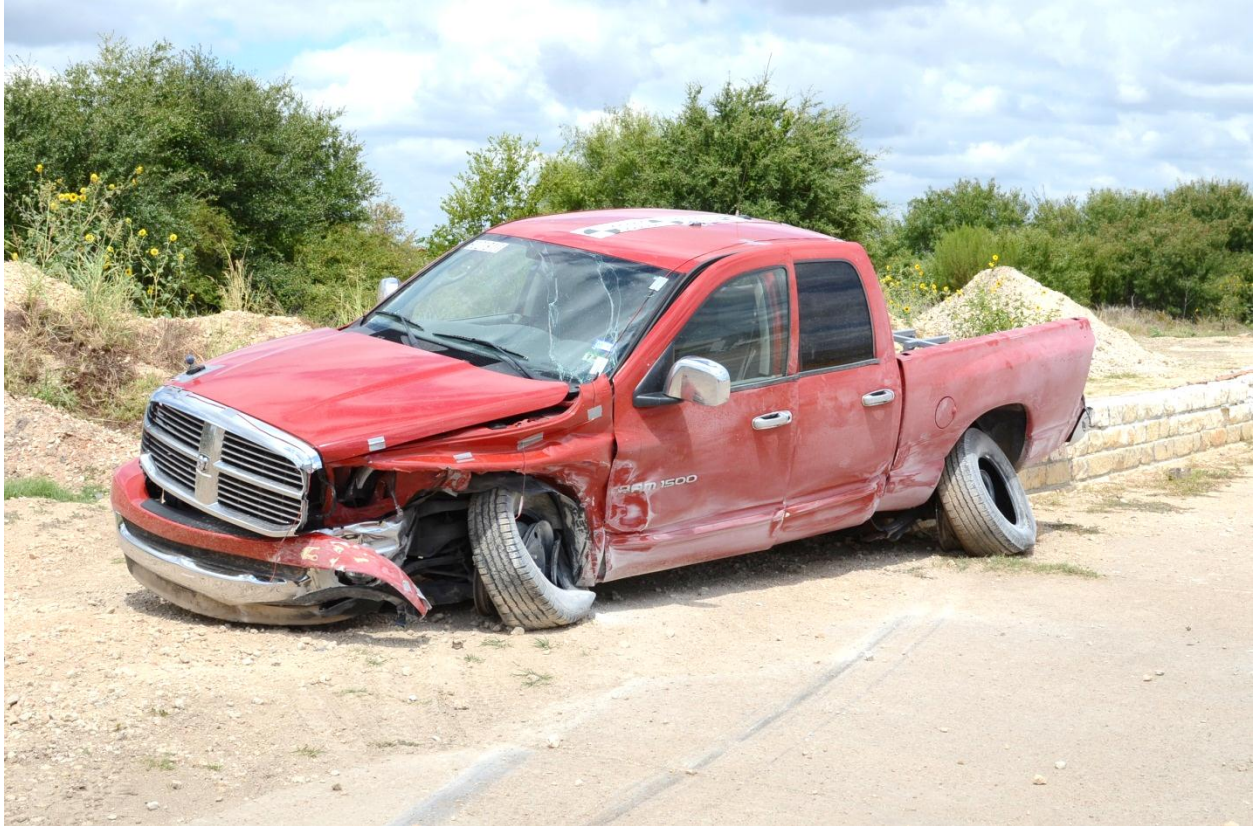
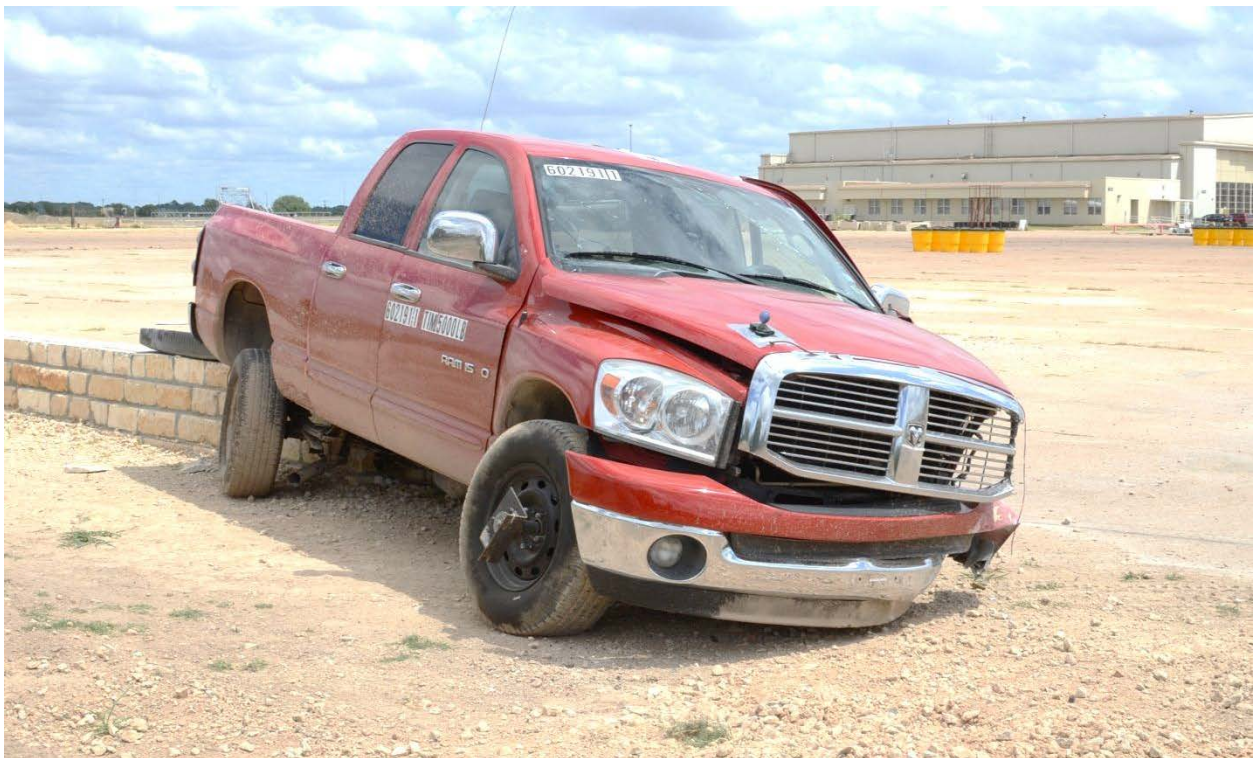
Figure 5.5. Vehicle after Test No. 602191-1.

Figure 5.5 shows damage to the vehicle after the test. The left frame rail, left front upper and lower A-arm, rear axle, and drive shaft were deformed. Also damaged were the front bumper, hood, grill, radiator and support, left front tire and wheel rim, left front fender, left front door, left rear door, left rear exterior bed, left rear tire and wheel rim, left rear tail gate, and left rear bumper. Maximum exterior crush to the vehicle was 24.0 inches in the side plane at the left front corner at bumper height. Maximum occupant compartment deformation was 2.25 inches in the left kick panel. Figure 5.6 shows the interior of the vehicle. Exterior vehicle crush and occupant compartment measurements are shown in Appendix D.2, Table D.3 and Table D.4.

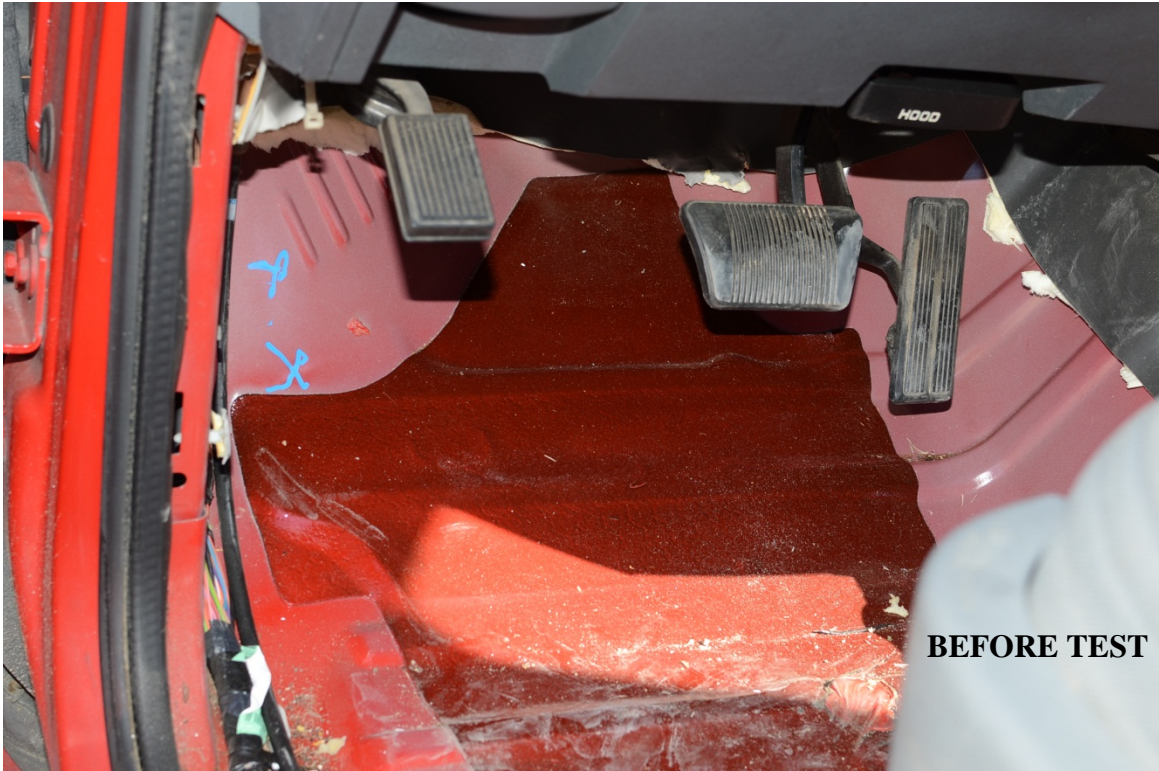
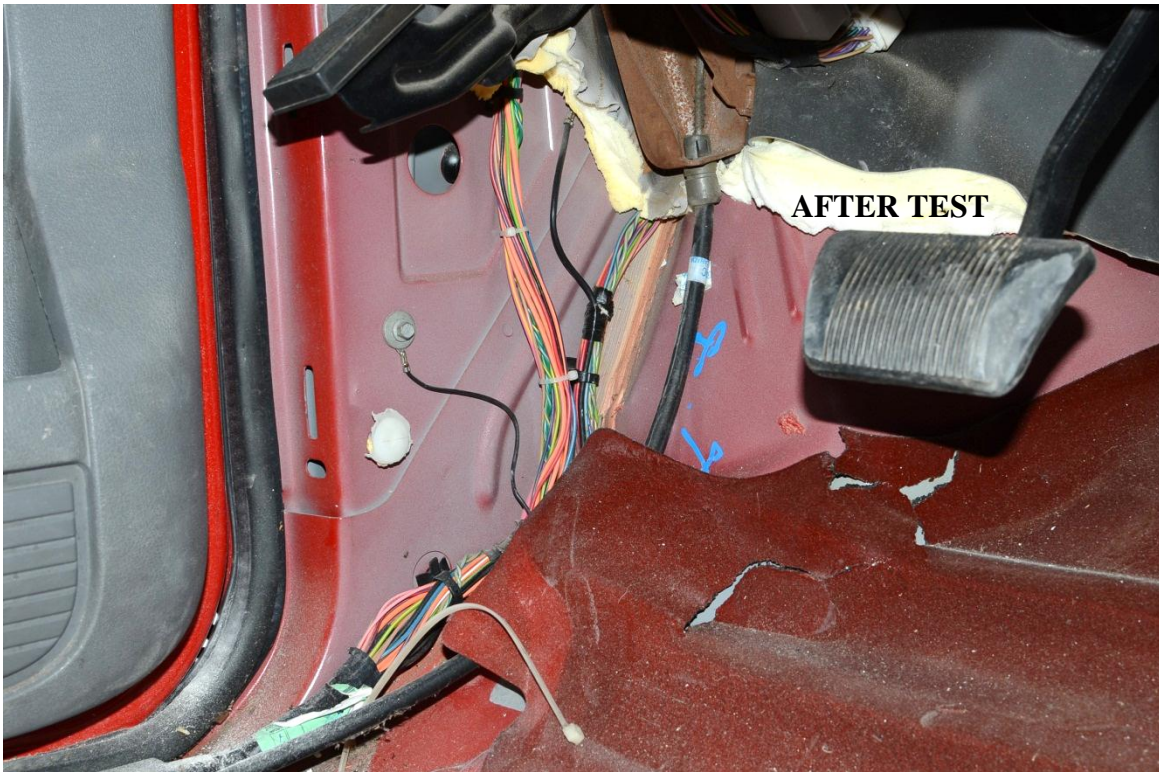
Figure 5.6. Interior of Vehicle for Test No. 602191-1.

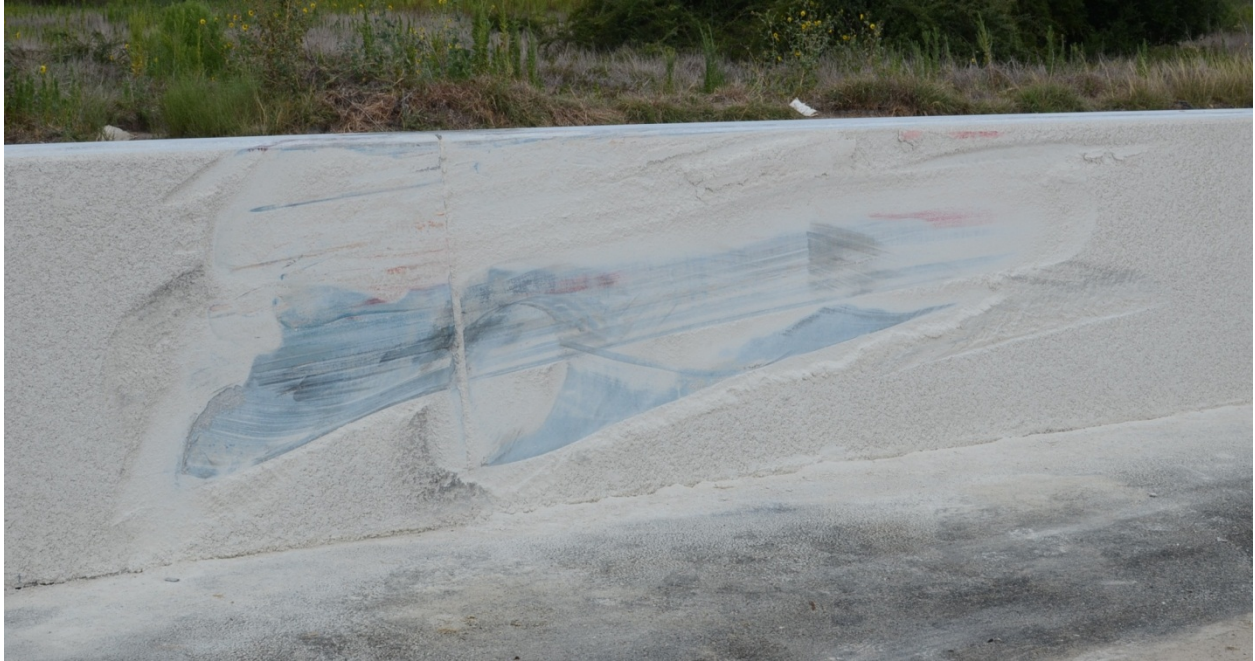
Figure 5.8. Damaged Coating after Test.

One week after the crash test, repairs were made to the Acoustement[®] 40 coating in the areas affected by the vehicle impact (see Figure 5.8). The edges of the damaged coating were first smoothed with a trowel (see Figure 5.9). The affected area was then washed down with water to remove any loose material (see Figure 5.10). The same equipment and similar procedures to those described for the initial coating installation were then used for the repair, with the exception of the Weld-Crete[®] concrete bonding agent that was already in place (see Figure 5.11). The repair process, including all four coats, was completed in one day. The area requiring repair was approximately 39 sq ft (see Figure 5.12), and required approximately three bags (105 lbs) of Acoustement[®] 40 material. The repairs took approximately 2 hours to complete, including setup, application, and cleanup. The coating immediately after repair (before site cleanup) is shown in Figure 5.13. The coating after a subsequent rain storm is shown in Figure 5.14.

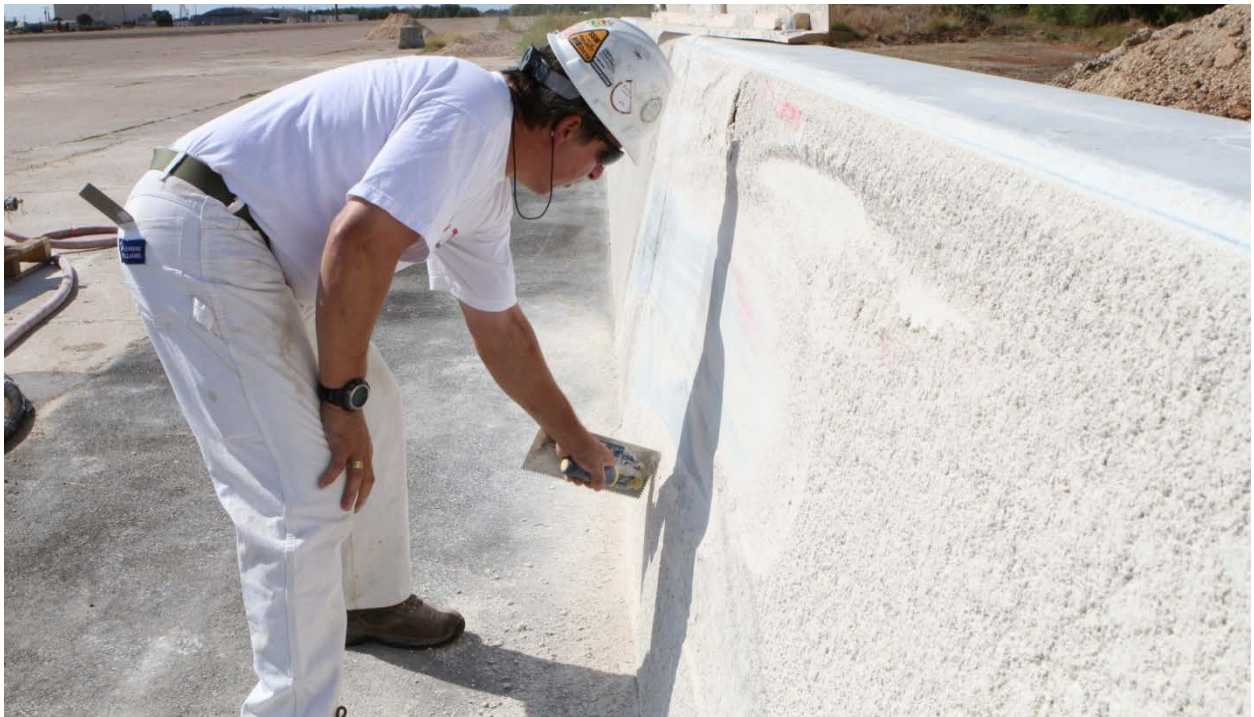
Figure 5.9. Preparing Edges of Damaged Coating for Repair.
