Test Report No. 602191-1
Test Report Date: October 2013

**MASH TEST 3-11 ON THE WASHINGTON CONCRETE
TRAFFIC BARRIER WITH ACOUSTIC COATING**

TEXAS A&M TRANSPORTATION INSTITUTE PROVING GROUND

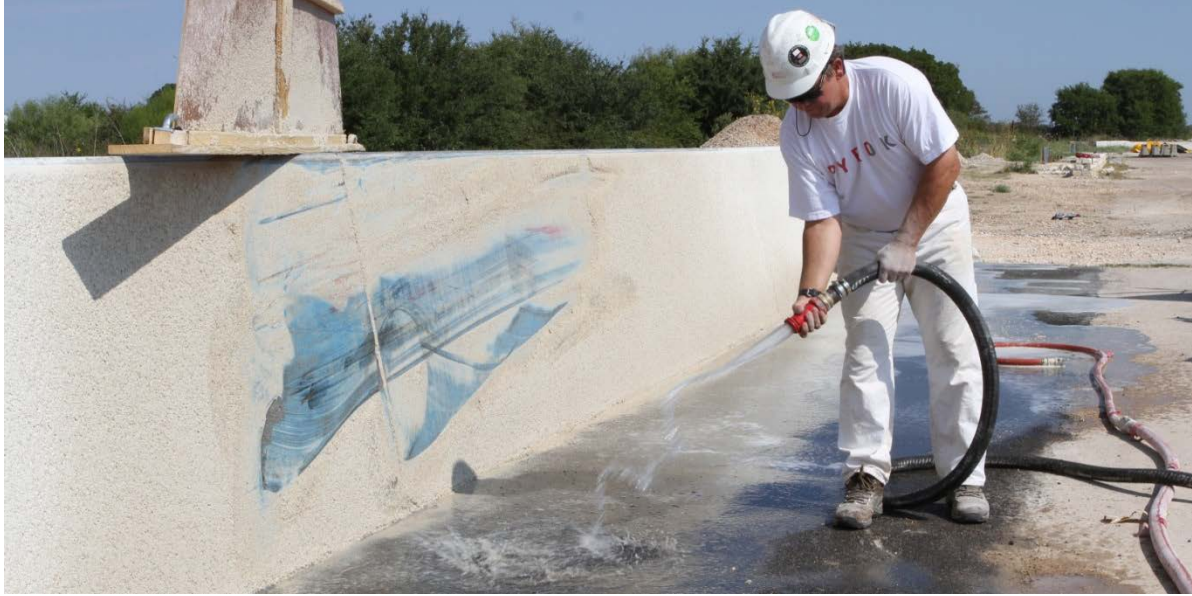
Figure 5.10. Washing Down Damaged Coating Area.

One week after the crash test, repairs were made to the Acoustement[®] 40 coating in the areas affected by the vehicle impact (see Figure 5.8). The edges of the damaged coating were first smoothed with a trowel (see Figure 5.9). The affected area was then washed down with water to remove any loose material (see Figure 5.10). The same equipment and similar procedures to those described for the initial coating installation were then used for the repair, with the exception of the Weld-Crete[®] concrete bonding agent that was already in place (see Figure 5.11). The repair process, including all four coats, was completed in one day. The area requiring repair was approximately 39 sq ft (see Figure 5.12), and required approximately three bags (105 lbs) of Acoustement[®] 40 material. The repairs took approximately 2 hours to complete, including setup, application, and cleanup. The coating immediately after repair (before site cleanup) is shown in Figure 5.13. The coating after a subsequent rain storm is shown in Figure 5.14.

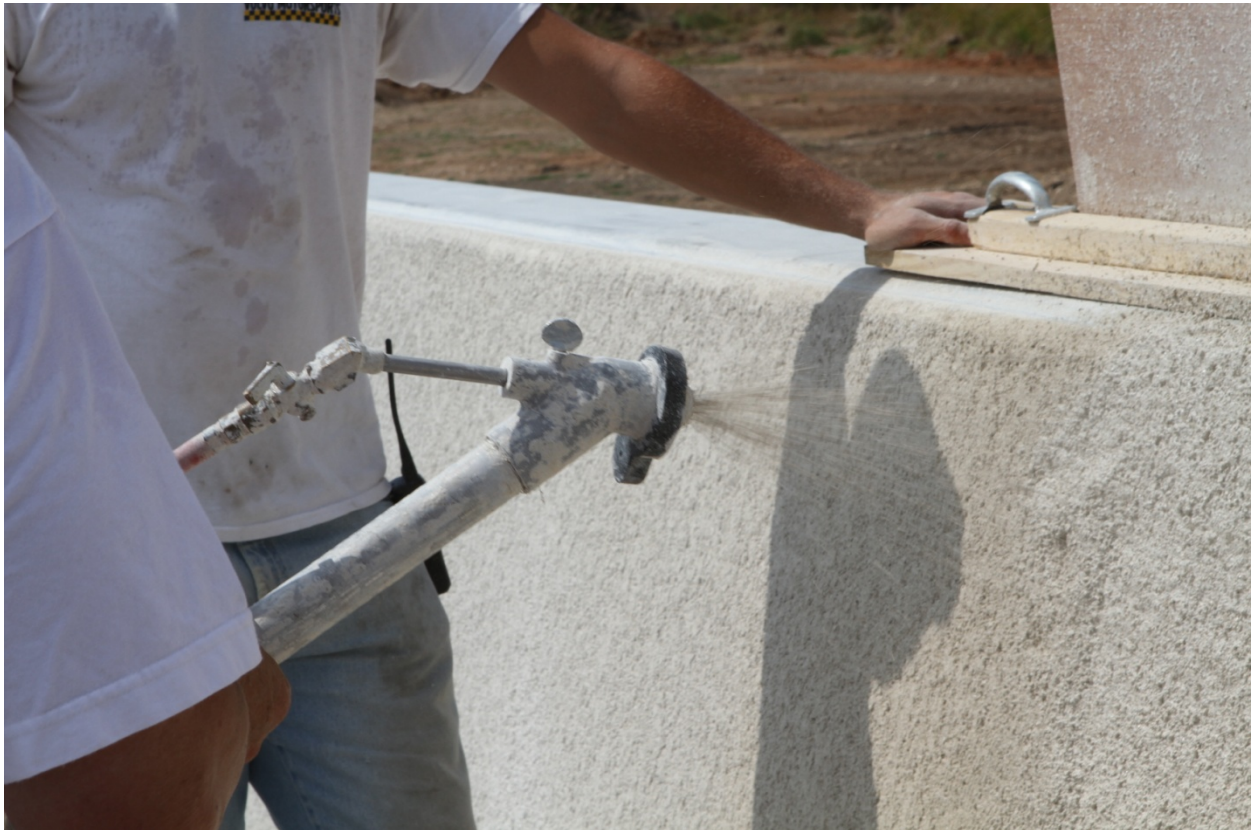
Figure 5.11. Application of Repair Coat.

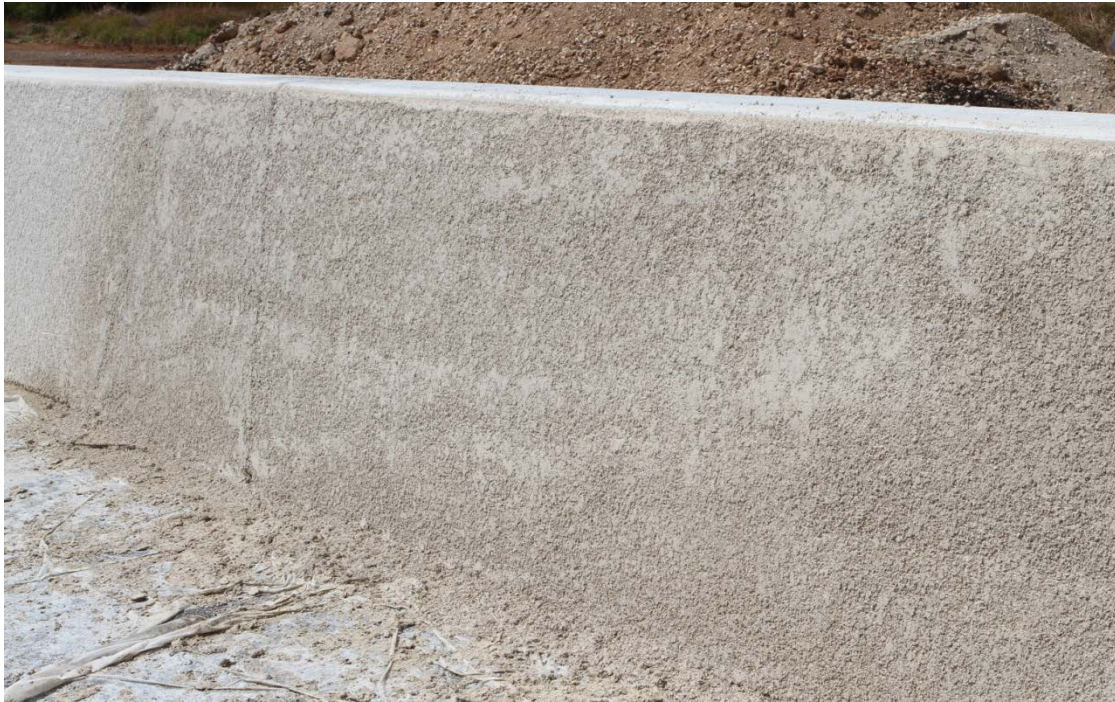
Figure 5.13. Repaired Coating.

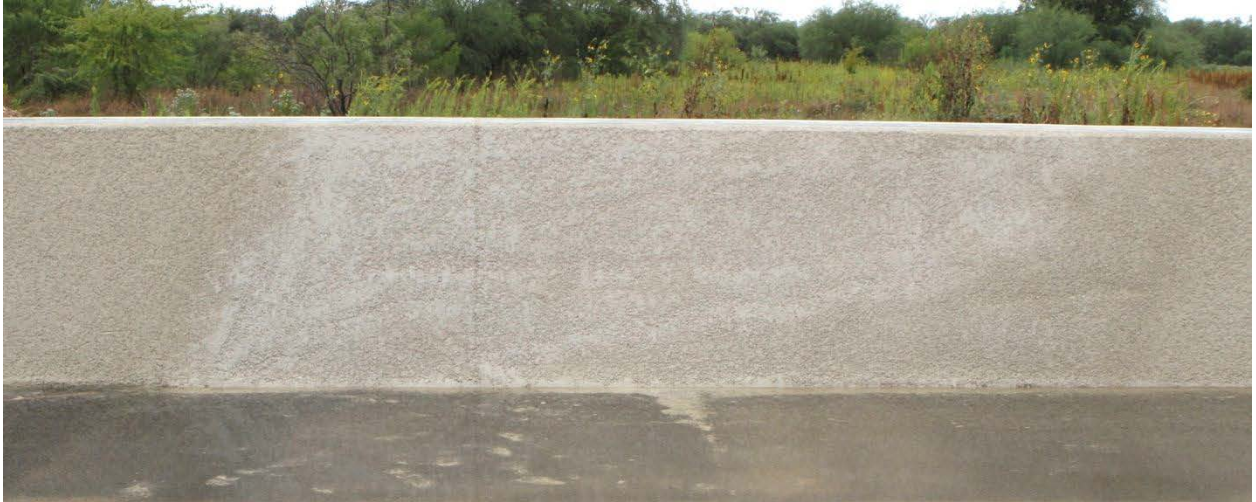
Figure 5.14. Repaired coating after rain.

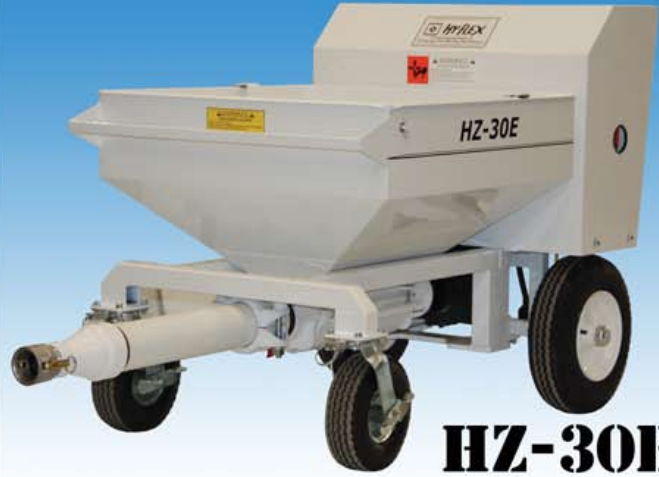
HZ-30E

Power	5 HP Variable Speed
Power Requirement	208/240 V 30A
	1 or 3 Phase
Air Output (optional)	12 cfm
Pump Size	Optimized 2L6
Hopper Capacity	60 Gal
Hopper Height	32" / 81 cm
Volume Control	Variable 0-10 gpm
Pressure Outout	500 PSI Maximum
Directional Control	Forward and Reverse
Controls	Manual/Remote
Machine Width	33" / 839 cm
Machine Length	72" / 1829 cm
Machine Height	43" / 1092 cm
Machine Weight	585 lbs / 266 kg
Wheels - Rear	15" / 38cm OD Pneumatic
Wheels - Front	10" / 25cm OD Pneumatic Casters
Max Aggregate Size	.125" / 3 mm
Max Pumping Distance	200' (Note: It can be greater or less)
Optional Equipment	Air Compressor

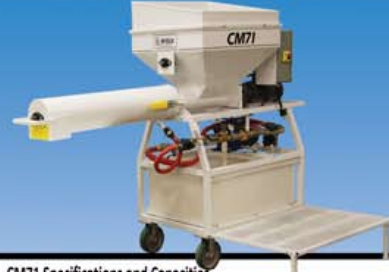
CM71

Power	3 HP	Machine Width	28" / 71cm - 30" / 76cm (with Platform)
Power Requirement	230 V Single Phase 20A	Machine Length	92.5" / 235 cm (with 40" mix tube)
Mixer Output	70 Bags Per Hour	Machine Height	70.5" / 179 cm
Hopper Capacity	3 Bags	Machine Weight	693 lbs / 314 kg
Charge Height	54" / 137 cm	Wheels	8" Rigid and Swivel Casters
Volume Control	Single Speed	Optional Equipment	Water System
Max Aggregate Size	Fireproofing		Work Platform

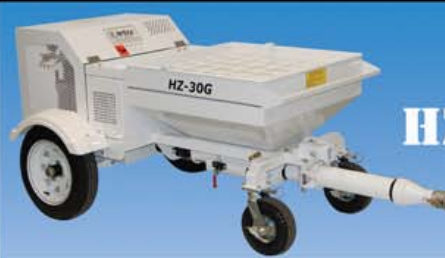
HZ-30G

Power	13 HP Honda Gas Engine	Controls	Manual/Remote
Fuel Tank	1.7 Gal / 6.9 qts	Machine Width	33" / 84cm (48" / 122cm w/ Tow Package)
Pump Output	0-10 gpm	Machine Length	84" / 213cm
Pump Size	Optimized 2L6	Machine Height	42" / 107cm
Air Output	12 cfm @ 90 psi	Machine Weight	675 lbs / 306 kg
Hopper Capacity	60 Gal	Wheels - Rear	20" OD Pneumatic
Hopper Height	30 in / 76 cm	Wheels - Front	10" OD Pneumatic Casters
Volume Control	Variable 0-10 gpm	Max Aggregate Size	.125 in / 3 mm
Pressure Outout	500 PSI Maximum	Max Pumping Distance	200' (Note: It can be greater or less)
Directional Control	Forward and Reverse	Optional Equipment	Tow Package

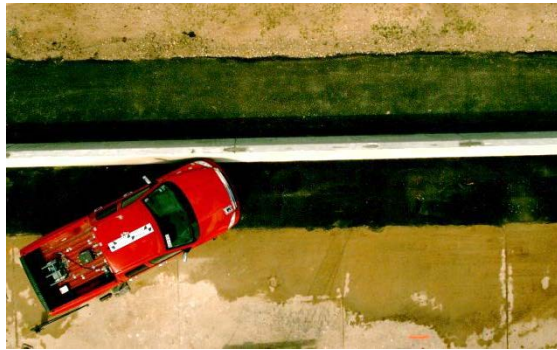
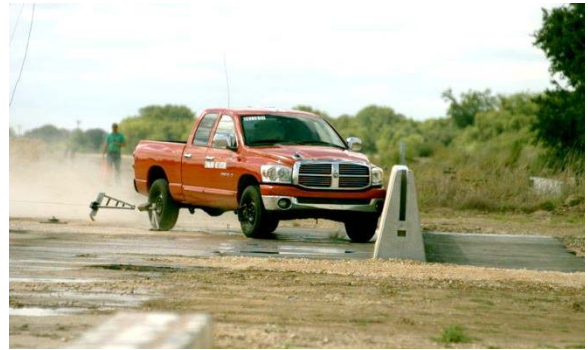
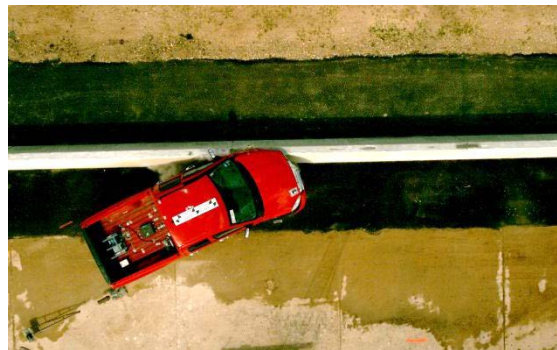
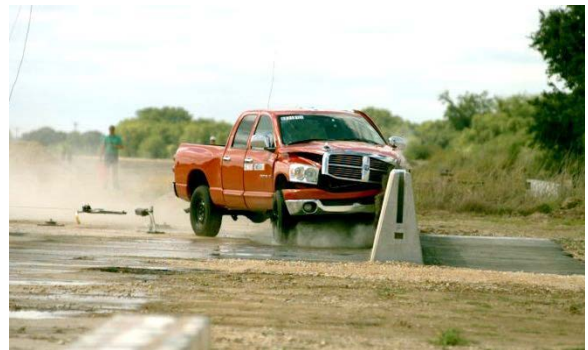
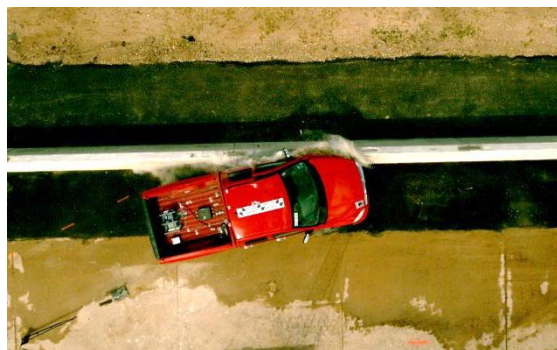
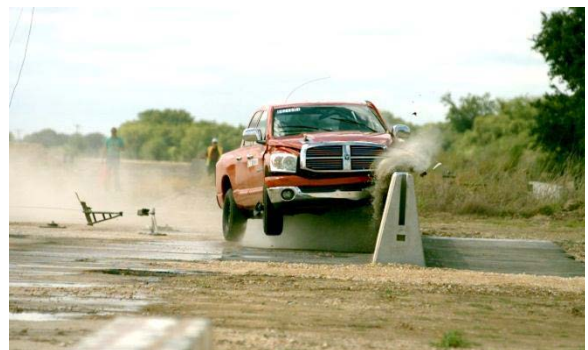
Figure D.1. Sequential Photographs for Test No. 602191-1 (Overhead and Frontal Views).

The 2007 Dodge Ram 1500 pickup truck, traveling at an impact speed of 63.2 mi/h, contacted the barrier 44 inches upstream of the joint between segments 2 and 3 at an impact angle of 24.8 degrees. At approximately 0.042 s, the 2270P vehicle began to redirect, and the vehicle yawed to be parallel with the barrier at 0.216 s. As the vehicle traveled forward, a dust cloud from the acoustic coating blocked much of the high-speed camera views. It is estimated that the vehicle lost contact with the barrier at 0.312 s, traveling at an exit speed and angle of 46.5 mi/h and 1.6 degrees, respectively. Brakes on the vehicle were applied 1.3 s after impact, and the vehicle came to rest 150.7 ft downstream of impact, with the centerline of the vehicle aligned with the centerline of the barrier. Appendix D.2, Figure D.1 and Figure D.2 present sequential photographs of the test.

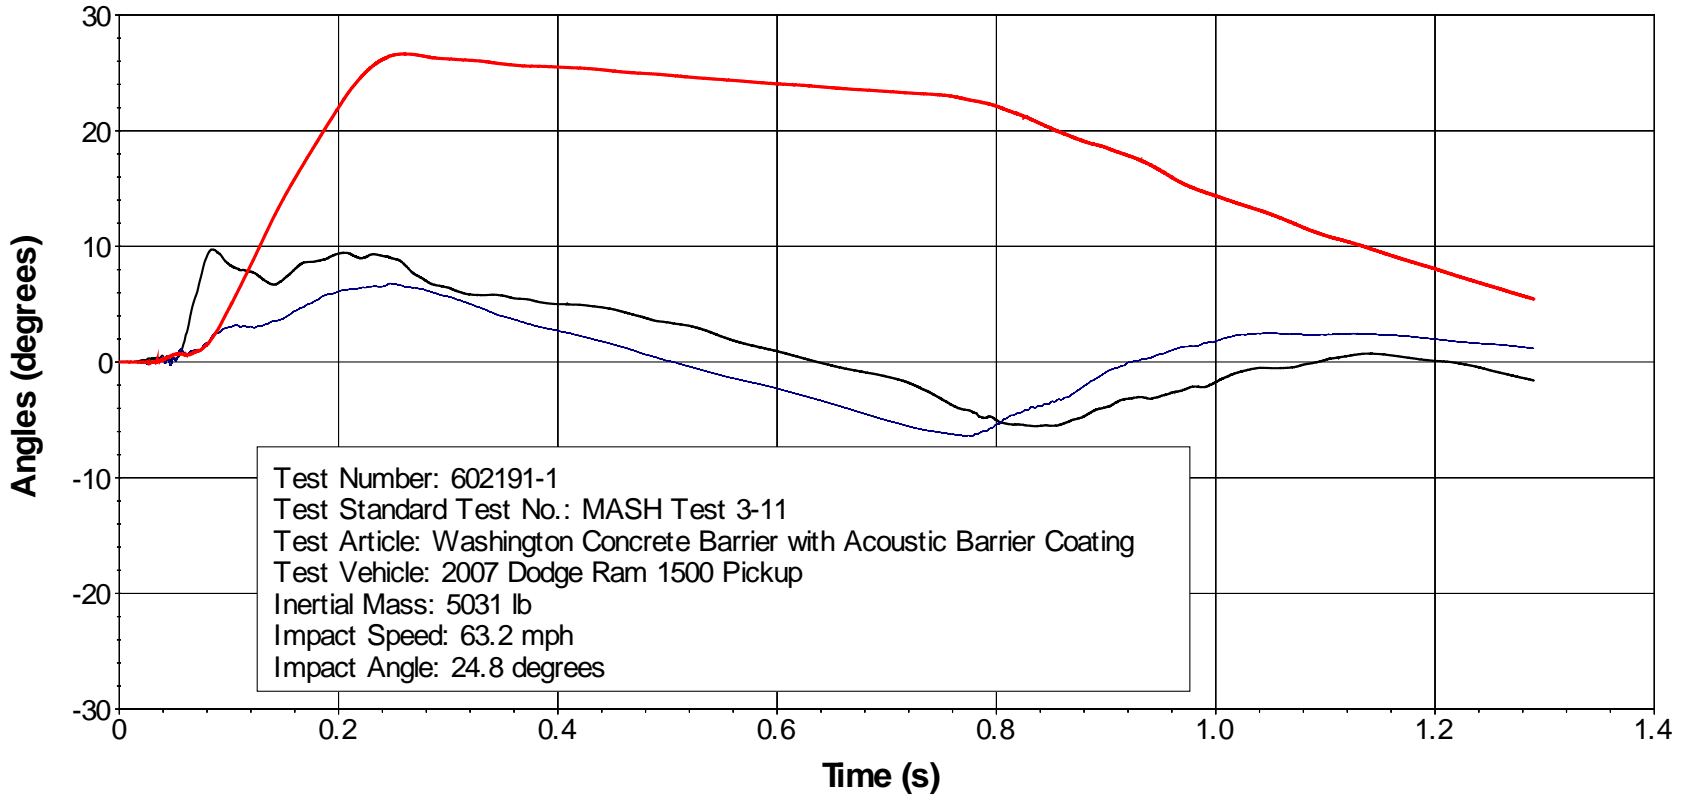
Figure D.3. Vehicle Angular Displacements for Test No. 602191-1.

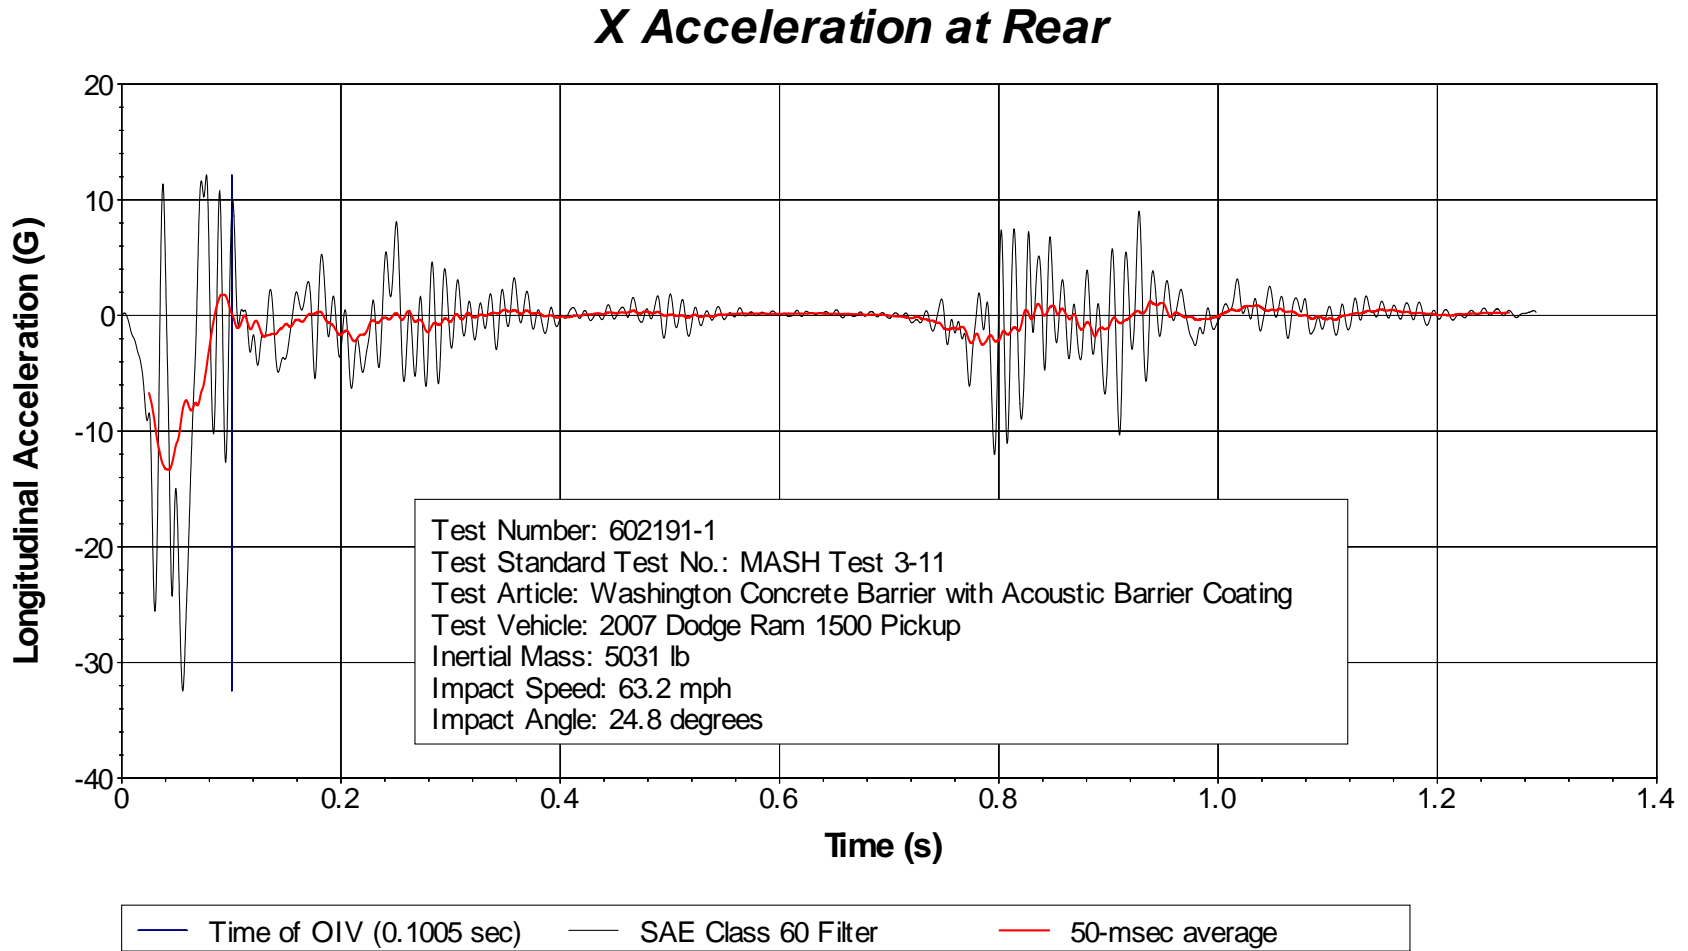
Figure D.4. Vehicle Longitudinal Accelerometer Trace for Test No. 602191-1 (Accelerometer Rear of Center of Gravity).

Data from the accelerometer, located at the vehicle center of gravity, were digitized for evaluation of occupant risk. The wire for the longitudinal accelerometer was cut during the test, therefore, the longitudinal accelerometer just to the rear of center of gravity was used for analysis. In the longitudinal direction, the occupant impact velocity was 20.3 ft/s at 0.101 s, the highest 0.010-s occupant ridedown acceleration was 6.4 Gs from 0.790 to 0.800 s, and the maximum 0.050-s average acceleration was -13.4 Gs between 0.018 and 0.068 s. In the lateral direction, the occupant impact velocity was 25.3 ft/s at 0.101 s, the highest 0.010-s occupant ridedown acceleration was 7.8 Gs from 0.208 to 0.218 s, and the maximum 0.050-s average was 13.7 Gs between 0.045 and 0.095 s. Theoretical Head Impact Velocity (THIV) was 37.2 km/h or 10.3 m/s at 0.098 s; Post-Impact Head Decelerations (PHD) was 8.8 Gs between 0.208 and 0.218 s; and Acceleration Severity Index (ASI) was 1.98 between 0.059 and 0.109 s. Figure 5.7 summarize these data and other pertinent information from the test. Vehicle angular displacements are presented in Appendix D3, Figure D.3, and accelerations versus time traces are presented in Appendix D4, Figure D.4 through Figure D.8.

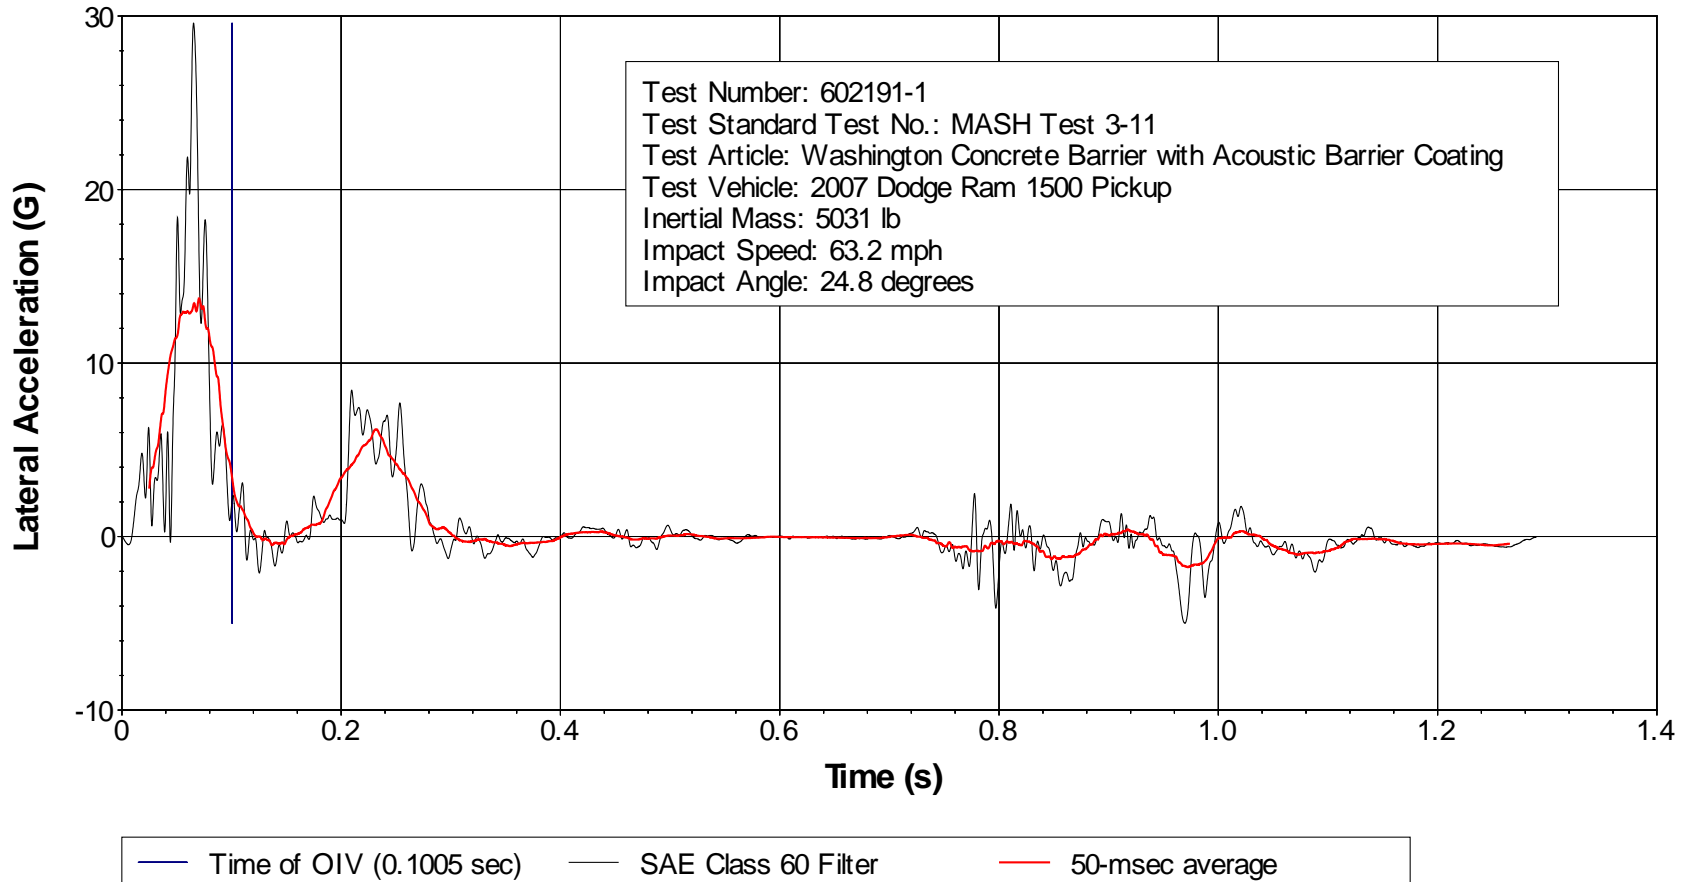
Figure D.5. Vehicle Lateral Accelerometer Trace for Test No. 602191-1 (Accelerometer Located at Center of Gravity).

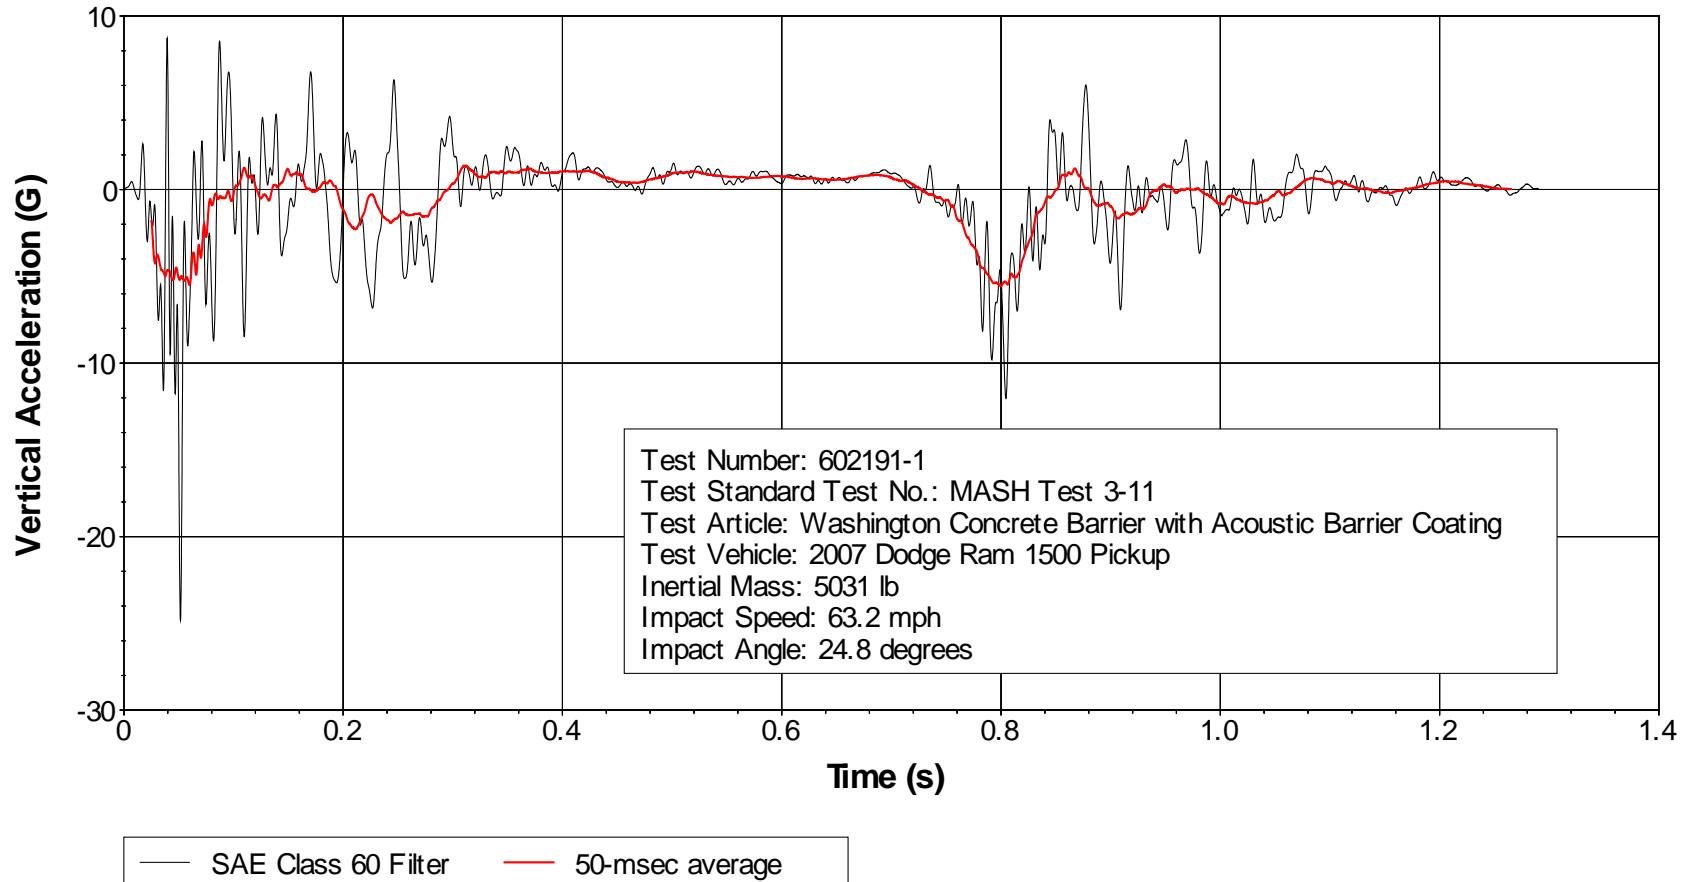
Figure D.6. Vehicle Vertical Accelerometer Trace for Test No. 602191-1 (Accelerometer Located at Center of Gravity).
