**Texas A&M
Transportation
Institute**
Proving Ground

Test Report No.: 602921-1
Test Report Date: August 2014

**MASH TEST 2-11 OF THE 31-INCH W-BEAM GUARDRAIL
WITH 12.5-FT POST SPACING**

Sponsored by **Roadside Safety Research Program Pooled Fund**
Study No. TPF-5(114)

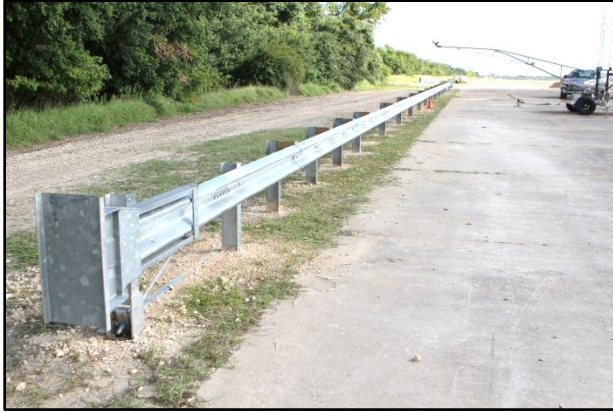
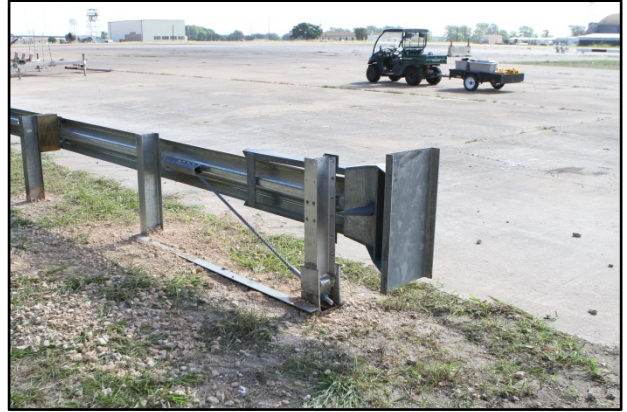
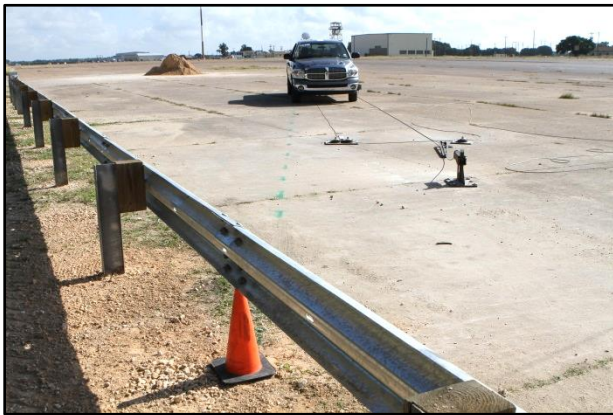
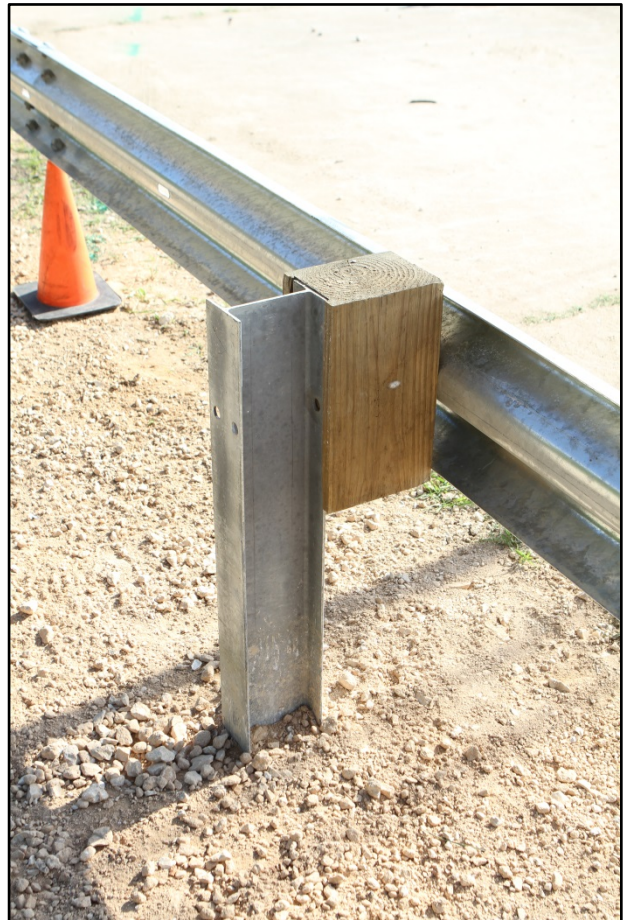
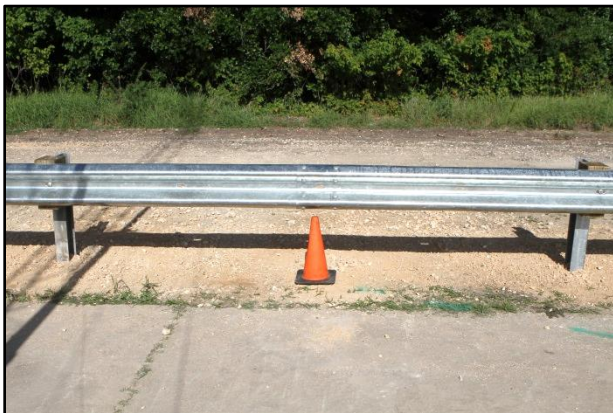
Figure 2.2. 31-inch Guardrail with 12 ft 6 inch Post Spacing Prior to Testing.

Figure 2.1 and Appendix A present further information on the 31-inch W-beam guardrail with 12 ft 6 inch post spacing, and Figure 2.2 provides photographs of the installation.

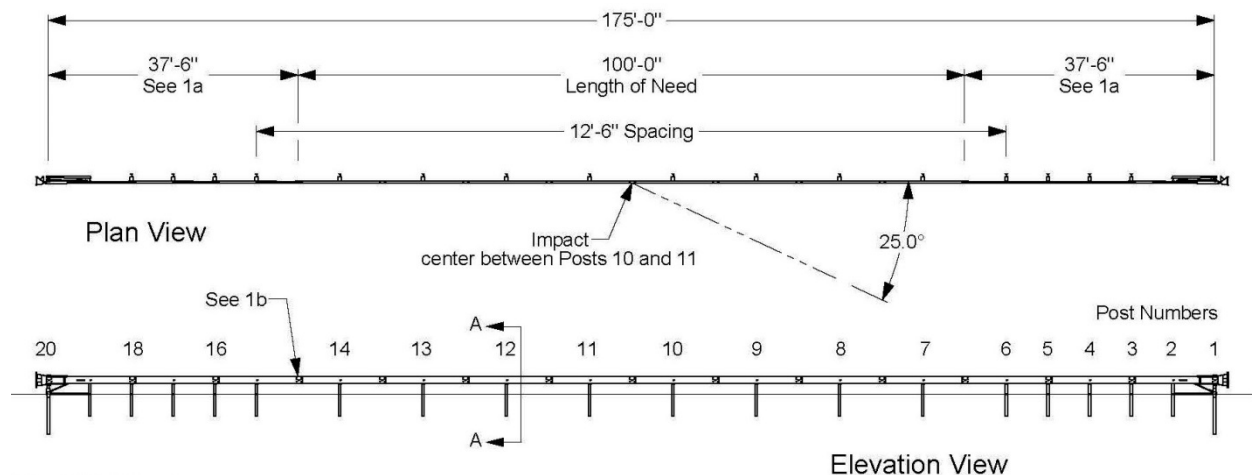
Figure 3.1. Impact Point for *MASH* Test 2-11 on the 31-inch W-Beam Guardrail with 12 ft 6 inch Post Spacing.

The test reported herein corresponds to *MASH* Test 2-11. The target CIP for *MASH* Test 2-11, determined using finite element analyses, was centered between posts 10 and 11, as shown in Figure 3.1.

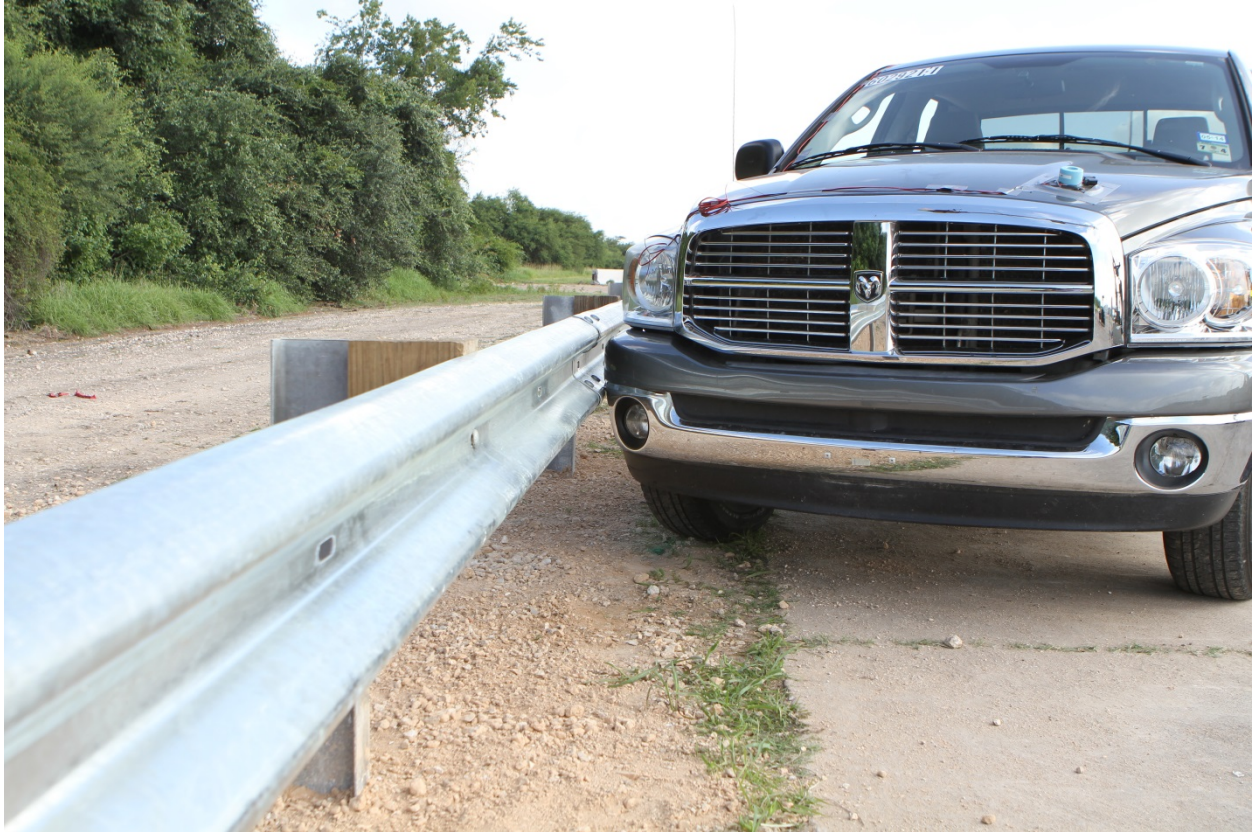
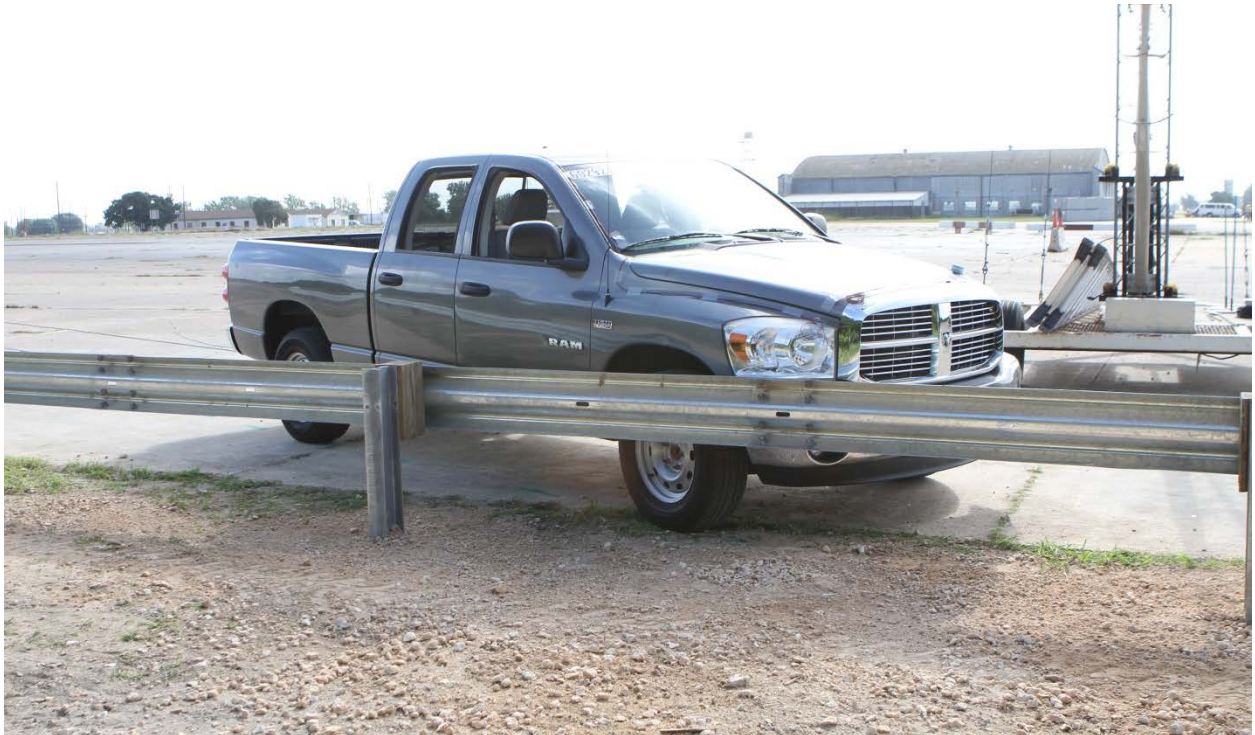
Figure 5.1. Vehicle and Installation Geometrics for Test No. 602921-1.

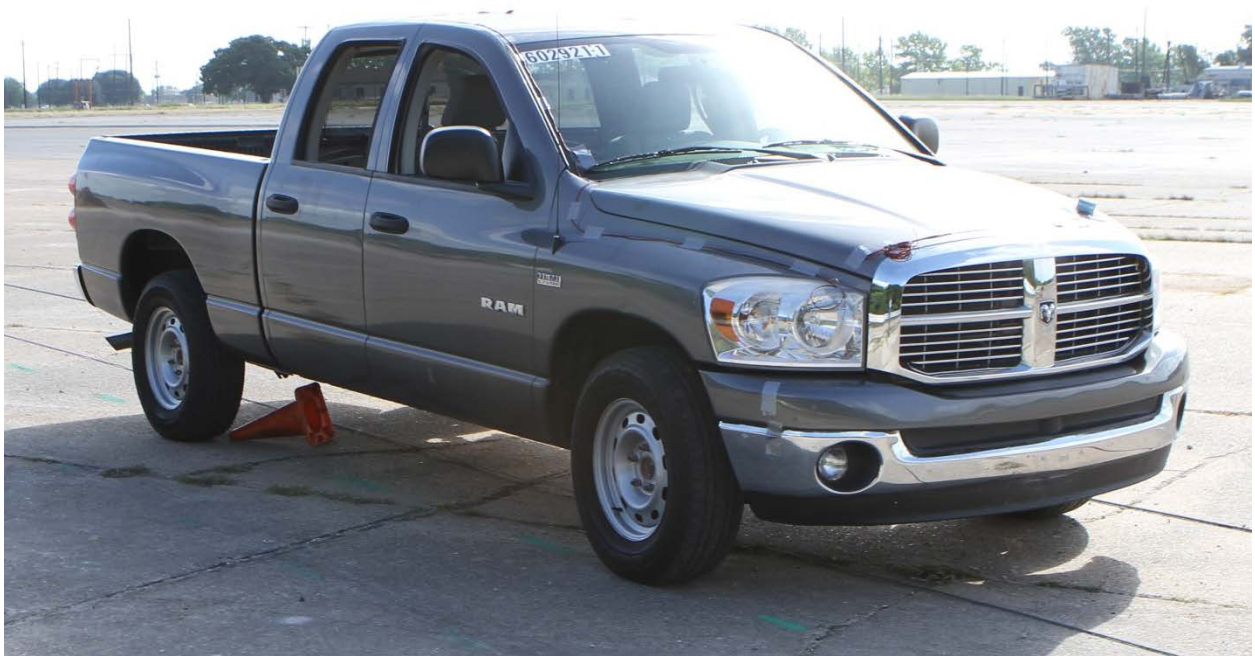
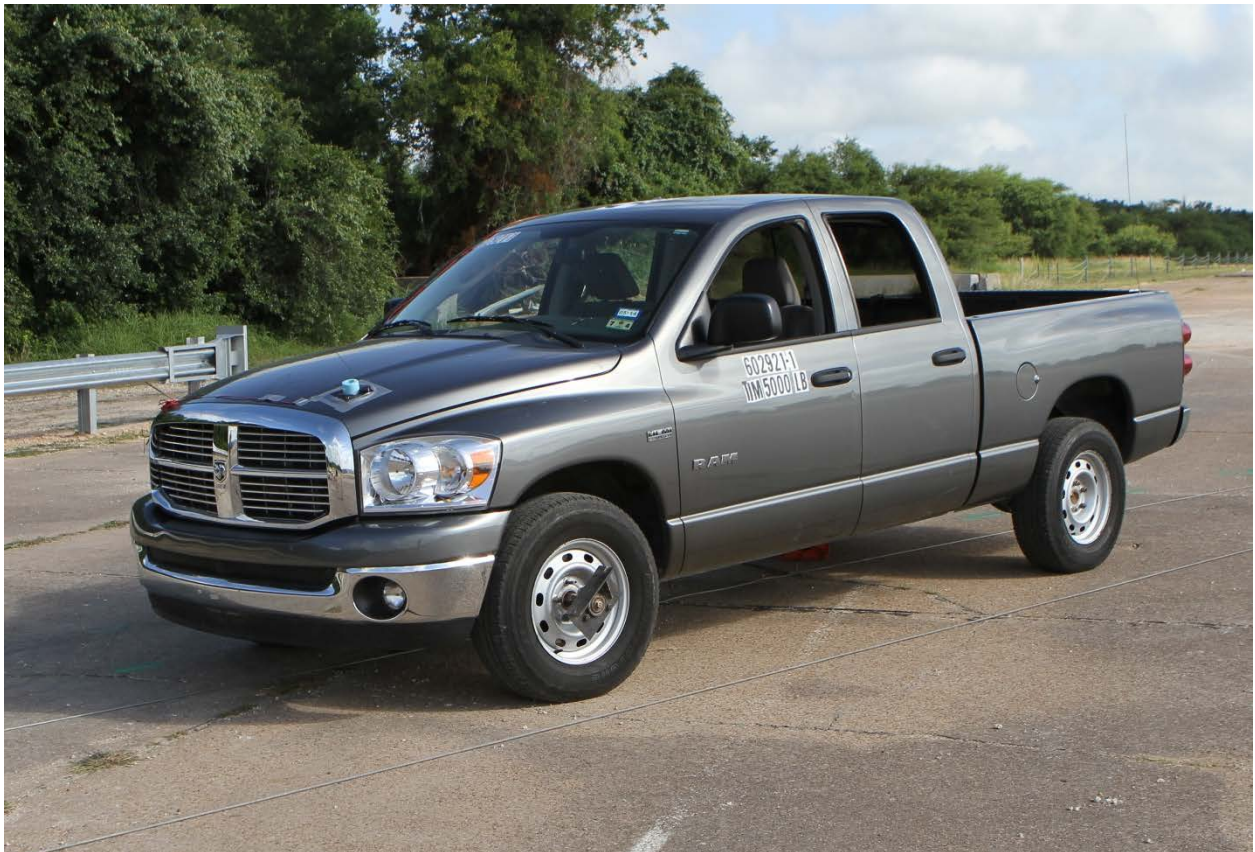
Figure 5.2. Vehicle before Test No. 602921-1.

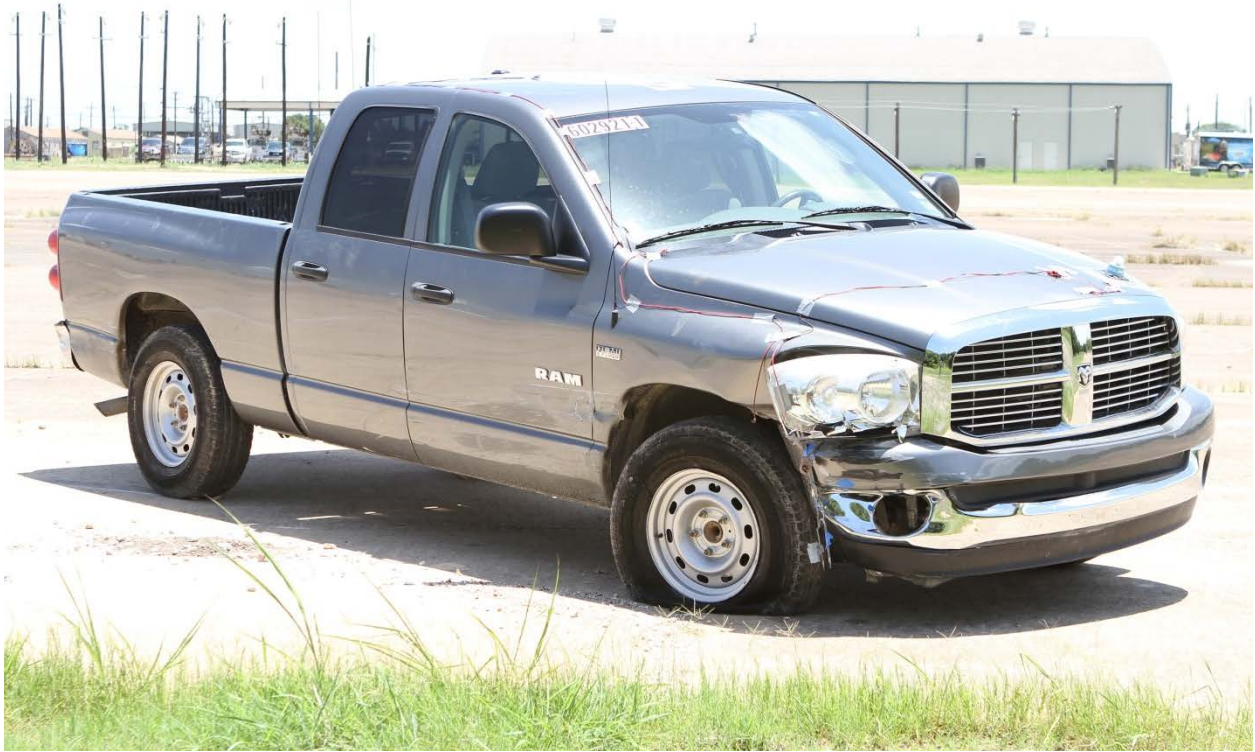
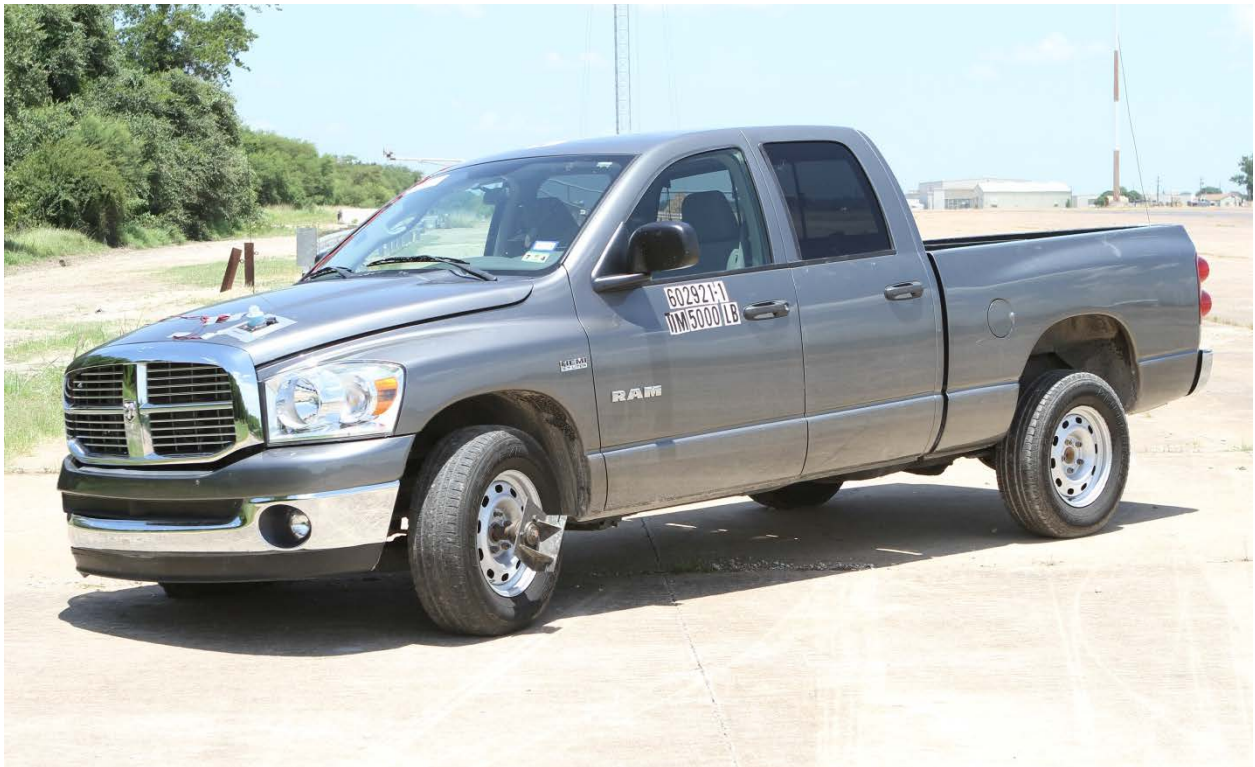
Figure 5.5. Vehicle after Test No. 602921-1.

Figure 5.5 shows damage to the vehicle after the test. The front bumper, right front tire and wheel rim, right front fender, right front and rear doors, right rear exterior bed, and rear bumper were scratched and deformed. Maximum exterior crush was 9.0 inches in the side plane at the right front corner at bumper height. No occupant compartment deformation or intrusion occurred. Figure 5.6 shows the interior of the vehicle. Exterior vehicle crush and occupant compartment measurements are shown in Appendix D2, Tables D.3 and D.4.

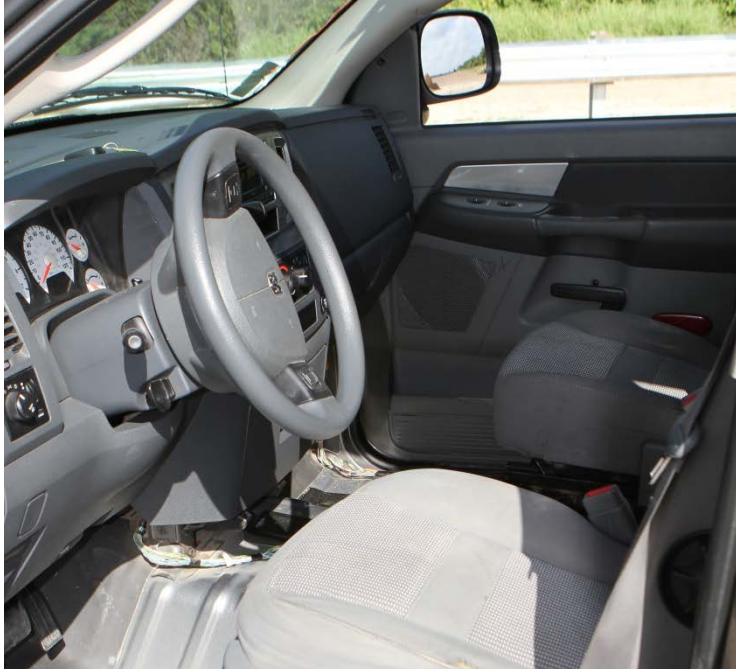
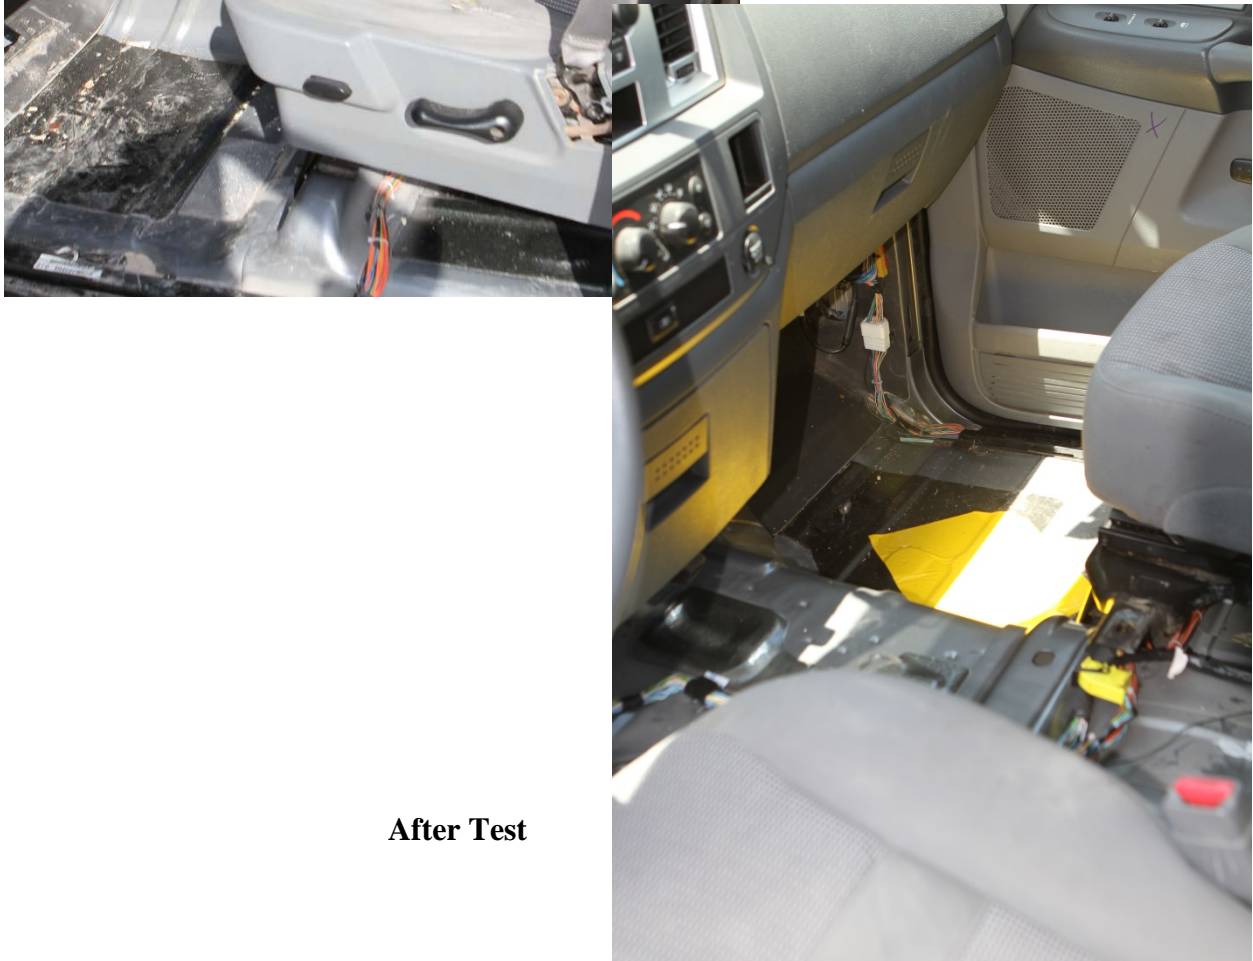
Before Test

After Test

Figure 5.6. Interior of Vehicle for Test No. 602921-1.

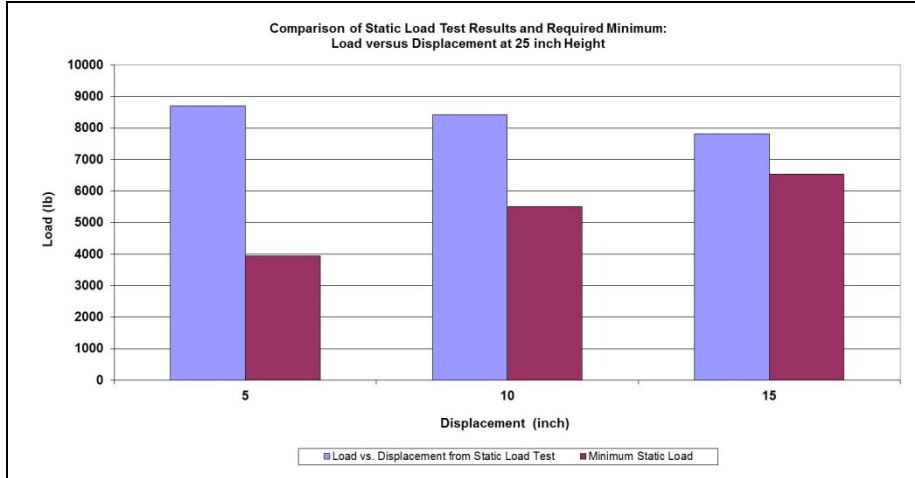
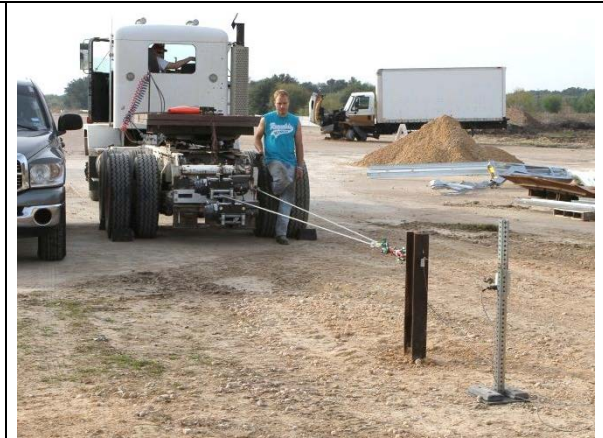
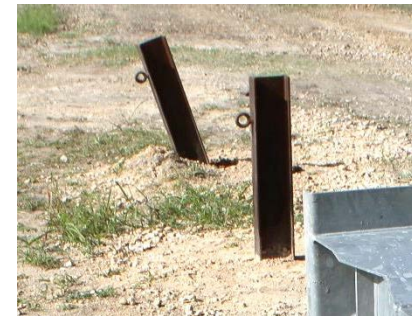
Static Load Setup

Post-Test Photo of Post

Date.....	2014-07-10
Test Facility and Site Location	TTI Proving Ground – 3100 SH 47, Bryan, Tx
In Situ Soil Description (ASTM D2487)	Sandy gravel with silty fines
Fill Material Description (ASTM D2487) and sieve analysis	AASHTO Grade B Soil-Aggregate (see sieve analysis)
Description of Fill Placement Procedure	6-inch lifts tamped with a pneumatic compactor

As determined in the tests shown in Appendix C, Figure C2, the minimum post load required for deflections at 5 inches, 10 inches, and 15 inches, measured at a height of 25 inches, is 3940 lb, 5500 lb, and 6540 lb, respectively (90 percent of static load for the initial standard installation). On the day of the test, July 10, 2014, load on the post at deflections of 5 inches, 10 inches, and 15 inches was 8695 lbf, 8415 lbf, and 7820 lbf, respectively. The strength of the backfill material met minimum requirements.

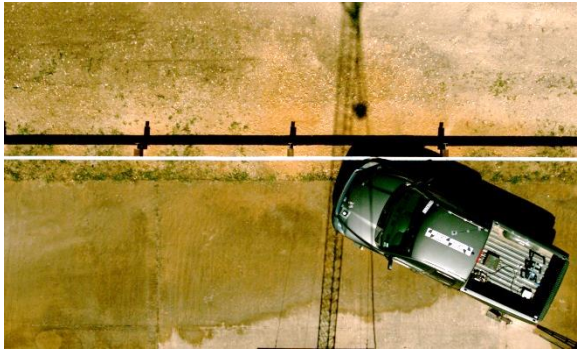
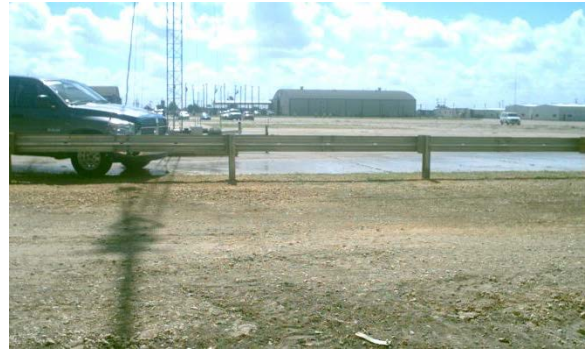
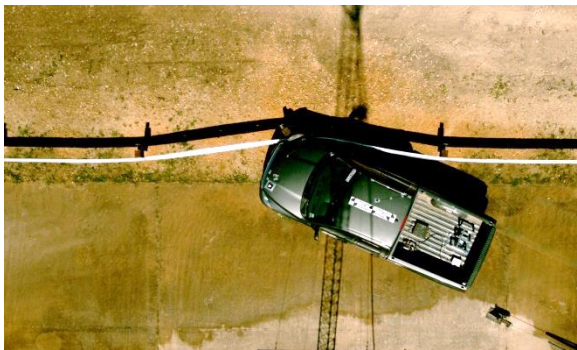
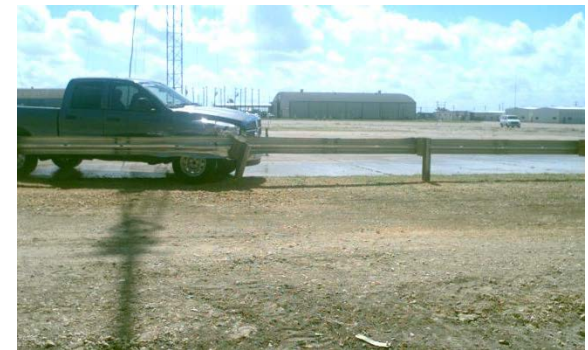
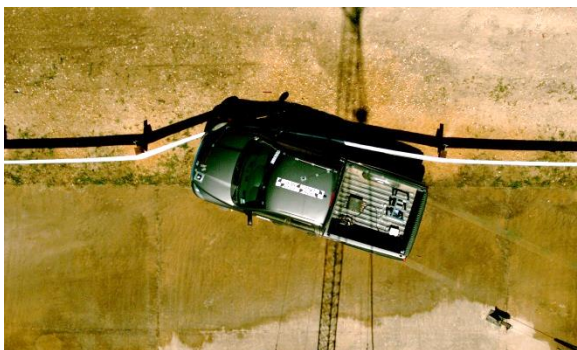
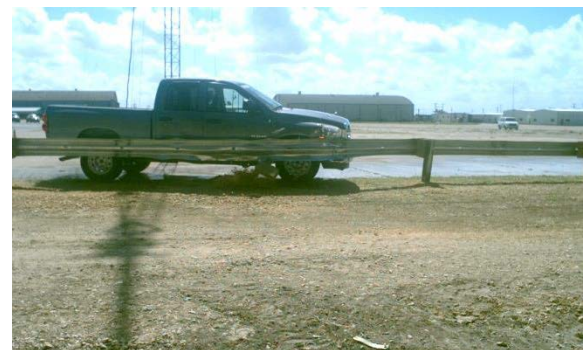
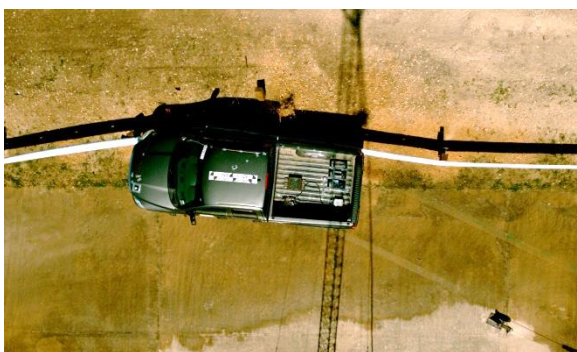
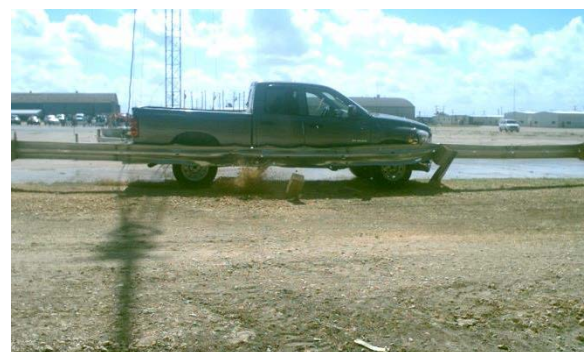
Figure D.1. Sequential Photographs for Test No. 602921-1 (Overhead and Frontal Views).

The 2008 Dodge Ram 1500 quad cab pickup truck, traveling at an impact speed of 45.7 mi/h, impacted the guardrail mid-span between posts 10 and 11 at an impact angle of 25.0 degrees. At approximately 0.072 s after impact, the vehicle began to redirect, and at 0.085 s, the right front corner of the vehicle bumper contacted post 11. The right front tire contacted post 11 at 0.124 s, and the right front corner of the vehicle bumper contacted post 12 at 0.319 s. At 0.324 s, the vehicle began traveling parallel with the guardrail, and at 0.338 s, the right front tire contacted post 12. The vehicle continued to ride along the traffic face of the guardrail and out of view of the high-speed cameras. Brakes on the vehicle were applied at 2.6 s after impact, and the vehicle subsequently yawed clockwise and came to rest 218.3 ft downstream of the point of impact and 7 ft toward traffic lanes. Appendix D2, Figure D.1 presents sequential photographs of the test.

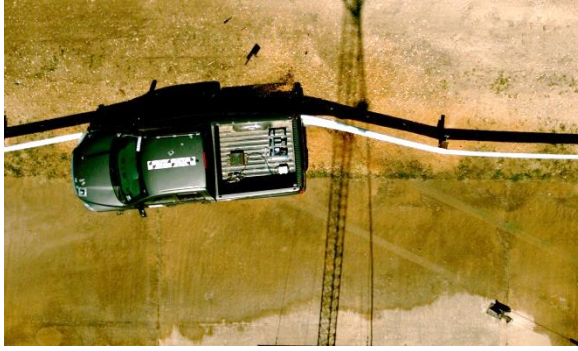
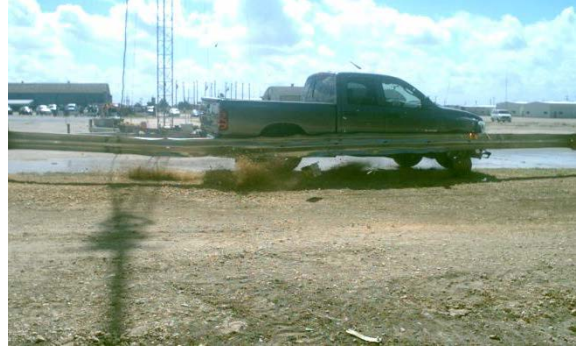
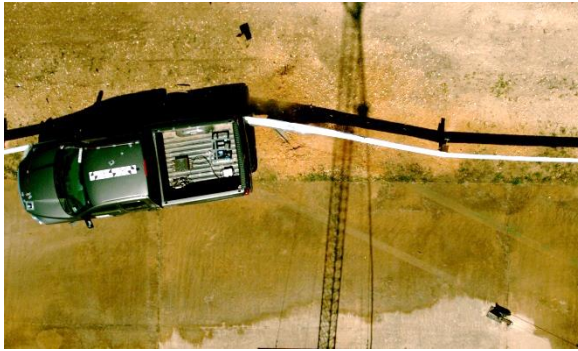
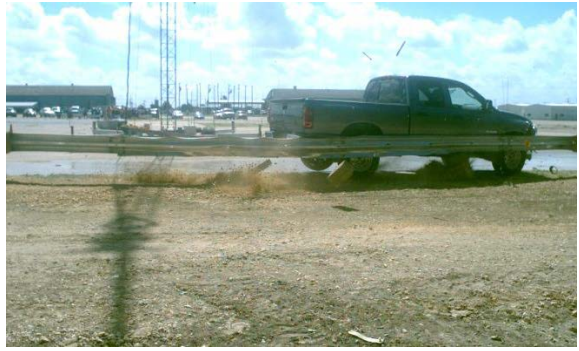
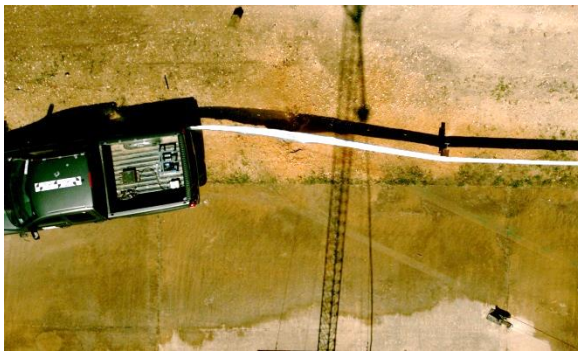
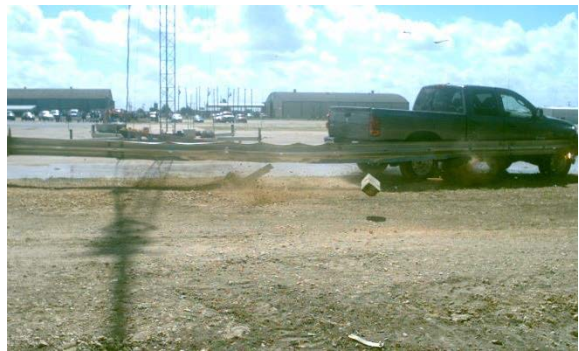
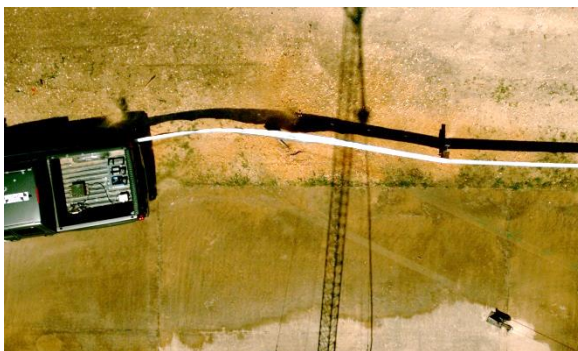
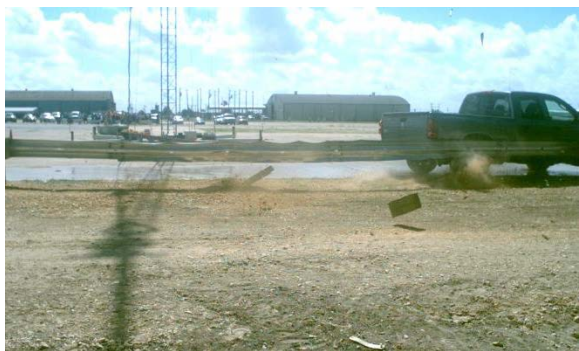
**Figure D.1. Sequential Photographs for Test No. 602921-1 (Overhead and Frontal Views)
(Continued).**
