## TECHNICAL MEMORANDUM

**Contract No.:** T4541 (CF) (MN-91)  
**Test Report No.:** 604671-S1-S18  
**Project Name:** W-Beam Wood Post Strength Analysis of Preservation Treatment Methods  
**Sponsor:** Roadside Safety Pooled Fund

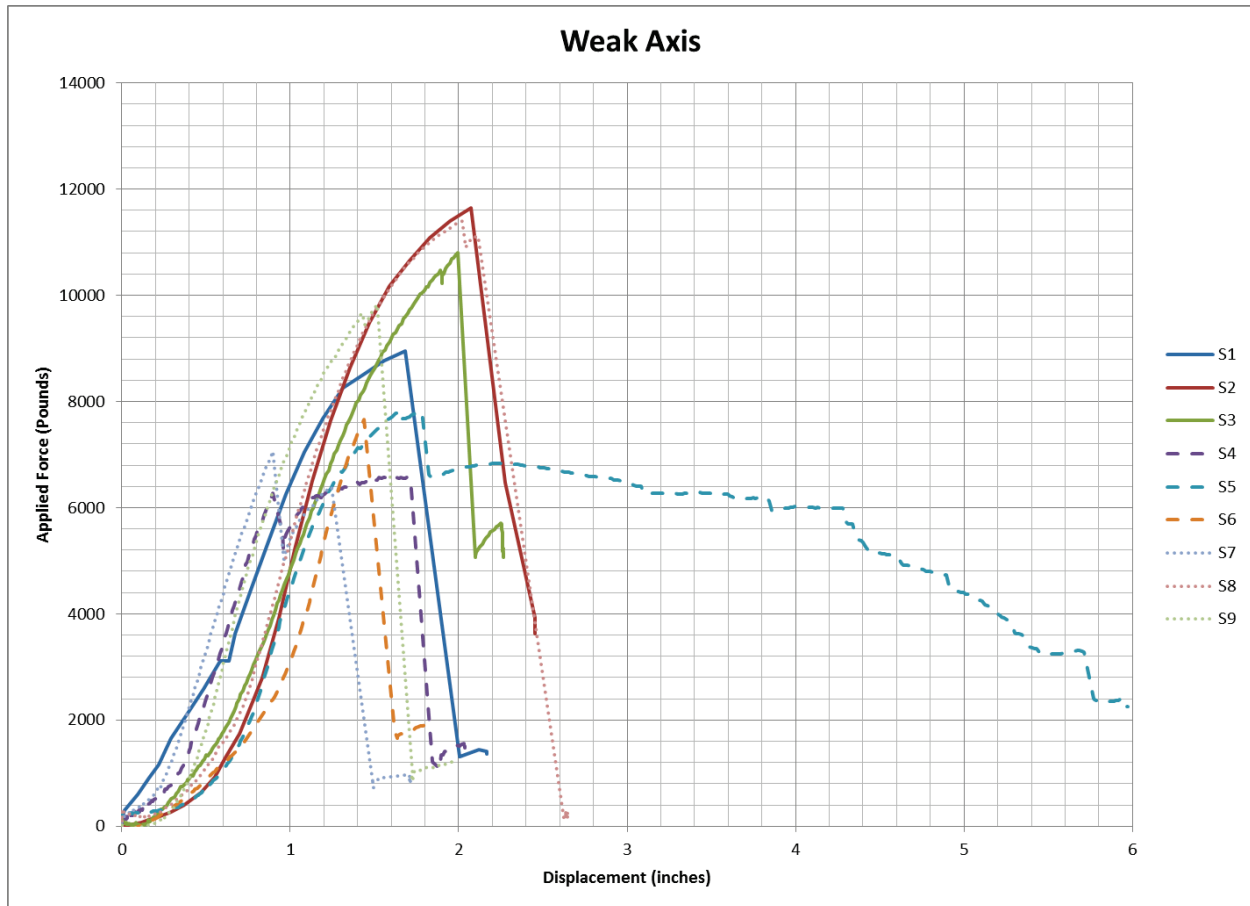
**Figure 2. Results of Testing in Weak Axis Direction.**

The maximum load on the CCA posts ranged from 8956 lb to 11,647 lb, with the average being 10,468 lb. The measured deflection was 1.68 inches to 2.07 inches and average was 1.91 inches. The maximum load on the ACQ posts ranged from 6597 lb to 7814 lb, with the average being 7356 lb. The measured deflection was 1.44 inches to 1.78 inches and average was 1.60 inches. The maximum load on the NT posts ranged from 7060 lb to 11,394 lb, with the average being 9428 lb. The measured deflection was 0.90 inches to 2.02 inches, and average was 1.48 inches.

The results of these tests in the weak axis are shown in Figure 2. Photographs for each test are provided in Attachment C, Figures C1 through C3.

A summary of test results is presented in Table 1. Table 1 details the maximum load and deflection measured for each static test. Table 1 also indicates the average maximum force for each treatment type for each axis. A review of the test results indicates that all three treatment methods have similar strengths (standard deviation of 1405 lb) in the strong axis. The test results also indicate the ACQ-D has the weakest strength in the weak axis. While these results are from only a small number of samples, there appears to be a pattern in the results.

When evaluating whether or not ACQ-D can adequately replace CCA, the expected application needs to be accounted for. The ACQ-D treated posts are of similar strength in strong axis and of similar or lesser strength in the weak axis. In most guardrail/terminal applications, the strong axis is the primary axis resisting the loads imparted by an impacting vehicle during a re-direction impact. The weak axis is primarily only loaded when the impacting vehicle makes direct contact with the post, usually during an “end-on” type impact or a wheel contacting the post during redirection. This post type is used extensively in W-beam guardrail terminal applications and in some non-proprietary long span applications. In this case the ACQ-D treated posts should perform similar to the previously tested CCA treated posts. The ACQ-D treated

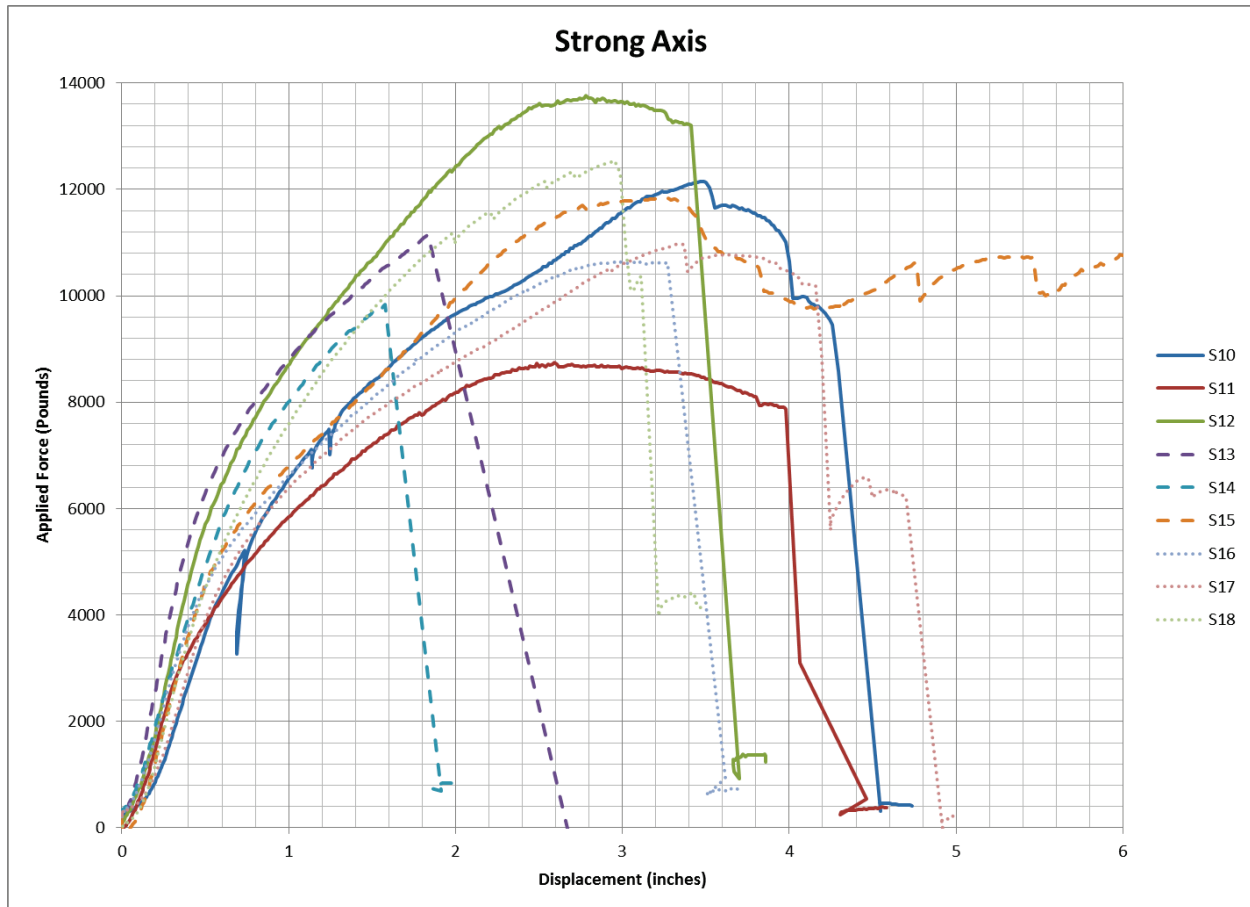
**Figure 3. Results of Testing in the Strong Axis Direction.**

The maximum load on the CCA posts ranged from 8742 lb to 13,759 lb, with the average being 11,548 lb. The measured deflection was 2.59 inches to 3.49 inches, and average was 3.00 inches. The maximum load on the ACQ posts ranged from 9838 lb to 11,830 lb, with the average being 10,940 lb. The measured deflection was 1.58 inches to 3.20 inches, and average was 2.20 inches. The maximum load on the NT posts ranged from 10,655 lb to 12,535 lb, with the average being 11,390 lb. The measured deflection was 2.96 inches to 3.36 inches, and average was 3.14 inches.

The results of the tests in the strong axis are graphed in Figure 3. Photographs for each test are provided in Attachment C, Figures C4 through C6.

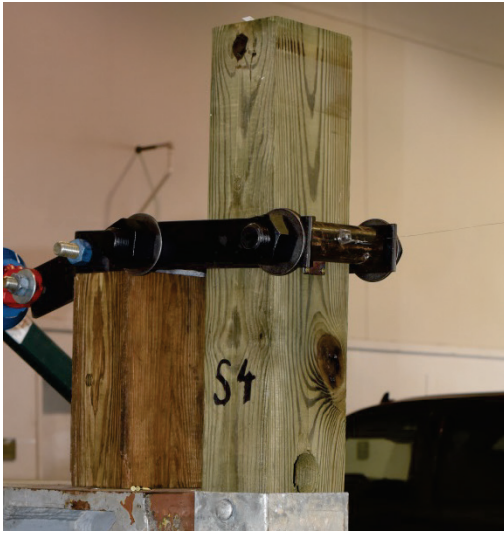
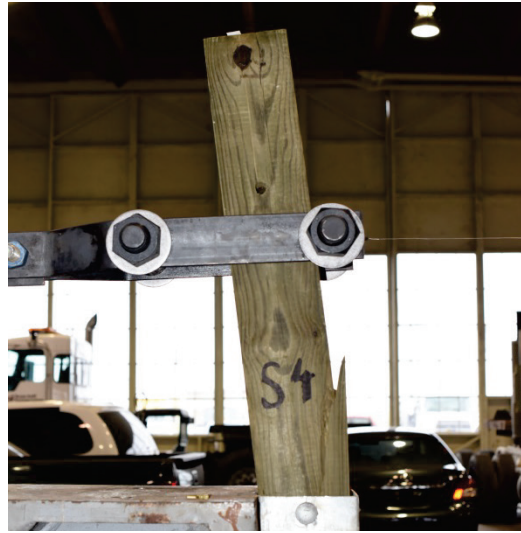
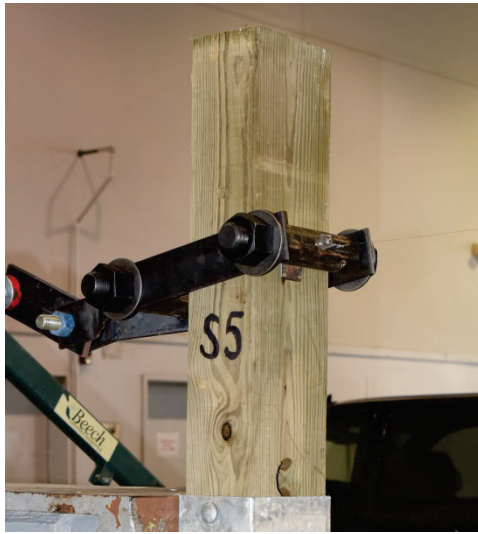
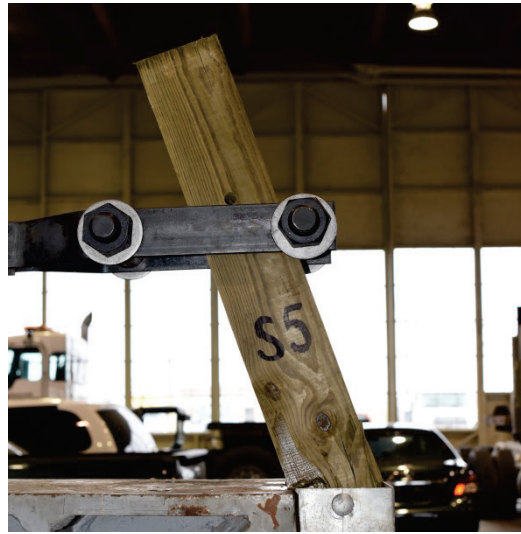
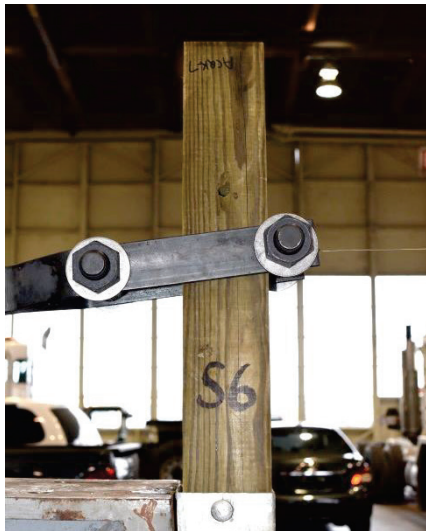
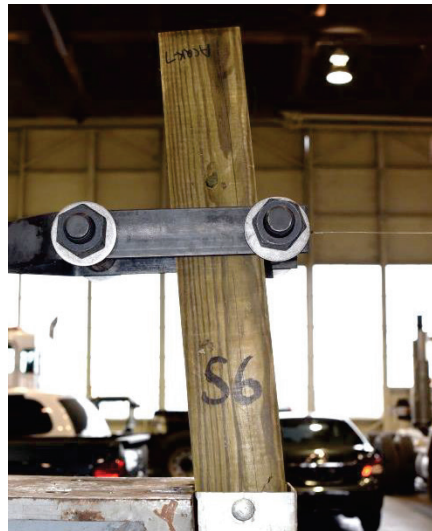
Figure C2. ACQ Posts – Weak Axis Tests

S4 – Before

S4 – After

S5 – Before

S5 – After

S6 – Before

S6 – After

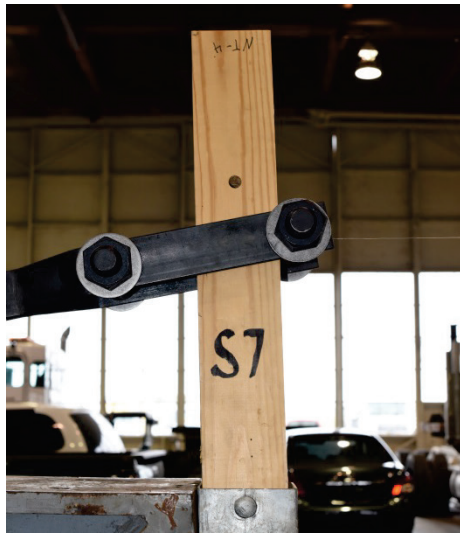
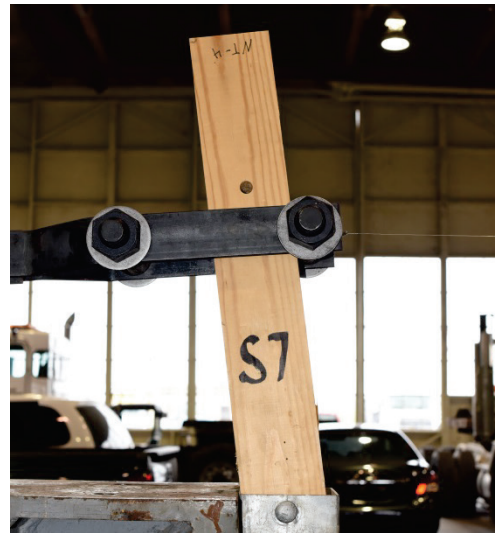
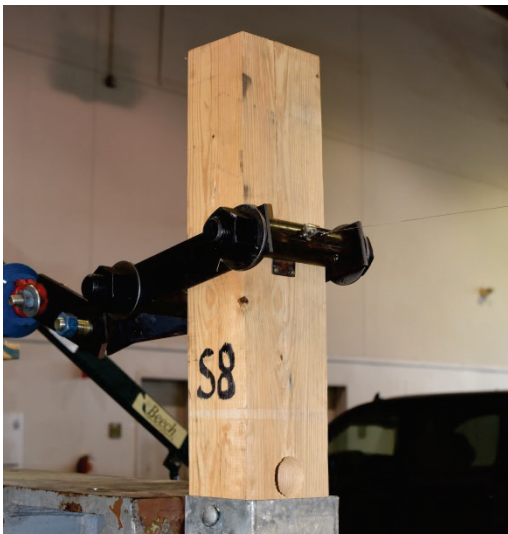
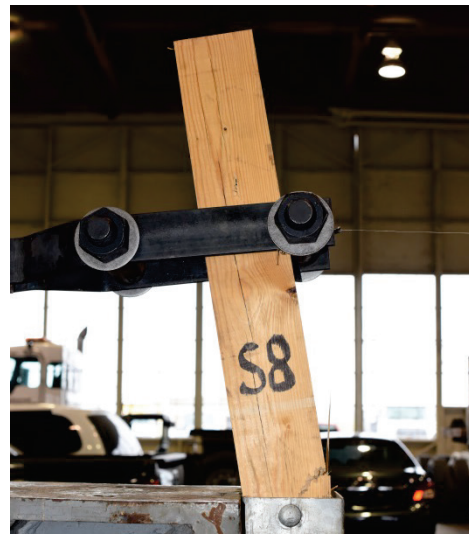
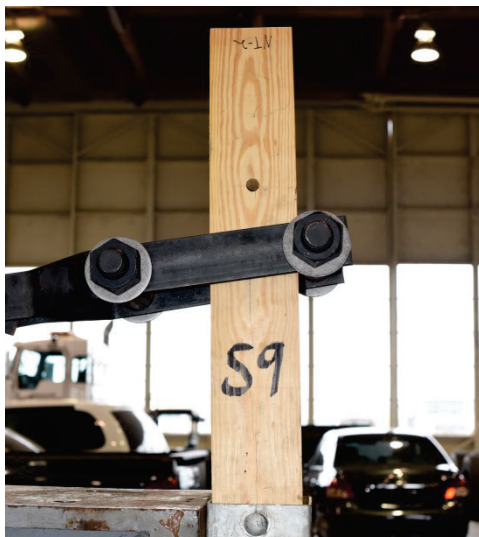
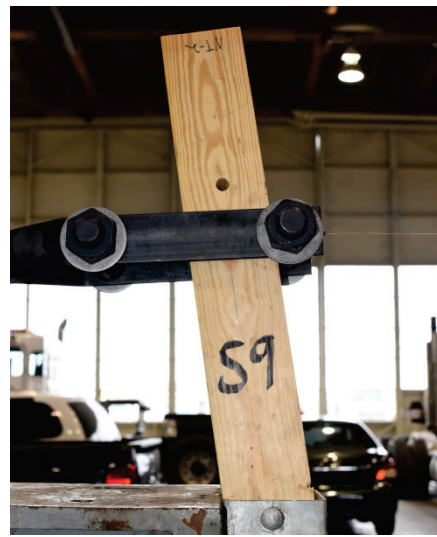
Figure C3. Untreated Posts – Weak Axis Tests

S7 – Before

S7 – After

S8 – Before

S8 – After

S9 – Before

S9 – After

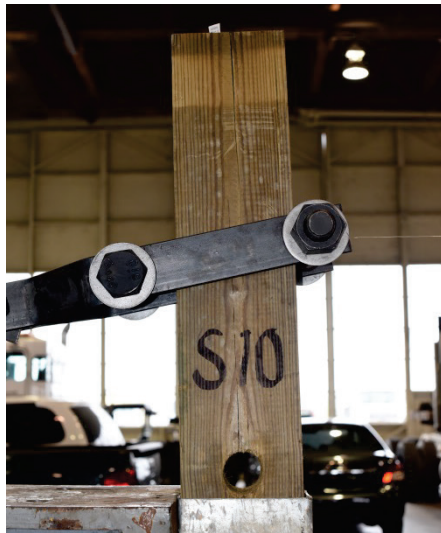
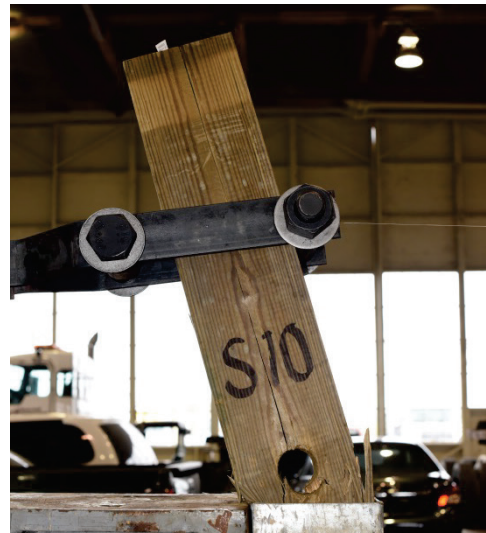
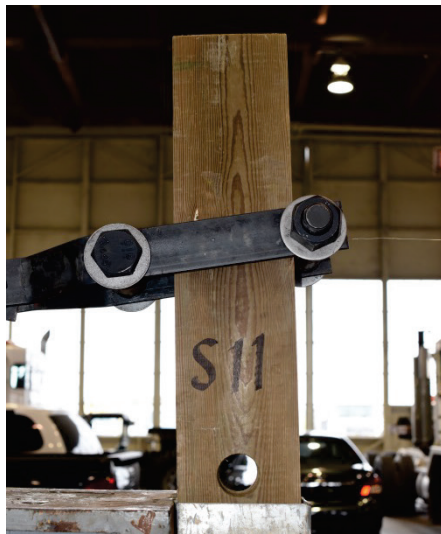
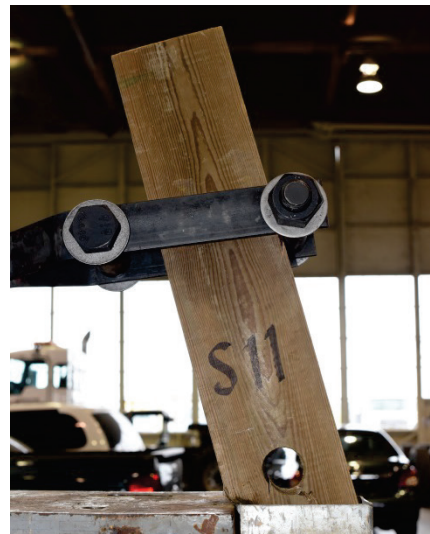
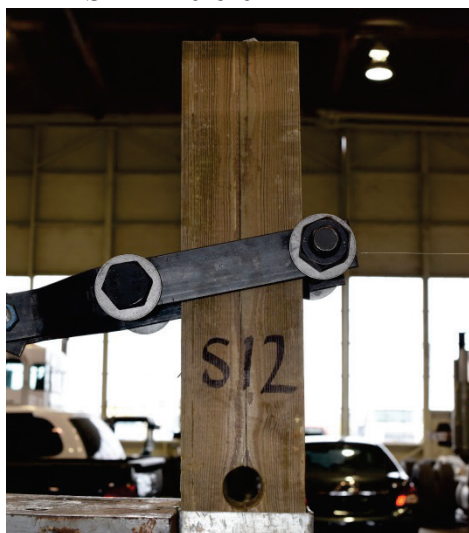
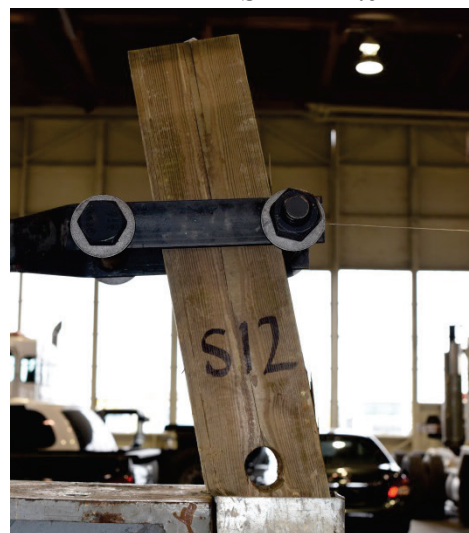
Figure C4. CCA Posts – Strong Axis Tests

S10 – Before

S10 – After

S11 – Before

S11 – After

S12 – Before

S12 – After

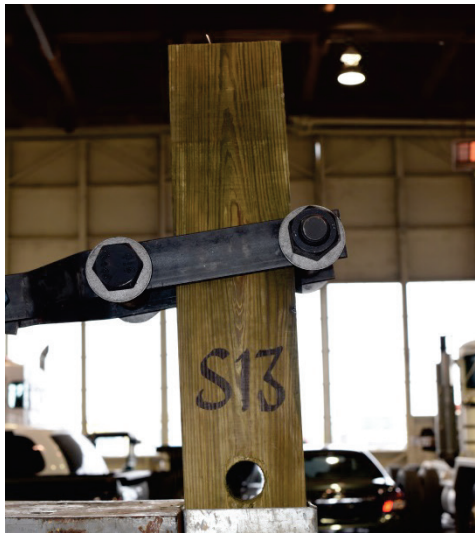
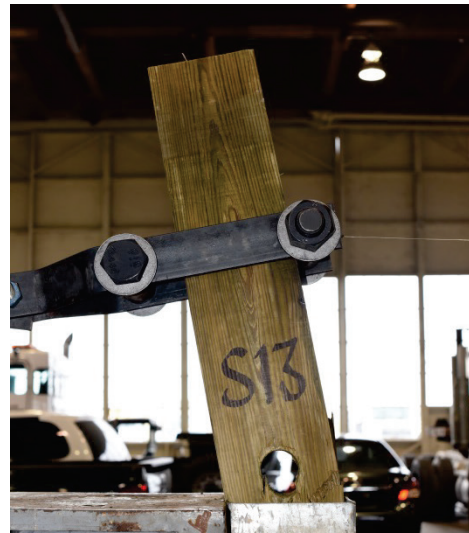
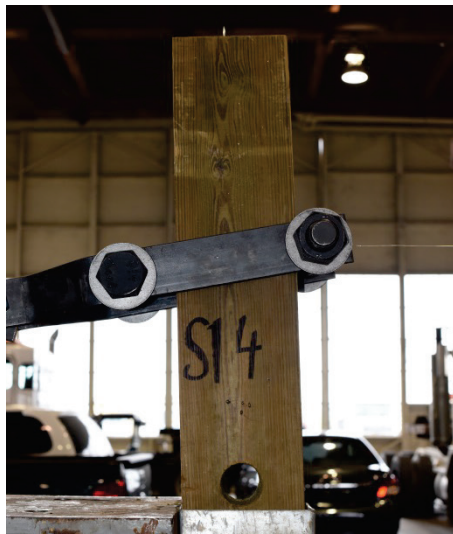
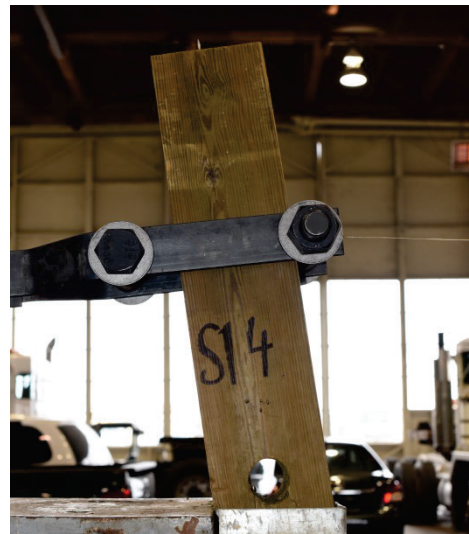
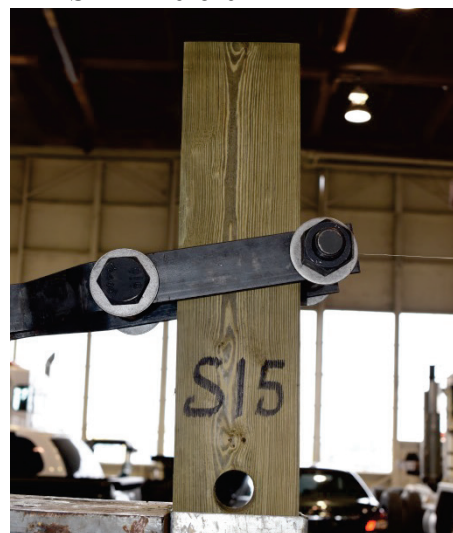
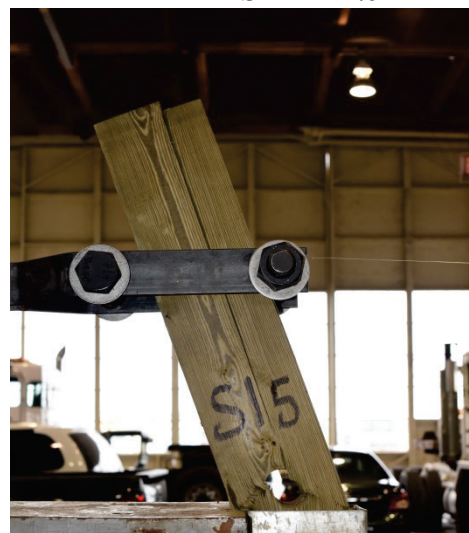
Figure C5. ACQ Posts – Strong Axis Tests

S13 – Before

S13 – After

S14 – Before

S14 – After

S15 – Before

S15 – After

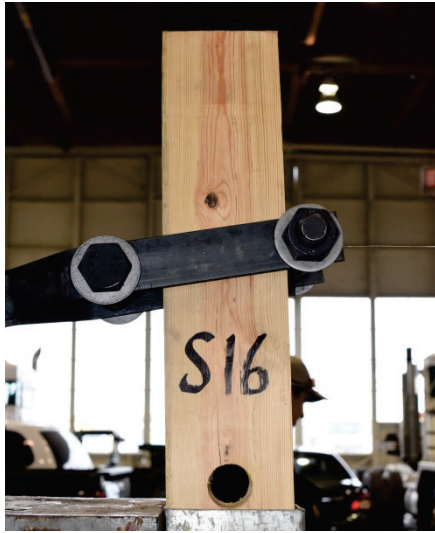
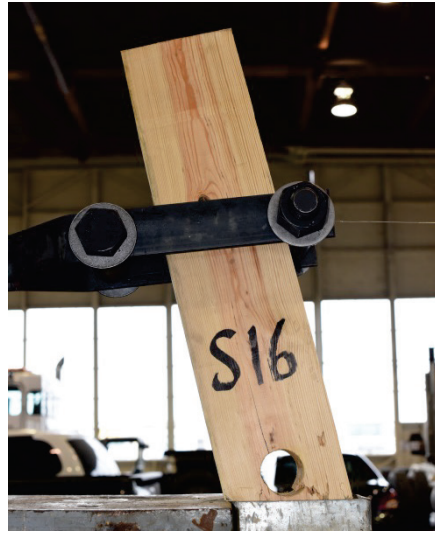
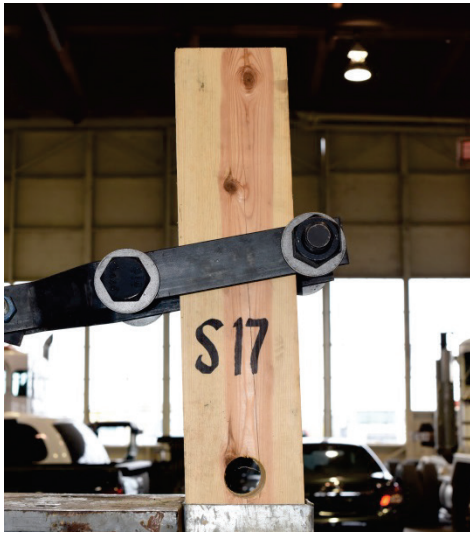
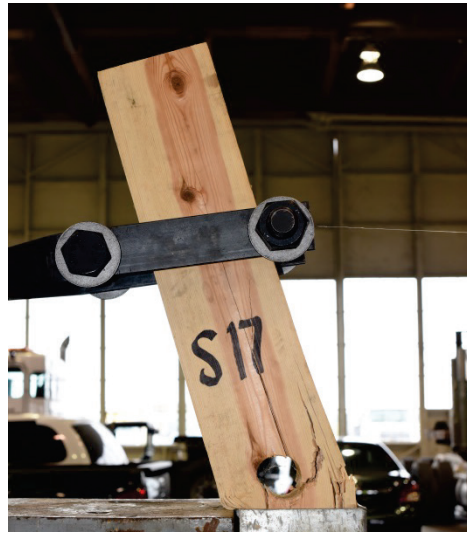
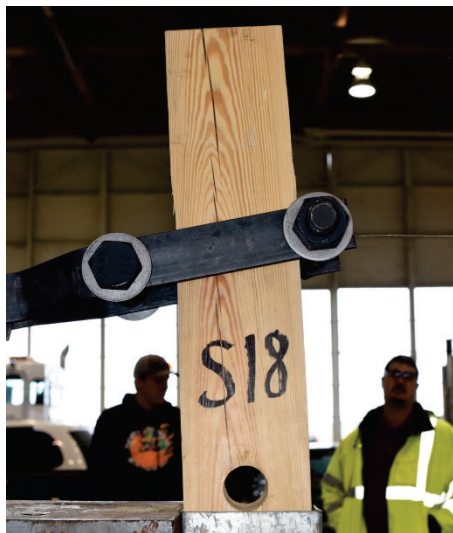
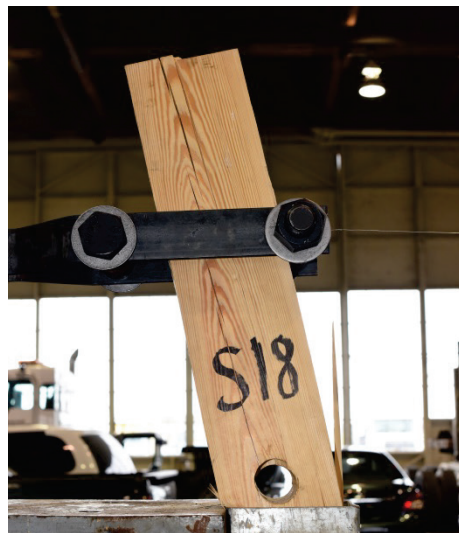
Figure C6. Untreated Posts – Strong Axis Tests

S16 – Before

S16 – After

S17 – Before

S17 – After

S18 – Before

S18 – After
