**Texas A&M
Transportation
Institute**
Proving Ground

Test Report No. 605641-1
Test Report Date: January 2016

**MASH TRANSITION FROM F-SHAPE TEMPORARY
CONCRETE BARRIER PINNED ON ASPHALT TO RIGID
SINGLE-SLOPE CONCRETE BARRIER**

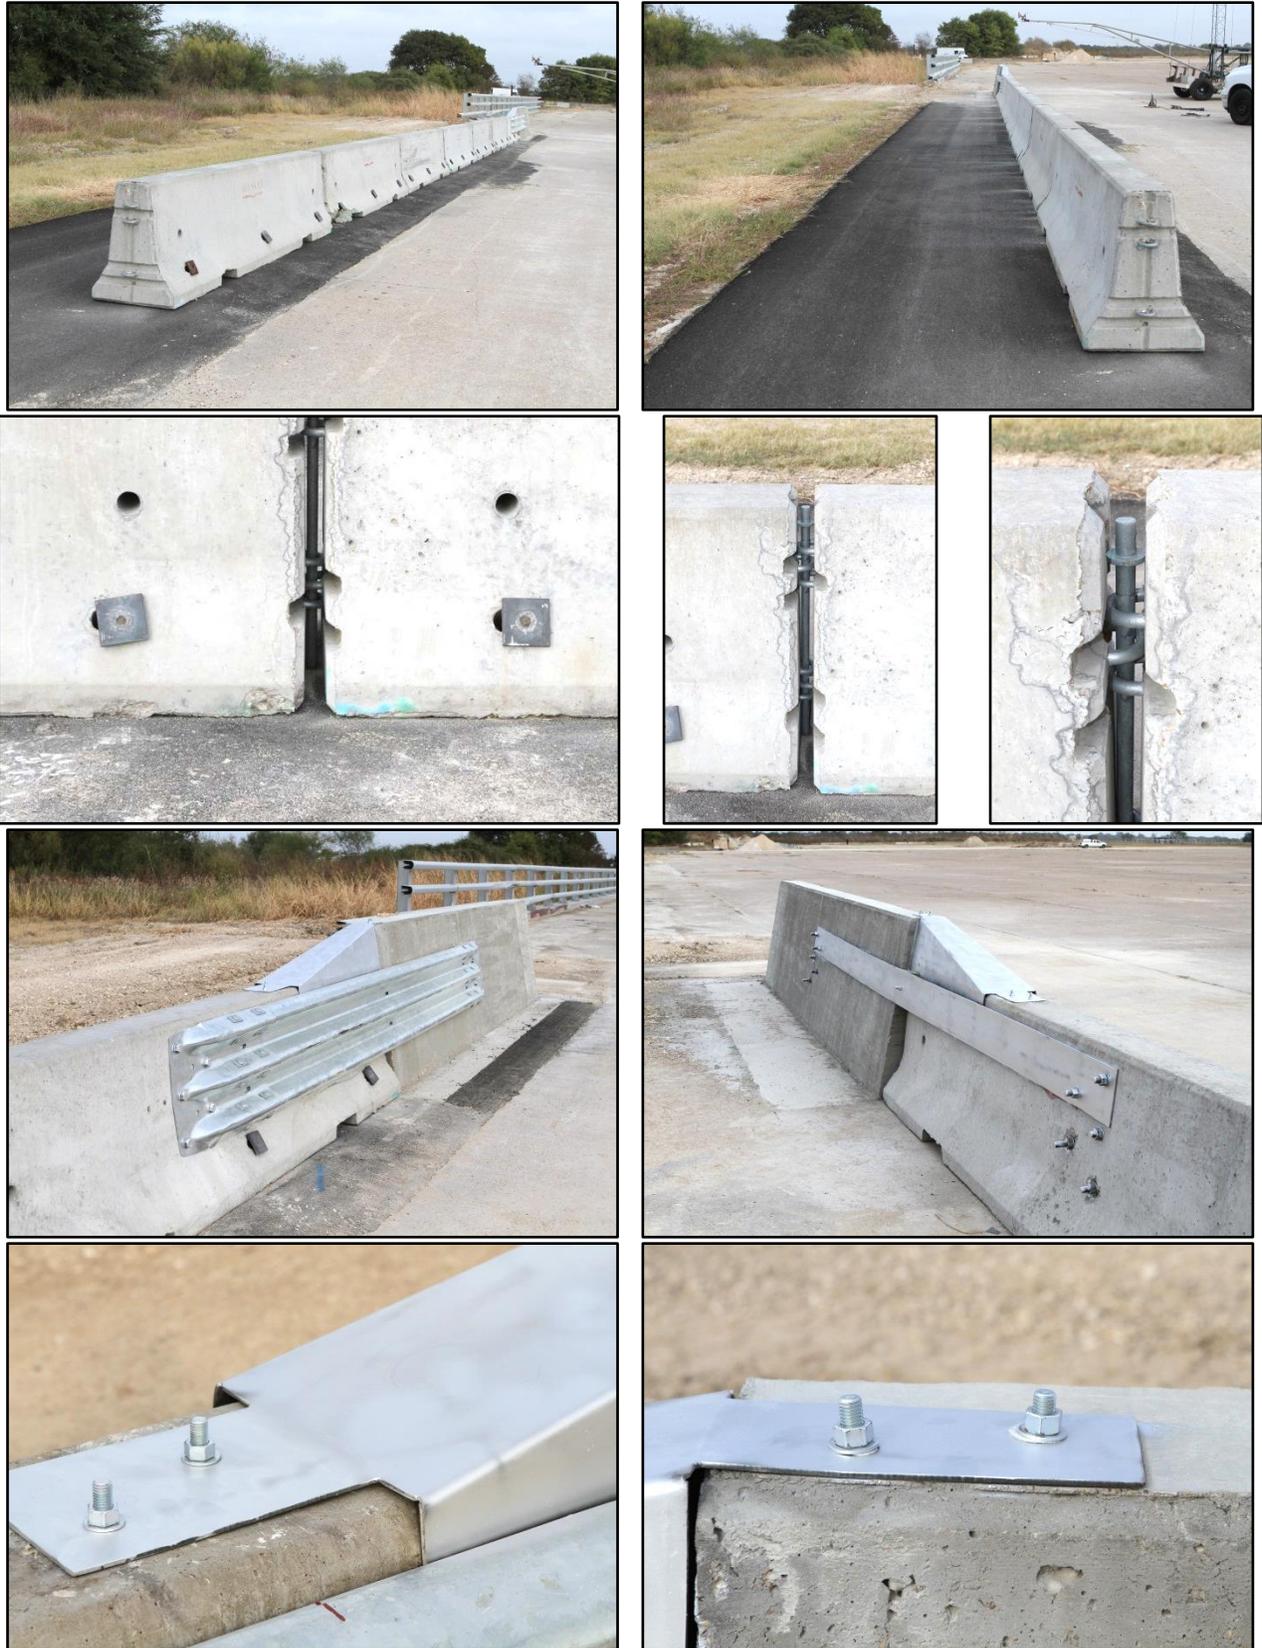
Figure 2.2. Transition Installation prior to Testing.

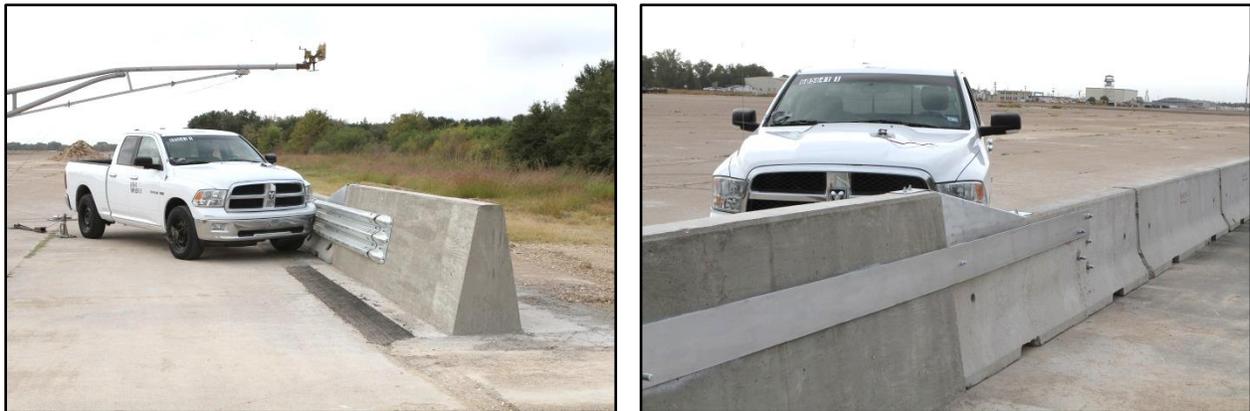
Figure 5.1. Transition/Test Vehicle Geometrics for Test No. 605641-1.

The 2010 Dodge Ram 1500 pickup truck, shown in Figure 5.1 and Figure 5.2, was used for the crash test. The vehicle's test inertia weight was 5064 lb, and its gross static weight was 5064 lb. The height to the lower edge of the vehicle bumper was 11.75 inches and 27.0 inches to the upper edge. The height to the vehicle's center of gravity was 28.6 inches. Tables C.1 and C.2 in Appendix C1 provide additional dimensions and information on the vehicle. The vehicle was directed into the installation using the cable reverse tow and guidance system, and was released to be freewheeling and unrestrained just prior to impact.

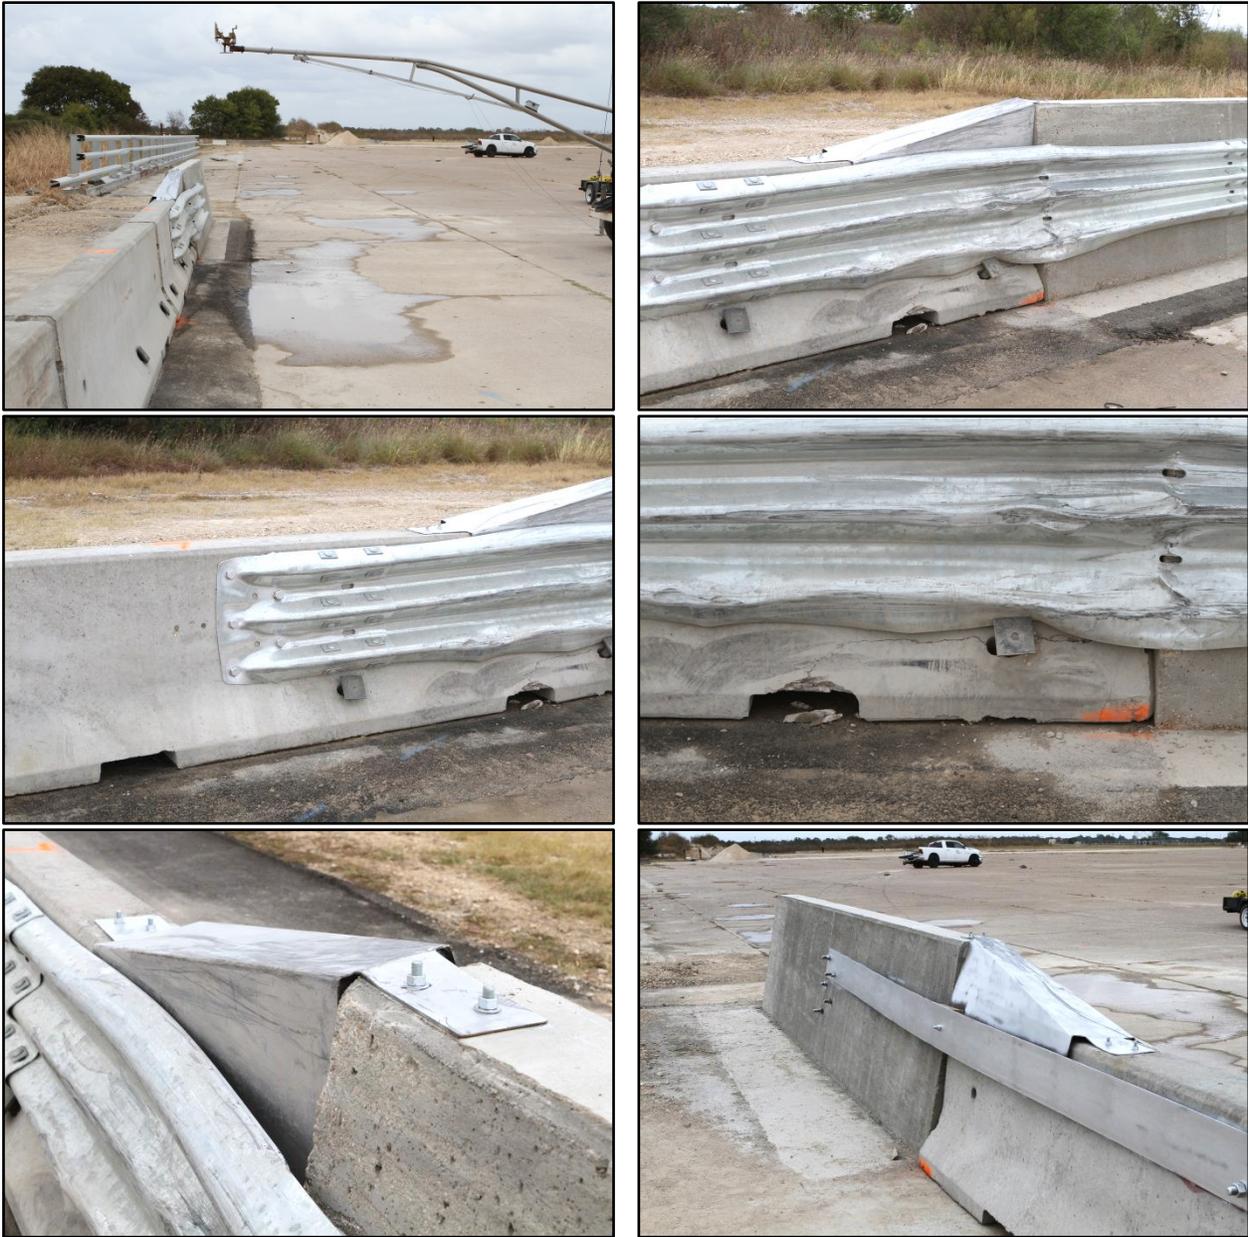
Figure 5.3. Transition after Test No. 605641-1.

Figure 5.3 shows the damage to the transition. The concrete on the downstream end of barrier segment 7 was cracked around the pin location. The downstream end was also displaced toward the field side 1.75 inches. The vehicle was in contact with the installation for 11.5 ft, leaving scrapes and tire marks along the traffic face of the barriers. The top of the metal transition piece on top of barrier segment 7 was slightly scraped and the thrie beam metal rail on the traffic side of the barriers was deformed. Working width was 25.8 inches. Maximum dynamic deflection during the test was 4.0 inches, and maximum permanent deformation was 1.5 inches.

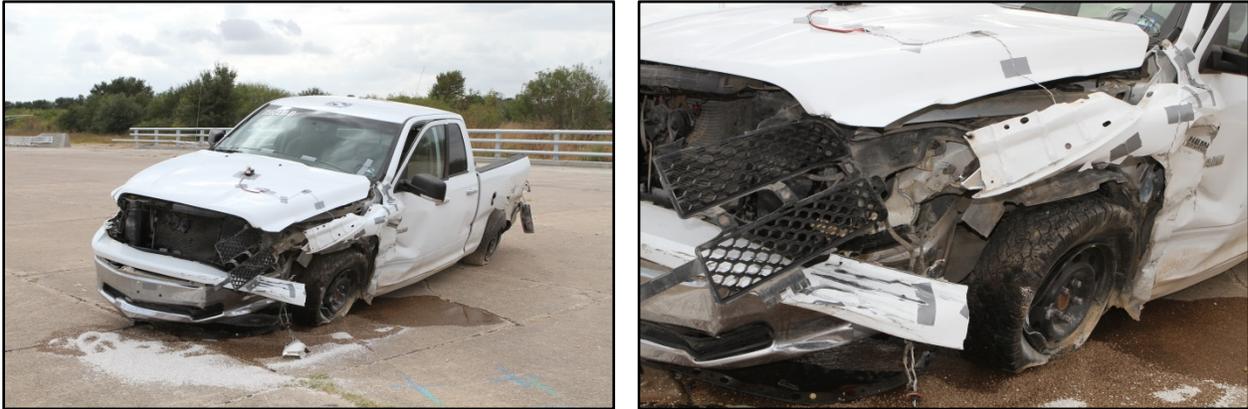
Figure 5.4. Test Vehicle after Test No. 605641-1.

Figure 5.4 shows the damage sustained by the vehicle. The left front upper and lower A-arms and the left frame rail were deformed. The front bumper, hood, grill, radiator, left front fender, left tire and rim, left front and rear doors, left exterior bed, left rear tire and rim, and rear bumper were damaged. Maximum exterior crush to the vehicle was 17.0 inches in the front plane at the left front corner at bumper height. Maximum occupant compartment deformation was 4.0 inches in the kickpanel on the driver's side. Figure 5.5 shows the interior of the vehicle.

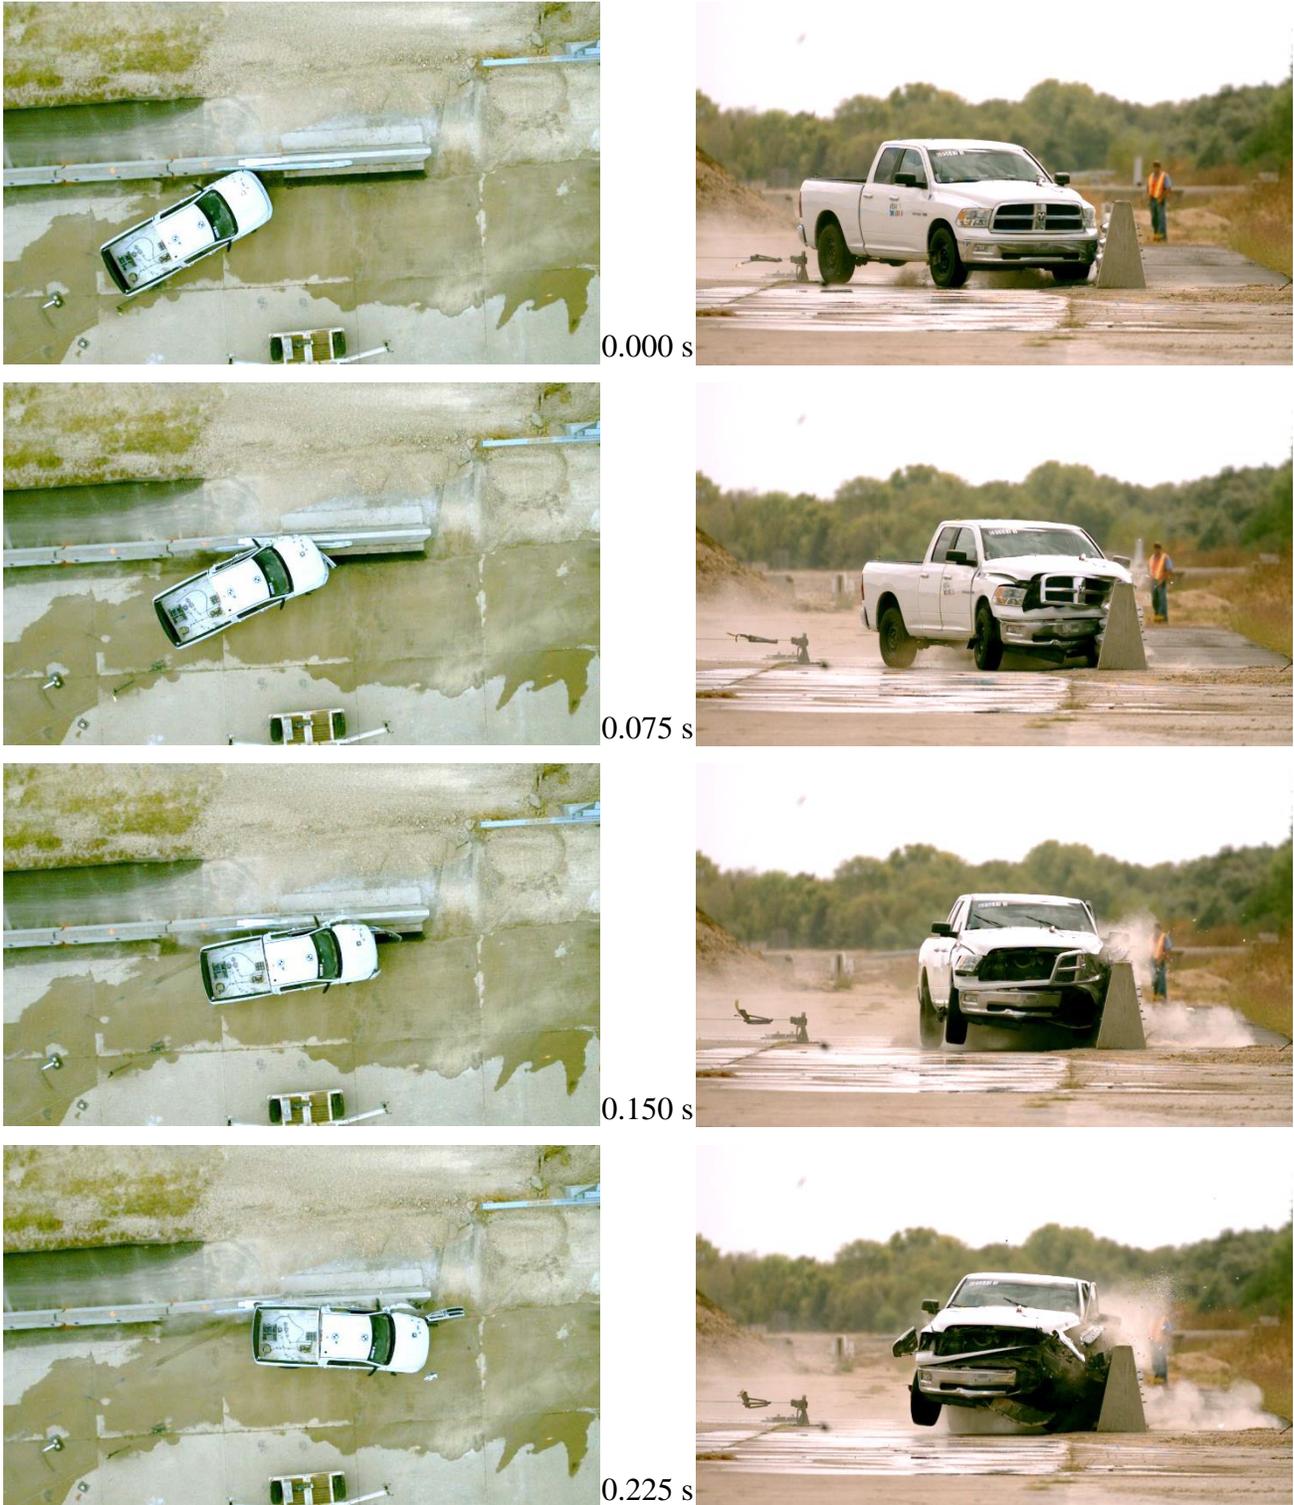
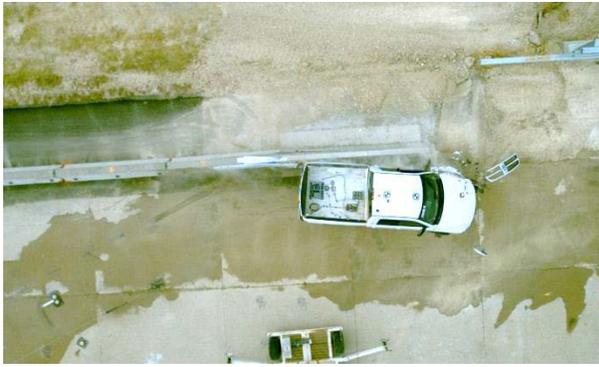
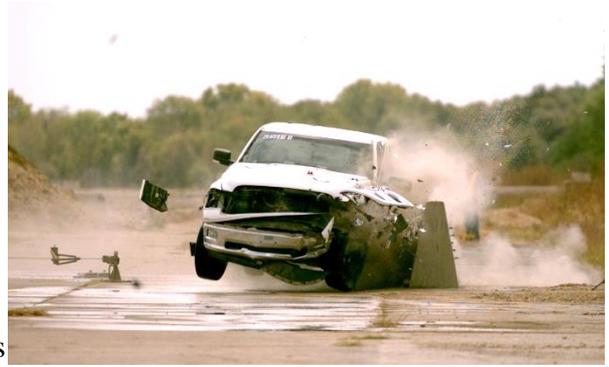
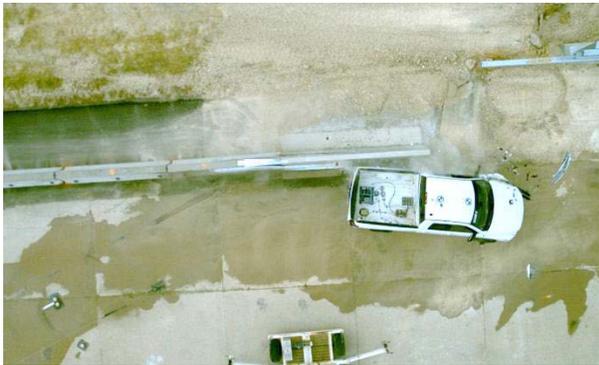
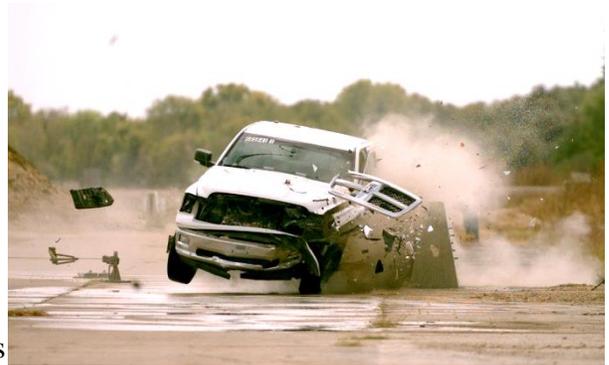
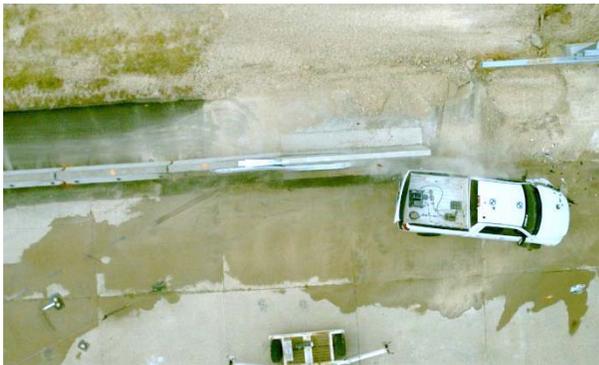
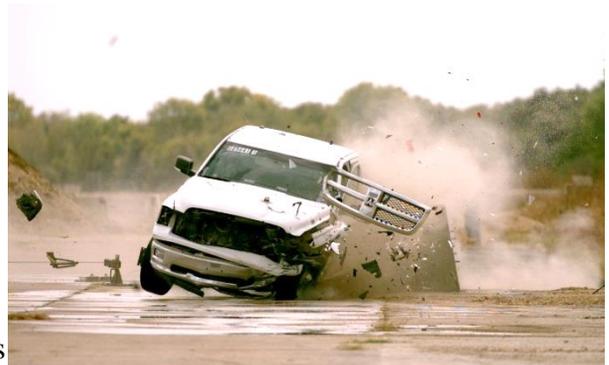
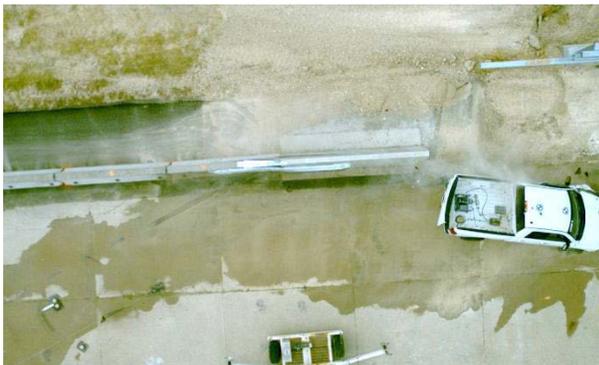
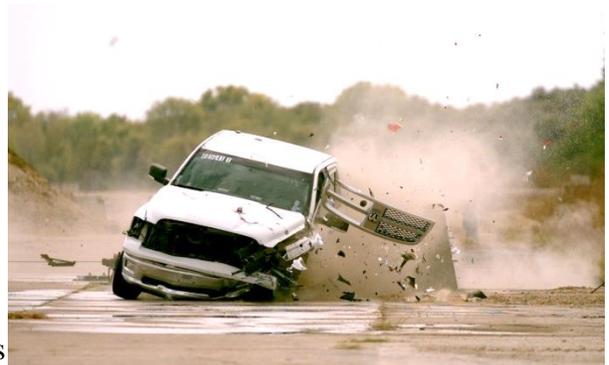
Figure C.1. Sequential Photographs for Test No. 605641-1 (Overhead and Frontal Views).

Figure C.1. Sequential Photographs for Test No. 605641-1 (Overhead and Frontal Views) (Continued).

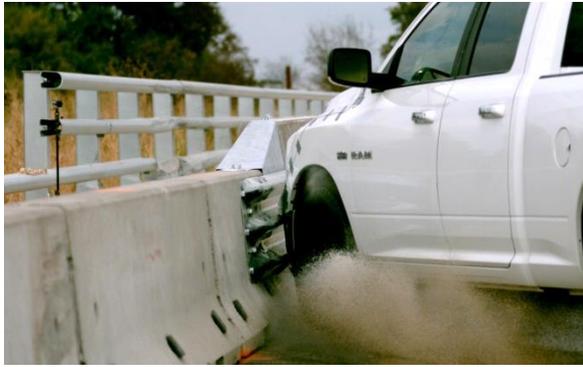
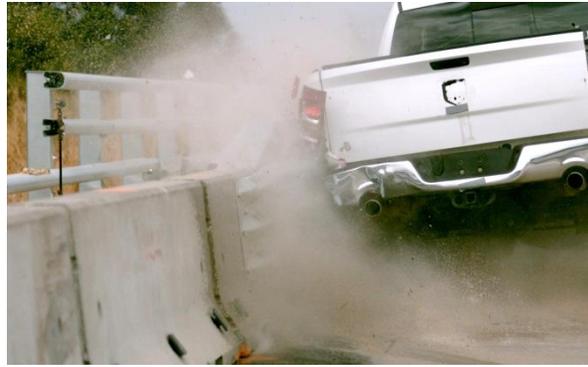
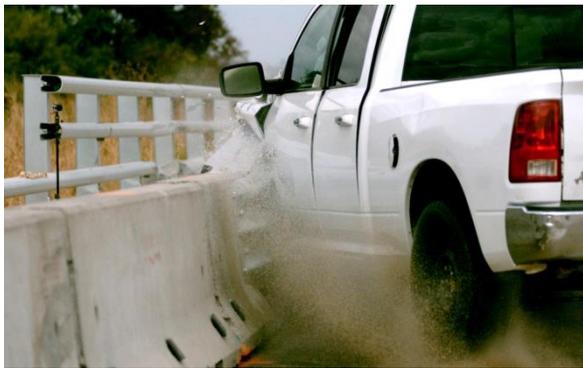
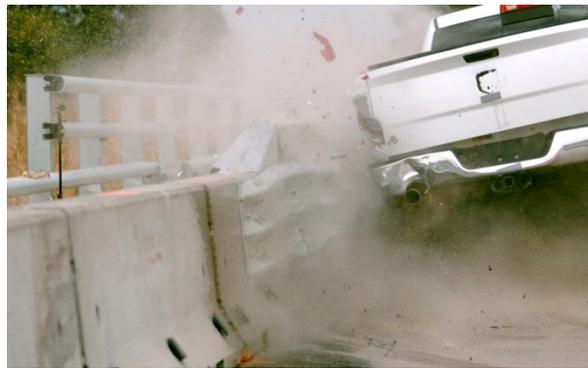
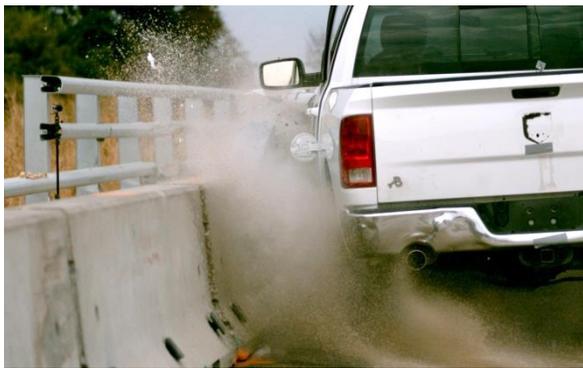
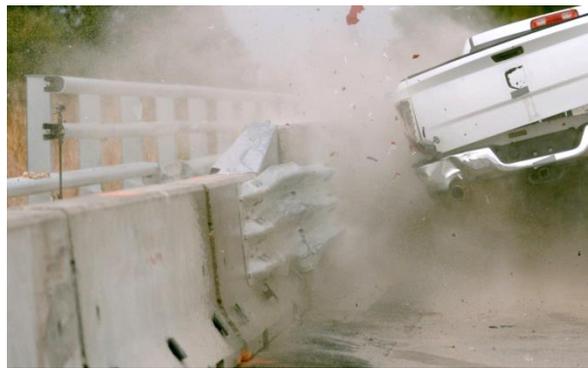
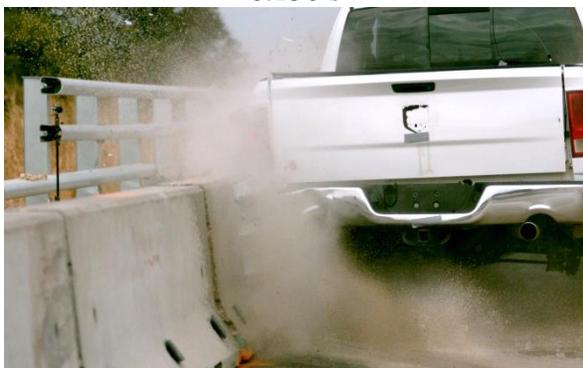
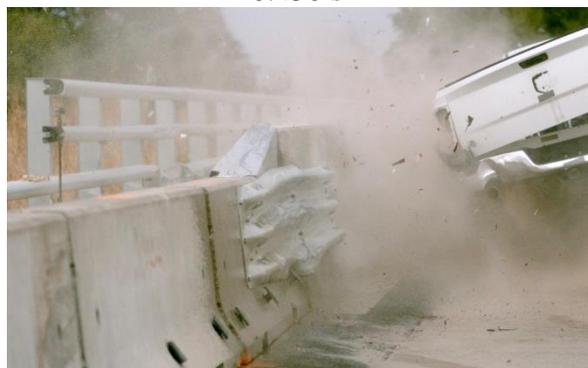
Figure C.2. Sequential Photographs for Test No. 605641-1 (Rear View).
