**NCHRP REPORT 350 UPDATE TEST 3-11  
OF THE TXDOT TYPE T-1F BRIDGE RAIL**

TxDOT IAC Contract No. 88-7DDIA001  
Report/Test No. 408019-1  
Test Date: May 22, 2007

**TEXAS TRANSPORTATION INSTITUTE  
THE TEXAS A&M UNIVERSITY SYSTEM  
COLLEGE STATION, TEXAS 77843**

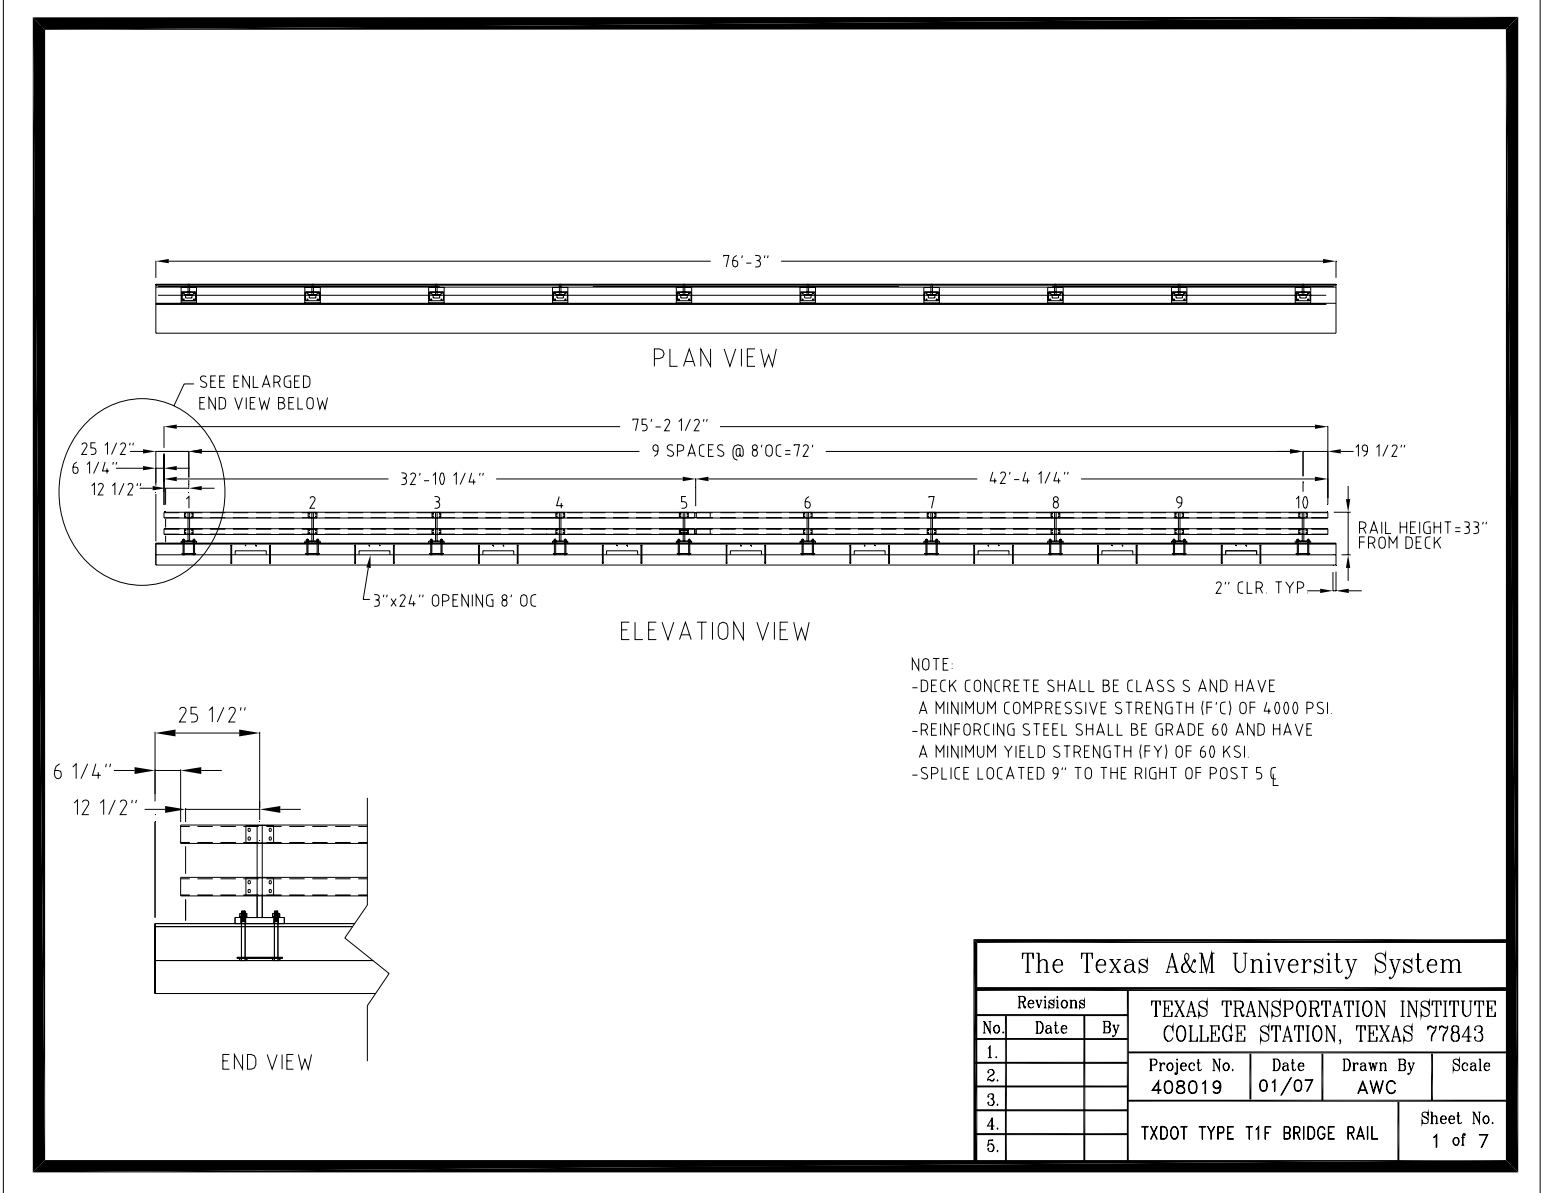
**Figure 2.1. Details of the TxDOT T-1F Bridge Rail Installation.**

A simulated concrete bridge deck cantilever and curb was constructed immediately adjacent to an existing concrete apron located at the TTI test facility. The total length of the concrete deck and curb installation was 76 ft-3 inches. The bridge deck cantilever was 2 ft-6 inches in width and 8 inches thick and was rigidly attached to an existing concrete foundation. A 1 ft-3½ inches wide by 9-inch high concrete curb was cast on top of the concrete deck. Transverse reinforcement in the deck consisted of #5 bars spaced 6 inches on centers in the top layer. Transverse reinforcement in the bottom layer consisted of #5 bars spaced at 18 inches on centers. Longitudinal reinforcement in the top layer of the deck consisted two #4 bars spaced 9 inches on centers. Longitudinal reinforcement in the bottom layer of the deck consisted of two #5's located 3 inches on centers closest to the field side edge with a third #5 bar located approximately 12 inches away. In addition to the deck reinforcement, #5 stirrups (“V” Bars) were closely spaced around each post. These bars were cast in the deck for reinforcement for the concrete curb. Longitudinal reinforcement in the curb consisted of three #5 bars equally spaced in the top of the “V” Bars. In addition, two #5 “Z” Bars were located within the curb. All reinforcement was bare steel (not epoxy coated) and was specified to have a minimum yield strength of 60 ksi.

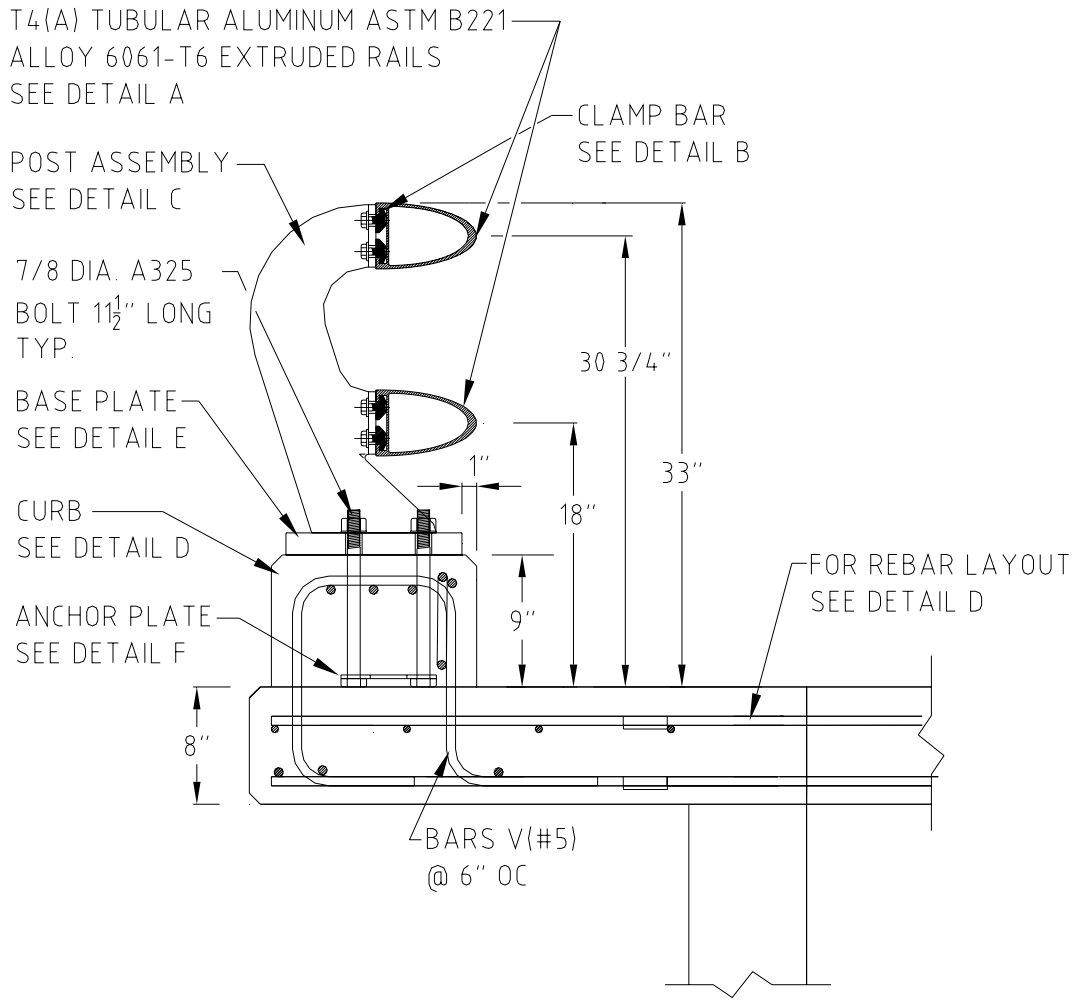
**Figure 2.2. Cross Section of the TxDOT T-1F Bridge Rail Installation.**

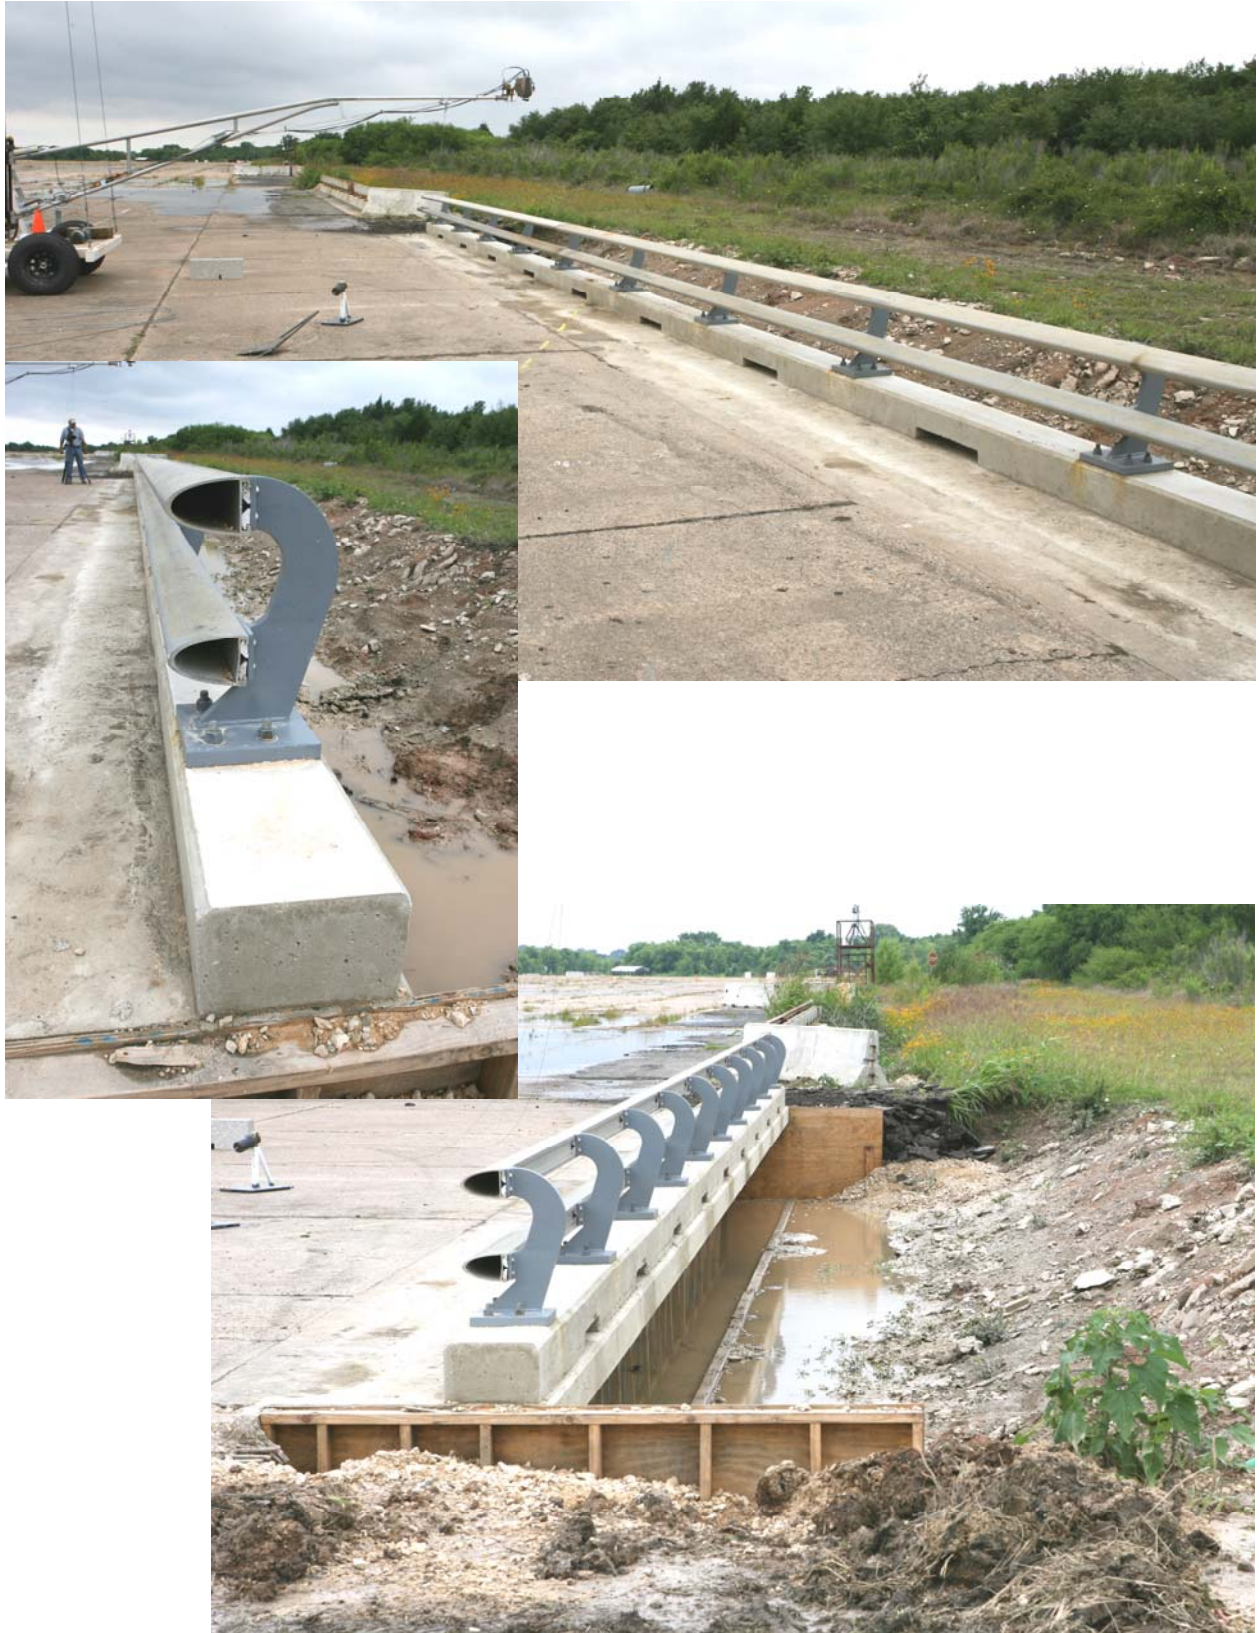
**Figure 2.3. TxDOT T-1F Bridge Rail Installation Before Test 408019-1.**

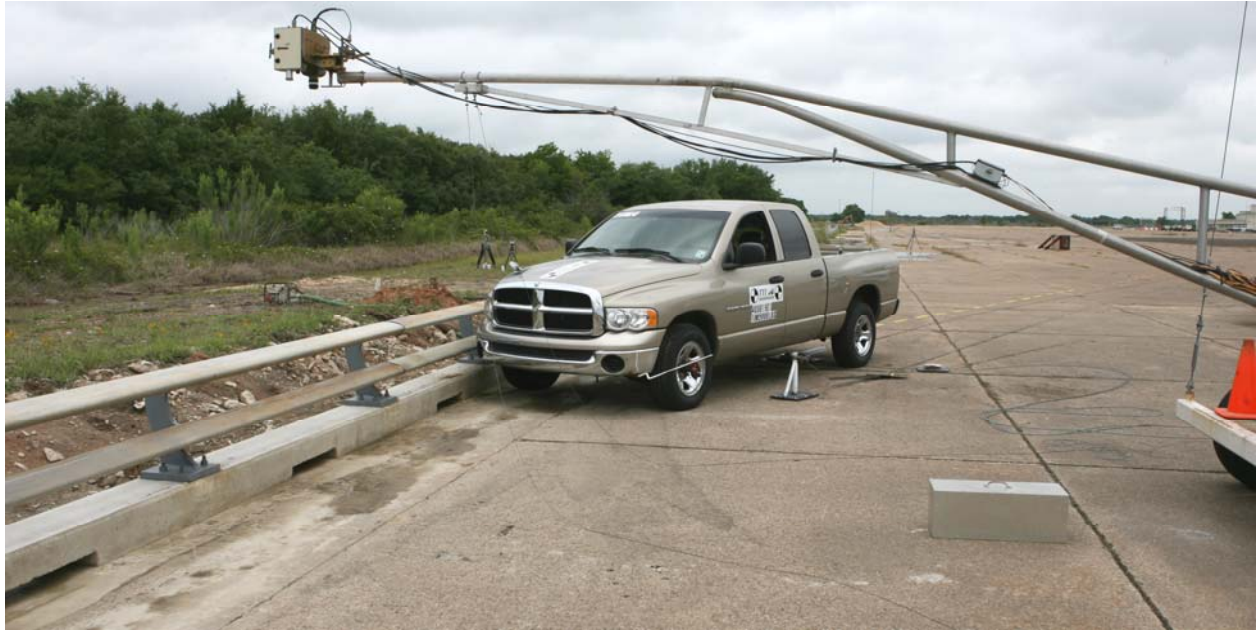
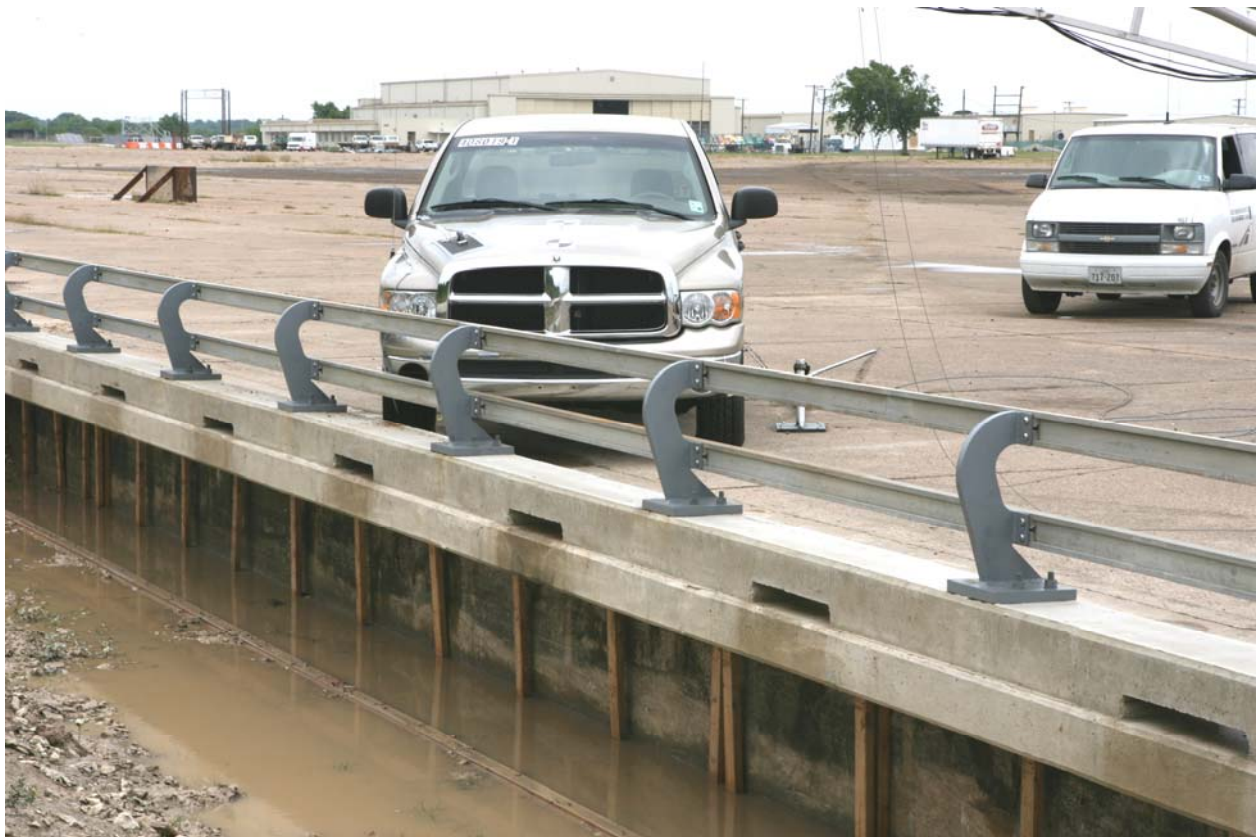
**Figure 5.1. Vehicle/Installation Geometrics for Test 408019-1.**

The 2003 Dodge 1500 pickup truck, traveling at an impact speed of 62.0 mi/h, impacted the bridge rail 66.25 inches upstream of the splice located near post 6 at an impact angle of 23.8 degrees. At approximately 0.022 s, the right front wheel rim contacted the curb and began to ride up the traffic face of the curb. At 0.045 s, the vehicle began to redirect. The left front tire became airborne at 0.084 s, and the left rear tire at 0.126 s. At 0.151 s, the front of the exterior bed of the vehicle contacted the top rail element, and at 0.158 s, the rear of the bed contacted the rail element. The vehicle was parallel with the bridge rail at 0.174 s, traveling at a speed of 32.1 mi/h. The rear bumper contacted the lower rail element at 0.179 s. At 0.329 s, the vehicle lost contact with the bridge rail and was traveling at an exit speed of 31.7 mi/h and an exit angle of 9.5 degrees. Brakes on the vehicle were applied at 1.25 s, and the vehicle came to rest 247 ft downstream of impact and 21 ft forward of the traffic face of the bridge rail. Figures B2 and B3 in Appendix B2 show sequential photographs of the test period.

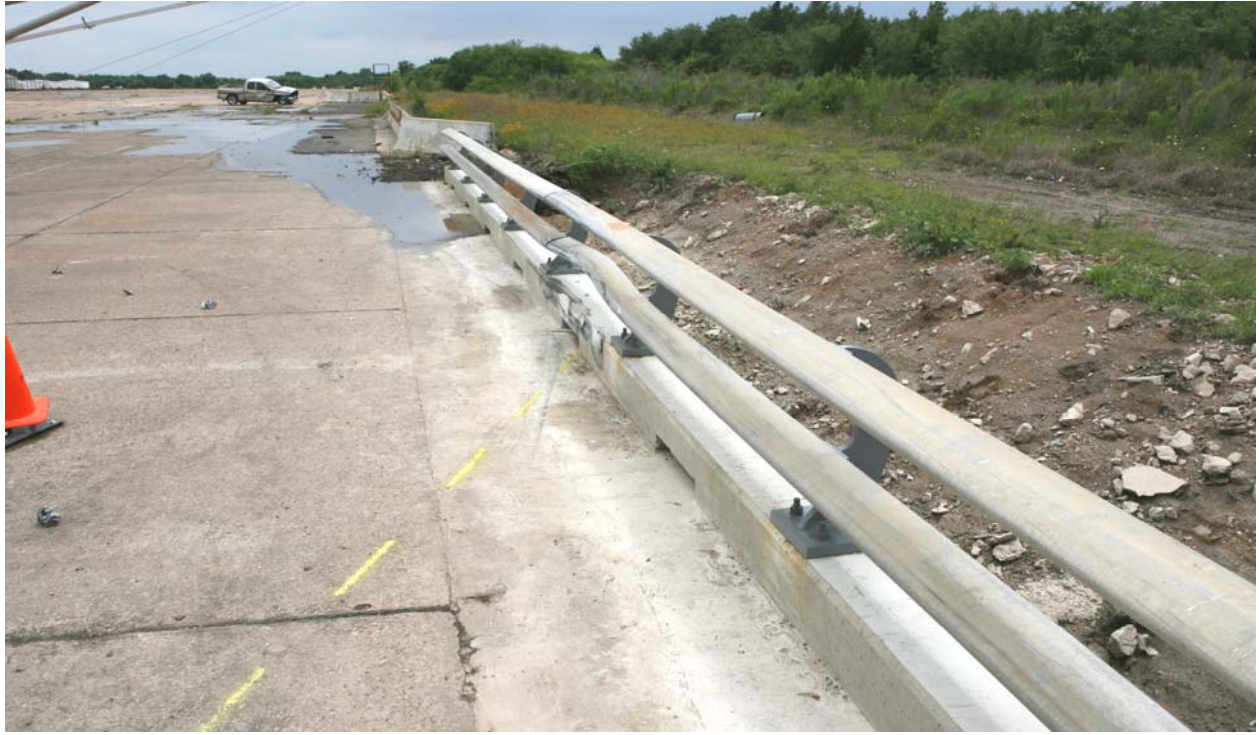
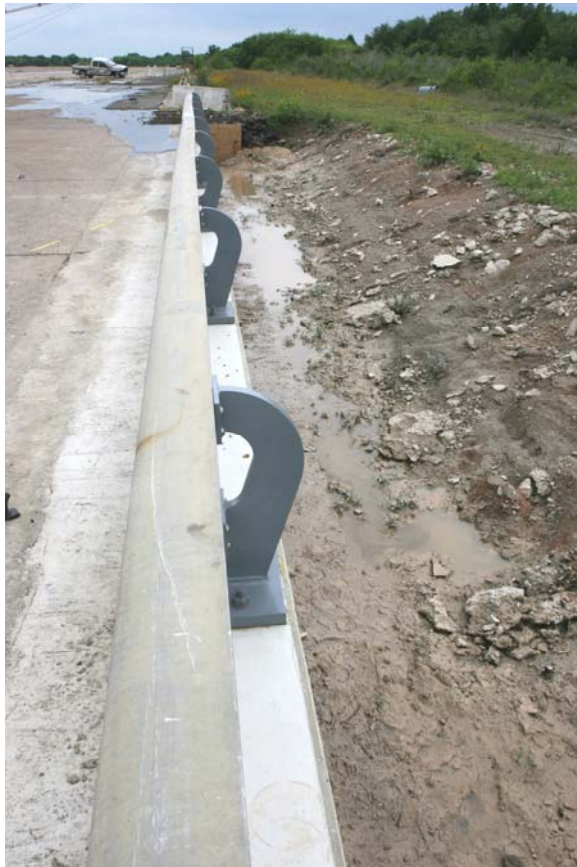
**Figure 5.3. After Impact Trajectory Path for Test 408019-1.**

The TxDOT T-1F Bridge Rail contained and redirected the 2270P vehicle. The vehicle did not penetrate, underride, or override the bridge rail. Maximum dynamic deflection of the bridge rail was not obtainable, but the maximum permanent deformation was 3.2 inches. No detached elements, fragments, or other debris were present to penetrate or to show potential for penetrating the occupant compartment, or to present hazard to others in the area. Maximum occupant compartment deformation was 1.25 inches in the right firewall area. The 2270P vehicle remained upright during and after the collision event. During the 1 second after impact, the maximum roll angle was 19 degrees and maximum pitch was -9 degrees. Occupant risk factors were within the limits specified. The 2270P vehicle remained within the exit box, and subsequently came to rest 247 ft downstream of impact and 21 ft forward of the traffic face of the bridge rail.

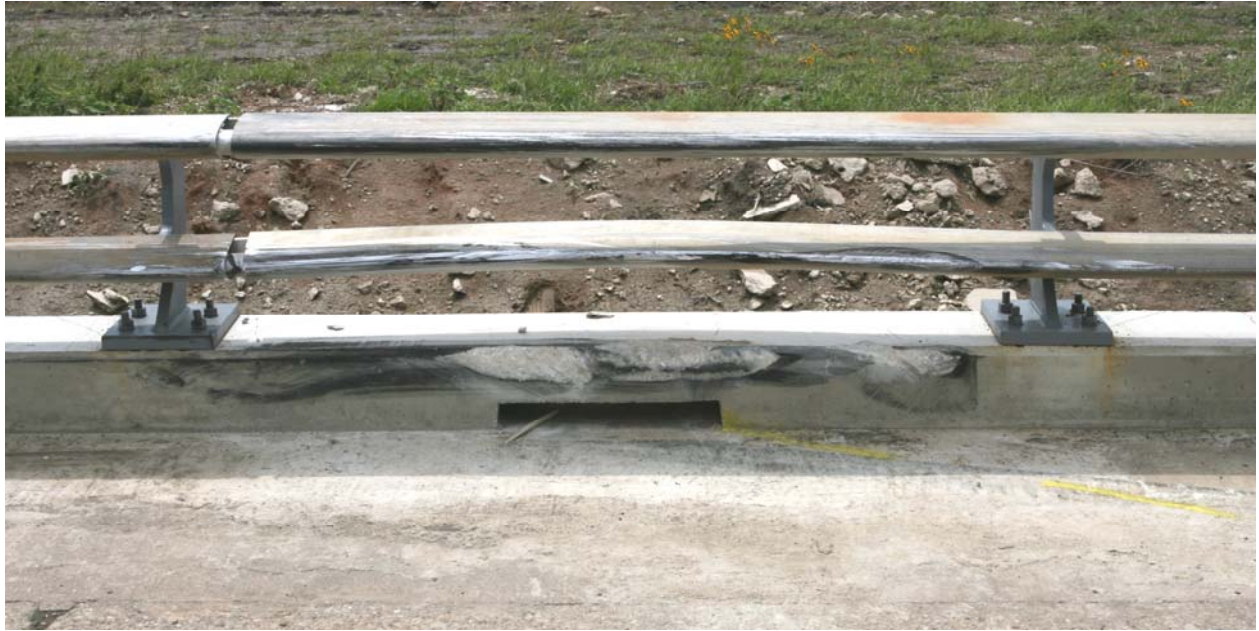
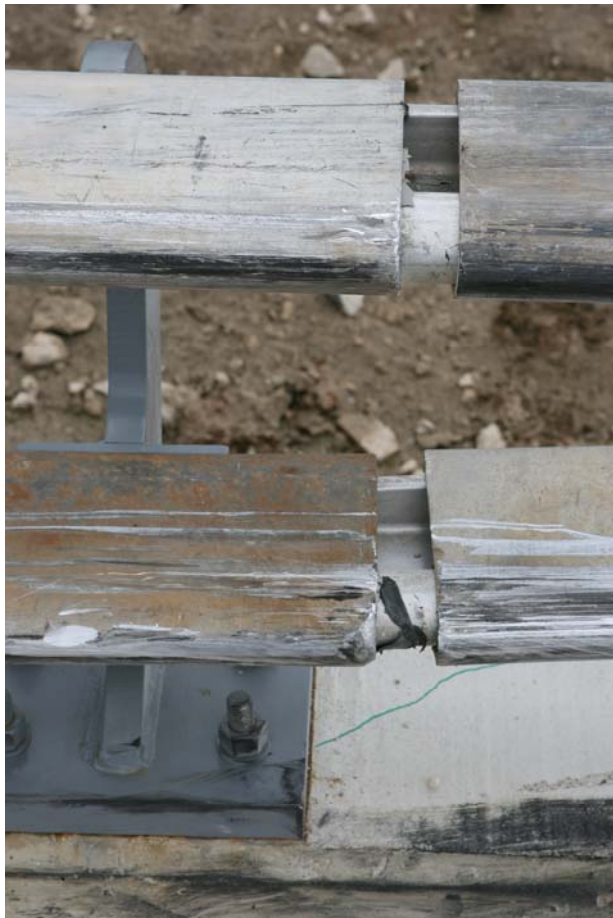
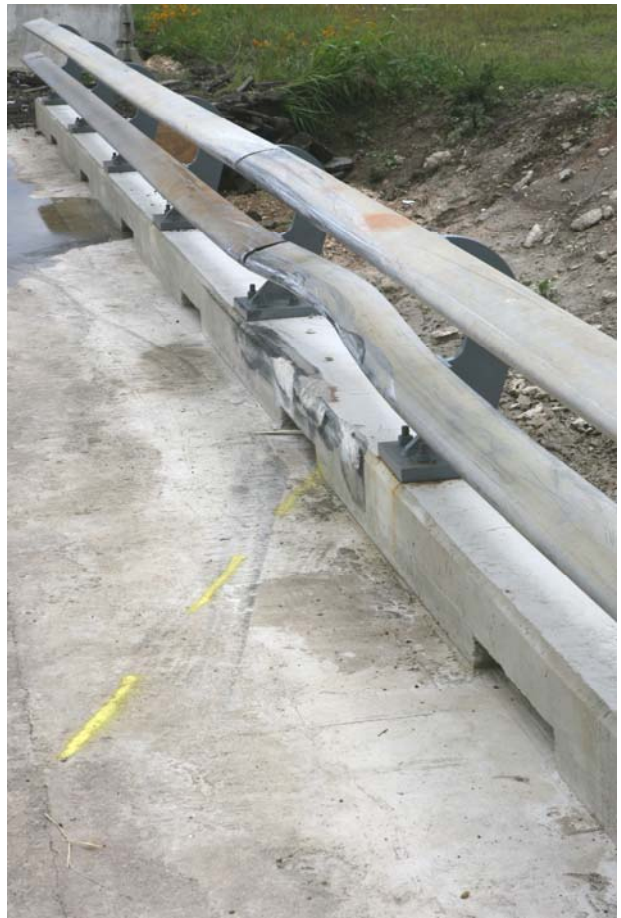
Damage to the TxDOT Type T-1F Bridge Rail is shown in figures 5.3 and 5.4. The concrete was gouged out of the traffic face of the curb. The curb also had cracks radiating out from the right front and rear and left rear anchor bolts at post 5 and both front anchors bolts at post 6. The rail splice at the top did not change, but the bottom splice opened up 0.24 inch. Length of contact of the vehicle with the top rail element, bottom rail element and curb was 142 inches, 146 inches, and 121 inches, respectively. Maximum permanent deformation of the top rail element was 0.7 inch and the bottom rail element was 3.2 inches. Working width was 15.0 inches. Maximum dynamic deformation of the top rail element during the test was not obtainable.

**Figure 5.4. Installation After Test 408019-1.**

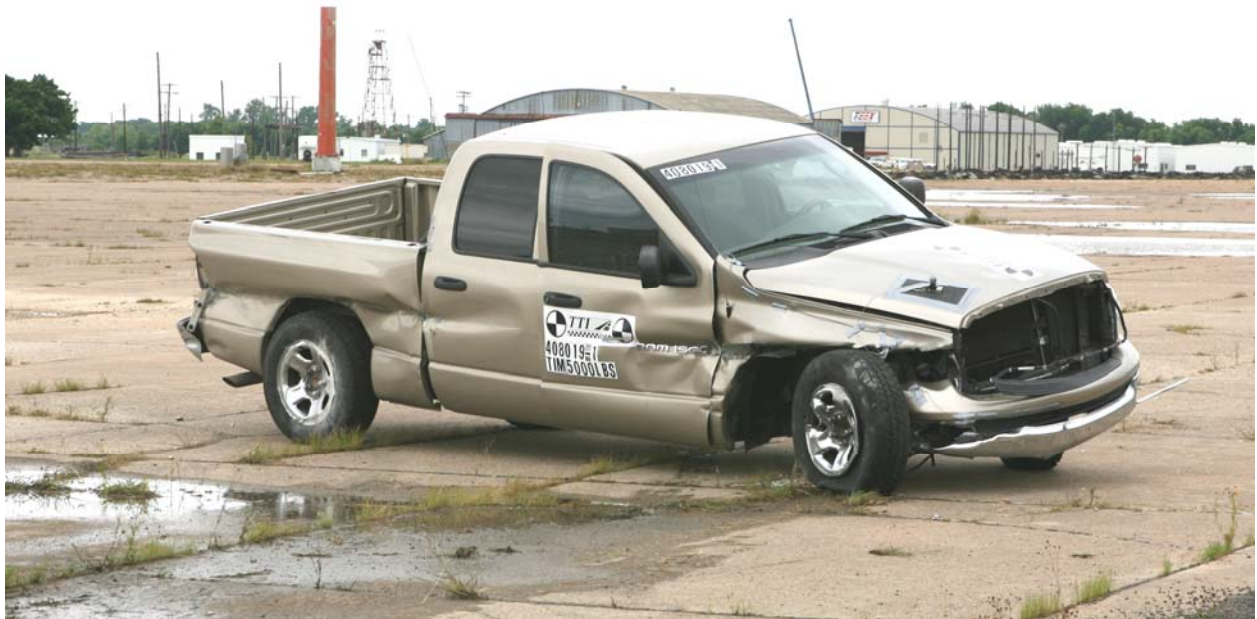
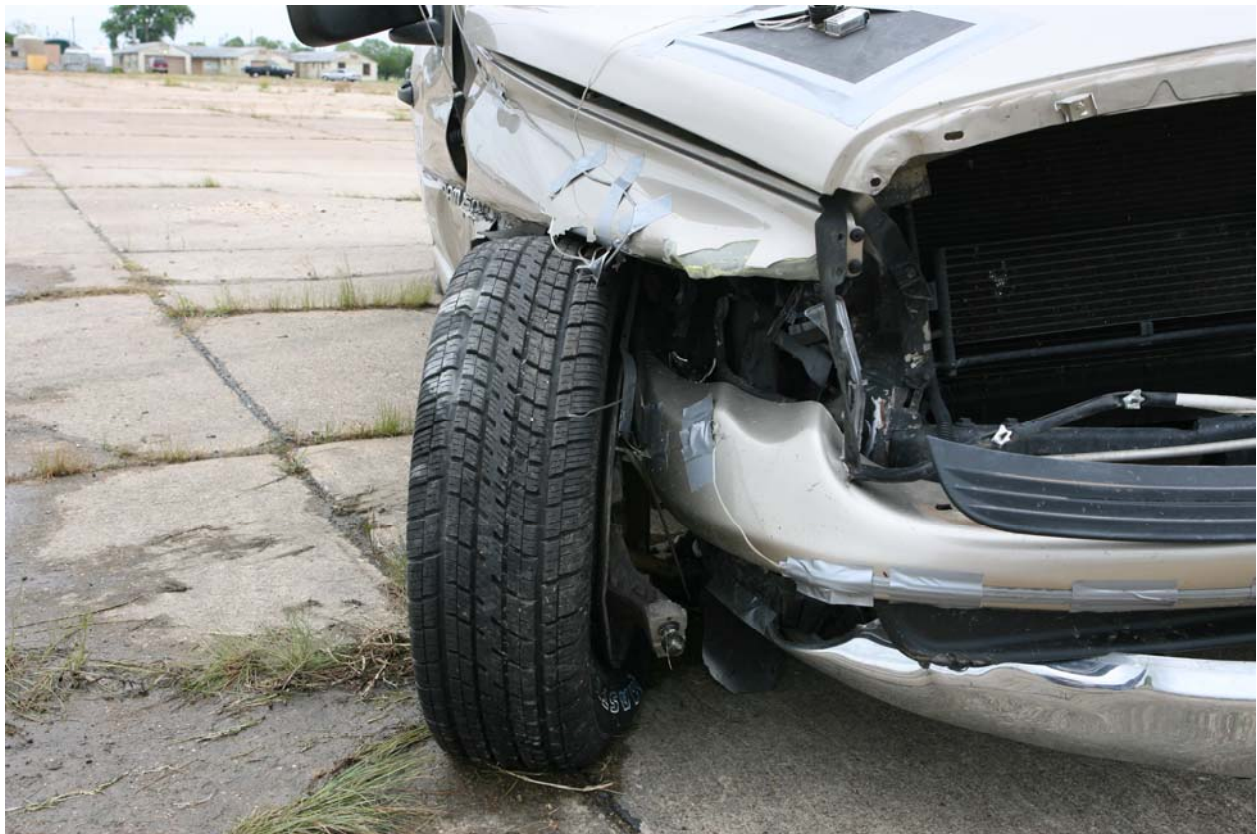
Damage to the 2270P is shown in figure 5.5. Structural damage was imparted to the right front upper and lower ball joints and A-arms, the right tie rod end and the right frame rail. Also damaged were the front bumper, hood, grill, radiator and radiator support, right front quarter panel, right front and rear doors and right rear exterior bed. The right front tire and rim separated from the vehicle and the right rear rim was deformed but the tire was not deflated. Maximum exterior crush to the vehicle was 15.0 inches in the frontal plane at the right front corner at bumper height. The floor pan, firewall, toe pan and kickpanel on the right side were deformed. Maximum occupant compartment deformation was 1.3 inches in the right firewall/toe pan area. Photographs of the interior of the vehicle are shown in figure 5.6. Exterior crush and occupant compartment deformations are shown in tables B1 and B2.

**Figure 5.5. Vehicle After Test 408019-1.**

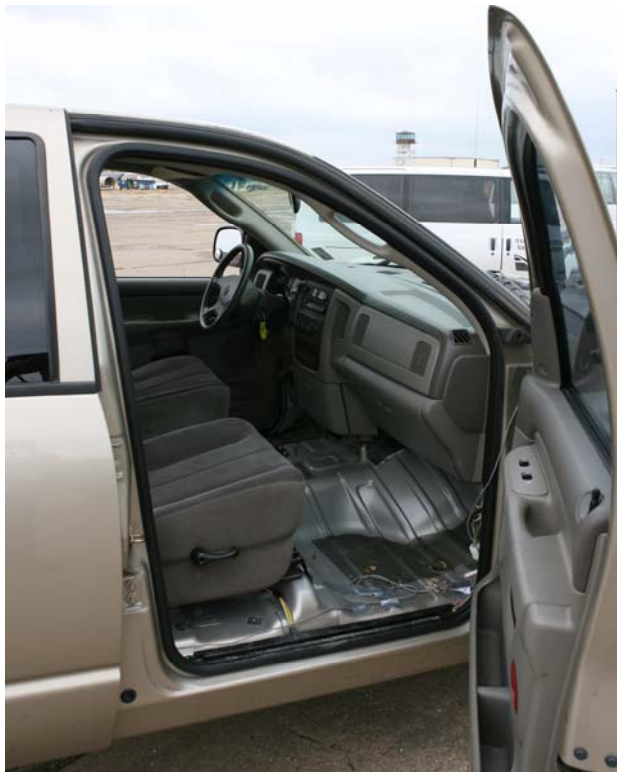
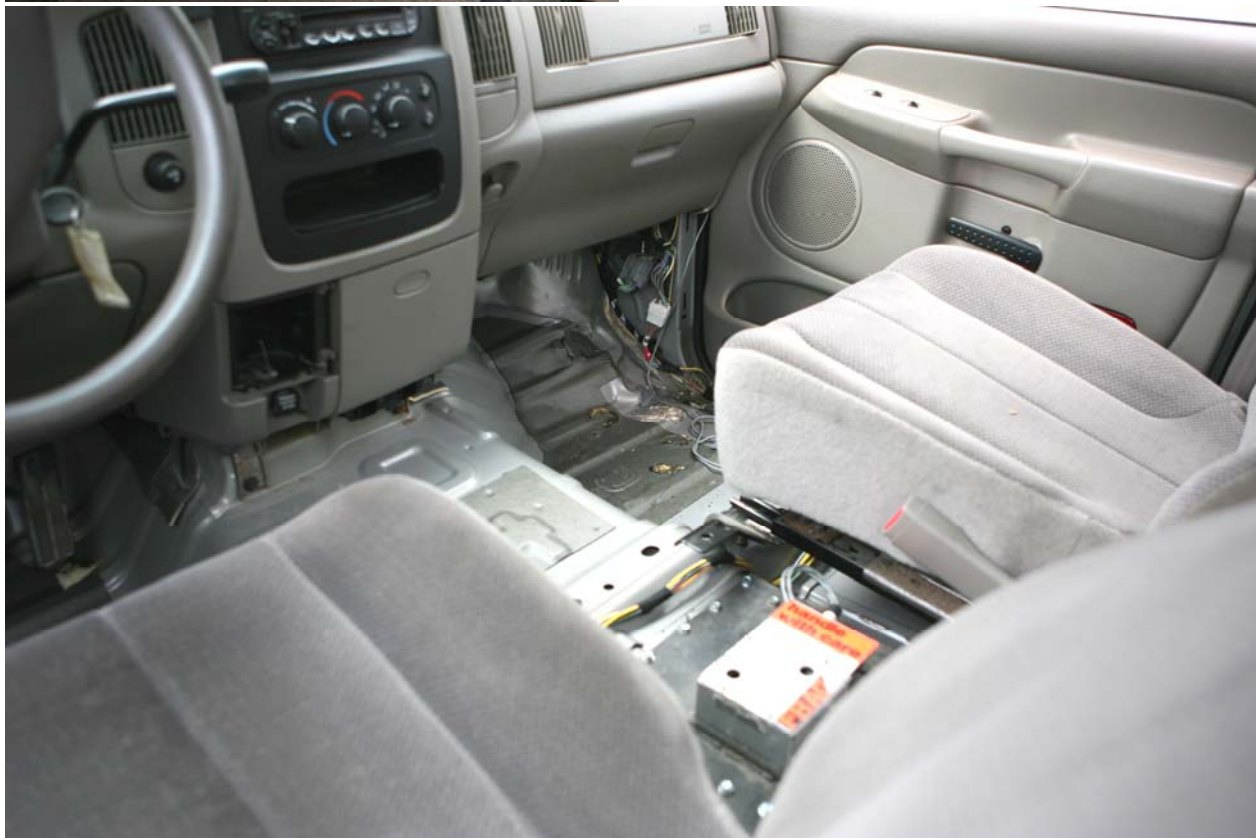
**Figure 5.6. Interior of Vehicle for Test 408019-1.**

Results: No detached elements, fragments, or other debris were present to penetrate or to show potential for penetrating the occupant compartment, or to present hazard to others in the area. (PASS)  
Maximum occupant compartment deformation was 1.25 inches in the right firewall area. (GOOD)

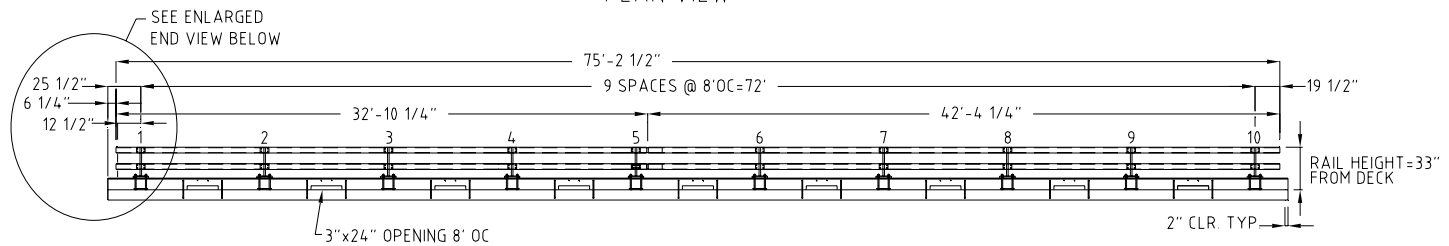
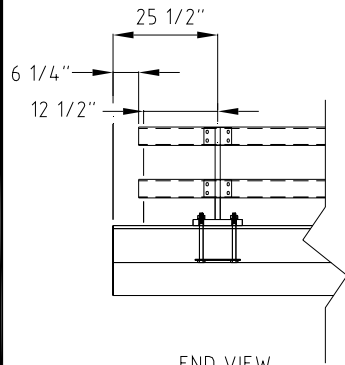
The Texas A&M University System				
TEXAS TRANSPORTATION INSTITUTE COLLEGE STATION, TEXAS 77843				
Revisions		Project No.	Date	Drawn By
No.	Date	By	408019	AWC
1.				
2.				
3.				
4.				
5.				
TXDOT TYPE T1F BRIDGE RAIL				Scale
				Sheet No.
				1 of 7

ELEVATION VIEW

END VIEW

NOTE:  
 -DECK CONCRETE SHALL BE CLASS S AND HAVE A MINIMUM COMPRESSIVE STRENGTH (F'C) OF 4000 PSI.  
 -REINFORCING STEEL SHALL BE GRADE 60 AND HAVE A MINIMUM YIELD STRENGTH (FY) OF 60 KSI  
 -SPLICE LOCATED 9" TO THE RIGHT OF POST 5

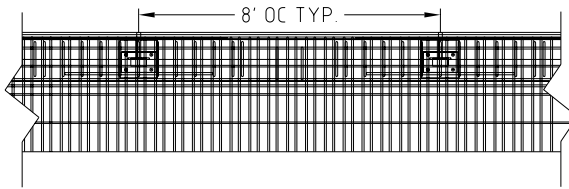
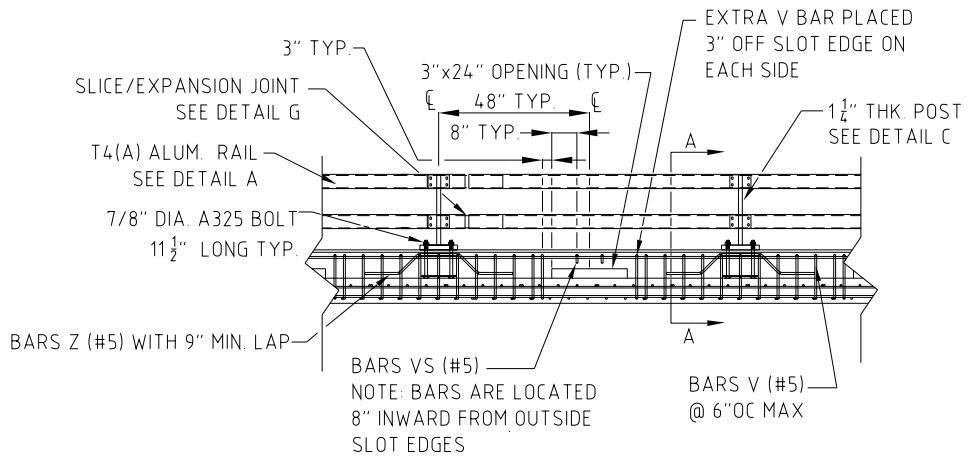
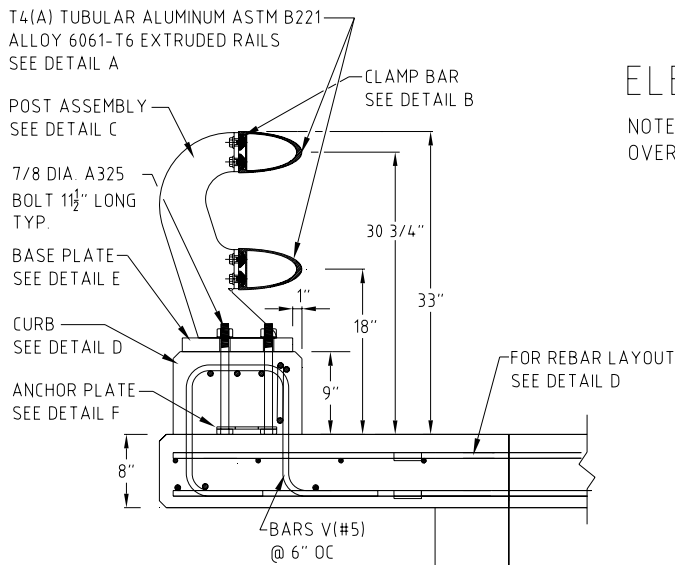
The Texas A&M University System																								
TEXAS TRANSPORTATION INSTITUTE COLLEGE STATION, TEXAS 77843																								
Project No.		Date	Drawn By																					
408019		01/07	AWC																					
TXDOT TYPE T1F BRIDGE RAIL			Sheet No. 2 of 7

PLAN VIEW

ELEVATION VIEW

NOTE: BARS C (#5) ARE CENTERED  
OVER EACH SLOT, SEE DETAIL D

SECTION A-A

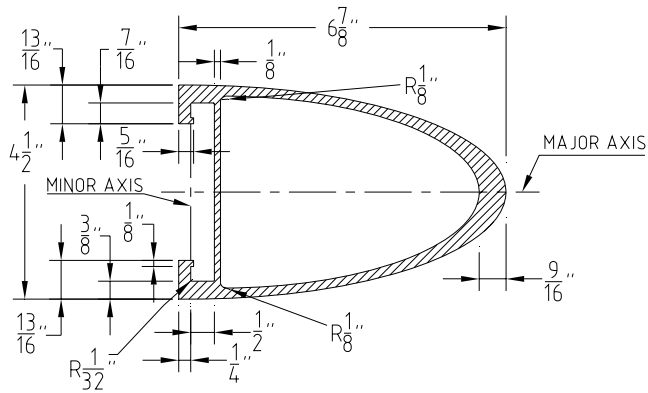
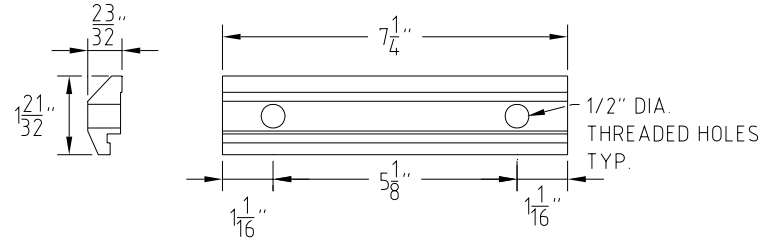
Revisions			TEXAS TRANSPORTATION INSTITUTE COLLEGE STATION, TEXAS 77843			
No.	Date	By	Project No.	Date	Drawn By	Scale
1.			408019	01/07	AWC	
2.						
3.						
4.			TXDOT TYPE T1F BRIDGE RAIL			Sheet No.
5.						3 of 7

DETAIL A  
T4(A) ALUMINUM RAIL

DETAIL B  
CLAMP BAR

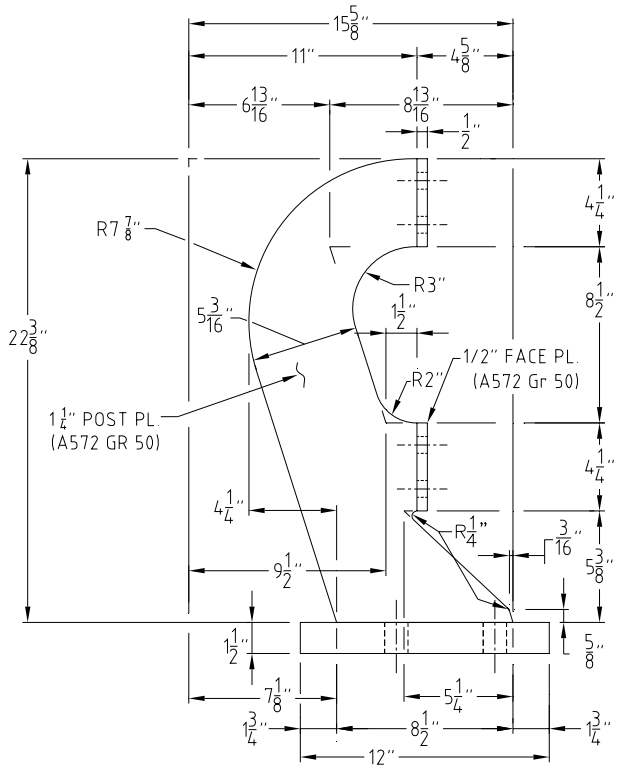
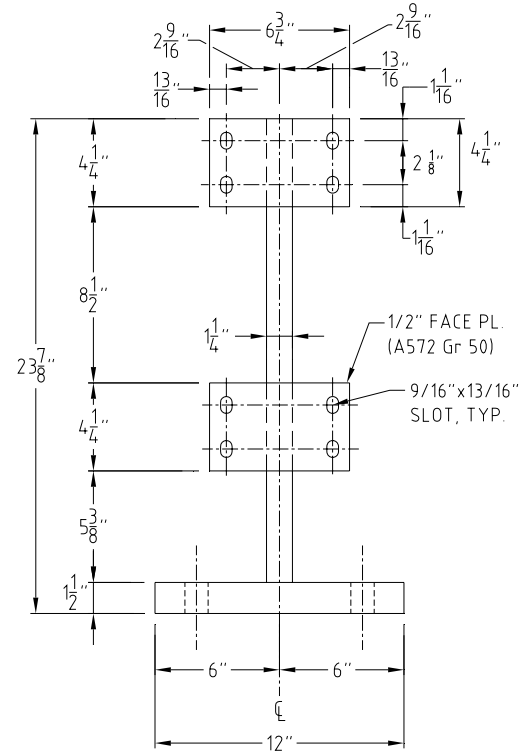
Revisions			TEXAS TRANSPORTATION INSTITUTE COLLEGE STATION, TEXAS 77843			
No.	Date	By	Project No.	Date	Drawn By	Scale
1.			408019	01/07	AWC	
2.			TXDOT TYPE T1F BRIDGE RAIL			Sheet No. 4 of 7
3.						
4.						
5.

POST SIDE VIEW

TRAFFIC SIDE VIEW

DETAIL C  
POST ASSEMBLY

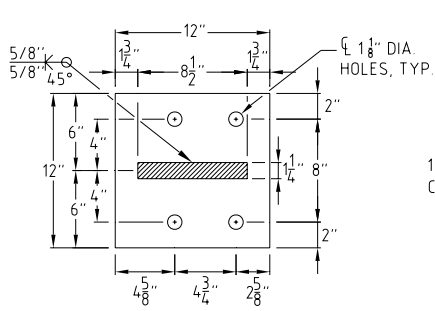
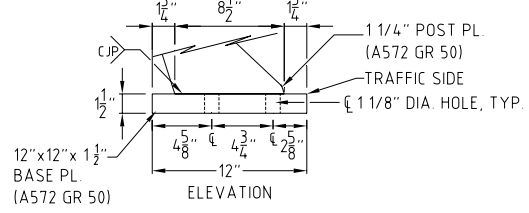
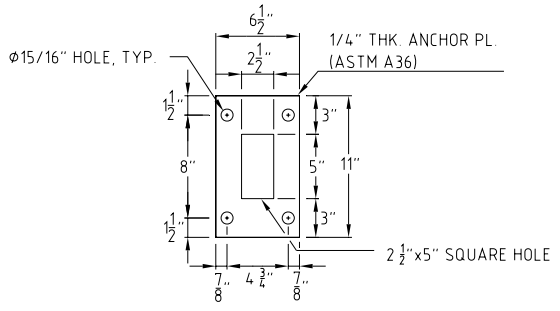
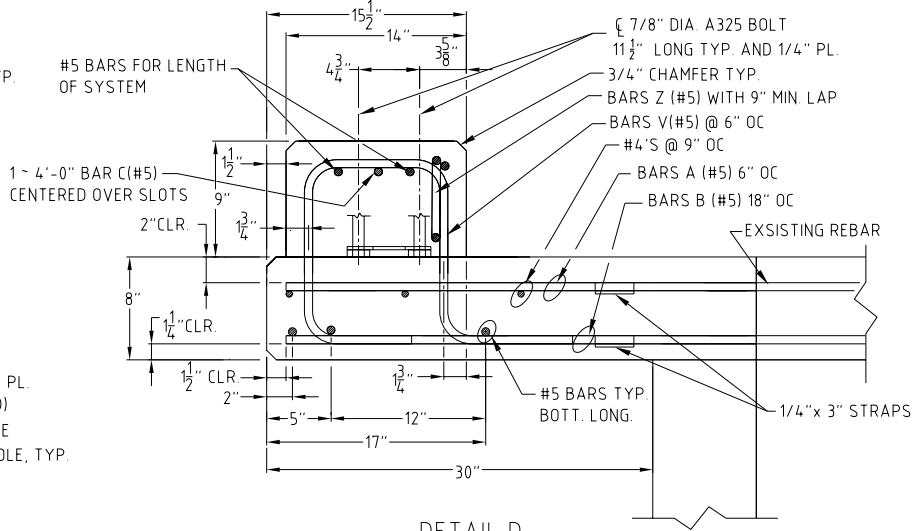
The Texas A&M University System				
Revisions		TEXAS TRANSPORTATION INSTITUTE COLLEGE STATION, TEXAS 77843		
No.	Date	By	Project No.	Date
1.			408019	01/07
2.			Drawn By	Scale
3.			AWC	
4.			TXDOT TYPE T1F BRIDGE RAIL	Sheet No.
5.				5 of 7

PLAN

DETAIL E  
 BASE PLATE

DETAIL F  
 PLAN VIEW OF ANCHOR PLATE

DETAIL D  
 REBAR DETAIL

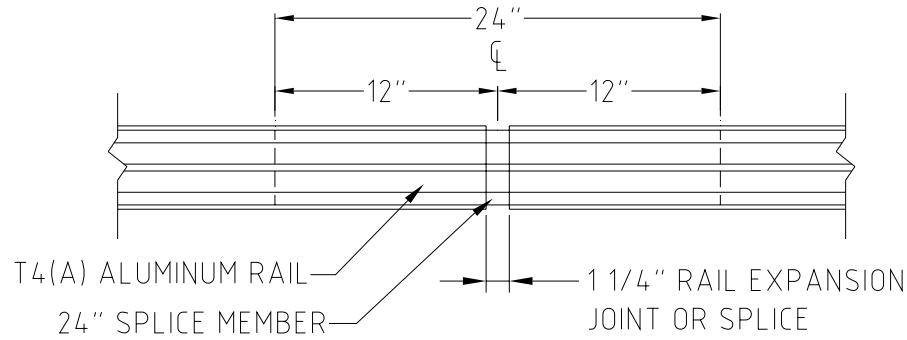
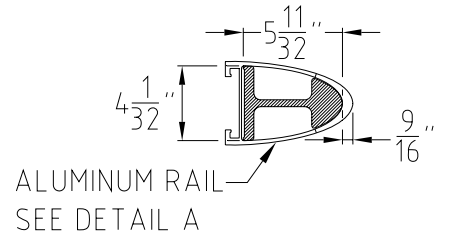
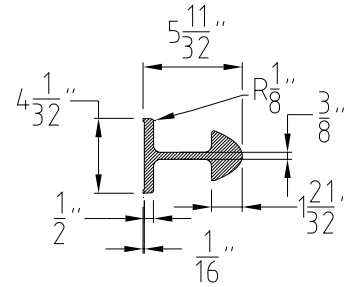
SPLICE FIT INSIDE ALUM. RAIL

SPLICE MEMBER SECTION

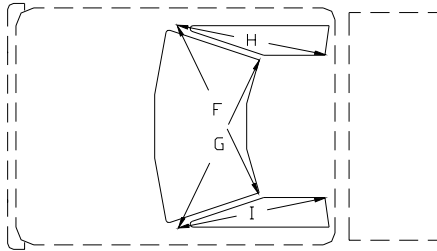
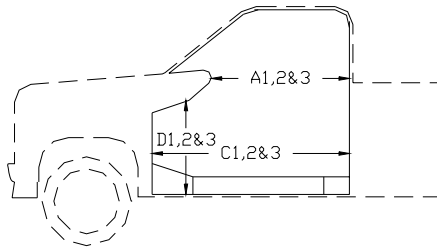
## Occupant Compartment Deformation

BEFORE (inches)	AFTER (inches)
A1	65.6	65.6
A2	65.7	65.7
A3	66.3	66.3
B1	44.7	44.7
B2	39.4	39.4
B3	45.6	45.6
C1	30.1	30.1
C2	---	---
C3	28.0	26.8
D1	12.7	12.7
D2	2.5	2.5
D3	11.5	11.5
E1	64.5	65.1
E2	63.9	64.0
F	59.8	59.8
G	59.8	59.8
H	39.5	39.5
I	39.5	39.5
J*	61.8	61.2

\*Lateral area across the cab from driver's side kickpanel to passenger's side kickpanel.

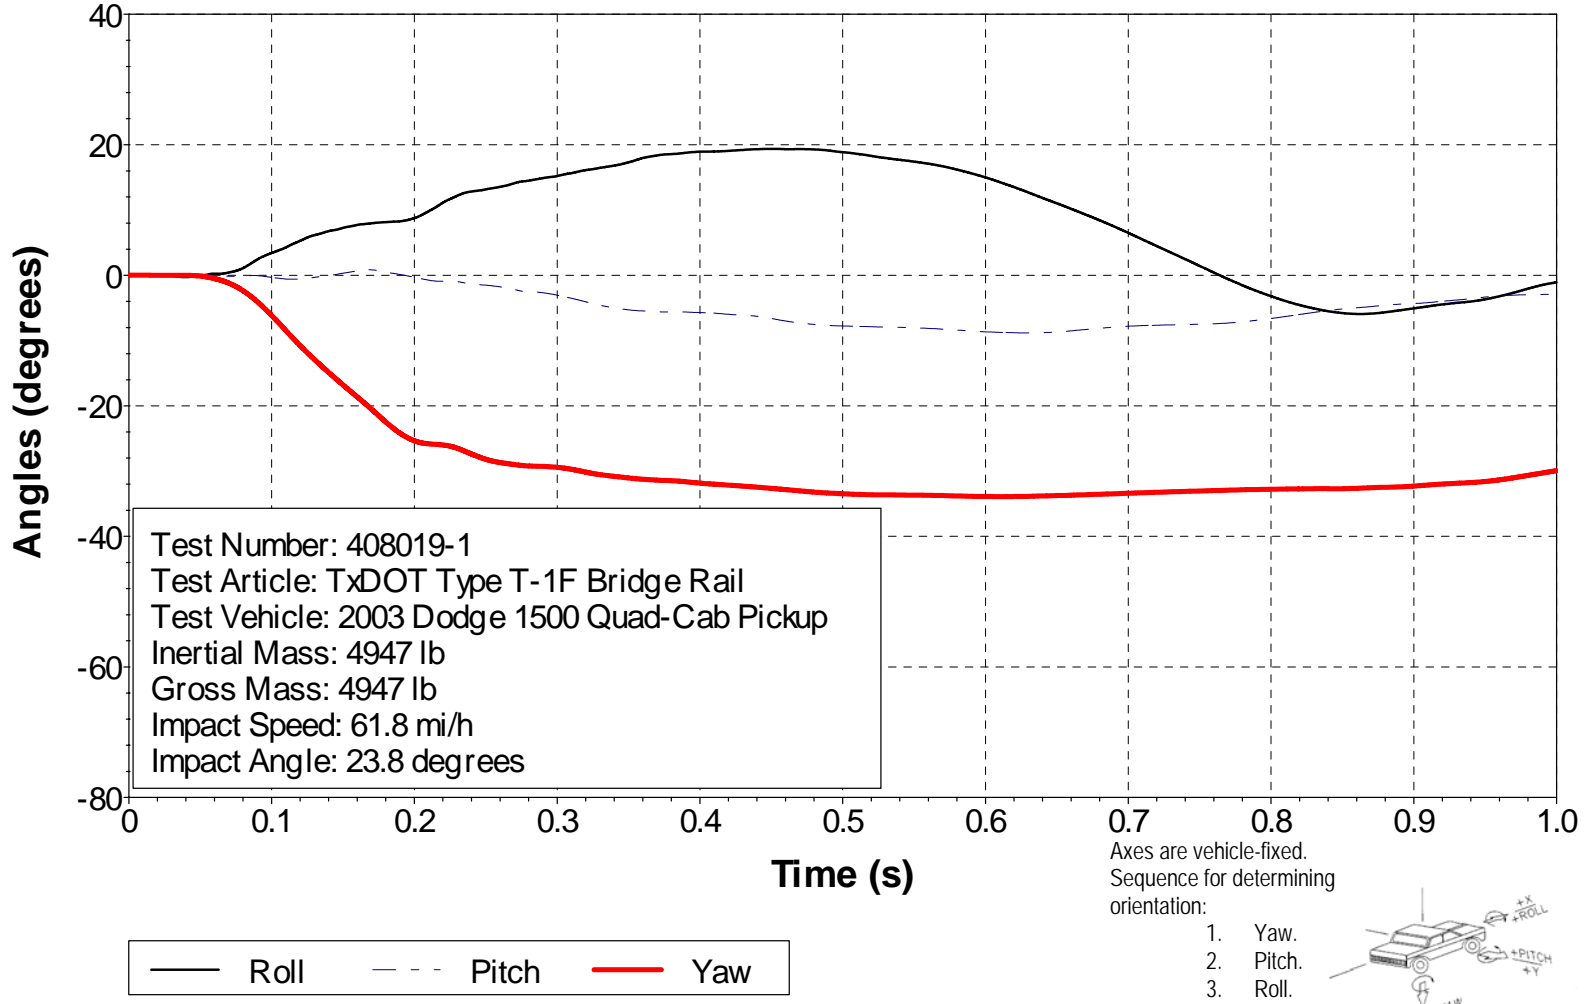
Figure B4. Vehicle Angular Displacements for Test 408019-1.
