**NCHRP REPORT 350 UPDATE TEST 3-11  
OF THE TXDOT TYPE T-1F BRIDGE RAIL**

TxDOT IAC Contract No. 88-7DDIA001  
Report/Test No. 408019-1  
Test Date: May 22, 2007

**TEXAS TRANSPORTATION INSTITUTE  
THE TEXAS A&M UNIVERSITY SYSTEM  
COLLEGE STATION, TEXAS 77843**

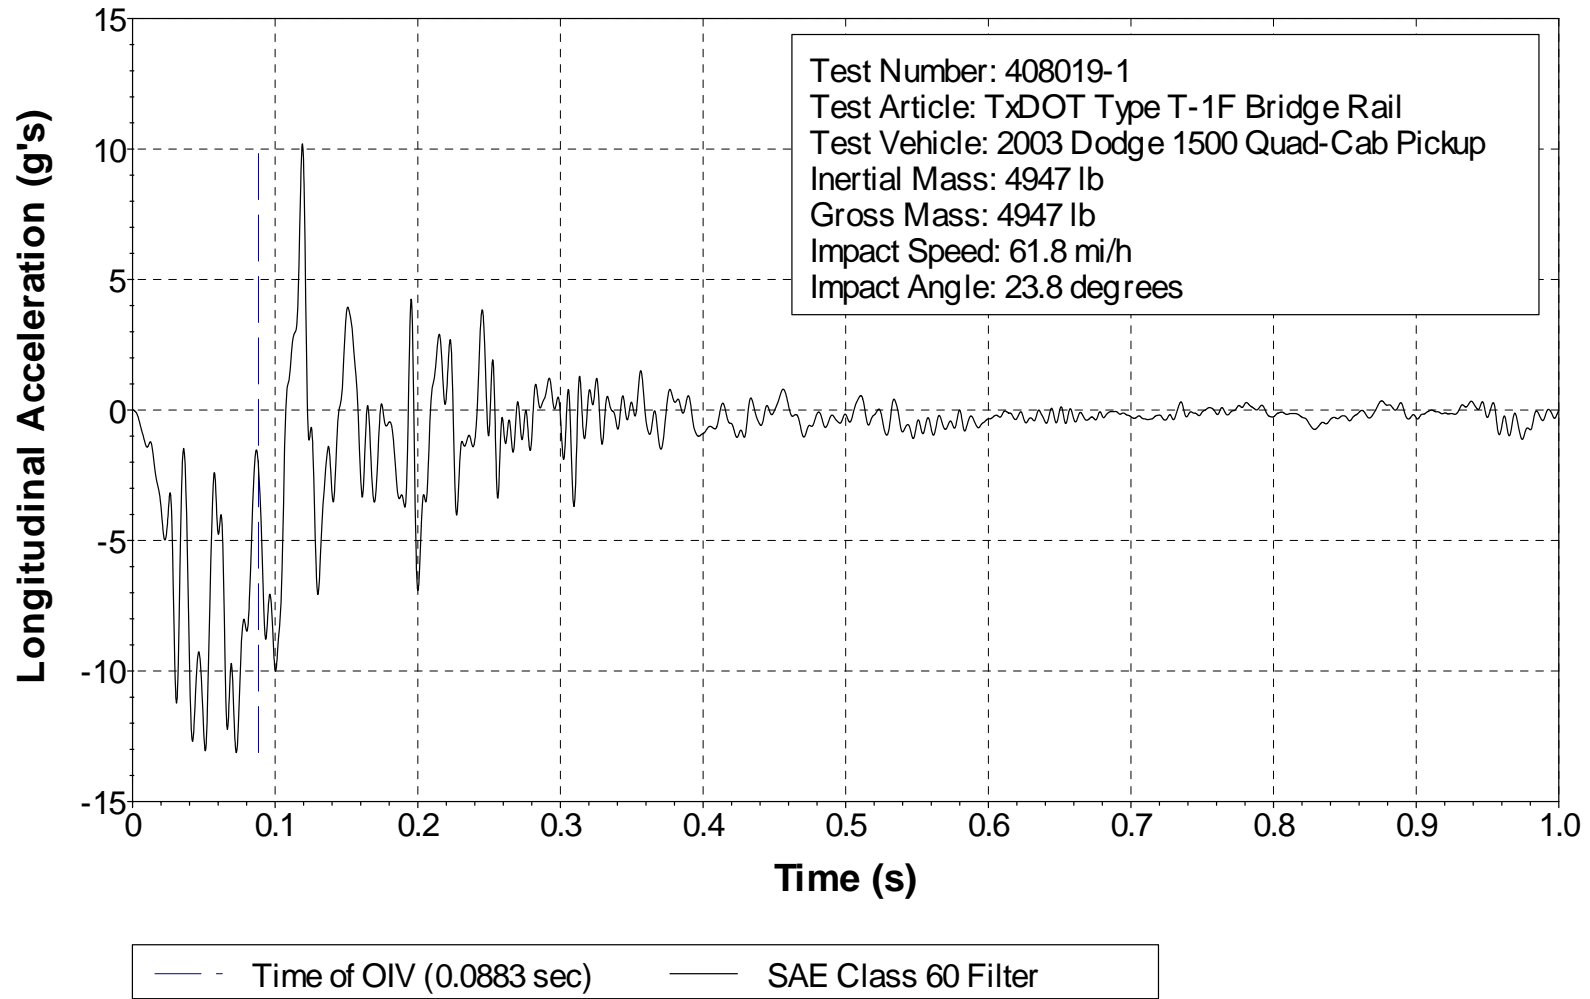
**Figure B5. Vehicle Longitudinal Accelerometer Trace for Test 408019-1  
(Accelerometer Located at Center of Gravity).**

Data from the accelerometer, located at the vehicle center of gravity, were digitized for evaluation of occupant risk. In the longitudinal direction, the occupant impact velocity was 17.4 ft/s at 0.088 s, the highest 0.010-s occupant ridedown acceleration was -8.9 Gs from 0.092 to 0.102 s, and the maximum 0.050-s average acceleration was -8.6 Gs between 0.029 and 0.079 s. In the lateral direction, the occupant impact velocity was 30.8 ft/s at 0.088 s, the highest 0.010-s occupant ridedown acceleration was -12.0 Gs from 0.202 to 0.212 s, and the maximum 0.050-s average was -15.9 Gs between 0.040 and 0.090 s. Figure 5.7 presents these data and other pertinent information from the test. Figures B4 through B10 in Appendix B3 presents vehicle angular displacements and accelerations versus time traces.

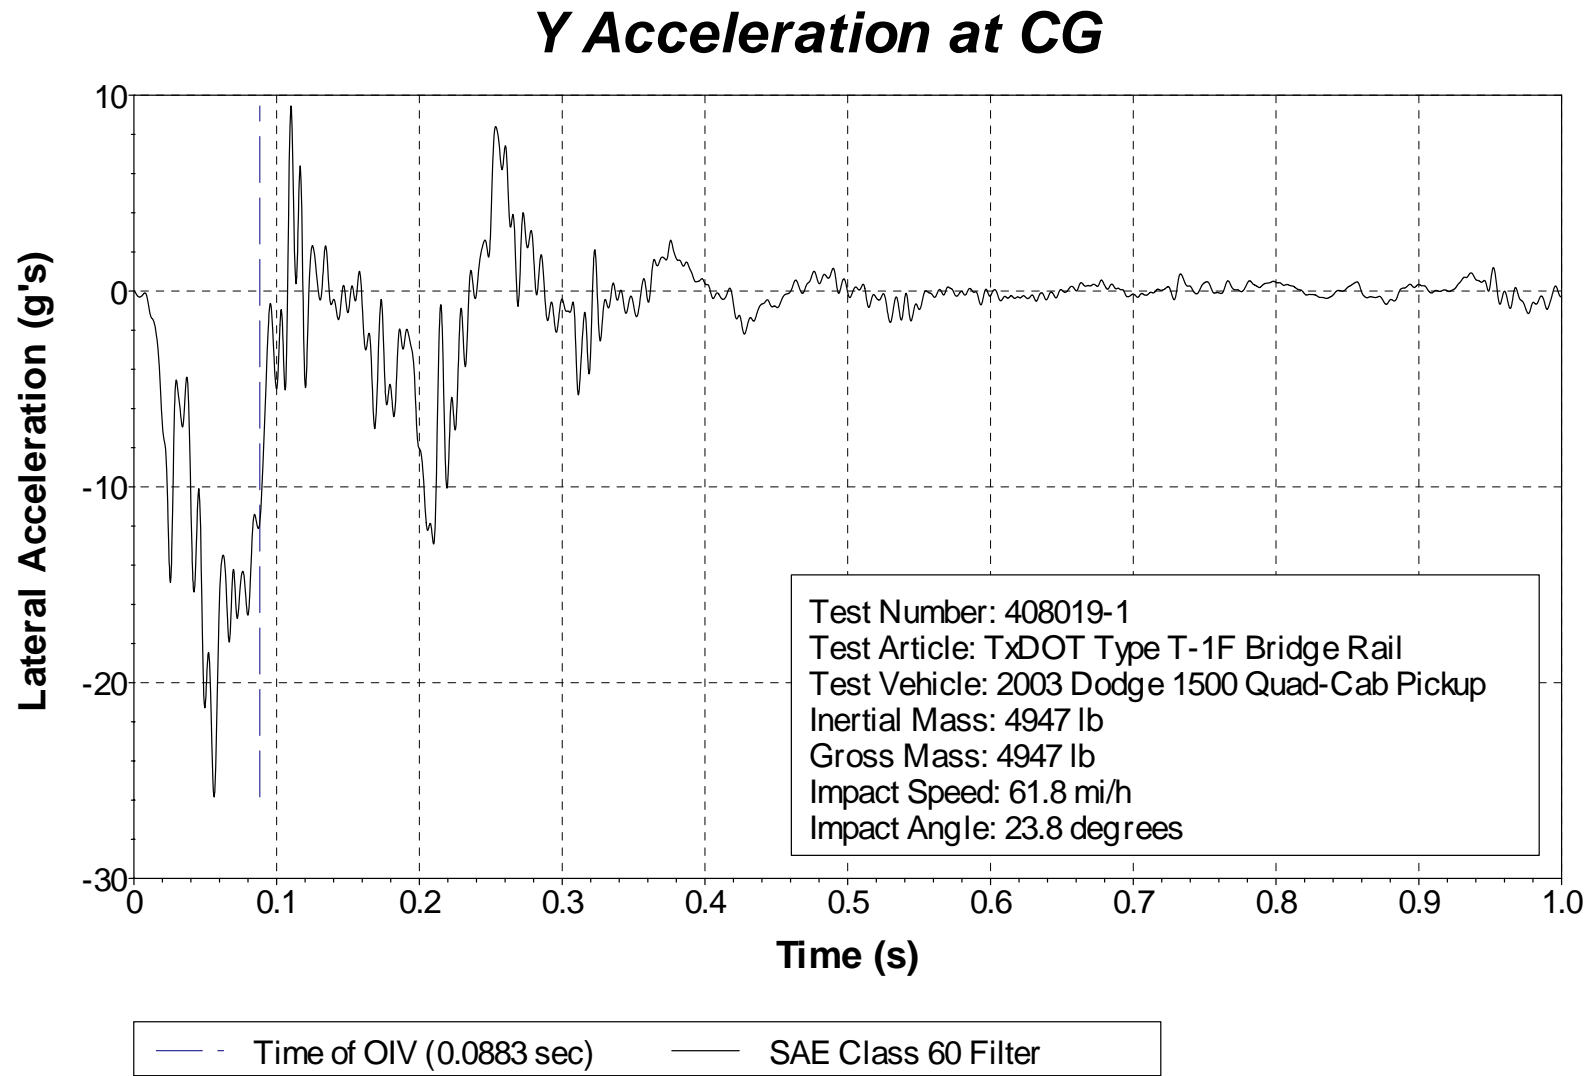
**Figure B6. Vehicle Lateral Accelerometer Trace for Test 408019-1  
(Accelerometer Located at Center of Gravity).**

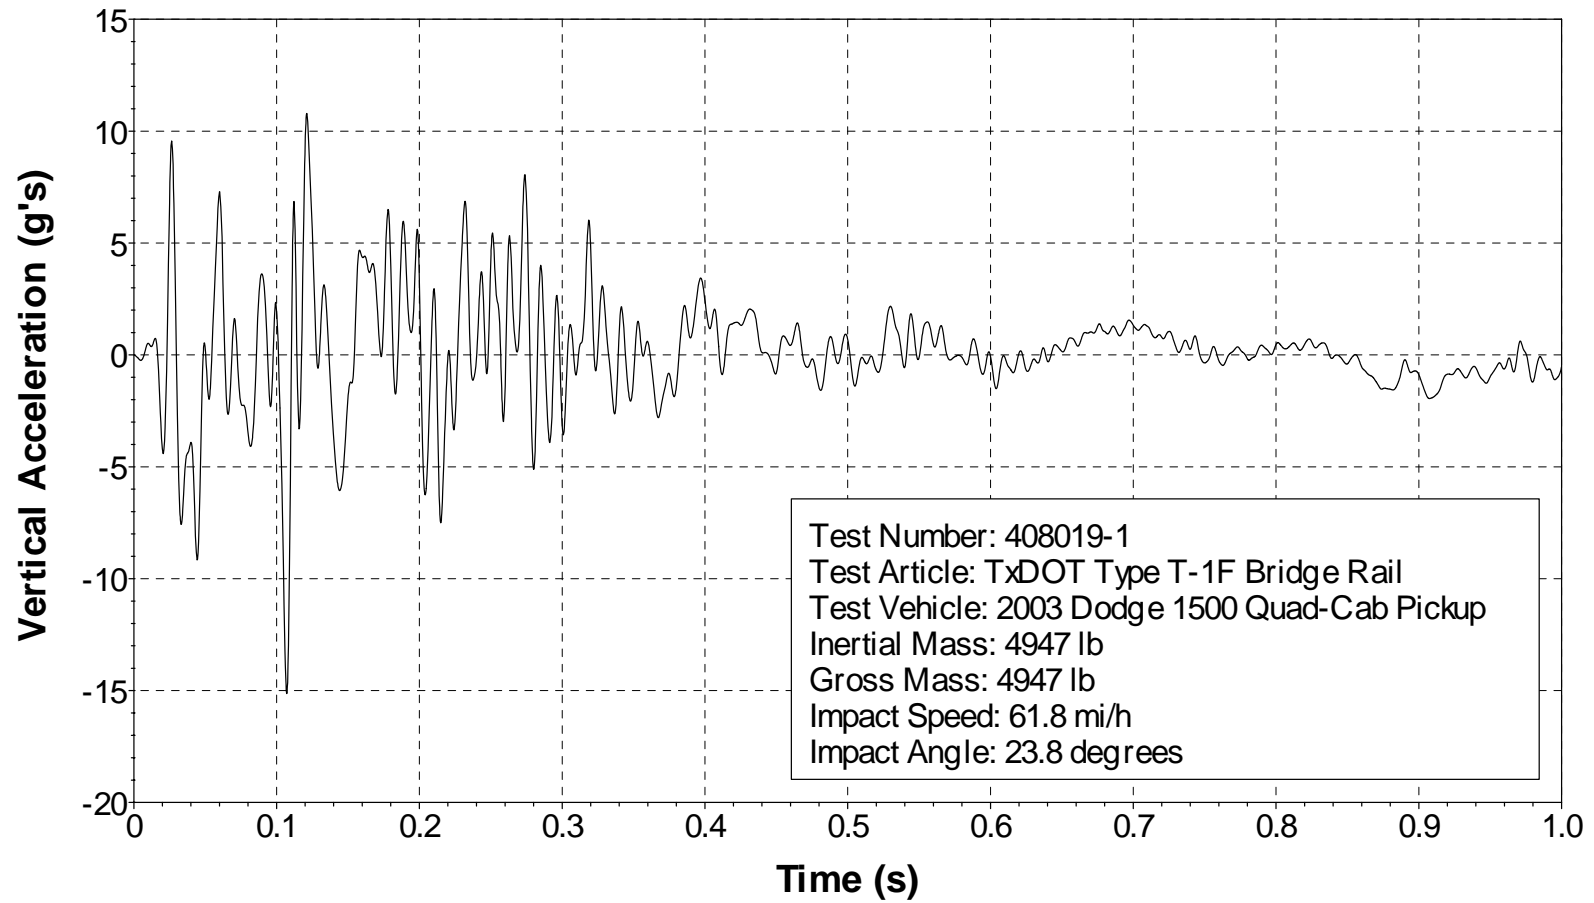
**Figure B7. Vehicle Vertical Accelerometer Trace for Test 408019-1  
(Accelerometer Located at Center of Gravity).**

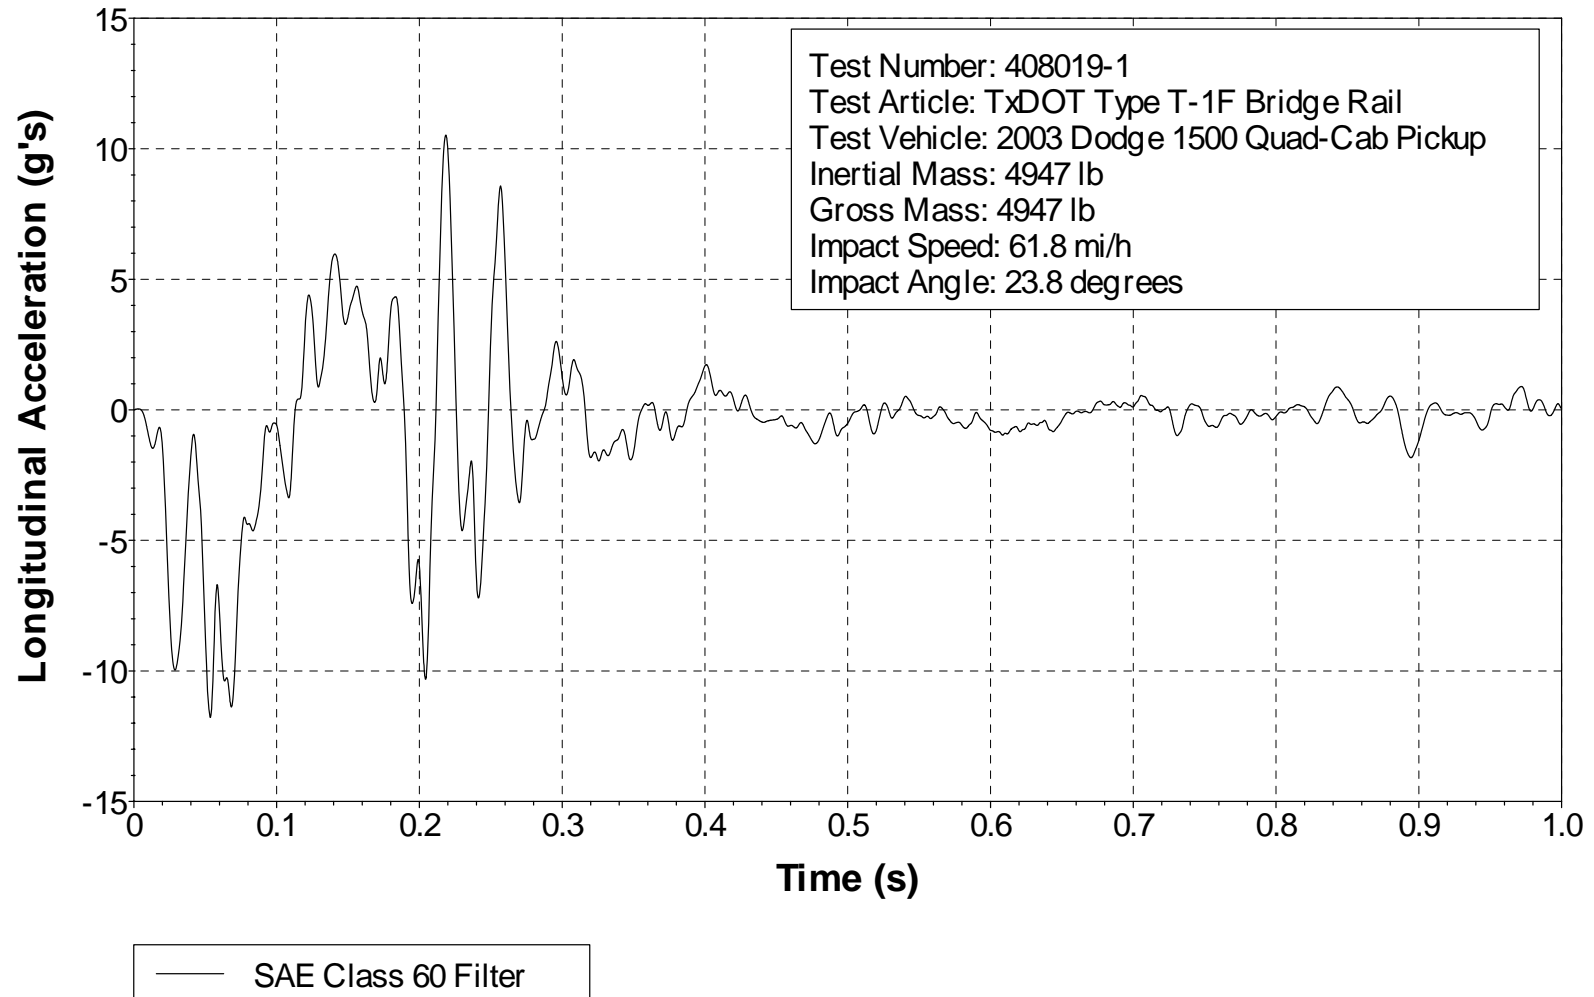
**Figure B8. Vehicle Longitudinal Accelerometer Trace for Test 408019-1  
(Accelerometer Located Over Rear Axle).**

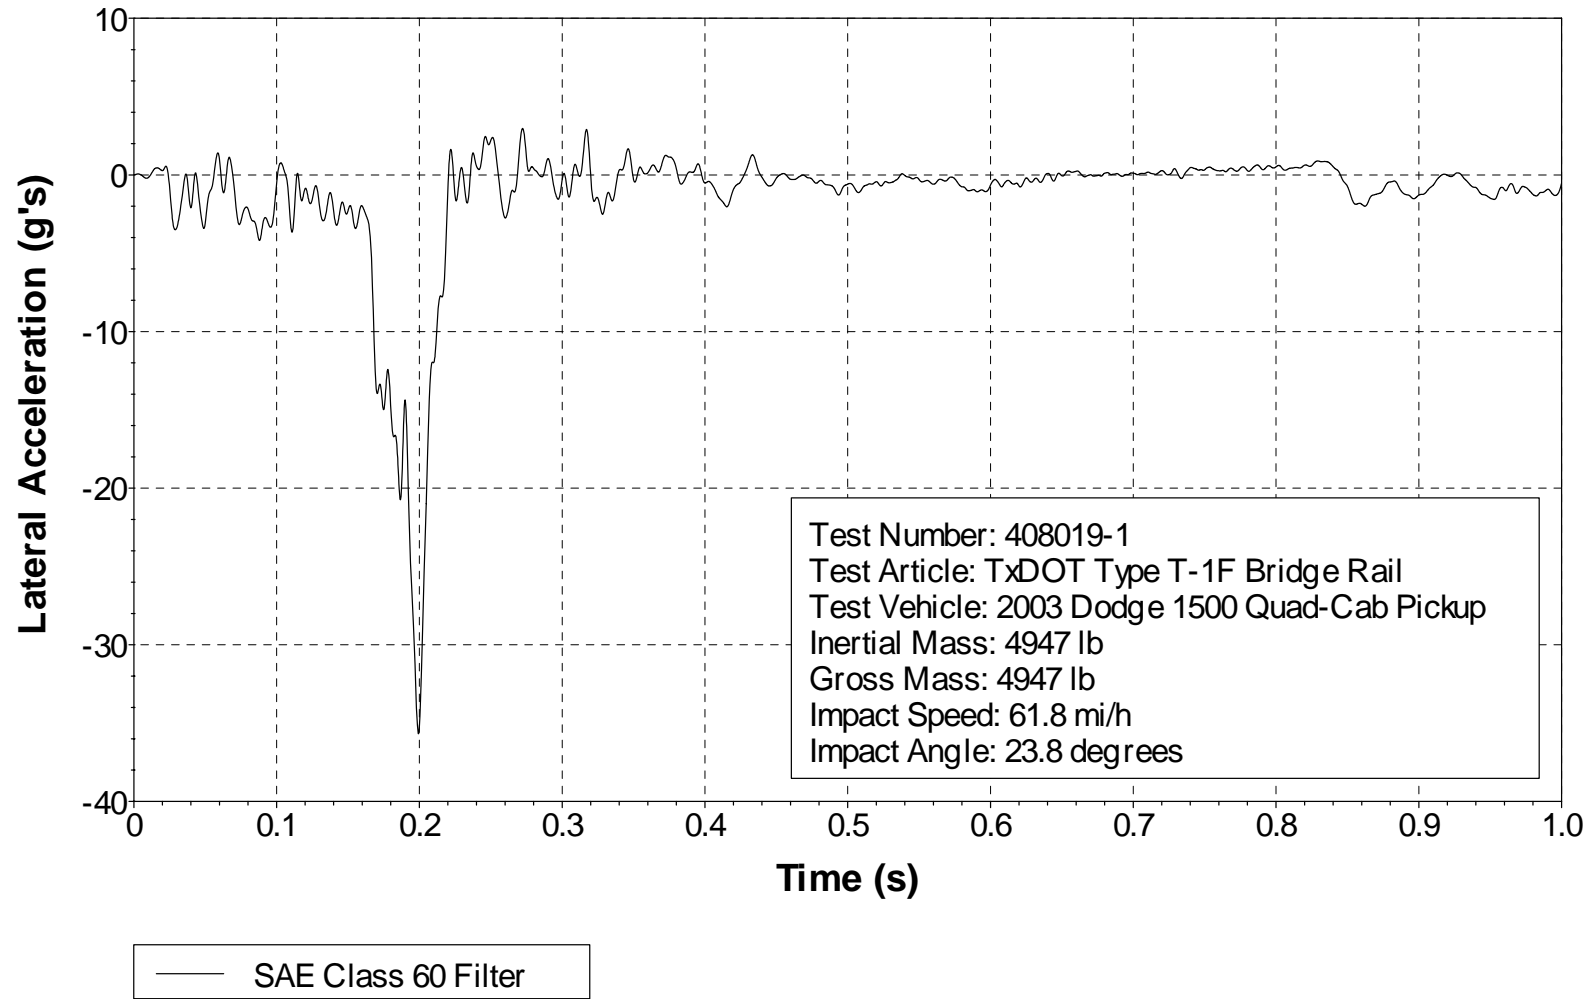
**Figure B9. Vehicle Lateral Accelerometer Trace for Test 408019-1  
(Accelerometer Located Over Rear Axle).**

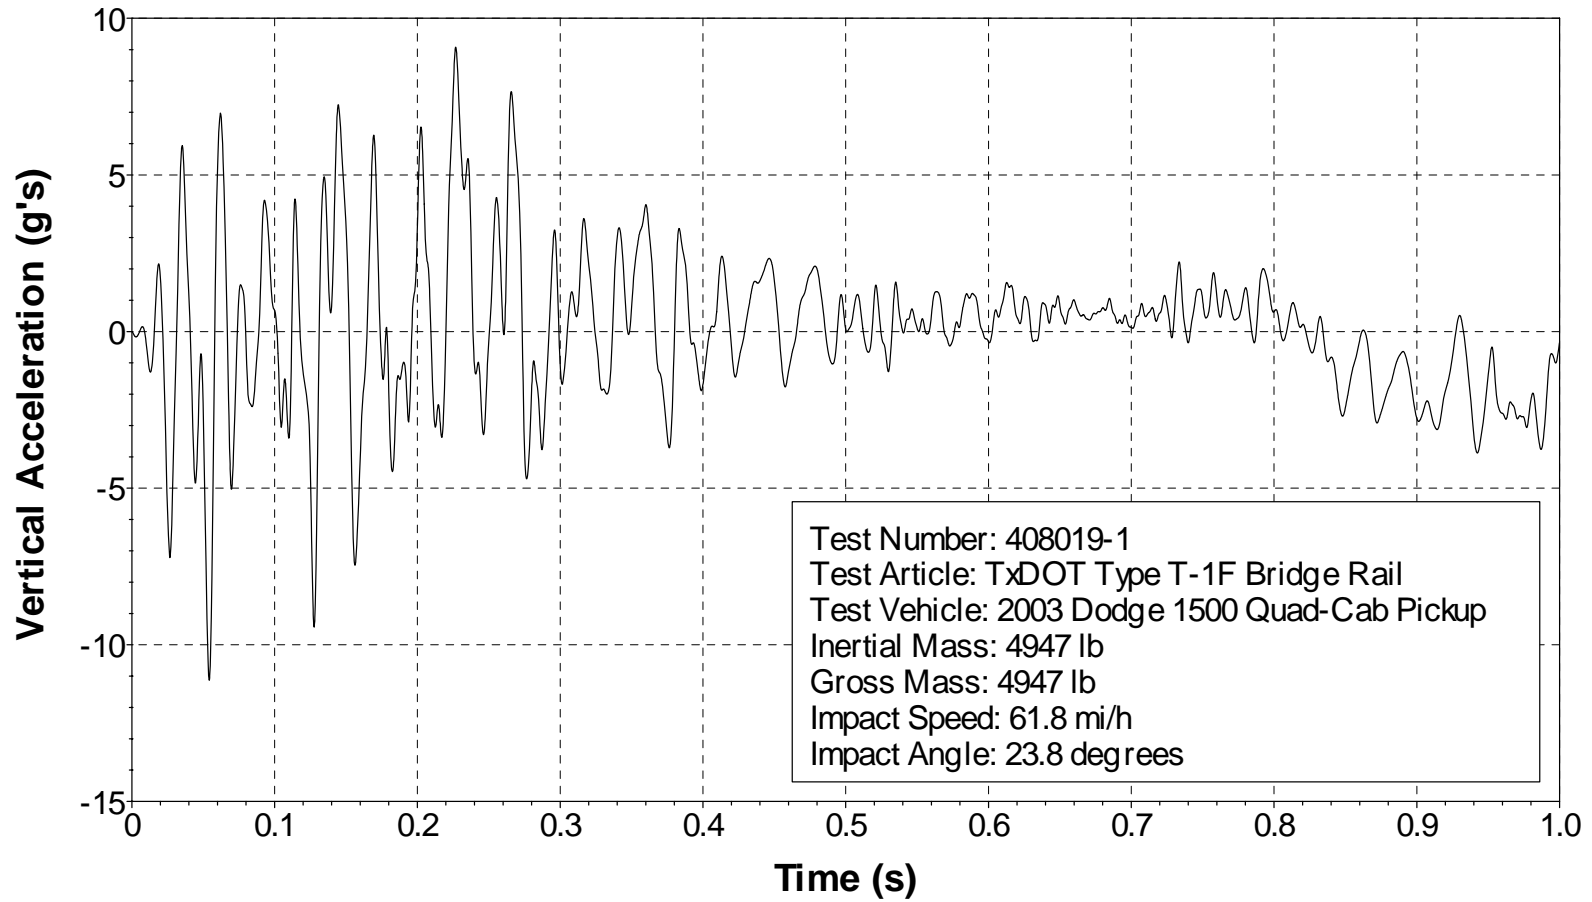
**Figure B10. Vehicle Vertical Accelerometer Trace for Test 408019-1  
(Accelerometer Located Over Rear Axle).**
