MASH TEST 3-11 OF THE TxDOT SINGLE SLOPE BRIDGE RAIL (TYPE SSTR) ON PAN-FORMED BRIDGE DECK

Research/Test Report 9-1002-3

**TEXAS TRANSPORTATION INSTITUTE
THE TEXAS A&M UNIVERSITY SYSTEM
COLLEGE STATION, TEXAS**

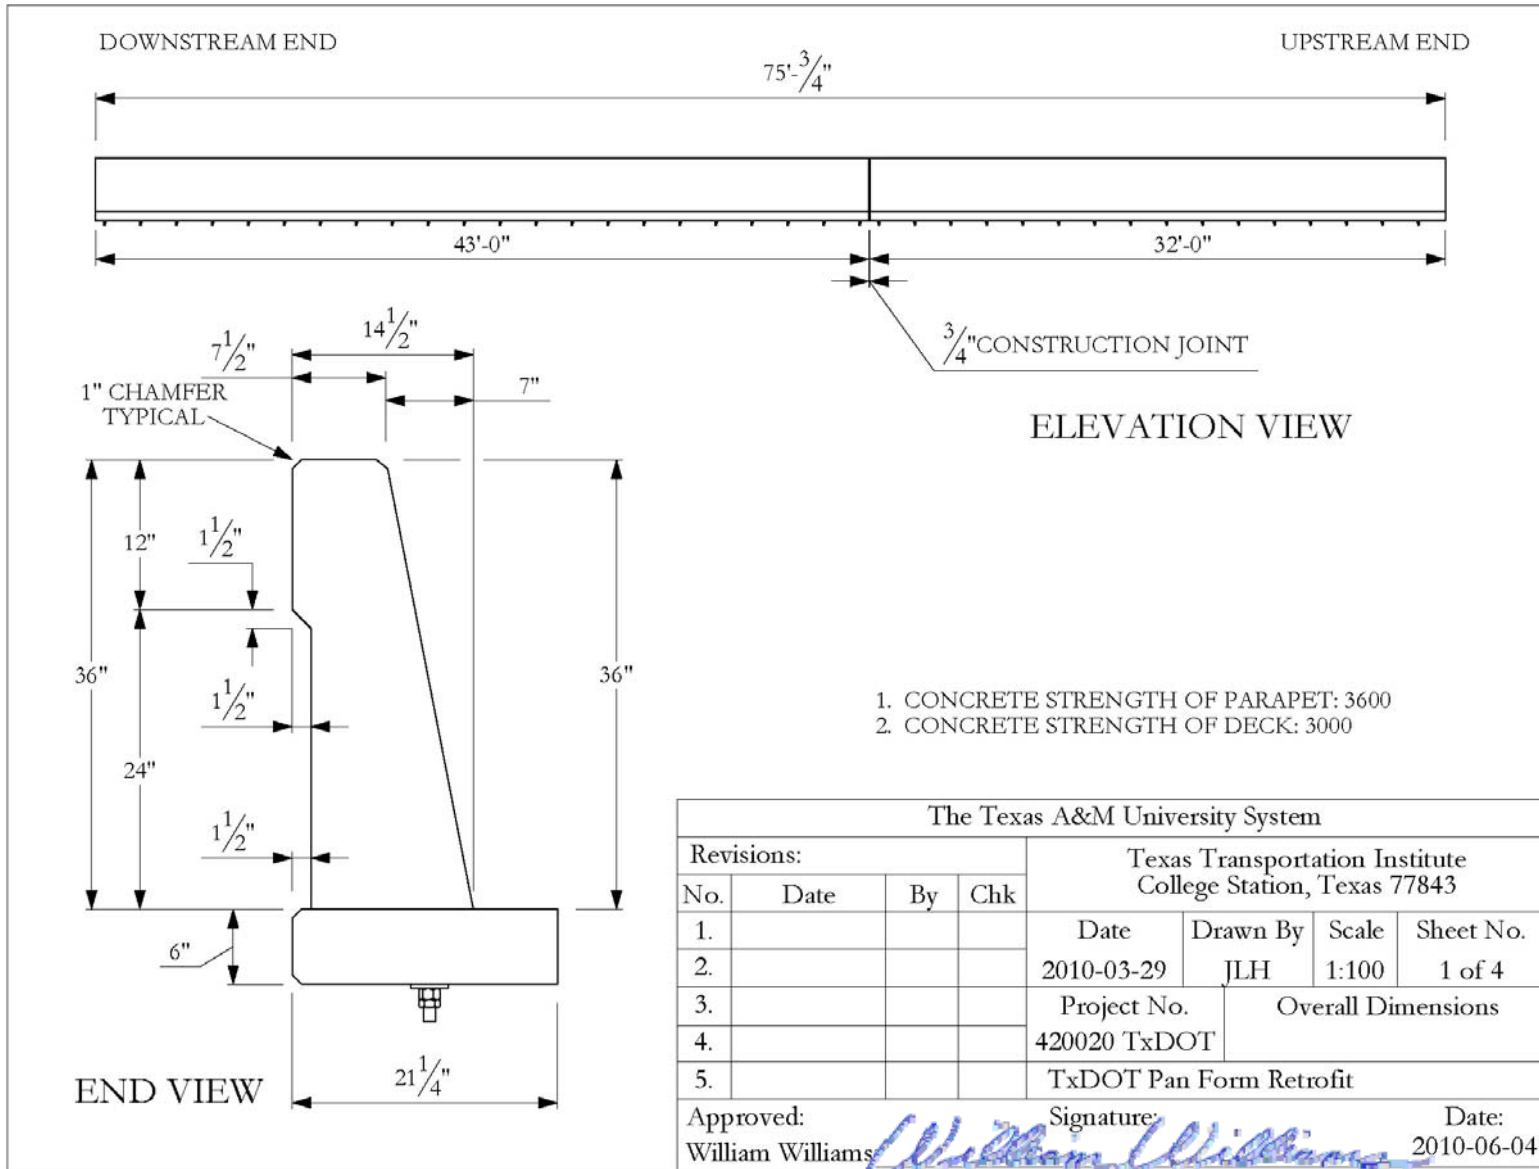
Figure 2.1. Details of the TxDOT Pan-Formed Bridge Rail Installation.

The TxDOT Single-Slope Traffic Rail (Type SSTR) bridge rail was anchored to the top of a 6-inch thick reinforced concrete deck cantilever. The TxDOT Type SSTR bridge rail is 36 inches in height and has a single sloped traffic face. The bridge rail is 13 inches wide at the base and 7½ inches wide at the top. The traffic face of the bridge rail is sloped 7 inches over the 36-inch height of the bridge rail. Reinforcement in the bridge rail consisted of pre-fabricated deformed welded wire (WWR) provided by Insteel Industries, Inc., Mount Airy, North Carolina. The welded wire mesh consisted of 31 ft preformed units with all unions of longitudinal and vertical wires welded. TTI received a drawing from Insteel Industries, Inc. entitled “SSTR Bridge Rail Texas DOT,” (Insteel Drawing No. 09-DS-99) and dated May 22, 2009. This drawing provided fabrication details for the welded wire reinforcement used in the TxDOT Type SSTR bridge rail tested for this project. Longitudinal reinforcement between the preformed units was lapped approximately 12 inches. The specified yield strength of the deformed wire used to fabricate the panels was specified to be 70 ksi steel material.

The TxDOT Type SSTR bridge rail was anchored to the 6-inch thick deck using 1-inch diameter ASTM F1554 Grade 55 galvanized anchor bolts 24 inches in length near the traffic side face of the bridge rail. The bolts were anchored through the deck in 1¼-inch diameter core drilled holes. The anchor bolts were located approximately 11 inches from the edge of the deck and were fabricated with a 15-degree bend. This bend helped accommodate approximately 15 inches of anchorage embedment within the deformed welded wire reinforcement of the TxDOT Type SSTR bridge rail. The bridge rail was additionally anchored to the deck using #4 dowels spaced on 48-inch centers 4½ inches from the edge of the deck and approximately 4 inches into the deck using the Hilti RE 500 Epoxy anchoring system. The length of these #4 dowels was approximately 16 inches.

A 6-inch thick by 21¼ inches wide deck cantilever was constructed for this project. Reinforcement in the deck cantilever consisted of one layer of steel reinforcement. Transverse reinforcement consisted of #4 bars located on 6-inch centers. One longitudinal #4 bar was placed within the deck approximately 1¾ inch from the field side edge of the deck.

The test installation for this project measured approximately 75 ft-¾ inch in length. The installation was constructed with a ¾-inch wide expansion joint in both the TxDOT Type SSTR bridge rail and 6-inch thick deck. This joint in the bridge rail and deck was located approximately 32 ft from the upstream end of the installation. Two #8 deformed bars, approximately 60 inches in length, were used to provide additional lateral strength to the two opposing ends of the bridge rail at the joint. The #8 bars were anchored approximately 31¾ inches within one end of the TxDOT Type SSTR bridge rail at the joint. On the adjacent bridge rail end, these dowels extended through the joint and were placed in sleeved PVC pipe sections. These pipe sections were approximately 32½ inches in length and accommodated movement in the opposing end of the bridge rail. For additional information, please refer to Figures 1 and 2 and the drawings in Appendix A.

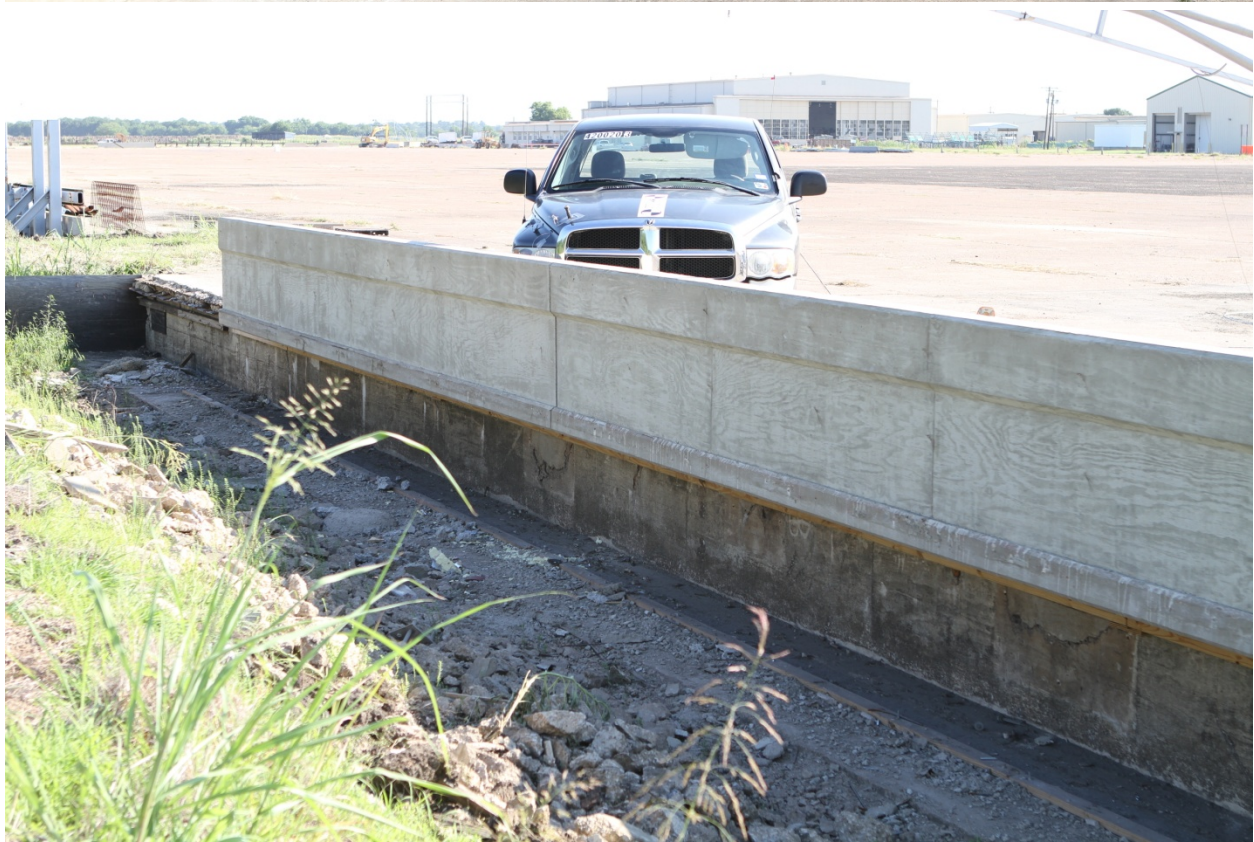
Figure 5.1. Vehicle/Installation Geometrics for Test No. 420020-3.

The 2270P vehicle, traveling at an impact speed of 63.8 mi/h, impacted the TxDOT pan-formed bridge rail with the right front corner of the bumper 5.2 ft upstream of the joint centerline in the TxDOT Type SSTR bridge rail at an impact angle of 24.8 degrees. Shortly after impact, the right front tire contacted the bridge rail, and the vehicle began redirection at 0.074 s after impact. The vehicle was traveling parallel with the bridge rail at 0.189 s, and was traveling at a speed of 50.6 mi/h. At 0.430 s, the 2270P vehicle lost contact with the bridge rail, traveling at an exit speed and angle of 49.5 mi/h and 7.2 degrees, respectively. Brakes on the vehicle were applied at 1.2 s after impact. The vehicle subsequently came to rest 170 ft downstream and 6 ft toward traffic lanes. Figures D1 and D2 in Appendix D show sequential photographs of the test period.

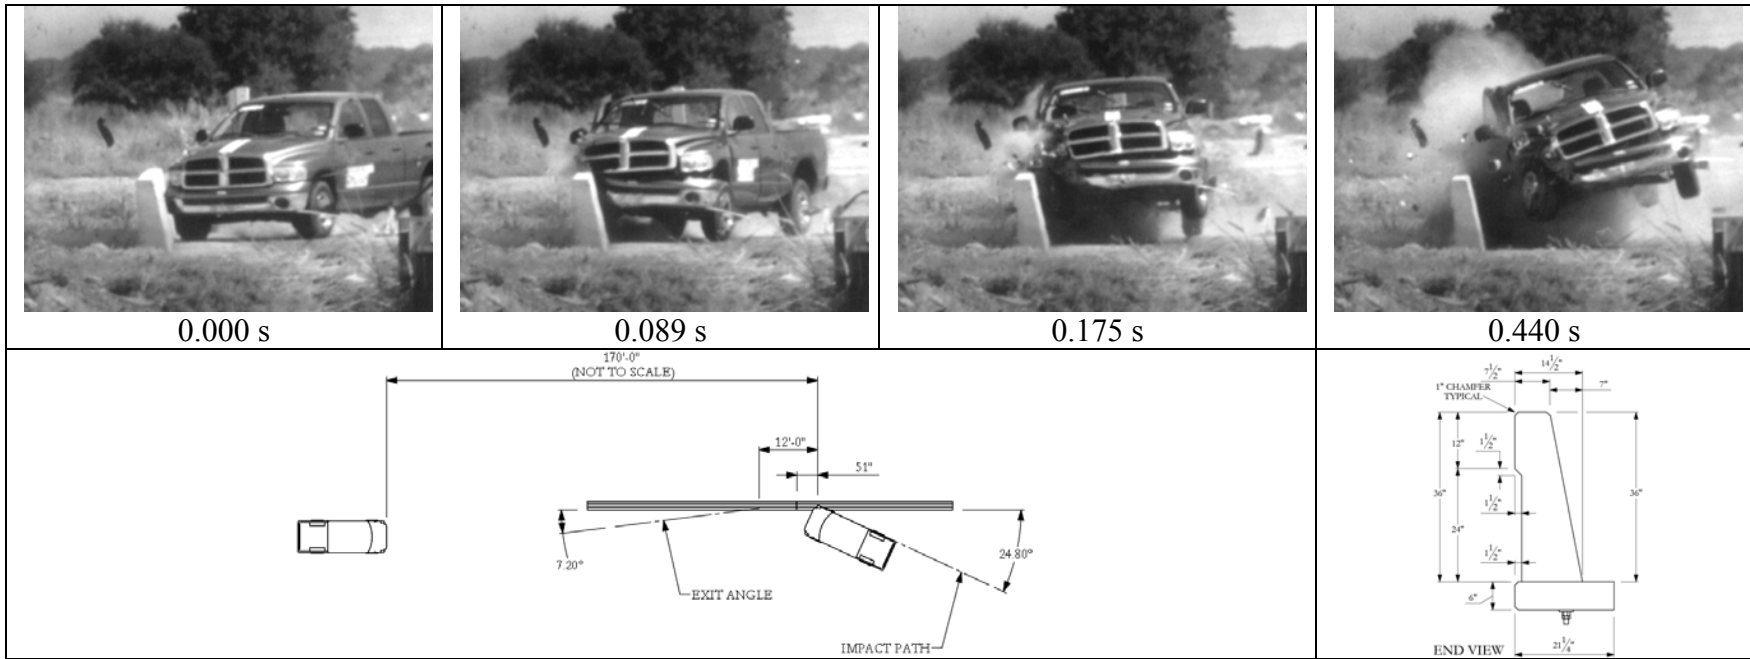
Type..... Bridge Rail
 Name TxDOT Pan-Formed Bridge Rail
 Installation Length 75 ft
 Material or Key Elements TxDOT Single Slope Traffic Rail (Type SSTR) anchored to top of 6-inch thick reinforced concrete deck cantilever

Speed63.8 mi/h
 Angle24.8 degrees
 Location/Orientation5.2 ft upstream of joint

Speed49.5 mi/h
 Angle7.2 degrees

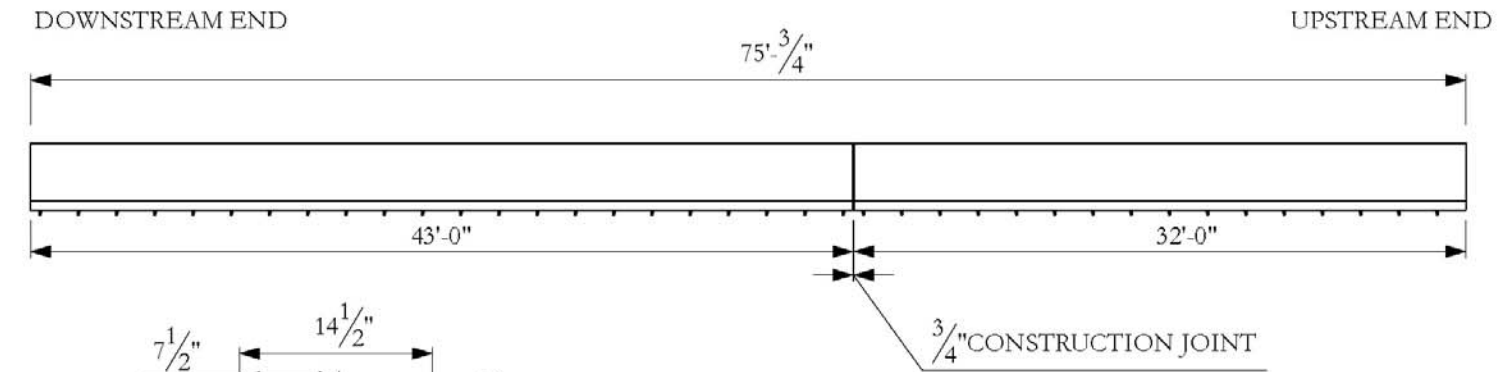
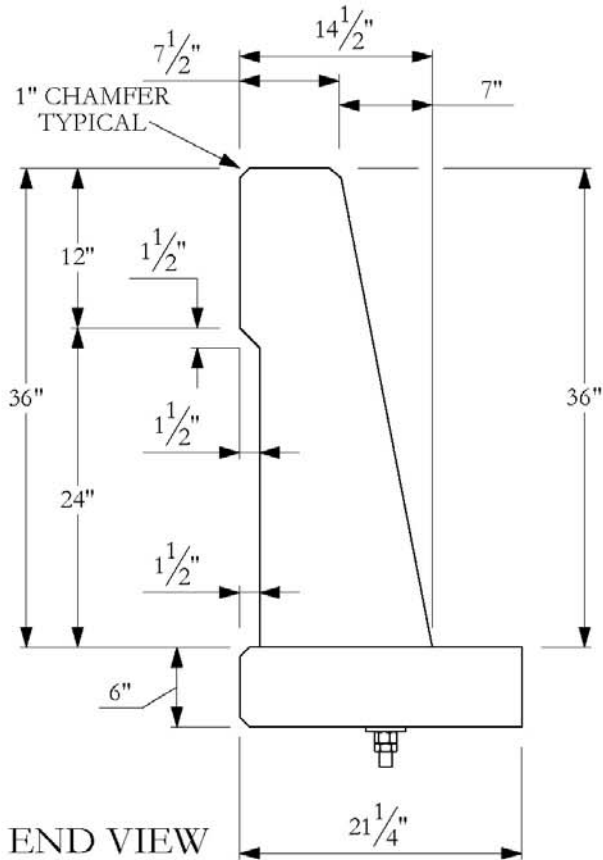
ELEVATION VIEW

1. CONCRETE STRENGTH OF PARAPET: 3600
2. CONCRETE STRENGTH OF DECK: 3000

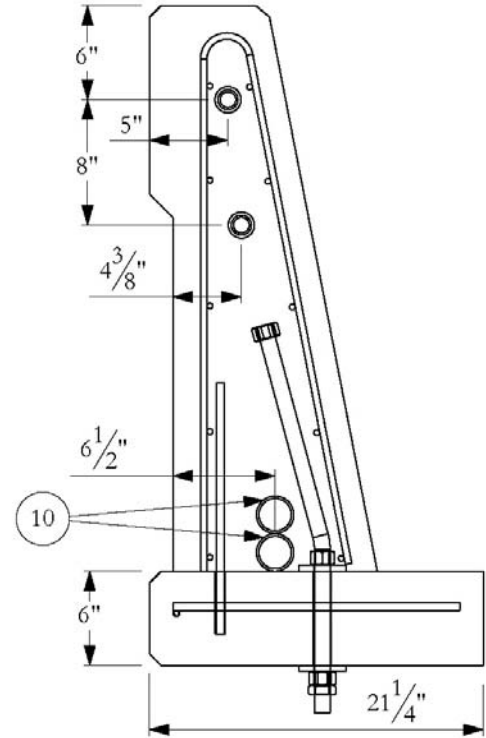
END VIEWS

1.) CONCRETE SPALLS IN BOTTOM OF DECK EXCEEDING 1/2" FROM EDGE OF HOLES SHALL BE PATCHED ACCORDING W/ TXDOT ITEM 429 CONCRETE STRUCTURE REPAIR

- 2.) ALL REBAR 1- 1/2" CLR. UNLESS OTHERWISE NOTED.
- 3.) WELDED WIRE SHALL MEET THE REQUIREMENTS OF ASTM A496 MATERIAL WITH A MINIMUM YIELD OF 70 KSI AND WELDED IN ACCORDANCE WITH ASTM A497 SPECIFICATIONS.

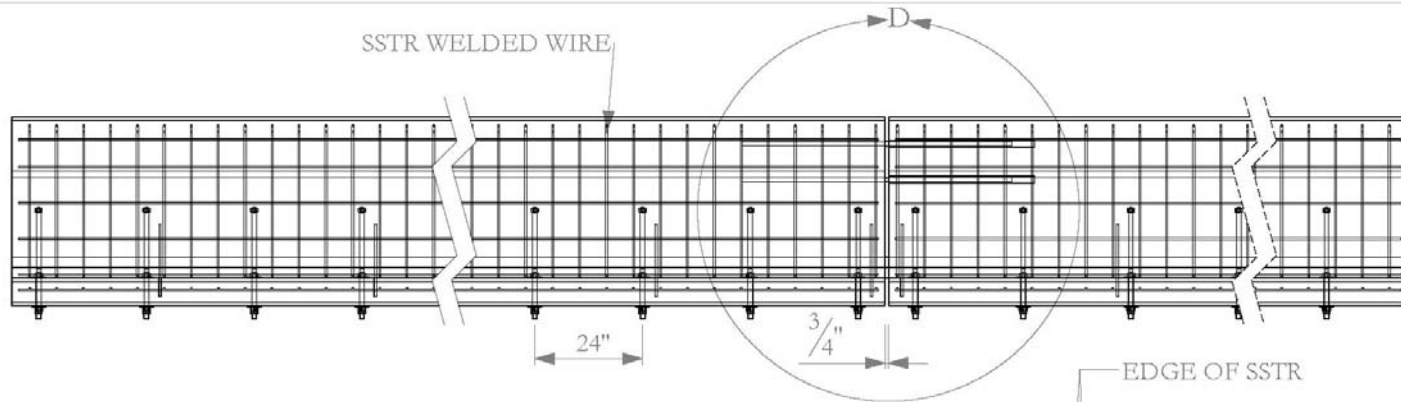
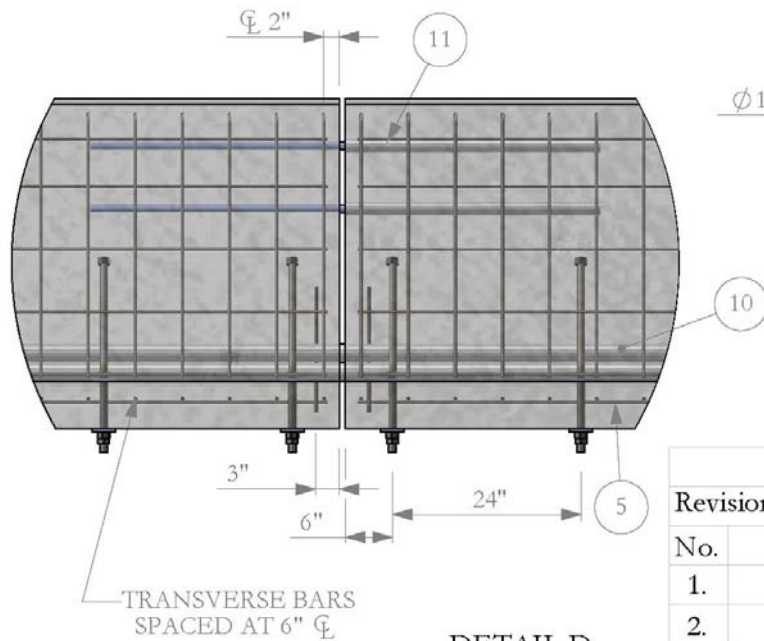
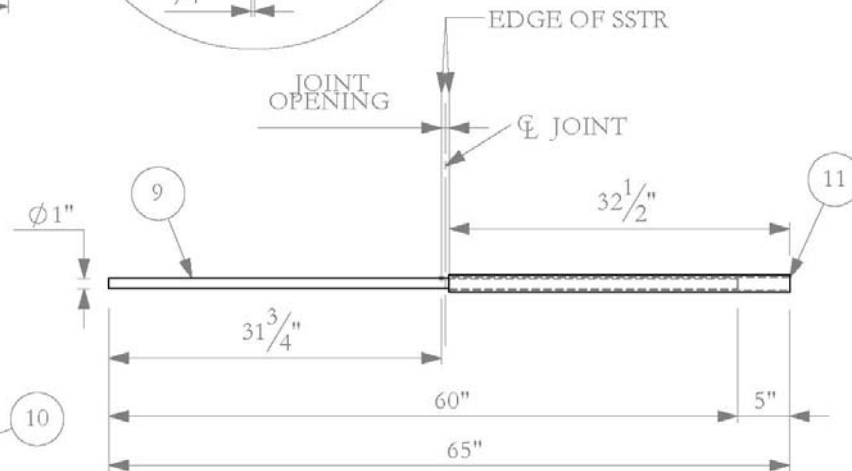
DETAIL D
SCALE 1 : 20

#8 REBAR & PVC SLEEVE
SLEEVE ON ONE SIDE OF JOINT ONLY

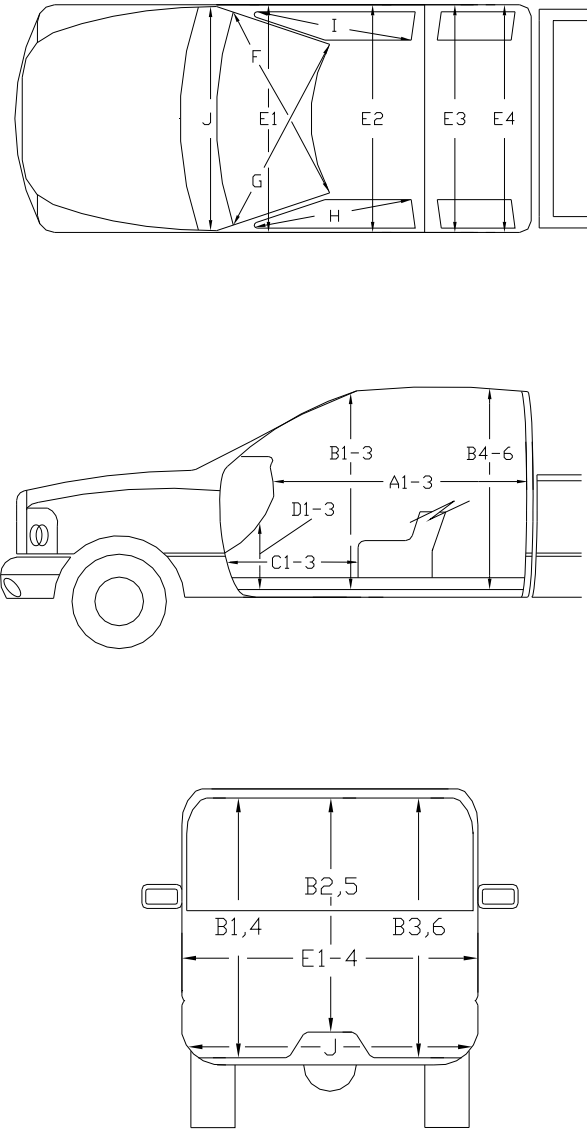
OCCUPANT COMPARTMENT DEFORMATION MEASUREMENT

Before (inches)	After (inches)
A1	64.25	64.25
A2	64.50	64.50
A3	65.25	65.50
B1	45.50	45.50
B2	39.25	38.25
B3	45.50	45.75
B4	42.25	42.50
B5	42.50	43.00
B6	42.25	42.62
C1	29.50	29.50
C2	----	----
C3	26.75	24.00
D1	12.50	12.50
D2	2.50	2.12
D3	11.50	12.50
E1	62.50	62.75
E2	64.25	66.00
E3	63.88	64.12
E4	64.00	64.25
F	60.00	60.00
G	60.00	60.00
H	39.50	39.50
I	39.50	39.50
J*	62.25	61.00

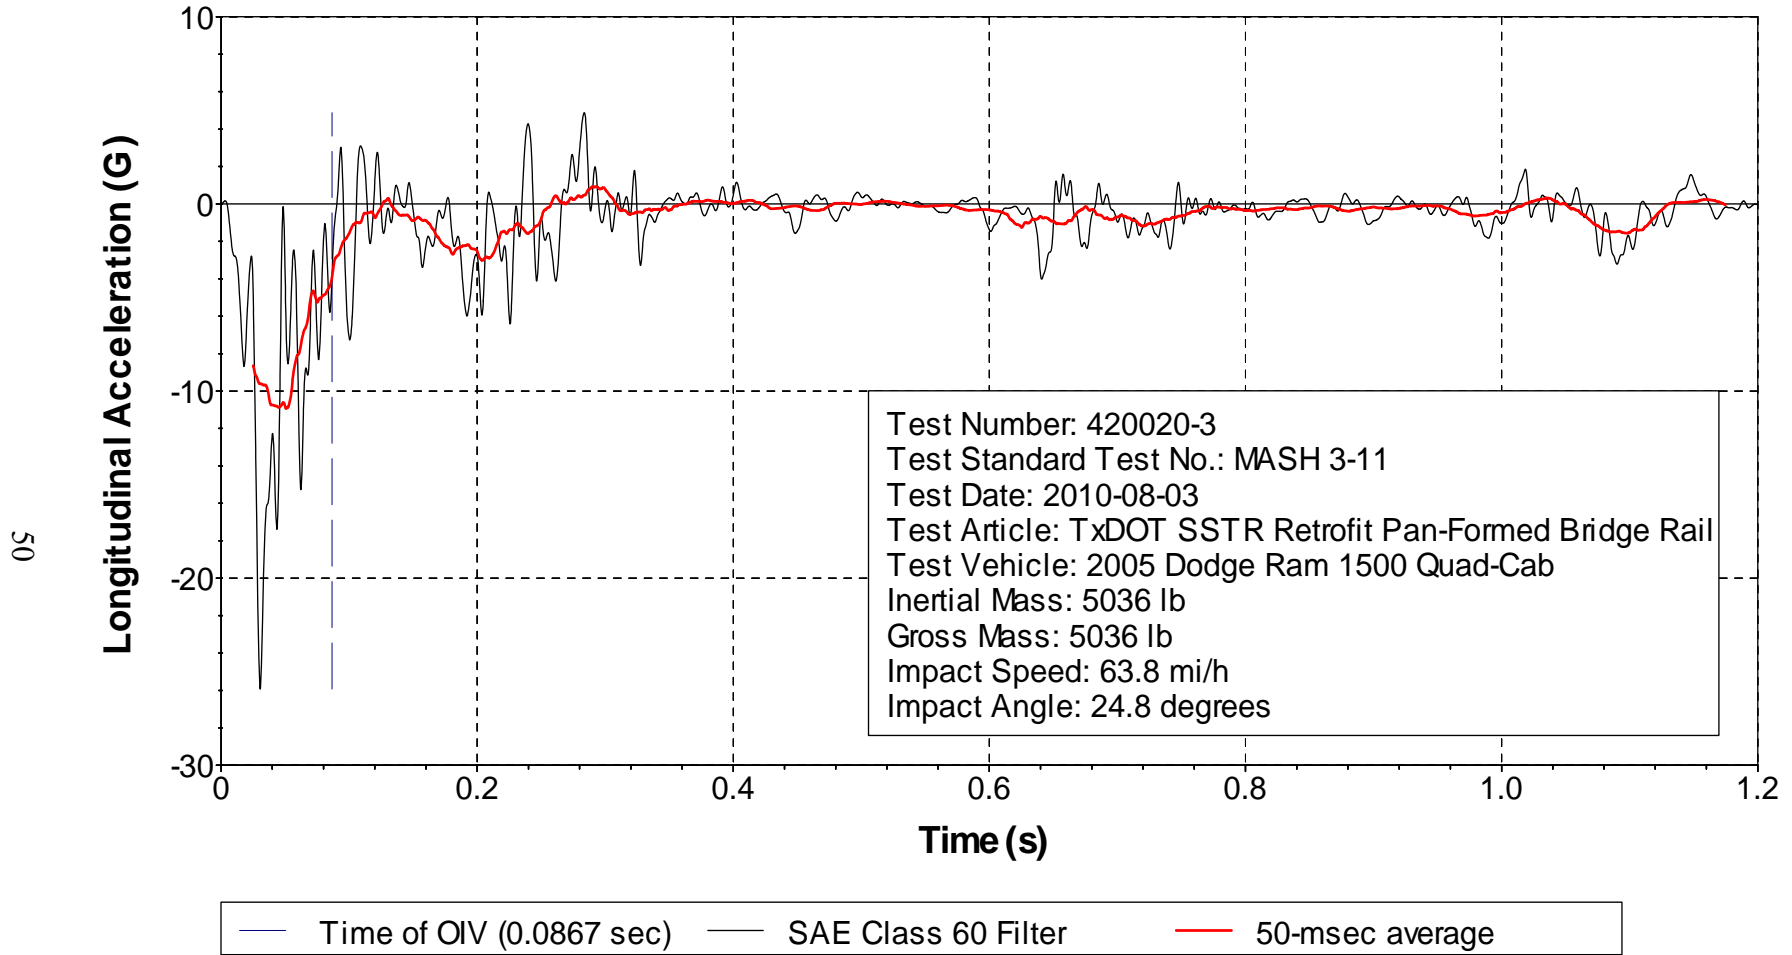
**Figure E2. Vehicle Longitudinal Accelerometer Trace for Test No. 420020-3
(Accelerometer Located at Center of Gravity).**

Data from the accelerometer, located at the vehicle center of gravity, were digitized for evaluation of occupant risk. In the longitudinal direction, the occupant impact velocity was 22.0 ft/s at 0.087 s, the highest 0.010-s occupant ridedown acceleration was -5.3 Gs from 0.095 to 0.105 s, and the maximum 0.050-s average acceleration was -10.9 Gs between 0.026 and 0.076 s. In the lateral direction, the occupant impact velocity was 29.9 ft/s at 0.087 s, the highest 0.010-s occupant ridedown acceleration was -11.7 Gs from 0.206 to 0.216 s, and the maximum 0.050-s average was -15.5 Gs between 0.026 and 0.076 s. Theoretical Head Impact Velocity (THIV) was 40.6 km/h or 11.3 m/s at 0.085 s; Post-Impact Head Decelerations (PHD) was 11.7 Gs between 0.206 and 0.216 s; and Acceleration Severity Index (ASI) was 2.02 between 0.026 and 0.076 s. Figure 5.7 summarizes these data and other pertinent information from the test. Vehicle angular displacements and accelerations versus time traces are presented in Appendix E, Figures E1 through E4.
