# MASH TEST 3-10 ON 31-INCH W-BEAM GUARDRAIL WITH STANDARD OFFSET BLOCKS

**Research Report 9-1002-4**

Cooperative Research Program

**TEXAS TRANSPORTATION INSTITUTE  
THE TEXAS A&M UNIVERSITY SYSTEM  
COLLEGE STATION, TEXAS**

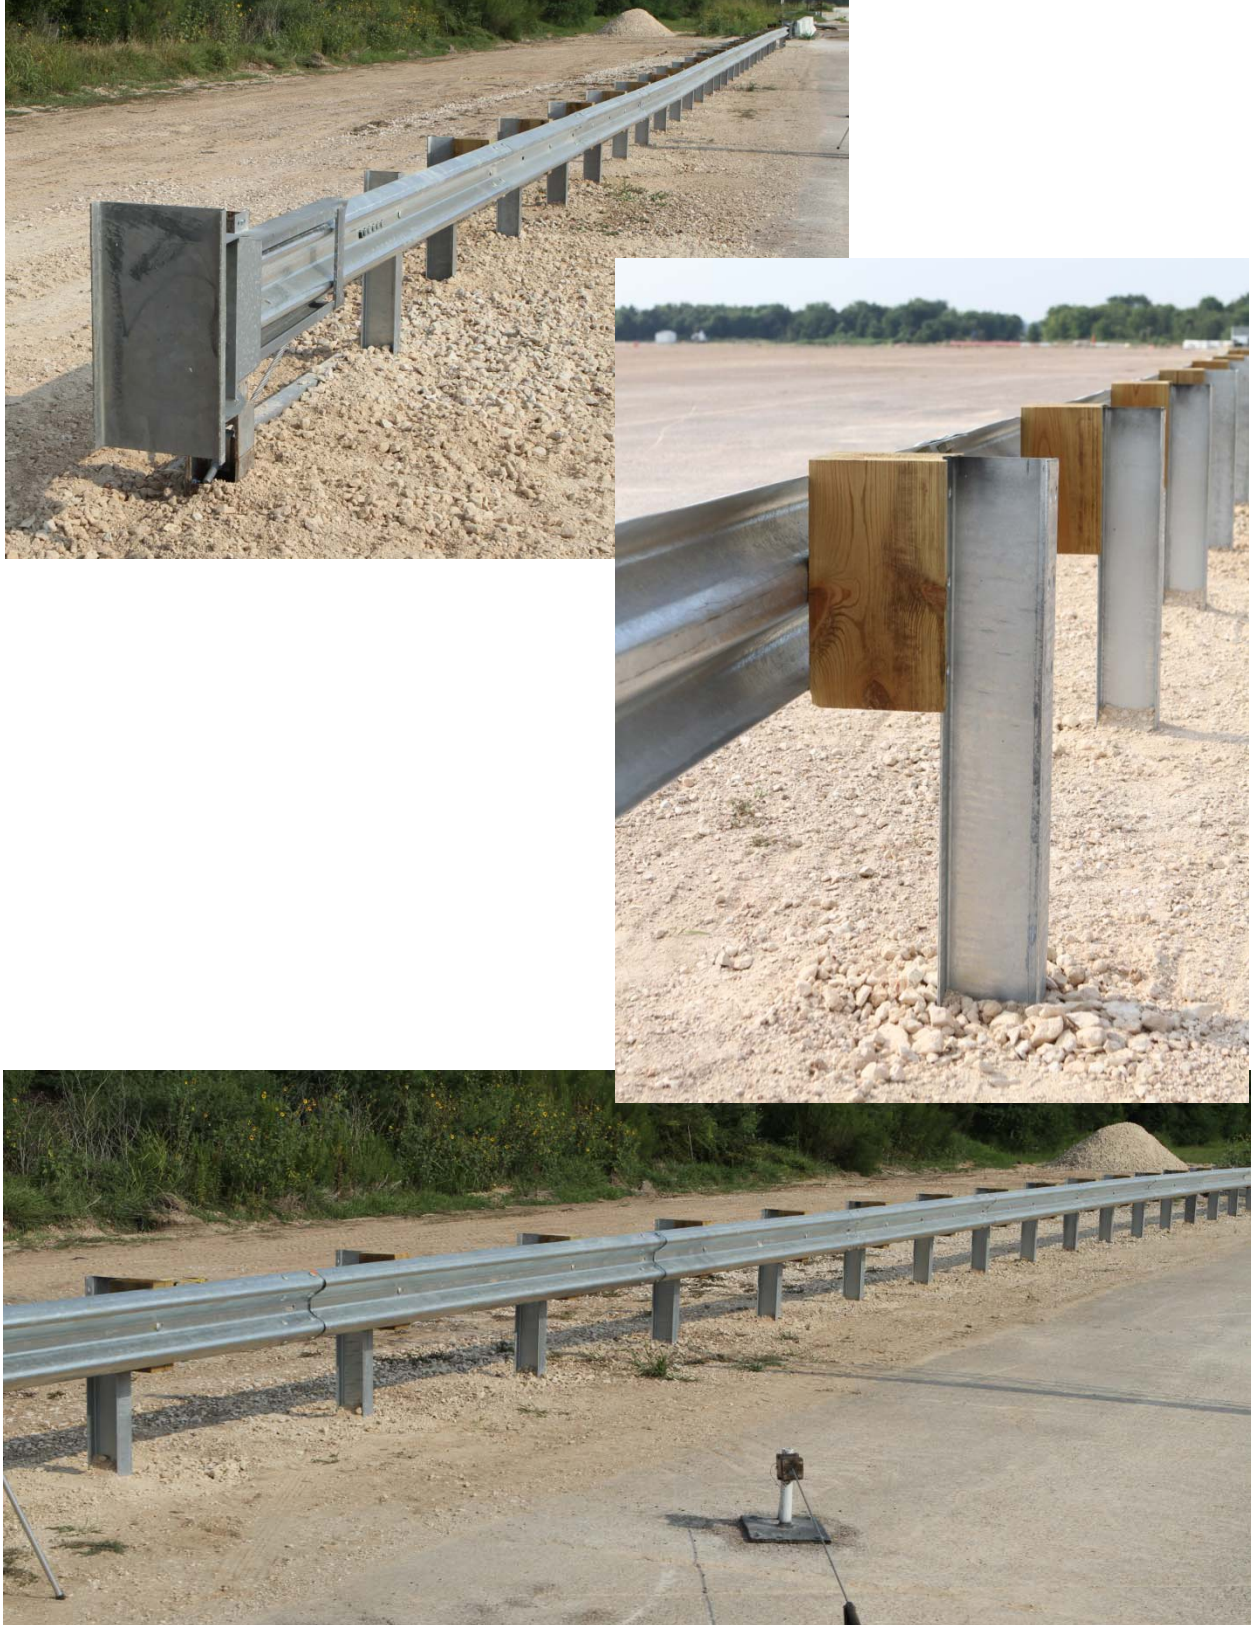
**Figure 2.2. Test Article/Installation before Test No. 420020-5.**

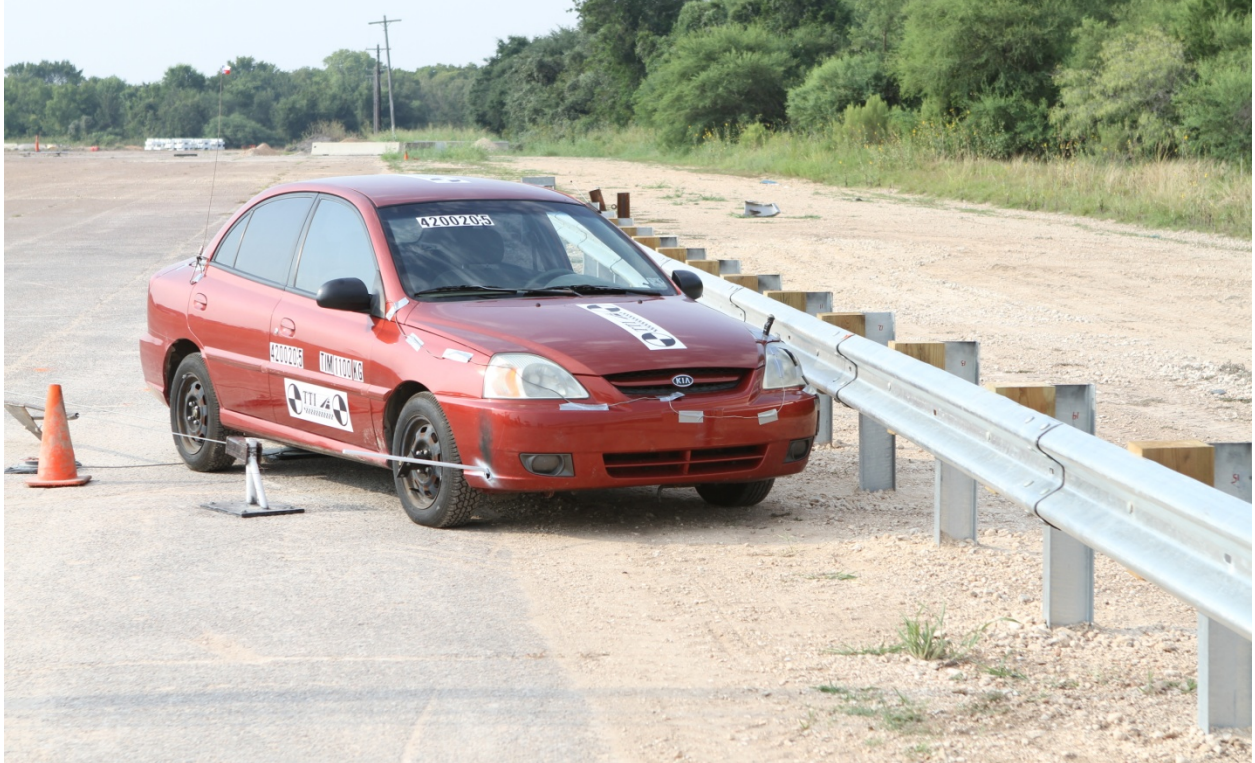
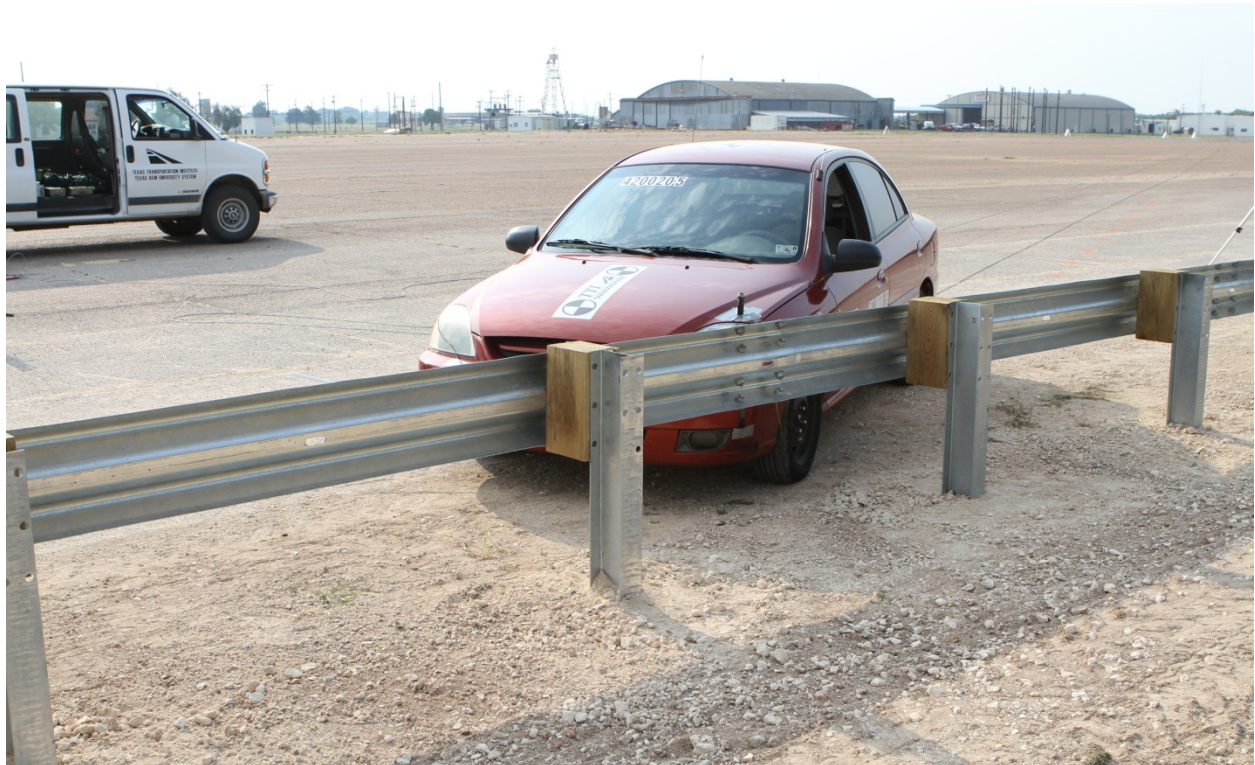
**Figure 5.1. Vehicle/Installation Geometrics for Test No. 420020-5.**

The 2003 Kia Rio, traveling at an impact speed of 60.4 mi/h, impacted the 31-inch W-beam guardrail with standard offset blocks 38 inches upstream of post 13 at an impact angle of 25.6 degrees. At approximately 0.015 s after impact, the W-beam rail element began to deflect toward the field side, and at 0.029 s, post 13 began to deflect toward the field side. The left front corner of the bumper of the vehicle contacted post 13 at 0.032 s, and the tire contacted post 13 at 0.039 s. Post 14 began to deflect toward the field side at 0.042 s. At 0.069 s, the vehicle began to redirect, and at 0.076 s, post 15 began to deflect toward field side. The left front corner of the vehicle contacted post 14 at 0.101 s, and post 16 began to deflect toward the field side at 0.179 s. At 0.199 s, the left front corner of the vehicle contacted post 15, and at 0.295 s, the left front corner of the vehicle contacted post 16. The vehicle became parallel with the guardrail at 0.327 s and was traveling at a speed of 37.3 mi/h. At 0.814 s, the vehicle lost contact with the guardrail and was traveling at an exit speed and angle of 29.2 mi/h and 15.0 degrees, respectively. Brakes on the vehicle were applied at 3.5 s, and the vehicle subsequently came to rest 185 ft downstream of impact and 47 ft from the traffic face of the rail toward traffic lanes. Figure E2 and Figure E3 in Appendix E show sequential photographs of the test period.

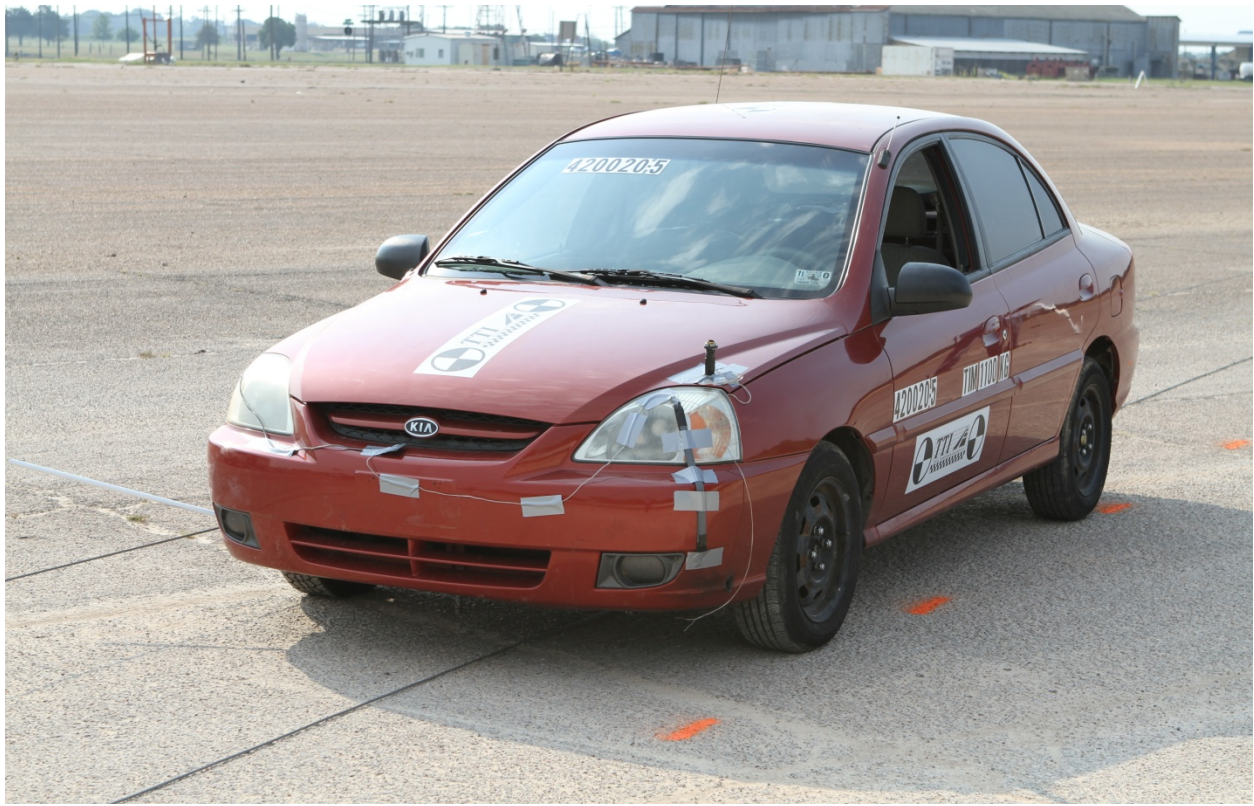
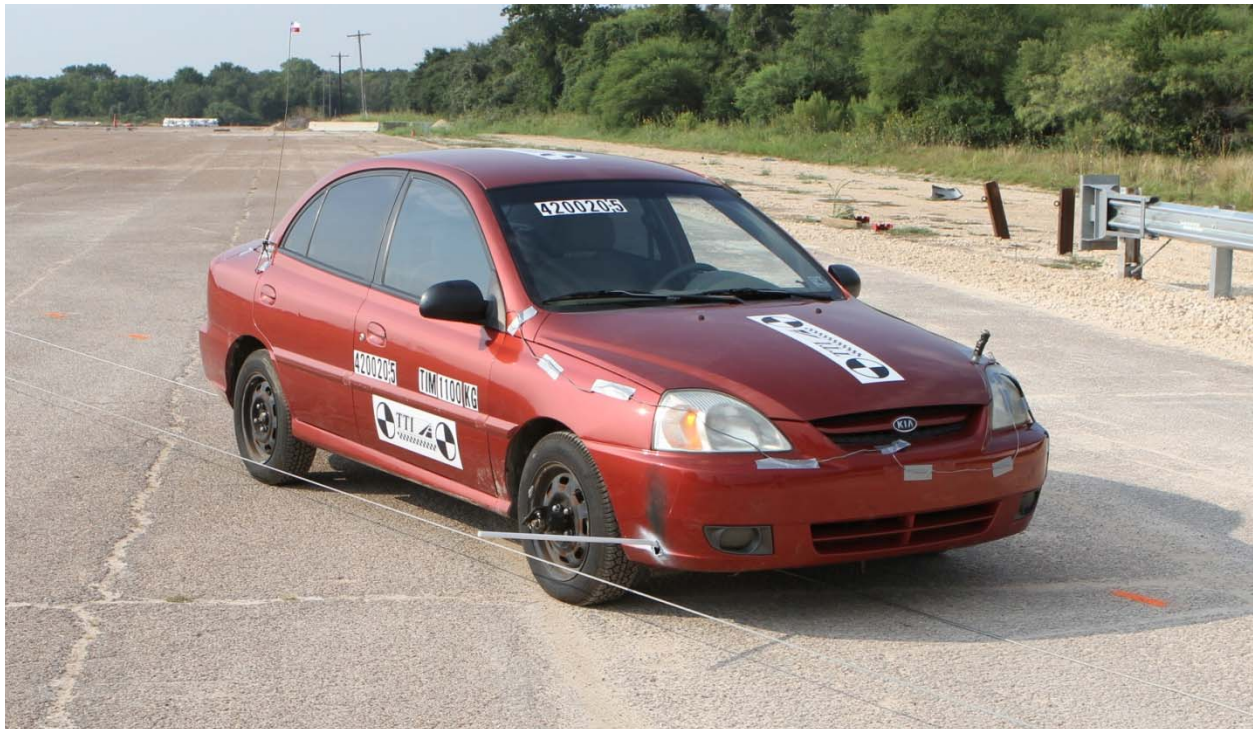
**Figure 5.2. Vehicle before Test No. 420020-5.**

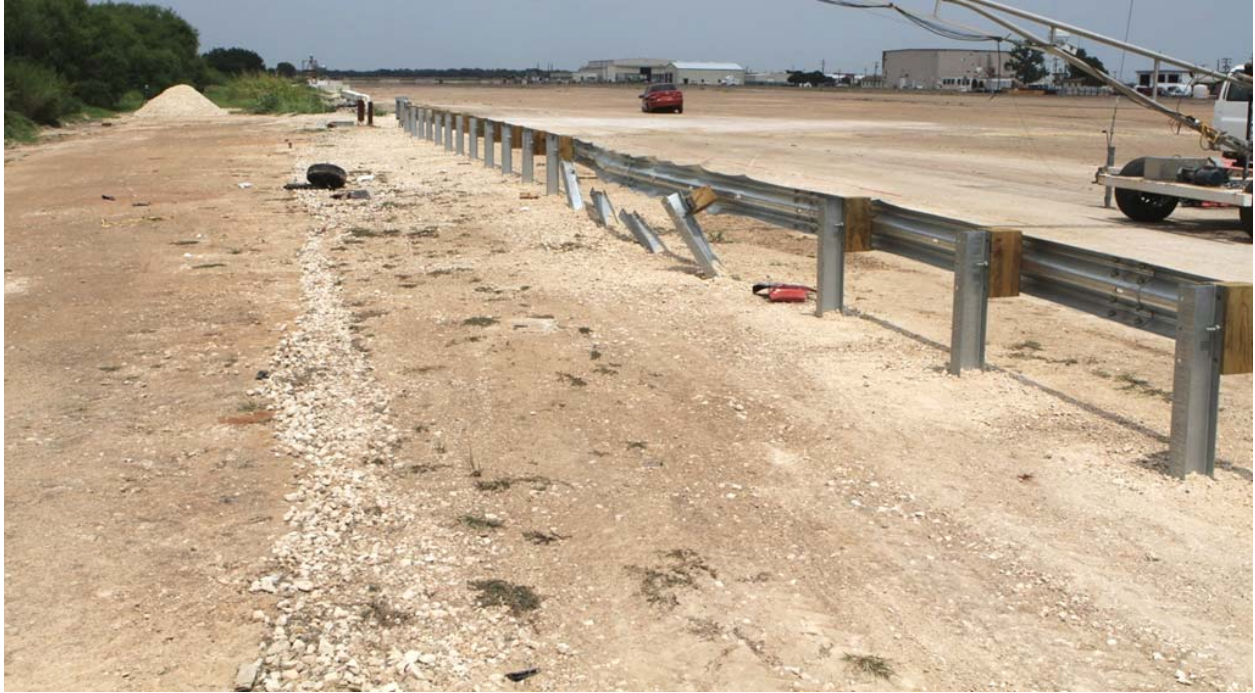
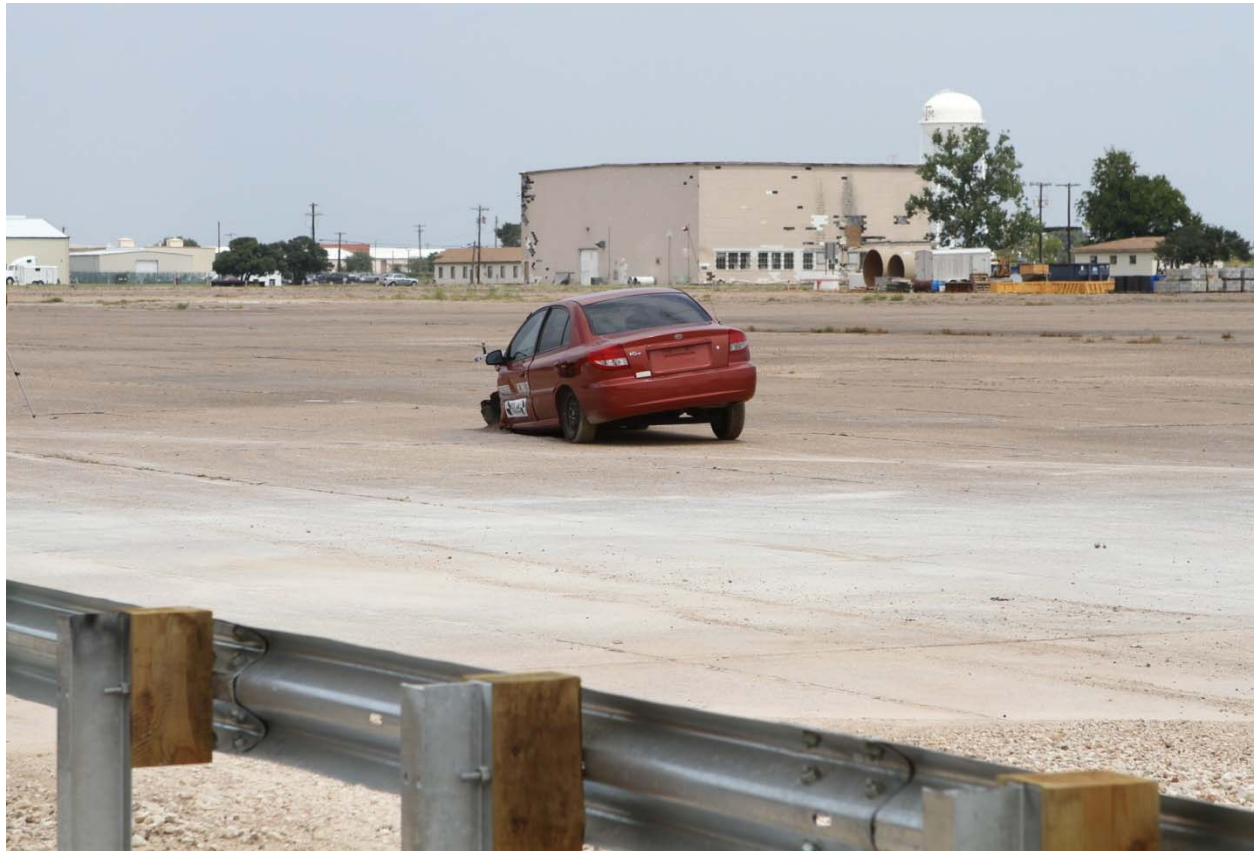
**Figure 5.3. Position of the Vehicle after Test No. 420020-5.**

Damage to the test installation is shown in Figures 5.3 and 5.4. Post 1 was pulled downstream 0.5 inches at ground level, and post 12 was pushed toward the field side 0.25 inches at ground level. Post 13 was leaning downstream and toward the field side 25 degrees, and there were tire marks on the traffic side flange of the post. Posts 14 and 15 were leaning downstream 80 degrees, and post 16 was leaning downstream 30 degrees. Post 30 was pulled upstream 0.25 inches. The W-beam rail element was separated from posts 13 through 17, and the bolt hole at post 2 was torn. Working width was 2.38 ft. Maximum dynamic deflection of the W-beam rail element during the test was 2.38 ft, and maximum permanent deformation was 1.58 ft.

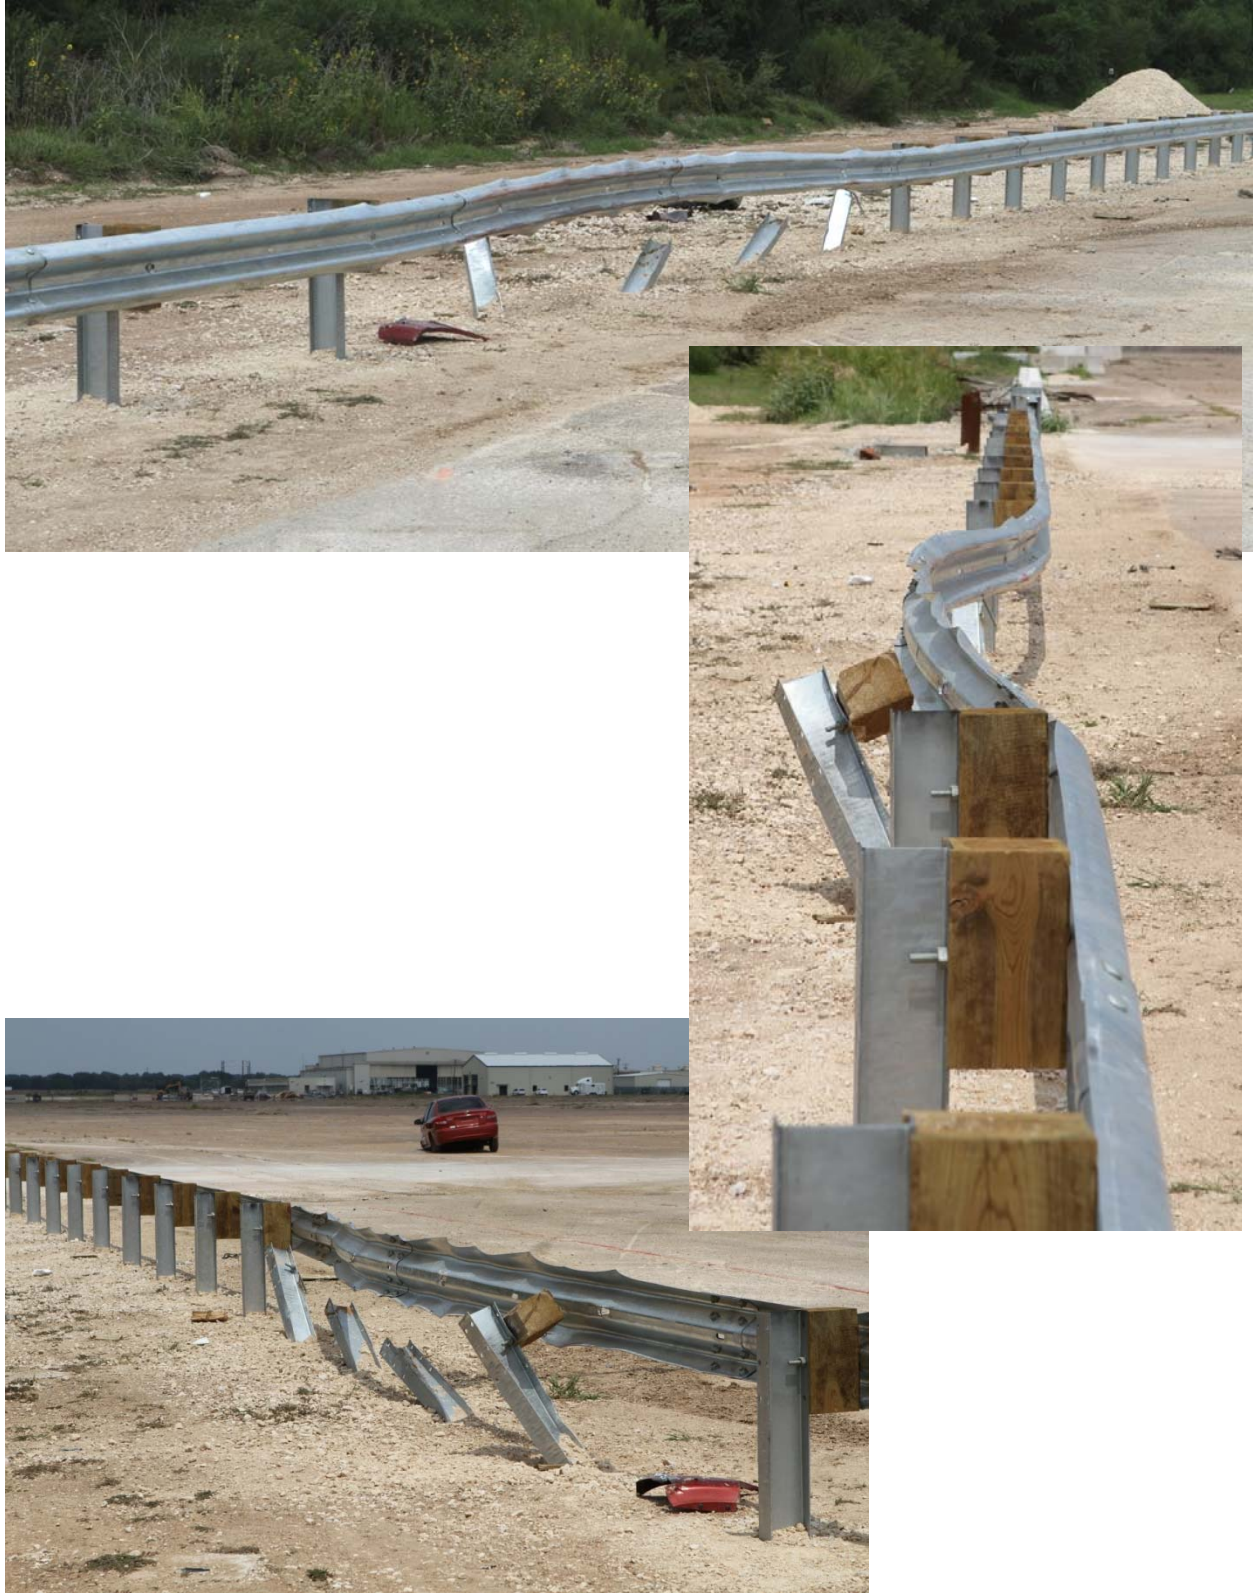
**Figure 5.4. Installation after Test No. 420020-5.**

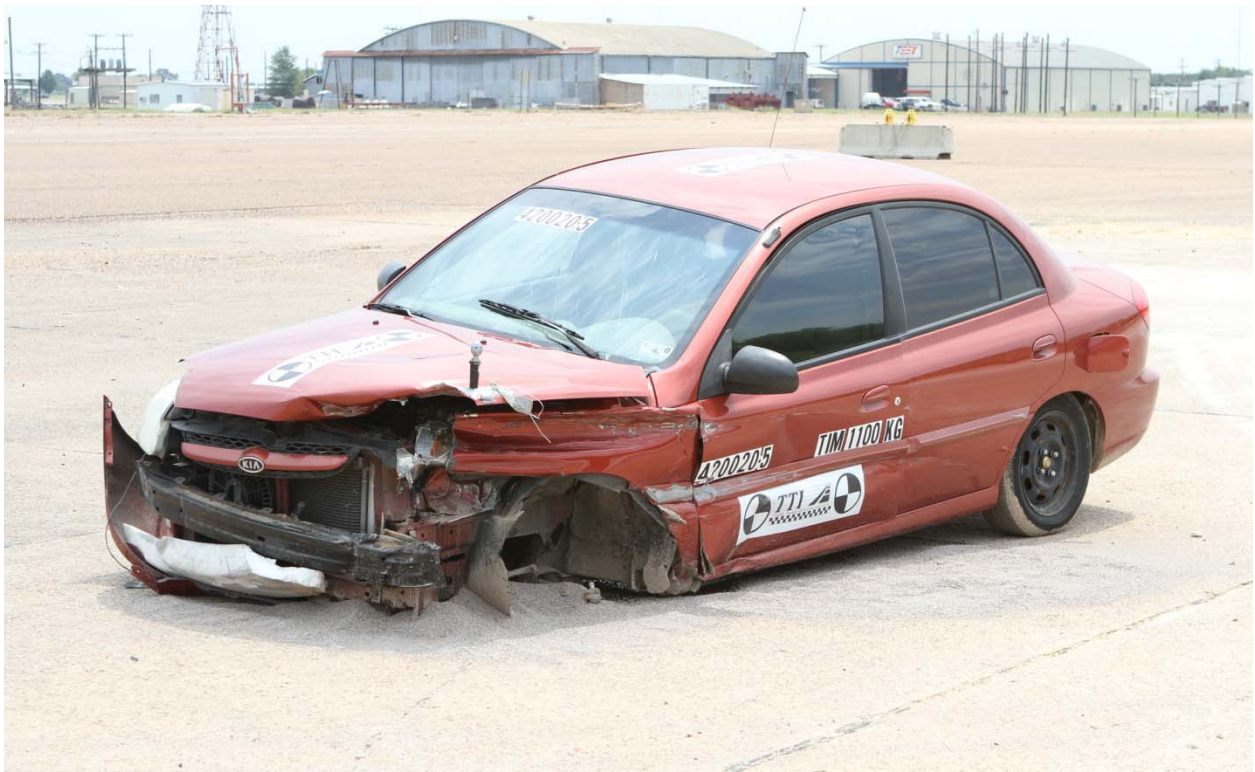
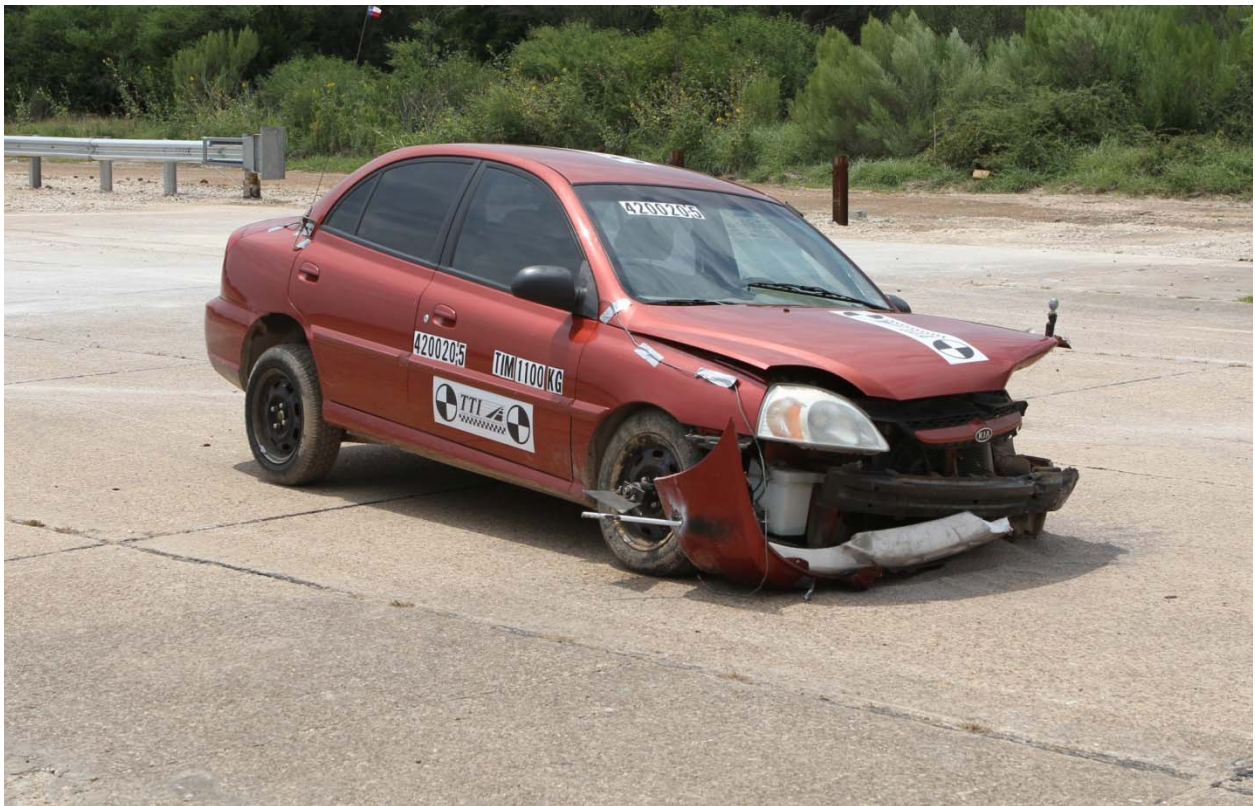
**Figure 5.5. Vehicle after Test No. 420020-5.**

The left front and left side of the 1100C vehicle were damaged as shown in Figures 5.5. The left front strut, left front strut tower, left front lower ball joint, left front lower ball joint, left front outer tie rod end, and left inner and outer CV joints were damaged. Also damaged were the front bumper, hood, grill, radiator and radiator support, left front fender, left front door, and left rear door. The left front tire and wheel rim were damaged and the windshield sustained stress cracking from the left lower corner. Maximum exterior crush to the vehicle was 12.5 inches in the side plane at the left front corner at bumper height. No occupant compartment deformation was noted. Figure 5.6 shows photographs of the interior of the vehicle. Exterior crush measurements and occupant compartment measures are provided in Appendix D, Tables D1 and D2.

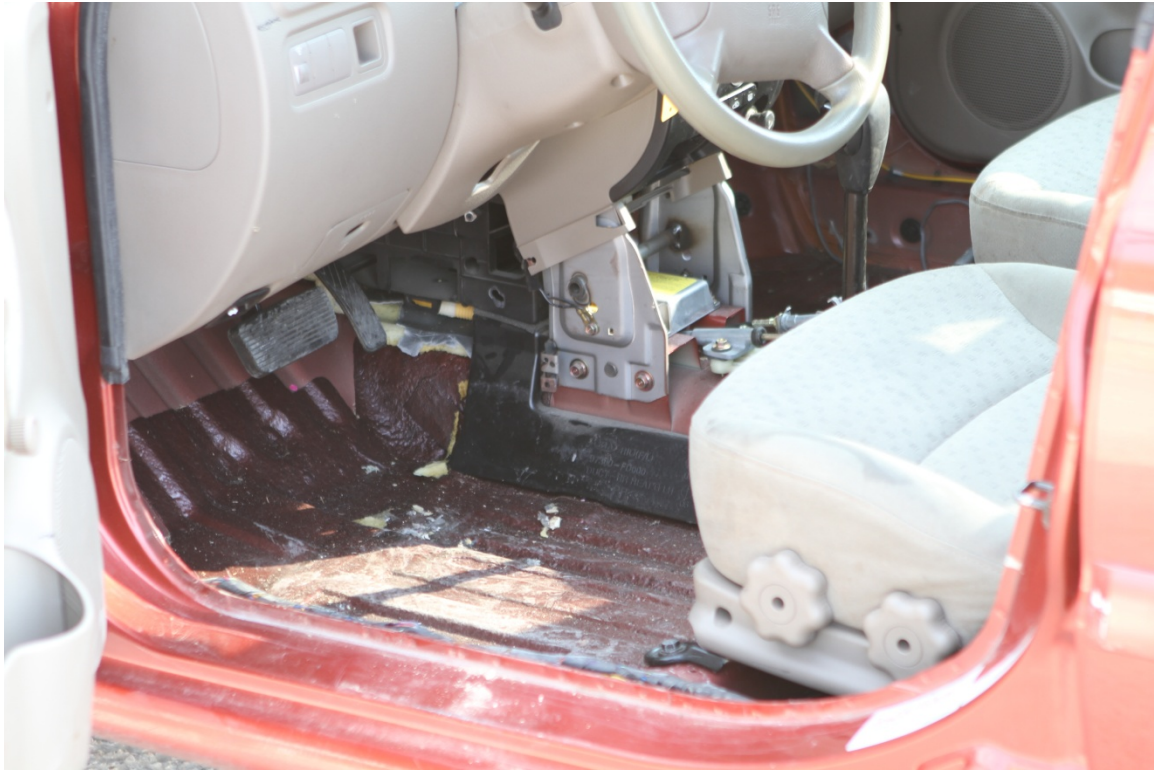
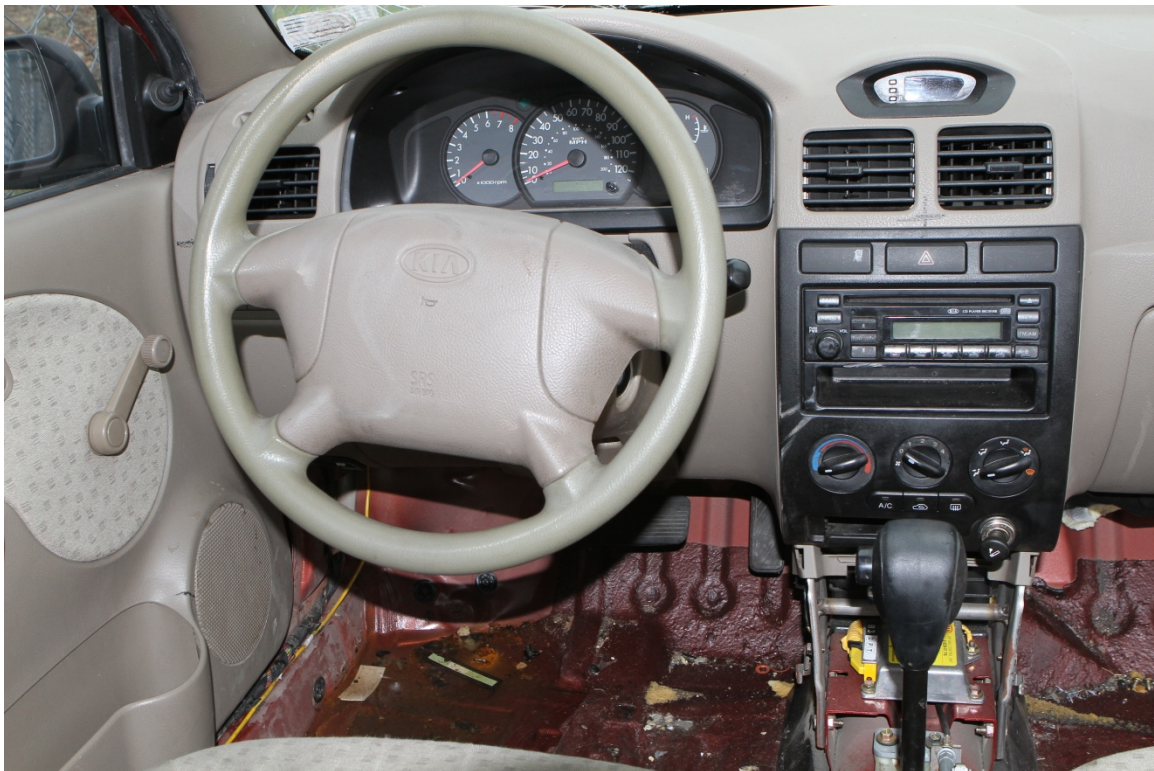
**Figure 5.6. Interior of Vehicle for Test No. 420020-5.**

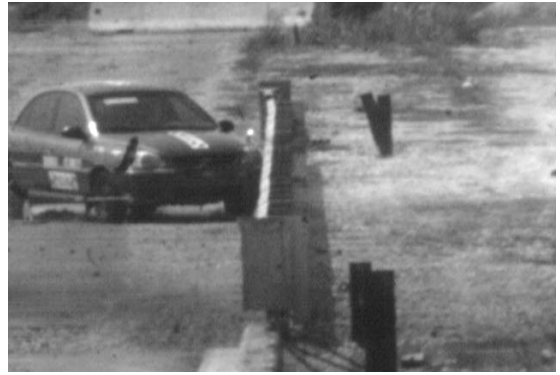
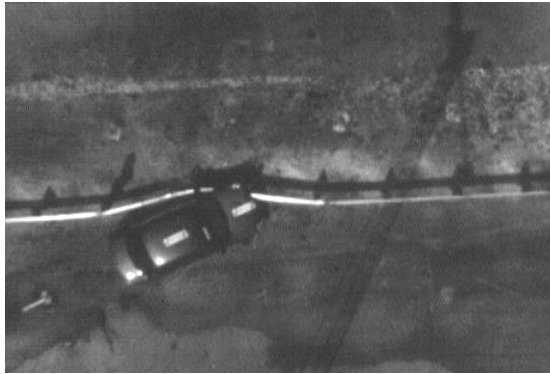
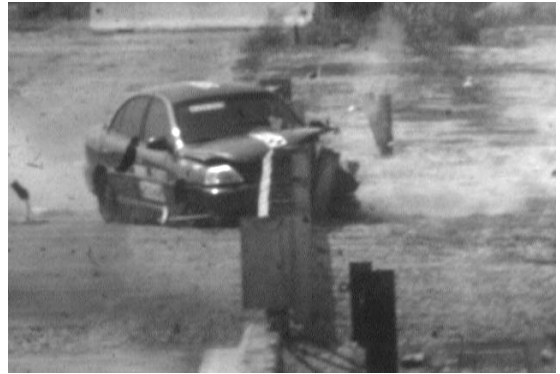
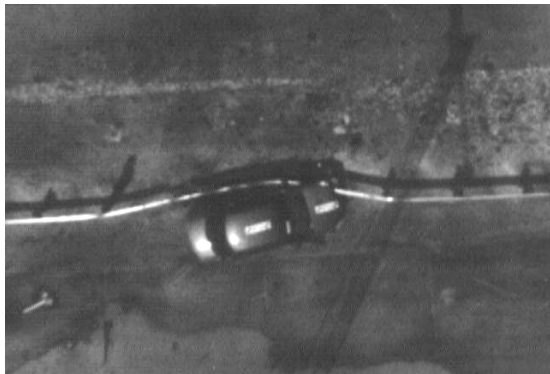
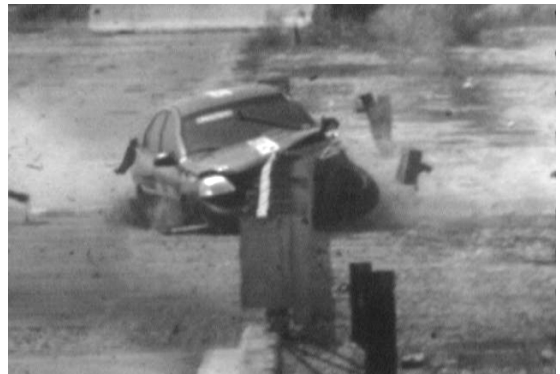
**Figure E1. Sequential Photographs for Test No. 420020-5  
(Overhead and Frontal Views).**

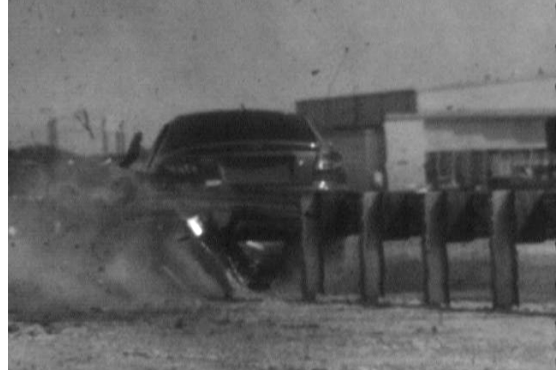
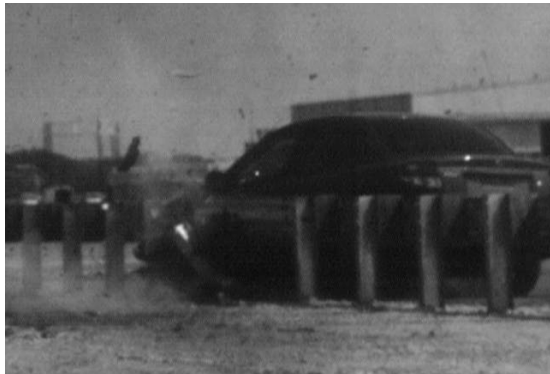
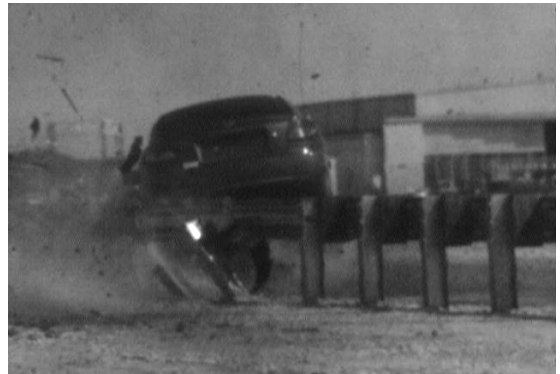
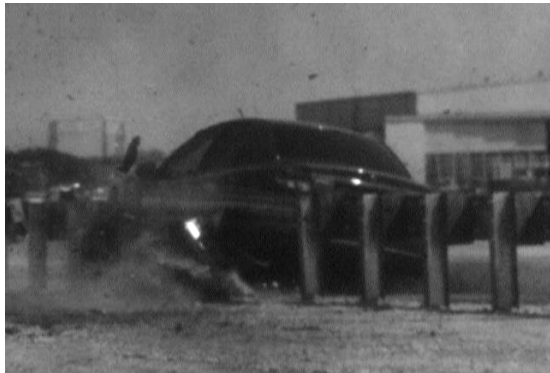
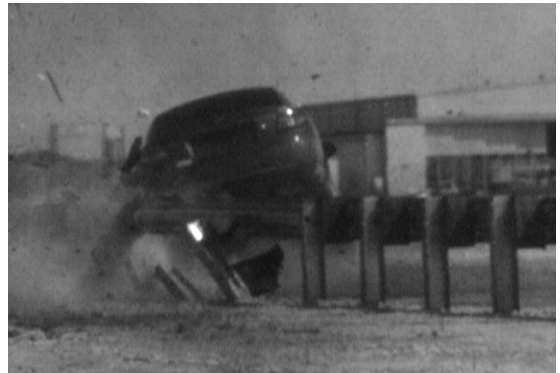
**Figure E2. Sequential Photographs for Test No. 420020-5  
(Rear View).**
