## DEVELOPMENT OF A *MASH* TL-3 MEDIAN BARRIER GATE

### Research/Test Report 9-1002-2

1. Report No. FHWA/TX-11/9-1002-2		2. Government Accession No.		3. Recipient's Catalog No.	
4. Title and Subtitle <b>DEVELOPMENT OF A MASH TL-3 MEDIAN BARRIER GATE</b>				5. Report Date February 2011 Published June 2011

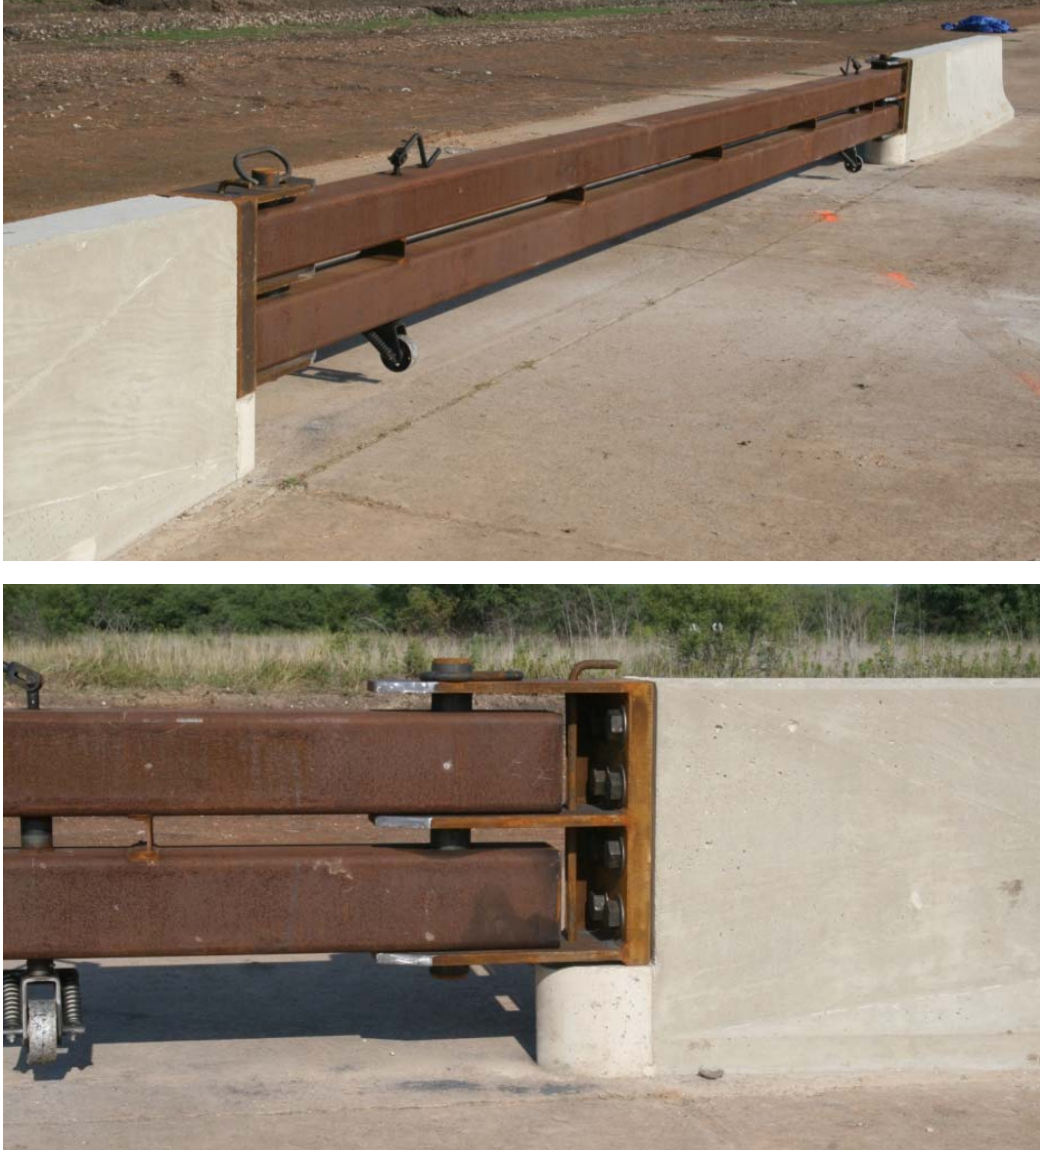
**Figure 1.1. Emergency Opening System (EOS).**

*MASH* test designation 3-10 was performed on the original EOS barrier design with some minor modifications incorporated to reduce the potential for vehicle snagging. The horizontal plates on the steel end bracket were tapered, and the curb protruding from the end of the concrete parapet was constructed with a straight taper rather than a rounded nose. Figure 1 shows the test installation. The test conditions were a 2420 lb vehicle (denoted 1100C) impacting the gate 3.6 ft upstream of the end of the concrete parapet at a nominal impact speed and angle of 62 mi/h and 25 degrees, respectively.

The 1100C test vehicle was contained and redirected. However, the gate failed to comply with *MASH* due to excessive occupant compartment deformation inside the vehicle (3).

Several modifications were made to the end of the EOS to help mitigate the severe vehicle snagging. These changes were developed with retrofit of the existing design as a goal. The horizontal steel plates on the end brackets were replaced with tapered sections of 2 inch  $\times$   $\frac{1}{4}$ -inch thick steel tubing. The ends of the tubular steel beams were cut off and tapered sections of tubing were added. These tubes tapered out 2 inches from the sides of the steel beams and then tapered back down to a width that was less than the width of the end of the concrete parapet to reduce snagging potential from a reverse direction impact. When assembled and installed, the tapered sections of tubing on the steel beams and end bracket overlapped each other to resemble

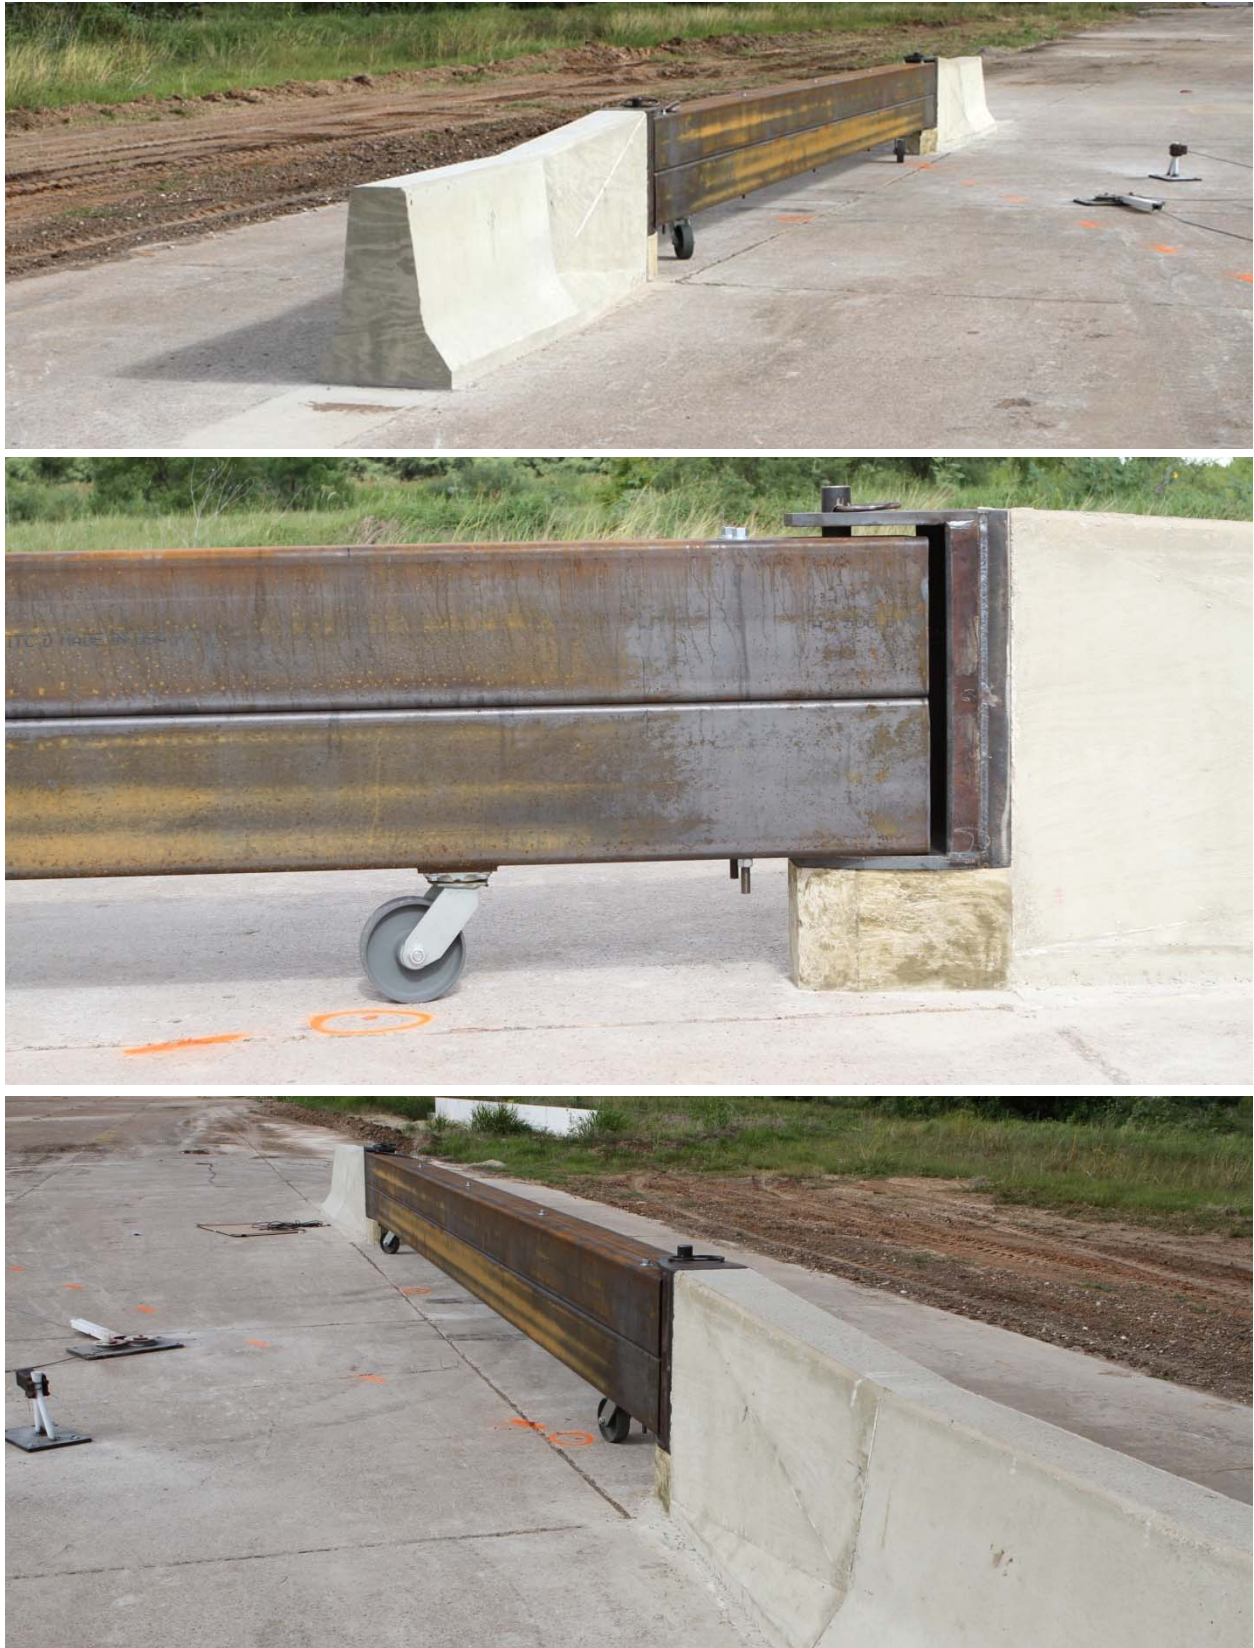
**Figure 3.3. TxDOT Median Barrier Gate Installation before Testing.**

The test installation was installed on an existing concrete apron.

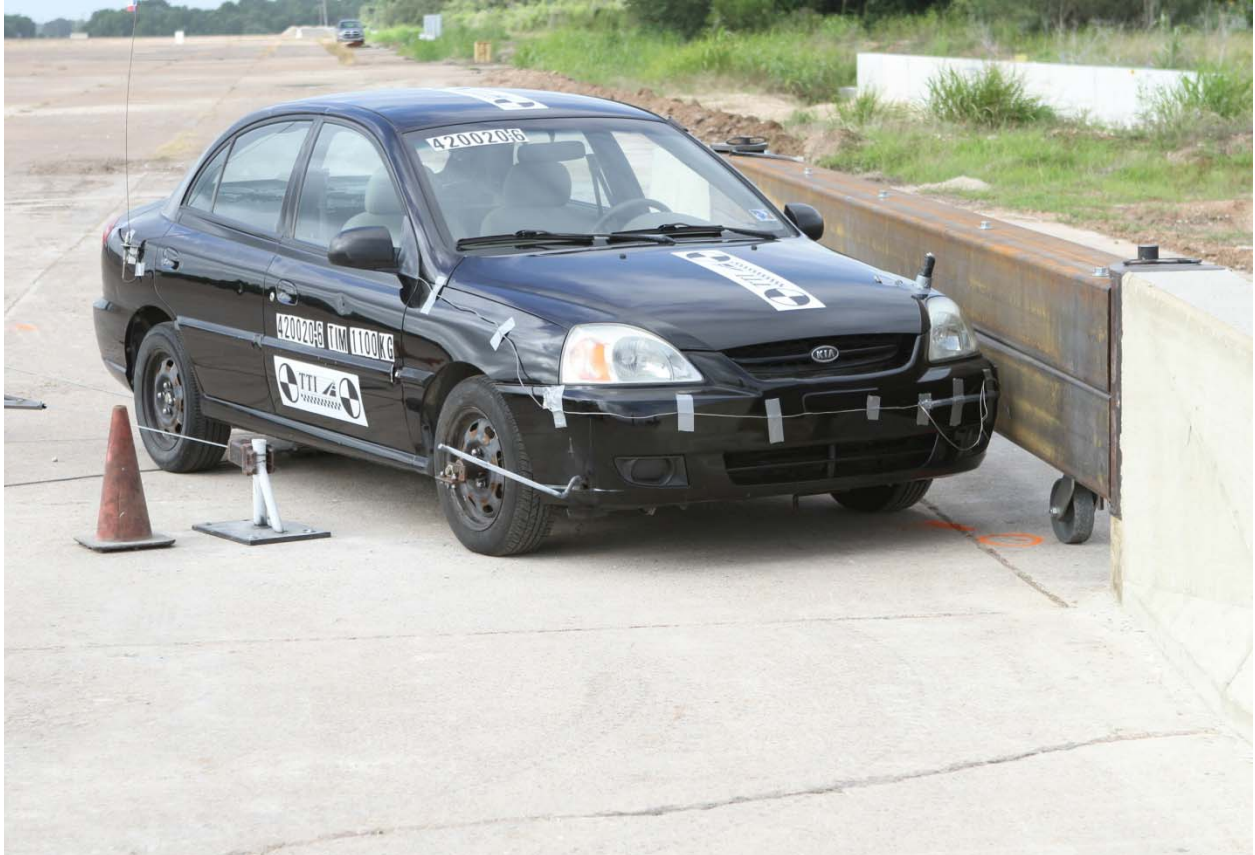
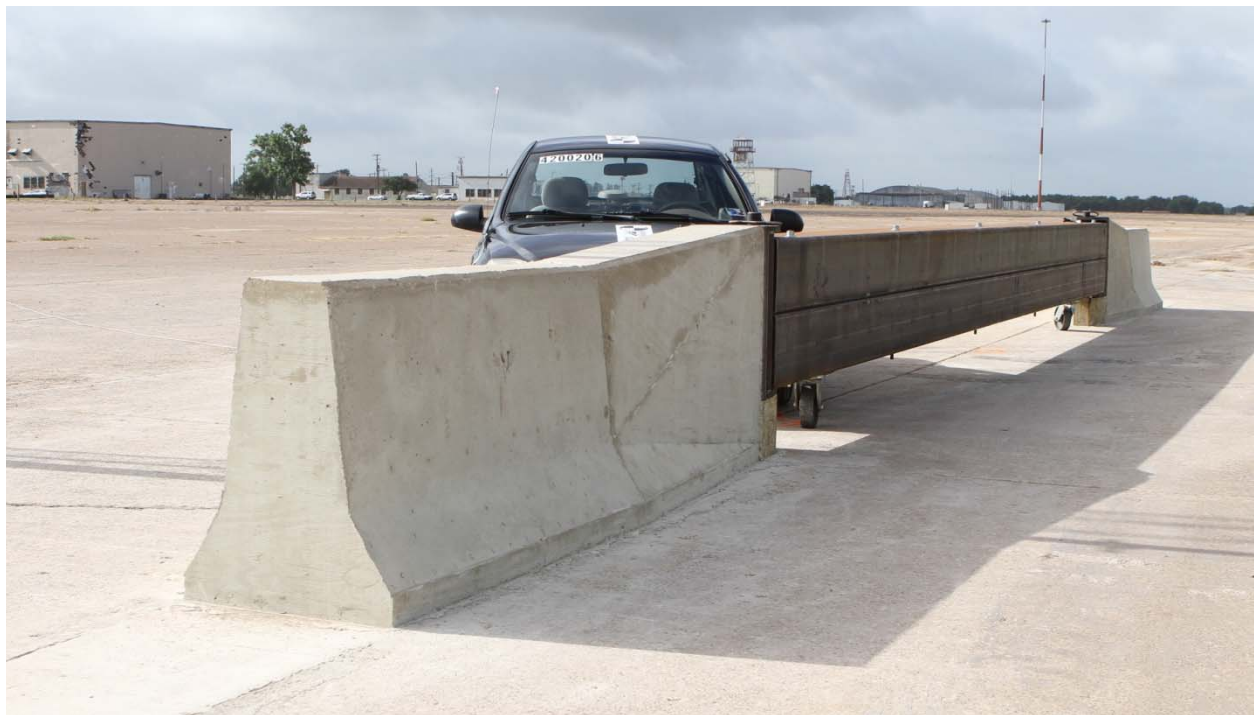
**Figure 6.1. Vehicle/Barrier Geometrics for Test No. 420020-6.**

A 2003 Kia Rio, shown in Figures 6.1 and 6.2, was used for the crash test. Test inertial weight of the vehicle was 2424 lb, and its gross static weight was 2592 lb. The height to the lower edge of the vehicle bumper was 8.50 inches, and it was 22.75 inches to the upper edge of the bumper. Figure C1 in Appendix C gives additional dimensions and information on the vehicle. The vehicle was directed into the installation using the cable reverse tow and guidance system, and was released to be free-wheeling and unrestrained just prior to impact.

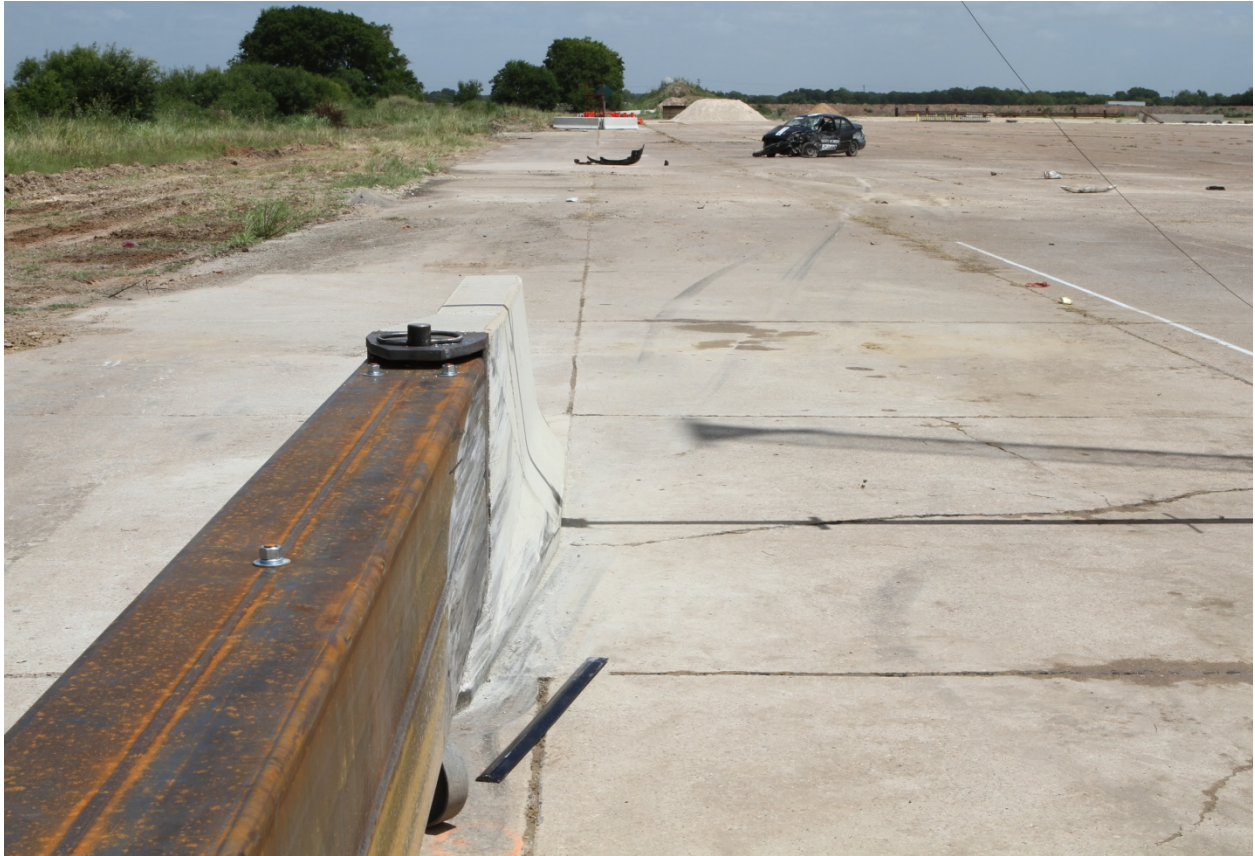
**Figure 6.3. Vehicle/Barrier Positions after Test No. 420020-6.**

Damage to the gate itself was only cosmetic and consisted of scuff marks as shown in Figures 6.3 and 6.4. The end of the upstream concrete parapet sustained two thin stress cracks on the field side. Minor concrete spalling was observed on the field side of the end of the downstream concrete parapet. No rebar was exposed and the spall was considered to be cosmetic in nature. The vehicle was in contact with the installation 10.2 ft. No measurable dynamic or permanent deflection was noted.

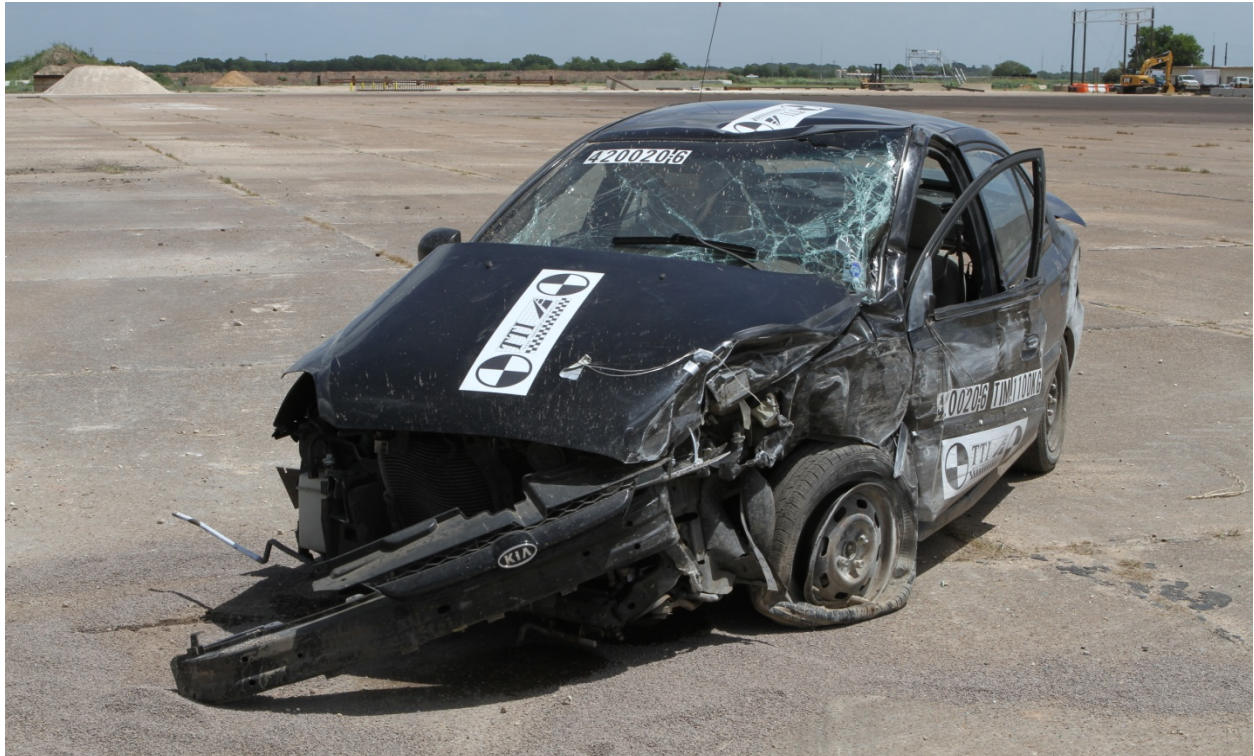
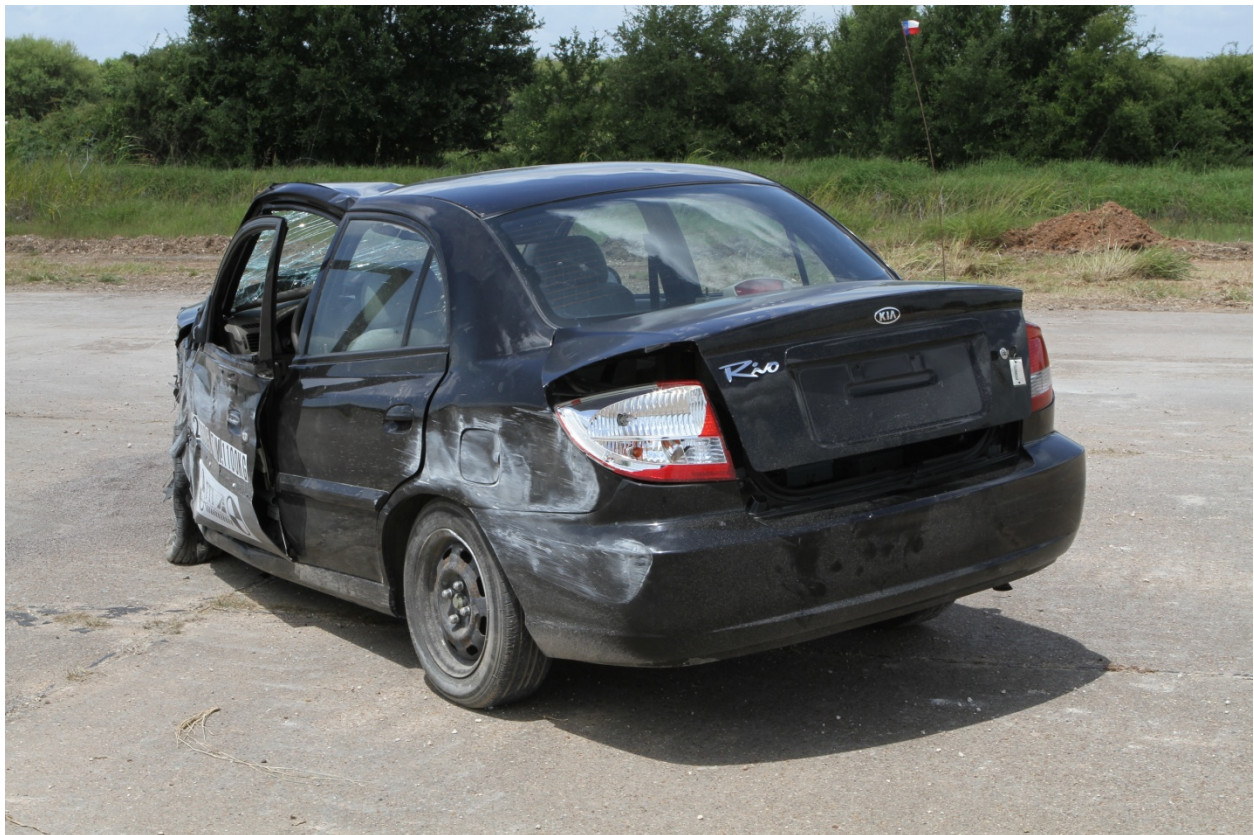
**Figure 6.5. Vehicle after Test No. 420020-6.**

As shown in Figure 6.5, the vehicle sustained damage to the front and left side. The left front strut, strut tower, and A-post were deformed. Also damaged were the front bumper, hood, grill, radiator and support, left front fender, left front tire and wheel rim, left front door and glass, the left rear door, and left rear quarter panel. The roof was deformed and the windshield sustained stress cracking. Maximum exterior crush to the vehicle was 12.0 inches in the side plane at the left front corner at bumper height. Maximum occupant compartment deformation was 3.0 inches in the firewall area near the toe pan on the driver side. Figure 6.6 shows photographs of the interior of the vehicle. Exterior crush and occupant compartment deformation measurements are provided in Appendix C, Tables C1 and C2.

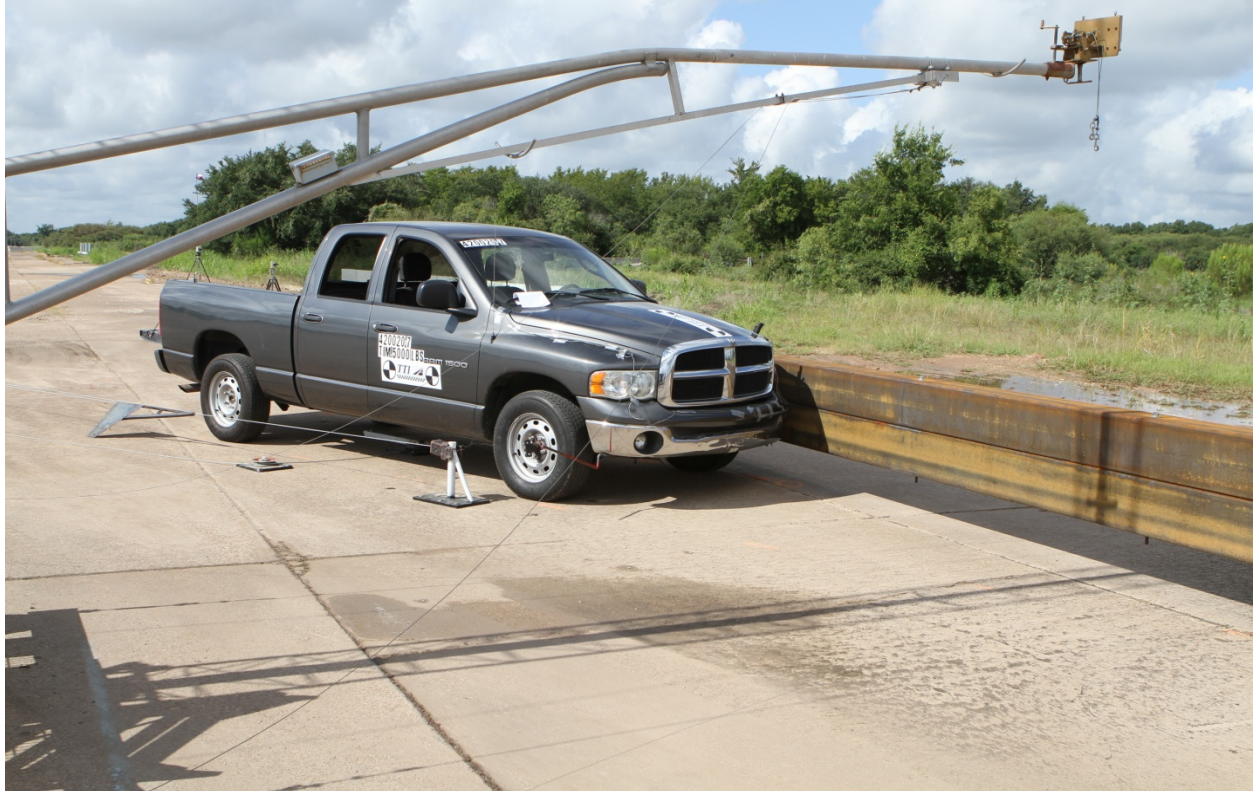
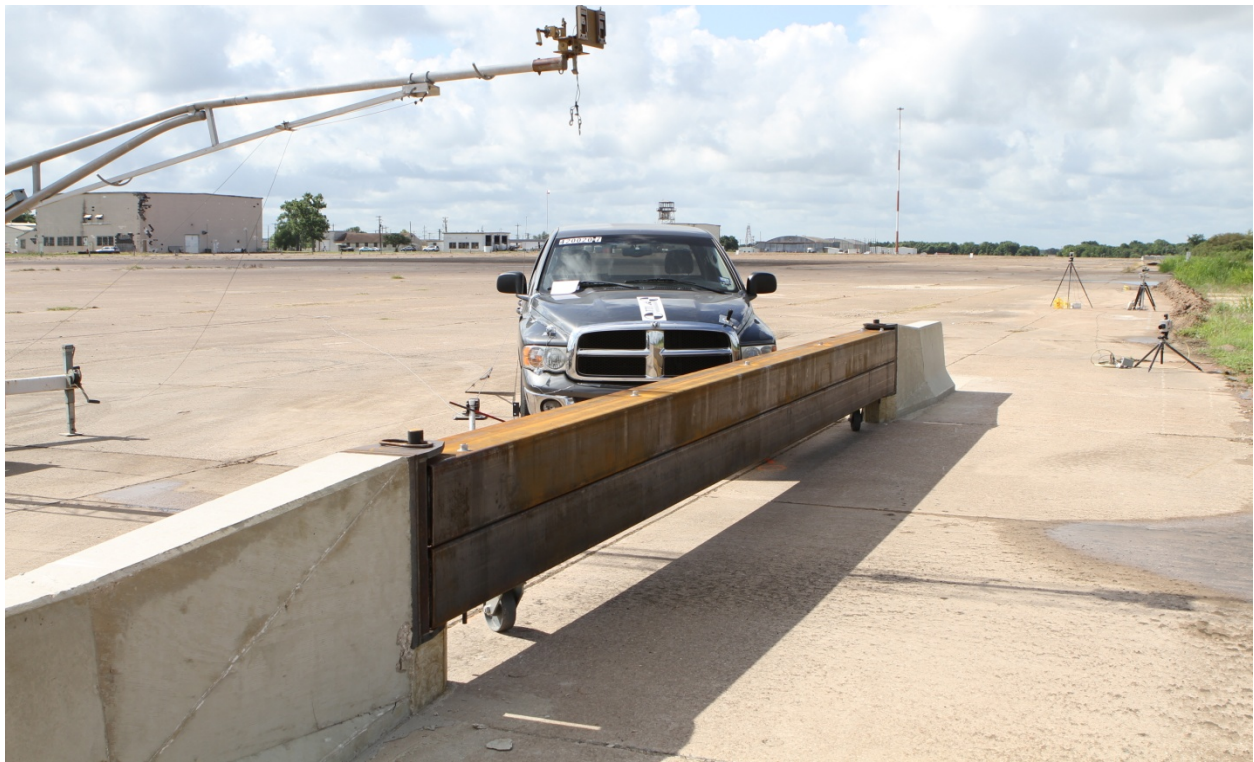
**Figure 7.1. Vehicle/Gate Geometrics for Test No. 420020-7.**

A 2003 Dodge Ram 1500 Quad-Cab pickup, shown in Figures 7.1 and 7.2, was used for the crash test. Test inertia weight of the vehicle was 5015 lb, and its gross static weight was 5015 lb. The height to the lower edge of the vehicle bumper was 13.5 inches, and it was 26.0 inches to the upper edge of the bumper. The vertical center of gravity (CG) height of the pickup truck was measured to be 28.12 inches. Figure C2 and Table C3 in Appendix C gives additional dimensions and information on the vehicle. The vehicle was directed into the installation using the cable reverse tow and guidance system, and was released to be free-wheeling and unrestrained just prior to impact.

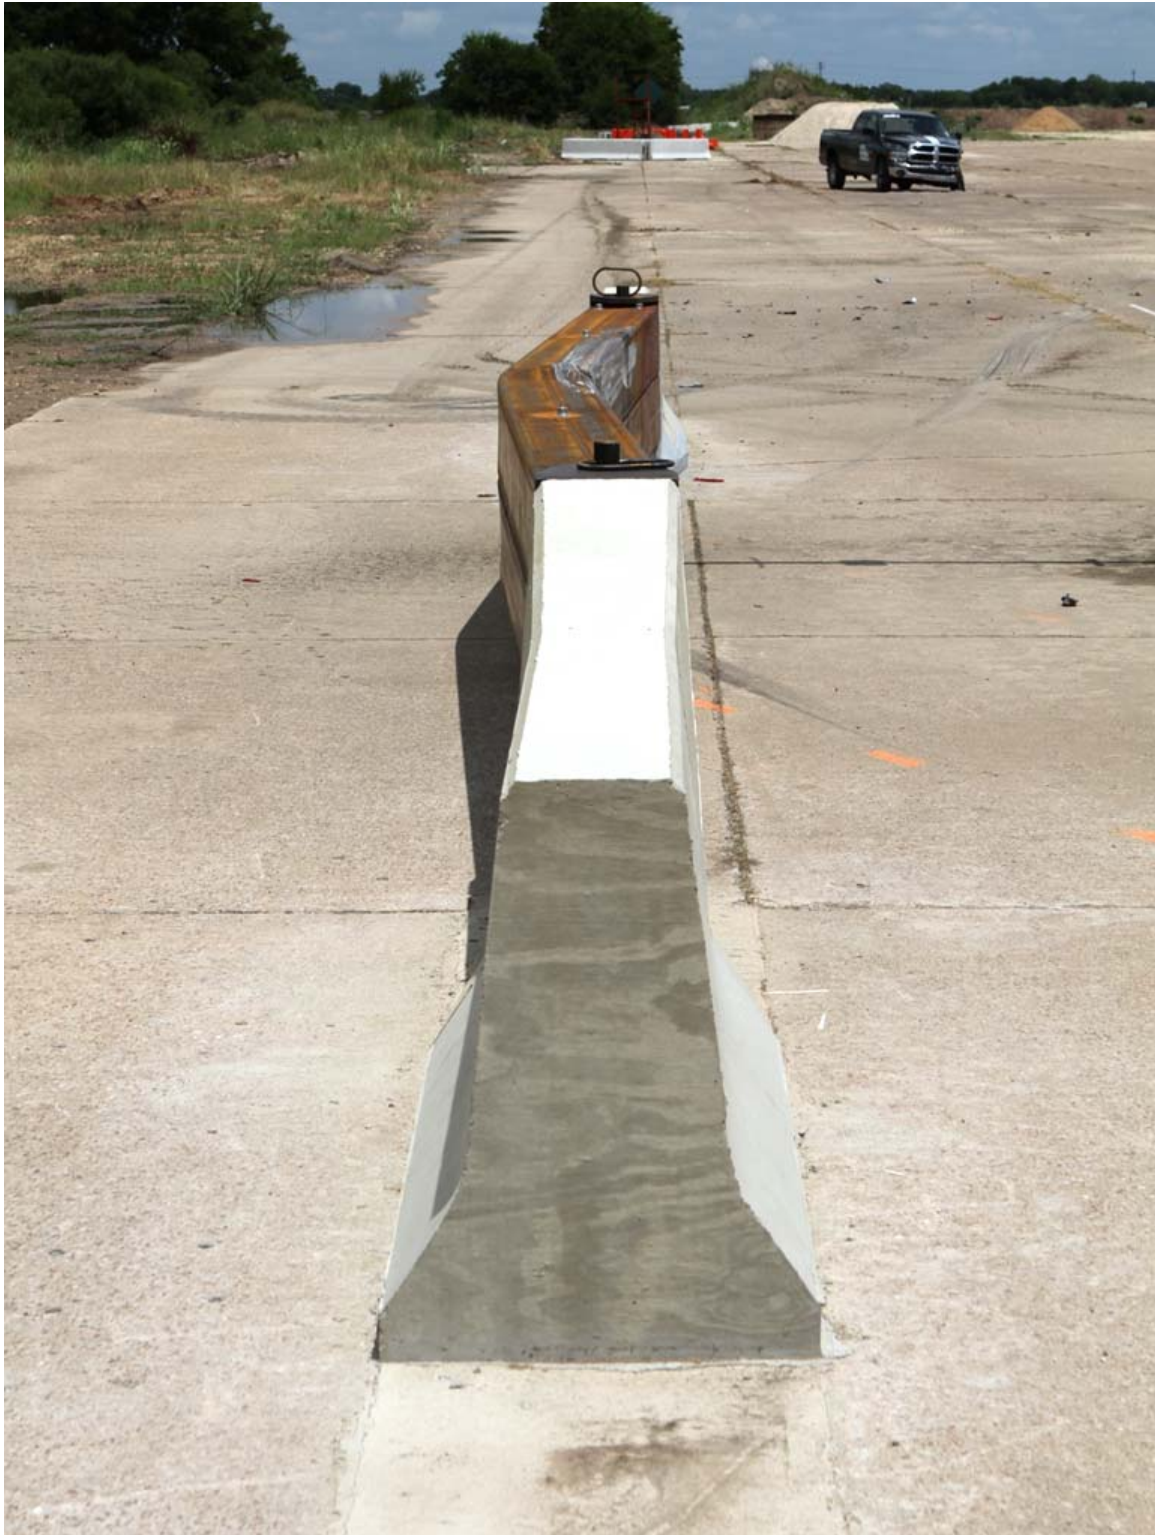
**Figure 7.3. Vehicle/Gate Positions after Test No. 420020-7.**

The steel barrier gate sustained moderate damage as shown in Figures 7.3 and 7.4. The traffic faces of the steel tubes were deformed inward and the tubular rails were buckled near mid-span. There was no damage noted to the concrete parapets. The vehicle was in contact with the installation a distance of 14.9 ft. Working width was 1.1 ft. Maximum dynamic deflection of the median barrier gate during the test was 1.1 ft, and maximum permanent deformation was 0.8 ft.

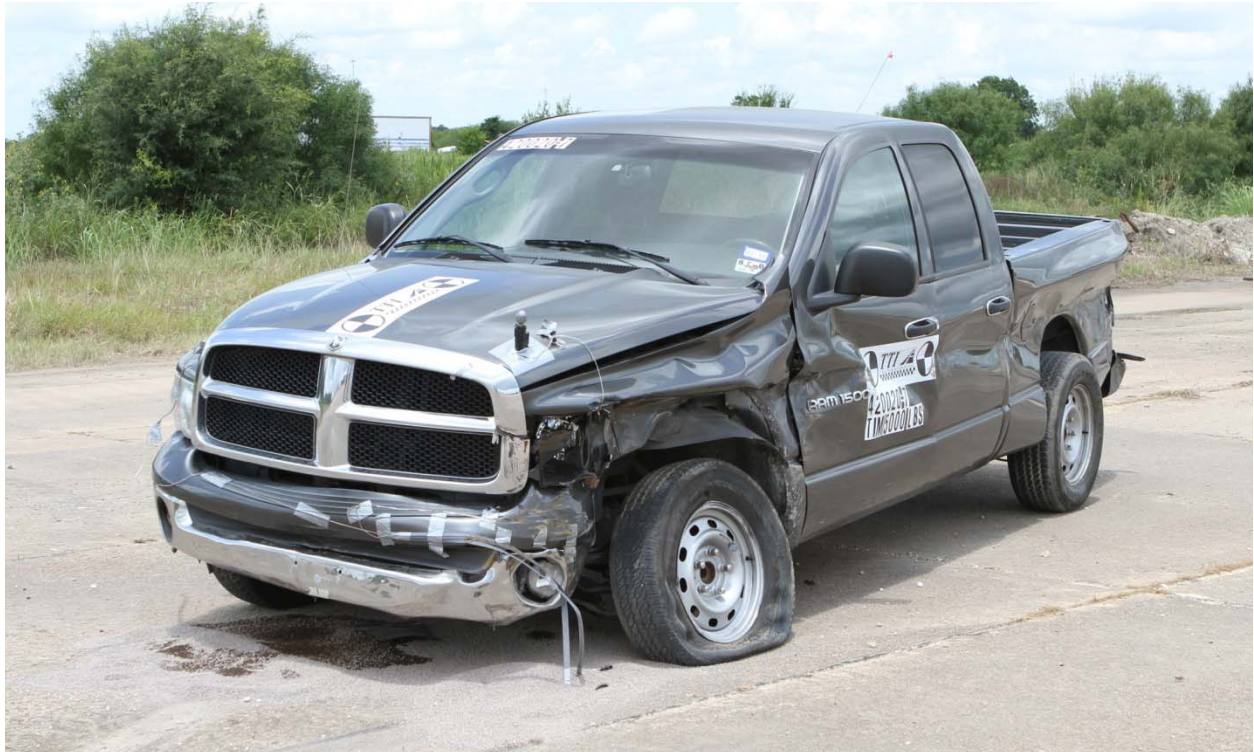
**Figure 7.5. Vehicle after Test No. 420020-7.**

As shown in Figure 7.5, the majority of the damage sustained by the 2270P vehicle was to the left front corner and above the top wheel line along the left side. The left upper A-arm was deformed. Also damaged were the front bumper, grill, left front fender, left front tire and wheel rim, left front and rear doors, rear of the cab, left exterior bed, left rear wheel rim (no loss of air in the tire), rear bumper, and tailgate. Maximum exterior crush to the vehicle was 12.0 inches in the side plane in the left front corner at bumper height. Maximum occupant compartment deformation was 0.5 inches across the cab at hip level on the driver side. Figure 7.6 shows photographs of the interior of the vehicle. Exterior crush measurements and occupant compartment deformation are provided in Appendix C, Tables C4 and C5.

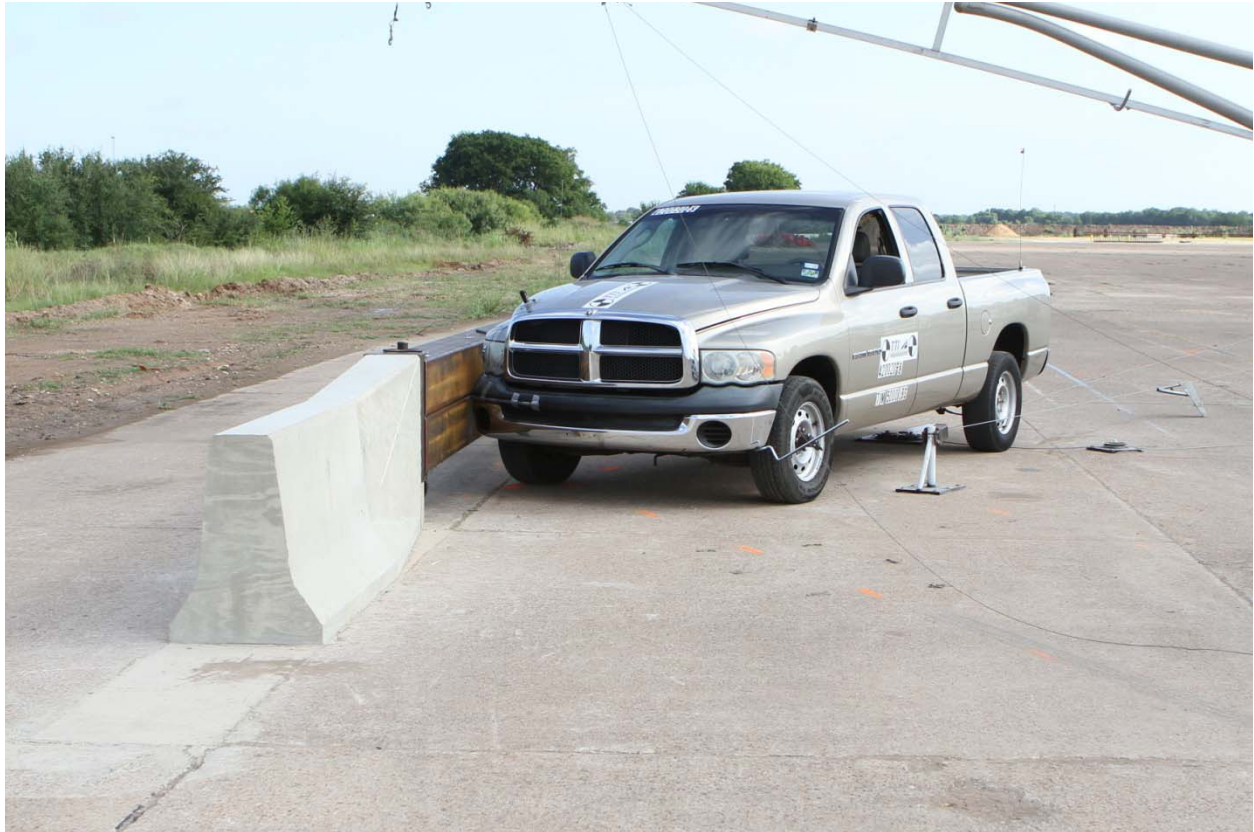
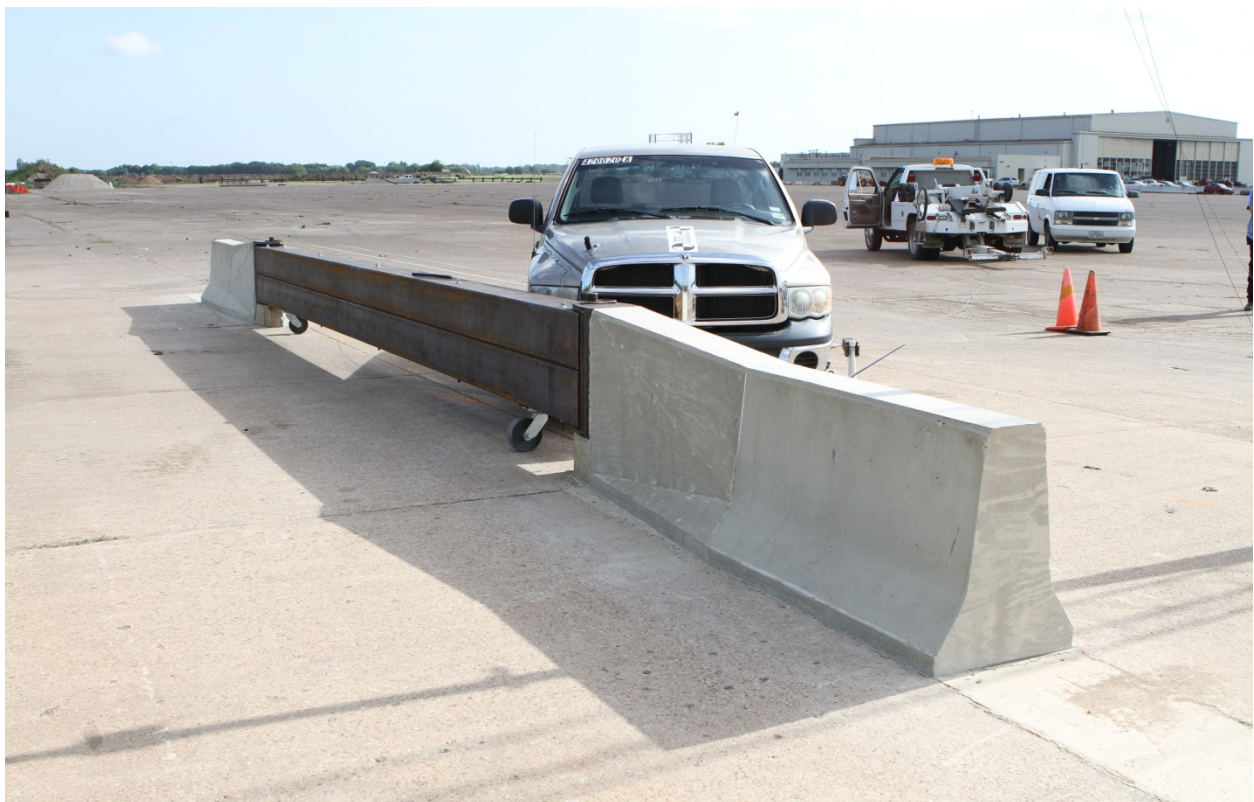
**Figure 8.1. Vehicle/Gate Geometrics for Test No. 420020-8.**

A 2003 Dodge Ram 1500 Quad-Cab pickup, shown in Figures 8.1 and 8.2, was used for the crash test. Test inertia weight of the vehicle was 5008 lb, and its gross static weight was 5008 lb. The height to the lower edge of the vehicle bumper was 13.5 inches, and it was 26.0 inches to the upper edge of the bumper. The vertical CG height of the pickup truck was 28.25 inches. Figure C3 and Table C6 in Appendix C gives additional dimensions and information on the vehicle. The vehicle was directed into the installation using the cable reverse tow and guidance system, and was released to be free-wheeling and unrestrained just prior to impact.

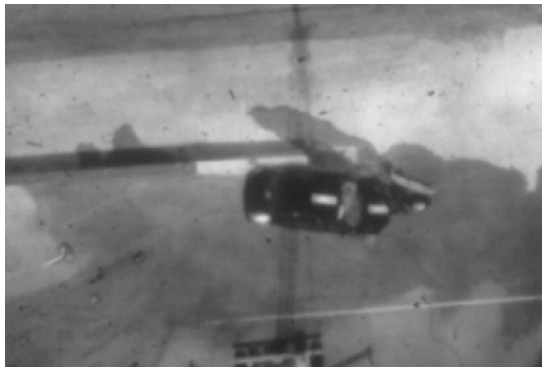
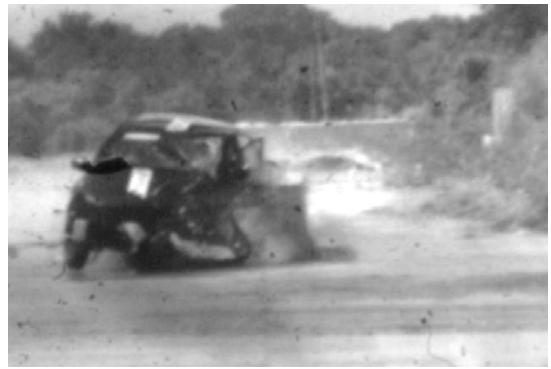
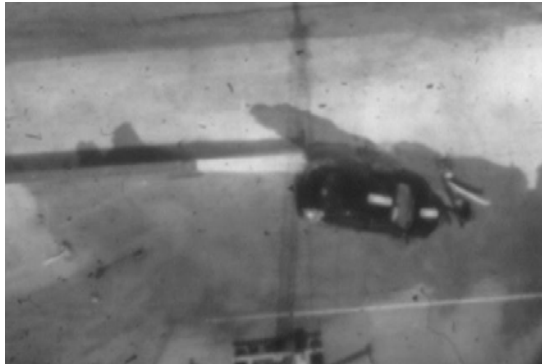
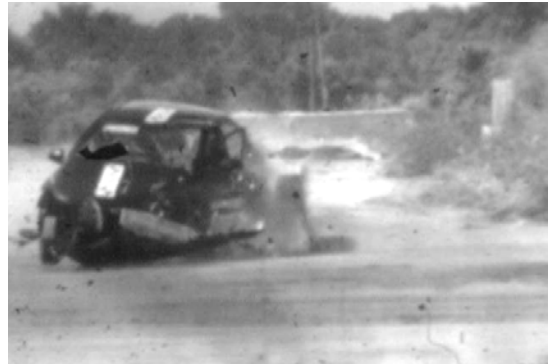
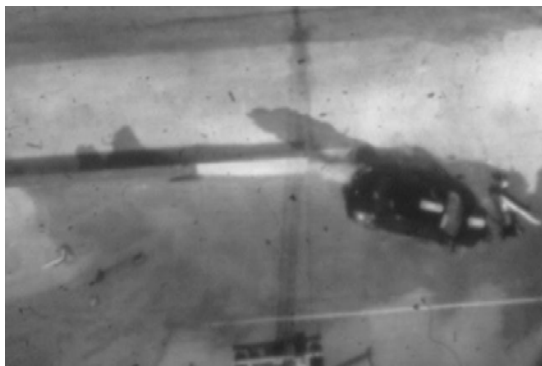
**Figure D1. Sequential Photographs for Test No. 420020-6  
(Overhead and Frontal Views).**

The 2003 Kia Rio, traveling at a speed of 62.6 mi/h, impacted the TxDOT median barrier gate 49 inches upstream of the end of the concrete parapet at an angle of 24.6 degrees. At approximately 0.009 s after impact, the left front tire of the vehicle contacted the downstream caster wheel of the gate, and at 0.026 s, the left front tire contacted the toe of the concrete barrier. The vehicle began to redirect 0.037 s after impact. At 0.167 s, the vehicle was traveling parallel with the median barrier gate and traveling at a speed of 45.6 mi/h. The rear of the vehicle contacted the barrier 0.199 s after impact. At 0.300 s, the vehicle lost contact with the barrier and was traveling at an exit speed and angle of 49.3 mi/h and 11.6 degrees, respectively. Brakes on the vehicle were applied at 1.4 s after impact, and the vehicle subsequently came to rest 183 ft downstream of impact and 27 ft toward traffic lanes. Figures D1 and D2 in Appendix D show sequential photographs of the test period.

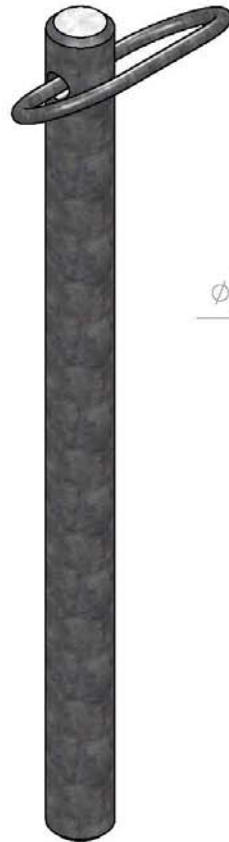
**PIN ASSEMBLY**  
2 NEEDED PER INSTALLATION

**HANDLE**  
A36

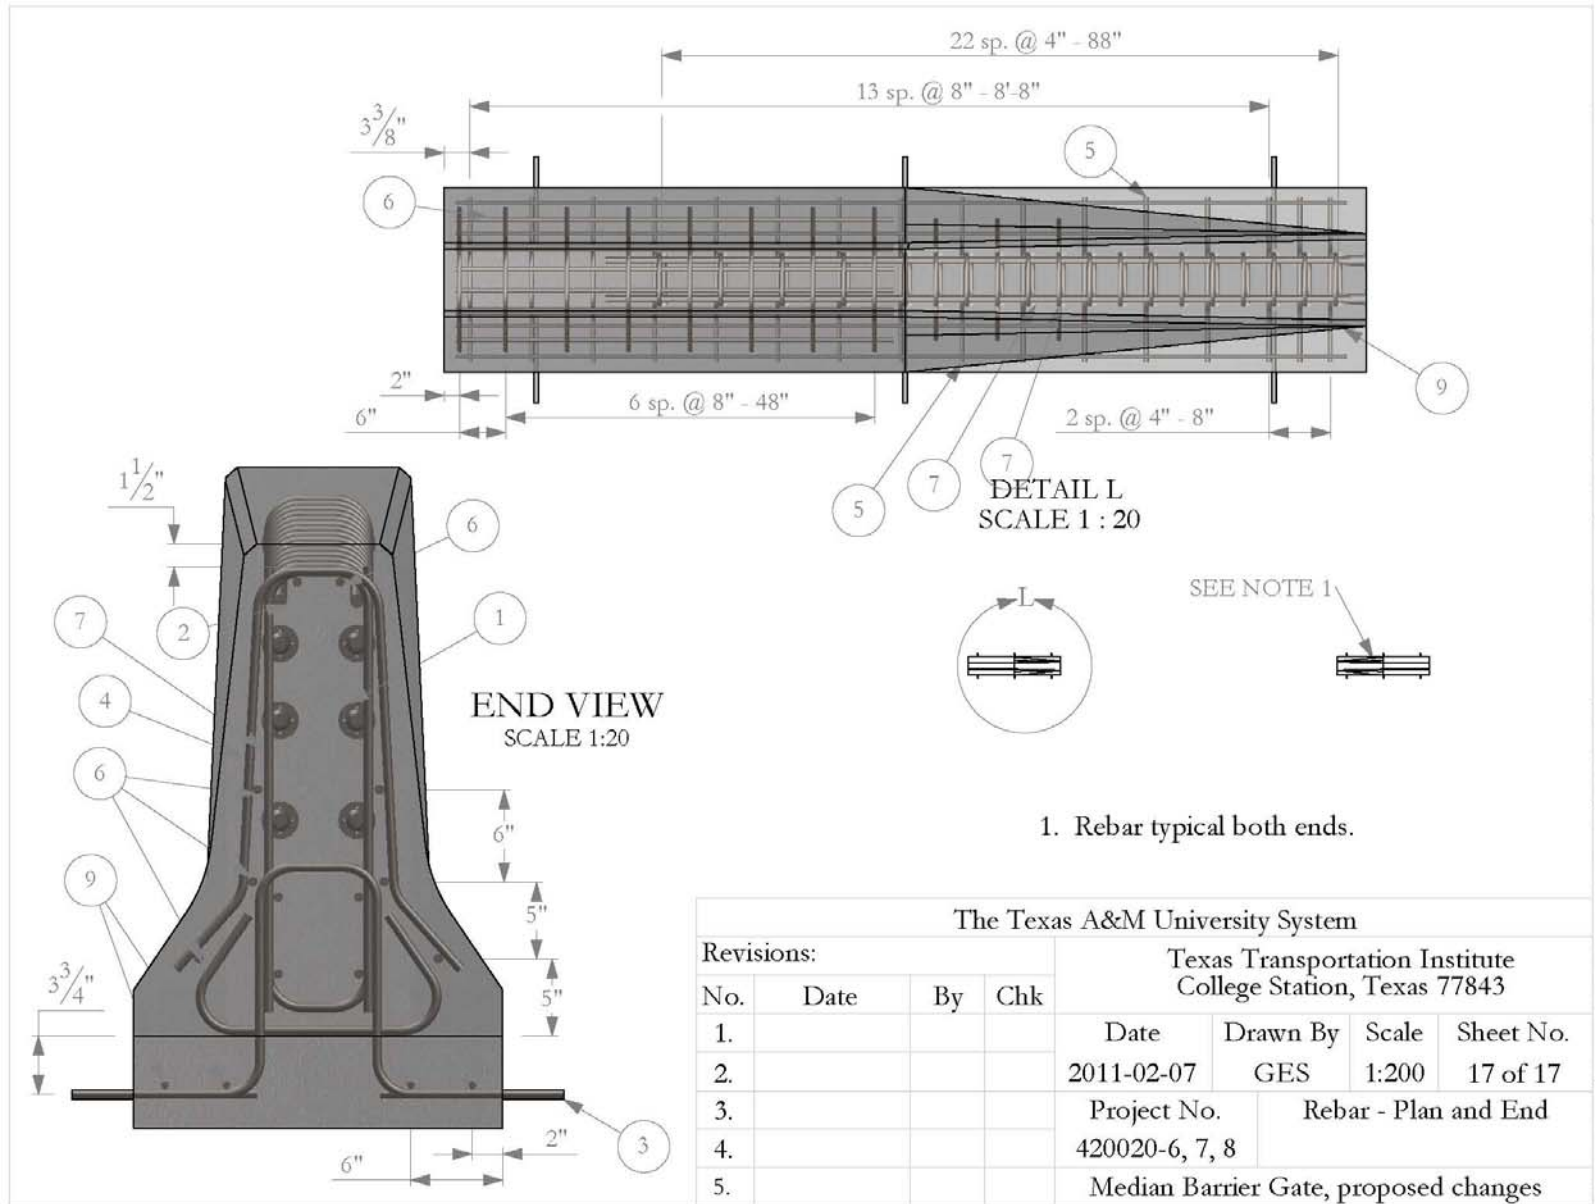
The Texas A&M University System							
Revisions:				Texas Transportation Institute College Station, Texas 77843			
No.	Date	By	Chk	Date	Drawn By	Scale	Sheet No.
1.				2011-02-07	GES	1:200	16 of 17
3.				Project No.		Rebar - Elevation	
4.				420020-6, 7, 8			
5.				Median Barrier Gate, proposed changes
