## ***MASH TEST 3-37 OF THE TxDOT 31-INCH W-BEAM DOWNSTREAM ANCHOR TERMINAL***

**Test Report 9-1002-6**

**TEXAS TRANSPORTATION INSTITUTE  
THE TEXAS A&M UNIVERSITY SYSTEM  
COLLEGE STATION, TEXAS**

**TEXAS DEPARTMENT OF TRANSPORTATION**

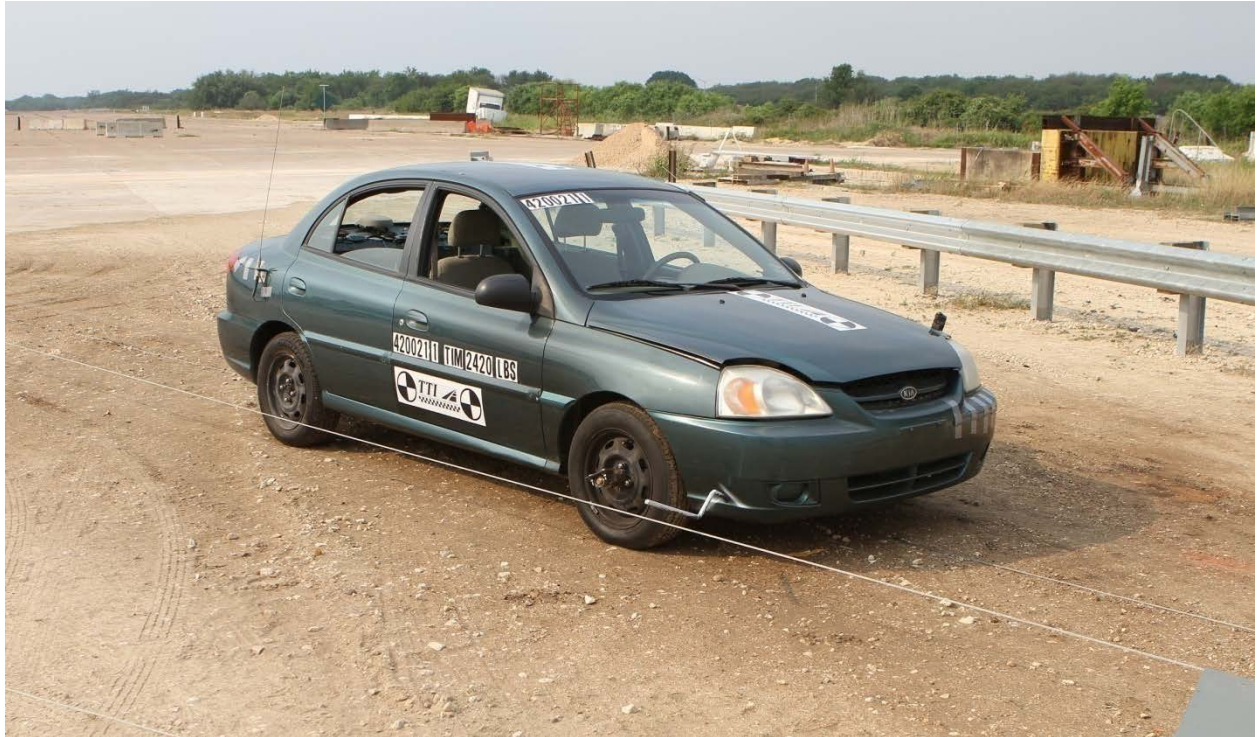
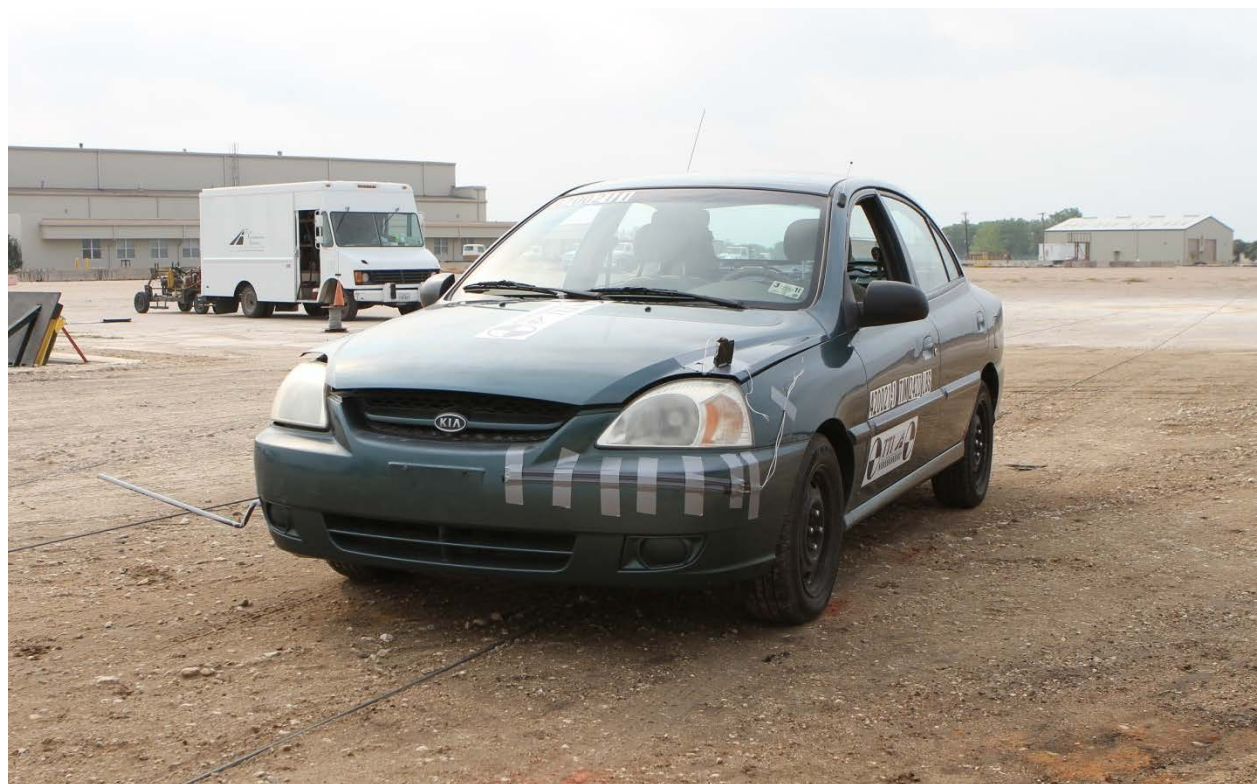
**Figure 5.2. Vehicle before Test No. 420021-1.**

The 2004 Kia Rio, shown in Figures 5.1 and 5.2, was used for the crash test. Test inertia weight of the vehicle was 2420 lb, and its gross static weight was 2585 lb. The height to the lower edge of the vehicle bumper was 8.5 inches, and it was 22.75 inches to the upper edge of the bumper. Table D1 in Appendix D gives additional dimensions and information on the vehicle. The vehicle was directed into the installation using the cable reverse tow and guidance system, and was released to be free-wheeling and unrestrained just prior to impact.

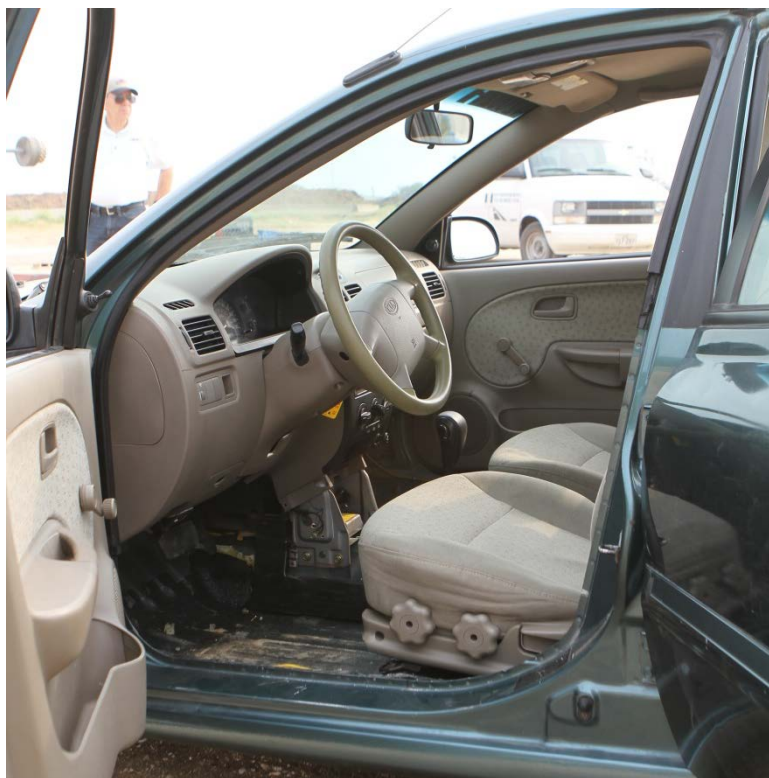
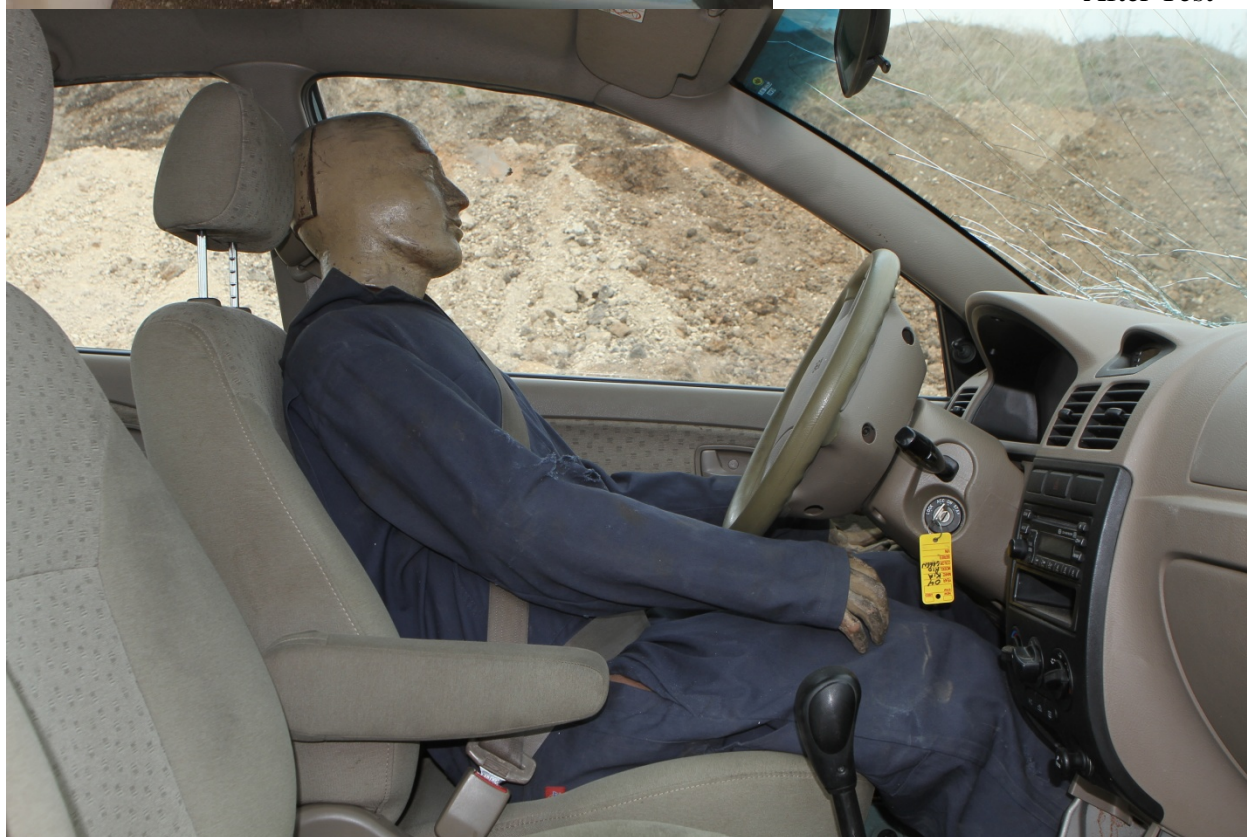
**Figure 5.6. Interior of Vehicle for Test No. 420021-1.**

Before Test

After Test

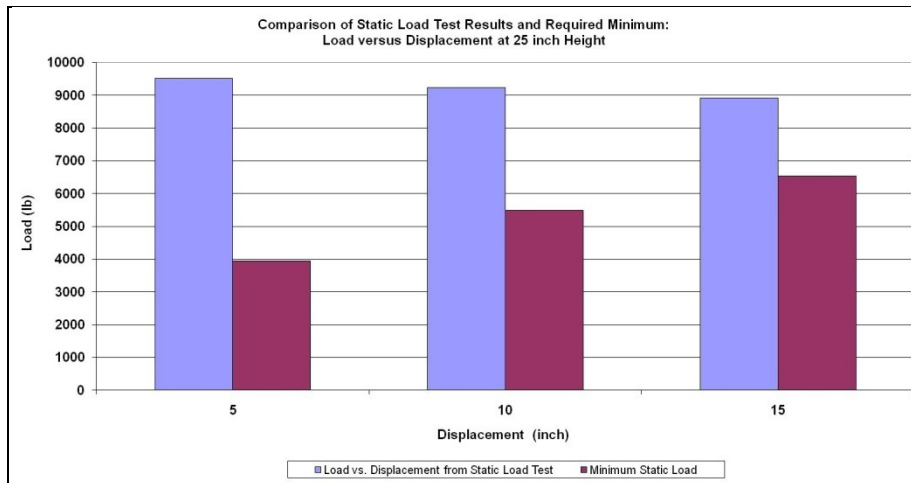
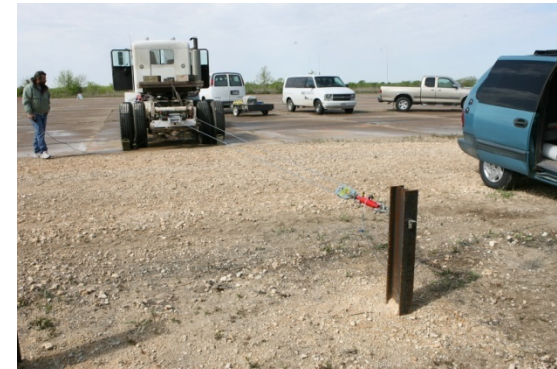
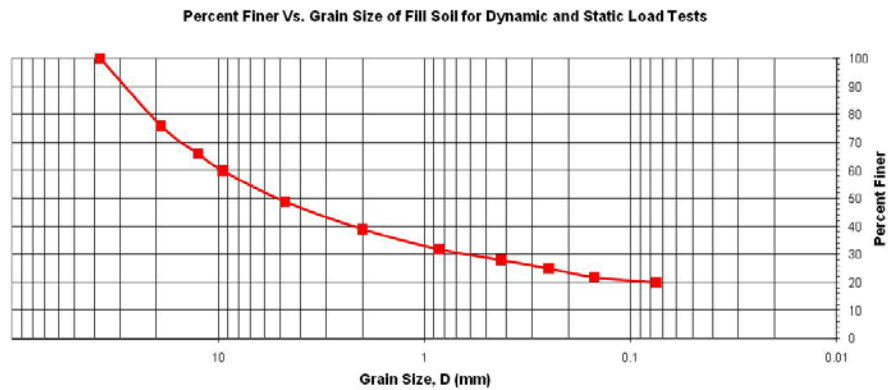
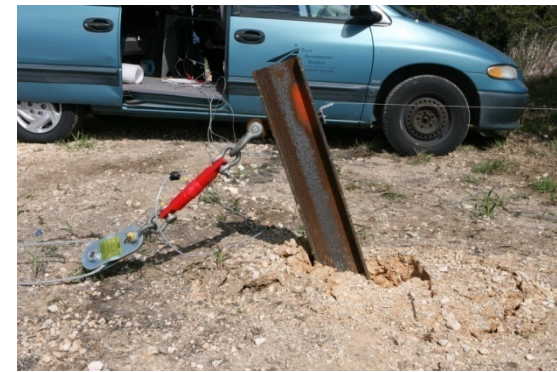
Static Load Setup

Post-Test Photo of Post

Date .....	2011-04-20
Test Facility and Site Location .....	TTI Proving Ground—3100 SH 47, Bryan, TX
In Situ Soil Description (ASTM D2487) .....	Sandy gravel with silty fines
Fill Material Description (ASTM D2487) and sieve analysis .....	AASHTO Grade B Soil-Aggregate (see sieve analysis)
Description of Fill Placement Procedure .....	6-inch lifts tamped with a pneumatic compactor

In accordance with Appendix B of *MASH*, soil strength was measured on the day of the crash test (see Appendix C, Figure C1). During construction of the TxDOT 31-inch W-Beam Downstream Anchor Terminal for the full-scale crash test, two W6×16 posts were installed in the

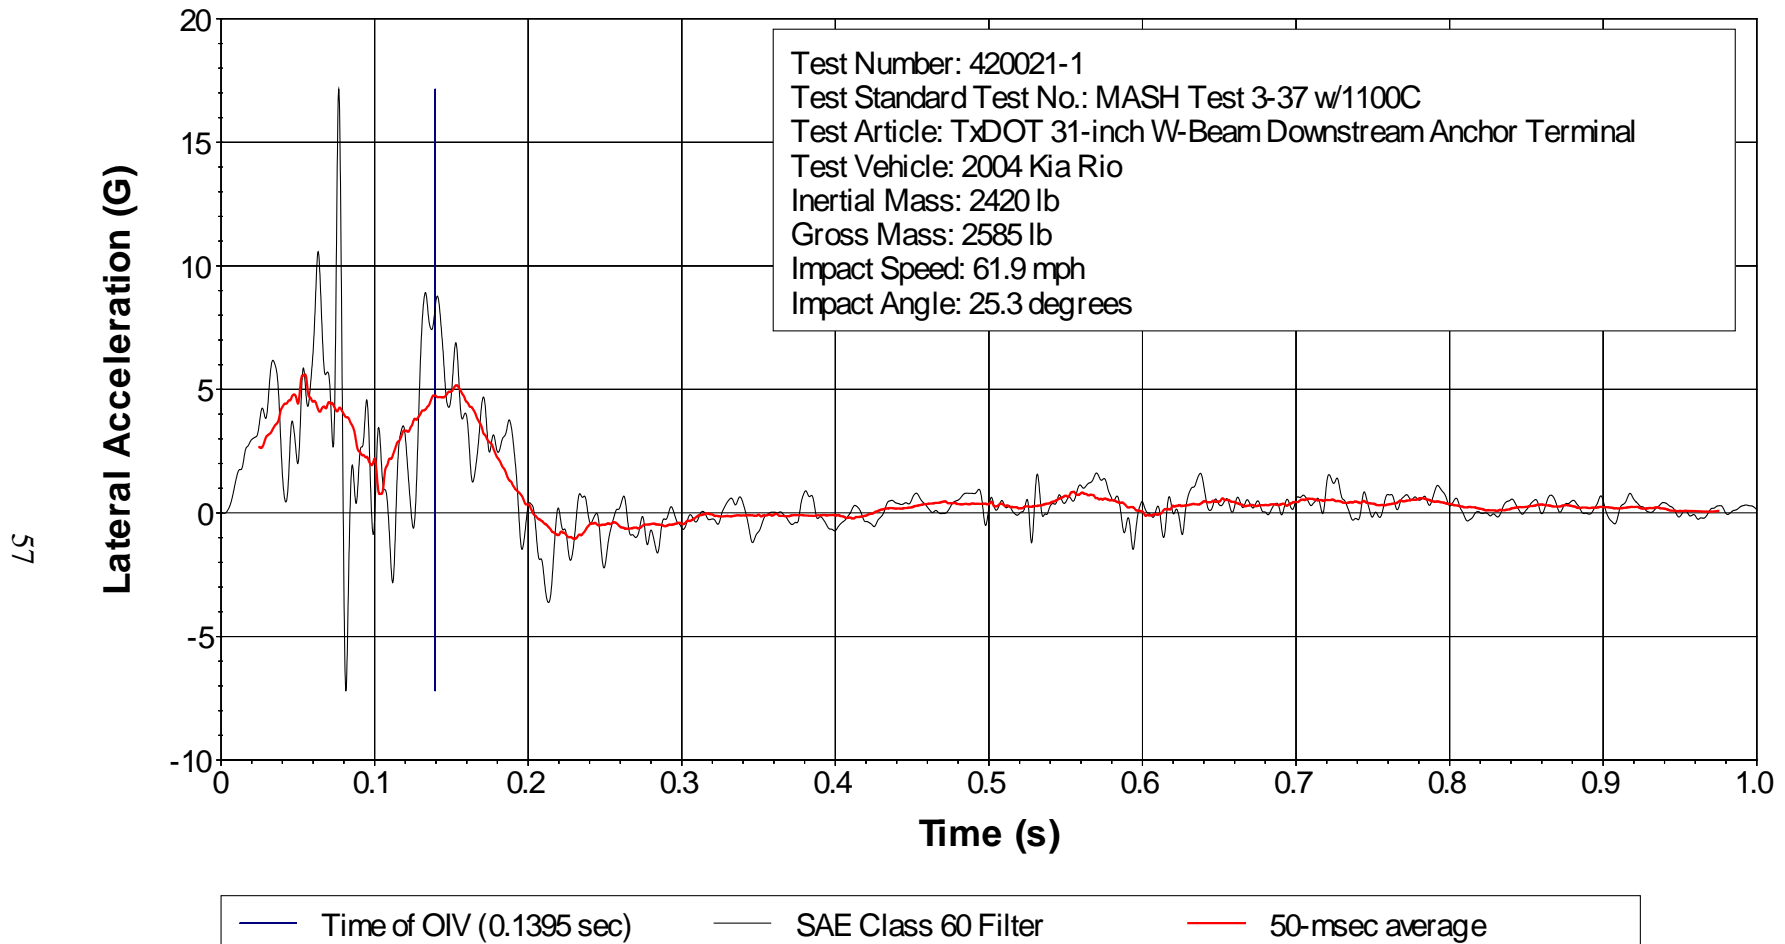
**Figure F3. Vehicle Lateral Accelerometer Trace for Test No. 420021-1  
(Accelerometer Located at Center of Gravity).**

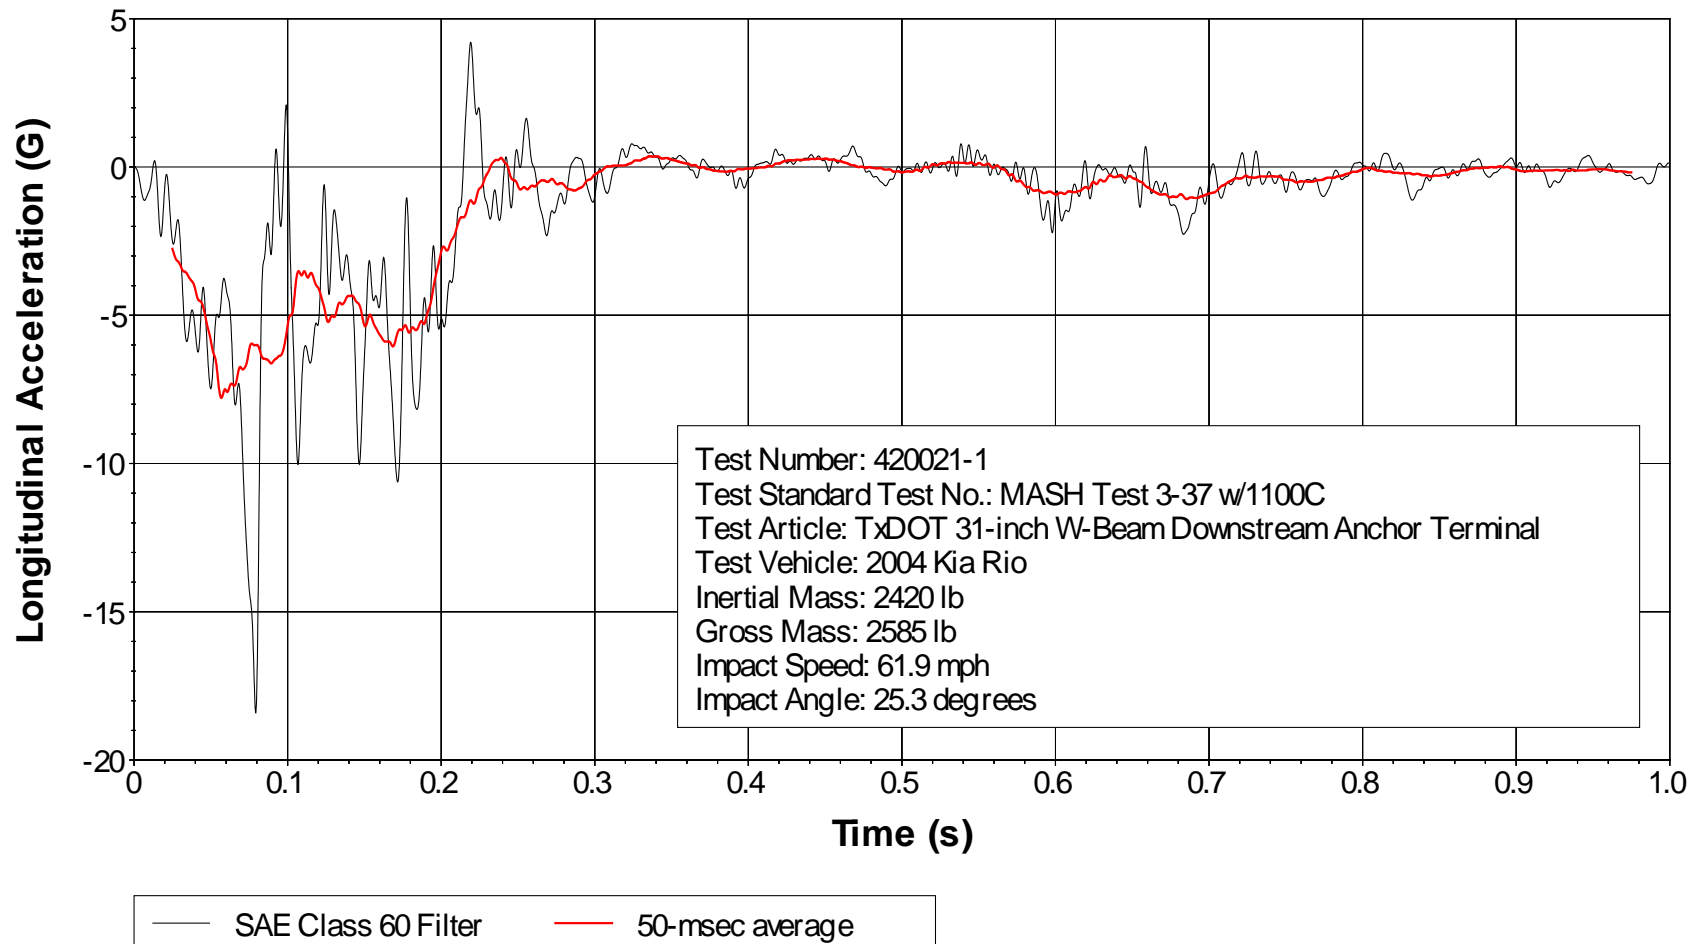
**Figure F5. Vehicle Longitudinal Accelerometer Trace for Test No. 420021-1  
 (Accelerometer Located over Rear Axle).**

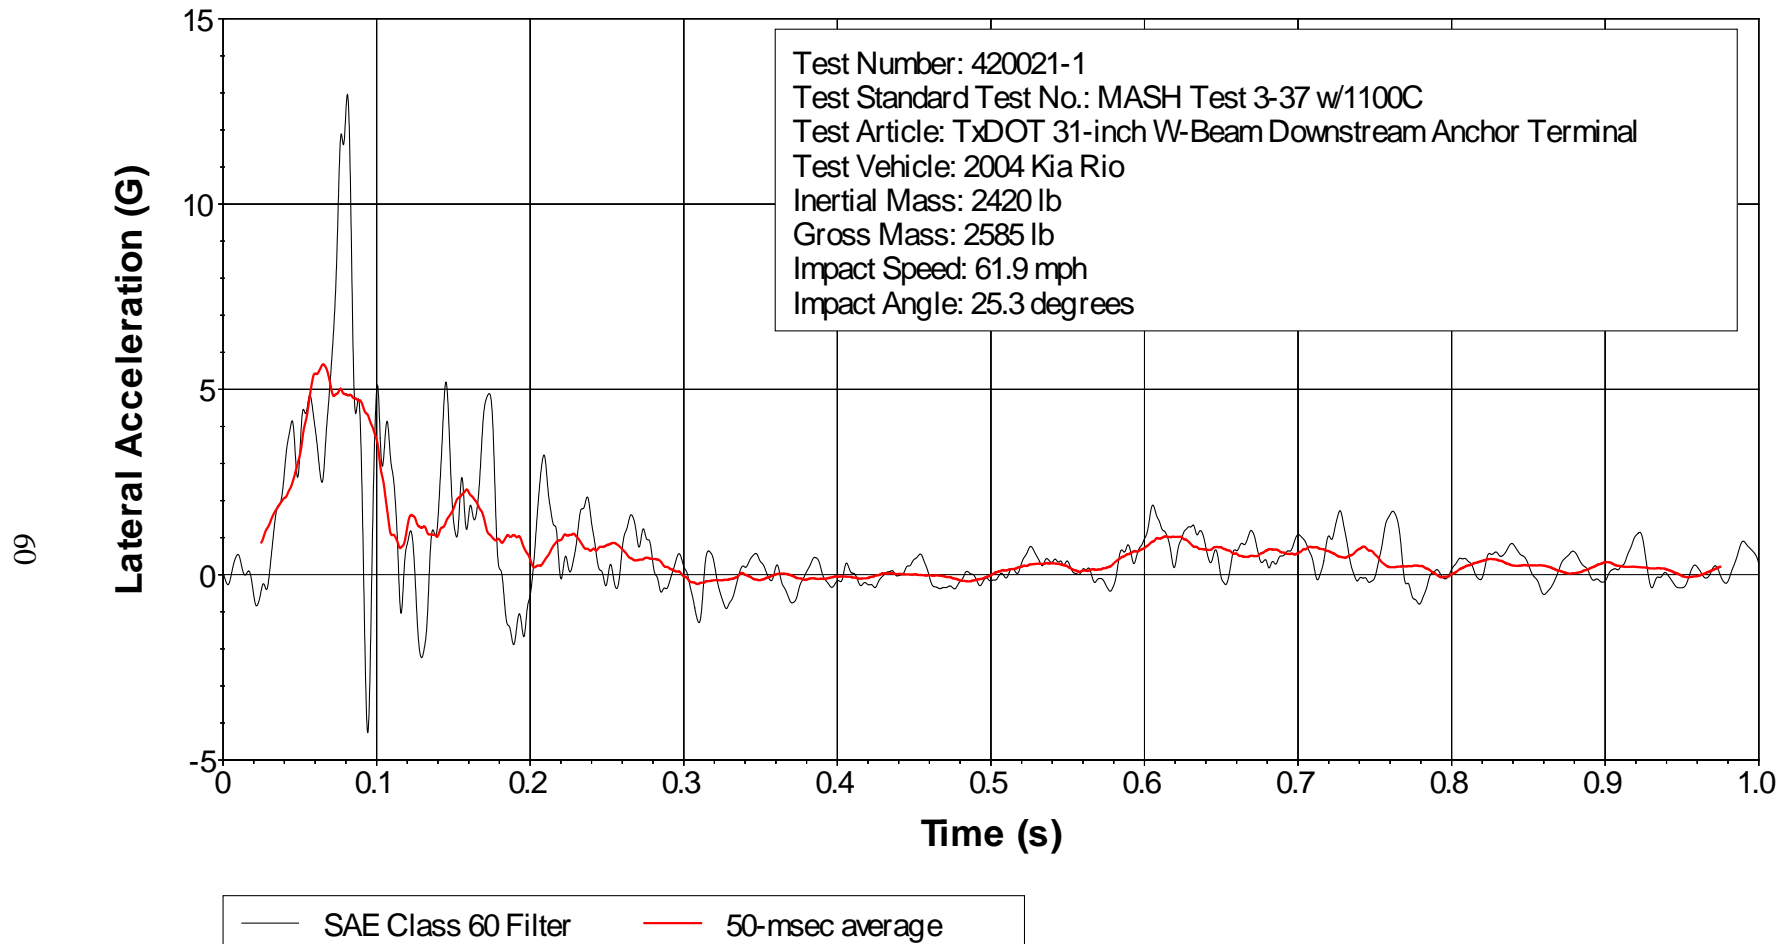
**Figure F6. Vehicle Lateral Accelerometer Trace for Test No. 420021-1  
(Accelerometer Located over Rear Axle).**
