MASH TEST 3-11 ON THE 5-INCH CIPD BARRIER ANCHORS

Test Report 9-1002-7

Report 9-1002-7
Project 9-1002
Project Title: Roadside Safety Device Crash Testing Program

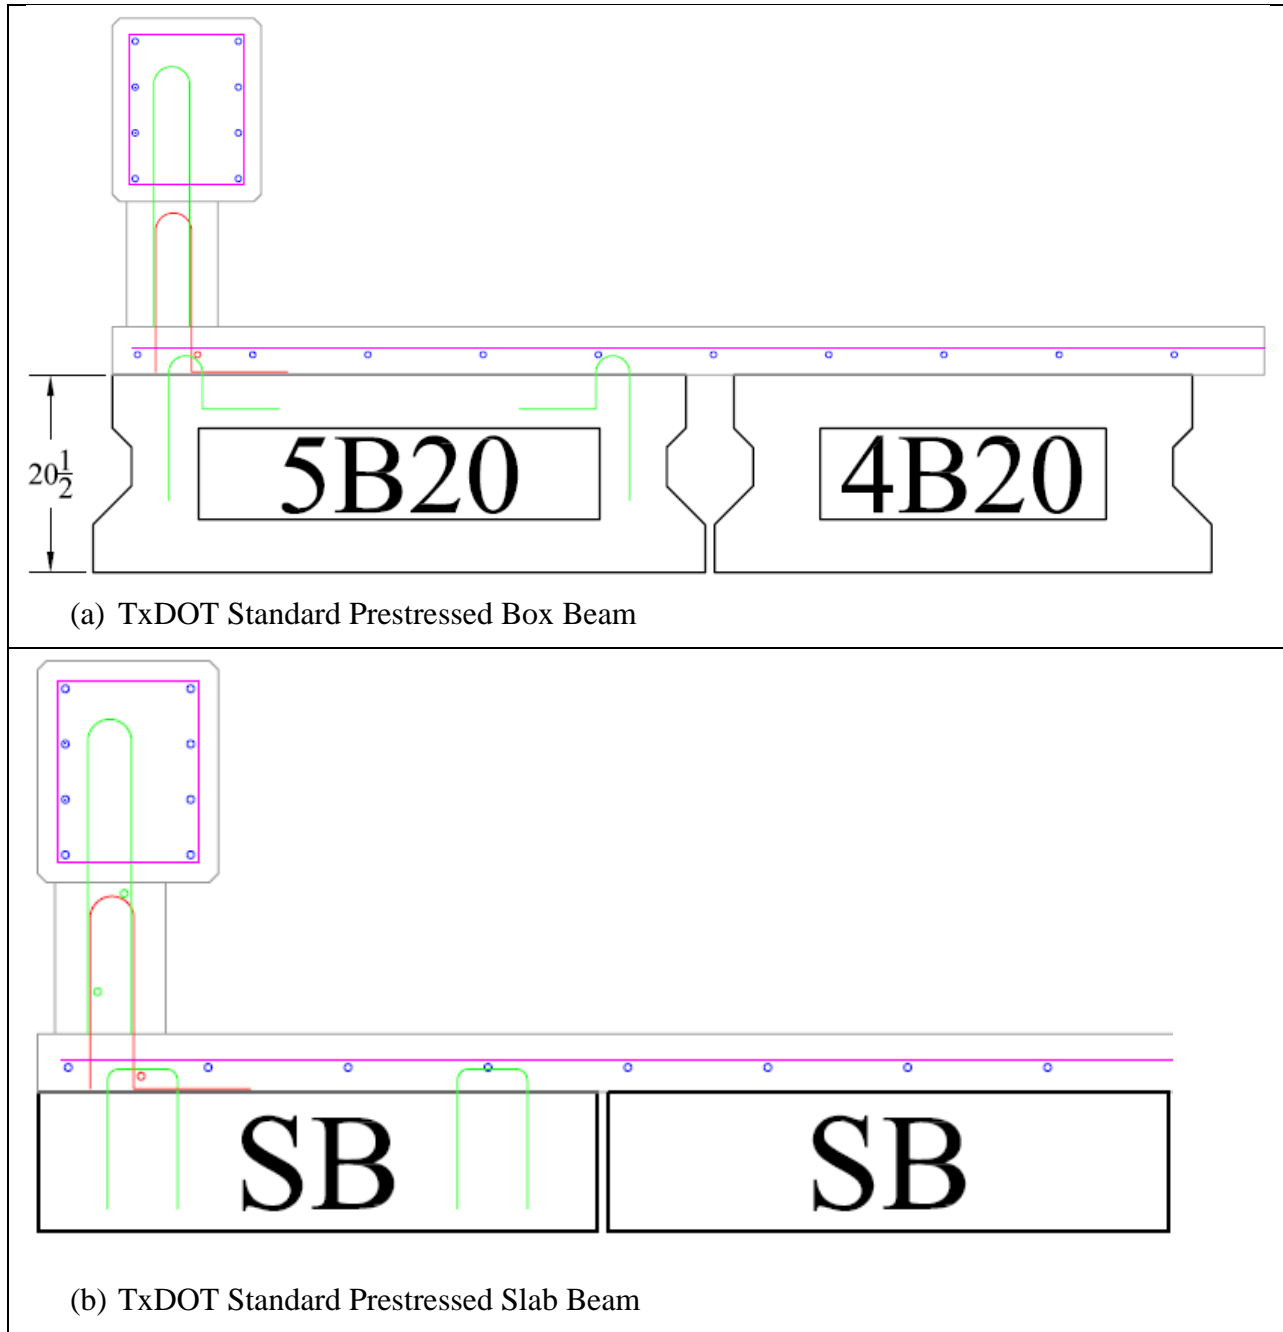
Figure 2.2. Comparison of TxDOT Standard Prestressed Box and Slab Beams.

Both the standard box and slab beam sections, illustrated in Figure 2.2, were evaluated to determine which would provide the worst case for anchorage of the T223 barrier profile. It was concluded that the 5.5-inch thick top flange of the prestressed concrete box beam made it a worst case for anchorage compared to the 12-inch thick uniform prestressed slab beam. Therefore, a simulated concrete box beam was selected for testing in conjunction with a T223 barrier profile anchored into 5-inch thick composite cast-in-place deck (CIPD).

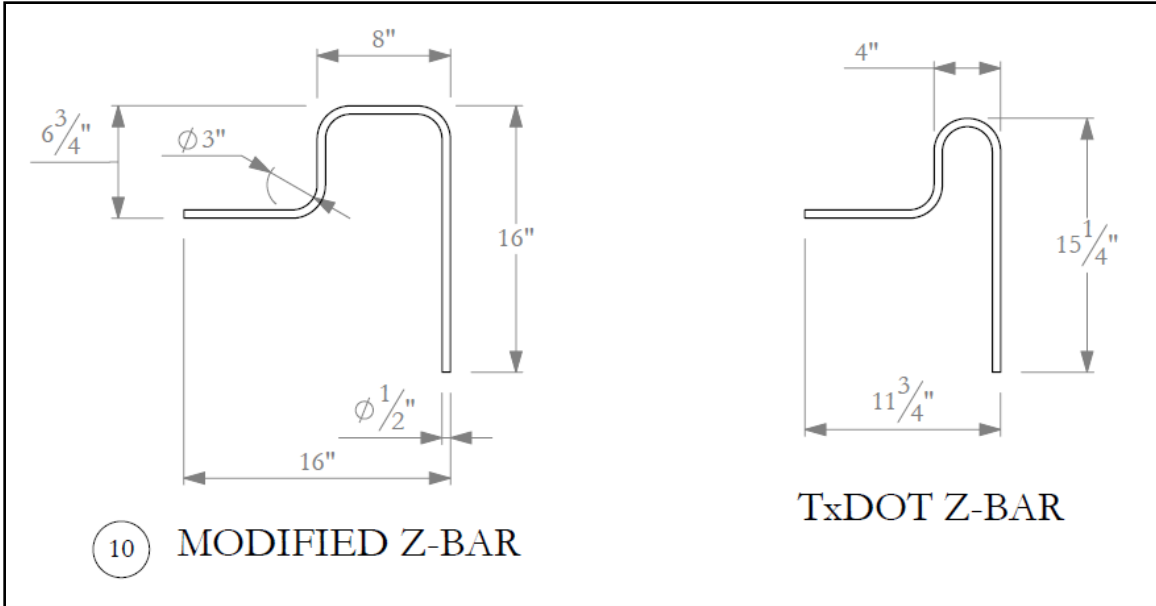
Figure 2.3. Comparison of TxDOT Standard “Z” Bar and Modified “Z” Bar Dimensions.

Third, due to the narrowness of the protruding portion of the “Z” bar, it is not possible for a #5 rebar to be thread through the “Z” bar and still traverse the embedded leg of the “U” bar. For this reason the protruding portion of the “Z” bar was widened, as shown in Figure 2.3.

Second, a #5 bar was added that runs inside of the “Z” bar anchor and over the “U” bar anchor. This added bar helps tie the “Z” bar to the “U” bar to provide more anchorage for the T223 barrier. This added anchorage is meant to replace some of the capacity lost due to the reduced embedment depth.

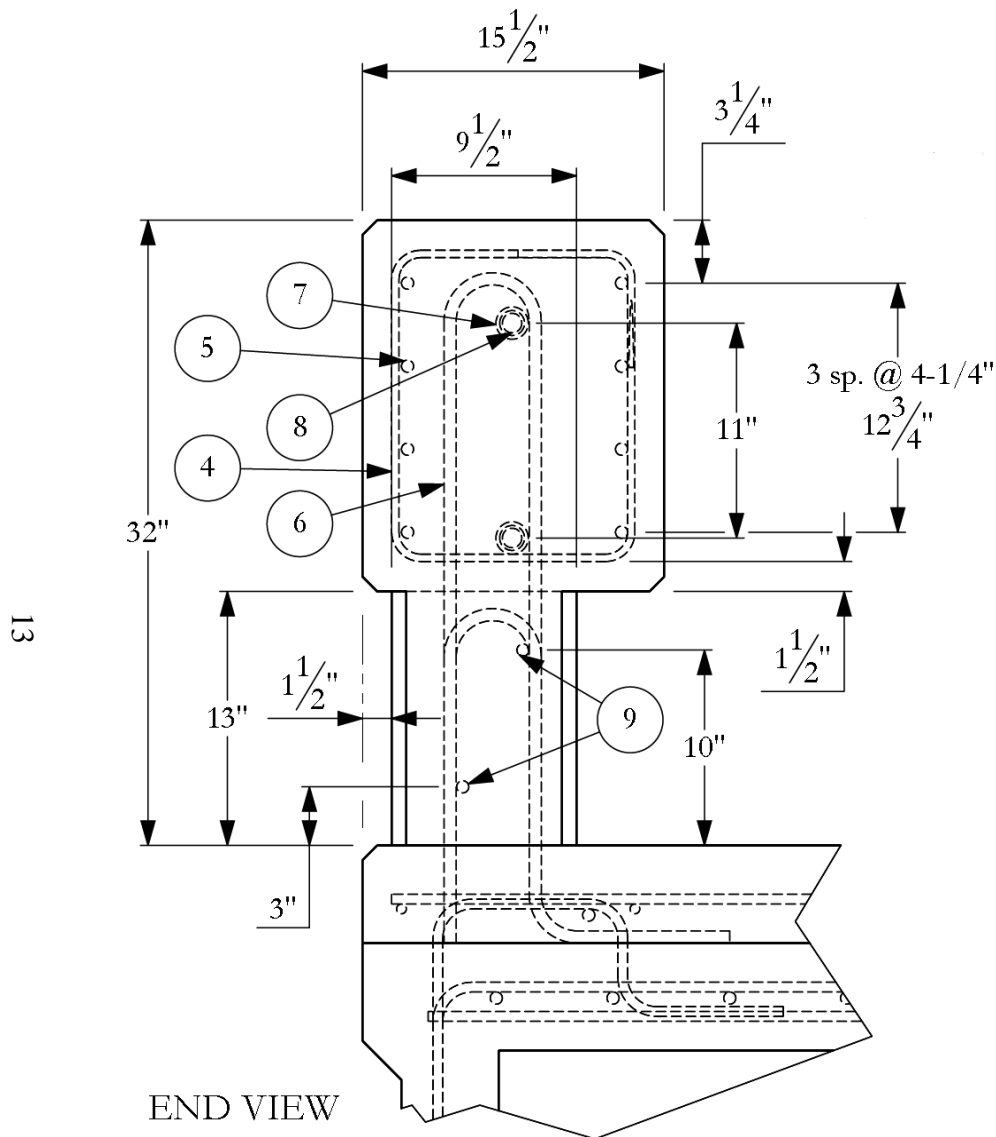
Figure 4.2. Details of the 5-inch CIPD Barrier Anchor Installation.

All rebar details followed the TxDOT box beam standard with the exception of the composite anchor bars (Z-bars). Eight #5 bars spaced 6-inches on centers were placed in the top deck along the length of the box beam section. Transverse “A” bars and 49-inch transverse “B” bars were placed in the top deck every 4 inches for the first 48-inches on each end of the beam. The spacing was then increased to 6-inches throughout the rest of the barrier. Modified “Z” bars were spaced every 12 inches along the length of the beam. Each “Z” bar protrudes out of the top of the beam approximately 2¼-inches. Finally, an additional #5 bar was tied inside the interior radius of the protruding modified “Z” bar. This bar was added to improve anchorage of the T223 bridge rail in the thin 5-inch thick cast-in-place bridge deck.

Finally, two 60-inch #8 rebar dowels spanned the expansion joint. The downstream end of each #8 bar was directly embedded into the T223 concrete beam. The upstream ends of the #8 rebars were inserted into 1¼-inch diameter Schedule 80 PVC pipe sleeves. This permitted longitudinal expansion of the bridge and barrier while providing shear resistance across the expansion joint. Further details of the test article can be found in reference 7.

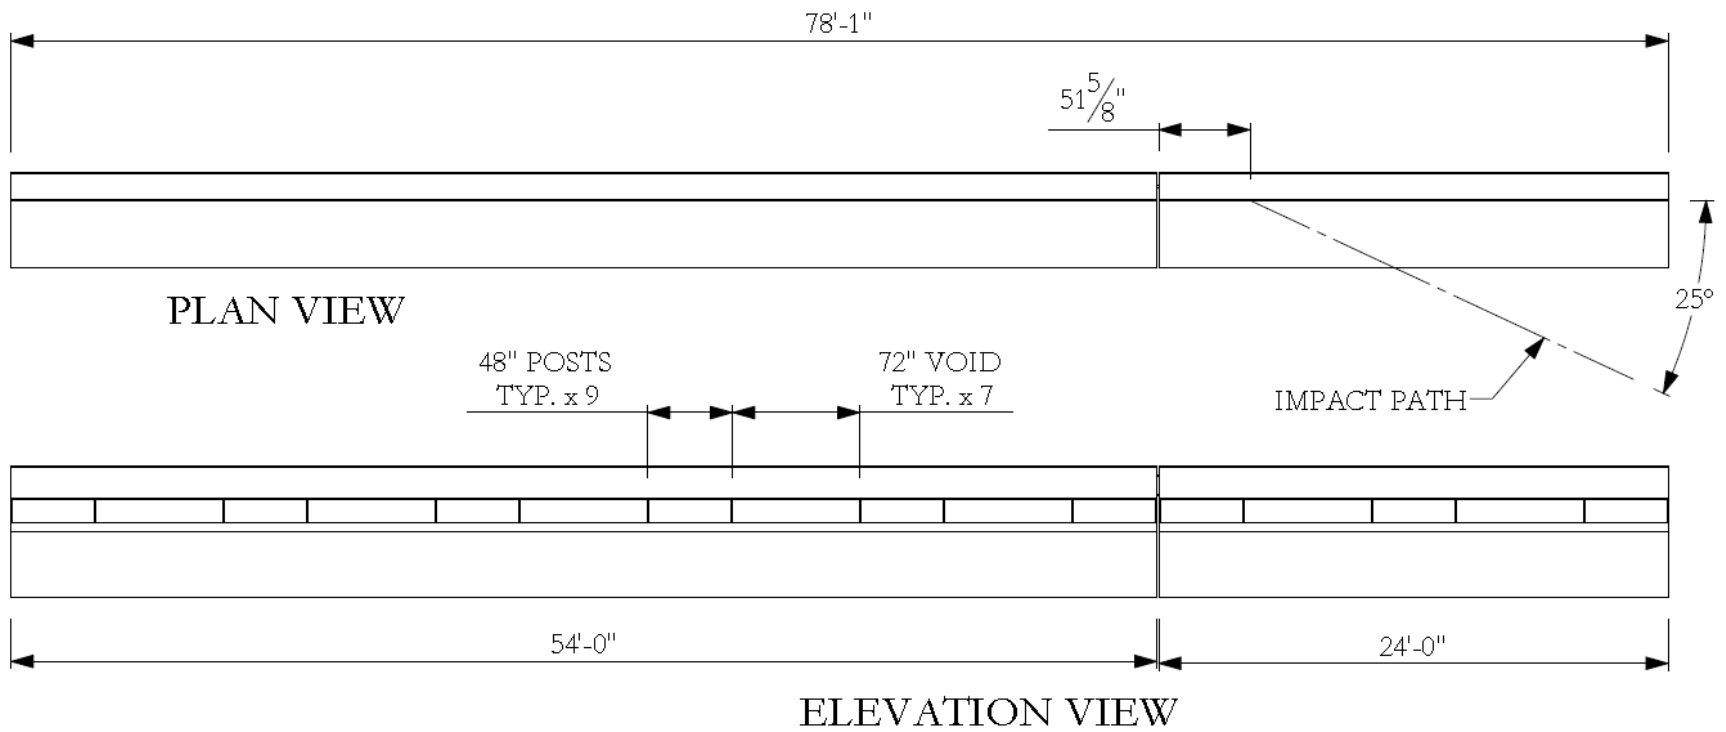
Figure 4.3. Layout of the 5-inch CIPD Barrier Anchor Installation.

The top deck of the box beam was then finished to provide a uniform rough wood float finish to enhance the bonding of the beam to the 5-inch thick CIPD. A 1-inch wide expansion joint was cast through the entire cross-section of the box beam 24-ft downstream of the upstream end of the installation.

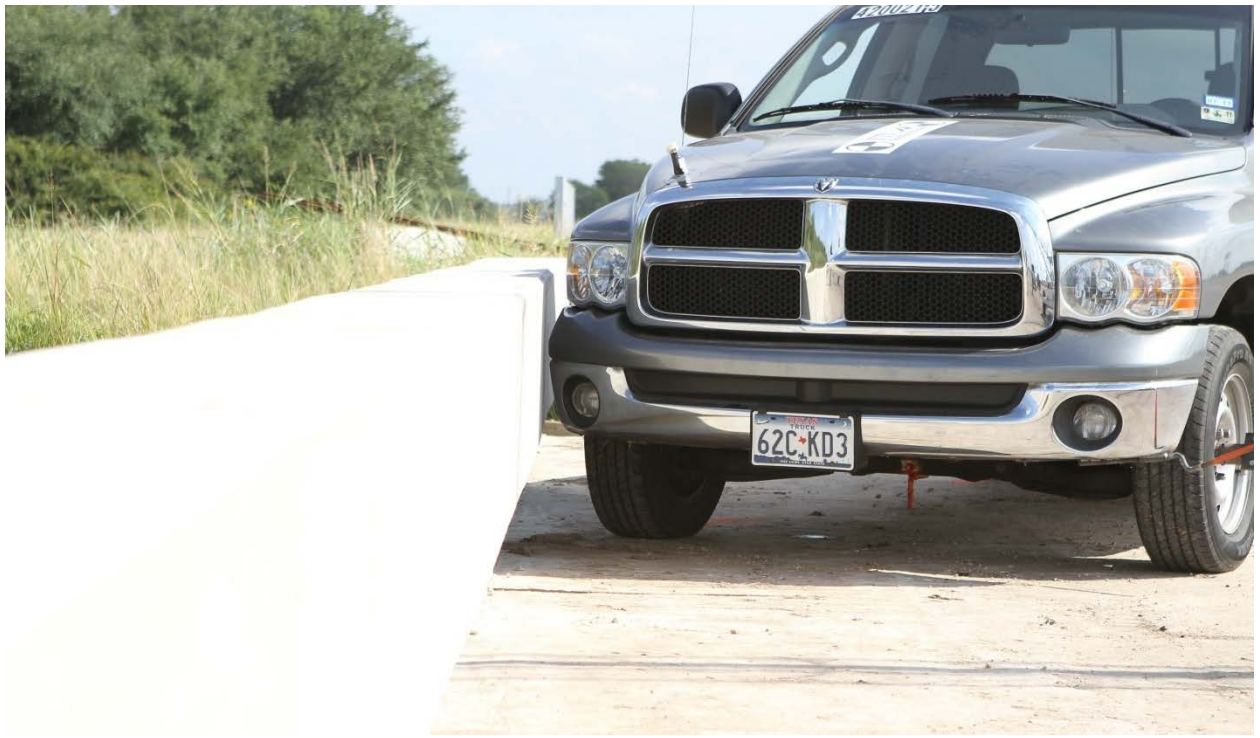
Figure 7.1. Vehicle/Installation Geometrics for Test No. 420021-5.

The 2005 Dodge Ram 1500 Quad-Cab pickup truck, travelling at an impact speed of 62.5 mi/h, impacted the TxDOT T223 bridge rail anchored to a 5-inch thick cast-in-place deck 54.5 inches upstream of the expansion joint between posts 3 and 4 at an impact angle of 26.3 degrees. At 0.022 s after impact, the 2270P vehicle began to redirect. The left front wheel steered abruptly clockwise at 0.035 s, and the right front passenger door contacted the barrier at 0.044 s. At 0.187 s, the vehicle was traveling parallel with the barrier at a speed of 50.7 mi/h. The rear bumper contacted the barrier at 0.203 s. At 0.356 s, the vehicle lost contact with the barrier at an exit speed and exit angle of 49.1 mi/h and 9.4 degrees, respectively. Brakes on the vehicle were applied 5.0 s after impact, and the vehicle came to rest 225 ft downstream of impact and 7.0 ft toward traffic lanes. Figures D1 and D2 in Appendix D show sequential photographs of the test period.

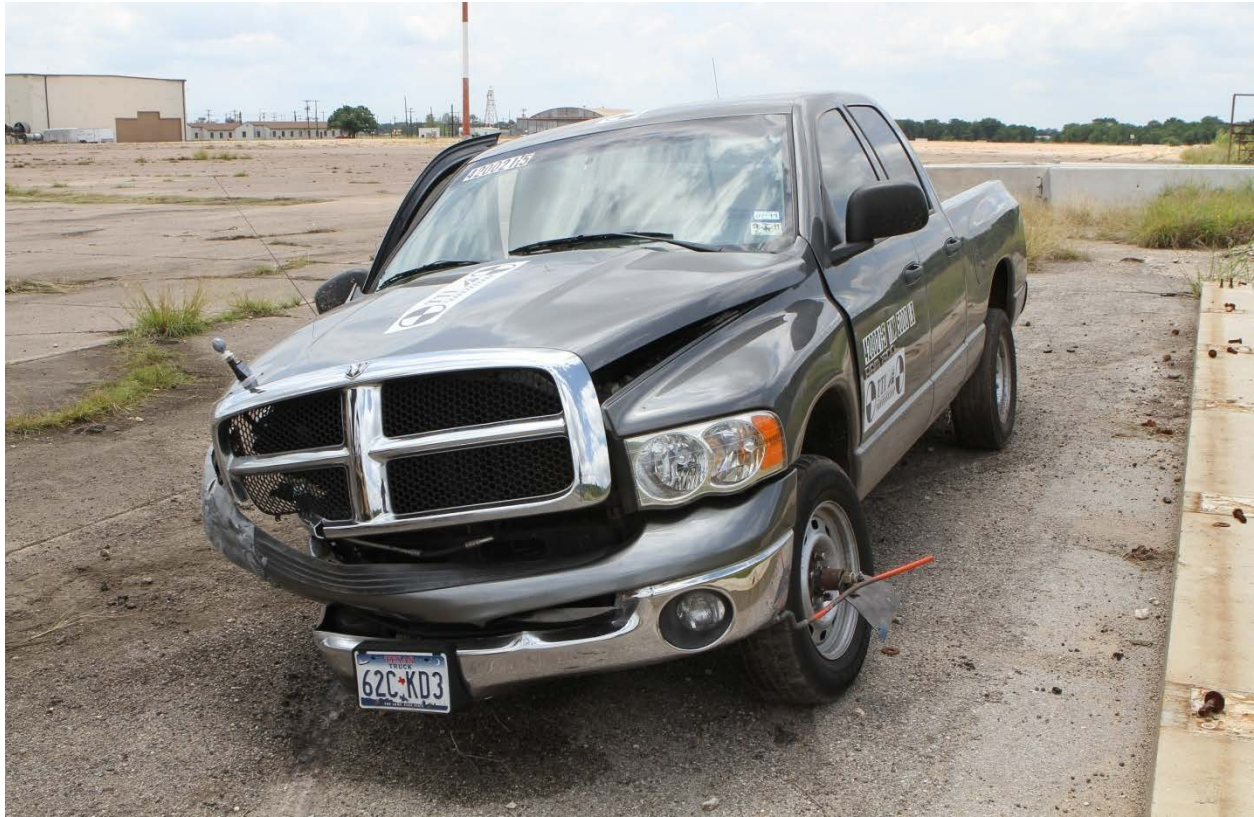
Figure 7.5. Vehicle after Test No. 420021-5.

The 2270P vehicle sustained structural damage to the right frame rail, right upper and lower A-arm, right side sway bar, and right front spring and cup. The right upper ball joint pulled out of the socket and the right lower ball joint broke. Figure 7.5 shows damage to the front bumper, right front fender, right front door, right front tire and wheel rim, right rear door, right rear exterior bed, right rear tire and wheel rim, and the rear bumper. Maximum exterior crush to the 2270P vehicle was 18.0 inches in the side plane at the right front corner at bumper height. Maximum occupant compartment deformation was 5.25 inches in the kick panel laterally across the lower cab near the right front passenger side foot well area. Figure 7.6 shows photographs of the interior of the vehicle. Tables C3 and C4 in Appendix D provide exterior crush and occupant compartment deformation measurements.

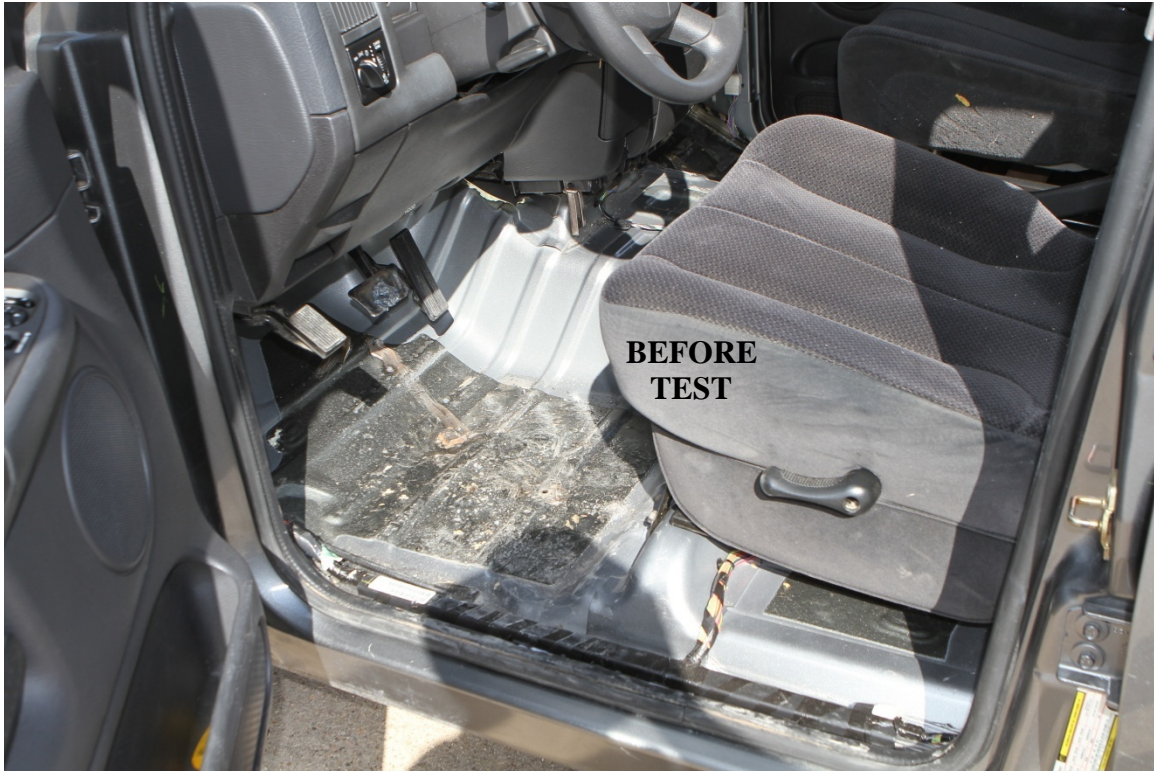
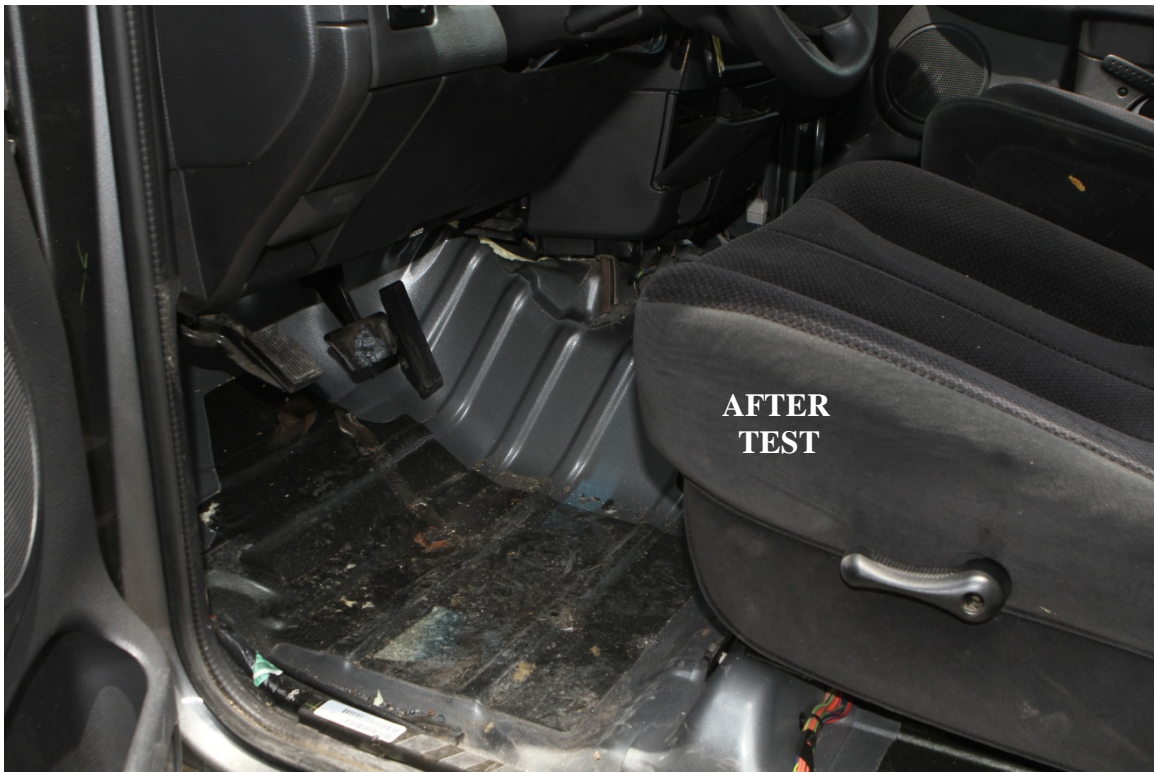
Figure 7.6. Interior of Vehicle for Test No. 420021-5.

Results: No detached elements, fragments, or other debris were present to penetrate or to show potential for penetrating the occupant compartment, or to present hazard to others in the area. (PASS)
Maximum occupant compartment deformation was 5.25 inches in the kick panel laterally across the lower cab near the right front passenger side foot well area. (PASS)

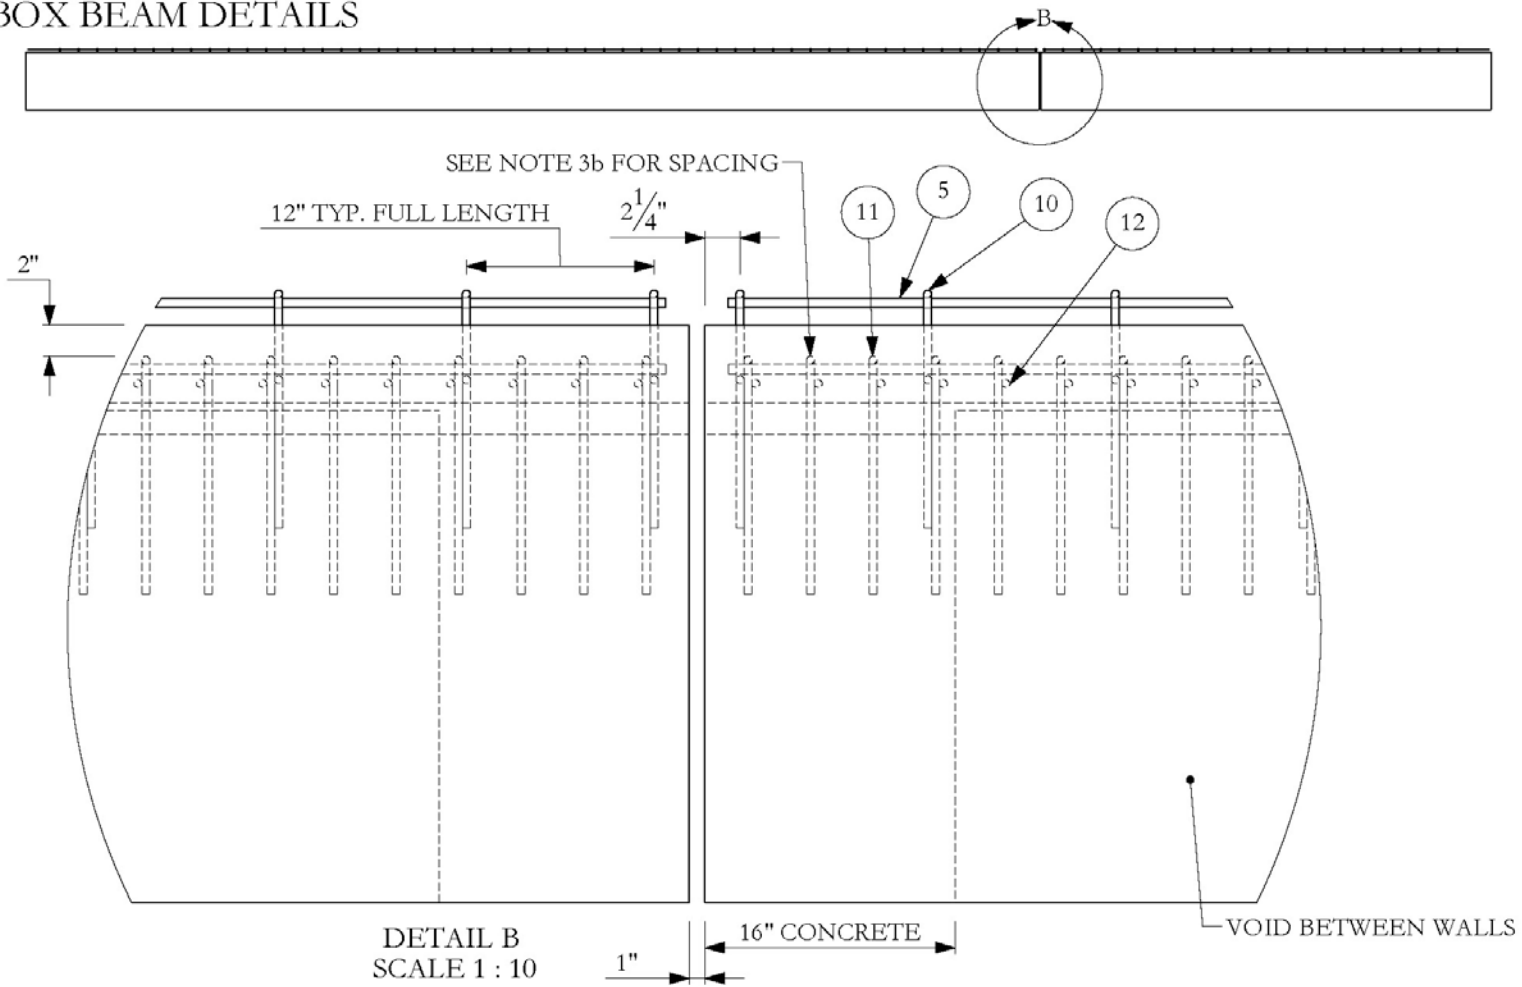
Revisions:				The Texas A&M University System College Station, Texas 77843			
No.	Date	By	Chk	Texas Transportation Institute			
1.				Drawn By	Scale	Sheet No.	Sheet Name
2.				GES	1:100	3 of 9	Box Beam a
3.				5" CIP Barrier Anchor			420021-5
4.

- 3a. Concrete is Class H.
- 3b. Spacing for Bar A (11) and Bar B (12) is 4" for 48" (12 spaces) each side of the expansion joint, then 6" to each end.
- 3c. Lap for #5 bars is 26", and not permissible within 10' of expansion joint.
- 3d. Rebar and concrete is symmetrical from expansion joint to end of short section.
- 3e. Provide a uniform rough wood float finish for the top surface of the concrete.

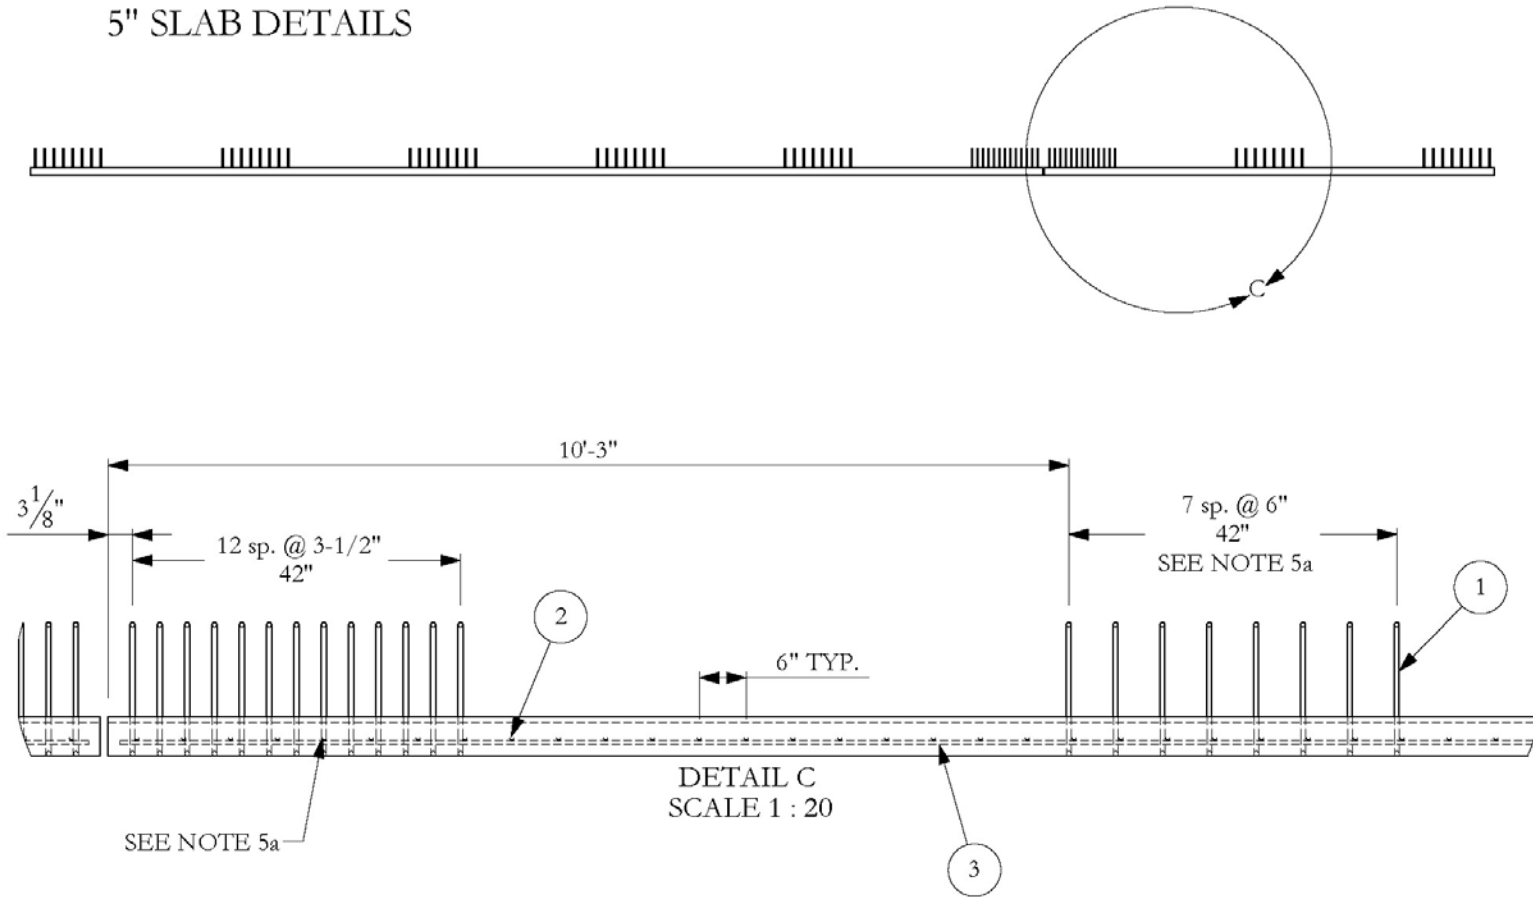
Revisions:				The Texas A&M University System College Station, Texas 77843			
No.	Date	By	Chk	Texas Transportation Institute			
1.				Drawn By	Scale	Sheet No.	Sheet Name
2.				GES	1:100	5 of 9	5" Deck a
3.				5" CIP Barrier Anchor			420021-5
4.

- 5a. U-bar (1) spacing is 3-1/2" at the first post on each side of the expansion joint, U-bar spacing at all other posts is 6". Adjust spacing of transverse bars (2) where necessary to maintain U-bar spacing.
- 5b. Rebar is symmetrical from expansion joint to end of short section.
- 5c. Concrete strength is 4000 psi.
- 5d. Lap for #4 bars is 17", and not permissible within 10' of expansion joint.

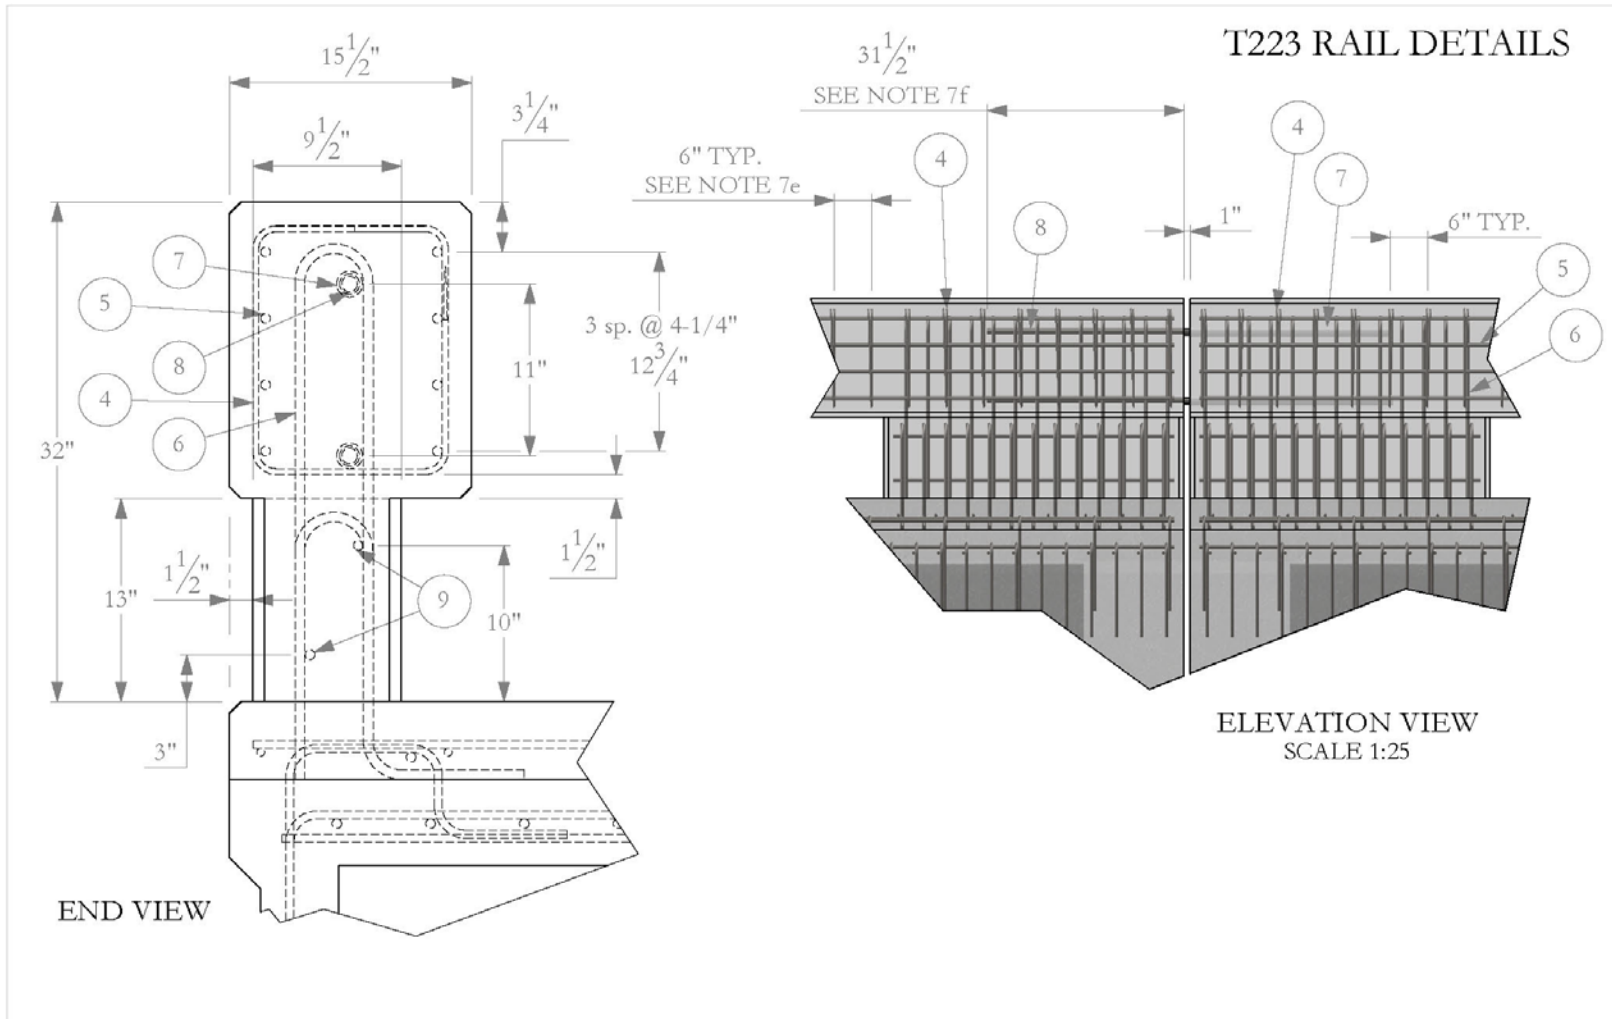
Revisions:				The Texas A&M University System College Station, Texas 77843			
No.	Date	By	Chk	Texas Transportation Institute			
1.				Drawn By	Scale	Sheet No.	Sheet Name
2.				GES	1:10	7 of 9	T223 Rail
3.				5" CIP Barrier Anchor			420021-5
4.

- 7a. 3/4" chamfer all exposed edges of parapet (some chamfers not shown here).
- 7b. Concrete is Class C.
- 7c. Lap for #5 bars is 26", and not permissible within 10' of expansion joint.
- 7d. Spacing on V-bars (6) is same as U-bars (1) (see Note 5a).
- 7e. Adjust spacing of S-bars (4) as necessary to maintain spacing of V-bars.
- 7f. Embedment depth of Ø1" rod (8) in concrete.

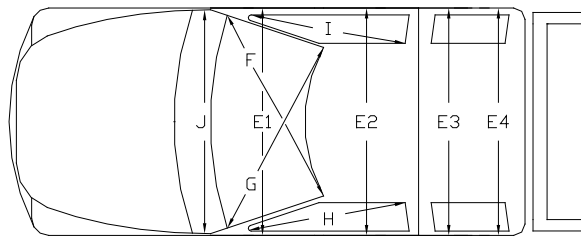
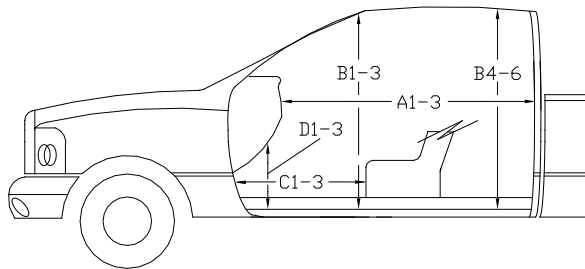
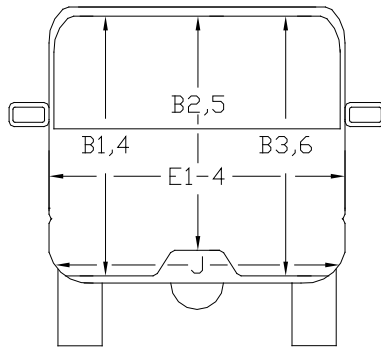
OCCUPANT COMPARTMENT DEFORMATION MEASUREMENT

Before (inches)	After (inches)
A1	64.50	64.50
A2	64.50	64.00
A3	65.50	64.50
B1	45.00	45.00
B2	39.25	38.75
B3	45.50	44.75
B4	42.25	42.25
B5	42.75	42.75
B6	42.25	42.25
C1	27.50	27.50
C2	----	----
C3	27.50	26.50
D1	12.75	12.75
D2	2.50	2.50
D3	11.25	11.75
E1	64.25	64.75
E2	64.25	64.50
E3	64.00	62.25
E4	64.00	63.50
F	60.00	60.00
G	60.00	60.00
H	39.50	39.50
I	39.50	39.50
J*	62.75	57.00

*Lateral area across the cab from driver's side kickpanel to passenger's side kickpanel.

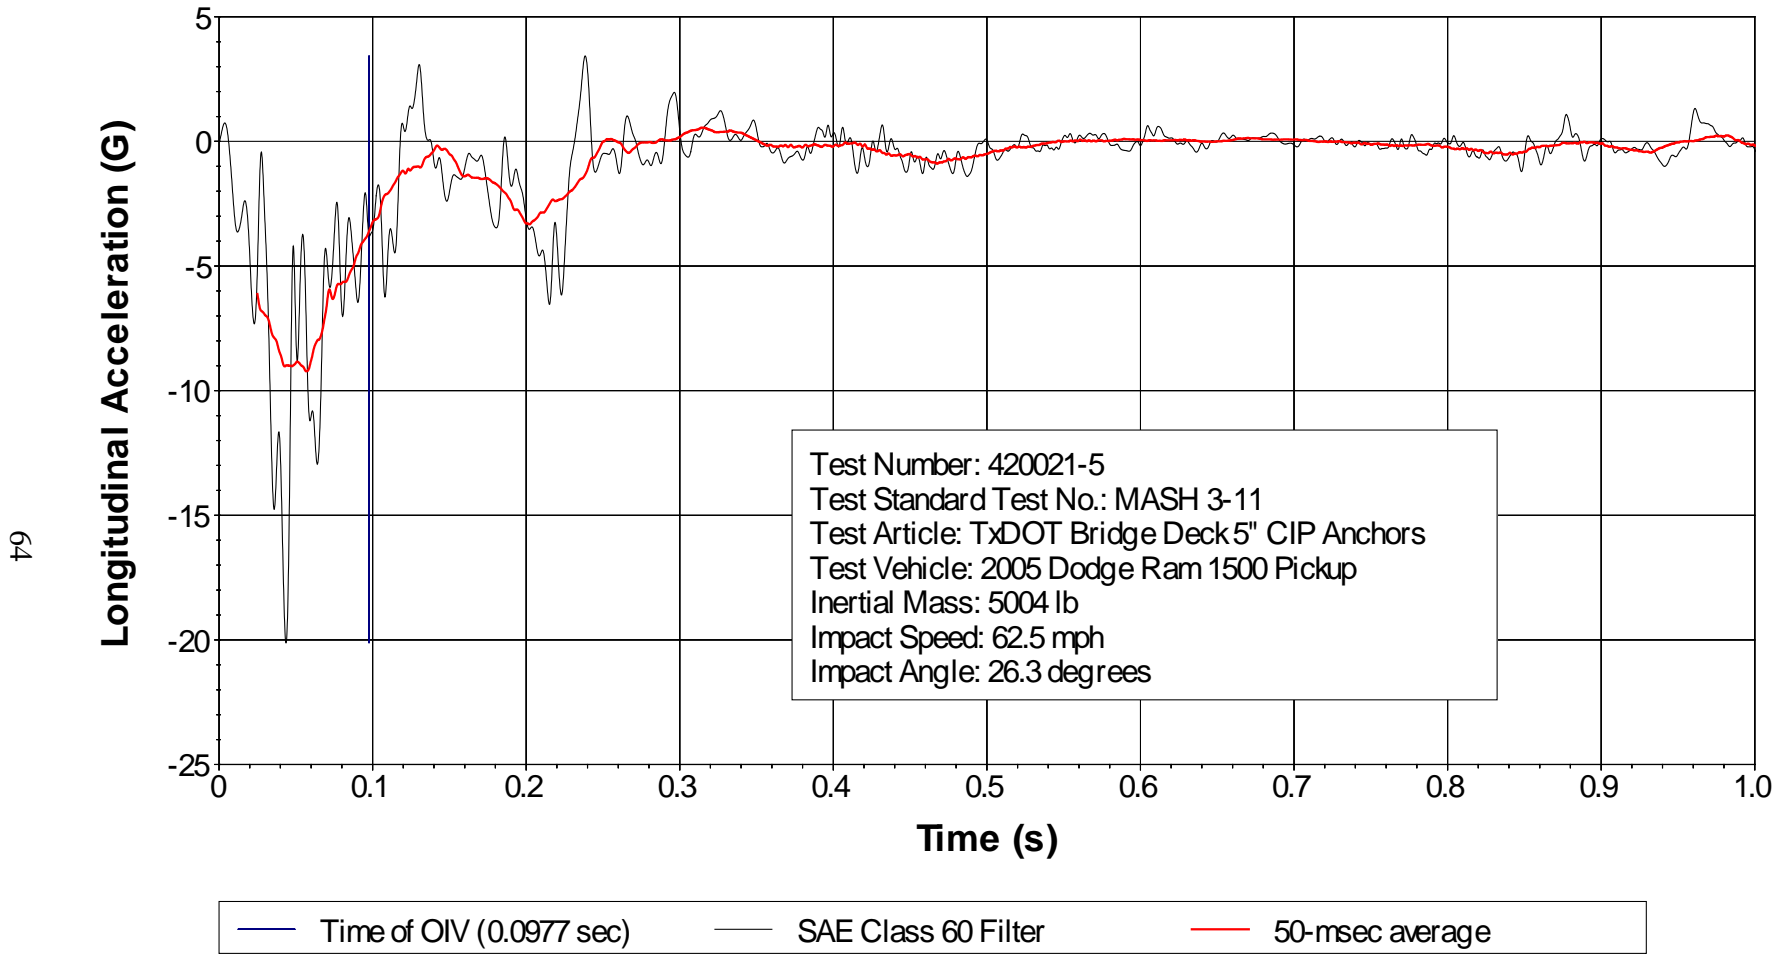
**Figure E2. Vehicle Longitudinal Accelerometer Trace for Test No. 420021-5
(Accelerometer Located at Center of Gravity).**

Data from the accelerometer, located at the vehicle center of gravity, were digitized for evaluation of occupant risk. In the longitudinal direction, the occupant impact velocity was 19.7 ft/s at 0.098 s, the highest 0.010-s occupant ridedown acceleration was 5.6 Gs from 0.207 to 0.217 s, and the maximum 0.050-s average acceleration was -9.2 Gs between 0.032 and 0.082 s. In the lateral direction, the occupant impact velocity was 26.6 ft/s at 0.098 s, the highest 0.010-s occupant ridedown acceleration was 7.2 Gs from 0.239 to 0.249 s, and the maximum 0.050-s average was -13.0 Gs between 0.041 and 0.081 s. Theoretical Head Impact Velocity (THIV) was 36.8 km/h or 10.2 m/s at 0.095 s; Post-Impact Head Decelerations (PHD) was 8.4 Gs between 0.210 and 0.220 s; and Acceleration Severity Index (ASI) was 1.62 between 0.033 and 0.083 s. Figure 7.7 summarizes these data and other pertinent information from the test. Vehicle angular displacements and accelerations versus time traces are presented in Appendix E, Figures E1 through D7.
