MASH Test 3-11 on the T131RC Bridge Rail

Test Report No. 9-1002-12-1

16. Abstract <p>Texas Department of Transportation (TxDOT) currently uses the TxDOT Type T101RC Bridge Rail, a steel post and beam bridge rail anchored to the top of concrete curbs. The T101RC Bridge Rail is 27 inches in height and can be anchored to the top of concrete curbs of varying heights. The heights of the posts and the number of bridge rail elements vary depending on the height of the concrete curb. The posts are anchored to the curb using four adhesive anchors.</p> <p>Based on crash testing of similar rail designs of the same height, the researchers believed that the TxDOT Type T101RC Bridge Rail would not meet the American Association of State Highway and Transportation Officials (AASHTO) Manual for Assessing Safety Hardware (<i>MASH</i>) Test Level 3 (TL-3) criteria. The purpose of this portion of the project was to design and crash test a modified design of the TxDOT T101RC Bridge Rail that would meet the strength and safety performance criteria for TL-3 of <i>MASH</i>. A new bridge rail was developed and tested for this project.</p> <p>The TxDOT T131RC Bridge Rail met all the strength and safety pe

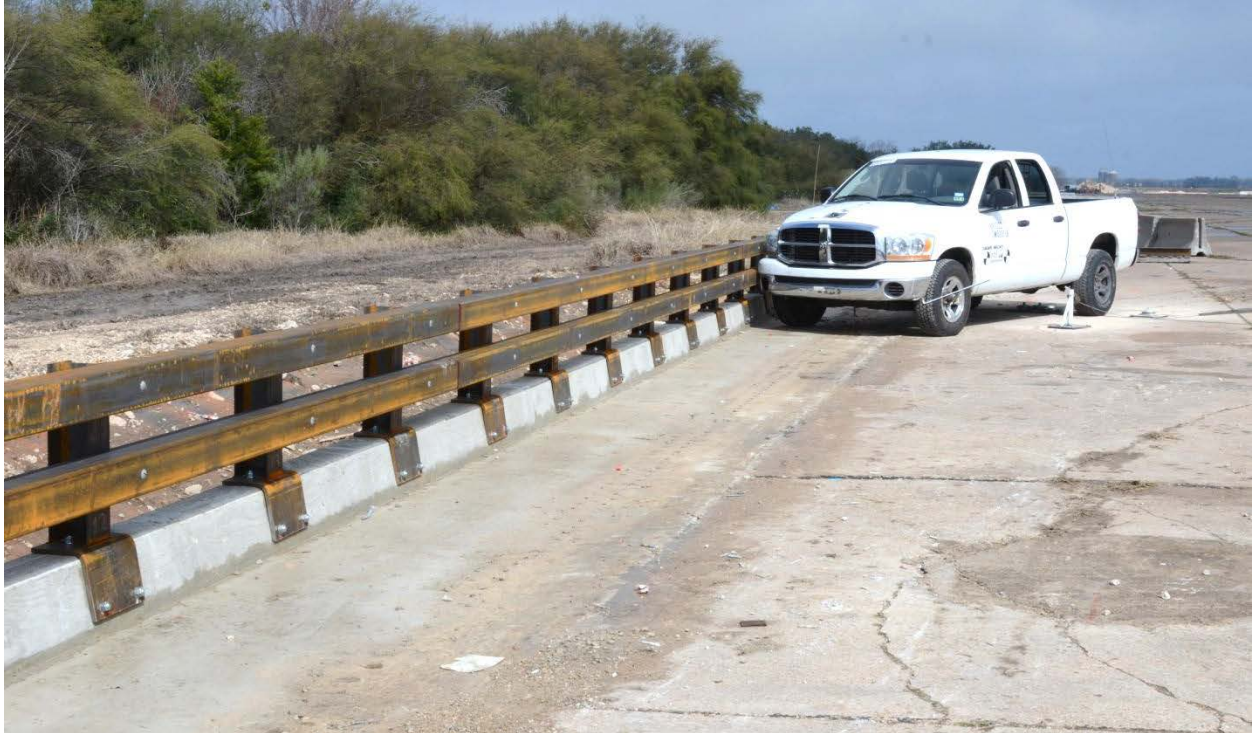
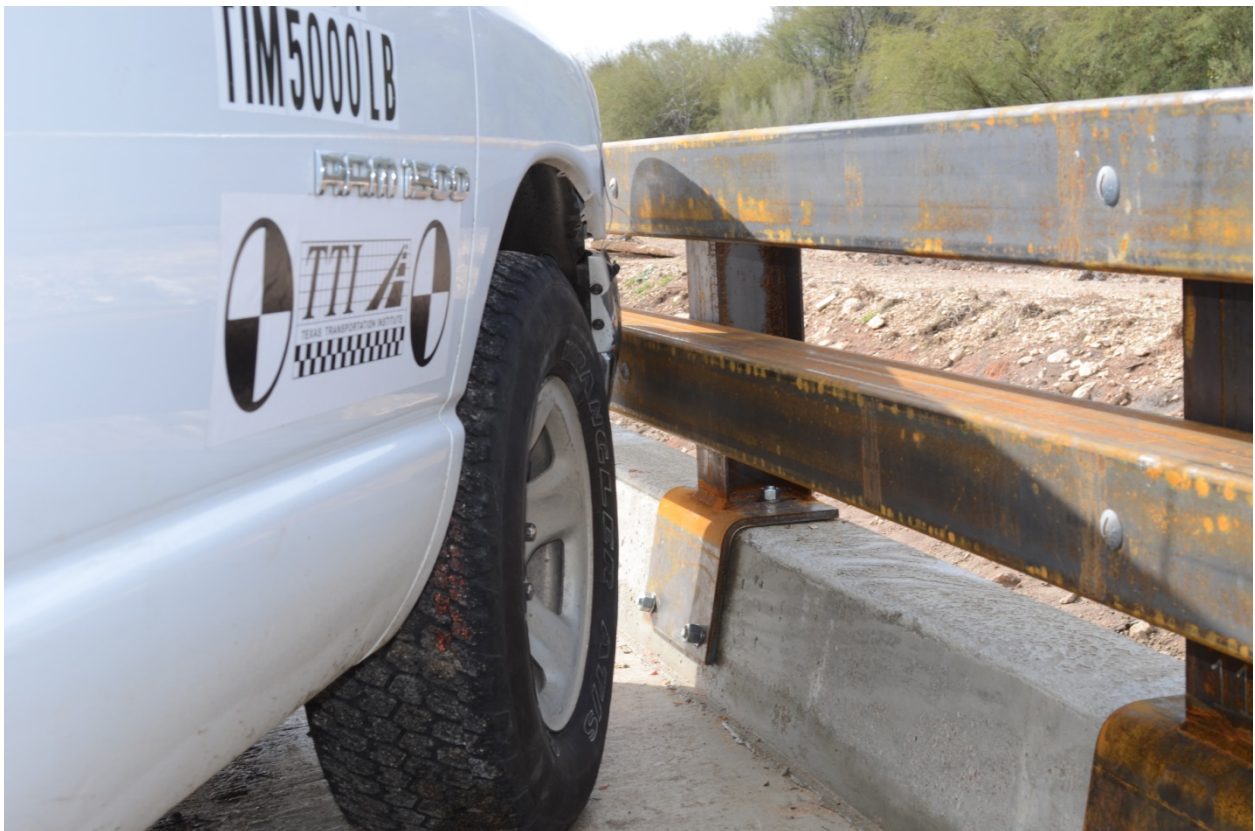
Figure 5.1. Vehicle/Installation Geometrics for Test No. 490022-1.

The 2007 Dodge Ram 1500 pickup, traveling at an impact speed of 63.0 mi/h, impacted the T131RC bridge rail 5 ft upstream of post 6 at an impact angle of 24.7 degrees. At 0.014 s after impact, post 5 began to deflect toward the field side, and posts 6 and 7 began to deflect towards field side at 0.017 s and 0.026 s, respectively. The concrete deck around post 5 began to crack at 0.031 s, and at 0.046 s on the downstream side. Post 7 began to deflect toward the field side at 0.048 s, and the concrete deck around posts 6 and 7 began to crack at 0.069 and 0.073 s, respectively. At 0.082 s, the right front tire blew out, and at 0.082 s, the concrete deck at post 8 began to crack. The rear of the vehicle contacted the bridge rail at 0.174 s. At 0.343 s, the vehicle lost contact with the bridge rail. The overhead camera failed, and therefore exit speed and angle were not obtainable. Brakes on the vehicle were not applied, and the vehicle subsequently came to rest 310 ft downstream of impact. Figures D1 and D2 in Appendix D show sequential photographs of the test period.

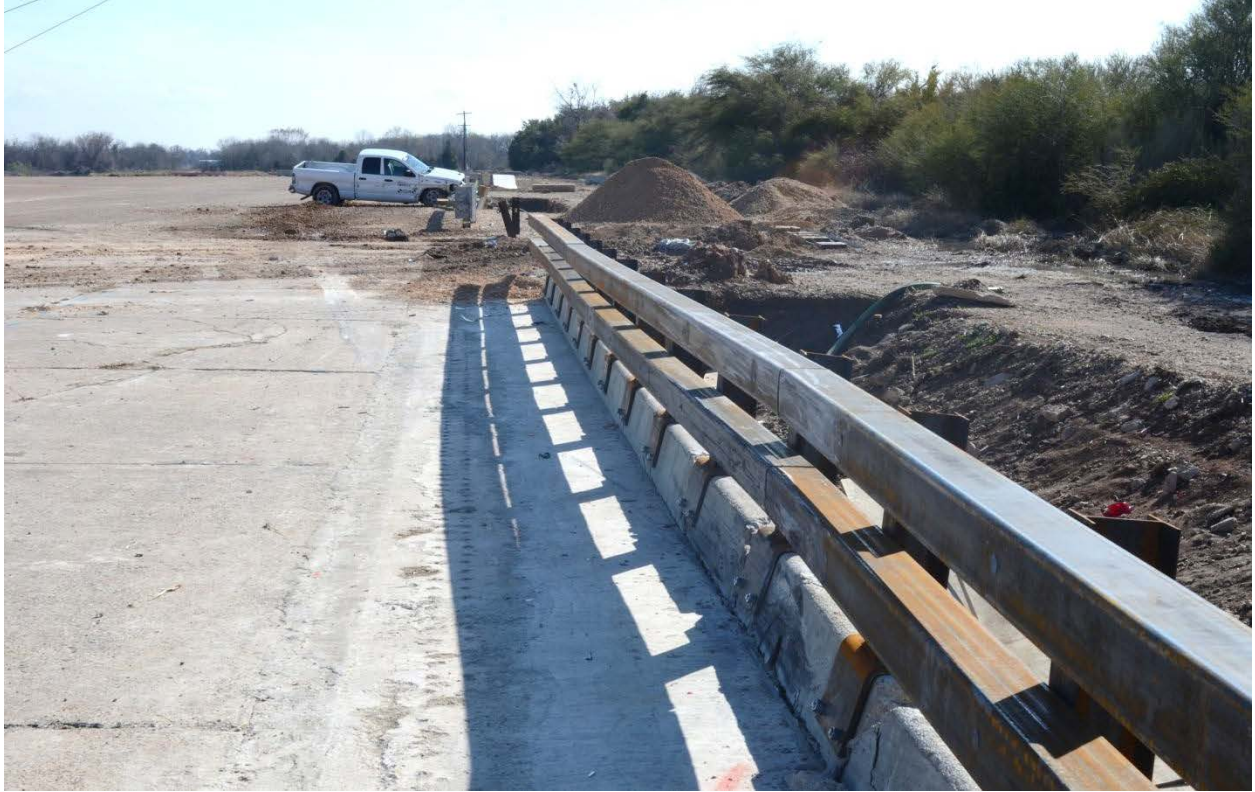
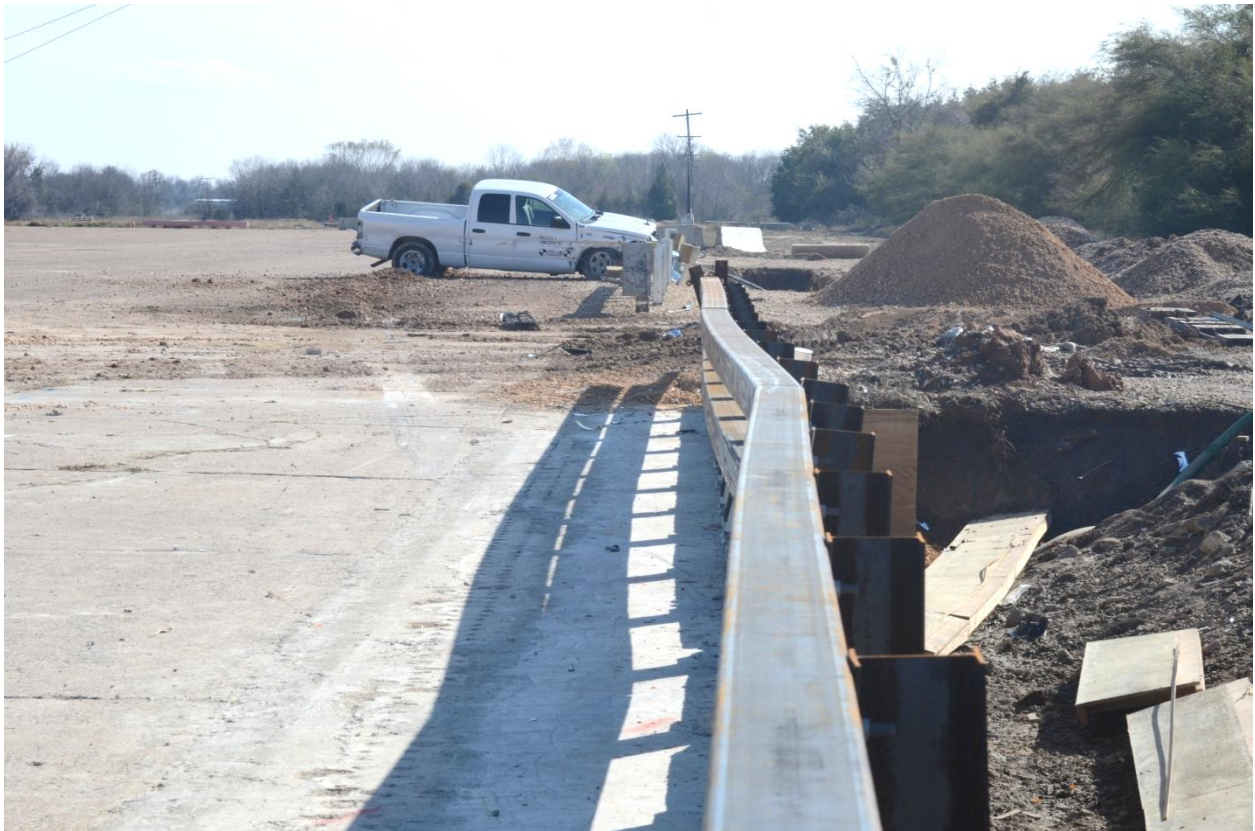
Figure 5.3. Vehicle/Installation after Test No. 490022-1.

Figures 5.3 and 5.4 show damage to the T131RC Bridge Rail after the test. The concrete curb sustained minor damage at posts 2 and 3, and more significant damage at posts 4 through 9. The curb separated 1 inch from the deck at posts 5 and 6. Posts 3 through 8 were leaning toward the field side between 3 degrees to a maximum of 8 degrees at post 6. Length of contact of the vehicle with the bridge rail was 13.2 ft. Maximum permanent deformation was 6.5 inches. The overhead camera failed to trigger, therefore, maximum dynamic deflection and working width were not obtainable.

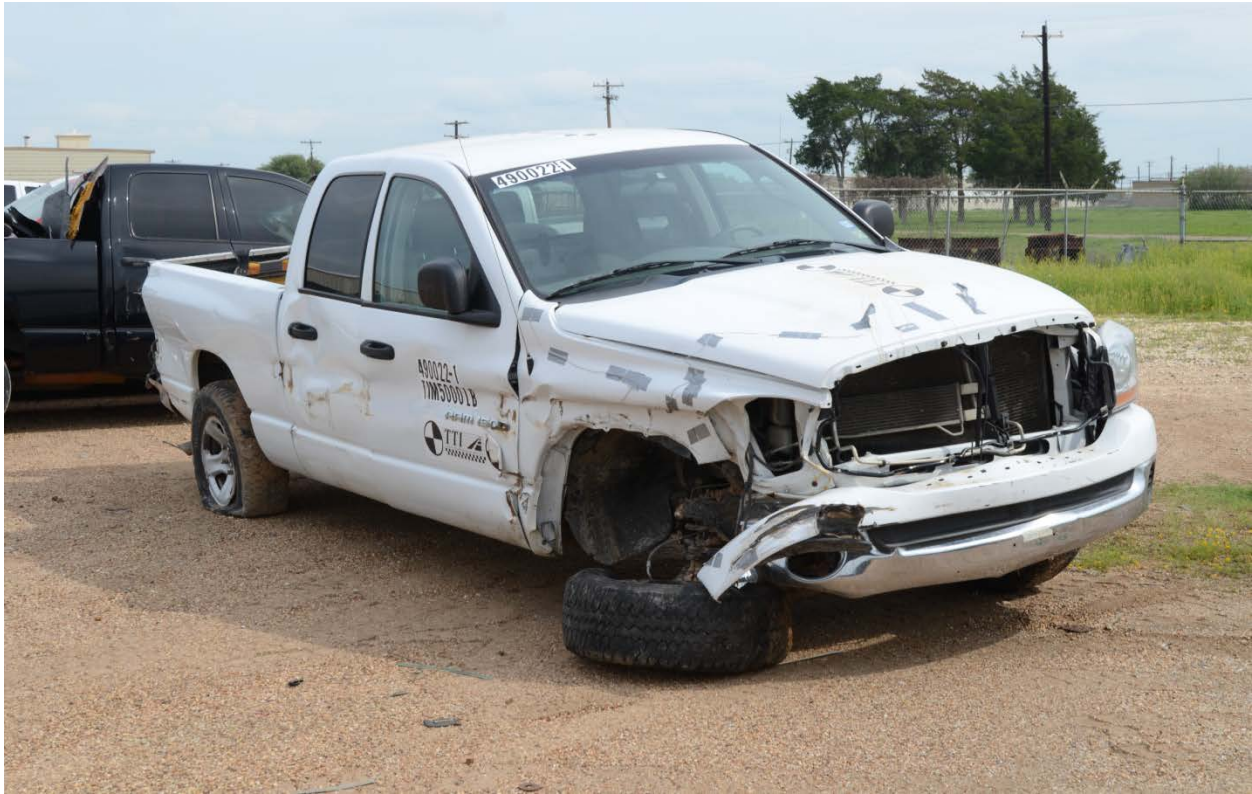
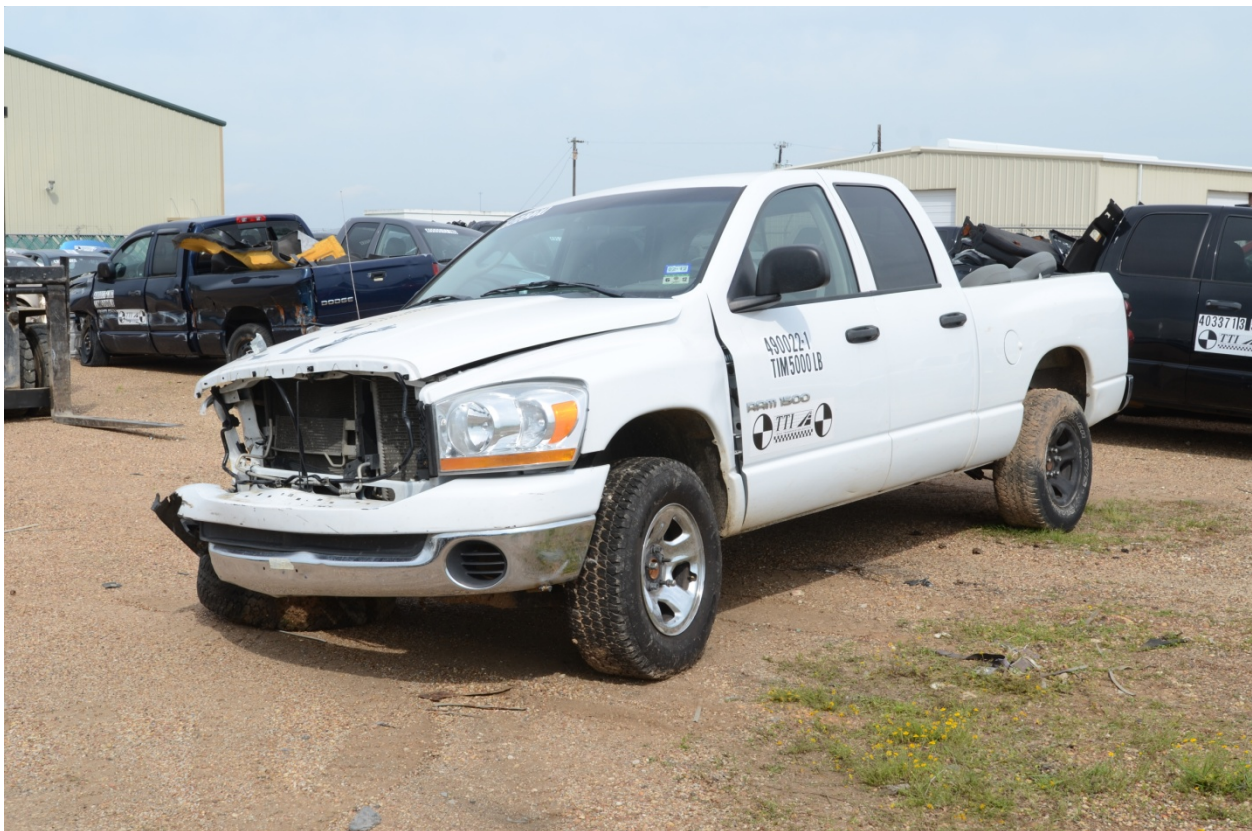
Figure 5.5. Vehicle after Test No. 490022-1.

Figure 5.5 shows damage that the 2270P vehicle sustained. The right front upper and lower ball joints pulled out of the sockets, and the tie rod, the right upper and lower A-arms, and the right frame rail were deformed. Also damaged were the front bumper, grill, hood, right front tire and wheel rim, right front fender, right front and rear doors, right cab corner, right rear exterior bed, right rear tire and wheel rim, and rear bumper. Maximum exterior crush to the vehicle was 15.0 inches in the side plane at the right front corner at bumper height. Maximum occupant compartment deformation was 0.5 inch in the lateral area across the cab at the left front passenger's kickpanel. Figure 5.6 has photographs of the interior of the vehicle. In Appendix C, Tables C3 and C4 provide exterior crush and occupant compartment measurements.
