***MASH Full-Scale Crash Testing of 4-ft
Mounting Height, 24"×30" Chevron Sign
Installed on 5.5H:1V Slope Ditch***

Test Report No. 9-1002-12-6

1. Report No. FHWA/TX-13/9-1002-12-6		2. Government Accession No.		3. Recipient's Catalog No.	
4. Title and Subtitle MASH Full-Scale Crash Testing of 4-ft Mounting Height, 24"×30" Chevron Sign Installed on 5.5H:1V Slope Ditch				5. Report Date November 2012

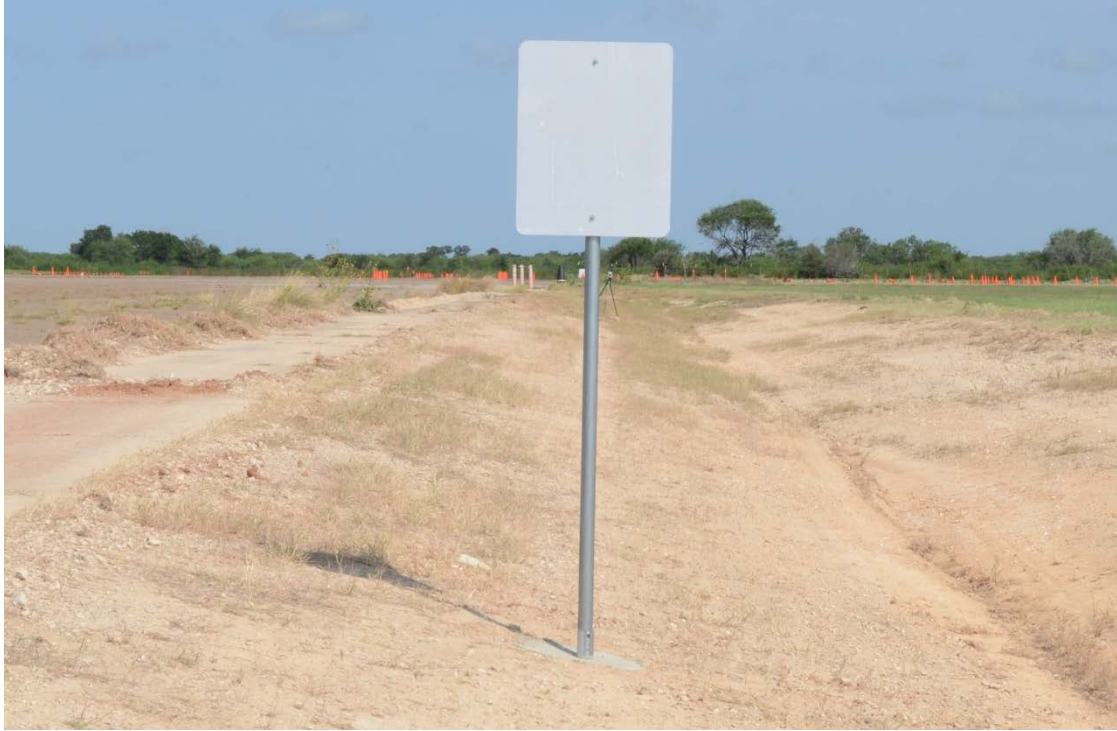
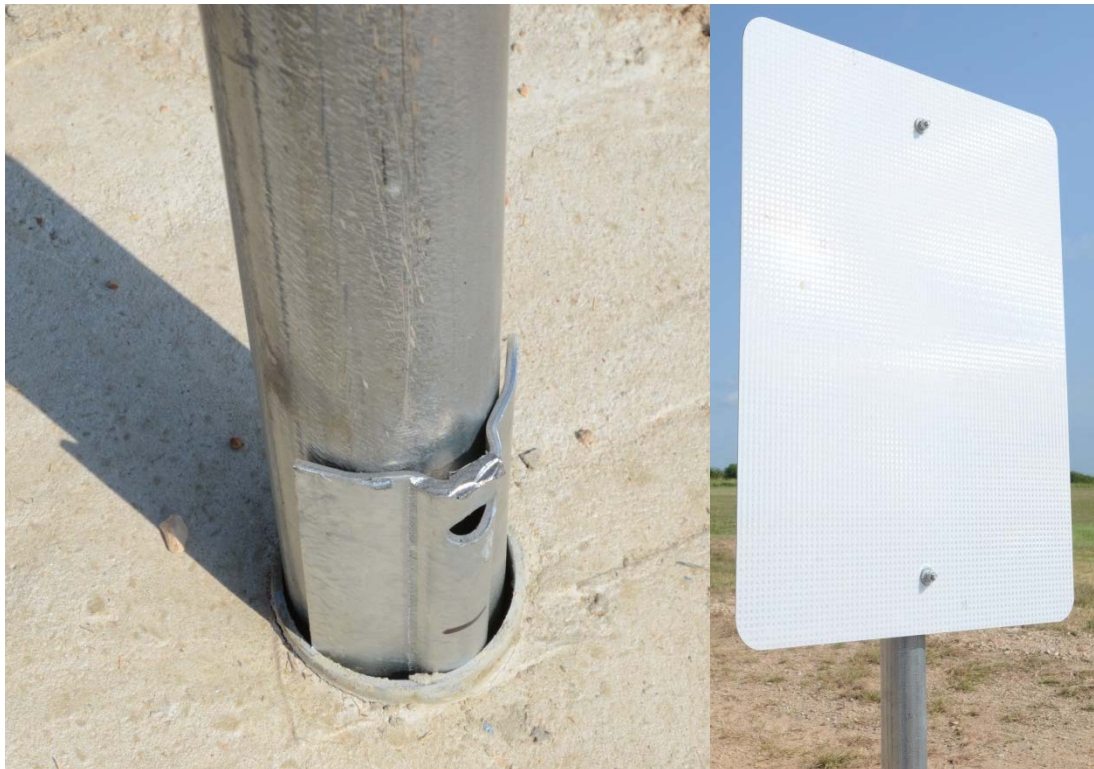
Figure 2.4. Sign Support Geometrics for Test No. 490022-9.

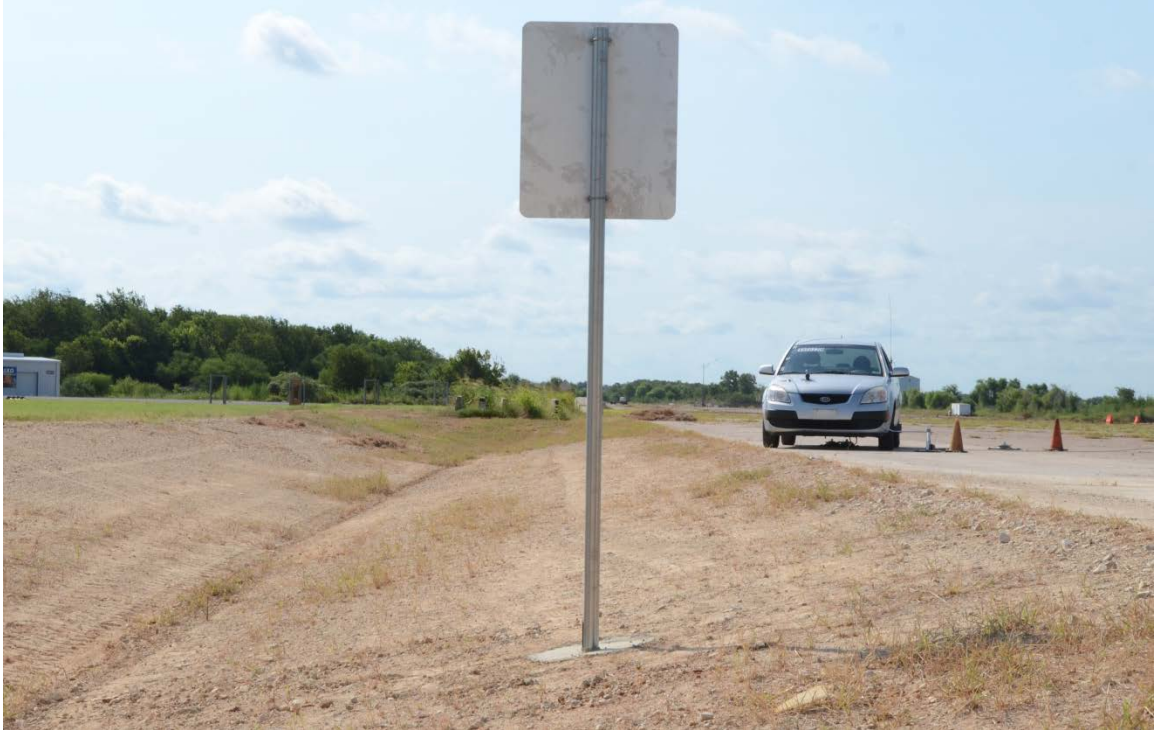
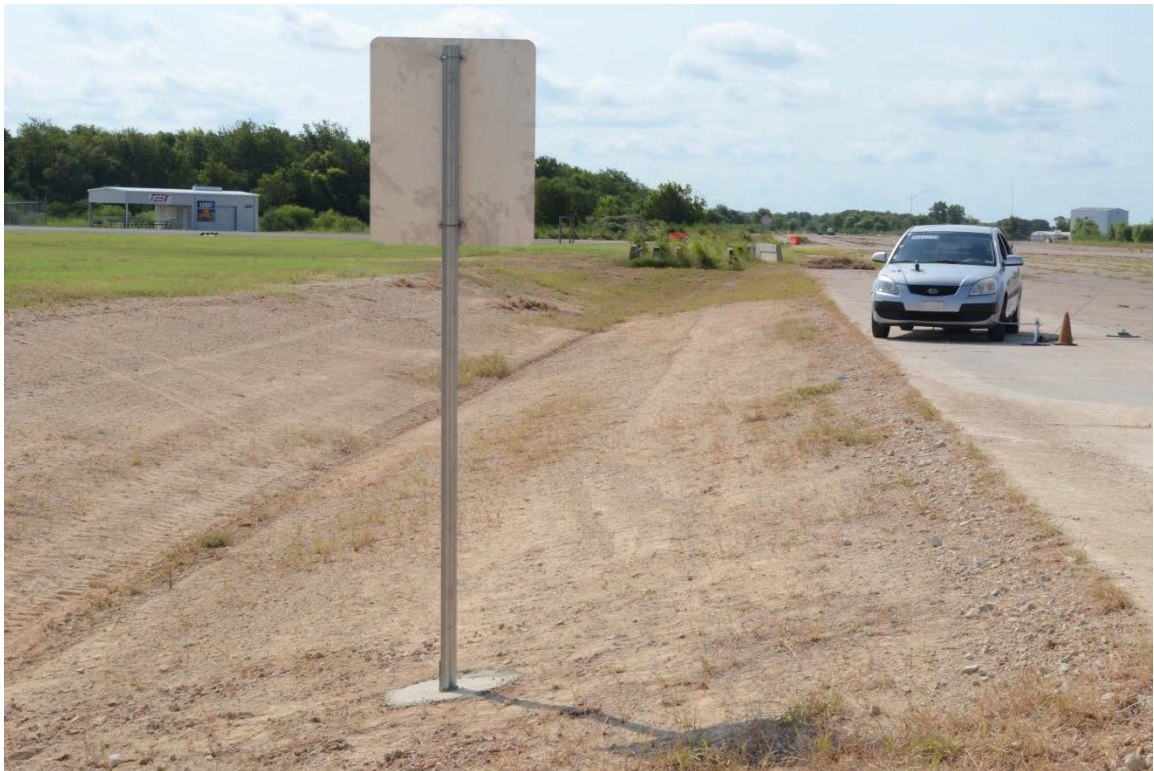
Figure 5.1. Vehicle/Installation Geometrics for Test No. 490022-9.

The 2007 Kia Rio small passenger car, traveling at an impact speed of 61.4 mi/h, impacted the chevron sign support 18 inches from the vehicle's centerline, on the driver's side. The encroachment angle at time of the release of the guide cable as the vehicle entered the ditch was 10.0 degrees. At 0.0035 s after impact, the sign support began to deflect. At 0.042 s, the sign impacted the hood of the vehicle and began to fold. The sign post ruptured at 0.065 s. At 0.070 s, the sign post lost contact with the front of the vehicle, and at 0.077 s, the top sign bracket slid off the sign post. Brakes on the vehicle were applied 0.54 s after impact, and the vehicle subsequently came to rest 187 ft downstream of impact. Figure C1 in Appendix C shows sequential photographs of the test period.

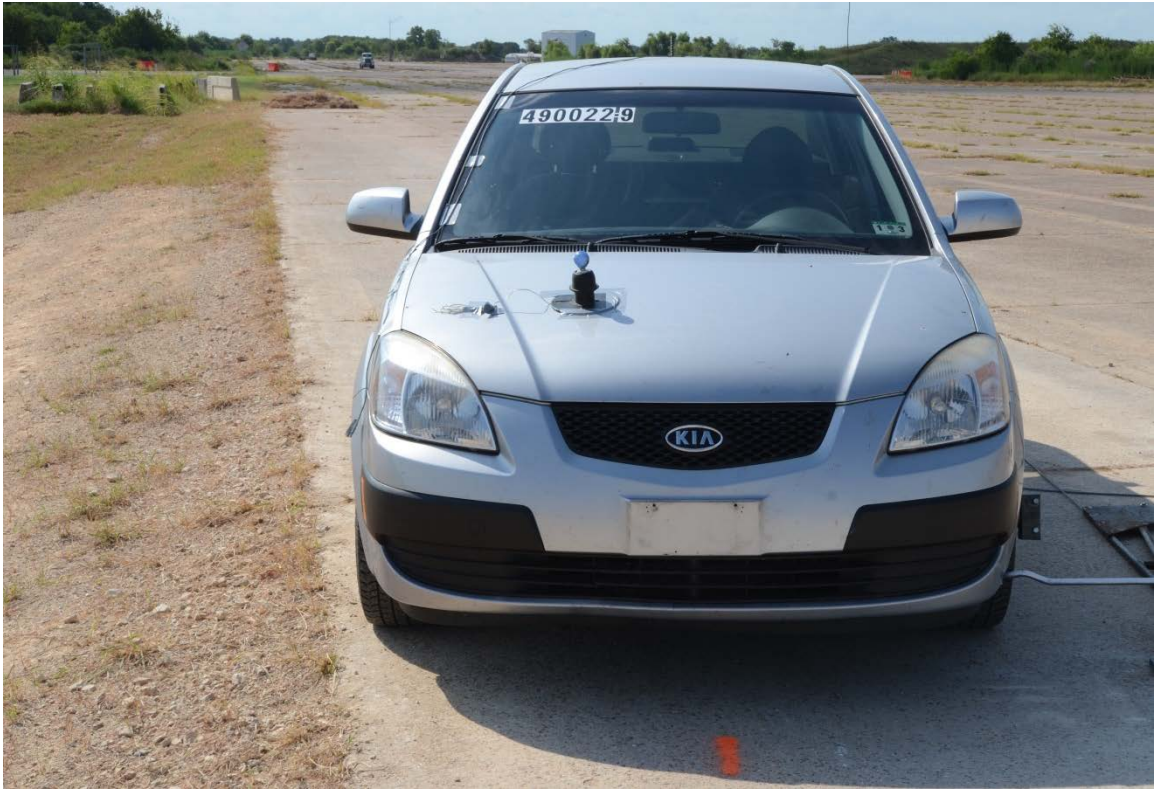
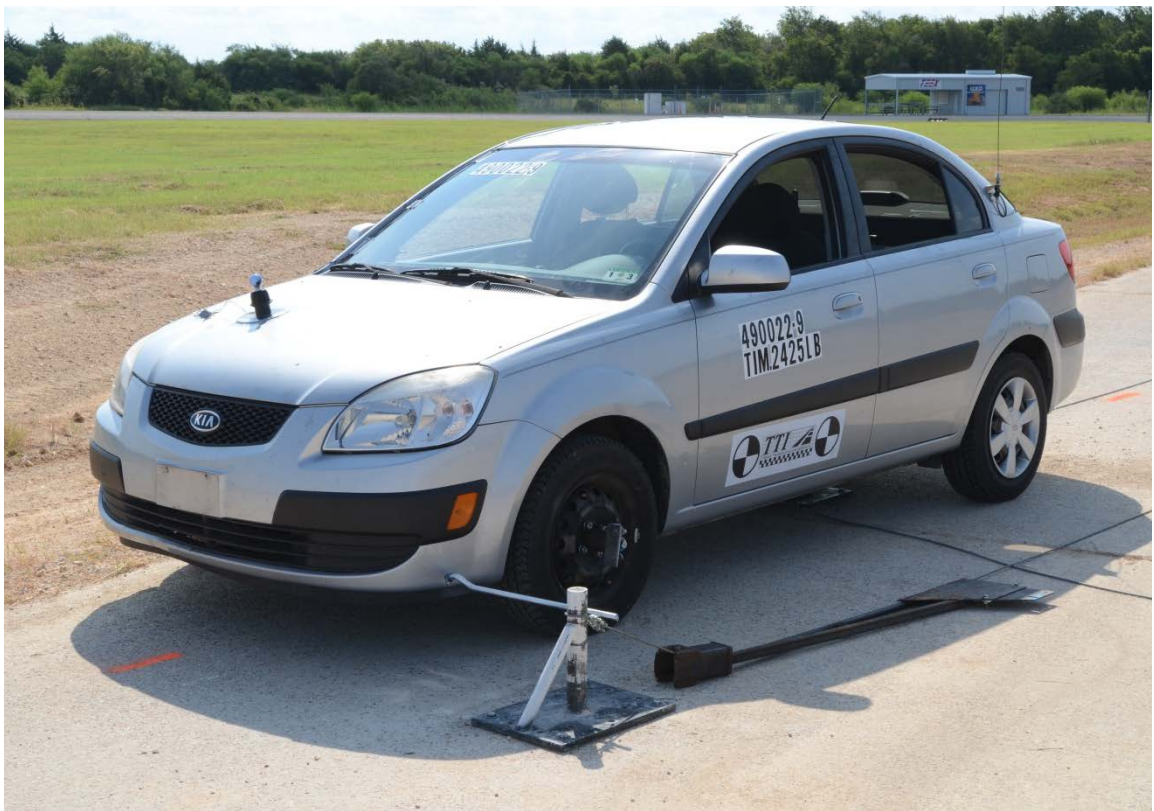
Figure 5.2. Vehicle before Test No. 490022-9.

A 2007 Kia Rio small passenger car, shown in Figures 5.1 and 5.2, was used for the crash test. The test inertia and the gross static weights were 2406 and 2573 lb, respectively. The height to the lower edge of the vehicle bumper was 7.125 inches, and it was 21 inches to the upper edge of the bumper. Table B1 in Appendix B gives additional dimensions and information on the vehicle. The vehicle was directed into the installation using the cable reverse tow and guidance system, and was released to be unrestrained just prior to impact.

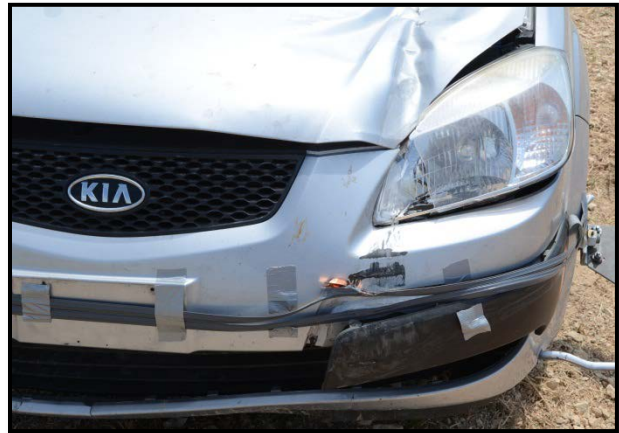
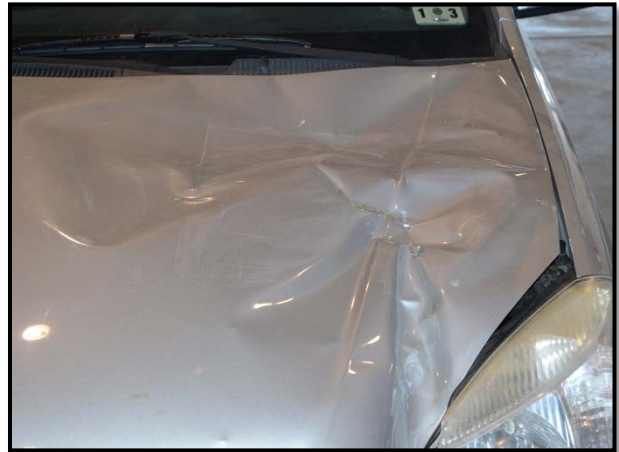
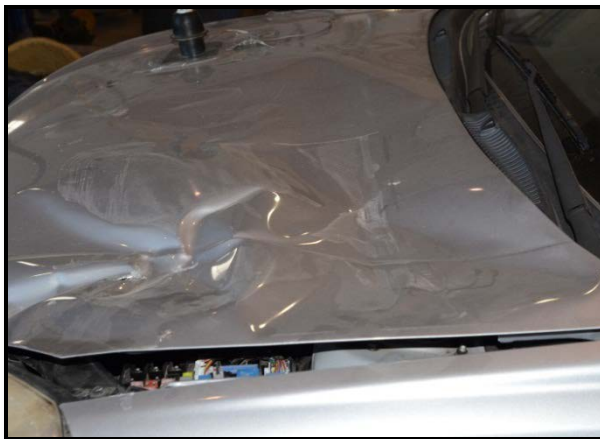
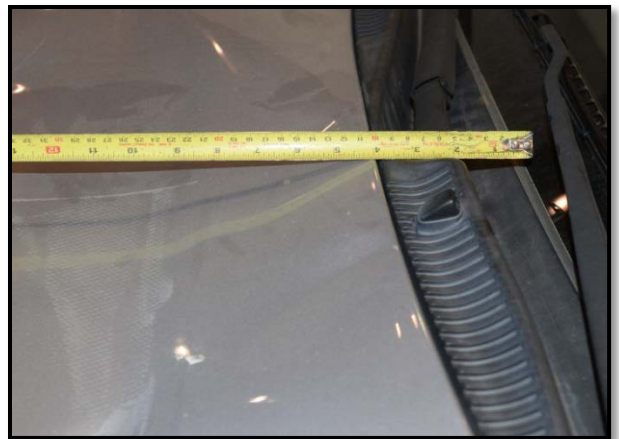
Figure 5.5. Vehicle after Test No. 490022-9.

Figure 5.5 shows damage sustained by the 1100C vehicle. The front bumper, hood, and left head light were damaged. The impact of the chevron sign support system with the vehicle caused a 31-inch \times 21-inch dent in the left-central portion of the hood. Maximum exterior crush to the vehicle was 1.75 inches on the hood. Figure 5.5 shows deformation and striations left by the sign during impact with the vehicle's hood. The upper edge of the striations caused by contact with the sign panel was approximately 8.5 inches from the base of the windshield. There was no deformation to the occupant compartment. Tables B2 and B3 in Appendix B provide exterior crush and occupant compartment measurements, respectively.

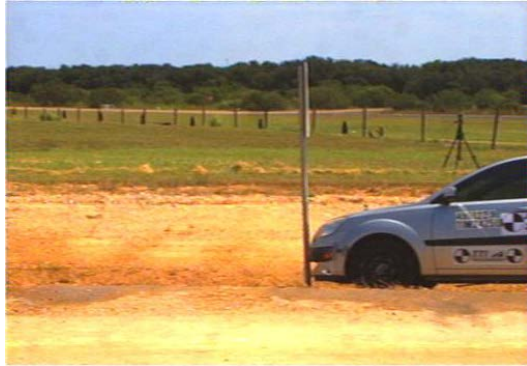
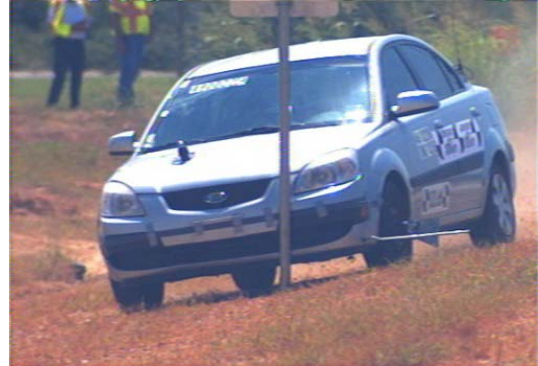
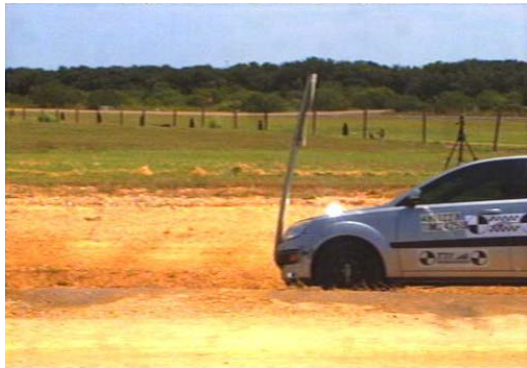
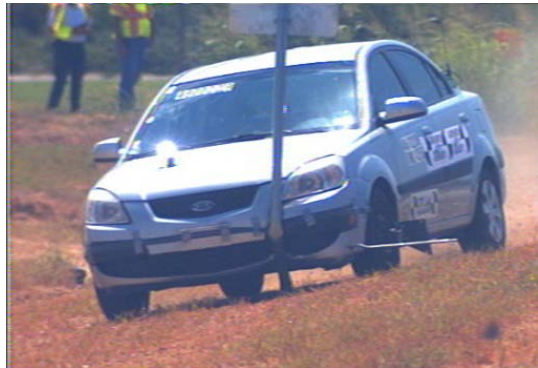
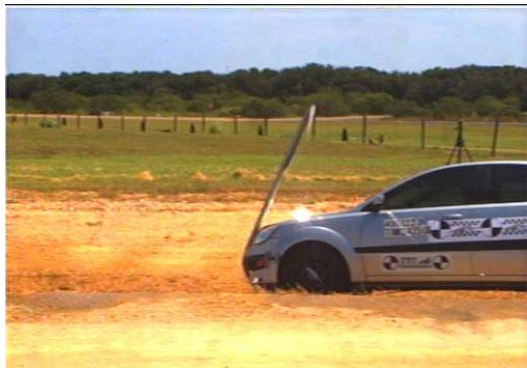
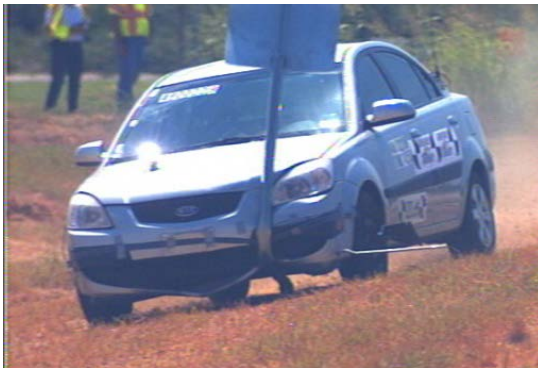
Figure C1. Sequential Photographs for Test No. 490022-9.

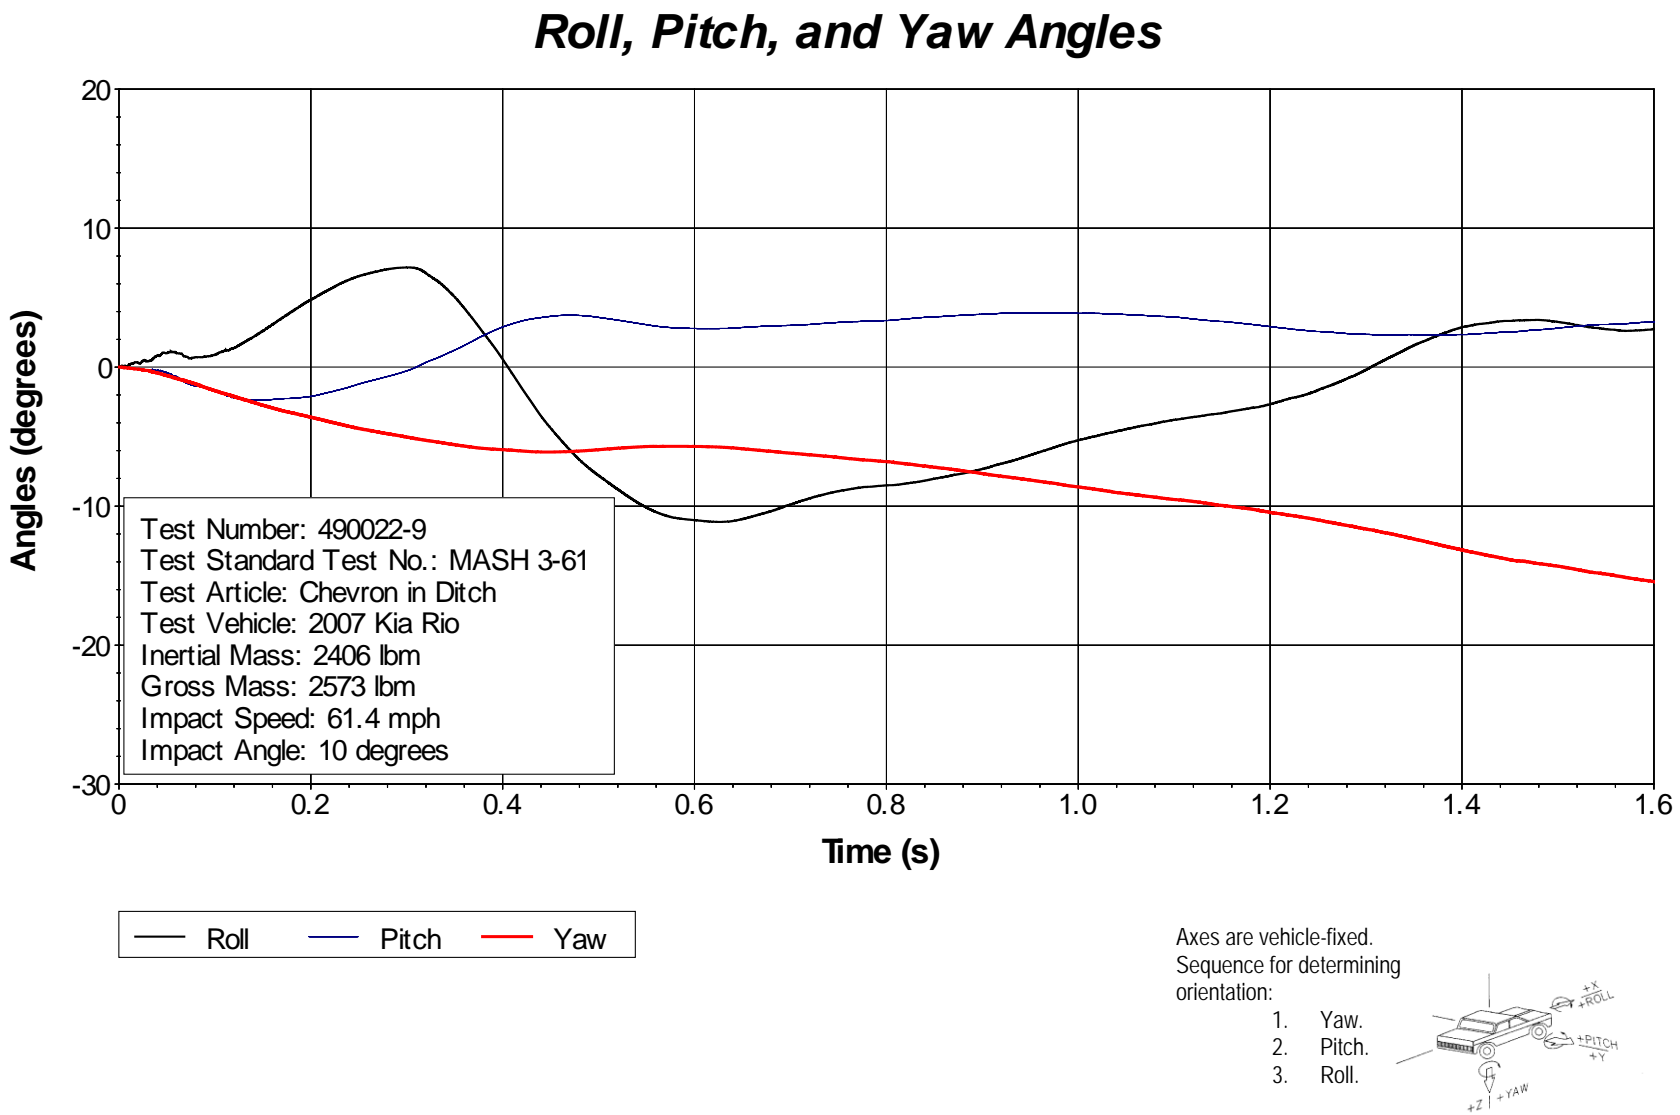
Figure D1. Vehicle Angular Displacements for Test No. 490022-9.

TRAP uses the data from the yaw, pitch, and roll rate transducers to compute angular displacement in degrees at 0.0001-s intervals and then plots yaw, pitch, and roll versus time. These displacements are in reference to the vehicle-fixed coordinate system with the initial position and orientation of the vehicle-fixed coordinate systems being initial impact.

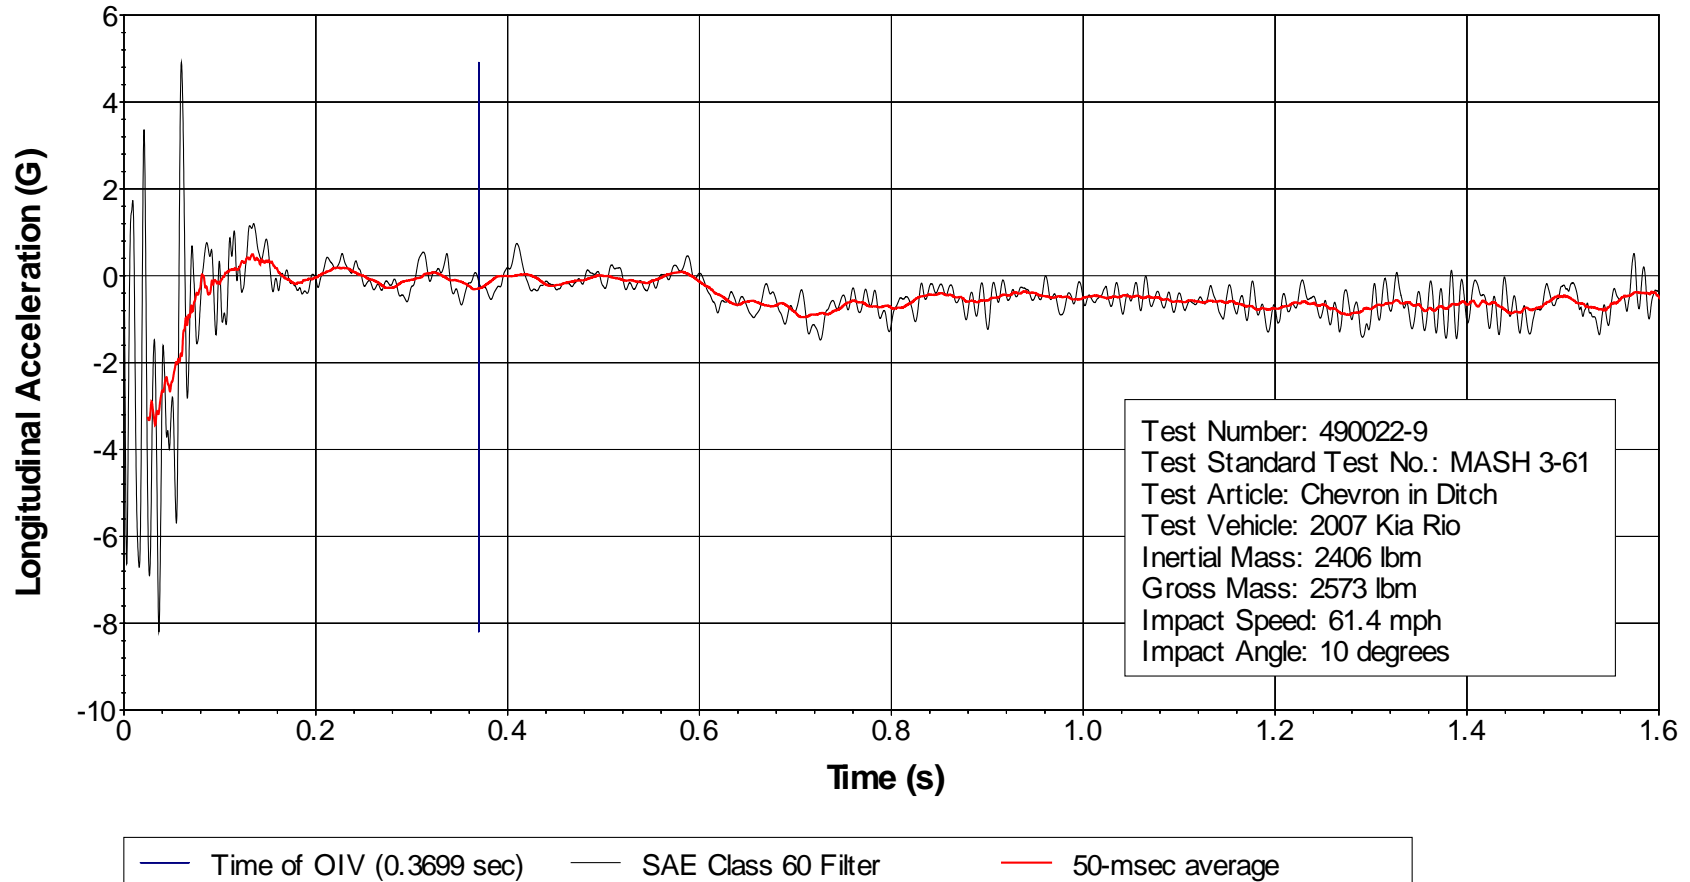
X Acceleration at CG

Figure D2. Vehicle Longitudinal Accelerometer Trace for Test No. 490022-9 (Accelerometer Located at Center of Gravity).

Data from the accelerometer, located at the vehicle center of gravity, were digitized for evaluation of occupant risk. In the longitudinal direction, the occupant impact velocity was 5.9 ft/s at 0.3699 s, the highest 0.010-s occupant ridedown acceleration was -2.1 Gs from 1.9645 to 1.9745 s, and the maximum 0.050-s average acceleration was -3.4 Gs between 0.0076 and 0.0576 s. In the lateral direction, the occupant impact velocity was 0.328 ft/s at 0.3699 s, the highest 0.010-s occupant ridedown acceleration was -1.1 Gs from 0.4376 to 0.4476 s, and the maximum 0.050-s average was 0.9 Gs between 0.0074 and 0.0574 s. Theoretical Head Impact Velocity (THIV) was 6.7 km/h or 1.9 m/s at 0.3690 s; Post-Impact Head Deceleration (PHD) was 2.1 Gs between 1.9645 and 1.9745 s; and Acceleration Severity Index (ASI) was 0.31 between 0.0075 and 0.0575 s. Figure 5.6 summarizes these data and other pertinent information from the test. Figures D1 through D7 in Appendix D present the vehicle angular displacements and accelerations versus time traces.
