# DEVELOPMENT OF A *MASH* TL-2 GUARDRAIL-TO-BRIDGE RAIL TRANSITION COMPATIBLE WITH 31-INCH GUARDRAIL

## Test Report 9-1002-8

TEXAS TRANSPORTATION INSTITUTE  
THE TEXAS A&M UNIVERSITY SYSTEM  
COLLEGE STATION, TEXAS

TEXAS DEPARTMENT OF TRANSPORTATION

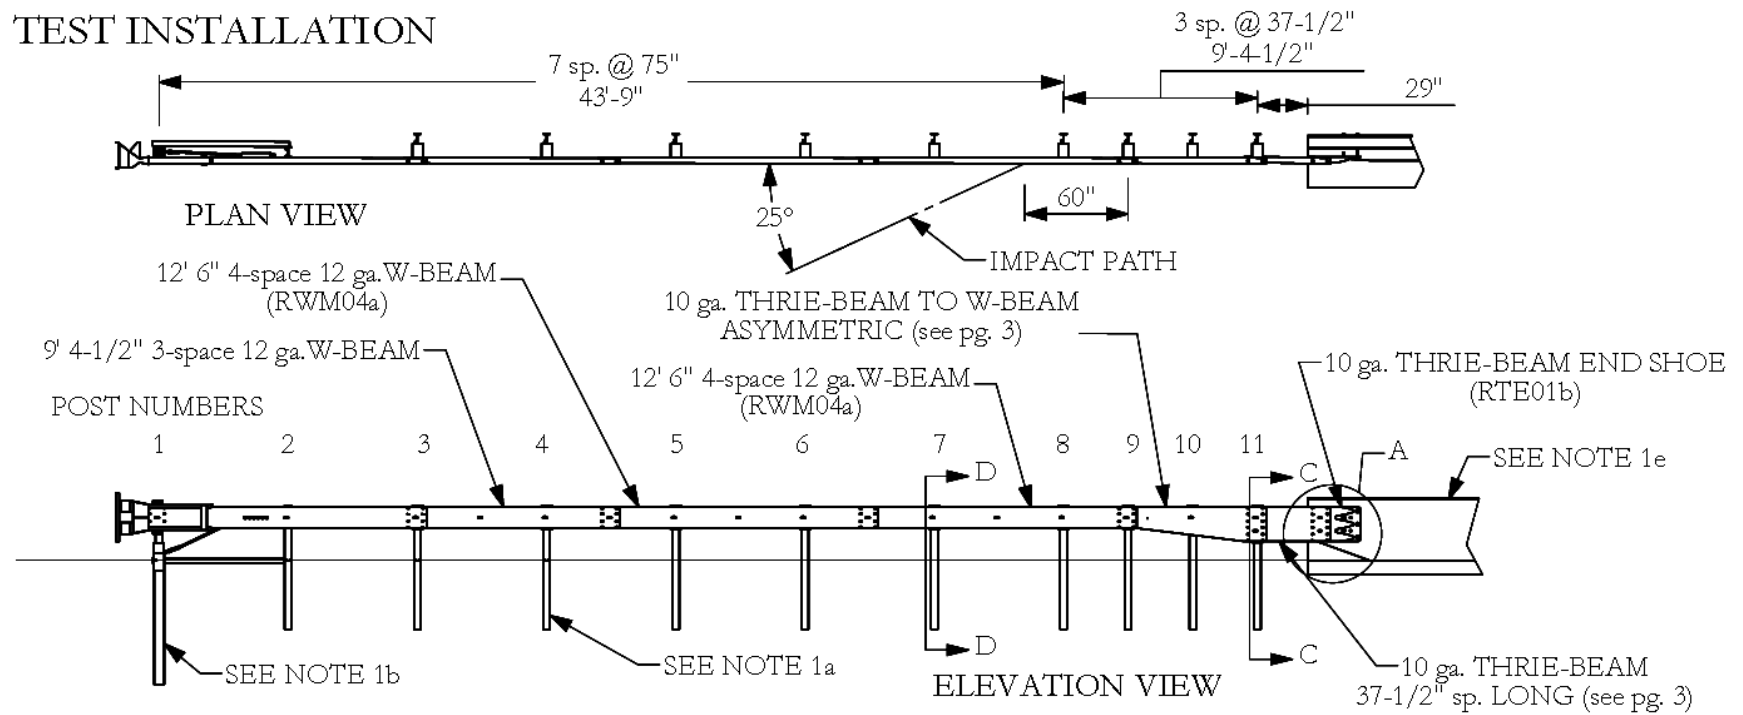
**Figure 3.1. Details of the MASH TL-2 Transition Installation.**

Figure 3.1 shows the layout of the test installation, and Figure 3.2 has the photographs of the completed test installation. Additional details of the test installation can be found in Appendix A.

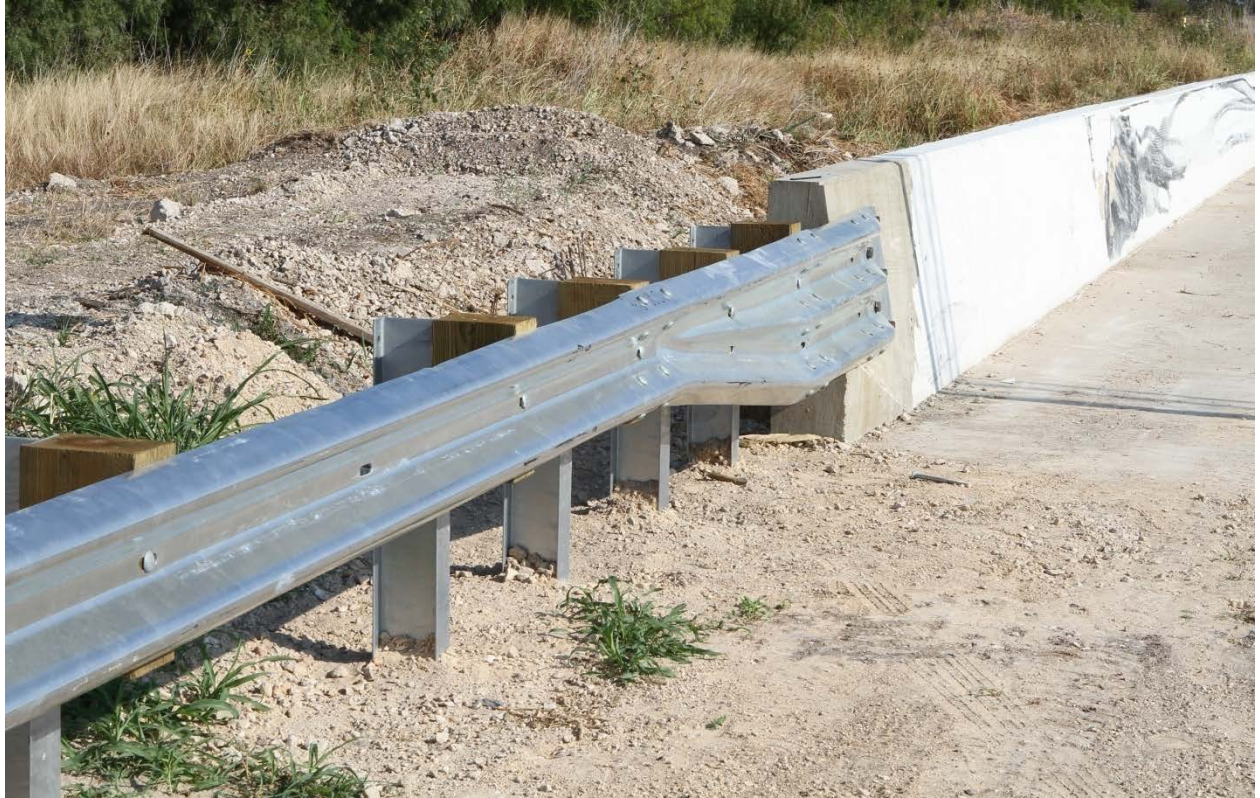
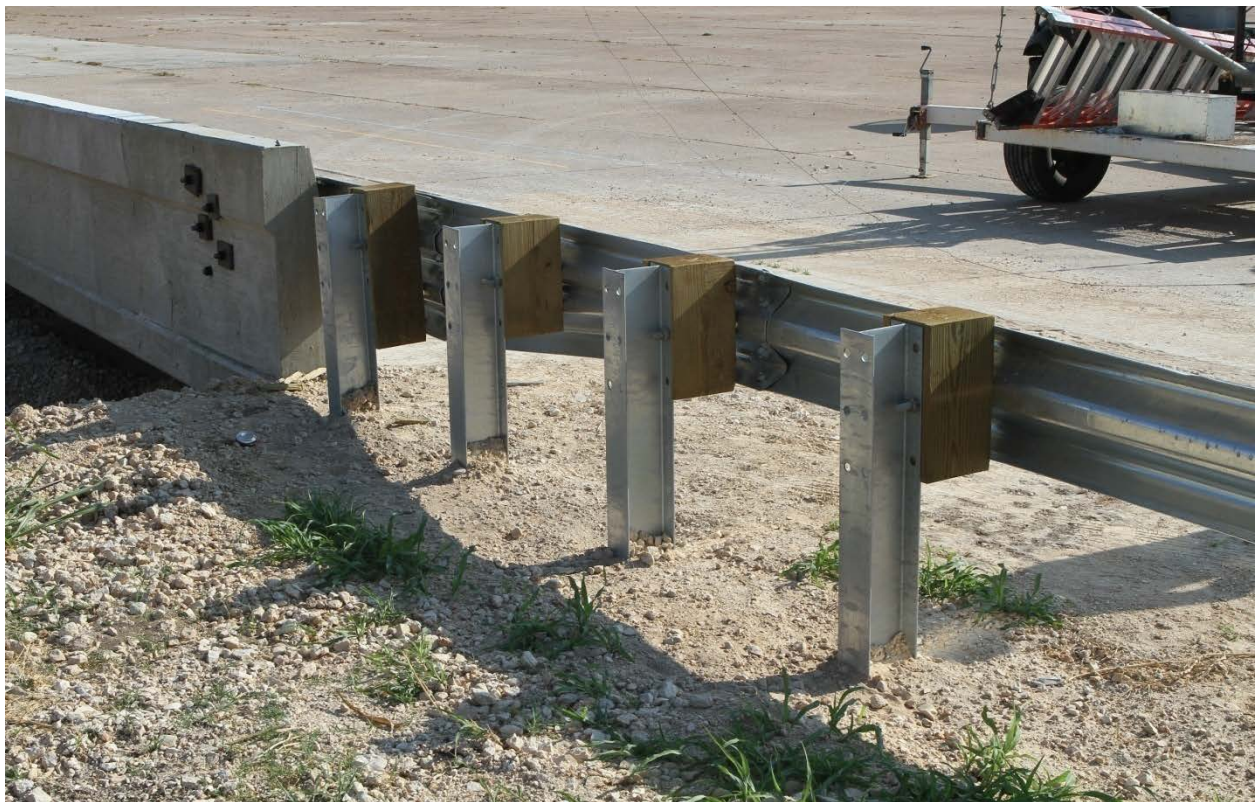
**Figure 3.2. MASH TL-2 Transition before Test No. 420021-4.**

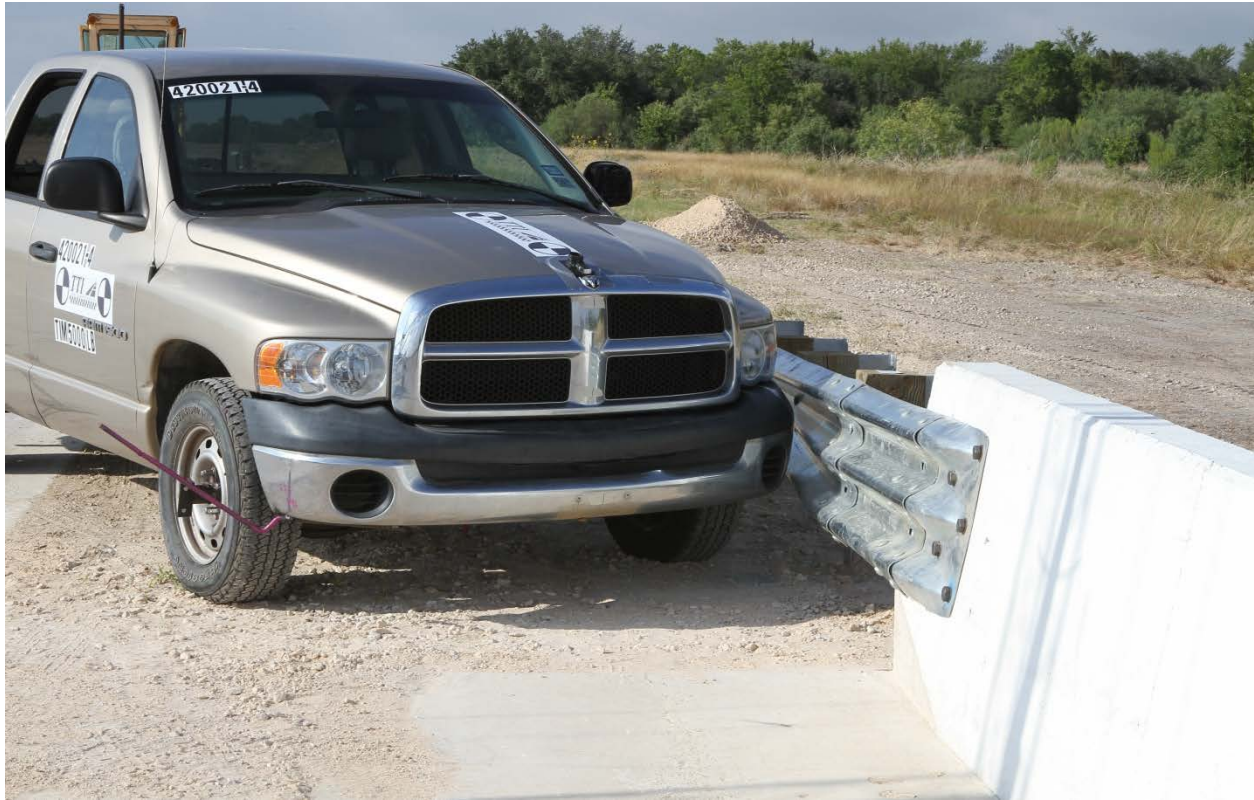
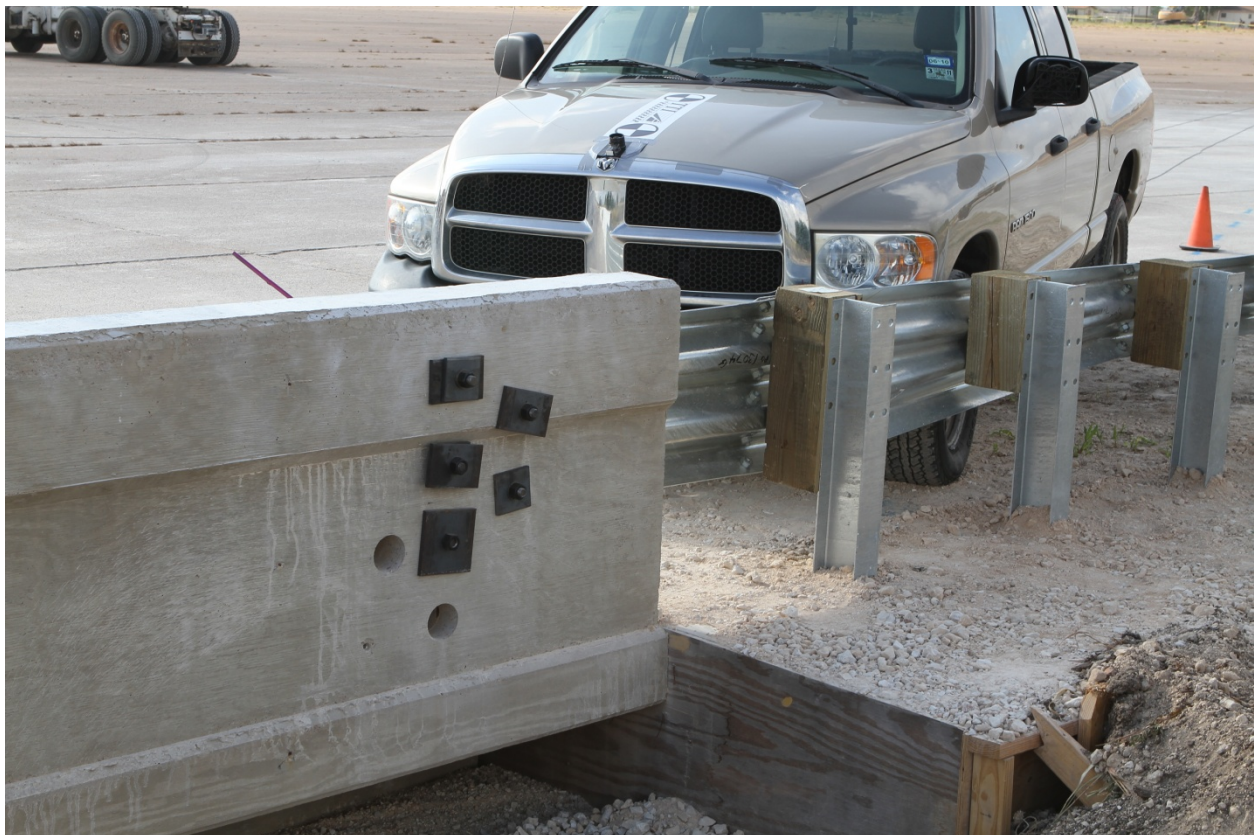
**Figure 6.1. Vehicle/Installation Geometries for Test No. 420021-4.**

The 2004 Dodge Ram 1500 pickup truck (shown in Figures 6.1 and 6.2) for the crash test. Test inertia weight of the vehicle was 5089 lb, and its gross static weight was 5089 lb. The height to the lower edge of the vehicle bumper was 13.5 inches, and the height to the upper edge of the vehicle bumper was 26.0 inches. Height to the vehicle center-of-gravity was 28.6 inches. Tables C1 and C2 in Appendix C give additional dimensions and information on the vehicle. The vehicle was directed into the installation using the cable reverse tow and guidance system, and was released to be free-wheeling and unrestrained just prior to impact.

The 2004 Dodge Ram 1500 pickup truck, traveling at an impact speed of 43.7 mi/h, impacted the *MASH* TL-2 transition 55 inches upstream of the end of the concrete parapet at an impact angle of 25.8 degrees. At 0.017 s, post 11 began to deflect toward the field side, and at 0.021 s, the vehicle began to redirect. The vehicle reached the end of the concrete parapet at 0.061 s, and the concrete parapet began to deflect toward the field side at 0.071 s. At 0.225 s, the vehicle was traveling parallel with the transition at a speed of 36.0 mi/h. The rear of the vehicle contacted the transition at 0.282 s, and the maximum dynamic deflection of 5.7 inches occurred at 0.324 s. At 0.331 s, the soil behind the posts began to displace towards the field side. At 0.423 s, the vehicle lost contact with the transition traveling at an exit speed and angle of 32.6 mi/h and 8.2 degrees, respectively. Brakes on the vehicle were not applied, and the vehicle came to rest 173 ft downstream of impact and adjacent to the traffic face of the concrete parapet. Figures D1 and D2 in Appendix D show sequential photographs of the test period.

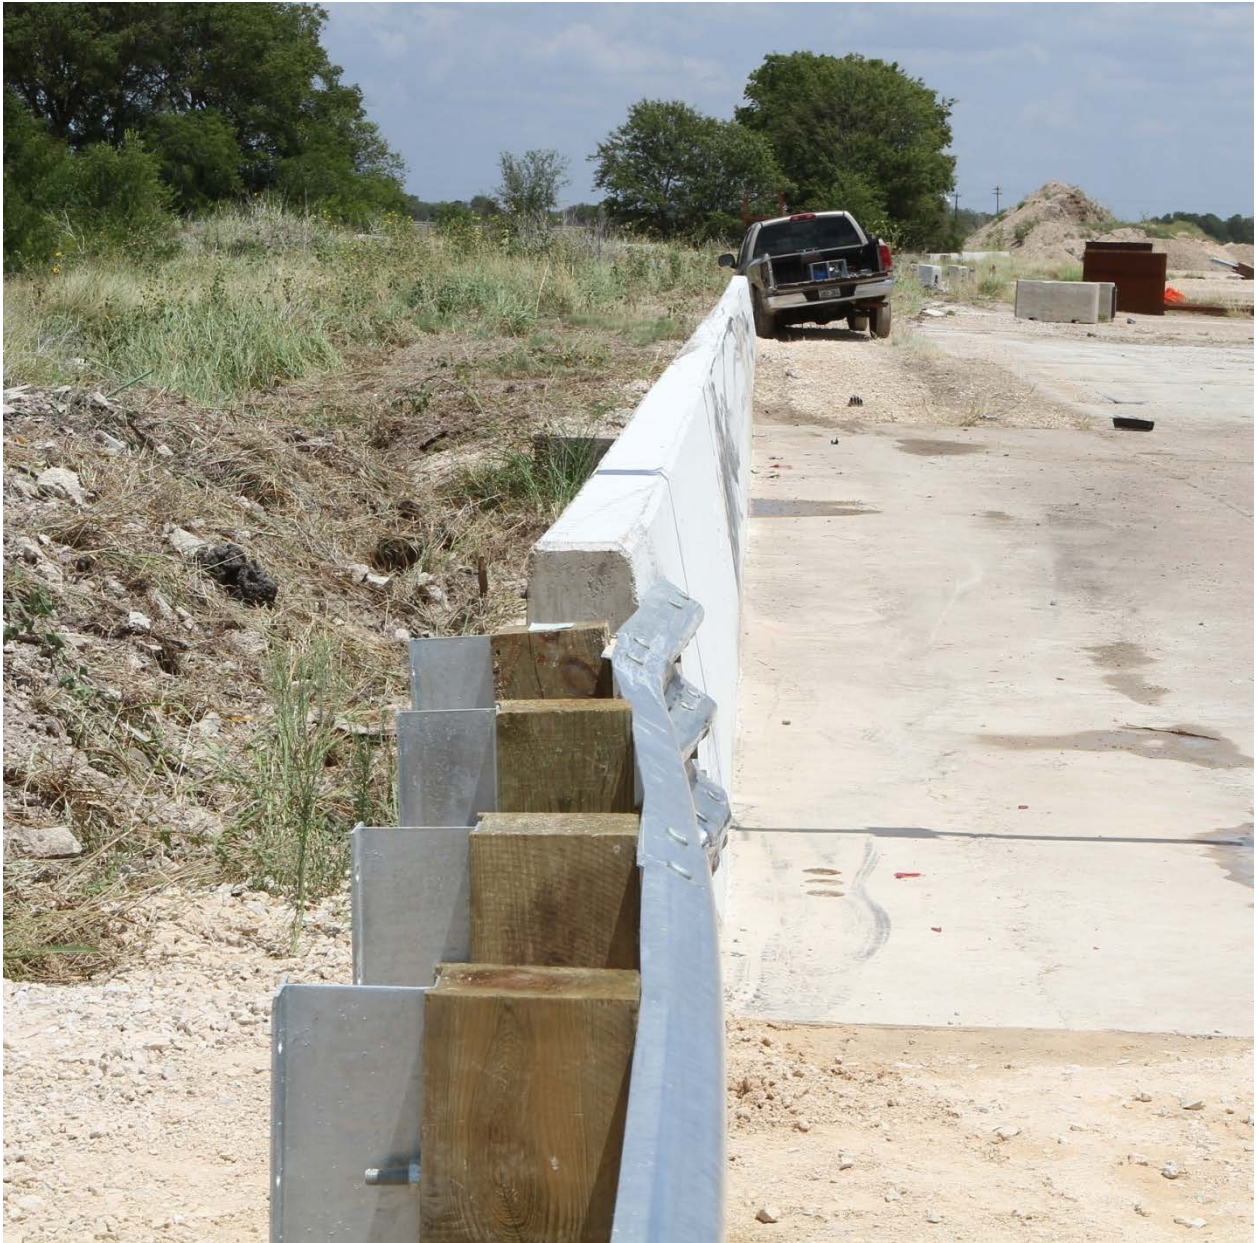
**Figure 6.3. Position of Vehicle/Installation after Test No. 420021-4.**

Figures 6.3 and 6.4 show damage to the *MASH* TL-2 transition. Posts 9, 10, and 11 were pushed toward the field side 0.4 inch, 1.1 inches, and 2.1 inches, respectively. The end of the concrete deck was cracked and the end of the concrete parapet was cracked near the anchor bolts attaching the rail to the parapet. Length of contact of the vehicle with the transition was 13.4 ft; working width was 15.8 inches. Maximum dynamic deflection during the test was 5.7 inches, and maximum permanent deformation was 2.9 inches.

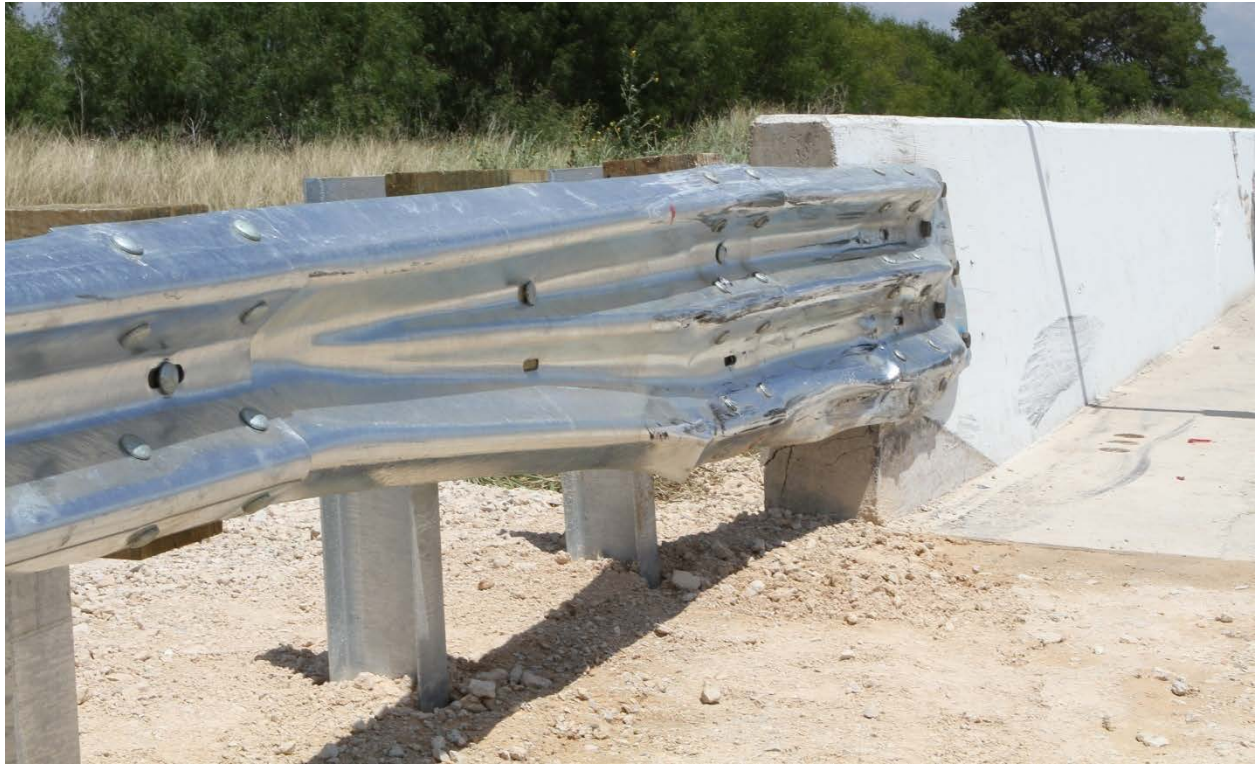
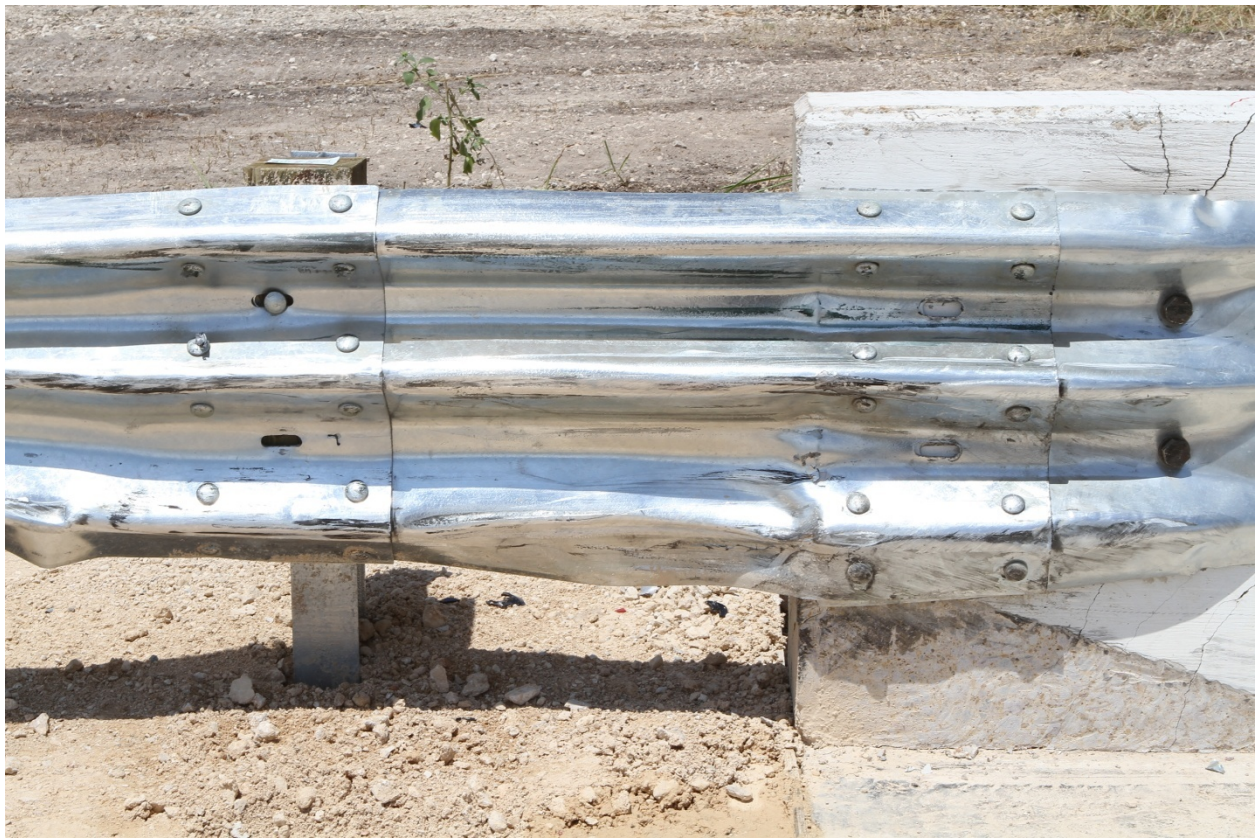
**Figure 6.4. Installation after Test No. 420021-4.**

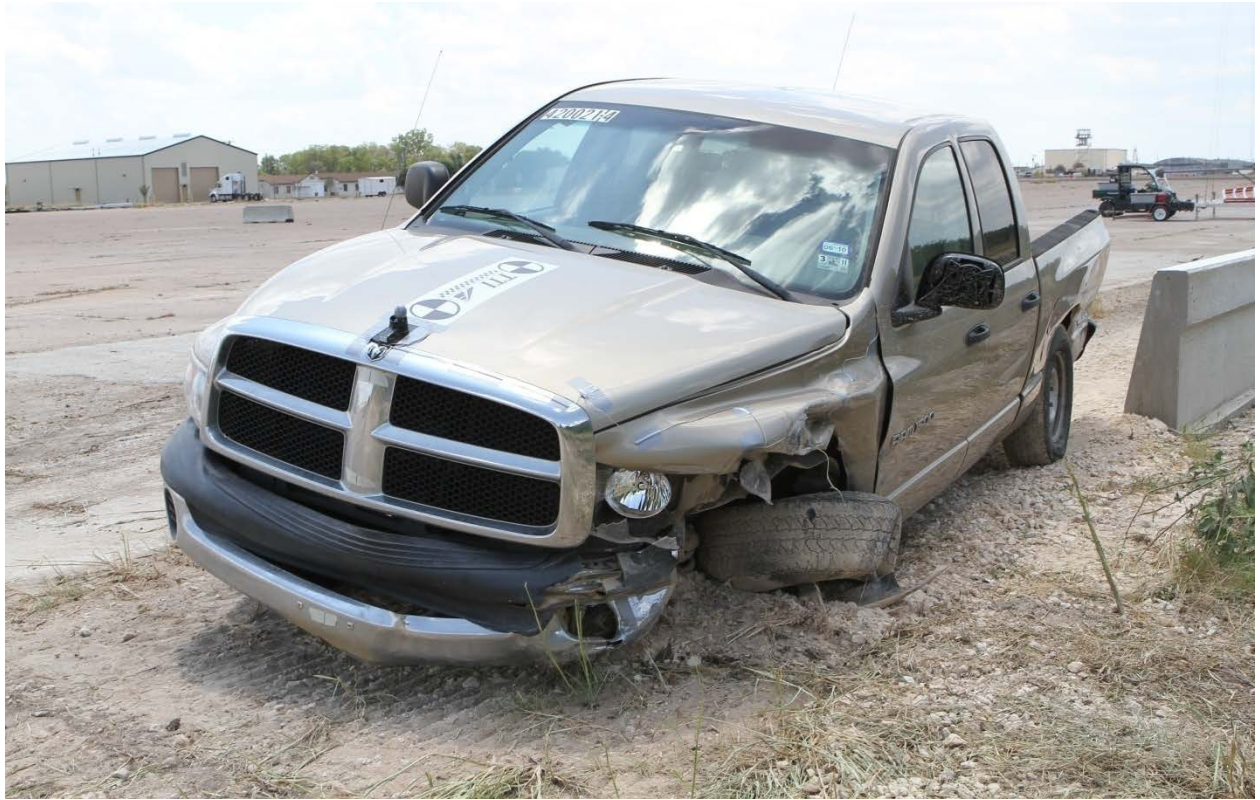
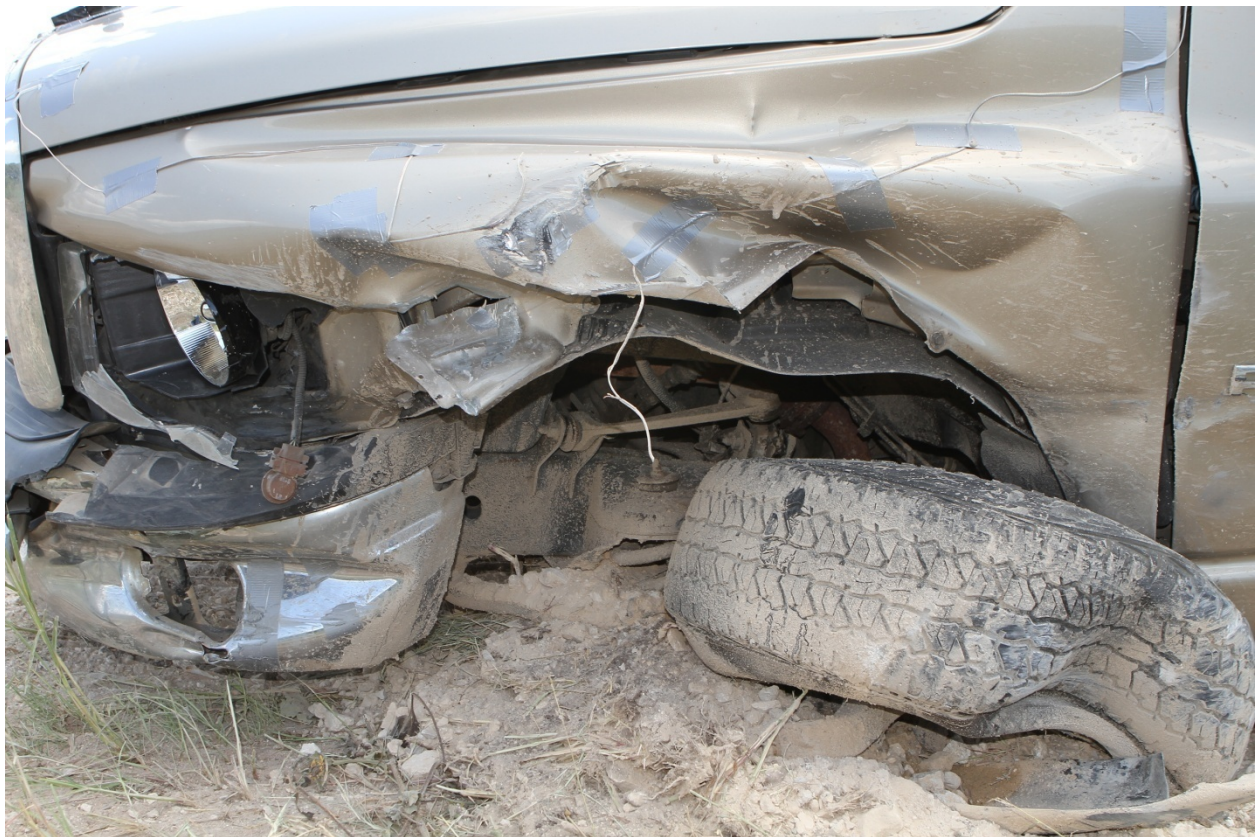
**Figure 6.5. Vehicle after Test No. 420021-4.**

Figure 6.5 shows damage to the 2004 Dodge Ram 1500. The left upper and lower A-arm, left upper and lower ball joint, sway bar, tie rod, and left frame rail were damaged. Also damaged were the front bumper, left front fender, left front door, left front tire and wheel rim, left rear exterior bed, left rear wheel rim, and rear bumper. Maximum exterior crush to the vehicle was 16 inches in the front plane at the left front corner at bumper height. Maximum occupant compartment deformation was 2.0 inches in the left side firewall. Figure 6.6 shows photographs of the interior of the vehicle. Exterior crush and occupant compartment deformations are provided in Appendix C, Tables C3 and C4.

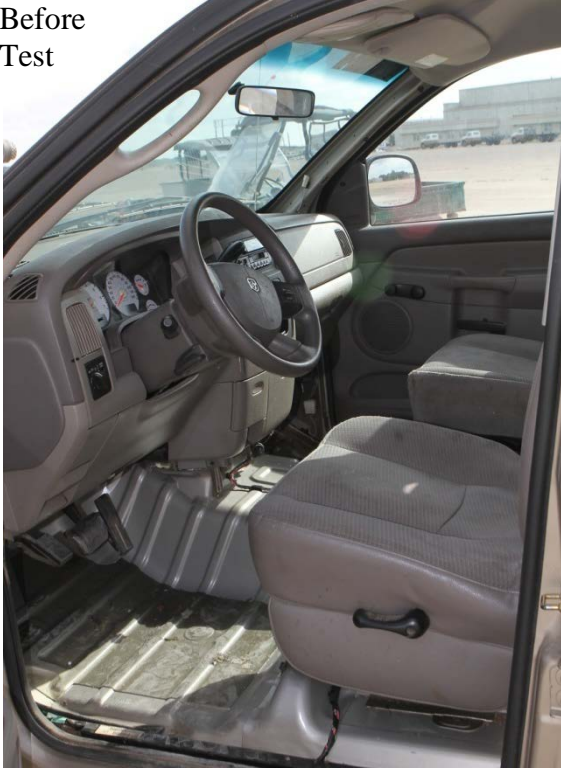
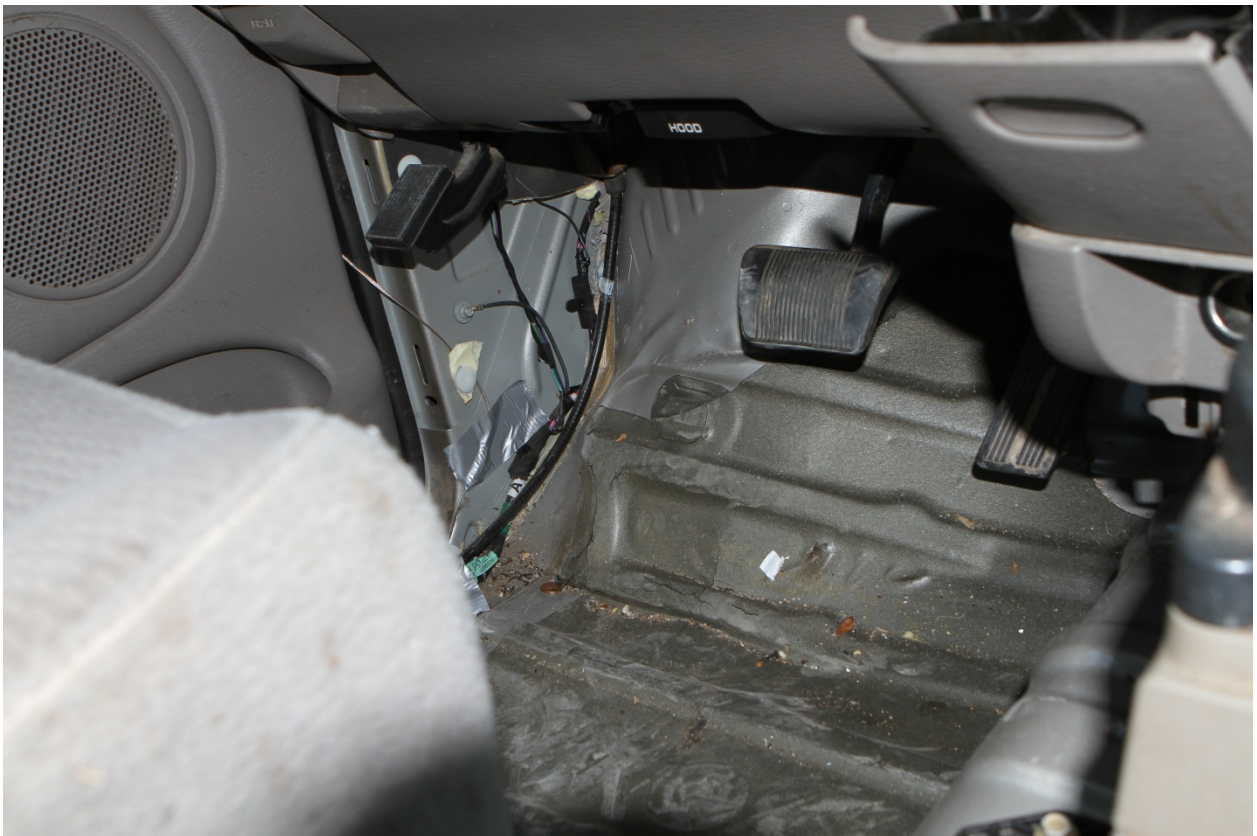
**Figure 6.6. Interior of Vehicle for Test No. 420021-4.**

Before  
Test

After Test

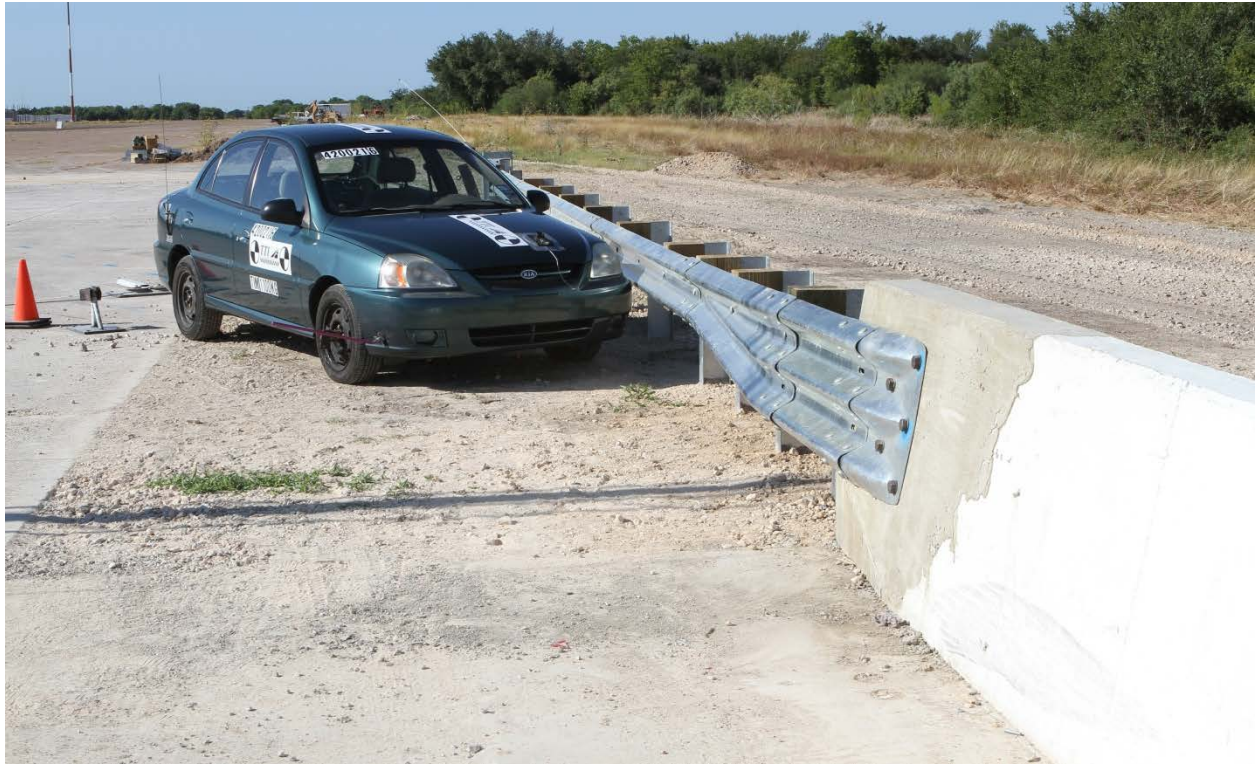
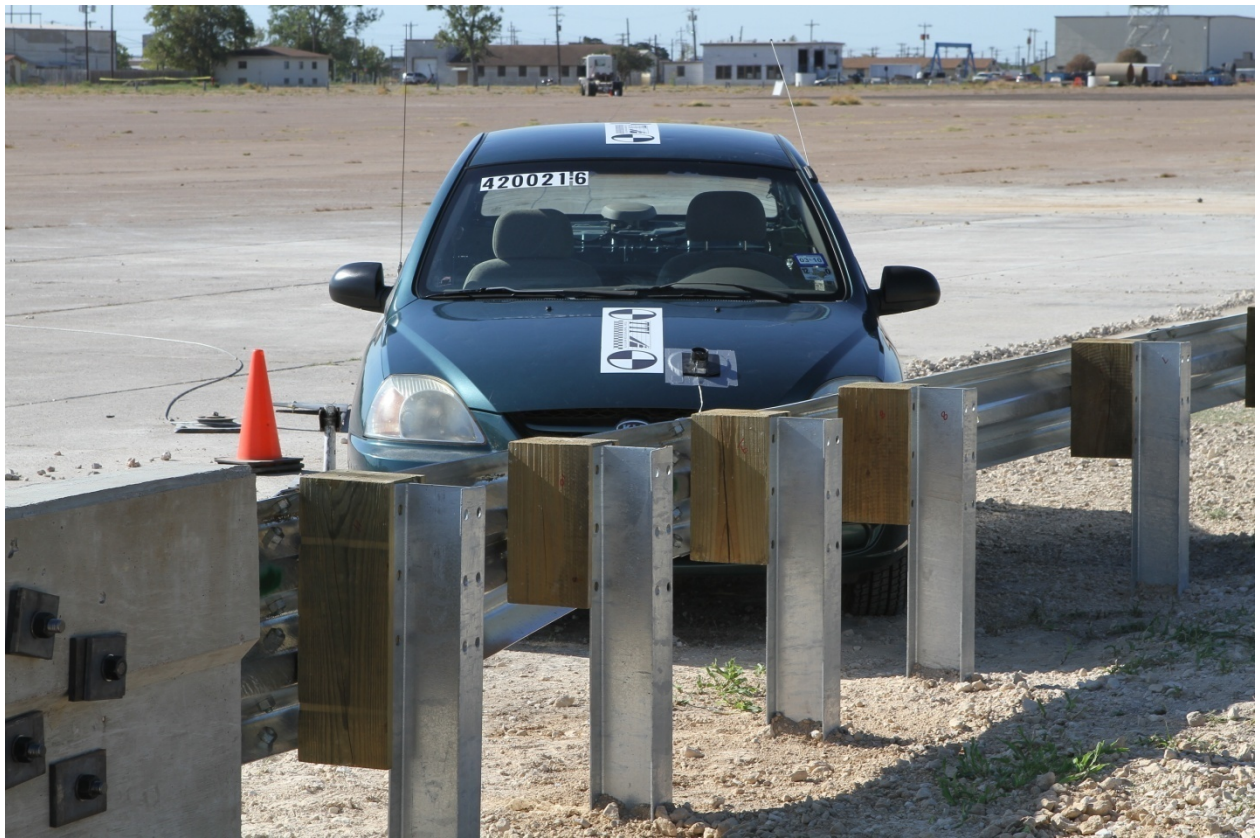
**Figure 7.1. Vehicle/Installation Geometrics for Test No. 420021-6.**

A 2004 Kia Rio, (shown in Figures 7.1 and 7.2) was used for the crash test. Test inertia weight of the vehicle was 2418 lb, and its gross static weight was 2586 lb. The height to the lower edge of the vehicle bumper was 8.50 inches, and the height to the upper edge of the bumper was 22.75 inches. Table C5 in Appendix C gives additional dimensions and information on the vehicle. The vehicle was directed into the installation using the cable reverse tow and guidance system, and was released to be free-wheeling and unrestrained just prior to impact.

The 2004 Kia Rio, traveling at an impact speed of 43.5 mi/h, impacted the *MASH* TL-2 transition 5.9 ft upstream of post 9 at an impact angle of 26.4 degrees. At 0.039 s, the vehicle began to redirect, and at 0.041 s, the bumper of the vehicle protruded under the rail element and contacted the traffic side flange of post 8. The left front tire of the vehicle contacted the flange of post 8 at 0.079 s, and the roof of the vehicle began to deform at 0.086 s. At 0.102 s, the windshield sustained stress cracks at the left lower corner, and at 0.104 s, the parts of the vehicle protruding under the rail contacted the traffic side flange of post 9. The bumper of the vehicle separated from the vehicle and the right side tire blew out at 0.147 s. The vehicle contacted post 10 at 0.169 s, and the vehicle began to yaw counterclockwise at 0.240 s. At 0.535 s, the vehicle lost contact with the transition. The exit speed and angle were not obtainable because the vehicle yawed counterclockwise (101 degrees) as it lost contact with the transition. Brakes on the vehicle were not applied, and the vehicle subsequently came to rest 54 ft toward traffic lanes in front of post 10. Figures D3 and D4 in Appendix D show sequential photographs of the test period.

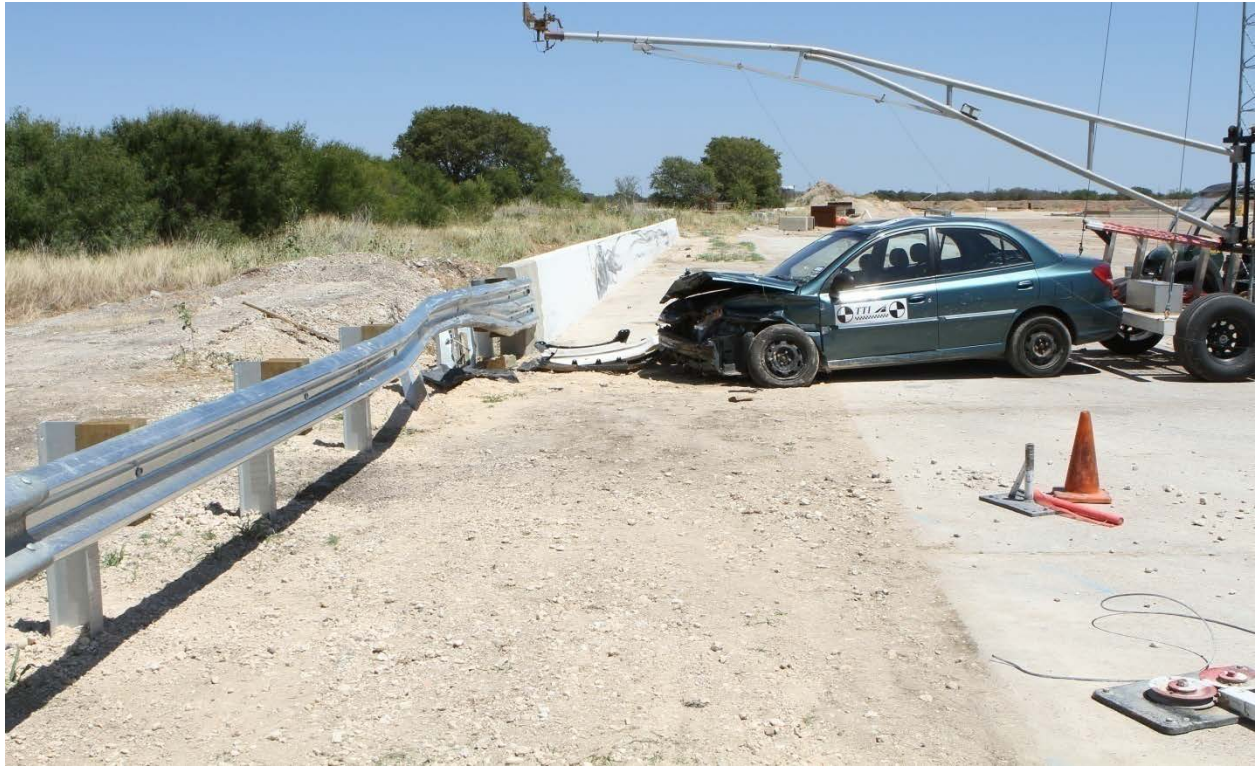
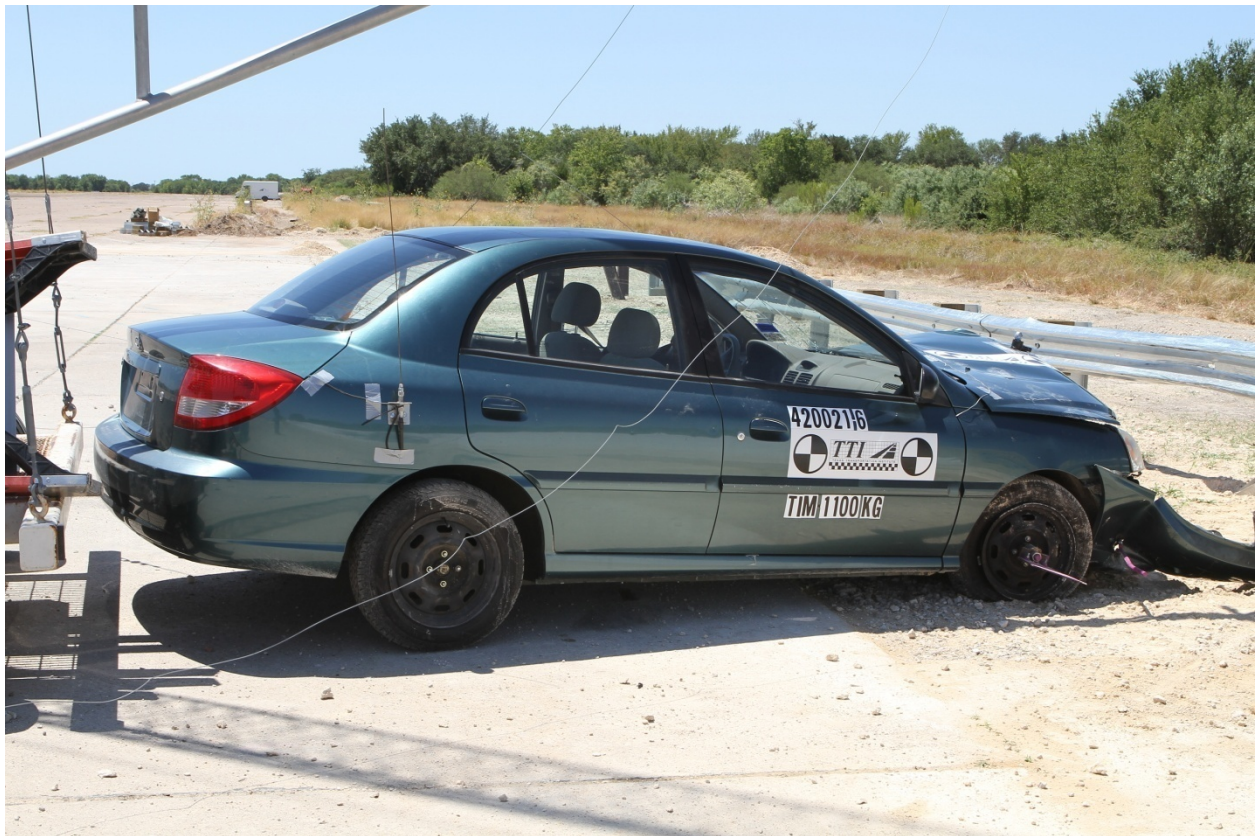
**Figure 7.3. Position of Vehicle/Installation after Test No. 420021-6.**

Figures 7.3 and 7.4 show damage to the *MASH* TL-2 transition. Post 1 was pulled downstream 0.38 inch at ground level and post 7 was leaning toward the field side at 2 degrees. Posts 8 and 9 were leaning toward the field side 30 degrees and downstream 50-55 degrees. Post 10 was leaning toward the field side 10 degrees and downstream 20 degrees. The rail element released from post 8 through 10, and the blockouts at posts 8 and 9 were shattered. Length of contact of the vehicle with the rail element was 12.3 ft; working width was 2.6 ft. Maximum dynamic deflection during the test was 14.4 inches, and maximum permanent deformation was 8.0 inches at post 8.

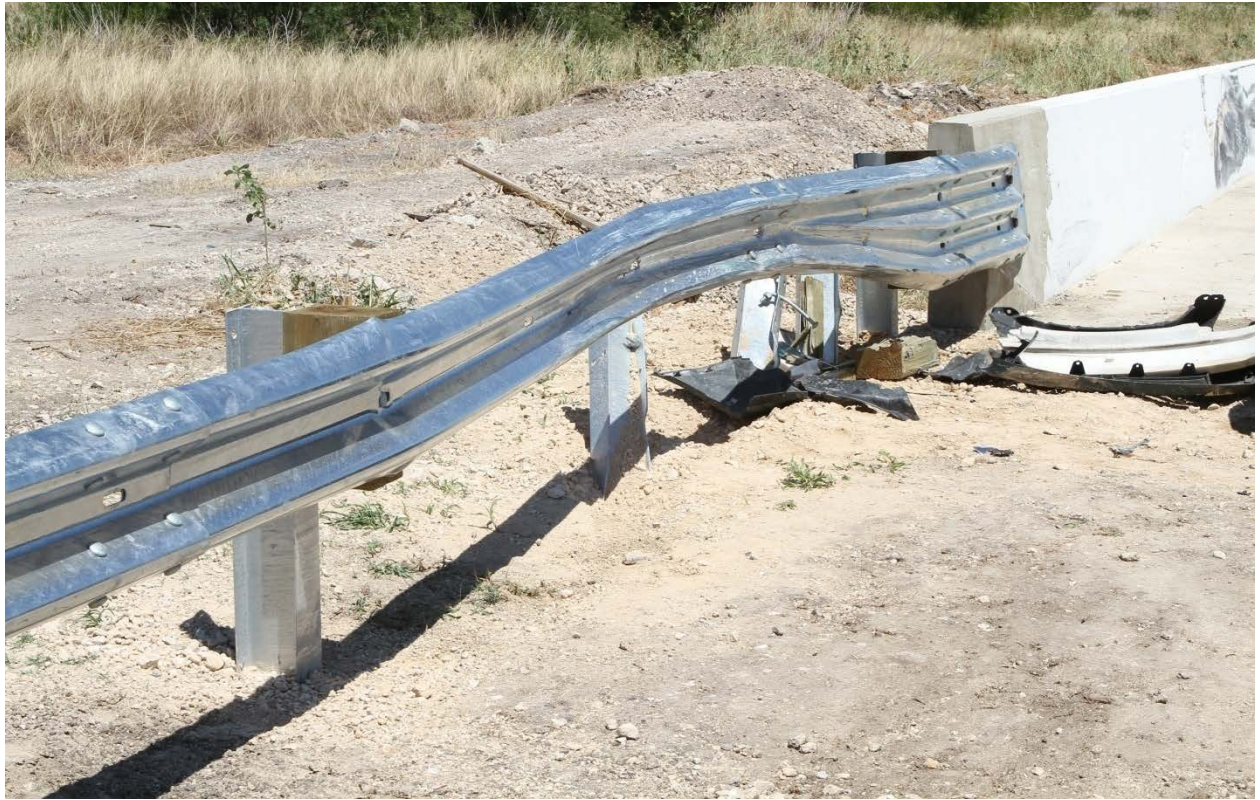
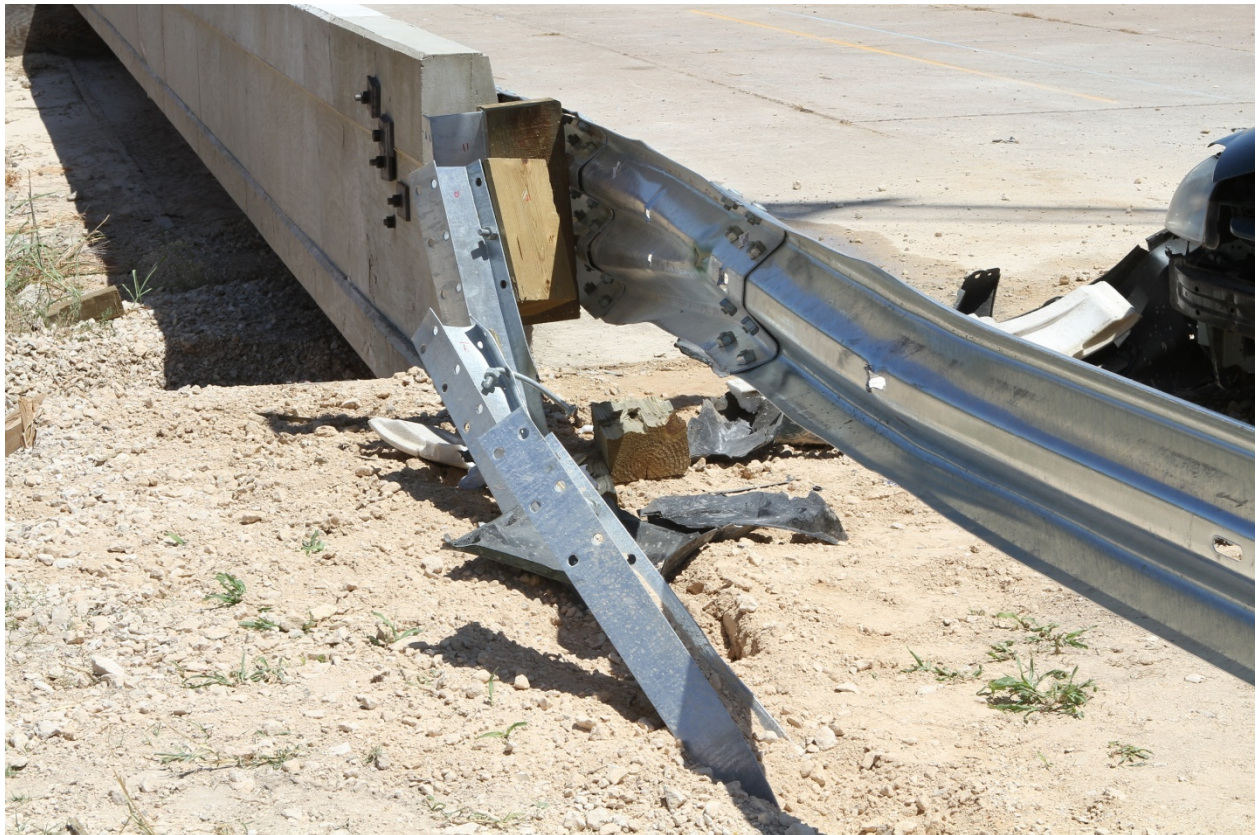
**Figure 7.4. Installation after Test No. 420021-6.**

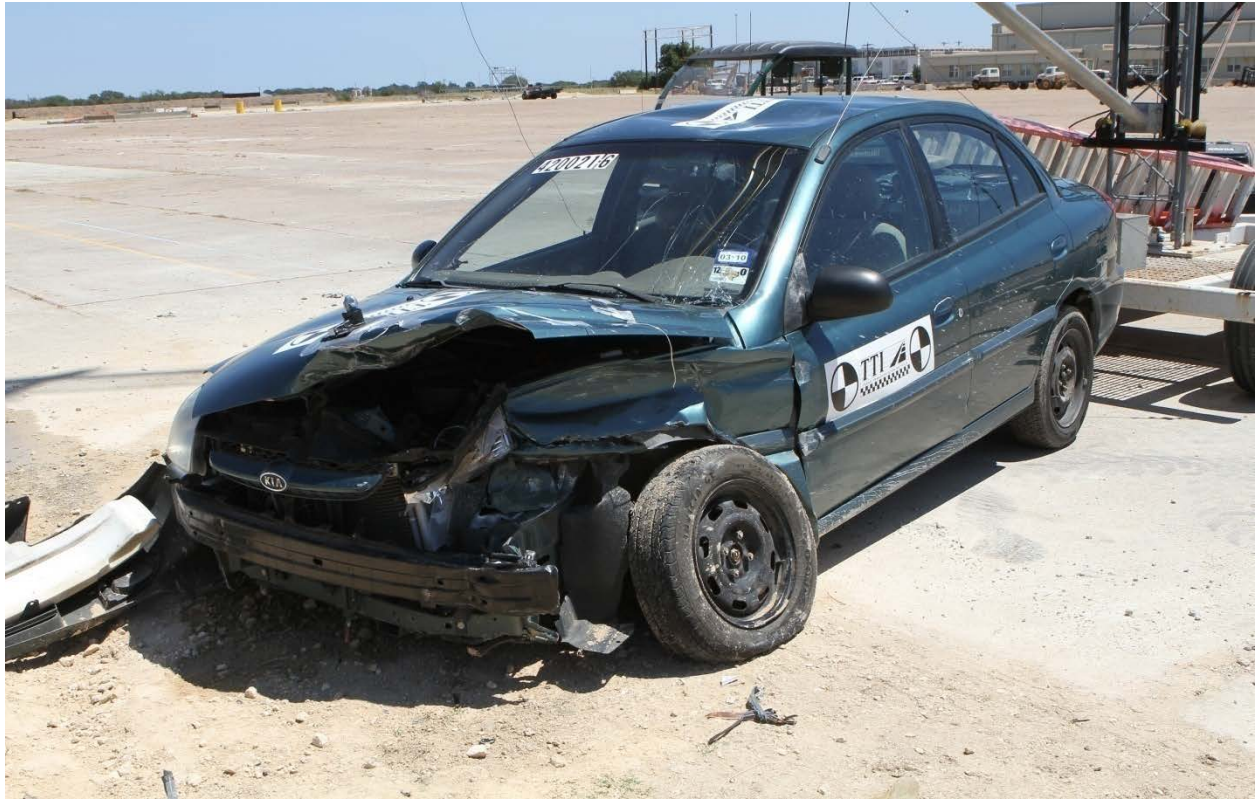
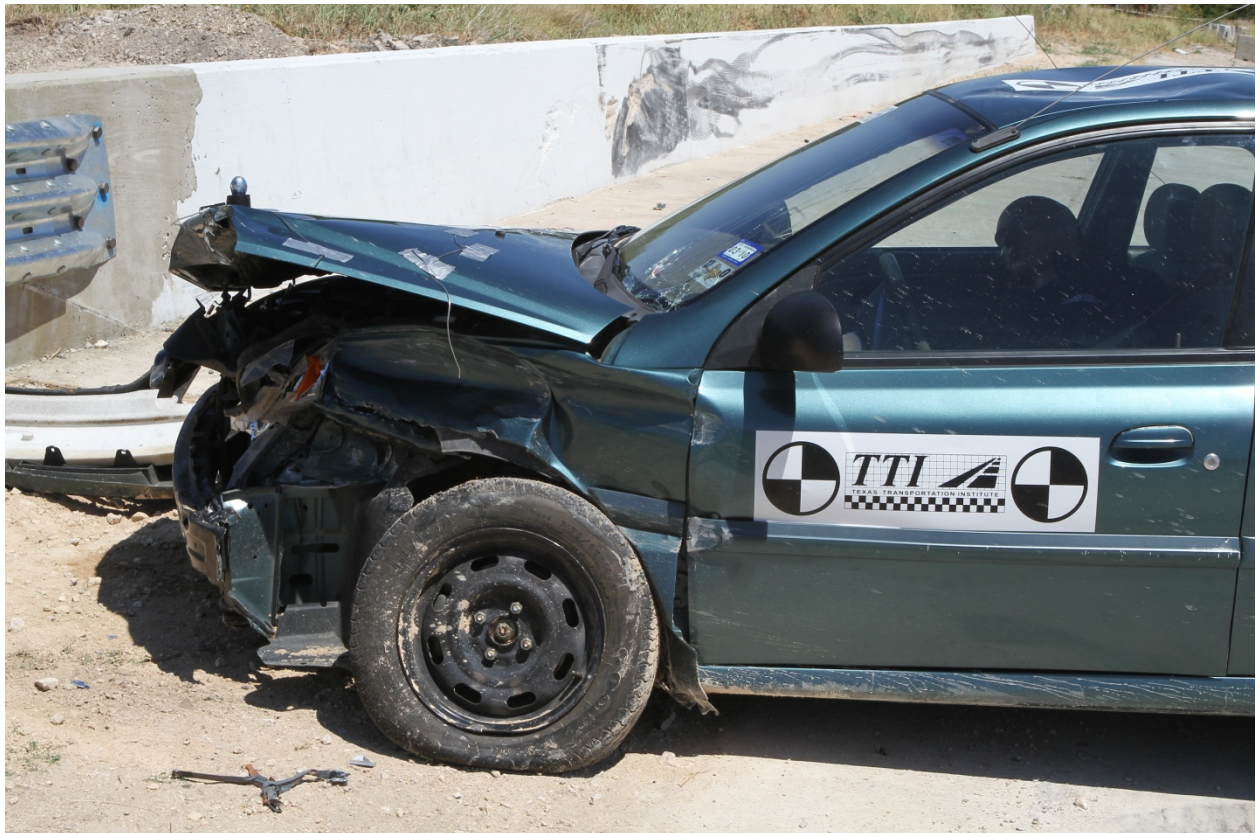
**Figure 7.5. Vehicle after Test No. 420021-6.**

Figure 7.5 shows that the 1100C vehicle sustained damage to the left front corner. The left front strut and strut tower, front bumper, hood, radiator, fan, radiator support, left front fender, left front wheel rim, left door, and right front tire and wheel rim were damaged. The windshield sustained stress cracks in the left lower corner. Maximum exterior crush to the vehicle was 15 inches in the side plane at the left front corner at bumper height. Maximum occupant compartment deformation was 0.25 inch in the lateral area across the cab at the kick panel near the driver's feet. Figure 7.6 has pictures of the interior of the vehicle. Tables C4 and C5 in Appendix C provide the exterior crush and occupant compartment deformation measurements.
