# DEVELOPMENT OF A *MASH* TL-2 GUARDRAIL-TO-BRIDGE RAIL TRANSITION COMPATIBLE WITH 31-INCH GUARDRAIL

## Test Report 9-1002-8

TEXAS TRANSPORTATION INSTITUTE  
THE TEXAS A&M UNIVERSITY SYSTEM  
COLLEGE STATION, TEXAS

TEXAS DEPARTMENT OF TRANSPORTATION

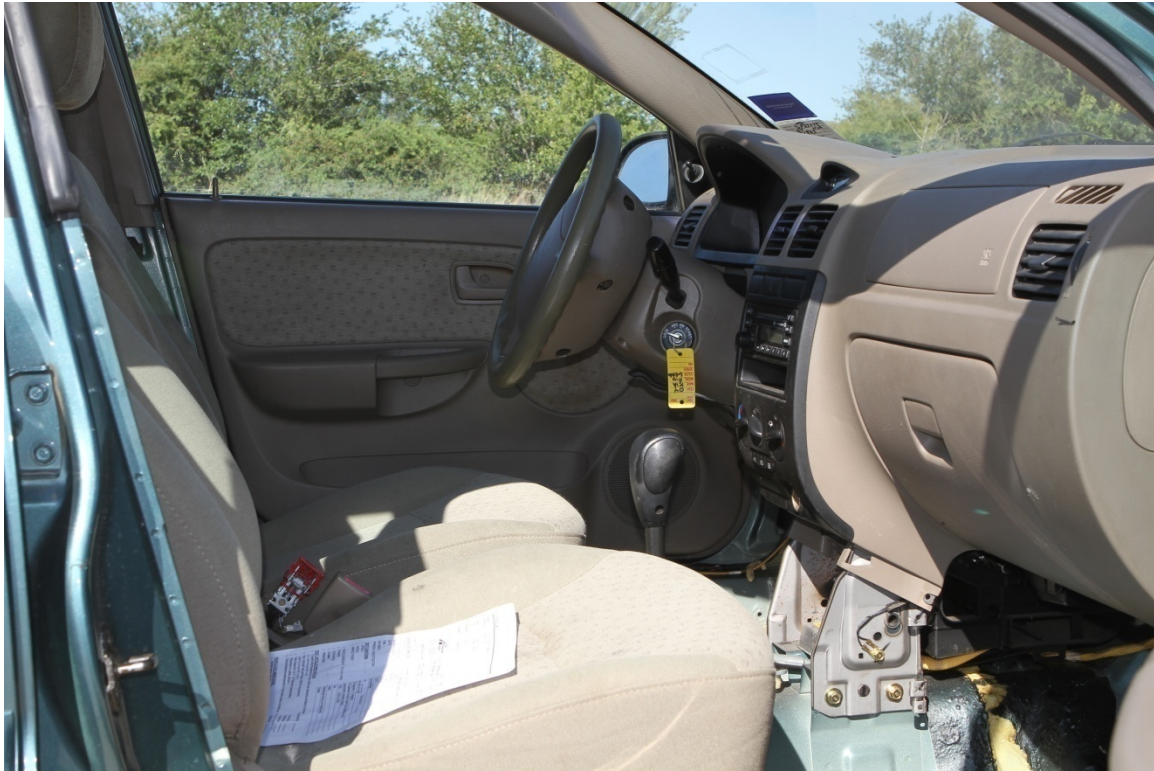
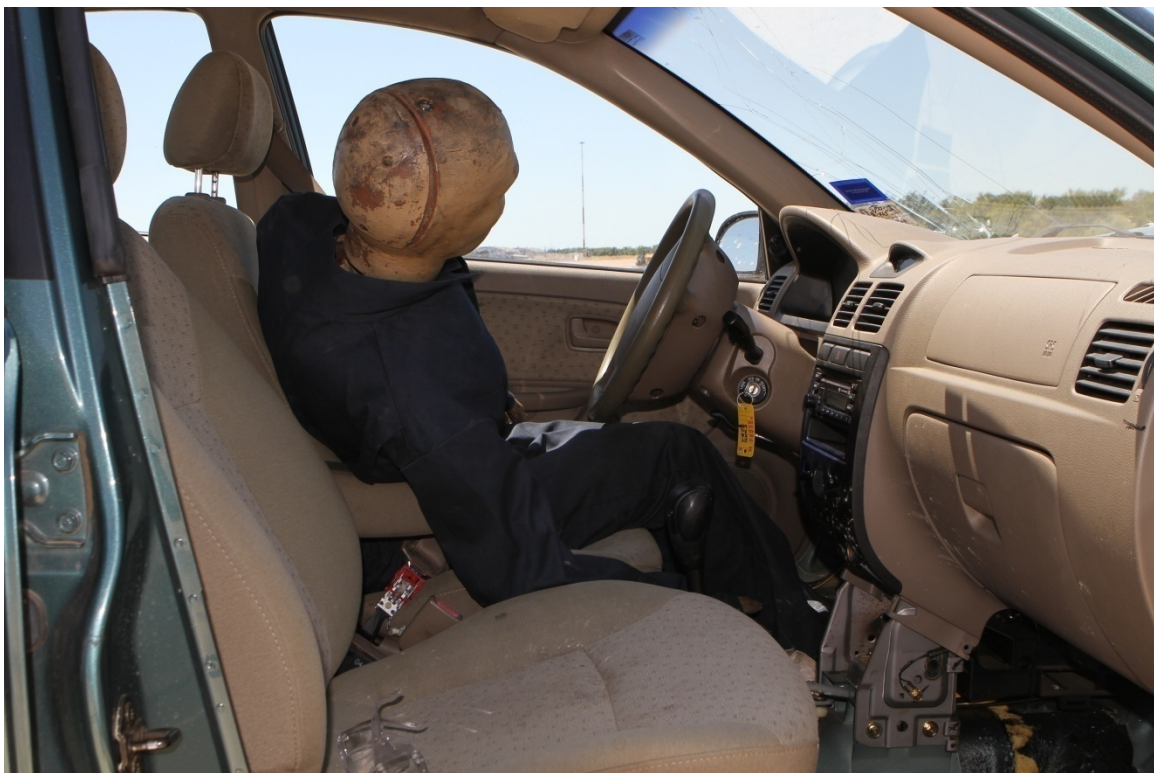
**Figure 7.6. Interior of Vehicle for Test No. 420021-6.**

Before Test  
After Test

Figure 7.5 shows that the 1100C vehicle sustained damage to the left front corner. The left front strut and strut tower, front bumper, hood, radiator, fan, radiator support, left front fender, left front wheel rim, left door, and right front tire and wheel rim were damaged. The windshield sustained stress cracks in the left lower corner. Maximum exterior crush to the vehicle was 15 inches in the side plane at the left front corner at bumper height. Maximum occupant compartment deformation was 0.25 inch in the lateral area across the cab at the kick panel near the driver's feet. Figure 7.6 has pictures of the interior of the vehicle. Tables C4 and C5 in Appendix C provide the exterior crush and occupant compartment deformation measurements.

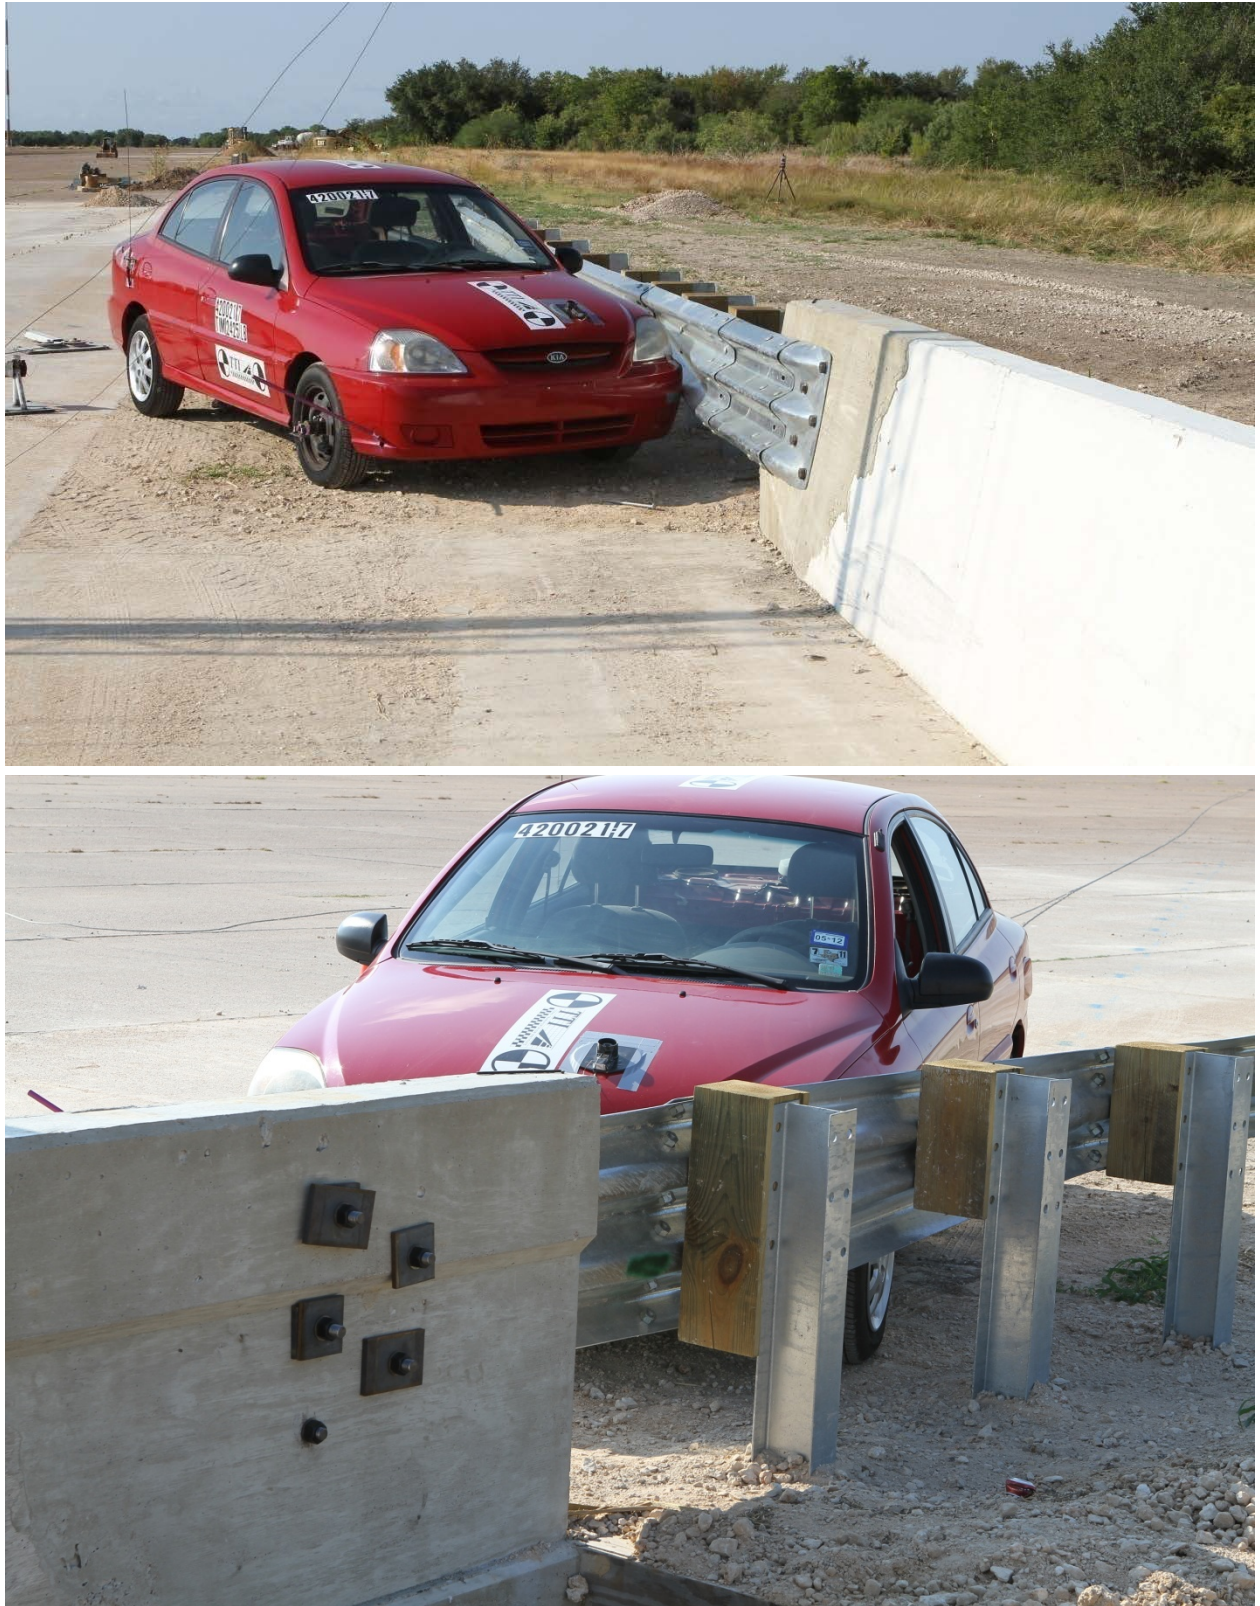
**Figure 8.1. Vehicle/Installation Geometrics for Test No. 420021-7.**

The 2004 Kia Rio (shown in Figures 8.1 and 8.2) was used for the crash test. Test inertia weight of the vehicle was 2416 lb, and its gross static weight was 2581 lb. The height to the lower edge of the vehicle bumper was 8.50 inches, and the height to the upper edge of the bumper was 22.75 inches. Table C8 in Appendix C gives additional dimensions and information on the vehicle. The vehicle was directed into the installation using the cable reverse tow and guidance system, and was released to be free-wheeling and unrestrained just prior to impact.

The 2004 Kia Rio, traveling at an impact speed of 43.5 mi/h, impacted the *MASH* TL-2 transition 54 inches upstream of the end of the concrete parapet at an impact angle of 24.4 degrees. At approximately 0.008 s, post 10 began to deflect toward impact, and at 0.012 s, post 11 began to deflect toward impact. Post 9 began to deflect toward the field side at 0.024 s, and the vehicle began to redirect at 0.029 s. The window in the driver's side front door shattered at 0.103 s. At 0.203 s, the vehicle was traveling parallel with the transition at a speed of 31.5 mi/h. The rear of the vehicle contacted the transition at 0.294 s. At 0.351 s, the vehicle lost contact with the transition traveling at an exit speed and angle of 30.7 mi/h and 17.1 degrees, respectively. Brakes on the vehicle were not applied, and the vehicle subsequently came to rest 141 ft downstream of impact and 75 ft toward traffic lanes. Figures D5 and D6 in Appendix D show sequential photographs of the test period.

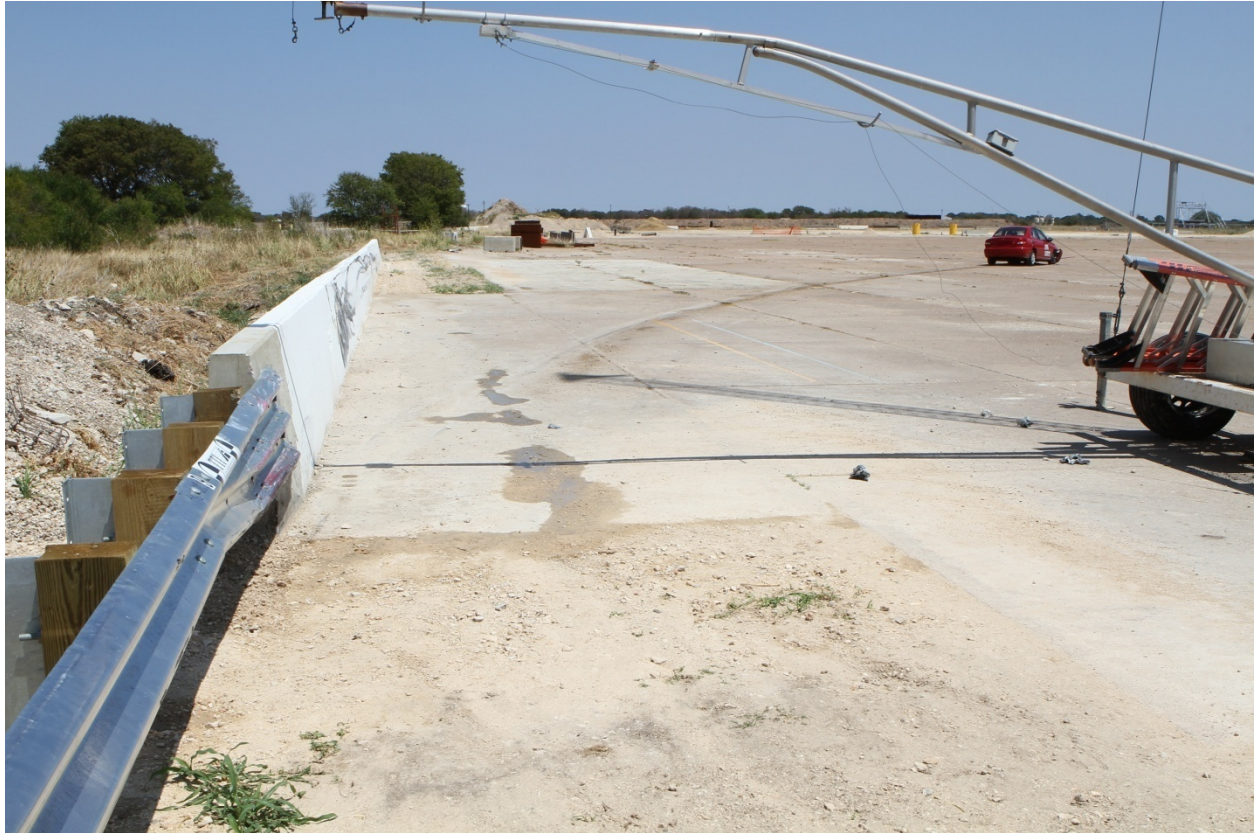
**Figure 8.3. Position of Vehicle/Installation after Test No. 420021-7.**

Figures 8.3 and 8.4 show damage to the *MASH* TL-2 transition. The wheel of the vehicle contacted the traffic face of post 11. Posts 10 and 9 deflected toward the field side 0.5 inch and 0.25 inch, respectively, measured at ground level. Post 8 was disturbed. No movement was noted in the remaining posts. Length of contact of the vehicle with the rail element was 6.4 ft. Working width was 11.7 inches. Maximum dynamic deflection during the test was 3.4 inches, and maximum permanent deformation was 3.0 inches.

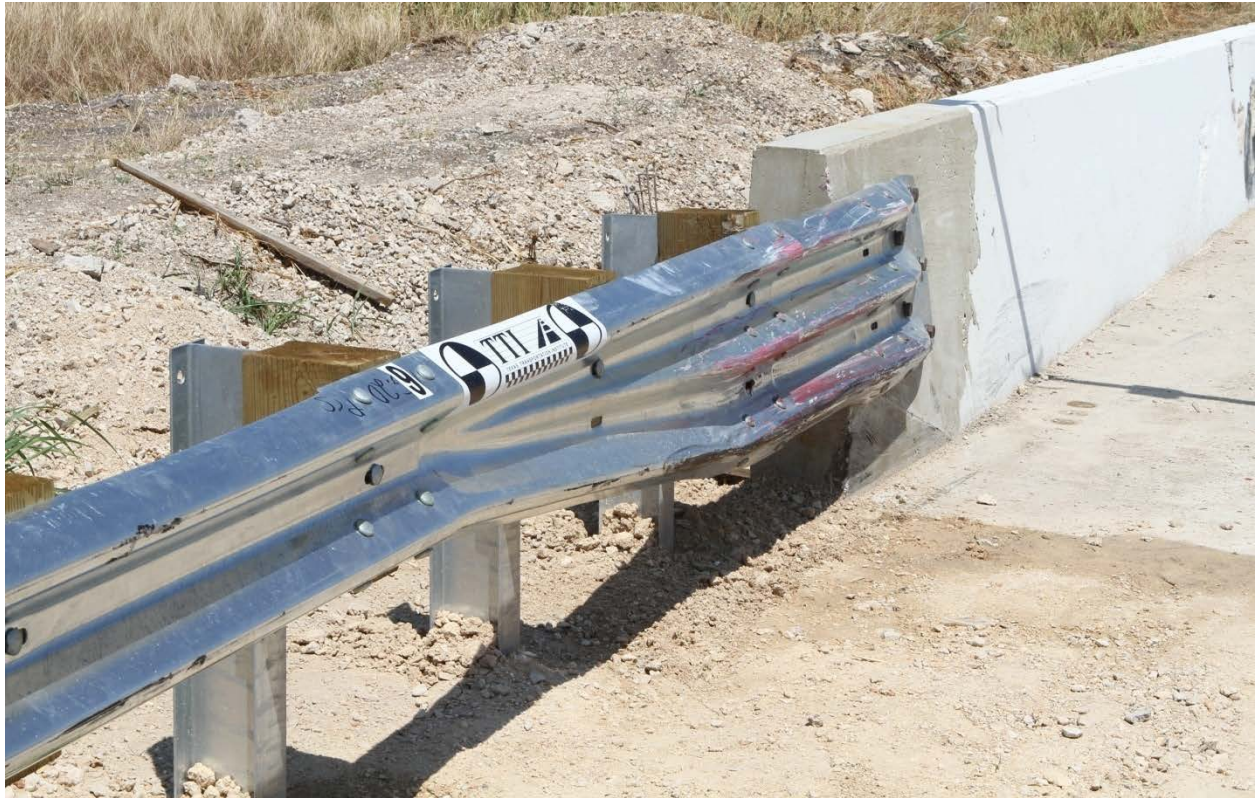
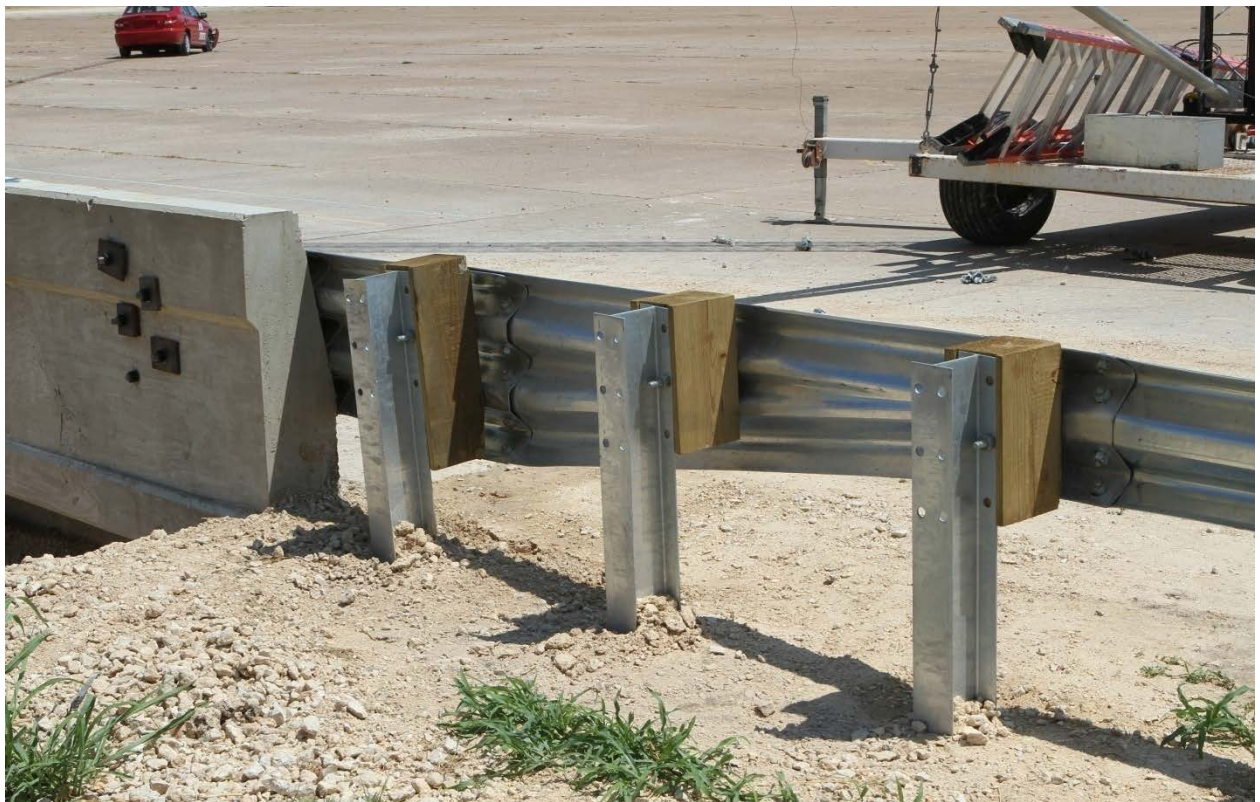
**Figure 8.4. Installation after Test No. 420021-7.**

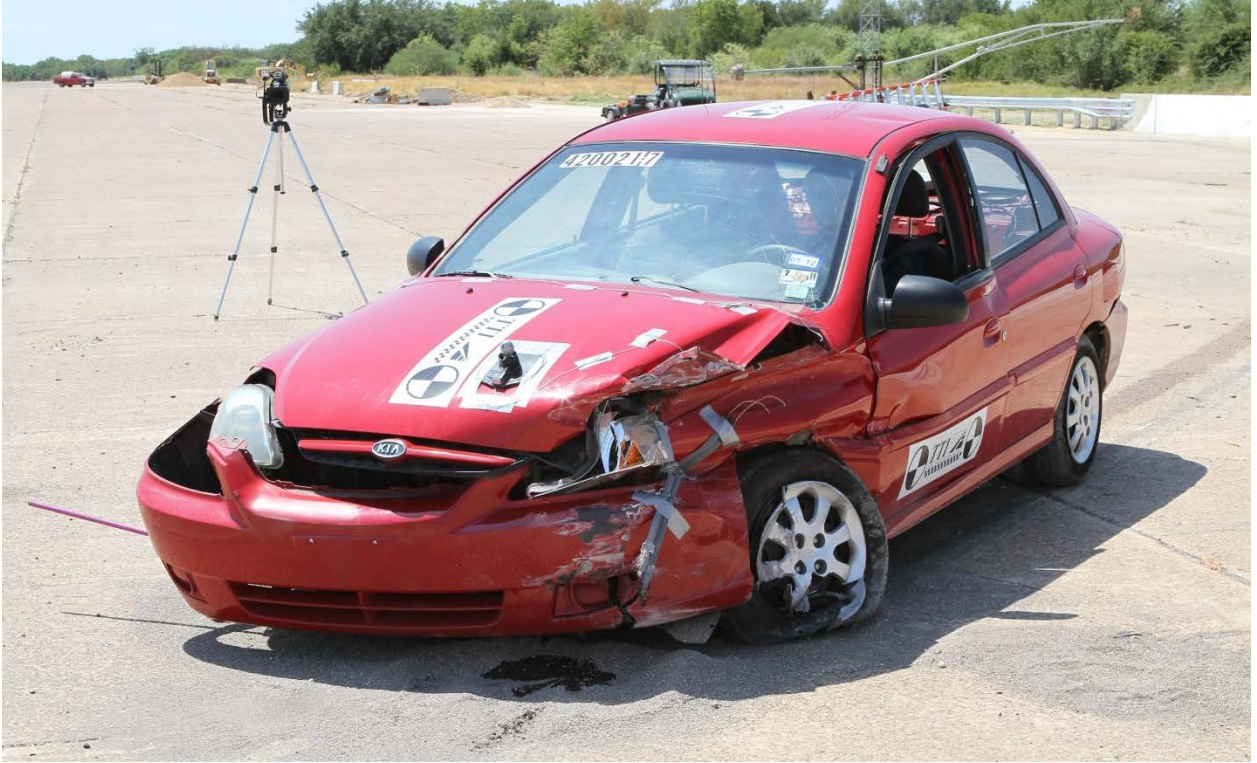
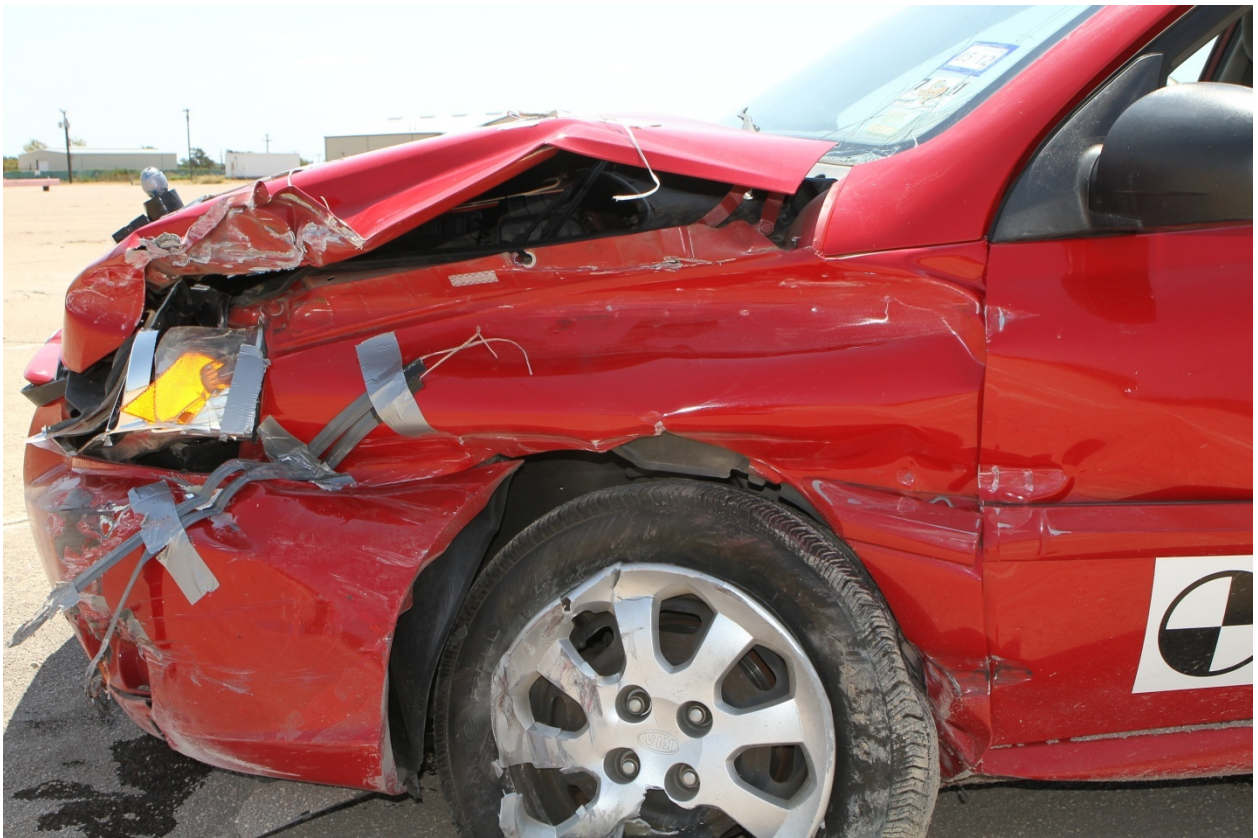
**Figure 8.5. Vehicle after Test No. 420021-7.**

Figure 8.5 shows the 1100C vehicle sustained damage to the left front corner. The left front strut and strut tower were deformed. Also damaged were the front bumper, hood, radiator and support, left front fender, left front tire and wheel rim, left front door and door glass, left rear quarter panel and rear bumper. The windshield sustained stress cracks, and the roof was buckled over an area measuring 3 inches  $\times$  5 inches  $\times$  0.5 inch deep. Maximum external crush of the vehicle was 13.0 inches in the front plane at the left front corner at bumper height. Maximum occupant compartment deformation was 0.5 inch in the lateral area across the occupant compartment at the level of the kick panel on the driver side. Figure 8.6 shows pictures of the interior of the vehicle. Tables C9 and C10 in Appendix C have data on the exterior crush and occupant compartment deformation measurements.

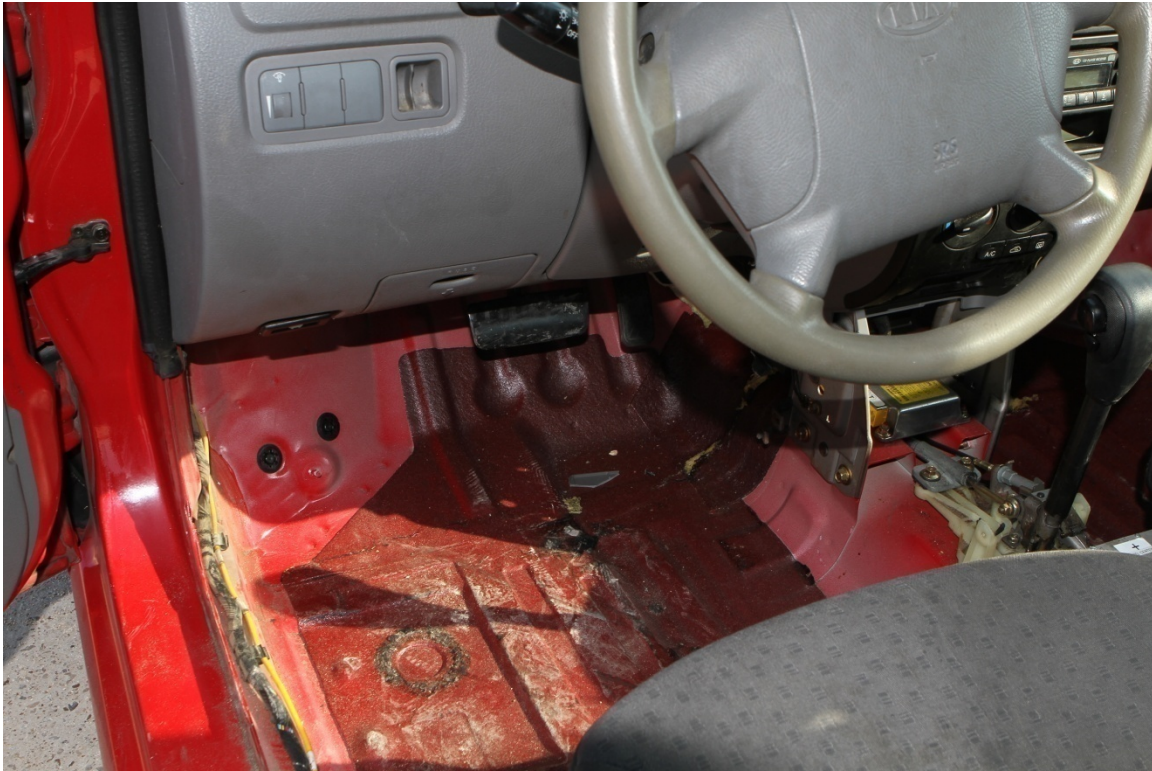
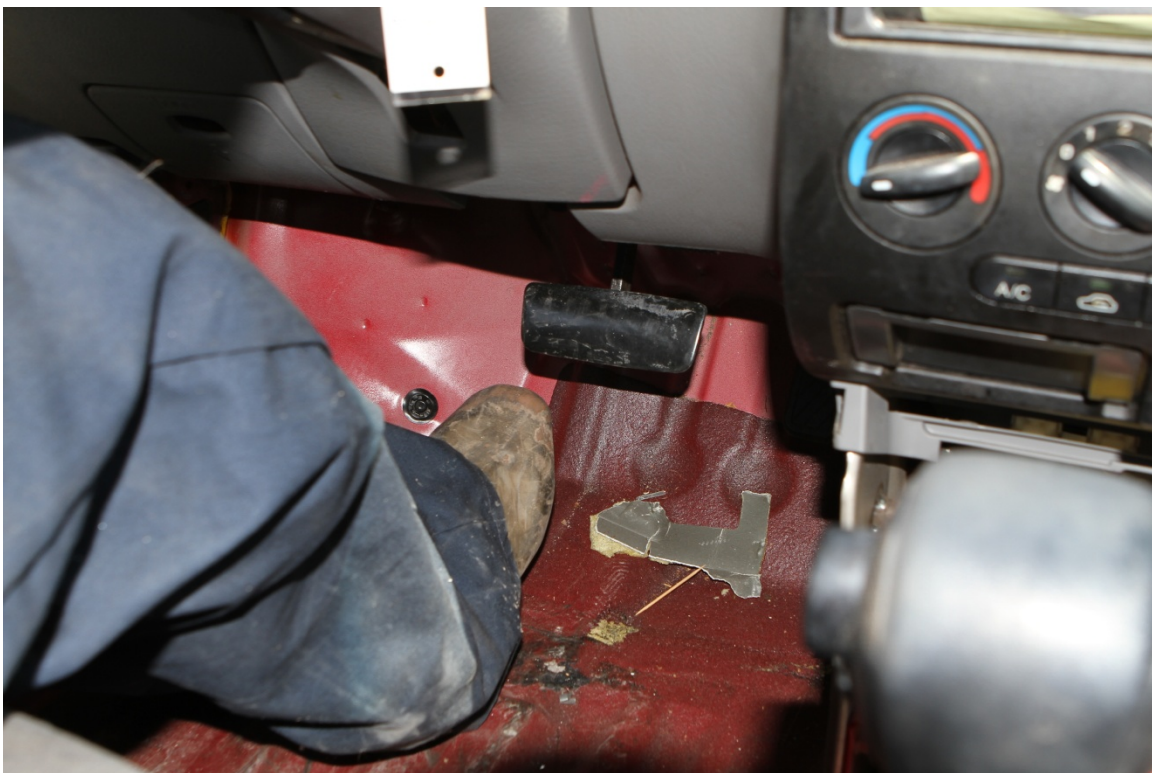
**Figure 8.6. Interior of Vehicle for Test No. 420021-7.**

Before Test  
After Test

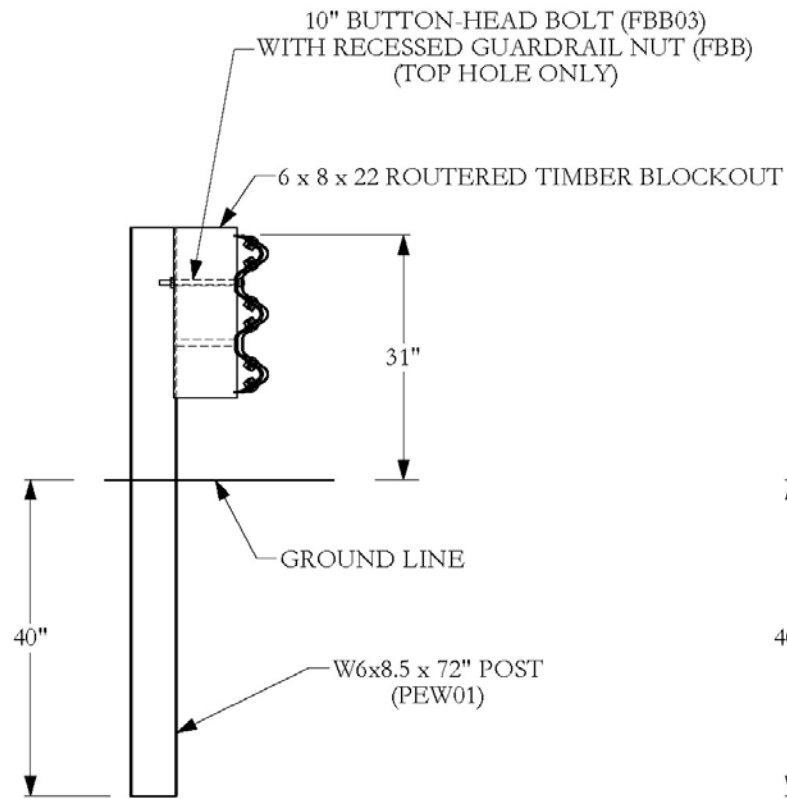
SECTION C-C  
SCALE 1 : 20

Texas Transportation Institute		The Texas A&M University System College Station, Texas 77843		
Project	420021-6	TL2 Bridge Rail Transition		
Drawn By	GES	Scale	1:20	Sheet 2 of 6 Section Views

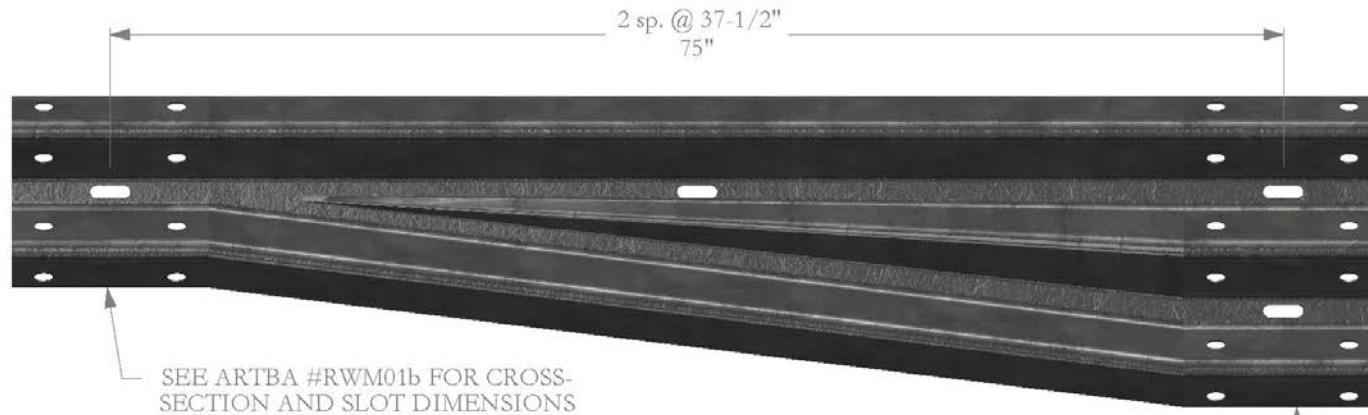
SEE ARTBA #RWM01b FOR CROSS-SECTION AND SLOT DIMENSIONS

10 ga. THRIE-BEAM TO W-BEAM  
ASYMMETRIC

SEE ARTBA #RTM01b FOR CROSS-SECTION AND SLOT DIMENSIONS

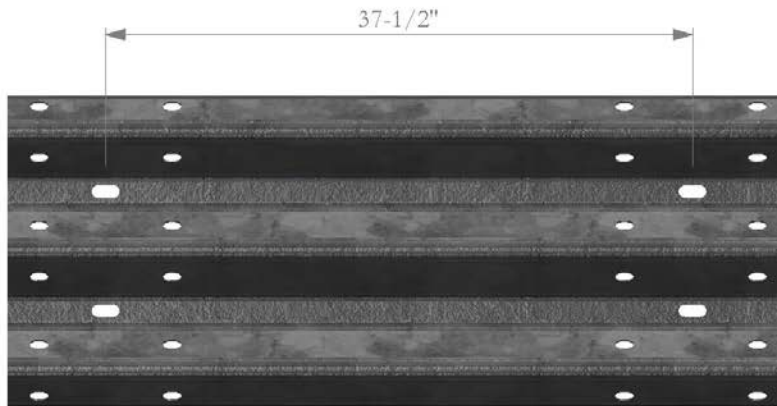
10 ga. THRIE-BEAM  
37-1/2" sp. LONG

SEE ARTBA #RTM01b FOR CROSS-SECTION AND SLOT DIMENSIONS

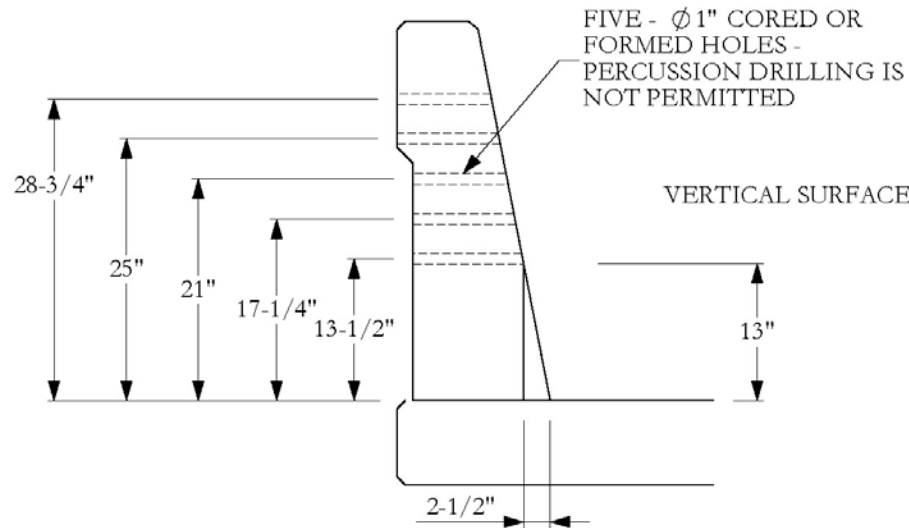
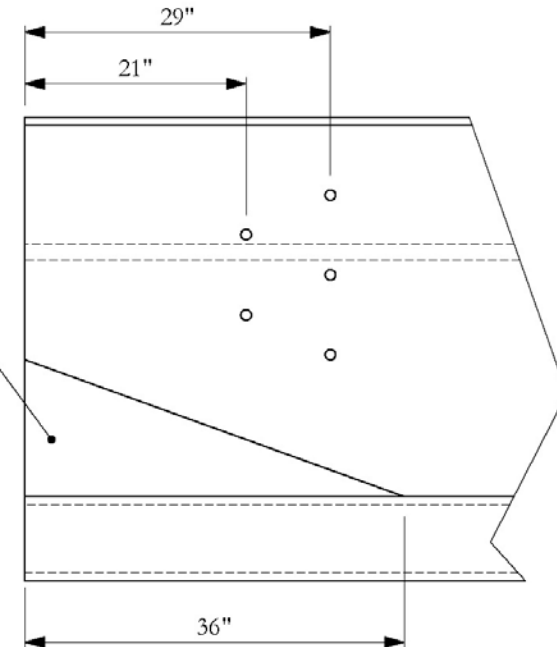
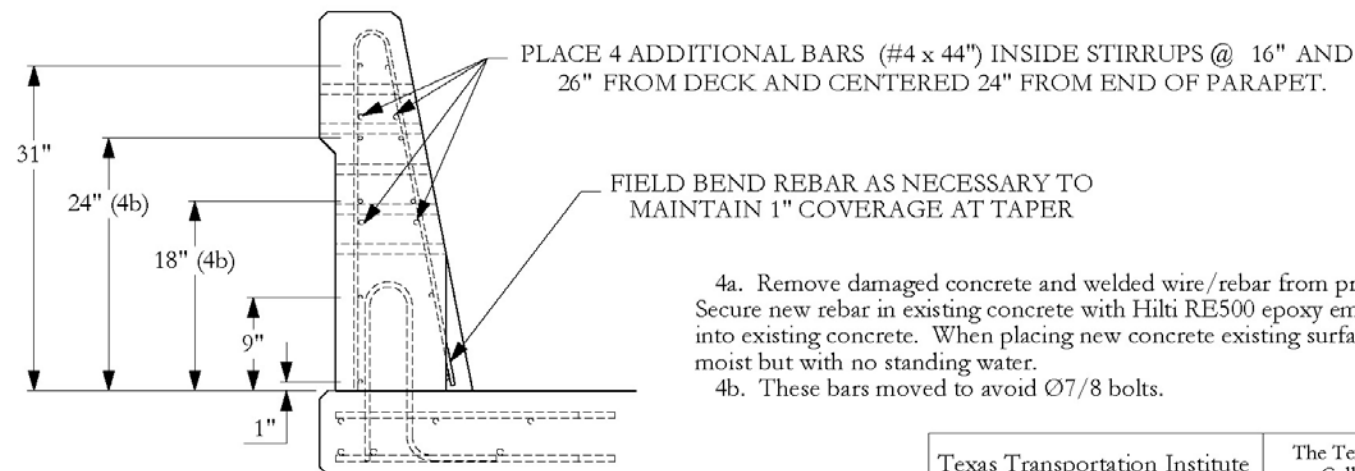
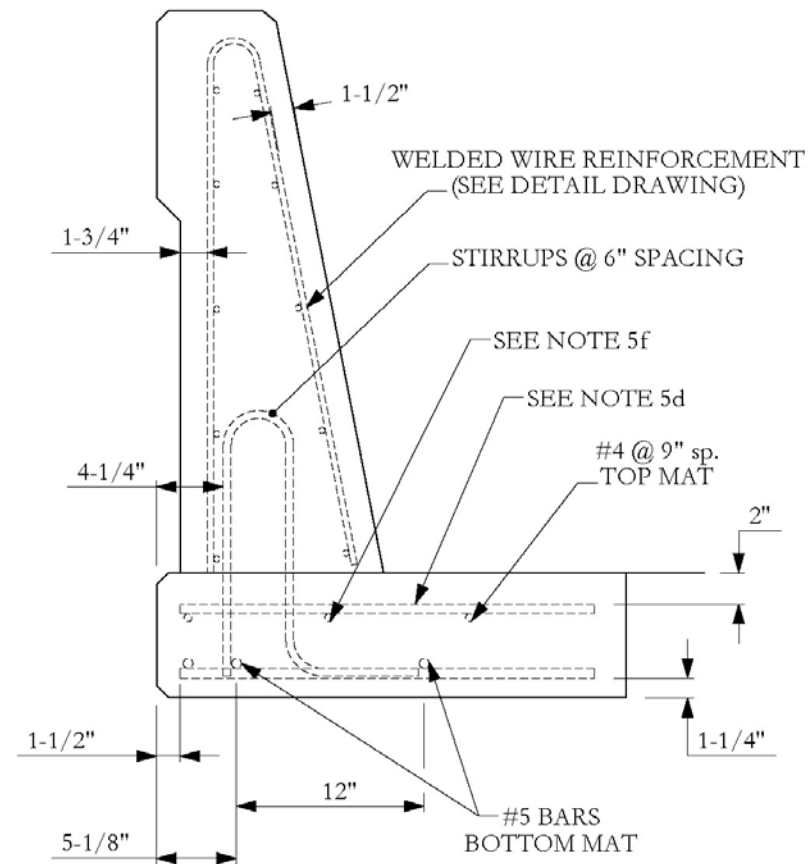
Texas Transportation Institute		The Texas A&M University System College Station, Texas 77843	
Project	420021-6	TL2 Bridge Rail Transition	
Drawn By	GES	Scale	1:10
Sheet	5 of 6	Concrete Details

4a. Remove damaged concrete and welded wire/rebar from previous test (app. 48"). Secure new rebar in existing concrete with Hilti RE500 epoxy embedded minimum 8" into existing concrete. When placing new concrete existing surfaces should be clean and moist but with no standing water.

4b. These bars moved to avoid  $\phi 7/8$  bolts.

CONCRETE CROSS-SECTION  
SCALE 1:15

REBAR PLACEMENT  
CROSS-SECTION

- 5a. Concrete is Class S (4000 psi) for the deck, and Class C (3600 psi) for the parapet.  
 5b. Transverse bars in deck weld to existing rebar (not shown) protruding from runway.  
 5c. Deck is canti-levered from runway.  
 5d. Transverse bars at 6" spacing in top mat, 18" at bottom.  
 5e. Rebar lap splices are 17" for #4's and 21" for #5's.  
 5f. This bar may be adjusted laterally +/- 3" to allow tying to stirrup.

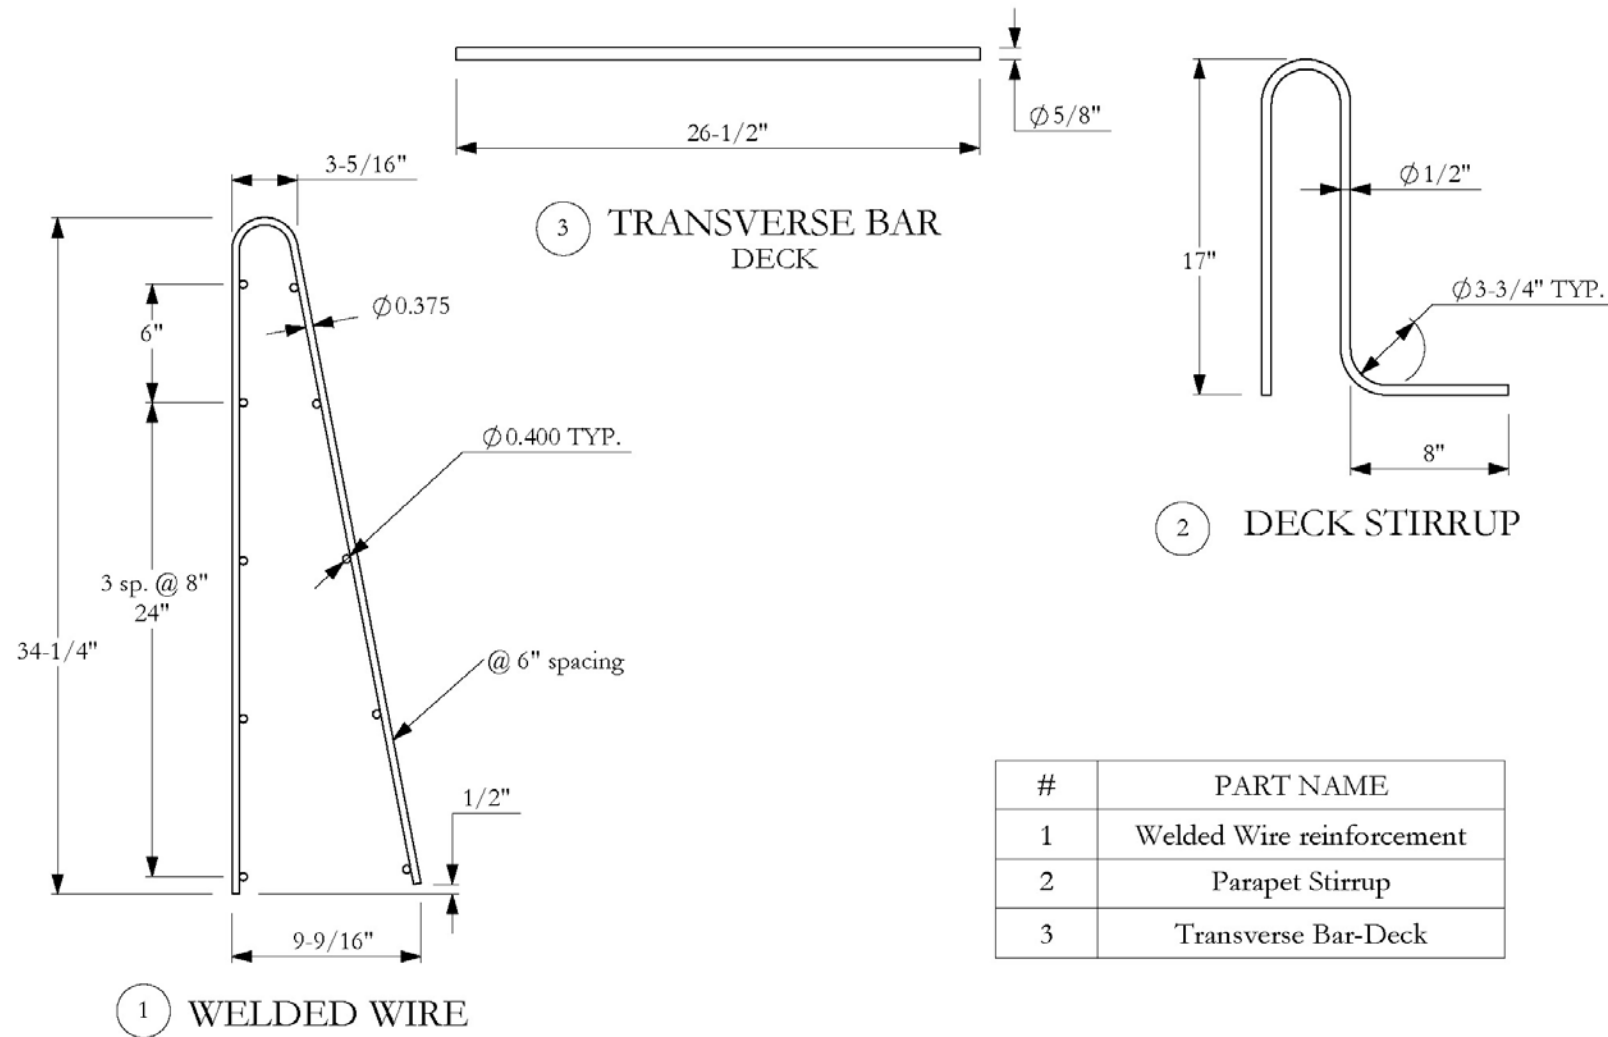
Texas Transportation Institute		The Texas A&M University System College Station, Texas 77843	
Project	420021-6	TL2 Bridge Rail Transition	
Drawn By	GES	Scale	1:8
Sheet		6 of 6	Rebar Details

- 6a. Welded Wire reinforcement is grade 70. All other rebar is grade 60.  
 6b. Where welded wire is removed to patch concrete for this test replace welded wire with #4 bars. Adjust spacing of longitudinal bars to avoid holes for  $\phi 7/8"$  bolts.

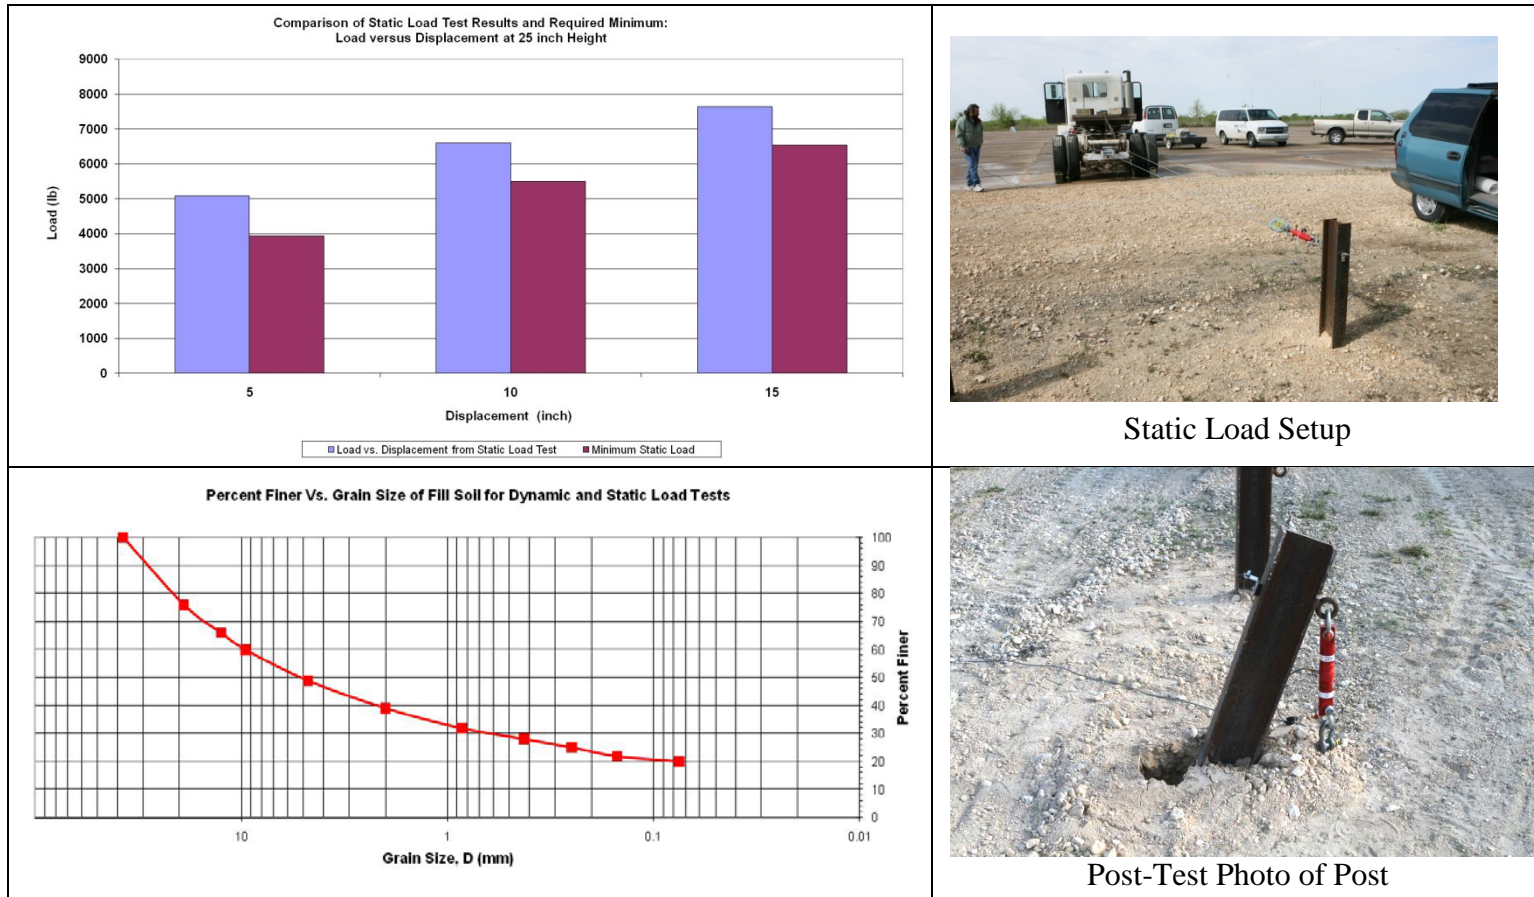
Date .....	2011-07-22
Test Facility and Site Location .....	TTI Proving Ground, 3100 SH 47, Bryan, TX
In Situ Soil Description (ASTM D2487) .....	Sandy gravel with silty fines
Fill Material Description (ASTM D2487) and sieve analysis .....	AASHTO Grade B Soil-Aggregate (see sieve analysis)
Description of Fill Placement Procedure .....	6-inch lifts tamped with a pneumatic compactor

**Figure B1. Test Day Static Soil Strength Documentation for Test No. 420021-4.**

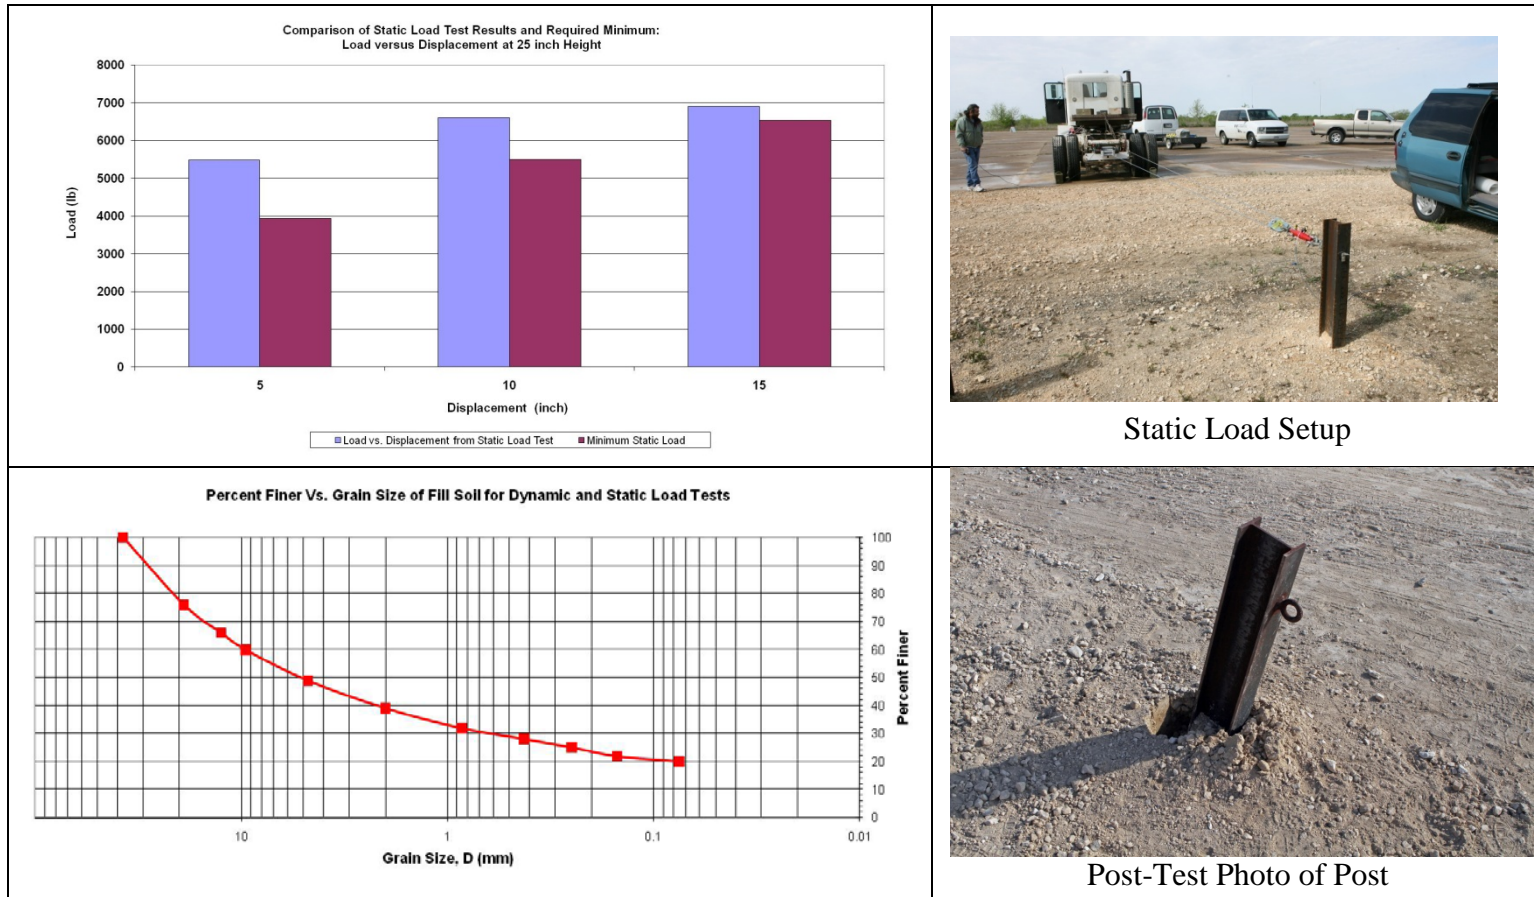
Date .....	2011-08-04
Test Facility and Site Location .....	TTI Proving Ground, 3100 SH 47, Bryan, TX
In Situ Soil Description (ASTM D2487) .....	Sandy gravel with silty fines
Fill Material Description (ASTM D2487) and sieve analysis .....	AASHTO Grade B Soil-Aggregate (see sieve analysis)
Description of Fill Placement Procedure .....	6-inch lifts tamped with a pneumatic compactor

**Figure B2. Test Day Static Soil Strength Documentation for Test No. 420021-6.**

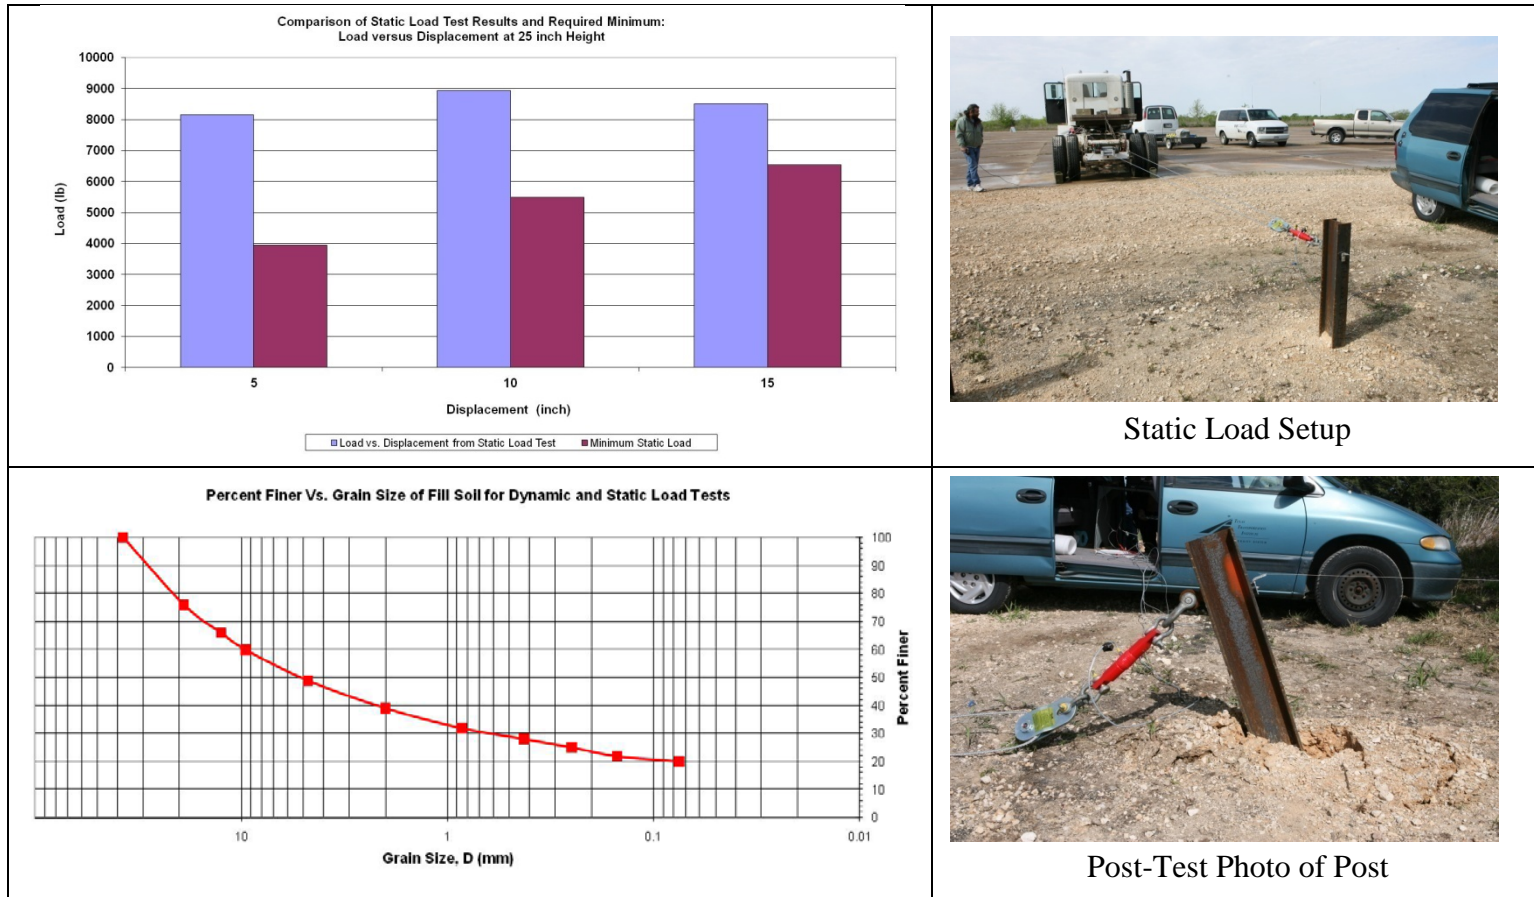
Date .....	2011-08-23
Test Facility and Site Location .....	TTI Proving Ground, 3100 SH 47, Bryan, TX
In Situ Soil Description (ASTM D2487) .....	Sandy gravel with silty fines
Fill Material Description (ASTM D2487) and sieve analysis .....	AASHTO Grade B Soil-Aggregate (see sieve analysis)
Description of Fill Placement Procedure .....	6-inch lifts tamped with a pneumatic compactor

**Figure B3. Test Day Static Soil Strength Documentation for Test No. 420021-7.**
