# DEVELOPMENT OF A *MASH* TL-2 GUARDRAIL-TO-BRIDGE RAIL TRANSITION COMPATIBLE WITH 31-INCH GUARDRAIL

## Test Report 9-1002-8

TEXAS TRANSPORTATION INSTITUTE  
THE TEXAS A&M UNIVERSITY SYSTEM  
COLLEGE STATION, TEXAS

TEXAS DEPARTMENT OF TRANSPORTATION

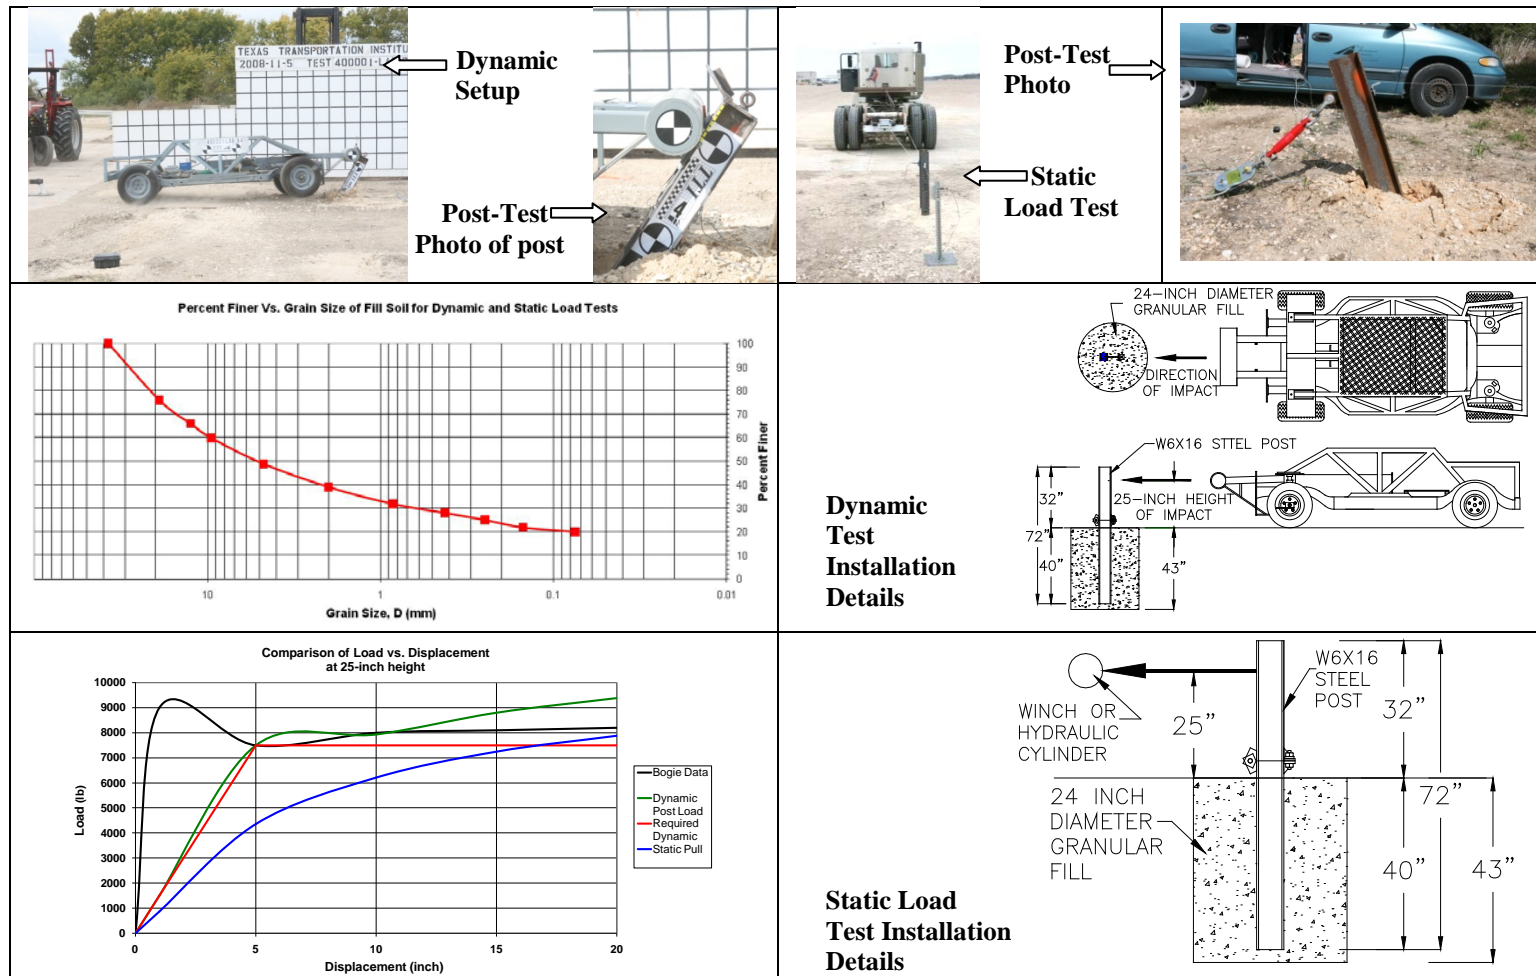
Date .....	2008-11-05
Test Facility and Site Location .....	TTI Proving Ground, 3100 SH 47, Bryan, TX 77807
In Situ Soil Description (ASTM D2487) .....	Sandy gravel with silty fines
Fill Material Description (ASTM D2487) and sieve analysis .....	AASHTO Grade B Soil-Aggregate (see sieve analysis above)
Description of Fill Placement Procedure .....	6-inch lifts tamped with a pneumatic compactor
Bogie Weight .....	5009 lb
Impact Velocity .....	20.5 mph

**Figure B4. Summary of Strong Soil Test Results for Establishing Installation Procedure.**

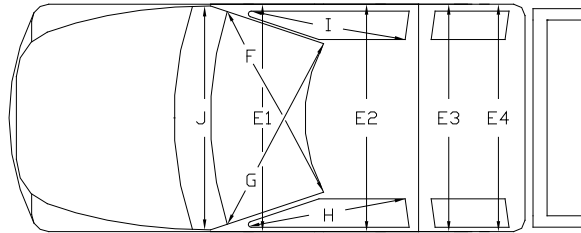
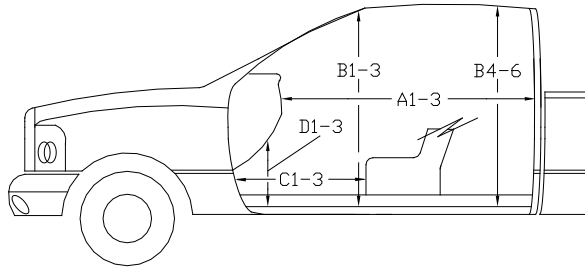
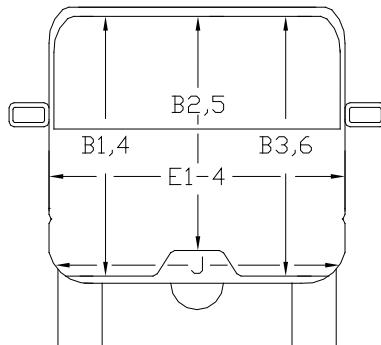
**Table C4. Occupant Compartment Measurements for Test No. 420021-4.**

**OCCUPANT COMPARTMENT  
DEFORMATION MEASUREMENT**

<b>Before ( inches )</b>	<b>After ( inches )</b>
A1	64.25	64.25
A2	64.50	64.50
A3	65.25	65.25
B1	45.50	45.50
B2	39.12	39.12
B3	45.50	45.50
B4	42.00	42.00
B5	42.75	42.75
B6	42.00	42.00
C1	29.75	27.75
C2	---	---
C3	27.25	27.25
D1	12.75	13.12
D2	2.50	2.50
D3	11.50	11.50
E1	62.50	62.50
E2	64.25	64.25
E3	64.00	64.00
E4	64.00	64.00
F	60.50	60.50
G	62.00	62.00
H	39.50	39.50
I	39.50	39.50
J*	62.25	61.75

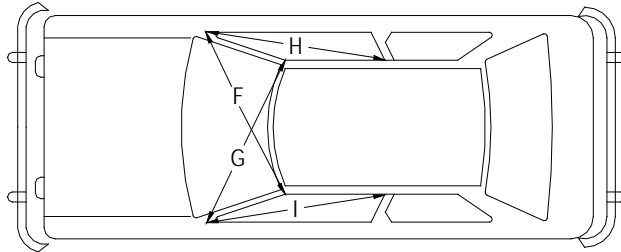
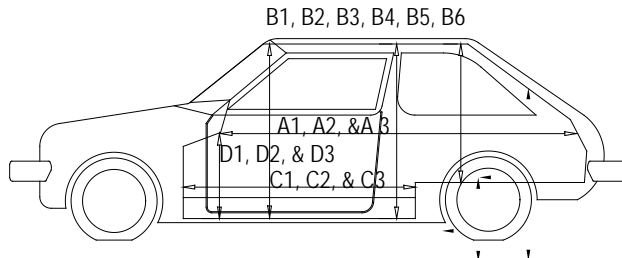
**Table C7. Occupant Compartment Measurements for Test No. 420021-6.**

**OCCUPANT COMPARTMENT  
DEFORMATION MEASUREMENT**

<b>Before</b> ( inches )	<b>After</b> ( inches )
A1	67.25	67.25
A2	65.00	65.00
A3	37.25	37.25
B1	39.50	39.50
B2	35.50	35.50
B3	39.50	39.50
B4	34.75	34.75
B5	35.00	35.00
B6	34.75	34.75
C1	27.00	27.00
C2	----	----
C3	27.00	27.00
D1	9.75	9.75
D2	----	----
D3	9.25	9.25
E1	48.50	48.50
E2	50.50	50.50
F	49.00	49.00
G	49.00	49.00
H	36.50	36.50
I	36.50	36.50
J*	50.25	50.00

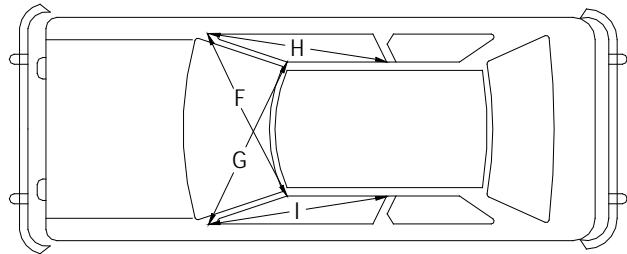
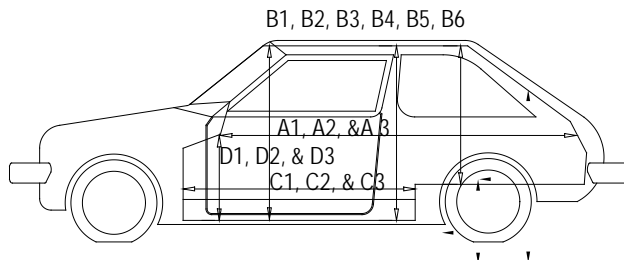
**Table C10. Occupant Compartment Measurements for Test No. 420021-7.**

**OCCUPANT COMPARTMENT  
DEFORMATION MEASUREMENT**

<b>Before</b> ( inches )	<b>After</b> ( inches )
A1	67.00	67.00
A2	65.25	65.25
A3	67.00	67.00
B1	39.50	39.50
B2	35.50	35.50
B3	39.50	39.50
B4	34.50	34.50
B5	34.75	34.75
B6	34.50	34.50
C1	26.25	26.25
C2	----	----
C3	26.25	26.25
D1	9.75	9.75
D2	-----	-----
D3	9.50	9.50
E1	48.50	49.00
E2	50.50	51.75
F	49.00	49.00
G	49.00	49.00
H	36.50	36.50
I	36.50	36.50
J*	20.25	49.75

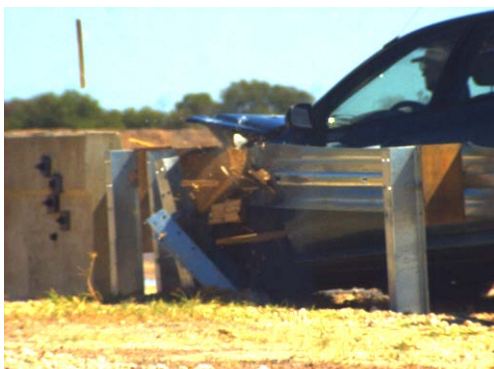
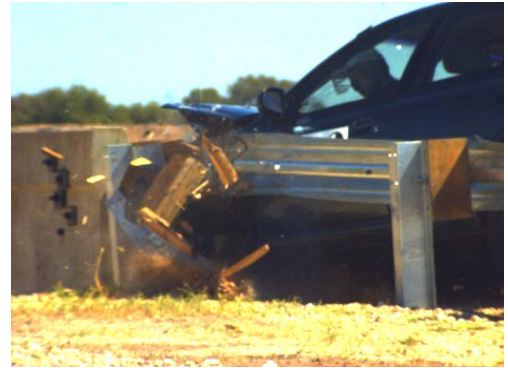
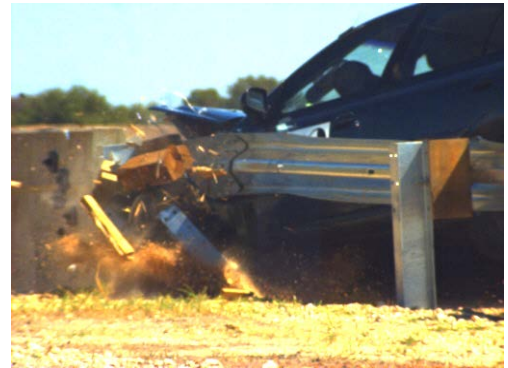
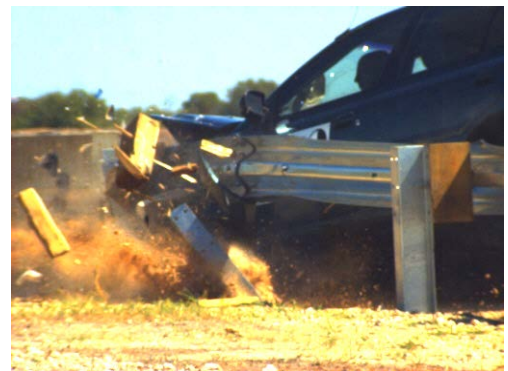
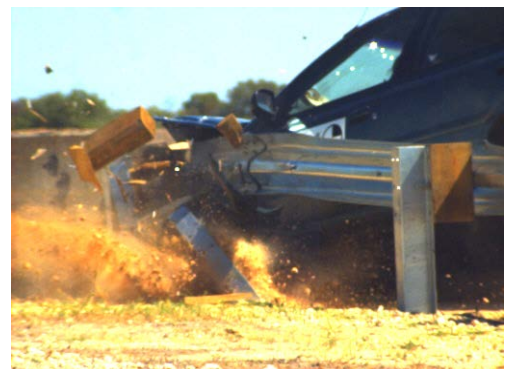
**Figure D4. Sequential Photographs for Test No.420021-6  
(Rear View).**

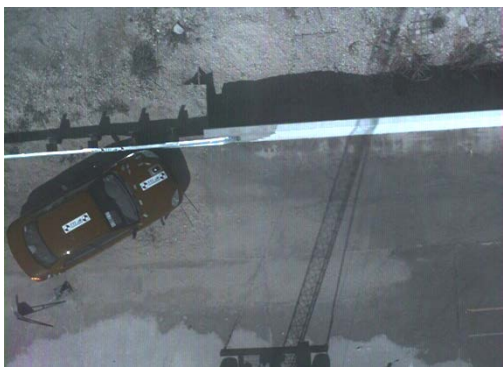
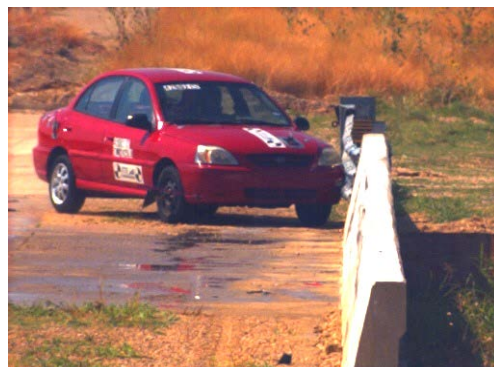
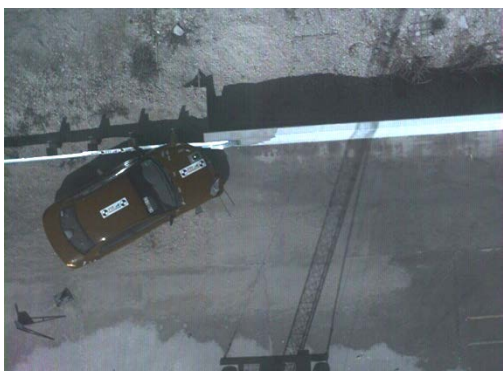
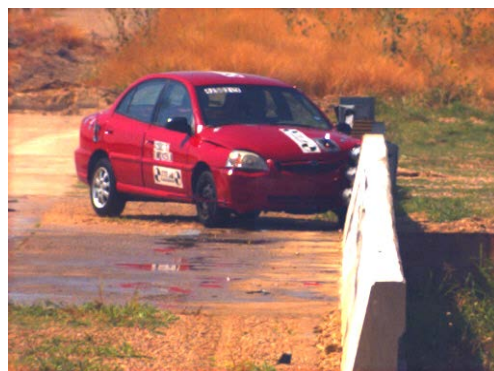
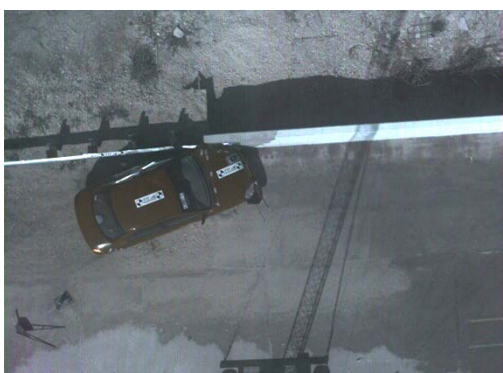
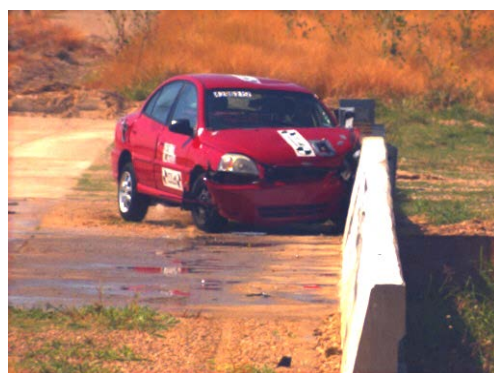
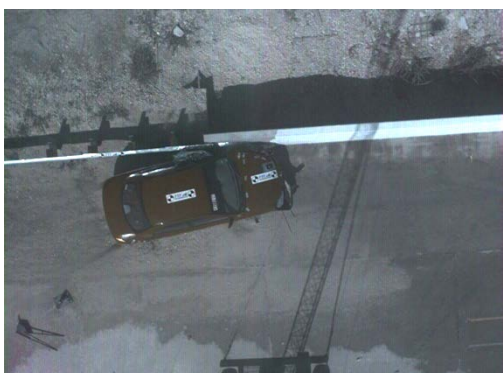
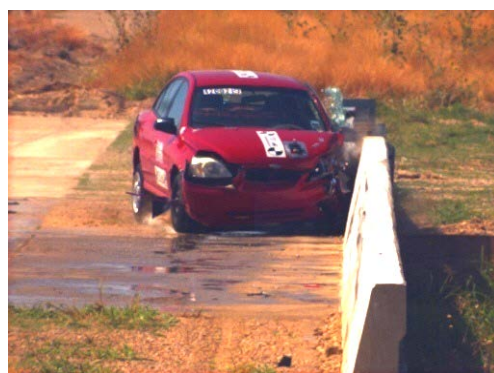
**Figure D5. Sequential Photographs for Test No. 420021-7  
(Overhead and Frontal Views).**

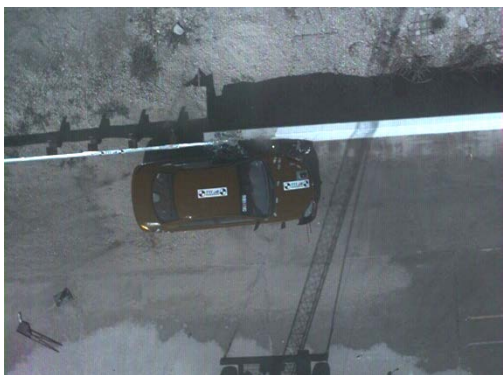
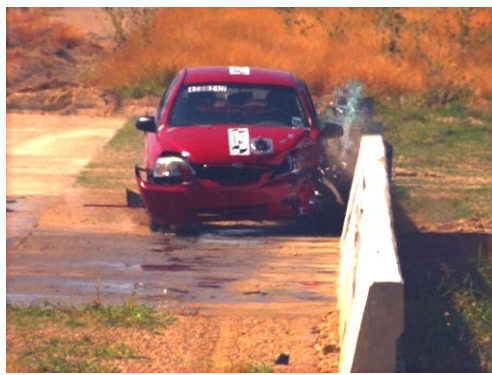
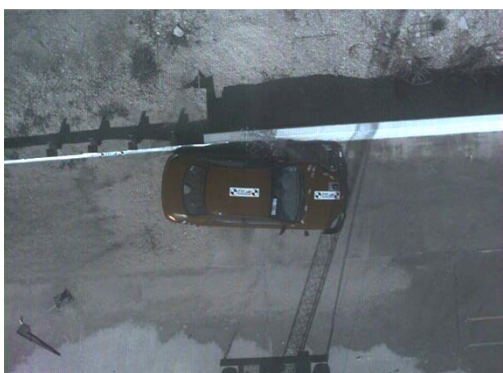
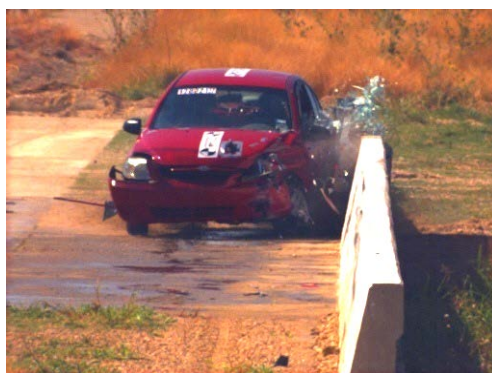
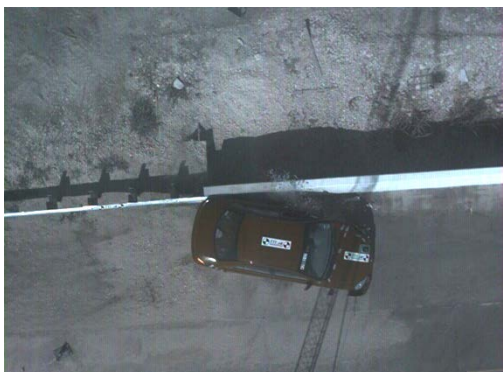
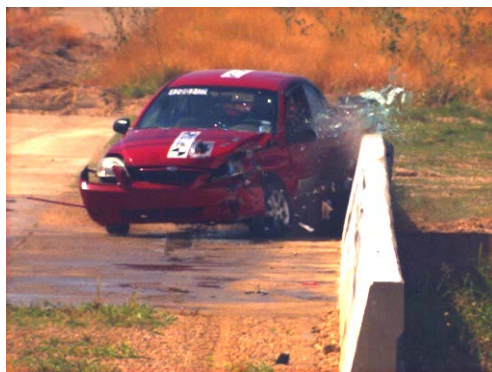
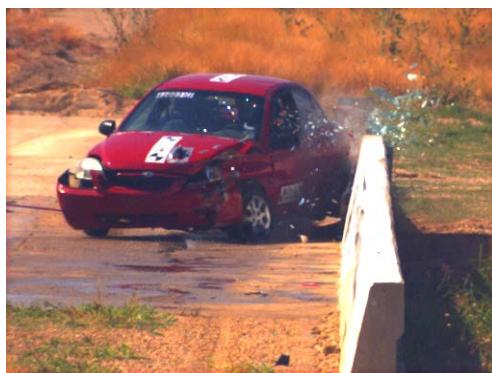
**Figure D5. Sequential Photographs for Test No. 420021-7  
(Overhead and Frontal Views) (continued).**

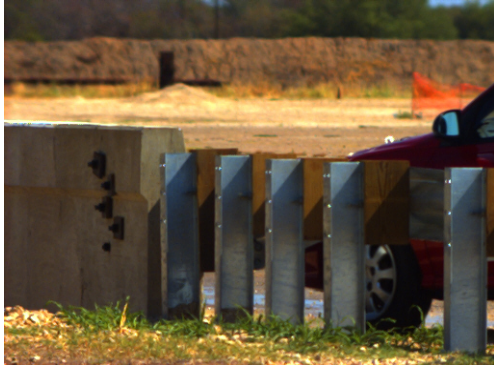
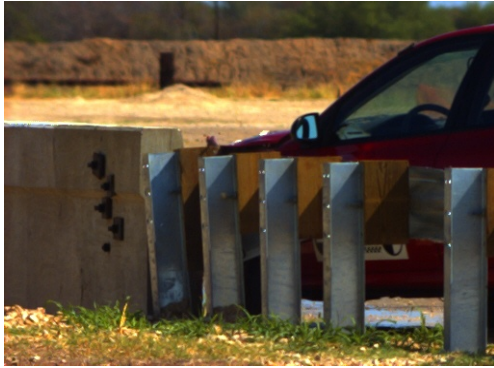
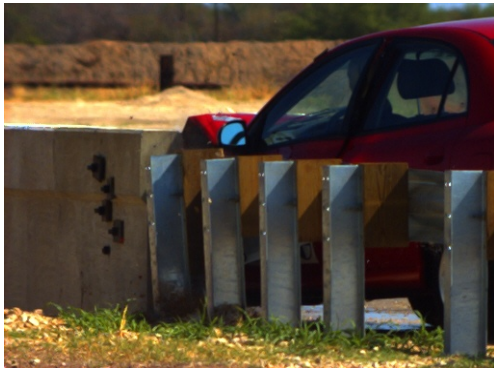
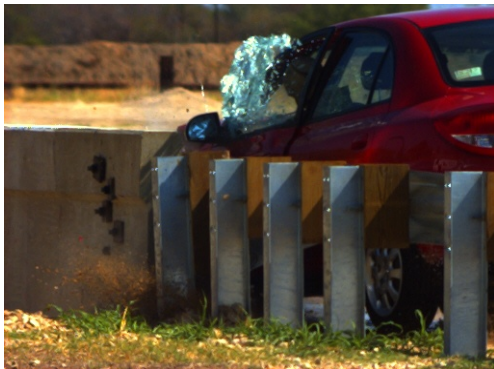
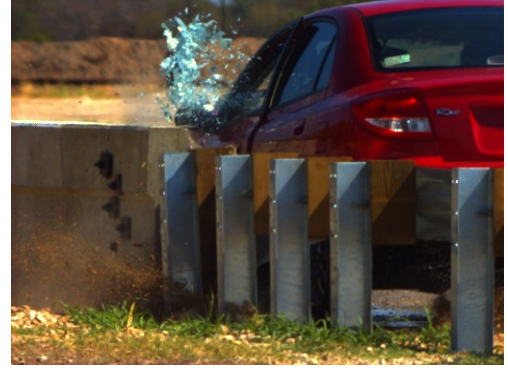
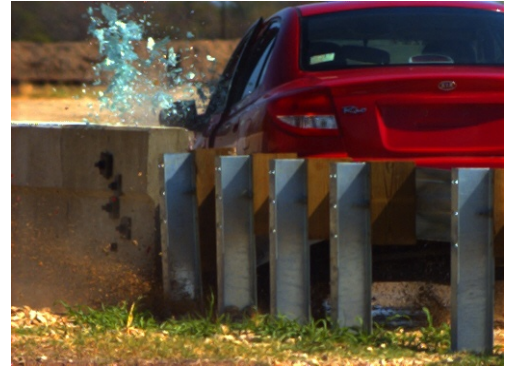
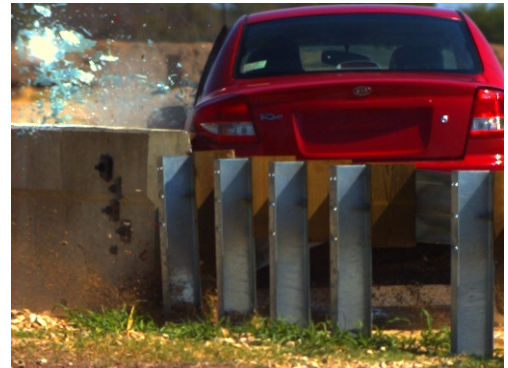
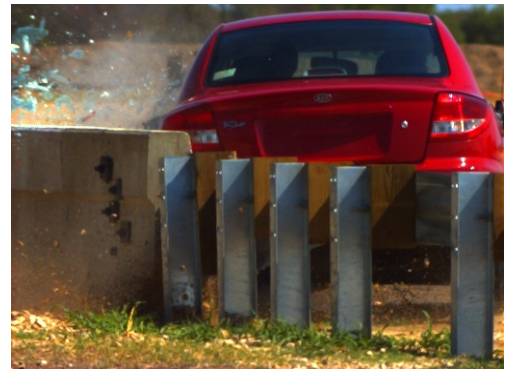
**Figure D6. Sequential Photographs for Test No.420021-7  
(Rear View).**

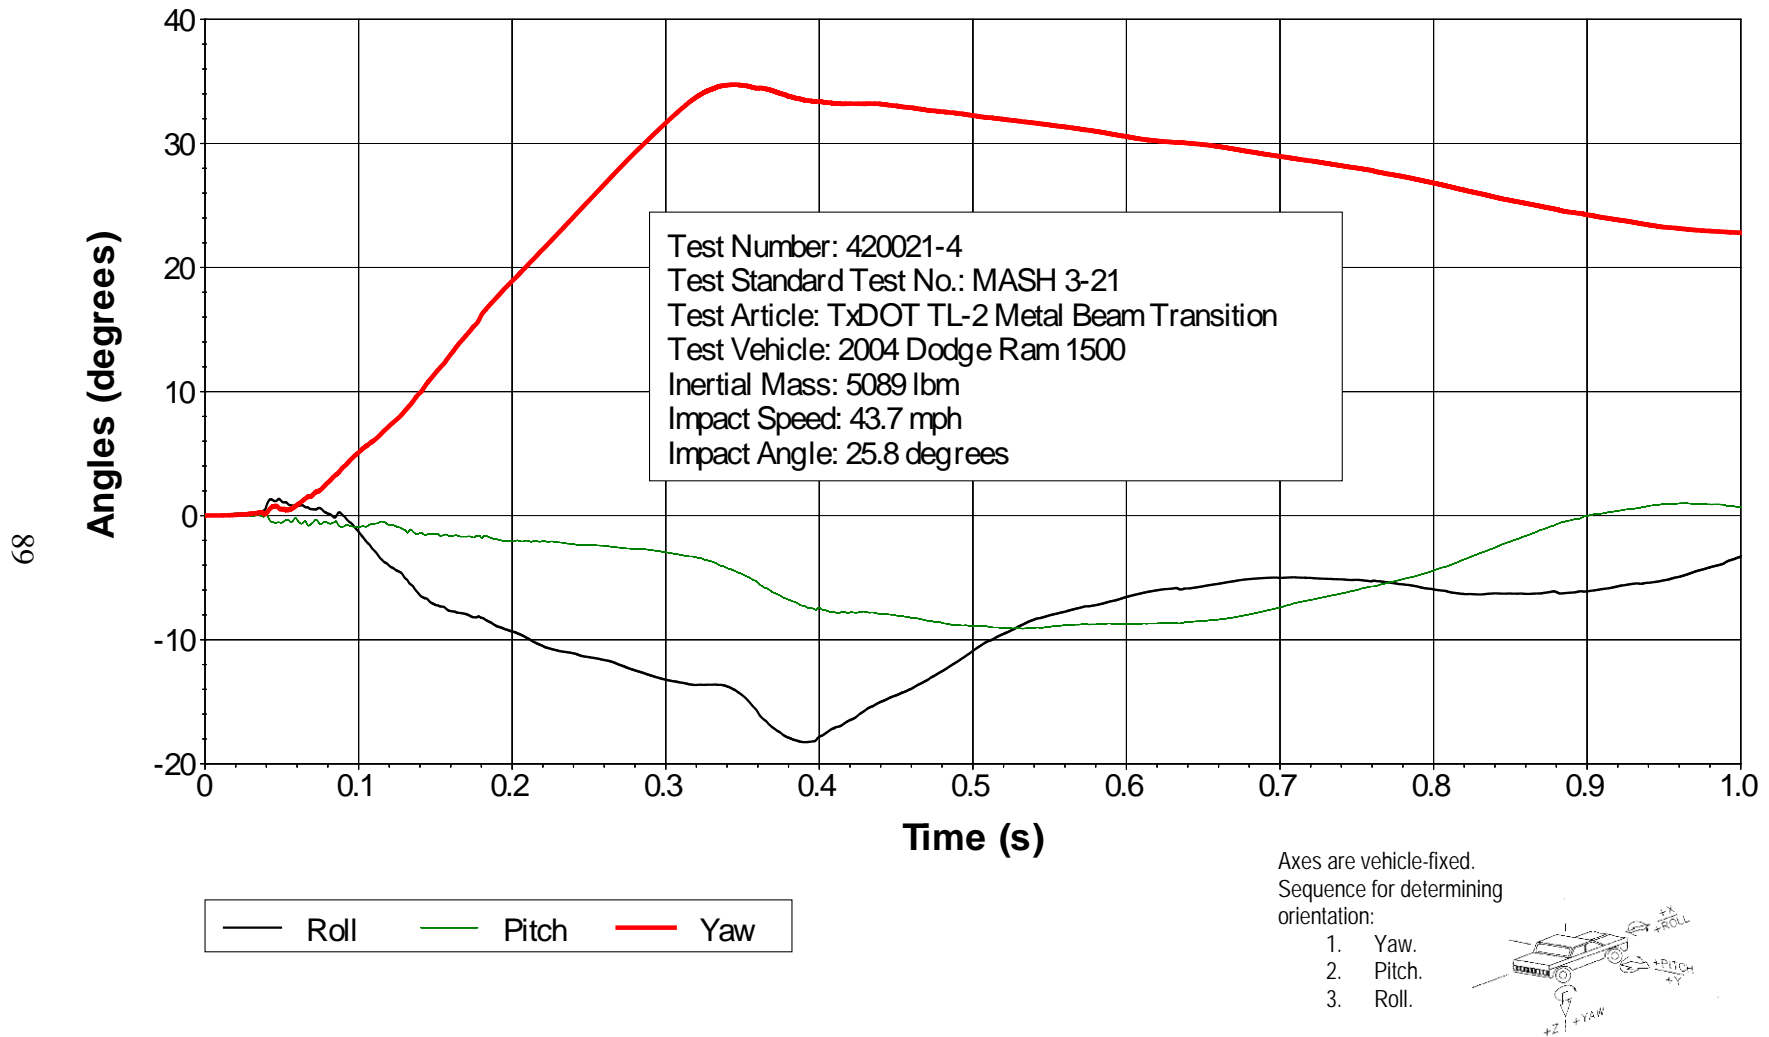
Figure E1. Vehicle Angular Displacements for Test No. 420021-4.

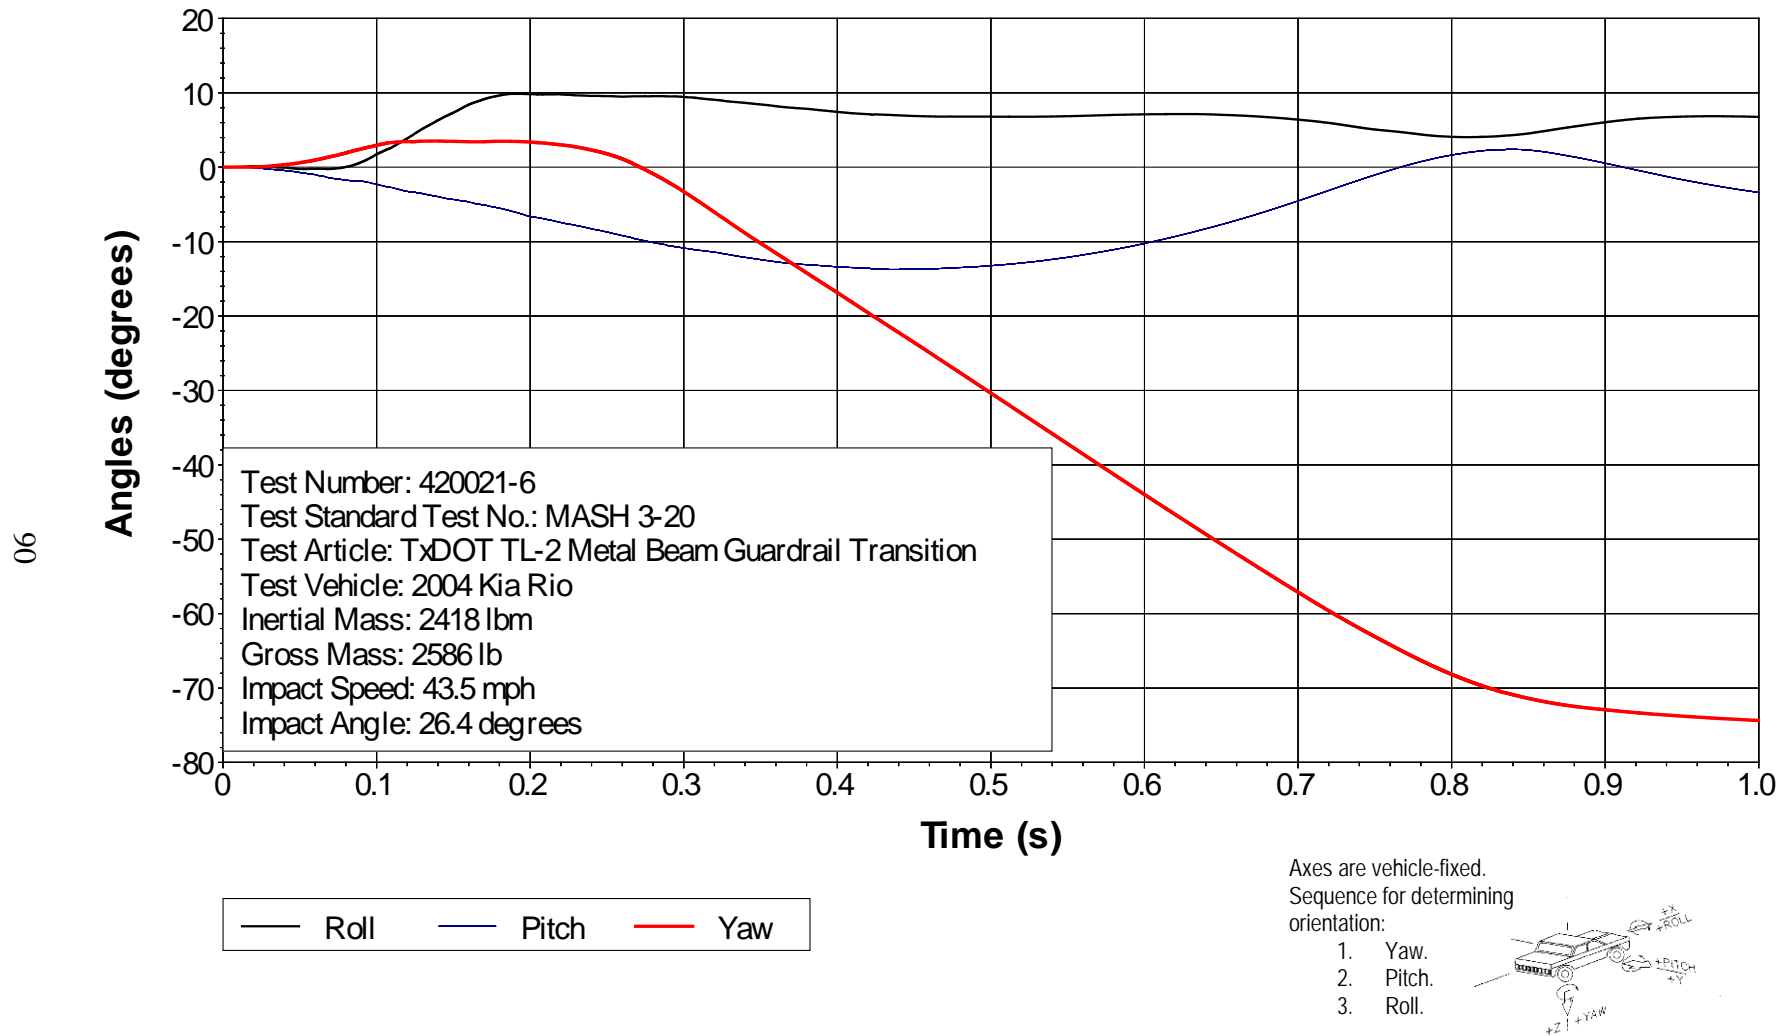
Figure E2. Vehicle Angular Displacements for Test No. 420021-6.

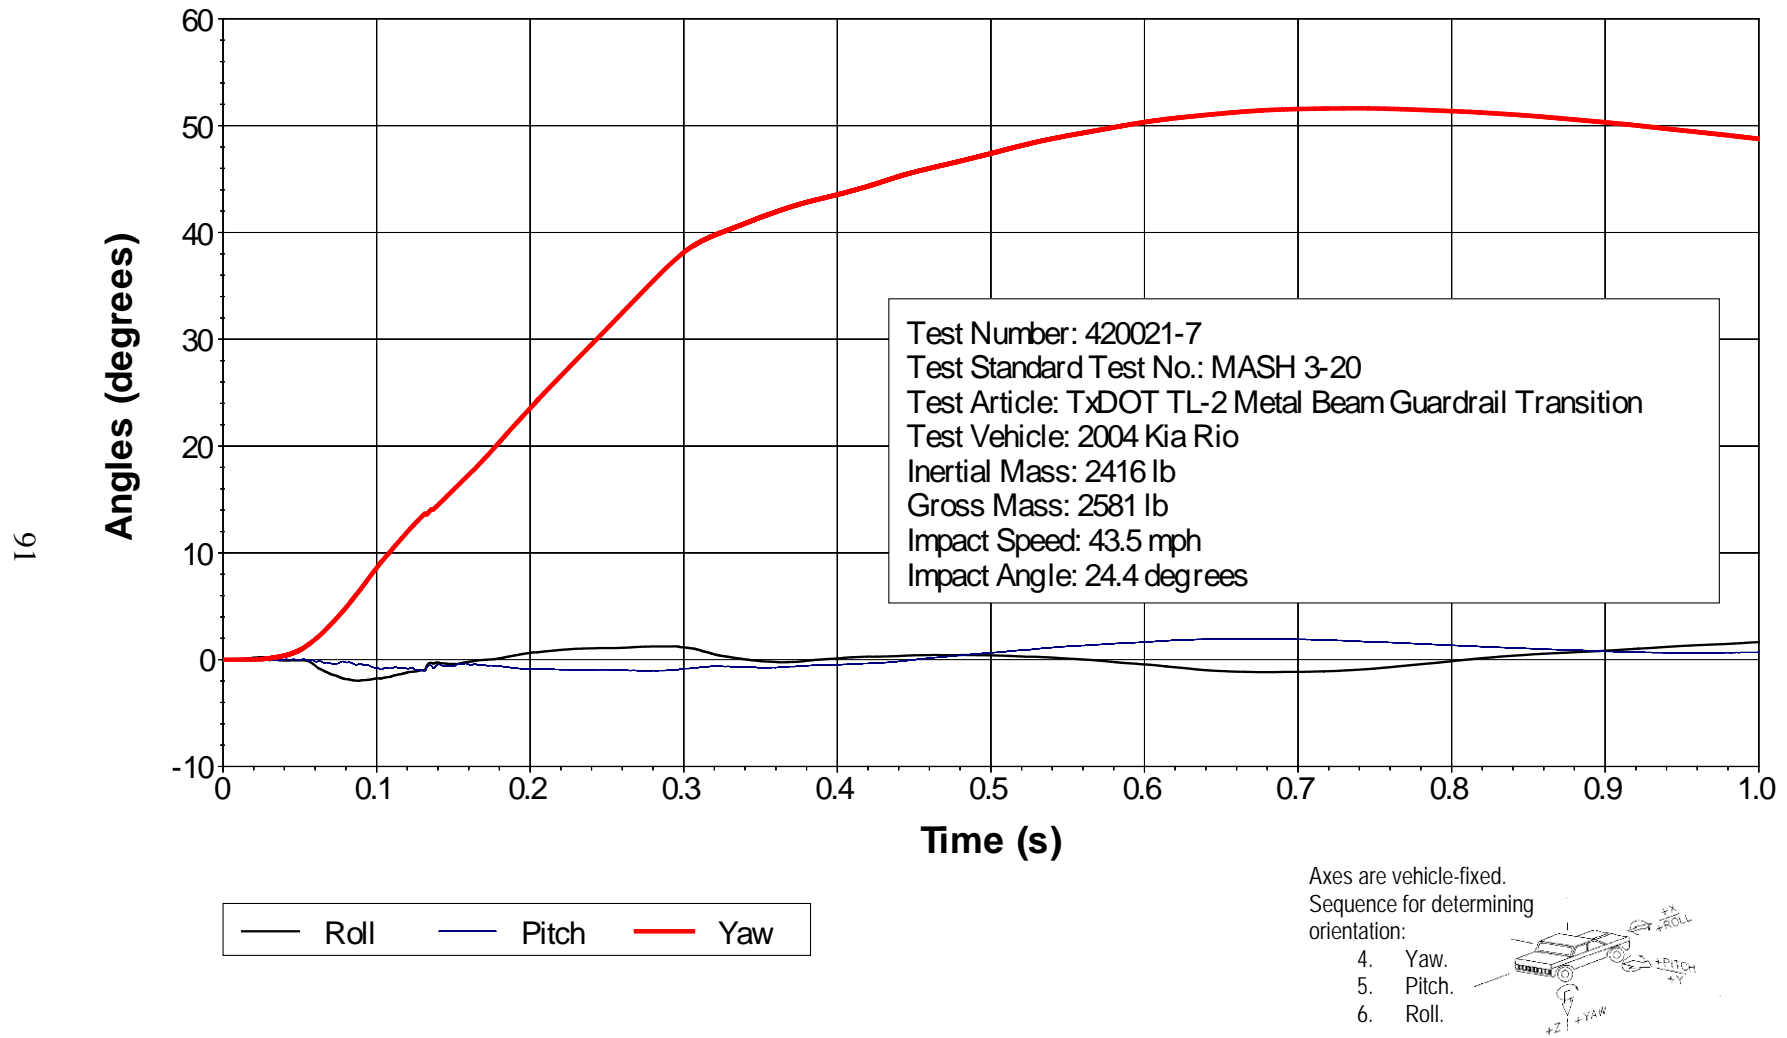
Figure E3. Vehicle Angular Displacements for Test No. 420021-7.

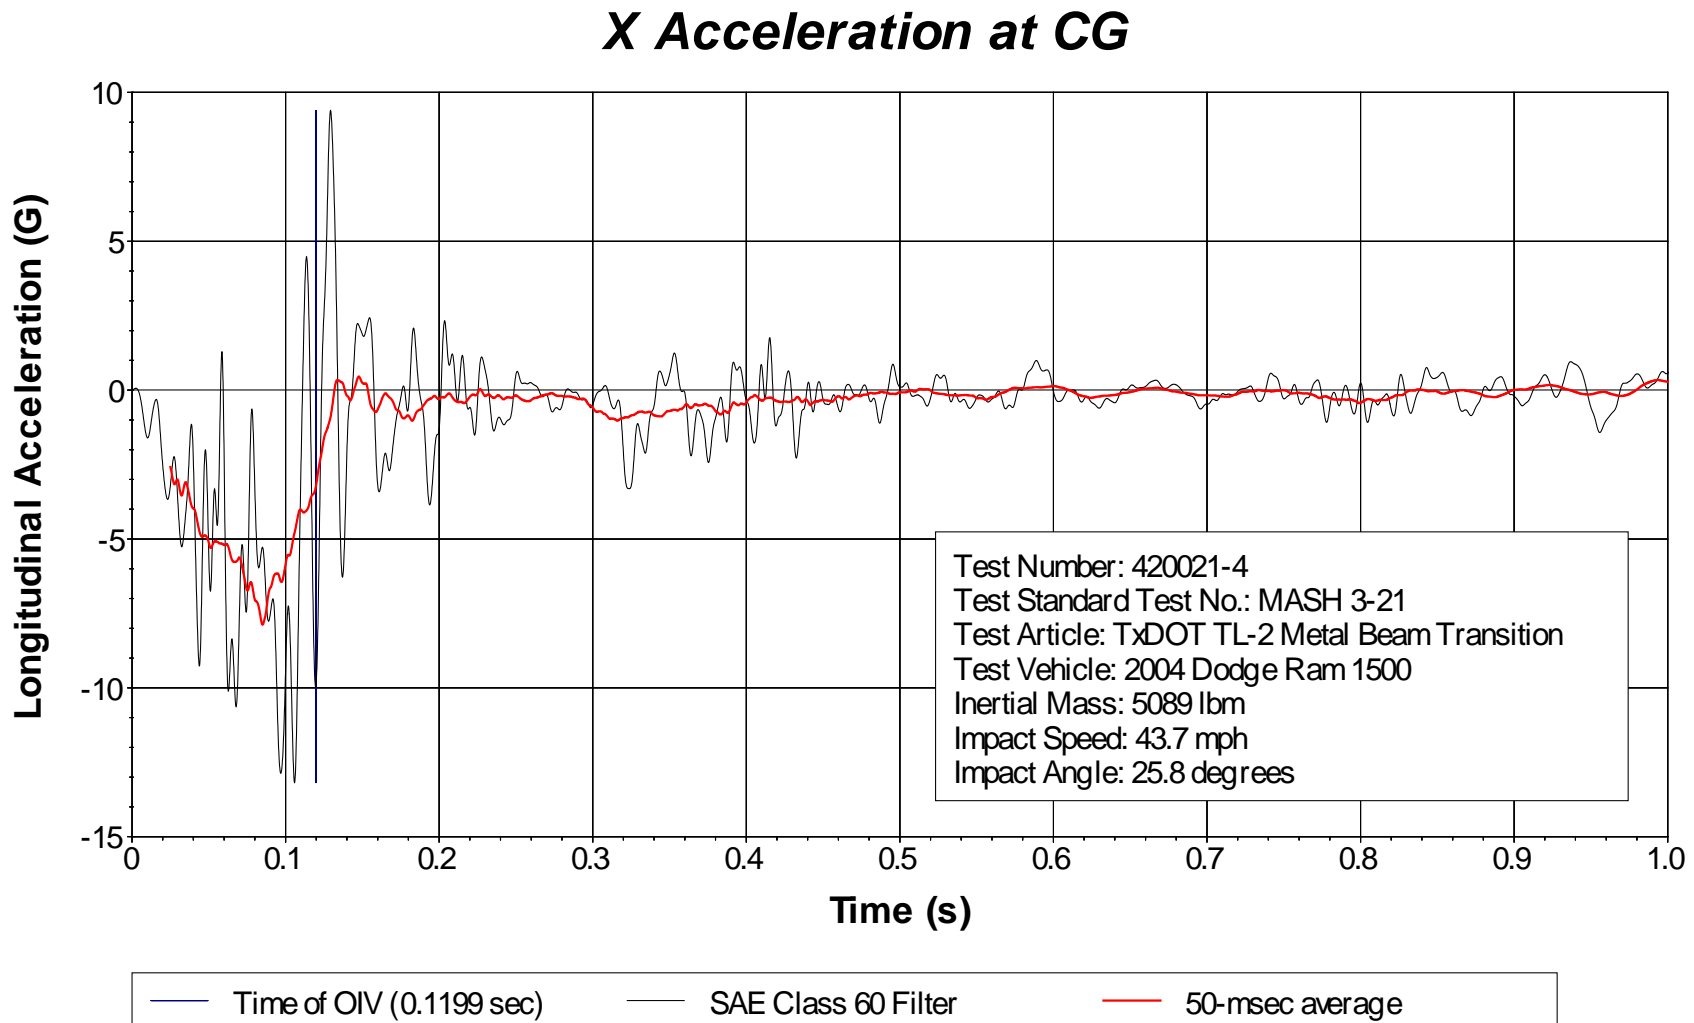
**Figure F1. Vehicle Longitudinal Accelerometer Trace for Test No. 420021-4  
 (Accelerometer Located at Center of Gravity).**

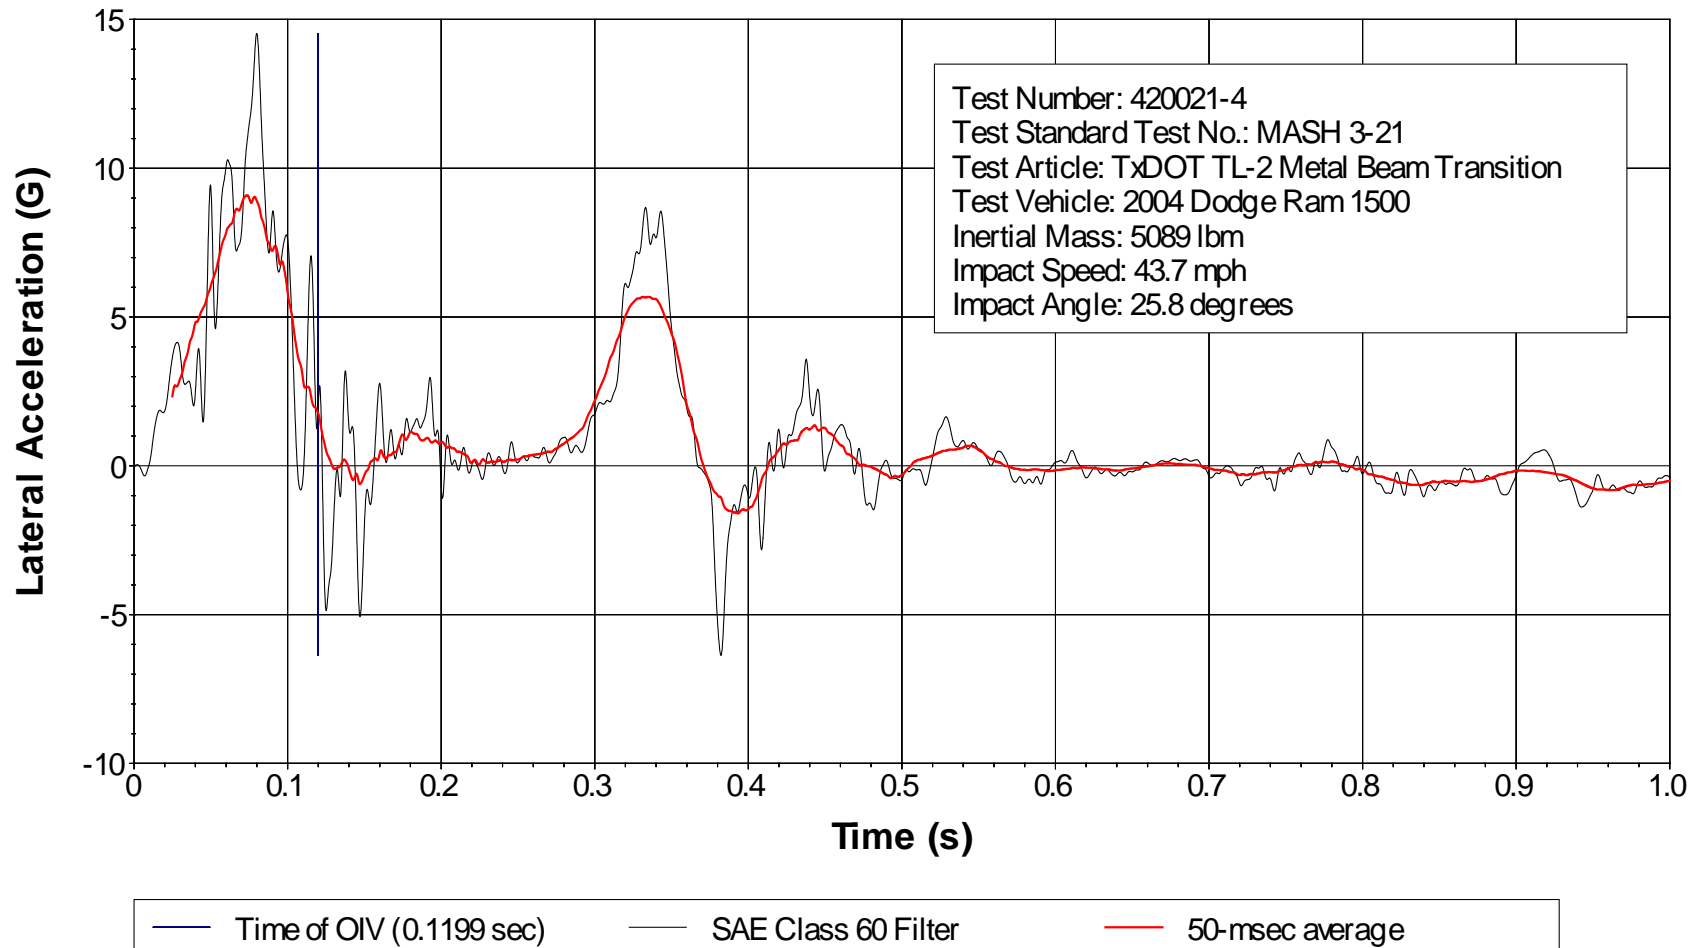
**Figure F2. Vehicle Lateral Accelerometer Trace for Test No. 420021-4  
(Accelerometer Located at Center of Gravity).**

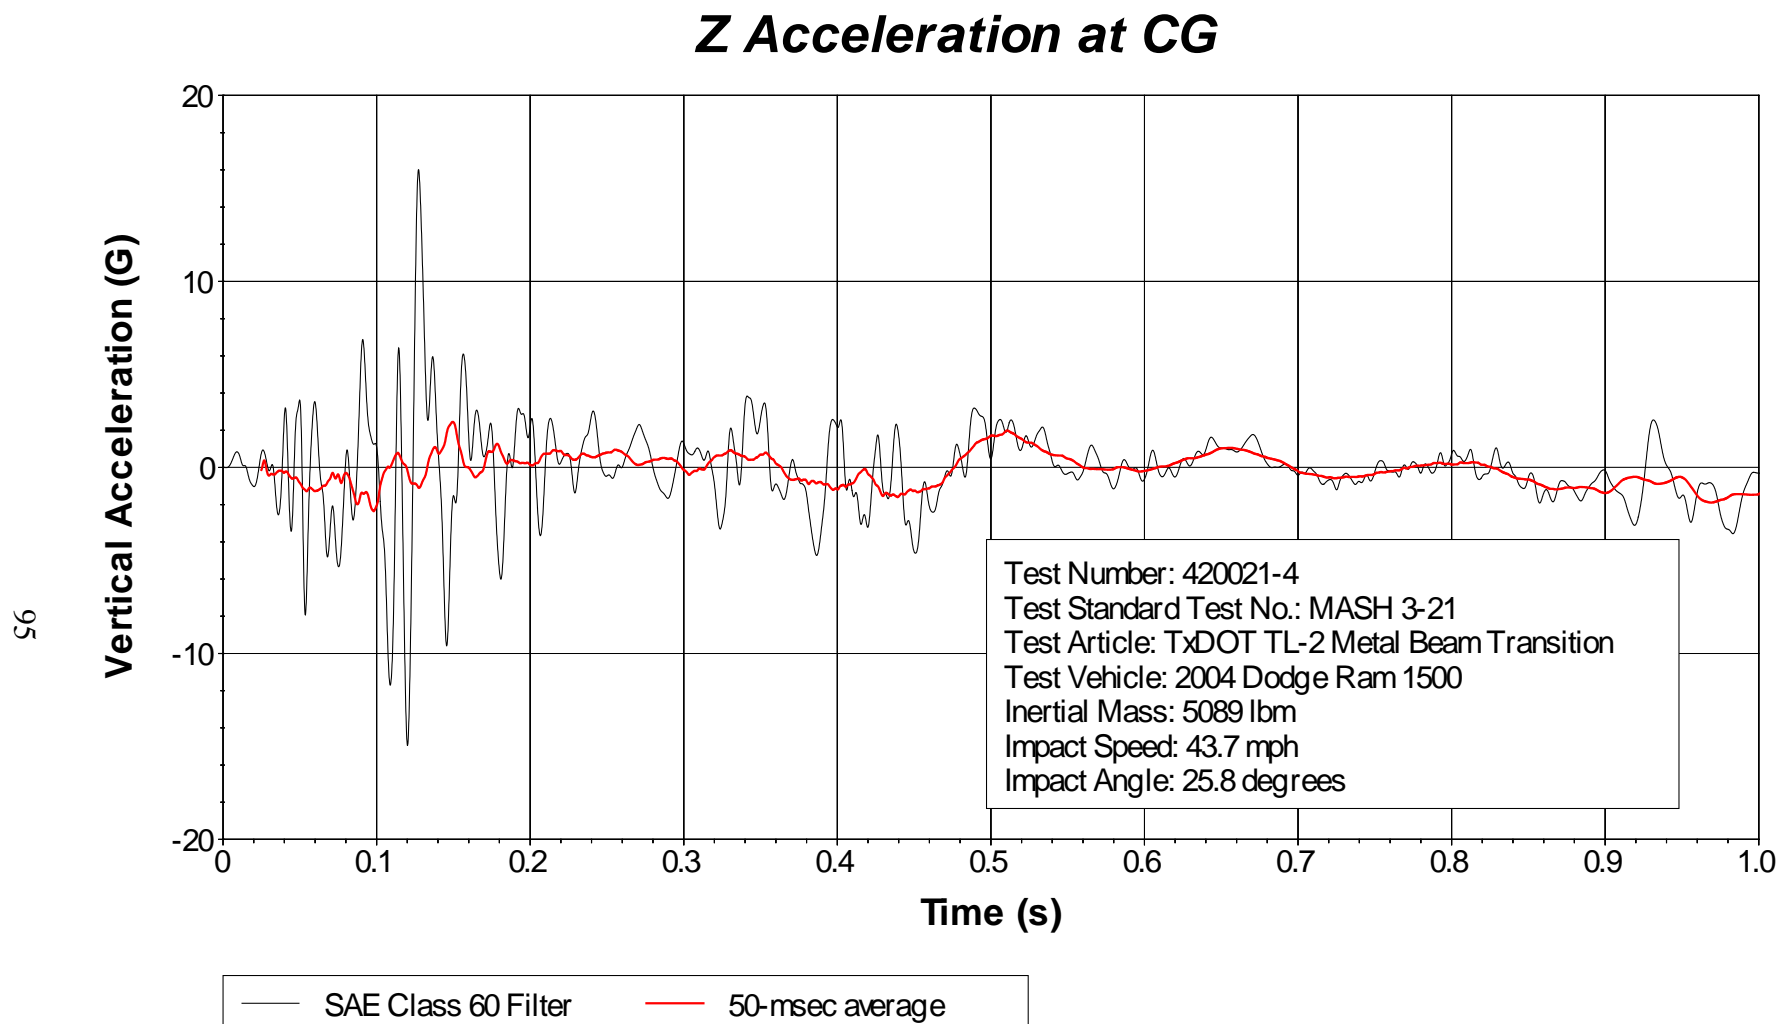
**Figure F3. Vehicle Vertical Accelerometer Trace for Test No. 420021-4  
(Accelerometer Located at Center of Gravity).**

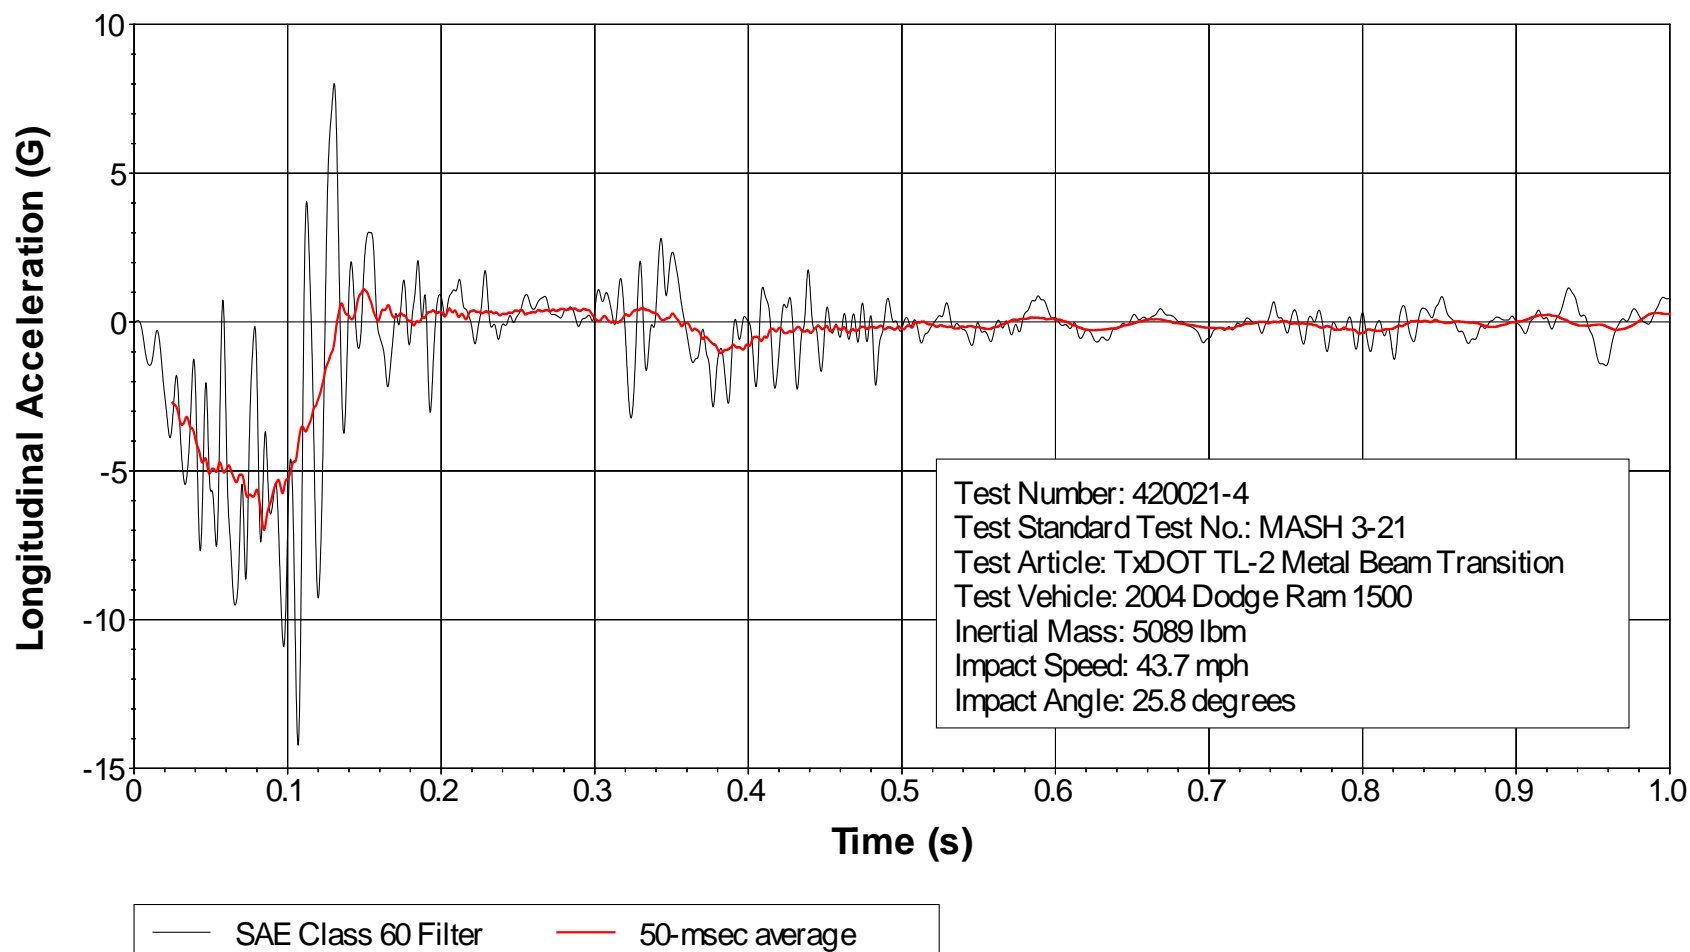
**Figure F4. Vehicle Longitudinal Accelerometer Trace for Test No. 420021-4  
(Accelerometer Located over Rear Axle).**

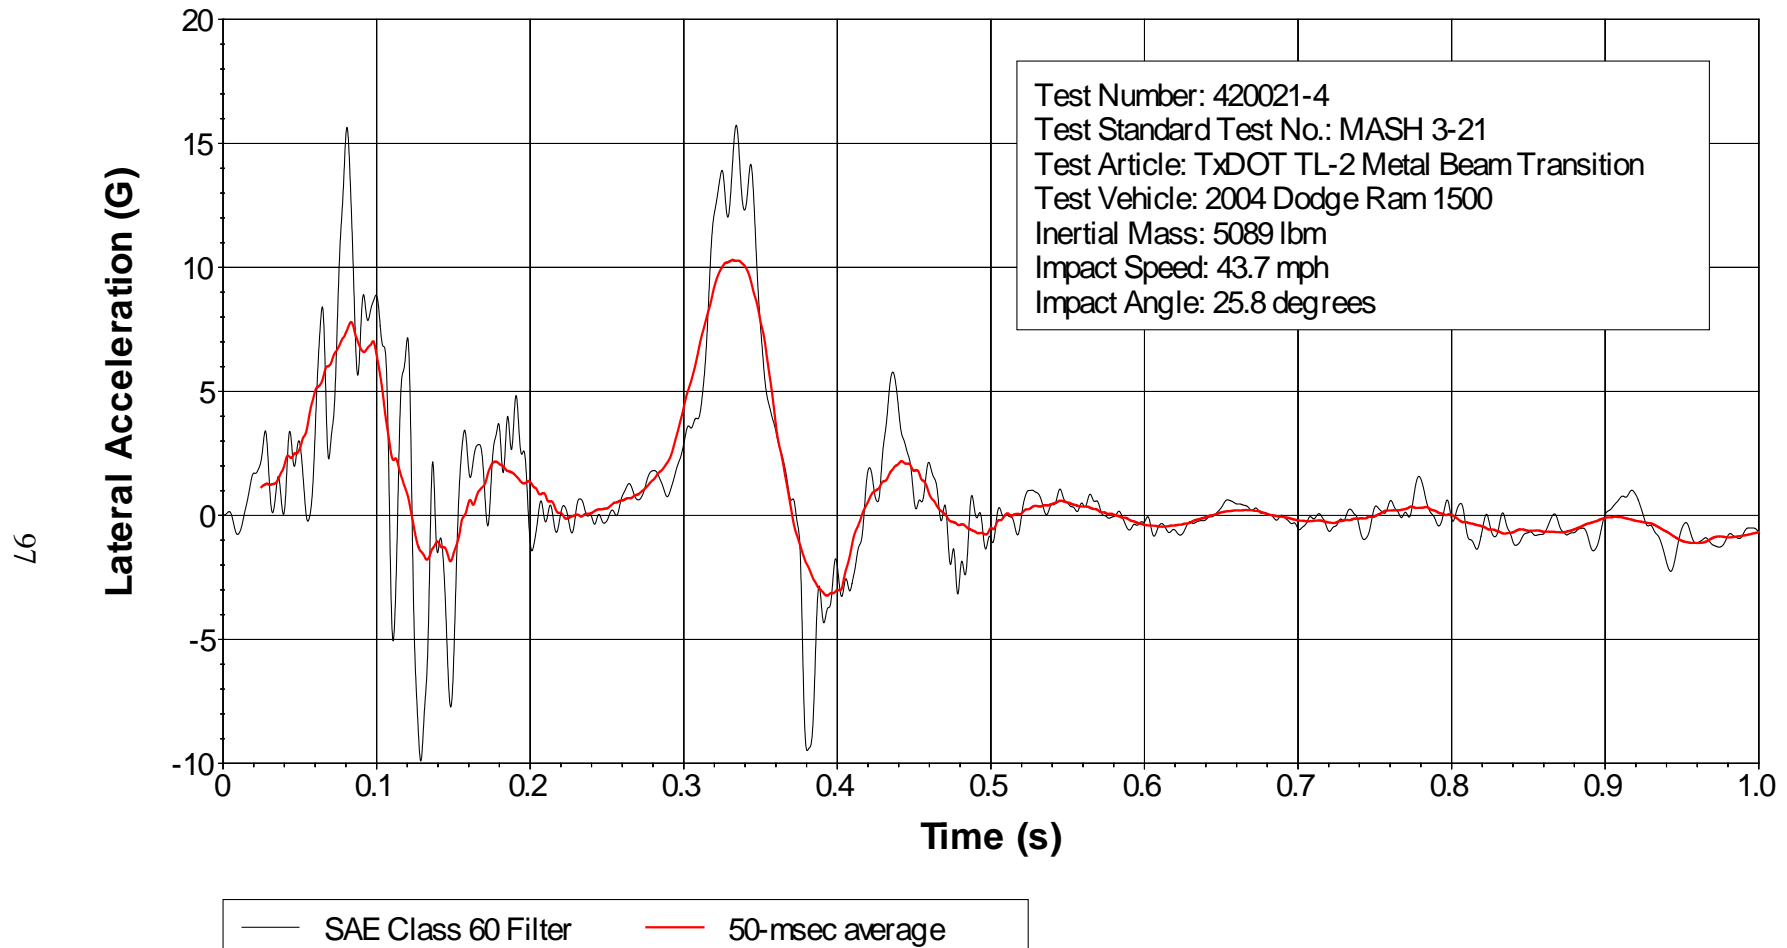
**Figure F5. Vehicle Lateral Accelerometer Trace for Test No. 420021-4  
(Accelerometer Located over Rear Axle).**
