# DEVELOPMENT OF A *MASH* TL-2 GUARDRAIL-TO-BRIDGE RAIL TRANSITION COMPATIBLE WITH 31-INCH GUARDRAIL

## Test Report 9-1002-8

TEXAS TRANSPORTATION INSTITUTE  
THE TEXAS A&M UNIVERSITY SYSTEM  
COLLEGE STATION, TEXAS

TEXAS DEPARTMENT OF TRANSPORTATION

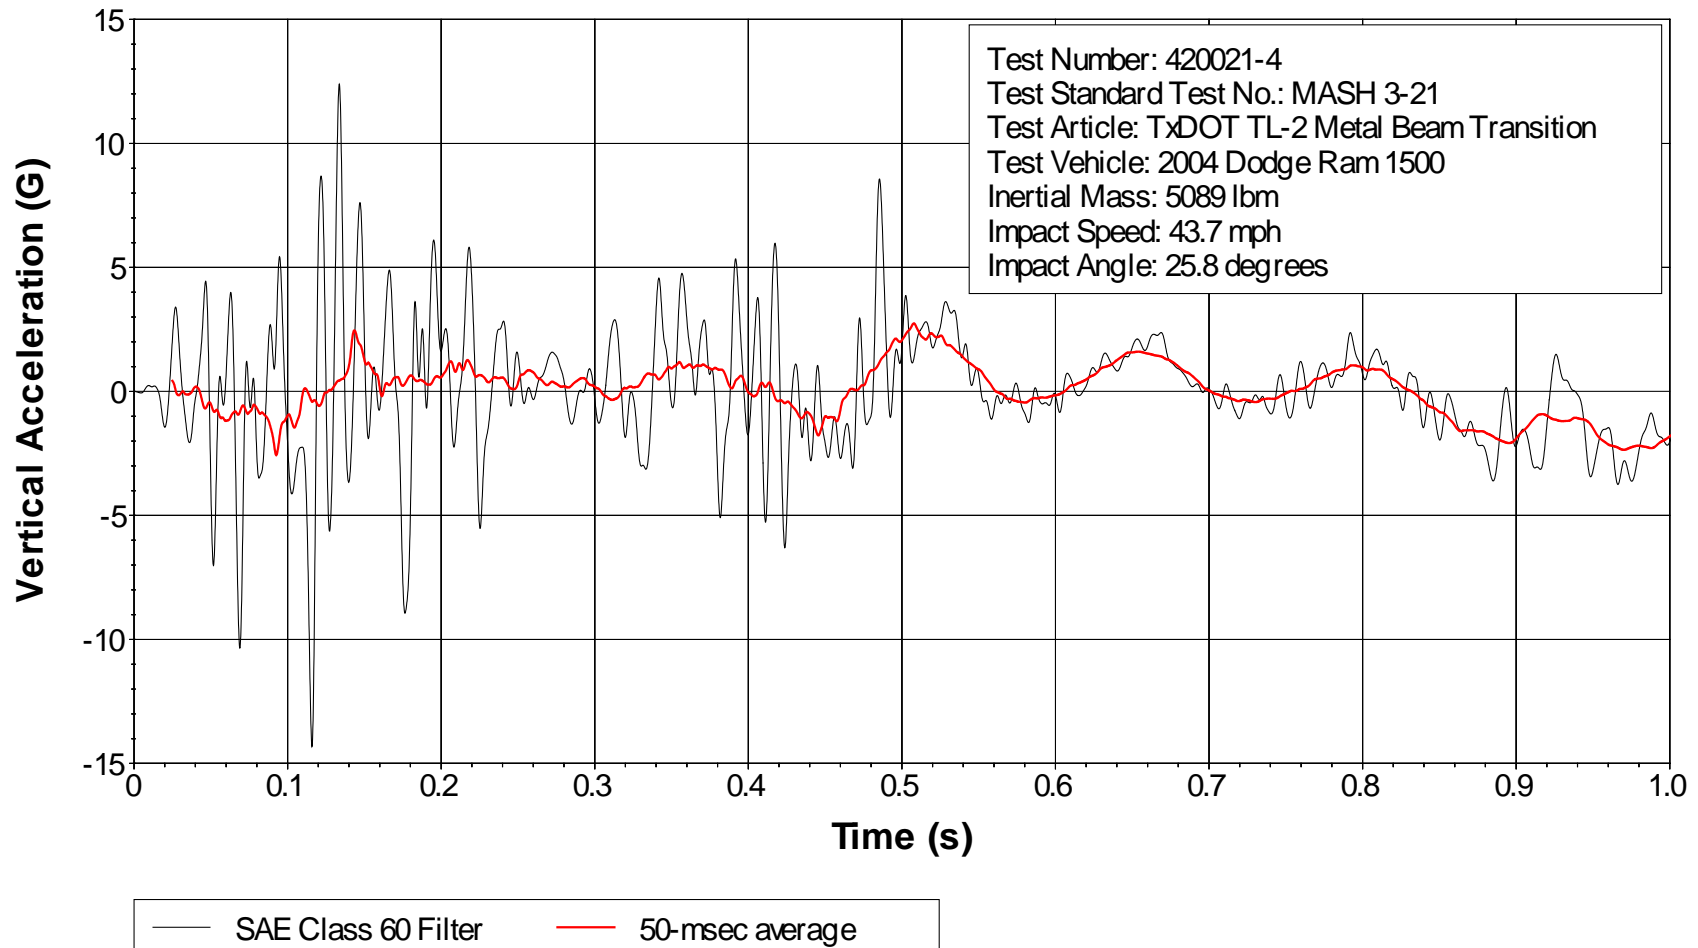
**Figure F6. Vehicle Vertical Accelerometer Trace for Test No. 420021-4  
(Accelerometer Located over Rear Axle).**

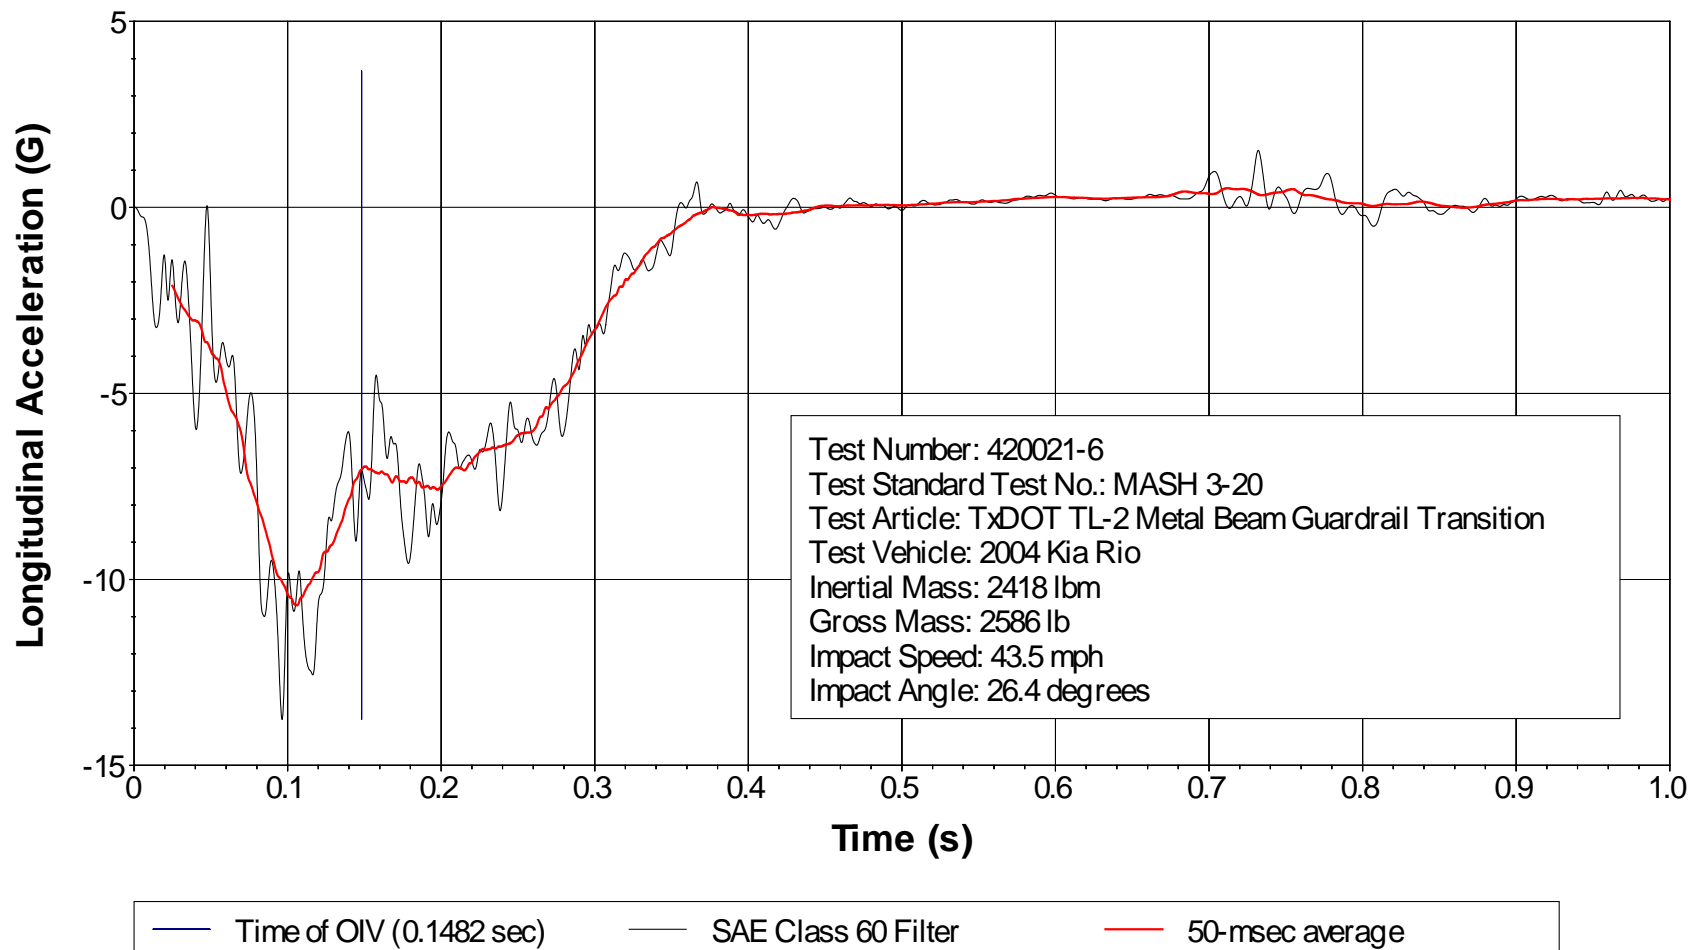
**Figure F7. Vehicle Longitudinal Accelerometer Trace for Test No. 420021-6  
(Accelerometer Located at Center of Gravity).**

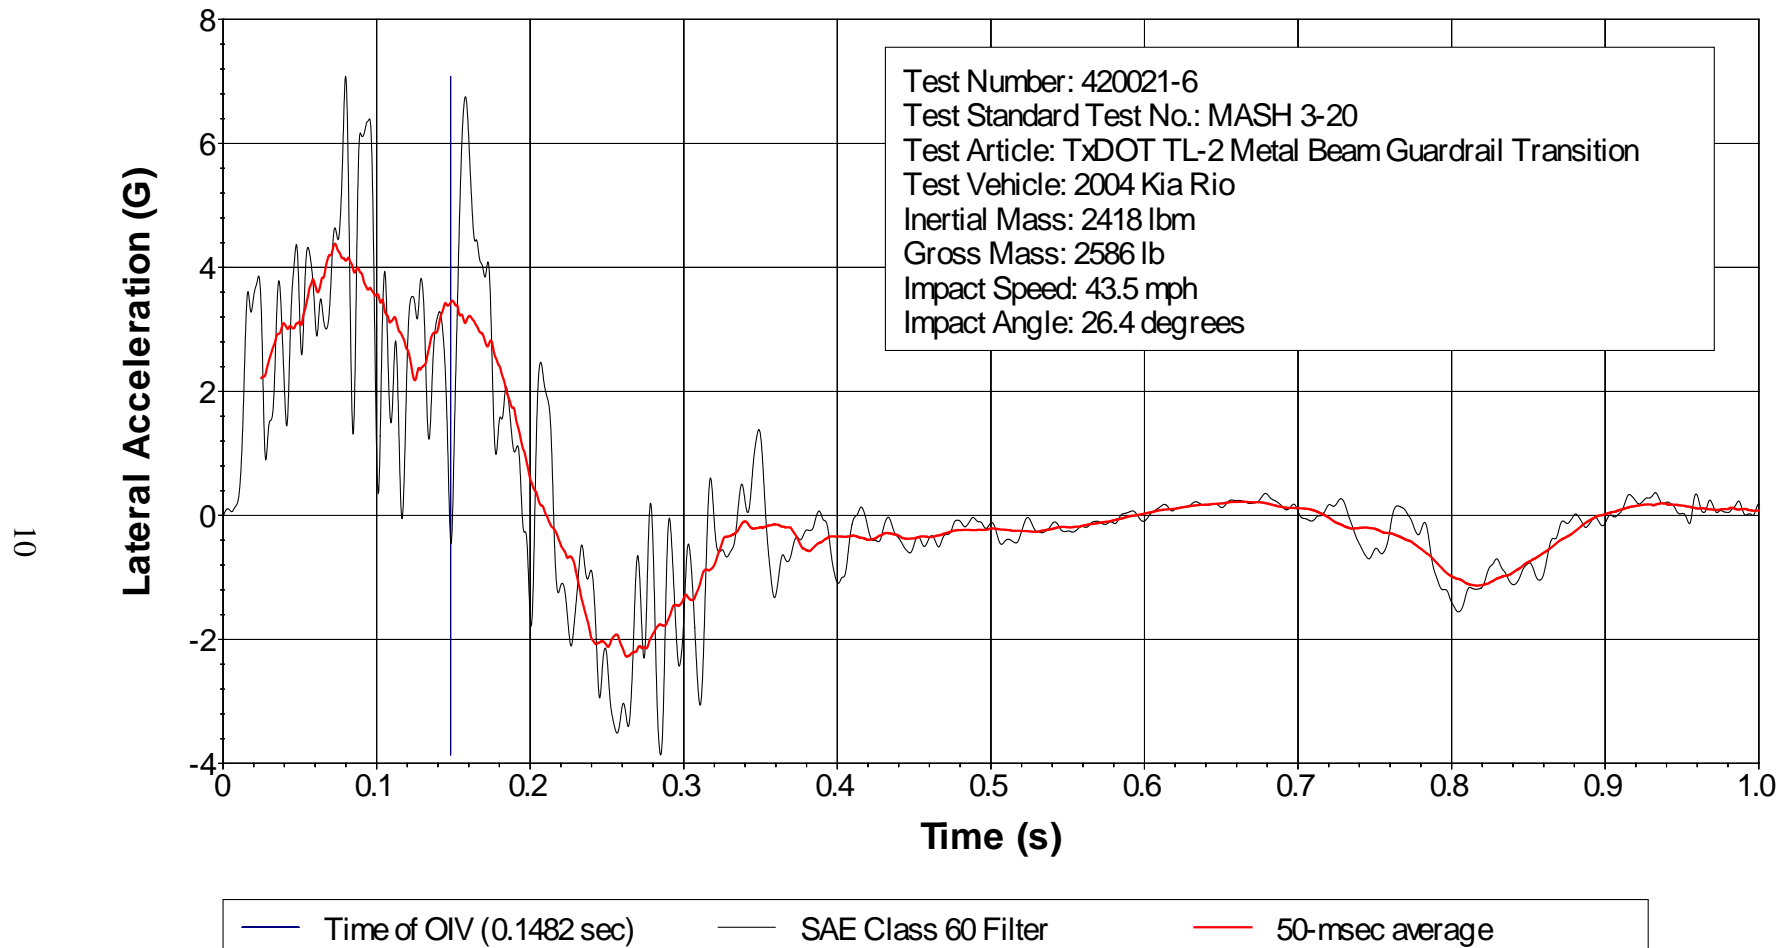
**Figure F8. Vehicle Lateral Accelerometer Trace for Test No. 420021-6  
(Accelerometer Located at Center of Gravity).**

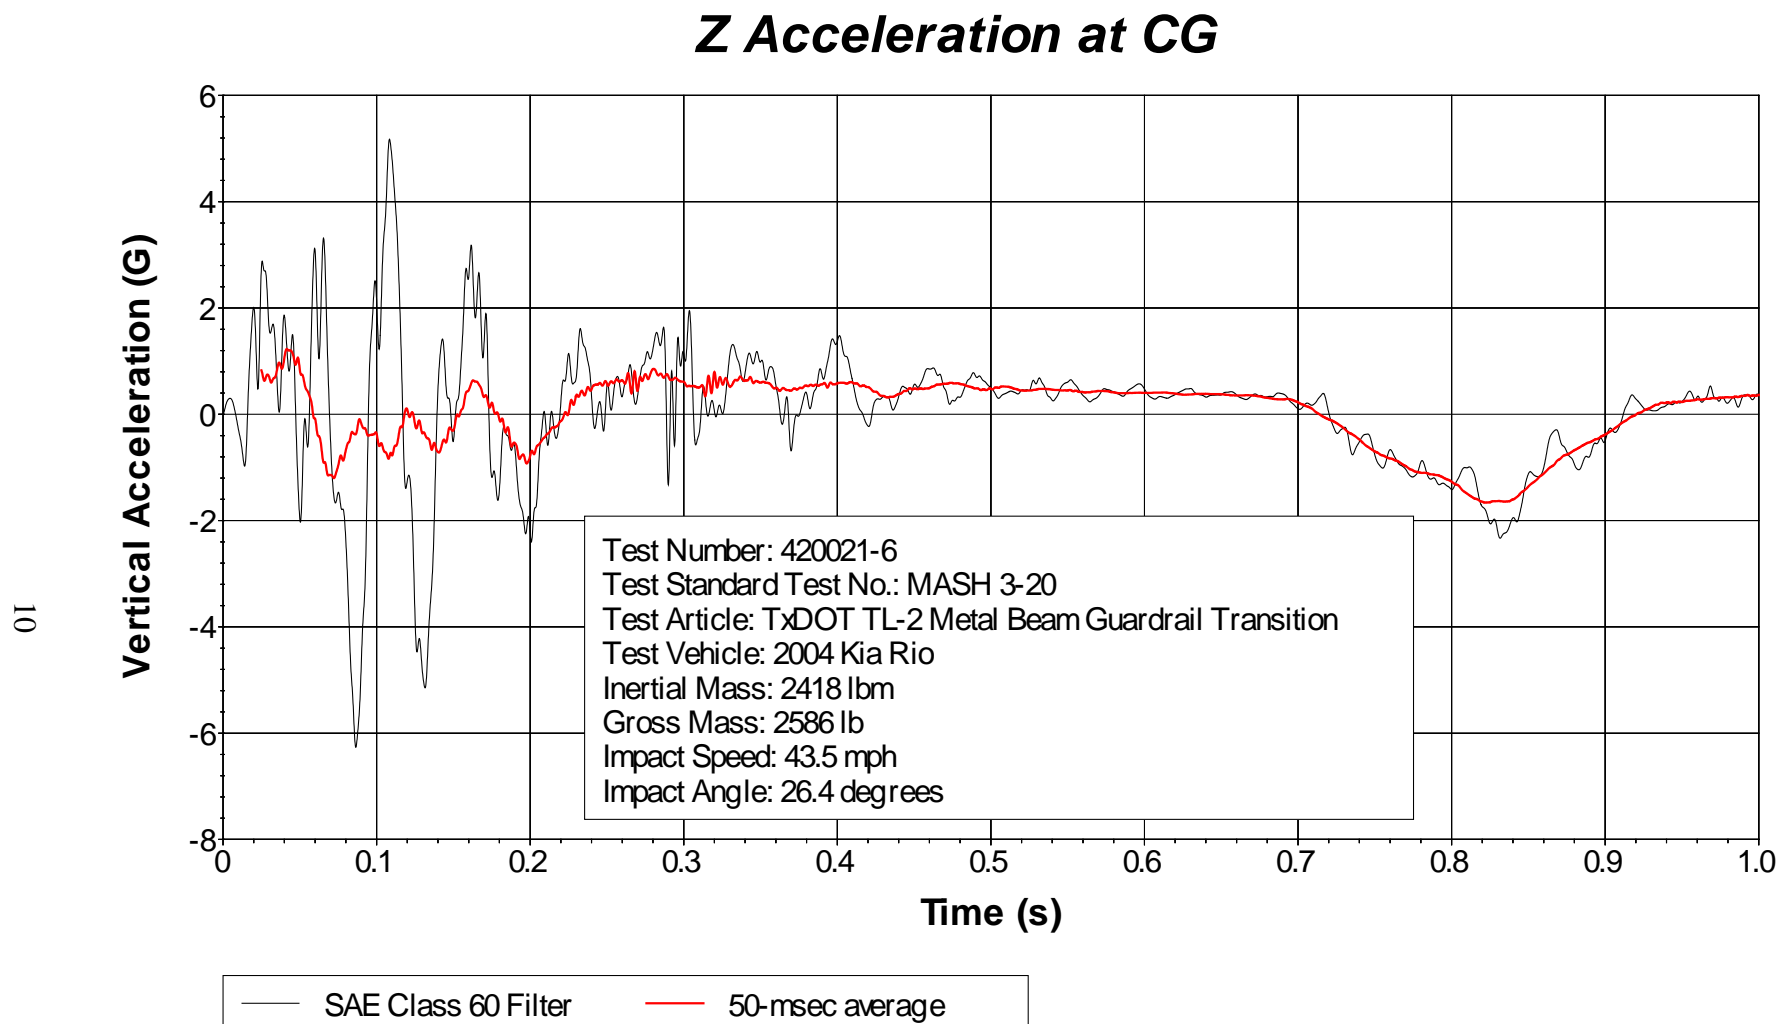
**Figure F9. Vehicle Vertical Accelerometer Trace for Test No. 420021-6  
(Accelerometer Located at Center of Gravity).**

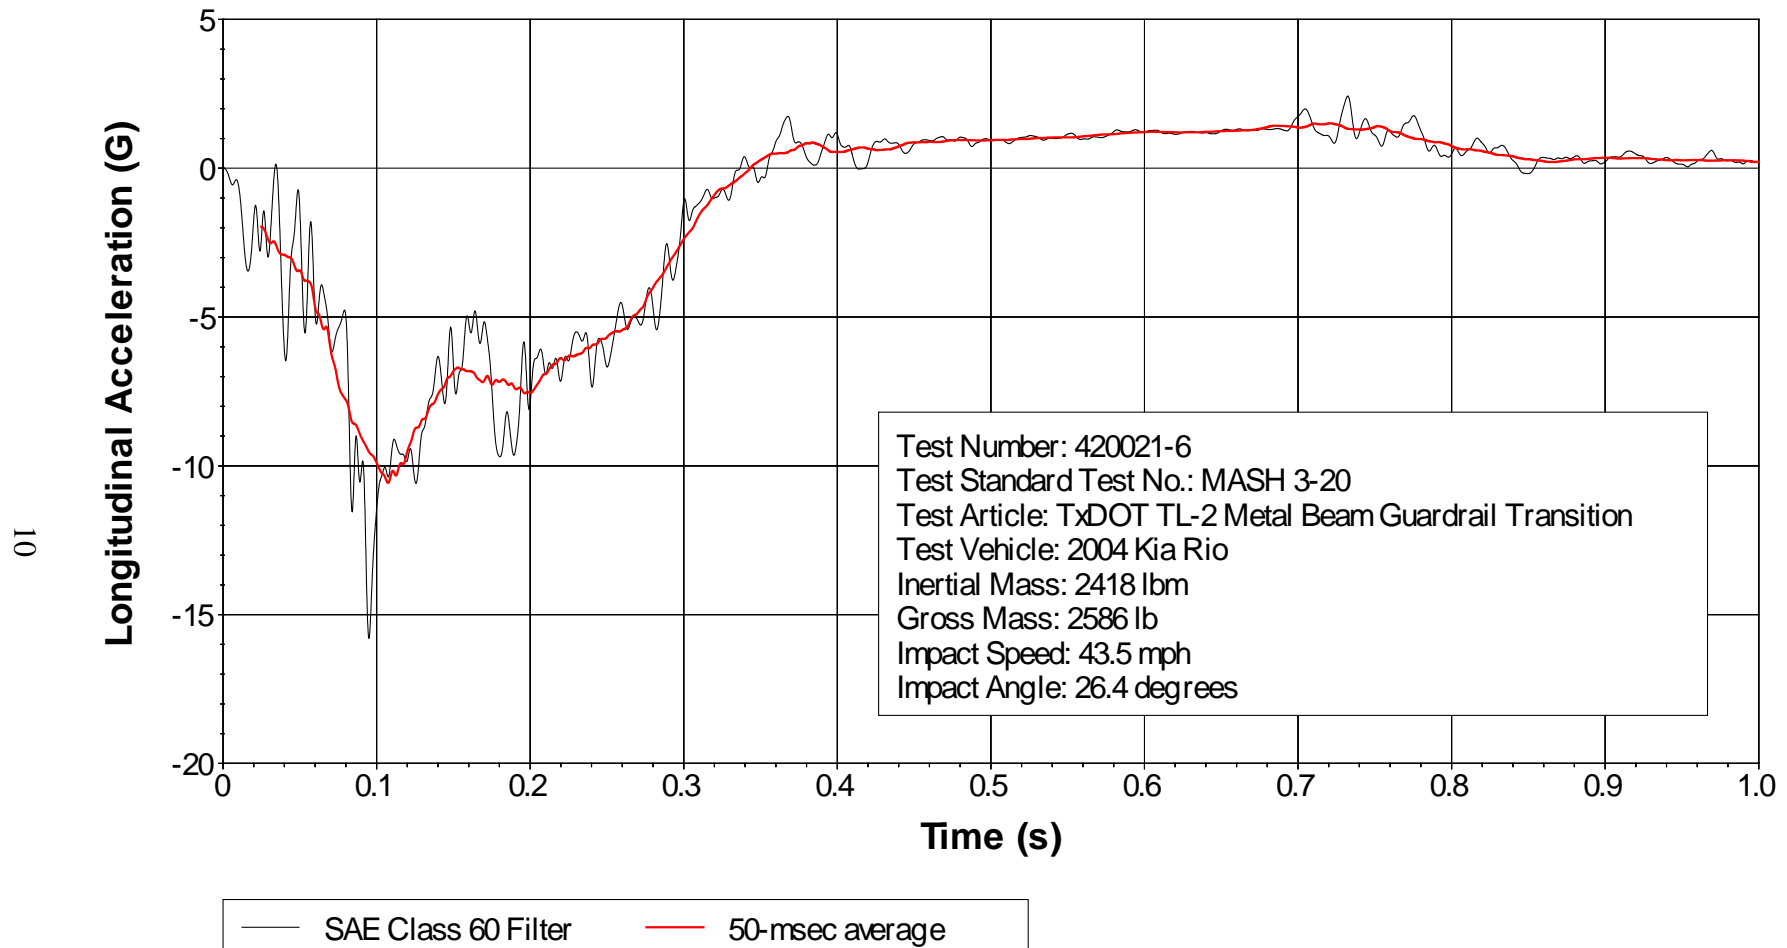
## ***X Acceleration over Rear Axle***

**Figure F10. Vehicle Longitudinal Accelerometer Trace for Test No. 420021-6  
(Accelerometer Located over Rear Axle).**

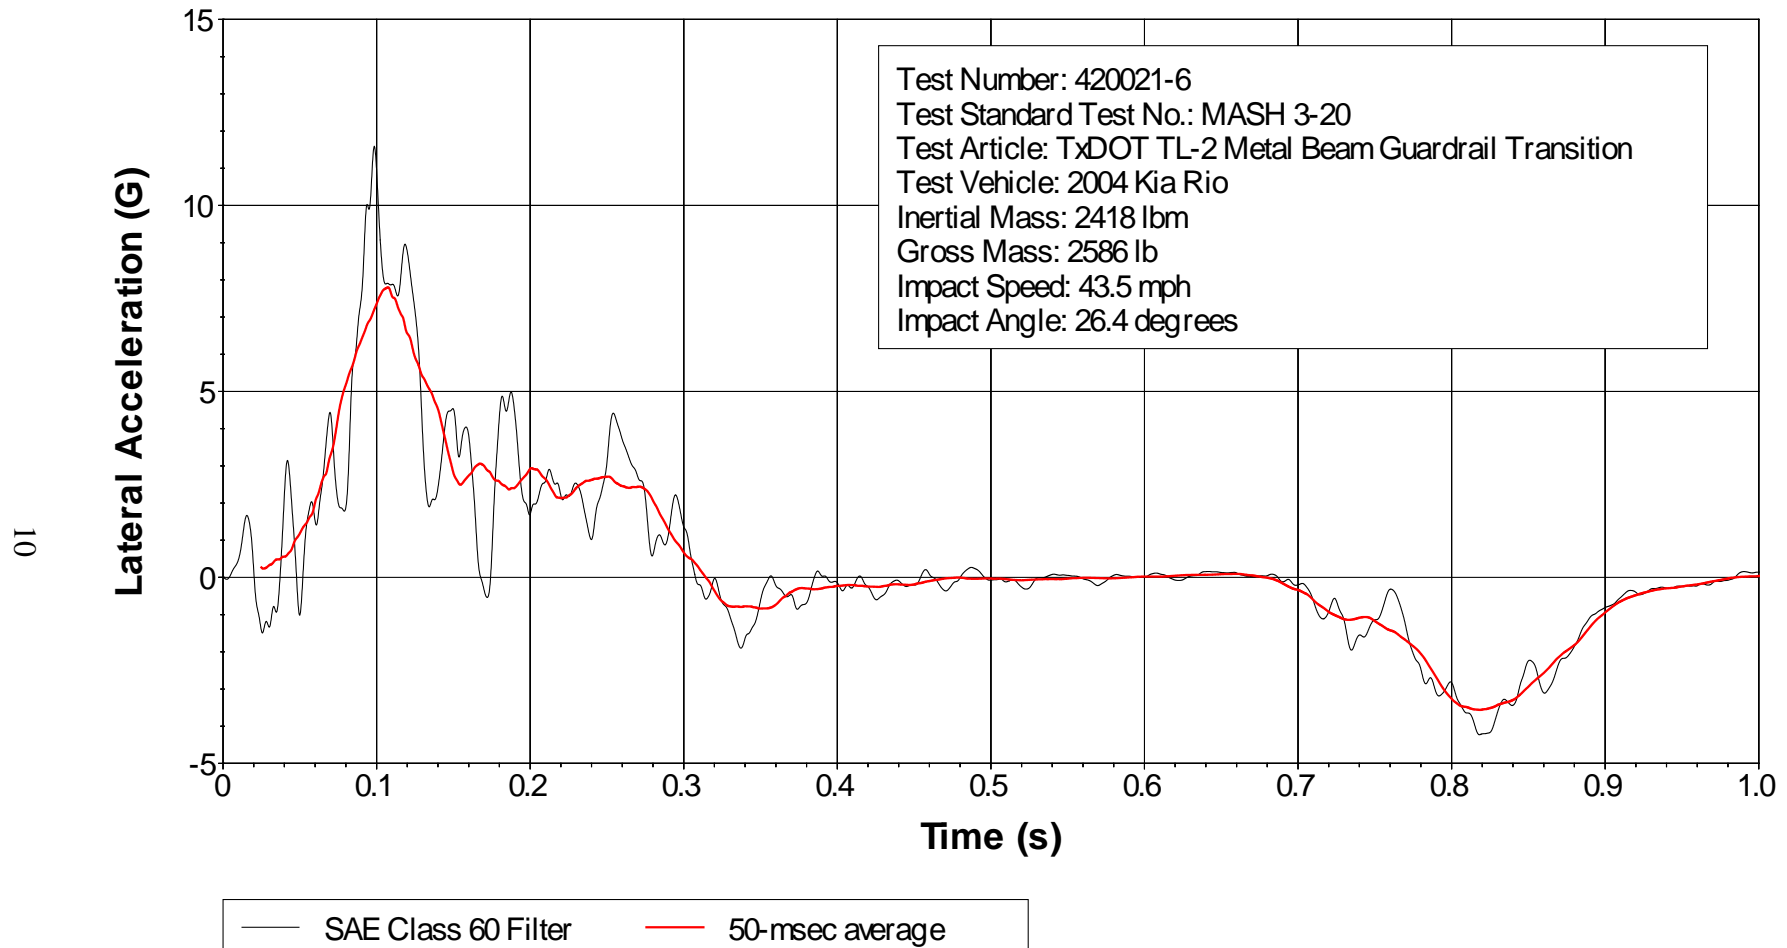
## Y Acceleration over Rear Axle

**Figure F11. Vehicle Lateral Accelerometer Trace for Test No. 420021-6  
(Accelerometer Located over Rear Axle).**

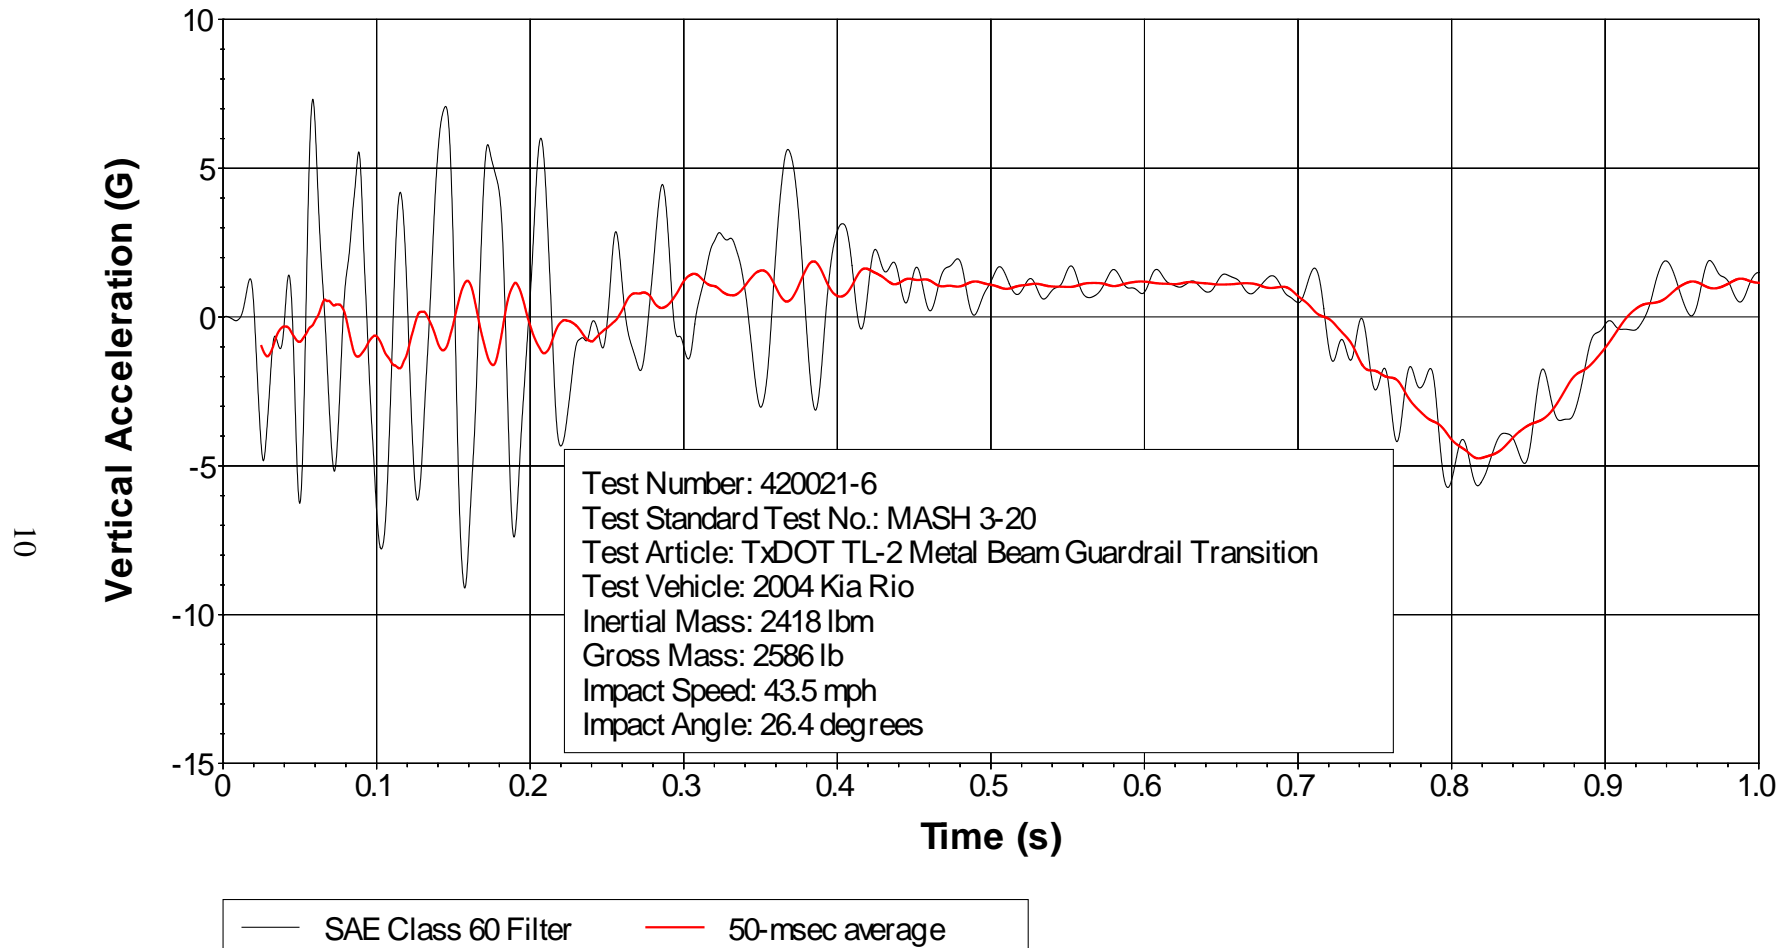
## ***Z Acceleration over Rear Axle***

**Figure F12. Vehicle Vertical Accelerometer Trace for Test No. 420021-6  
(Accelerometer Located over Rear Axle).**

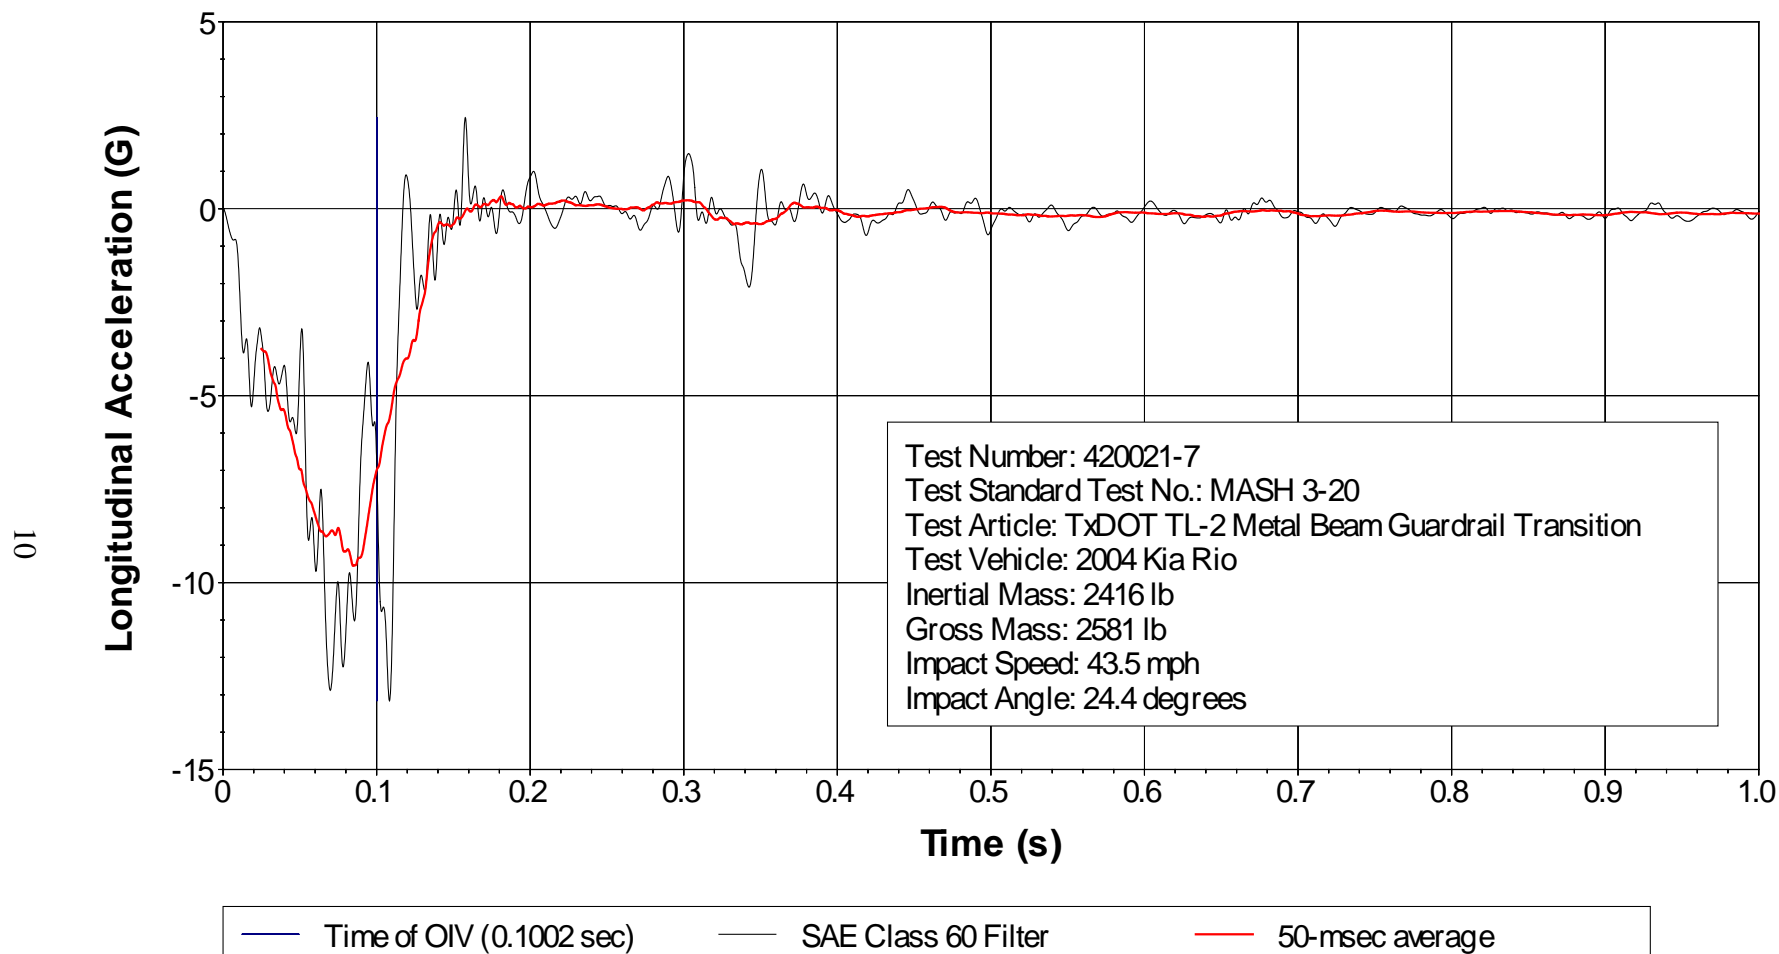
## ***X Acceleration at CG***

**Figure F13. Vehicle Longitudinal Accelerometer Trace for Test No. 420021-7  
(Accelerometer Located at Center of Gravity).**

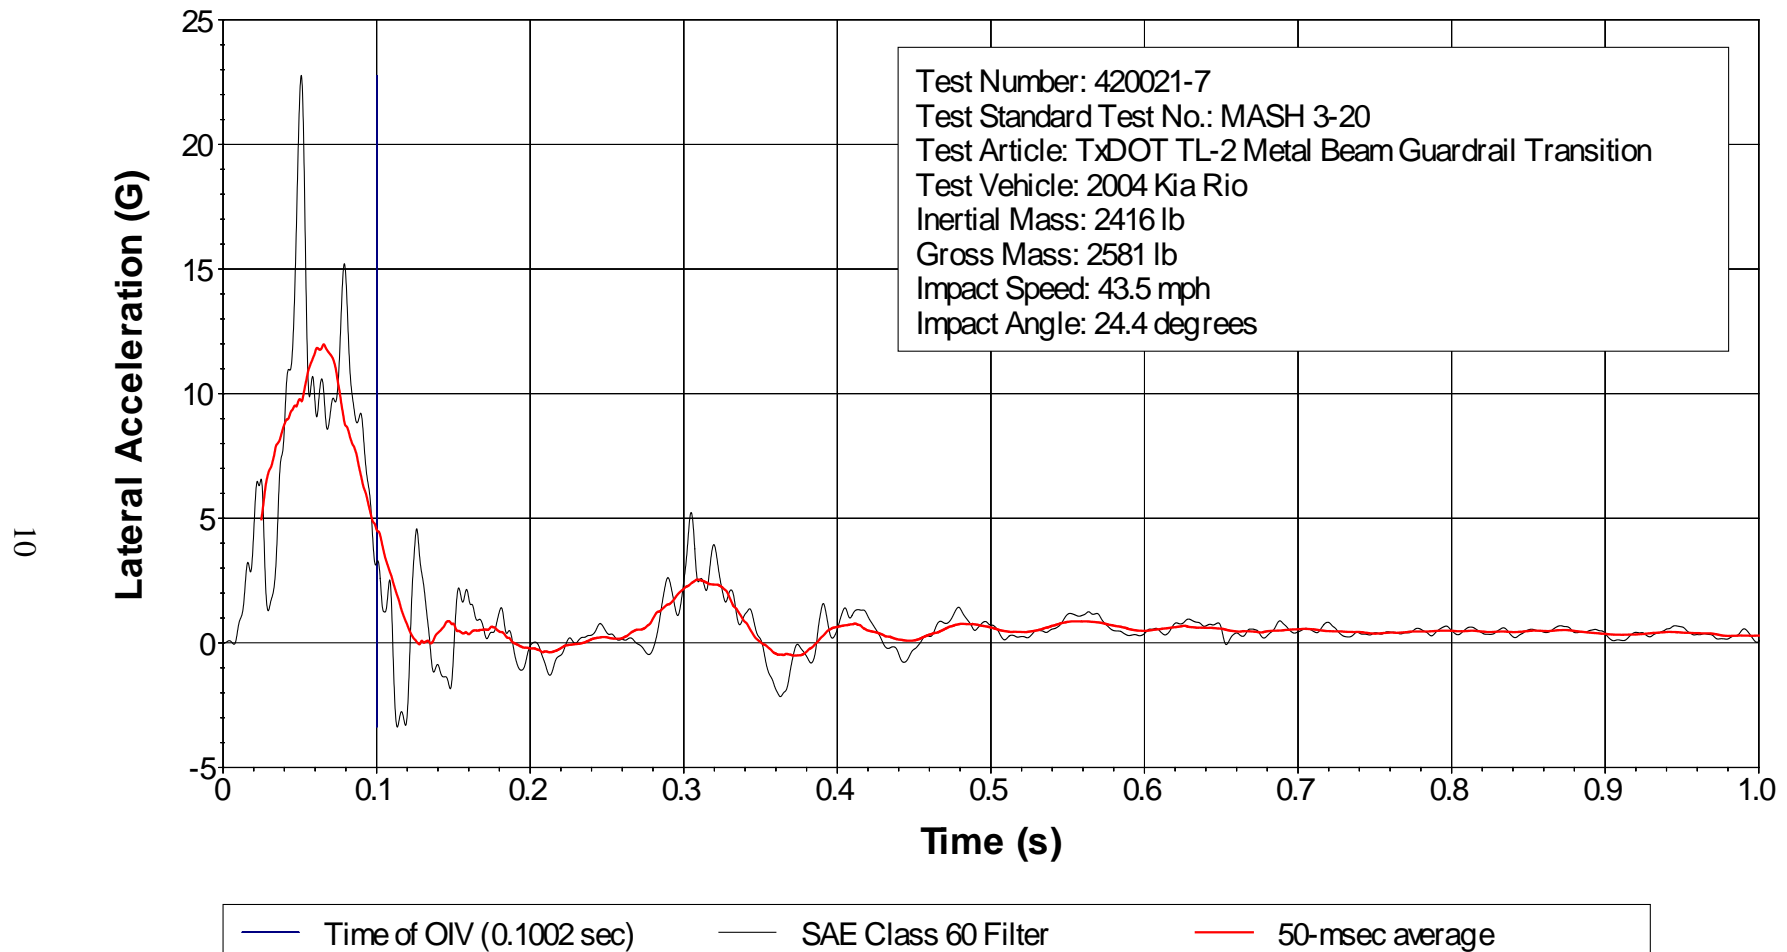
## Y Acceleration at CG

**Figure F14. Vehicle Lateral Accelerometer Trace for Test No. 420021-7  
(Accelerometer Located at Center of Gravity).**

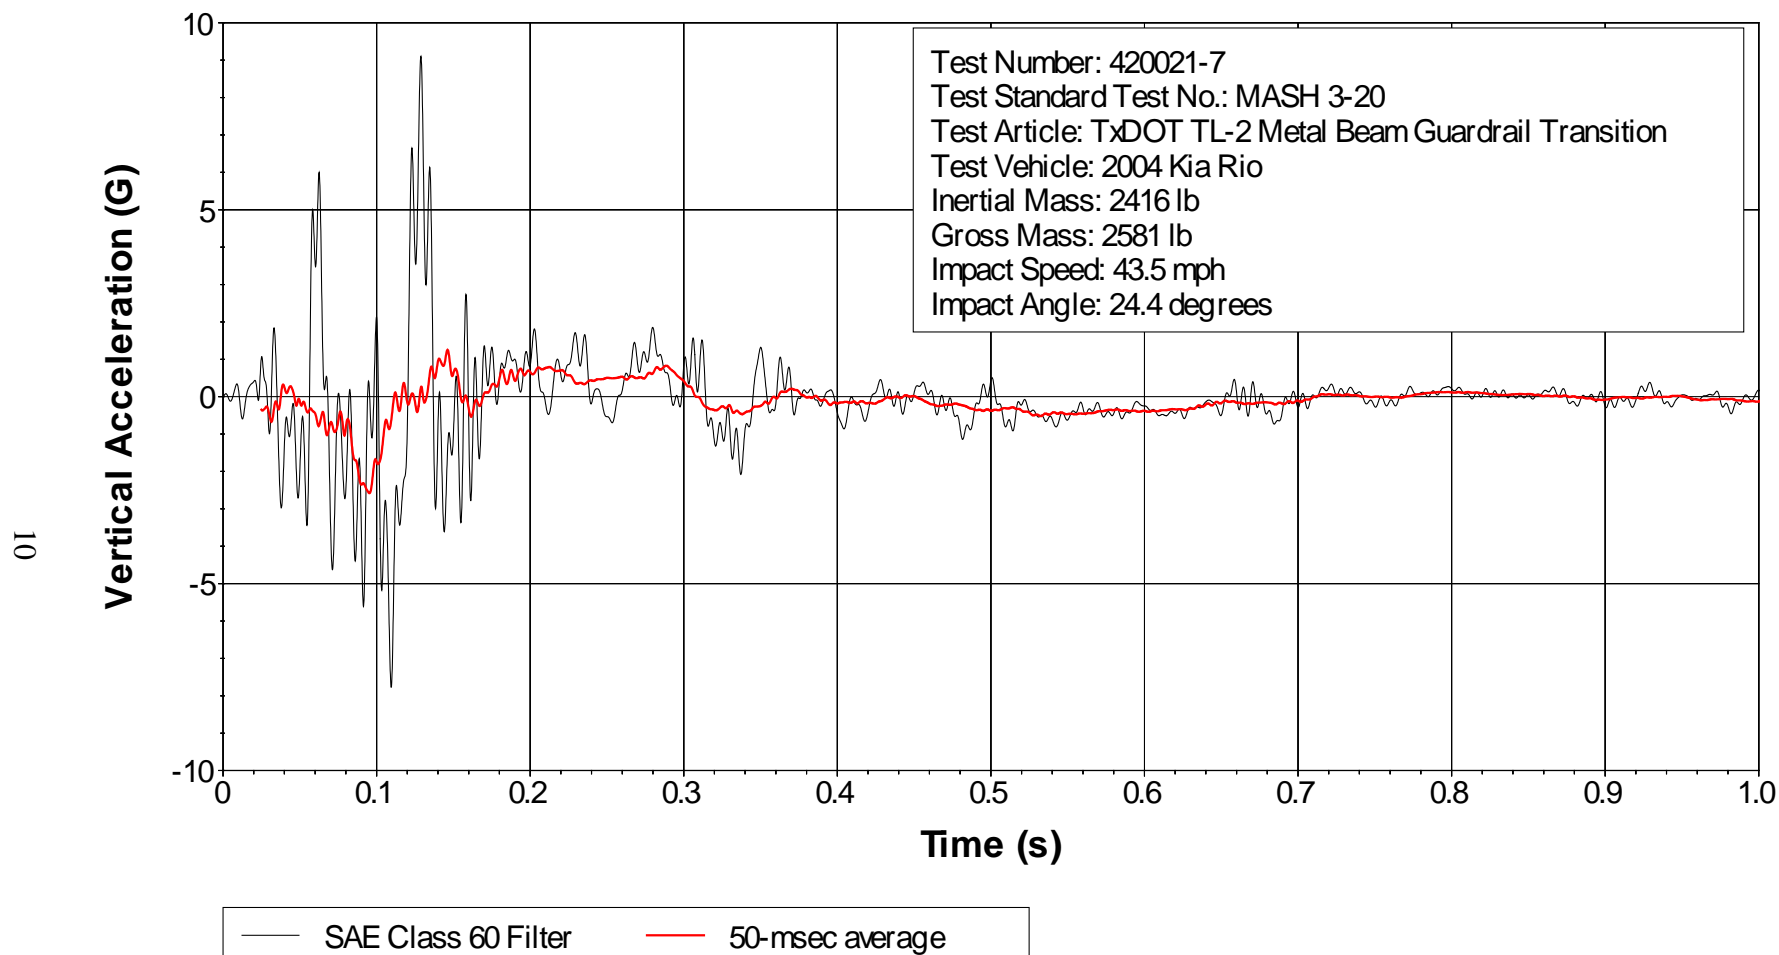
## ***Z Acceleration at CG***

**Figure F15. Vehicle Vertical Accelerometer Trace for Test No. 420021-7  
(Accelerometer Located at Center of Gravity).**

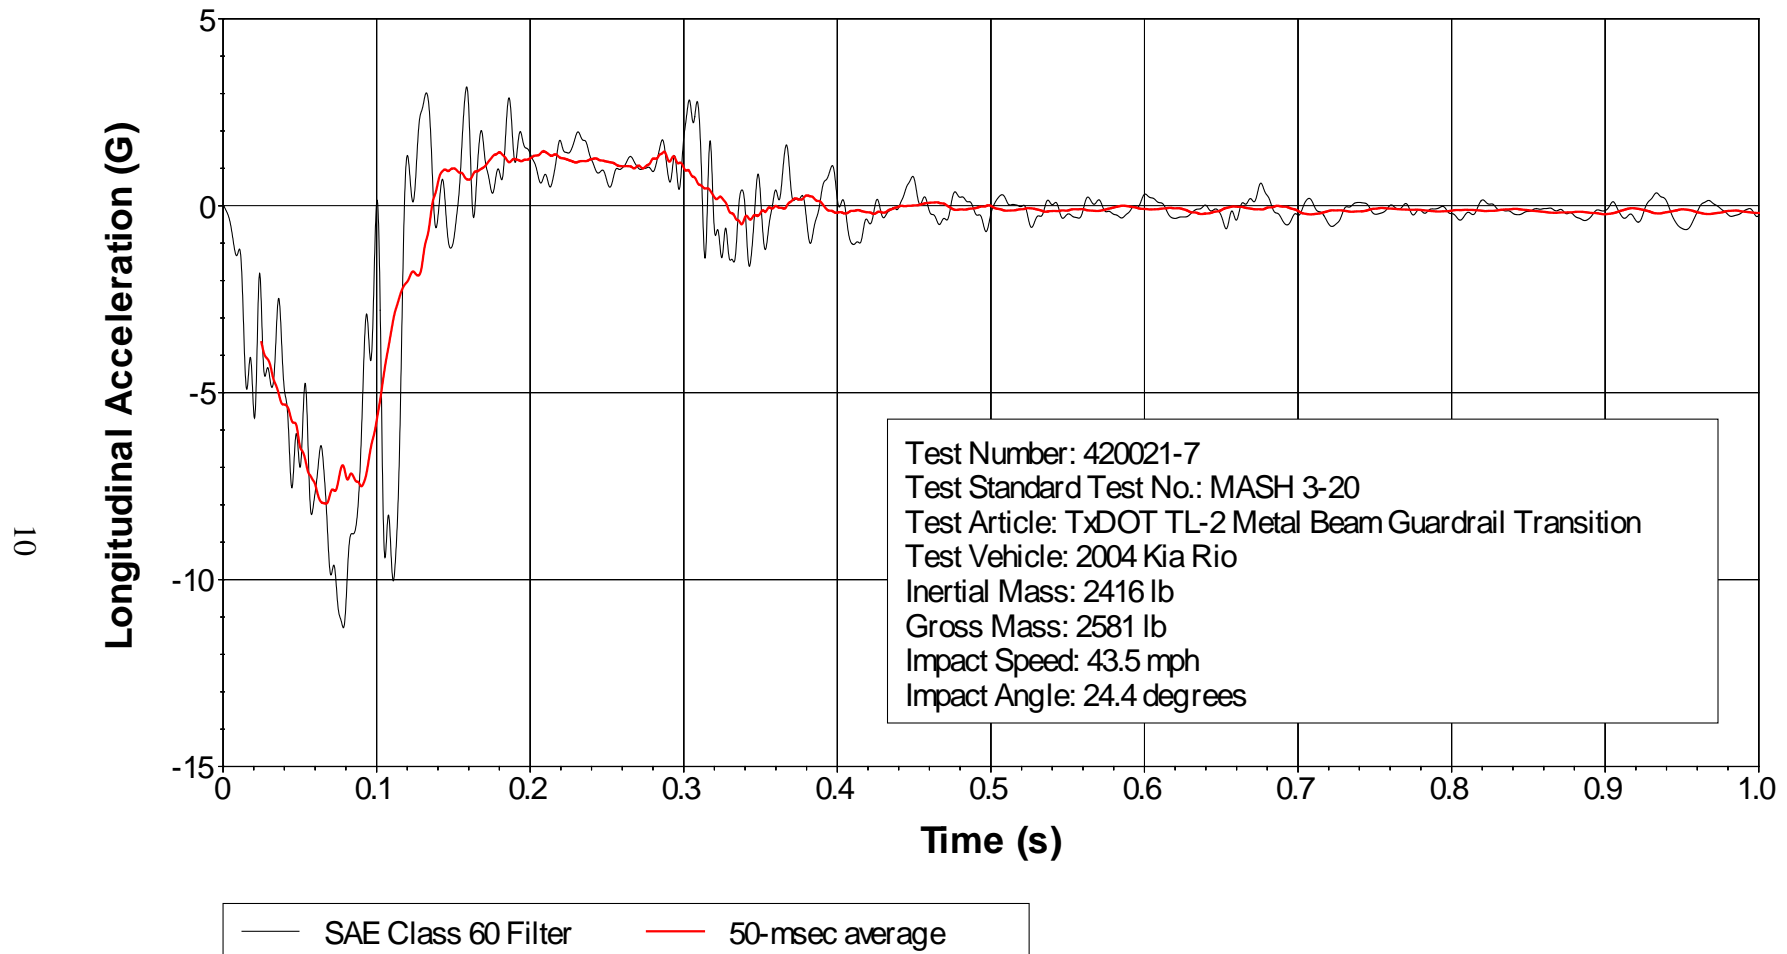
## ***X Acceleration over Rear Axle***

**Figure F16. Vehicle Longitudinal Accelerometer Trace for Test No. 420021-7  
(Accelerometer Located over Rear Axle).**

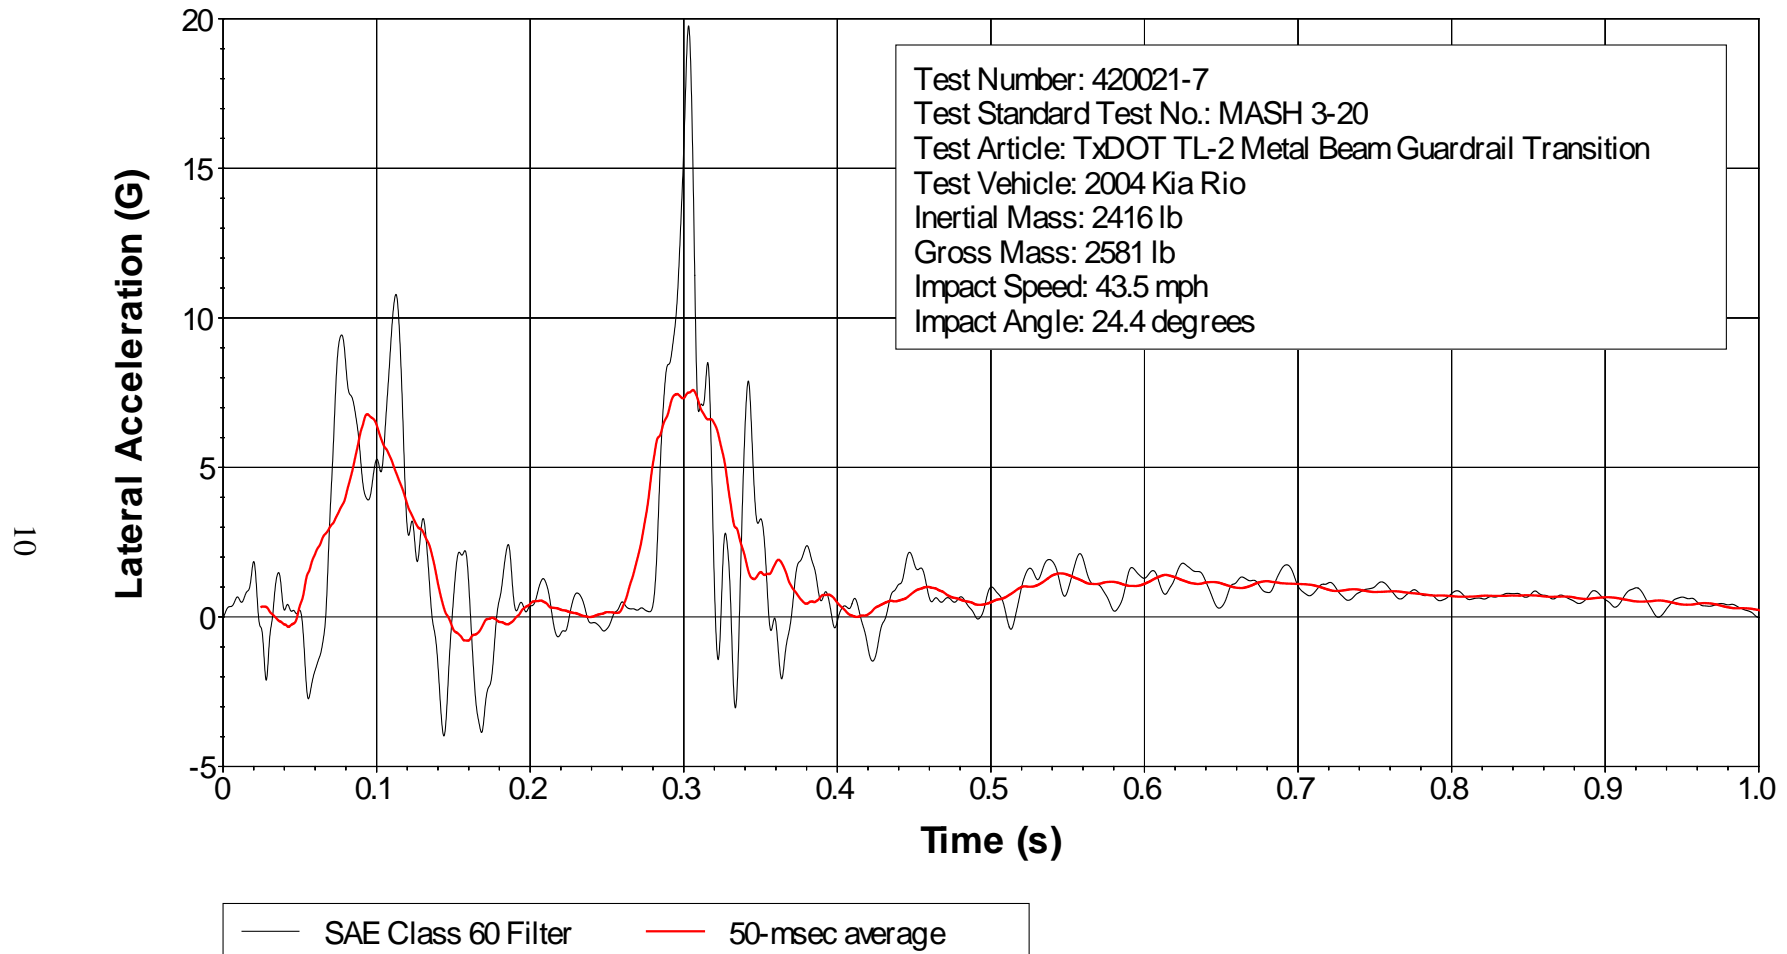
## ***Y Acceleration over Rear Axle***

**Figure F17. Vehicle Lateral Accelerometer Trace for Test No. 420021-7  
(Accelerometer Located over Rear Axle).**

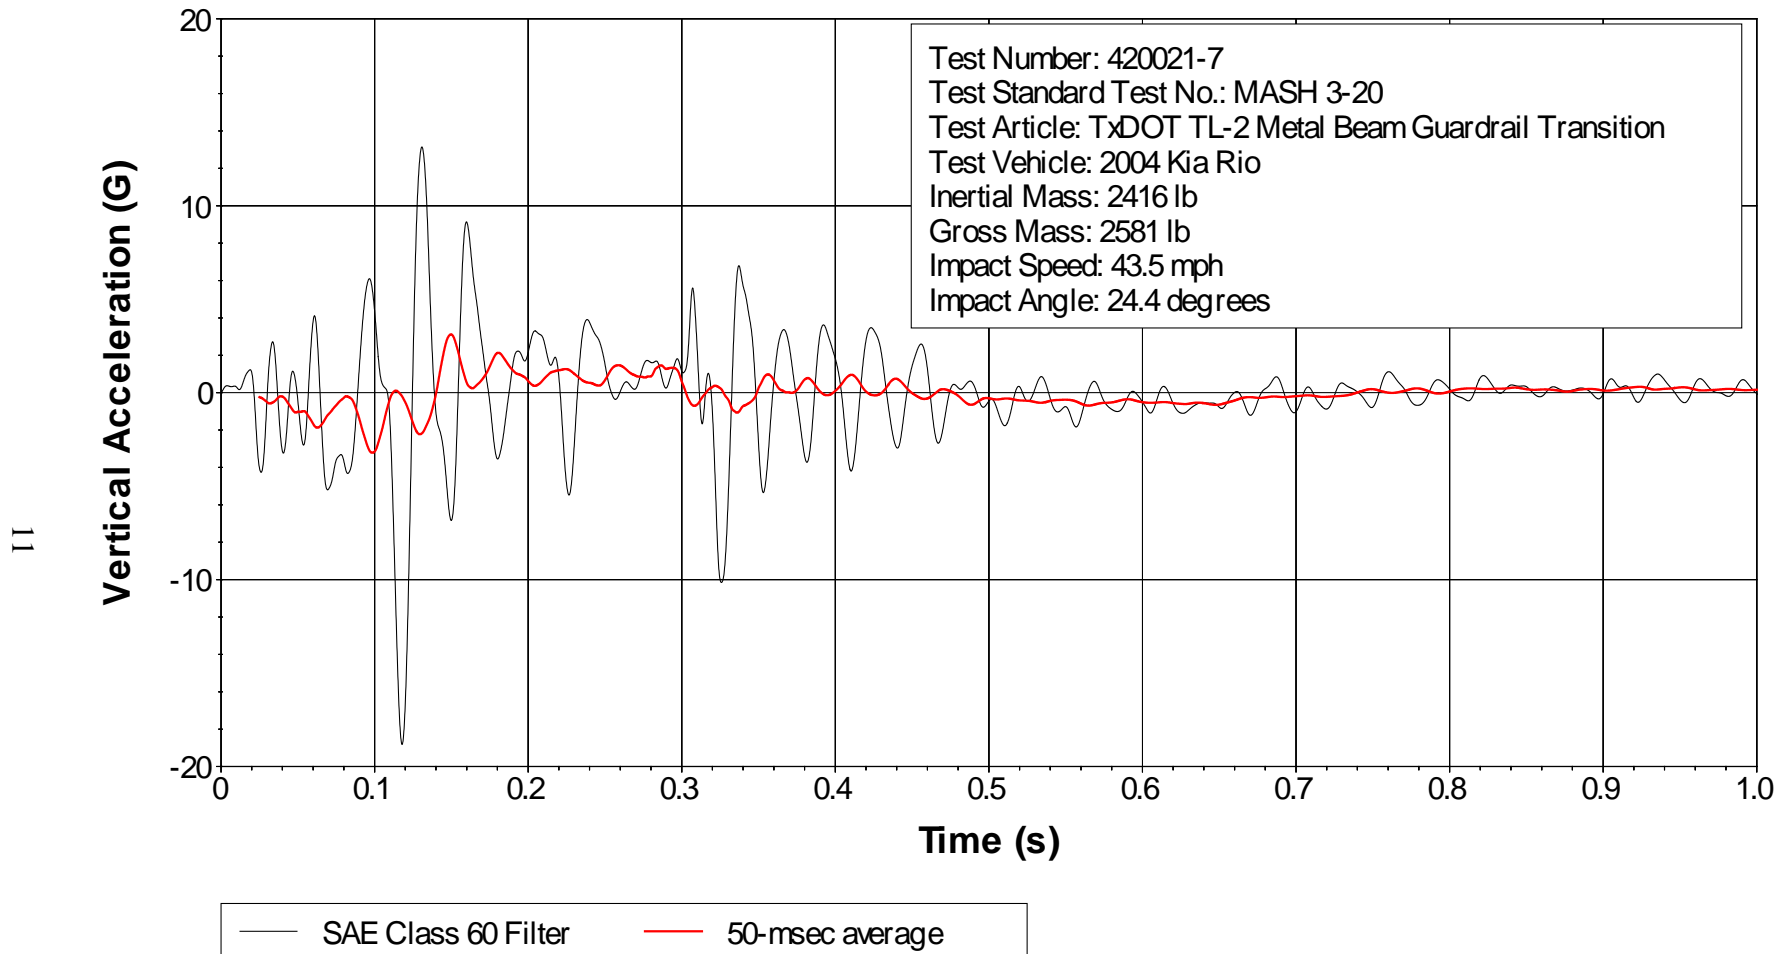
## ***Z Acceleration over Rear Axle***

**Figure F18. Vehicle Vertical Accelerometer Trace for Test No. 420021-7  
(Accelerometer Located over Rear Axle).**
