Termination and Transition of Temporary Concrete Barrier

Transportation Research Board

89th Annual Meeting
January 10-14, 2010
Washington, D.C.

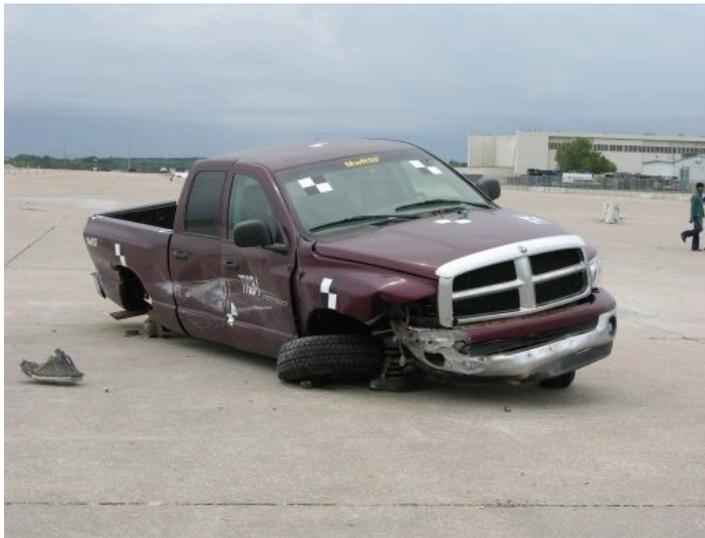
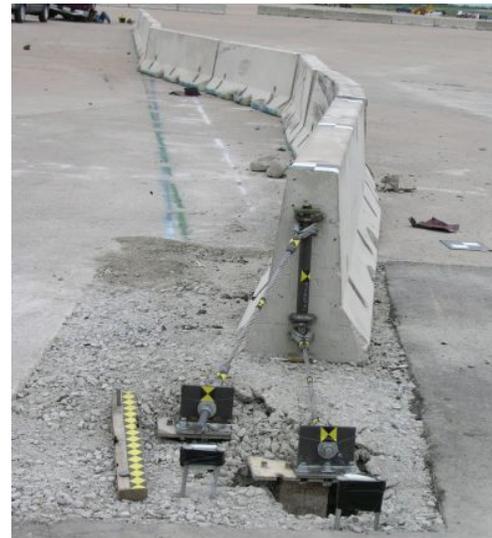
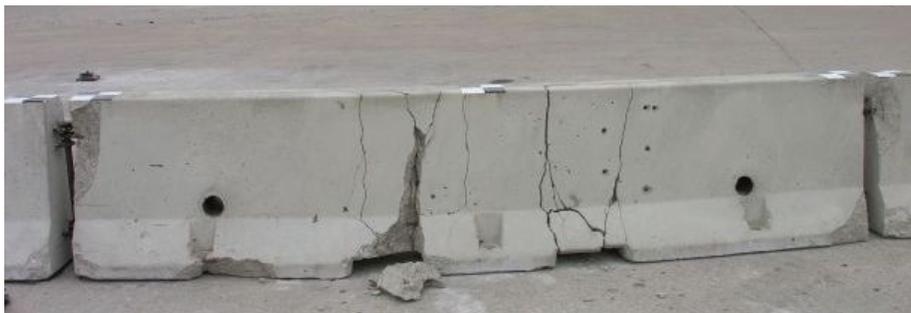
Figure 4. Post Test Damage, Test No. TTCB-1

Vehicle damage was moderate, and the most extensive damage was concentrated at the right-front corner of the pickup truck where the quarter panel and bumper were crushed inward. The right-front tire was detached from the pickup truck and was resting flat underneath the right-side occupant compartment. Damage to the barrier system was also moderate. The most extensive barrier damage occurred to barrier no. 2 where cracks were found through the entire cross section of the barrier spanning the middle 60 in. of barrier no. 2. The data from the string potentiometer mounted on the anchors showed maximum dynamic anchor deflections of 5.28 in. for the offset anchorage and 6.19 in. for the in-line anchorage. Post test damage photographs are shown in Figure 4.

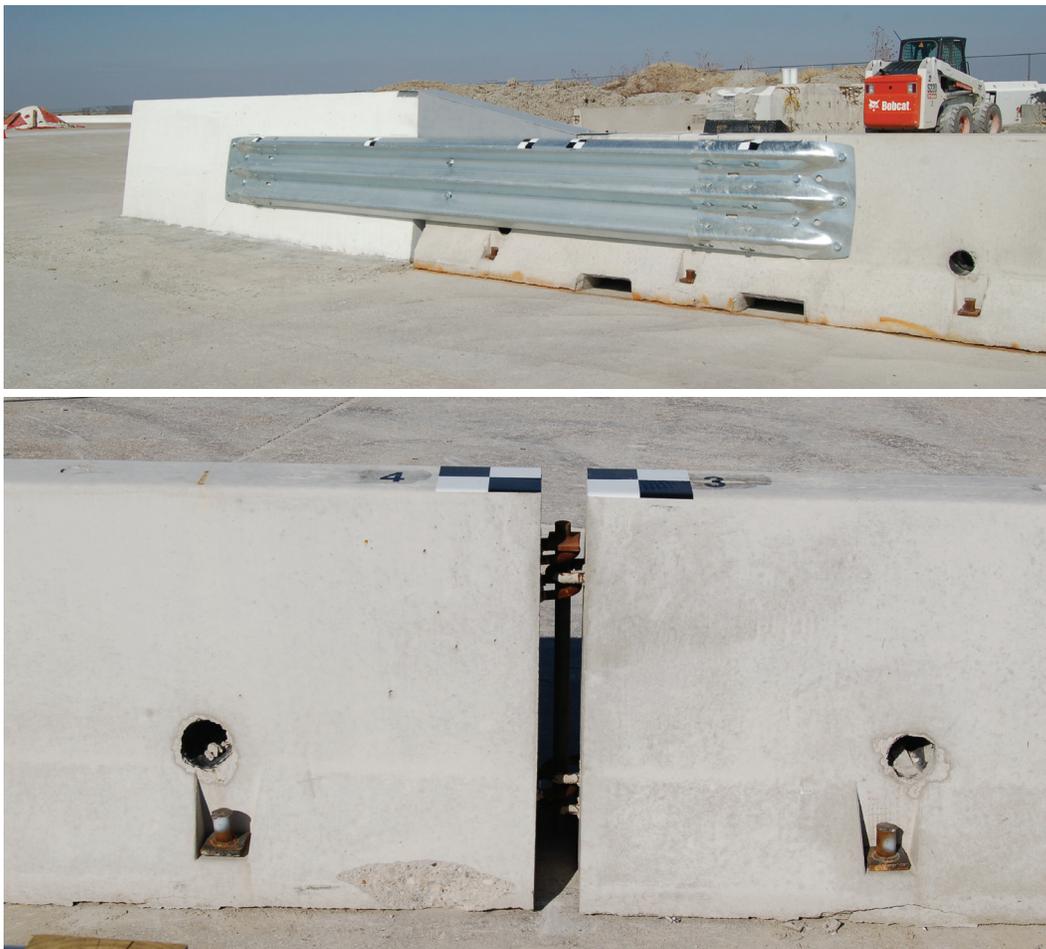
Figure 6. TCB Approach Transition to 42-in. High Single-Slope Barrier

Design details for the TCB approach transition to a 42-in. high single-slope barrier are shown in Figure 6. The test installation consisted of a rigid parapet, four transition barriers, eight free-standing barriers on the upstream end, and a transition cap. The transition and free-standing barriers were installed on a 3-in. thick asphalt pad.

The transition utilized a varied spacing of the asphalt pin tie-down system to create a transition in stiffness over a series of four barrier segments. The asphalt pins were 1.5-in. diameter x 38 1/2-in long ASTM A36 steel pins with 3-in. x 3-in. x 0.5-in. ASTM A36 steel cap plates. These pins were installed in the holes on both the front and back face of the four barriers in the transition section of the installation. The first barrier in the transition (the one adjacent to the free-standing barrier) had a single pin at the downstream end on both the front and back sides. The second barrier had pins installed at the two outermost hole locations on both the front

and back faces. The final two barriers had all three pins installed on both the front and back faces.

In order to reduce the potential for vehicle snag at the joint between the pinned barriers and the rigid parapet, a transition cap and nested three beam sections were added. The nested 12-gauge three beam was bolted across both sides of the barrier at the joint between the pinned barrier and the rigid parapet. The 12-gauge, ASTM A36 steel cap was 6 1/16 in. and 8 1/8 in. wide at the top and bottom, respectively, with a height of 10 in. and a length of 49 11/16 in. Four 12-gauge ASTM A36 gussets were stitch welded on three sides inside the cap.

The single-slope permanent concrete barrier was 21.5 in. and 8 in. wide at the base and top, respectively, with an overall height of 42 in. from the ground to the top of the barrier. The single-slope concrete barrier had a overall length of 13 ft – 4 in.

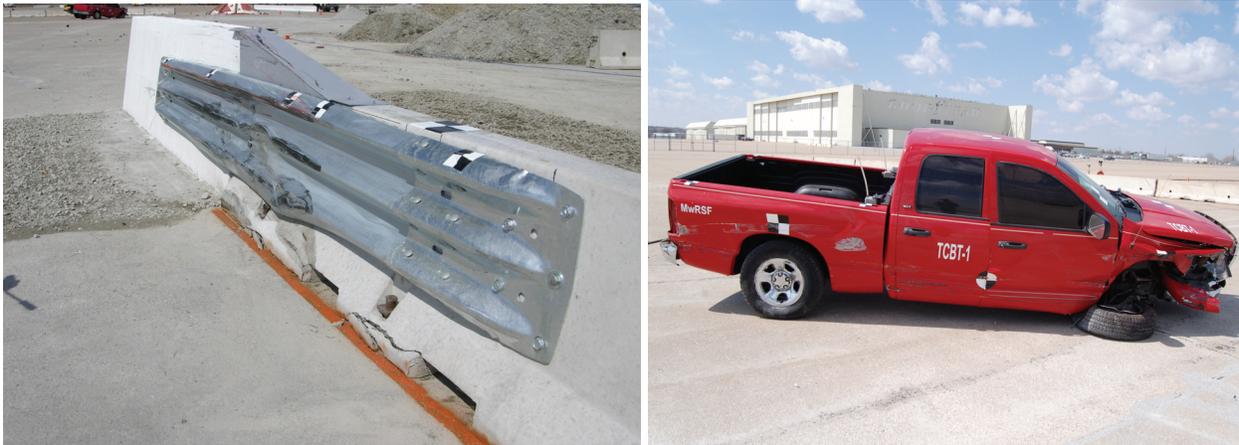
Figure 8. Post Test Damage, Test No. TCBT-1

Vehicle damage was moderate, and damage was concentrated on the right-front corner of the vehicle. The right-front corner, hood, and bumper were deformed inward. Major sheet metal deformations were found above the right-side wheel well and along the lower portion of the right-side doors. The right-front wheel was detached from the vehicle. Barrier damage consisted of scrapes and contact marks on the TCB, permanent barrier, and the thrie beam section, cracking of temporary barrier sections, and deformed thrie beam. The maximum lateral permanent set barrier deflection was 1/4 in. at the downstream end of barrier no. 1. The maximum lateral dynamic barrier deflection was 2.6 in. on middle of the non-impact-side of the thrie beam, as determined from high speed digital video analysis. Post test damage photographs are shown in Figure 8.

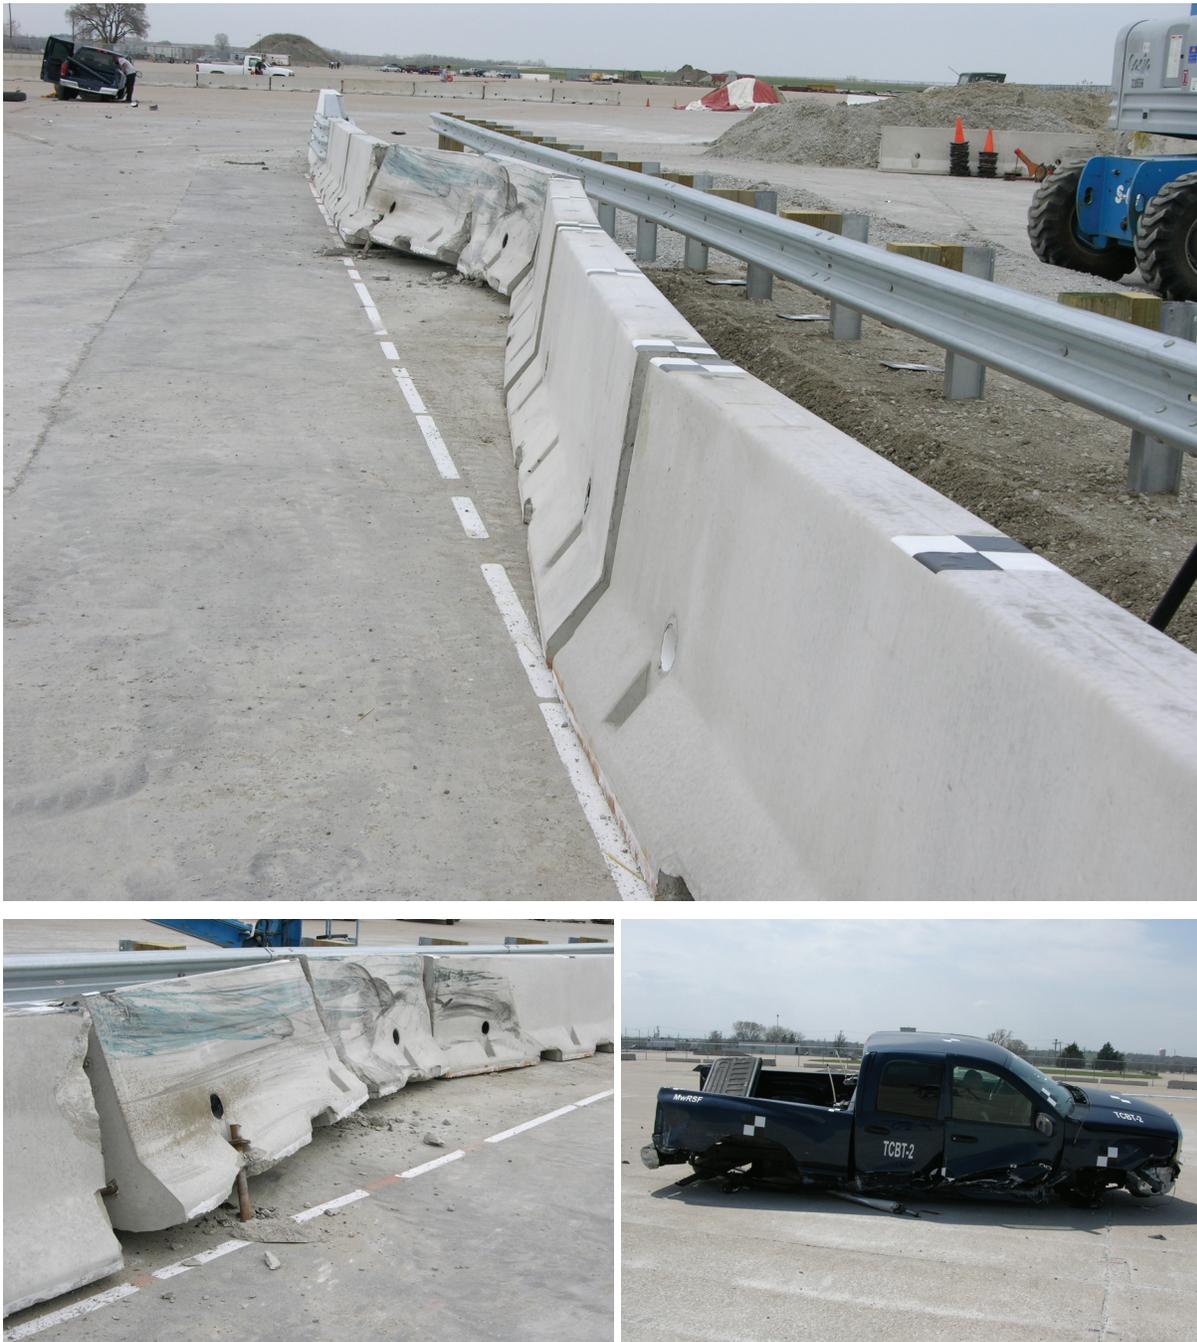
Figure 10. Post Test Damage, Test No. TCBT-2

Vehicle damage was moderate, and the damage was concentrated on the right side of the vehicle. The right-front corner including the front bumper and the right-front fender were deformed inward. The right-front wheel assembly disengaged from upper and lower control arms. Sheet metal deformation and contact marks were noted along the entire right side of the vehicle. The right-rear wheel disengaged from the vehicle. System damage consisted of scrapes, contact marks, and concrete spalling on TCB and asphalt pin deflections, cracking of temporary barrier sections, and a fractured temporary barrier. As noted above, barrier no. 4 was cracked and fractured near the midspan of the barrier, and some of the longitudinal rebar was fractured. Deformation of several concrete temporary barrier loop joints and connection pins were noted in the impact region. The maximum lateral permanent set barrier deflection was 34 in. at the

downstream end of barrier no. 5, as measured in the field. The maximum lateral dynamic barrier deflection was 34 in. at the upstream end of barrier no. 5, as determined from high-speed digital video analysis. Post test damage photographs are shown in Figure 10.
