Roadside Safety Pooled Fund

TPF-5(114)
Roadside Safety Research Program
Pooled Fund Study

W-Beam Guardrail on Low-Fill Box Culvert

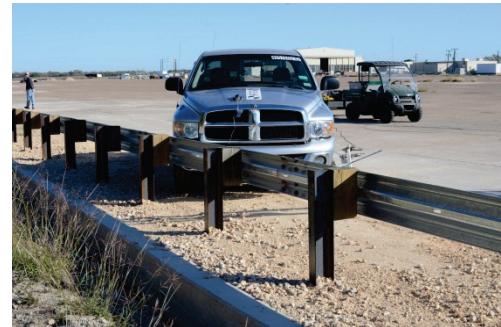
31-inch W-Beam Guardrail on Low-Fill Box Culvert

In Phase II, the box culvert guardrail installation consisted of a 12 gage W-beam guardrail system supported by W6×9 steel posts anchored to a simulated box culvert. Standard 6-inch × 8-inch × 14-inch long wood blockouts were used to block out the W-beam guardrail from the steel posts. The height of the W-beam guardrail system was 31 inches above finished grade. The posts were spaced on 6 ft-3 inches centers. The W-beam rail splices were located at the midspan of the 6 ft-3 inch post spacing. The posts were anchored to the top of a simulated box culvert slab using the Hilti RE500 epoxy anchoring system. For this test installation, 9 inches of compacted standard soil material was constructed on top of the simulated box culvert slab. The total length of the simulated concrete box culvert slab was 105 ft. The W-beam guardrail system was anchored on each end using ET Plus end terminals.

The W6×9 steel posts were welded to 12-inch × 12-inch × $\frac{7}{8}$ -inch thick base plates. The total length of the posts was 40 $\frac{1}{2}$ inches. Each steel post with base plate was anchored to the 9-inch thick simulated box culvert slab using four

$\frac{7}{8}$ -inch diameter A193 Super HAS all-threaded rods, $8\frac{1}{2}$ inches in length. These threaded rods were embedded approximately 6 inches in the box culvert slab and were anchored using the HILTI RE500 Epoxy Anchoring System.

The simulated box culvert slab tested for this project was 105 ft in length by 75 inches in width by 9 inches thick. The fill height constructed on top of the box culvert slab was approximately 9 inches. A 9-inch high by 10-inch wide concrete headwall was constructed on the field side edge of the box culvert slab. The W6x9 steel posts were located 28 inches from the field side edge of the simulated box culvert slab. Transverse steel reinforcement in the slab consisted of #3 bars spaced at 12 inches on centers in the top and bottom mats. Longitudinal steel reinforcement in the bottom mat consisted of #5 bars spaced $4\frac{1}{2}$ inches on centers. Longitudinal steel reinforcement in the top mat consisted of #3 bars spaced 6 inches on centers. Transverse reinforcement in the 9-inch high headwall consisted of #3 stirrups spaced at 12 inches on centers. Four #3 longitudinal steel bars were evenly spaced inside the stirrup reinforcement in the headwall.

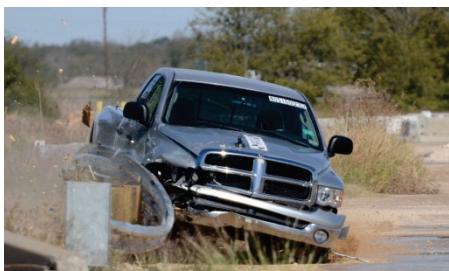
2270P Vehicle Redirecting during Test with W-Beam Guardrail over Low-Fill Box Culvert

point was 5 ft-3 inches upstream of post 12. The 2003 Dodge Ram 1500 Quad Cab pickup truck used in the test weighed 5005 lb and the actual impact speed and angle were 62.9 mi/h and 26.1 degrees, respectively. The actual impact point was 5 ft-4 inches upstream of post 12.

The W-Beam Guardrail on Low-Fill Box Culvert contained and redirected the 2270P vehicle. The vehicle did not penetrate, underride, or override the installation, however, the rail element was torn half the width at post 12. Maximum dynamic deflection during the test was 45.1 inches. Several blockouts separated from the installation. However, none of these detached elements penetrated or showed potential for penetrating the occupant compartment, nor to present undue hazard to others in the area. No occupant compartment deformation occurred. The 2270P vehicle remained upright during and after the collision event. Maximum roll and pitch angles were -9 degrees and -11 degrees, respectively. Occupant risk factors were within the limits specified in MASH. The 2270P vehicle exited within the exit box specifications. The W-Beam Guardrail on Low-Fill Box Culvert performed acceptably according to the specifications for MASH test 3-11.

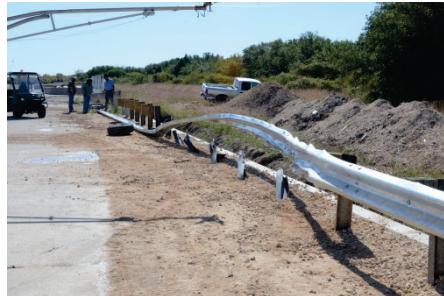
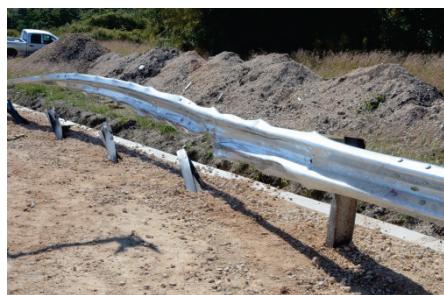
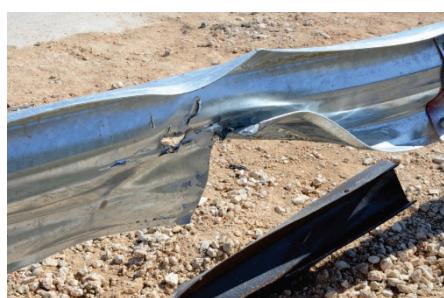
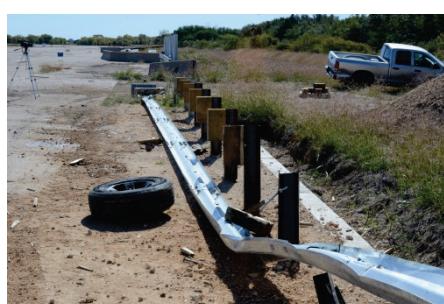
W-Beam Guardrail on Low-Fill Box Culvert after Test

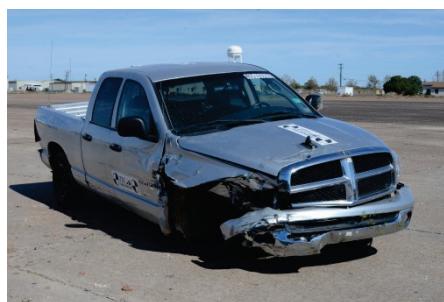
Vehicle after Test
