**Test Report No.: 405160-26**  
**Test Report Date: March 2013**

**DEVELOPMENT AND TESTING OF A TRANSITION  
FROM FREE-STANDING TO PINNED TEMPORARY  
CONCRETE BARRIER**

**TEXAS A&M TRANSPORTATION INSTITUTE PROVING GROUND**

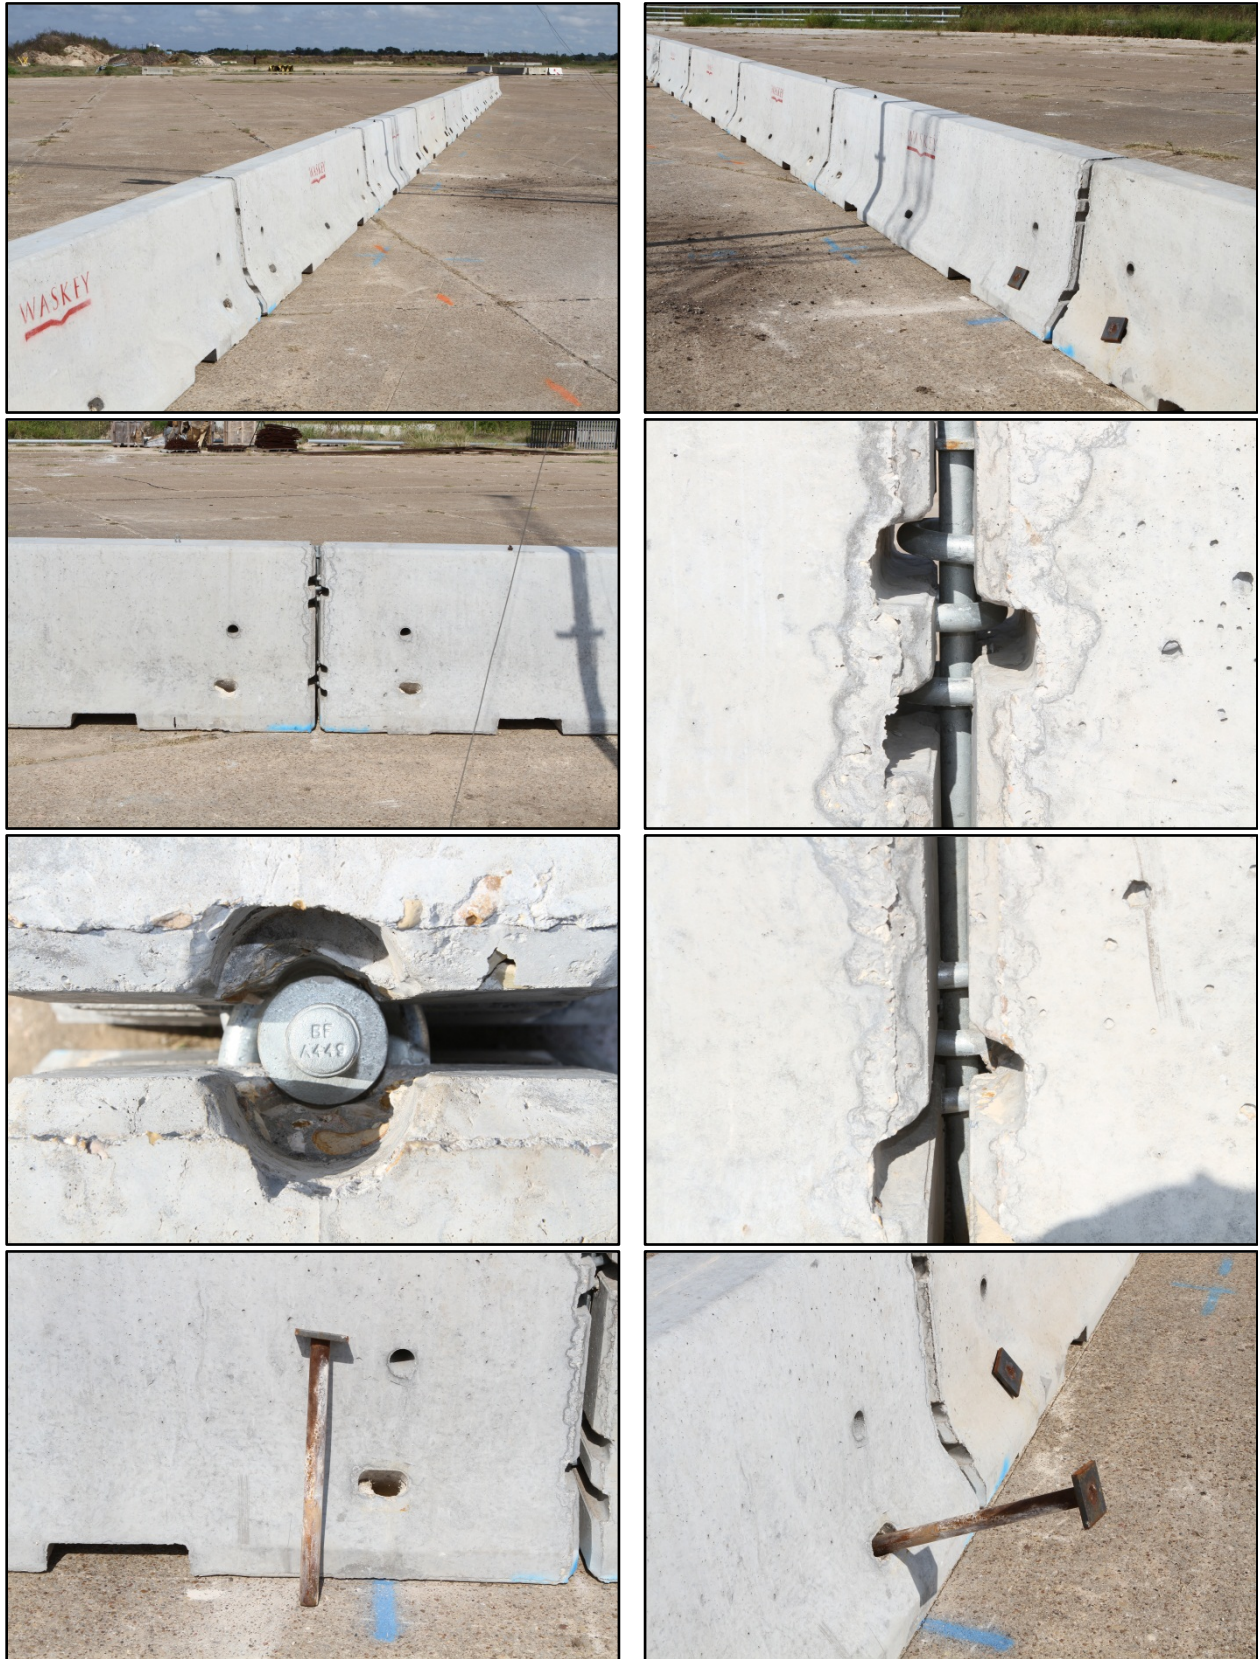
Figure 5.2. Transition from free-standing F-shape barrier to pinned F shape barrier prior to test 405160-26-2.

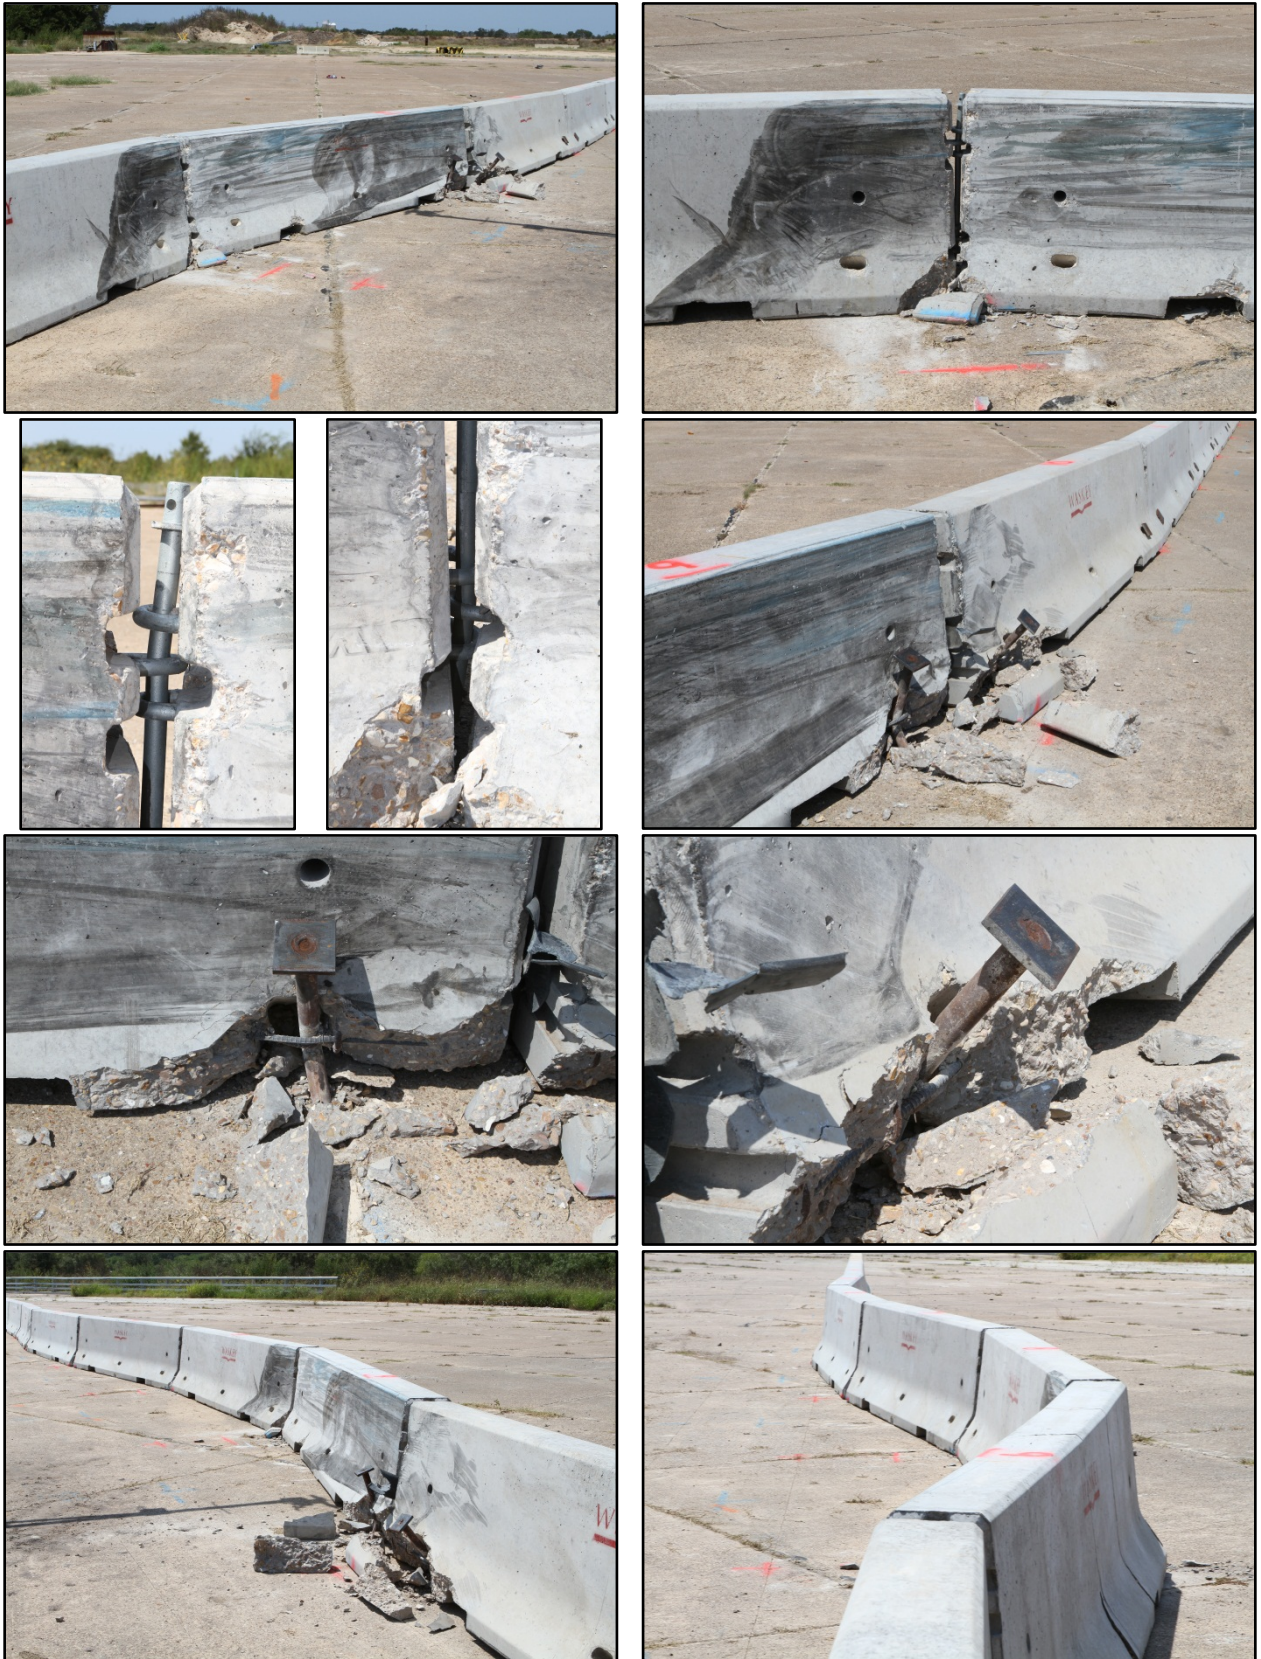
Damage to the transition installation is shown in figures 5.5 and 5.6. The downstream ends of segments 1 through 4 deflected downstream 1.0 inch, 1.5 inches, 2.0 inches and 2.25 inches, respectively. Segment 5 moved downstream 3.0 inches and toward the traffic side 5.0 inches. Segment 6 moved downstream 6.0 inches and 8.0 inches toward the field side. Segment 7 moved downstream 3.0 inches and 30.0 inches toward the field side. Segment 8 moved 44.0 inches toward the field side. Segment 9 deflected toward the field side 9.0 inches and upstream 3.0 inches. Segment 10 deflected toward the field side 1.0 inch and upstream 1.0 inch. Segment 11 moved upstream 0.5 inch. Moderate concrete damage occurred at the adjacent ends of segments 8 and 9, and significant damage to the adjacent ends of segments 9 and 10. The pins on the adjacent ends of segments 9 and 10 pulled upward 5.0 inches and were deformed. The downstream pin on segment 10 pulled upward 0.75 inch. Working width was 5.8 ft, vehicle penetration was 4.7 ft, maximum dynamic deflection during the test was 3.9 ft, and maximum permanent deformation was 3.7 ft.

Figure 5.6. Installation after test 405160-26-2.

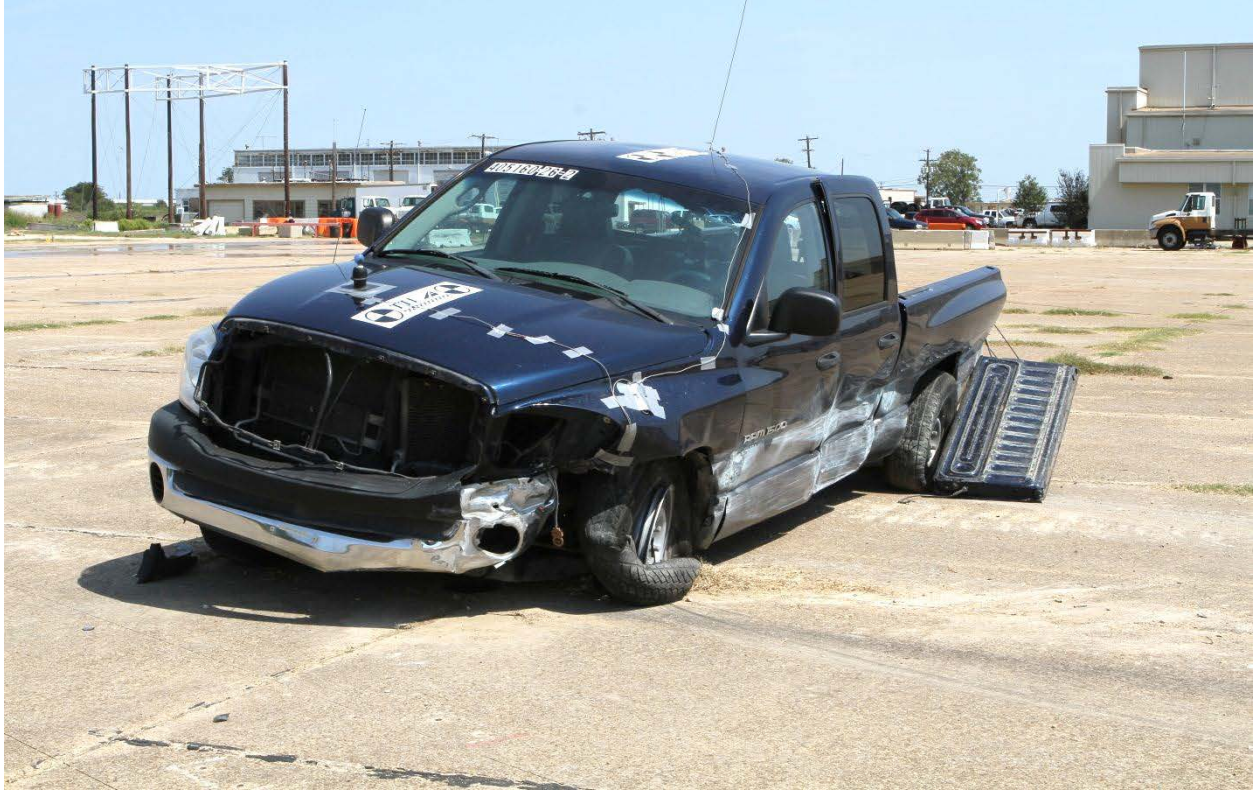
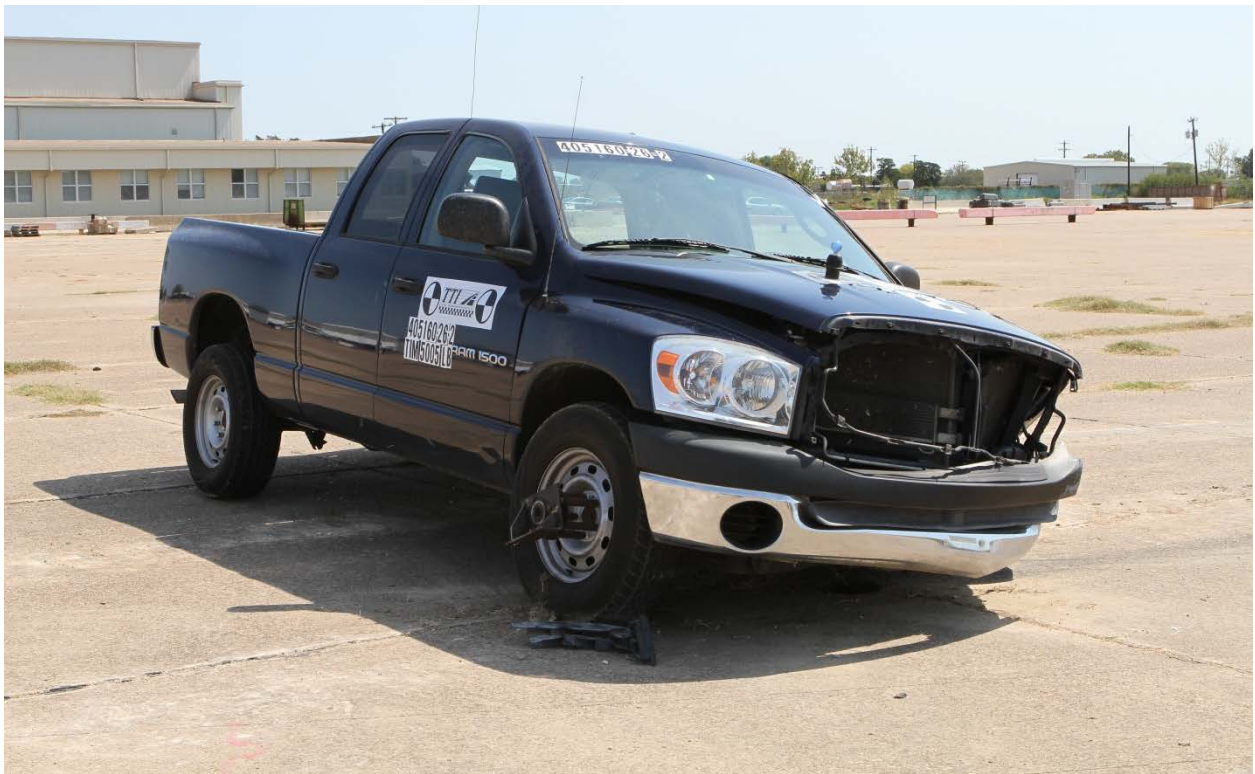
Damage to the 2270P vehicle is shown in figure 5.7. The upper and the lower ball joints on the left side broke and left frame rail was deformed. Also damaged were the front bumper, grill, left front fender, left front door, left rear door, left front and left rear tires and wheel rims, left exterior bed, rear bumper and tailgate. Maximum exterior crush to the vehicle was 15.0 inches in the side plane at the left front corner at bumper height. Maximum occupant compartment deformation was 1.5 inches in the lateral area across the cab at hip height. Photographs of the interior of the vehicle are shown in figure 5.8 Exterior vehicle crush and occupant compartment measurements are shown in appendix B.3, tables B.3 and B.4.

Figure 5.7. Vehicle after test 405160-26-2.

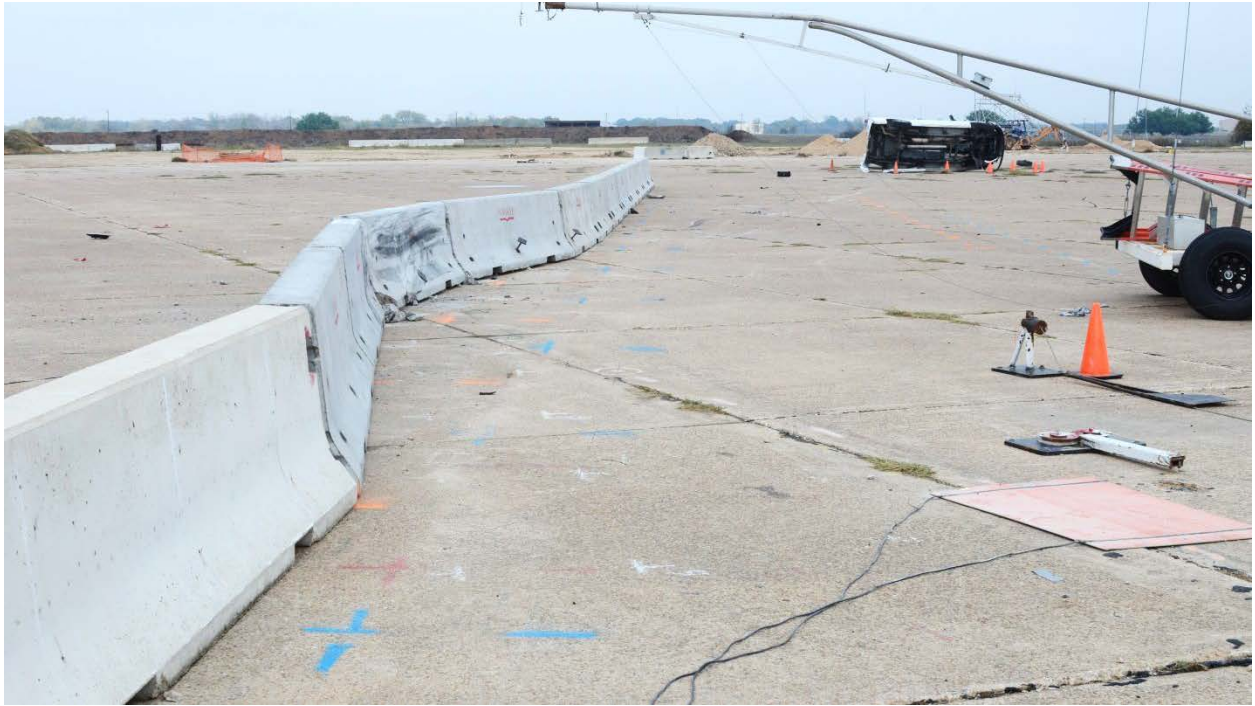
Damage to the transition installation is shown in figures A.5 and A.6. The upstream end of segment 2 deflected upstream 0.5 inch, and the upstream ends of segment 3 and 4 deflected upstream 1.5 inches each. Segment 5 moved upstream 2.0 inches and toward the field side 0.75 inch. Segment 6 moved upstream 6.0 inches and 1.0 inch toward the field side on the upstream end and 2.0 inches toward traffic lanes on the downstream end. Segment 7 moved upstream 2.5 inches and 1.5 inches toward traffic lanes on the upstream end and 22.0 inches toward the field side on the downstream end. Segment 8 moved 3.5 inches upstream and 22.75 inches toward the field side on the upstream end and 44.5 inches toward the field side on the downstream end. Segment 9 deflected toward the field 44.0 inches on the upstream end and 37.5 inches on the downstream end. Segment 10 deflected toward the field side 37.5 inches on the upstream end and 4.5 inches on the downstream end. Segment 11 moved downstream 2.5 inches and 4.5 inches toward the field side. Segment 12 moved 1.5 inches downstream, and segments 13 and 14 moved 1.0 inch downstream. Working width was 5.1 ft, maximum dynamic deflection during the test was 3.7 ft, and maximum permanent deformation was 3.7 ft.

Figure A.5. Vehicle/installation positions after test 405160-26-1.

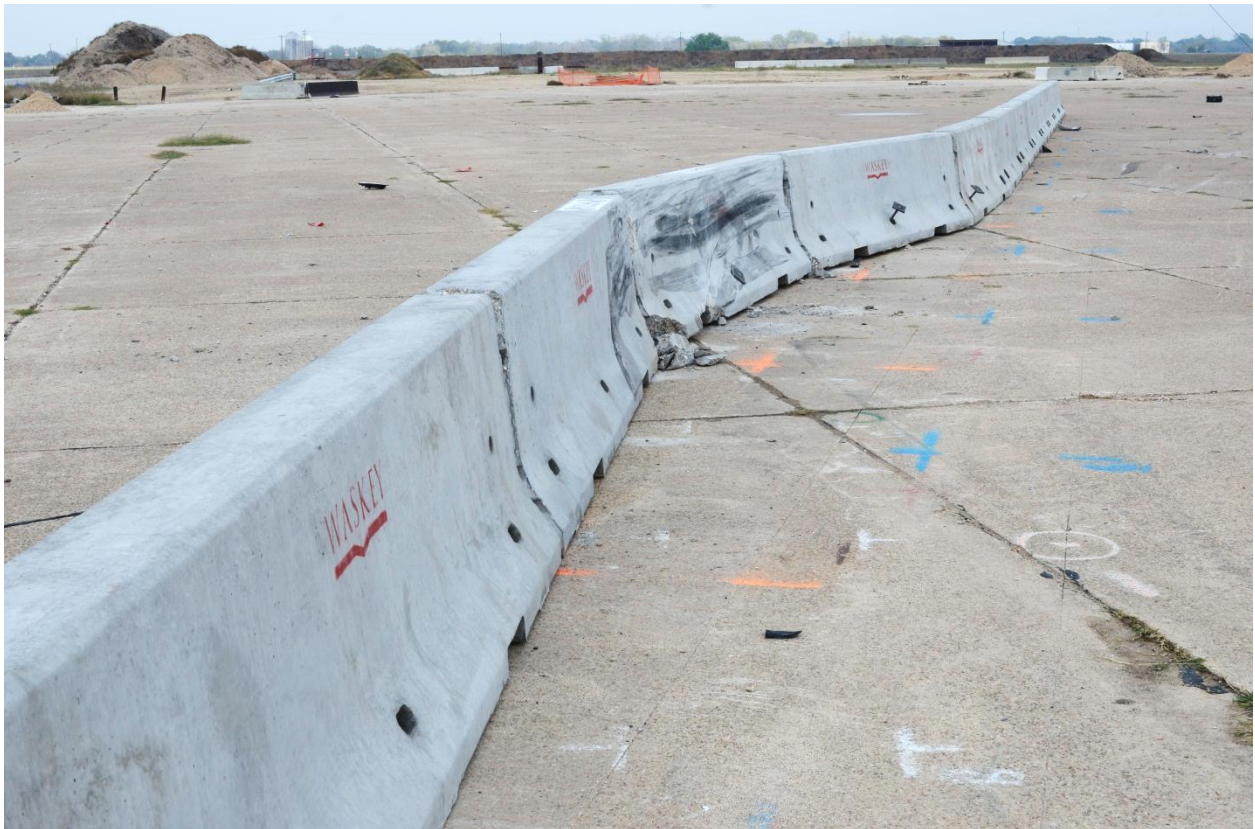
Figure A.6. Installation after test 405160-26-1.

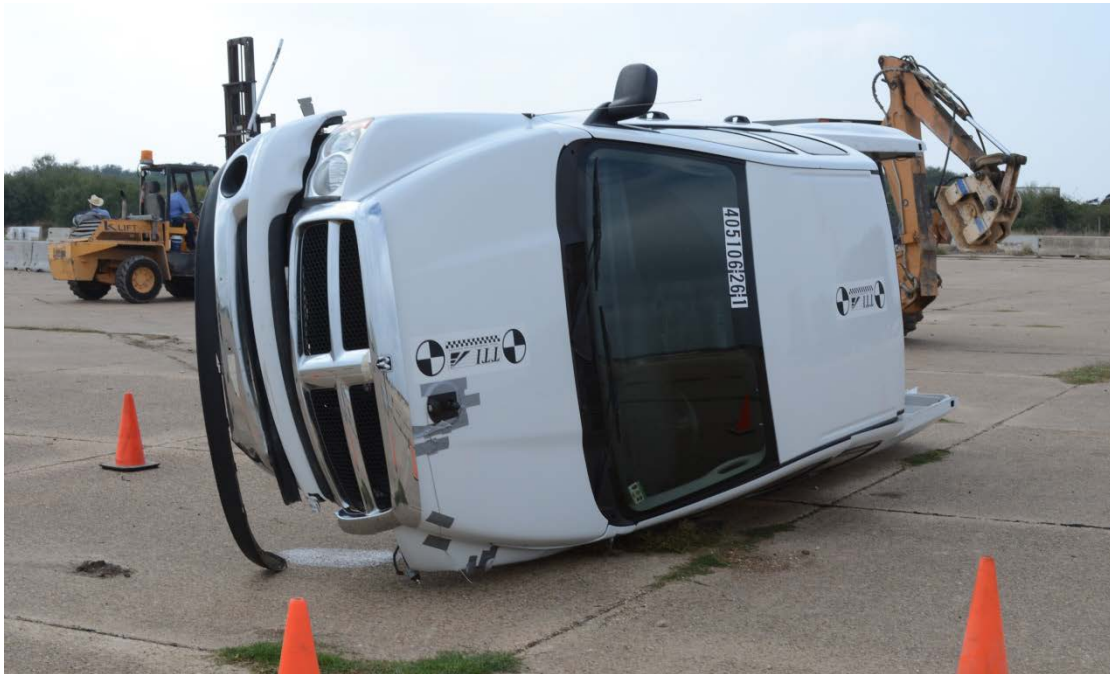
Damage to the 2270P vehicle is shown in figure A.7. The upper ball joints on the left side pulled out of the socket and the lower ball joint on the left side broke. The tie rod end broke, the left upper and lower A-arms, sway bar, and left frame rail were deformed. Also damaged were the front bumper, grill, left front fender, left front door, left rear door, left front and left rear tires and wheel rims, left exterior bed, and rear bumper. Maximum exterior crush to the vehicle was 20 inches in the side plane at the left front corner at bumper height. Maximum occupant compartment deformation was 5.0 inches in the left side floor pan. The seam opened in the left front corner of the floor pan forming a 6-inch  $\times$  8-inch hole. Exterior vehicle crush and occupant compartment measurements are shown in tables A.3 and A.4.

Figure A.7. Vehicle after test 405160-26-1.

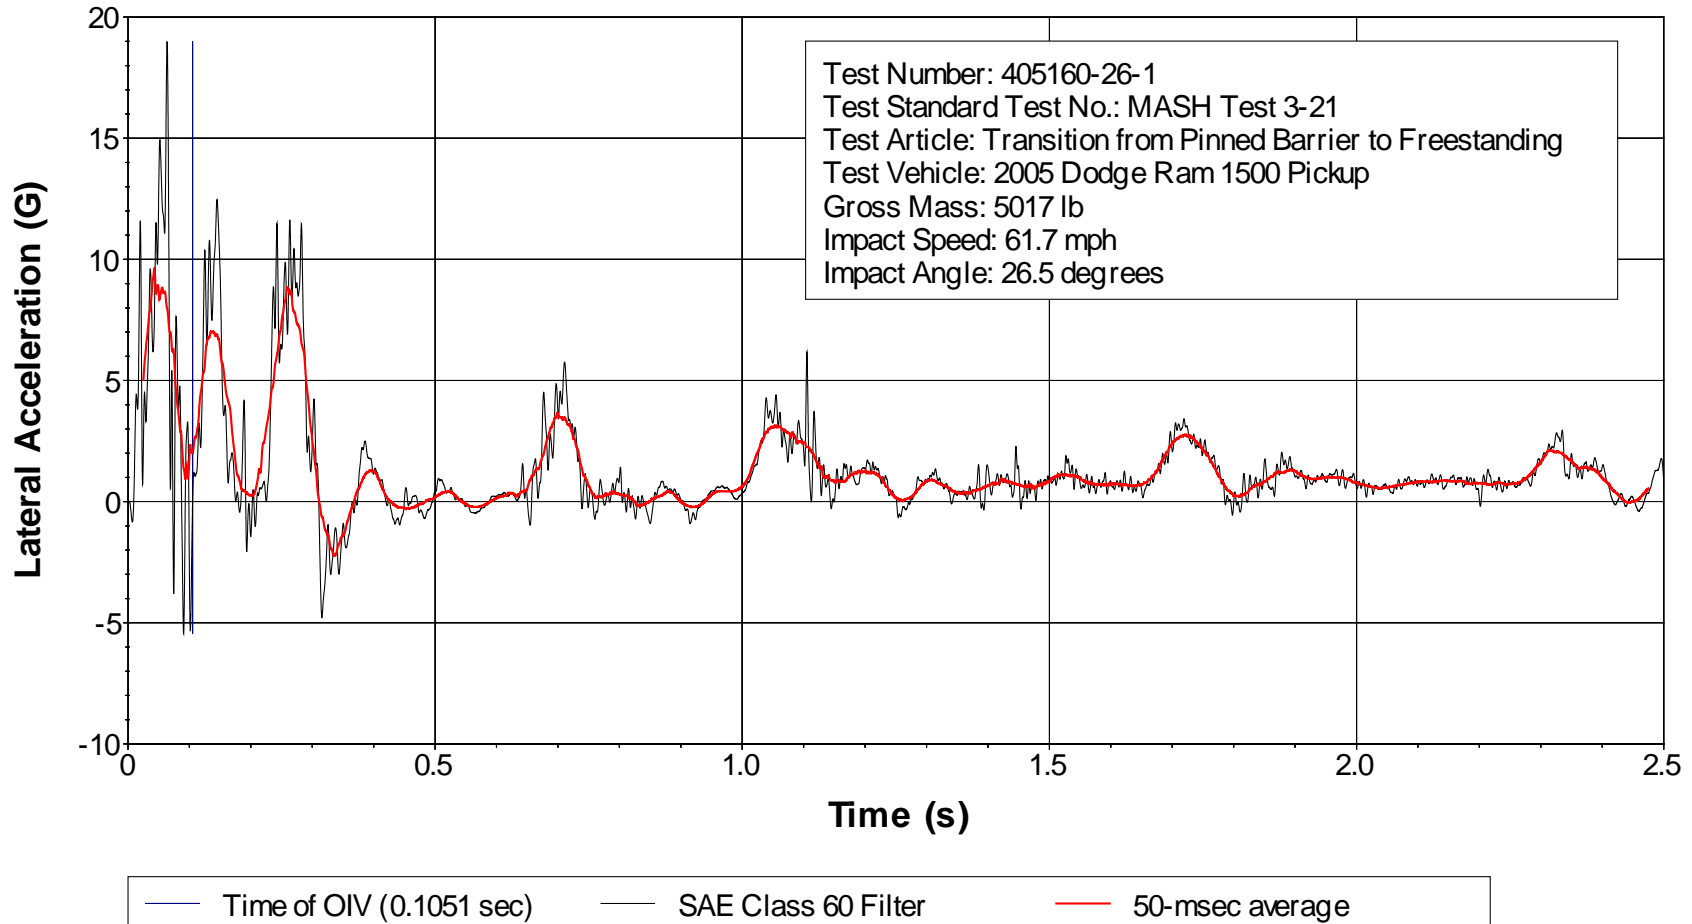
Figure A.11. Vehicle lateral accelerometer trace for test 405160-26-1 (accelerometer located at center of gravity).

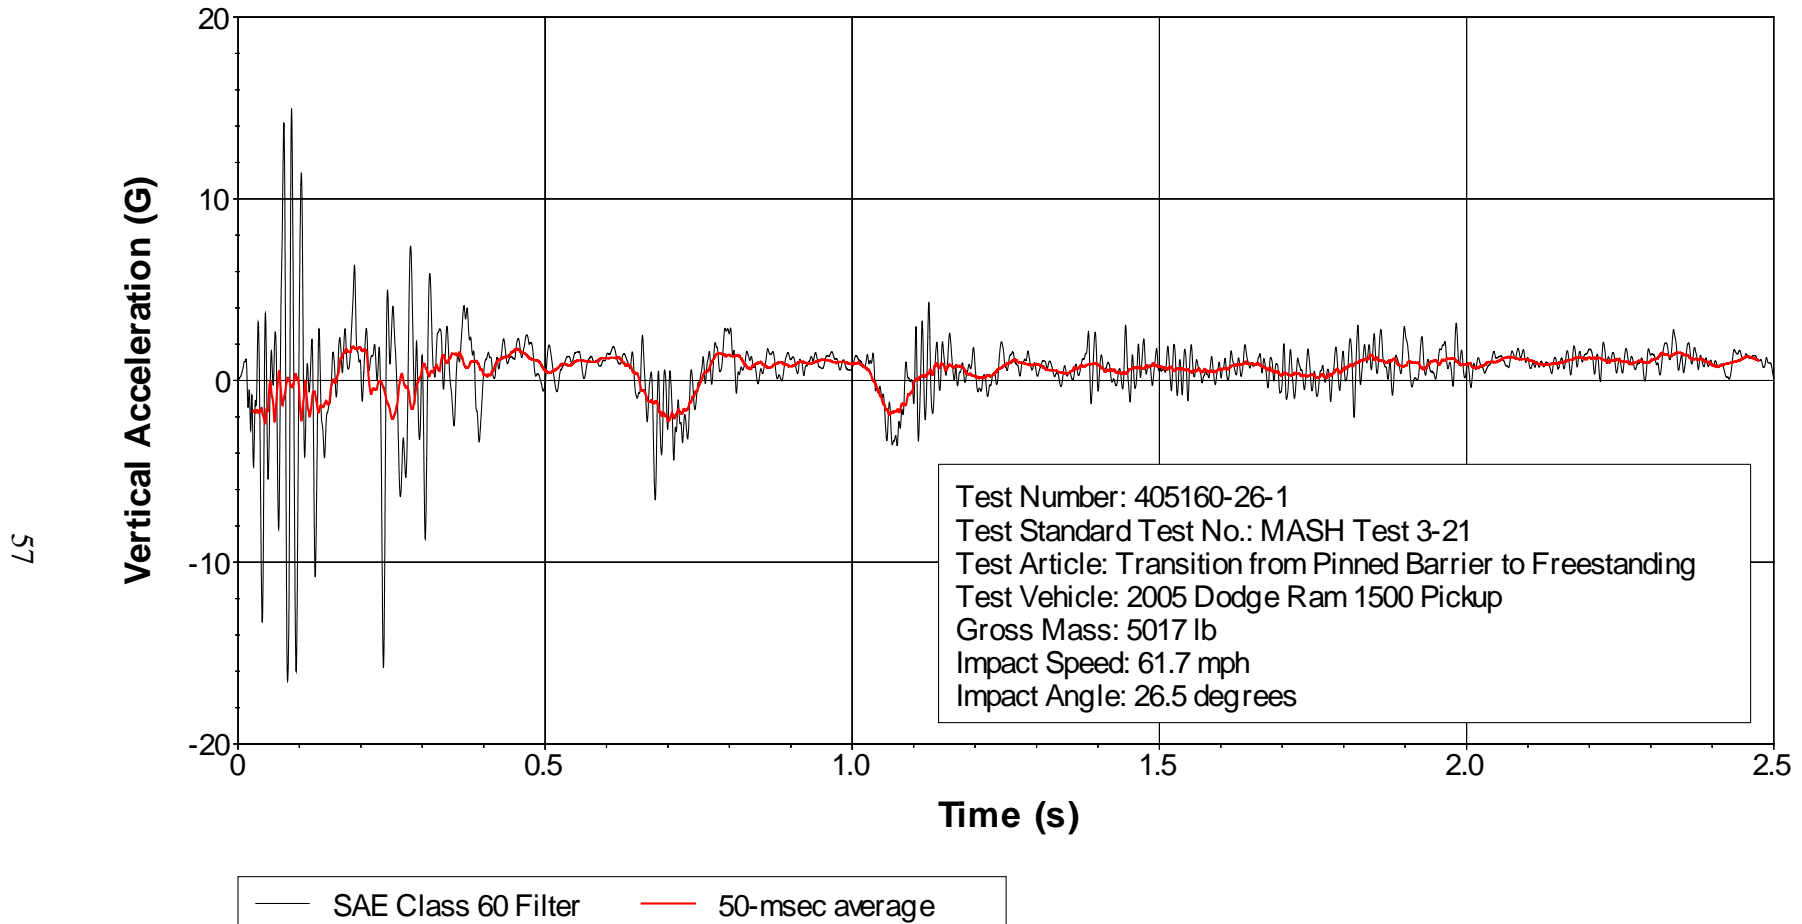
Figure A.12. Vehicle vertical accelerometer trace for test 405160-26-1 (accelerometer located at center of gravity).

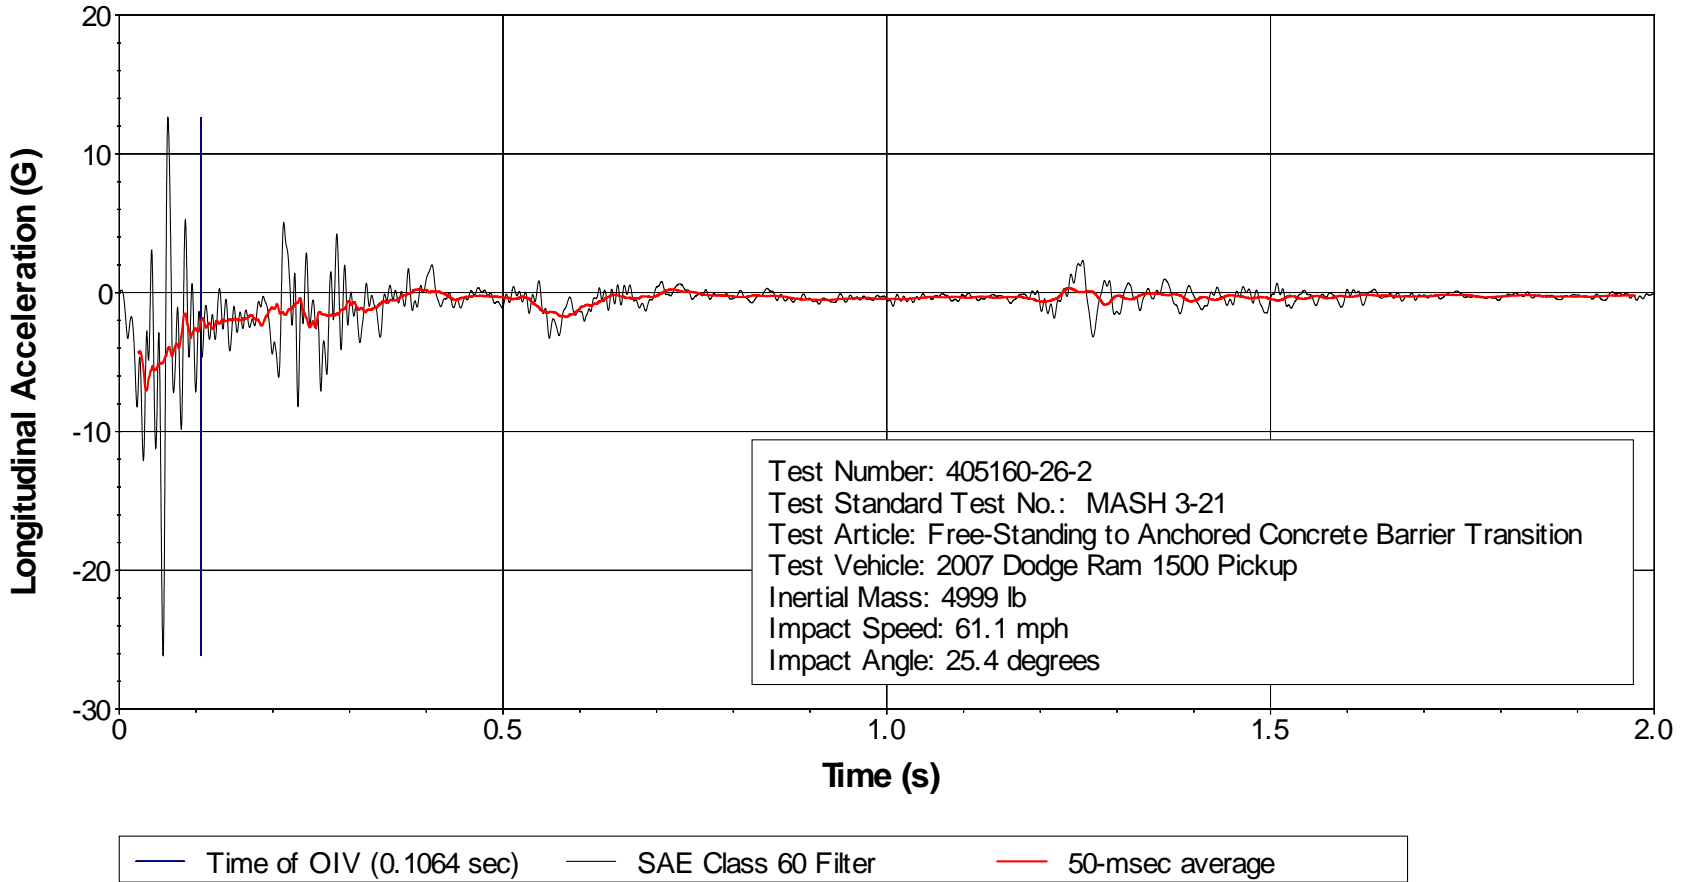
Figure B.4. Vehicle longitudinal accelerometer trace for test 405160-26-2 (accelerometer located at center of gravity).

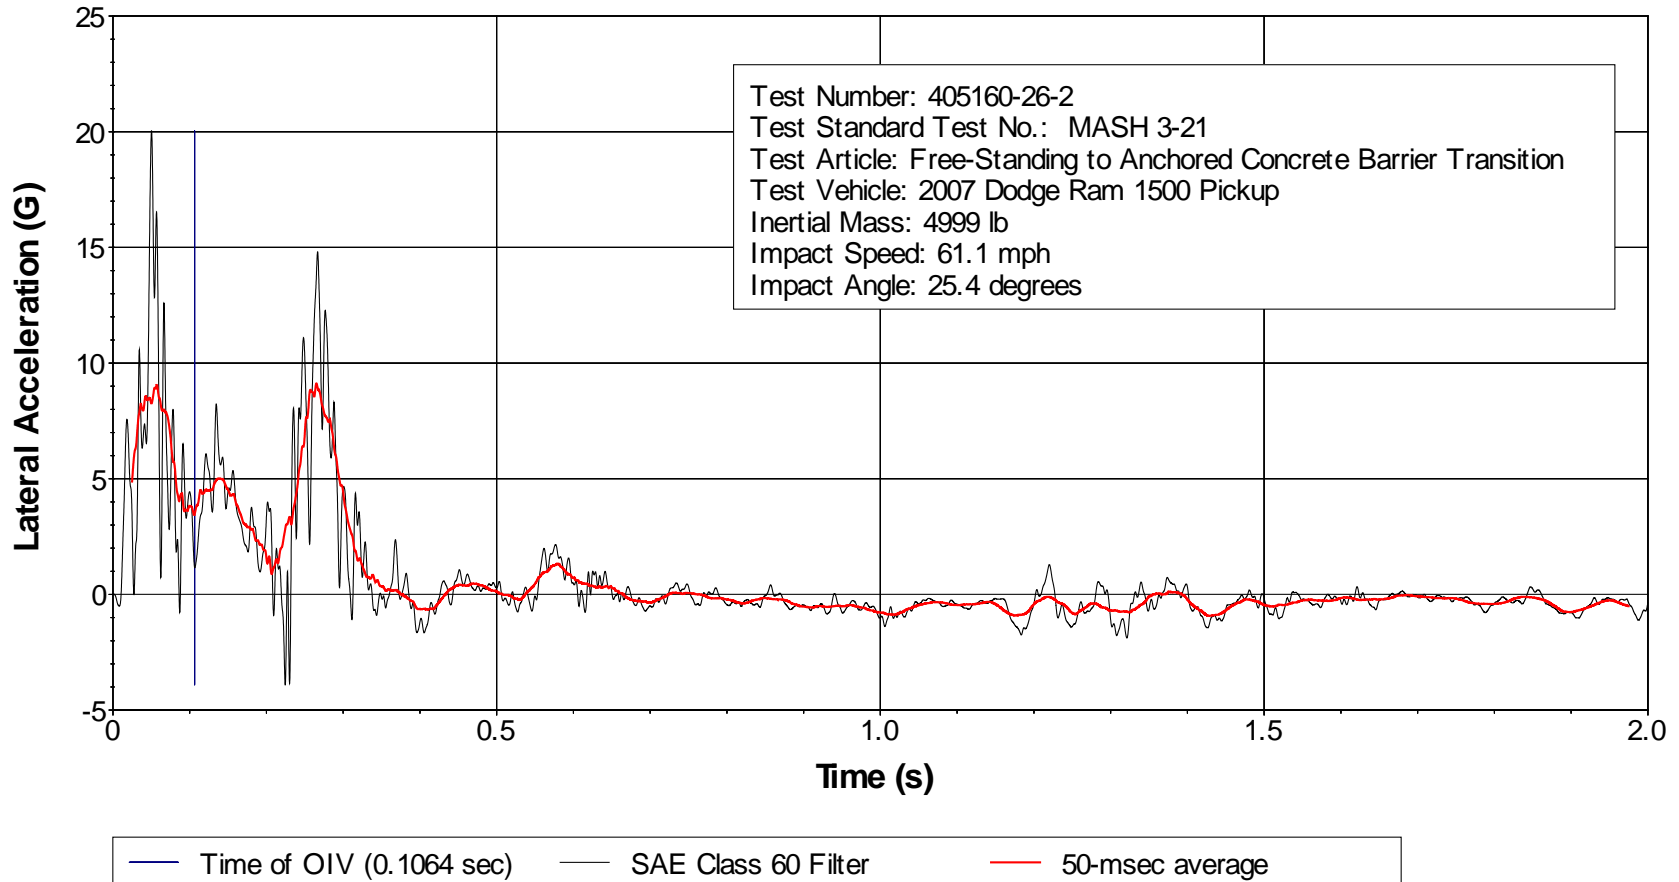
Figure B.5. Vehicle lateral accelerometer trace for test 405160-26-2 (accelerometer located at center of gravity).
