Report No. 405160-13-1
Report Date: August 2009

**DEVELOPMENT AND TESTING OF A CONCRETE
BARRIER DESIGN FOR USE IN FRONT OF SLOPE OR
ON MSE WALL**

Contract No.: T4541
Test No.: 405160-13-1
Test Date: 2009-04-16

Sponsored by
**Roadside Safety Research Program Pooled Fund
Study No. TPF-5(114)**

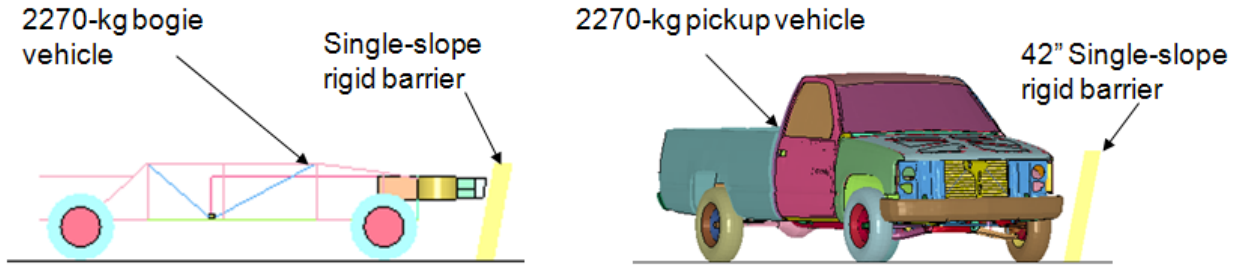
Figure 2.2. Simulation setup for determining lateral force levels for impacts with rigid single slope barrier.

An appropriate impact speed of the bogie vehicle was determined using simulation analysis. A simulation was performed with the 5000-lb pickup truck vehicle impacting a rigid single slope barrier at 62 mi/h and 25 degree angle (as required by test 3-11 of *MASH*. See figure 2.2). The force of contact between the vehicle and rigid barrier were measured. Another set of simulations was performed where a finite element model of the 5000-lb surrogate bogie vehicle impacted a rigid single slope barrier at 90 degrees (as shown in figure 2.2). The contact force between the bogie vehicle and the rigid barrier were measured for several impact speeds and then compared to the forces resulting from the pickup truck impact with the barrier (as shown in figure 2.3). The comparison revealed that a 15 mi/h impact at 90 degrees provided forces that were approximately equivalent to those resulting from a 62 mi/h impact of the pickup at 25 degrees. Thus, the impact speed of the bogie vehicle in the test was selected to be 15 mi/h.

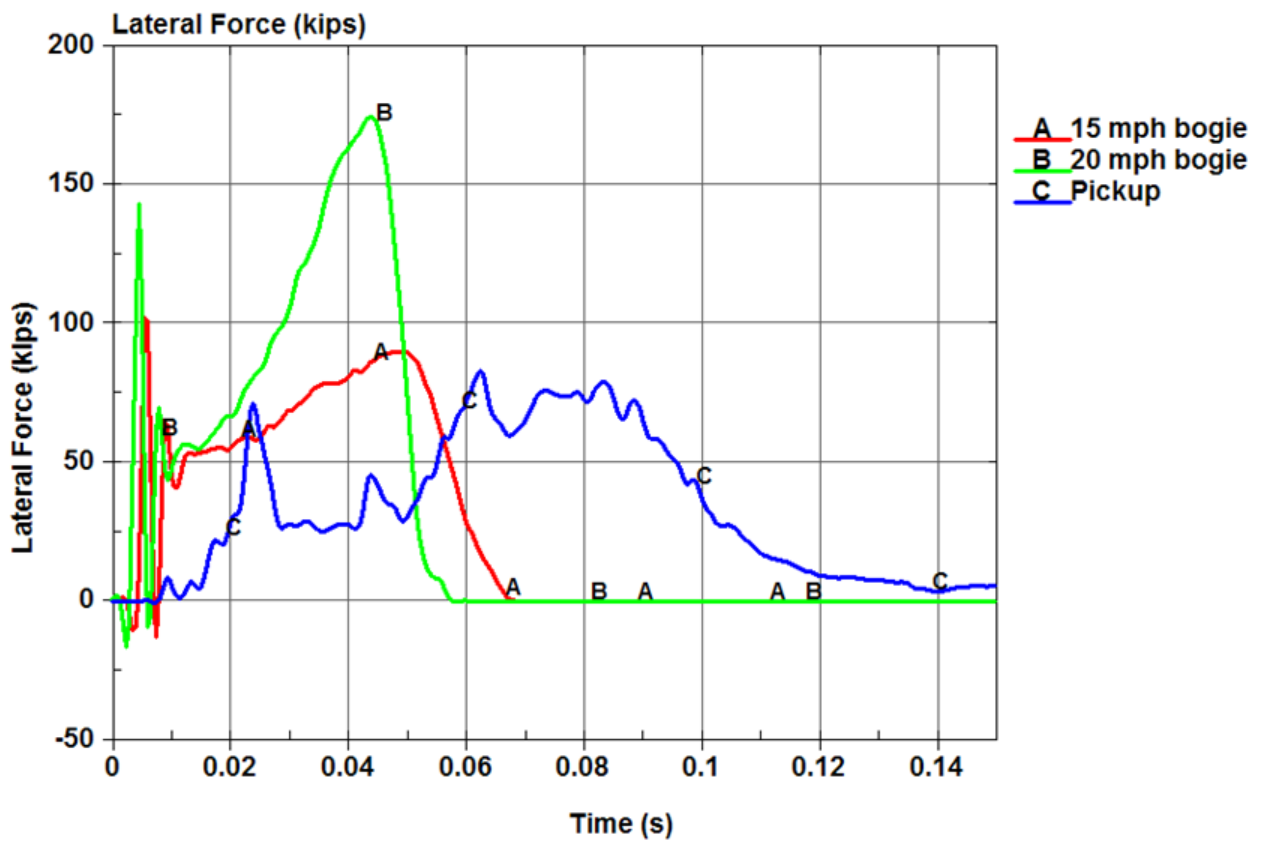
Figure 2.3. Lateral force comparison of pickup truck and bogie vehicle impacts on rigid single slope barrier.

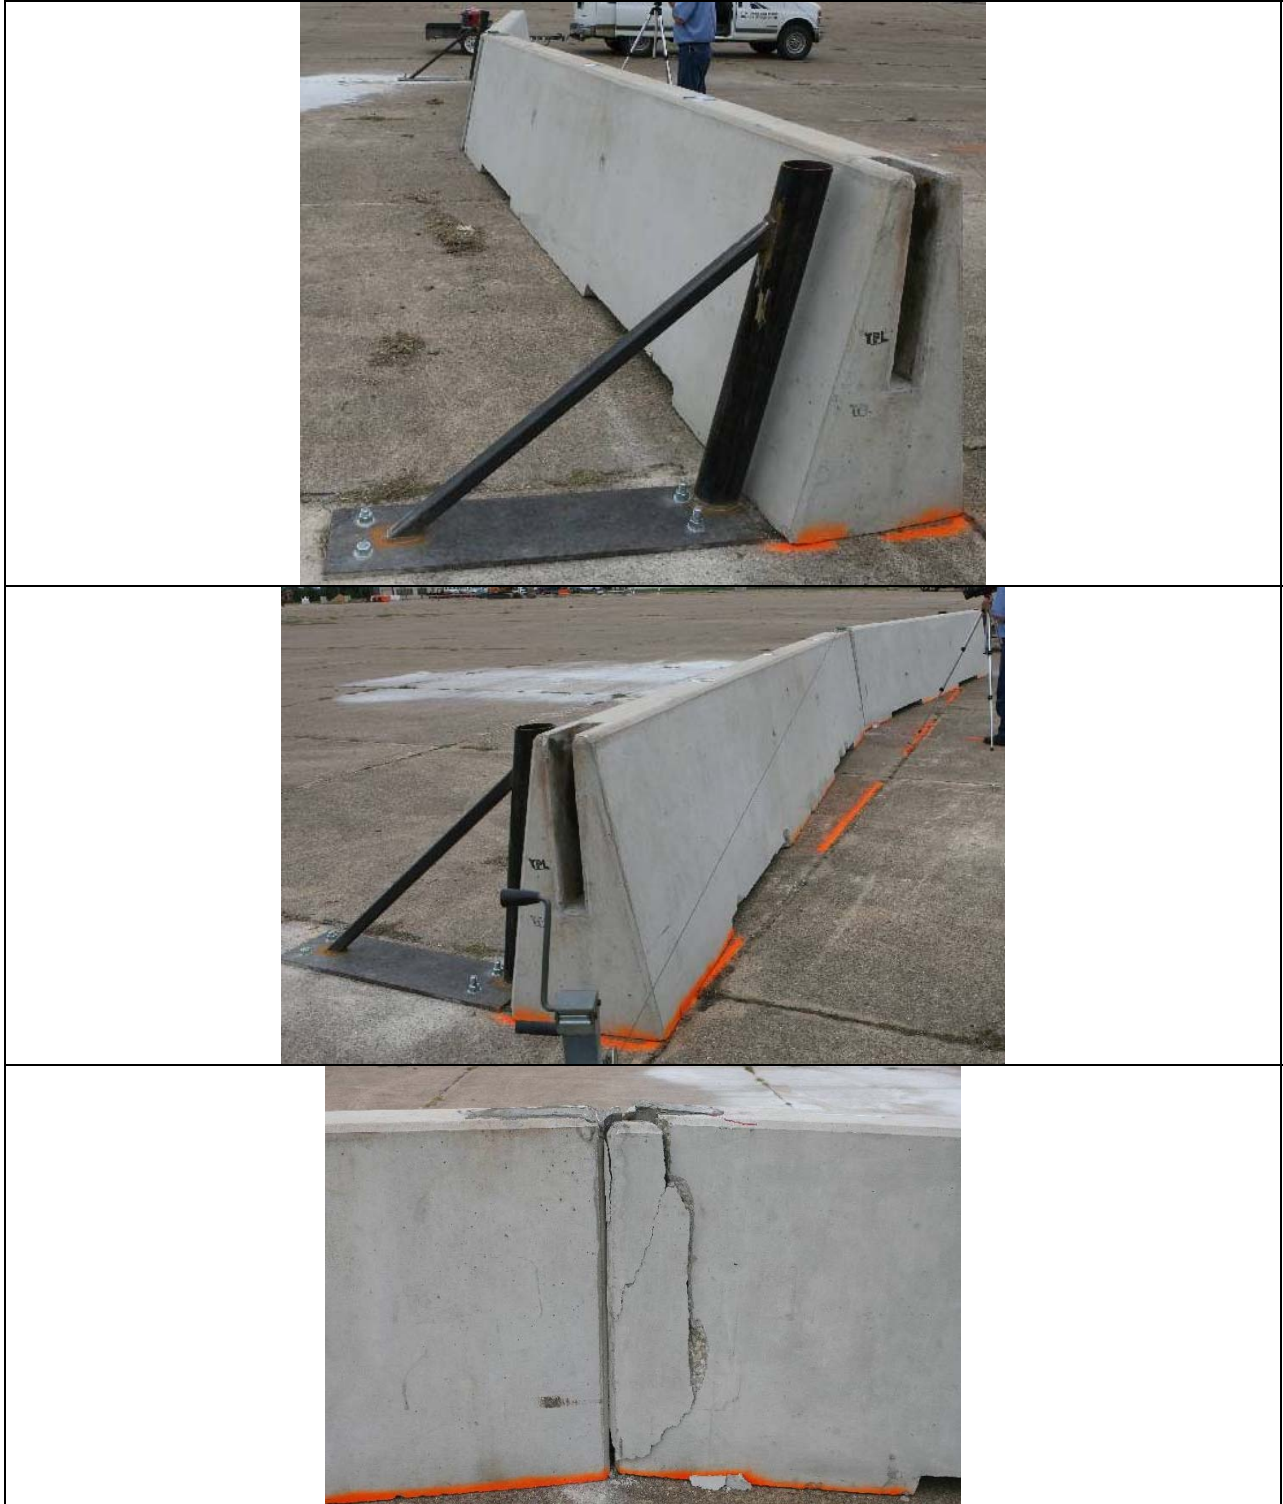
Figure 2.4. Barrier after impact from bogie vehicle.

The 5000-lb bogie vehicle impacted the barriers at the center of the joint at an impact speed of 14 mi/h. The impact in the test resulted in a maximum permanent lateral deflection of 22 inches. The grouted rebar-grid connection cracked near the centerline of the connection (see figure 2.4).

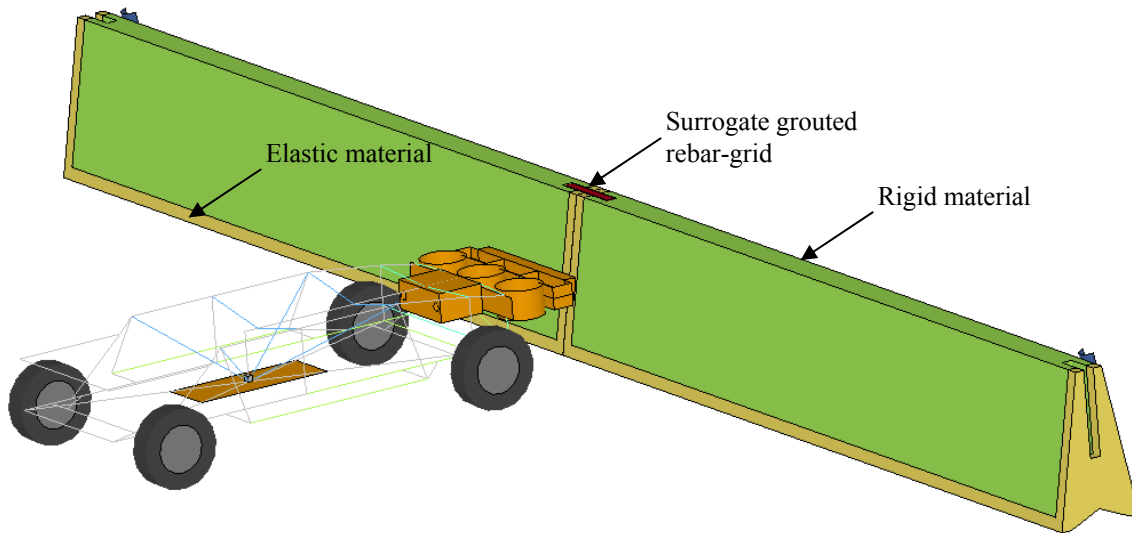
Figure 2.5. Finite element model of the bogie test.

The researchers then developed a finite element model of the barrier installation used in the bogie test. The single slope barrier segments were modeled with mostly rigid material representation. To improve the distribution of forces at interfaces between adjacent barriers and between the barrier and the ground, elastic material representation was used in these regions. The grouted rebar-grid connection was modeled using bi-linear elastic-plastic material and a rebar-grid comprised of beam elements. A 5000-lb bogie vehicle model impacted the barrier model at the test speed and location. The model of the barrier bogie test setup is shown in figure 2.5.

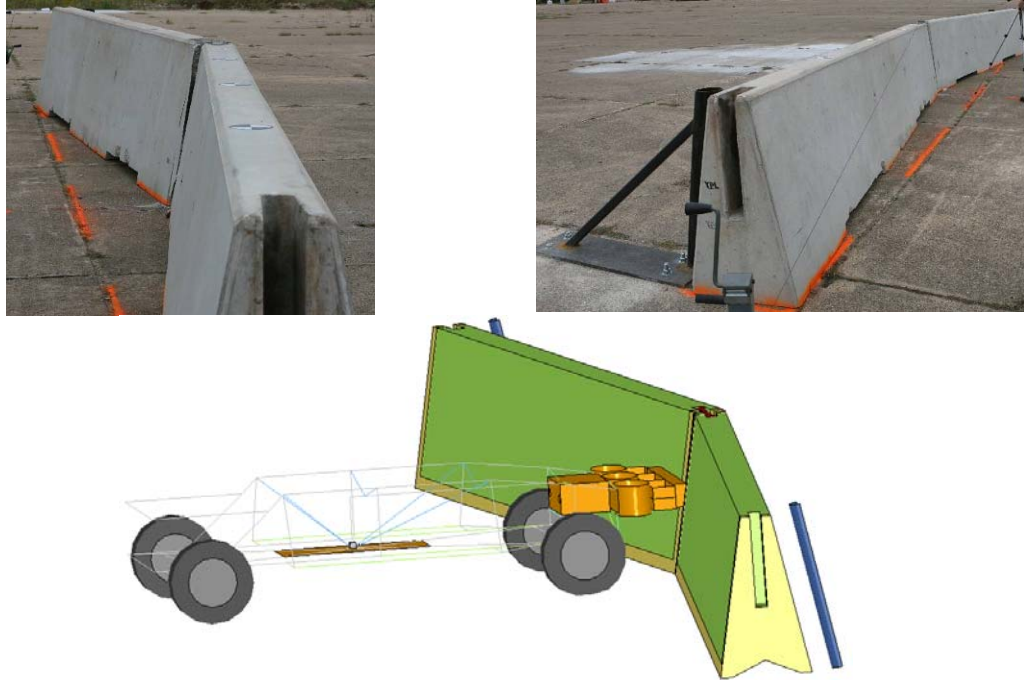
Figure 2.6. Results of the bogie crash test and simulation analysis.

The properties of the surrogate grouted rebar-grid connection in the simulation model were calibrated to match the lateral deflection of the barrier observed in the test. Figure 2.6 shows the calibrated simulation results compared to the crash test results.

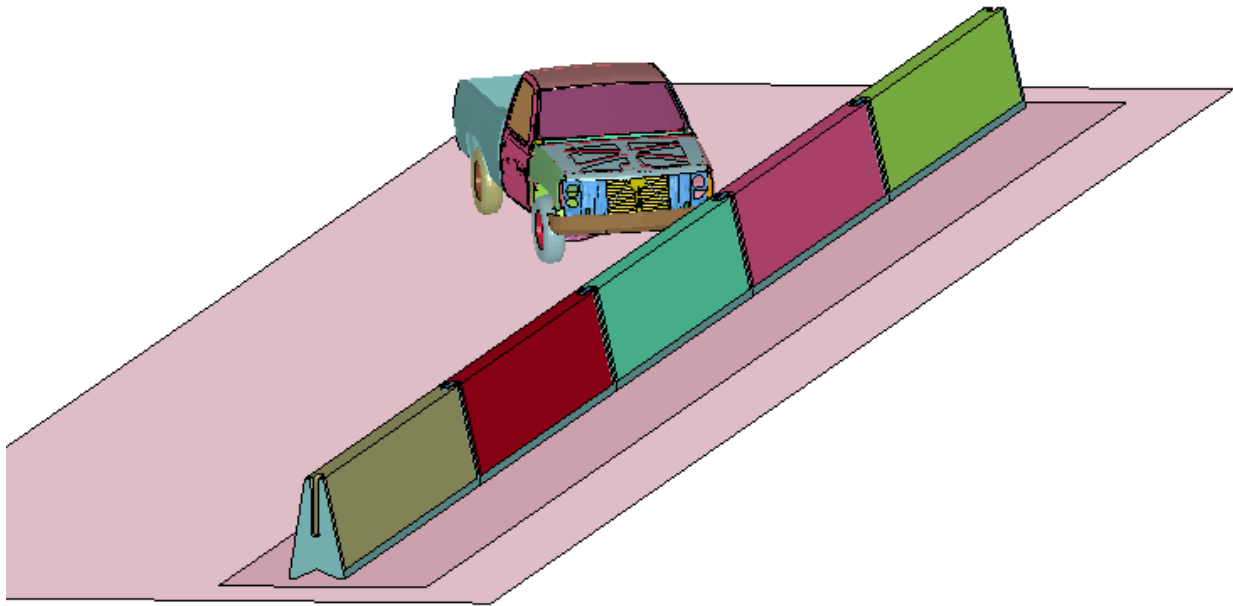
Figure 2.7. Finite element model of the 100-ft installation of free-standing single slope barrier.

Once the response of a single grouted rebar-grid connection was calibrated, the researchers developed a 100-ft long full-scale barrier system model to evaluate the free-standing single slope barrier under *MASH* TL-3 impact conditions (i.e. impact with a 5000-lb vehicle at 62 mi/h and 25 degrees). The objective of this simulation was to determine if the overall lateral deflection of the free-standing barrier installation was small enough to allow its use adjacent to slopes or on MSE walls without requiring any restraining mechanisms. The barrier system model was comprised of five 20-ft long single slope barrier segments that were connected using the calibrated grouted rebar-grid slot connection model. The 5000-lb vehicle impacted the barrier 4 ft upstream of the connection between the second and the third barrier segment as shown in figure 2.7.

In the simulated impact, the free standing barrier had a deflection greater than 30 inches. This deflection was much higher than acceptable as per the objectives of this research. Hence, the researchers started investigating ways of restraining the barrier to limit lateral deflections.

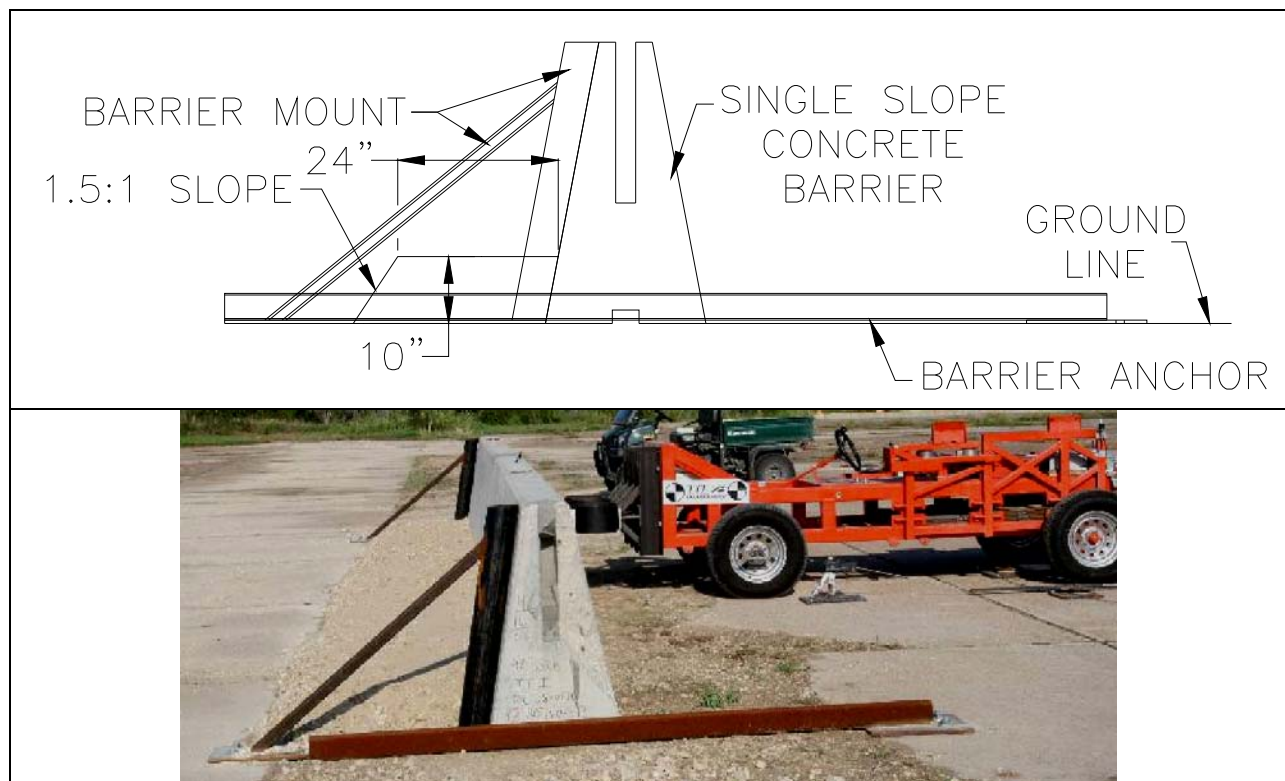
Figure 2.8. Bogie test setup for embedded barriers.

The researchers conducted another bogie impact test with two single-slope barrier segments connected via grouted rebar-grid slot connection and embedded 10 inches in soil. The width of the soil behind the barrier was 24 inches behind the barrier. A 1.5H:1V slope was used for the soil cut, as shown in the test setup in figure 2.8. The type of soil and the compaction method used were as specified in the *MASH* guidelines. The 5004-lb bogie vehicle impacted the barrier at the joint at a speed of 14.4 mi/h. The maximum permanent barrier deflection was 4.45 inches at the joint. The researchers then incorporated a 10-inch soil layer into the finite element model and calibrated the soil properties by conducted bogie vehicle impact simulations until the results matched the barrier deflection observed in the test (see figure 2.9).

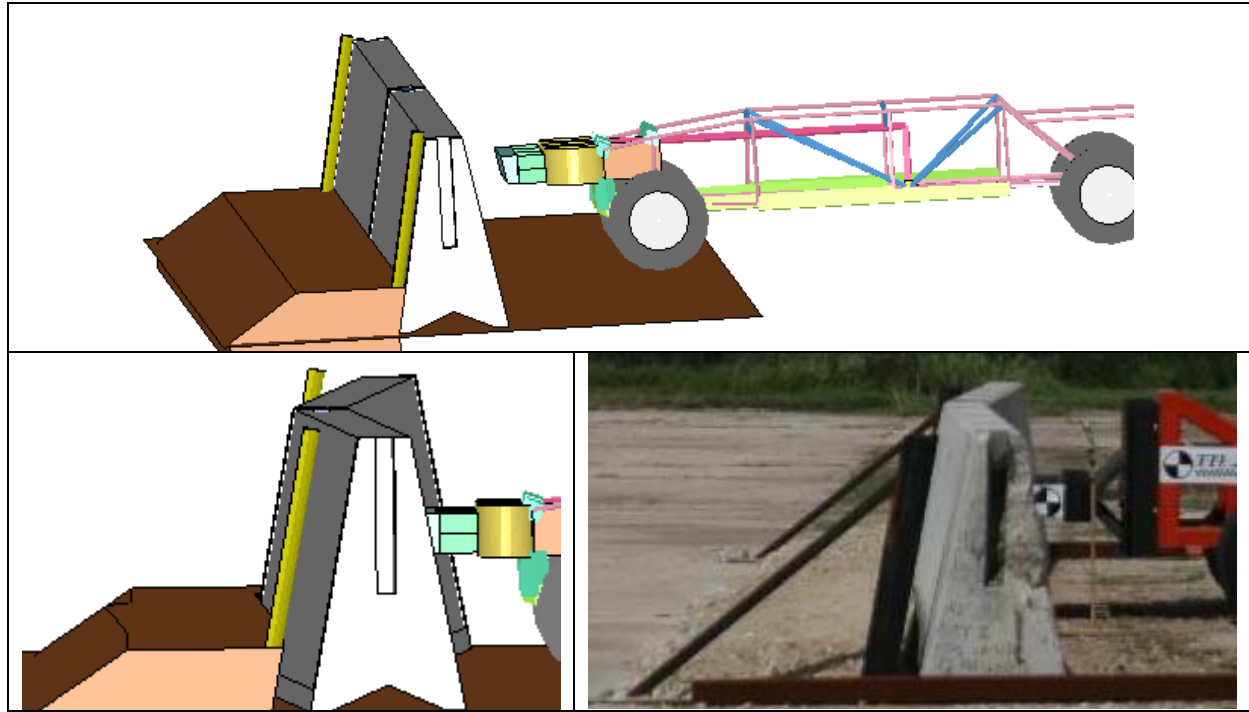
Figure 2.9: Simulation and test results of bogie impacted with embedded barriers.

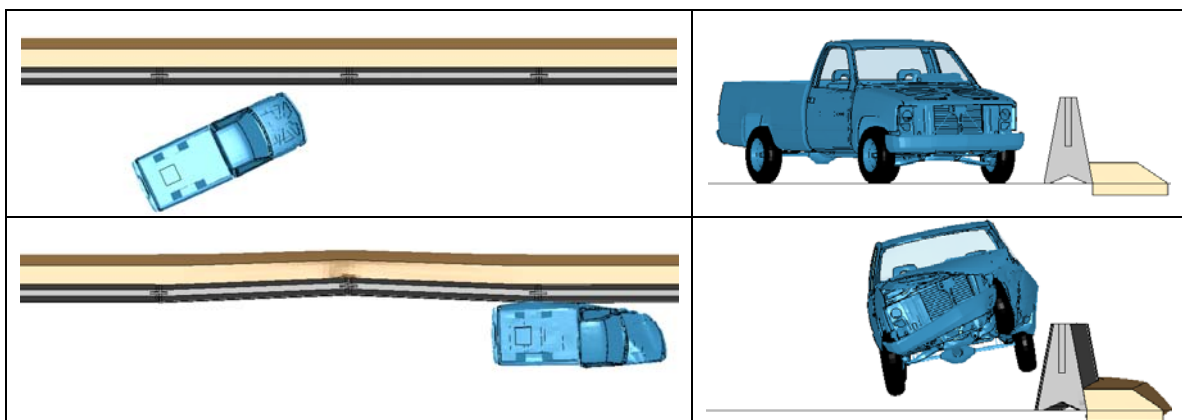
Figure 2.10: Simulation results with soil behind the barrier (initial (top) and final (bottom) states).

The researchers used the calibrated embedded barrier to develop a 100-ft long full-scale barrier system model. The installation was comprised of five 20-ft long single-slope barrier segments, connected using grouted rebar-grid connection and embedded 10 inches in soil behind the barrier (i.e. on the field side). The field side of the barriers was offset 2 ft from the 1.5H:1V slope. A simulation was performed with a 5000-lb vehicle impacting the barrier at 25 degrees and 62 mi/h (see figure 2.10). The vehicle impacted the barrier 4 ft upstream of the connection between the second and the third barrier segment. The vehicle was successfully contained and redirected by the embedded barrier system. The maximum permanent deflection of the barrier was 10 inches. The deflection of the barrier after the impact is shown in figure 2.10.

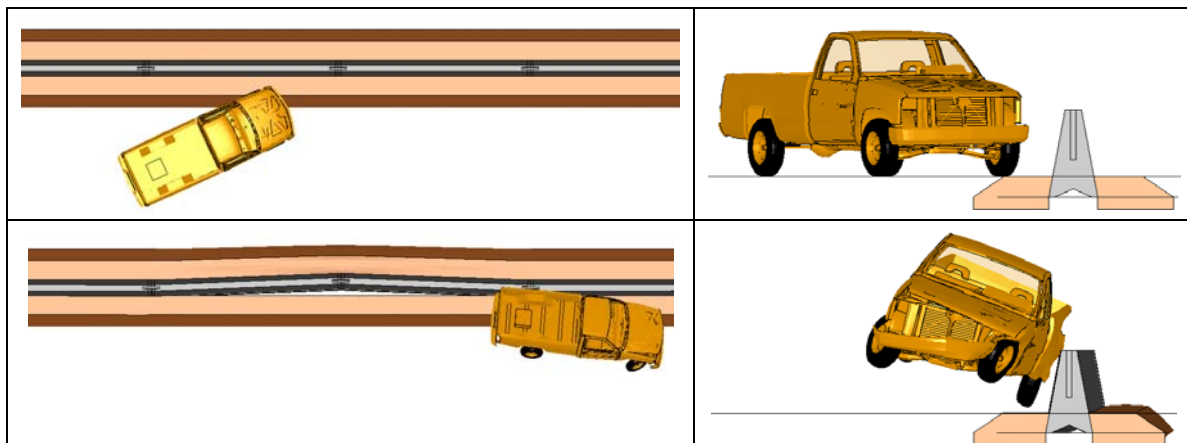
Figure 2.11. Simulation results with soil on both sides of barrier (initial (top) and final (bottom) states).

As mentioned above, in the initial simulation the soil was present only behind the barrier, to match the bogie test configuration. Thus, the effective height of the barrier remained 42 inches for the impacting vehicle. A field installation of the embedded barrier can involve scenarios when the barrier is embedded in soil both in front and back of the barrier. In this case, the effective height of the barrier for the impacting vehicle is reduced to 32 inches, which could result in greater vehicular instability. Presence of the soil in front and back of the barrier is expected to lower the lateral barrier deflection slightly, which would be desirable for this design. To quantify the differences between the two installation scenarios, the researchers performed another simulation where soil was added to the front of the barrier as well. The mass of the vehicle and the impact conditions remained the same. Simulation results showed that the maximum permanent deflection of the barrier in this case was 9.75 inches (see figure 2.11). When compared to the previous simulation, the reduction in lateral barrier deflection was insignificant. Even though the vehicle was redirected successfully in both simulations, slightly greater vehicle roll was observed when the barrier was installed with soil on both sides (i.e. when the effective barrier height was reduced to 32 inches).

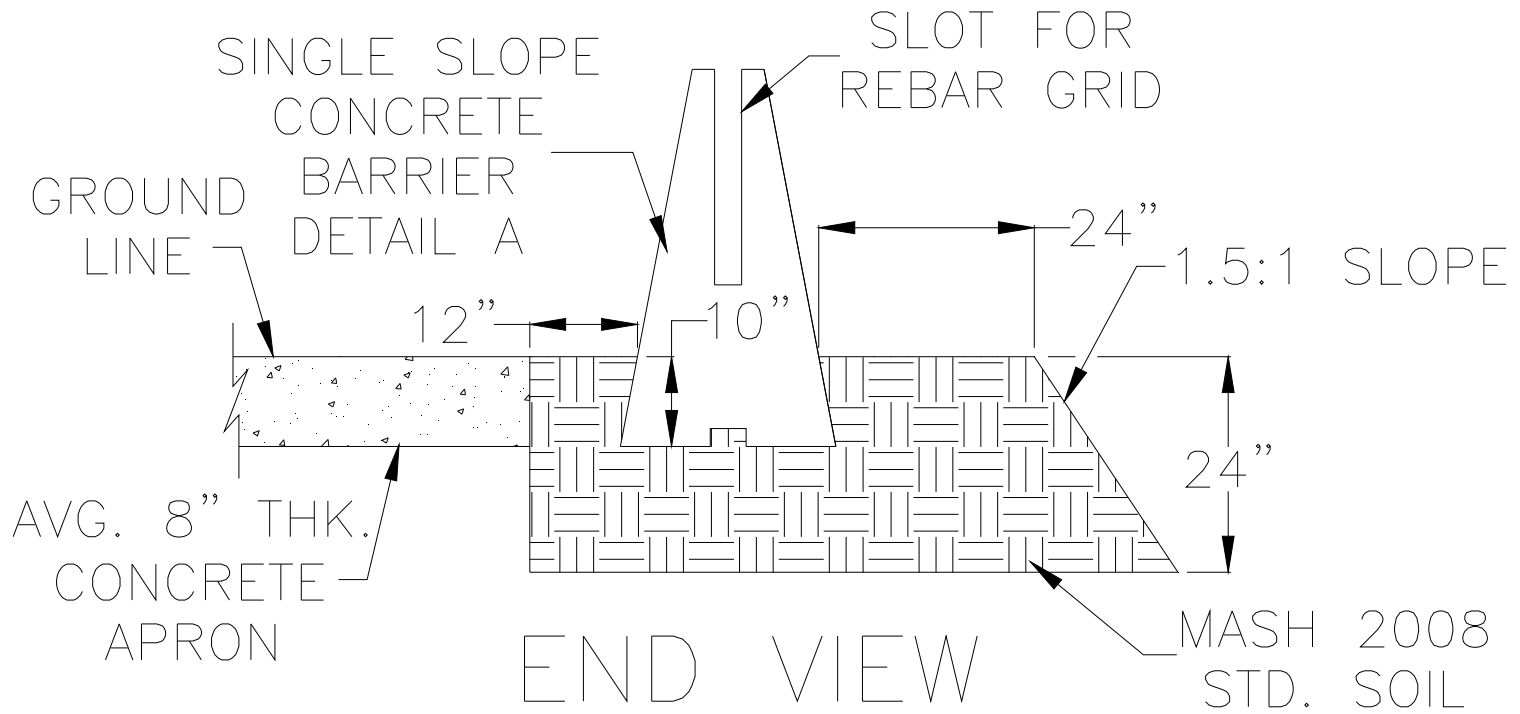
Figure 3.1. Layout of the single-slope barrier in front of 1.5:1 slope.

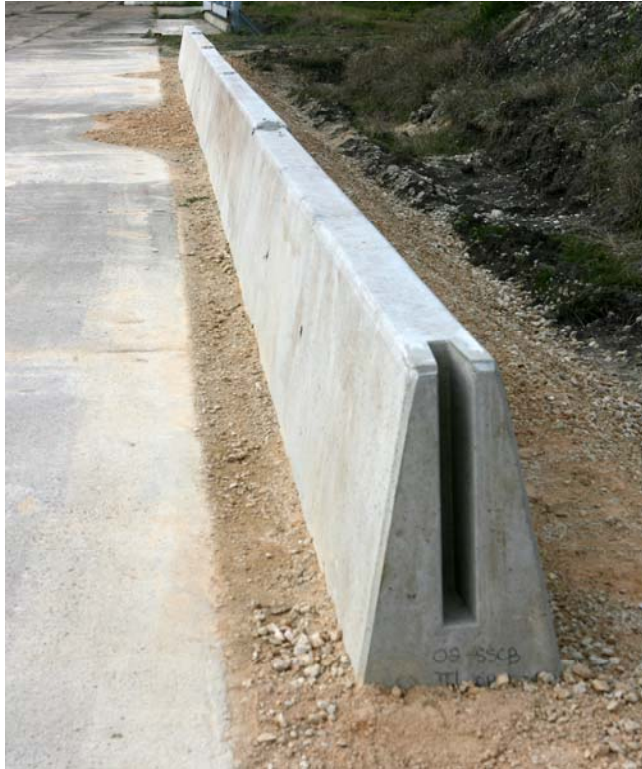
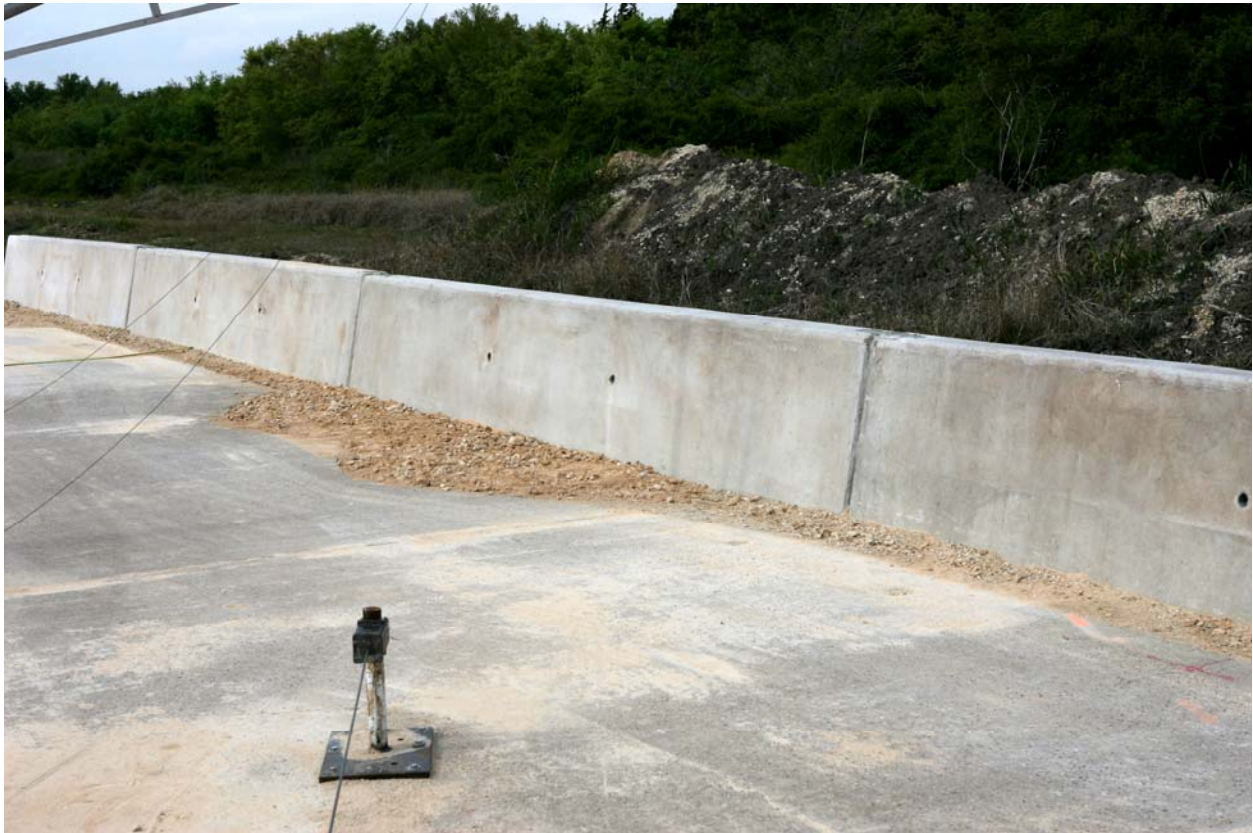
Figure 3.2. Single-slope barrier in front of 1.5:1 slope prior to testing.

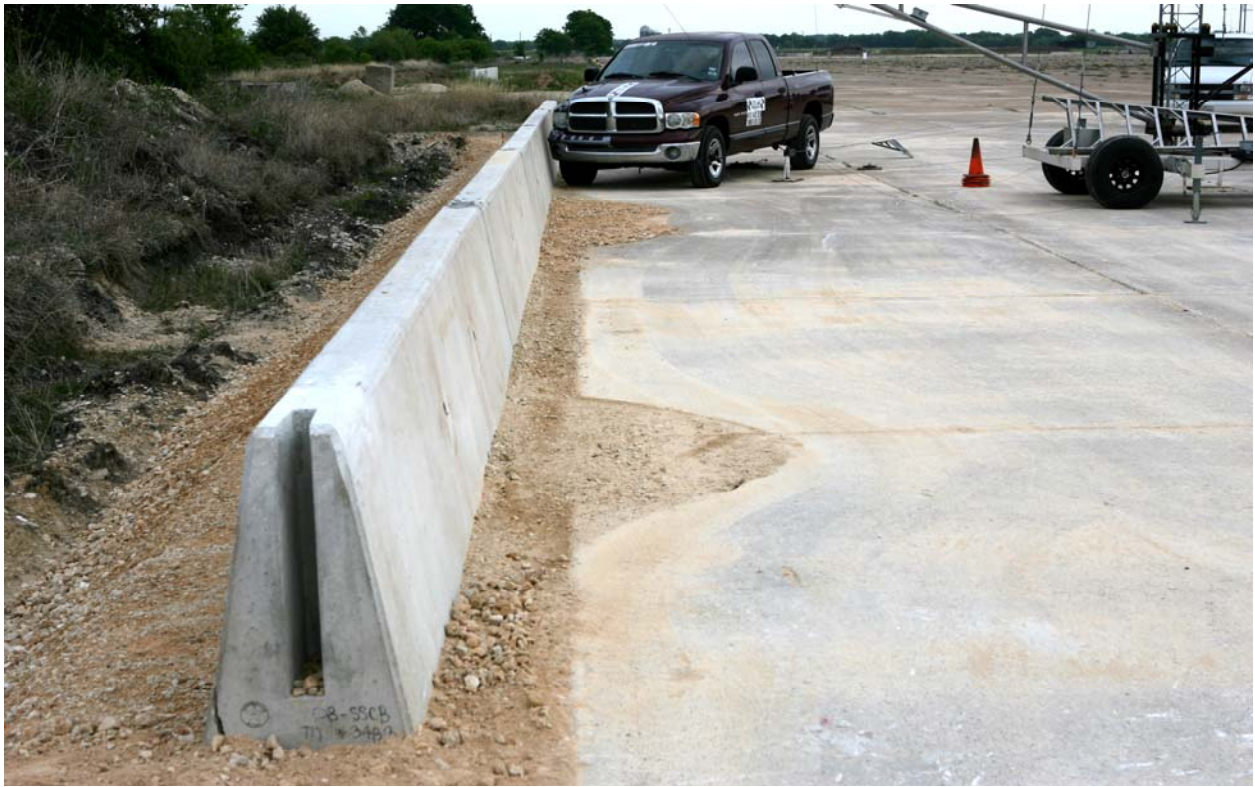
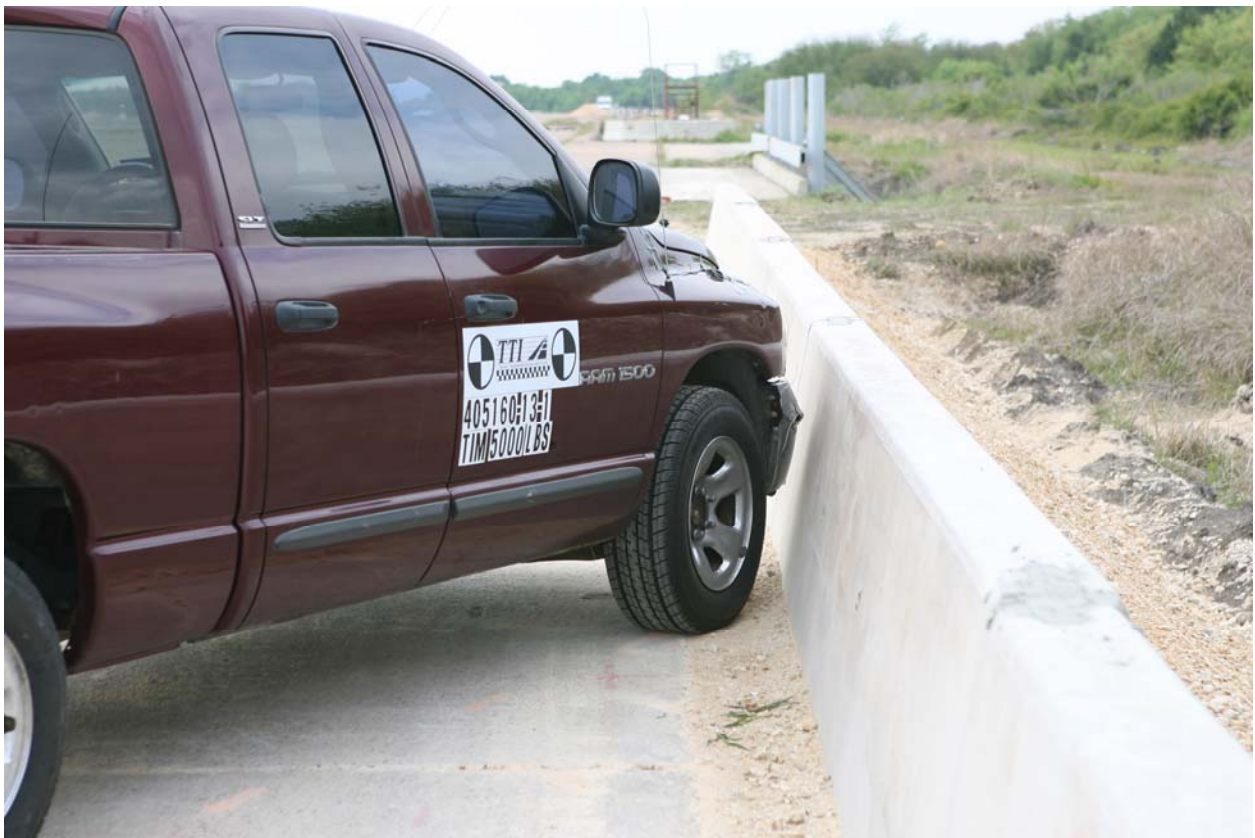
Figure 6.1. Vehicle/installation geometrics for test 405160-13-1.

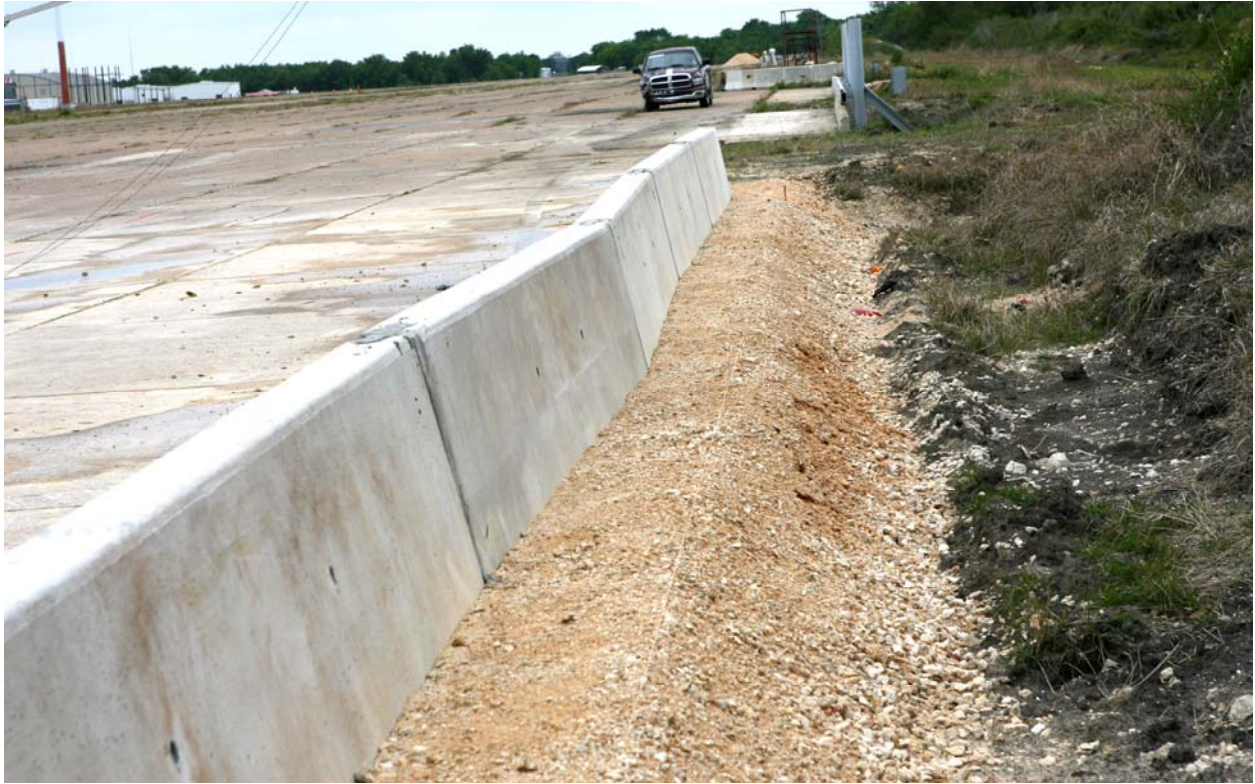
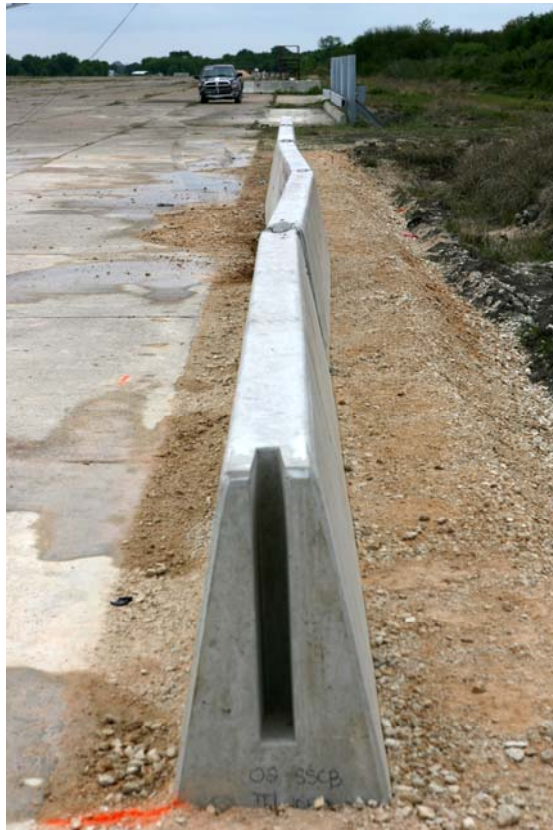
Figure 6.3. Vehicle trajectory path after test 405160-13-1.

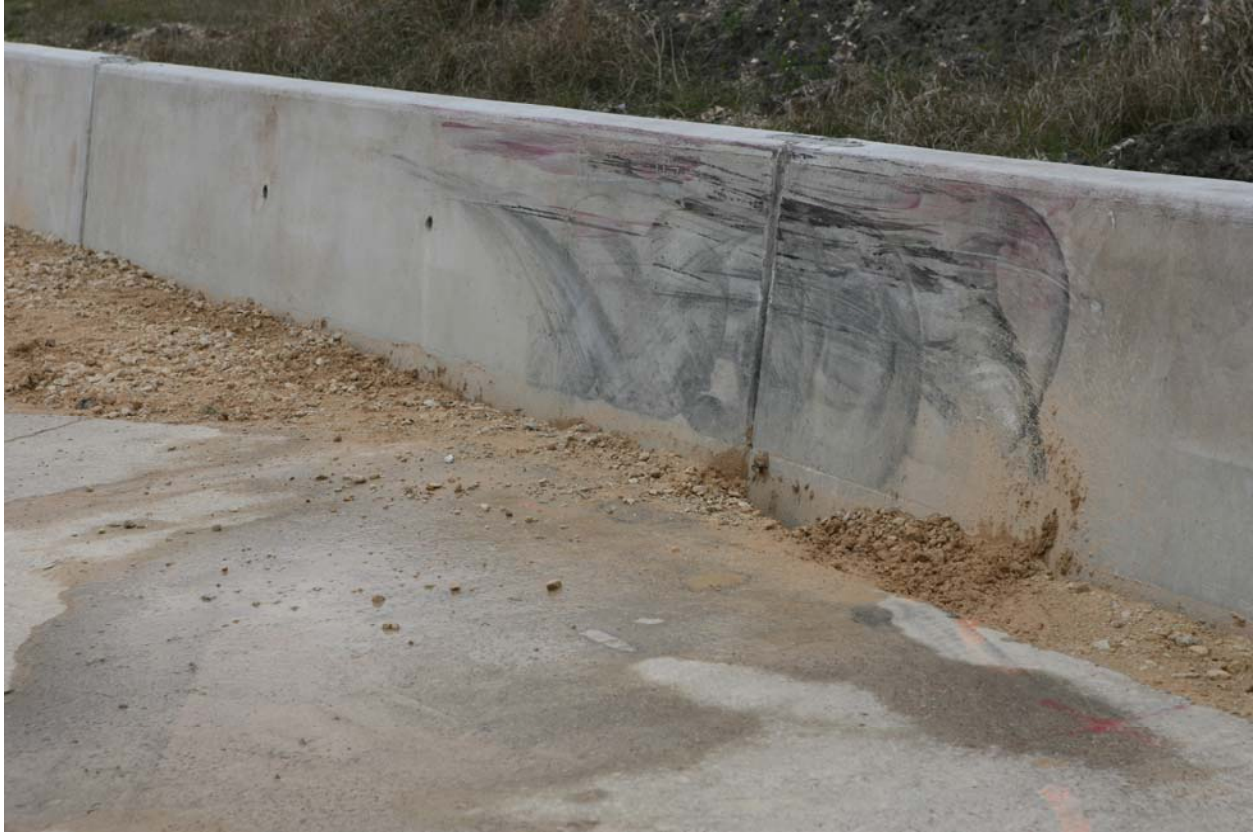
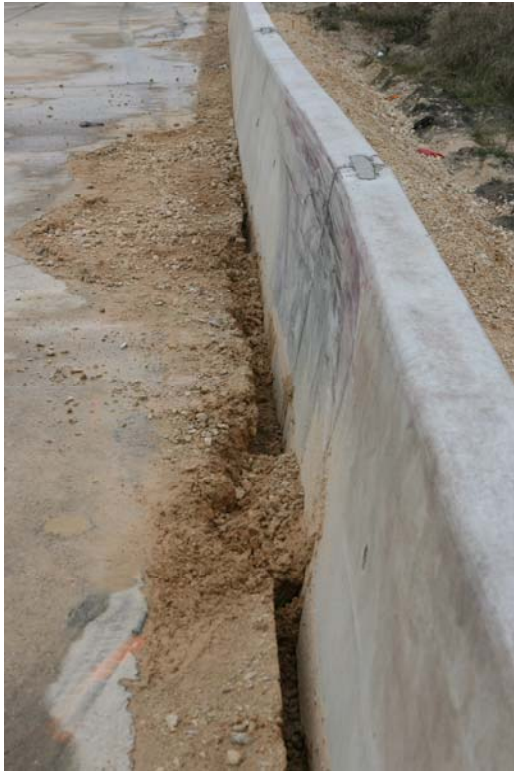
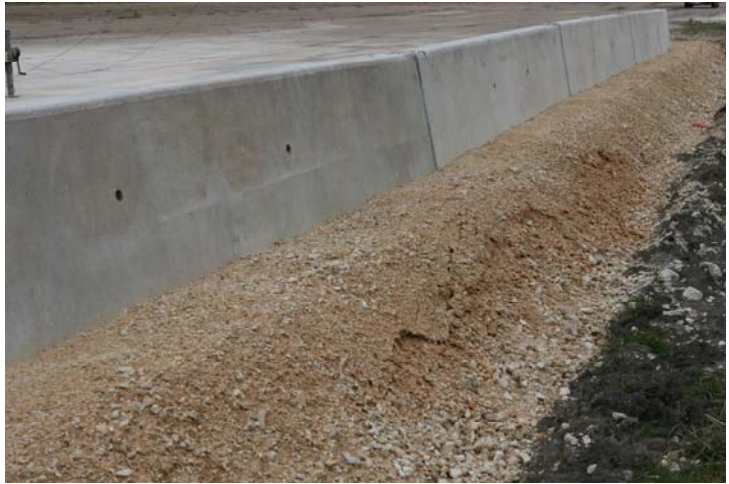
Figure 6.4. Installation after test 405160-13-1.

Damage to the barrier is shown in figures 6.3 and 6.4. Tire marks were observed on the traffic face of the barrier and there was no evidence of cracking in the barrier. Length of contact of the vehicle with the barrier was 14.0 ft. Maximum permanent deflection of the barrier was 5.5 inches. Working width was 19.6 inches. Maximum dynamic deflection during the test was 5.6 inches.

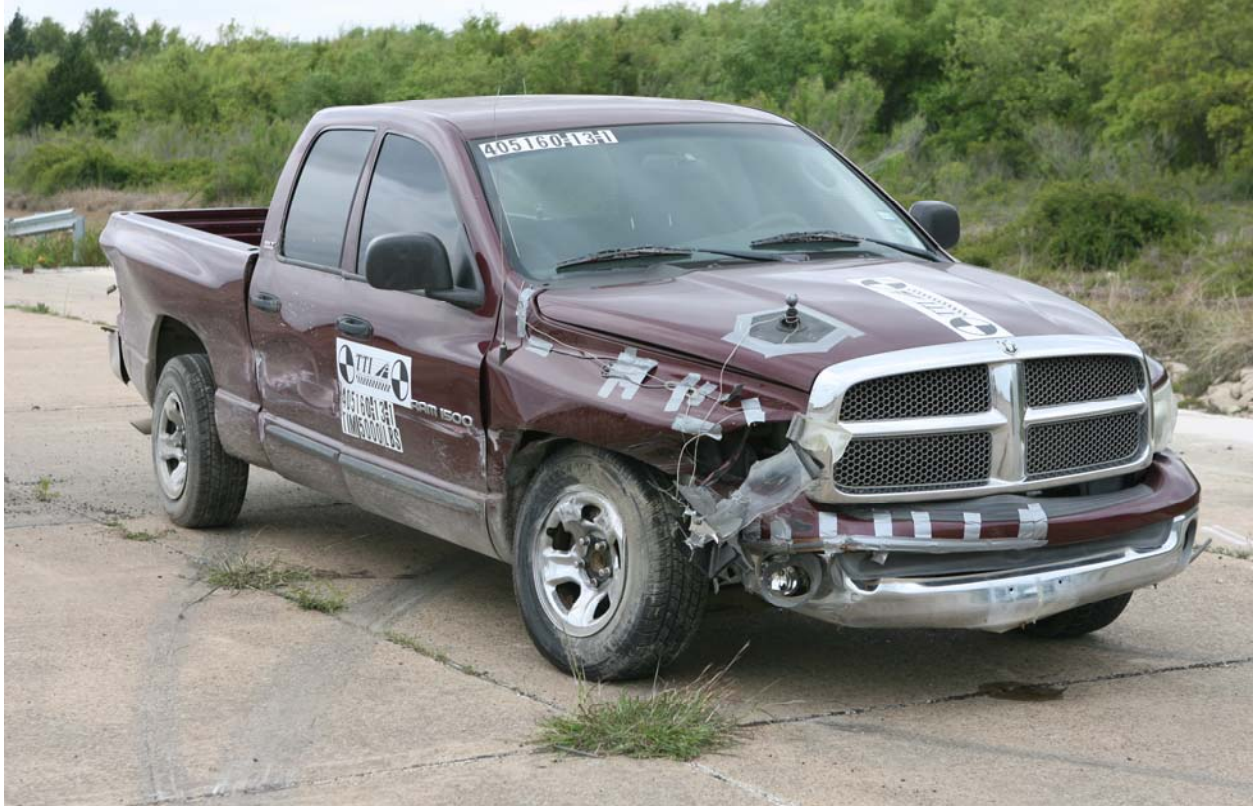
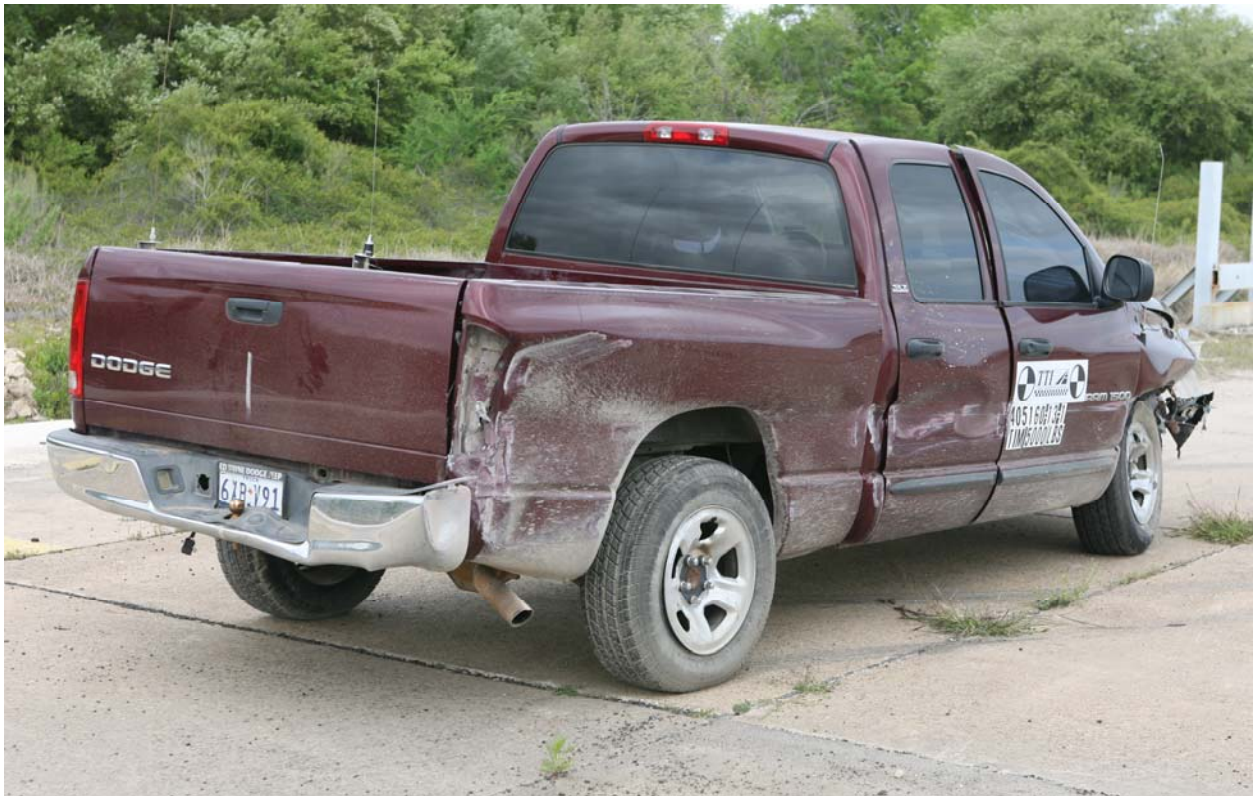
Figure 6.5. Vehicle after test 405160-13-1.

The 2270P vehicle sustained damage to the right front corner and along the right side, as shown in figure 6.5. The right upper A-arm, right tie rod end, and sway bar were deformed. Also damaged were the front bumper, grill, right front fender, right front and rear doors, right exterior side of bed, rear bumper, and tailgate. The right front and rear wheel rims were deformed and the right front tire was deflated. Maximum exterior crush to the vehicle was 14.0 inches in the side plane at the right front corner at bumper height. Maximum occupant compartment deformation was 0.5 inches in the right front door at hip height. Photographs of the interior of the vehicle are shown in figure 6.6. Exterior vehicle crush and occupant compartment measurements are shown in appendix D, tables D1 and D2.

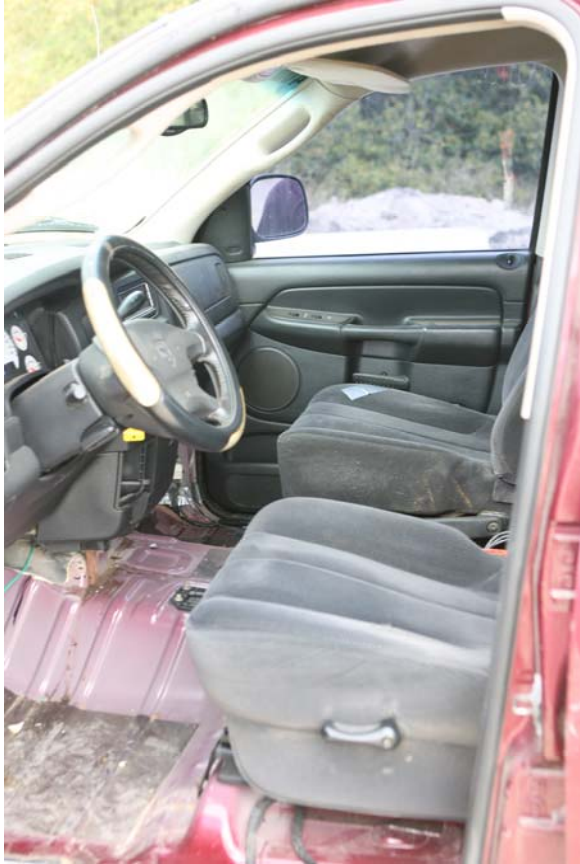
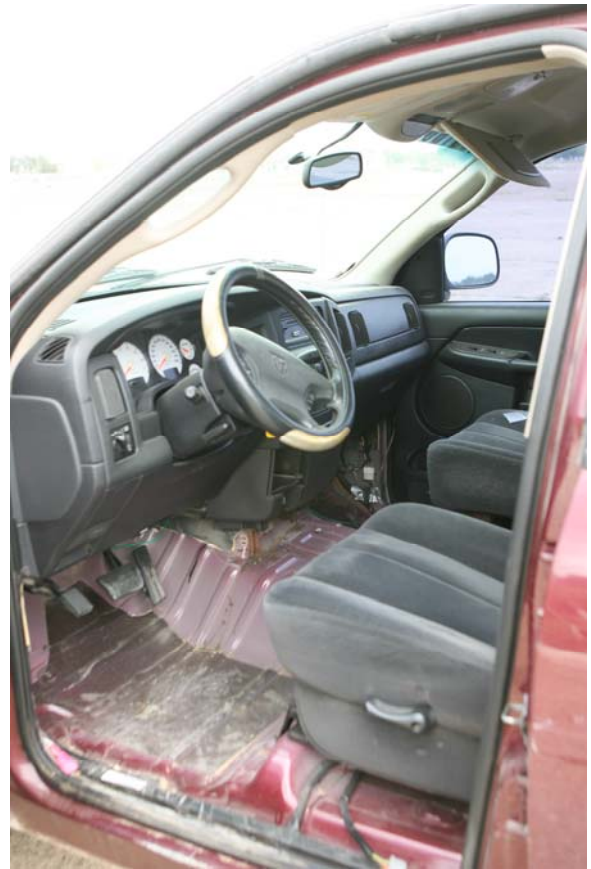
Figure 6.6. Interior of vehicle for test 405160-13-1.

Before Test

After Test
