Report No. 405160-13-1
Report Date: August 2009

**DEVELOPMENT AND TESTING OF A CONCRETE
BARRIER DESIGN FOR USE IN FRONT OF SLOPE OR
ON MSE WALL**

Contract No.: T4541
Test No.: 405160-13-1
Test Date: 2009-04-16

Sponsored by
**Roadside Safety Research Program Pooled Fund
Study No. TPF-5(114)**

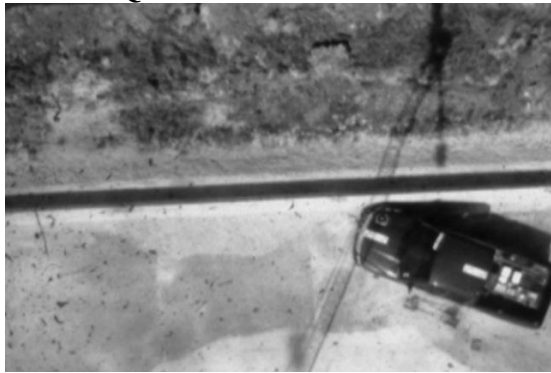
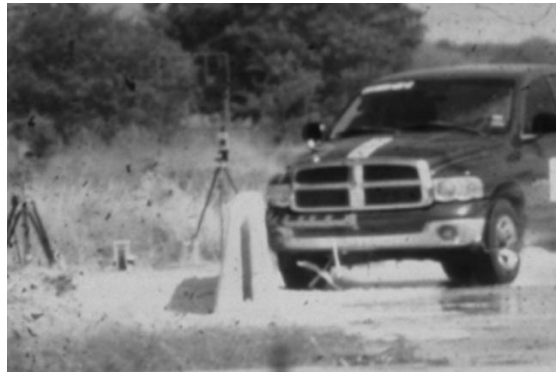
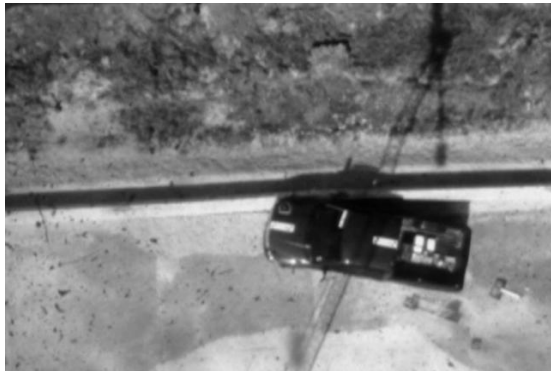
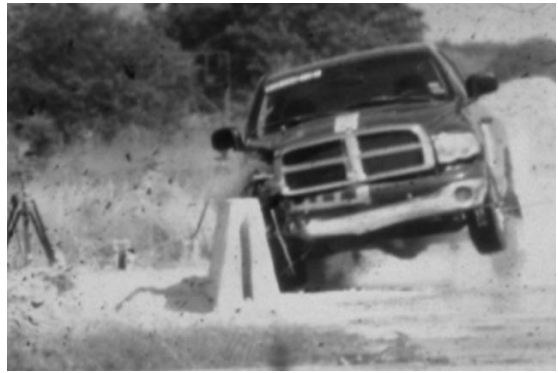
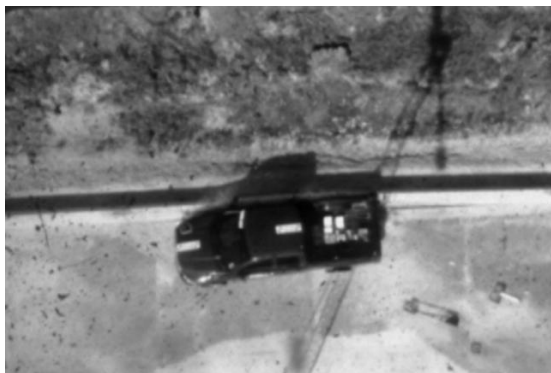
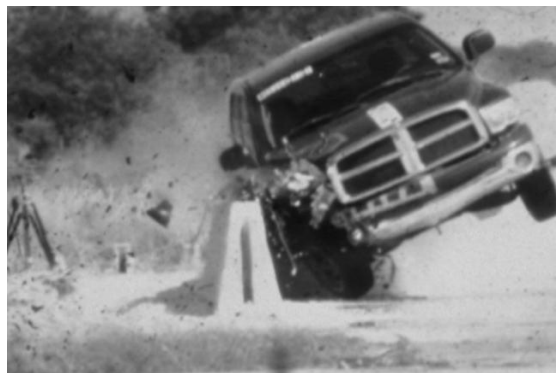
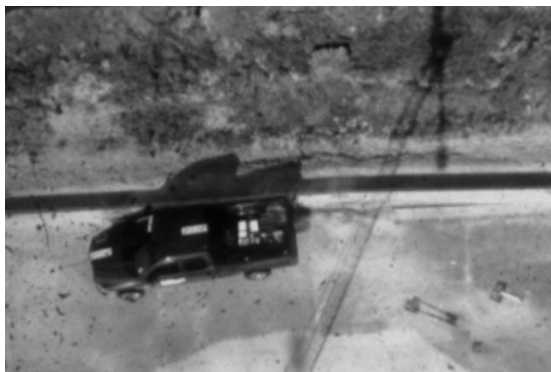
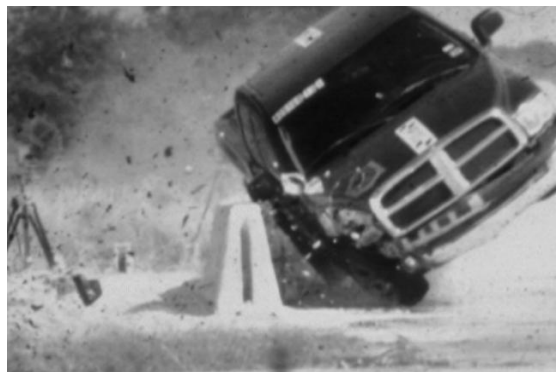
Figure D2. Sequential photographs for test 405160-13-1 (overhead and frontal views).

0.000 s

0.098 s

0.198 s

0.296 s

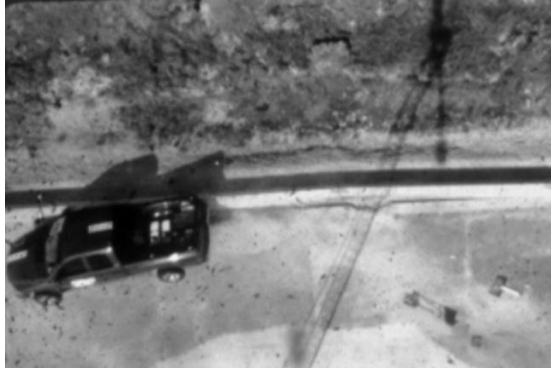
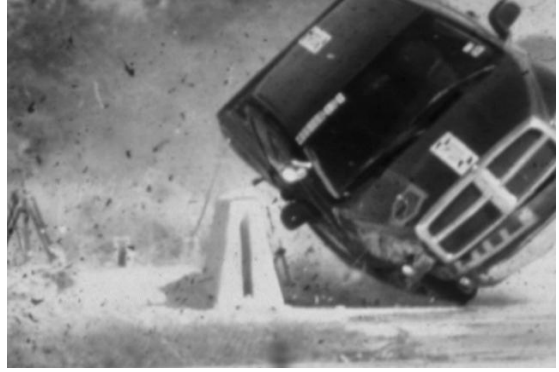
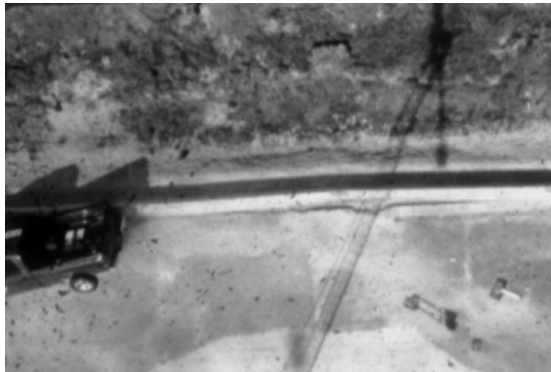
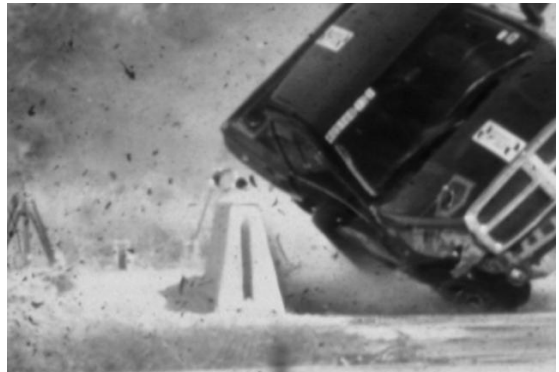
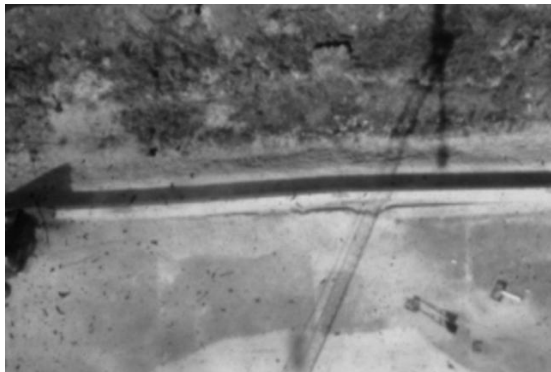
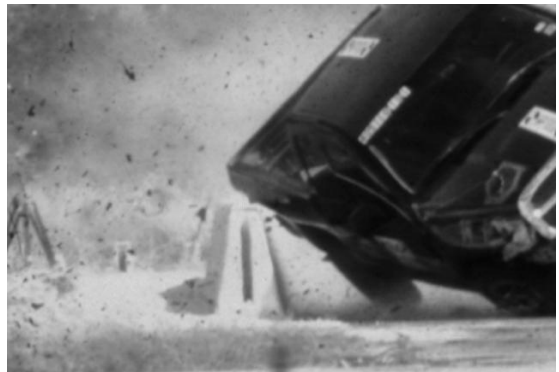
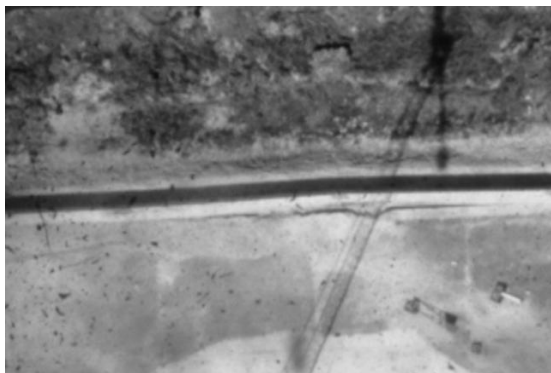
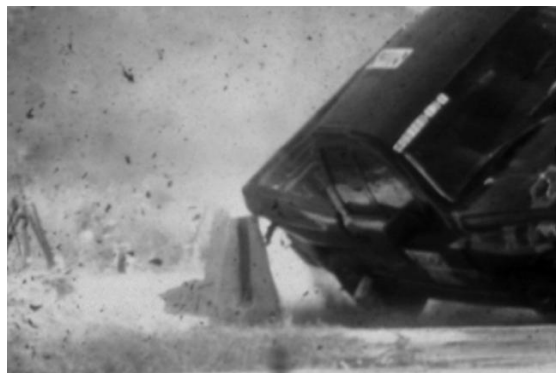
Figure D2. Sequential photographs for test 405160-13-1 (overhead and frontal views) (continued).

0.393 s

0.491 s

0.591 s

0.689 s

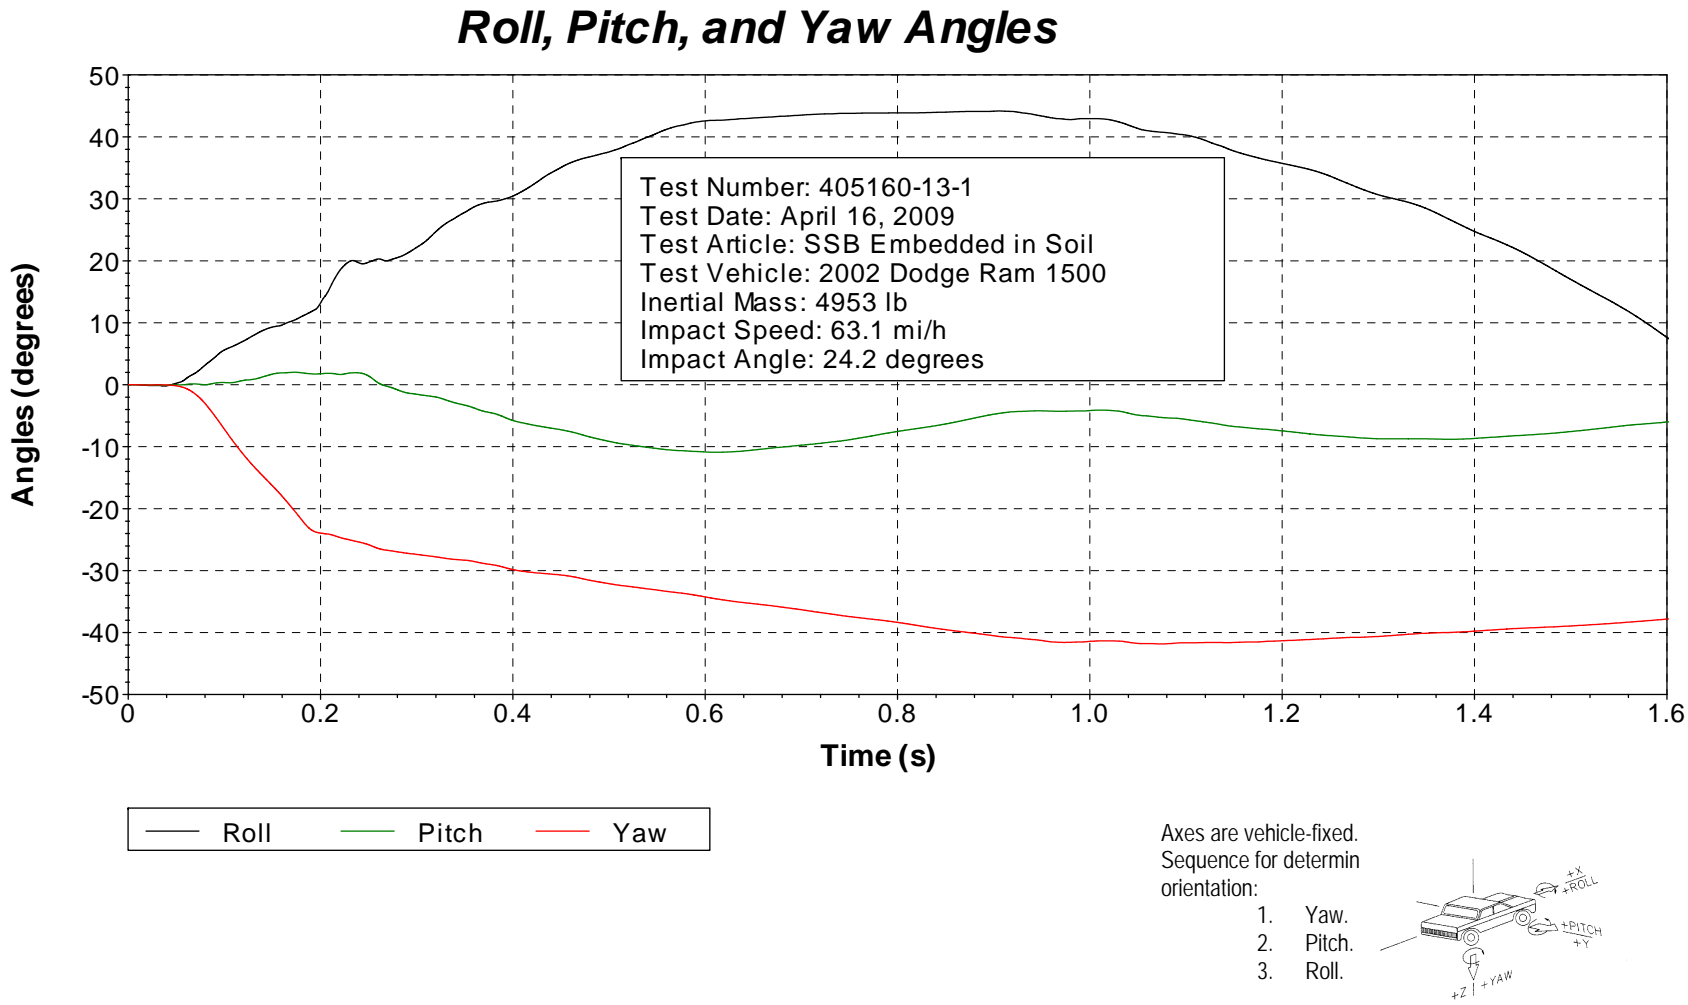
Figure D4. Vehicle angular displacements for test 405160-13-1.

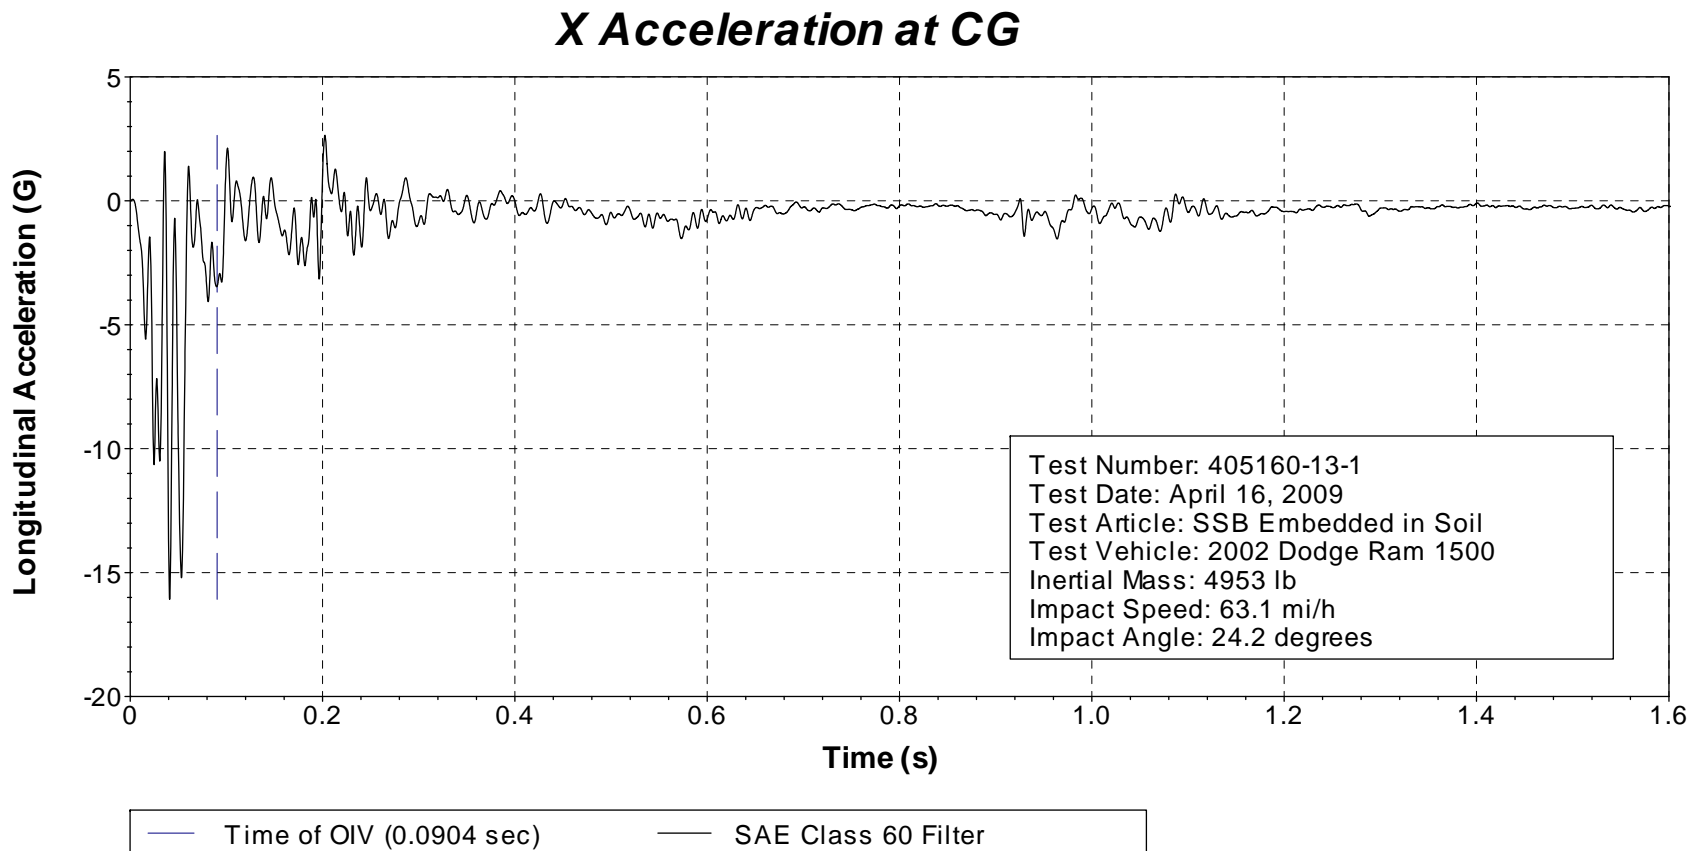
Figure D5. Vehicle longitudinal accelerometer trace for test 405160-13-1 (accelerometer located at center of gravity).

Data from the accelerometer, located at the vehicle's center of gravity, were digitized for evaluation of occupant risk. In the longitudinal direction, the occupant impact velocity was 12.1 ft/s (3.7 m/s) at 0.090 s, the highest 0.010-s occupant ridedown acceleration was -2.4 Gs from 0.173 to 0.183 s, and the maximum 0.050-s average acceleration was -6.5 Gs between 0.009 and 0.059 s. In the lateral direction, the occupant impact velocity was 24.6 ft/s (7.5 m/s) at 0.090 s, the highest 0.010-s occupant ridedown acceleration was -11.3 Gs from 0.187 to 0.197 s, and the maximum 0.050-s average was -13.0 Gs between 0.026 and 0.076 s. Theoretical Head Impact Velocity (THIV) was 29.6 km/h or 8.2 m/s at 0.089 s; Post-Impact Head Decelerations (PHD) was 11.3 Gs between 0.187 and 0.197 s; and Acceleration Severity Index (ASI) was 1.56 between 0.020 and 0.070 s. These data and other pertinent information from the test are summarized in figure 6.7. Vehicle angular displacements and accelerations versus time traces are presented in appendix D, figures D4 through D10.

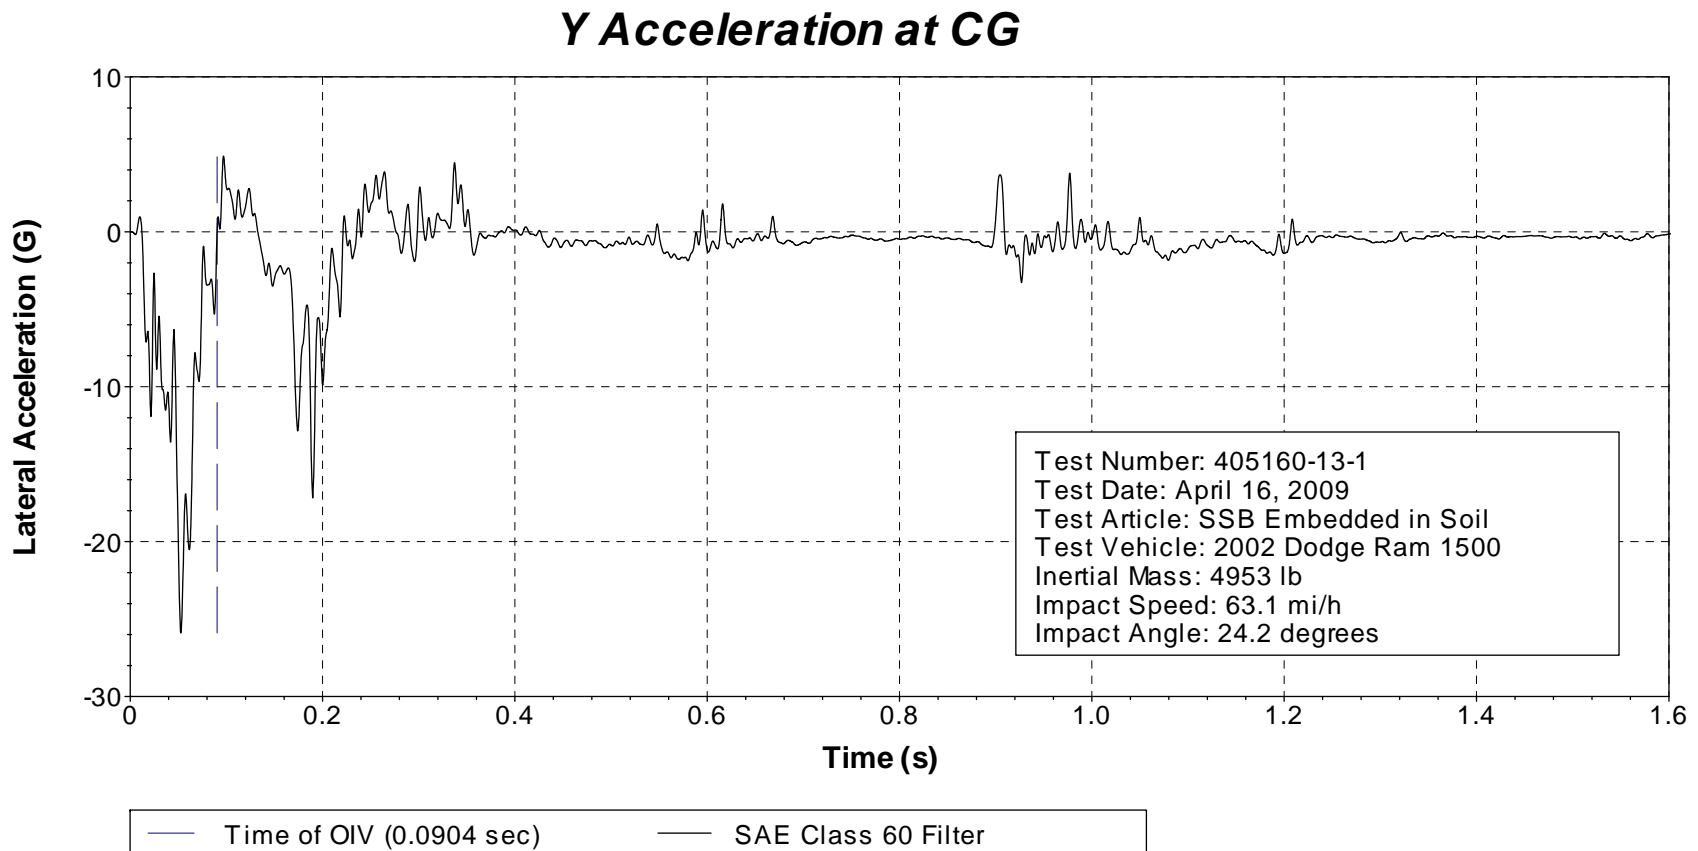
Figure D6. Vehicle lateral accelerometer trace for test 405160-13-1 (accelerometer located at center of gravity).

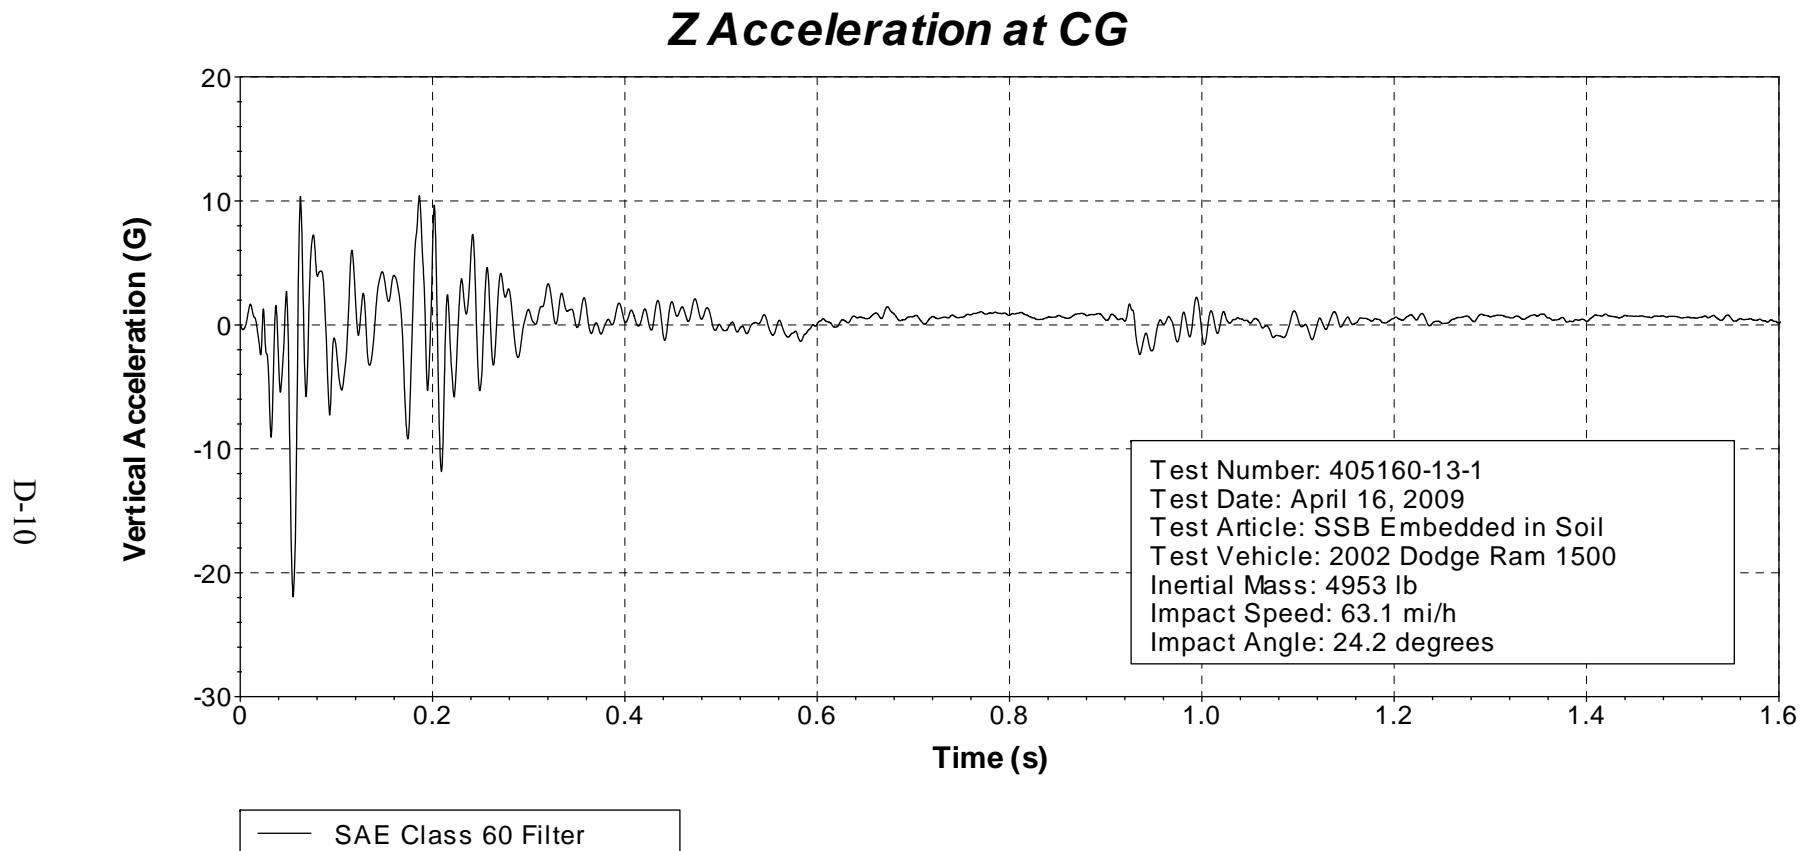
Figure D7. Vehicle vertical accelerometer trace for test 405160-13-1 (accelerometer located at center of gravity).

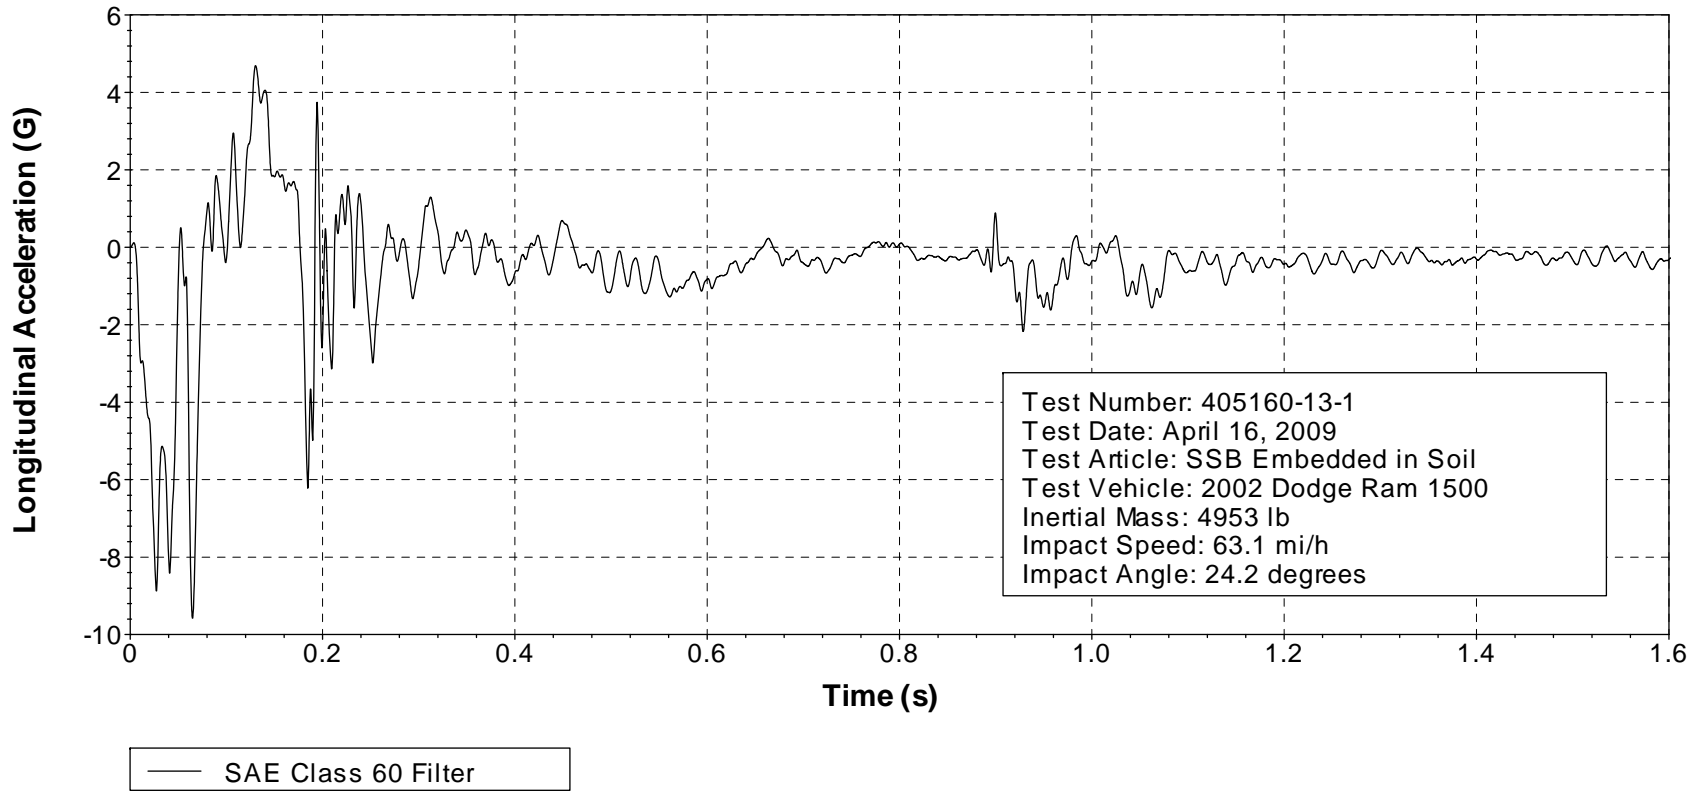
Figure D8. Vehicle longitudinal accelerometer trace for test 405160-13-1 (accelerometer located over rear axle).

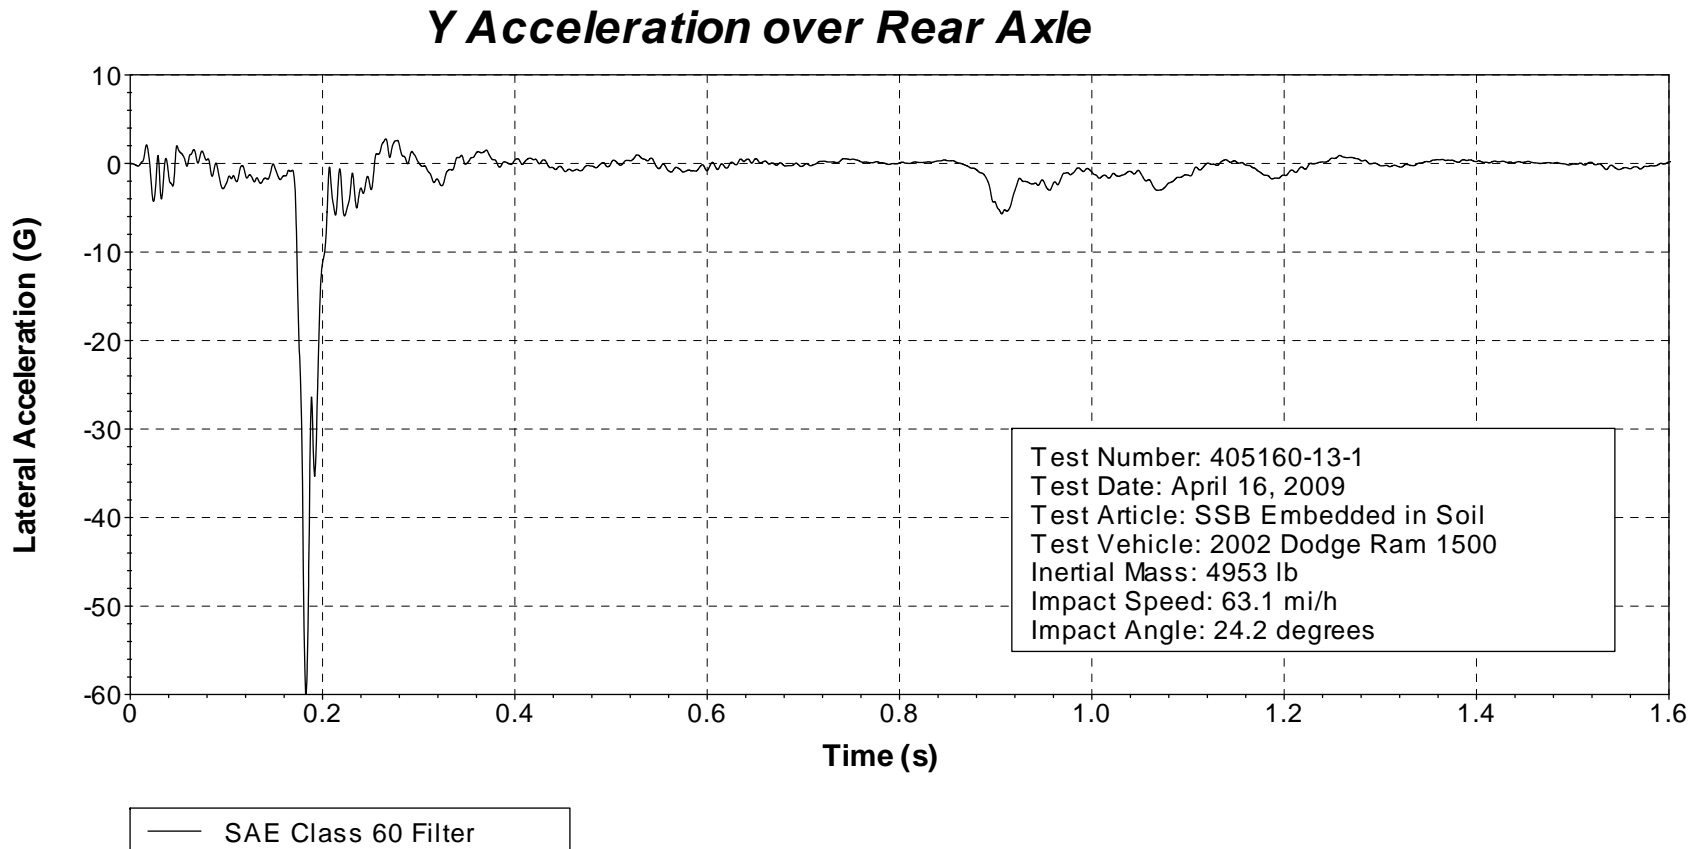
Figure D9. Vehicle lateral accelerometer trace for test 405160-13-1 (accelerometer located over rear axle).

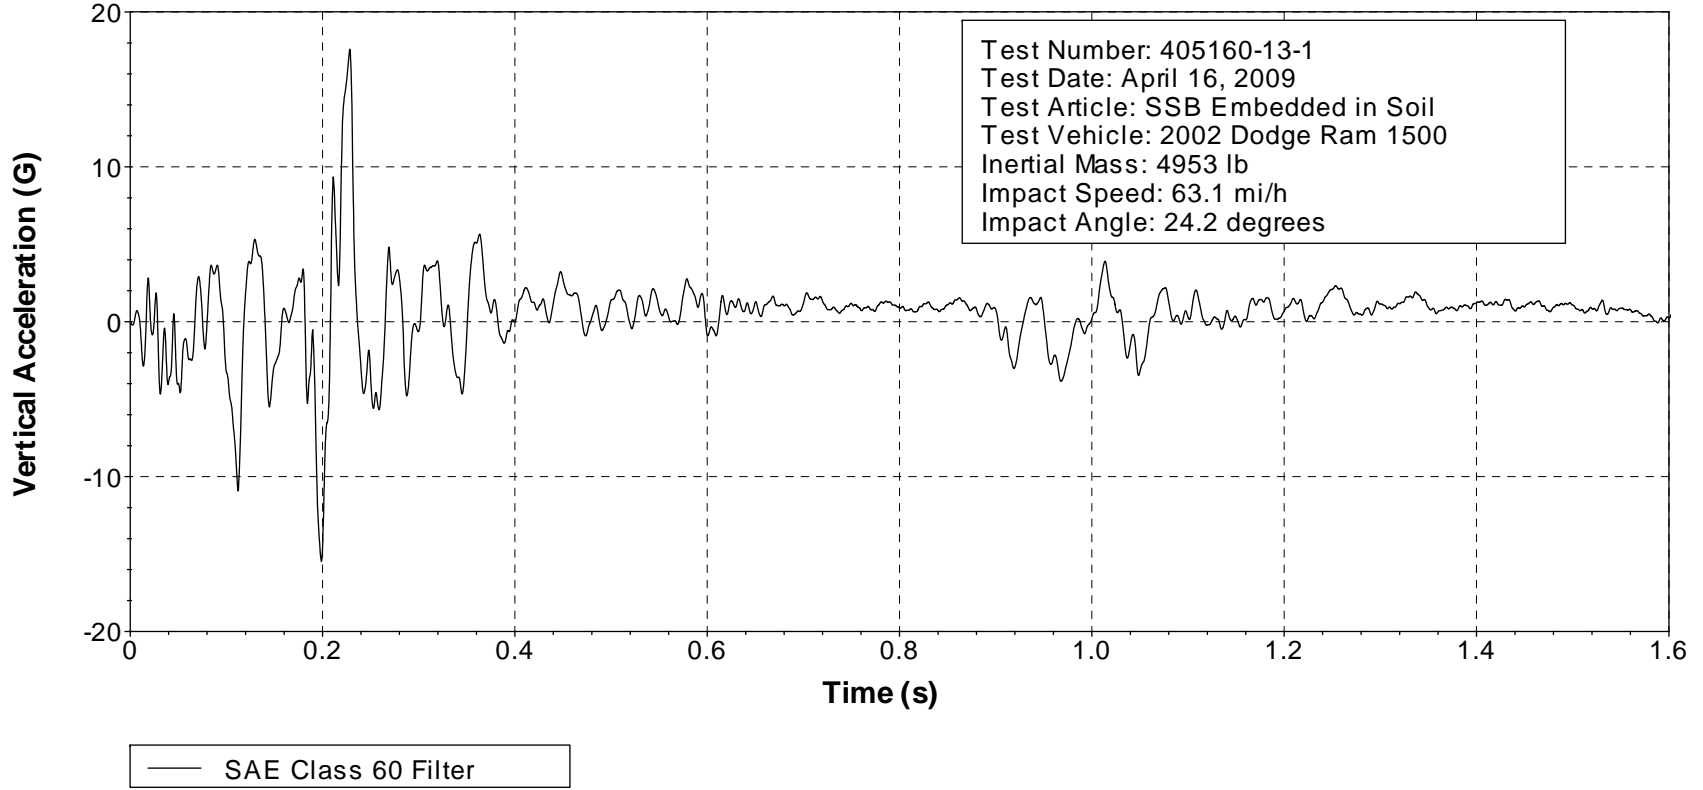
Figure D10. Vehicle vertical accelerometer trace for test 405160-13-1 (accelerometer located over rear axle).
