Report No. 405160-18-1
Report Date: November 2010

**MASH TEST 3-11 OF THE WSDOT PIN AND LOOP
CONCRETE BARRIER WITH DRAINAGE SLOTS**

Test No.: 405160-18-1

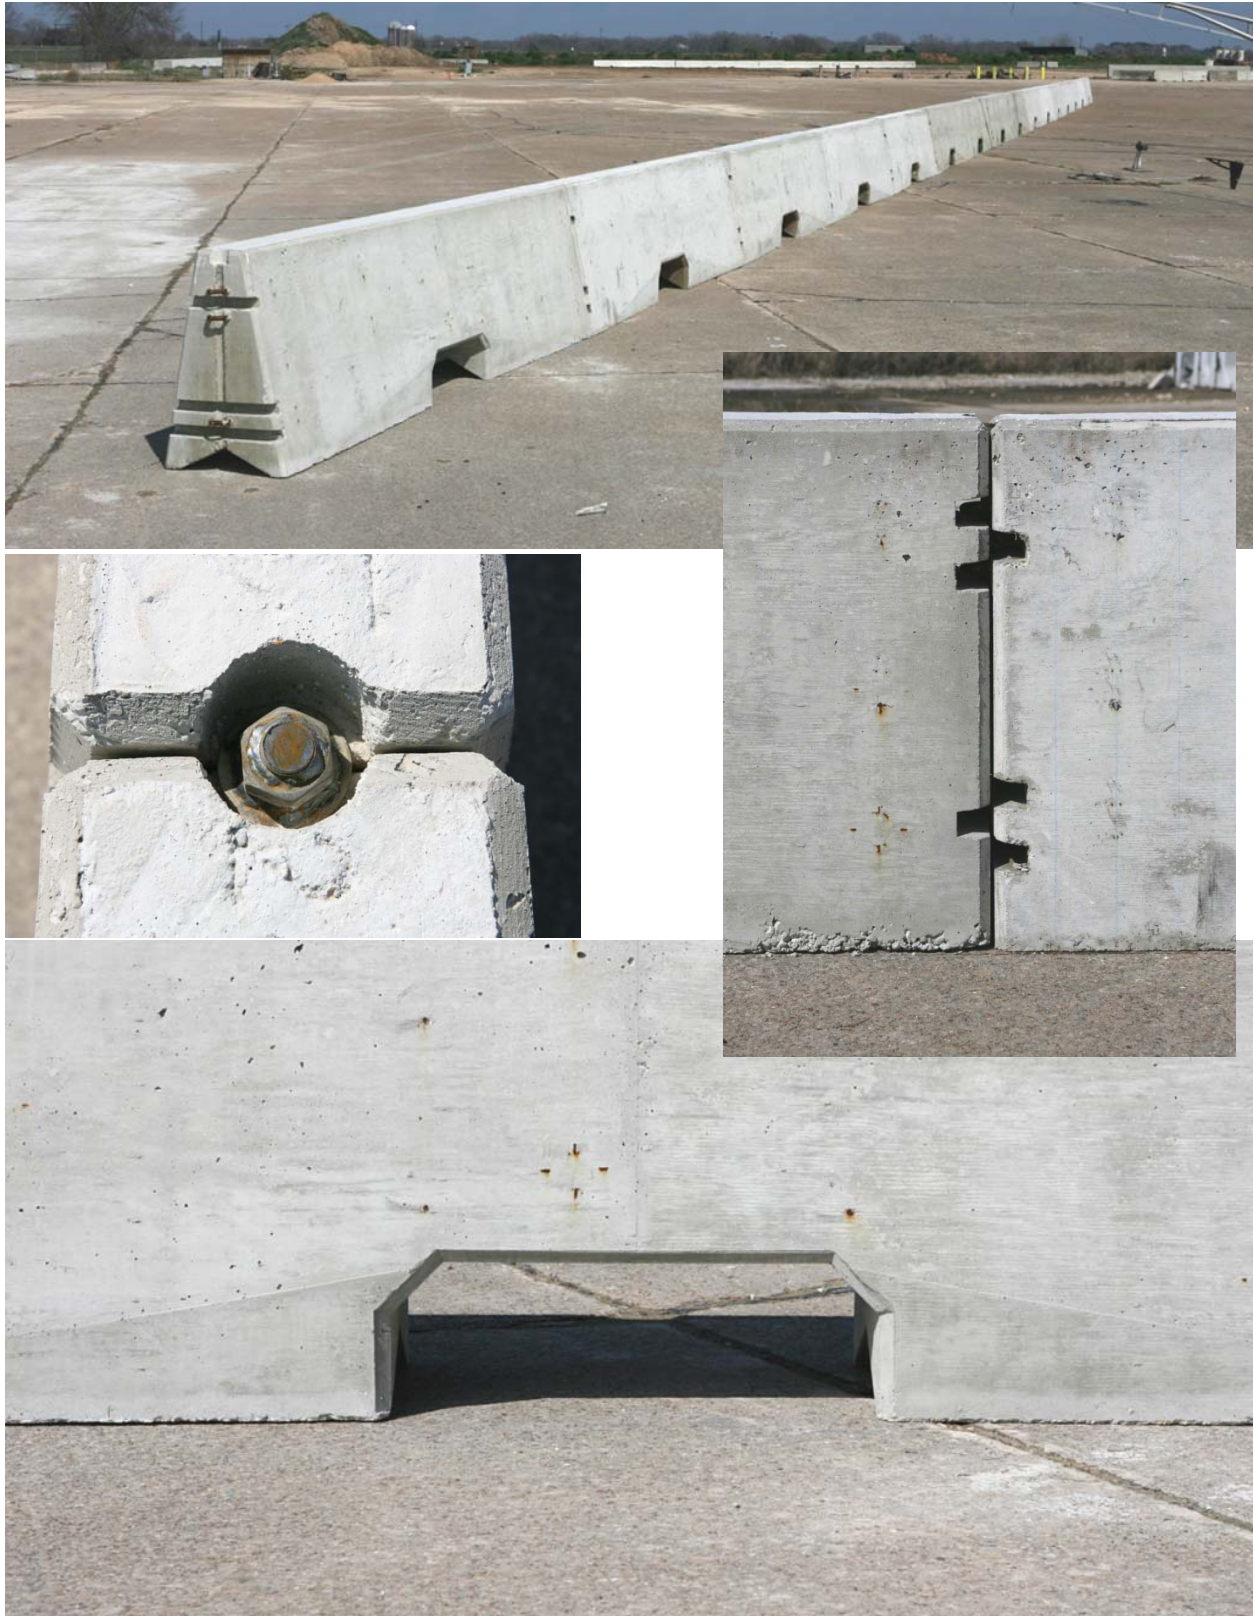
Figure 4.3. Washington DOT pin and loop concrete barrier with drainage slots prior to testing.

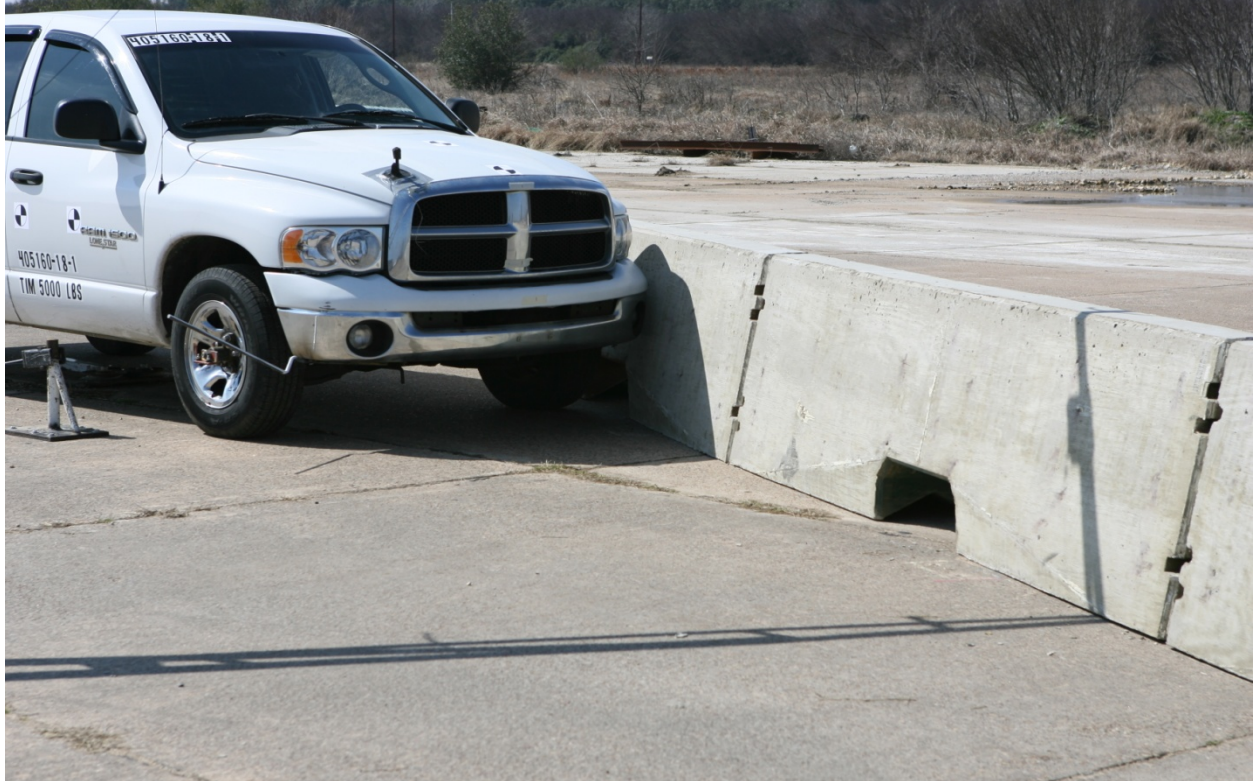
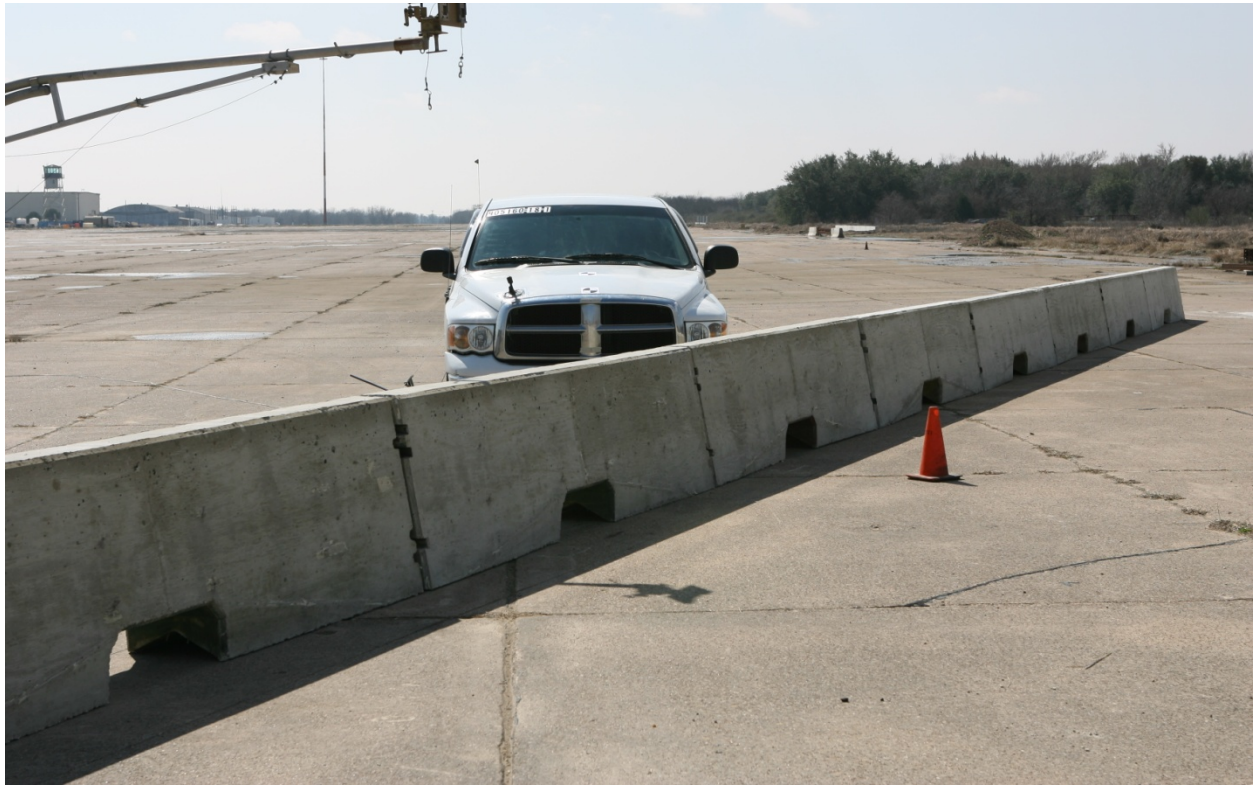
Figure 7.1. Vehicle/installation geometrics for test 405160-18-1.

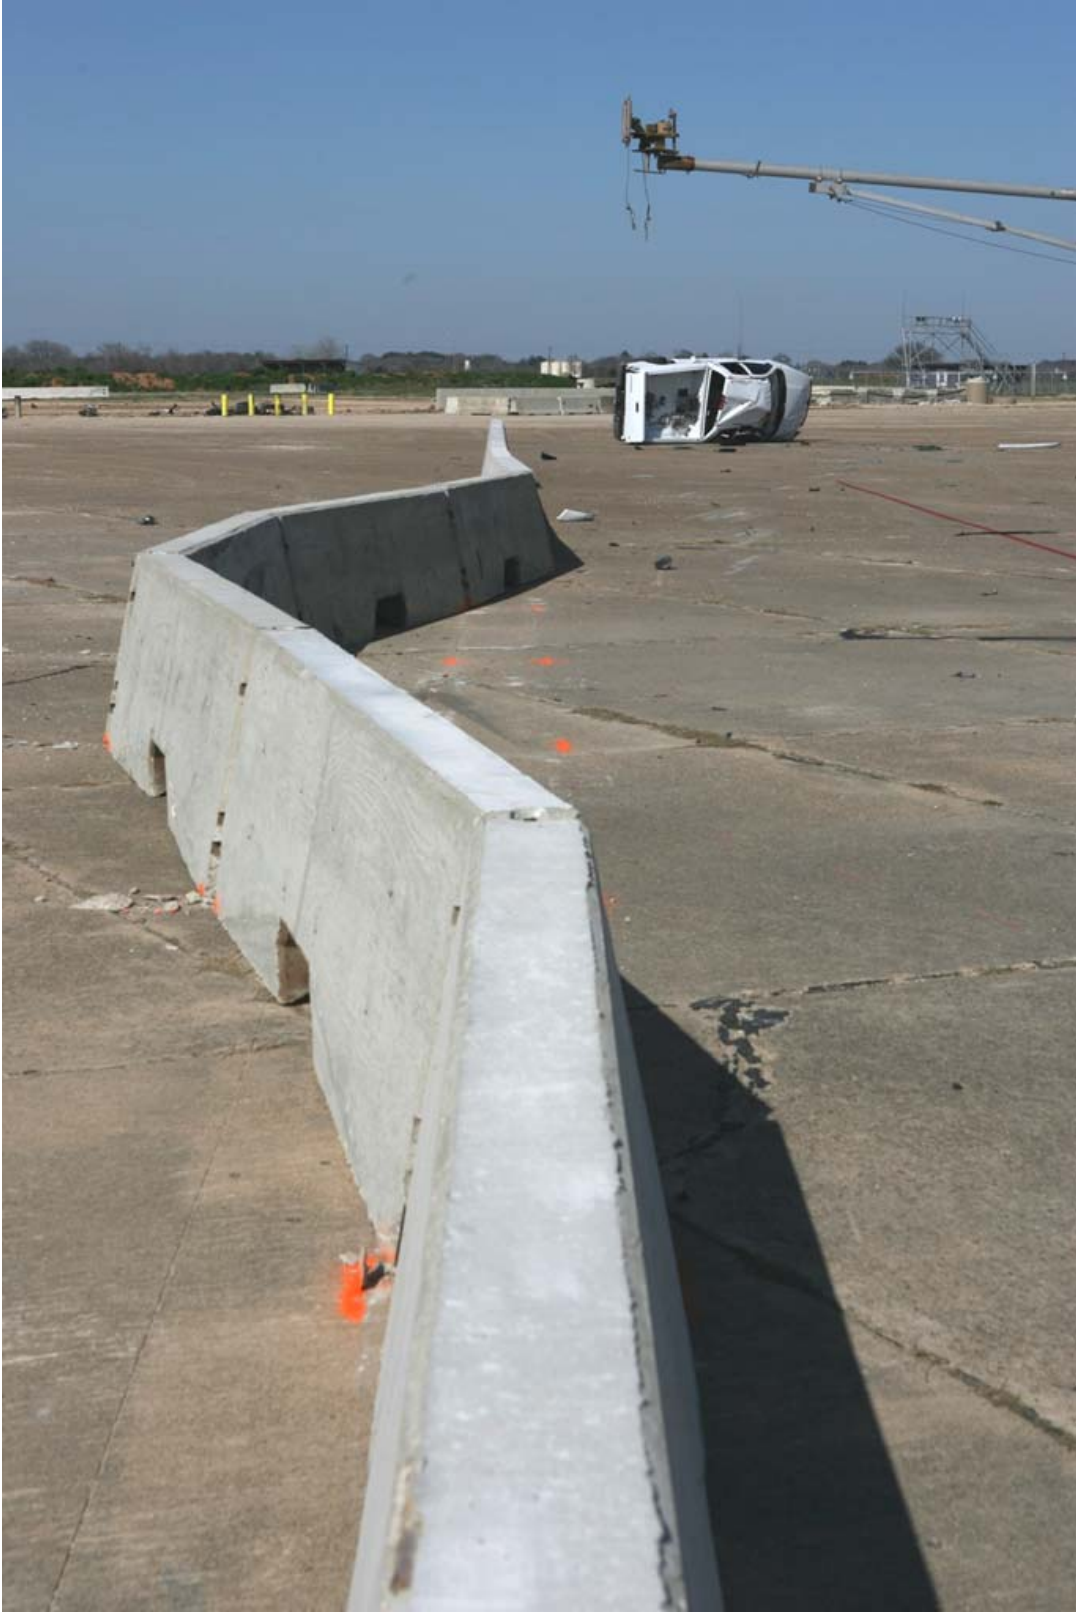
Figure 7.3. Vehicle trajectory after test 405160-18-1.

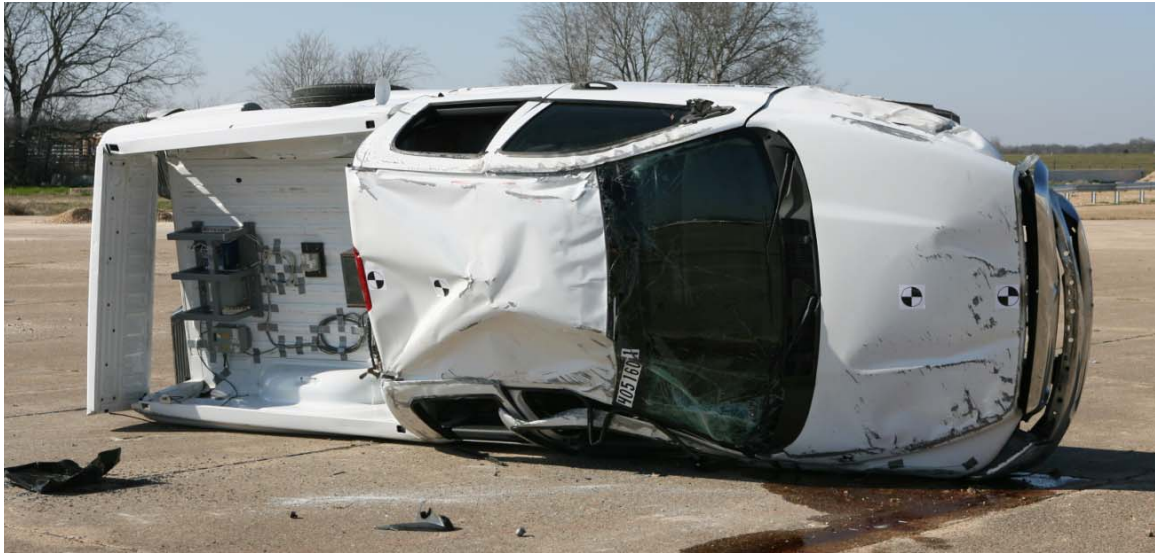
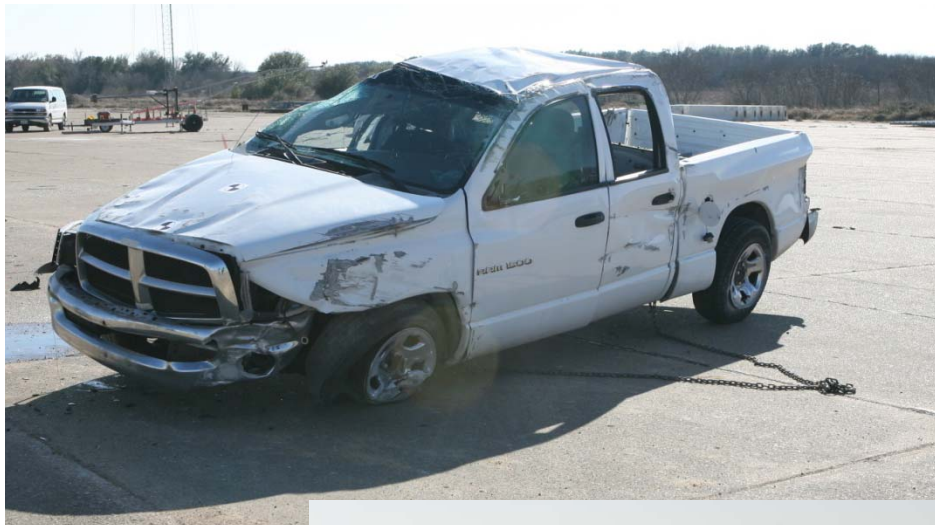
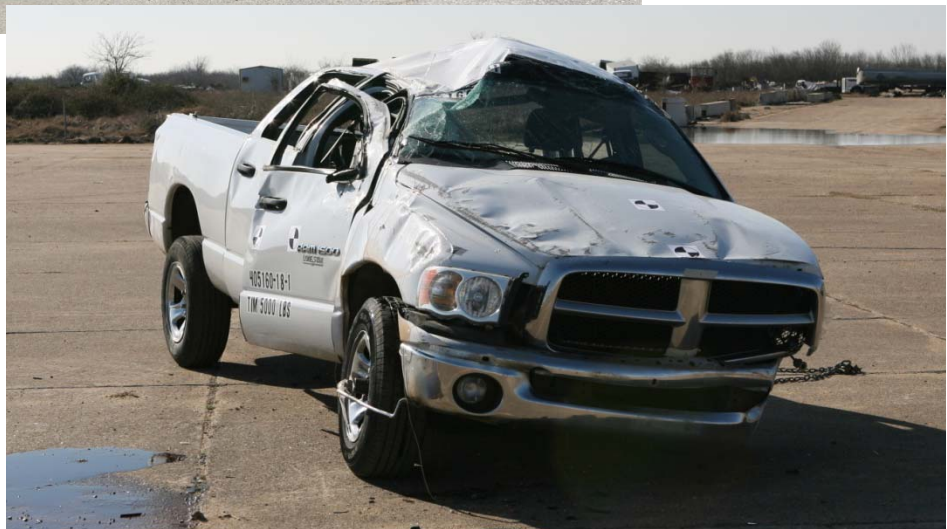
Figure 7.5. Vehicle after test 405160-18-1.

The left front and left side of the vehicle was damaged due to impact with the barrier, while the remainder of the damage occurred during rollover, as shown in Figure 7.5. The front bumper, grill, hood, left front fender, left doors, left exterior bed were damaged while in contact with the barrier. Maximum exterior crush to the vehicle was 10.5 inches in the side plane at the left front quarter at bumper height. Maximum occupant compartment deformation was 13.25 inches in the left rear passenger roof area. Exterior vehicle crush and occupant compartment measurements are shown in Appendix C, Tables C1 and C2.

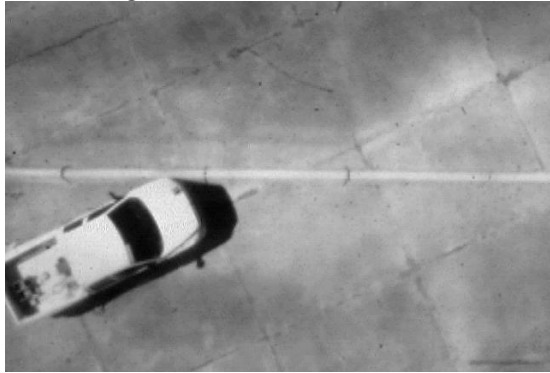
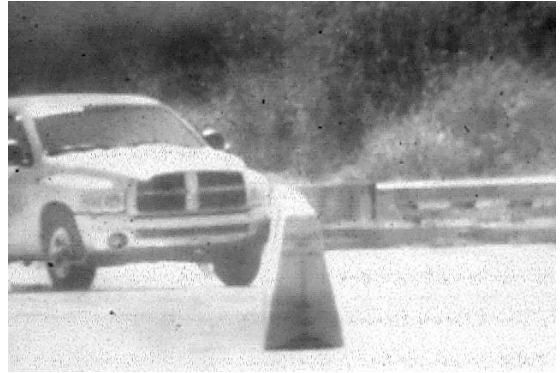
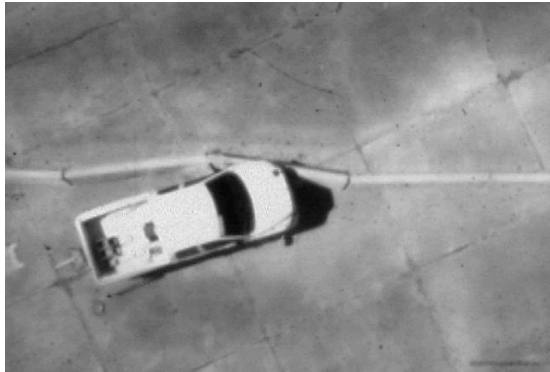
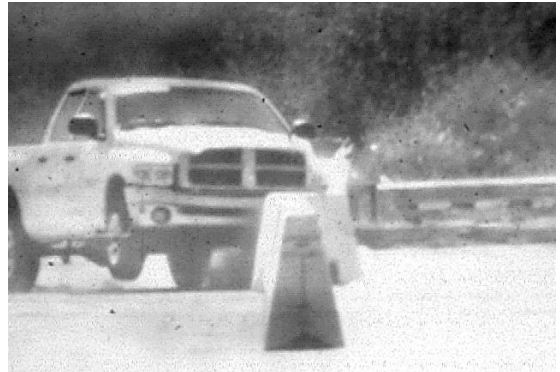
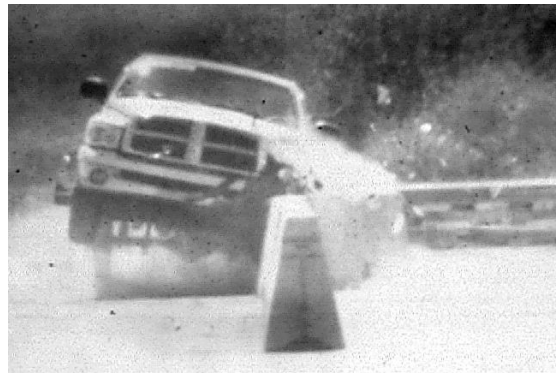
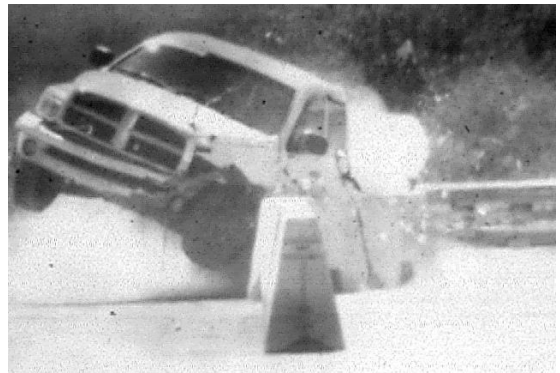
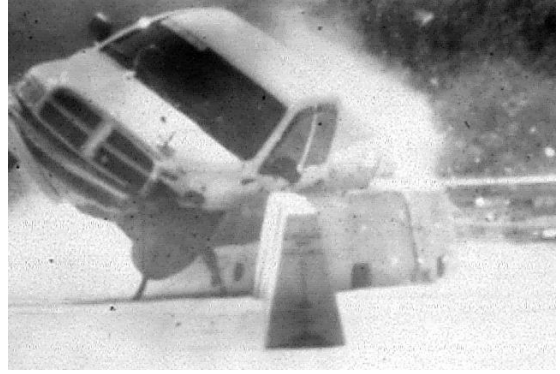
Figure C2. Sequential photographs for test 405160-18-1 (overhead and frontal views).

The 2270P vehicle, traveling at an impact speed of 60.2 mi/h, impacted the Washington DOT pin and loop concrete barrier with drainage slots 51.2 inches upstream of joint between segments 6 and 7 at an impact angle of 26.2 degrees. At approximately 0.017 s after impact, the downstream end of segment 6 began to deflect towards the field side, and at 0.029 s, the vehicle began to redirect. The upstream end of segment 7 began to deflect toward the traffic side at 0.036 s, and the downstream end of segment 7 began to deflect toward the field side at 0.056 s. At 0.077 s, the upstream end of segment 8 began to deflect toward the traffic side, and at 0.147 s, the ends of the barrier at the 8-9 joint began to move toward traffic lanes. The left front corner of the 2270P vehicle contacted the exposed end of segment 8 nearest segment 7 at 0.206 s. The 2270P vehicle began to travel parallel with the barrier at 0.208 s and was traveling at a speed of 49.5 mi/h. The 2270P vehicle exited the view of the overhead camera, and lost contact with the barrier while still airborne at 0.705 s. As the vehicle touched ground, the vehicle rolled 2-3/4 revolutions and came to rest upright 192 ft downstream of impact and 18 ft toward traffic lanes. Sequential photographs of the test period are shown in Appendix C, Figures C2 and C3.

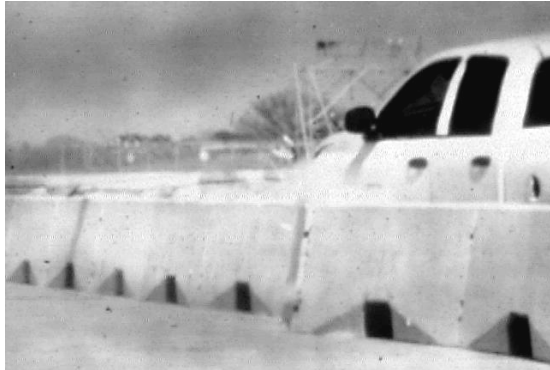
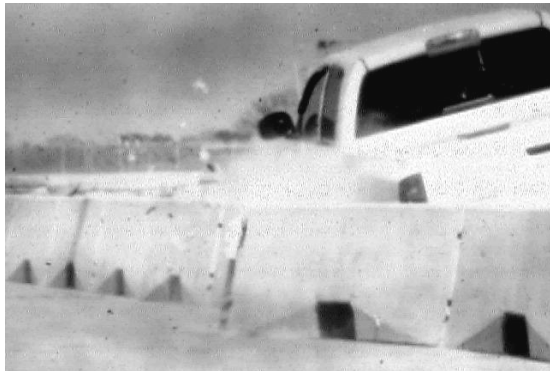
Figure C3. Sequential photographs for test 405160-18-1 (rear view).

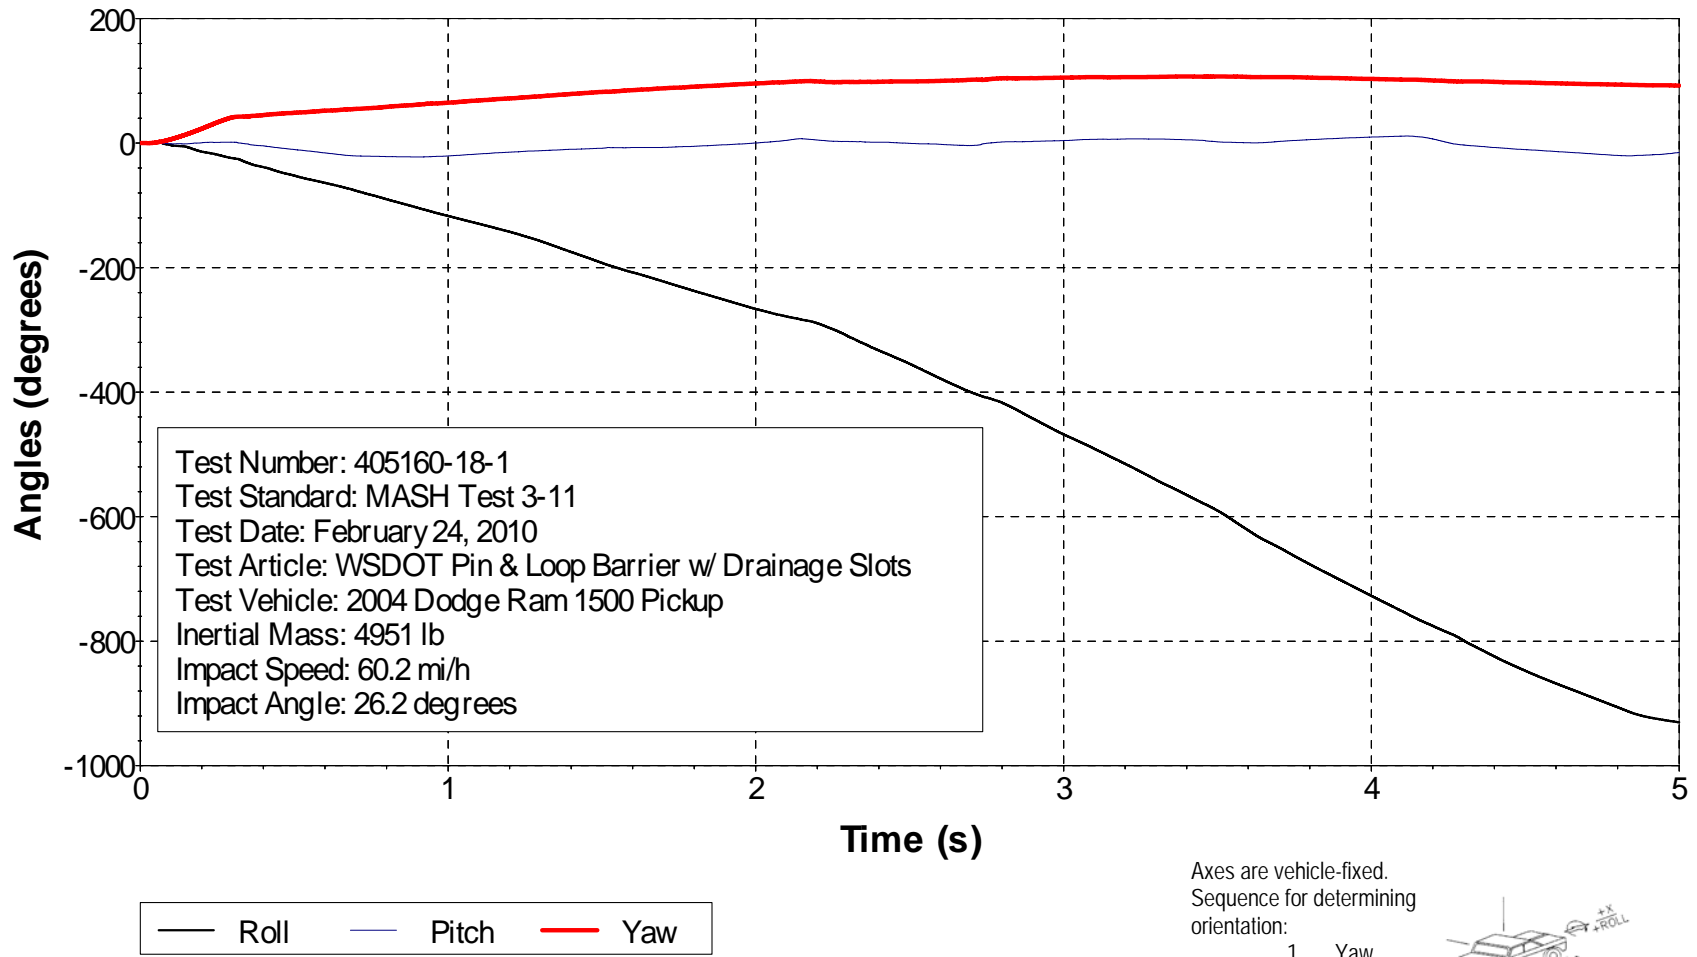
Axes are vehicle-fixed.
 Sequence for determining orientation:

Figure C4. Vehicle angular displacements for test 405160-18-1.

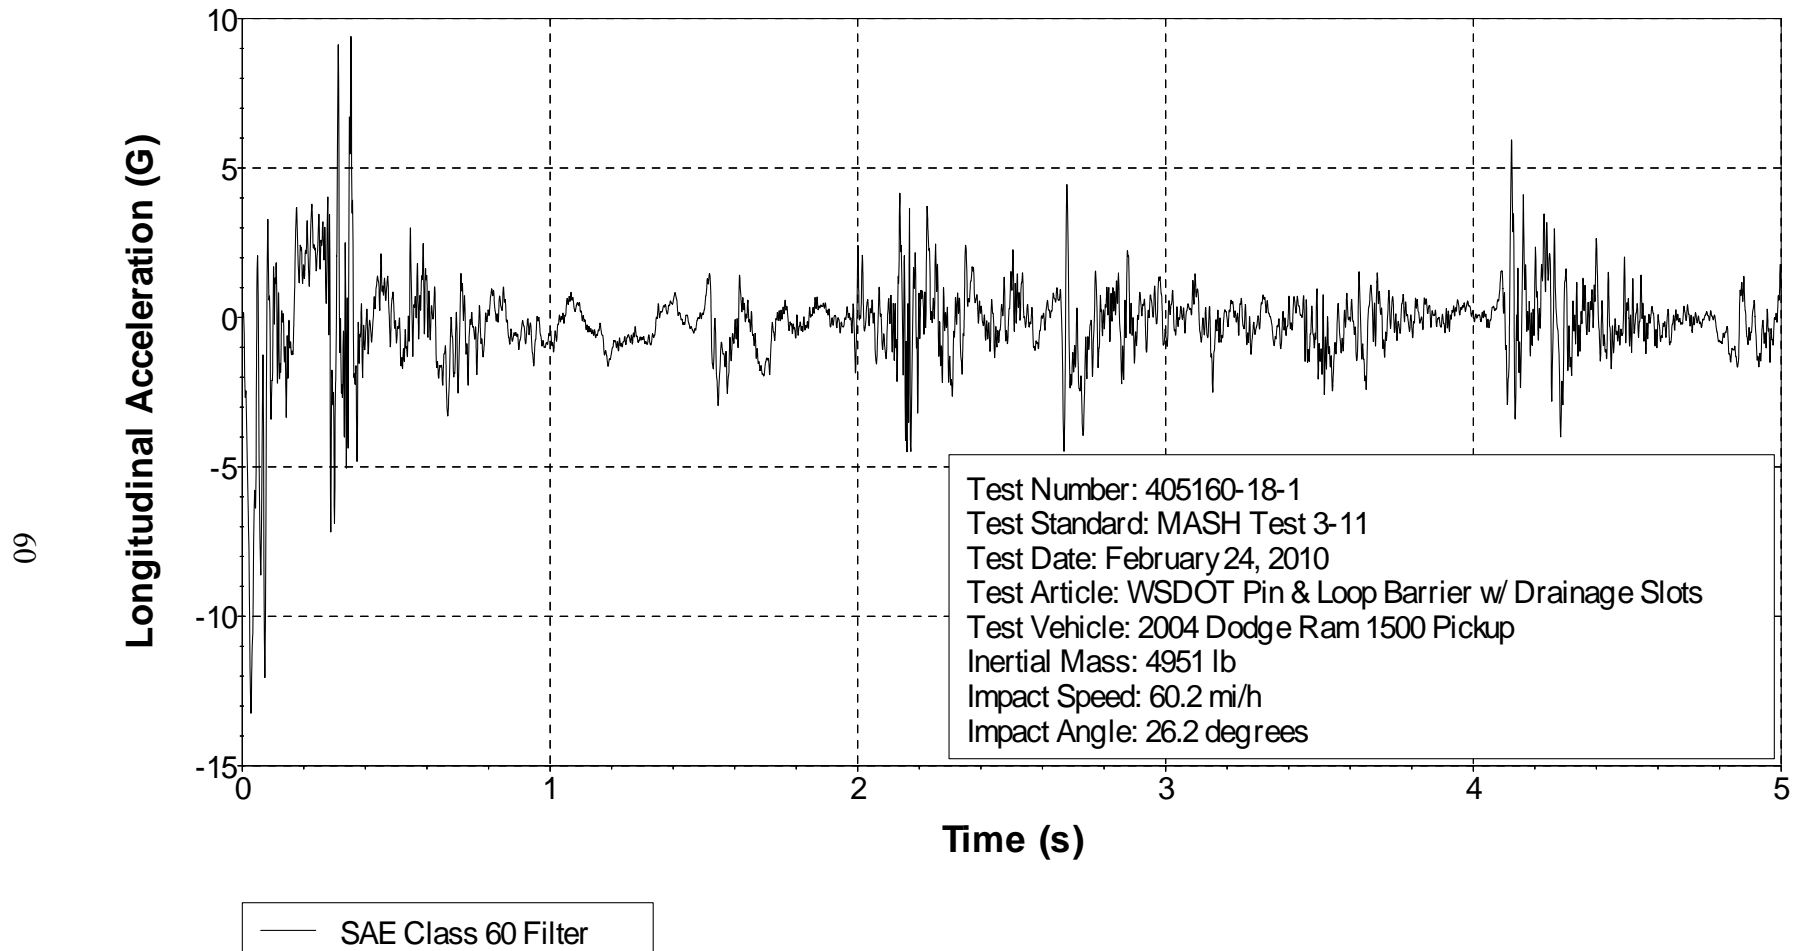
Figure C8. Vehicle longitudinal accelerometer trace for test 405160-18-1 (accelerometer located over rear axle).
