**TPF-5(114)  
Roadside Safety  
Research Program  
Pooled Fund Study**

**MODIFIED G4(1S) W-BEAM GUARDRAIL ON 2H:1V SLOPE**

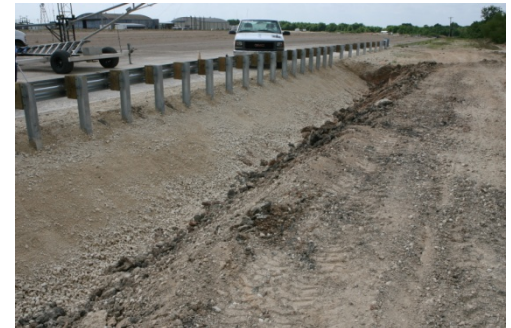
**Modified G4(1S) W-Beam Guardrail on 2H:1V Slope**

Based on the results of the simulation effort, a candidate guardrail design was selected for crash testing. The design was a W-beam (12 gauge) guardrail system with 8-ft posts placed on a 2H:1V slope. The posts were placed 1-ft off the slope break and were spaced at 3 ft-1.5 inches (half the standard spacing for a common strong-post W-Beam guardrail).

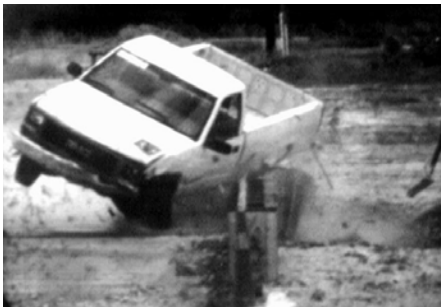
A 2000 GMC C2500 pickup, truck weighing 4610 lb and traveling at a speed of 62.3 mi/h, impacted the guardrail on 2H:1V slope 5.9 inches downstream of post 15 at an impact angle of 25.1 degrees. The guardrail on 2H:1V slope contained and redirected the 2000P vehicle. The 2000P vehicle did not penetrate, underide, or override the installation. However, the vehicle rolled onto its side while exiting the test installation.

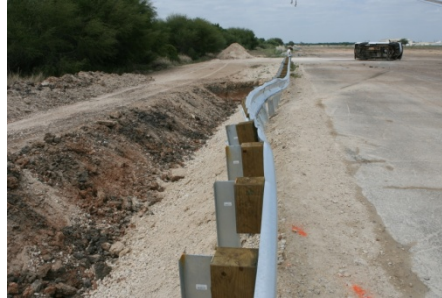
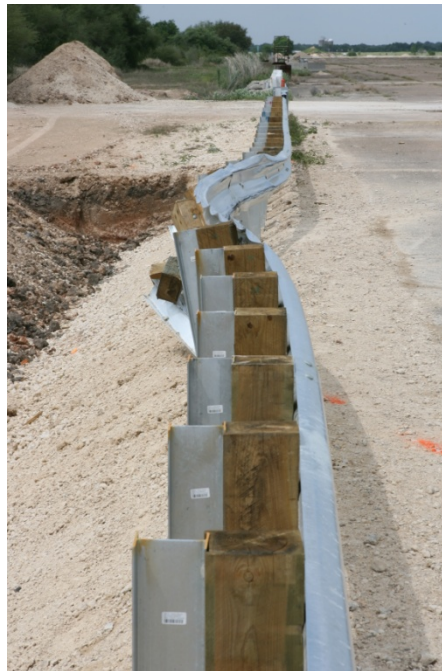
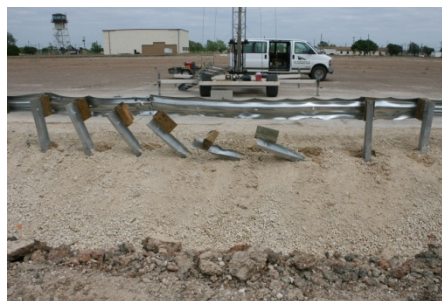
Barrier after Test

Maximum dynamic deflection of the W-beam rail element during the test was 2.71 ft.

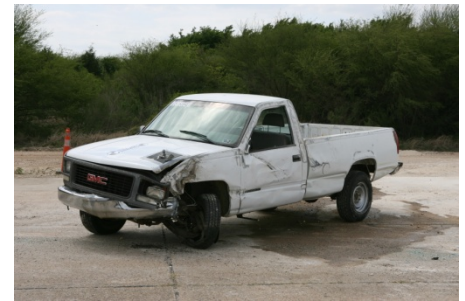
Test Vehicle after being uprighted

In the full-scale crash test, the 2000P vehicle was contained and redirected. However, after exiting the installation, the vehicle rolled onto its left side and came to rest on its left side 135 ft downstream of impact and 34 ft forward of the traffic face of the rail. Due to this rollover event, the guardrail on 2H:1V slope did not meet the criteria for *NCHRP Report 350* test 3-11.
