Roadside Safety Pooled Fund

TPF-5(114)
Roadside Safety
Research Program
Pooled Fund Study

Field Applied Fittings for Wire Rope Barrier

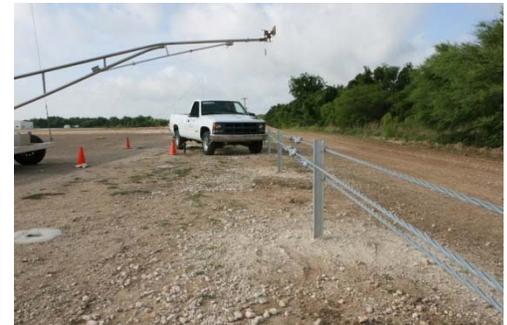
The full scale test installation was 476 ft long and consisted of 336 ft of modified

Crash Test Configuration

“Weak-Steel Post Wire Rope Guardrail System SGR01a-b” with a high-tension terminal on each end. Wire rope heights were the same as detailed in the SGR01a-b specification. The system was terminated with Trinity CASS terminals that utilize Cable Release Posts (CRP). To match field applications Standard 3x7 non-prestretched wire ropes were used. A splice connection was placed midspan between support posts 24 ft downstream of first contact with the test vehicle at post 13.

A Crosby 3/4-inch G-416 epoxy socket was used for termination of each wire rope. The epoxy socket termination provides the same capacity as the field swage termination. However, this termination was considered more critical than the field swage because it presented an increased potential for vehicle snagging. It was concluded that if the epoxy socket termination was successful then the field swage would also be successful. Each epoxy socket requires 86 cc of Crosby Wirelock W416-7 socket compound. A standard Crosby HG-226 1-inch x 12-inch eye and eye turnbuckle were used to connect the two epoxy sockets at each splice. A 1-inch x 6-inch Crosby G-291 eye bolt with double nuts was used to terminate the wire ropes at the CRP. The wire ropes were tensioned between 5620-5640 lb for the full-scale crash test.

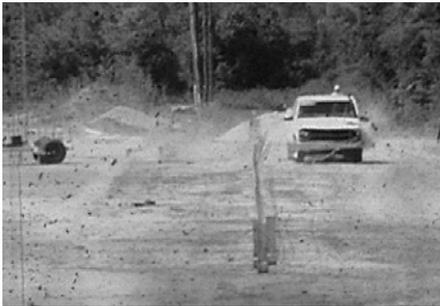
The modified low-tension wire rope barrier system contained and redirected the 2000P vehicle. The vehicle rode over the top and bottom wire ropes, which were under the vehicle as it came to rest. Maximum dynamic

deflection during the test was 10.2 ft. The ropes detached from some of the posts, however, no loose posts or other debris were present to penetrate or show potential for penetrating the occupant compartment, or to present hazard to others in the area. Maximum occupant compartment deformation was 2.2 inches laterally across the floorpan. The 2000P vehicle remained upright during and after the collision event. The 2000P vehicle came to rest within the barrier system and did not intrude into adjacent traffic lanes. Longitudinal occupant impact velocity was 6.9 ft/s (2.1 m/s), and longitudinal ridedown acceleration was -16.4 g's. The vehicle did not exit the system.

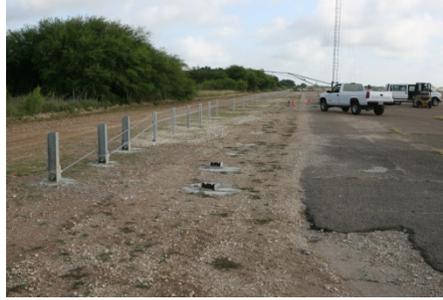
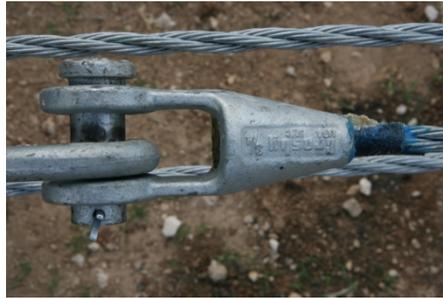
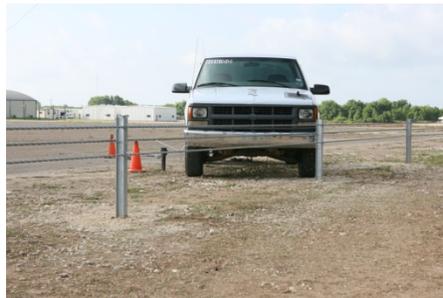
Barrier before Test

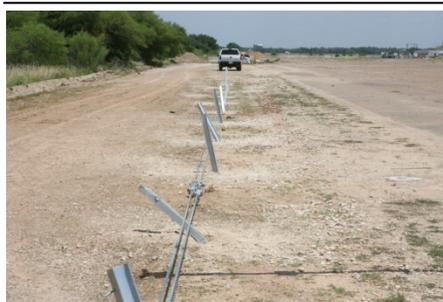
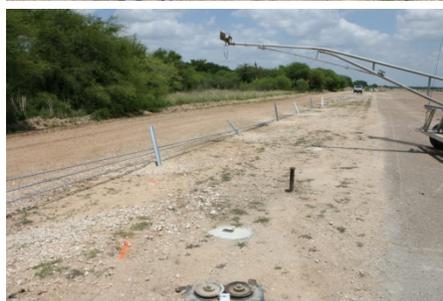
Barrier after Test

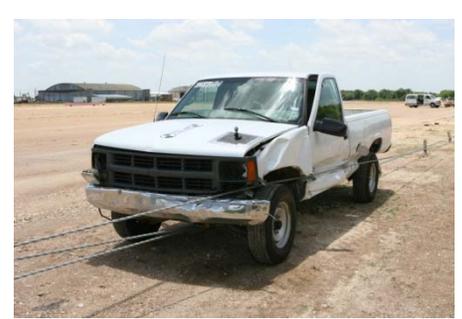
Test Vehicle after Test
