TECHNICAL MEMORANDUM

Contract No.: T4541 Task Order BD
Test Report No.: TM 405160-30-1
Project Name: Washington State Department of Transportation Pin and Loop Barrier with Drainage Slots
Sponsor: Roadside Safety Research Program Pooled Fund Study

DATE: January 13, 2012

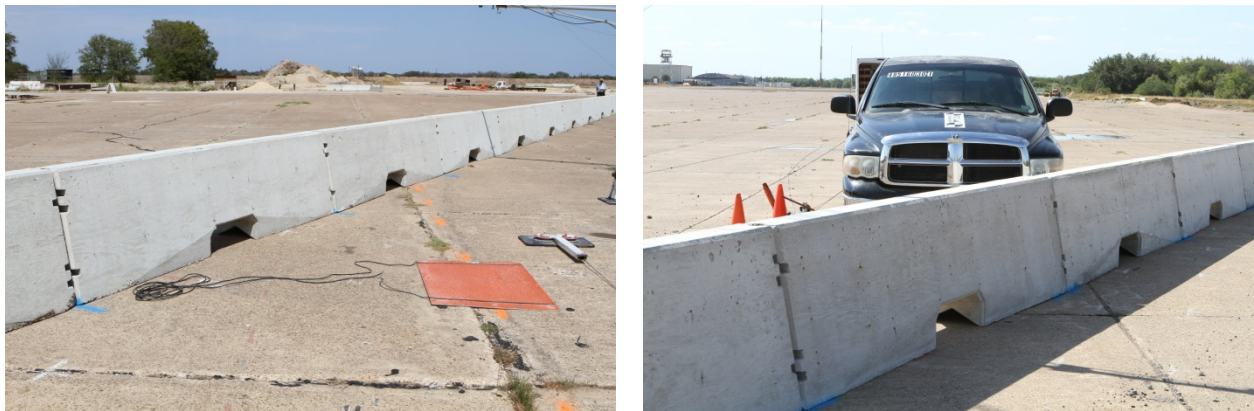
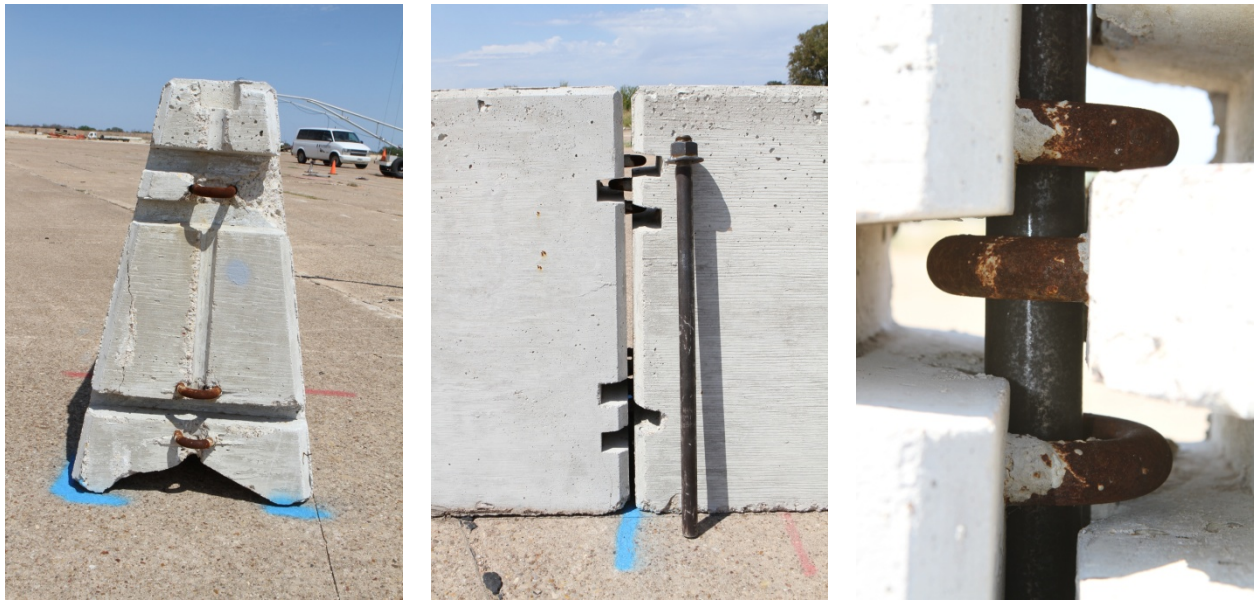
Figure 1. WSDOT pin and loop barrier with drainage slots before test 405160-30-1.

The Washington Pin and Loop Barrier system tested for this project consisted of precast concrete barrier segments that were 12 ft-6 inches in length and 34 inches in height. The barrier segment was 8 inches wide at the top and 21 inches wide at the base with a uniform single slope surface on each side face of the barrier. A 4-inch high by 15-inch wide “V” shaped cutout was centered in the base of the barrier and continuous along the entire length of the barrier segment. In addition to this longitudinal drainage slot, a drainage scupper opening was located at the center of the barrier segment. The drainage scupper opening was 9-inch high by 28 inches in width. This drainage scupper opening would permit drainage from the roadway through the barrier segment or along the barrier through the “V” shape drainage slot located in the base of the barrier. Three ¾-inch diameter steel loops were constructed on the ends of the barrier segments. These loops overlay three loops on the end of the adjacent barrier segment. The segments are connected together by inserting a 1¼-inch diameter steel rods. The ¾-inch steel loops were fabricated using A36 material. The 1¼-inch diameter steel rods were fabricated from ASTM F1554 grade 105 material and were 31 inches in length.

Vertical reinforcement (stirrups) in each barrier segment consisted of #4 rebar stirrups spaced as close as 4 inches on the ends to 11½ inches toward the center of the barrier segment . The stirrups were spaced on 7-inch centers (3 spaces) immediately above the drainage scupper located in the center of the segment. Longitudinal reinforcement in the barrier segment consisted of twelve #5 bars. The bars located in the bottom of the barrier segment were bent to accommodate the drainage scupper opening located in the center of the barrier segment.

The test installation for this project consisted of 16 barrier segments connected together using the 1¼-inch diameter ASTM F1554 grade 105 rods. The total length of the test installation was approximately 200 ft. The minimum compressive strength of the concrete used to construct the units was specified to be 4000 psi. All reinforcing steel used to construct the barrier units was specified to be grade 60 material. For additional information, please refer to the drawings shown as Attachment A and figure 1 in this report.

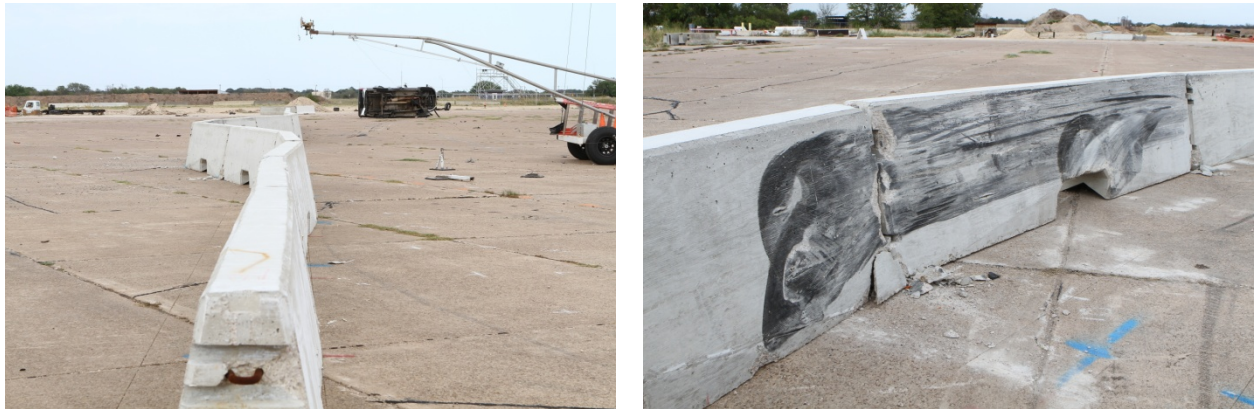
Figure 2. Damage to WSDOT pin and loop barrier with drainage slots after test 405160-30-1.

Damage to the WSDOT pin and loop barrier with drainage slots is shown in figure 2. There was no visible damage to the pins. Spalling of the concrete at the joints and gouging of the traffic face of the barrier segments in the impact area was evident. Movement of the barriers is recorded in table 1. Working width was 6.0 ft. Maximum dynamic deflection and maximum permanent deformation of the barrier was 5.4 ft.

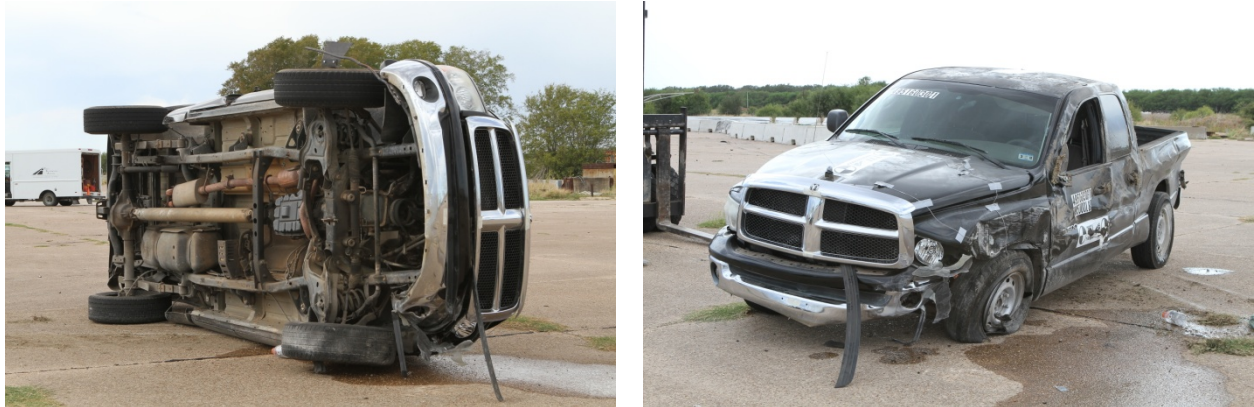
Figure 3. Vehicle after test 405160-30-1.

Damage to the vehicle is shown in figure 3. Damage was imparted to the front bumper, grill, left front fender, left tire and wheel rim, left upper and lower A-arms, left front door and glass, left rear door, left rear exterior bed, left rear wheel rim and the rear bumper. The windshield sustained stress cracks near the left A-pillar. Maximum exterior crush to the vehicle was 11.0 inches at the left front corner at bumper height. The floor pan sustained a small dent measuring 4 inches \times 6 inches \times 0.5 inch deep. Maximum occupant compartment deformation was 1.0 inch in the rear passenger compartment near hip height.

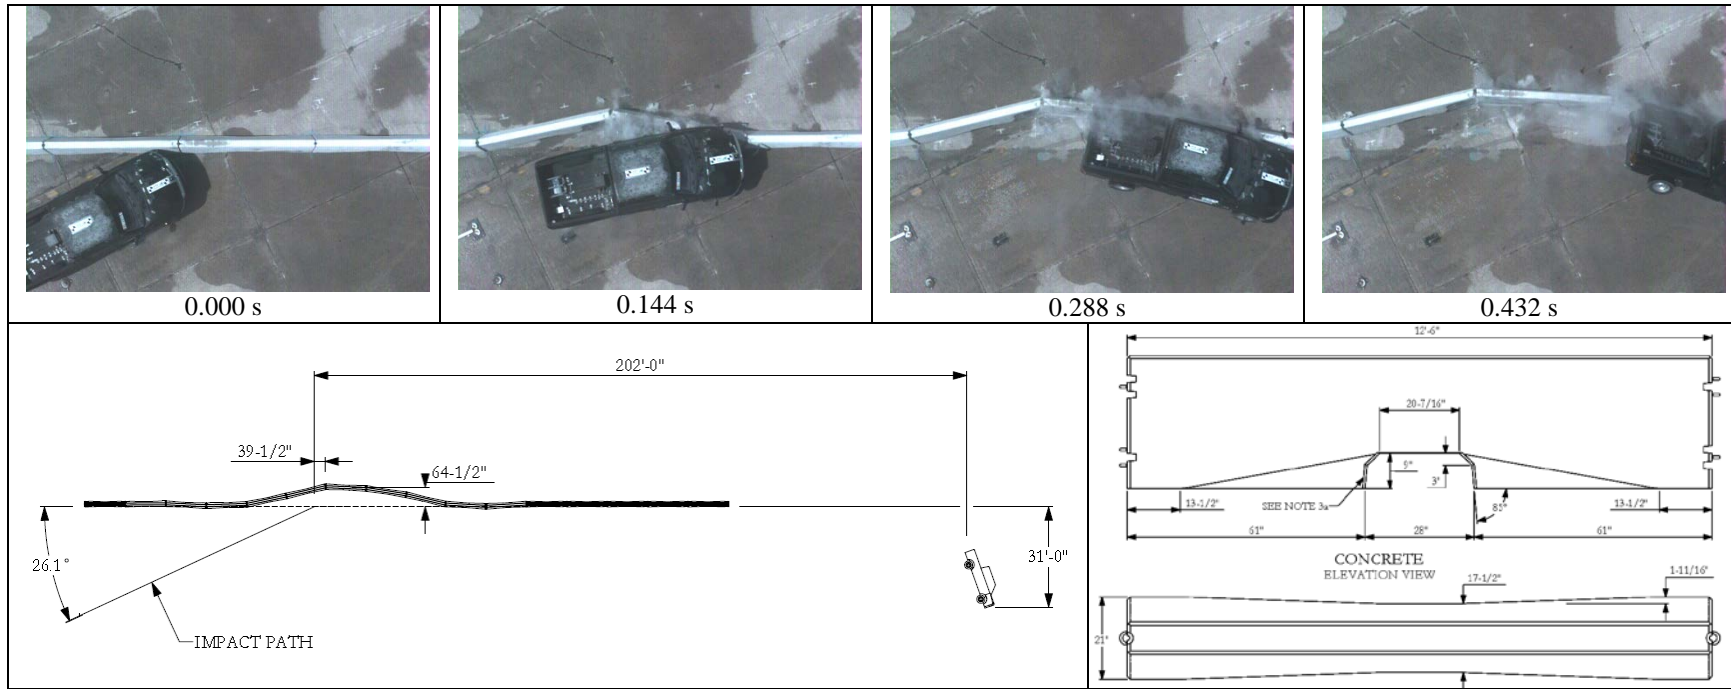
Figure 4. Summary of results for MASH test 3-11 on the WSDOT pin and loop barrier with drainage slots.

Data from the accelerometer, located at the vehicle center of gravity, were digitized for evaluation of occupant risk. In the longitudinal direction, the occupant impact velocity was 14.4 ft/s at 0.100 s, the highest 0.010-s occupant ridedown acceleration was 5.9 Gs from 0.266 to 0.276 s, and the maximum 0.050-s average acceleration was -6.7 Gs between 0.020 and 0.070 s. In the lateral direction, the occupant impact velocity was 22.3 ft/s at 0.100 s, the highest 0.010-s occupant ridedown acceleration was 10.4 Gs from 0.279 to 0.289 s, and the maximum 0.050-s average was 10.2 Gs between 0.032 and 0.082 s. Theoretical Head Impact Velocity (THIV) was 29.2 km/h or 8.1 m/s at 0.097 s; Post-Impact Head Decelerations (PHD) was 10.4 Gs between 0.280 and 0.290 s; and Acceleration Severity Index (ASI) was 1.24 between 0.032 and 0.082 s. These data and other pertinent information from the test are summarized in figure 4.

The WSDOT pin and loop barrier with drainage slots contained and redirected the 2270P vehicle. Maximum deflection of the barrier during the test was 5.4 ft. No detached elements, fragments or other debris were present to penetrate the occupant compartment, show potential for penetrating the occupant compartment or to present undue hazard to others in the area. Maximum occupant compartment deformation was 1.0 inch in the rear passenger area near the hip level. After loss of contact with the barrier, the 2270P vehicle rolled counterclockwise 121 degrees and came to rest on its left side. Occupant risk factors were within the limits specified in *MASH*. The 2270P vehicle exited within the exit box.

According to criteria for *MASH* test 3-11 shown in table 2, the WSDOT pin and loop barrier with drainage slots did not perform acceptably due to rollover of the test vehicle.

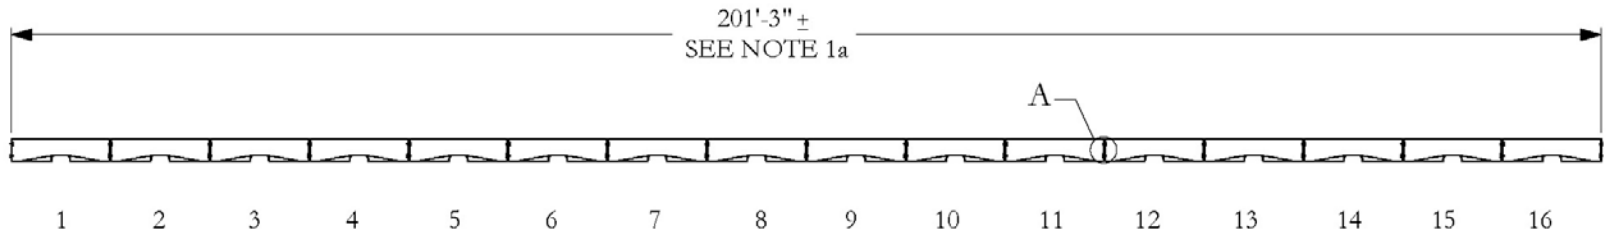
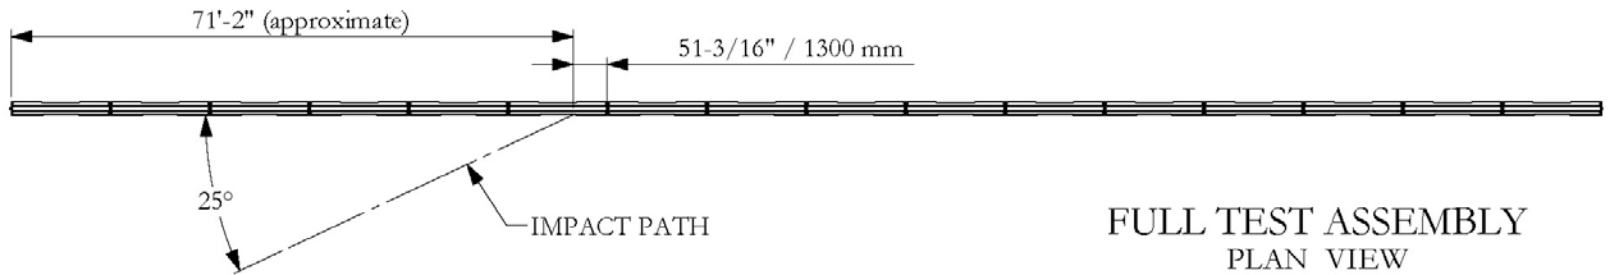
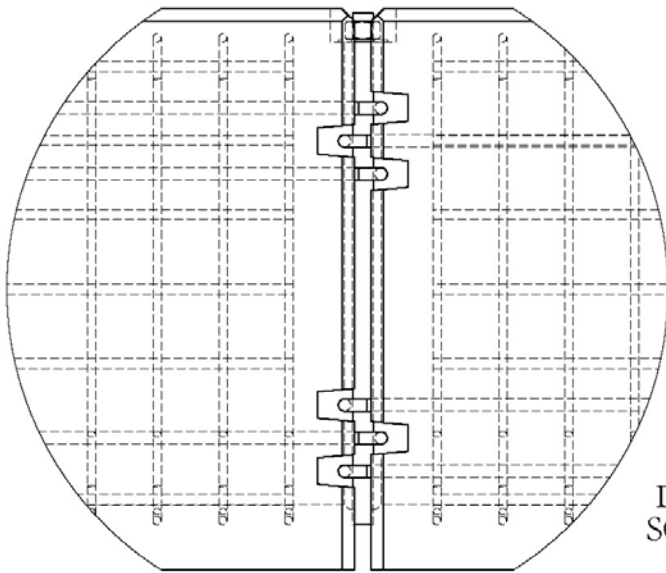
Texas Transportation Institute		The Texas A&M University System College Station, Texas 77843	
Project	405160-30	Wash DOT Pin and Loop Barriers	
Drawn By	GES	Scale 1:250	Sheet 1 of 8 200' Installation
Approved:	Signature:		Date:
William Williams:	<i>William Williams</i>		2011-09-08

FULL TEST ASSEMBLY
ELEVATION VIEW

FULL TEST ASSEMBLY
PLAN VIEW

DETAIL A
SCALE 1 : 10

1a. 16 barriers @ 12'-6" with ≈1" space between barriers.

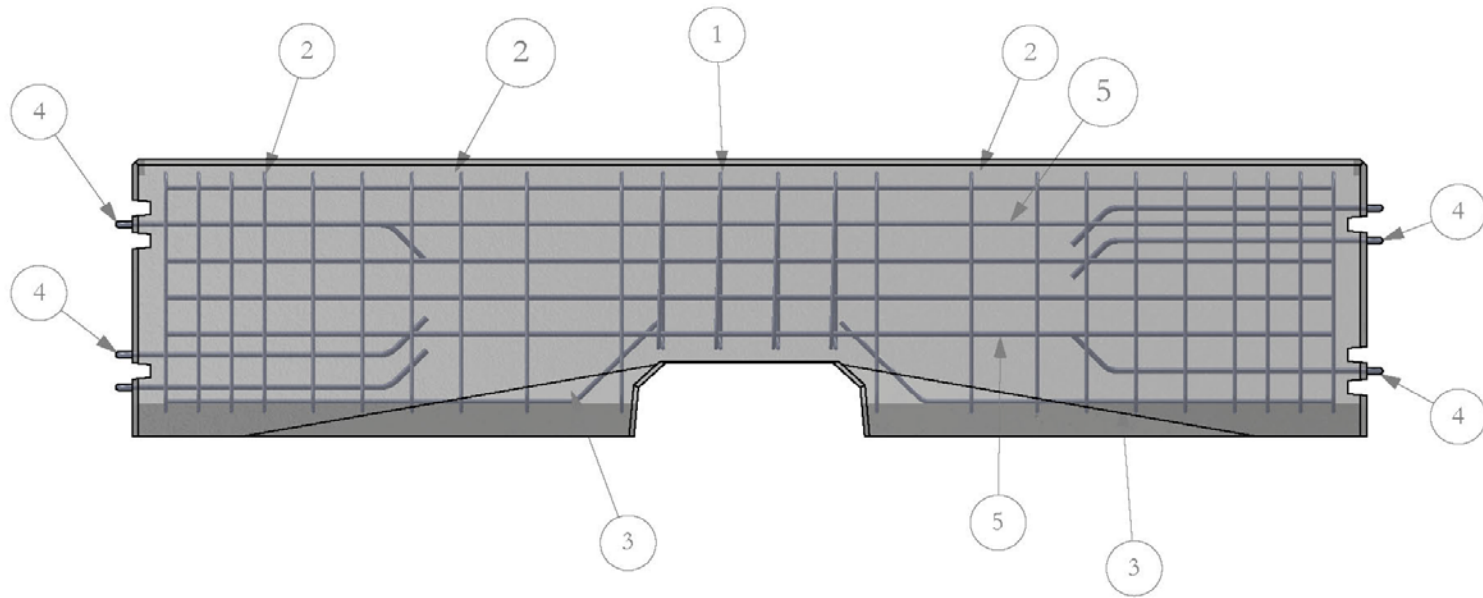
Texas Transportation Institute		The Texas A&M University System College Station, Texas 77843	
Project	405160-30	Wash DOT Pin and Loop Barriers	
Drawn By	GES	Scale	1:20
Sheet		2 of 8	Parts List

- 2a. All rebar is grade 60.
- 2b. Concrete strength is 4000 psi.
- 2c. Rebar stirrups are detailed on page 7.

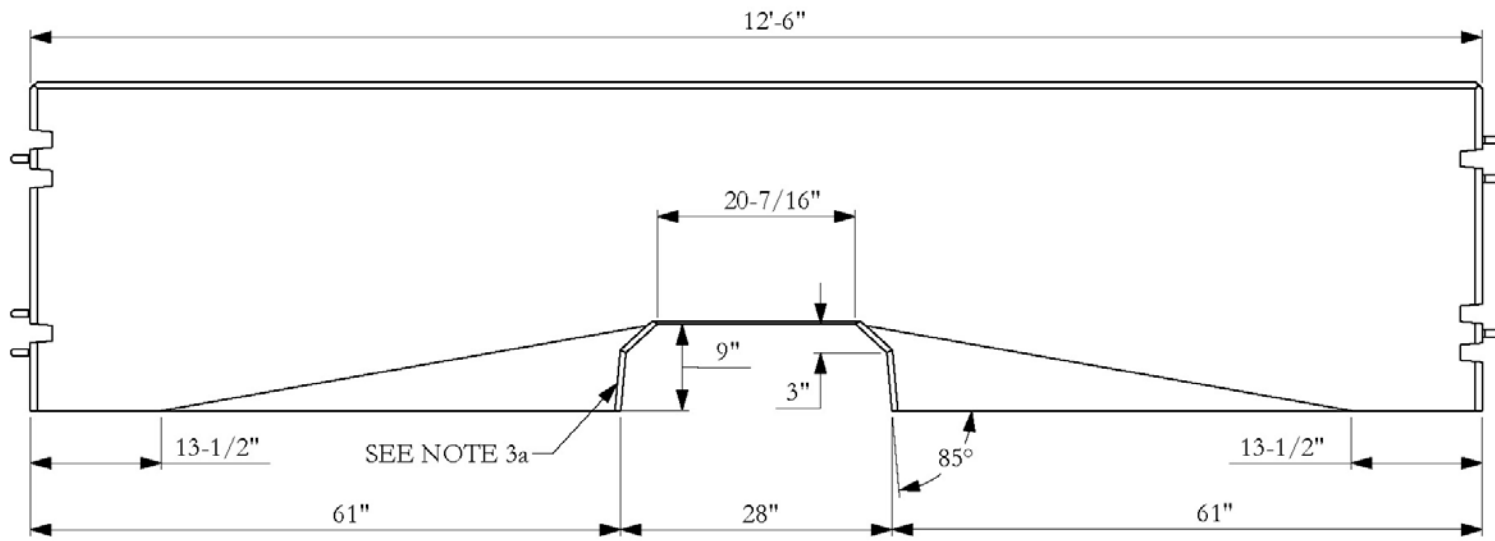
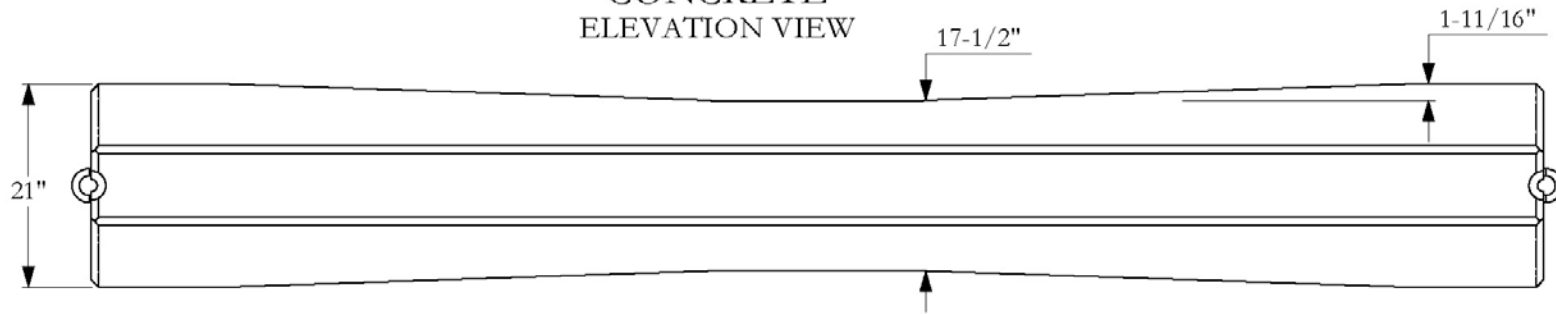
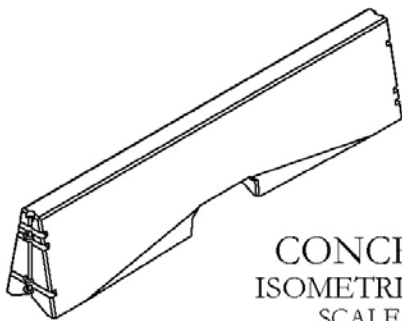
Texas Transportation Institute		The Texas A&M University System College Station, Texas 77843	
Project	405160-30	Wash DOT Pin and Loop Barriers	
Drawn By	GES	Scale	1:17
Sheet		3 of 8	Concrete

CONCRETE ELEVATION VIEW

CONCRETE PLAN VIEW

CONCRETE ISOMETRIC VIEW
SCALE 1:50

3a. 3/4" chamfer scupper edges.

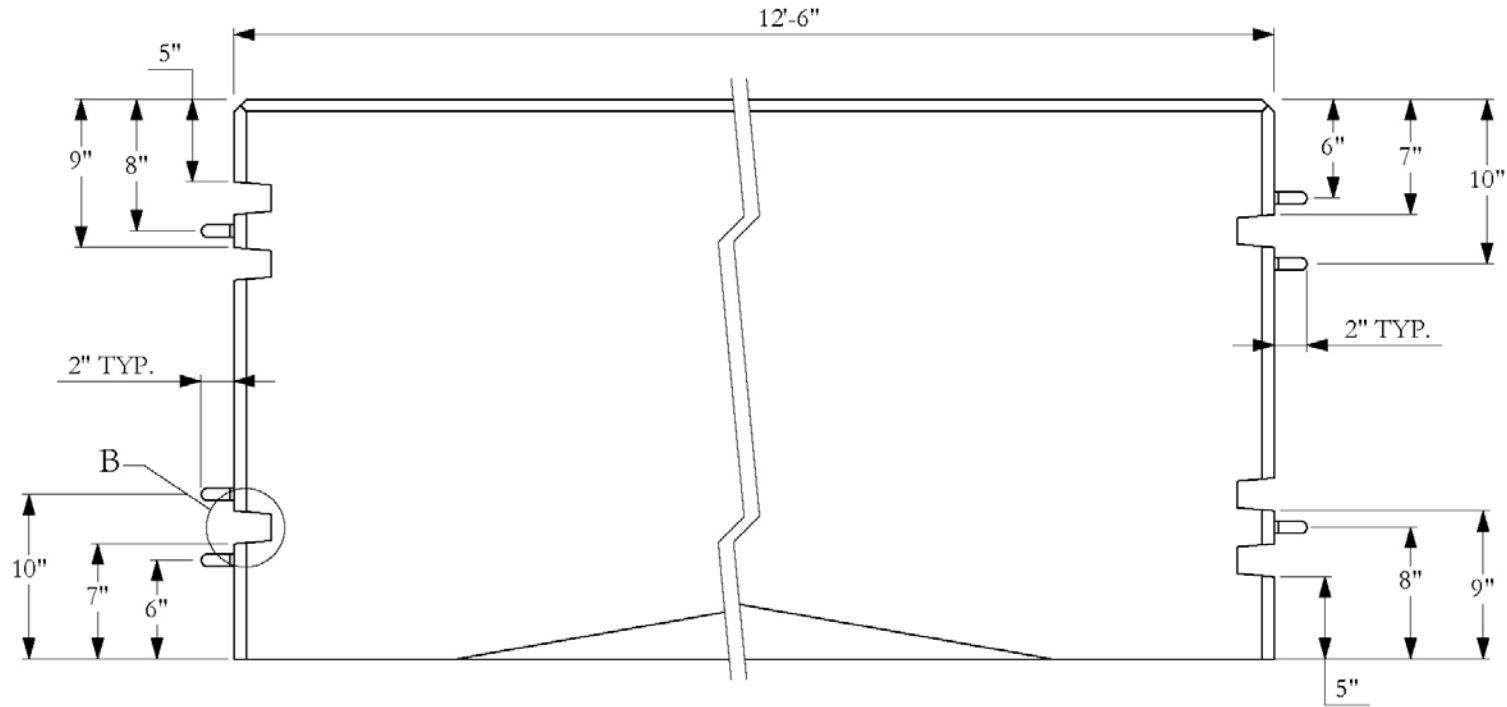
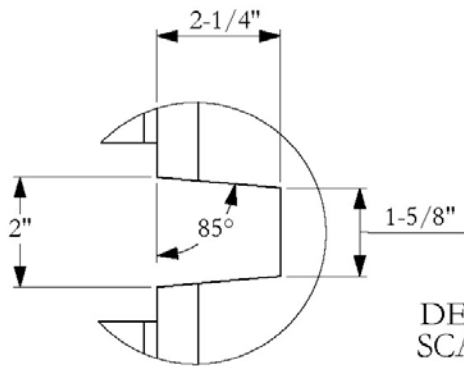
Texas Transportation Institute		The Texas A&M University System College Station, Texas 77843	
Project	405160-30	Wash DOT Pin and Loop Barriers	
Drawn By	GES	Scale	1:10
Sheet	4 of 8	Loops

DETAIL B
SCALE 1 : 3
TYPICAL 6 SLOTS

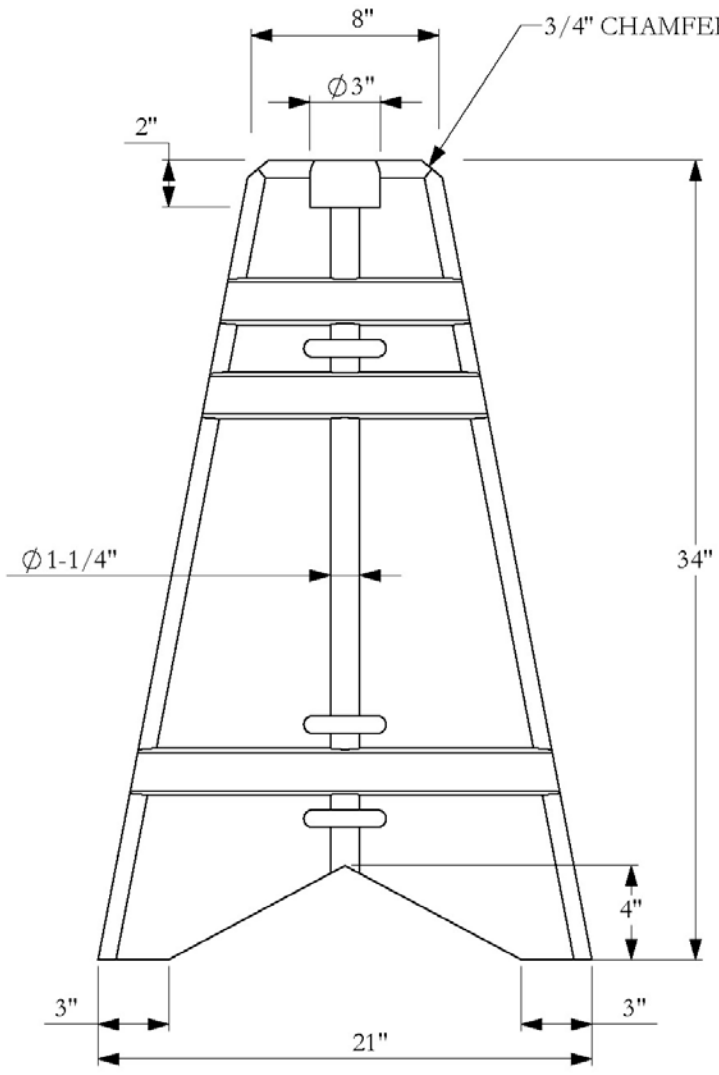
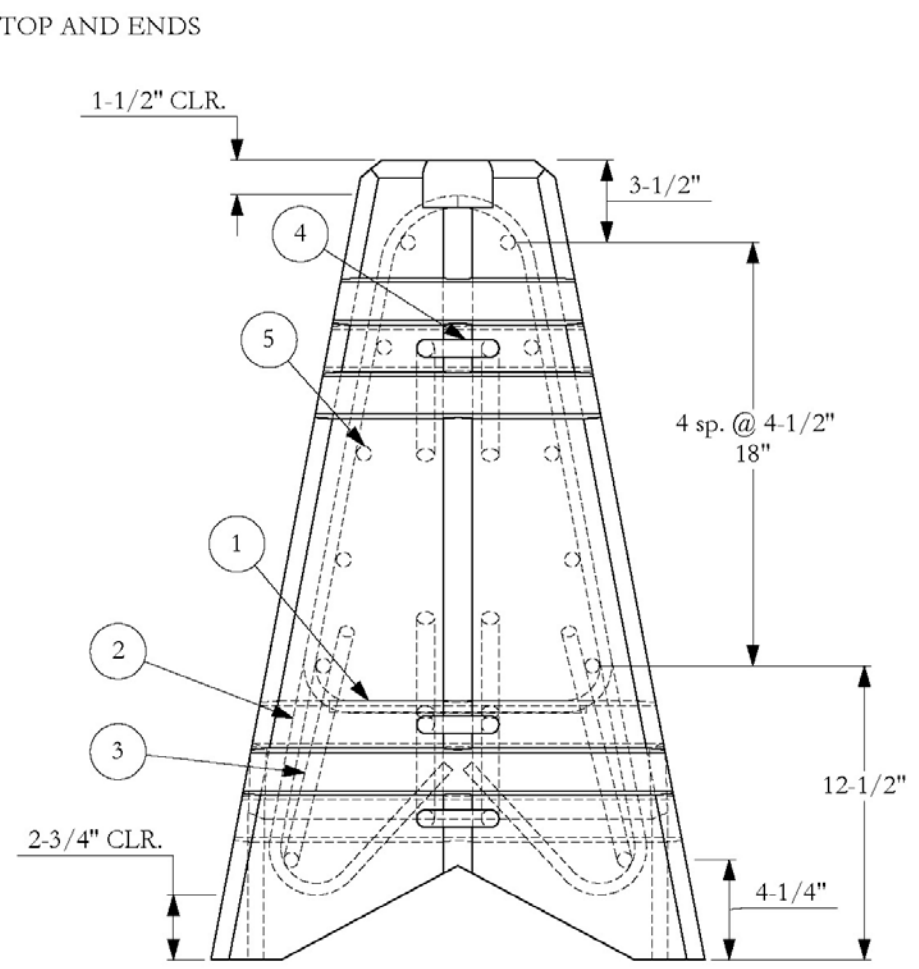
Texas Transportation Institute		The Texas A&M University System College Station, Texas 77843	
Project	405160-30	Wash DOT Pin and Loop Barriers	
Drawn By	GES	Scale	1:7
		Sheet	5 of 8
		End Views

CONCRETE
ELEVATION VIEW - END

REBAR
ELEVATION VIEW - END

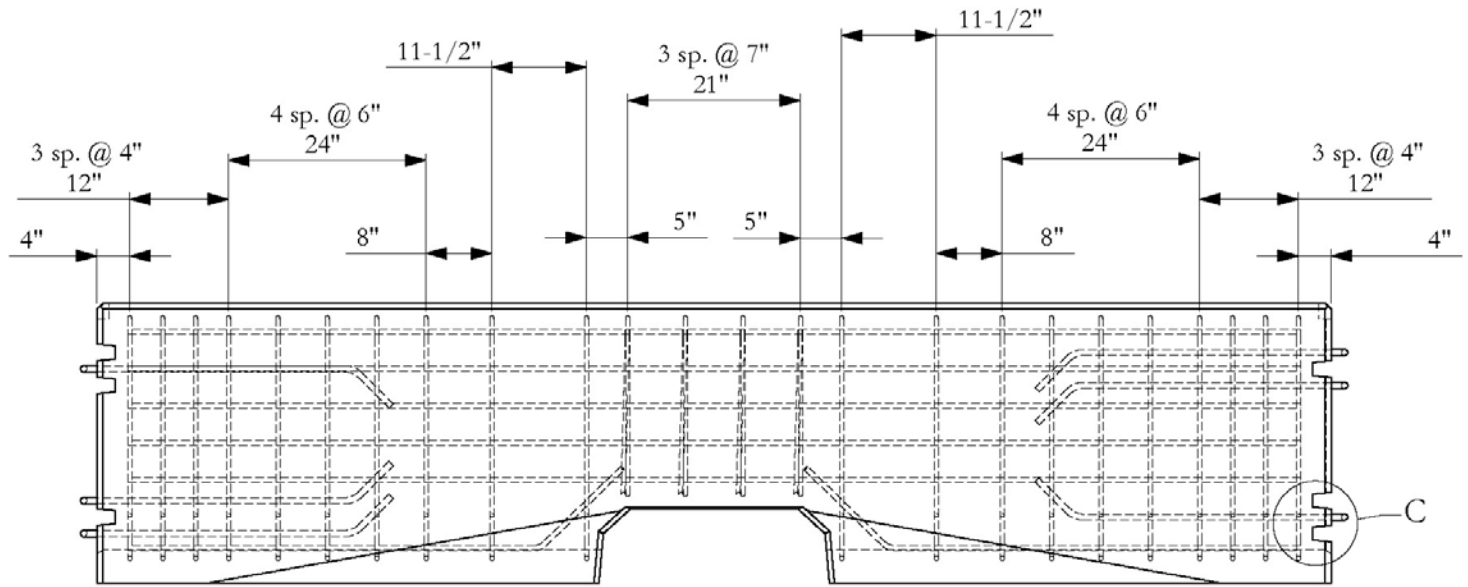
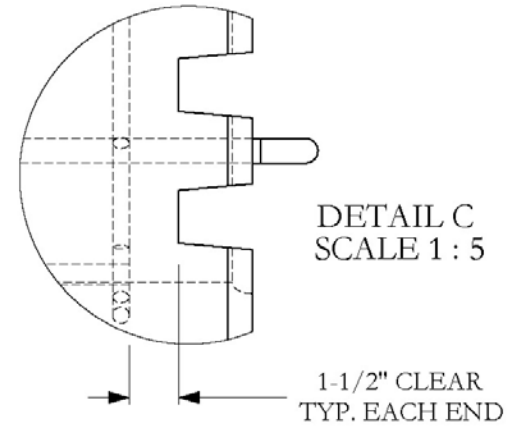
Texas Transportation Institute		The Texas A&M University System College Station, Texas 77843	
Project	405160-30	Wash DOT Pin and Loop Barriers	
Drawn By	GES	Scale 1:20	Sheet 6 of 8 Rebar - Elevation

REBAR
ELEVATION VIEW

6a. All rebar spacing dimensions are to \varnothing unless otherwise noted.

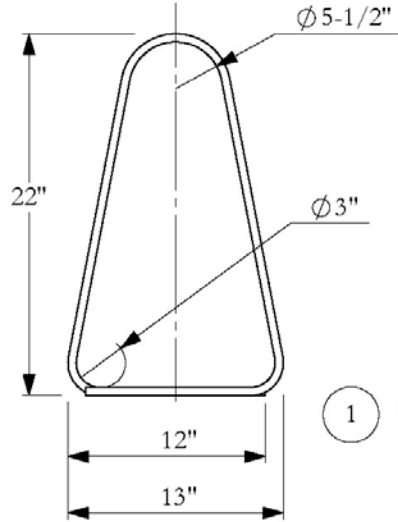
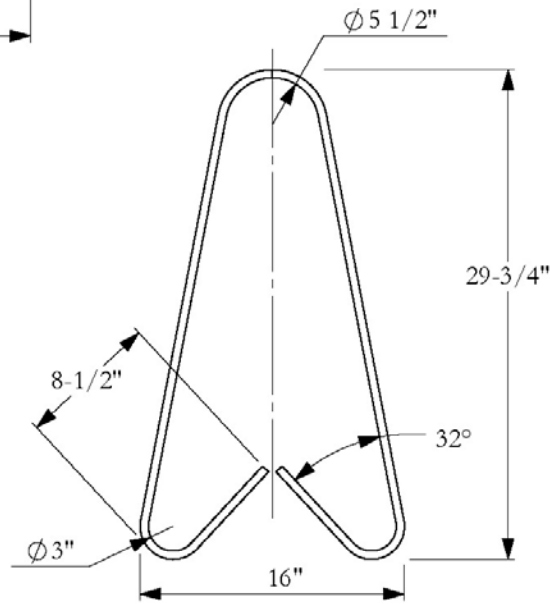
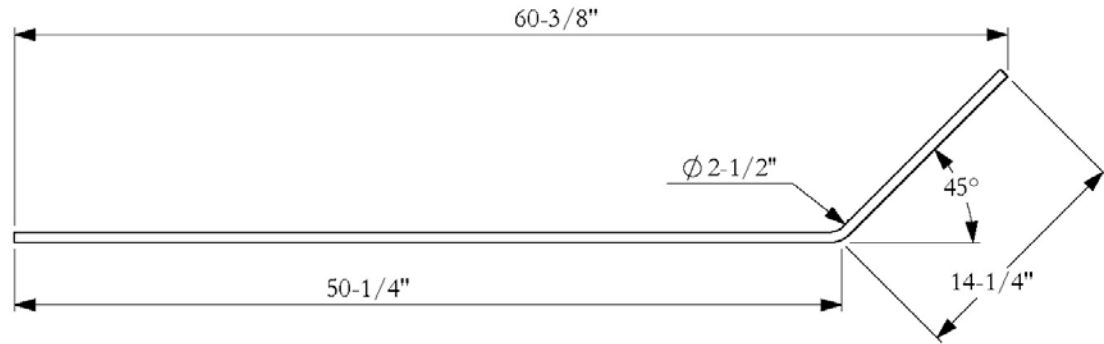
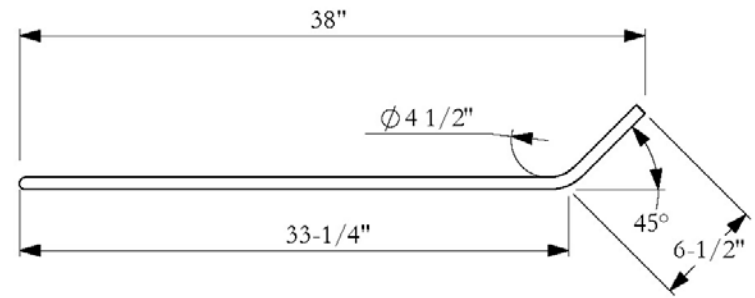
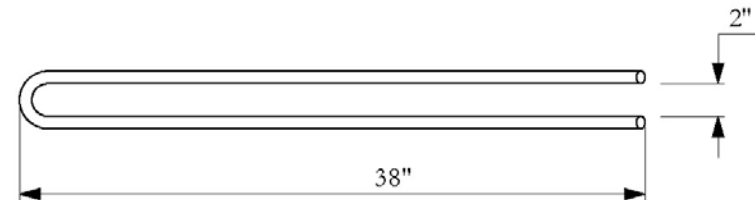
Texas Transportation Institute		The Texas A&M University System College Station, Texas 77843	
Project	405160-30	Wash DOT Pin and Loop Barriers	
Drawn By	GES	Scale	1:10
Sheet		7 of 8	Rebar Details

① #4 CENTER STIRRUP

② #4 END STIRRUP

③ #5 BENT REBAR

④ END LOOP
Ø3/4" A36 ROD

7a. Stirrups (1) and (2) are symmetrical about \bar{C} 's.
