# **TECHNICAL MEMORANDUM**

Contract No.: Tech Memo No. Project Name: Sponsor:	T4541-AV : 602181 Small Bridge Barrier/Guide Rail Retrofits (Phase 1) Roadside Safety Research Program Pooled Fund Study
DATE:	July 7, 2015
TO:	Leni Oman, Director Research Office Washington State Department of Transportation Transportation Building, MS: 47372 Olympia, Washington 98504-7372
СОРҮ ТО:	Rhonda Brooks, Washington State DOT Erlinda Olivarez, TTI RDO D. L. Bullard, Jr., Head, TTI Roadside Safety & Physical Security Systems Roger P. Bligh, TTI Roadway Safety Program Rebecca Haug, TTI Roadside Safety & Physical Security Systems
FROM:	William F. Williams, P.E., Associate Research Engineer, TTI Roadside Safety & Physical Security Systems

## **SUMMARY REPORT:**

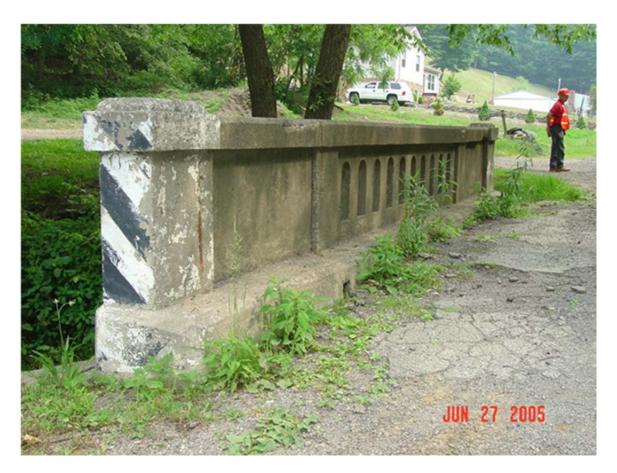
Figure 4 – Typical Photo of Concrete Post and Beam Railing with Concrete Pickets

A typical photo of a concrete post and beam bridge railing with concrete pickets is shown in Figure 4.

In April 1998, TTI performed full-scale crash testing on the T411 (32 inches high) with respect to NCHRP Report 350 TL- $3^{(4)}$ . The Texas Type T411 is an aesthetic bridge rail design that utilizes rail openings similar to the concrete rail shown in Figures 2 through 4. The Texas Type T411 did not meet the requirements of NCHRP Report 350 for TL-3.

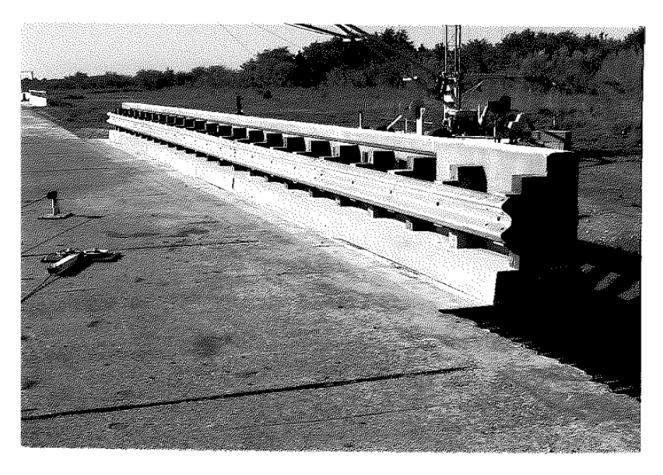
Figure 7 – Photograph of Traffic Side View of Concrete Rail Retrofit Project No. 472070

Study Number RF 472070. Details of the Retrofit are shown in Figure 5. Photographs of the test installation are shown in Figures 6 to 8. This railing was retrofitted with a blocked W-Beam Rail element.

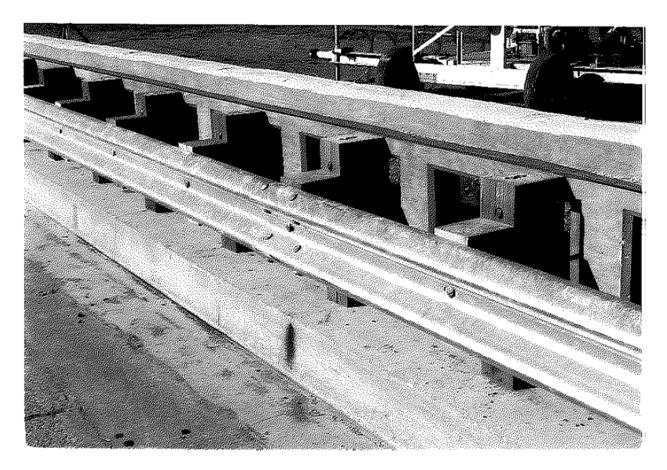
Figure 8 – Photograph of Traffic Side View of Concrete Rail Retrofit Project No. 472070

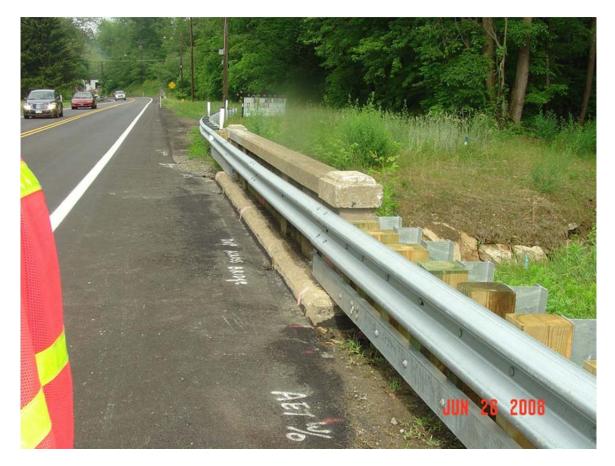
Figure 9 – Retrofit Option Using W-Beam Guardrail

The purpose of the study will be to perform engineering strength calculations and develop retrofit details for a few common type of bridge railings surveyed for this project. These retrofit designs will be considered for further analyses and full-scale crash testing for another project. Several retrofit options were considered in the analyses and detailing for the most common types (shapes) of concrete post and beam railing with concrete pickets that are used in the State of Pennsylvania. A photograph showing one option using a bolted W-Beam guardrail is shown in Figures 9 and 10.

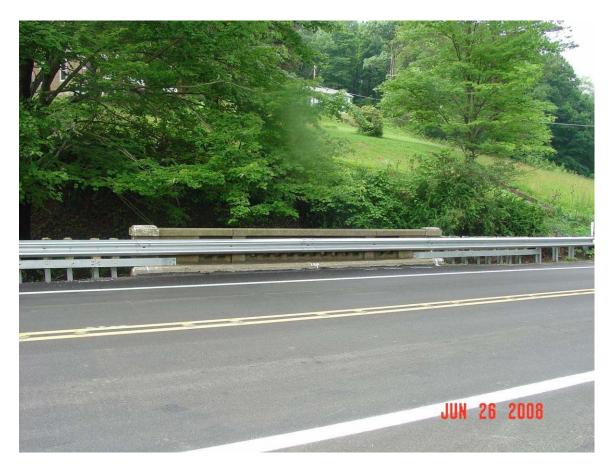
Figure 10 – Front View of Retrofit Option Using W-Beam Guardrail

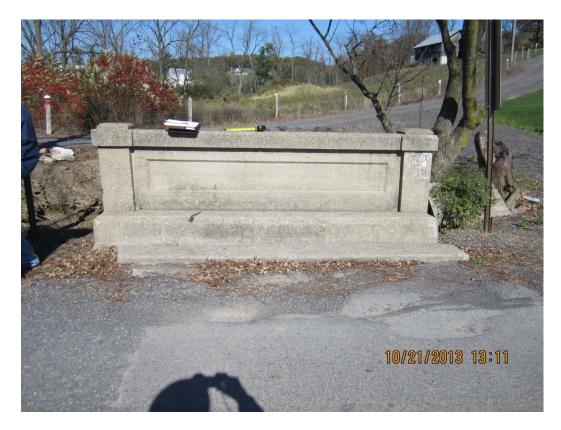
Figure 15 – Photo of Typical Concrete Parapet Without Openings

Several sites were visited that consisted of small streams with small bridges spanning the streams. The railings on these structures consisted of concrete continuous concrete parapets with a small beam on top of the parapet. Most of the bridges visited consisted of concrete bridge constructed in the early to mid 1930's. The condition of these bridges varied. In some cases, the bridge railings were severely damaged due to vehicular crashes or by road deicing salts and chemicals. Details of this common rail type are shown in the previous Figures 13 and 14. A few photos of this bridge type are shown in Figures 15 and 16.

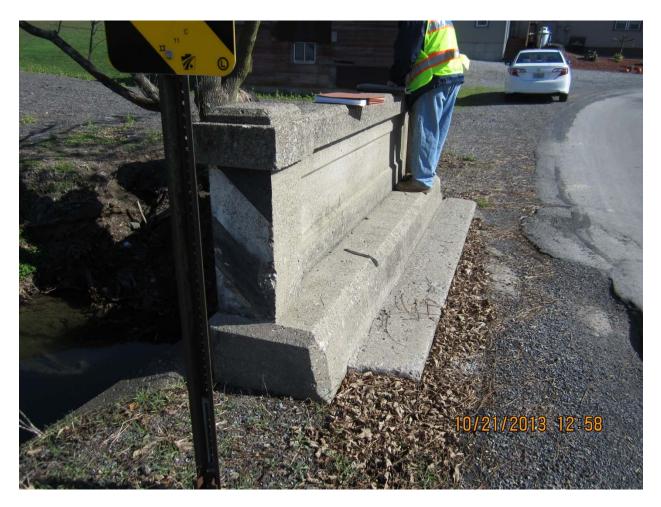
Figure 16 – Photo of Typical Concrete Parapet Without Openings

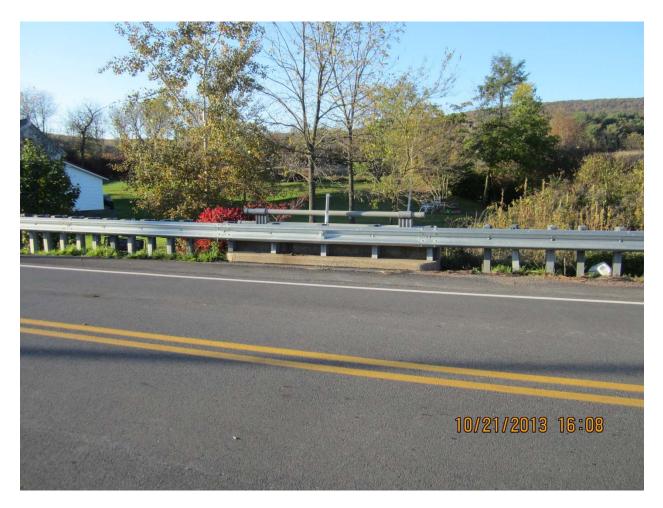
Figure 22 – Photo of Combination Concrete Rail with Aluminum Post and Rail

A few small bridges with bridge railings that consisted of a combination concrete rail and aluminum post and beam rail system. The combination bridge rail usually consisted of a concrete parapet on top of a concrete curb. The aluminum rail system consisted of a cast aluminum post with two aluminum tubular rail elements. This bridge railing system was constructed typically in the 1930's. The condition of these bridges varied. Details of this common rail type are shown in Figures 19 to 21. A few photos of this bridge type are shown in Figures 22 and 23.

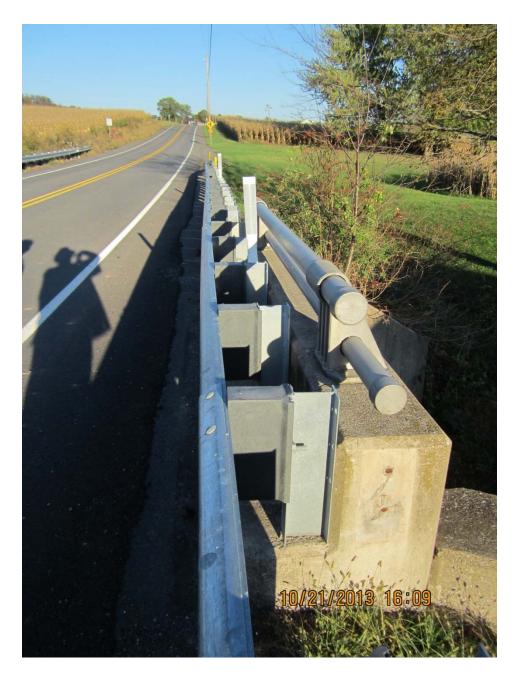
Figure 23 – Photo of Combination Concrete Rail with Aluminum Post and Rail
