**Report No. 12-602951-00001**  
**Report Date: September 2015**

**Design and Finite Element Analysis of a MASH 31-inch  
W-Beam Guardrail System for Placement on 3H:1V Sloped  
Terrain Configuration (2014 WV-62)**

Sponsored by  
**Roadside Safety Research Program Pooled Fund**  
**Study No. TPF-5(114)**

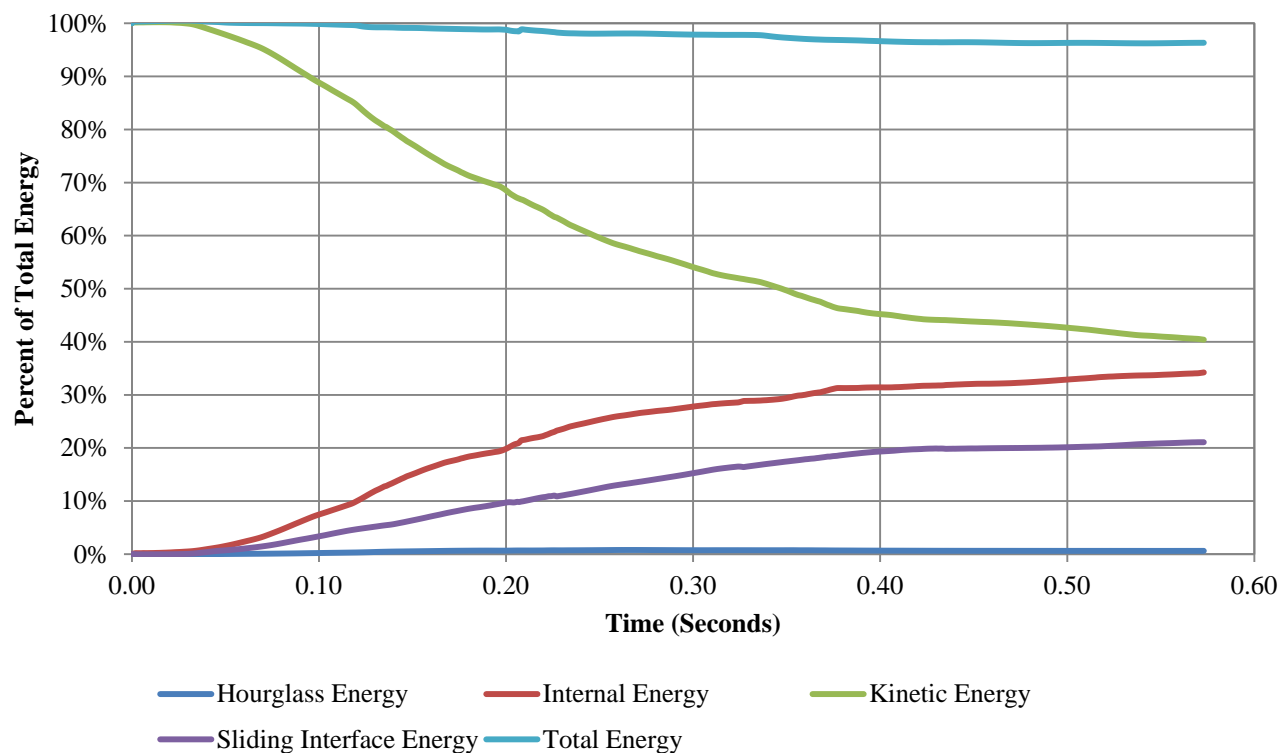
Since this is a closed system and energy is conserved, the sum of the kinetic energy, hourglass energy, sliding energy, and internal energy at any time during the simulation should equate to the initial kinetic energy of the vehicle. As shown in Figure 2.4, approximately 35 percent of the initial kinetic energy of the impacting vehicle is converted into internal energy (damage or deformation of the vehicle and barrier components). Approximately one percent of the initial kinetic energy is converted into hourglass energy. Approximately 21 percent of the initial kinetic energy is converted into sliding interface energy. Forty percent of the initial kinetic energy has yet to be dissipated by the system at the time of final impact configuration, mainly due to the remaining velocity of the vehicle.

**Figure 2.4. Energy Distribution Time History (W-Beam Guardrail on 2H:1V Slope with Tire Rod Failure).**

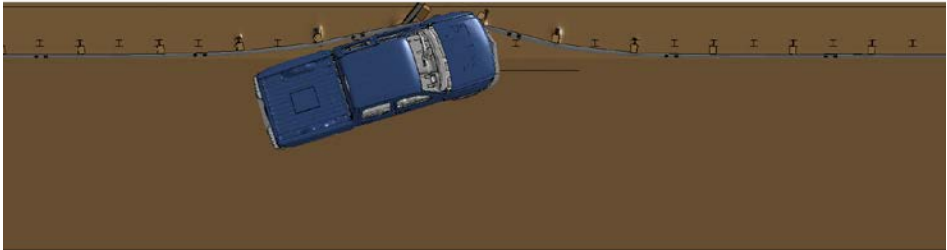
0.175

A top-down view of the blue vehicle in contact with the W-beam guardrail. The vehicle's front end is touching the guardrail, and it is beginning to rotate.

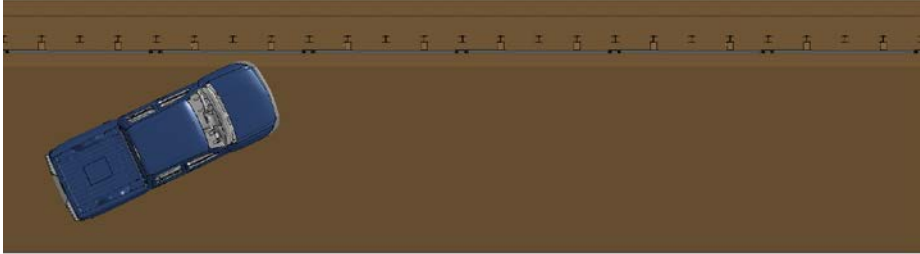
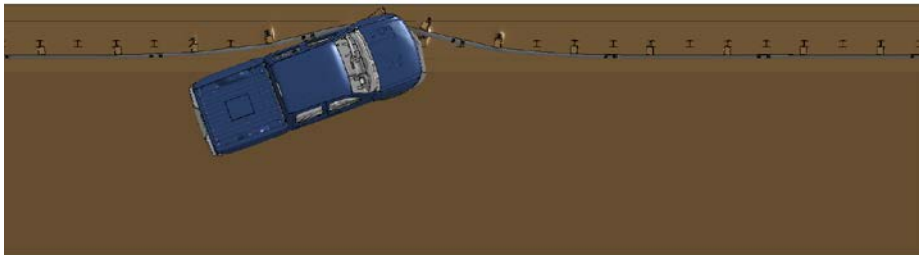
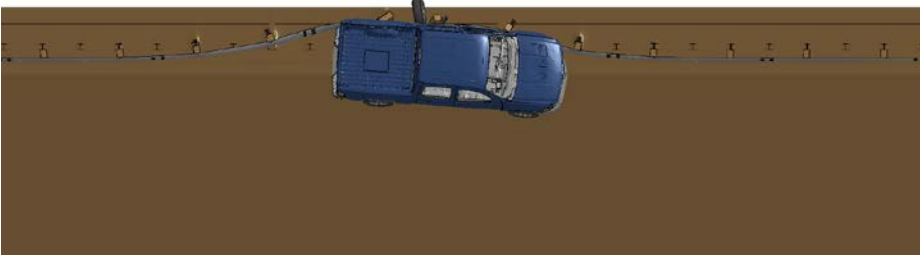
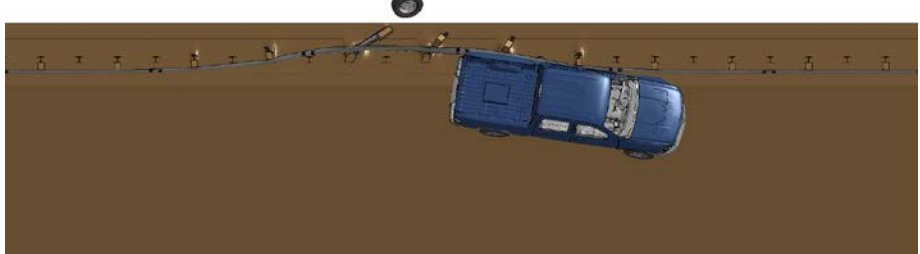
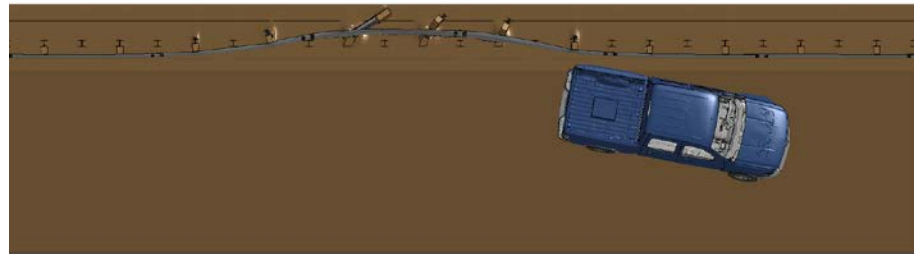
**Table 3.7. Sequential Images of the 2270P Vehicle Interaction with the W-Beam Guardrail on 3H:1V Slope (2-ft) (Front View).**

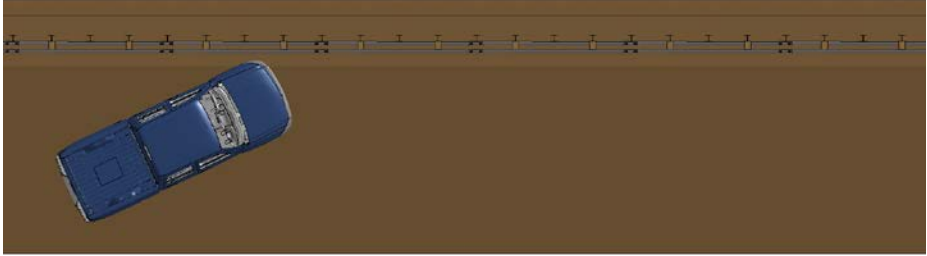
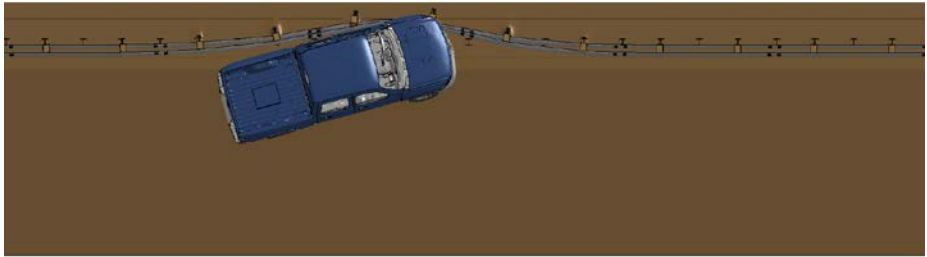
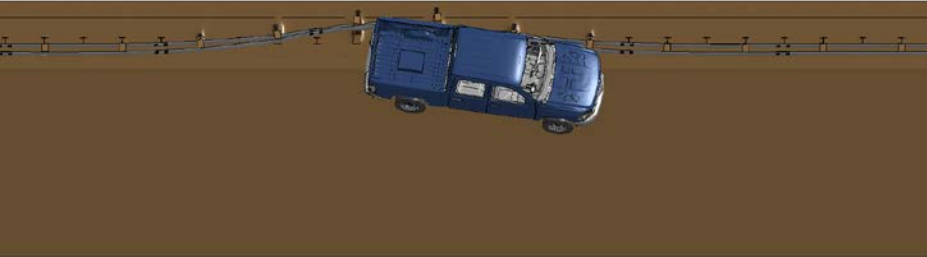
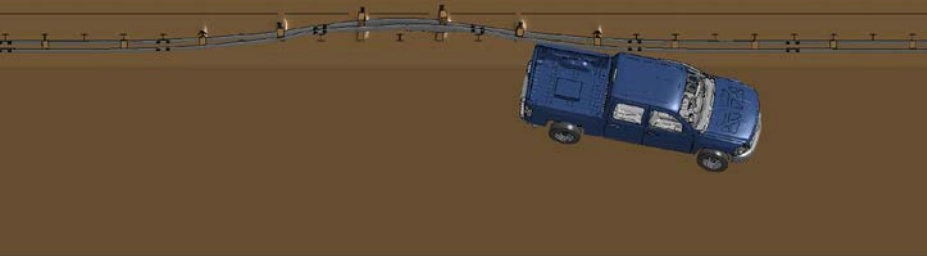
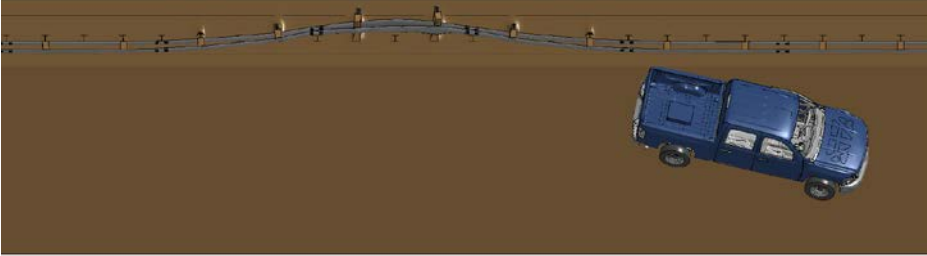
**Table 3.11. Sequential Images of the 2270P Vehicle Interaction with the W-Beam Guardrail on 3H:1V Slope (2-ft) with Rubrail (Front View).**

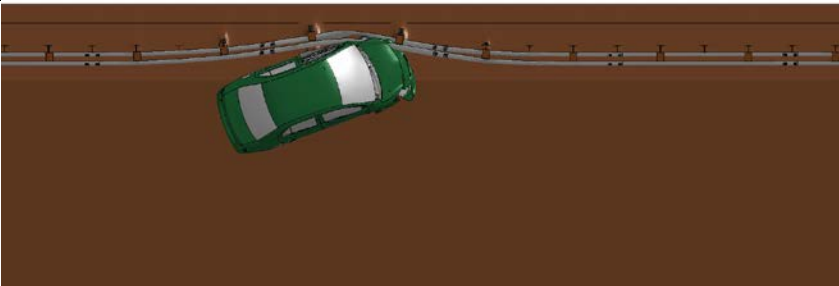
The green car is now in contact with the guardrail. The car's front end is touching the rail, and it is beginning to rotate.
0.240

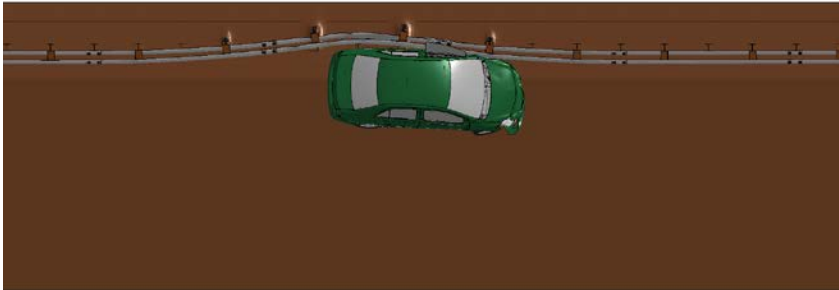
The green car is sliding along the guardrail. The car is oriented more parallel to the rail, and its front end is further along it.
0.360

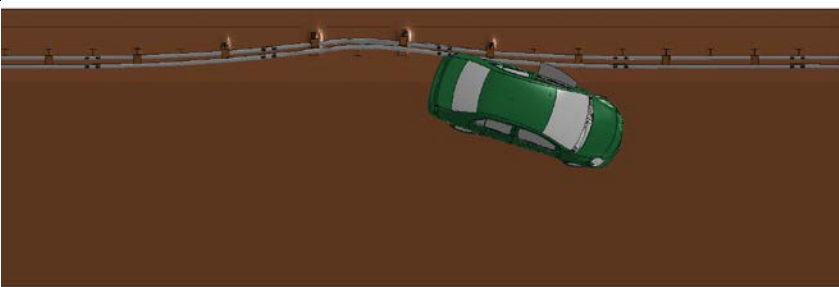
The green car has lost contact with the guardrail and is now sliding away from it. The car is angled away from the rail.
0.484
