## TECHNICAL MEMORANDUM

**Contract No.:** T4541  
**Test Report No.:** TM No. 605311  
**Project Name:** Pendulum Testing on Composite Blockouts Raised on Steel Posts  
**Sponsor:** Roadside Safety Pooled Fund

### SUMMARY REPORT:

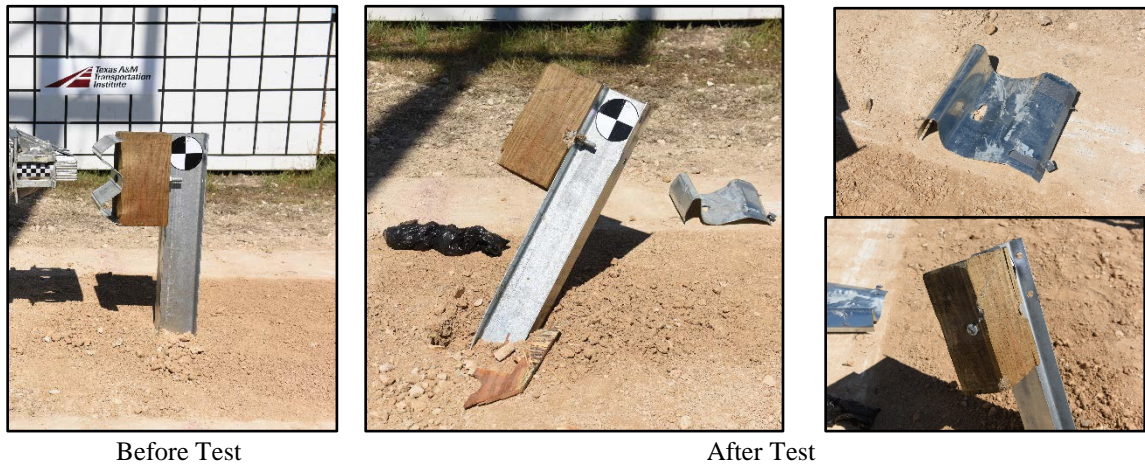
**Figure 2. Wood Block A at Standard Height before and after Test No. 605311-P2.**

For Test P2, a 72-inch long steel post (PWE01) with a wood PDB-01b blockout was installed such that the top of the post was 32 inches above grade, and the top of the W-beam back-up plate was 31 inches above grade. The post was installed to a depth of 40 inches. The centerline of the pendulum's nose impacted the W-beam backup plate at a height of 29½ inches above grade. Details are provided in Sheet 4 of 6 in Appendix B1.

The pendulum contacted the blockout while traveling at an impact speed of 21.5 mi/h. At 0.004 s after impact, the post began to deflect toward the field side, and at 0.005 s, the top edge of the guardrail back-up plate began to climb up and over the blockout. At 0.136 s, the post was leaning toward the field side at 29 degrees and had a maximum displacement of 19 inches measured at the top of the post. The nose of the pendulum lost contact with the post and blockout at 0.180 s, and the pendulum was traveling at 9.1 mi/h. The pendulum nose lost contact with the backup plate at 0.200 s and the blockout was intact and did not rotate about the post. The skid plate of the pendulum contacted the guardrail and blockout at 0.269 s.

The post was pushed toward the field side through the soil 5¾ inches at ground level, with a 1-inch gap on the field side. The post was leaning 25 degrees downstream. As shown in Figure 1, the blockout remained intact. Maximum dynamic deflection during the test was 19.0 inches.

The 50-ms average longitudinal acceleration was -6.5 g, maximum 50-ms average force was 12.8 kips, and energy was 488 kip-inch. These values and other pertinent information from the test are summarized in Table C2 of Attachment C.

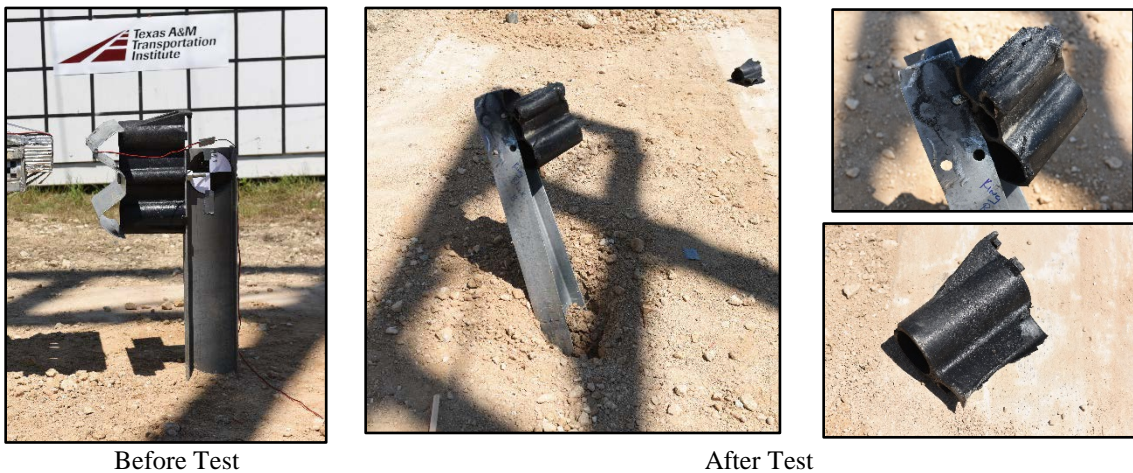
**Figure 3. Plastic King™ Block B Raised 4 inches before and after Test No. 605311-P3.**

For Test P3, a 72-inch long steel post (PWE01) with a King Block™ TM blockout was installed such that the top of the post was 28 inches above grade, and the top of the W-beam back-up plate was 31 inches above grade. The post was installed to a depth of 44 inches. The centerline of the pendulum’s nose impacted the W-beam backup plate at a height of 29½ inches above grade. Details are provided in Sheet 2 of 6 in Appendix B1.

The pendulum contacted the blockout while traveling at an impact speed of 19.9 mi/h. At 0.003 s after impact, the post began to deflect toward the field side, and at 0.005 s, the top edge of the guardrail back-up plate began to climb up and over the blockout. At 0.056 s, the blockout began to ride up the face of the post and rotate counterclockwise, and by 0.074 s, the blockout had rotated 90 degrees counterclockwise. The post was leaning toward the field side at 10.5 degrees and had a maximum displacement of 10½ inches measured at the top of the post at 0.094 s. The blockout fractured horizontally at 0.097 s, the upper part of the blockout remained attached to the guardrail back-up plate, and the lower portion remained attached to the post. At the time of the blockout fracture, the post was still leaning toward the field side at 10.5 degrees, and was twisted counterclockwise approximately 20 degrees with the blockout rotated 90 degrees from its original position to the face of the post. The nose of the pendulum lost contact with the post and blockout at 0.120 s, and the pendulum was traveling at 12.3 mi/h. The skid plate of the pendulum contacted the lower portion of the blockout at 0.182 s.

The post was pushed toward the field side through the soil 4 inches at ground level, with a 1-inch gap on the field side. The post was leaning 15 degrees toward the field side. The blockout was fractured horizontally just above the center of the blockout, with the upper portion remaining attached to the guardrail back-up plate, and the lower portion remaining attached to the post (see Figure 2). Maximum dynamic deflection during the test was 10.5 inches.

The 50-ms average longitudinal acceleration was -5.0 g, maximum 50-ms average force was 9.8 kips, and energy was 310 kip-inch. These values and other pertinent information from the test are summarized in Table C3 of Attachment C.

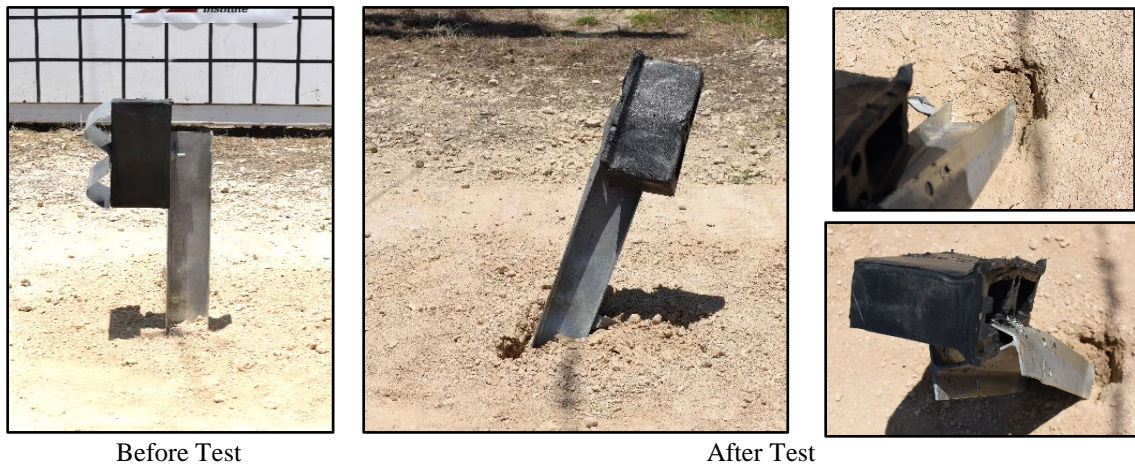
**Figure 7. Mondo Plastic Block Raised 4 inches before and after Test No. 605311-P7.**

For Test P7, a 72-inch long steel post (PDE01) with an 8-inch deep Mondo #GB14SH2 blackout was installed such that the top of the post was 28 inches above grade, and the top of the W-beam was 31 inches above grade. A 10-inch long bolt was used to attach the blackout to the post. The post was installed to a depth of 44 inches. The centerline of the pendulum’s nose impacted the W-beam backup plate at a height of 29½ inches above grade. Details are provided in Sheet 3 of 6 in Appendix B2.

The pendulum contacted the blackout while traveling at an impact speed of 19.8 mi/h. At 0.003 s after impact, the post began to deflect toward the field side, and at 0.007 s, the blackout began to rotate clockwise over the top of the post. At 0.048 s, the upper section of the post began to rotate counterclockwise. The post was leaning toward the field side at 7 degrees and had a maximum displacement of 5.5 inches measured at the top of the post at 0.057 s. The blackout began to rotate and separate on the face of the post at 0.060 s, and the backup plate detached from the blackout and post at 0.063 s. At 0.068 s, the blackout was 90 degrees to its original position, and the post was twisted approximated 10 degrees. At 0.070 s, the blackout abruptly released around the face flange of the post, but did not fracture and remained bolted to the post. The nose of the pendulum lost contact with the post and blackout at 0.145 s, and the pendulum was traveling at 13.5 mi/h. The skid plate of the pendulum contacted the lower portion of the blackout at 0.164 s.

Figure 7 shows the blackout rotated almost 180 degrees, but it remained attached to the post. The post deflected through the soil 3.75 inches at grade. Maximum dynamic deflection during the test was 6.0 inches.

The 50-ms average longitudinal acceleration was -4.8 g, maximum 50-ms average force was 9.3 kips, and energy was 310 kip-inch. These values and other pertinent information from the test are summarized in Table C7 of Attachment C.

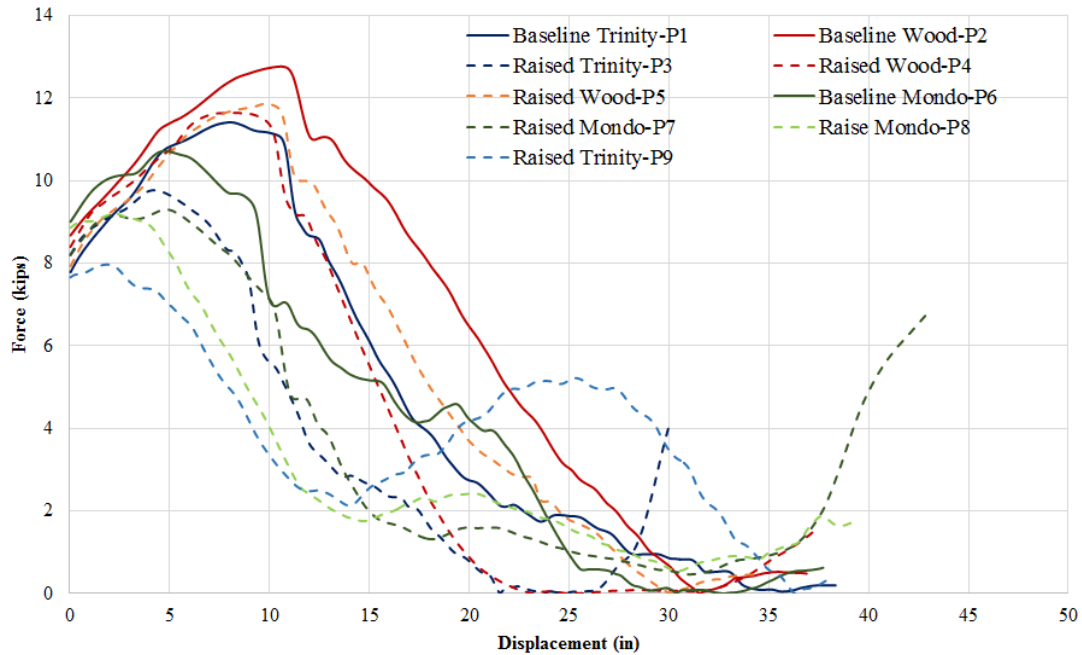
**Figure 10. Force-Displacement histories for the performed tests.**

Figures 9 and 10 summarize force-displacement and the energy-time plots from the performed tests. These plots are grouped by breakout type in Figures 11 and 12.

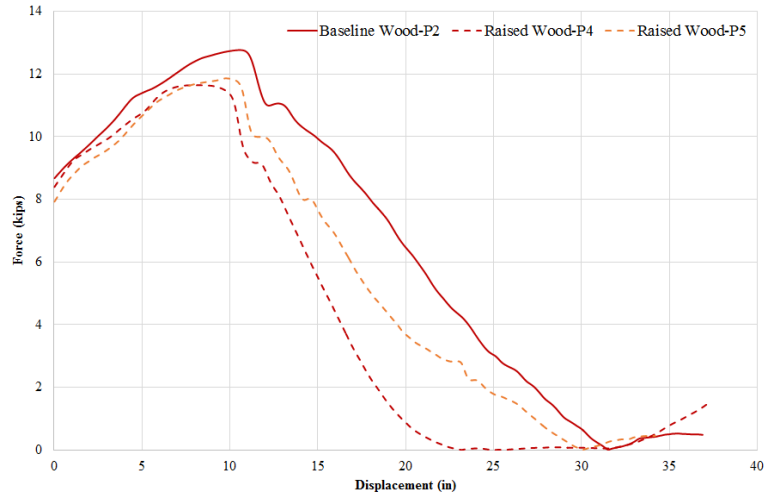
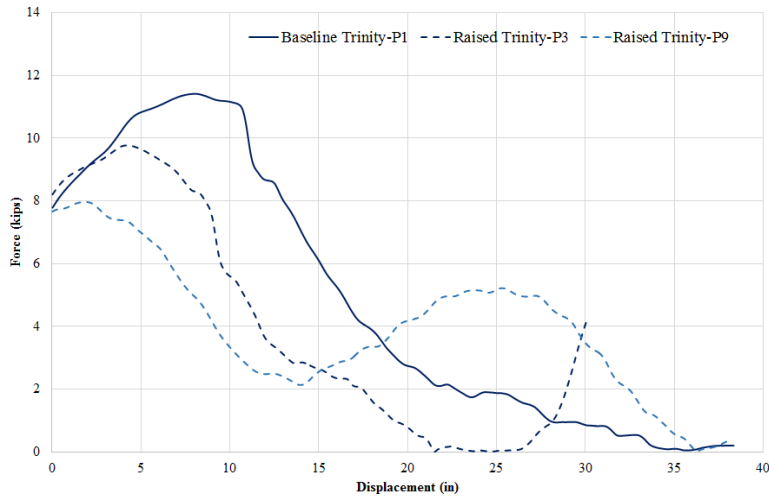
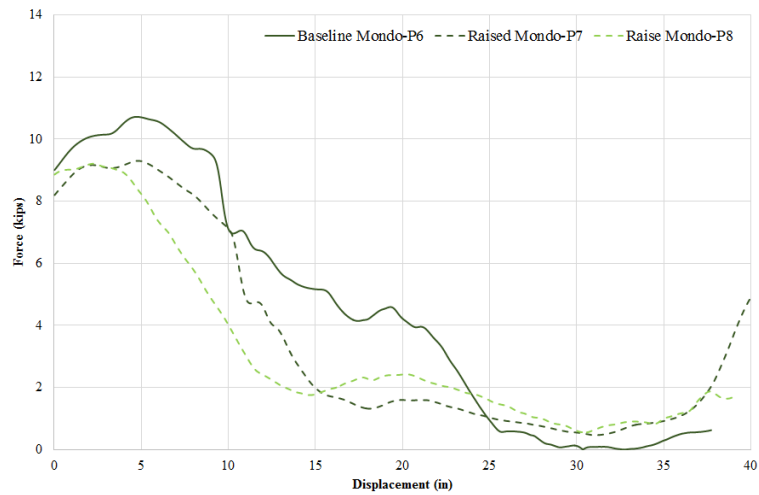
(a) Wood blockouts

(b) King™ Block blockouts

(c) Mondo™ Plastic blockouts

**Figure 12. Force-Displacement histories categorized by breakout type.**

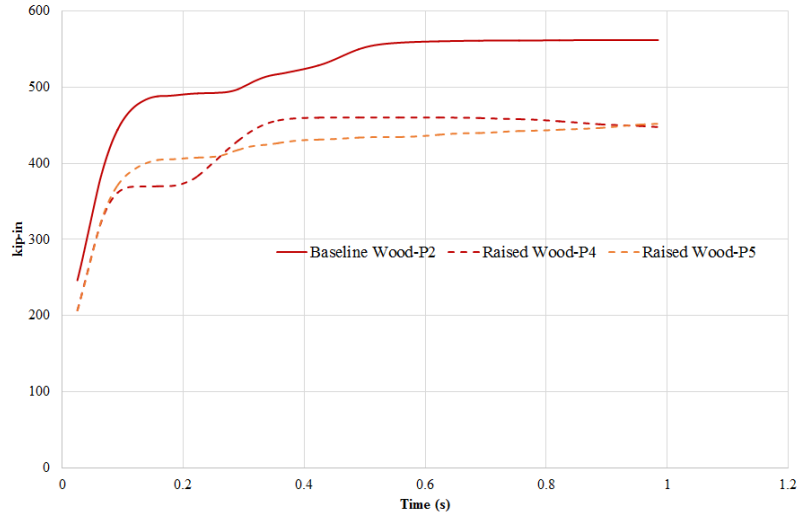
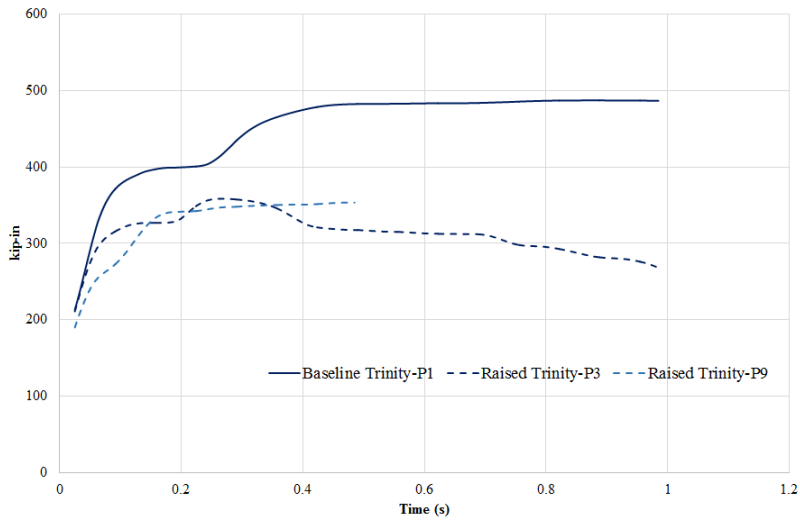
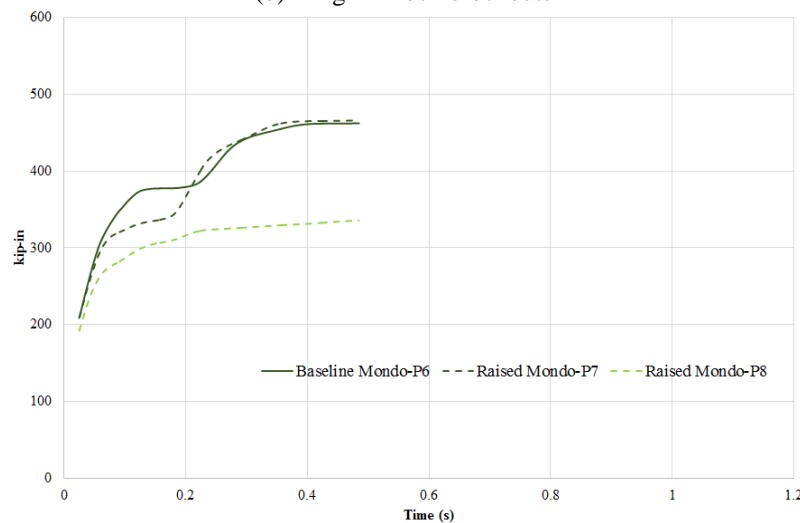
(a) Wood blockouts

(b) King™ Block blockouts

(c) Mondo™ Plastic blockouts

**Figure 13. Energy-Time histories categorized by blockout type.**

From the comparison of the energy plots, it appears that the system with wood blockouts was able to absorb more energy during the impact event in comparison to the systems which used proprietary composite blockouts (Figure 11) – this was true during the impact in the baseline condition (when blockout was not raised on post), and in the case where blockouts were raised on posts. The wood blockouts remained attached to the post and were not fractured as a consequence of the first impact from the pendulum nose. A summary table is reported below (Table 2).

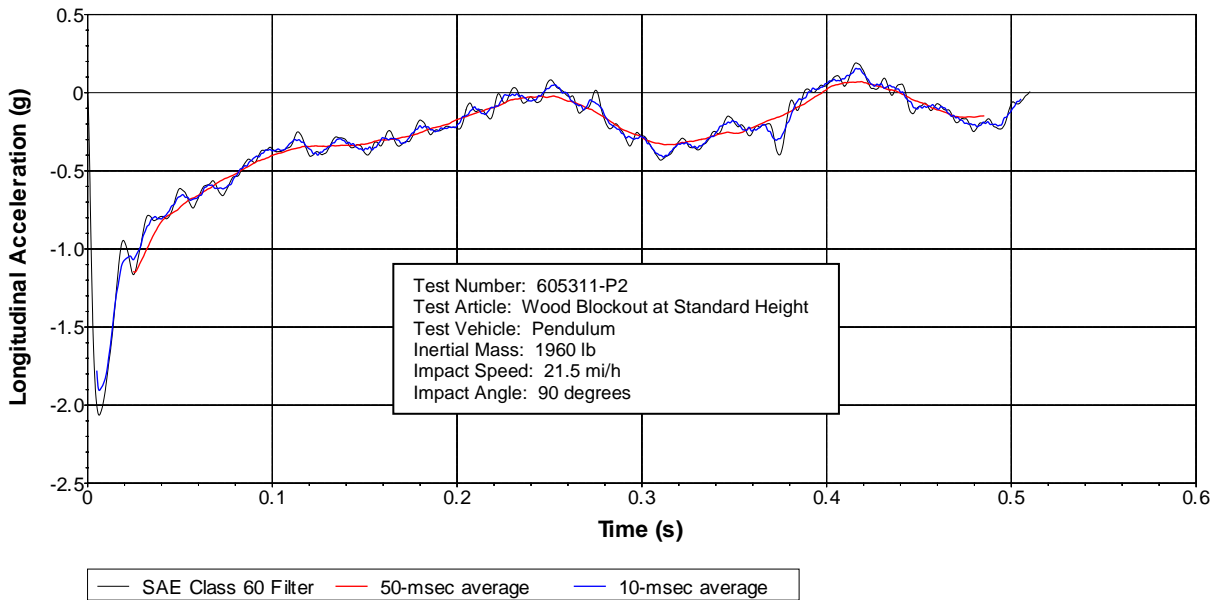
Figure D2. Accelerometer Trace for test 605311-P2.
