Transportation Pooled Fund Program

Test Report No. 405160-23-2
Test Report Date: February 2012

***MASH TEST 3-11 OF THE W-BEAM GUARDRAIL ON
LOW-FILL BOX CULVERT***

TEXAS TRANSPORTATION INSTITUTE PROVING GROUND

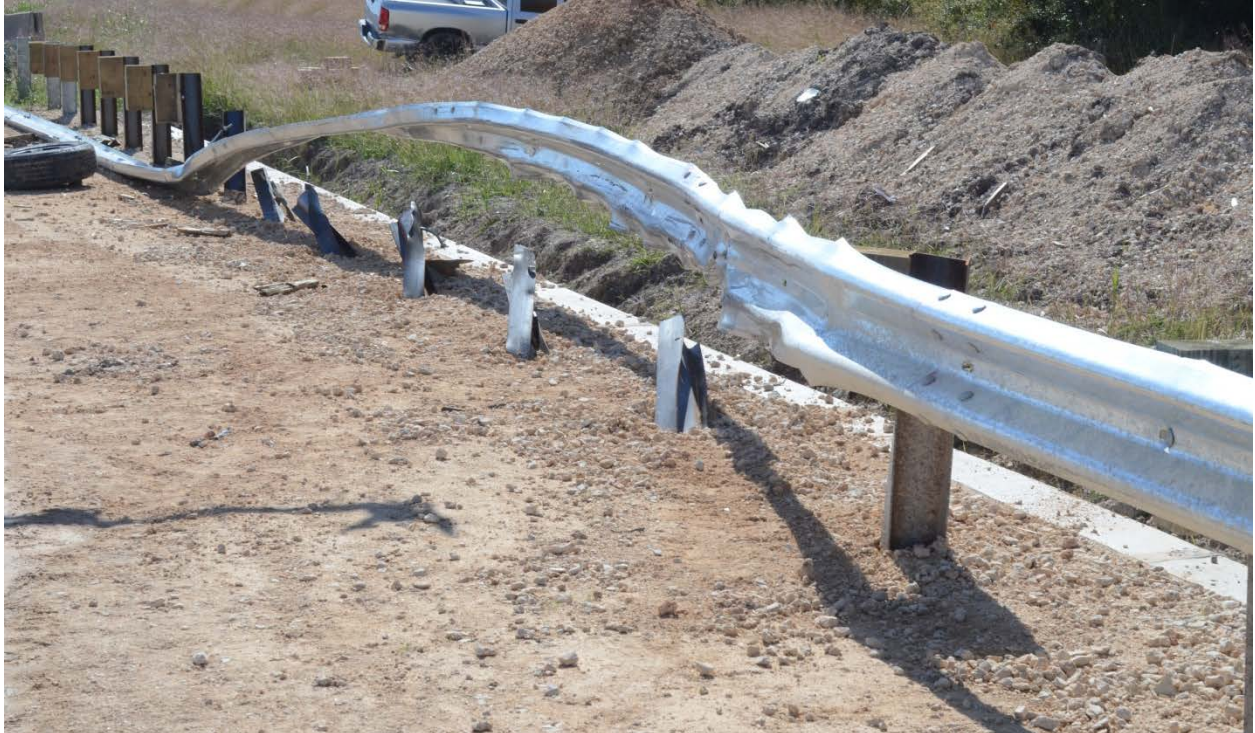
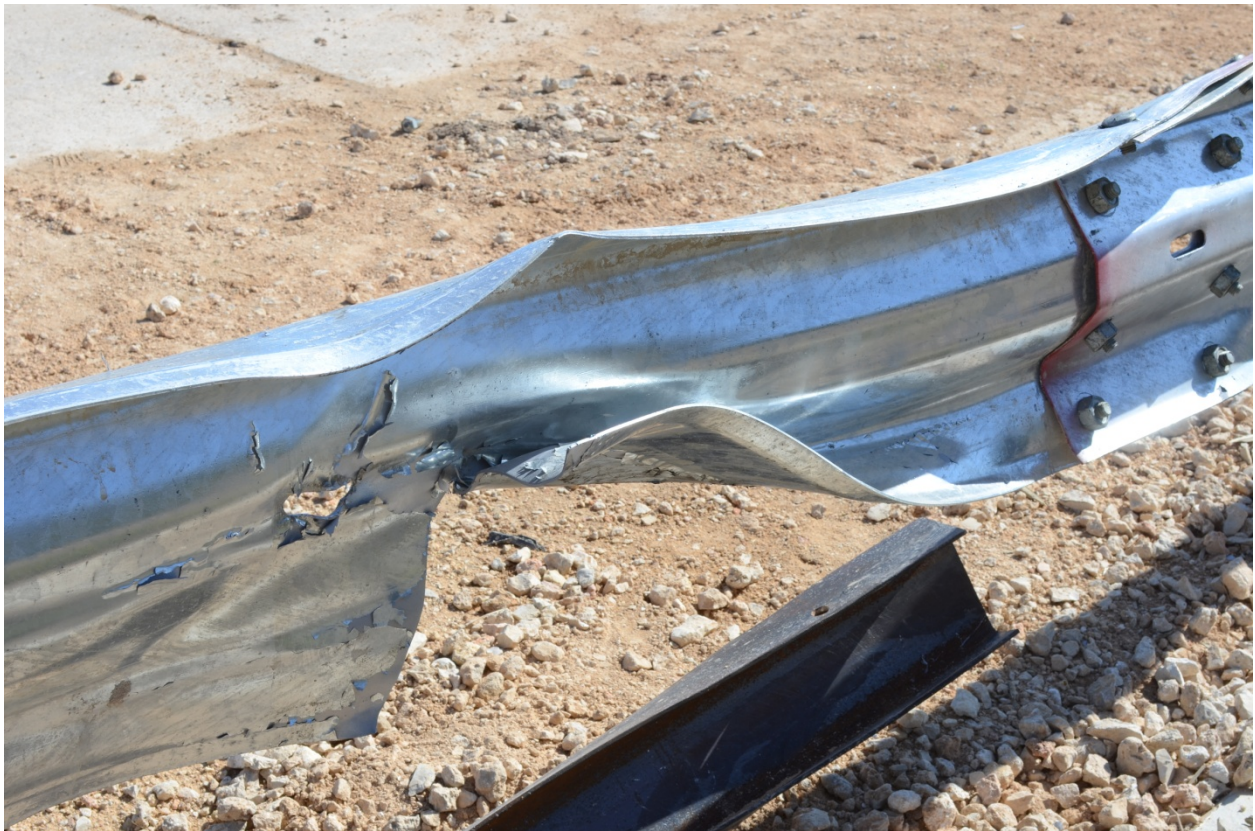
Figure 5.4. Installation after test 405160-23-2.

Figures 5.3 and 5.4 shows damage to the W-Beam Guardrail on Low-Fill Box Culvert. Post 1 was pulled downstream 1 inch. Post 11 was deflected toward the field side 0.5 inch at ground level and rotated 30 degrees clockwise. At post 12, the W-beam rail element was torn from the lower edge to half the height of the rail element. Posts 12 through 16 rotated clockwise and were leaning downstream 50 degrees, and the W-beam rail element and blockouts released from the posts. Post 17 was leaning downstream 40 degrees and the blockout separated from the post. Post 18 was leaning downstream 5 degrees. The top half of the cable release post (CRP) at post 26 released at the base, but the head remained on the post. The ground piece of the CRP was pulled upstream 2 inches. Working width during the test was 49.6 inches, dynamic deflection of the W-beam rail element was 45.1 inches.

The W-Beam Guardrail on Low-Fill Box Culvert contained and redirected the 2270P vehicle. The vehicle did not penetrate, underride, or override the installation, however, the rail element was torn half the width at post 12. Maximum dynamic deflection during the test was 45.1 inches. Several blockouts separated from the installation. However, none of these detached elements penetrated or showed potential for penetrating the occupant compartment, nor to present undue hazard to others in the area. No occupant compartment deformation occurred. The 2270P vehicle remained upright during and after the collision event. Maximum roll and pitch angles were -9 degrees and -11 degrees, respectively. Occupant risk factors were within the limits specified in *MASH*. The 2270P vehicle exited within the exit box specifications.

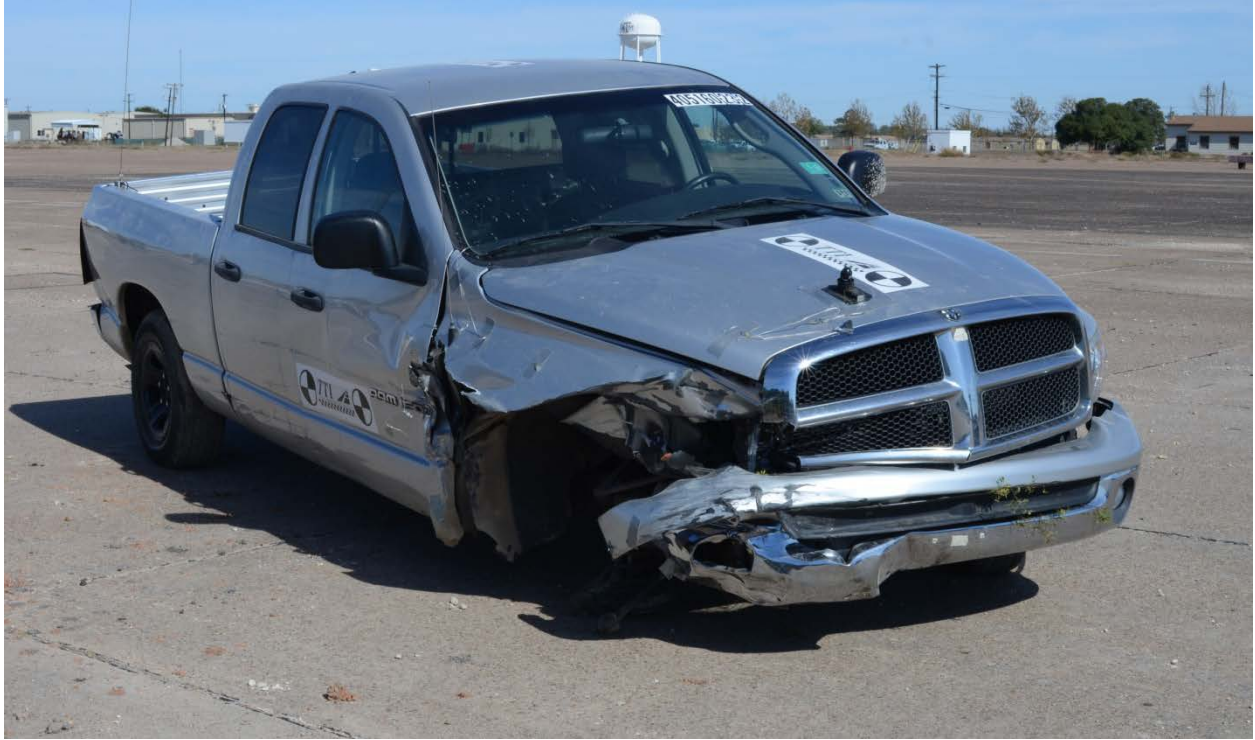
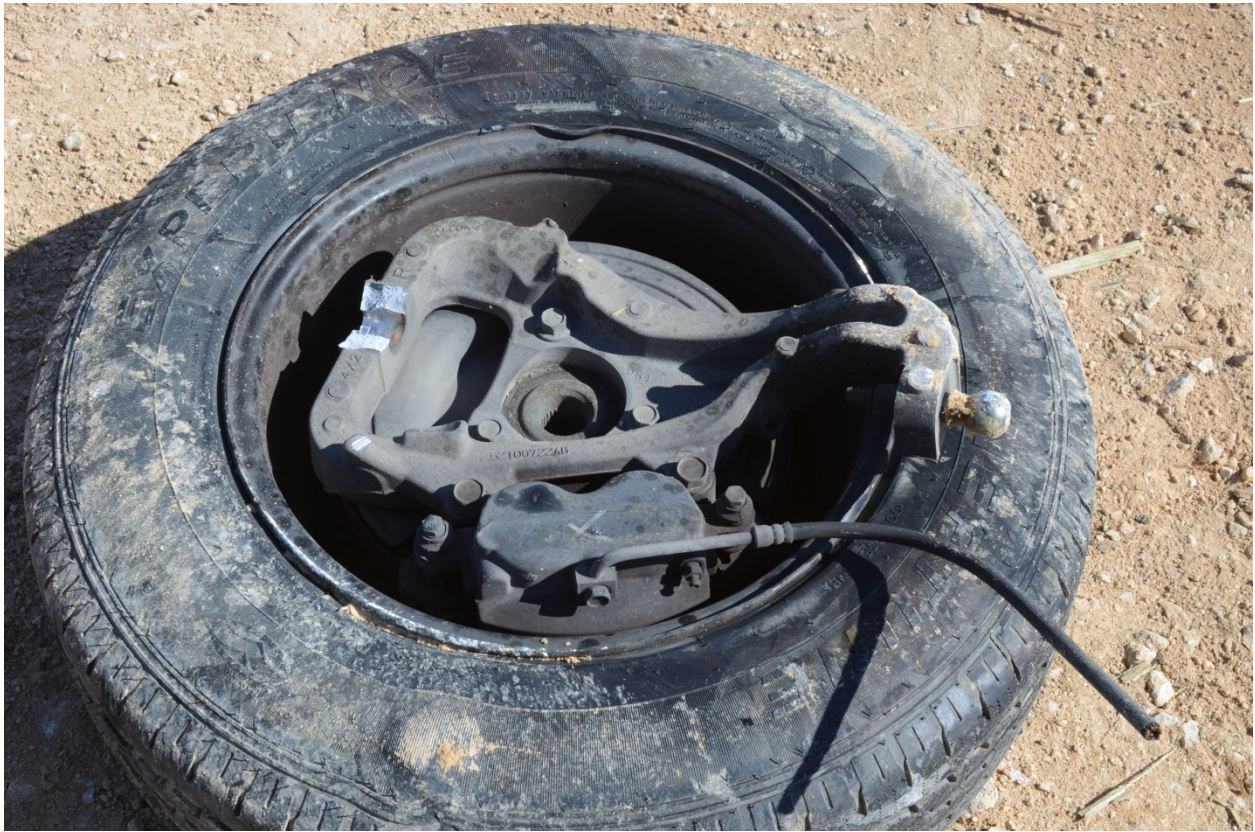
Figure 5.5. Vehicle after test 405160-23-2.

Damage to the vehicle is shown in figure 5.5. The right upper and lower ball joints were pulled out and the right upper and lower A-arms and right frame rail were deformed. Also damaged were the front bumper, grill, right front fender, right front and rear doors, right front tire and wheel rim, right rear exterior bed, right rear tire and wheel rim, and the rear bumper. Maximum exterior crush to the vehicle was 14.0 inches in the side plane at the right front corner at bumper height. No measureable occupant compartment deformation occurred. Photographs of the interior of the vehicle are shown in figure 5.6. Exterior vehicle crush and occupant compartment measurements are shown in Appendix D, tables D3 and D4.

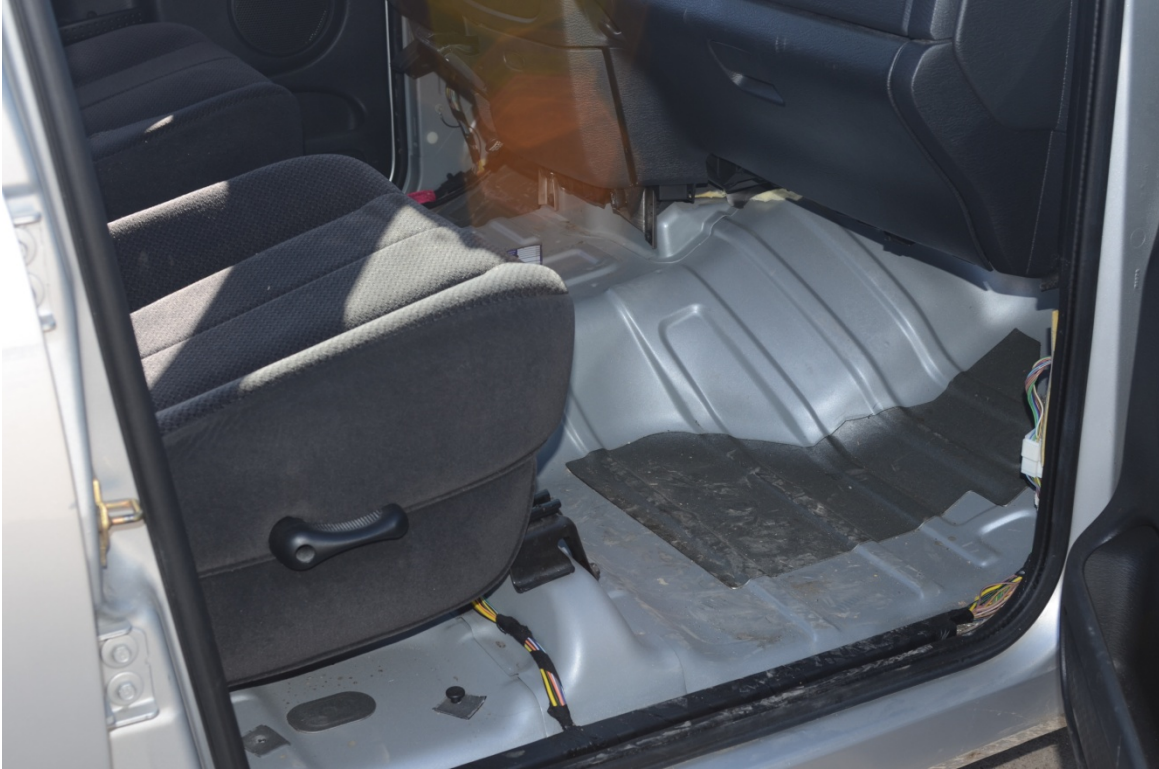
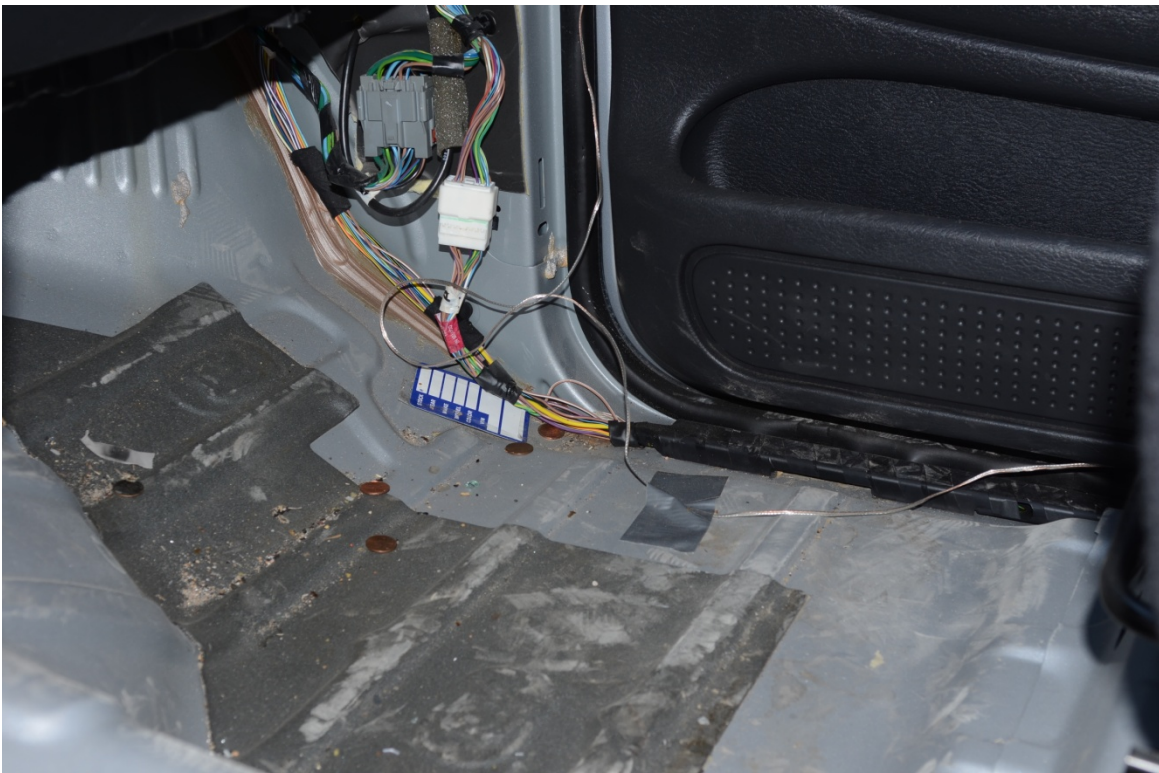
Figure 5.6. Interior of vehicle for test 405160-23-2.

Before Test
After Test

Results: Several blockouts separated from the installation. However, none of these detached elements penetrated or showed potential for penetrating the occupant compartment, nor to present undue hazard to others in the area. (PASS)
No occupant compartment deformation occurred. (PASS)

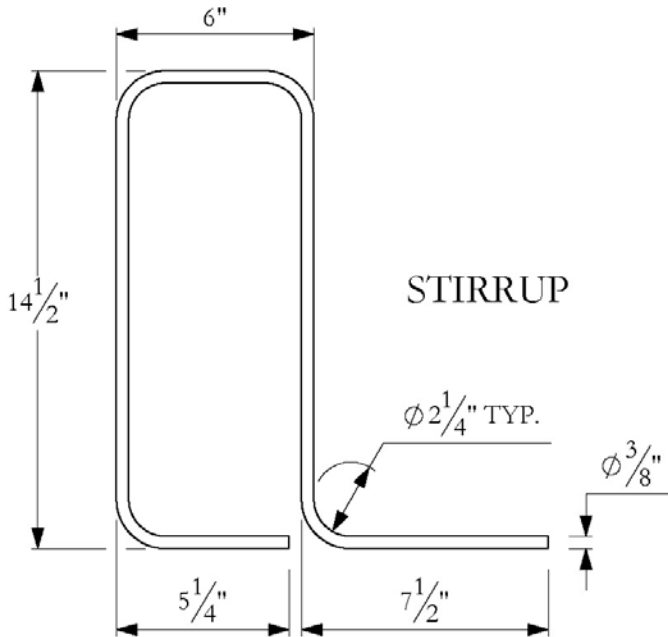
CONCRETE AND REBAR
END VIEW

- 4a. Chamfer top edges of curb 3/4".
- 4b. Concrete strength is 5000 psi.
- 4c. Rebar laps are 20" for #3 bars and 30" for #5 bars.

The specified concrete strength used in the box culvert slab was 5000 psi compressive strength, and the strength of the concrete on the day of the test (at 29 days of age) was 5586 psi. Materials used for this installation are summarized in Appendix B. For further details of the certification documentation for these materials, please contact Texas Transportation Institute (TTI) Proving Ground for documents on file.

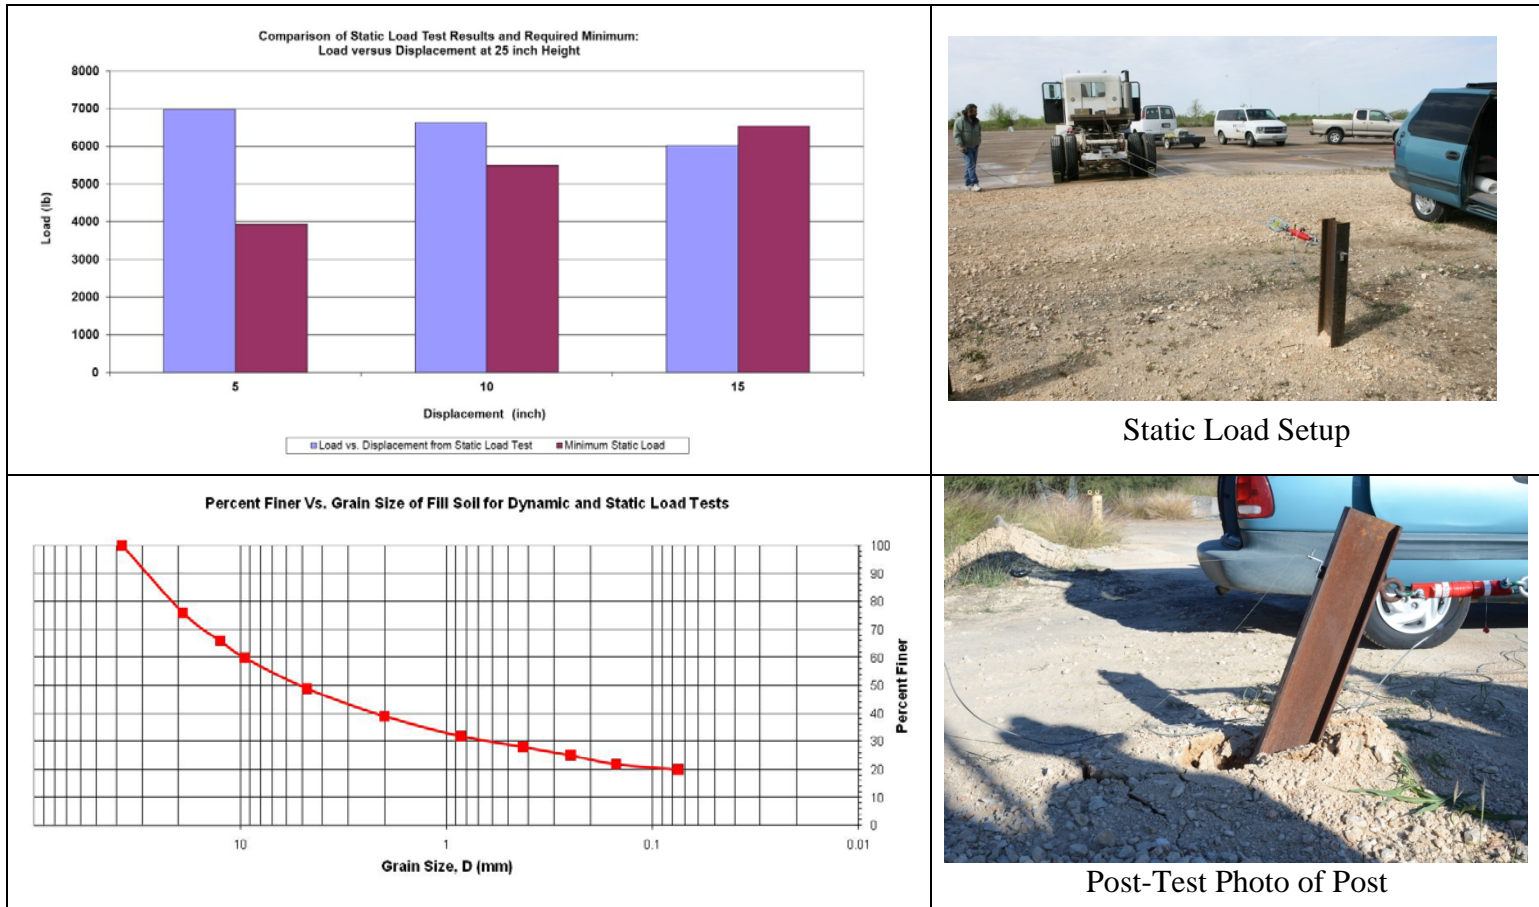
Figure C1. Test day static soil strength documentation.

Description of Fill Placement Procedure 6-inch lifts tamped with a pneumatic compactor

In accordance with Appendix B of *MASH*, soil strength was measured the day of the crash test (see Appendix C, figure C1). During the installation of the end terminals used to anchor each end of the box culvert guardrail, two standard W6×16 test posts were installed in the immediate vicinity for soil strength testing. These test posts were installed for soil strength testing of the posts used in the construction of the end terminals. These W6×16 test posts were installed using the same construction materials and procedures as the posts used in the end terminals. The end terminal posts and W6×16 test posts were installed in standard soil.

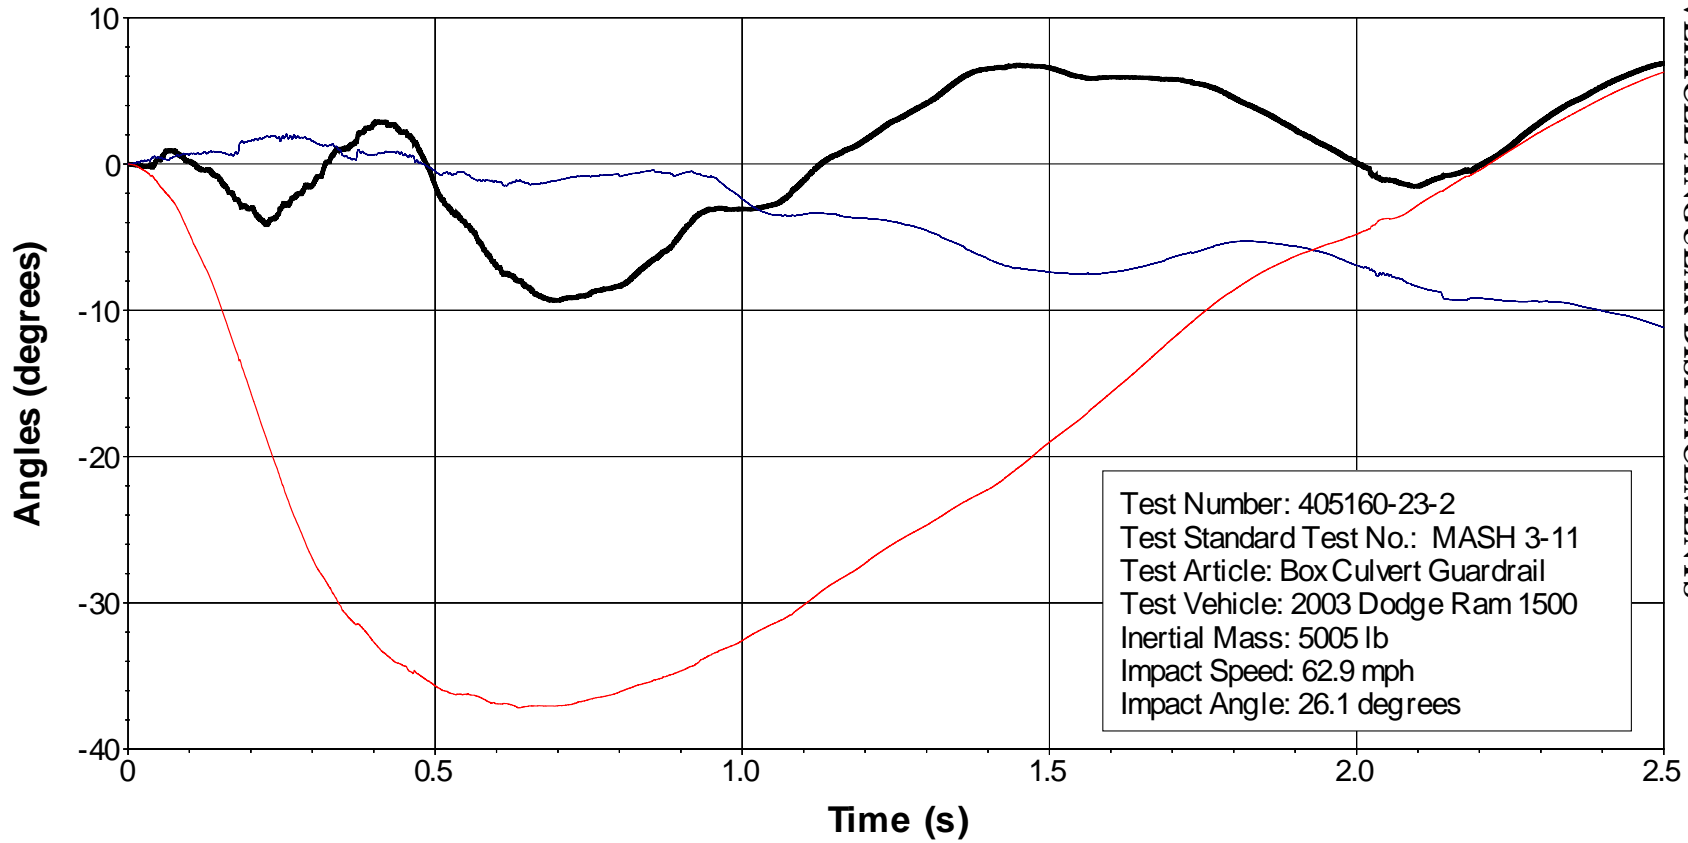
Figure D2. Vehicle angular displacements for test 405160-23-2.

Test Number: 405160-23-2
 Test Standard Test No.: MASH 3-11
 Test Article: Box Culvert Guardrail
 Test Vehicle: 2003 Dodge Ram 1500
 Inertial Mass: 5005 lb
 Impact Speed: 62.9 mph
 Impact Angle: 26.1 degrees
