**Test Report No. 608221-1**  
**Test Report Date: September 2017**

**MASH TEST 3-10 OF PENNDOT G2 WEAK POST W-BEAM  
GUARDRAIL**

Contract No.: PDT E03657  
Test No.: 608221-1  
Test Date: 2017-07-14

**TEXAS A&M TRANSPORTATION INSTITUTE PROVING GROUND**

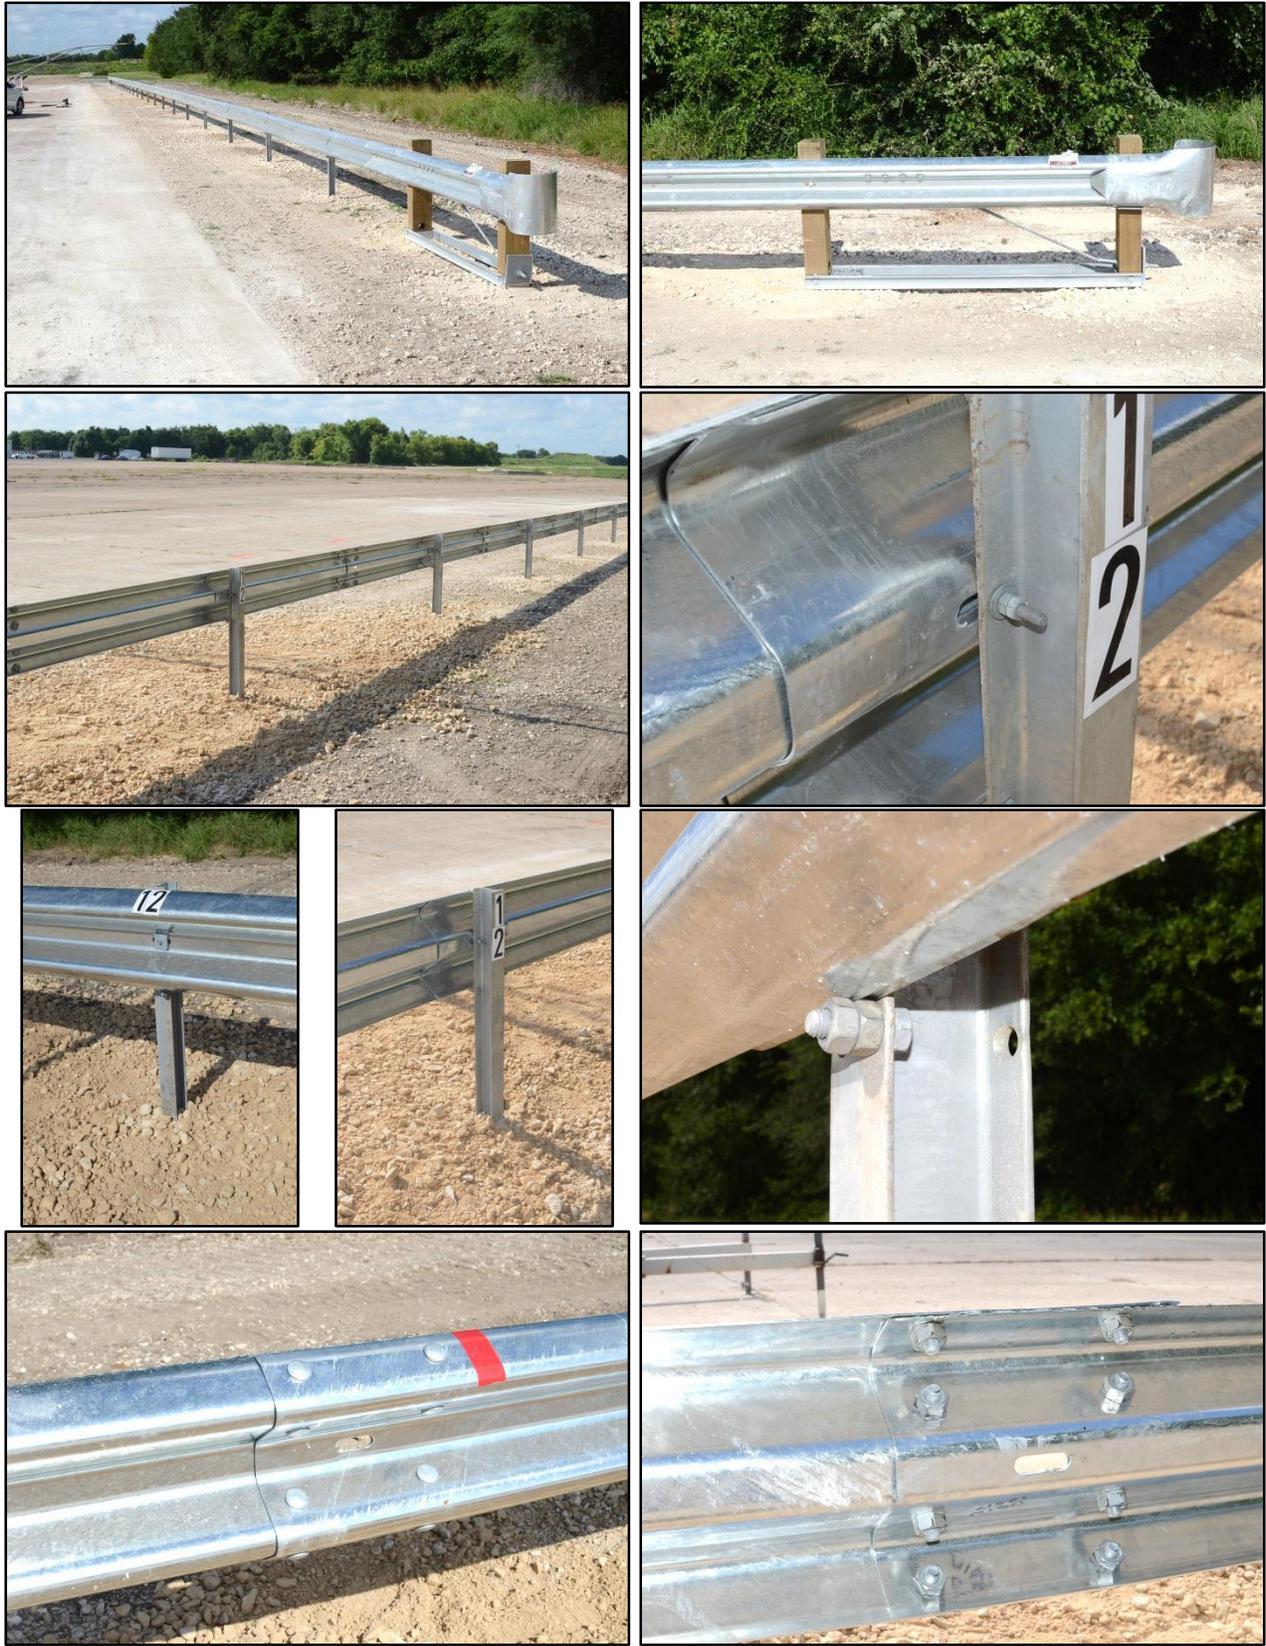
**Figure 2.2. G2 Weak Post W-Beam Guardrail System prior to Testing.**

Figure 2.1 presents overall information on the G2 weak post W-beam guardrail system, and Figure 2.2 provides photographs of the installation. Appendix A provides further details of the G2 weak post W-beam guardrail system.

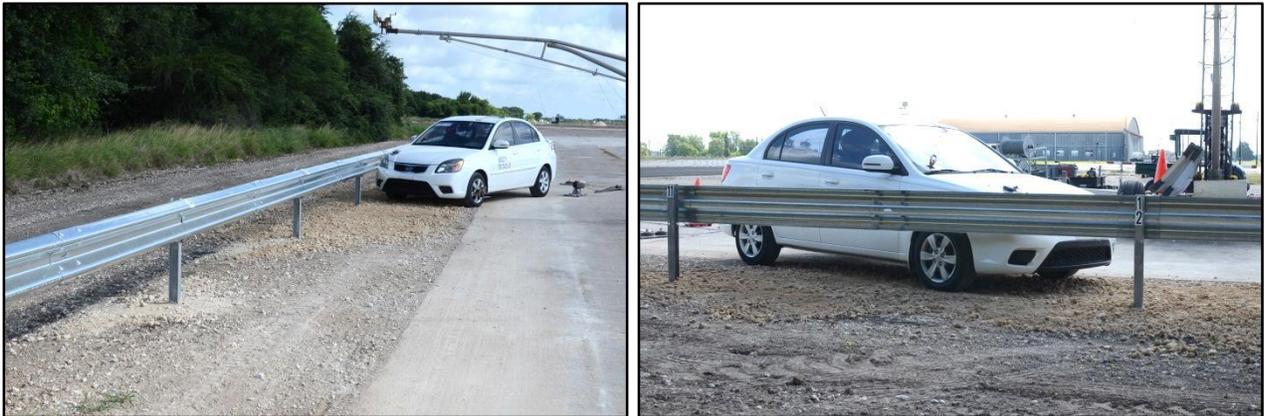
**Figure 5.1. G2 Weak Post W-Beam Guardrail System/Test Vehicle Geometrics for Test No. 608221-1.**

The 2011 Kia Rio, shown in Figures 5.1 and 5.2, was used for the crash test. The vehicle's test inertia weight was 2443 lb, and its gross static weight was 2608 lb. The height to the lower edge of the vehicle bumper was 7.5 inches, and height to the upper edge of the bumper was 21.5 inches. Table D.1 in Appendix D1 gives additional dimensions and information on the vehicle. The vehicle was directed into the installation using the cable reverse tow and guidance system, and was released to be freewheeling and unrestrained just prior to impact.

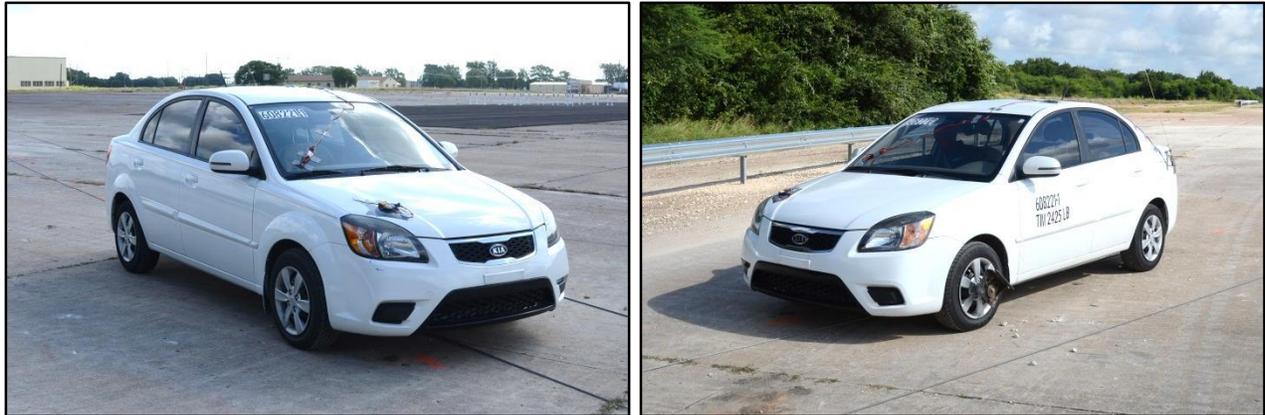
**Figure 5.2. Test Vehicle before Test No. 608221-1.**

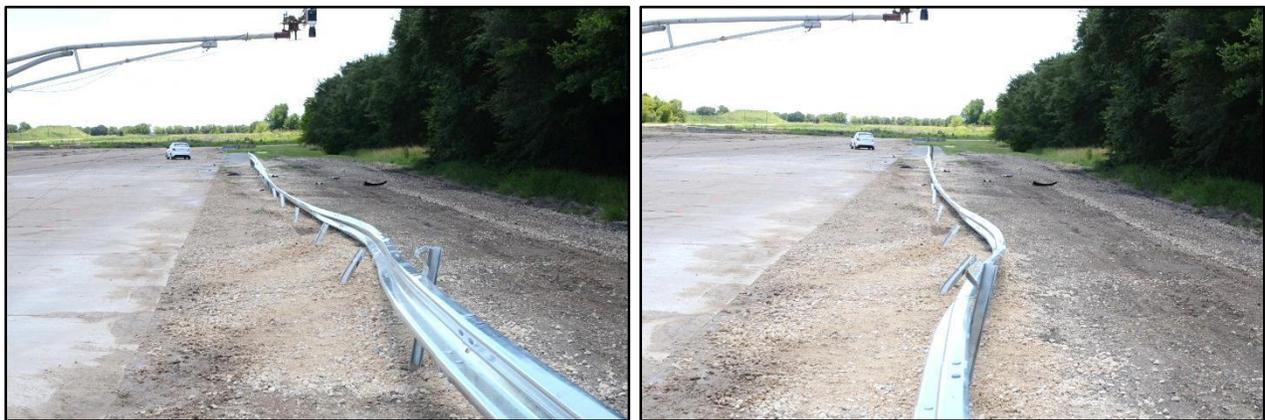
**Figure 5.3. G2 Weak Post W-Beam Guardrail System and Test Vehicle after Test No. 608221-1.**

Figures 5.3 through 5.7 show the damage to the G2 weak post W-beam guardrail system. Post 1 was pulled downstream 1 inch, and the rail element released from posts 10 through 19. Post 11 displaced 2.5 inches toward the field side and was leaning toward the field side 79 degrees. Posts 12 through 18 were leaning downstream at approximately 15 degrees from horizontal. Post 19 was leaning downstream at 39 degrees. Eight backup plates separated from the rail element and posts, and all came to rest 7 ft to 50 ft toward the field side. Working width was 92.0 inches at a height of 35.6 inches above ground. Maximum dynamic deflection during the test was 71.8 inches, and maximum permanent deformation was 28.0 inches.

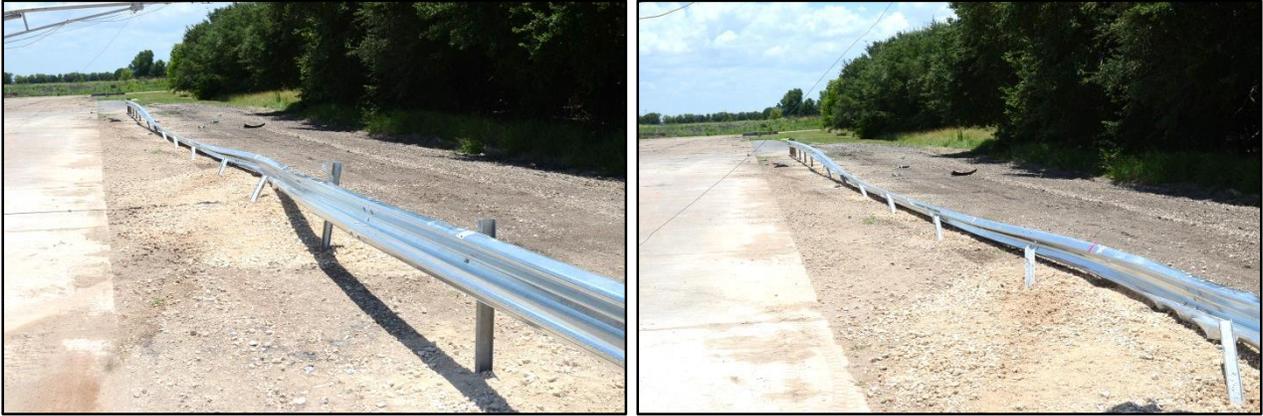
**Figure 5.4. G2 Weak Post W-Beam Guardrail System after Test No. 608221-1.**

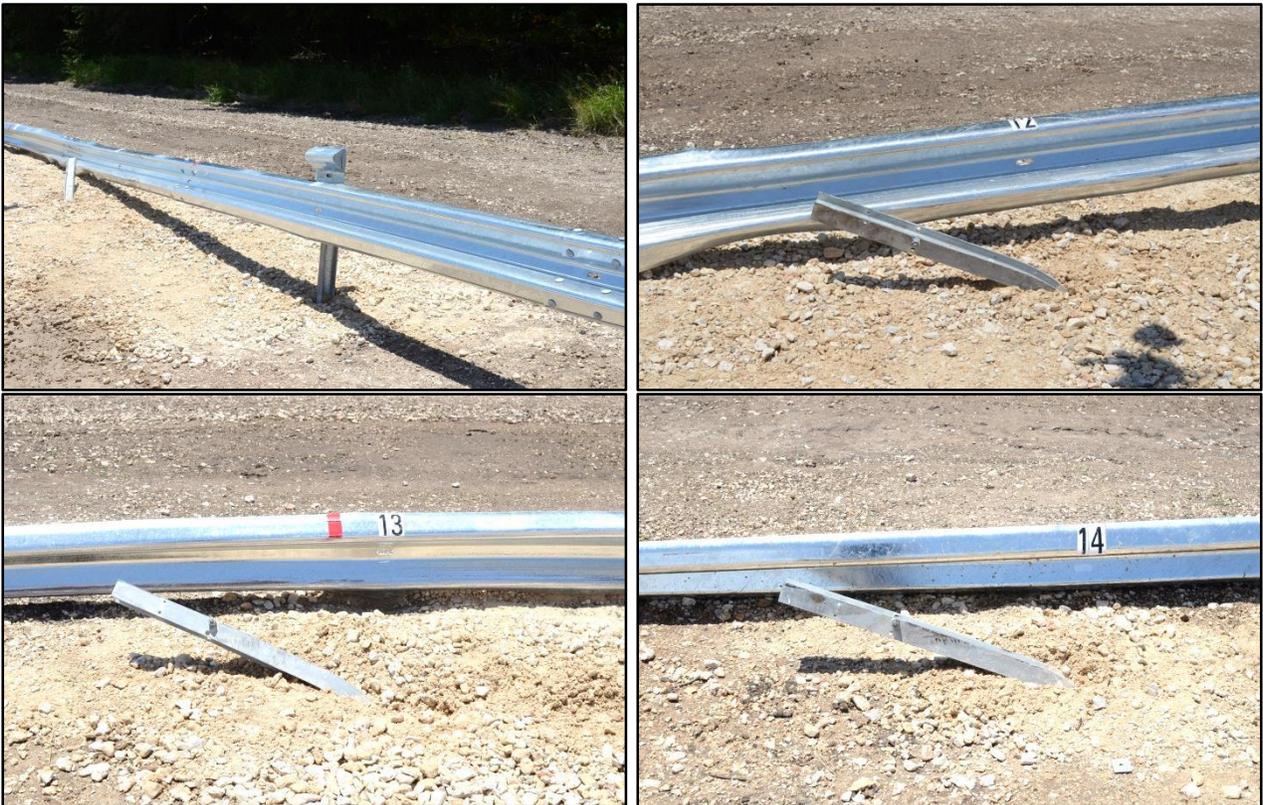
**Figure 5.5. Posts 11 through 14 after Test No. 608221-1.**

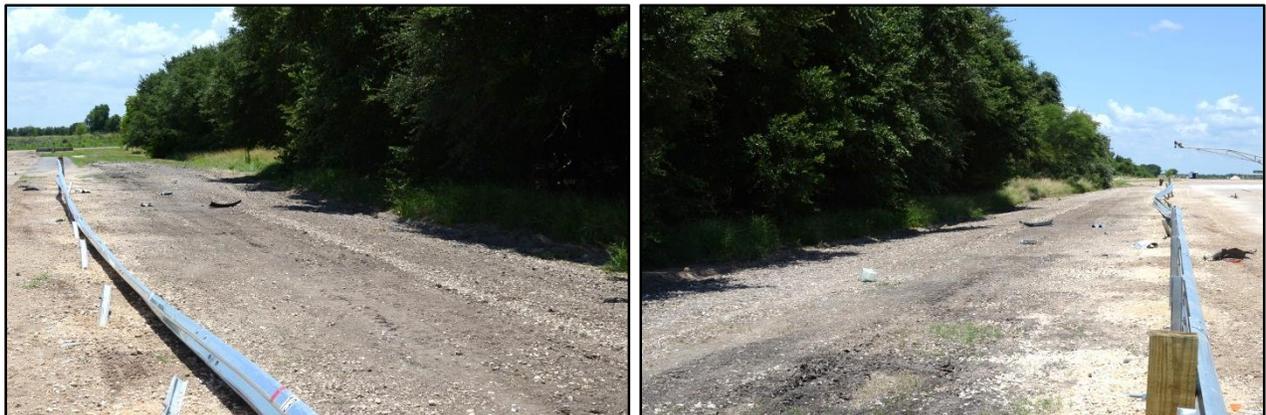
**Figure 5.7. Field Side of G2 Weak Post W-Beam Guardrail System after Test No. 608221-1.**

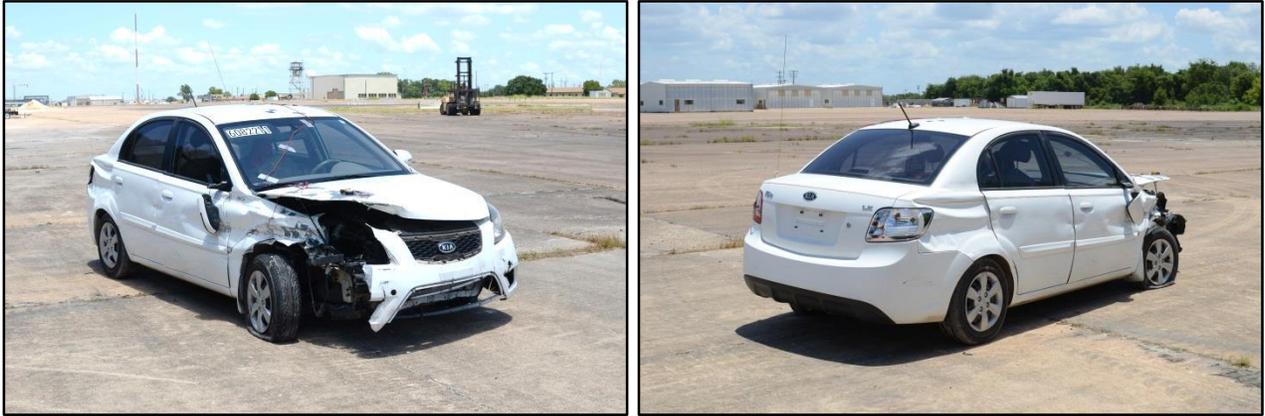
**Figure 5.8. Test Vehicle after Test No. 608221-1.**

Figures 5.8 and 5.9 show the damage sustained by the vehicle. The front bumper, hood, radiator support, right front fender, right front strut and tower, right front tire, right front and rear doors, right rear quarter panel, and left rear tire were damaged. Several small scrapes were noted on the underside of the vehicle (see Figure 5.9), including the floor pan, oil pan, fuel tank, and

trunk floor. No punctures were observed anywhere on the vehicle. Maximum exterior crush to the vehicle was 9.25 inches in the side plane at the right front corner at bumper height. Maximum occupant compartment deformation was 0.5 inches in the floor pan/toe pan area. Figure 5.10 shows the interior of the vehicle. Tables D.2 and D.3 in Appendix D1 provide exterior crush and occupant compartment measurements.

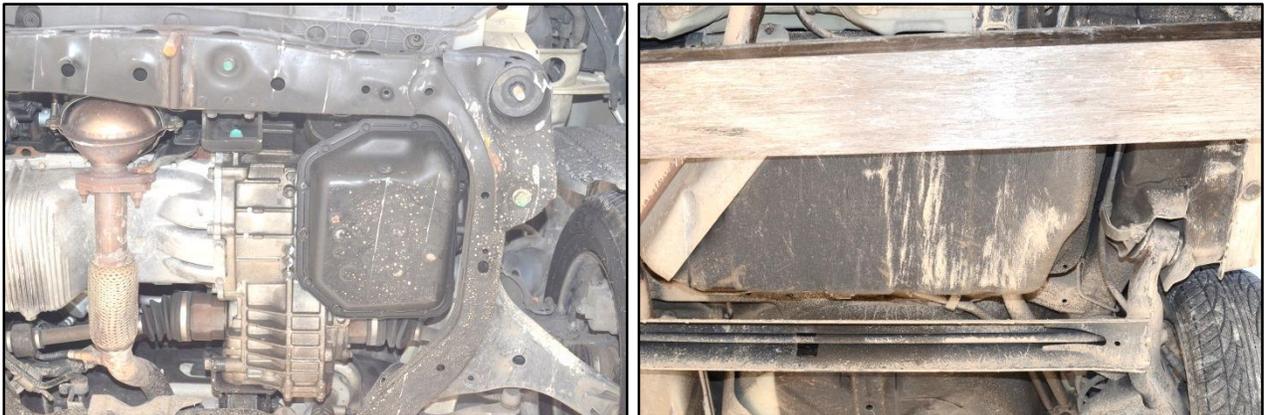
**Figure 5.9. Under Side of Test Vehicle after Test No. 608221-1.**

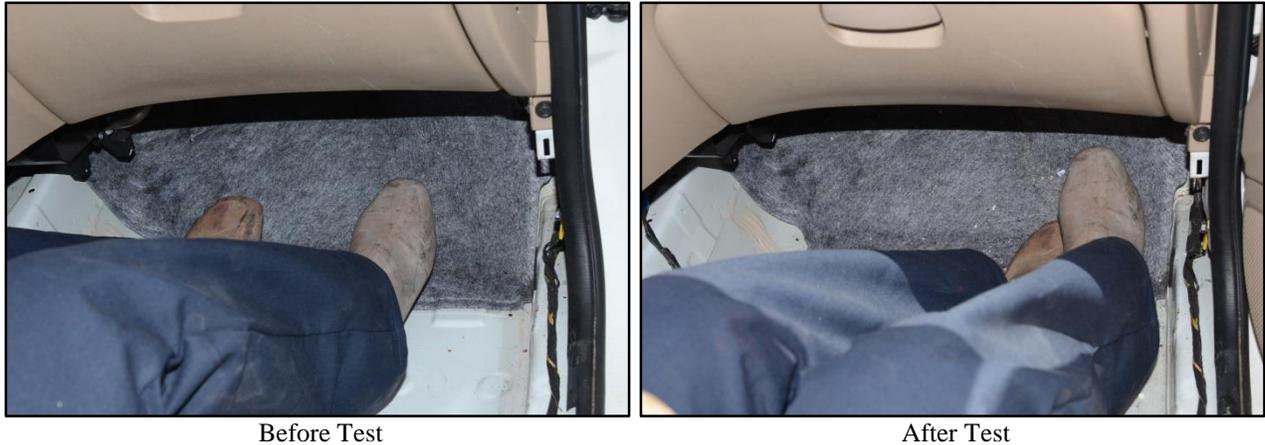
**Figure 5.10. Interior of Test Vehicle for Test No. 608221-1.**

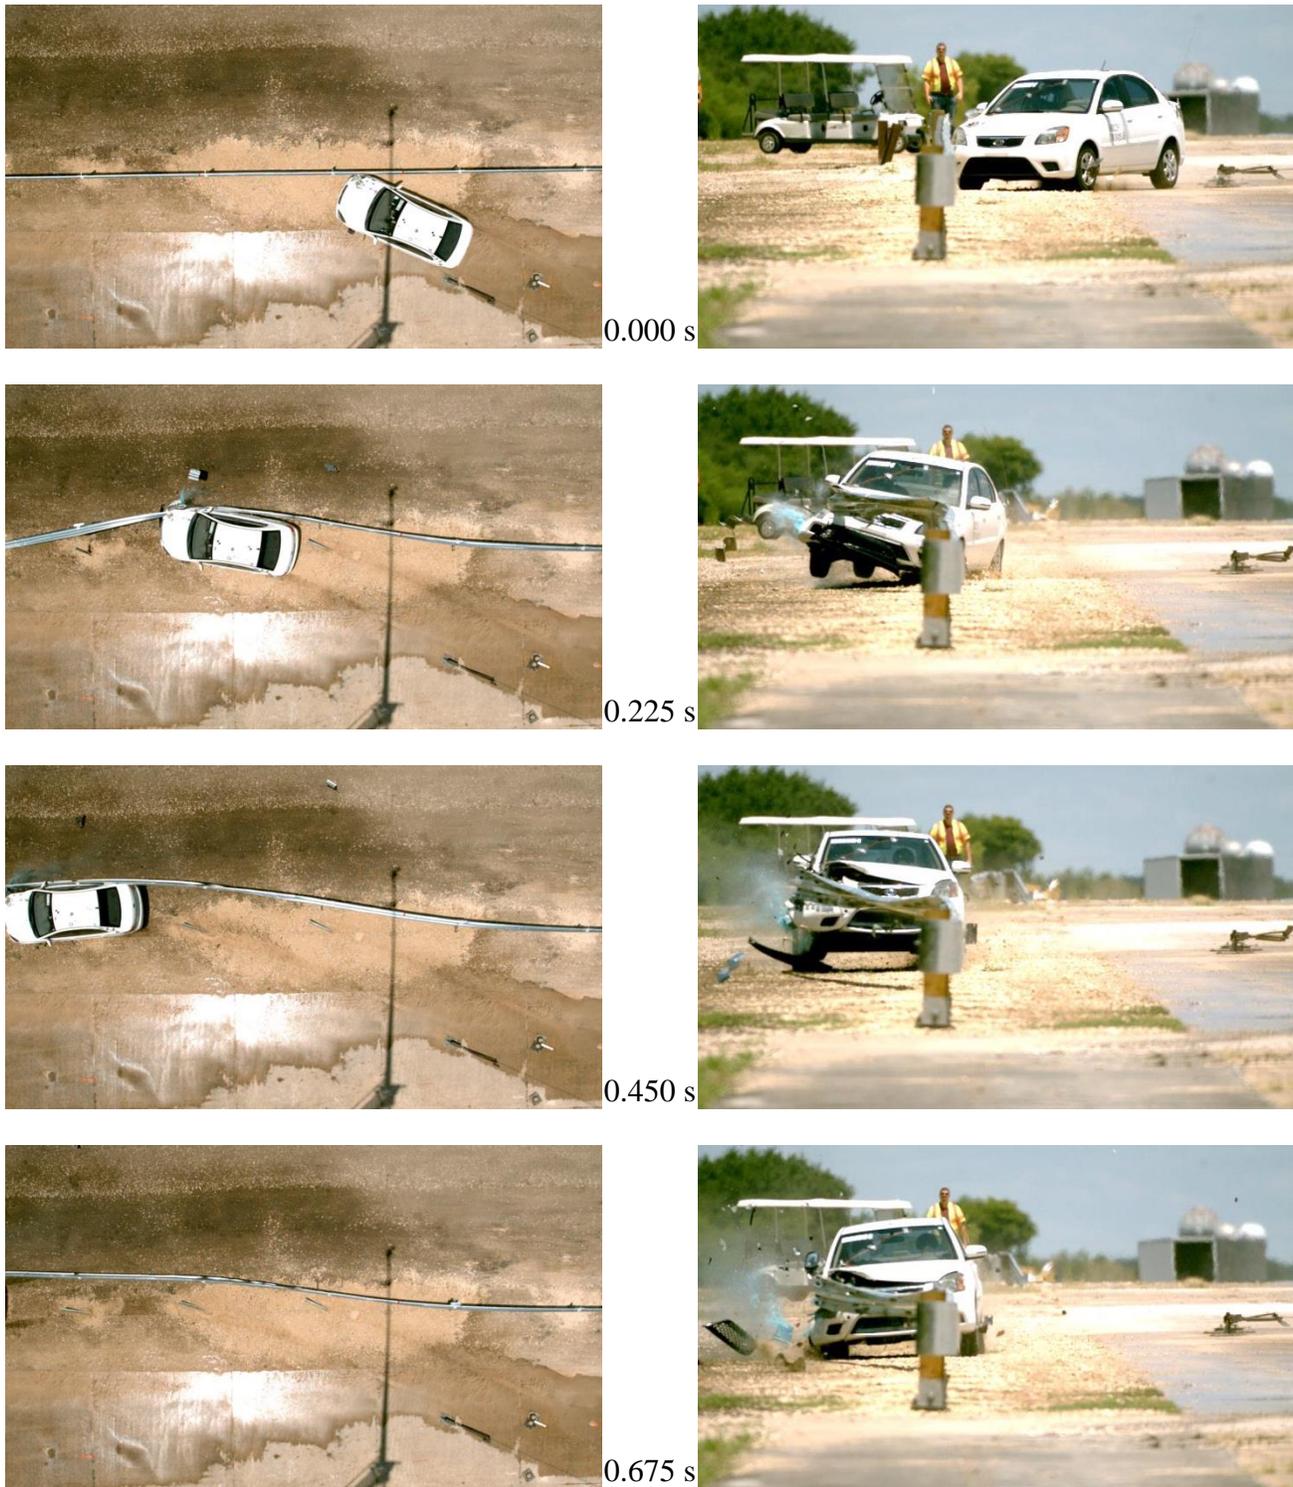
**Figure D.1. Sequential Photographs for Test No. 608221-1 (Overhead and Frontal Views).**
