Non-Blocked, Midwest Guardrail System for Wire-Faced, MSE Walls

Transportation Research Board
90th Annual Meeting
January 23-27, 2011
Washington, D.C.

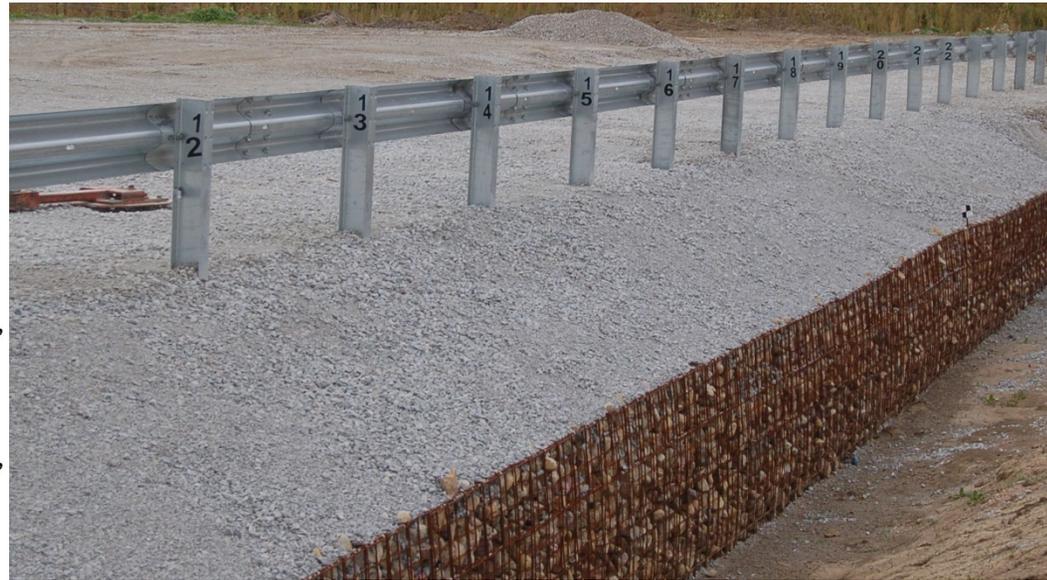
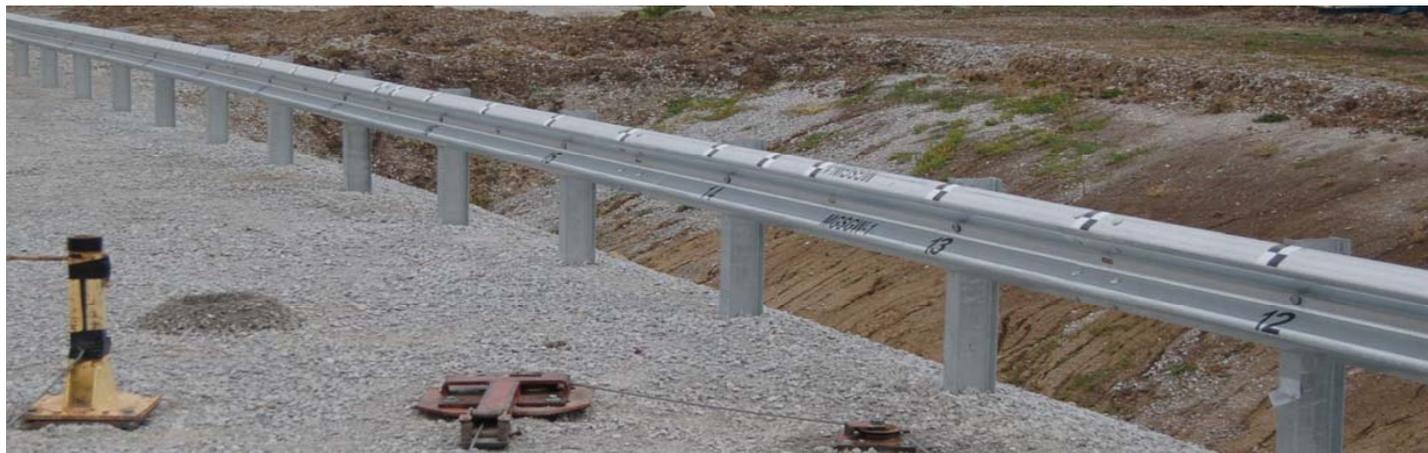
FIGURE 2 Non-Blocked MGS for MSE Wall Systems

Design details and photographs of the non-blocked MGS installed on top of a MSE wall system are shown in Figure 2. The test installation was 175 ft (53.3 m) long and consisted of standard 12-gauge (2.66-mm thick) corrugated W-beam guardrail supported by steel posts. The entire system was constructed with twenty-nine posts. Post nos. 3 through 27 were galvanized ASTM A36 W6x8.5 (W152x12.6) steel sections measuring 72 in. (1,829 mm) long. Post nos. 1, 2, 28, and 29 utilized timber Breakaway Cable Terminal (BCT) posts measuring 5½ in. wide x 7½ in. deep x 46 in. long (140 mm x 190 mm x 1,168 mm) and were placed in 72-in. (1,829-mm) long steel foundation tubes. A tangent anchorage system was utilized on the upstream and downstream ends of the guardrail system in order to develop the barrier's tensile capacity. The anchorage system consisted of timber posts, foundation tubes, anchor cables, bearing plates, rail brackets, and channel struts, which closely resembled the hardware used in the Modified BCT system.

Post nos. 1 through 29 were spaced on 75 in. (1,905 mm) centers. For post nos. 3 through 27, the soil embedment depth was 40 in. (1,016 mm), and the posts were driven into the soil at the slope break point of a 6-ft (1,829-mm) wide, 3H:1V fill slope located on the wire-faced, rock gabion wall. Wood spacer blocks were not used to offset the rail away from the front face of the steel posts. However, 12-gauge (2.66-mm thick) W-beam backup plates, measuring 12 in. (305 mm) in length, were located between the rail and the front face of the steel posts.

The center rail mounting height of the W-beam rail was 24⅞ in. (632 mm). All guardrail splice connections between the rail sections were lapped in the direction of traffic to reduce vehicle snag at the splice during the crash tests.

The actual, wire-faced, rock gabion wall system measured 84 ft (25.6 m) in length and was configured with a 3H:1V fill slope at its outer edge. The gabion wall was located behind post nos. 9 through 21, as shown in Figure 2. The gabion wall was placed in an excavated pit measuring 11 ft – 10 in. (3.6 m) wide by 7 ft (2.1 m) deep with three 2-ft (0.6-m) thick layers of roller-compacted, course, crushed limestone material that met Grading B of AASHTO M147-65 denoted in MASH [13] and NCHRP Report No. 350 [25], which also closely conformed to select wall backfill material denoted in Sections 255 and 704 of the 2003 FHWA Standards Specifications for Highway Construction of Roads and Bridges on Federal Highway Projects [26]. The outer region of the bottom two layers contained a wall facing fill material that consisted of 4 to 6-in. (102 to 152-mm) diameter rocks that were placed by hand. A 4-ft (1.2-m) wide void space was excavated behind the MSE wall system. Steel-wire reinforcement mats were used to construct and stabilize the MSE wall system. Further details on the construction of the MSE wall system can be found in the MwRSF research report [14].

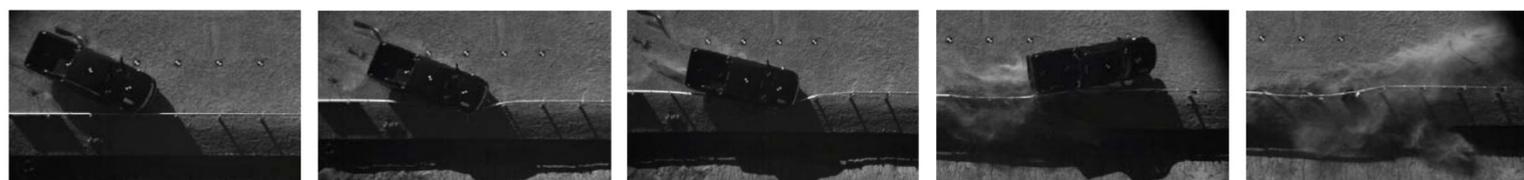
FIGURE 5 Summary of Test Results and Sequential Photographs, Test MGSGW-2

- Test AgencyMwRSF
- Test Number..... MGSGW-2
- Date 11/20/2009
- MASH Test Designation..... 3-11
- Test Article..... Non-blocked MGS adjacent to 3:1 slope of gabion wall

- Total Length 175ft (53.4 m)
- Key Component – Steel W-Beam
 - Thickness..... 12-guage (2.66 mm)
 - Top Mounting Height..... 31 in. (787 mm)
- Key Component – Steel Posts

- Post nos. 3-27 W6x8.5 (W152x12.6) by 6 ft (1.8 m) long
 - Post Location..... Centerline of posts at slope break point
 - Spacing..... 6 ft - 3 in. (1.9 m)

- Blockouts.....None
- Key Component – BCT Posts
 - Post nos. 1-2, 28-29..... 5½ by 7½ by 46 in. long (140x191x1,186 mm)
 - Foundation Tube 6 ft (1.8 m) long

- Soil Type AASHTO M147-65 Grading B
- Vehicle Model..... 2003 Dodge Ram 1500 Quad Cab
 - Curb 5,081 lb (2305 kg)
 - Test Inertial 4,999 lb (2268 kg)
 - Gross Static 5,169 lb (2345 kg)

- Impact Conditions
 - Speed 65.27 mph (105.04 km/h)
 - Angle 25.1 deg
 - Impact Location..... 16 ft (4.9 m) US of splice btwn posts 14 & 15
- Exit Conditions

- Speed 43.78 mph (70.46 km/h)
 - Angle 20.4 deg
 - Exit Box Criteria Fail
- Vehicle Stability..... Satisfactory
- Vehicle Stopping Distance..... 103 ft 4 ½ in.(31.5 m) downstream
16 ft - 3 in. (4.9 m) laterally in front of traffic-side face

- Vehicle Damage..... Moderate
 - VDS 1-RFQ-3
 - CDC 01-RDEW2
 - Maximum Interior Deformation 1 1/4 in. (32 mm) right toe pan
- Test Article Damage Moderate
- Test Article Deflections
 - Permanent Set 26¼ in. (667 mm)
 - Dynamic 35.7 in. (907 mm)
 - Working Width 45.2 in. (1148 mm)
- Maximum Angular Displacements (DTS)
 - Roll 16.4 deg <75°
 - Pitch -15.7 deg <75°
 - Yaw 38.0 deg
- IS 132.3 kip-ft (180 kJ)
- Transducer Data

For test no. MGSW-2, a 5,169-lb (2,345-kg) pickup truck with a simulated occupant seated in the right-front seat, impacted the non-blocked MGS placed on top of the gabion wall system at a speed of 65.3 mph (105.0 km/h) and at an angle of 25.1 degrees. A summary of the test results and the sequential photographs are shown in Figure 5. Initial impact occurred at 16 ft (4.9 m) upstream from the centerline of the splice between post nos. 14 and 15. At 0.230 sec after impact, the vehicle became parallel to the guardrail with a speed of 46.7 mph (75.2 km/h). At 0.452 sec, the vehicle exited the guardrail at an angle of 20.4 degrees and at a speed of 43.8 mph (70.5 km/h). The vehicle was smoothly redirected even though the vehicle encountered moderate pitching. Vehicle pitching occurred when the driveshaft was disconnected and lodged in the ground, thus allowing the vehicle's undercarriage to snag on the shaft's exposed end. The exterior vehicle damage, as shown in Figure 6, was moderate, and the interior occupant compartment deformations were minimal, with a maximum of 1½ in. (38 mm), consequently not violating the limits established in MASH. As shown in Figure 6, damage to the barrier was moderate, consisting mostly of deformed W-beam and guardrail posts as well as contact marks on guardrail and posts.
