TECHNICAL MEMORANDUM

Contract No.: T4541-CN
Test Report No.: 607911-3
Project Name: *MASH* Testing of Portable Concrete Barrier Pinned on Concrete Pavement
Sponsor: Roadside Safety Pooled Fund

This technical memo provides details of the pinned PCB, documentation of the crash test performed, the results, and the assessment of the performance of the pinned PCB according to *MASH* Test 3-11 criteria.

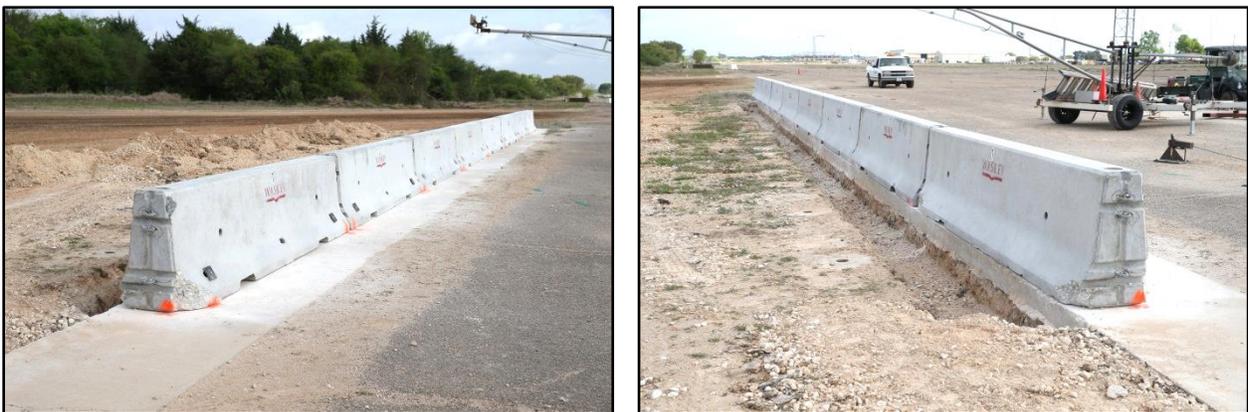
Figure 1. Pinned PCB before Test No. 607911-3.

The overall length of the test installation was 100 ft-7 inches. The installation was comprised of eight 12 ft-6 inch long precast concrete F-shape barrier segments connected end-to-end. The F-shape segments were 32 inches tall, 24 inches wide at the base, and 9½ inches wide at the top. The barrier segments were set on the edge of 8-inch thick unreinforced concrete pavement. Two steel anchor pins were used to secure each of the segments to the pavement. The pins passed through slots cast into the segments near each end (no pin in the middle slot) and into 1¾-inch diameter holes drilled in the concrete pavement. An 18-inch deep × 12-inch wide excavation was made on the field side of barrier segments 1 through 7. Details of the segments, including steel reinforcement, can be found in Attachment A.

The anchor pins were 1½ inches in diameter × 21¼ inches long and had blunt ends. A 4-inch square × ½ inch thick plate washer with a 1⅝-inch diameter centered hole was positioned at a 95° angle and welded (¼-inch fillet) near the top of the anchor pin. Refer to Sheet 5 of 5 in Attachment A for details. Photographs of the installation are shown in Figures 1 through 3.

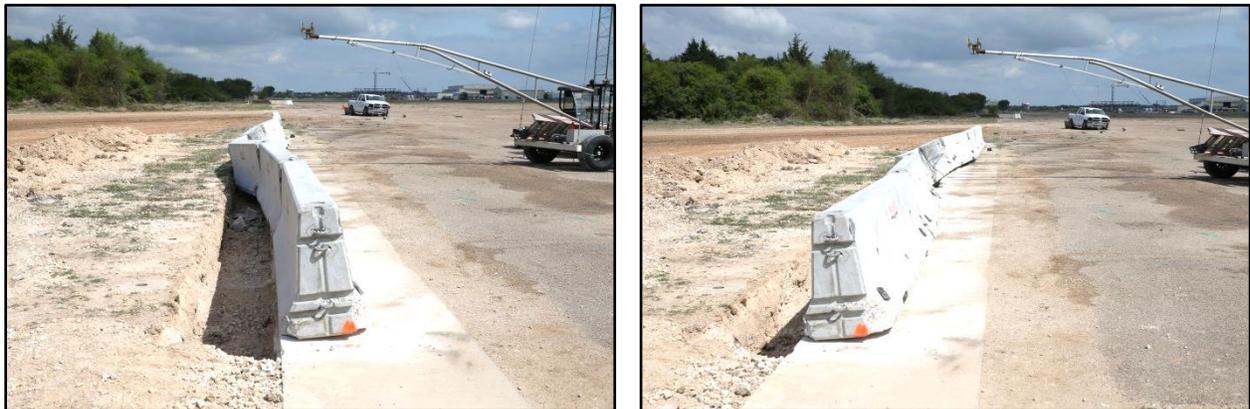
Figure 4. Pinned PCB and Test Vehicle after Test No. 607911-3.

The 2012 Dodge RAM 1500 pickup truck, traveling at an impact speed of 63.5 mi/h, impacted the pinned PCB 4.2 ft upstream of the joint between segments 3 and 4 at an impact angle of 25.7 degrees. At 0.016 s after impact, segment 3 at the joint between segments 3 and 4 began to displace toward the field side, at 0.017 s, the left front tire began to climb the traffic face of segment 3. Segment 4 at the joint between segments 3 and 4 began to displace toward the field side at 0.032 s, and the concrete pavement began to crack under the joint between segments 3 and 4 at 0.034 s. At 0.035 s, the vehicle began to redirect and segment 4 at the joint between segments 4 and 5 began to rotate toward the traffic side. The field side toe on the upstream end of segment 3 began to crack at 0.058 s, and the right side tires were airborne at 0.099 s and 0.163 s, respectively. At 0.208 s, the vehicle was traveling parallel with the barrier, and at 0.263 s, the left rear exterior bed and rear bumper contacted the barrier. The vehicle lost contact with the barrier at 0.550 s, traveling at an exit speed and angle of 54.2 mi/h and 2.7 degrees. Brakes on the vehicle were not applied. The vehicle subsequently rolled 471 degrees counterclockwise, then 111 degrees clockwise, and came to rest upright 167 ft downstream of impact and 27 ft toward traffic lanes. Figure 4 show the barrier and test vehicle after Test No. 607911-3.

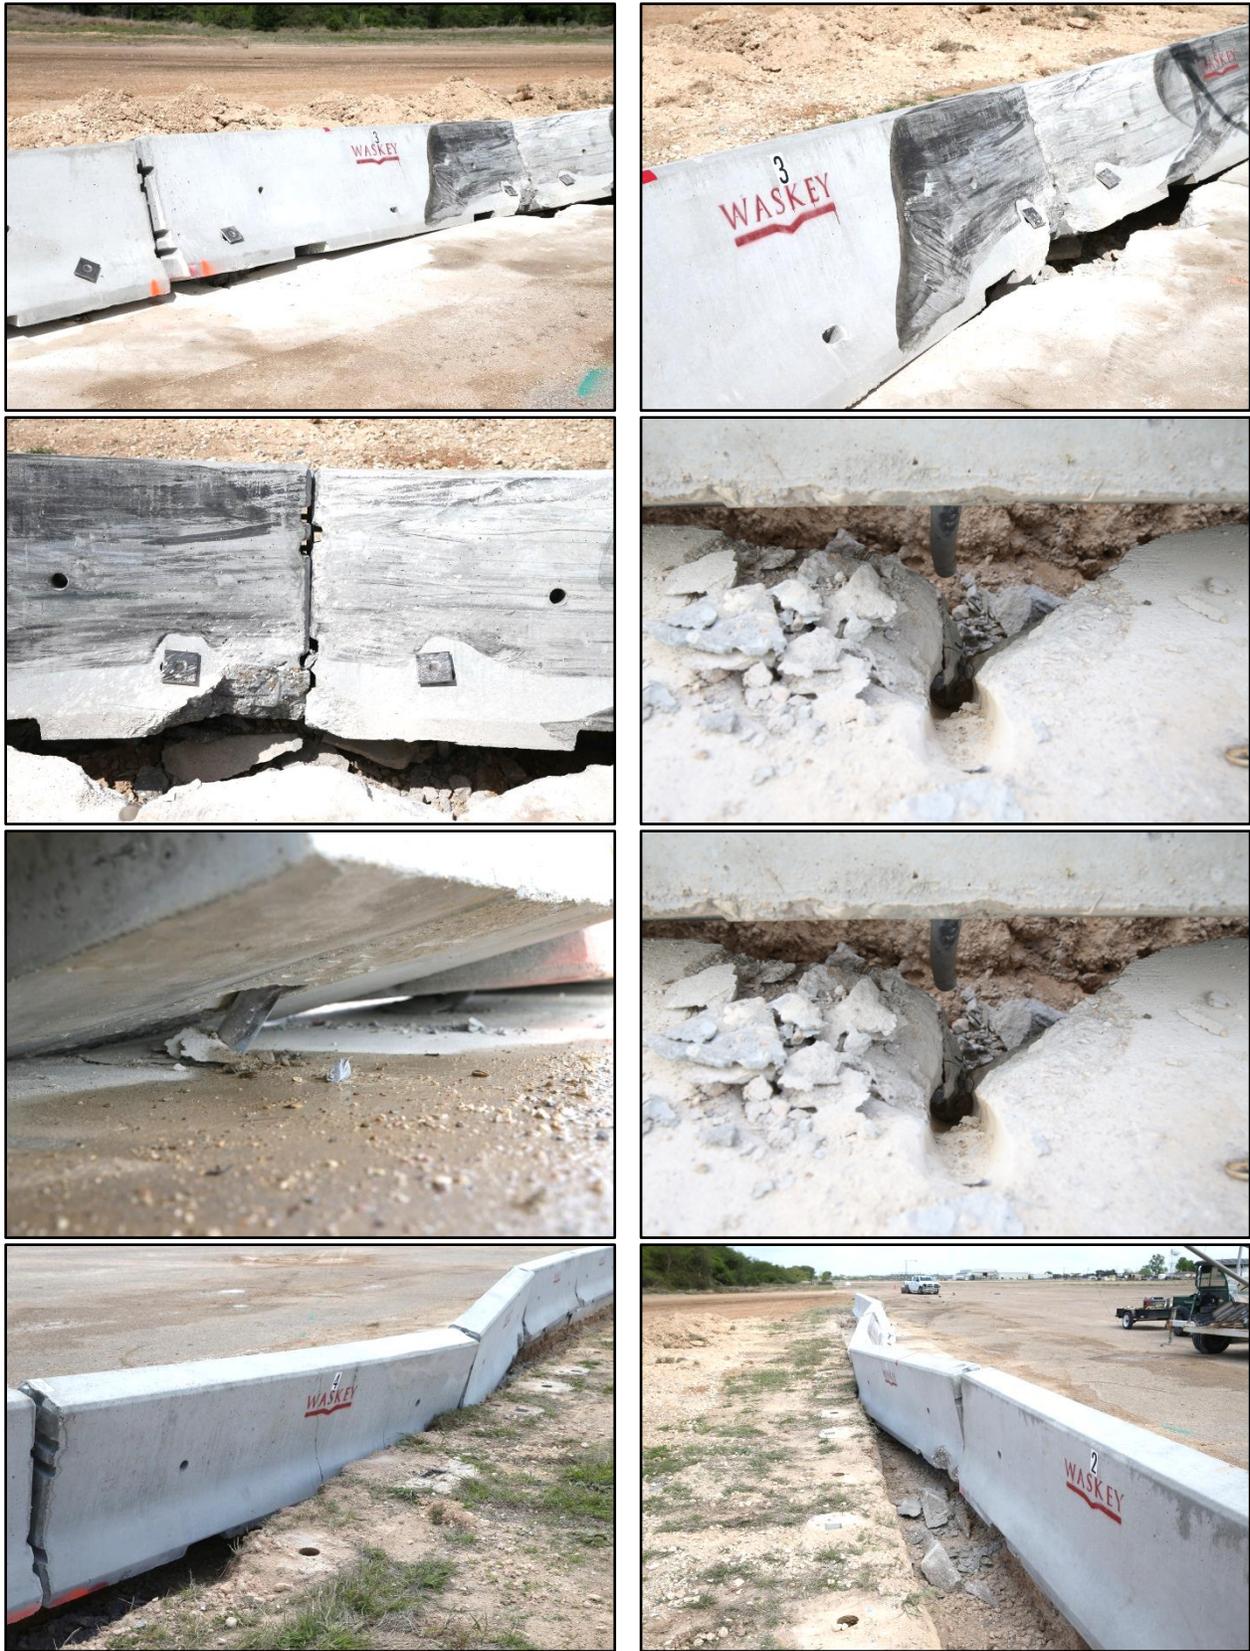
Figure 5 shows damage to the barrier. The upstream field side corner of segment 2, the upstream field side and downstream traffic side corner of segment 3, the downstream traffic side corner of segment 4, and the upstream field side corner of segment 6 were damaged. The anchor pins broke through the concrete pavement at segments 2 through 5, and the pavement was also cracked downstream of the upstream field side pin of segment 6.

Figure 5. Pinned PCB after Test No. 607911-3.

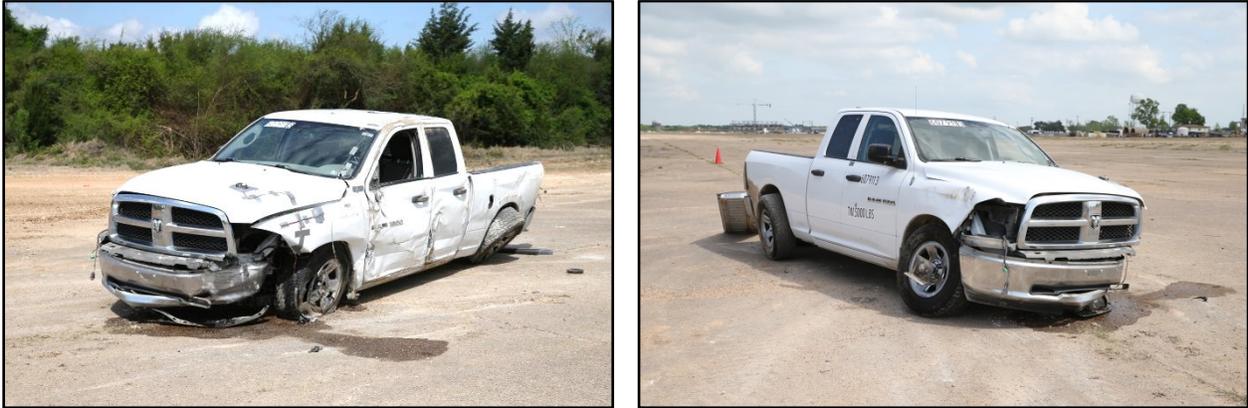
Figure 6 shows the damage sustained by the vehicle. The front bumper, hood, radiator and support, left front fender, left front tire and rim, left front door and window glass, left rear door, left rear exterior bed, left rear tire and rim, rear bumper, tailgate, rear springs, right rear exterior bed, right rear tire and rim, right front fender, right front tire and rim, right front ball joint, left frame rail, left upper and lower A-arms, and roof were damaged. Maximum exterior crush to the vehicle was 12.0 inches in the front plane at the left front corner at bumper height. Occupant compartment deformation was 2.0 inches in the kick panel/toe panel area.

Figure 6. Vehicle after Test No. 607911-3.
