**Texas A&M
Transportation
Institute**
Proving Ground

Test Report No. 608421-1
Test Report Date: September 2017

MASH TEST 3-11 OF 28-INCH W-BEAM GUARDRAIL SYSTEM WITH 8-INCH COMPOSITE BLOCKOUTS RAISED 4 INCHES ON STEEL POSTS

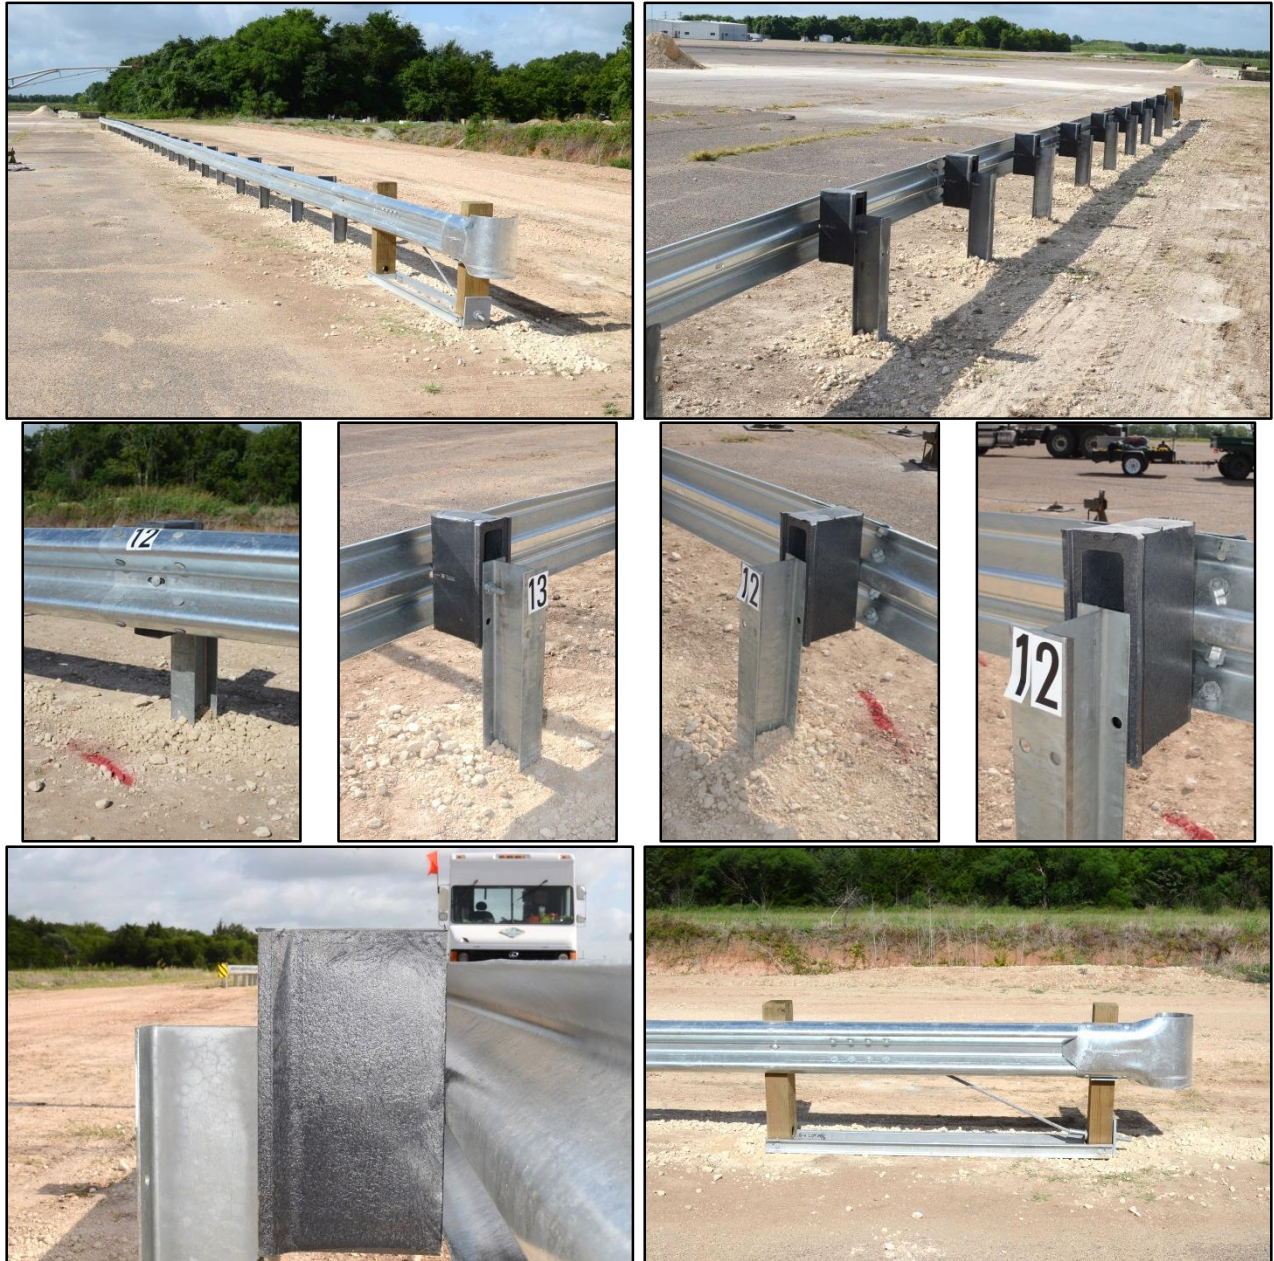
Figure 2.2. 28-inch W-Beam Guardrail System with Raised Composite Blockouts prior to Testing.

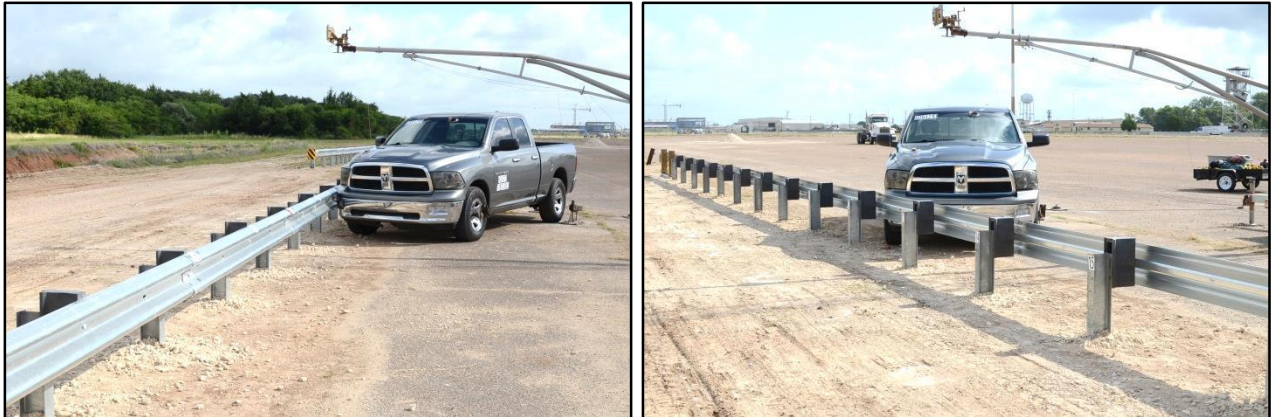
Figure 5.1. 28-inch W-Beam Guardrail System with Raised Composite Blockouts/Test Vehicle Geometrics for Test No. 608421-1.

The 2011 Dodge RAM 1500 pickup truck, shown in Figure 5.1 and Figure 5.2, was used for the crash test. The vehicle's test inertia weight was 5017 lb, and its gross static weight was 5017 lb. The height to the lower edge of the vehicle bumper was 11.5 inches, and height to the upper edge of the bumper was 27.0 inches. The height to the vehicle's center of gravity was 28.375 inches. Tables D.1 and D.2 in Appendix D1 give additional dimensions and information on the vehicle. The vehicle was directed into the installation using a cable reverse tow and guidance system, and was released to be freewheeling and unrestrained just prior to impact.

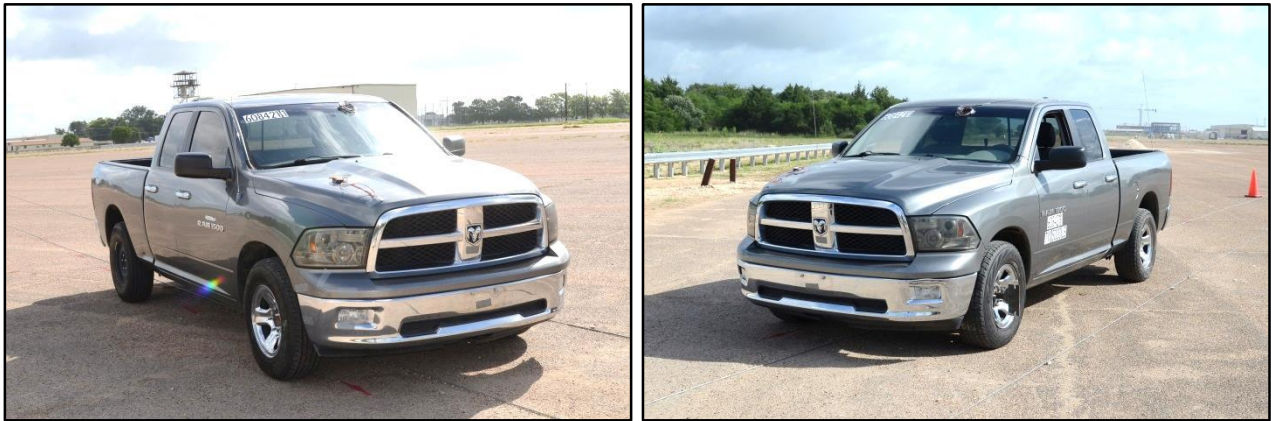
Figure 5.2. Test Vehicle before Test No. 608421-1.

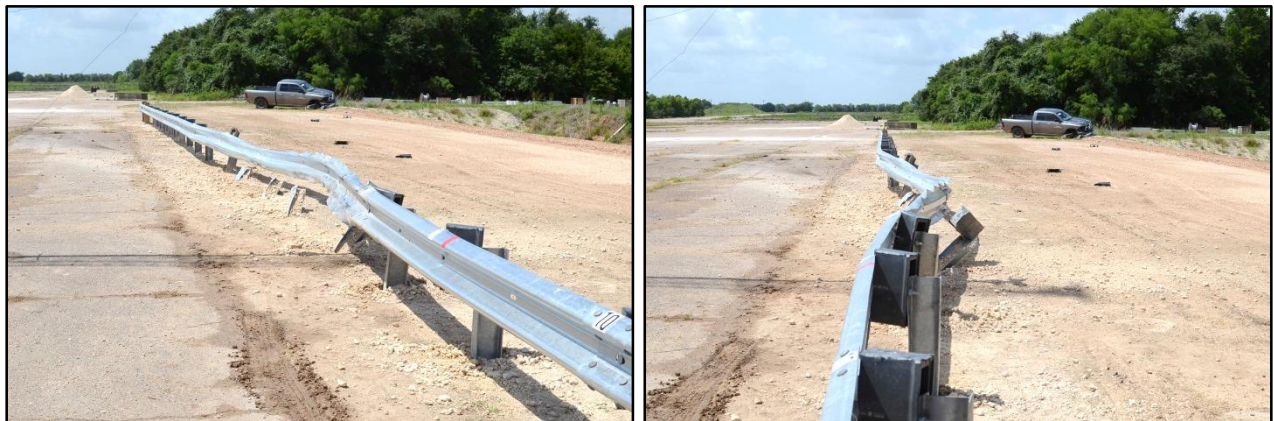
Figure 5.3. Test Vehicle and Guardrail System after Test No. 608421-1.

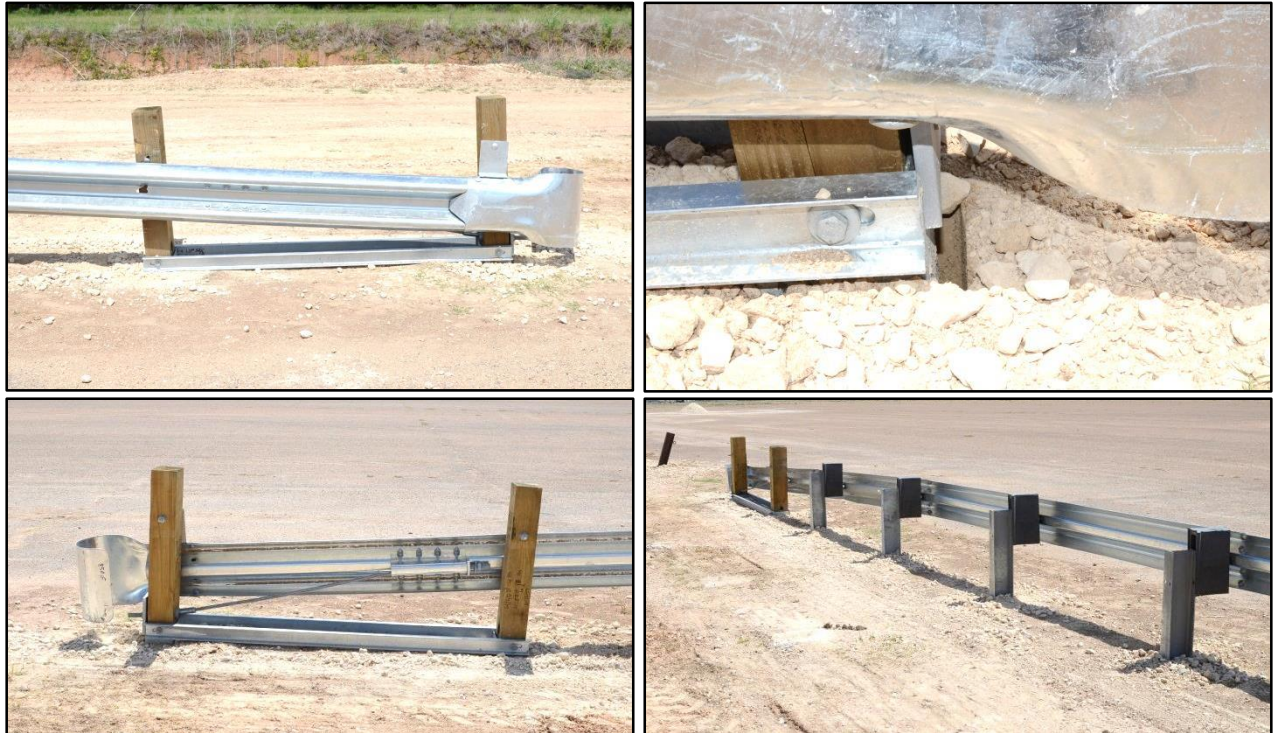
Figure 5.4. Upstream Terminal after Test No. 608421-1.

Figure 5.4 shows the damage to the 28-inch W-beam guardrail system with raised composite blockouts. Post 1 was pulled downstream 1.25 inches at ground level, and post 2 was pulled downstream 0.625 inch at ground level. The rail element separated from the shelf bracket at post 1 and released from posts 2 and 3. The rail element was pulled downstream 3.0 inches from post 1 toward impact. Post 11 had gaps between the post and the soil of 0.75 inch on the traffic side and 0.25 inch on the field side, and the post was leaning toward the field side at 88 degrees. Post 12 had gaps between the post and the soil of 2.5 inch on the traffic side and 0.75 inch on the field side, and the post was leaning toward the field side at 88 degrees. The blockouts separated from the posts and rail element from posts 14 through 16, and the rail element released from posts 13 through 17. Post 17 was leaning downstream at 79 degrees and toward the field side 76 degrees. Post 18 had gaps between the post and the soil of 0.125 inch on the traffic side and 0.5 inch on the field side. No movement in the rail or posts was noted beyond post 18. Working width was 69.6 inches at a height of 53.0 inches. Maximum dynamic deflection during the test was 52.6 inches, and maximum permanent deformation was 36.0 inches.

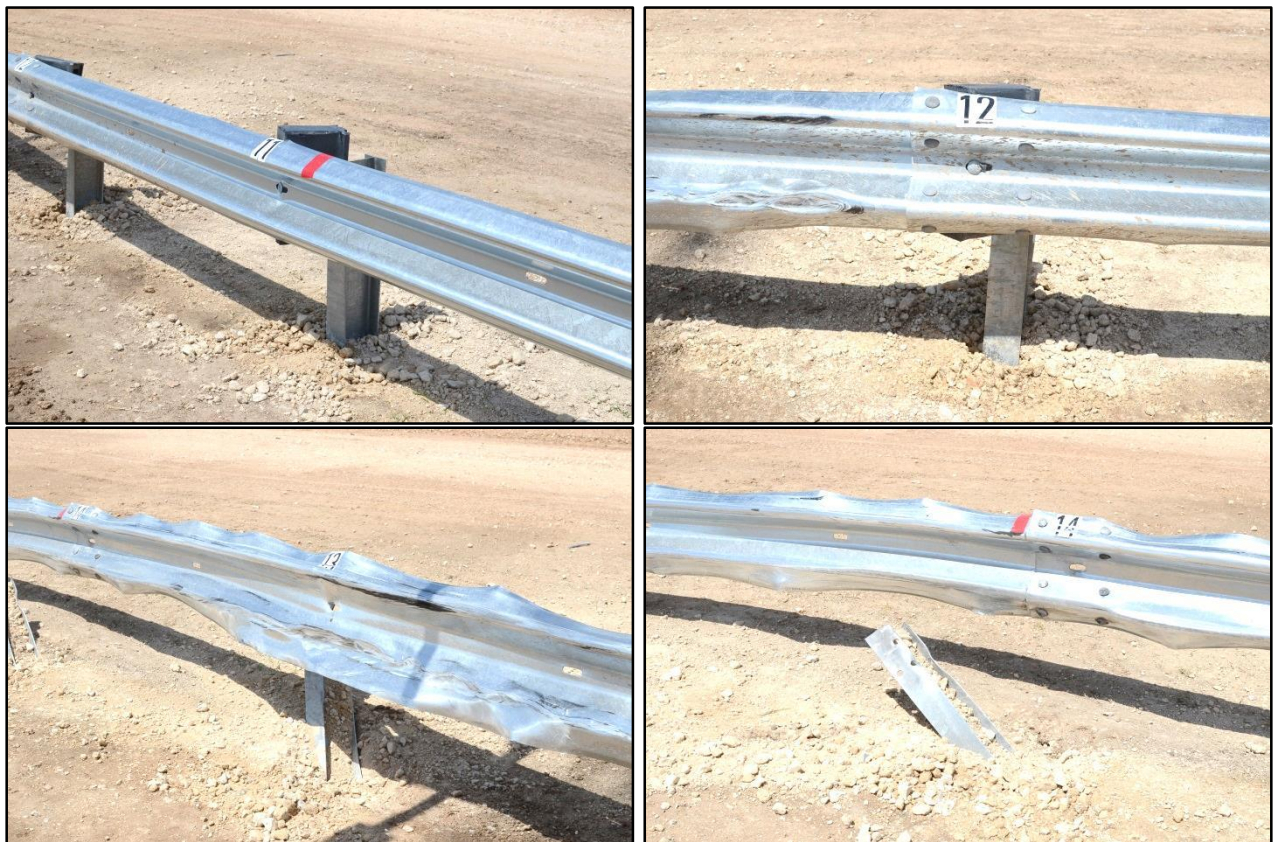
Figure 5.5. Posts 11 through 14 after Test No. 608421-1.

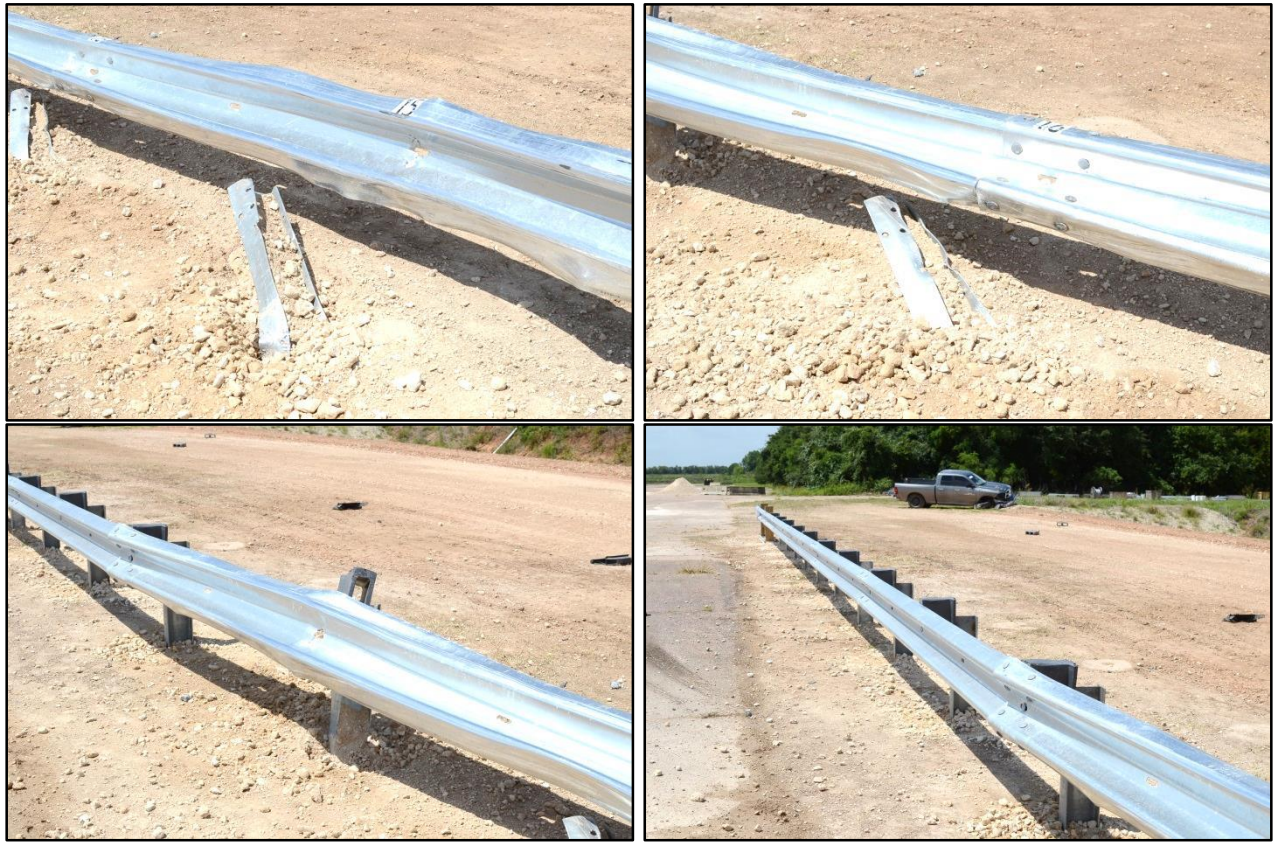
Figure 5.6. Posts 15 through 18 after Test No. 608421-1.

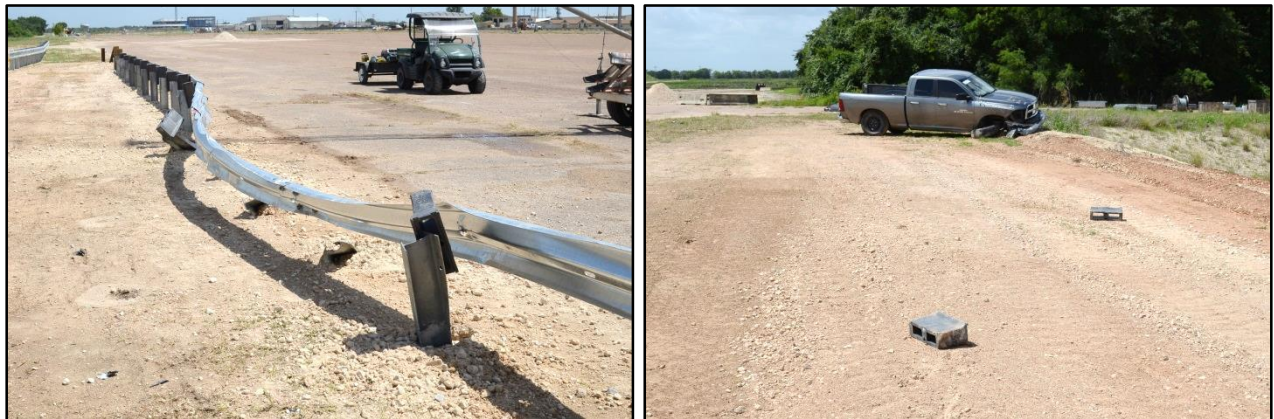
Figure 5.7. Field Side of Guardrail and Released Blockouts after Test No. 608421-1.

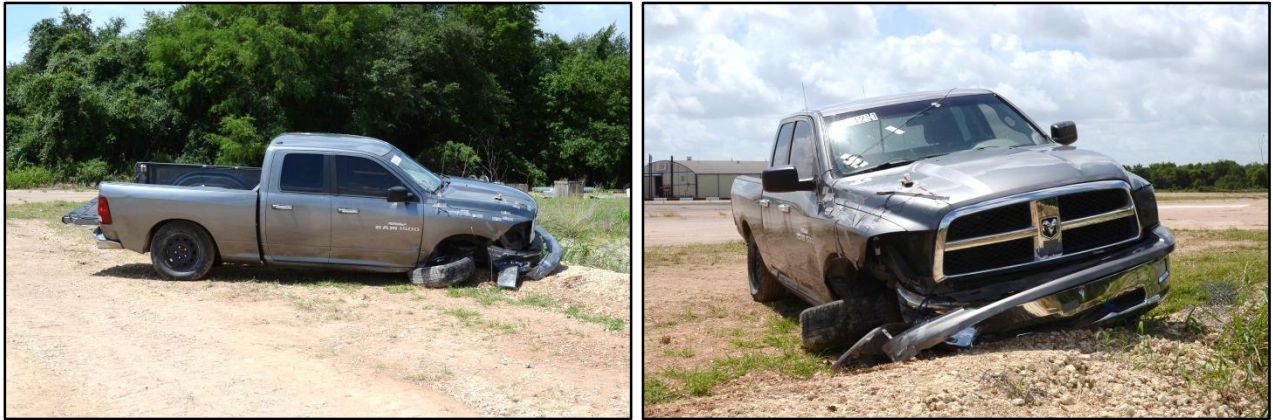
Figure 5.8. Test Vehicle after Test No. 608421-1.

Figure 5.8 shows the damage sustained by the vehicle. The front bumper, right front fender, right front upper and lower A-arms, right front upper ball joint, right front tire and rim, sway bar, right front tie rod, right front and rear doors, right rear exterior bed, right rear rim, and rear bumper were damaged. Maximum exterior crush to the vehicle was 10.0 inches in the front

plane at the right front corner at bumper height. No reduction or intrusion of the occupant compartment occurred. Figure 5.9 shows the interior of the vehicle. Tables D.3 and D.4 in Appendix D1 provide exterior crush and occupant compartment measurements.

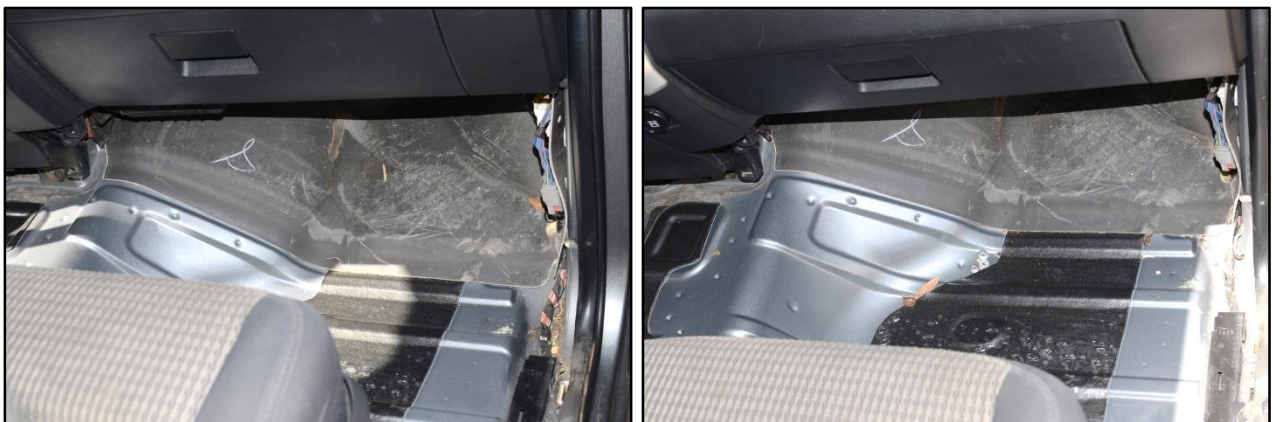
Figure 5.9. Interior of Test Vehicle for Test No. 608421-1.

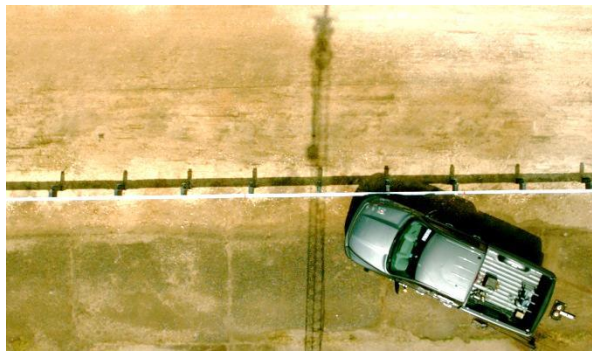
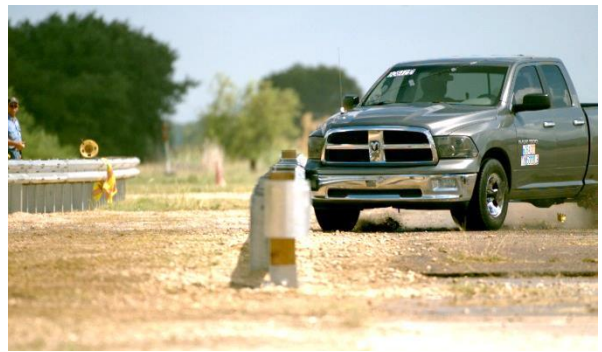
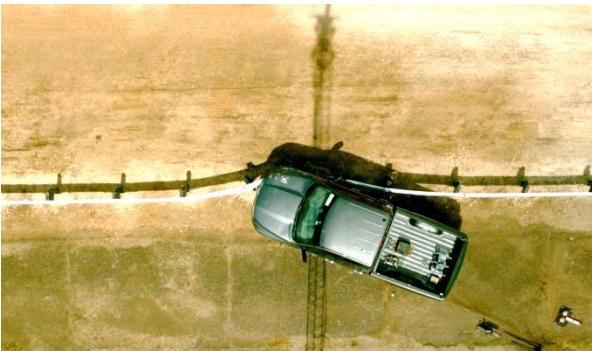
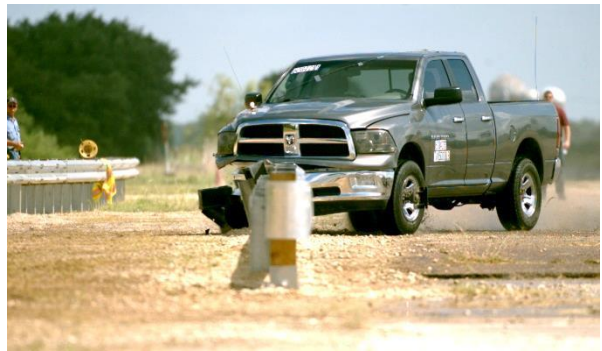
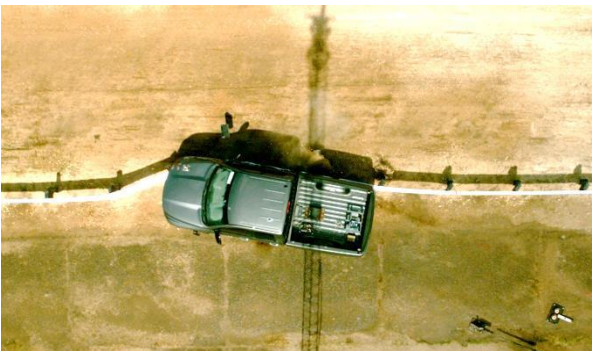
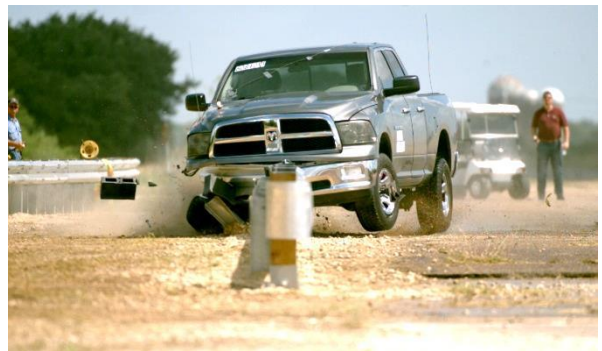
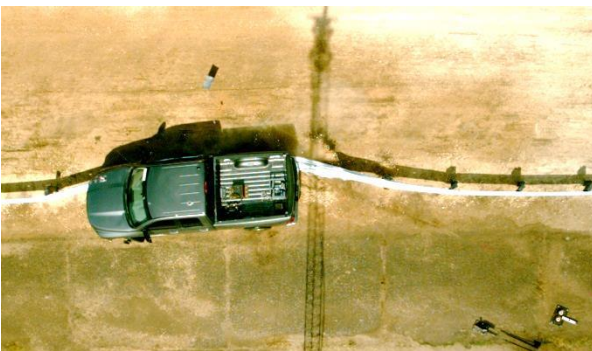
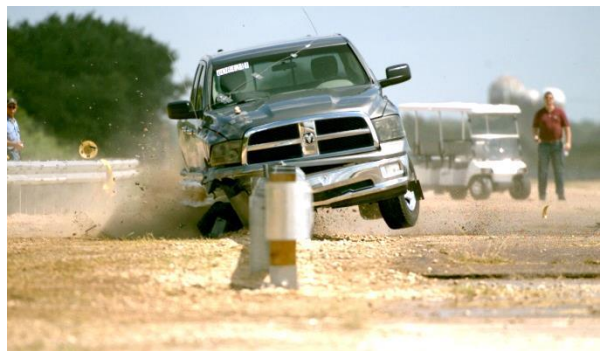
Figure D.1. Sequential Photographs for Test No. 608421-1 (Overhead and Frontal Views).

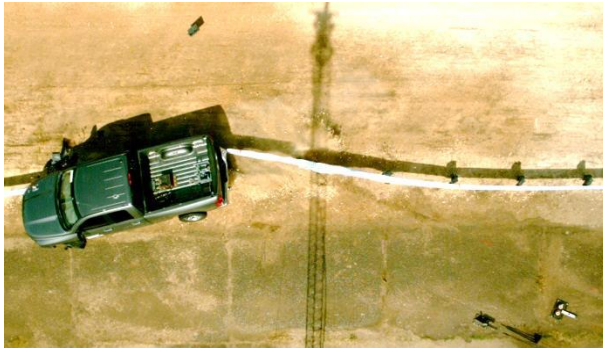
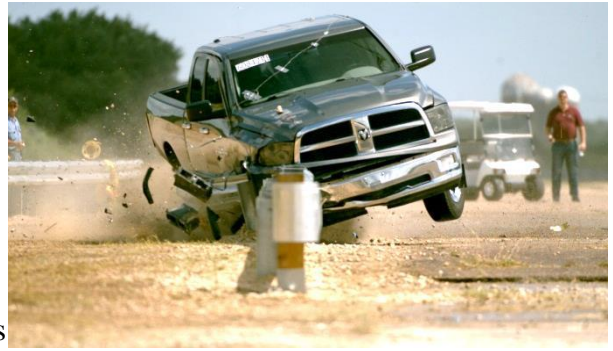
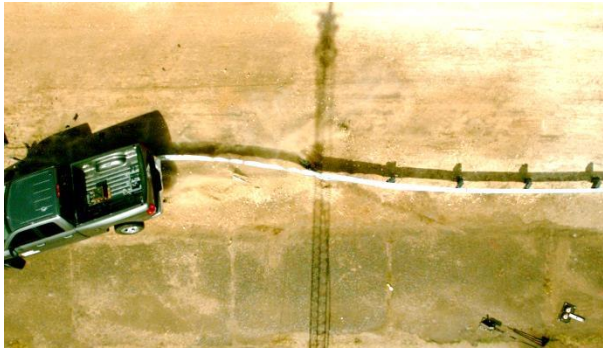
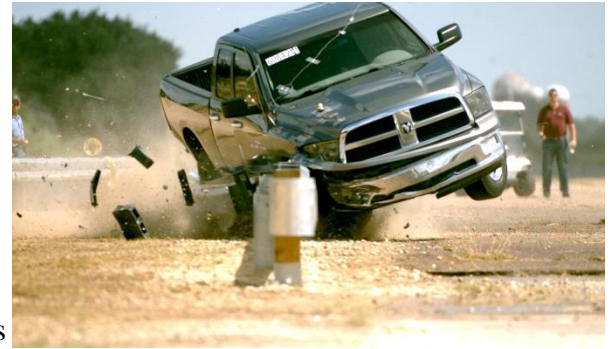
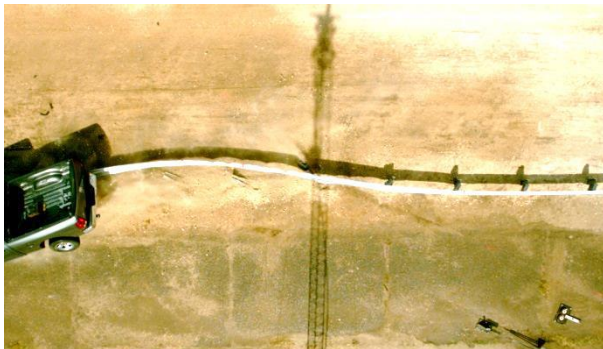
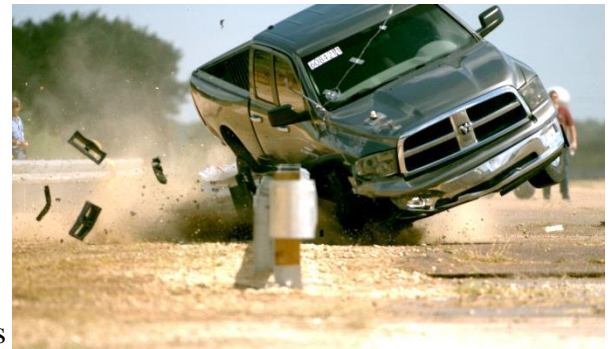
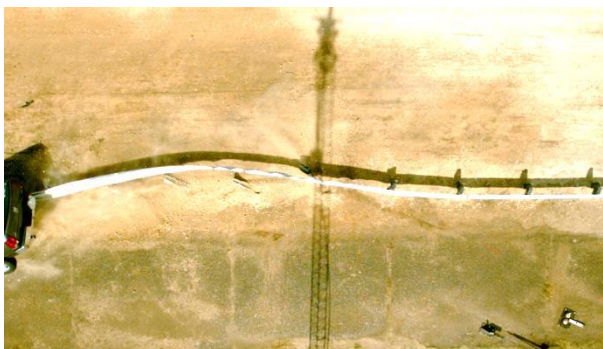
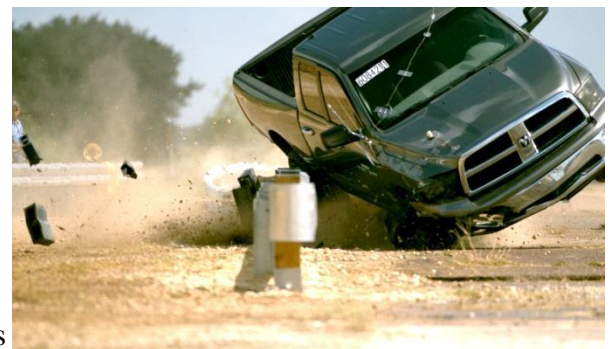
**Figure D.1. Sequential Photographs for Test No. 608421-1 (Overhead and Frontal Views)
(Continued).**

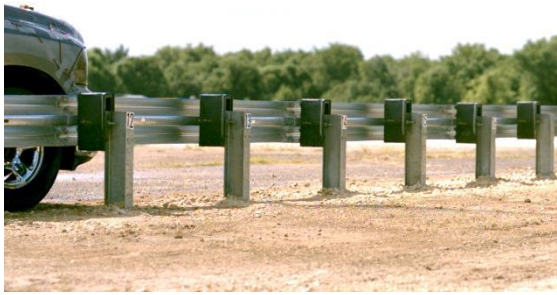
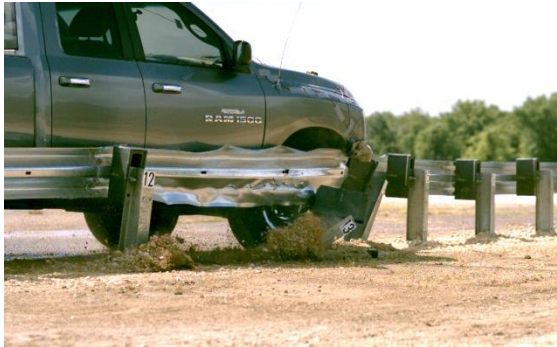
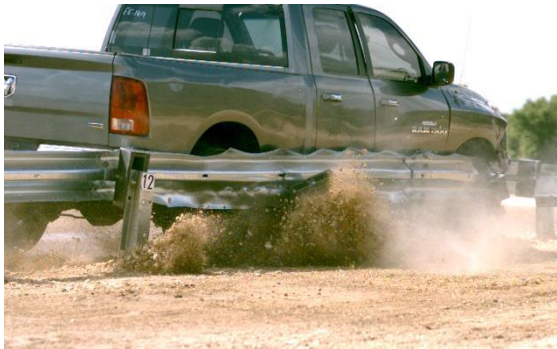
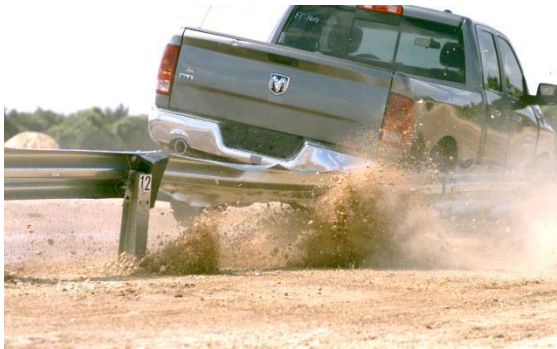
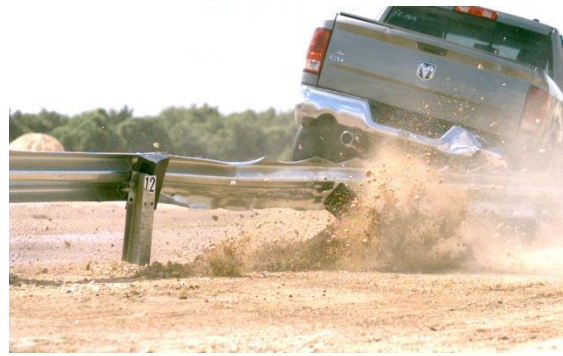
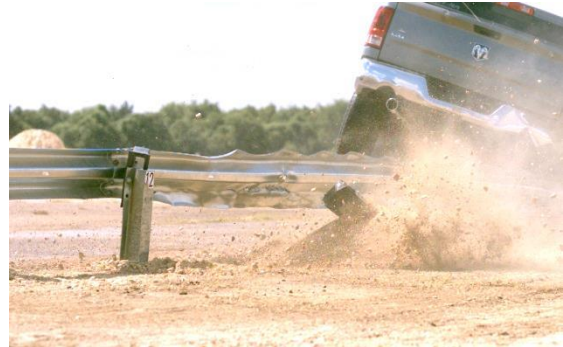
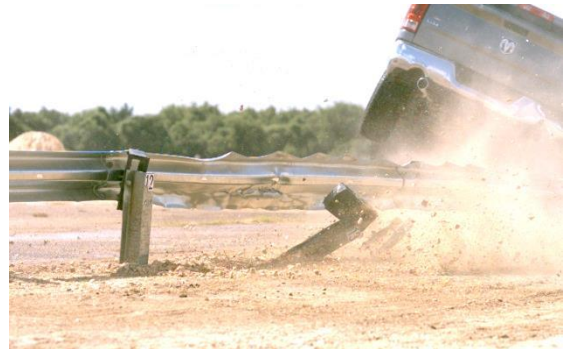
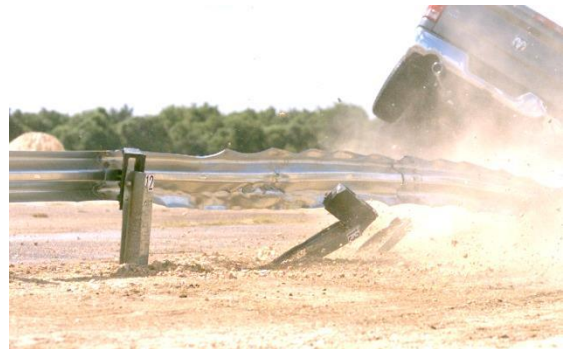
Figure D.2. Sequential Photographs for Test No. 608421-1 (Rear View).

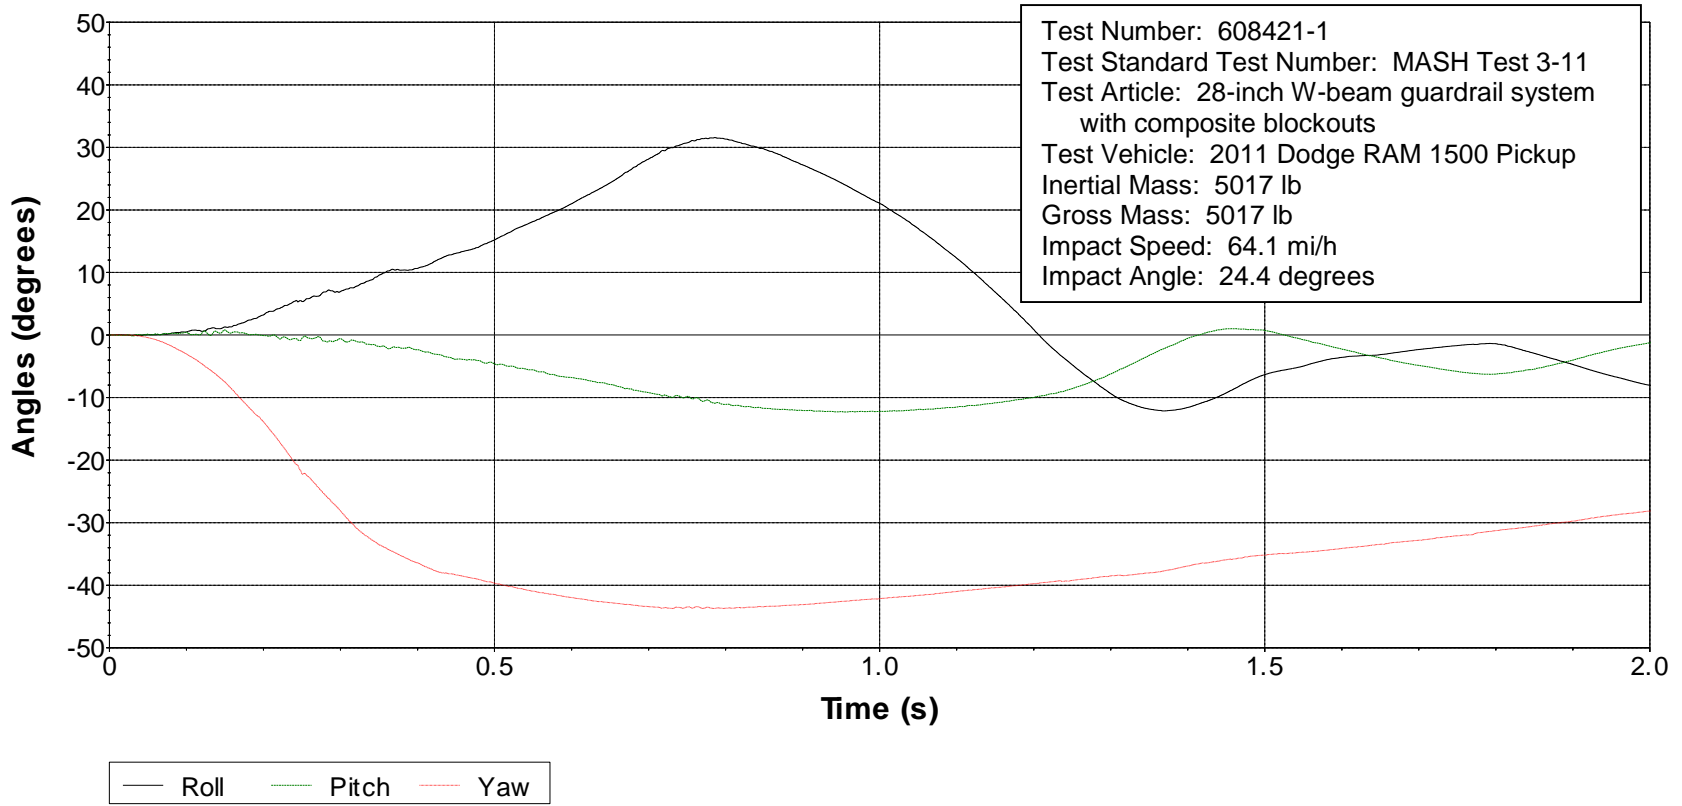
Axes are vehicle-fixed.
 Sequence for determining orientation:

1. Yaw.
2. Pitch.
3. Roll.

Figure D.3. Vehicle Angular Displacements for Test No. 608421-1.

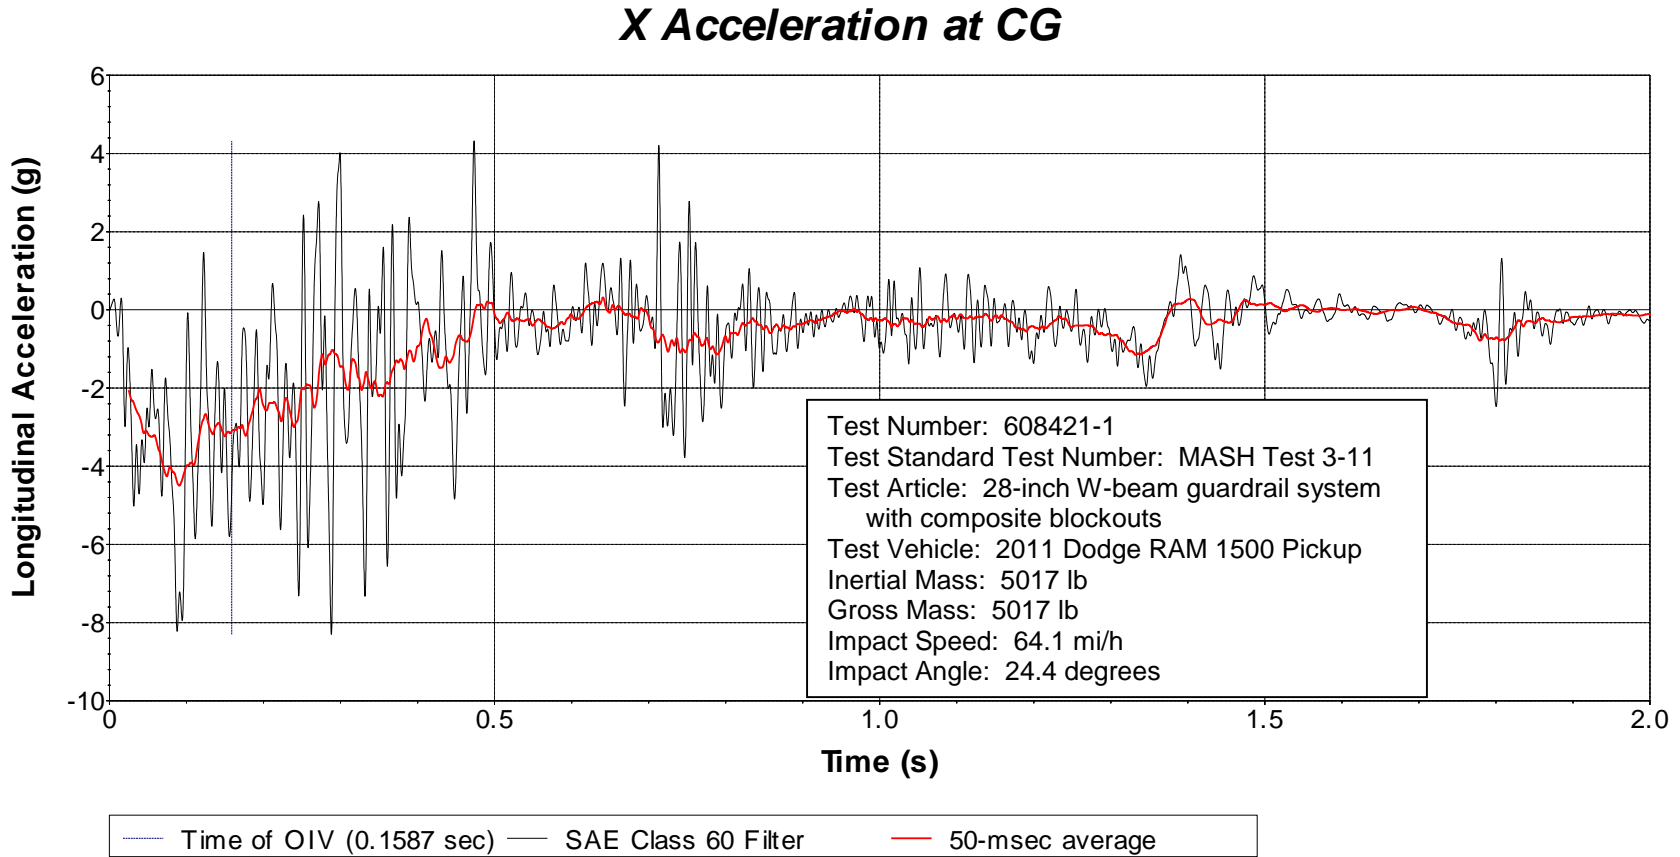
Figure D.4. Vehicle Longitudinal Accelerometer Trace for Test No. 608421-1 (Accelerometer Located at Center of Gravity).

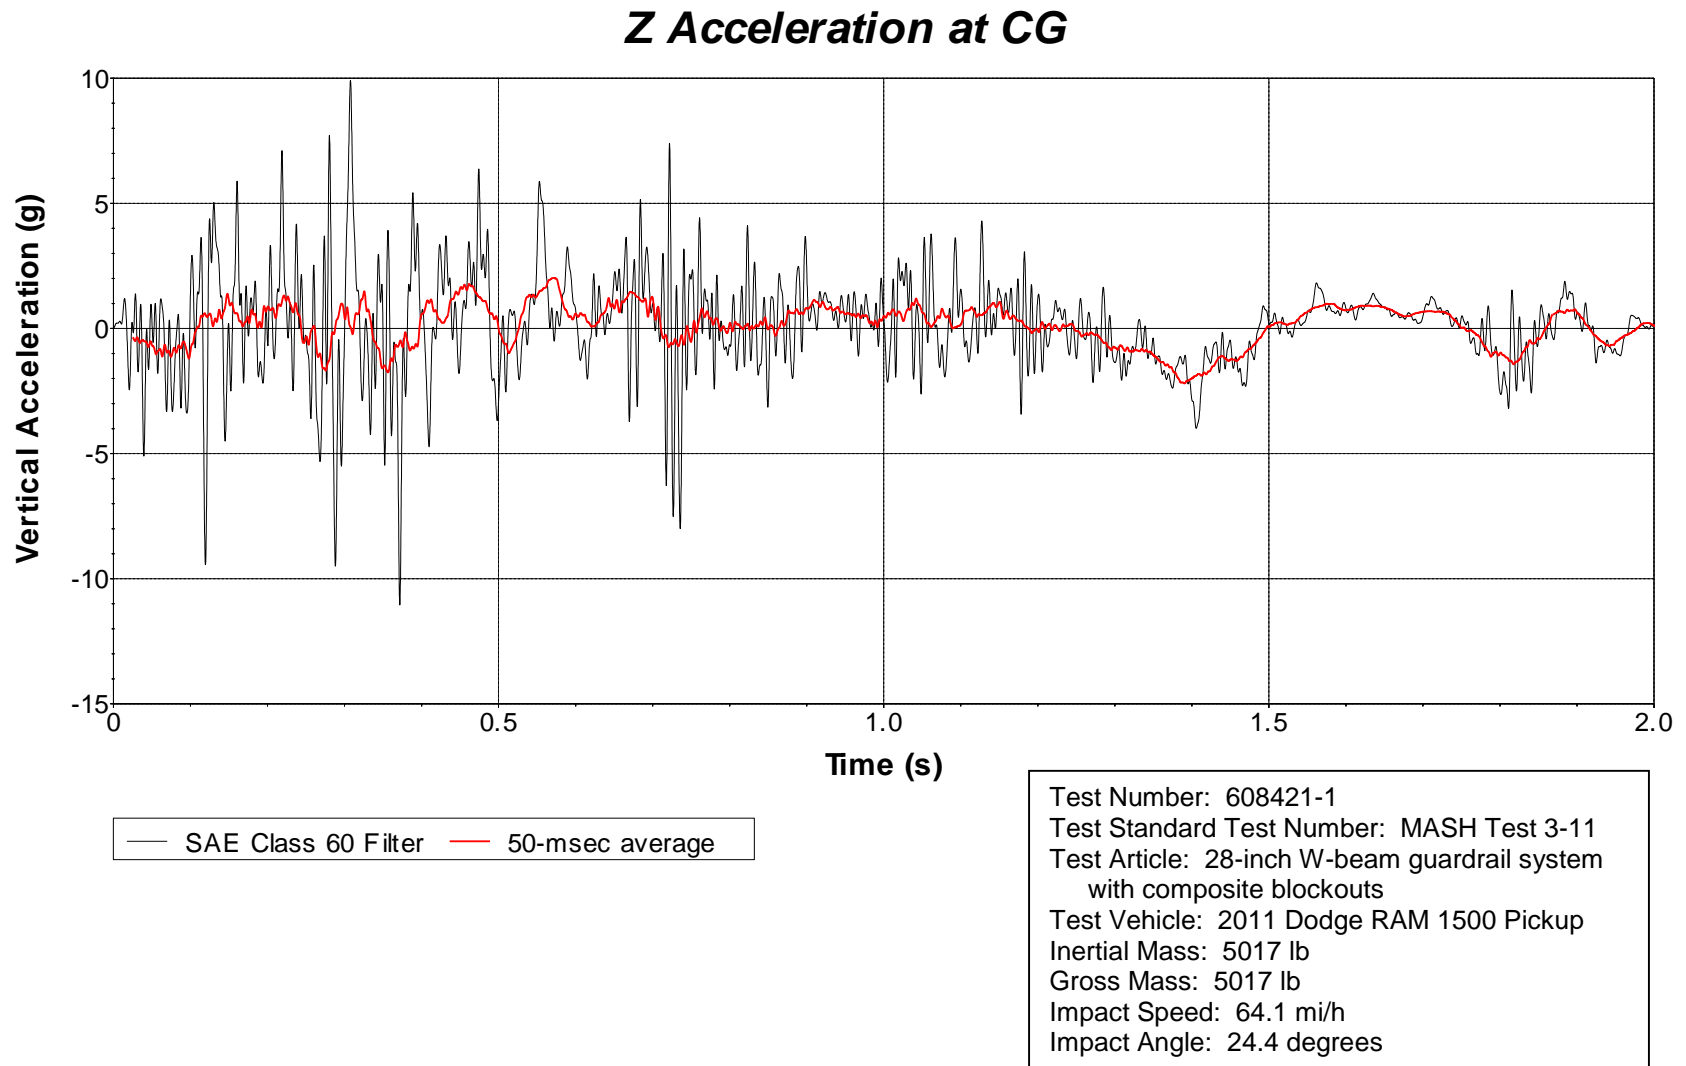
Figure D.6. Vehicle Vertical Accelerometer Trace for Test No. 608421-1 (Accelerometer Located at Center of Gravity).

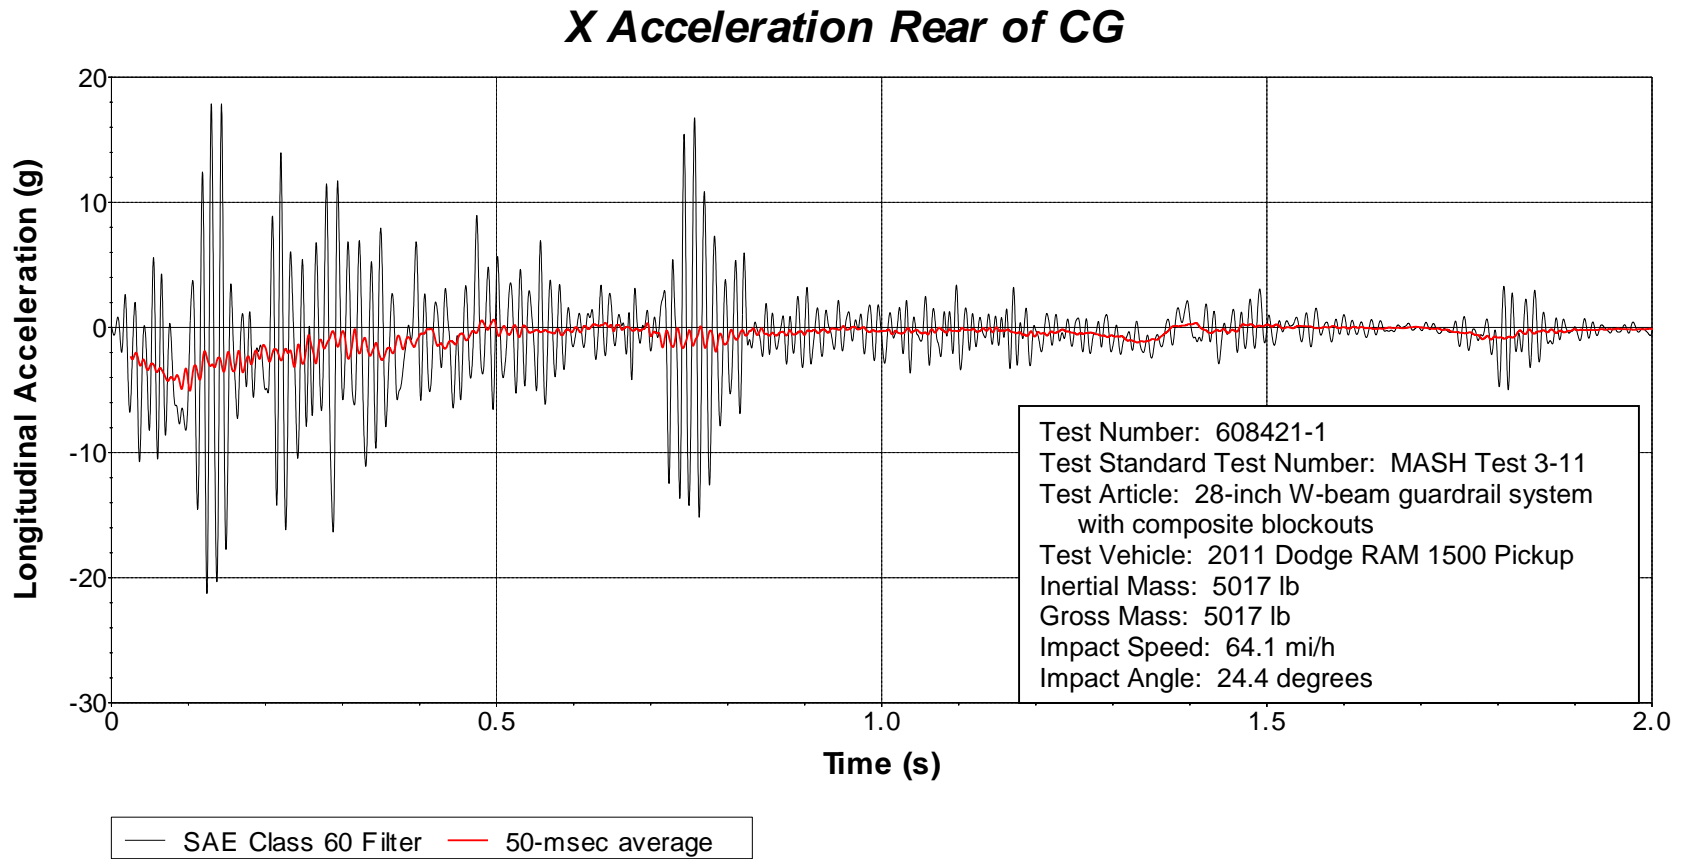
Figure D.7. Vehicle Longitudinal Accelerometer Trace for Test No. 608421-1 (Accelerometer Located Rear of Center of Gravity).

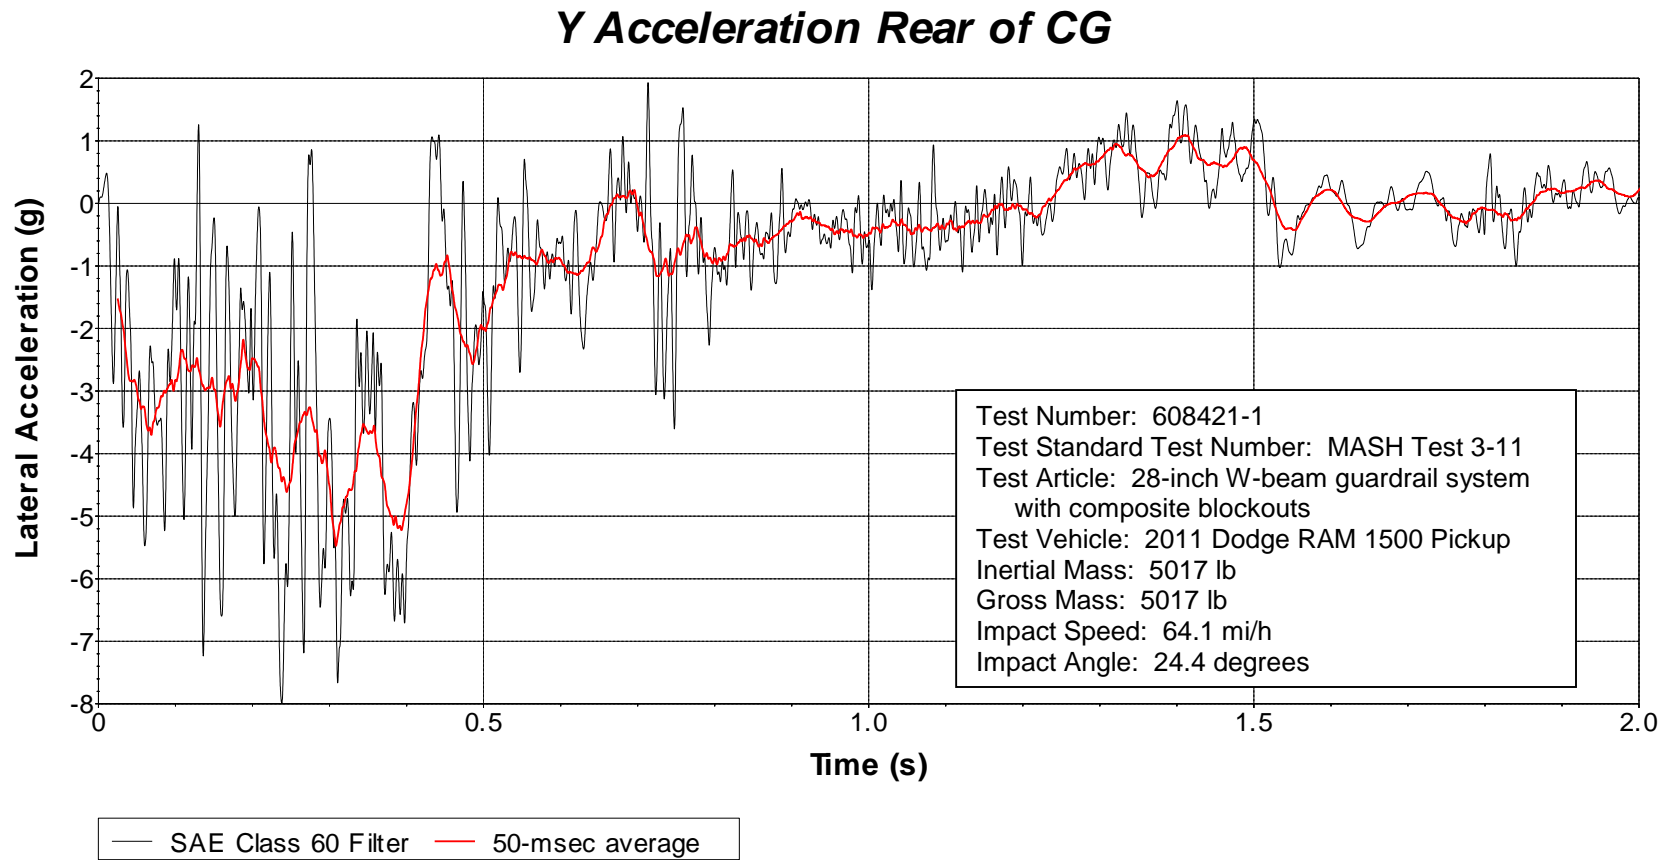
**Figure D.8. Vehicle Lateral Accelerometer Trace for Test No. 608421-1
(Accelerometer Located Rear of Center of Gravity).**

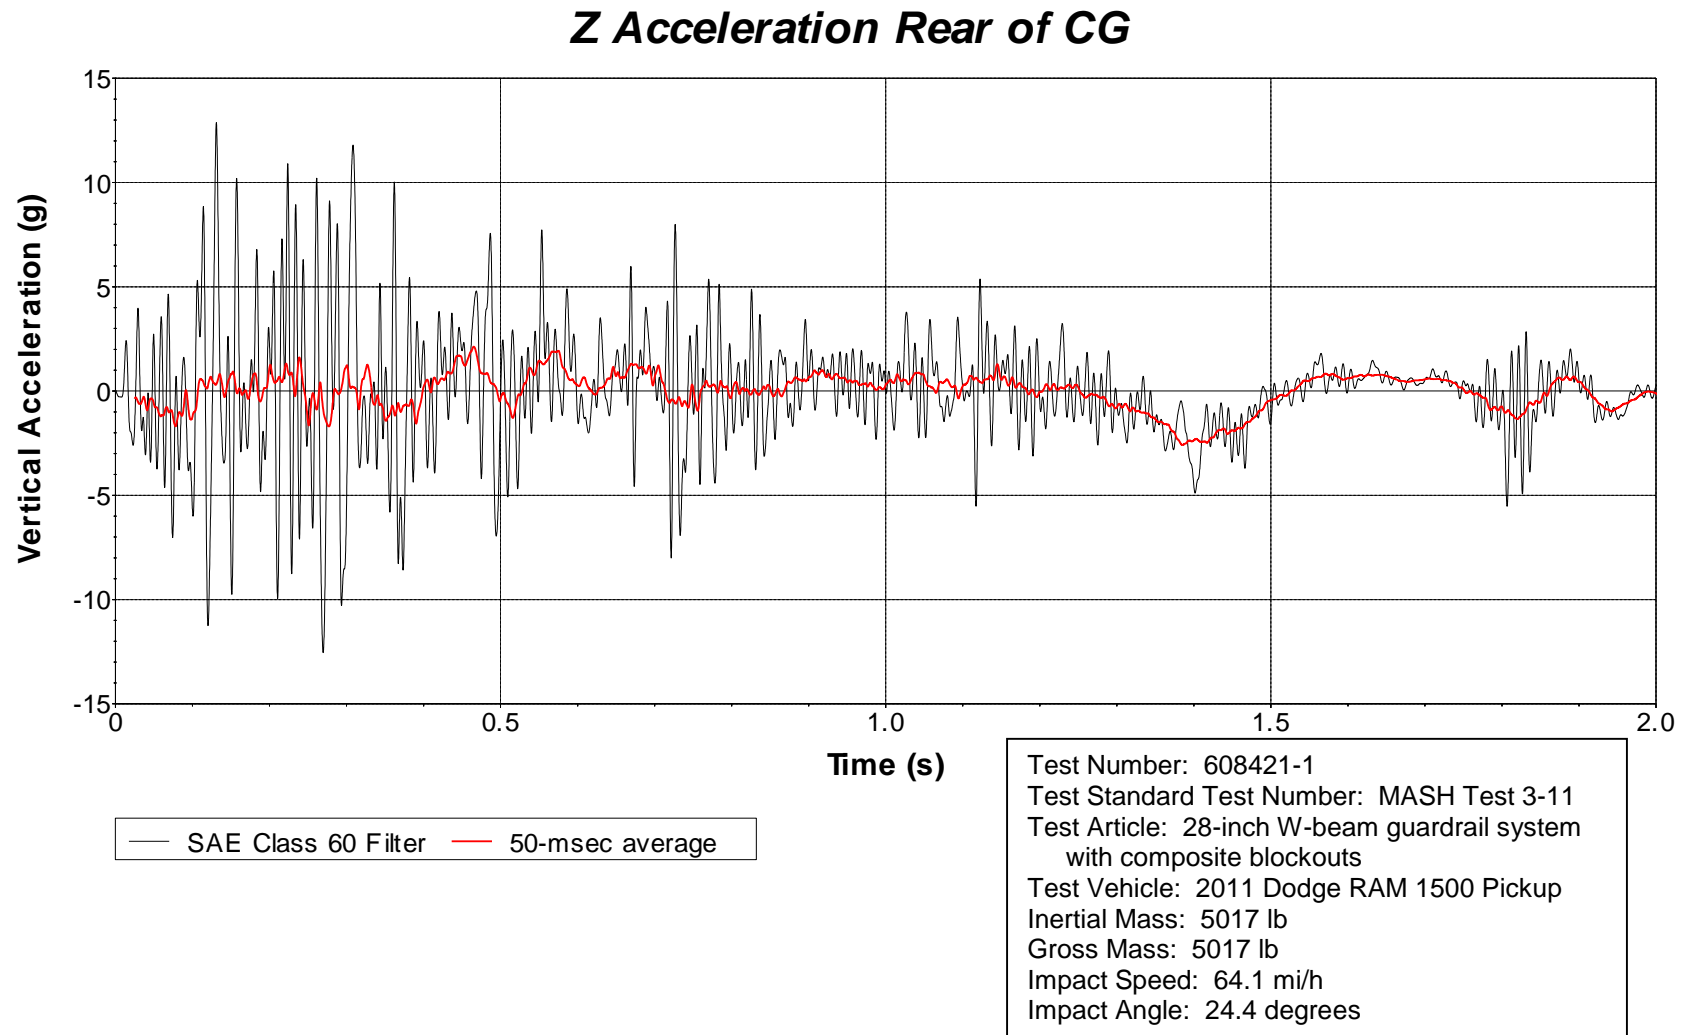
**Figure D.9. Vehicle Vertical Accelerometer Trace for Test No. 608421-1
(Accelerometer Located Rear of Center of Gravity).**
