MASH TL-2 Evaluation of Strong-Post W-Beam Guardrail with Reduced Rail Heights

Test Report No.: 602361-1&2

Test Report Date: December 2014

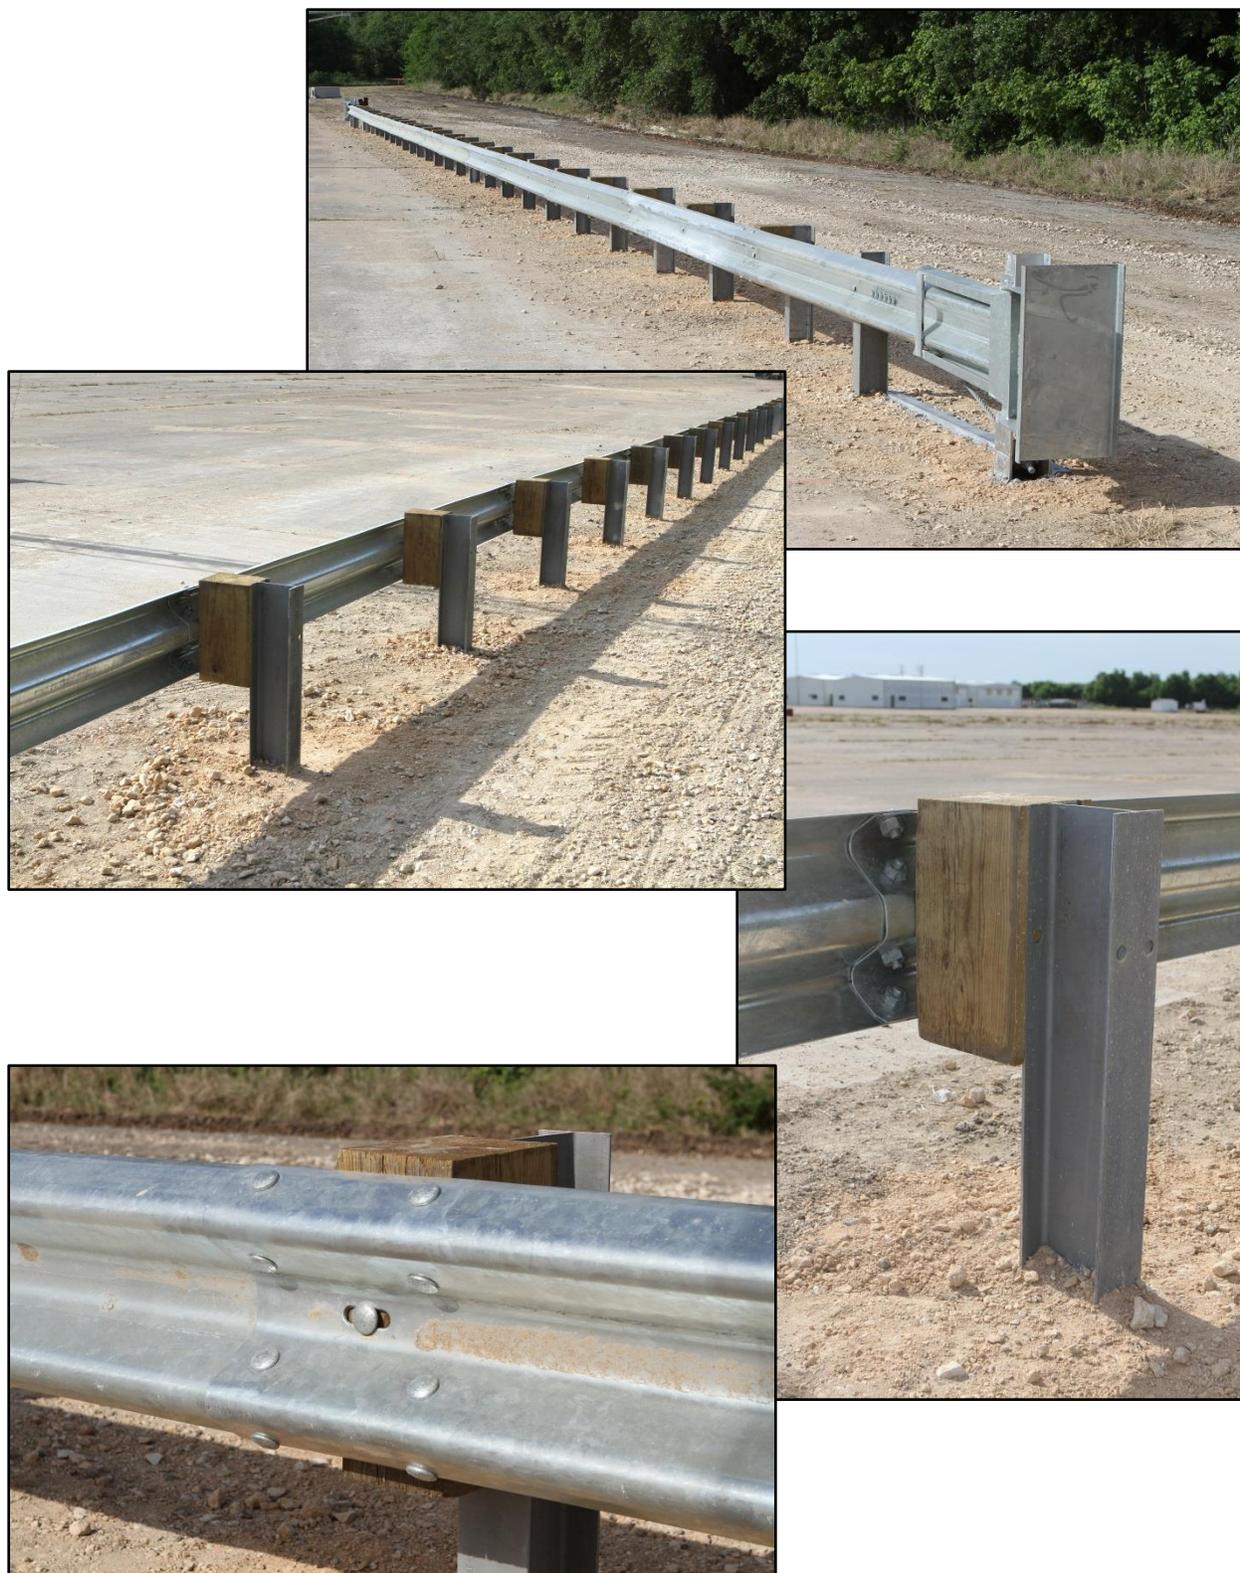
Figure 4.2. 25-inch Tall Strong-post W-beam Guardrail Installation Prior to Testing.

Figure 4.1 presents further information on the 25-inch TL-2 strong-post W-beam guardrail system, and Figure 4.2 provides photographs of the installation.

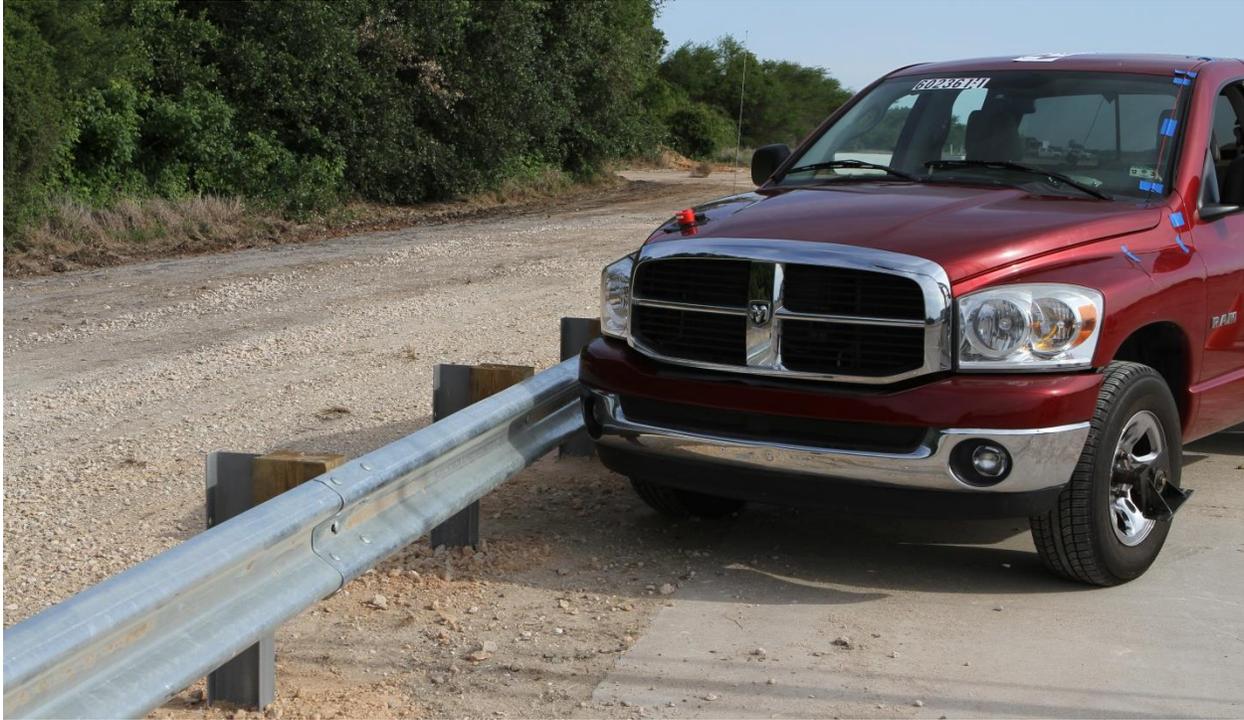
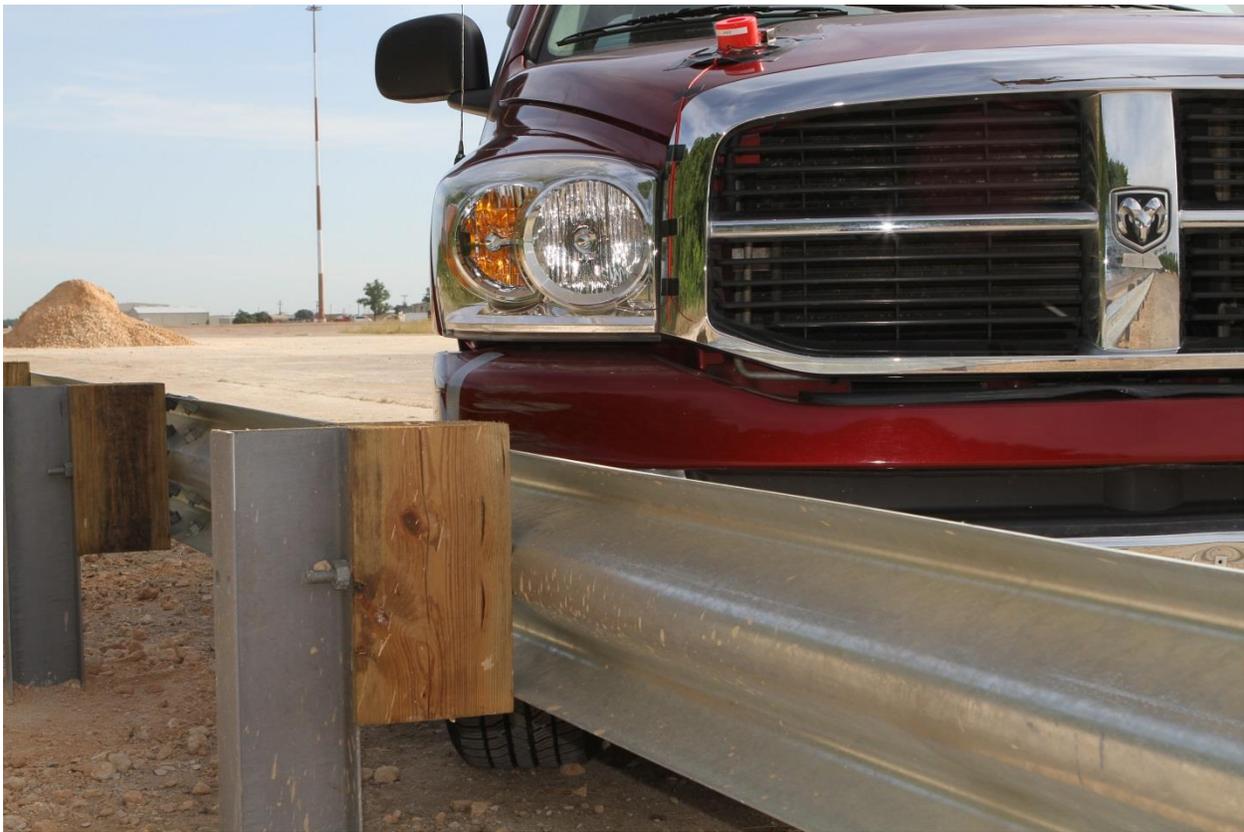
Figure 4.3. Vehicle and Installation Geometrics for Test No. 602361-1.

Figures 4.3 and 4.4 show the 2008 Dodge Ram 1500 pickup truck used for this crash test. Test inertia weight of the vehicle was 5049 lb, and its gross static weight was 5049 lb. The height to the lower edge of the vehicle front bumper was 15.75 inches, and the height to the upper edge of the front bumper was 28.00 inches. The height to the center of gravity was 28.25 inches. Additional dimensions and information on the vehicle are given in Appendix C, Table C.1 and Table C.2. The vehicle was directed into the installation using the cable reverse tow and guidance system, and was released to be freewheeling and unrestrained just prior to impact.

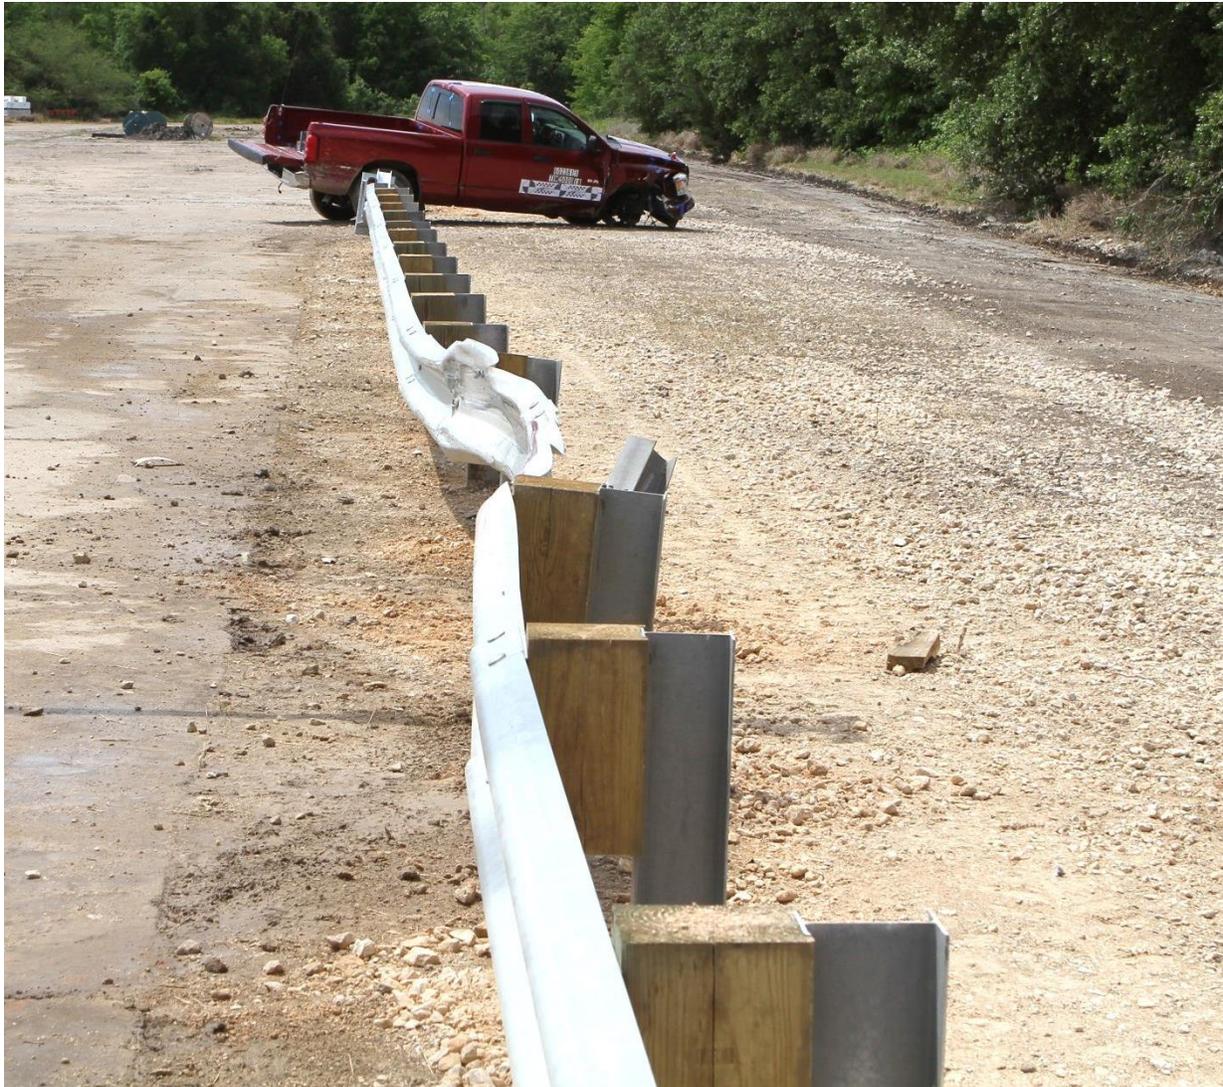
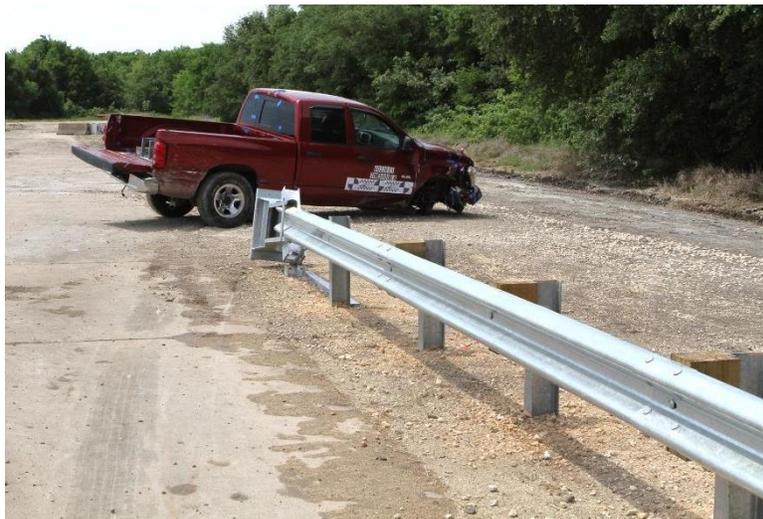
Figure 4.5. Vehicle and 25-inch tall W-beam Guardrail after Test No. 602361-1.

Figures 4.5 and 4.6 show damage to the 25-inch tall W-beam guardrail installation. The soil around post 1 and post 13 was disturbed. Post 14 was slightly rotated clockwise and was pushed toward the field side 1.75 inches at ground level. Post 15 was rotated counterclockwise, separated from the rail element and the blockout, and pushed toward the field side 4.75 inches at ground level. The blockout at post 15 split along the bolt hole. Post 16 was slightly rotated counterclockwise and was pushed toward the field side 1.75 inches at ground level. The soil around post 17 was disturbed. The vehicle was in contact with the guardrail 28 ft 6 inches before losing contact with the rail. The vehicle contacted the installation a second time at post 29, which became dislodged from the ground base, but remained directly over the base. The ET head was partially pulled off the rail element. Working width was 26.3 inches. Maximum dynamic deflection during the test was 18.0 inches, and maximum permanent deformation was 13.5 inches.

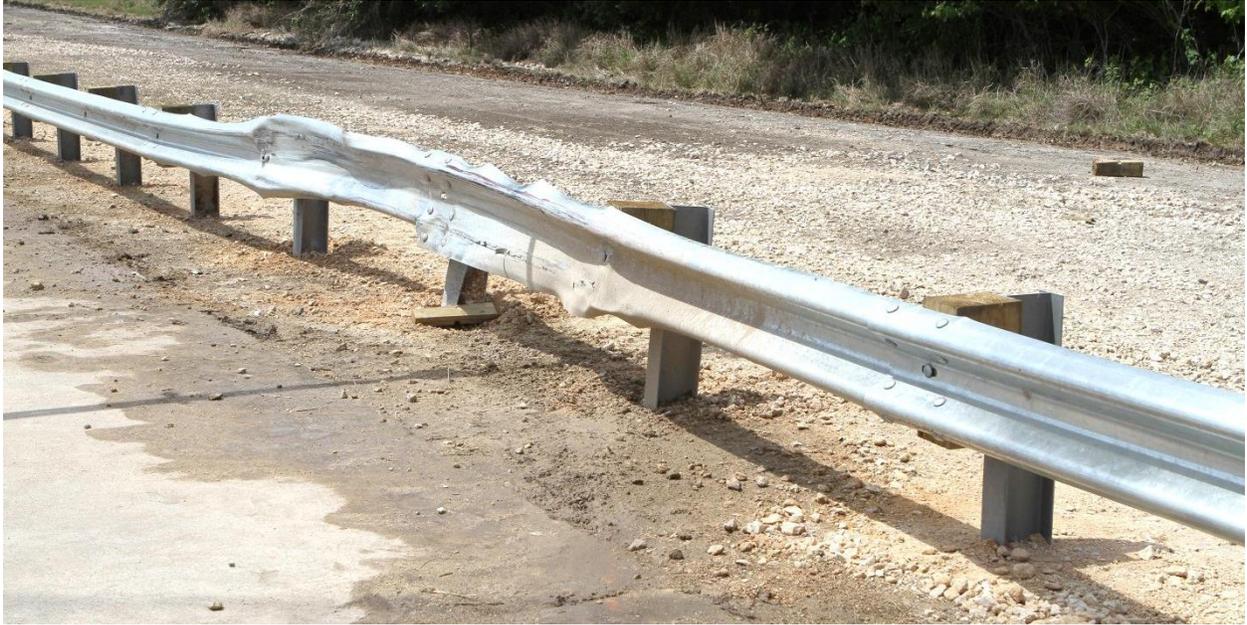
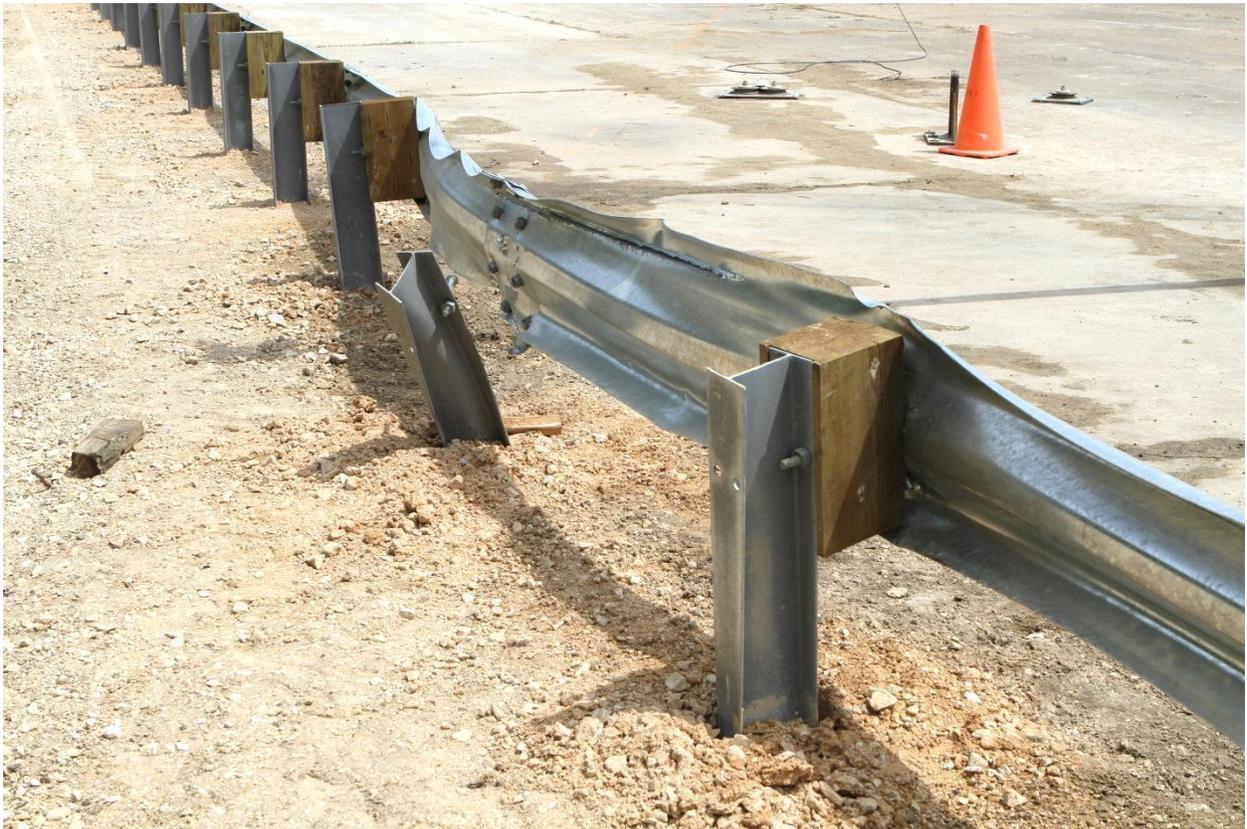
Figure 4.6. Installation after Test No. 602361-1.

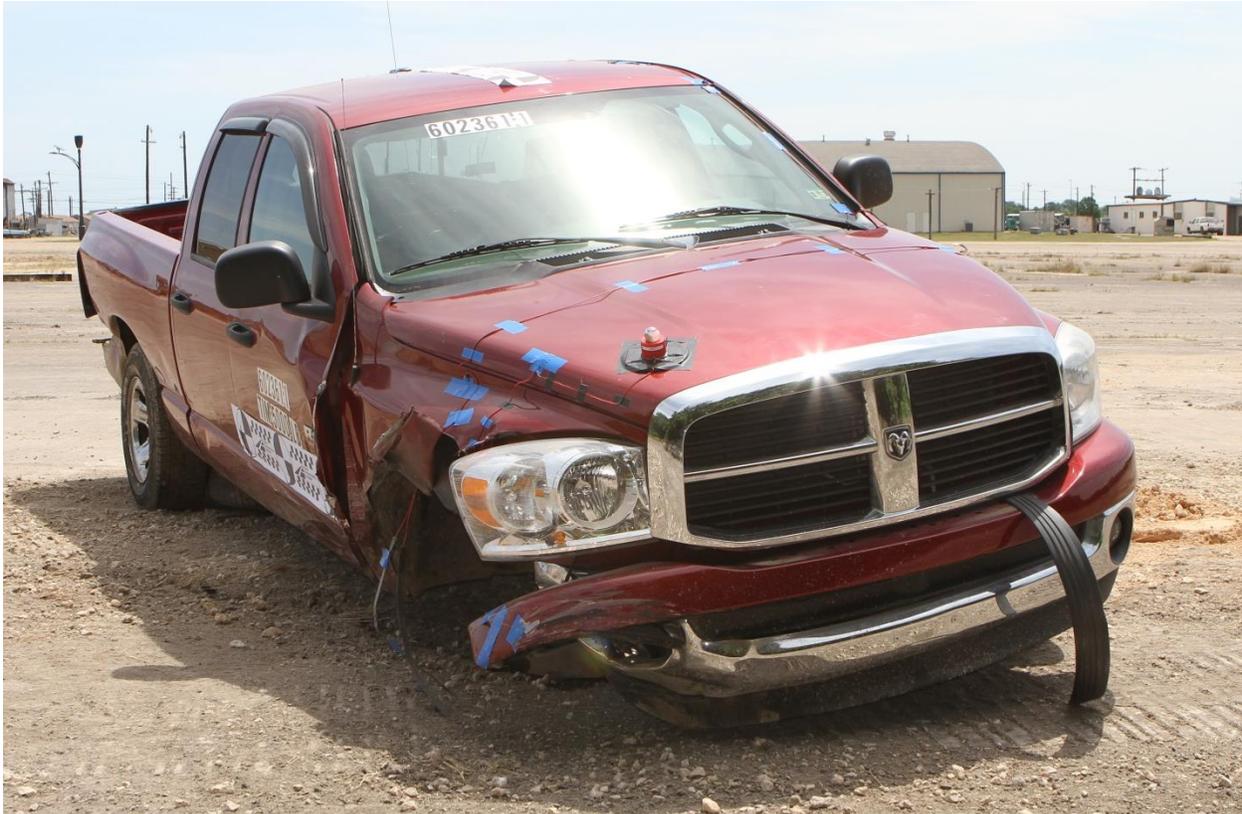
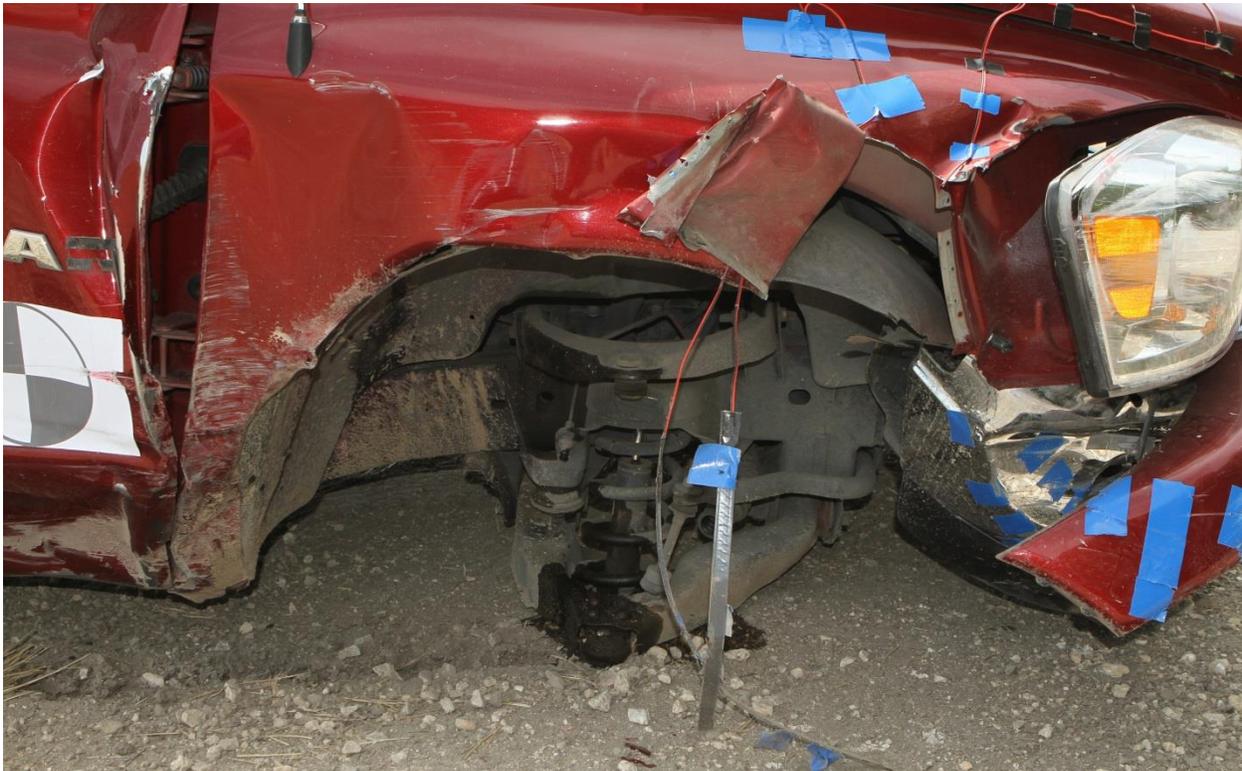
Figure 4.7. Vehicle after Test No. 602361-1.

Figure 4.7 shows damage to the 2270P vehicle after the test. The right front upper ball joint was pulled out of the socket, the right lower ball joint broke at the mount, and the inner tie rod was pulled out of the socket. Also damaged were the front bumper, right front fender, right front and rear doors, right rear exterior bed, and the rear bumper. Maximum exterior crush to the vehicle was 10.0 inches in the side plane at the right front corner of the vehicle at bumper height. No occupant compartment deformation occurred. Figure 4.6 shows the interior of the vehicle. Exterior vehicle crush and occupant compartment measurements are shown in Appendix C1, Tables C.3 and C.4.

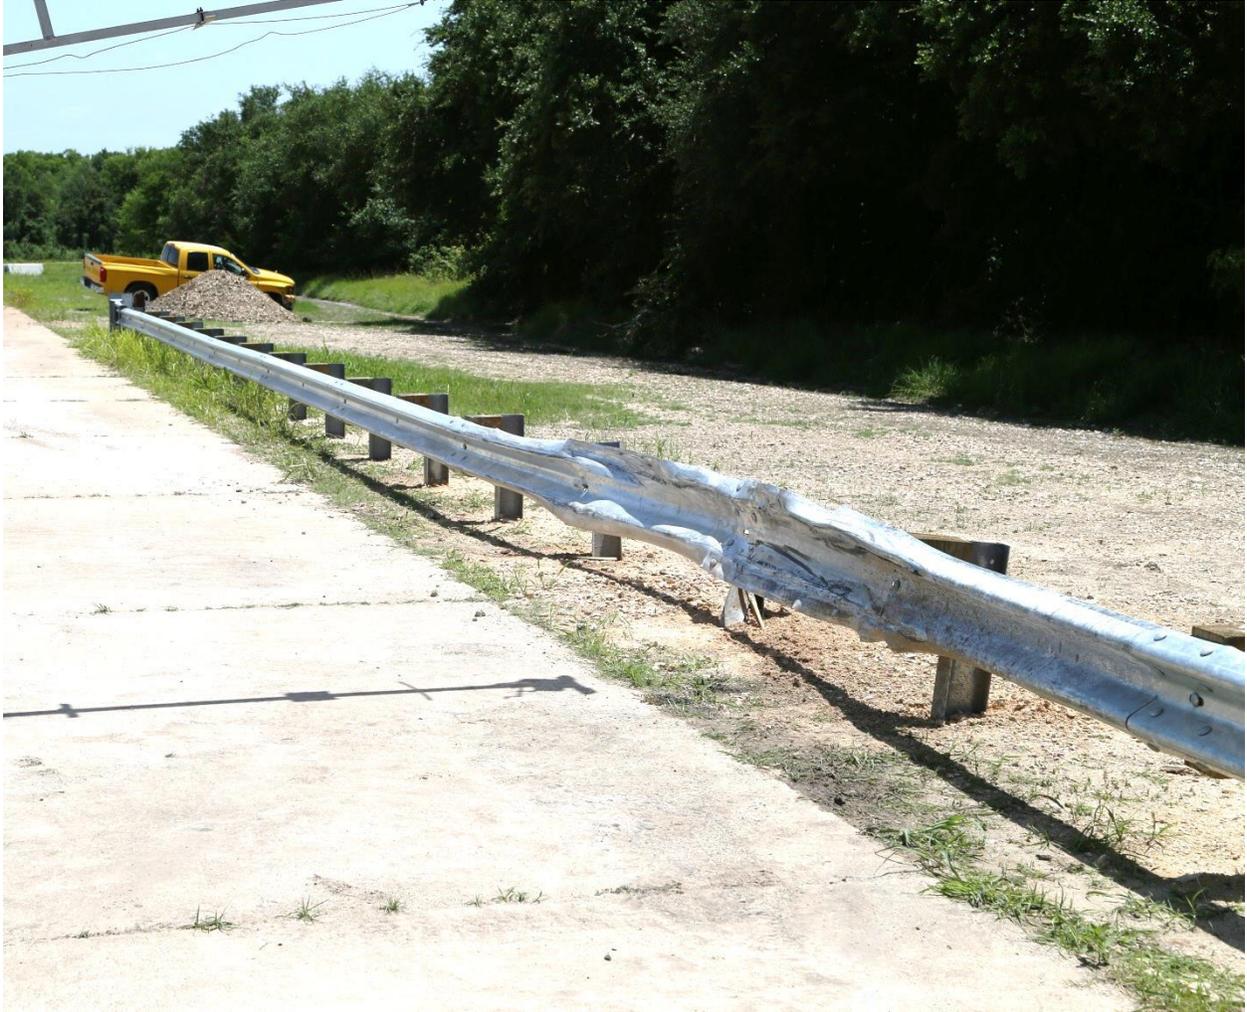
Figure 5.5. Vehicle and Installation Positions after Test No. 6012361-2.

Figures 5.5 and 5.6 show damage to the 24-inch tall strong-post W-beam guardrail. Post 1 was pulled downstream 0.25 inch. The guardrail bolt pulled through the rail at post 12, and the soil around post 12 and 13 was disturbed. Post 14 was leaning toward the field side 9 degrees, and there was a gap between the post and soil of 1.1 inches on the field side. Post 15 rotated clockwise 95 degrees, released from the rail, and was leaning downstream 40 degrees. Post 16 rotated clockwise 45 degrees, released from the rail, and was leaning downstream 15 degrees. The soil around post 17 was disturbed. The length of contact of the vehicle with the guardrail was 20 ft. Maximum permanent deformation of the rail element was 15.0 inches at post 15. Working width was 29.7 inches. Maximum dynamic deflection during the test was 22.4 inches.

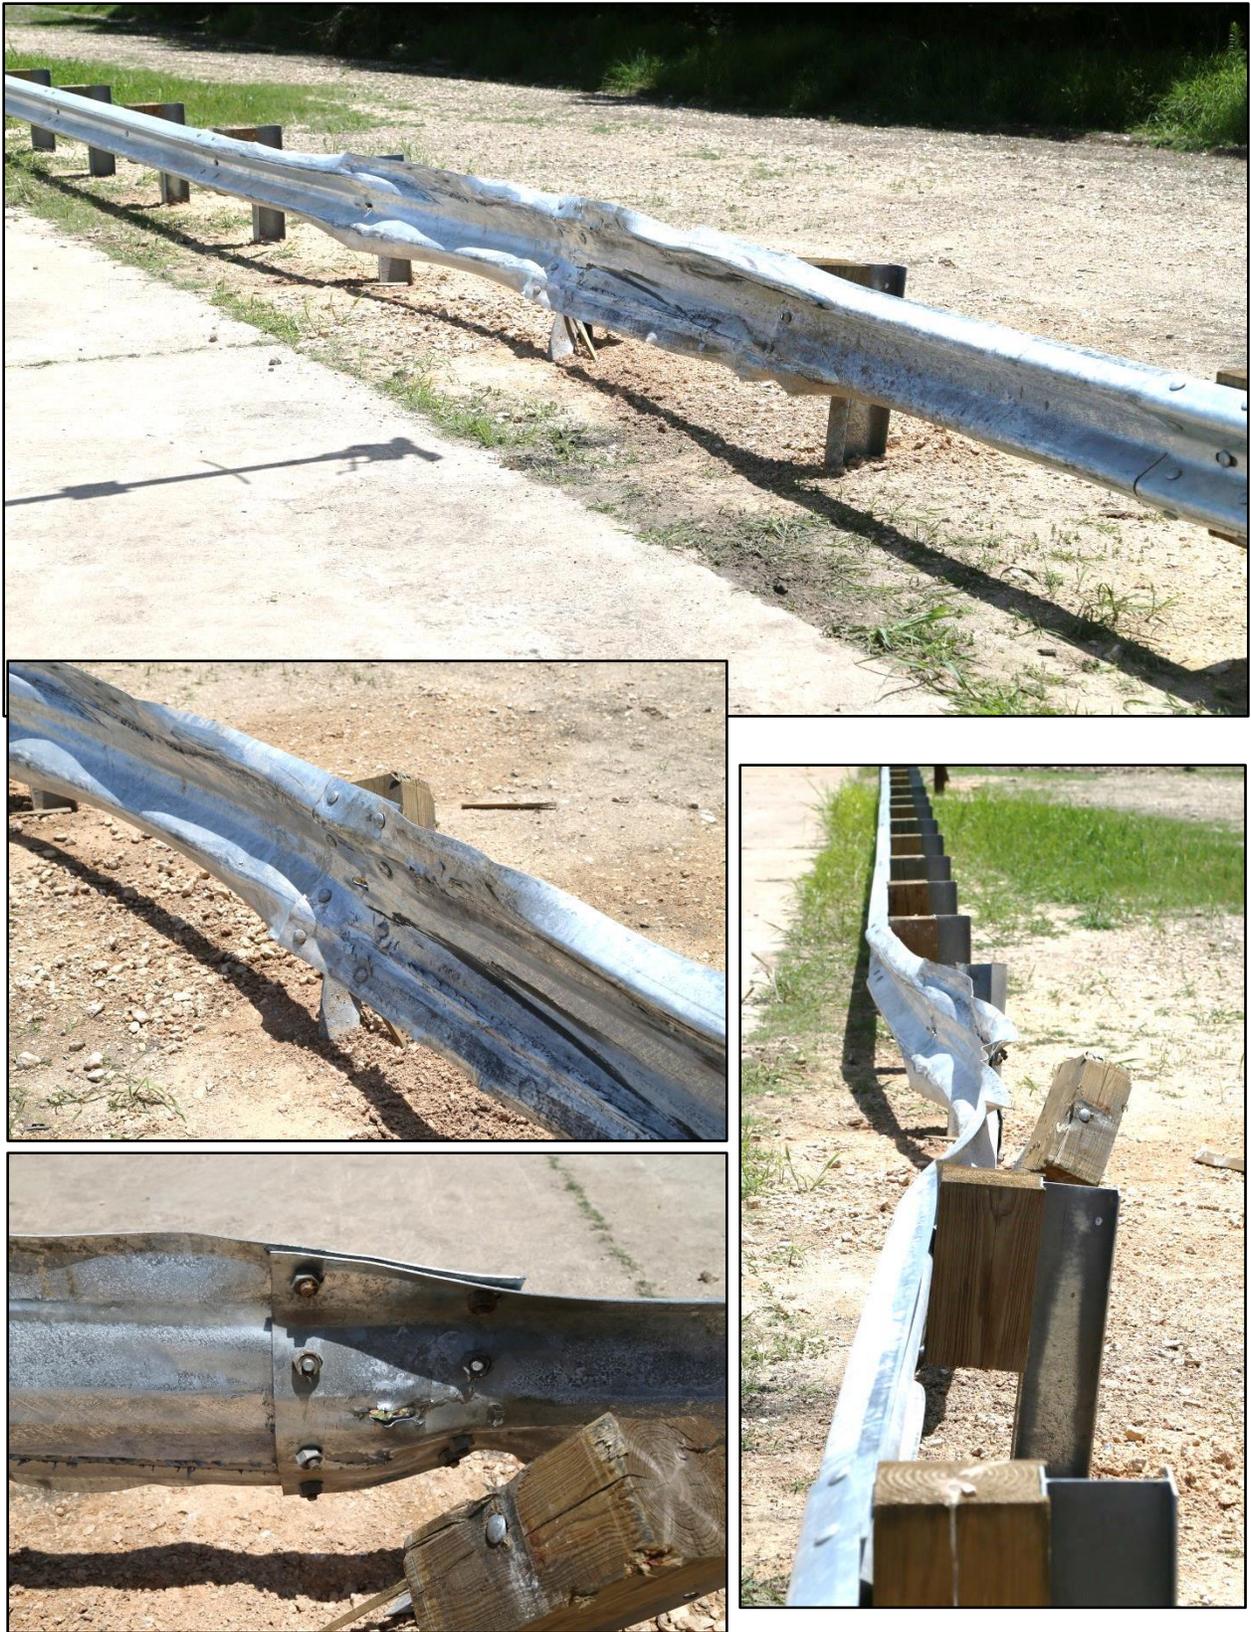
Figure 5.6. Installation after Test No. 6012361-2.

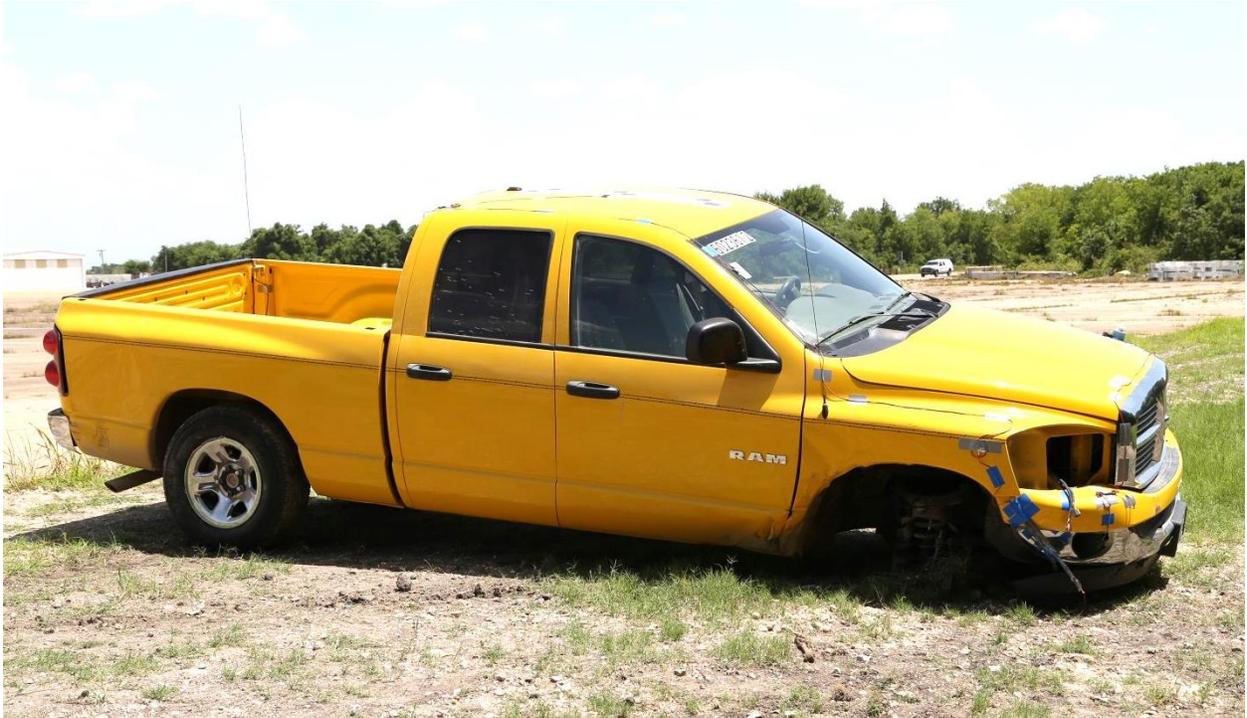
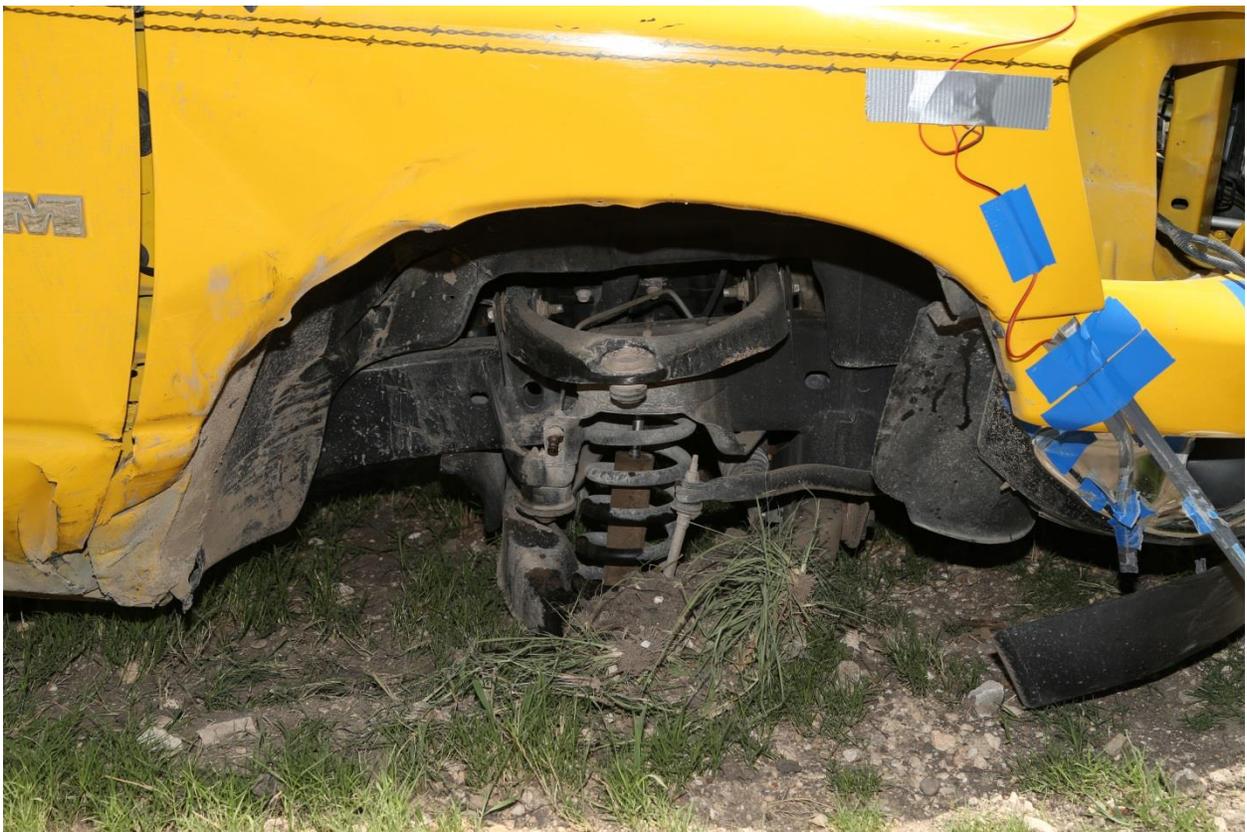
Figure 5.7. Vehicle after Test No. 6012361-2.

Figure 5.7 shows damage to the vehicle after the test. The right front upper ball joint was pulled out of the socket, the right lower ball joint broke at the mount, and the inner tie rod was pulled out of the socket. The front bumper, right front tire and wheel rim, right front fender, right front door, right rear quarter panel, and rear bumper were deformed. Maximum exterior crush was 13.0 inches in the side plane at the right front corner at bumper height. No occupant compartment deformation or intrusion was evident. Figure 5.8 shows the interior of the vehicle. Exterior vehicle crush and occupant compartment measurements are shown in Appendix C.1, Table C.3 and Table C.4, respectively.
