*Research Project Number 2015-17-TE*

# DEVELOPMENT OF THE MANITOBA CONSTRAINED-WIDTH, TALL WALL BARRIER

**MIDWEST ROADSIDE SAFETY FACILITY**

**MANITOBA INFRASTRUCTURE**

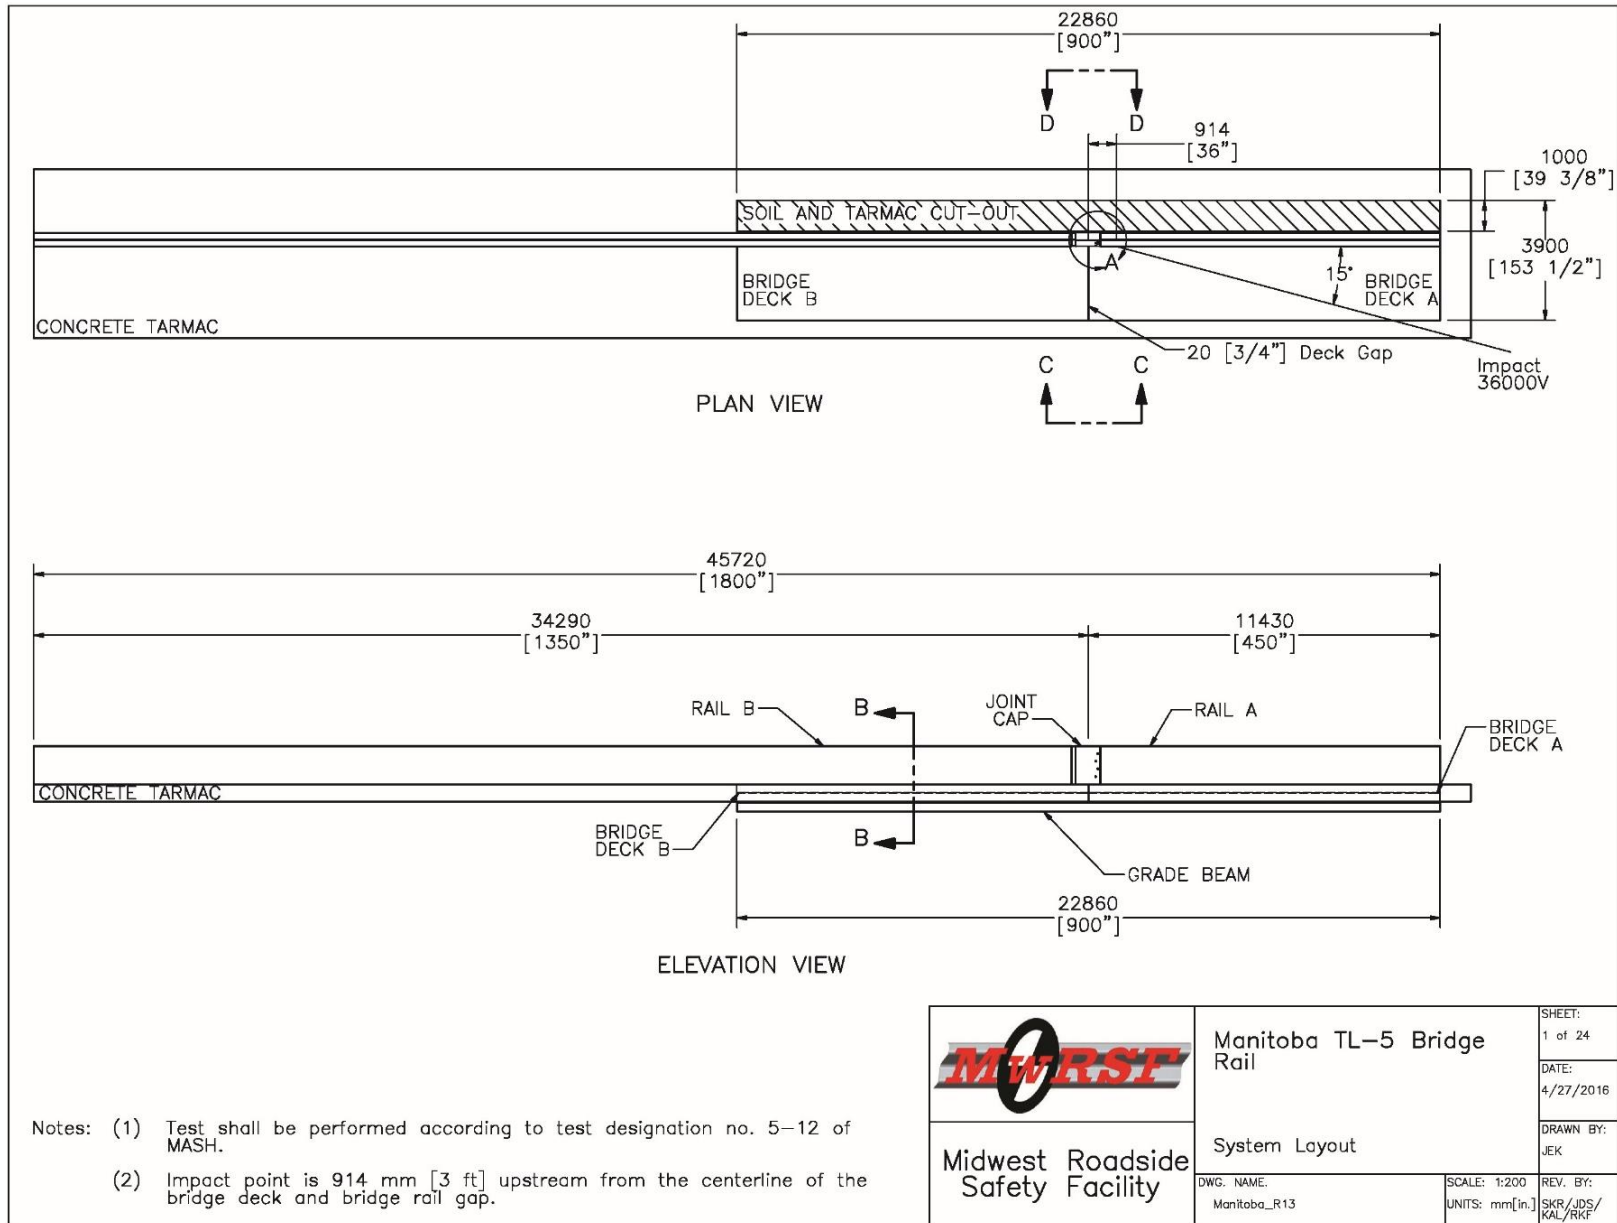
Figure 2 Test Installation Layout, Test No. MAN-1

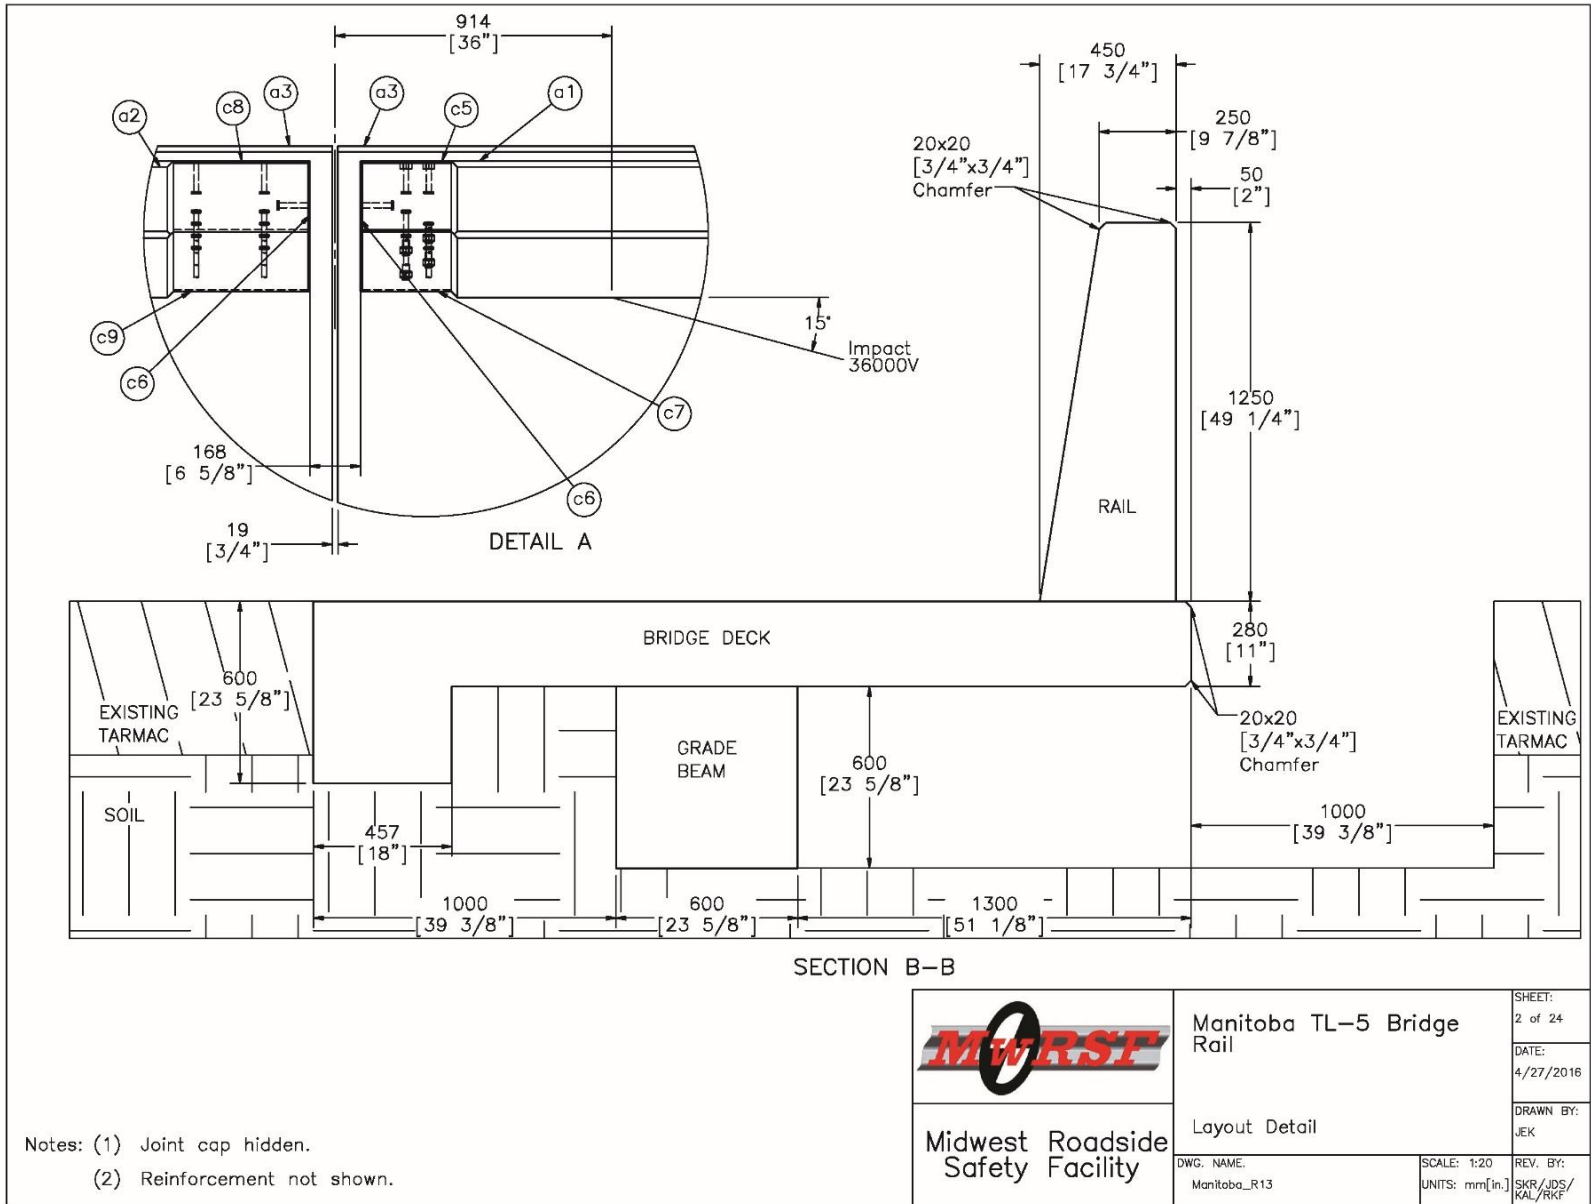
Figure 3. Layout Detail, Test No. MAN-1

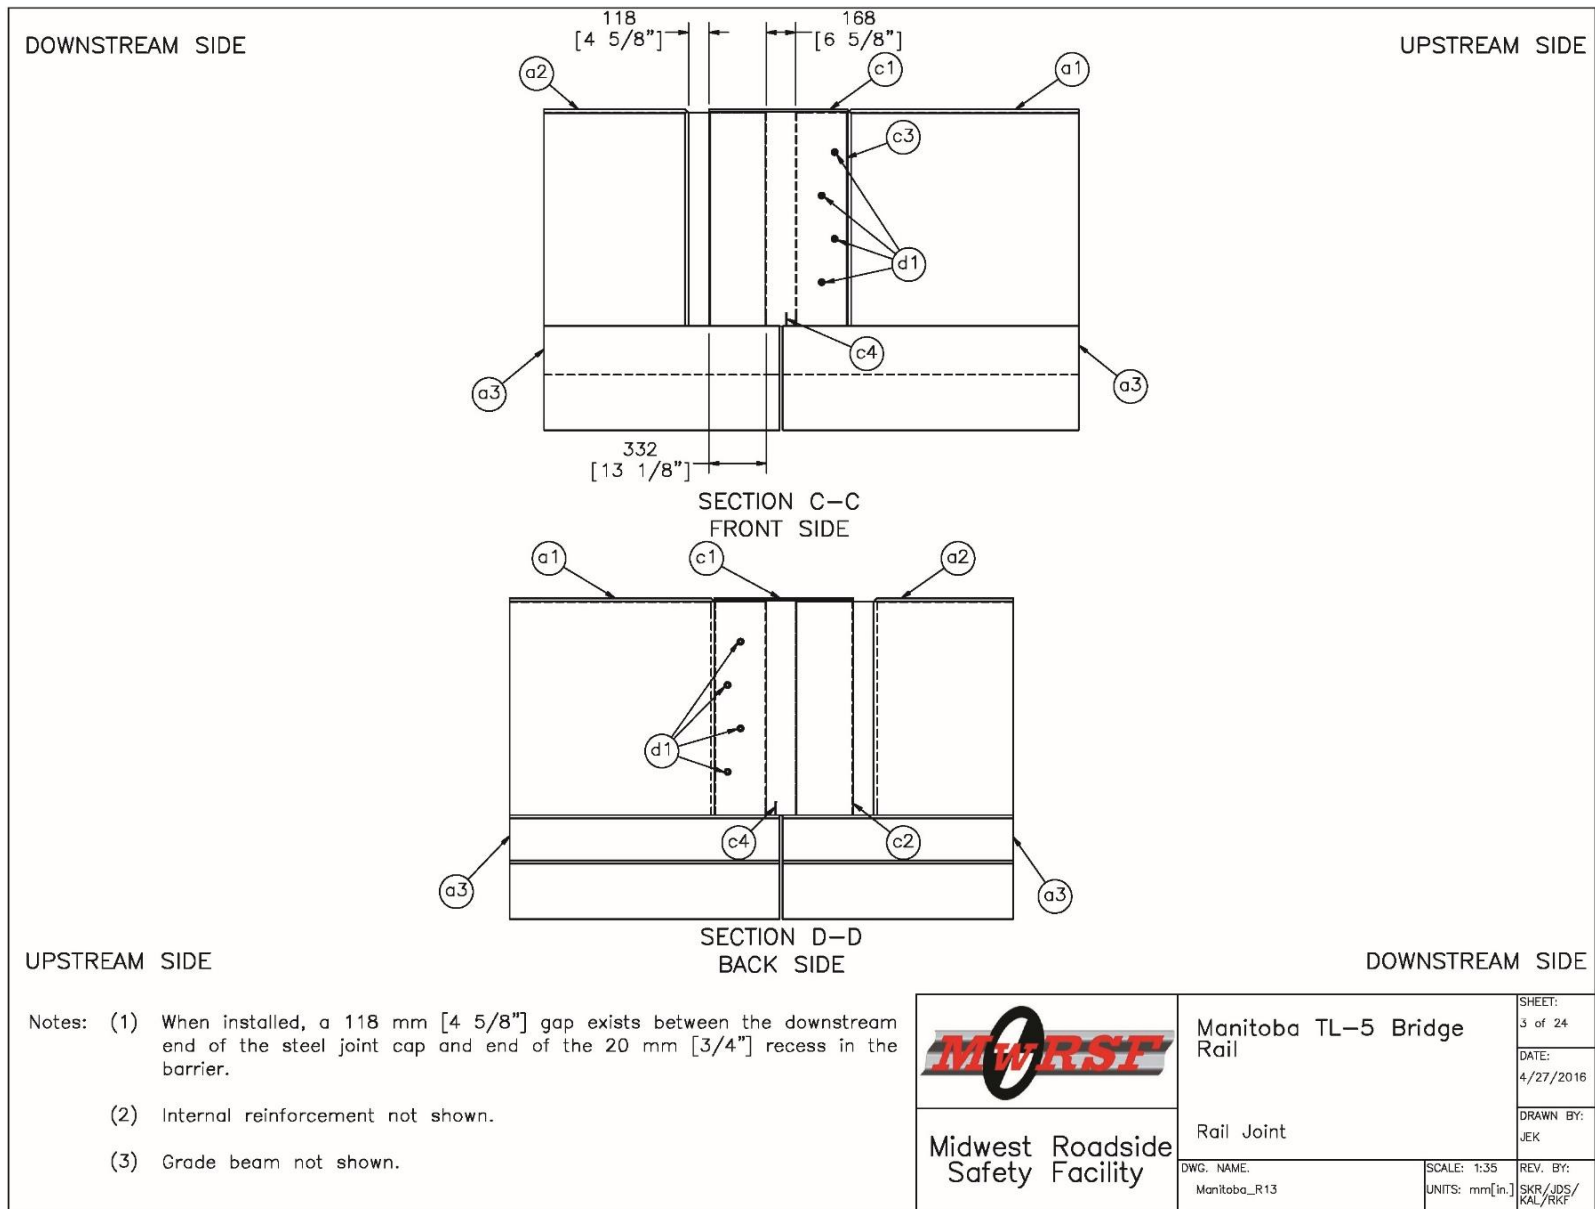
Figure 4. Rail Joint with Cover Plate, Test No. MAN-1

The 168-mm ( $6\frac{5}{8}$ -in.) gap placed in the bridge rail was selected to represent a typical joint opening and to align the transverse reinforcement spacings of the barrier and deck segments without having an odd spacing or extra bar. Joint openings larger than that utilized in test no. MAN-1 are likely to occur in real-world installations. Basic bending calculations indicate the cover plate should be sufficient to shield gap lengths up to 300 mm (12 in.) without it negatively affecting system performance. However, the only sure way to evaluate the maximum gap length is through full-scale crash testing. If gaps larger than 300 mm (12 in.) are necessary due to an inability to cast barrier segments directly to expansion joint hardware in the deck, it is recommended to cast cantilevered extension sections of the barrier over the expansion joint hardware to reduce the gap length. The cantilevered extensions of the barrier should have the same geometry as the adjacent barrier, only the bottom 200 mm (8 in.) of the barrier should be removed. The length of the cantilevered extensions should be held to a minimum while reducing the maximum gap length to less than 300 mm (12 in.), as shown in Figure 76. Barrier reinforcement should be continued into the cantilevered extensions to ensure proper strength. If necessary, the length the steel cover plate should be increased such that it covers at least 100 mm (4 in.) of the full barrier cross section on both sides of the joint.

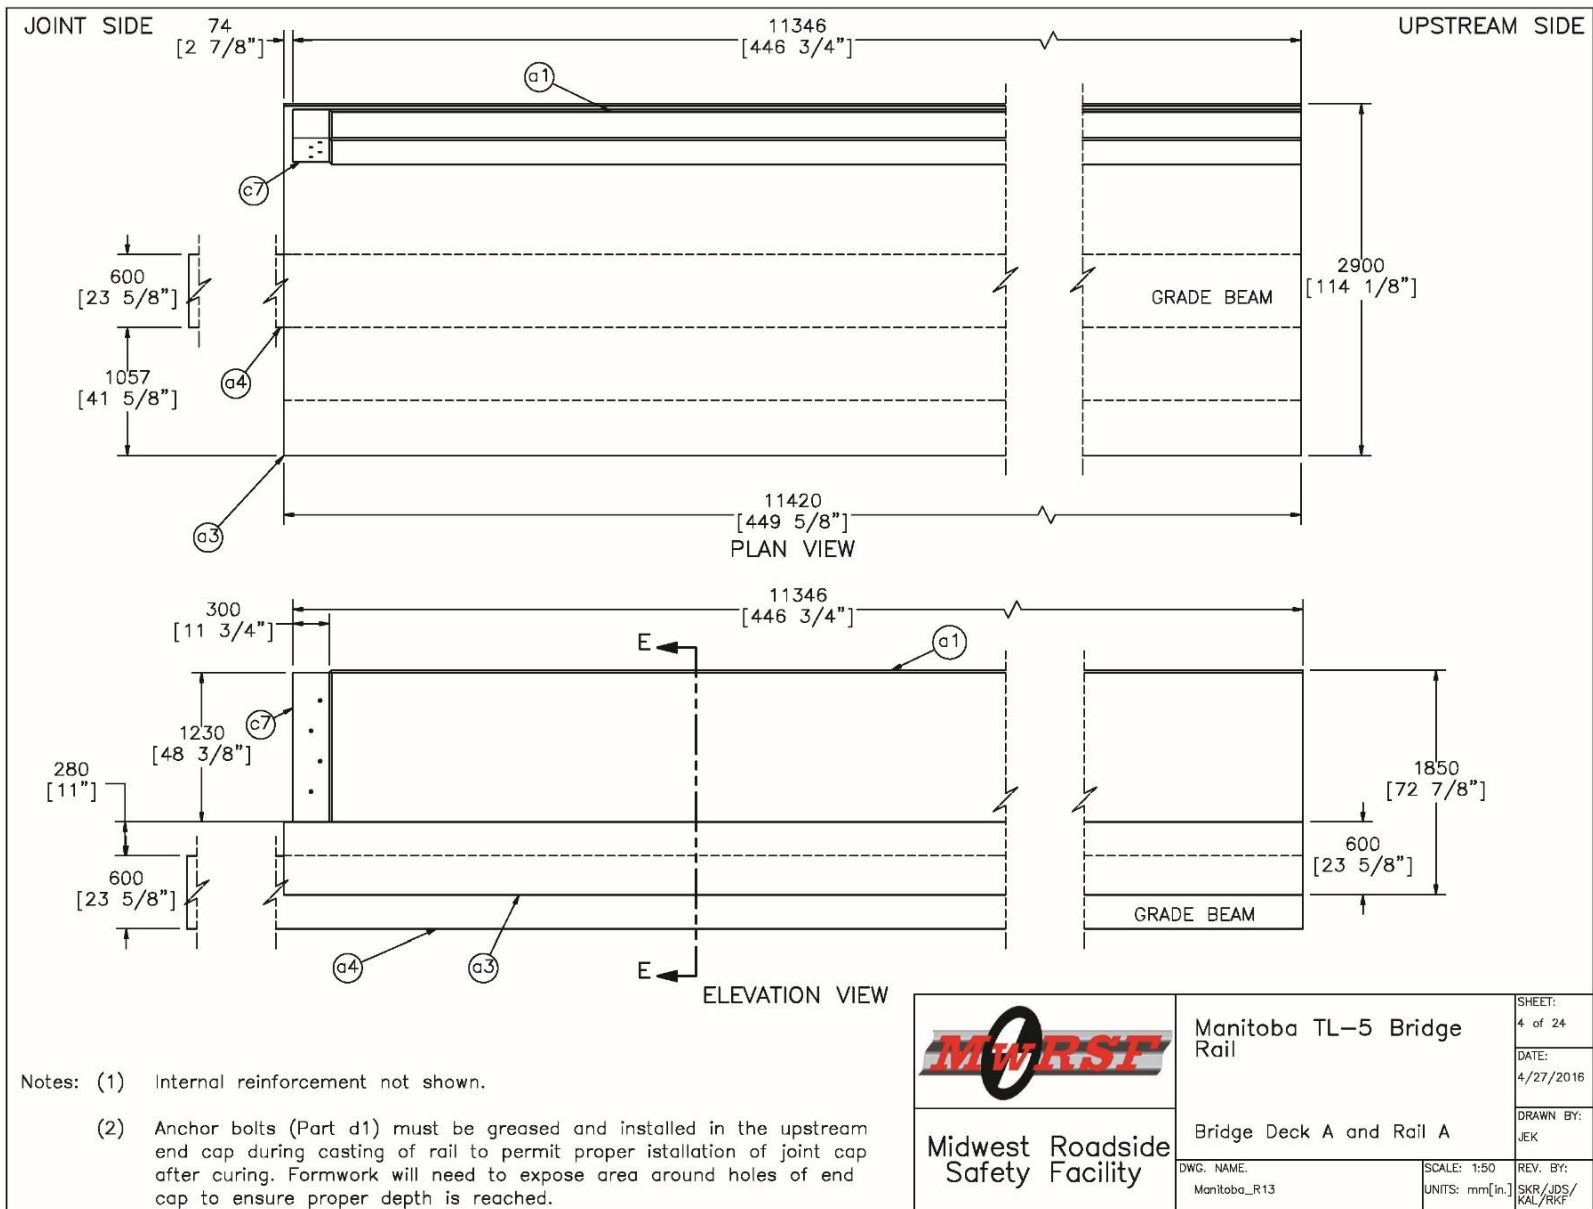
Figure 5. Bridge Deck A and Rail A, Test No. MAN-1

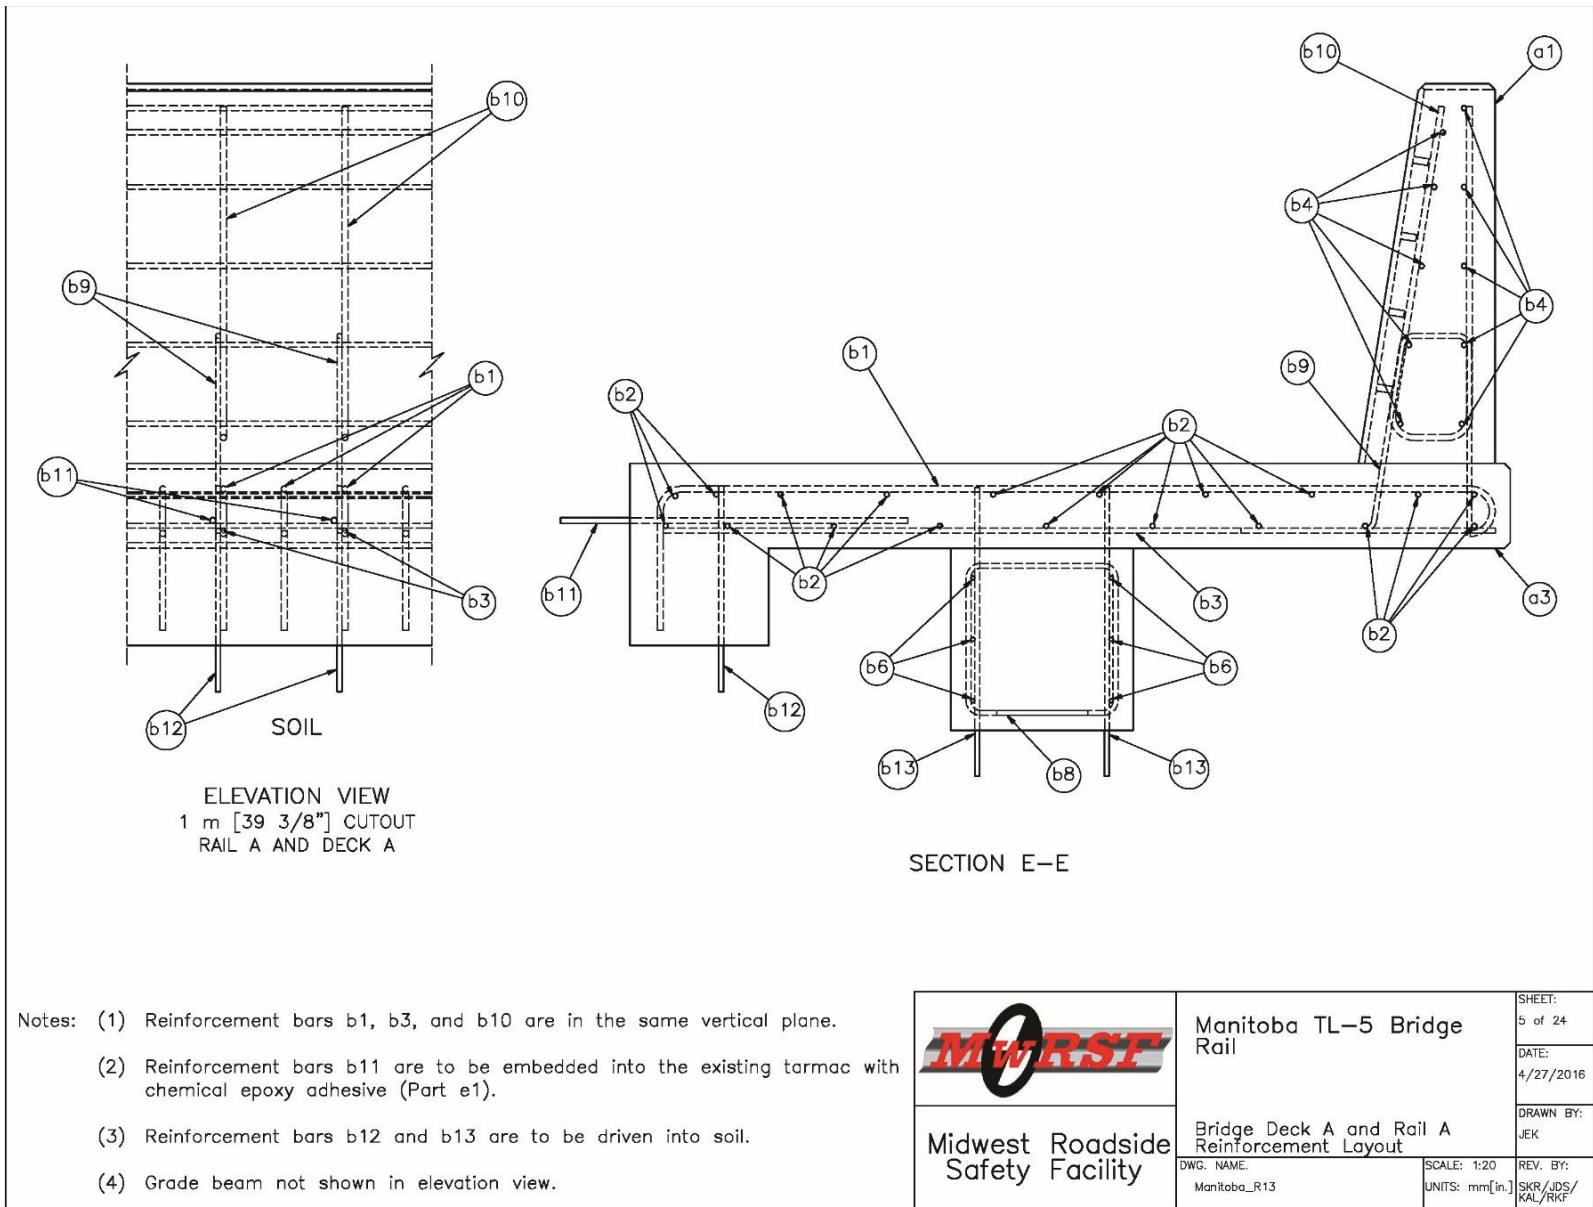
Figure 6. Bridge Deck A and Rail A Reinforcement Layout, Test No. MAN-1

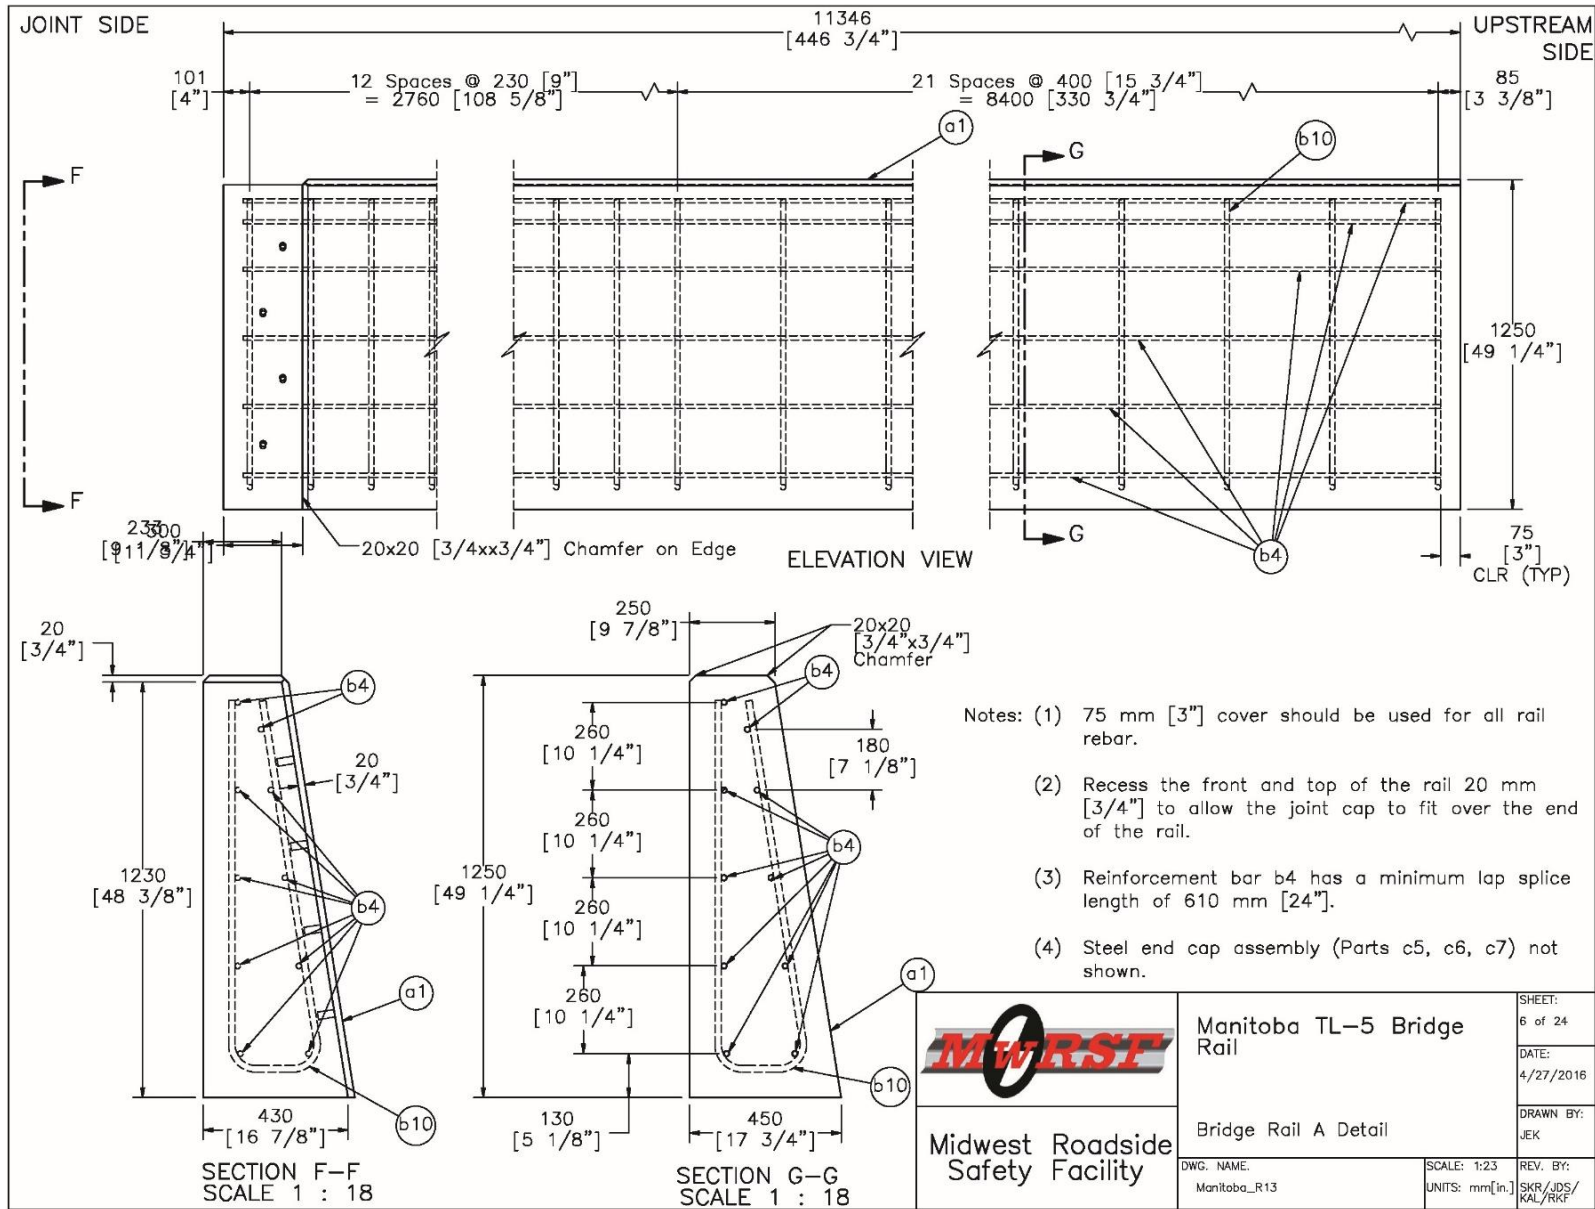
Figure 7. Bridge Rail A Detail, Test No. MAN-1

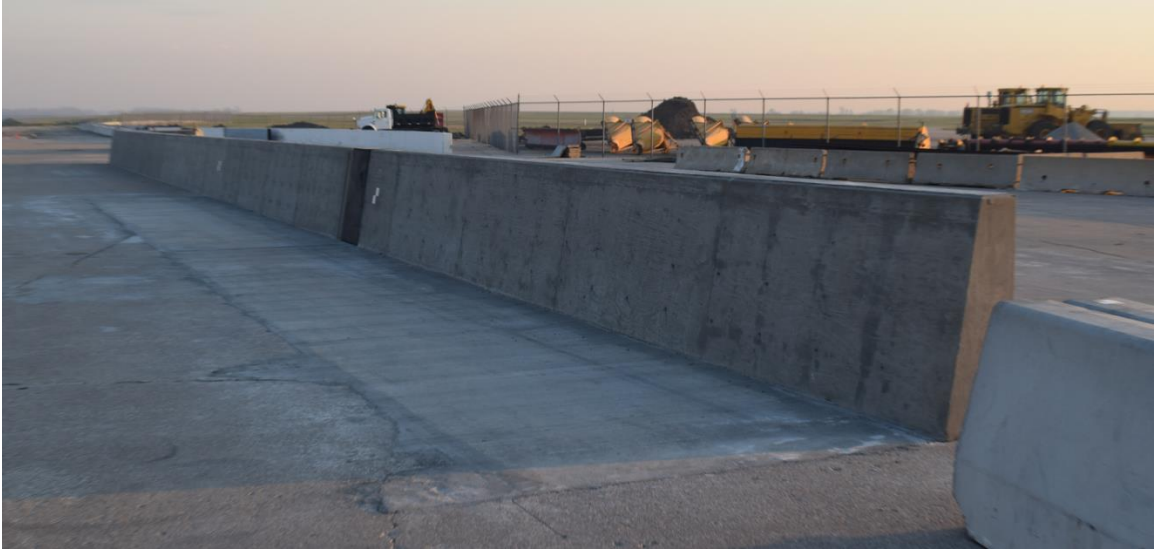
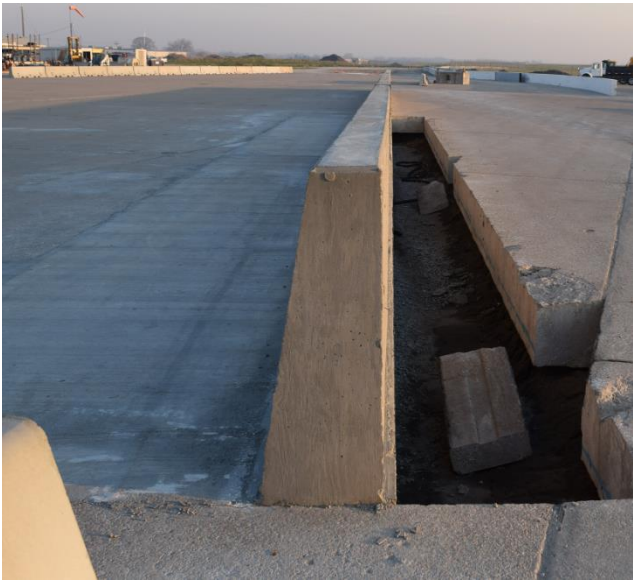
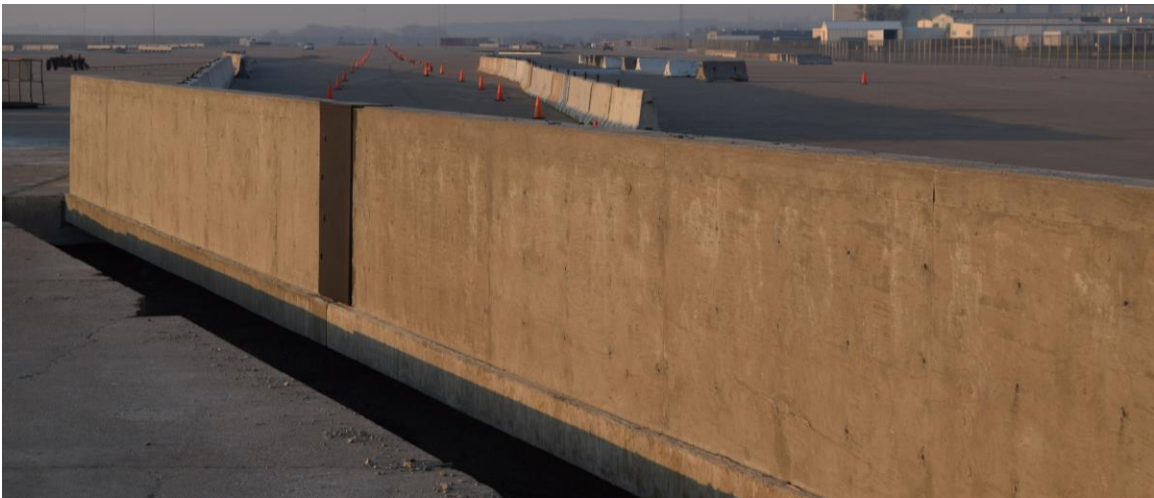
Figure 26. Test Installation Photographs, Test No. MAN-1

The test installation was comprised of a reinforced concrete bridge rail installed on a simulated concrete bridge deck. The total length of the barrier was 45.72 m (150 ft). The upstream half of the barrier was installed on a simulated reinforced concrete bridge deck, while the downstream half was installed on the test site's concrete tarmac. Design details for the test installation are shown in Figures 2 through 25. Photographs of the test installation are shown in Figures 26 and 27. Material specifications, mill certifications, and certificates of conformity for the system materials are shown in Appendix A.

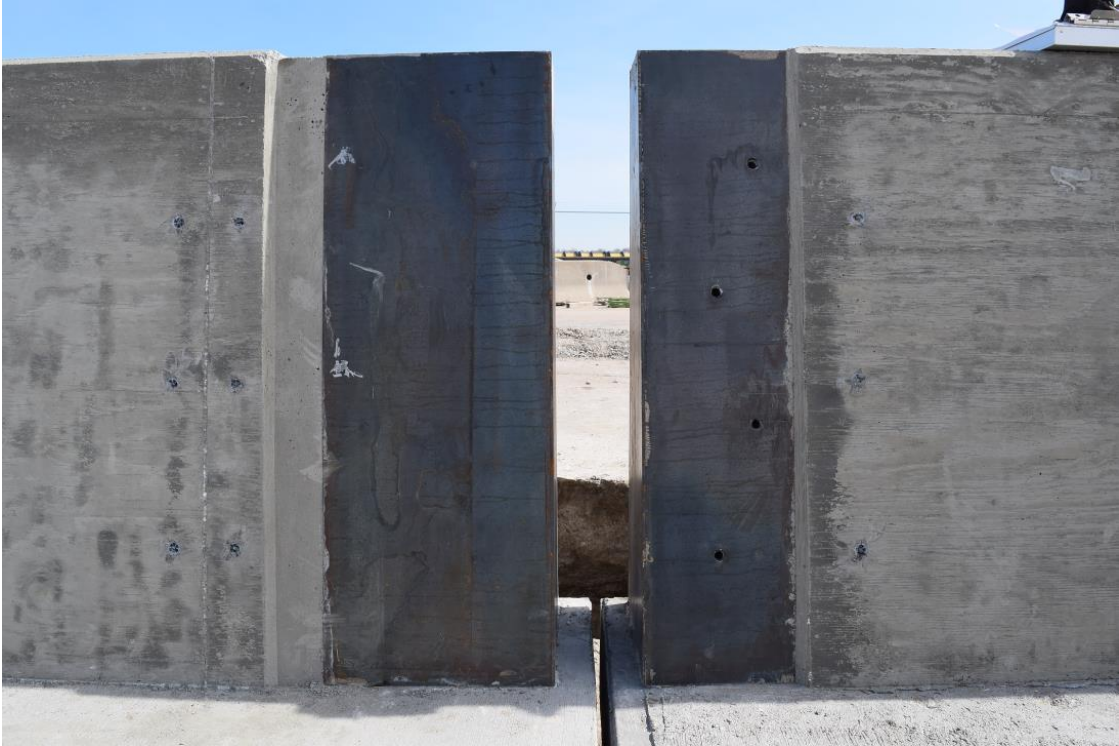
Figure 27. Barrier Joint Photographs, Test No. MAN-1

The bridge rail contained a simulated expansion/contraction joint consisting of a 168-mm (6⅝-in.) open gap in the barrier. This distance was selected to represent typical gaps widths in real-world installations and to match up with the transverse steel reinforcement in the deck without requiring abnormal rebar spacing. A cover plate, fabricated from 13-mm (½-in.) thick steel, was placed over the joint and bolted to the upstream side of the barrier, as shown in Figures 18 and 19. The bolts were 19-mm (¾-in.) diameter, flat head, countersunk bolts that laid flush with the cover plate when installed. Steel end caps, containing the corresponding nuts, as shown in Figures 20 through 22, were cast into the ends of the bridge rail adjacent to the open gap. The barrier was recessed 19 mm (¾ in.) adjacent to the joint so that the cover plate was flush with the face of the barrier. Additionally, the leading edge of the cover plate cap was chamfered to prevent vehicle snagging. Photographs of the joint with and without the cover plate are shown in Figure 27. End section reinforcement, characterized by reduced stirrup spacing, was utilized for a distance of 2.86 m (9.4 ft) both upstream and downstream from the open joint.

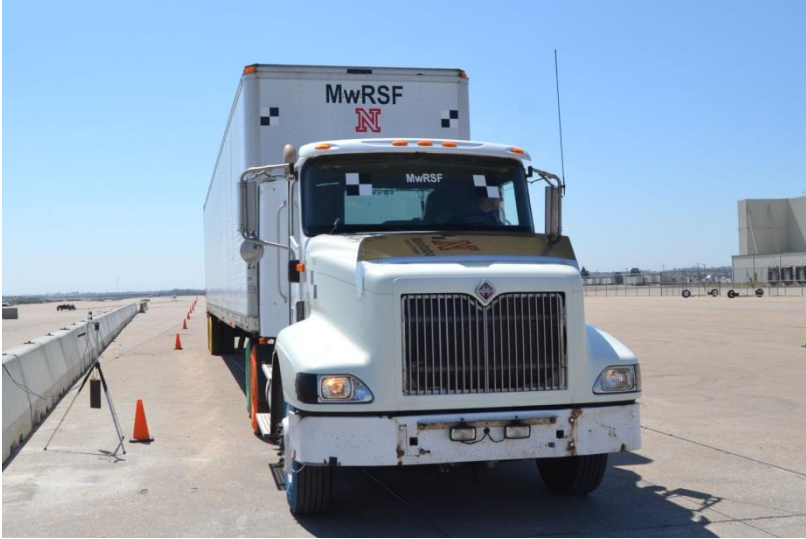
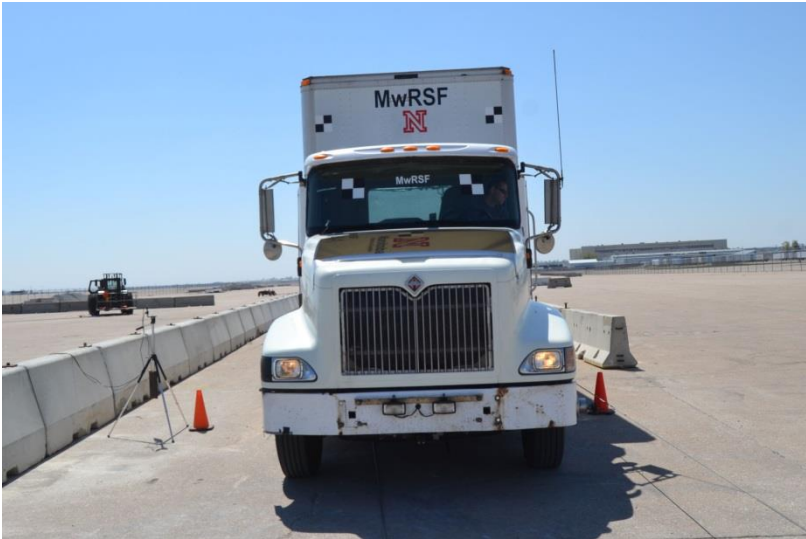
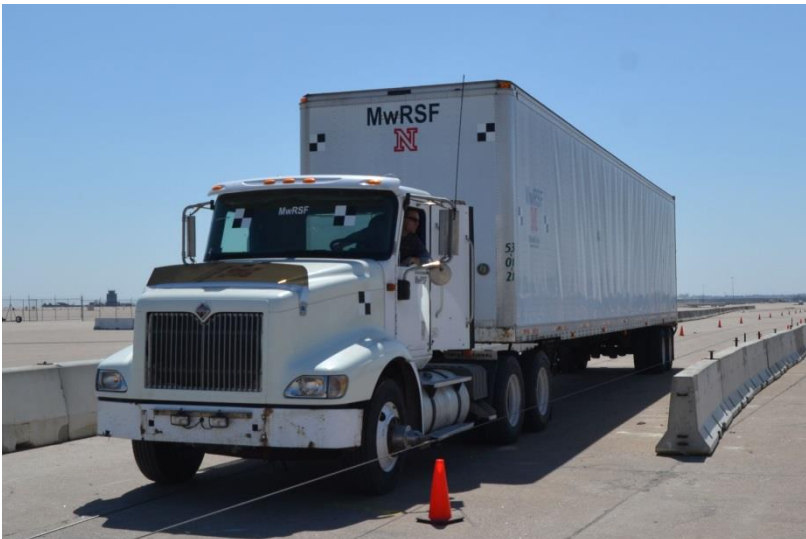
Figure 28. Test Vehicle, Test No. MAN-1

For test no. MAN-1, a 2004 International 9200 tractor with a 2001 Wabash National 16-m (53-ft) trailer was used as the test vehicle. The curb, test inertial, and gross static vehicle weights were 13,481 kg (29,720 lb), 36,322 kg (80,076 lb), and 36,322 kg (80,076 lb), respectively. The impact-side tires were sprayed with different colored chalk in order to determine where each wheel impacted the bridge rail during the test. From front to rear, the five tires were colored blue, orange, green, yellow, and red. Portable concrete barriers utilized to ballast the vehicle trailer were bolted to the floor, anchored to the walls with nylon straps, and supported laterally by foam. The test vehicle is shown Figures 28 through 30, and vehicle dimensions are shown in Figure 31.

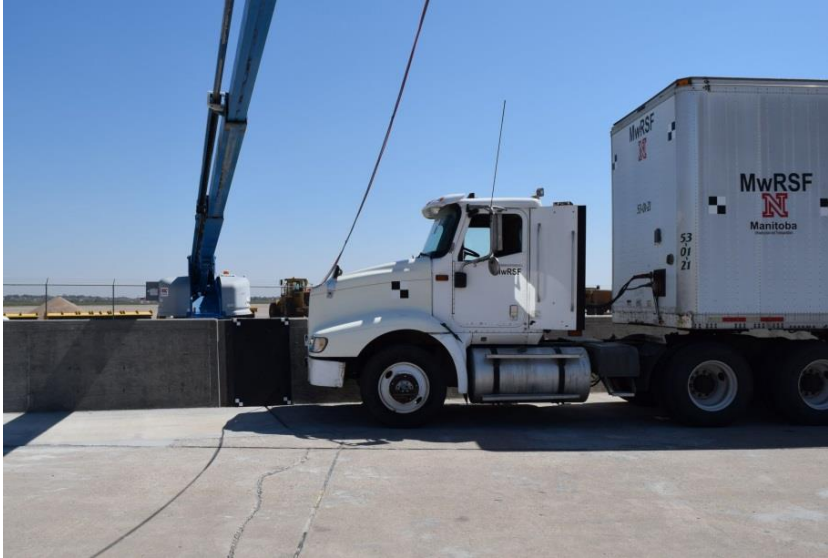
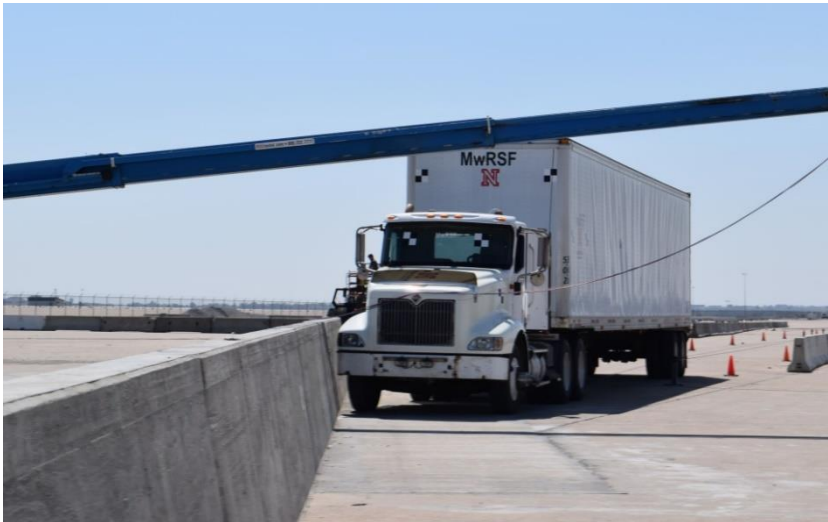
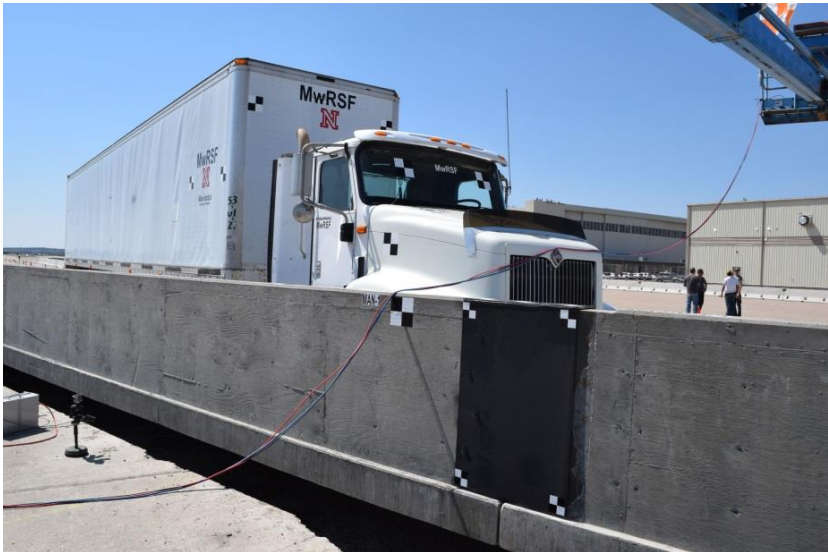
Figure 34. Impact Location, Test No. MAN-1

The 36,322-kg (80,076-lb) van-type, tractor-trailer impacted the bridge rail at a speed of 83.2 km/h (51.7 mph) and at an angle of 15.2 degrees. Initial vehicle impact was to occur 914 mm (3 ft) upstream from the midpoint of the barrier gap, as shown in Figure 34, which was selected to cause the rear tandems to impact and load the bridge rail just upstream from the open joint. The actual point of impact was 462 mm (18.2 in.) upstream from the joint. A sequential description of the impact events is contained in Table 11. A summary of the test results and sequential photographs are shown in Figure 35. Additional sequential photographs are shown in Figures 36 through 37. Documentary photographs of the crash test are shown in Figure 38. The vehicle came to rest against a separate concrete barrier approximately 96 m (315 ft) downstream from the impact point. The vehicle trajectory and final position are shown in Figures 35 and 39.

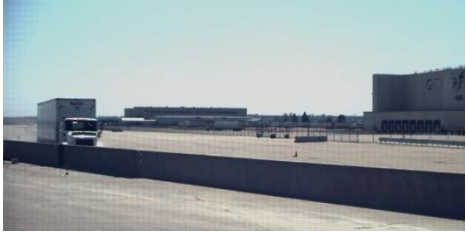
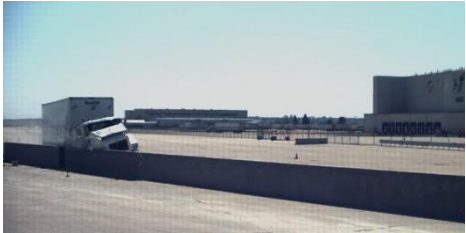
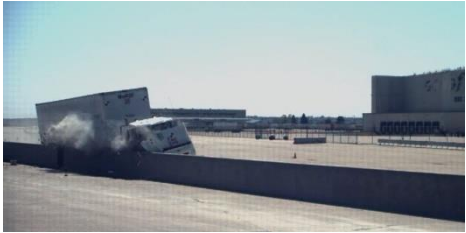
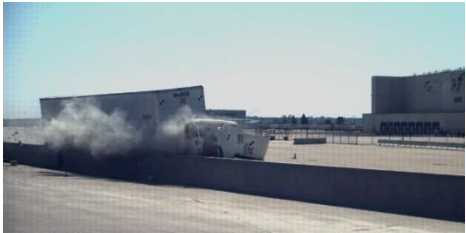
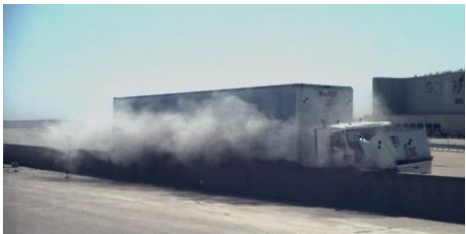
Figure 35. Summary of Test Results and Sequential Photographs, Test No. MAN-1

- Exit Conditions
  - Speed.....61.6 km/h (38.3 mph)
  - Angle .....0 deg.
- Exit Box Criterion .....Pass
- Vehicle Stopping Distance .....96 m (315 ft)
- Vehicle Damage .....Moderate
  - Vehicle Damage Scale [30] .....1FR-6 and 1-RP-1
  - Collision Deformation Classification [31] .....1-FREW3 and 1-RDES1
- Maximum Vehicle Roll
  - Cab .....16.4 deg.
  - Trailer .....13.3 deg.
- Test Article Damage.....Minimal Cracking and Spalling
- Maximum Test Article Deflections
  - Permanent Set .....0 mm (0 in.)
  - Dynamic .....52 mm (2 in.)
  - Working Width .....949 mm (37.4 in.)

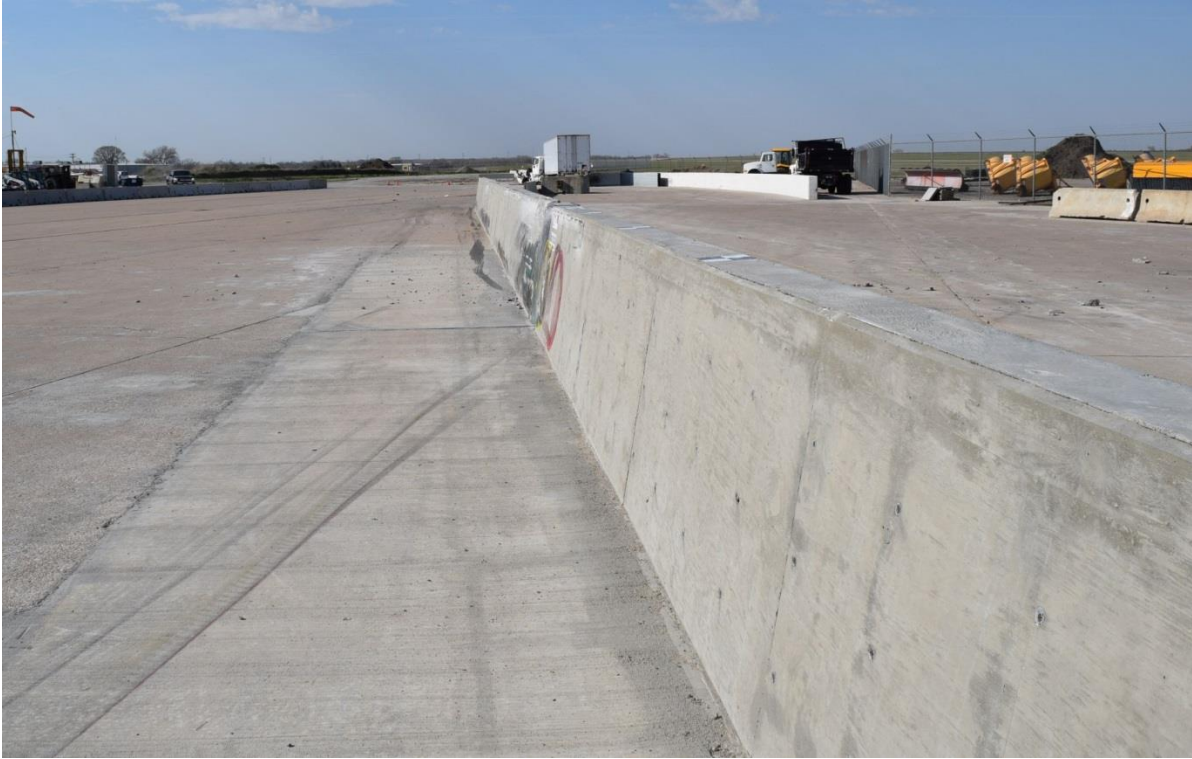
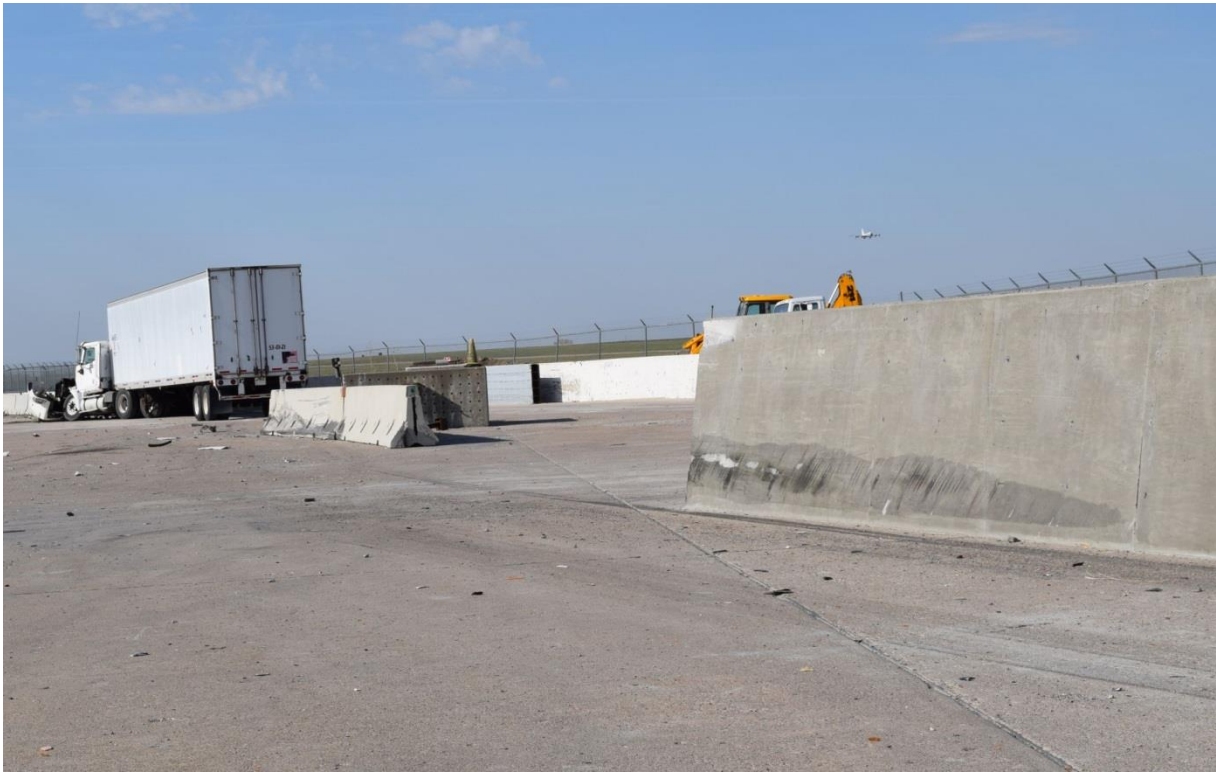
Figure 39. Vehicle Final Position and Trajectory Marks, Test No. MAN-1

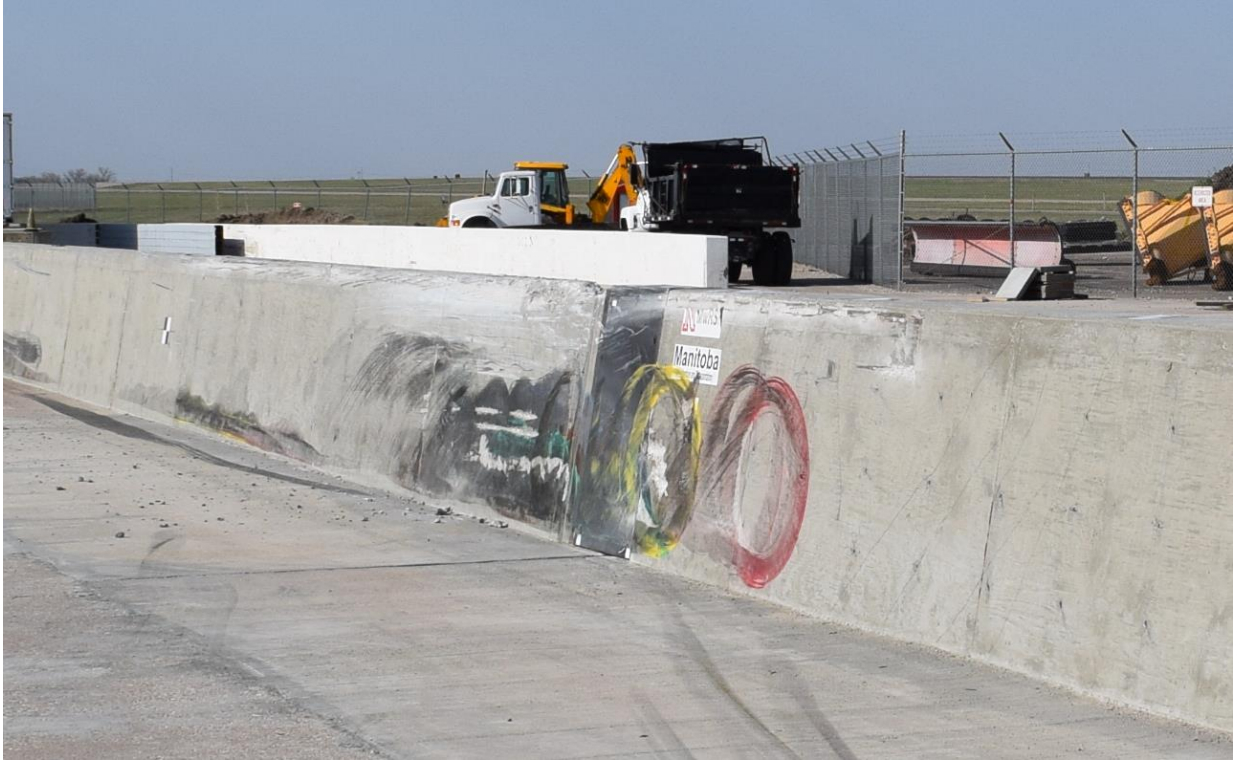
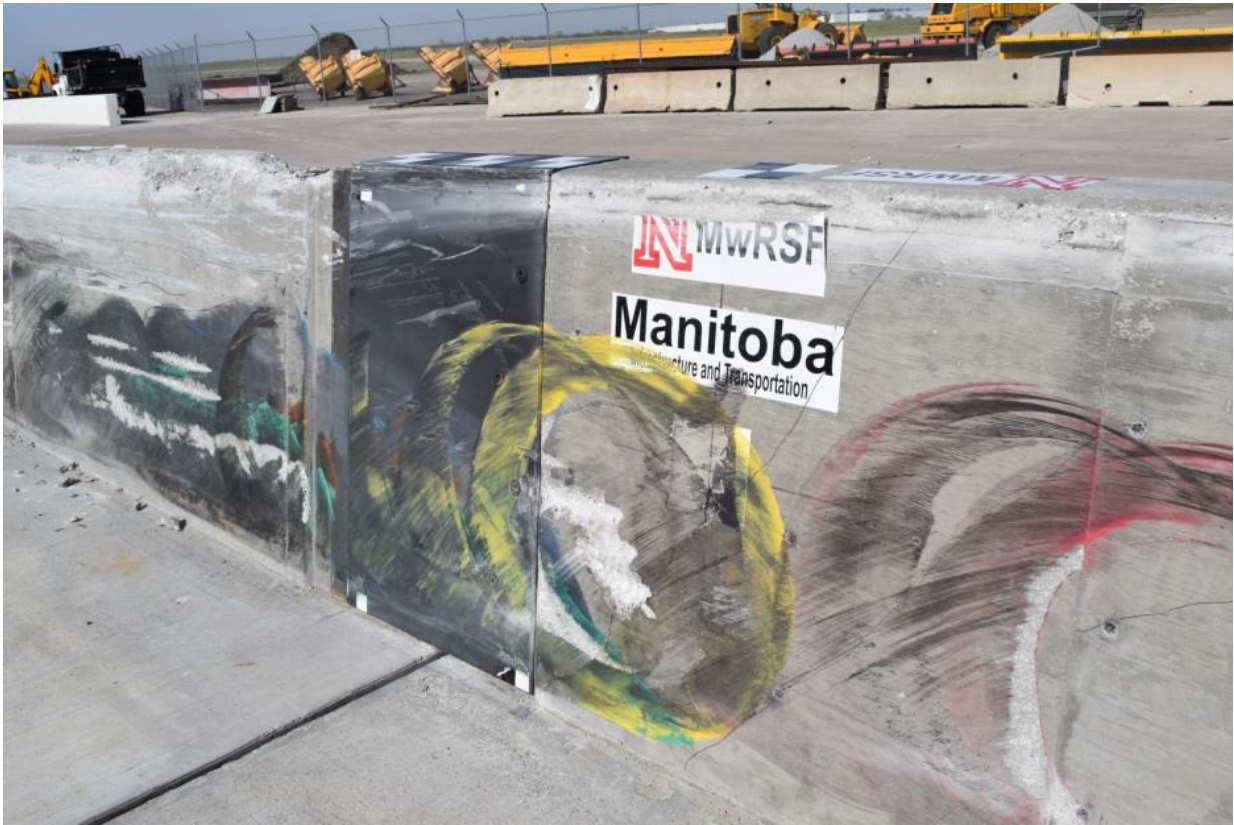
Figure 40. System Damage, Test No. MAN-1

The permanent set of the barrier system was 0 mm (0 in.), as measured in the field. The maximum lateral dynamic barrier deflection was 52 mm (2 in.), as measured at the top of the barrier adjacent to the joint and determined from high-speed digital video analysis. The working width of the system, defined as the furthest lateral extent of the vehicle beyond the front of the barrier, was found to be 949 mm (37.4 in.), also determined from high-speed digital video analysis.
