*Research Project Number 2015-17-TE*

# DEVELOPMENT OF THE MANITOBA CONSTRAINED-WIDTH, TALL WALL BARRIER

**MIDWEST ROADSIDE SAFETY FACILITY**

**MANITOBA INFRASTRUCTURE**

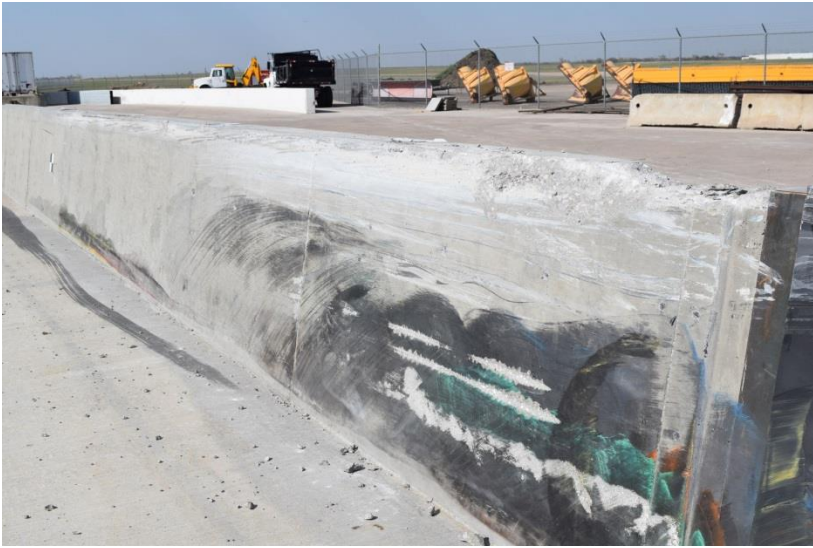
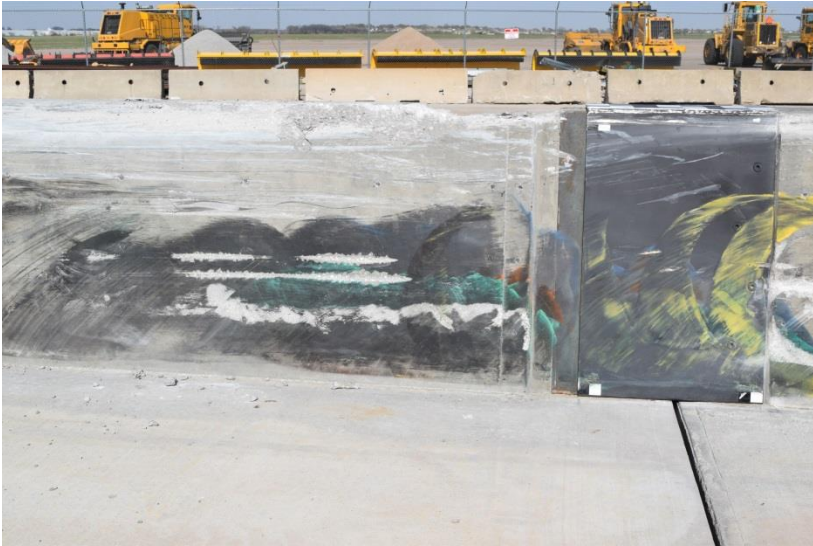
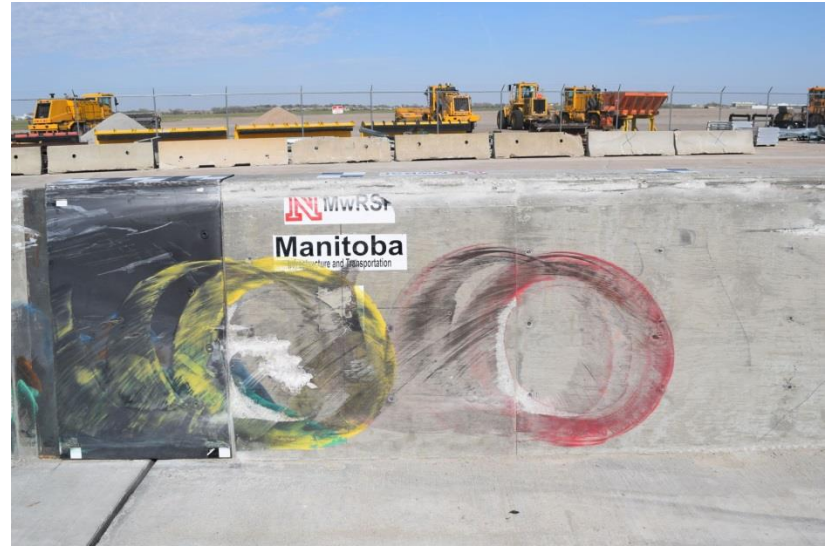
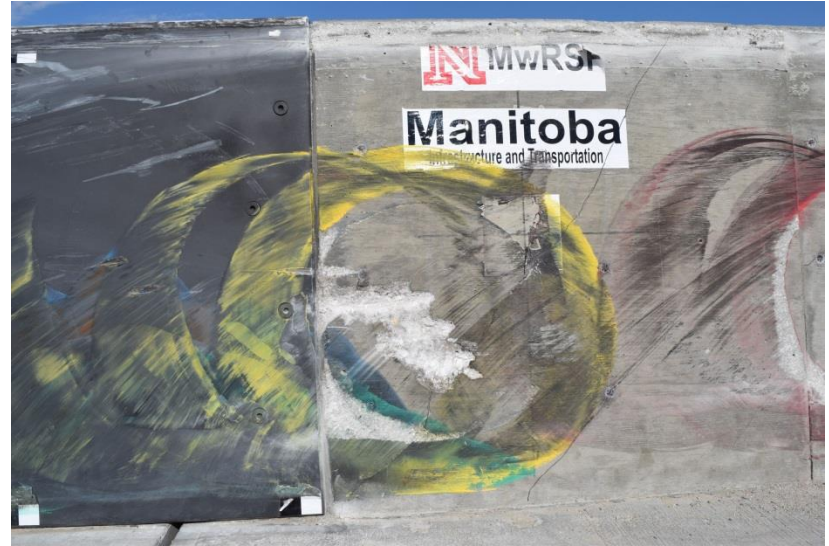
Figure 41. System Damage, Test No. MAN-1

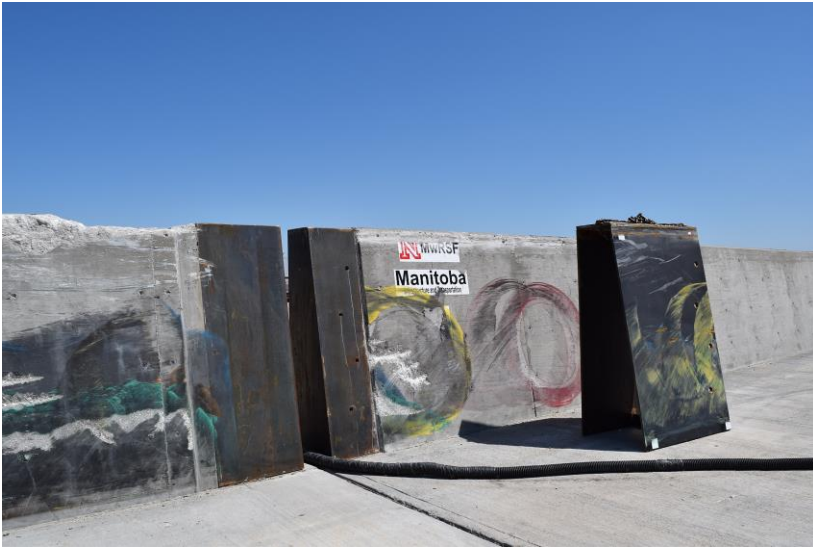
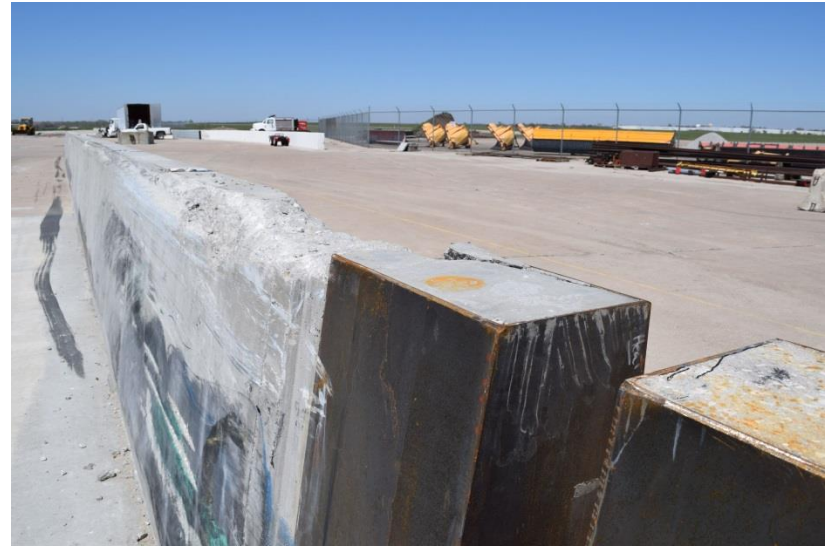
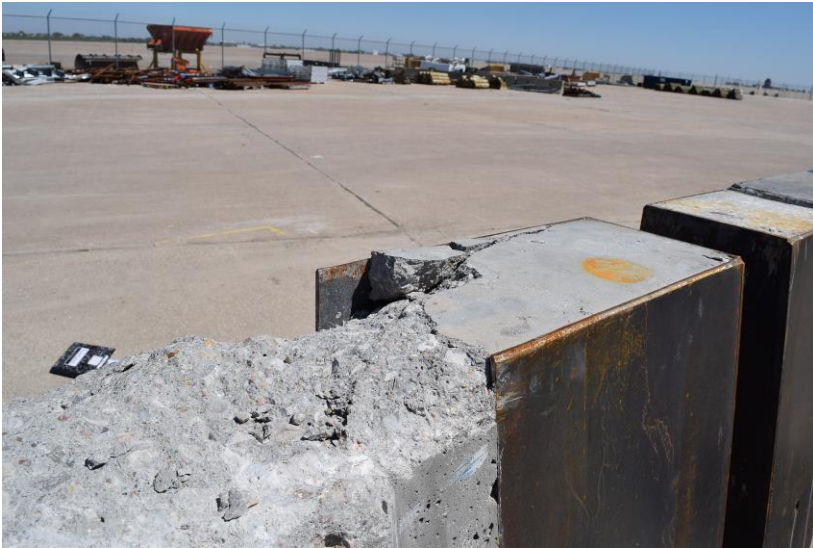
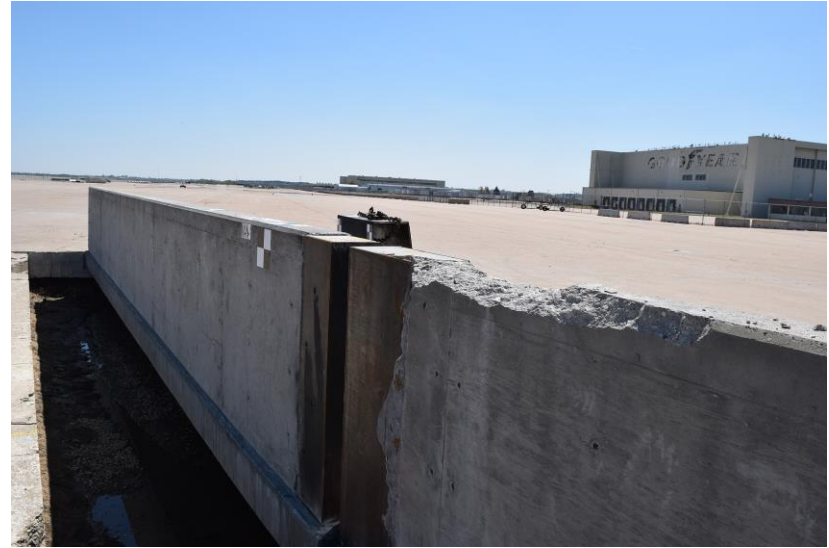
Figure 42. System Damage, Cover Plate Removed, Test No. MAN-1

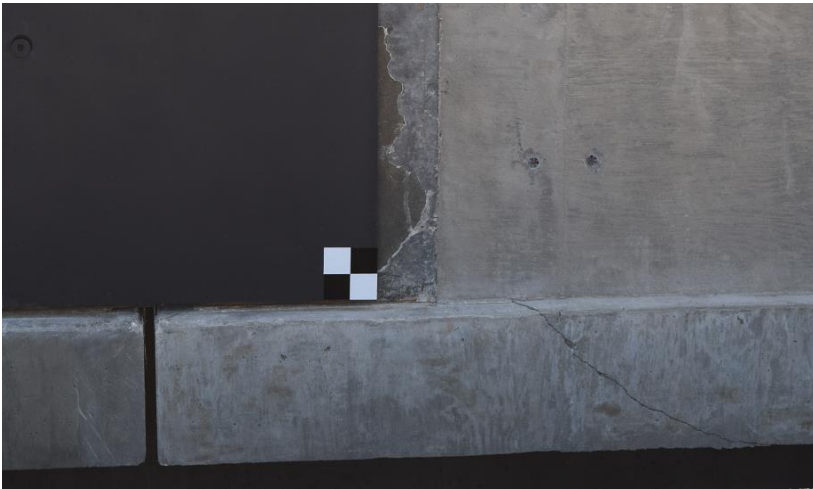
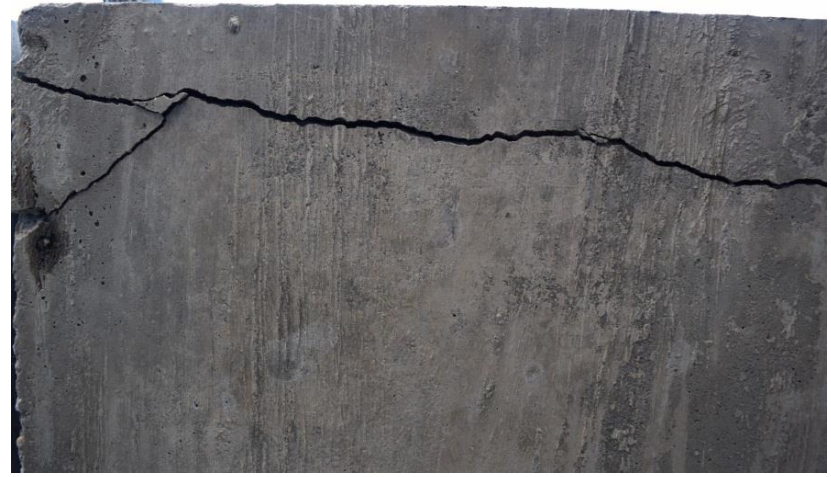
Behind barrier

Bottom of deck, downstream of joint

Figure 43. Deck Damage, Test No. MAN-1

The bridge deck sustained only minor cracking as a result of the impact. A series of longitudinal hairline cracks were found on the surface of the downstream half of the bridge deck located directly over the outside edge of the grade beam. Each individual crack was no longer than 450 mm (18 in.), but all together these cracks spanned a total length of approximately 3 m (10 ft). Two cracks with a maximum opening width of 3 mm ( $1/8$  in.) extended between the steel end cap and the open joint in the deck on the downstream side of the joint, as shown in Figure 43. These cracks continued through the thickness of the deck and merged into a single crack on the bottom surface of the deck. This crack extended 0.6 m (2 ft) downstream from the joint within the outer 50 mm (2 in.) of the bridge deck behind the barrier. The crack continued up the outside face of the bridge deck and diagonally back toward the joint until it reached the base of the barrier. The bridge deck upstream of the open joint experienced no visible cracking.

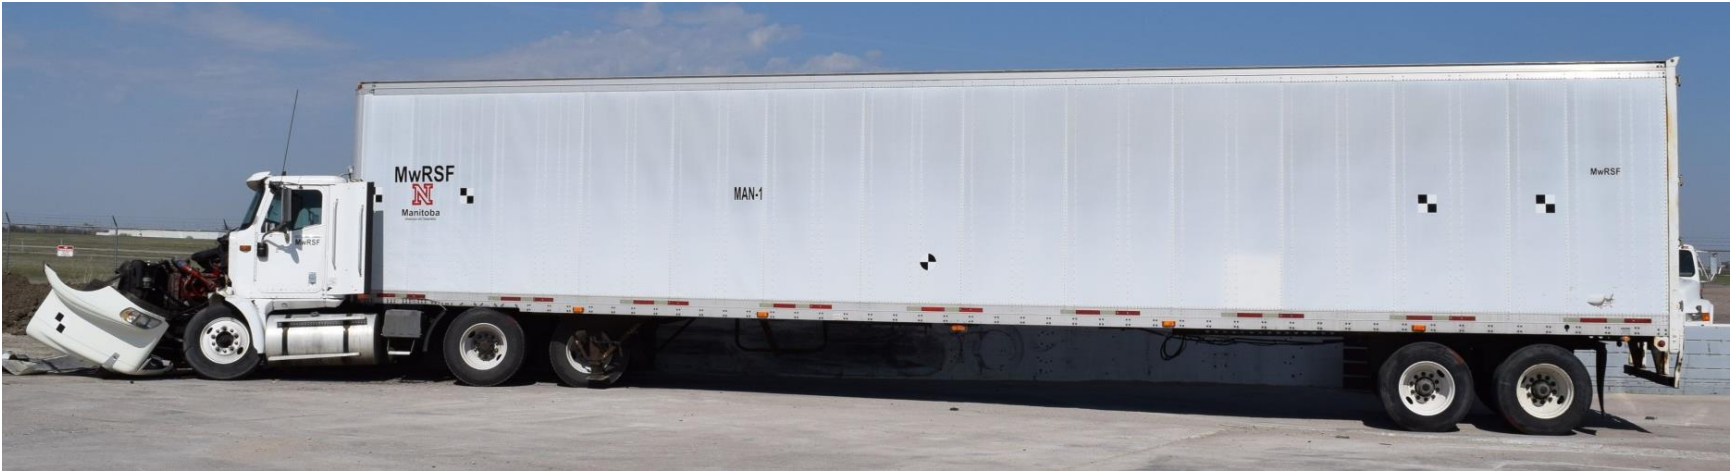
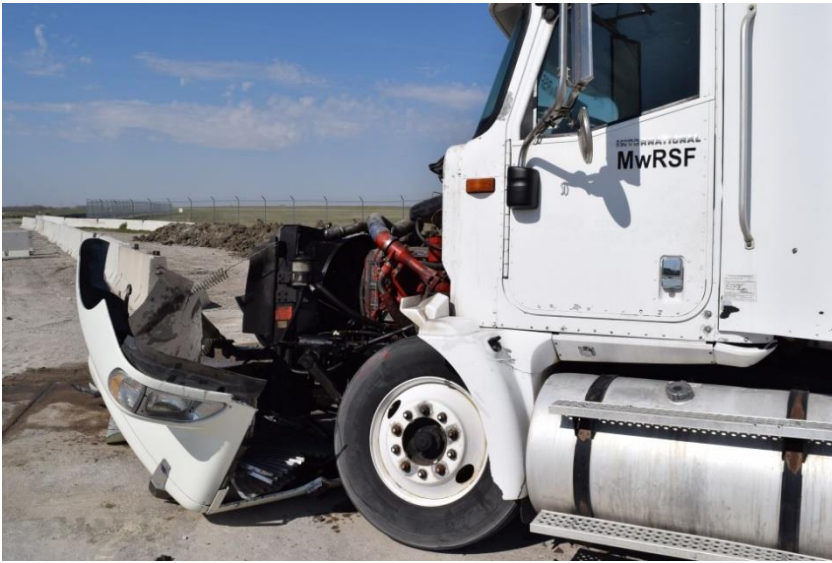
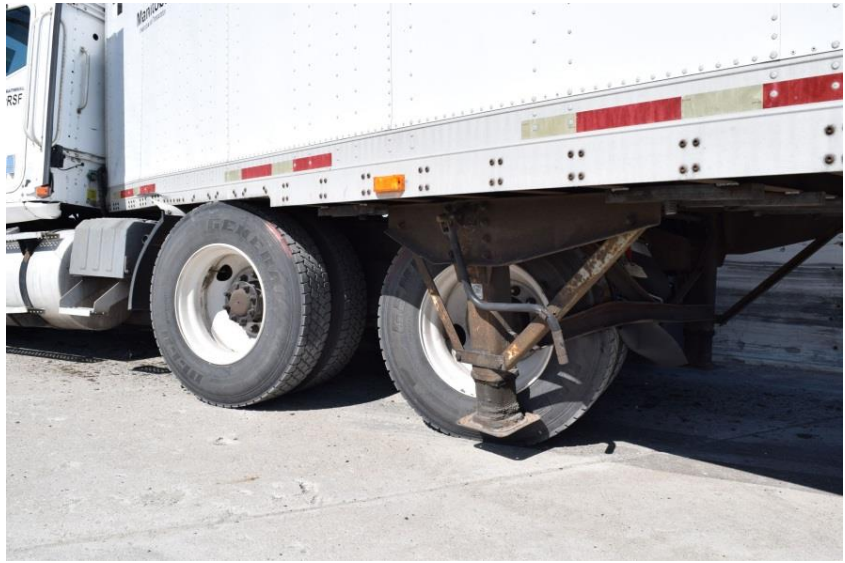
Figure 44. Vehicle Damage, Test No. MAN-1

Although the trailer was still resting on the truck tandem axles, the fifth-wheel plate had torn away from the truck. There was deformation of left-side vehicle support beams under the trailer. The trailer had scraping and dents along the length of its bottom-right edge, with 50 mm (2 in.) of inward crushing extending 432 mm (17 in.) from the front-right corner of the trailer. A 432-mm (17-in.) long tear occurred in the bottom lip of the trailer adjacent to the front-right corner, and a 559-mm (22-in.) long tear occurred in the right-side bottom lip located 1,575 mm (62 in.) behind the front of the trailer. There were 127-mm and 89-mm (5-in. and 3½-in.) long vertical tears in the right side of the trailer located 559 mm and 1,194 mm (22 in. and 47 in.) from the front of the trailer, respectively. The right side of the rear bumper was bent downward, and the right side of the trailer was bulging outward slightly. The left side of the trailer had a 610-mm (24-in.) long tear located 737 mm (29 in.) from the front of the trailer.

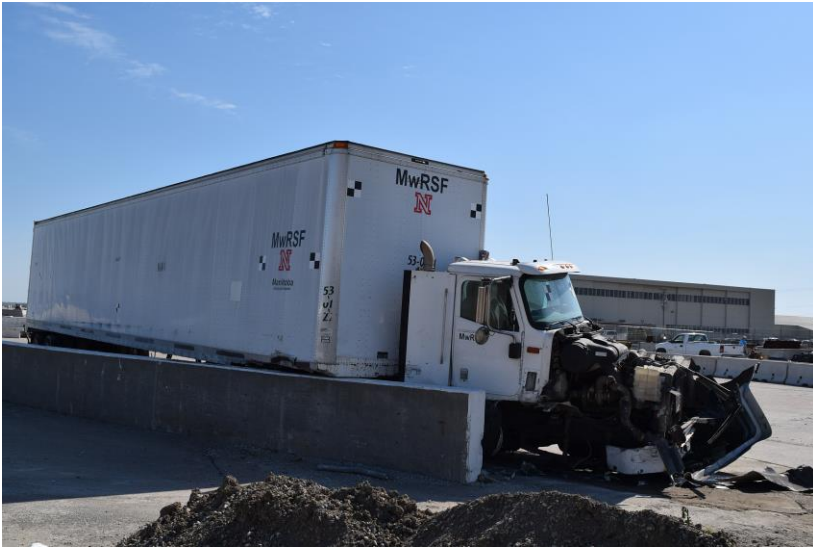
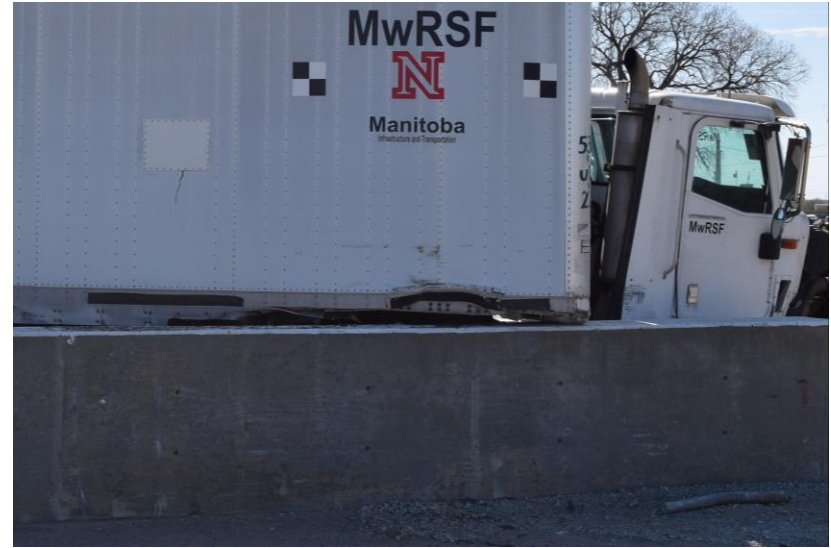
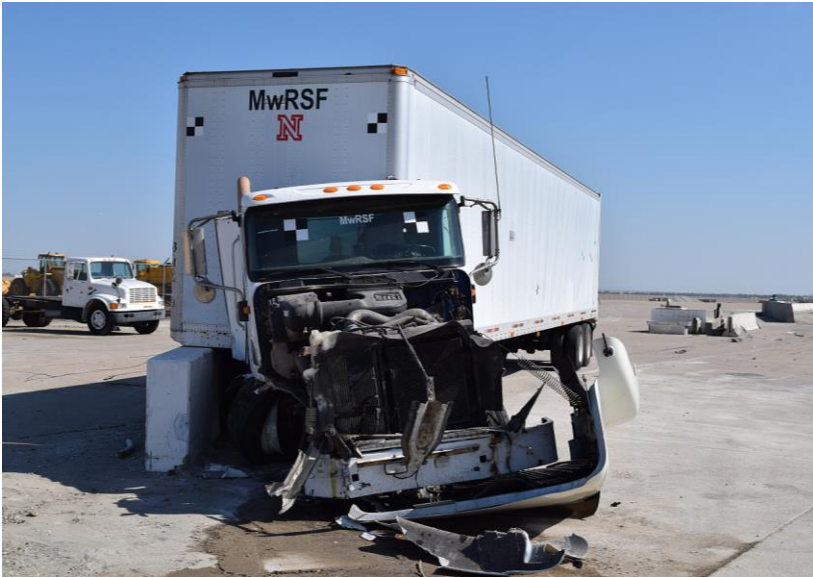
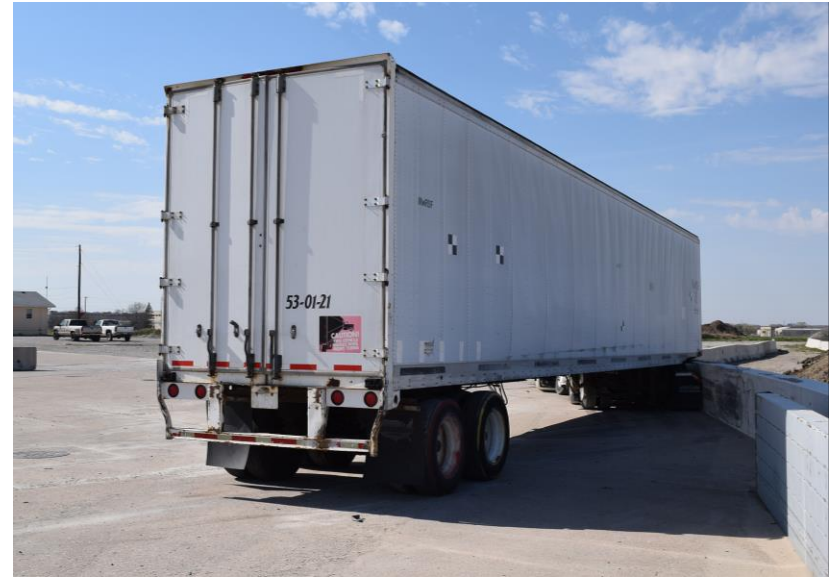
Figure 45. Vehicle Damage, Test No. MAN-1

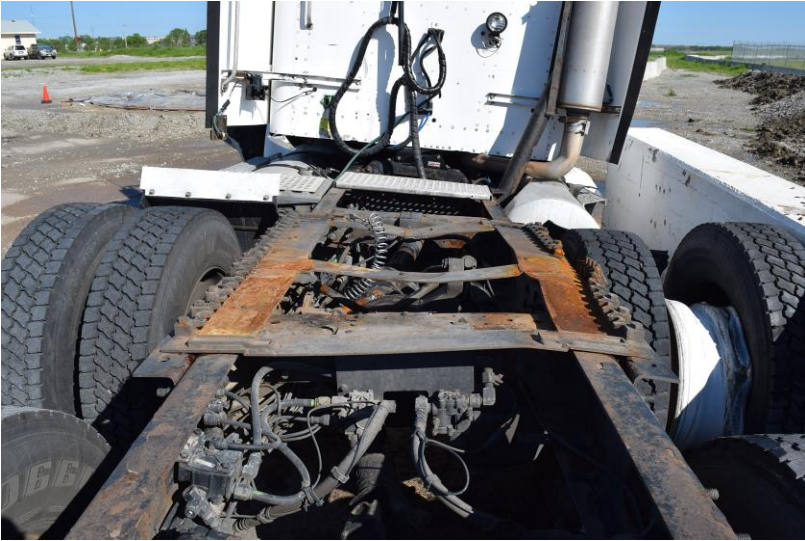
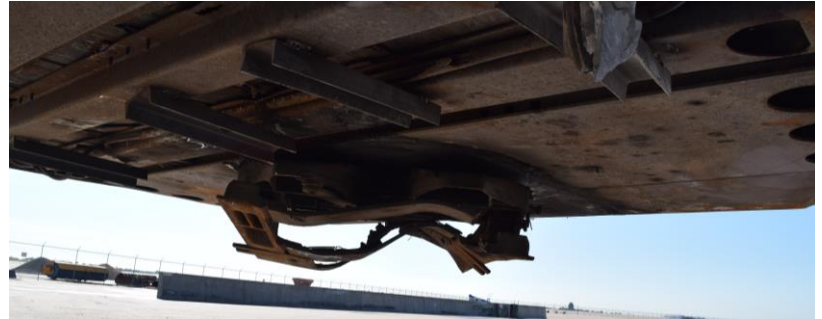
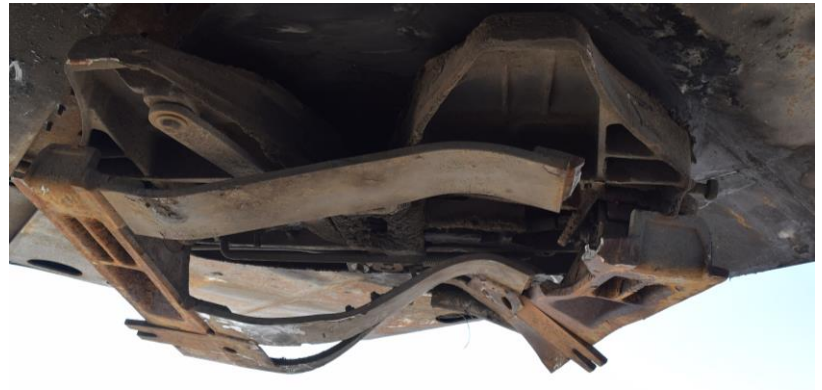
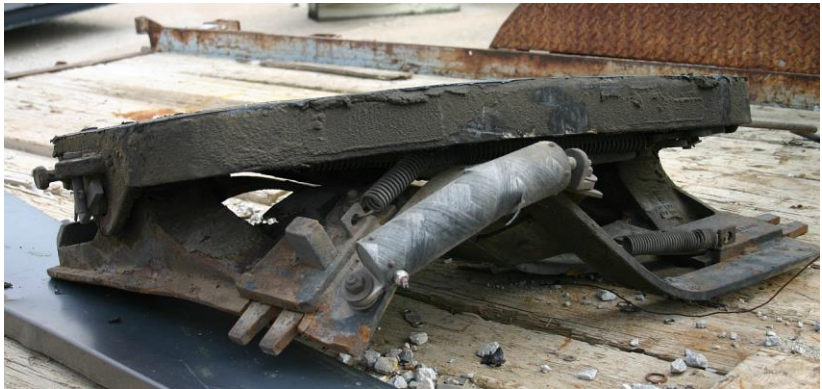
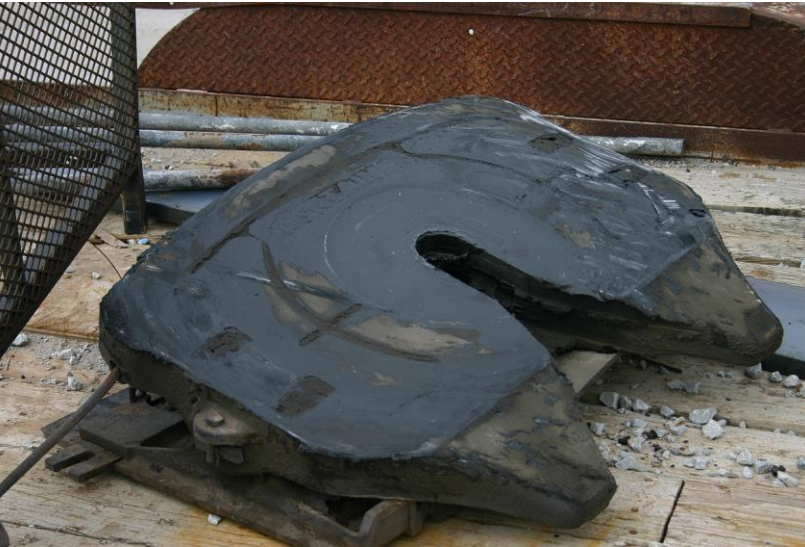
Figure 46. Fifth Wheel Plate Damage, Test No. MAN-1

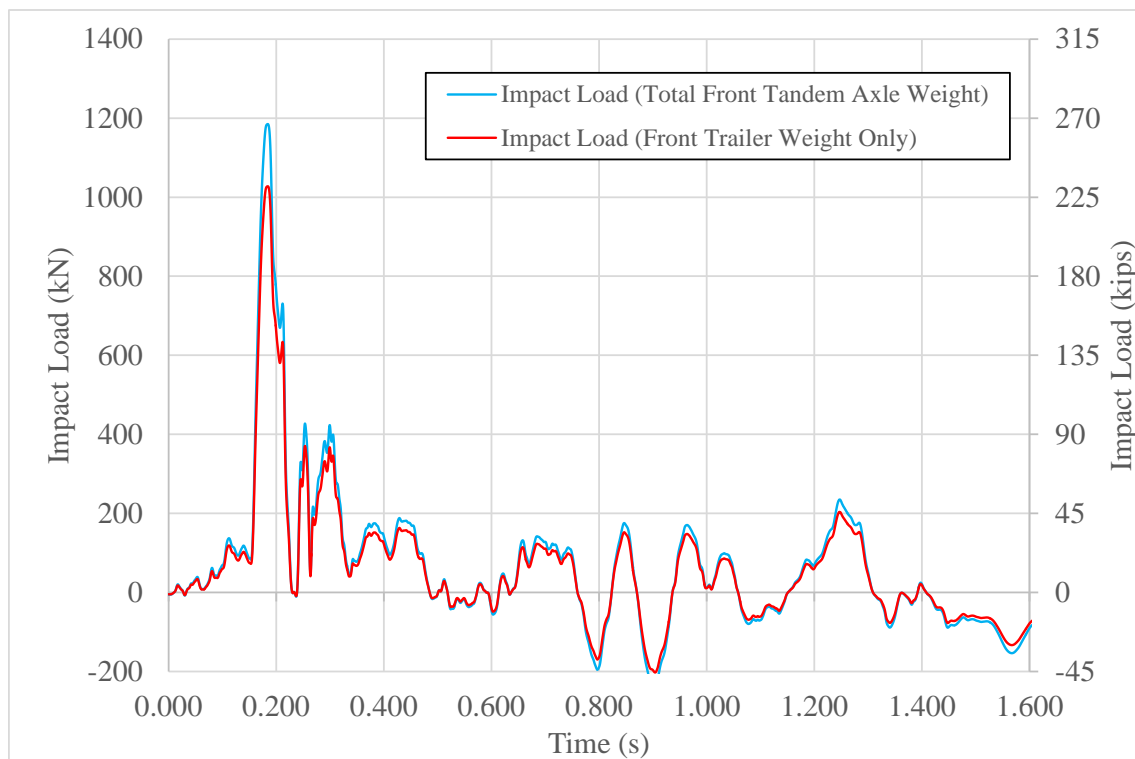
After coupling the trailer's orientation with the SLICE-2 accelerations, the lateral peak load imparted into the barrier from the front tandem axles was estimated to range between 1,027 kN and 1,183 kN (231 kips and 266 kips), depending on the mass utilized in the calculation. The peak load occurred approximately 0.190 s into the impact event, which corresponded to the time in which the right-front corner of the trailer impacted the top of the barrier. Two additional force spikes of approximately 400 kN (90 kips) followed the initial peak and were likely the result of continued contact between the barrier face and the vehicle front tandem axle wheels and trailer.

Figure 47. Estimated Impact Load, Test No. MAN-1

The calculated impact loads shown in Figure 47 represented the loads imparted to the barrier by the front tandem axles and front of the trailer. Previous TL-5 crash testing has demonstrated that the maximum impact load typically occurs during the vehicle tail slap (i.e., when the rear tandem axles and rear of the trailer impacts the barrier) [21]. Based on the observed bridge rail deflections, the rear of the trailer likely applied a greater impact load during

The estimated impact load from contact with the front of the trailer ranged between 1,027 kN and 1,183 kN (231 kips and 266 kips), which represented an 18 to 35 percent increase over the calculated Yield Line design strength of the bridge rail, 874 kN (196 kips). The impact load was based on an assumed vehicle mass subjected to the measured accelerations, and the uncertainty of this calculation is unknown. However, the impact load resulting from the rear of the trailer likely produced an even higher impact load, which was much higher than the barrier's design strength. With the bridge rail sustaining only minor damage, the results further demonstrate that Yield Line analysis produces a conservative (low) design strength for solid concrete parapets.

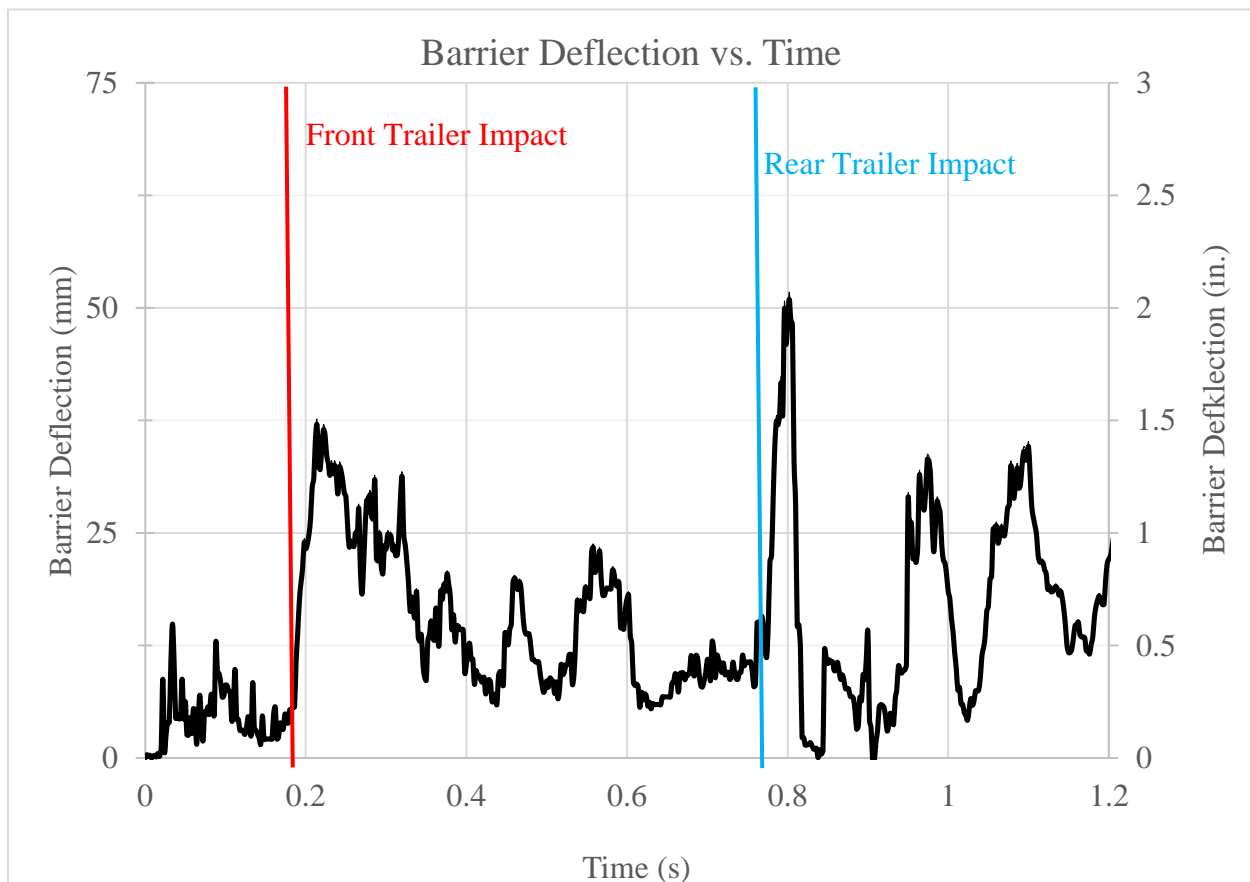
test no. MAN-1. As shown in Figure 48, the barrier deflected 36 mm (1.4 in.) as a result of the impact at the front of the trailer. The barrier restored nearly back to its original position before the rear of the trailer impacted the barrier and caused a deflection of 52 mm (2.0 in.). Greater deflections indicate that a higher impact load was likely imparted to the system by the rear of the trailer. Thus, the impact load resulting from the tail slap of the trailer was likely higher than the peak load estimated using the SLICE-2 unit at the front of the trailer. Unfortunately, the SLICE-1 unit that was mounted adjacent to the rear tandem axles experienced technical difficulties and did not record the crash event. Between 0.80 s and 0.95 s after impact, the trailer roll blocked the view of the overhead camera utilized to measure barrier deflections. Thus, the rail displacements measured between 0.80 s and 0.95 s were taken from points outside of the immediate impact region, which resulted in the lower deflections recorded at these times.

Figure 48. Barrier Deflection vs. Time, Test No. MAN-1

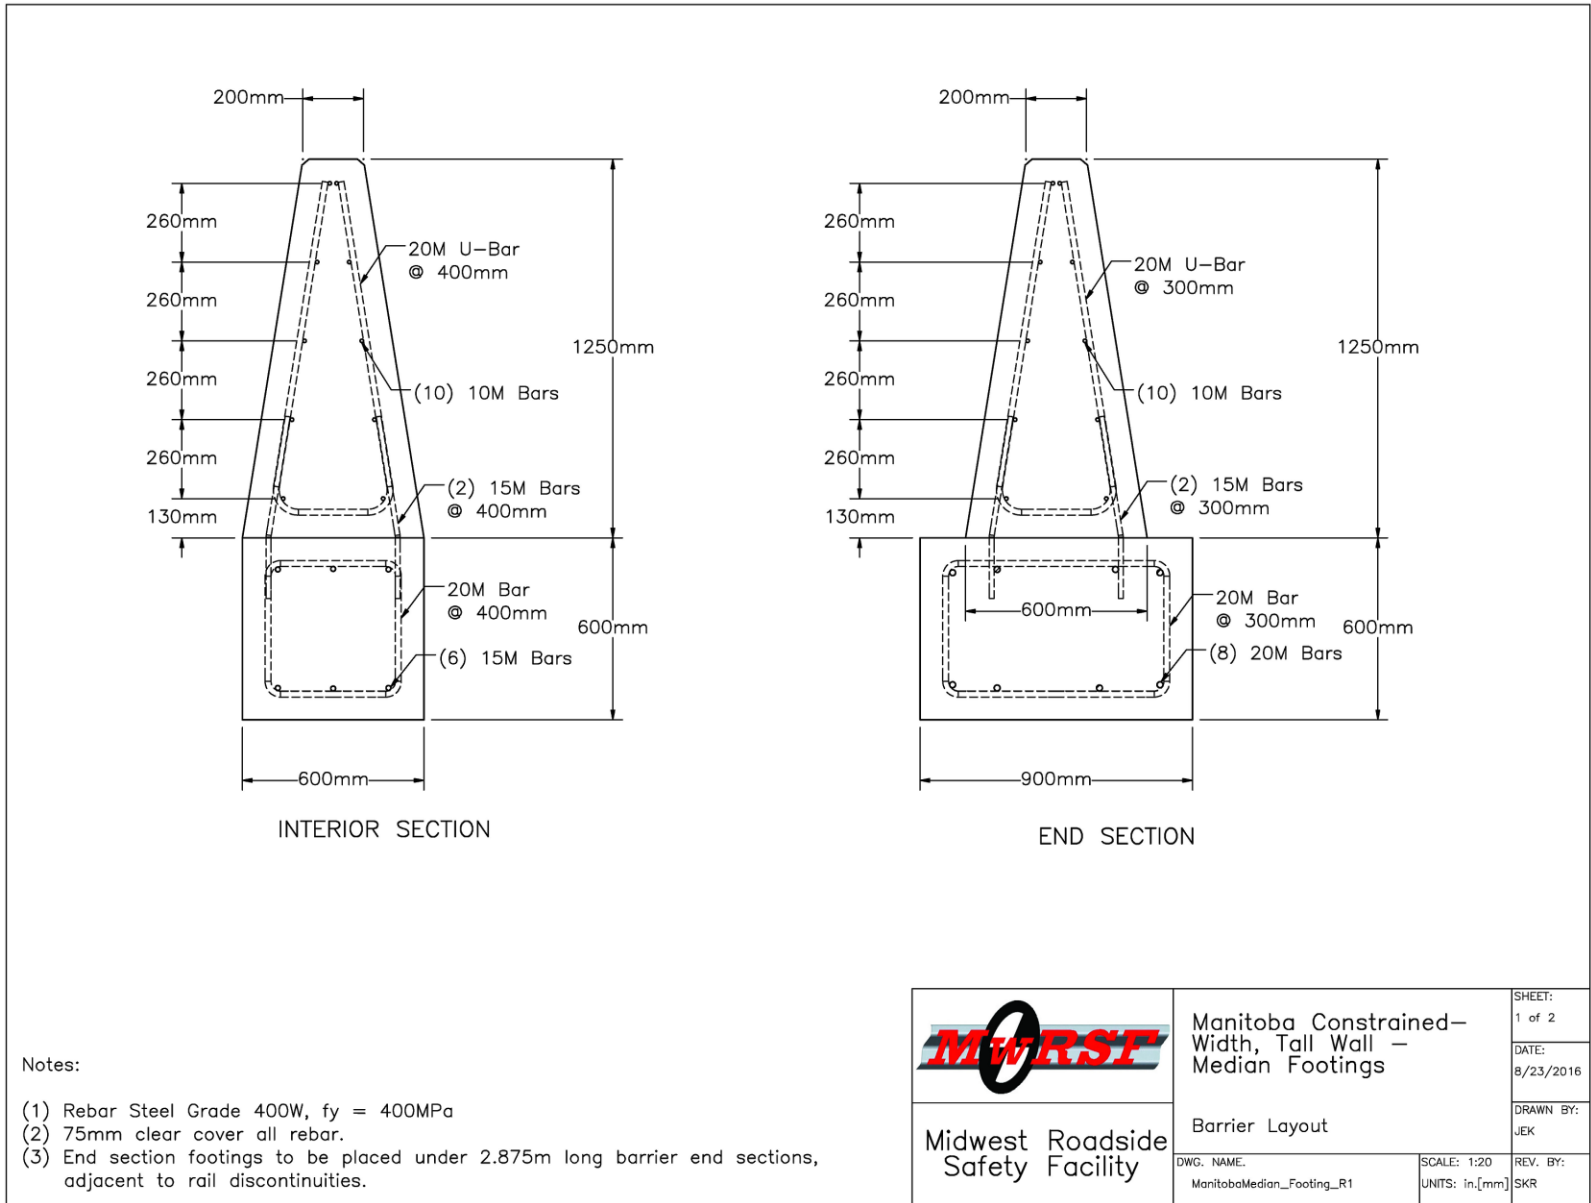
Figure 51. Footing Anchorage Details for Median Barrier

Asphalt keyways are only recommended for use to anchor interior sections of the new median barrier. Asphalt keyways can be placed over the entire system length, but anchorage requirements will increase for impacts adjacent to barrier discontinuities. Unfortunately, testing of concrete barriers in asphalt keyways has not been conducted on a barrier end section. Thus, the actual strength, durability, and effectiveness of an asphalt keyway remain unknown for barrier end sections. Therefore, the barrier end sections should be anchored to a foundation slab or footing, as shown in Figures 49 through 52.

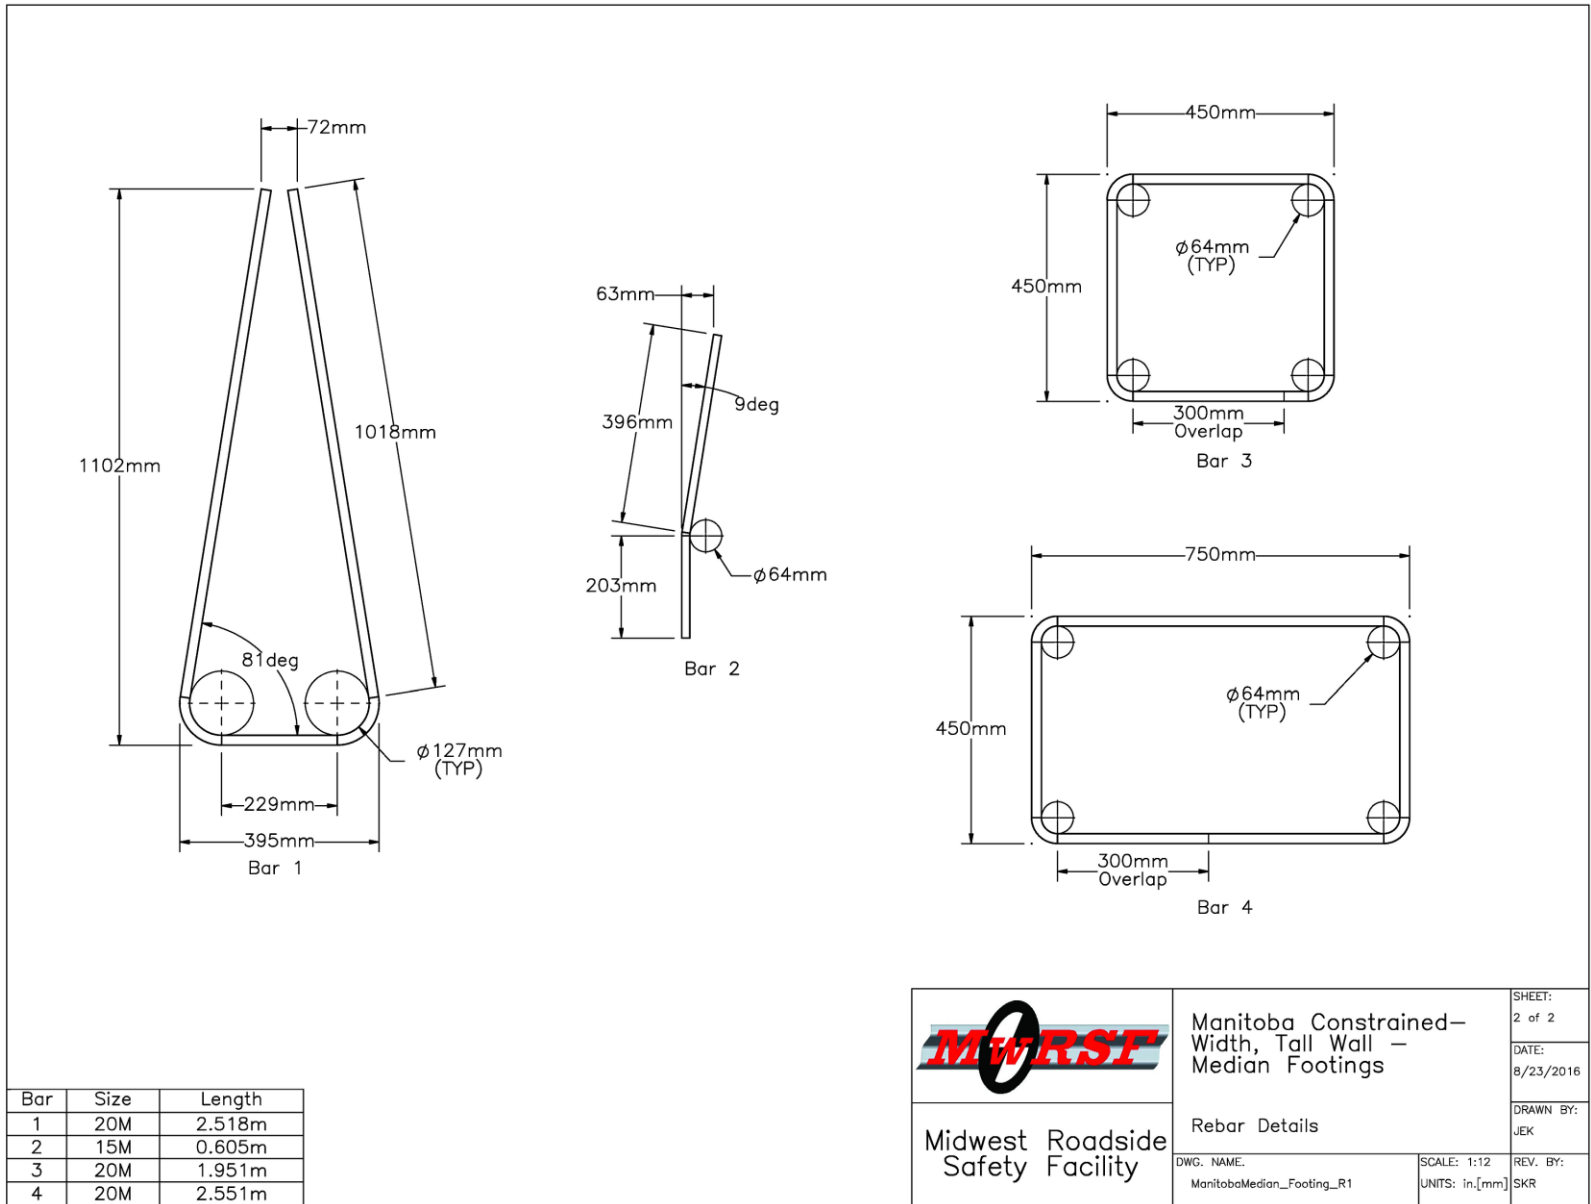
Figure 52. Footing Reinforcement Details for Median Barrier

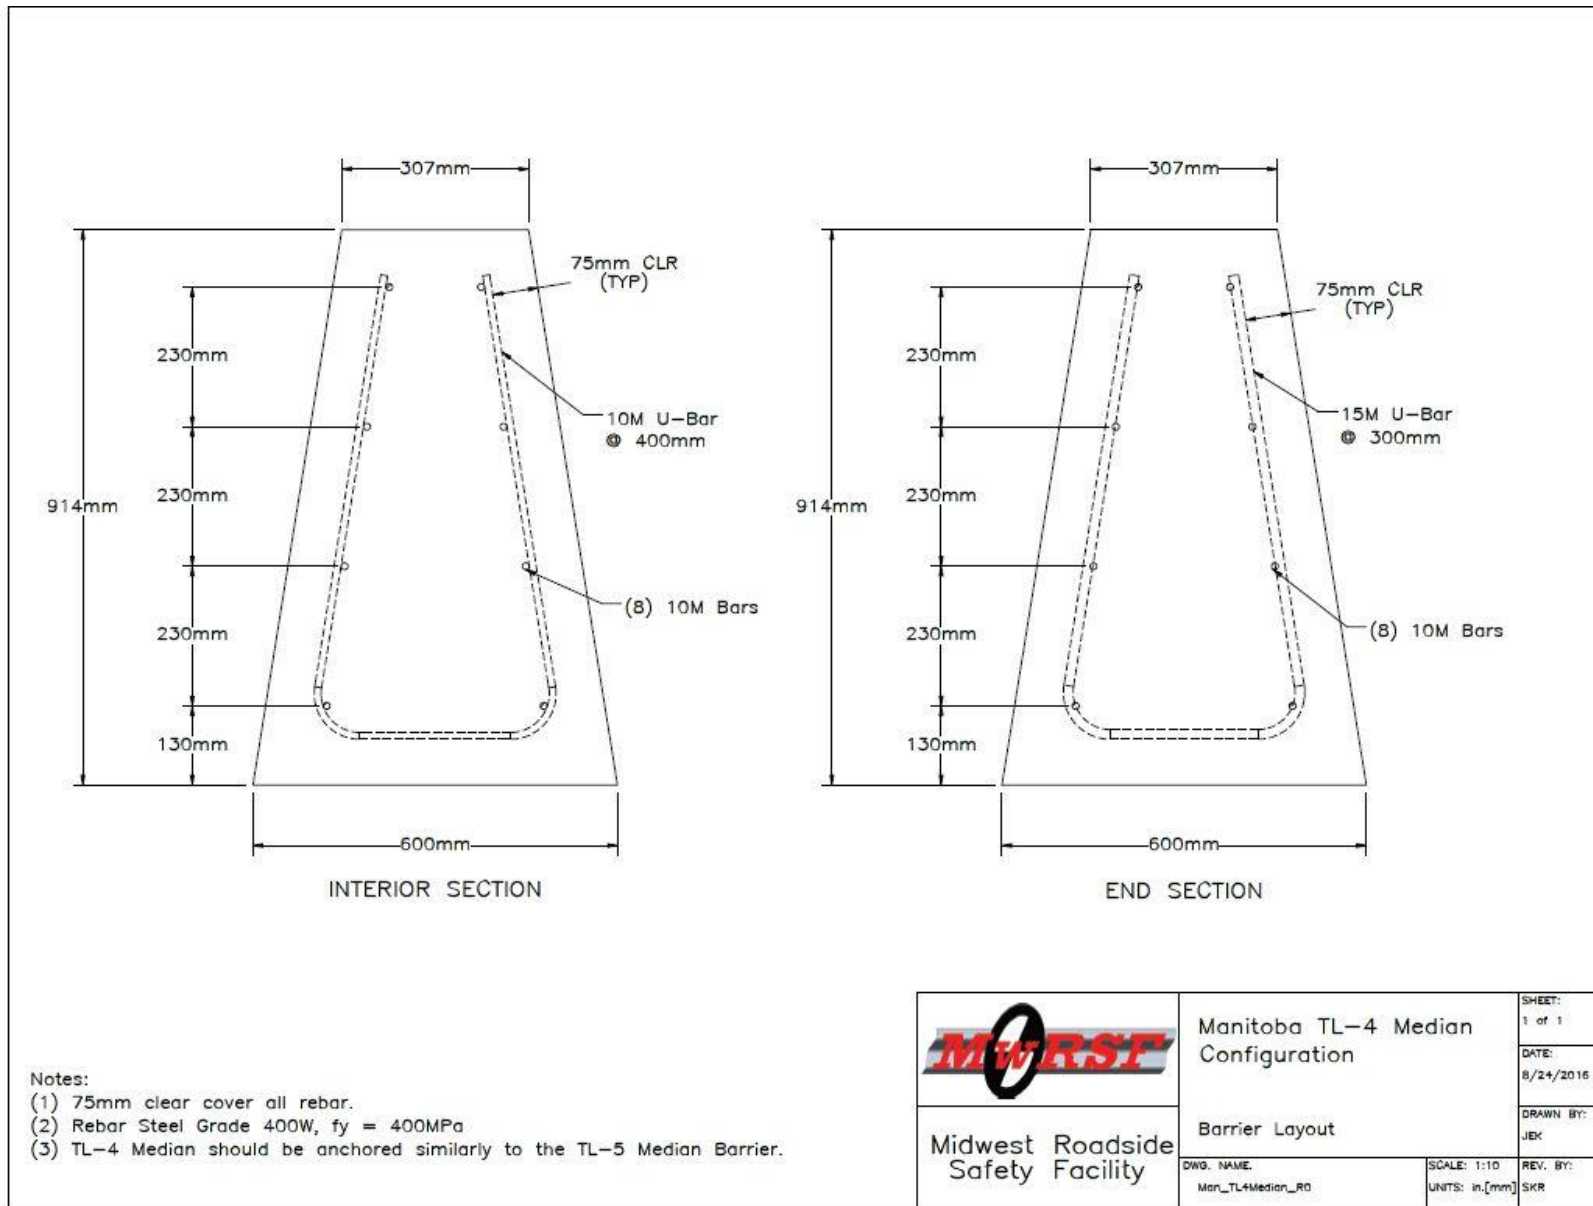
Figure 54. TL-4 Median Barrier Details

barrier may be anchored utilizing either foundation slab, footing, or asphalt keyway, as shown in Sections 10.1 and 10.2.

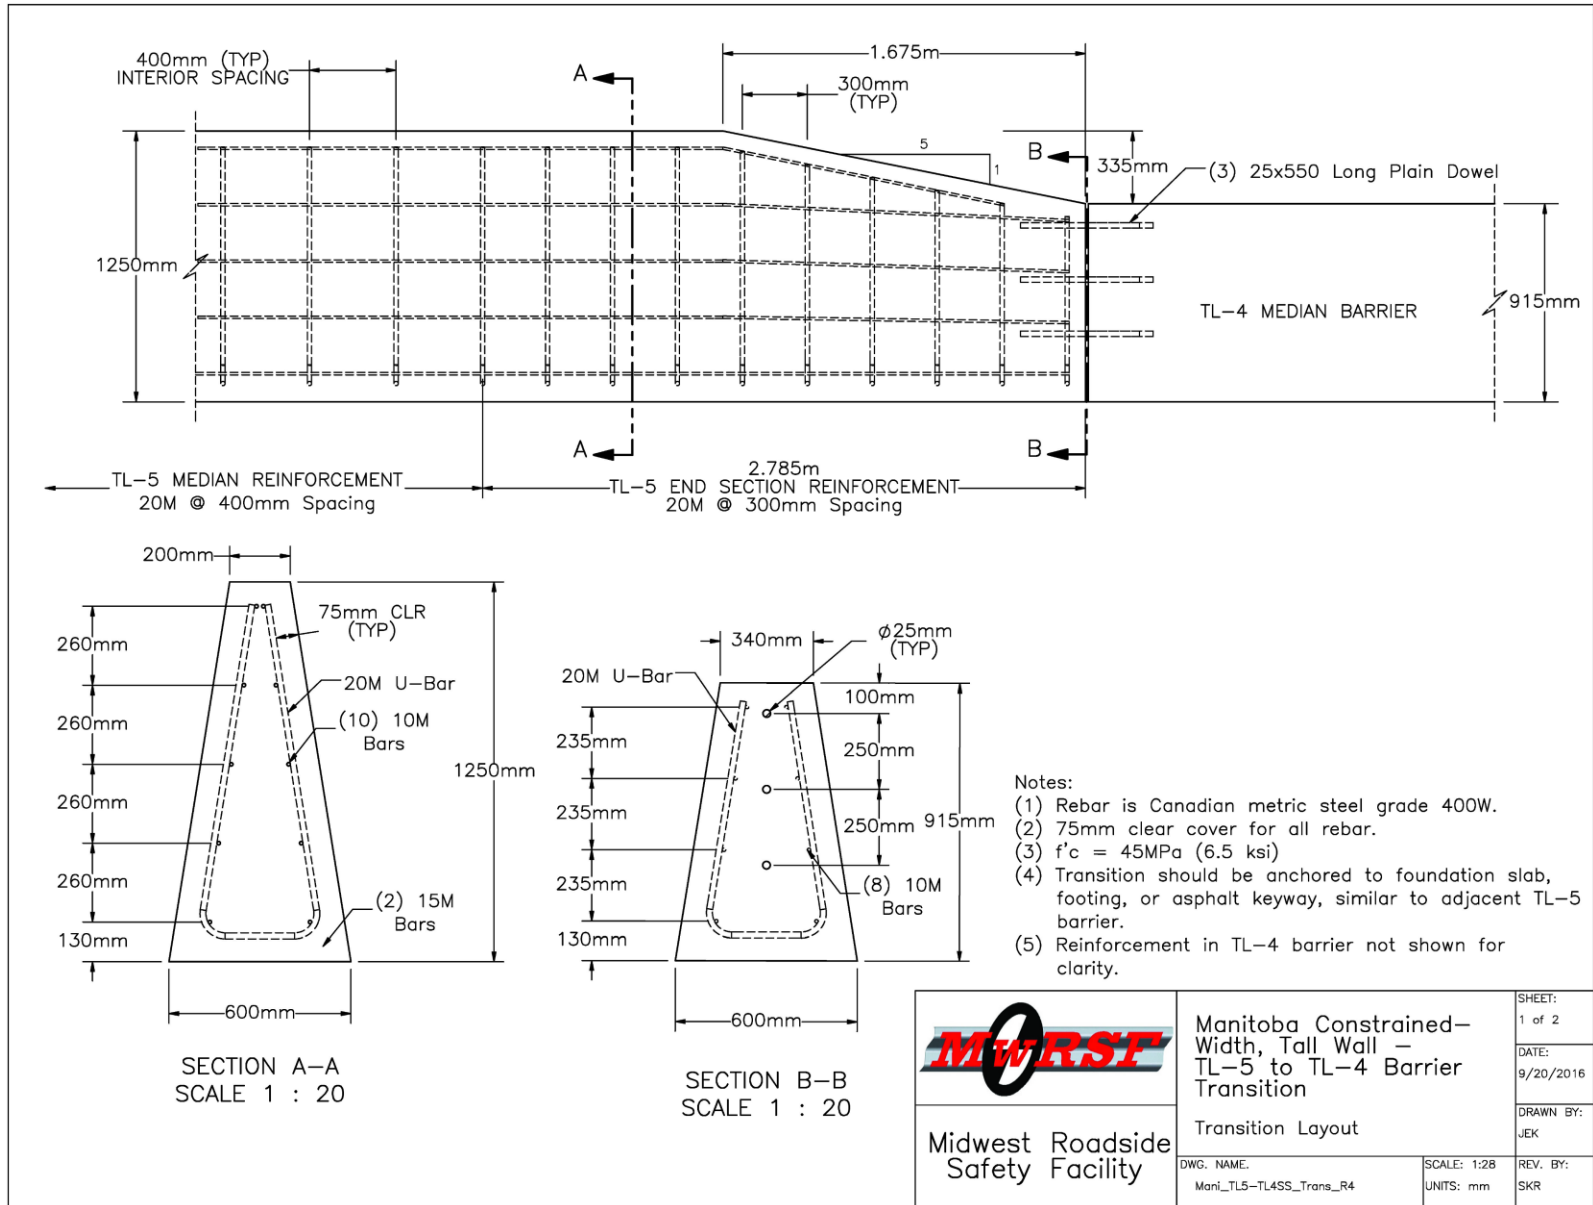
Figure 59. Transition Details, TL-5 Median Barrier to TL-4 Single Slope Barrier

If desired, the longitudinal bars from the TL-4 barrier could be extended into the transition segment during construction, which would eliminate the need for the three dowel bars placed across the joint. Providing the proper lap splice length between the longitudinal bars of the TL-4 barrier and transition segment and casting the transition segment directly adjacent to the TL-4 barrier (no gaps) would eliminate the barrier discontinuity and the need for end section reinforcement in the TL-4 barrier. TL-5 end section reinforcement is still recommended in the transition segment adjacent portion of the TL-5 barrier to maximize the length of need distance of the TL-5 barrier. Although not shown in the drawings, the entire barrier system should be properly anchored utilizing a foundation slab, footing, or asphalt keyway, as discussed in Chapter 10.

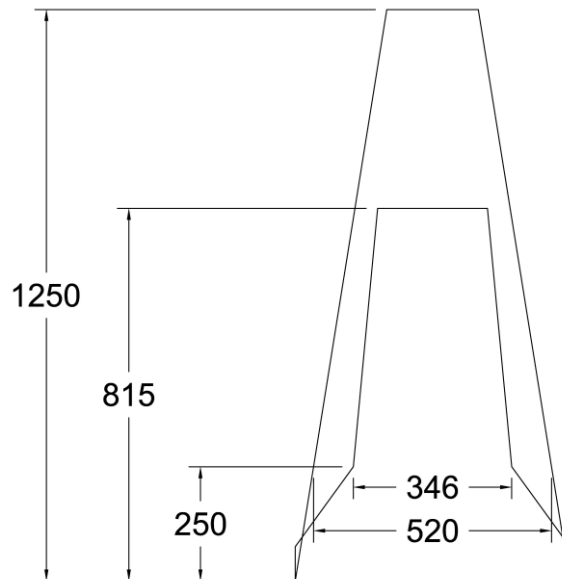
Figure 61. TL-5 Median Barrier and F-Shape Median Barrier Comparison

Installation sites may exist where the Manitoba Constrained-Width, Tall Wall barrier will be placed adjacent to existing F-shape barriers. Thus, a transition was required to safely connect these two barrier types. MI's typical F-shape barrier was 815 mm (32 in.) tall, or 435 mm (17¼ in.) shorter than the TL-5 single slope barrier. Utilizing the 5:1 maximum vertical slope to transition between barrier heights, the transition required 2.175 m (7.14 ft) of longitudinal distance. The greatest change in lateral distance between the two barriers occurred at a height of 250 mm (10 in.) above the ground, or the slope transition point of the F-shape barrier. At this height, the F-shape barrier was 346 mm (13.6 in.) wide, while the TL-5 single slope was 520 mm (20.5 in.) wide, as shown in Figure 61. With a lateral offset distance of 87 mm (3.4 in.) on each side and a maximum lateral slope of 10:1, the changes to the barrier face geometry required a transition length of 870 mm (34.3 in.). Thus, the required transition length for the height change controlled the design, and the transition length was selected to be 2.175 m (7.14 ft). This transition length allows for a constant lateral taper of 25:1. Details for the transition between the Manitoba Constrained-Width, Tall Wall median barrier and F-shape median barrier are shown in Figures 62 and 63.
