*Research Project Number 2015-17-TE*

# DEVELOPMENT OF THE MANITOBA CONSTRAINED-WIDTH, TALL WALL BARRIER

**MIDWEST ROADSIDE SAFETY FACILITY**

**MANITOBA INFRASTRUCTURE**

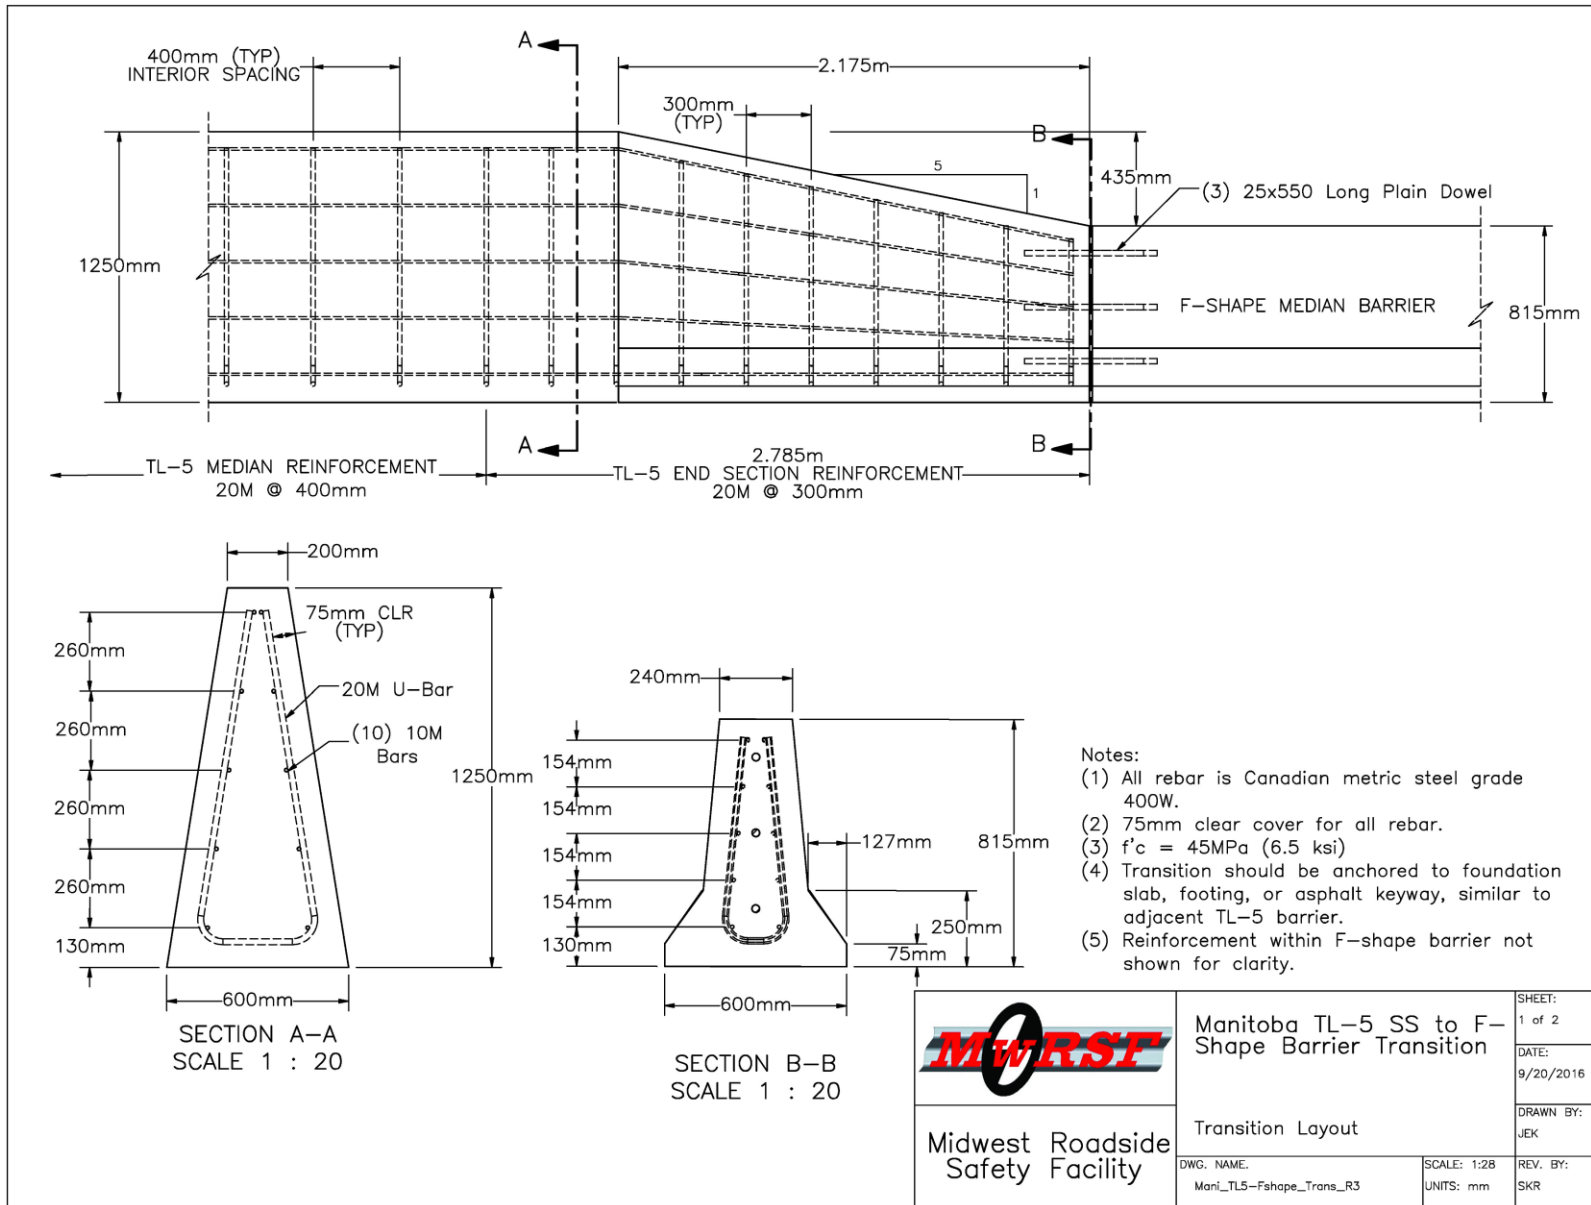
Figure 62. Transition Details, TL-5 Median Barrier to F-Shape Barrier

Similar to the transition to TL-4 single slope median barrier, a joint was placed between the transition segment and the F-shape barrier, which incorporated three dowel bars stacked vertically. End section reinforcement for the TL-5 barrier, which required a length of 2.785 m (9.14 ft), was recommended to be placed through the entire transition segment and a short distance of the adjacent TL-5 barrier. By utilizing the TL-5 end section reinforcement through the transition region, the beginning of the TL-5 barrier length of need is located at the beginning of the TL-5 barrier installation (for traffic traveling toward the TL-5 system). For traffic traveling toward the TL-4 barrier, the end of the TL-5 barrier length of need would be approximately 21.3 m (70 ft) upstream of the transition segment. Though not shown in the

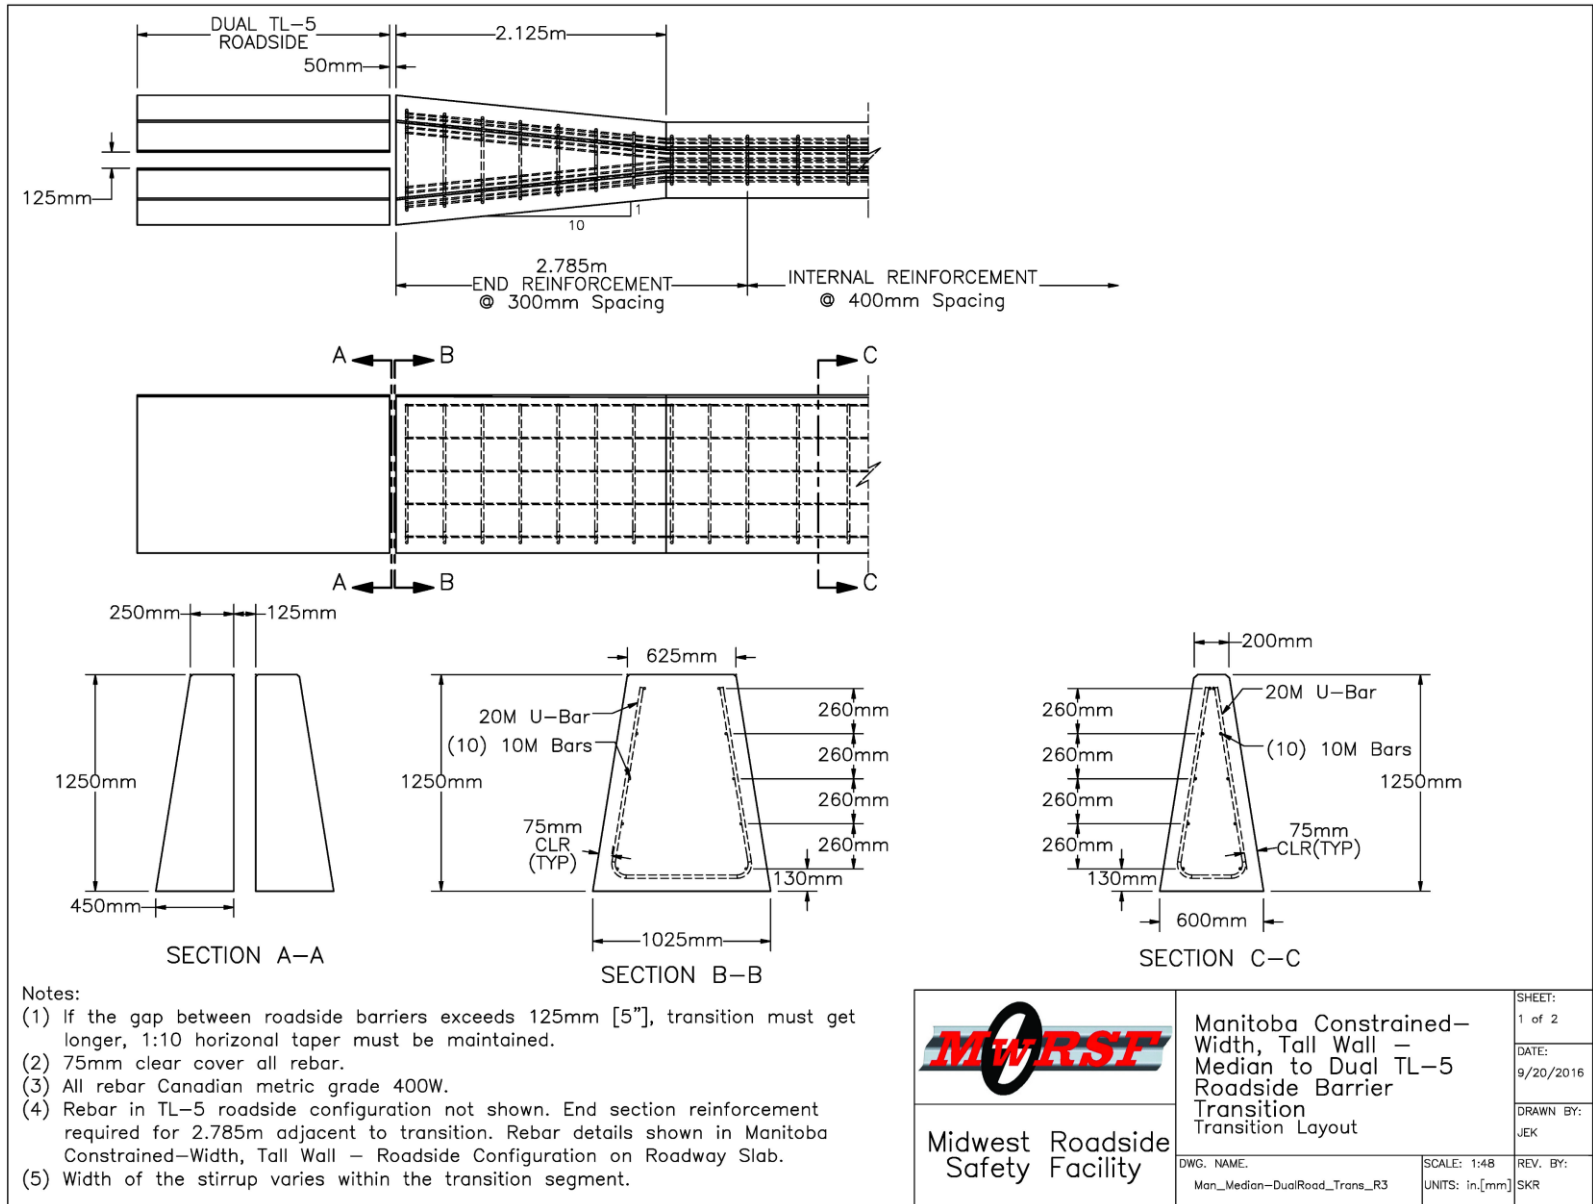
Figure 64. Transition Details, TL-5 Median Barrier to Dual TL-5 Roadside Barriers

entire width would be excessive. Thus, a better option may be to utilize the transition segment as detailed in Figures 64 and 65 and install the ends of the dual roadside barriers at a 10:1 flare, or flatter, until the desired gap distance is achieved, as shown in Figure 66.

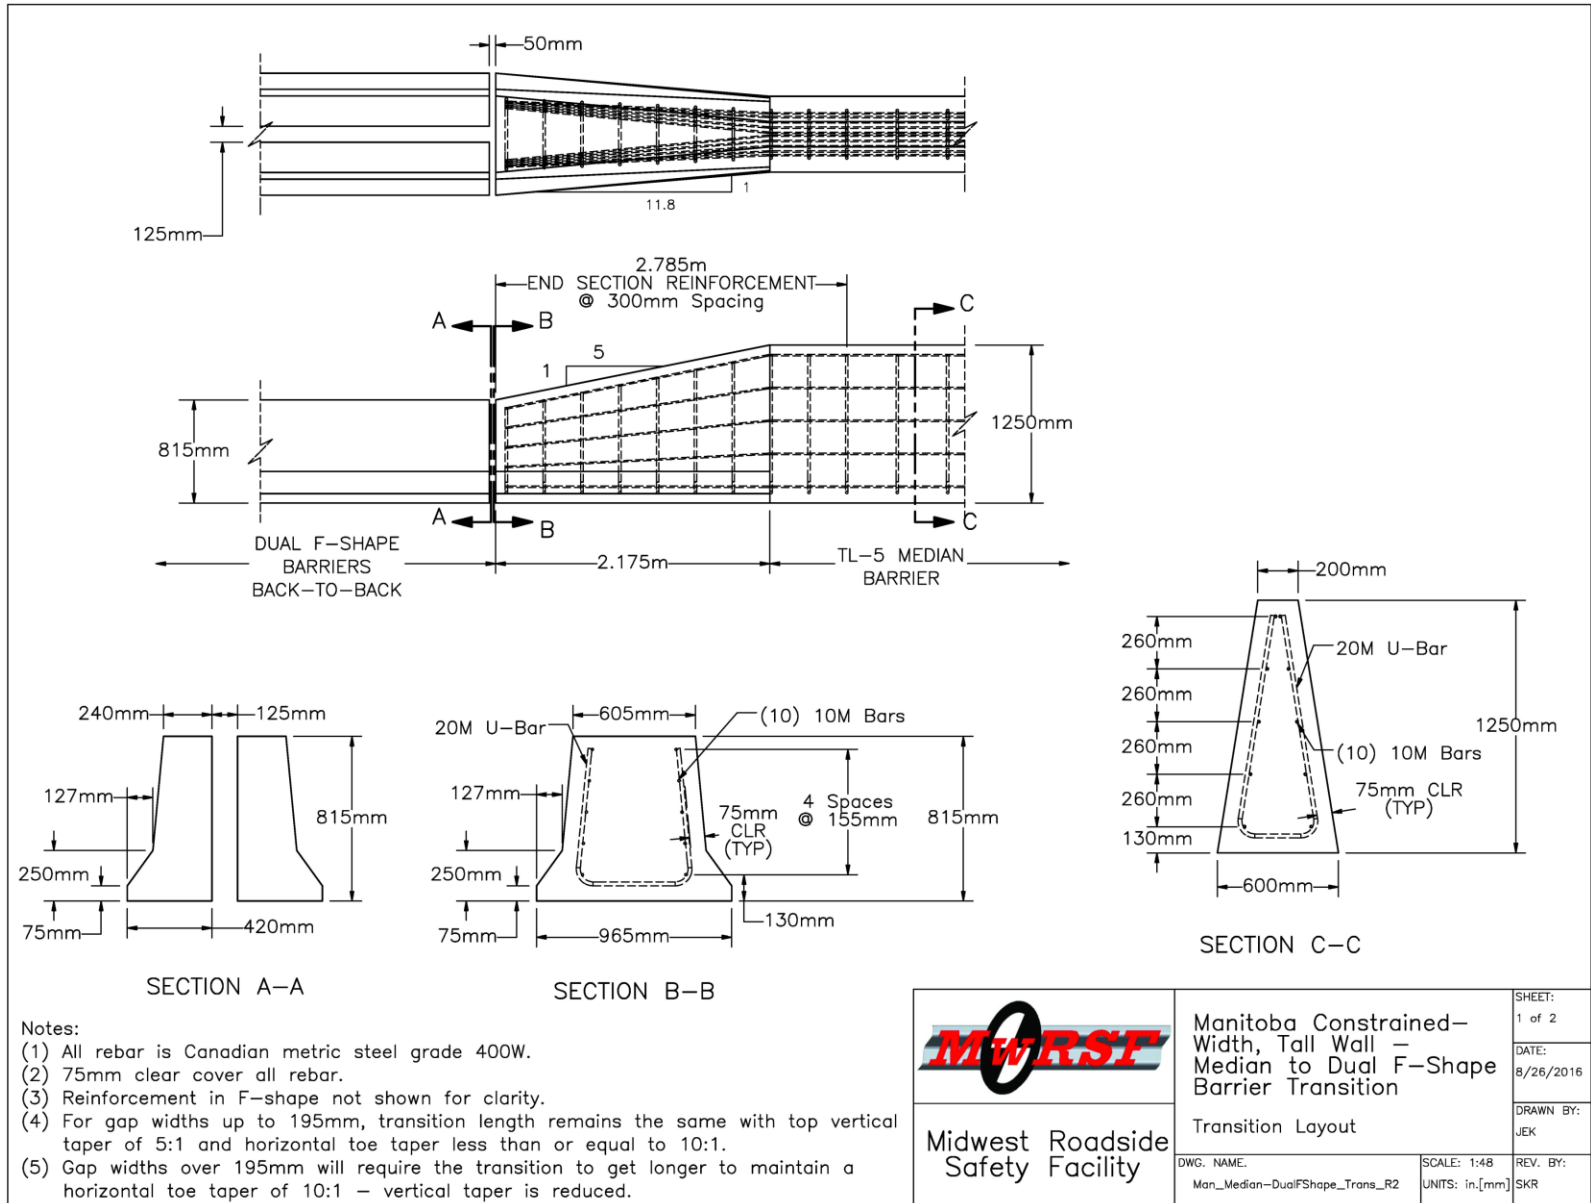
Figure 67. Transition Details, TL-5 Median Barrier to Dual F-Shape Roadside Barriers

Some installations will require a lateral offset between the dual barriers greater than the 125 mm (5 in.) detailed herein. For gaps widths up to 195 mm ( $7\frac{5}{8}$  in.), the downstream width of the transition segment can be widened without changing the transition length as the lateral slope would remain below the 10:1 maximum. For lateral gaps larger than 195 mm ( $7\frac{5}{8}$  in.), it is recommended to install new dual F-shape barrier segments adjacent to the transition segment at a 10:1 longitudinal flare until the desired gap distance is achieved. This option for large lateral gaps was previously discussed for the transition to dual TL-5 roadside barriers and sketched in Figure 66. The new flared F-shape barrier segments should be reinforced and tied into the existing F-shape barriers.

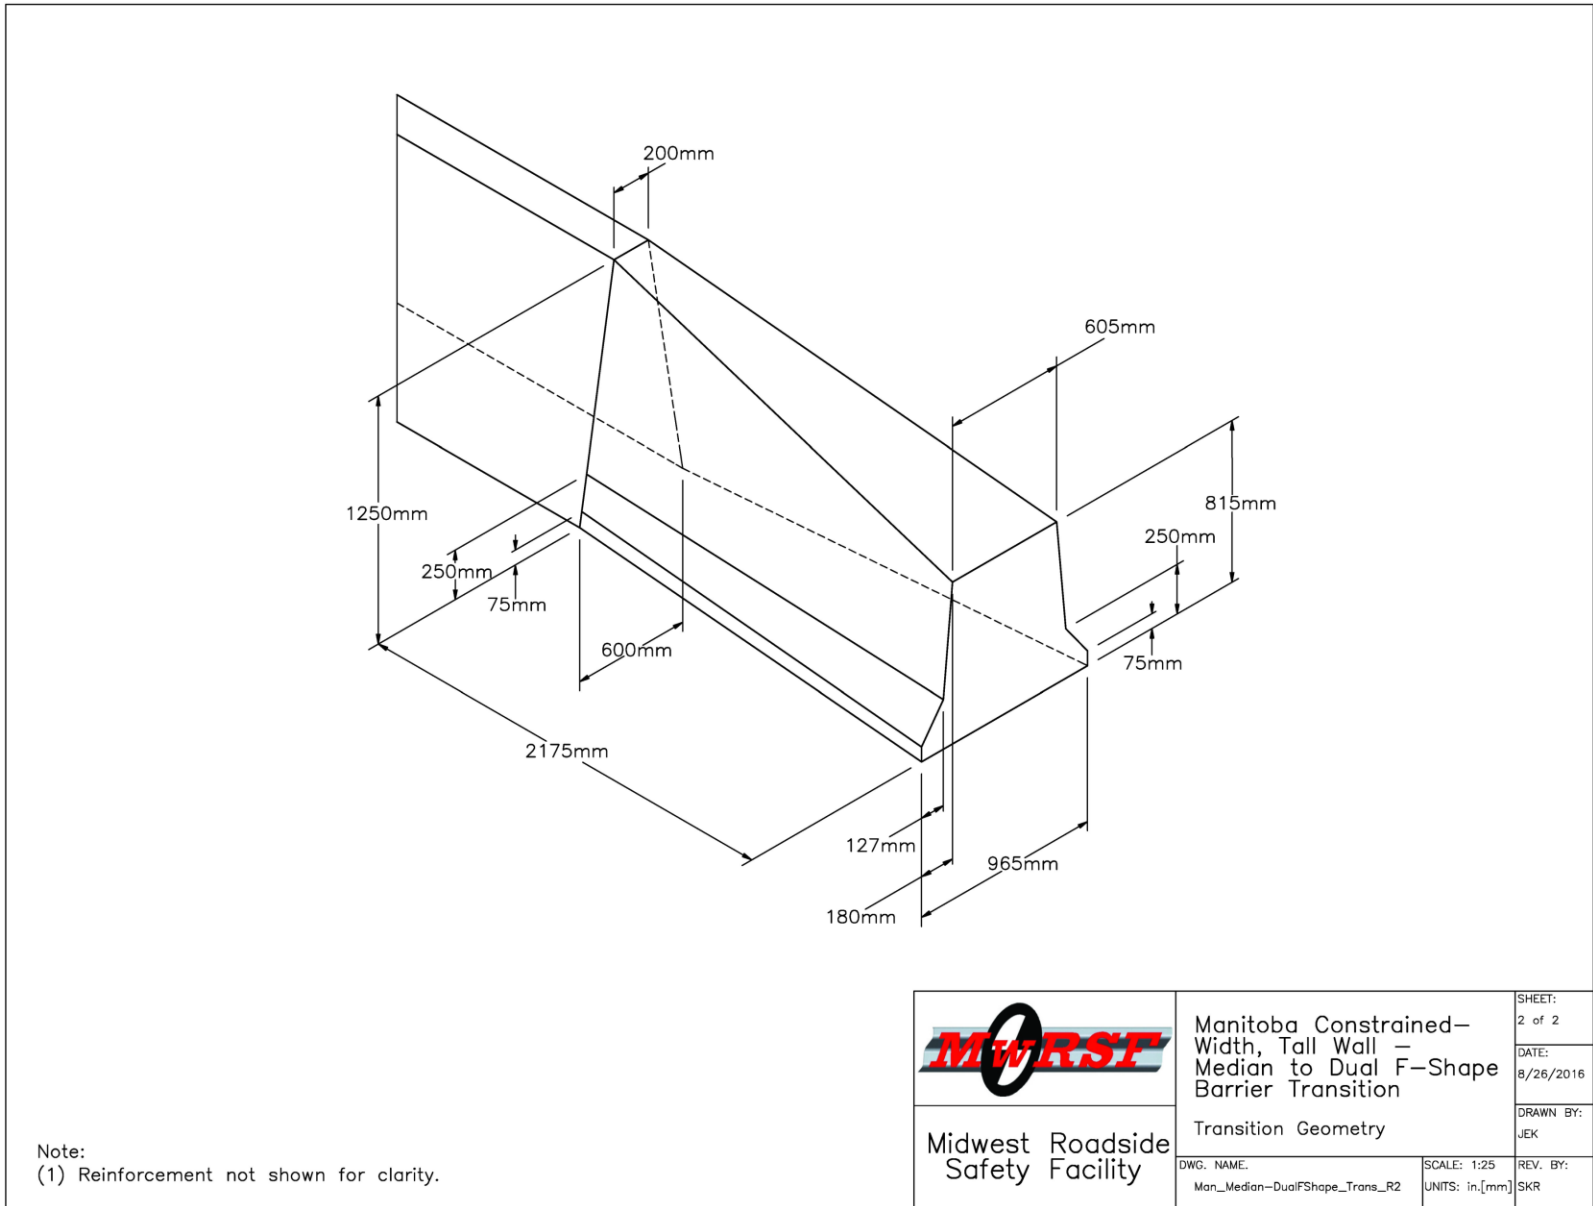
Figure 68. Transition Details, TL-5 Median Barrier to Dual F-Shape Roadside Barriers

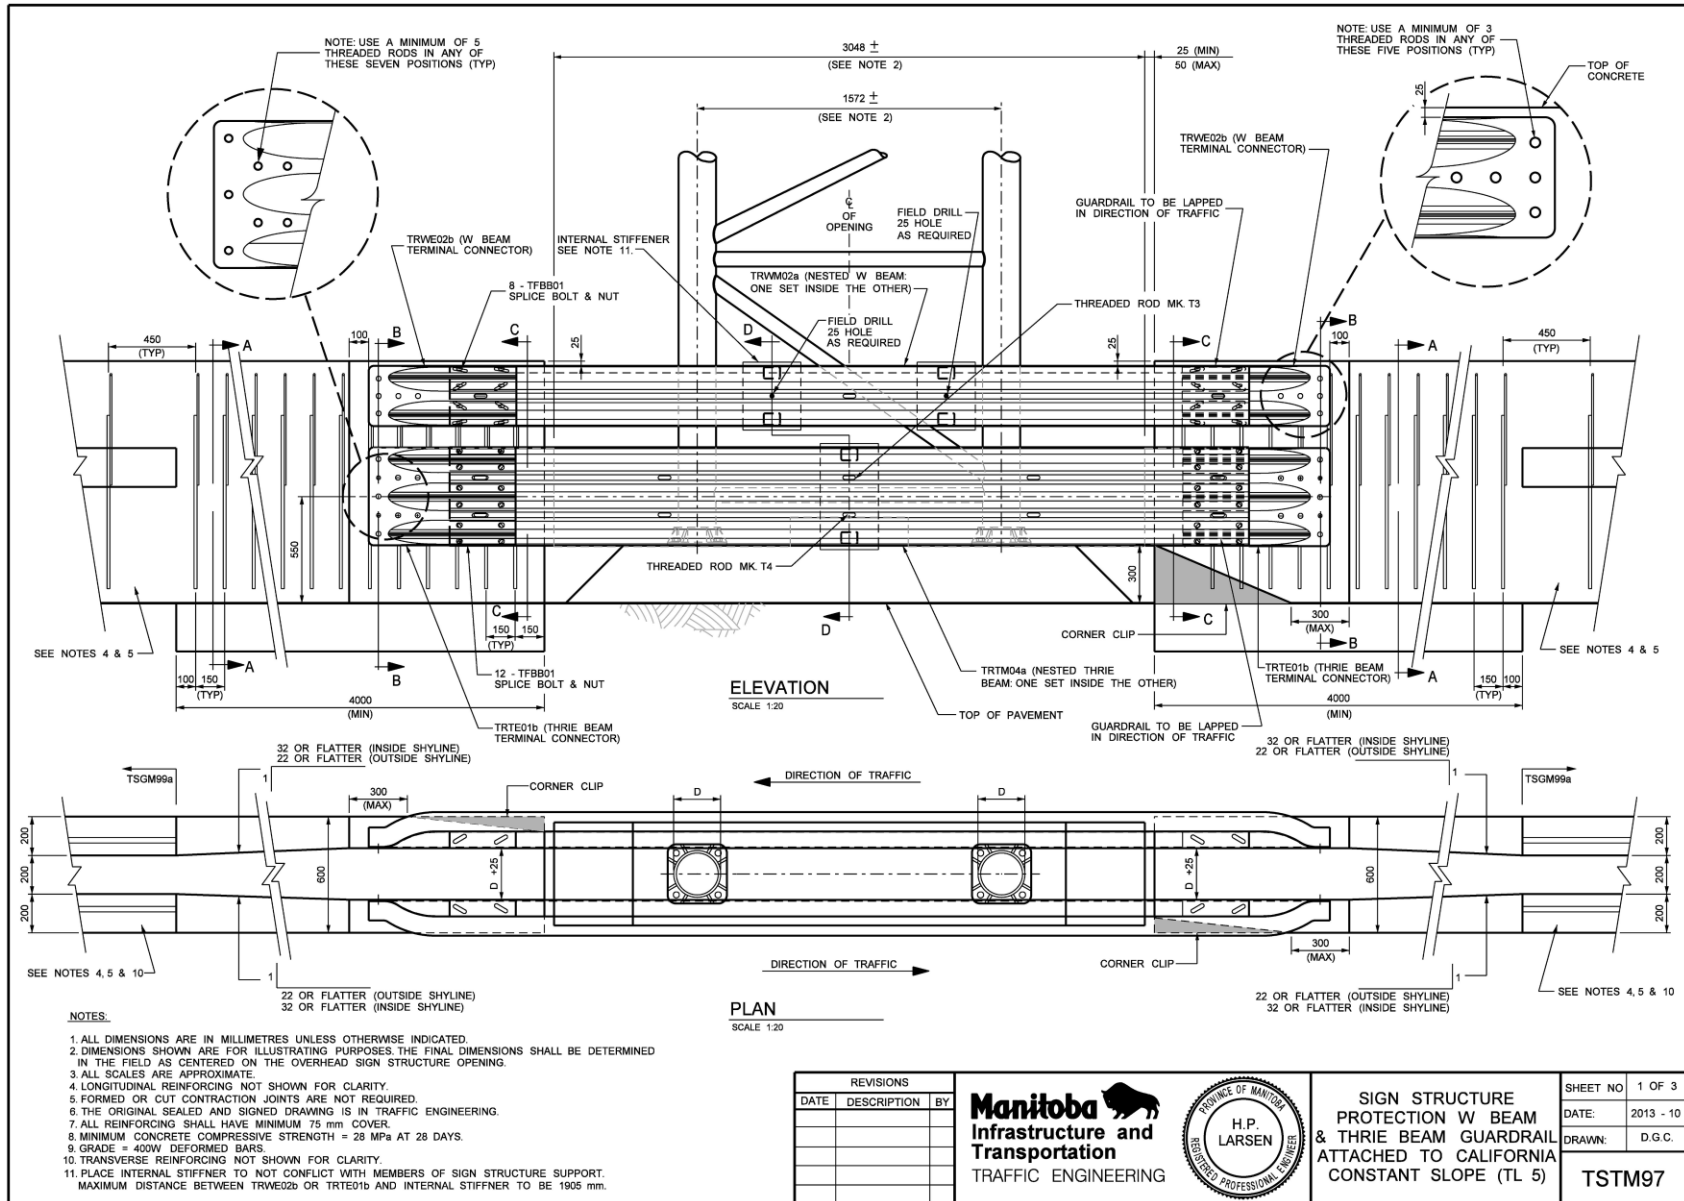
Figure 71. MI Treatment Concept for Barrier Gaps Spanning Sign Support Structures

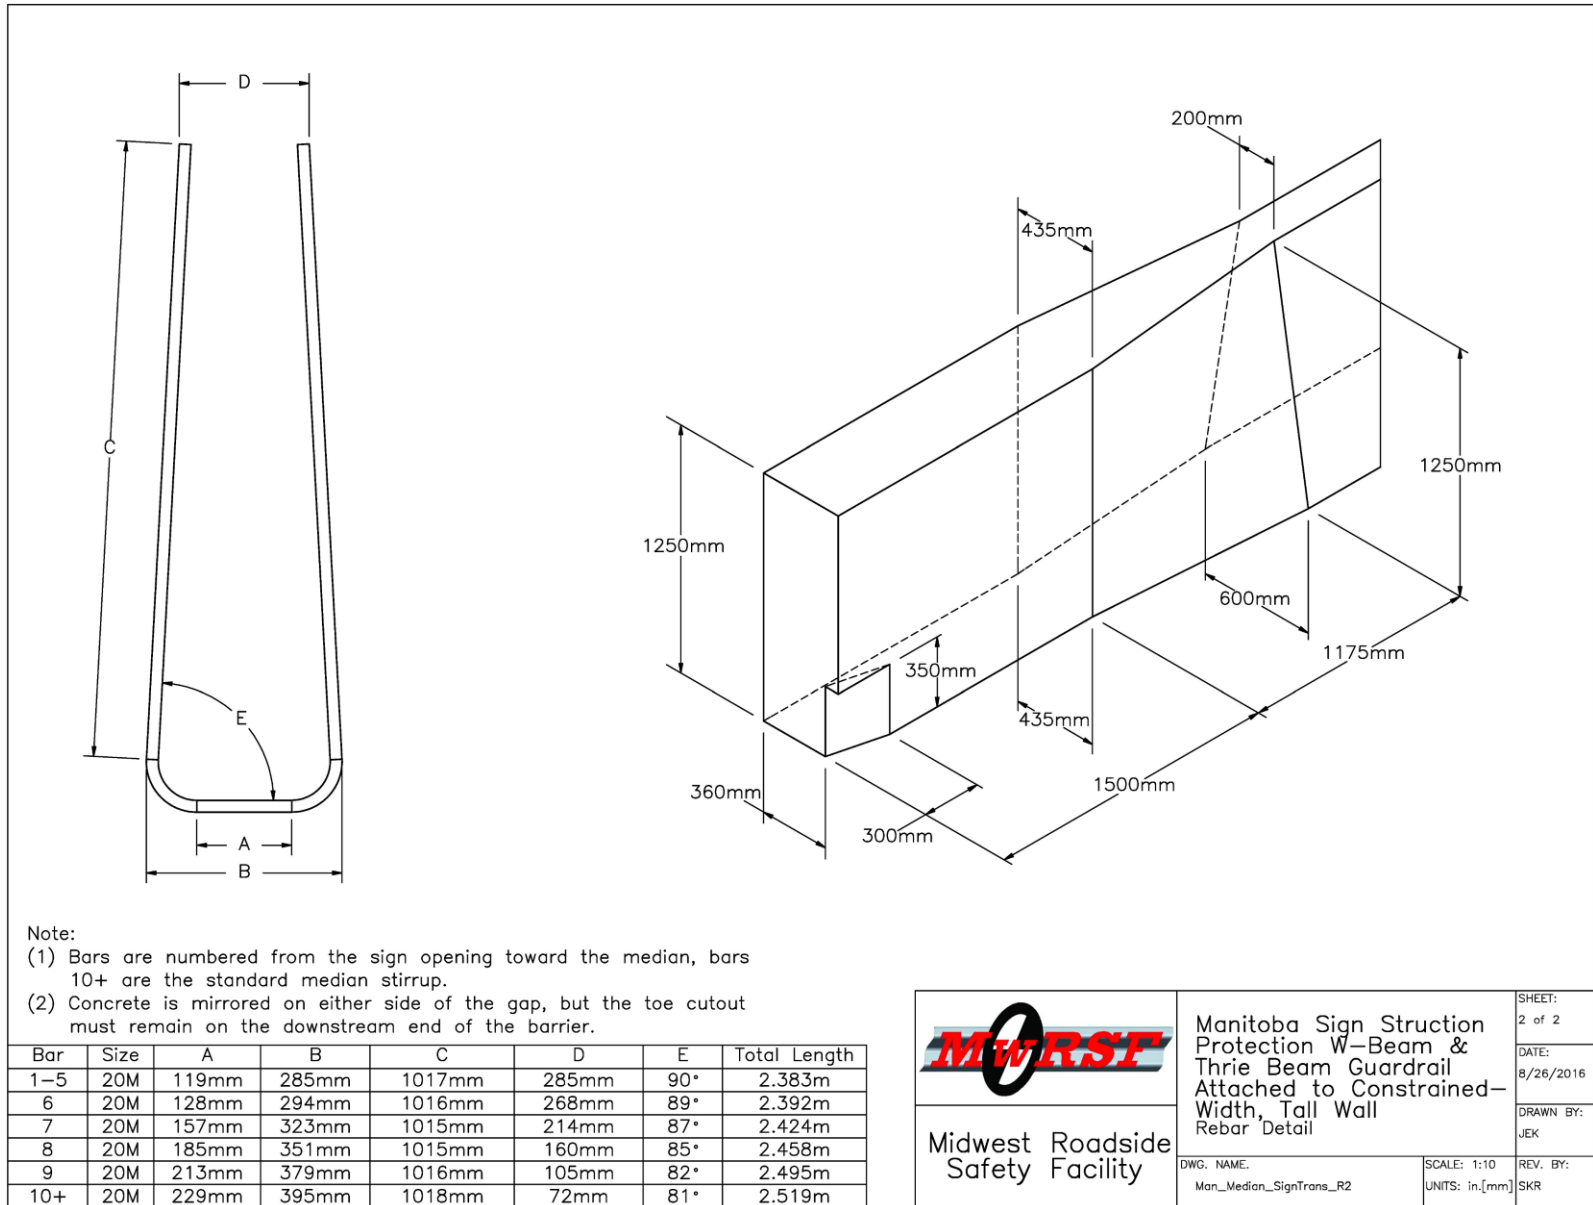
Figure 73. Treatment Details for TL-5 Barrier Gaps Spanning Large Sign Supports

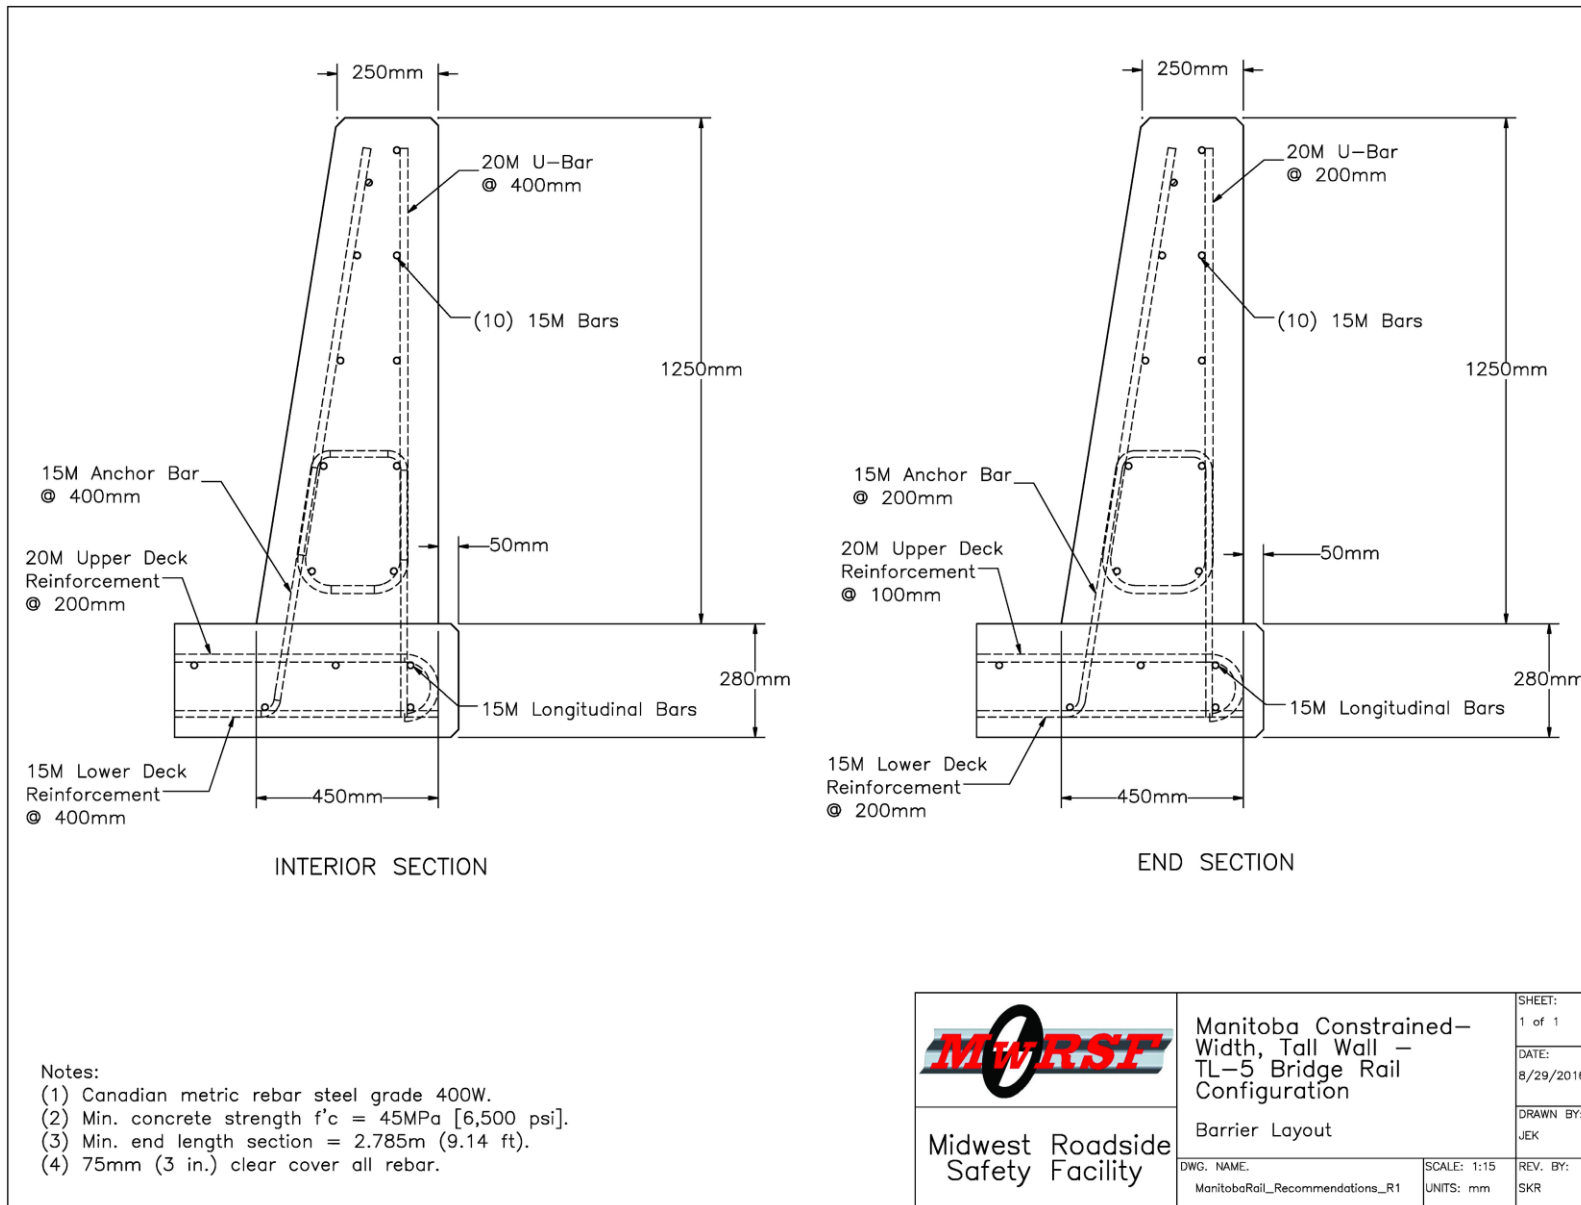
Figure 74. Recommended Reinforcement Configurations for the TL-5 Bridge Rail

Although the TL-5 median barrier developed herein was never full-scale crash tested, it was designed to have a greater strength than the crash-tested bridge rail. Additionally, the median barrier utilized the same barrier height and face geometry. Therefore, it should be considered a MASH TL-5 crashworthy system. Similarly, the TL-4 median barrier has a similar height and geometry as other successfully-tested MASH TL-4 barriers. Since it was designed with a higher strength than these barriers, it should also be considered crashworthy to MASH TL-4. Finally, the TL-5 roadside configuration developed herein was nearly identical to the crash-tested bridge rail. The anchorage of the roadside barrier to a reinforced concrete foundation slab or footing should provide adequate strength when compared to the thin, cantilevered bridge deck. Thus, the TL-5 roadside barrier should also be considered crashworthy to MASH TL-5.

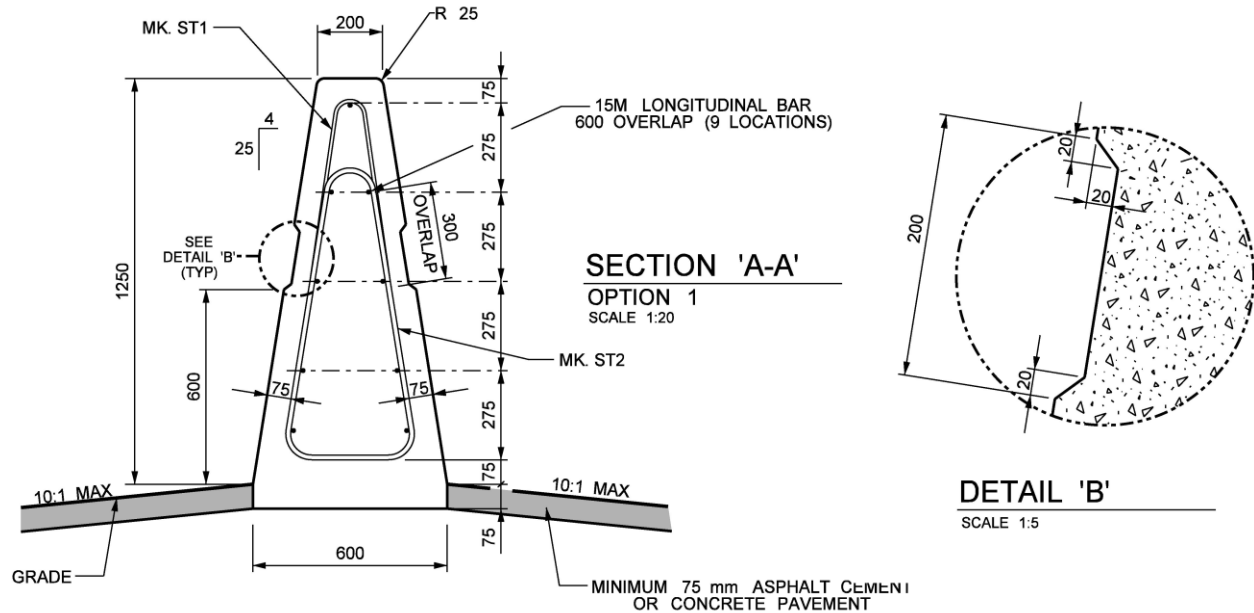
Figure 75. Longitudinal Recess for Roadway Delineators

MI commonly utilizes a Lineator Delineation System by 3M on its concrete barriers and desire to create longitudinal recesses in the concrete barriers for the placement of roadway delineators, as shown in Figure 75. These recesses were not implemented into the test article due to ease of construction. The small reduction in barrier cross section from the 20-mm ( $\frac{3}{4}$ -in.) indentation should not affect barrier strength. Additionally, the recesses extend longitudinally along the barrier, so vehicle snag should not occur. Therefore, the inclusion of these recesses is not thought to negatively affect the performance of the Manitoba Constrained-Width, Tall Wall barrier.
