1. REPORT NO. <b>FHWA/CA17-2654</b>	2. GOVERNMENT ACCESSION NO.	3. RECIPIENT'S CATALOG NO.	
4. TITLE AND SUBTITLE <b>COMPLIANCE CRASH TESTING OF THE TYPE 60 MEDIAN BARRIER, Test 140MASH3C16-04</b>  <b>TYPE 60 MEDIAN BARRIER</b>		5. REPORT DATE  May 2018

**COMPLIANCE CRASH TESTING OF THE TYPE 60 MEDIAN BARRIER  
(TEST 140MASH3C16-04)**

**COMPLIANCE CRASH TESTING OF THE TYPE 60 MEDIAN BARRIER**  
**Test 140MASH3C16-04**

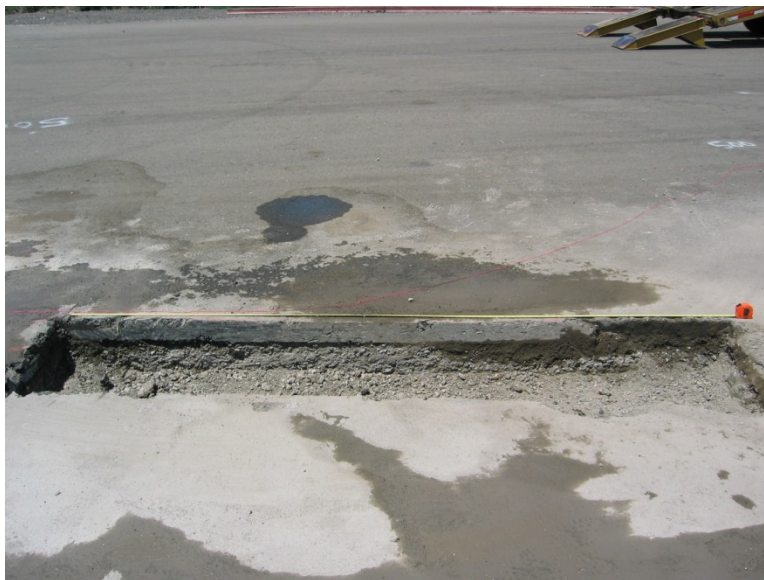
**Figure 2-1 Asphalt and Aggregate Base Removed for End Anchorage Footing**

A section of Type 60 concrete barrier, 46 m (150 ft.) in length, was constructed in 2006 at the Caltrans Dynamic Test Facility for a previous tort response project. The section of Type 60 was still in place when it was decided to run MASH Test 3-10, so it was utilized for this project. Construction photos are shown below.

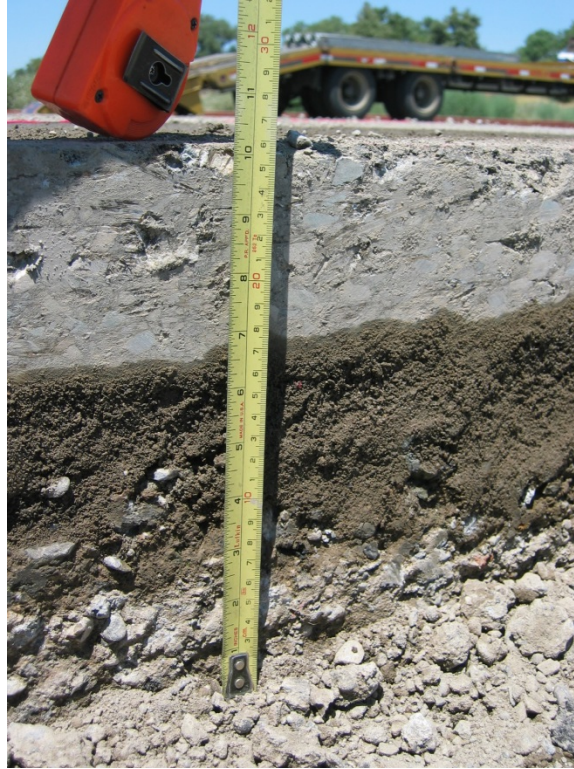
**Figure 2-2 Footing Depth**

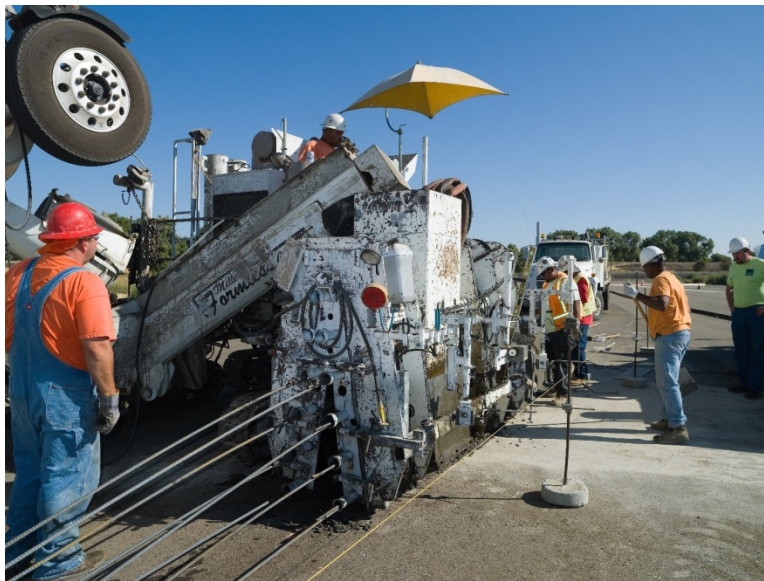
**Figure 2-3 Beginning of Slip-forming**

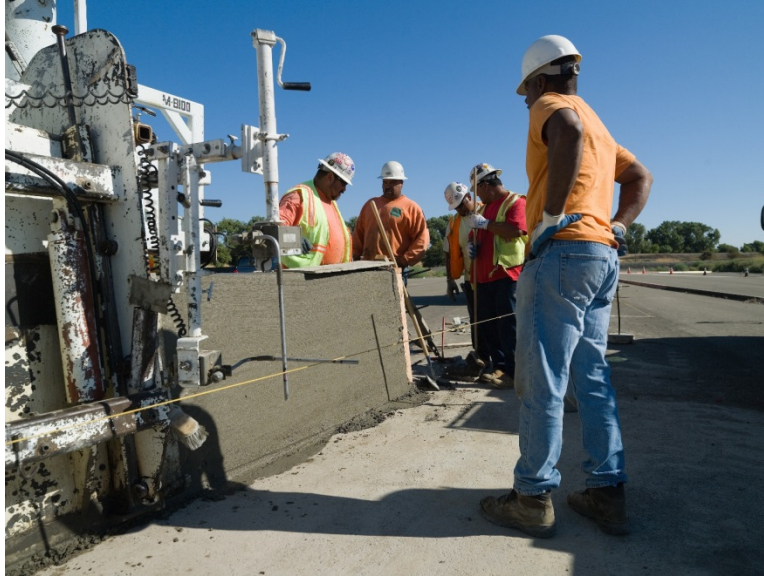
**Figure 2-4 Slip-forming the Barrier**

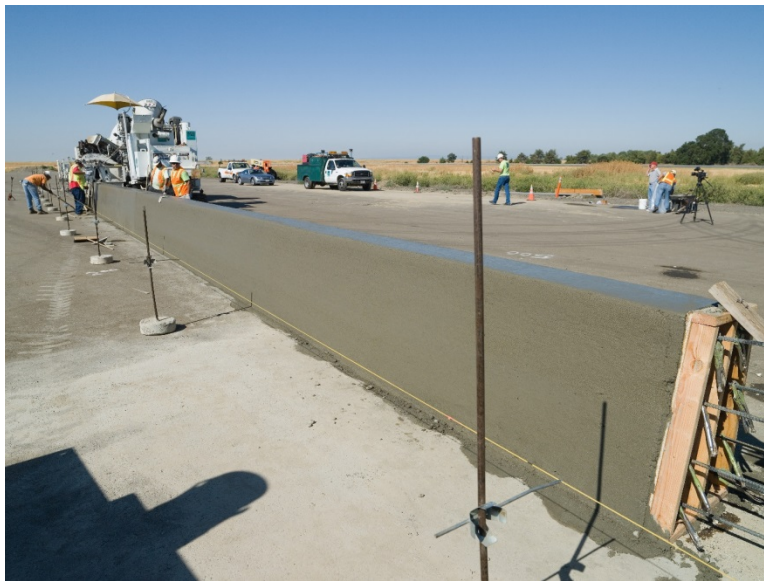
**Figure 2-5 Slip-forming Nearly Complete**

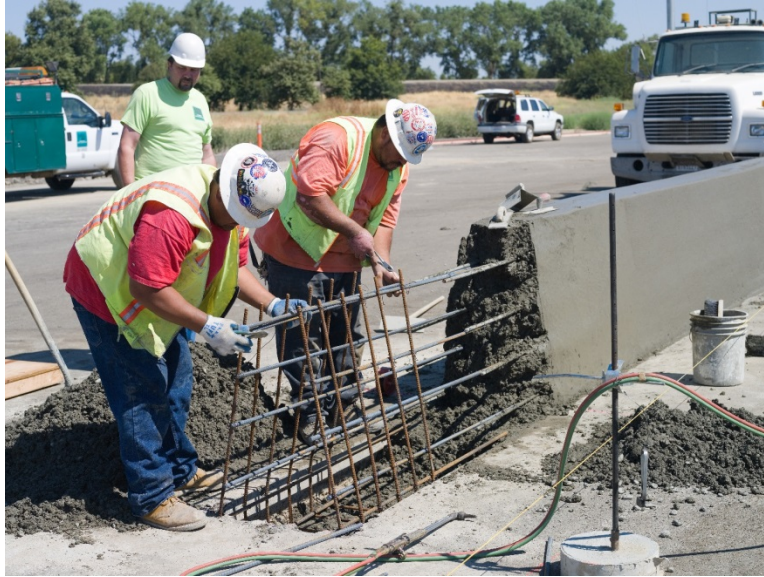
**Figure 2-6 Placing Rebar for the End Anchorage**

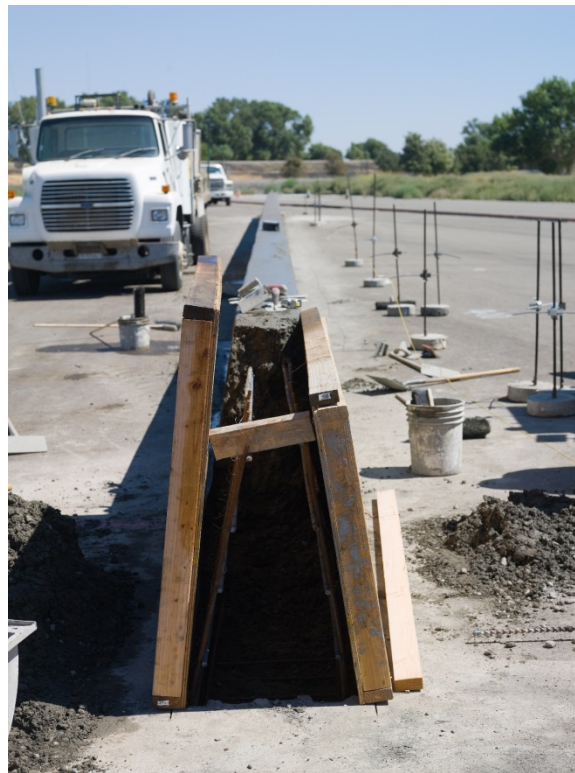
**Figure 2-7 Formwork and Steel in Place for End Anchorage**

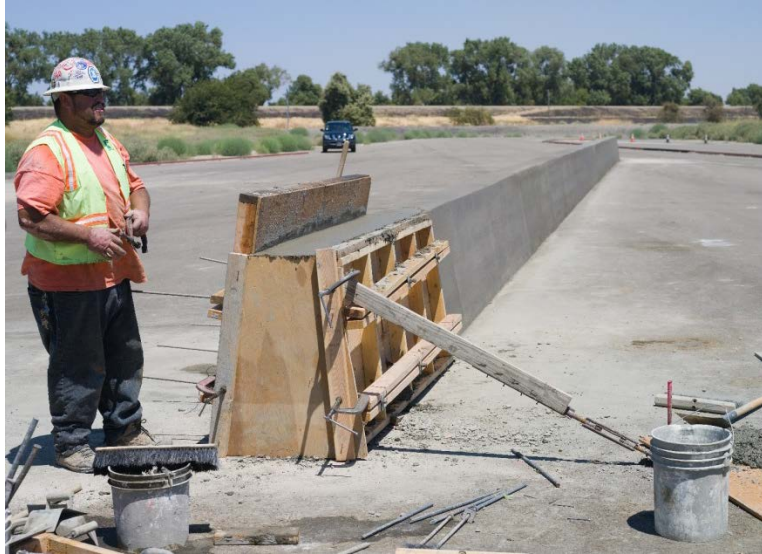
**Figure 2-8 End Anchorage Pour Complete**

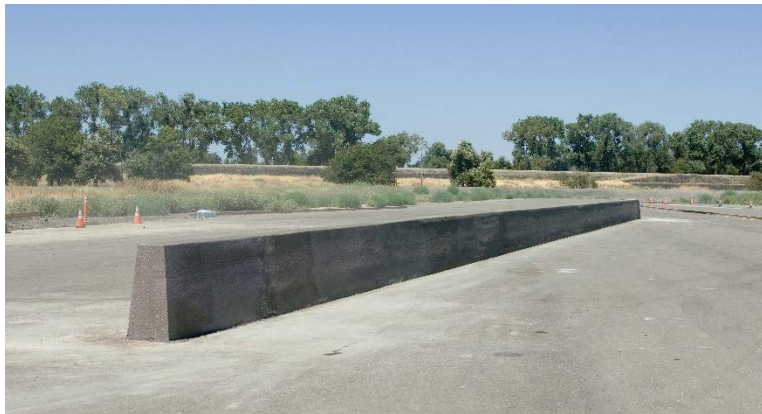
**Figure 2-9 Completed Test Article: Concrete Barrier Type 60**

The completed test article is 46 m (150 feet) long with a nominal height of 910 mm (36 inches). The actual test article height at the area of impact was approximately 965 mm (38 inches). The nominal width at the top and the base were 320 mm (12.6 in) and 610 mm (24 in), respectively. The nominal slope of the barrier face was 9.1 degrees. As constructed, the barrier face slope was shallower at approximately the upper two feet and steeper at the bottom foot due to concrete slump during slip forming. The average slope of the barrier face at the area of impact was measured to be approximately 7.9 degrees<sup>2</sup>. The measured face slope is not within the scope of our accreditation. The ends were anchored per the End Anchorage detail in Figure 8-2. The concrete was sampled and cast into standard 6" x 12" cylinders for testing. A615 Grade 60 rebar with a tested yield strength of approximately 70 ksi was used for reinforcement, see Figure 2-10. The average compressive strength of two cylinders at 28 days was 4,440 psi. The reported rebar strength and concrete strength fall outside the lab's scope of accreditation.

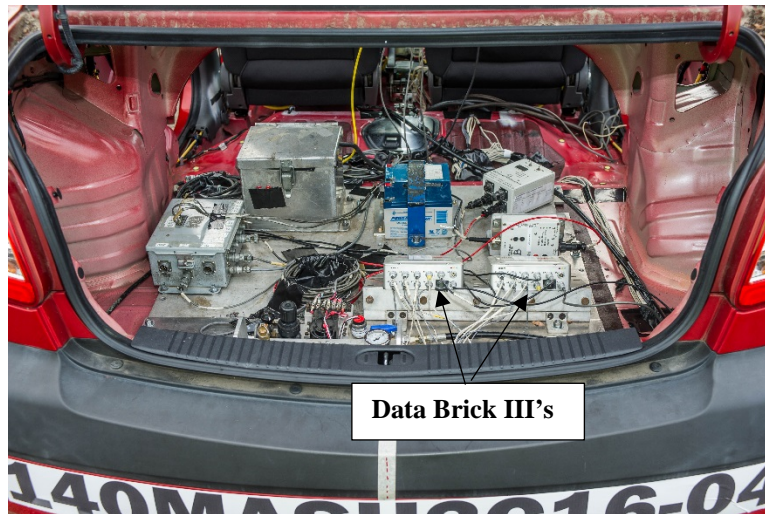
Figure 4-7 Data Brick III's

The test was documented through the use of still cameras, video cameras, high-definition high-speed digital video cameras, and GMH Engineering Data Brick III data acquisition systems to record accelerations and rotational rate changes. The impact phase of the crash test was recorded with five high-definition high-speed digital video cameras, a normal-speed DVC format video camera, digital SLR cameras and three action cameras mounted inside the test vehicle set to record video. The test vehicle and barrier were photographed before and after impact with the DVC format camera and a digital SLR camera.

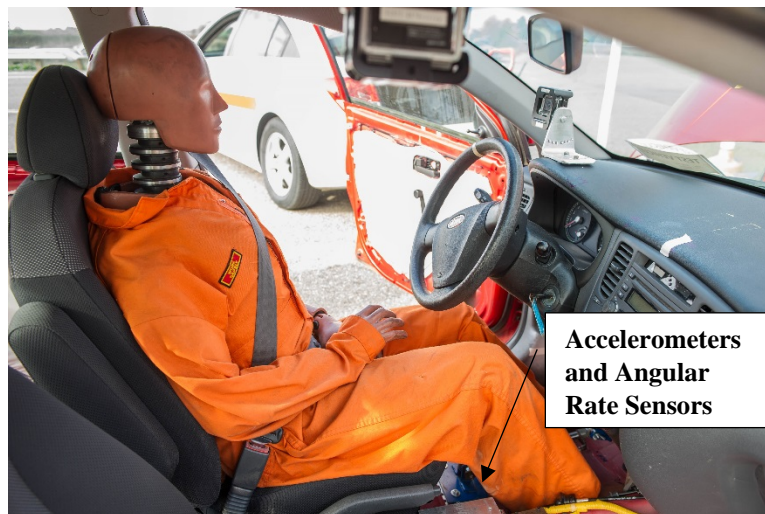
Figure 4-8 Test Vehicle Dummy and Instrumentation

Two sets of orthogonal accelerometers were mounted at the center of gravity of the test vehicles (as per MASH 2009 specifications). The rate gyro transducers (angular rate sensors) were also placed at the center of gravity of the test vehicles to measure roll, pitch, and yaw rates. The data was analyzed in Test Risk Assessment Program version 2.3.10 (TRAP) to determine the occupant impact velocities, ridedown accelerations, and maximum vehicle rotation. See Appendix 7.4 for more information on vehicle instrumentation.

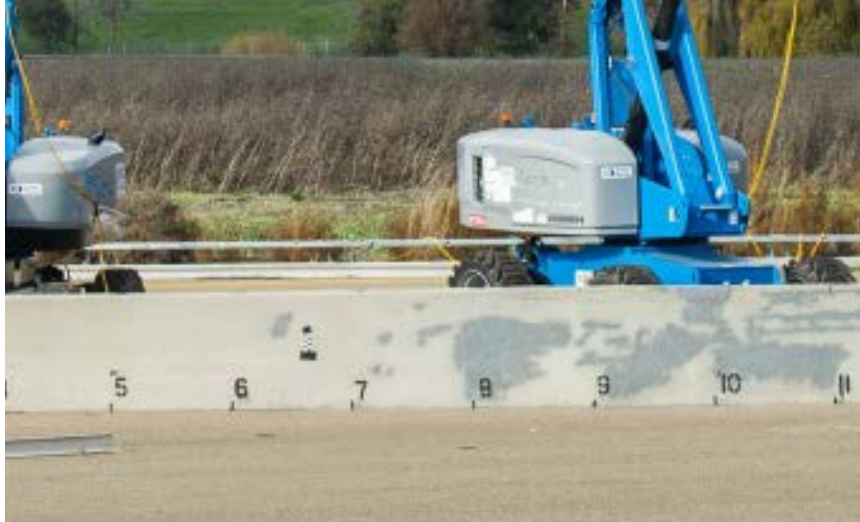
**Figure 5-1 Test Article Impact Area with Checkered Tape at Impact Point**

The point of impact was approximately 6.25 meters from the upstream barrier end. The impact angle of 25° was set with a Total Station. The intended impact speed was 100 kph.

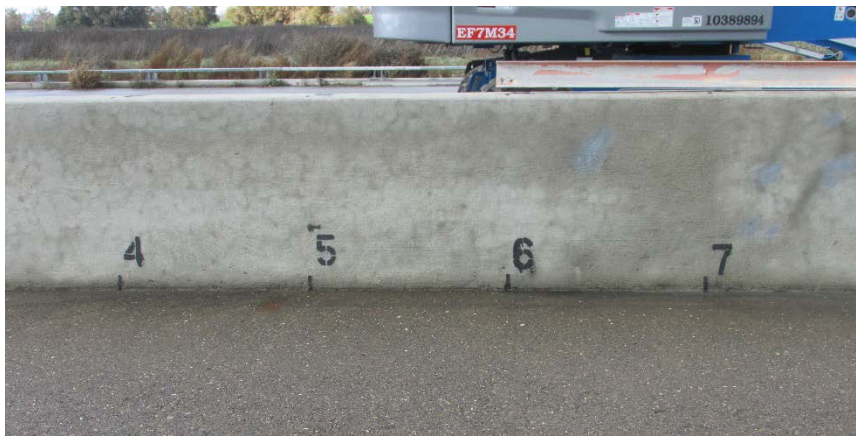
**Figure 5-2 Type 60 Barrier Point of Impact (I-beam on barrier was removed prior to test)**

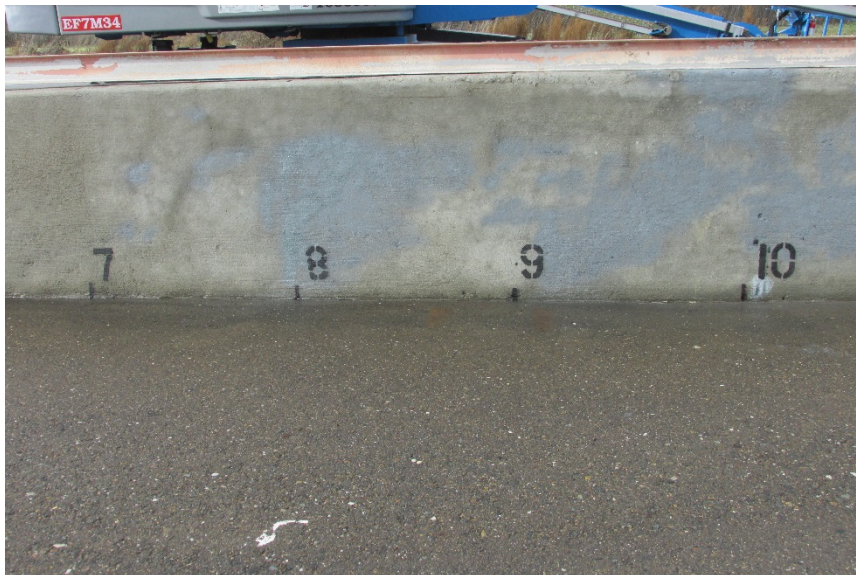
**Figure 5-3 Barrier Face Downstream of Impact (I-beam on barrier was removed prior to test)**

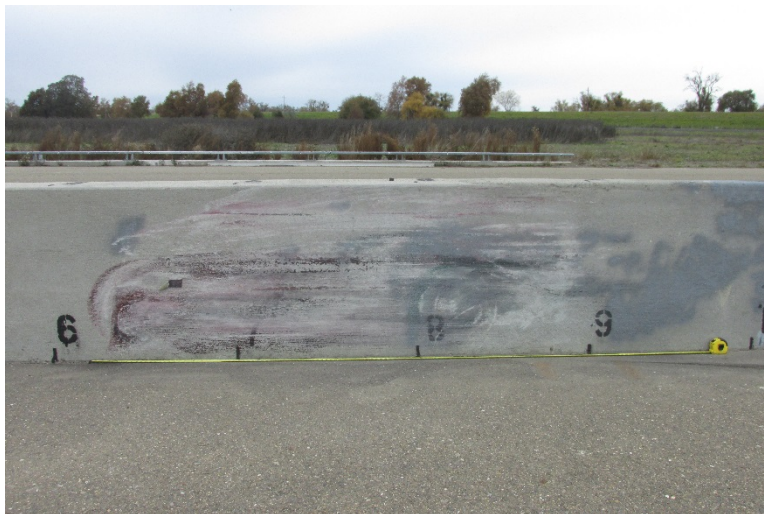
**Figure 5-6 Vehicle Marks on Type 60 Barrier**

There was no significant damage to the barrier. The only damage was extremely minor surface scrapes and gouges (see Figure 5-6, Figure 5-7, and Figure 5-8). The red contact marks are from the front left tire. The green contact marks are from the rear left tire. The barrier did not move.

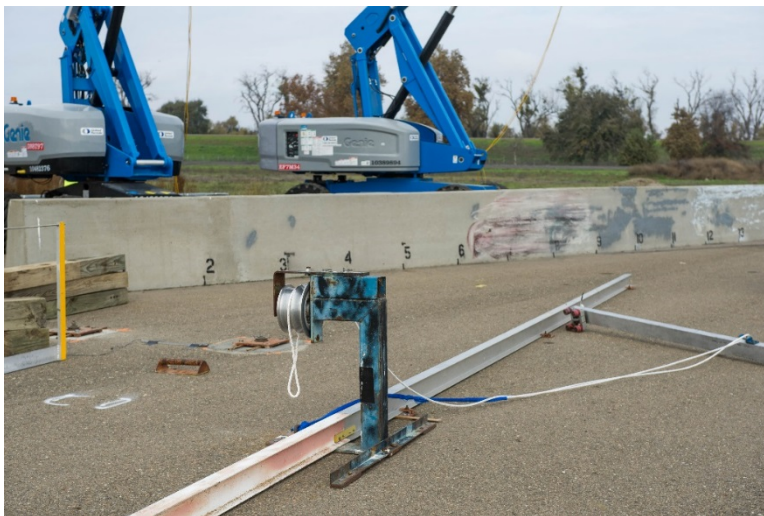
**Figure 5-7 Type 60 Barrier Post Test Upstream of Impact**

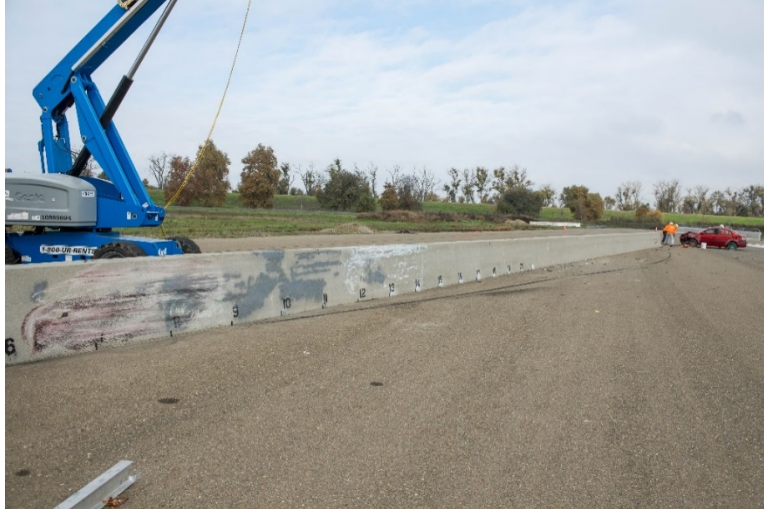
**Figure 5-8 Type 60 Barrier Post-Test Downstream of Impact**

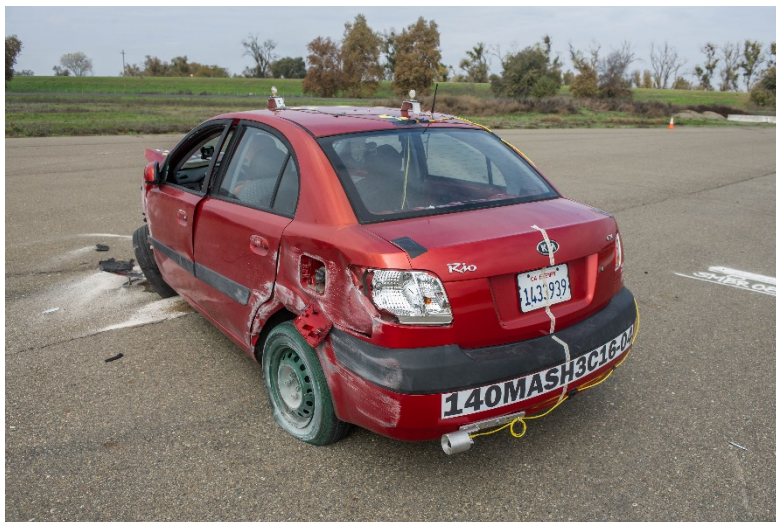
**Figure 5-10 140MASH3C16-04 Kia Rio Damage (Rear Left)**

The front left corner and driver's side of the test vehicle sustained most of the damage from the initial impact while the front and front left corner sustained additional damage from the secondary impact. The entire length of the passenger side of the vehicle made contact with the barrier. Nearly the entire front bumper was torn off. The driver's side headlight was completely shattered and/or torn off the vehicle. As mentioned previously, the driver's side front window was shattered and broken out. The bumper, hood, left doors, and front and rear fenders were severely damaged. The airbags did not deploy because the vehicle was towed and there was no power to the airbag system. The maximum amount of passenger compartment deformation measured by known points was 2.1 inches (53 mm), which occurred at the floorboard. However, the maximum floorboard deformation occurred between known points and is estimated to be 2.6 inches (66 mm). See Figure 5-14 140MASH3C16-04 Kia Rio Floorboard Crease with Maximum Deformation. The maximum amount of deformation for the roof and dashboard were 0.5 inches (13 mm) and 1.6 inches (41 mm), respectively. These values are below the maximum MASH 2009 limits. See Table 7-7 and Table 7-8 for complete interior deformation measurements. The Vehicle Damage Scale (VDS) and Collision Deformation Classification (CDC) reported under vehicle damage on the test data summary sheet do not include the secondary impact.

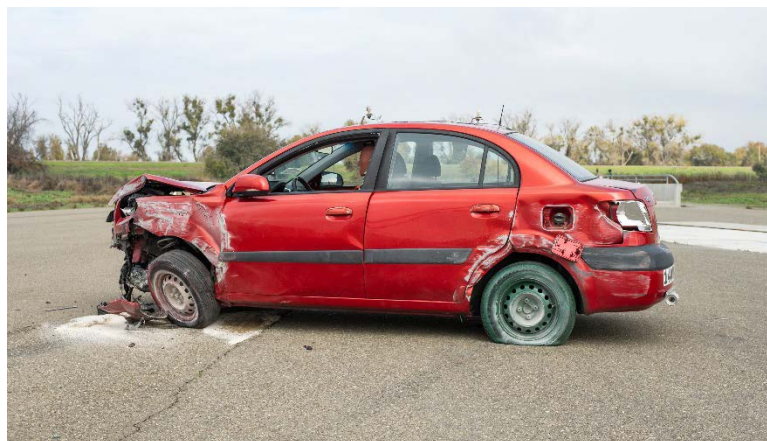
**Figure 5-11 140MASH3C16-04 Kia Rio Driver Side Damage**

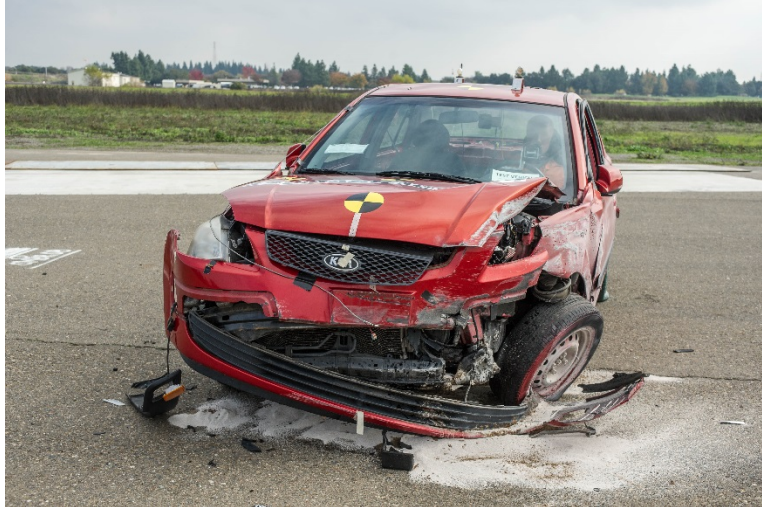
Figure 5-12 140MASH3C16-04 Kia Rio Damage (Front)

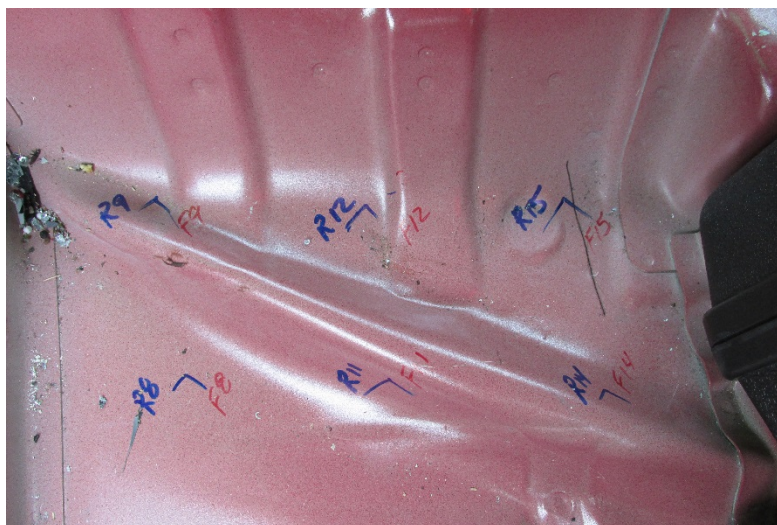
Figure 5-14 140MASH3C16-04 Kia Rio Floorboard Crease with Maximum Deformation

The occupant risk was acceptable. The maximum interior dashboard, roof, and floorboard measured deformations were 1.6 inches (41 mm), 0.5 inches (13 mm), and 2.5 inches (63 mm), respectively. As mentioned previously, the maximum floorboard measurement was estimated to be 2.6 inches because the point of greatest deformation did not appear to occur at a predefined point. There was no occupant compartment intrusion or potential for it. The occupant compartment was not compromised. The dummy head protruded slightly beyond the plane of the driver's side window when it was broken but did not show potential for striking any portion of the barrier. The yaw, pitch, and roll of the vehicle were within acceptable limits.

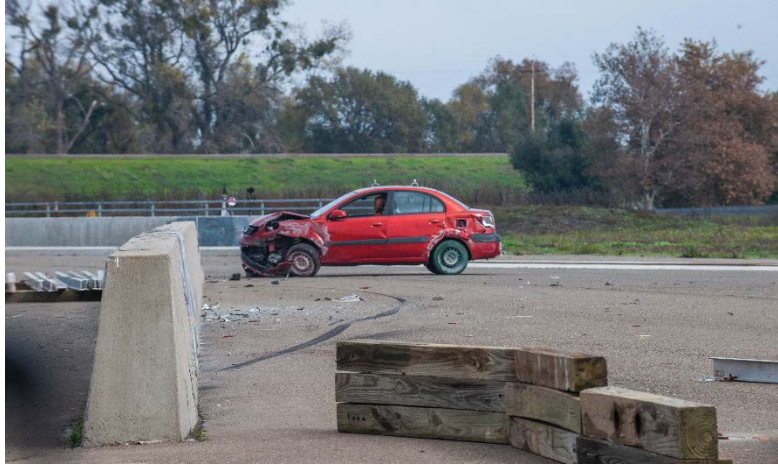
**Figure 5-15 Trajectory after Impact**

The vehicle was towed up to the intended target speed of 100 km/hr. The vehicle impacted the Type 60 barrier at approximately 6.25 meters from the upstream end at a speed of 61.2 mph (98.5 kph) and angle of 25.7°. The vehicle impacted on the driver's side; the front corner of the hood and front panel contacted the barrier and crumpled. The vehicle began to redirect and slide along the face of the barrier. The buckling of the front panel appears to cause the driver door to separate from the vehicle (as if it were opening and then quickly closing) at approximately 0.04 seconds to 0.05 seconds after impact. The buckling forces on the driver's side of the vehicle appear to cause the driver's side-window to spider-crack and shatter at approximately 0.066 seconds after impact. The dummy's head subsequently hit the glass fragments at approximately 0.076 seconds after impact. The vehicle continued to redirect and became parallel to the rail at approximately 0.168 seconds after impact. At approximately 0.276 seconds after impact, the rear of the vehicle lost contact with the barrier. There were approximately 3 meters of contact with the barrier. The exit speed and angle were measured to be 39.6 mph (63.8 kph) and 8.6°, respectively. The brakes were applied approximately 1.0 seconds after the initial impact and while the vehicle was moving away from the barrier. The braking action caused the car to yaw back toward the barrier, resulting in a secondary impact with the barrier. The vehicle came to a stop with the front end of the vehicle facing the barrier, approximately 2.7 feet (0.82 m) from the face of the barrier and approximately 139 feet (42.4 m) downstream from the initial point of impact.

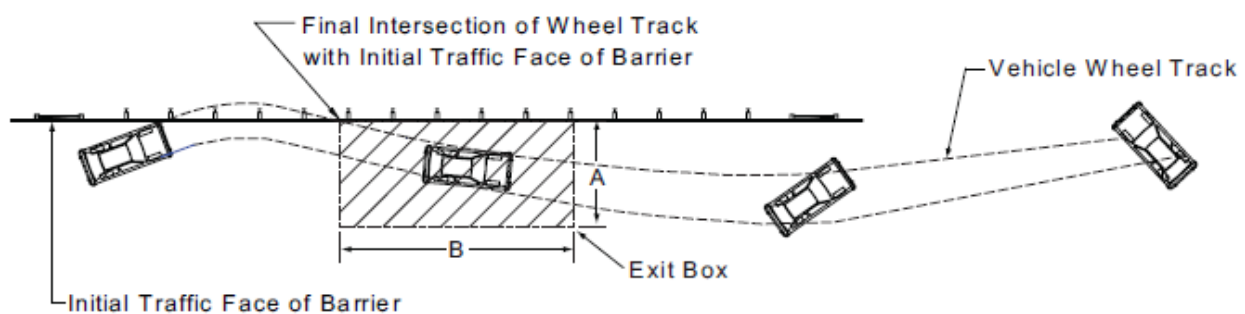
**Figure 5-18. Exit Box for Longitudinal Barriers**

The vehicle trajectory was acceptable. The exit trajectory was within the exit box. The yaw, pitch, and roll of the vehicle were below the maximum limits.

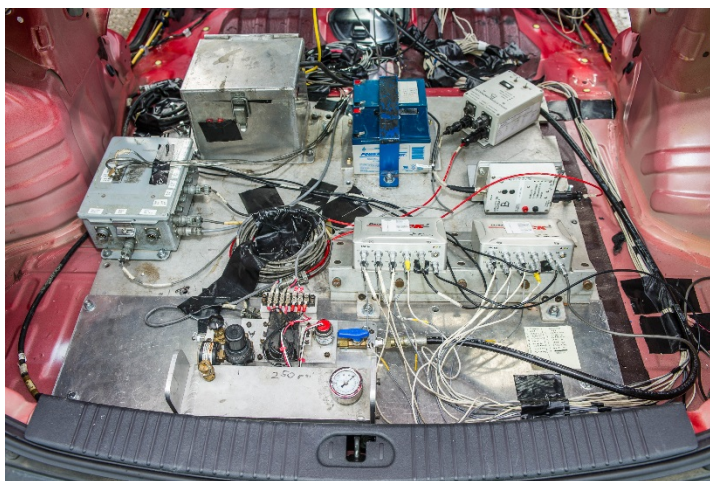
**Figure 7-1 Instrumentation Board Mounting Location**

Test 140MASH3C16-04: The vehicle used for this test was a 2007 Kia Rio. Since the vehicle was towed and not self-powered, the fuel in the gas tank was pumped out and gaseous CO<sub>2</sub> added in order to purge the gas vapors and eliminate oxygen. One pair of 12-volt wet cell batteries was mounted in the vehicle. The batteries powered the GMH DataBrick 3 transient data recorders. A 12-volt deep-cycle gel cell battery powered the Electronic Control Box.

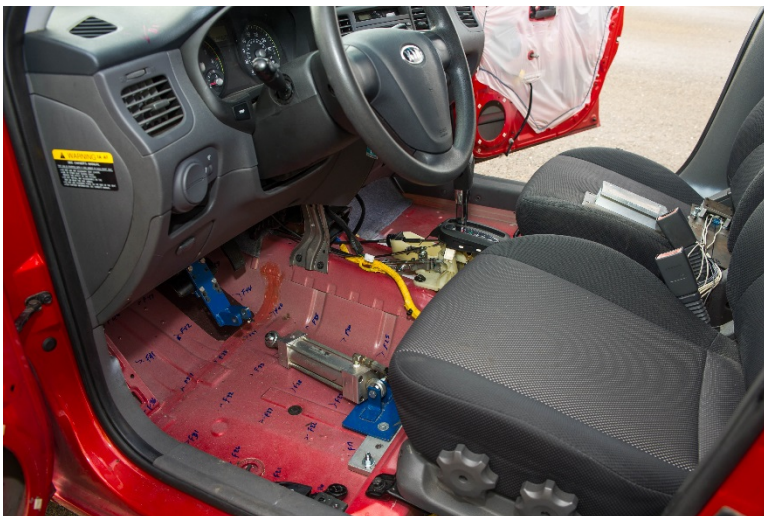
**Figure 7-4 Brake Pedal Actuator**

A 4800 kPA CO<sub>2</sub> system, actuated by a solenoid valve, controlled remote braking after the impact and emergency braking if necessary. Part of this system was a pneumatic ram which was attached to the brake pedal. The operating pressure for the ram was adjusted through a pressure regulator during a series of trial runs prior to the actual test. Adjustments were made to ensure the shortest stopping distance without locking up the wheels. When activated, the brakes could be applied in less than 100 milliseconds.

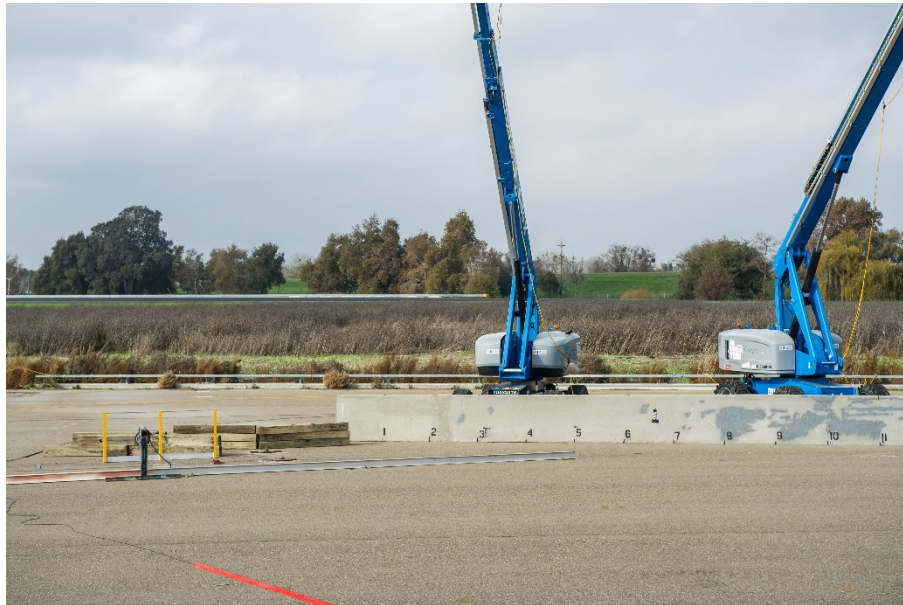
**Figure 7-5 Rail Guidance System Set-Up**

A rail guidance system directed the vehicle into the barrier. The guidance rail, anchored at 3.8 m intervals along its length was used to guide a mechanical arm, which was attached to the hub of the front right wheel of the vehicle. A plate and lever were used to trigger the release pin on the guidance arm, thereby releasing the vehicle from the guidance system before impact.

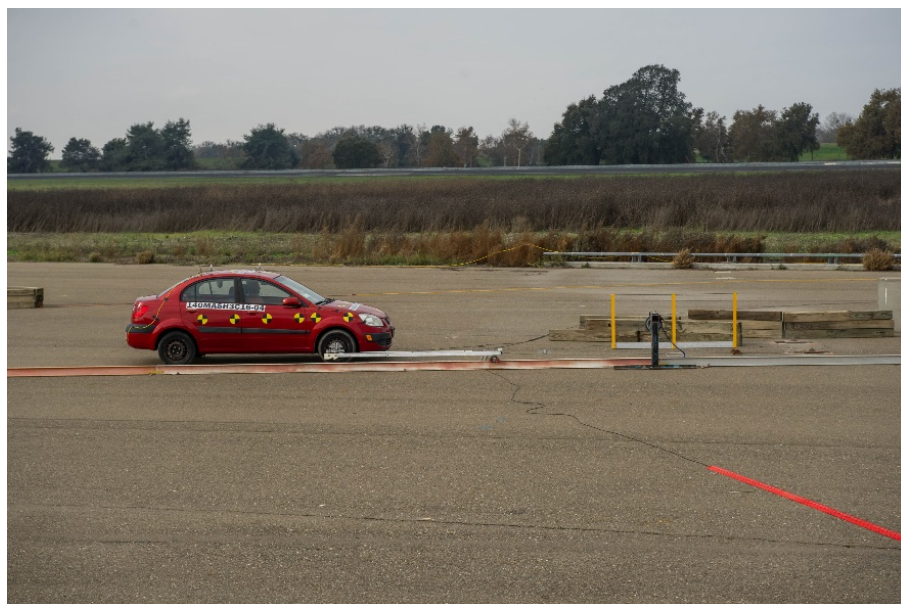
**Figure 7-6 Rail Guidance System**

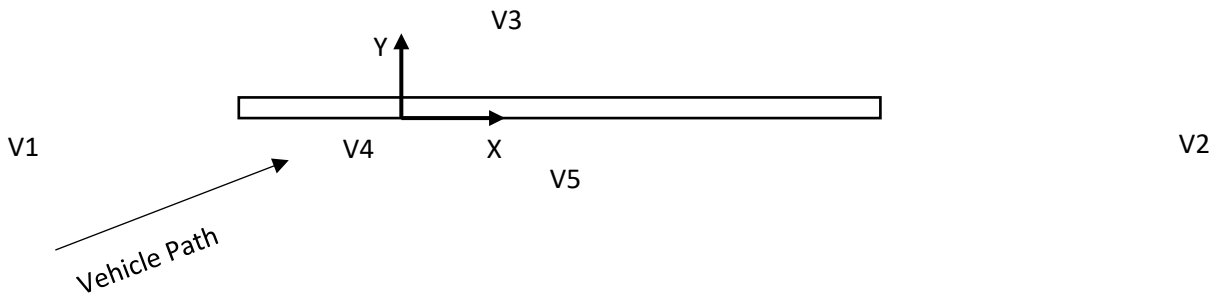
**Figure 7-7 High-Speed Video Camera Locations (Not to Scale)**

Several high-speed video cameras recorded the impact during the test. The high-speed video frame rates were set to 500 frames per second. The types of cameras and their locations are shown in Figure 7-7 and Table 7-1. The origin of the coordinates is at the intended point of impact.

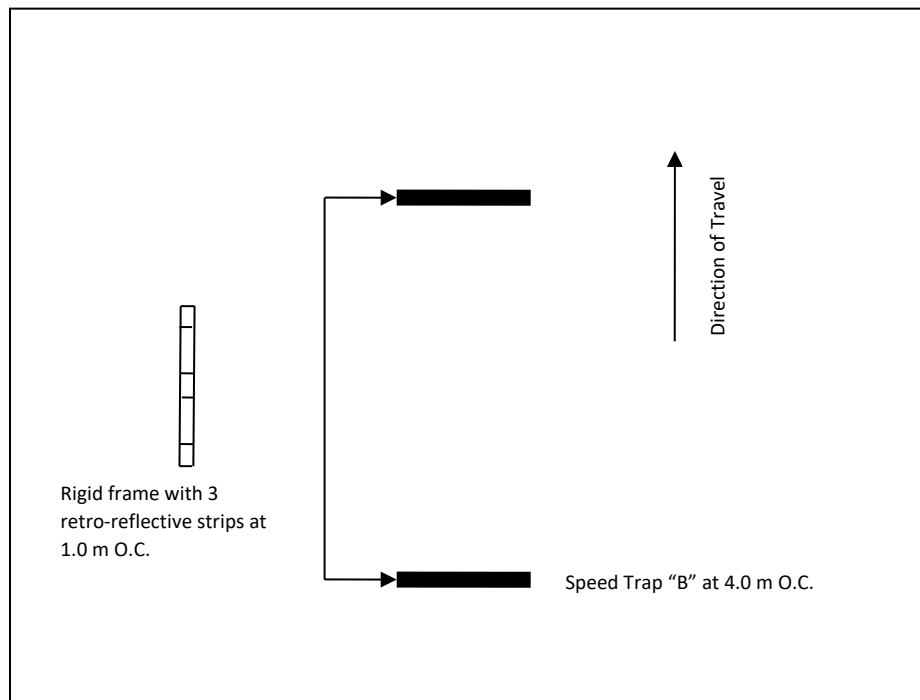
**Figure 7-8 Speed Trap Tape Layout**

A rigid stand with three retro-reflective 90° polarizing tape strips spaced 1000 mm apart was placed on the ground near the test article and alongside the path of the test vehicle. The strips were measured immediately before the test to account for any thermal expansion. The test vehicle had an onboard optical sensor that produced sequential impulses or “event blips” as the vehicle passed the reflective tape strips. The event blips were recorded concurrently with the accelerometer signals on the TDR, serving as “event markers”. The impact velocity of the vehicle could be determined from these sensor impulses, the data record time, and the known distance between the tape strips. A pressure sensitive tape switch on the front bumper of the vehicle closed at the instant of impact and triggered two events: 1) “event marker” was added to the recorded data, and 2) a flashbulb mounted on the top of the vehicle was activated. One set of pressure activated tape switches, connected to a speed trap, was placed 4 m apart just upstream of the test article to check the impact speed of the test vehicle (not a reported measurement). The layout for all of the pressure sensitive tape switches and reflective tape is shown in Figure 7-8.

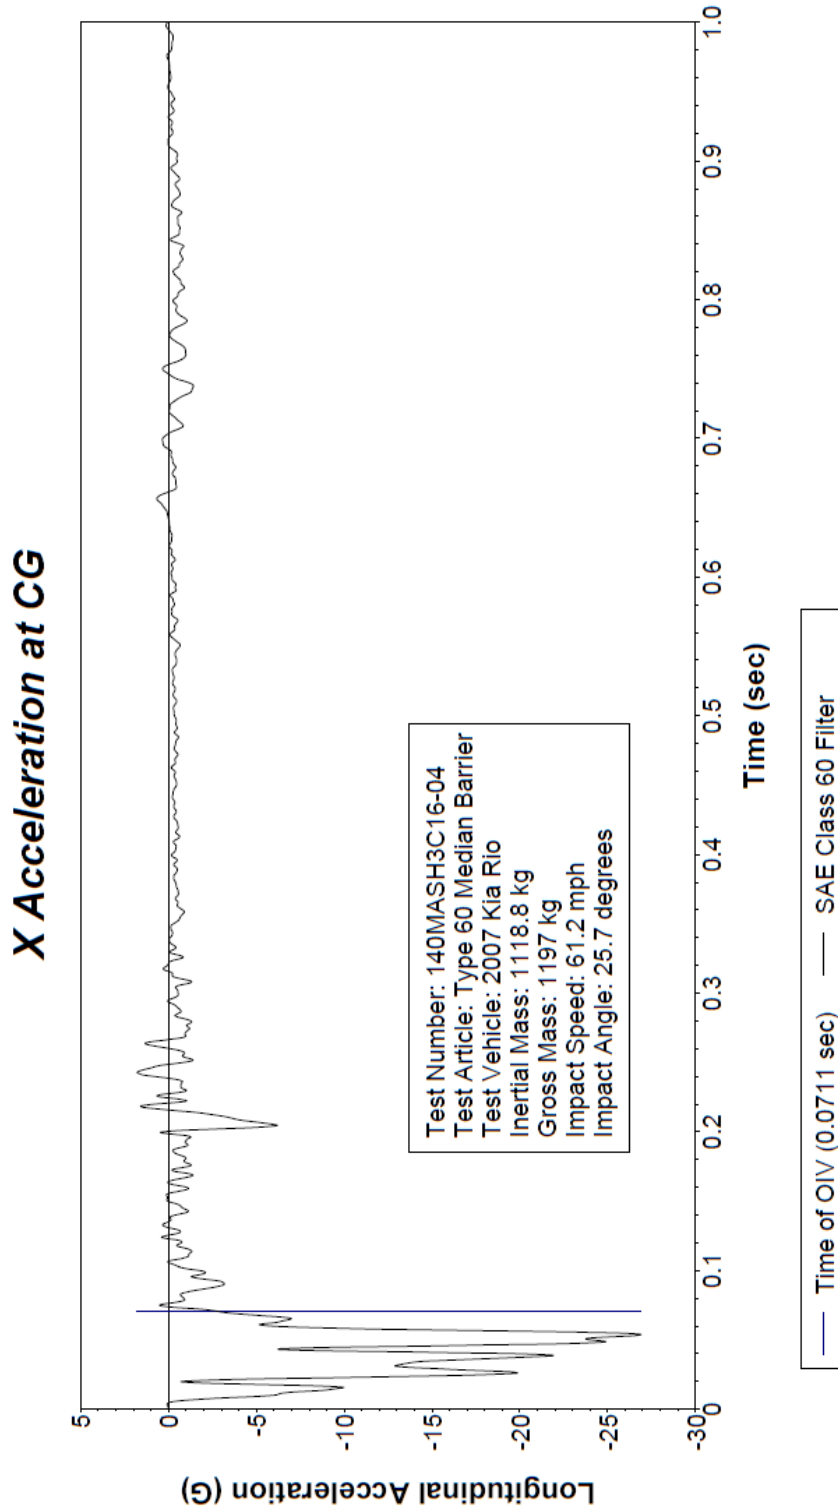
Figure 7-9 Longitudinal Acceleration at CG - Secondary

The TRAP data plots are shown in Figure 7-9 through Figure 7-18. The plots included are the accelerations, angular rate sensor rates, angular rate sensor degrees, Acceleration Severity Index (ASI), and TRAP test summary sheets. All data were analyzed using TRAP. As noted on the Test Data Summary Sheet, the data was analyzed using the “Secondary” Acceleration records and a hybrid of the “Primary” and “Secondary” Angular Rate Sensor (ARS) records. The reasons for this are: 1) The “Secondary” channels were closer to the vehicle CG and 2) Some of the ARS Channels did not record properly so the ARS channels that recorded properly were combined to provide a complete set of ARS data<sup>3</sup>. The plots of data used for the TRAP analysis are shown on the following pages preceding the TRAP summary with the “Primary” Acceleration plots shown thereafter for reference.

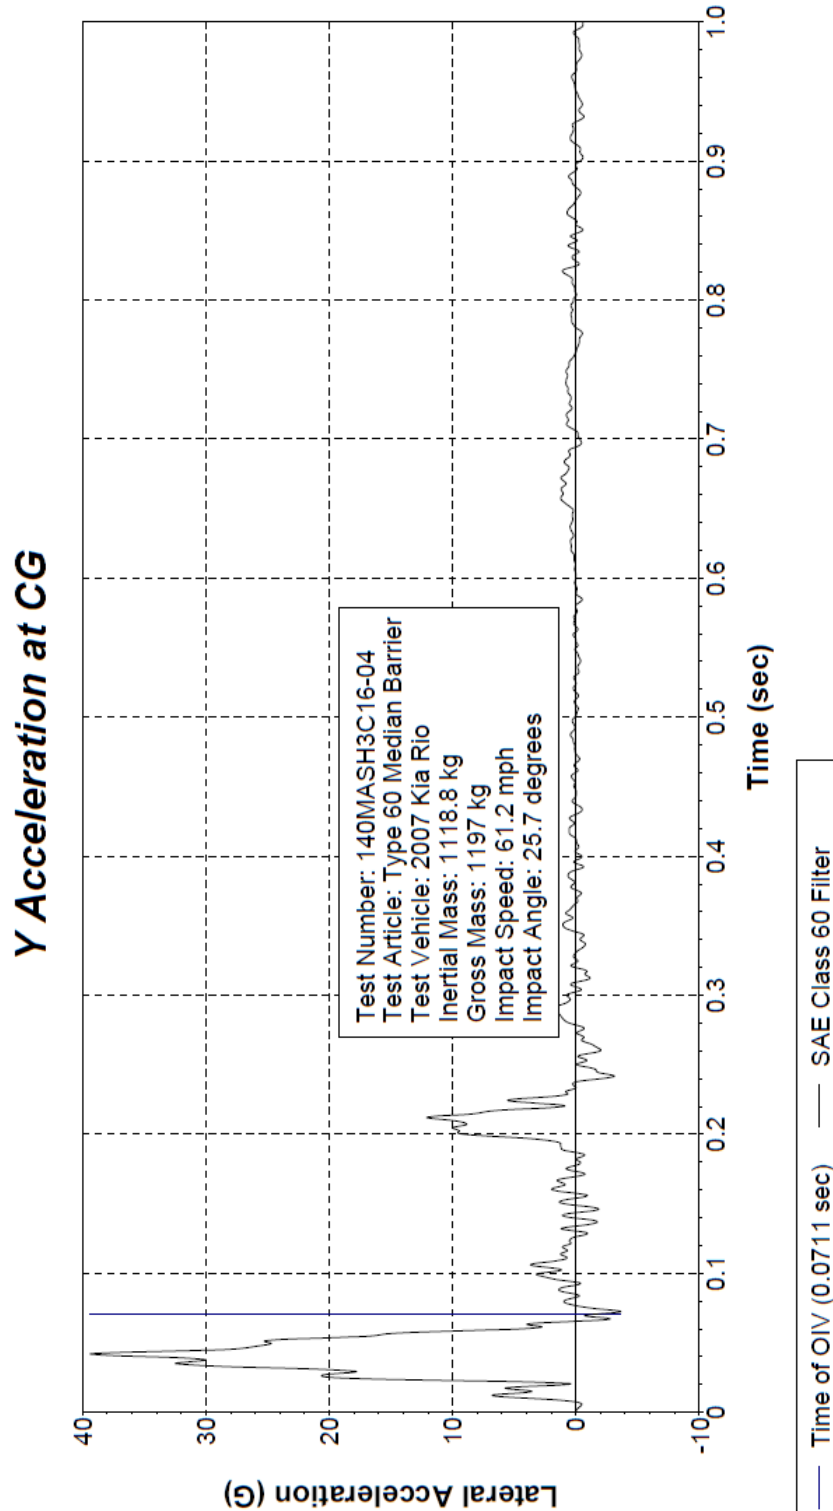
Figure 7-10 Lateral Acceleration at CG – Secondary

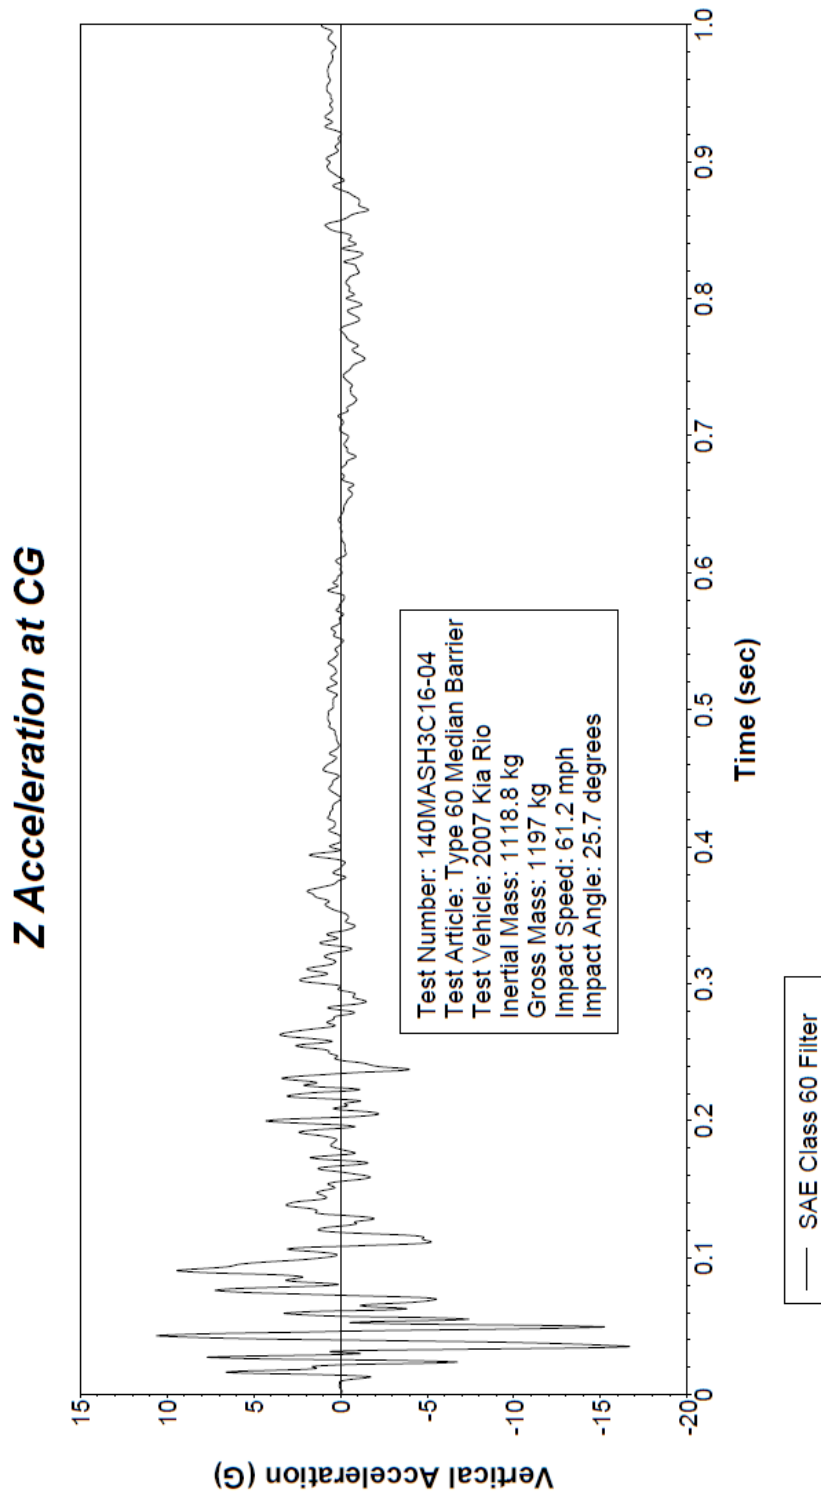
Figure 7-11 Vertical Acceleration at CG – Secondary

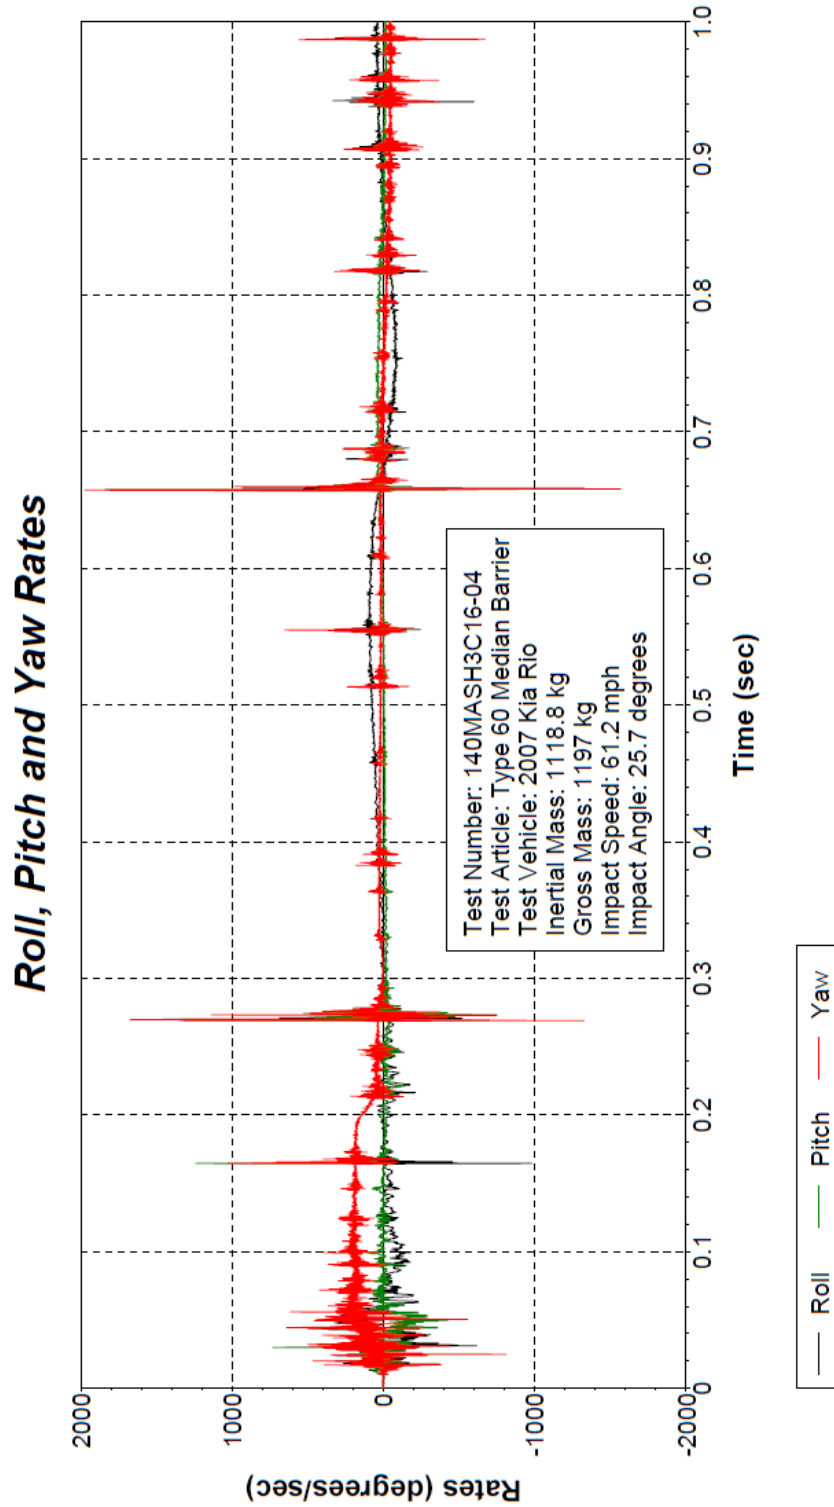
Figure 7-12 Roll, Pitch, and Yaw Rates at CG – Combined

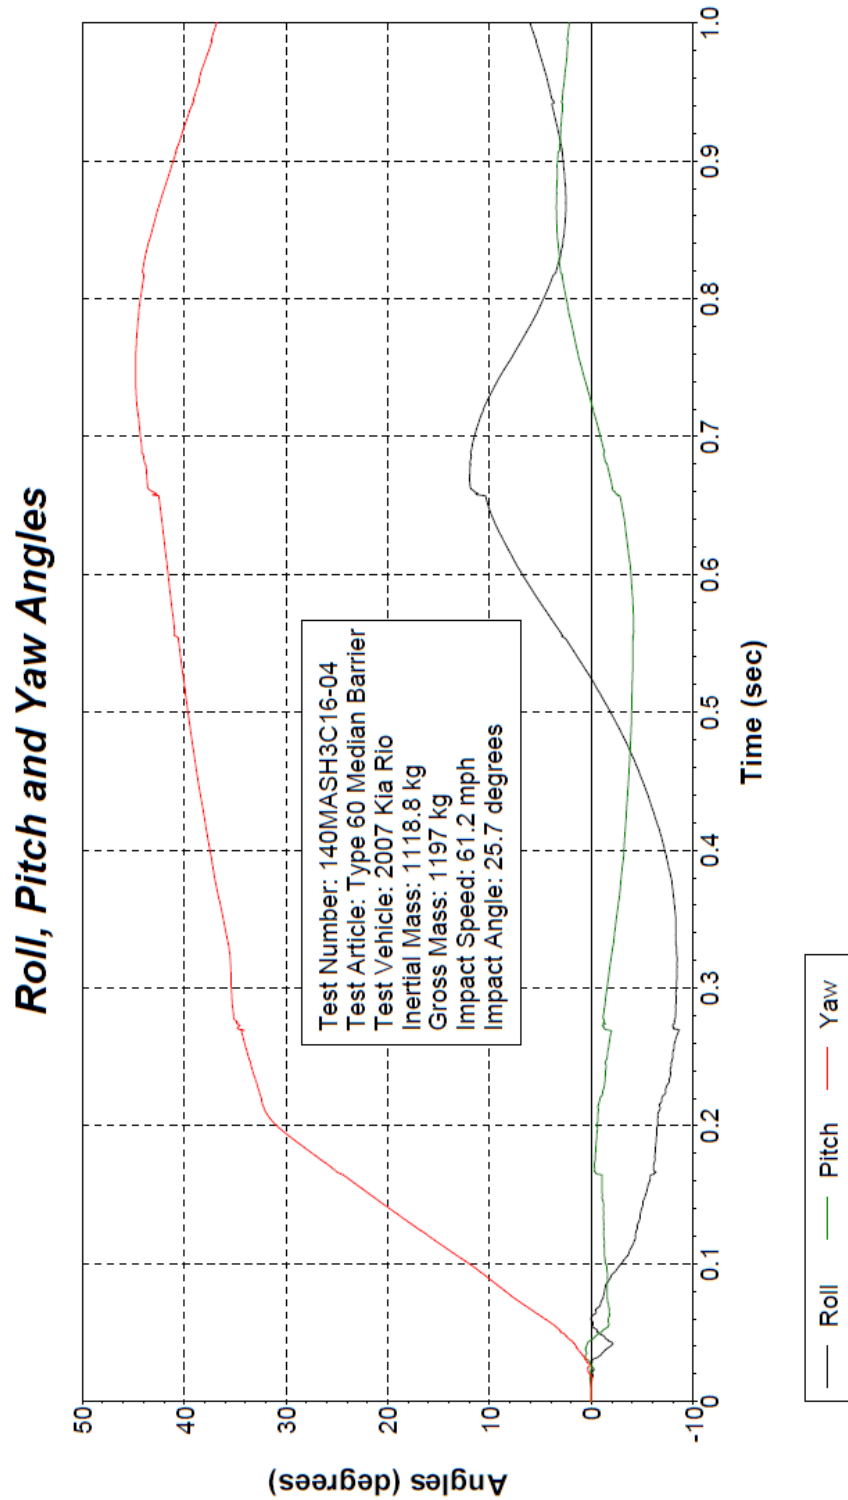
Figure 7-13 Roll, Pitch, and Yaw Angles at CG - Combined
