1. REPORT NO. <b>FHWA/CA17-2654</b>	2. GOVERNMENT ACCESSION NO.	3. RECIPIENT'S CATALOG NO.	
4. TITLE AND SUBTITLE <b>COMPLIANCE CRASH TESTING OF THE TYPE 60 MEDIAN BARRIER, Test 140MASH3C16-04</b>  <b>TYPE 60 MEDIAN BARRIER</b>		5. REPORT DATE  May 2018

**COMPLIANCE CRASH TESTING OF THE TYPE 60 MEDIAN BARRIER  
(TEST 140MASH3C16-04)**

**COMPLIANCE CRASH TESTING OF THE TYPE 60 MEDIAN BARRIER**  
**Test 140MASH3C16-04**

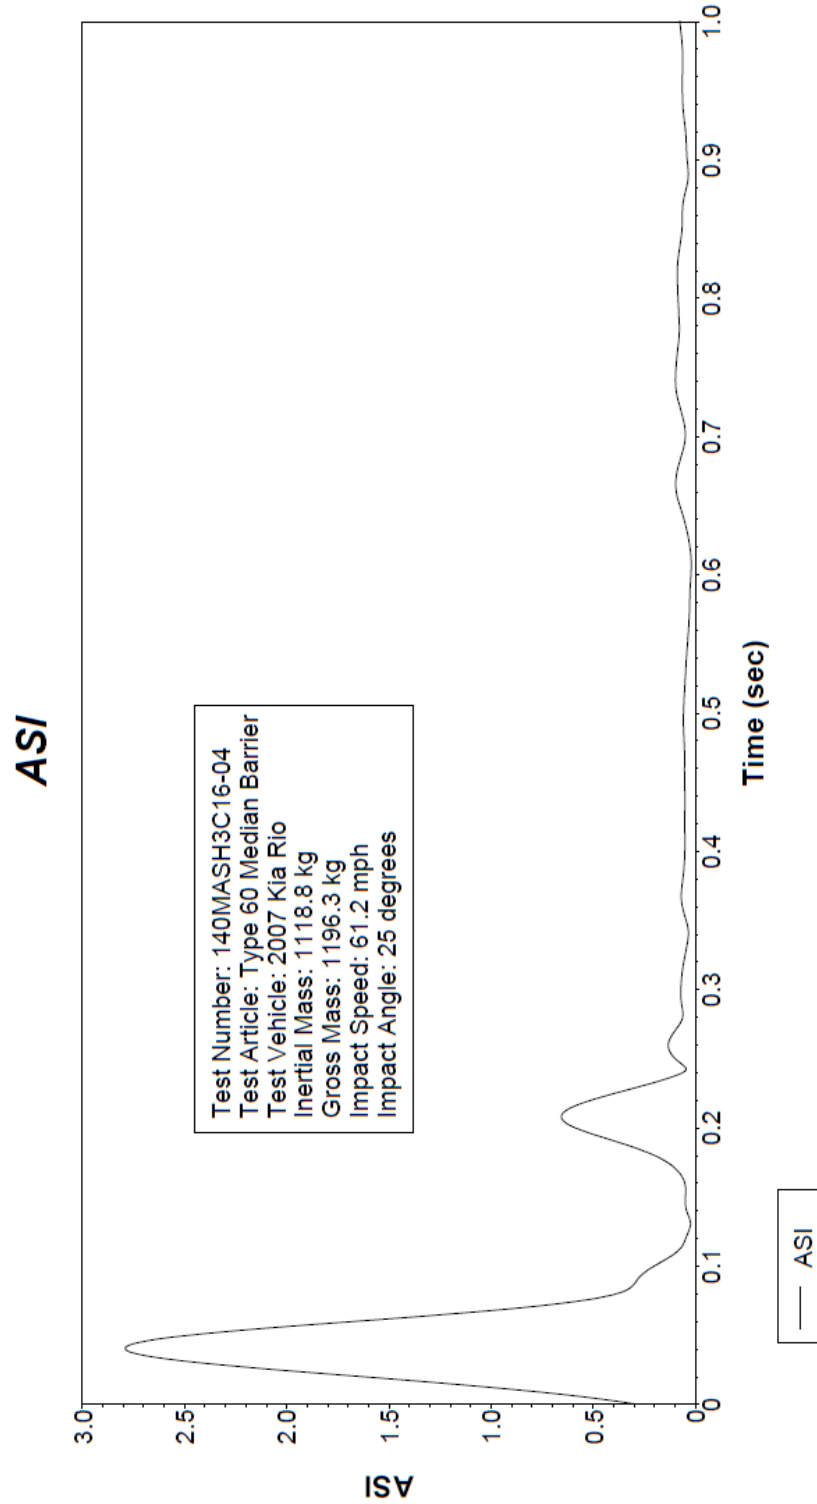
Figure 7-14 Acceleration Severity Index (ASI) - Combined

The TRAP data plots are shown in Figure 7-9 through Figure 7-18. The plots included are the accelerations, angular rate sensor rates, angular rate sensor degrees, Acceleration Severity Index (ASI), and TRAP test summary sheets. All data were analyzed using TRAP. As noted on the Test Data Summary Sheet, the data was analyzed using the “Secondary” Acceleration records and a hybrid of the “Primary” and “Secondary” Angular Rate Sensor (ARS) records. The reasons for this are: 1) The “Secondary” channels were closer to the vehicle CG and 2) Some of the ARS Channels did not record properly so the ARS channels that recorded properly were combined to provide a complete set of ARS data<sup>3</sup>. The plots of data used for the TRAP analysis are shown on the following pages preceding the TRAP summary with the “Primary” Acceleration plots shown thereafter for reference.

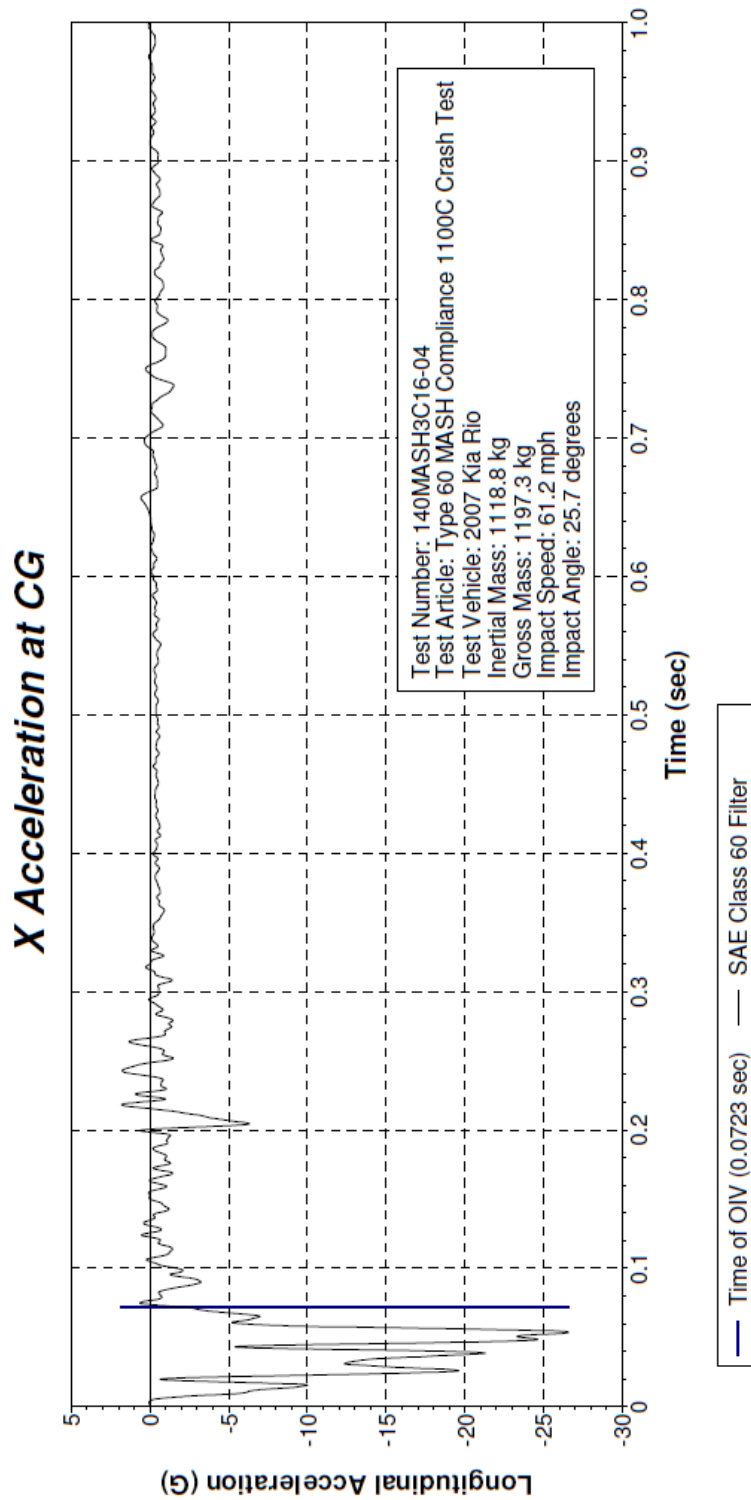
Figure 7-16 Longitudinal Acceleration at CG - Primary

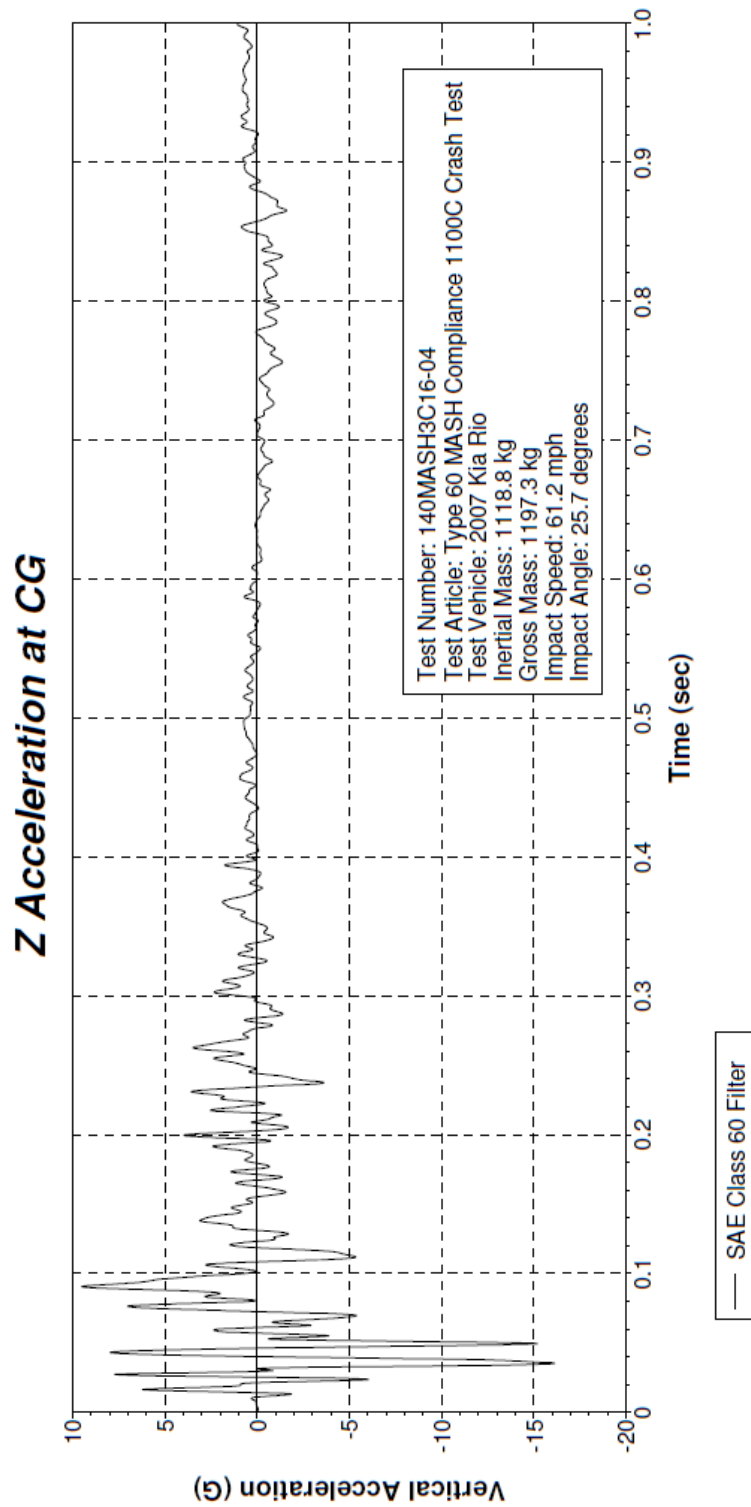
Figure 7-18 Vertical Acceleration at CG – Primary

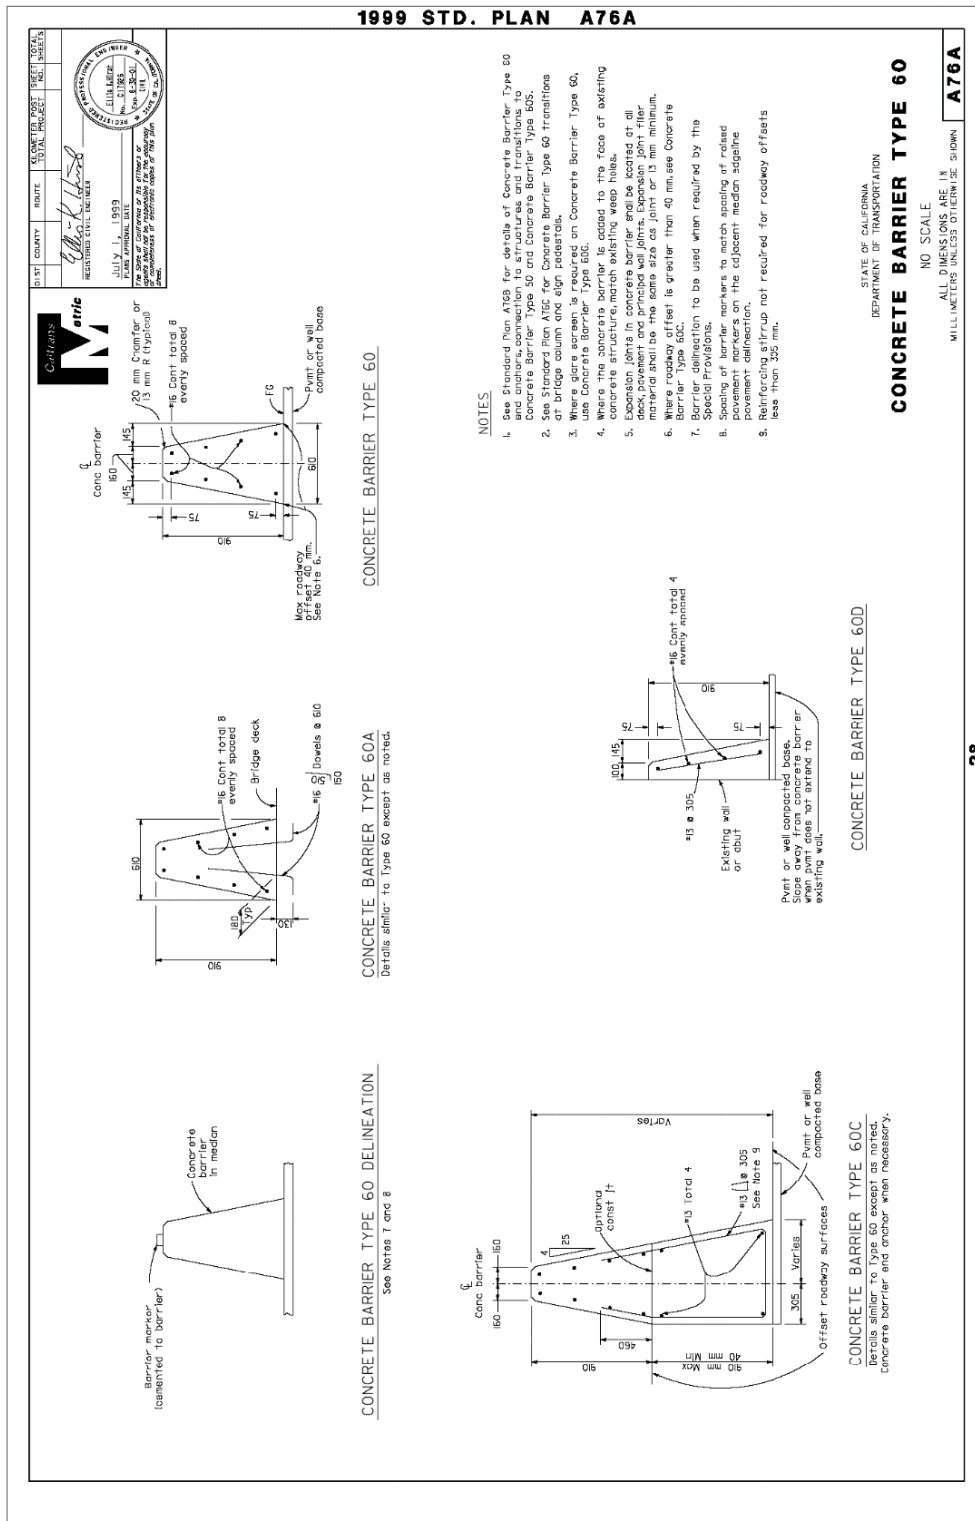
Figure 8-1. Standard Plan for Type 60 Barrier

The following details in Figure 8-1 and Figure 8-2 are Type 60 Median Barrier Standard Plans.

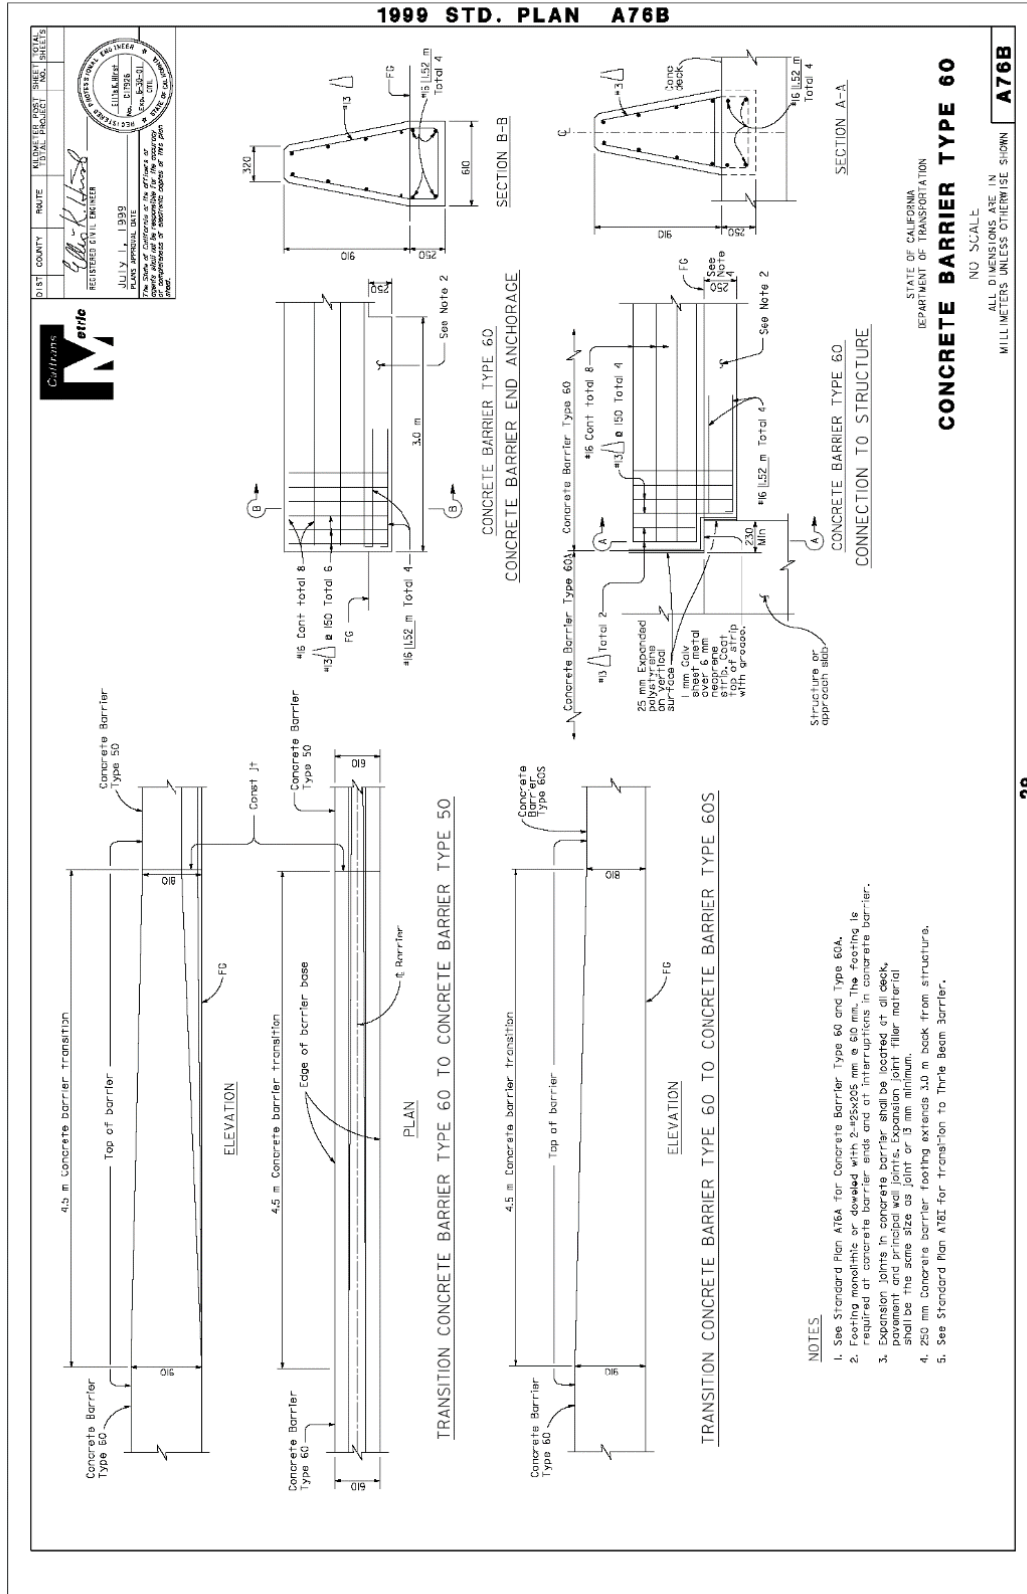
Figure 8-2. Standard Plan for Type 60 Barrier (End Anchorage)
