DYNAMIC EVALUATION OF A PINNED ANCHORING SYSTEM FOR NEW YORK STATE'S TEMPORARY CONCRETE BARRIERS – PHASE II

MIDWEST ROADSIDE SAFETY FACILITY

MwRSF Research Report No. TRP-03-224-10

January 27, 2010

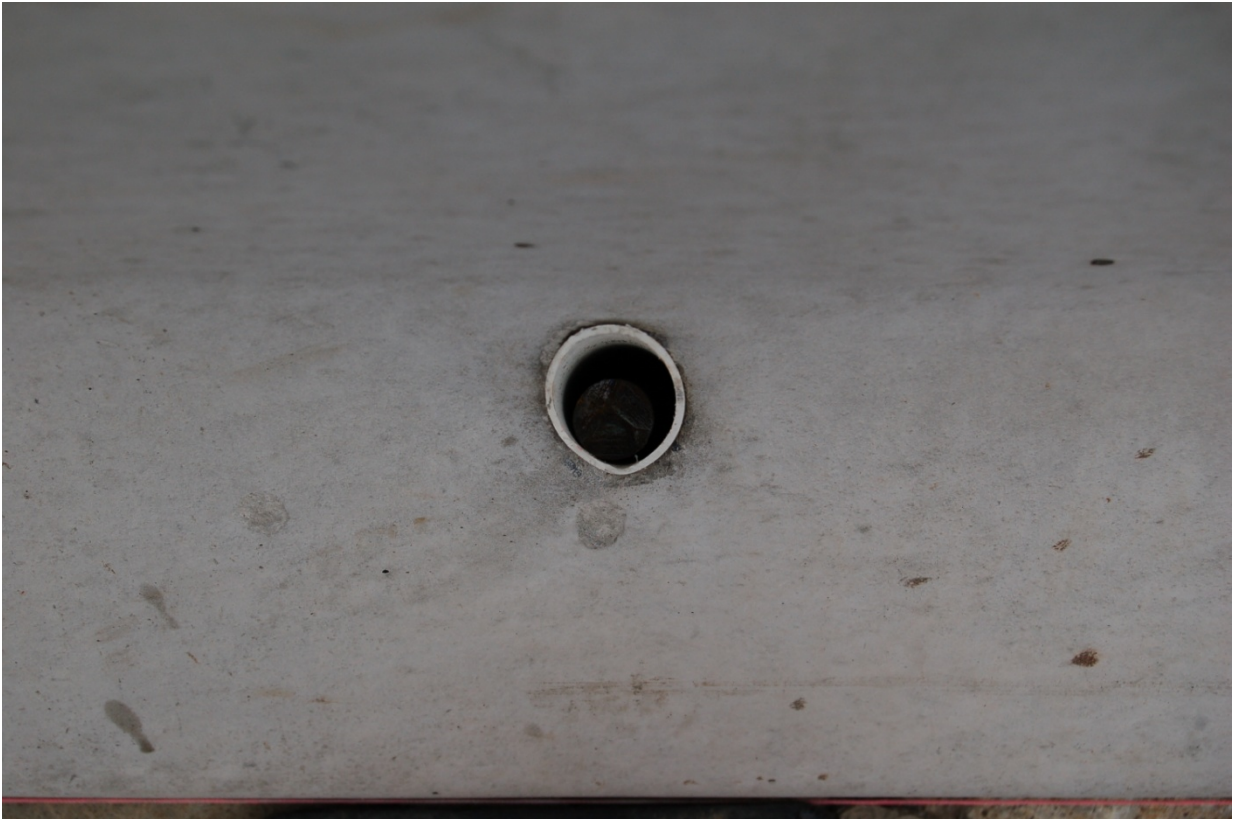
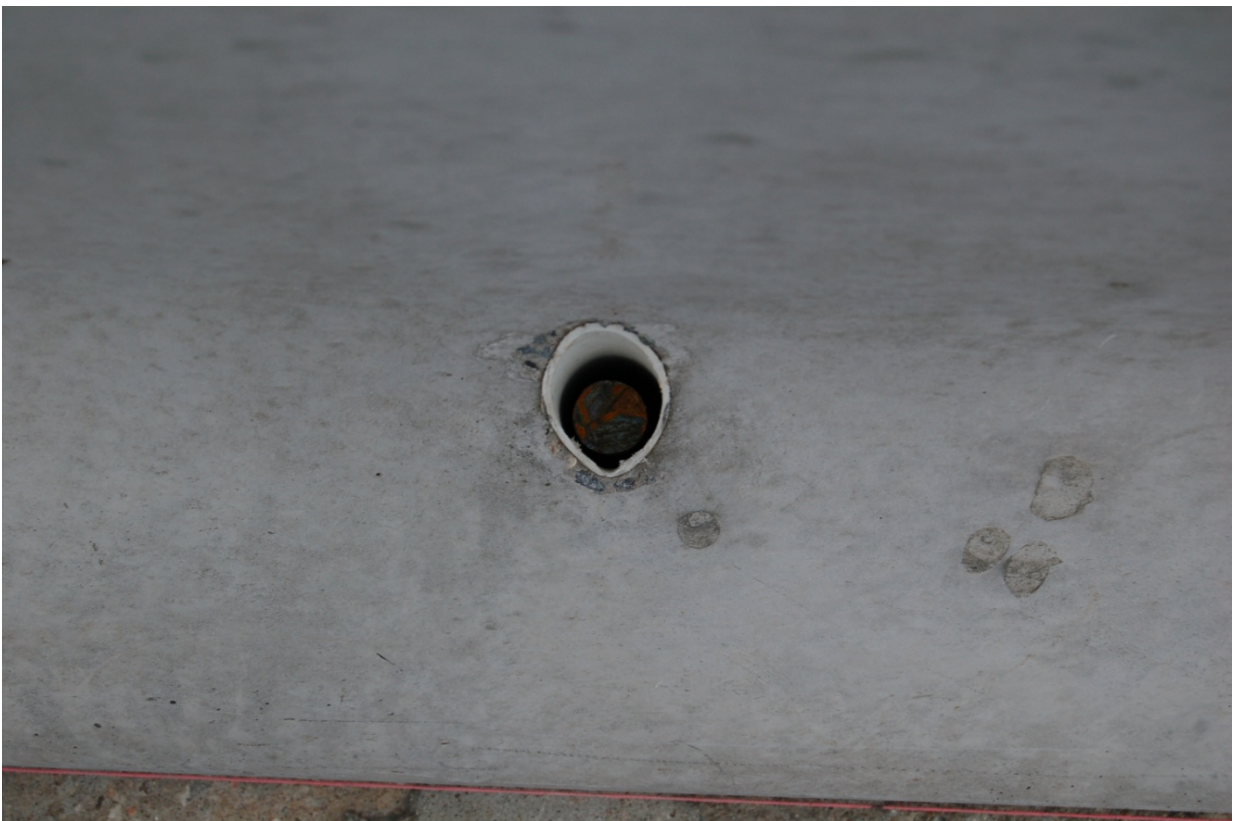
Figure 12. Temporary Concrete Barrier Section Anchor, Test No. NYTCB-5

All barrier sections were pinned to the rigid concrete pavement with four 1-in. (25-mm) diameter by 15½-in. (394-mm) long, ASTM A36 (hot rolled) steel rods. The steel rods or pins were passed through the precast holes on the back-side toe of the barrier sections, as shown in Figures 1, 2, and 12. Each anchor rod was then inserted into a 1¼-in. (29-mm) diameter, drilled hole in the rigid concrete surface using an embedment depth of 5 in. (127 mm), as shown in Figure 1. In addition, the system was installed with the back side of the sections placed 12 in. (305 mm) away from the edge of a simulated bridge deck, as shown in Figure 1.

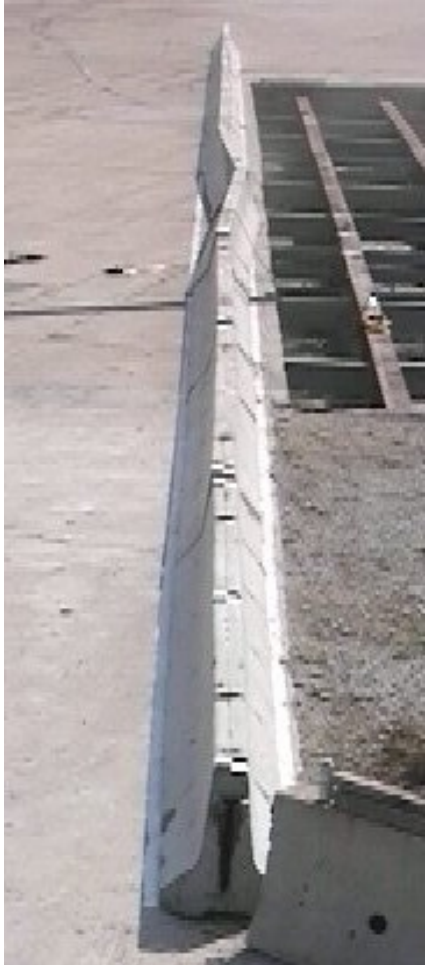
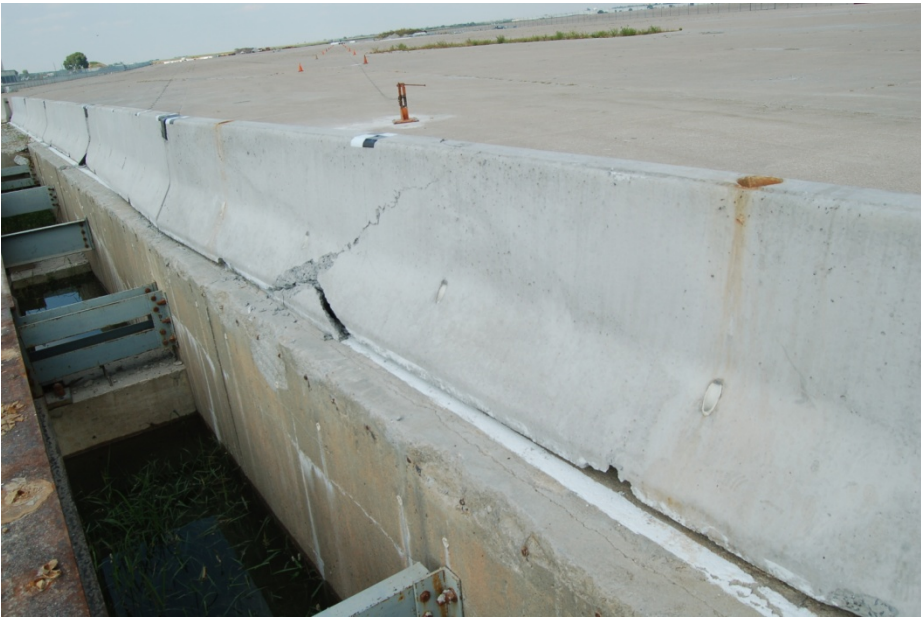
Figure 25. System Damage, Test No. NYTCB-5

Damage to the barrier was moderate, as shown in Figures 25 through 32. Barrier damage consisted of contact and gouge marks, spalling of concrete, and concrete cracking and failure. The length of vehicle contact along the barrier was approximately 22 ft – 8 in. (6.9 m) which spanned from 6 ft – 4 in. (1.9 m) upstream from the center of the joint between barrier nos. 4 and 5 to 16 ft – 4 in. (5.0 m) downstream from the center of the joint between barrier nos. 4 and 5.

The maximum permanent set of the barrier system was 9 in. (229 mm) at the downstream end of barrier no. 4, as measured in the field. The maximum lateral dynamic barrier deflection, including tipping of the barrier along the top surface, was 20.5 in. (521 mm) at the upstream end of barrier no. 5, as determined from high-speed video analysis. The working width of the system was found to be 32.5 in. (826 mm).

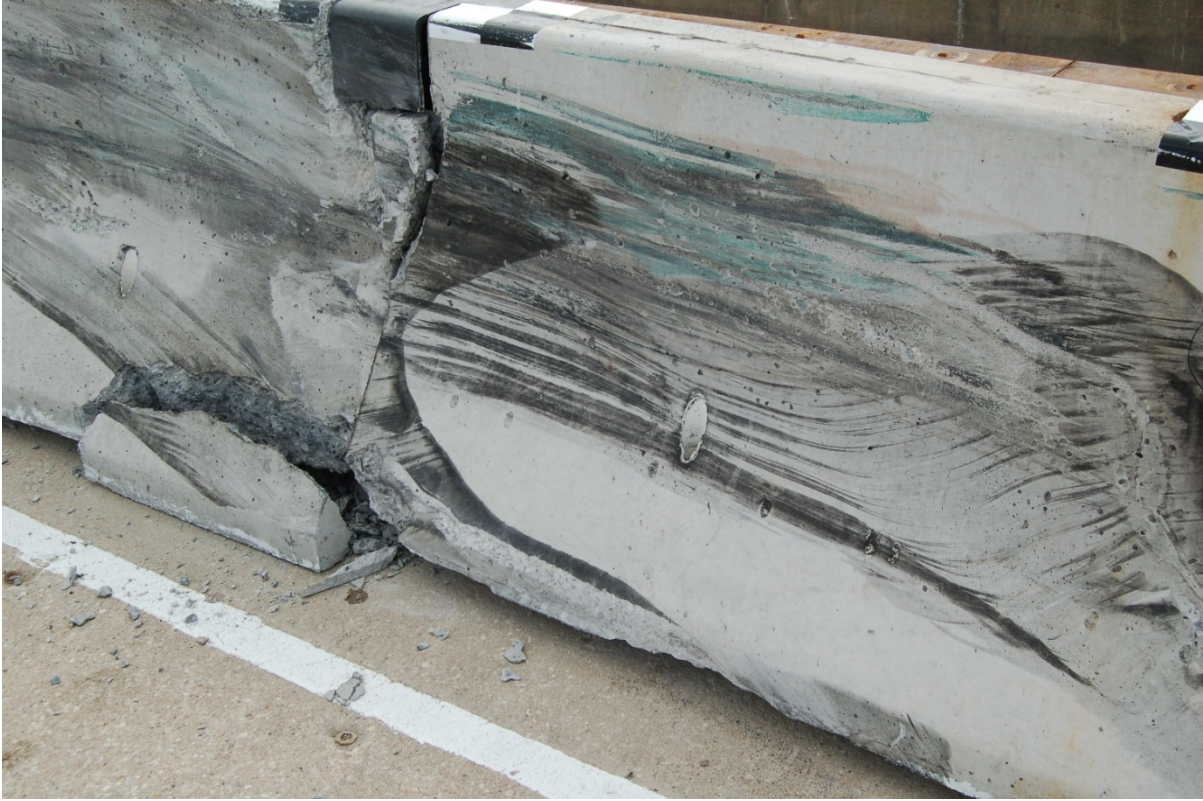
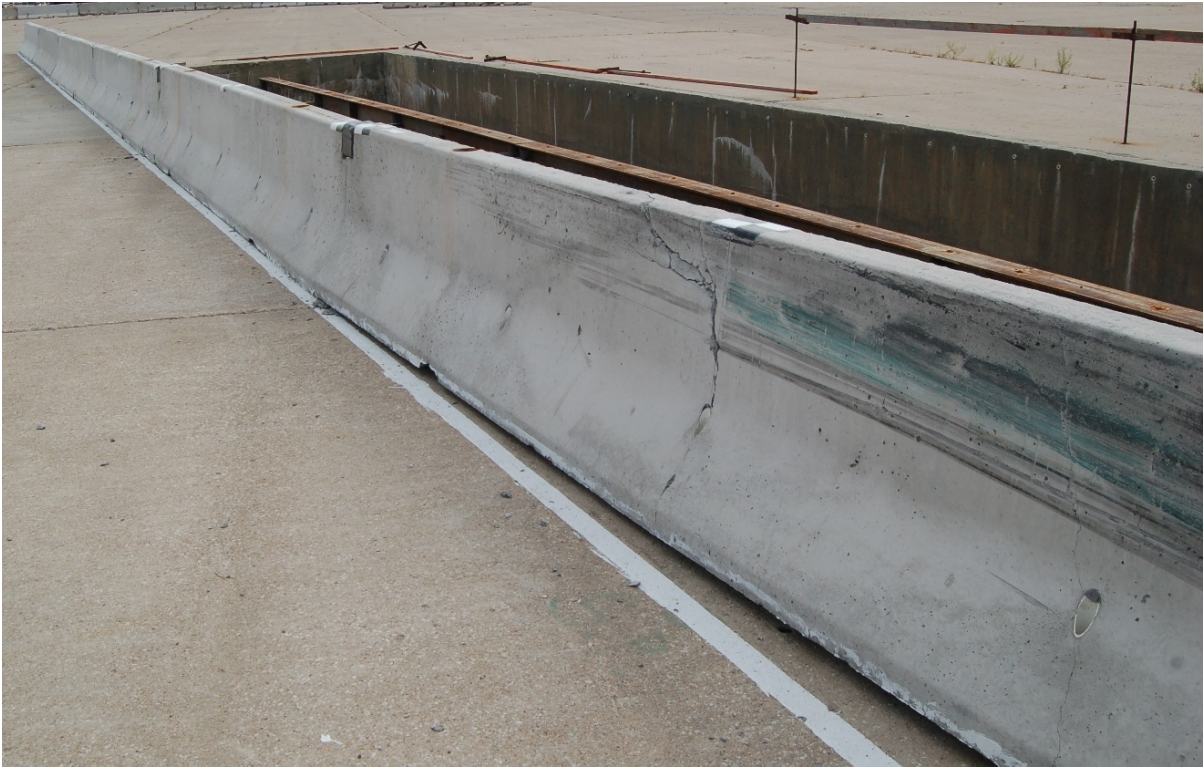
Figure 26. System Damage, Test No. NYTCB-5

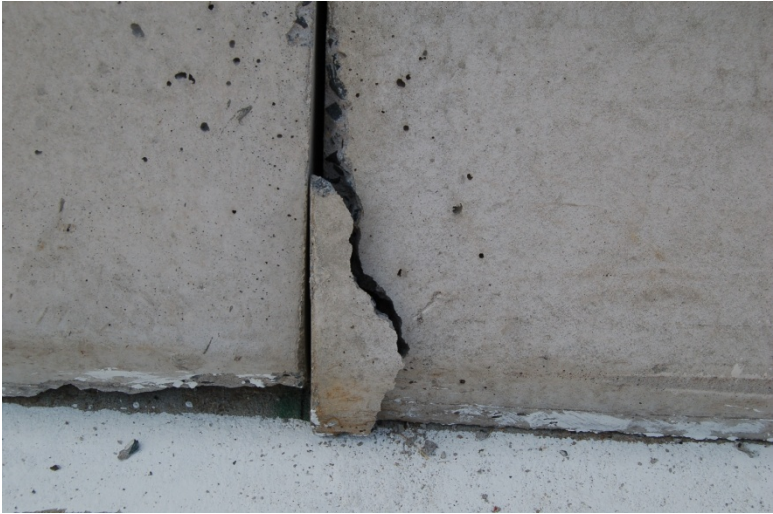
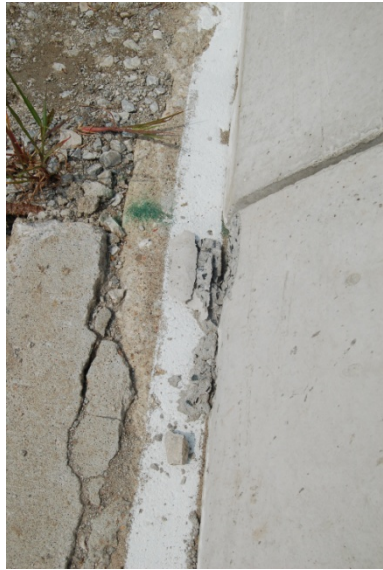
Figure 27. Barrier Nos. 2 and 3 Damage, Test No. NYTCB-5

Minor cracking was found on barrier nos. 2 and 6. A 7½-in. (191-mm) long vertical crack was found at the corner of the upstream connection key socket in barrier no. 3. Barrier no. 4 experienced a vertical crack that extended the height of the barrier near the center anchor hole on the front side as well as cracking around the downstream-most anchor hole on the back side. Vertical cracks were found in the front and back face of barrier no. 5 at 19 in., 50 in., and 79 in. (483 mm, 1,270 mm, and 2,007 mm) downstream from the upstream end and at the middle of the

Concrete spalling occurred on barrier nos. 3 through 7. The back side of barrier no. 3 experienced concrete spalling at the lower-upstream corner, the upper-downstream corner, and near the middle of the barrier. Concrete spalling also occurred at the lower-downstream corner at the front of barrier no. 3. An 8-in. x 14-in. x 3-in. (203-mm x 356-mm x 76-mm) piece of concrete was removed from the bottom-upstream corner on the back side of barrier no. 4. A 5-in x 12-in. (127-mm x 305-mm) piece of concrete was fractured near the connection key, but it remained attached to the barrier. A 4-in. x 15-in. (102-mm x 381-mm) piece of concrete was removed from the upstream toe on the front side of barrier no. 5. A 28-in. (711-mm) long piece of concrete was removed from the back side of barrier no. 5, slightly upstream of the middle of the barrier. Concrete spalling, measuring 15 in. x 11 in. (381 mm x 279 mm), was found at the bottom-downstream corner on the back side of barrier no. 5. Concrete spalling occurred on barrier no. 6 at the front upstream-most anchor hole. Concrete spalling, measuring 33 in. x 7 in. (838 mm x 178 mm), occurred near the upstream quarter-point of the toe on the back side of barrier no. 7.

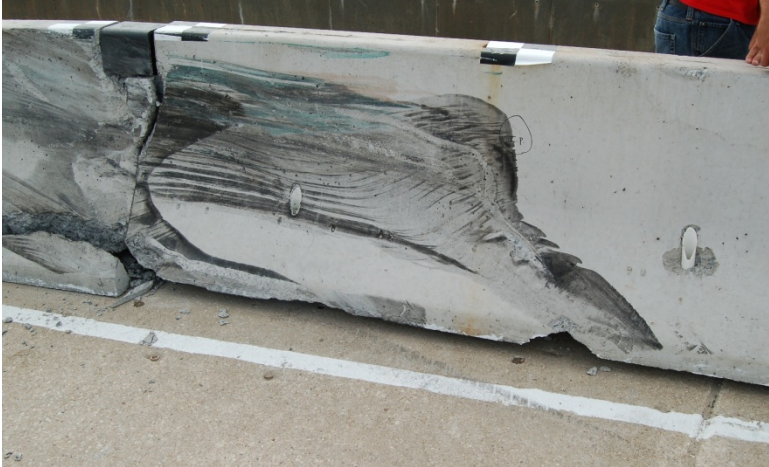
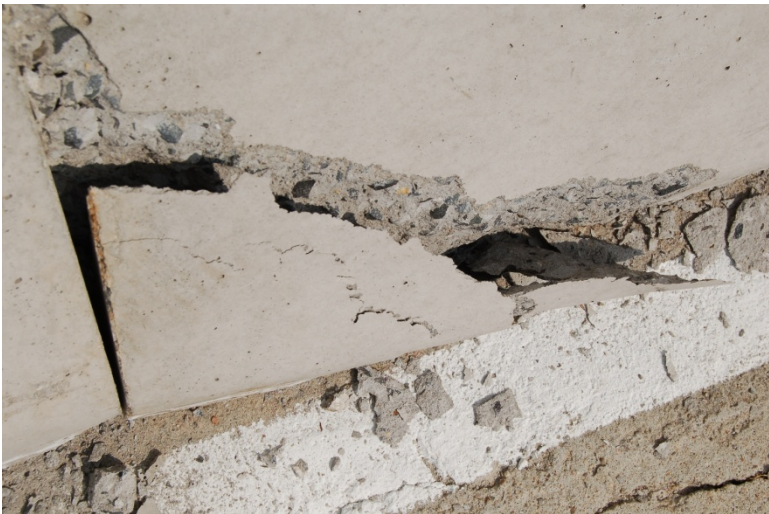
Figure 28. Barrier No. 4 Damage, Test No. NYTCB-5

A 28-in. (711-mm) long gouge was found on the front face of barrier no. 4 and began 51 in. (1,295 mm) upstream from the downstream end. A 19-in. (483-mm) long gouge was found on the front face of barrier no. 4 and began 39 in. (991 mm) upstream from the downstream end. A 7-in. (178-mm) and a 32-in. (813-mm) long gouge was found on the front face of barrier no. 5 near the upstream end. Gouges, 7 in. (178 mm) and 6 in. (152 mm) long, were found on the front- and back-top edges, respectively, beginning 65 in. (1,651 mm) upstream from the downstream end of barrier no. 5. Gouges, 4 in. (102 mm) and 3 in. (76 mm) long, were found on the front- and back-top edges, respectively, near the upstream quarter point of barrier no. 5. A 4-in. (102-mm) gouge was found on the front and back-top edges near the upstream quarter-point of barrier no. 8.

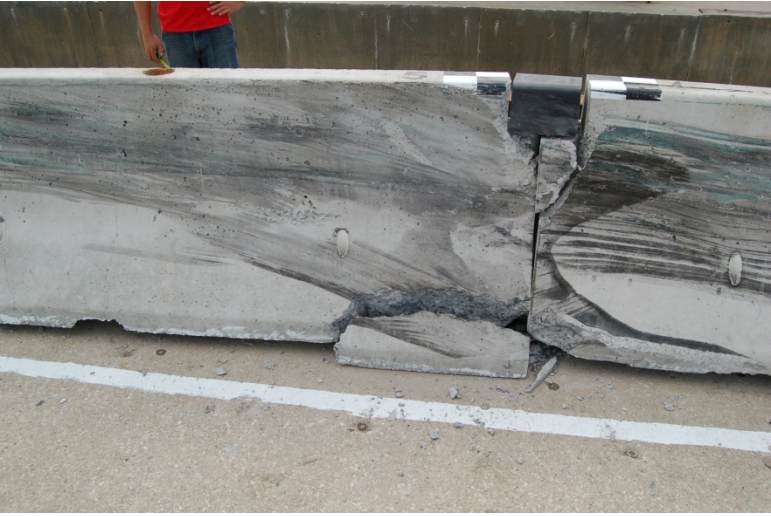
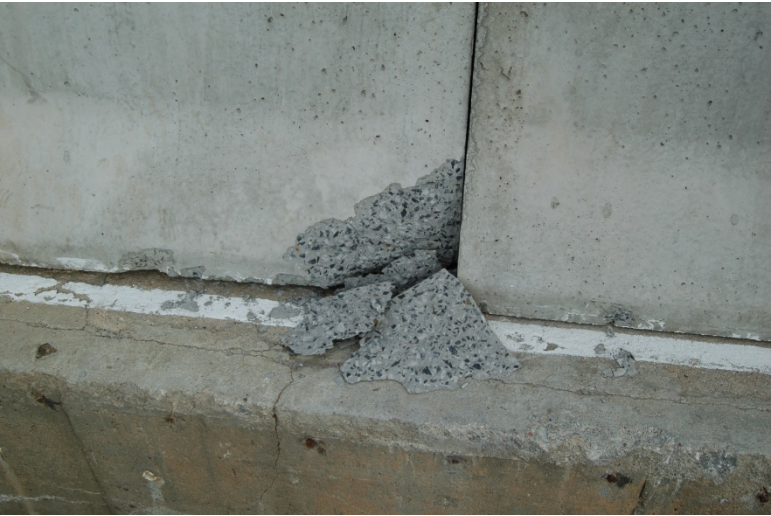
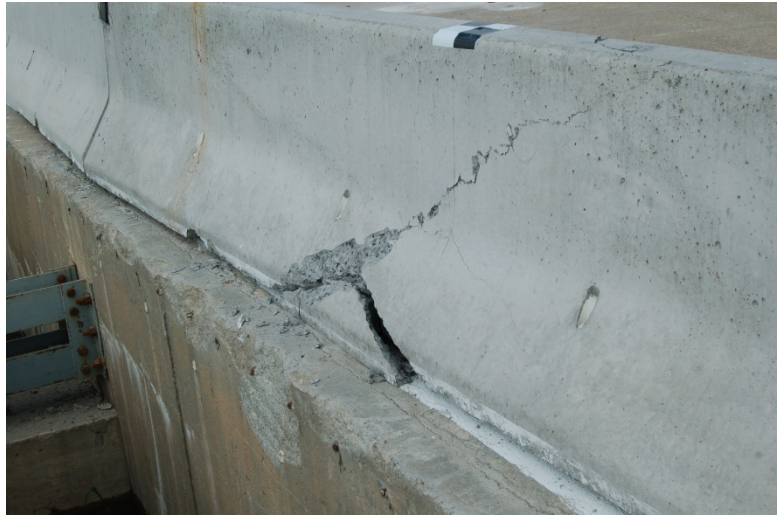
Figure 29. Barrier No. 5 Damage, Test No. NYTCB-5

barrier. A 15-in. (381-mm) long, vertical crack was found at the downstream anchor hole on the front face of barrier no. 5.

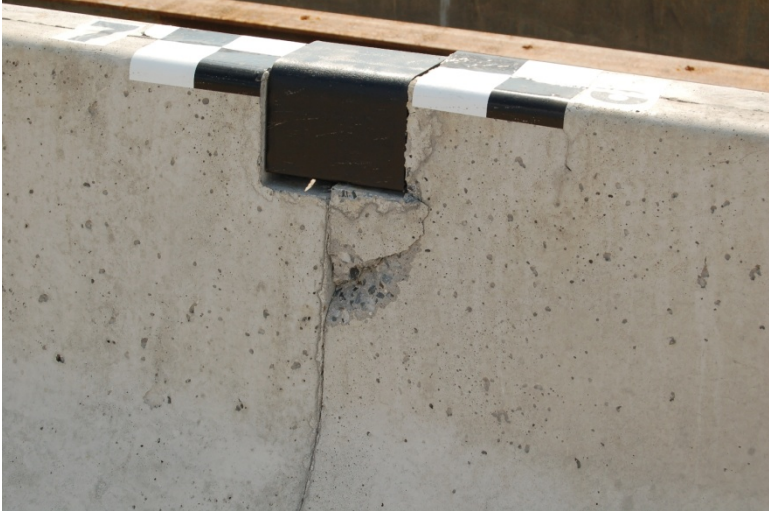
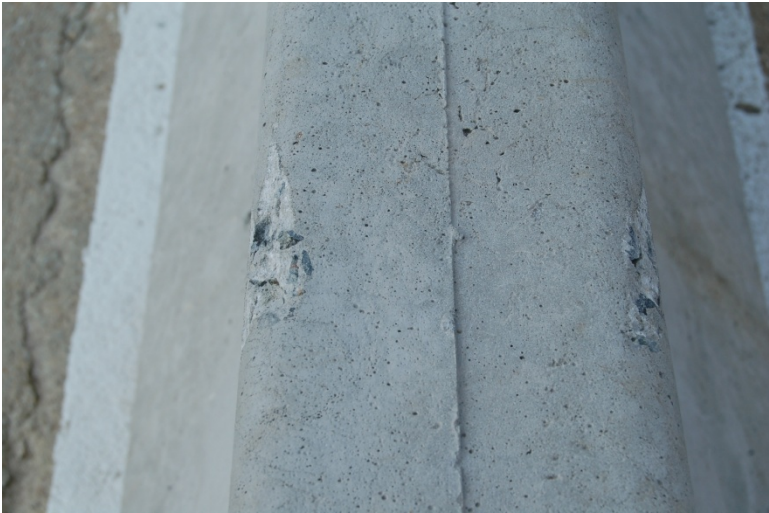
Figure 30. Barrier Nos. 6 and 7 Damage, Test No. NYTCB-5

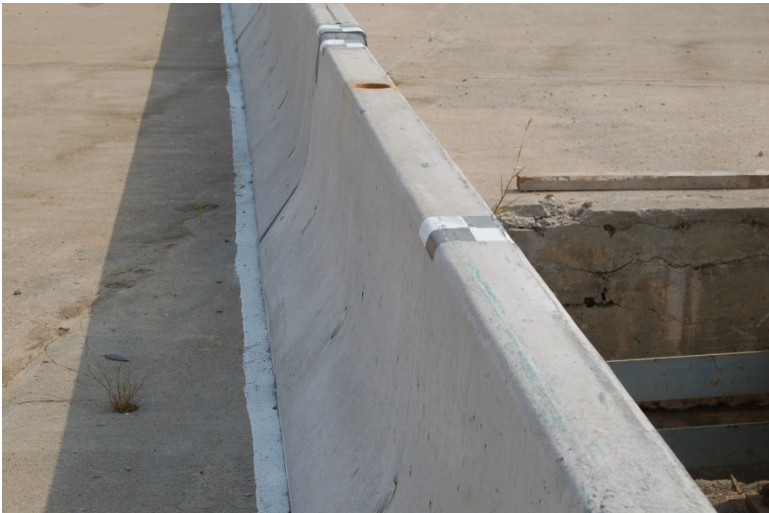
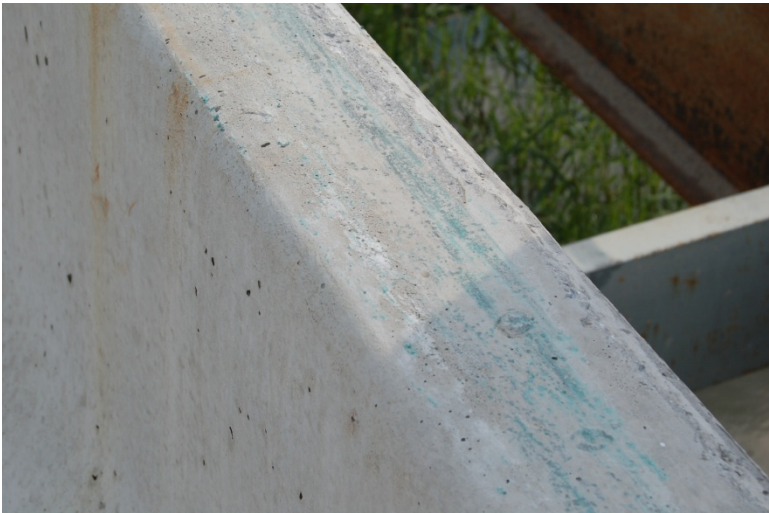
Figure 31. Barrier No. 8 Damage, Test No. NYTCB-5

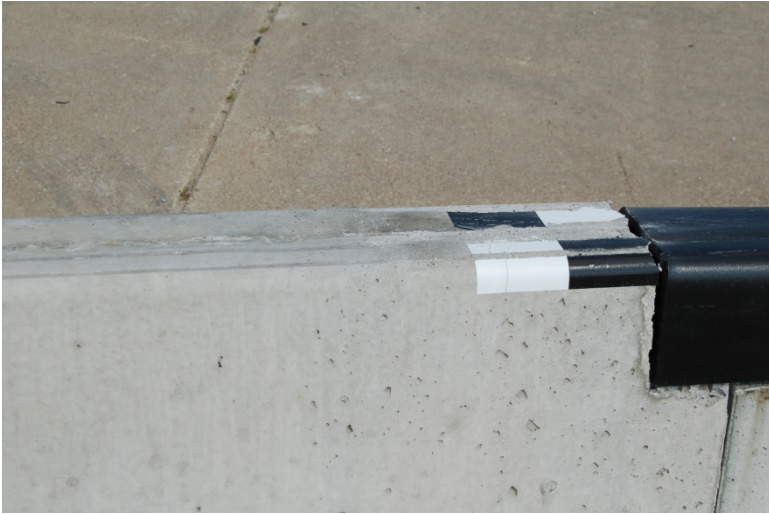
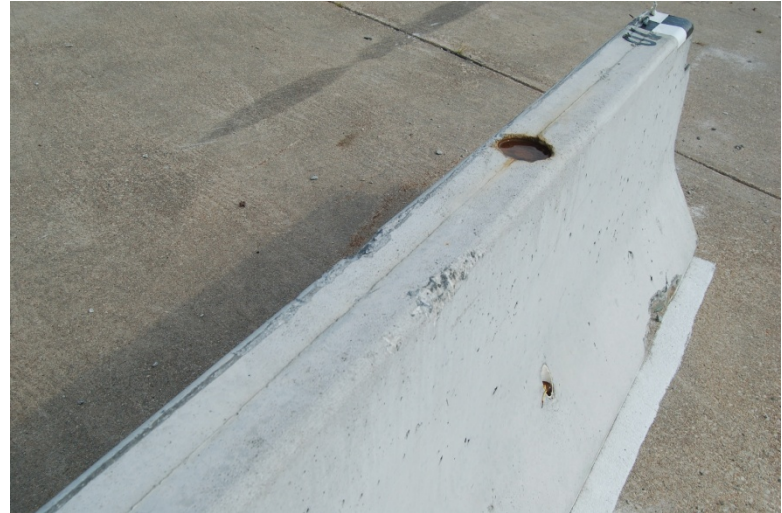
Figure 32. Barrier Nos. 9 and 10 Damage, Test No. NYTCB-5

Tire marks were visible on the front fact of barrier nos. 4 and 5 and started 76 in. (1,930 mm) upstream from the downstream end of barrier no. 4 and continued through 44 in. (1,118 mm) upstream from the downstream end of barrier no. 5. Contact marks were also found on the top faces of barrier nos. 8 through 10 as well as the connection keys between barrier nos. 4 and 7.

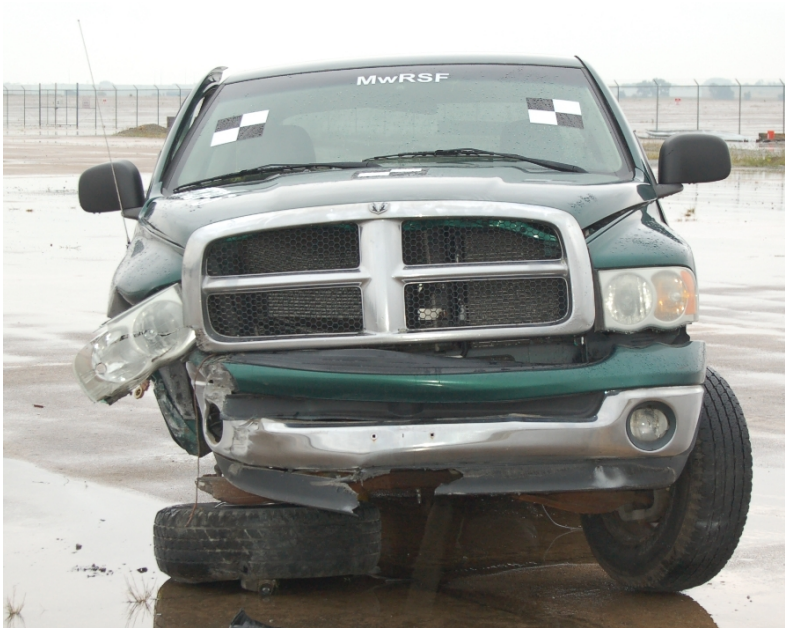
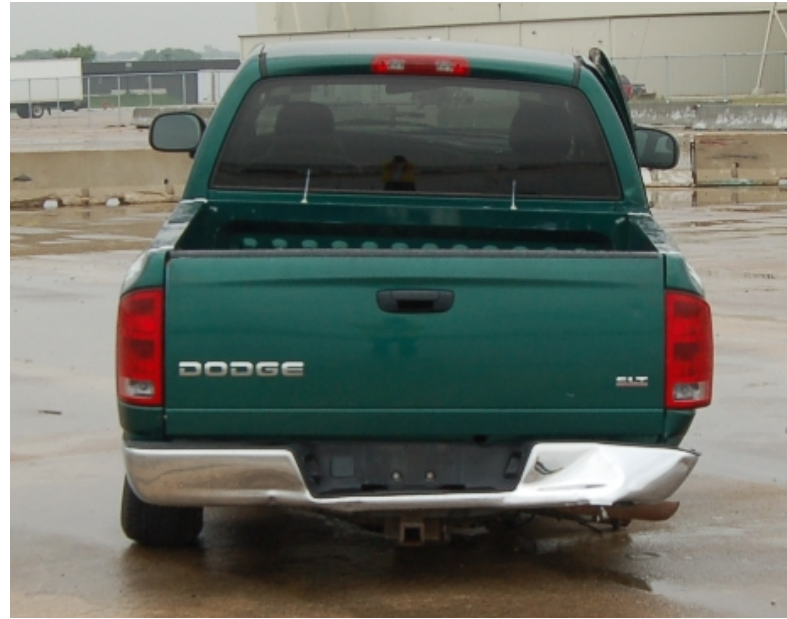
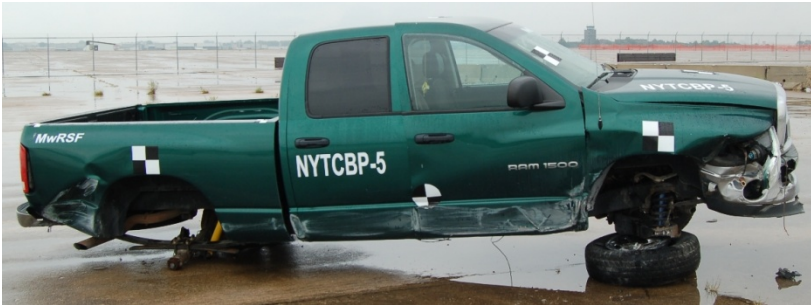
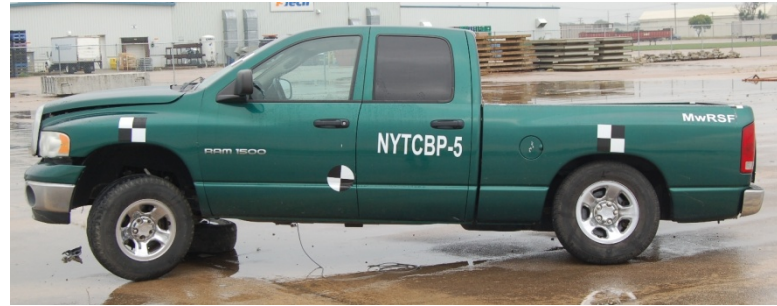
Figure 33. Vehicle Damage, Test No. NYTCB-5

The majority of the damage was concentrated on the right-front corner and right side of the vehicle where the impact occurred. The right side of the bumper was crushed inward and back and the plastic portion was fractured. The left side of the front bumper was deformed downward 2 in. (51 mm). Denting and scraping were observed on the entire right side. The right-front and right-rear quarter-panels were deformed inward toward the engine compartment and truck box, respectively. The top of the right-front door, the left side of the hood, and the tailgate were ajar. The grill was fractured around the bottom of the right-side headlight assembly. The

right-side headlight and left-side foglight were fractured, and the right-side foglight was removed from the vehicle. The right-front wheel and tire disengaged from the vehicle and were located under the rest of the wheel assembly. The right upper control arm and tie rod disengaged, while the right upper control arm fractured. The right-rear axle sheared, and the brake assembly disengaged from the vehicle. The right taillight was removed. The right side of the rear bumper was deformed outward, while a kink was found in the left side. The left-rear wheel assembly was deformed outward. The right side of the floorpan encountered significant deformation. The roof and all window glass remained undamaged.

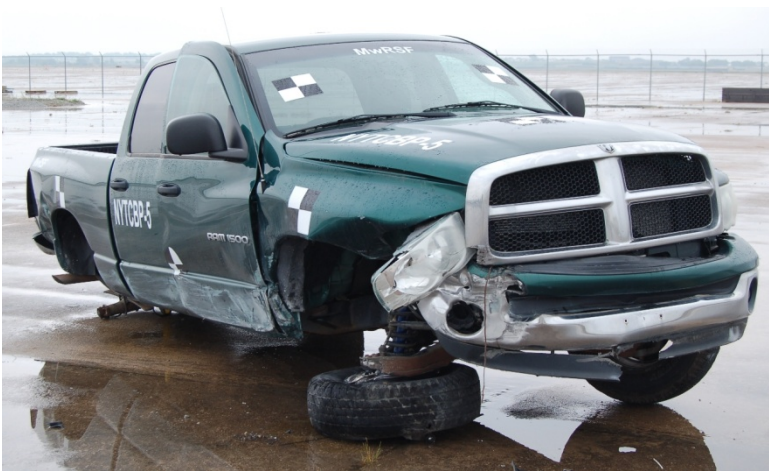
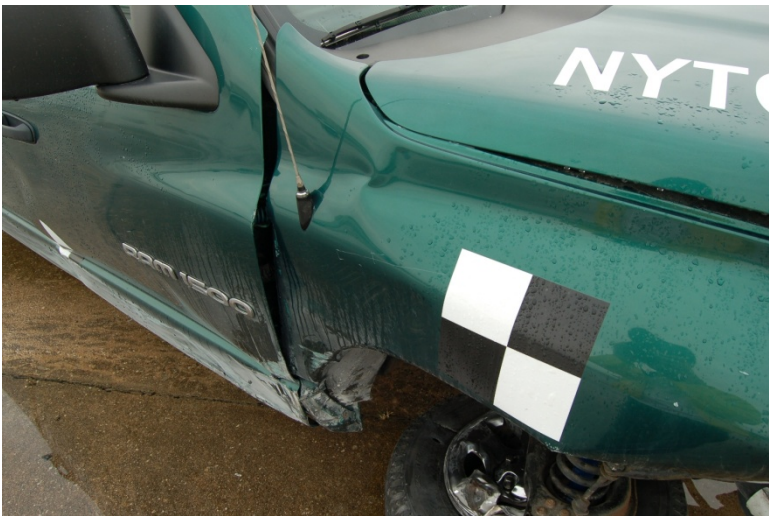
Figure 34. Vehicle Damage, Test No. NYTCB-5

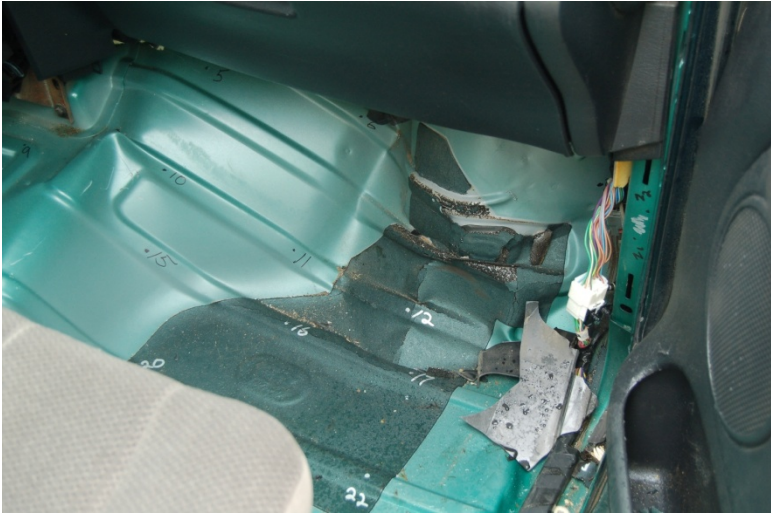
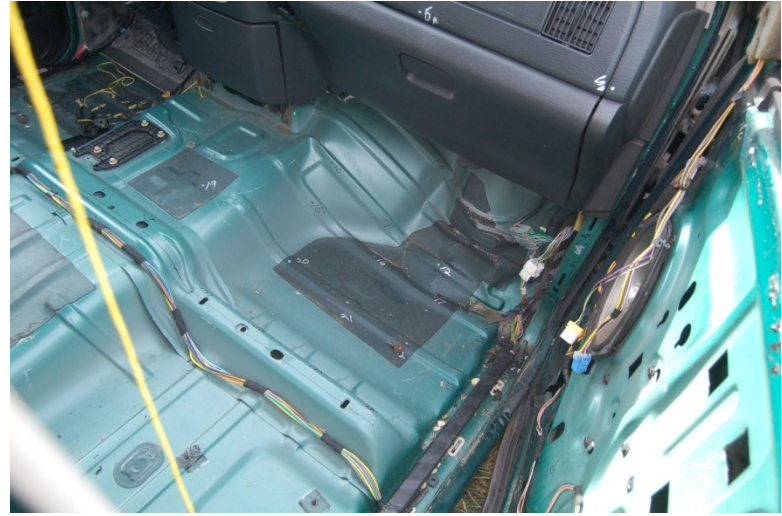
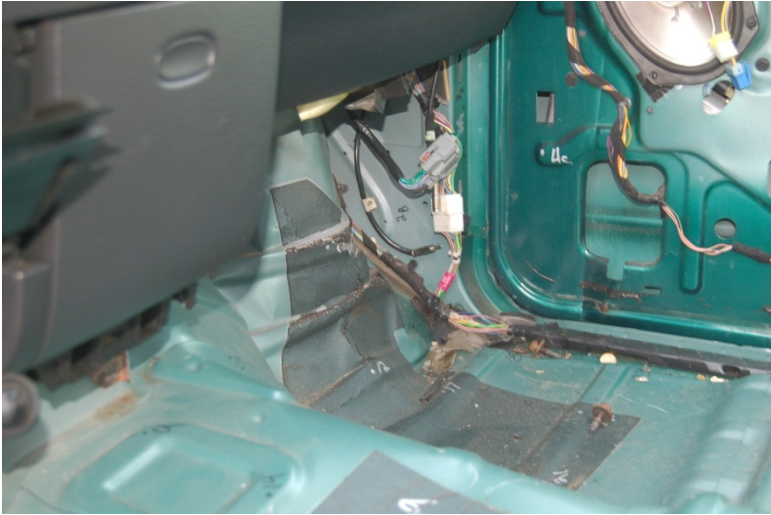
Figure 35. Occupant Compartment Deformation, Test No. NYTCB-5

The damage to the vehicle was moderate, as shown in Figures 33 through 35. The maximum occupant compartment deformations are listed in Table 5 with the deformation limits established in MASH for various areas of the occupant compartment. It should be noted that none of the MASH established deformation limits were violated. Complete occupant compartment and vehicle deformations and the corresponding locations are provided in Appendix C.

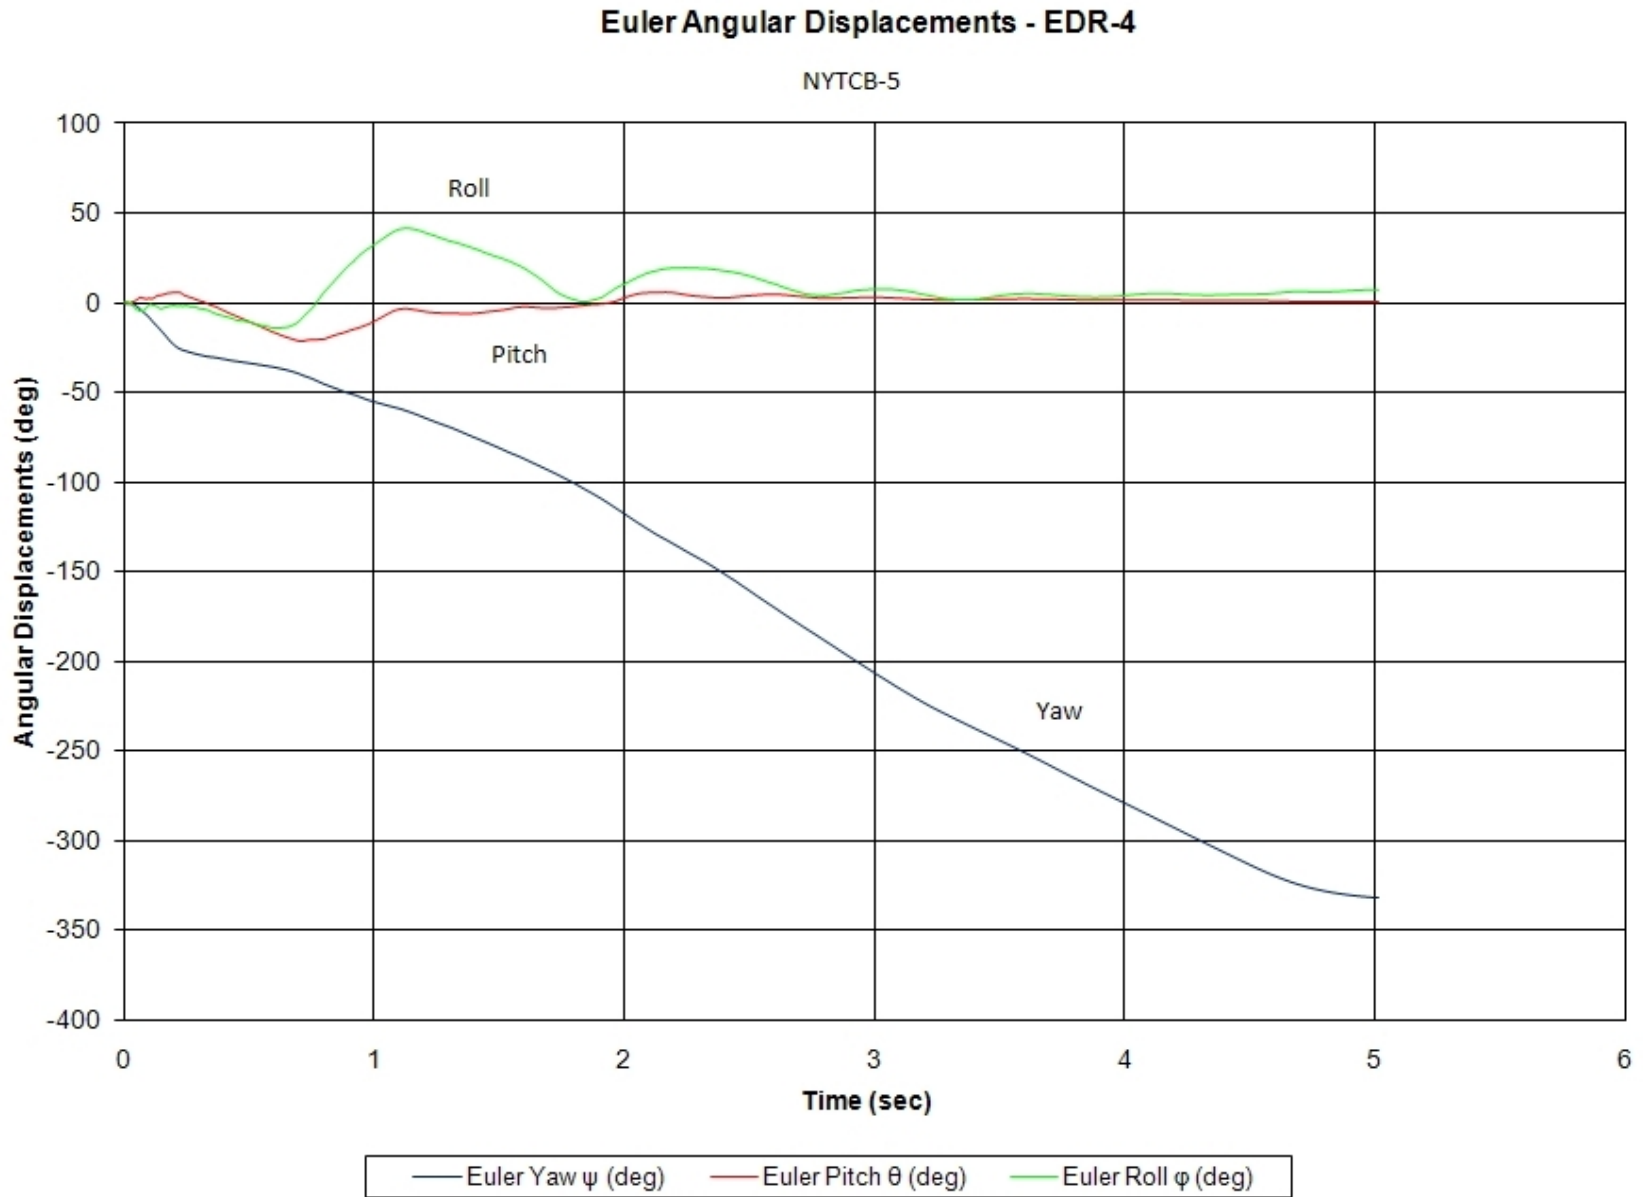
Figure D-7. Vehicle Angular Displacements (EDR-4), Test No. NYTCB-5

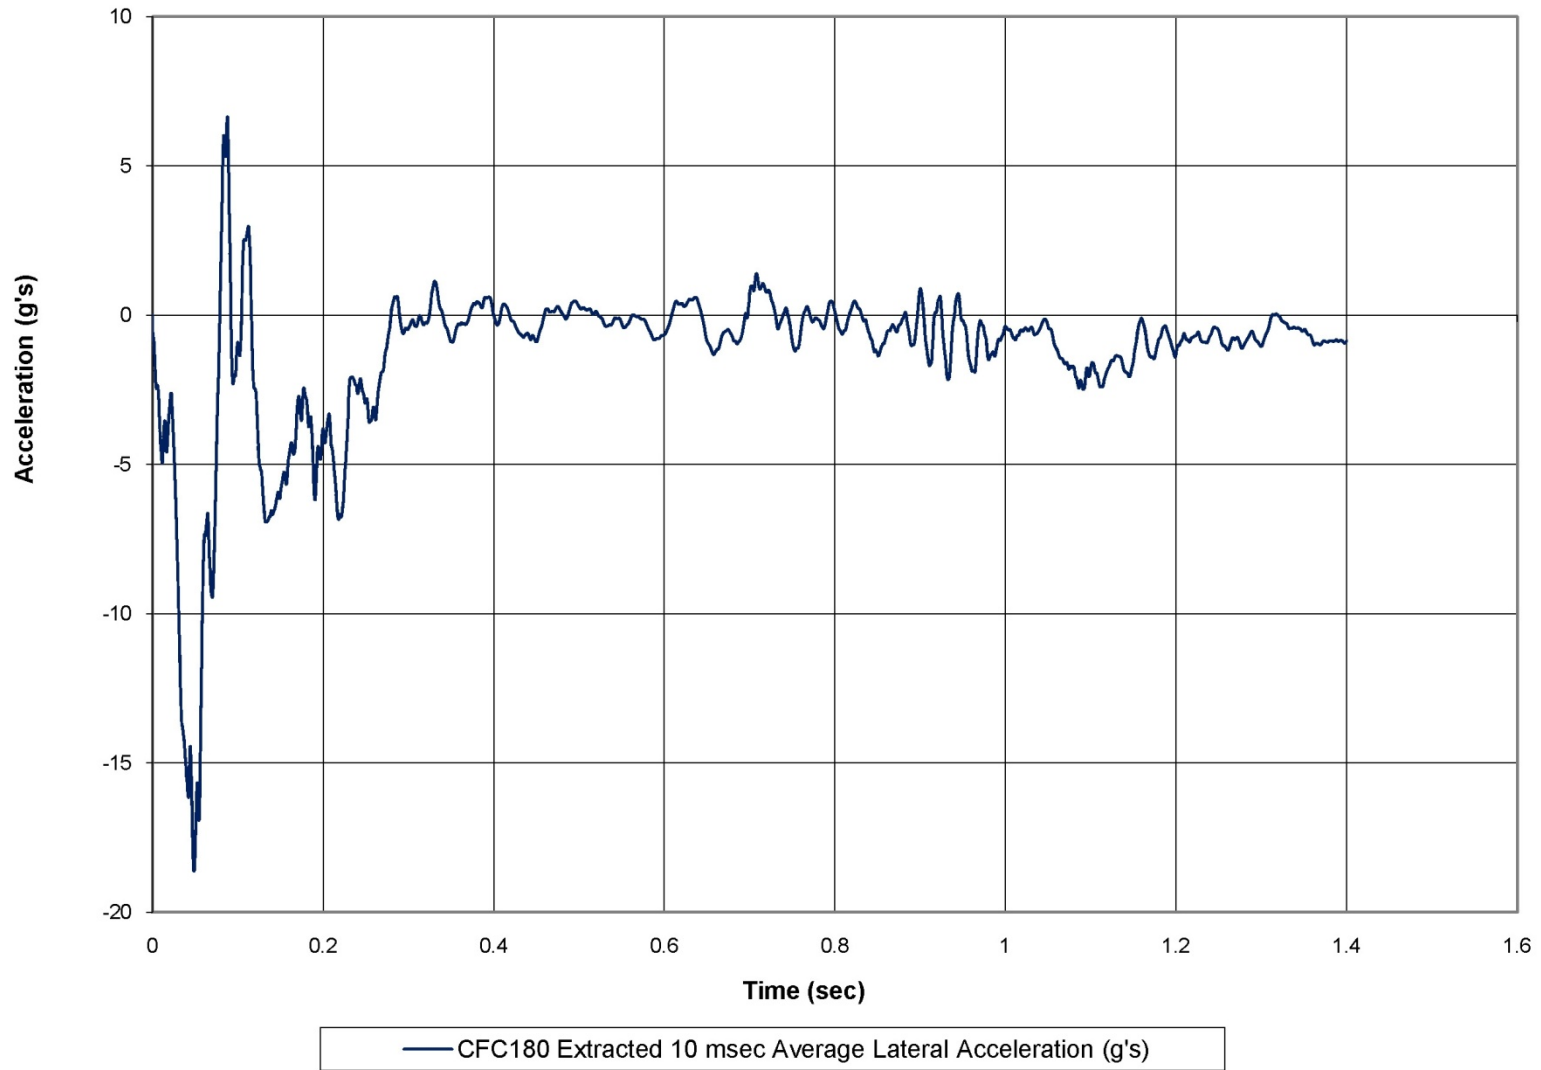
Figure D-9. 10-ms Average Lateral Deceleration (DTS), Test No. NYTCB-5

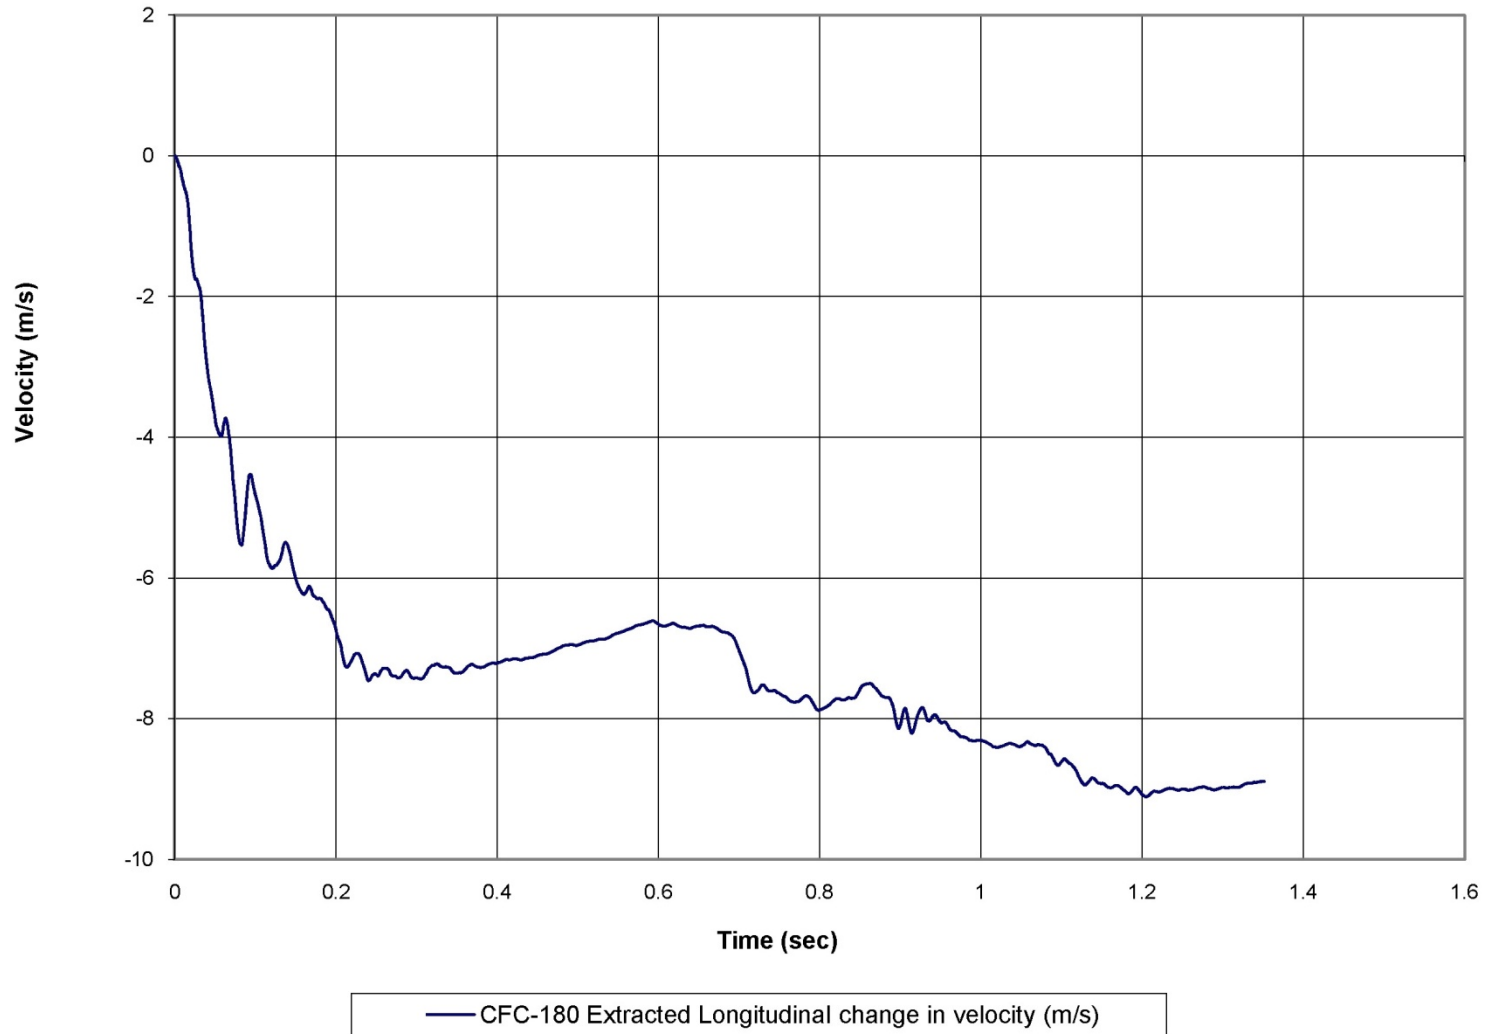
Figure D-14. Longitudinal Occupant Impact Velocity (EDR-3), Test No. NYTCB-5
