Research Project Number TPF-5(193) Supplement #88

**PERFORMANCE EVALUATION OF NEW JERSEY'S
PORTABLE CONCRETE BARRIER WITH A BOX-BEAM
STIFFENED CONFIGURATION AND GROUTED TOES –
TEST NO. NJPCB-5**

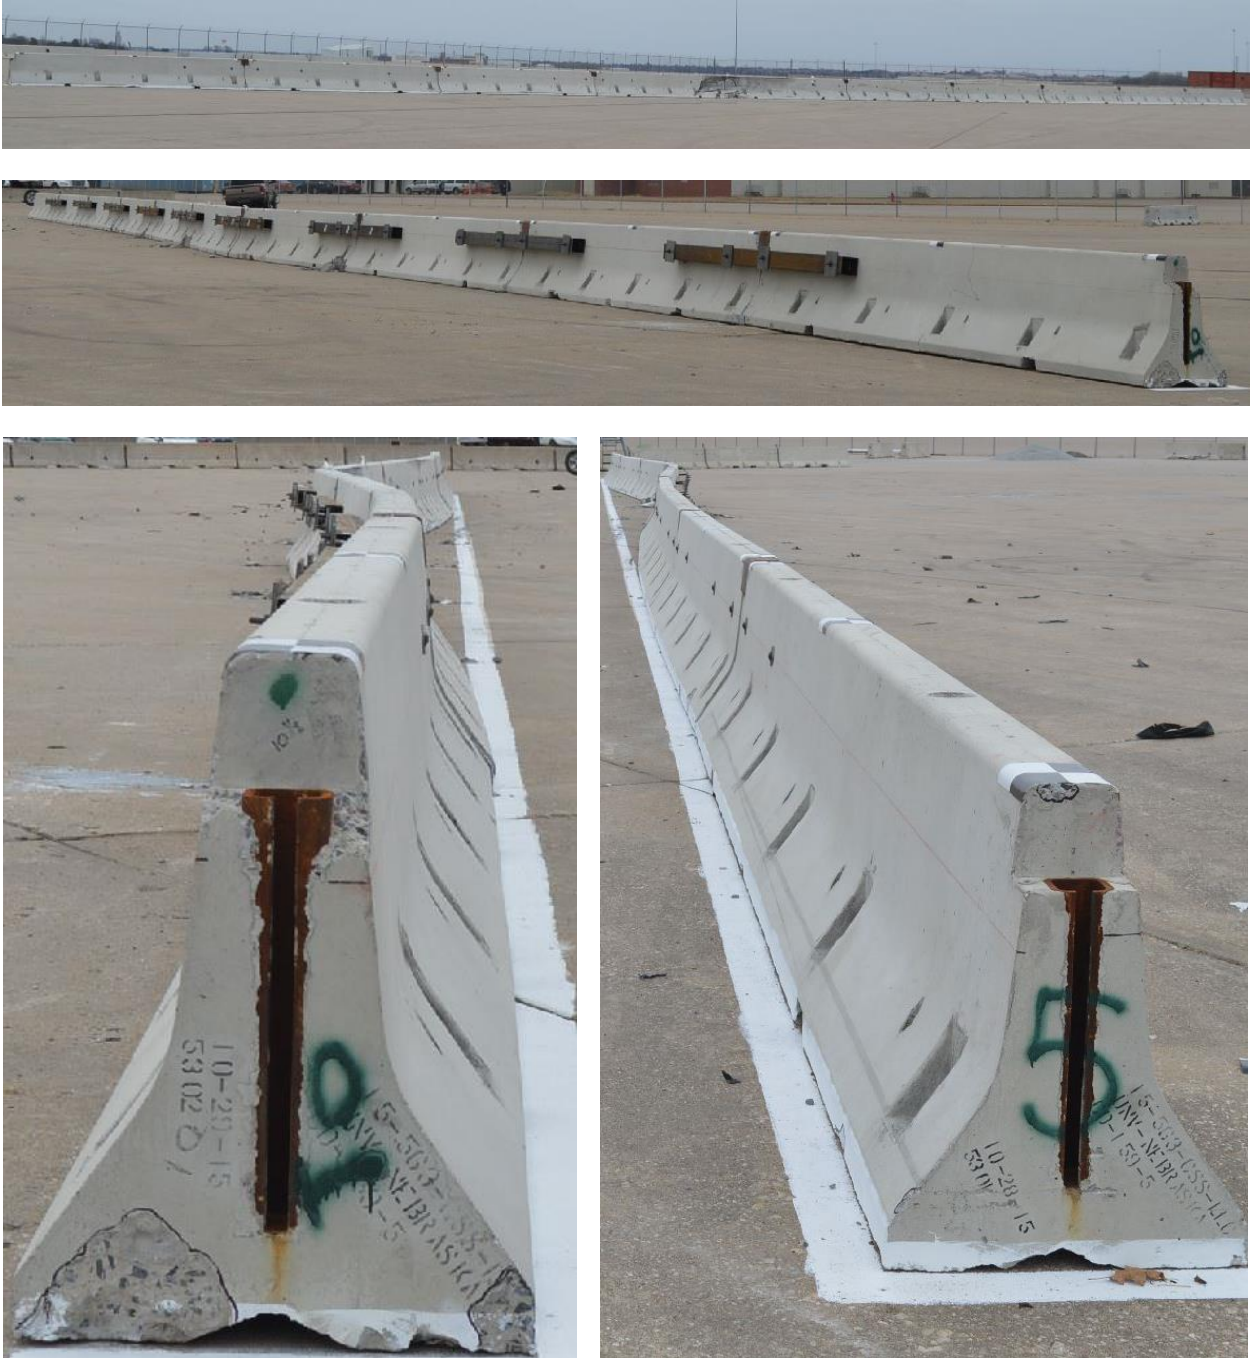
Figure 35. System Damage - Front, Back, Upstream, and Downstream Views, Test No. NJPCB-5

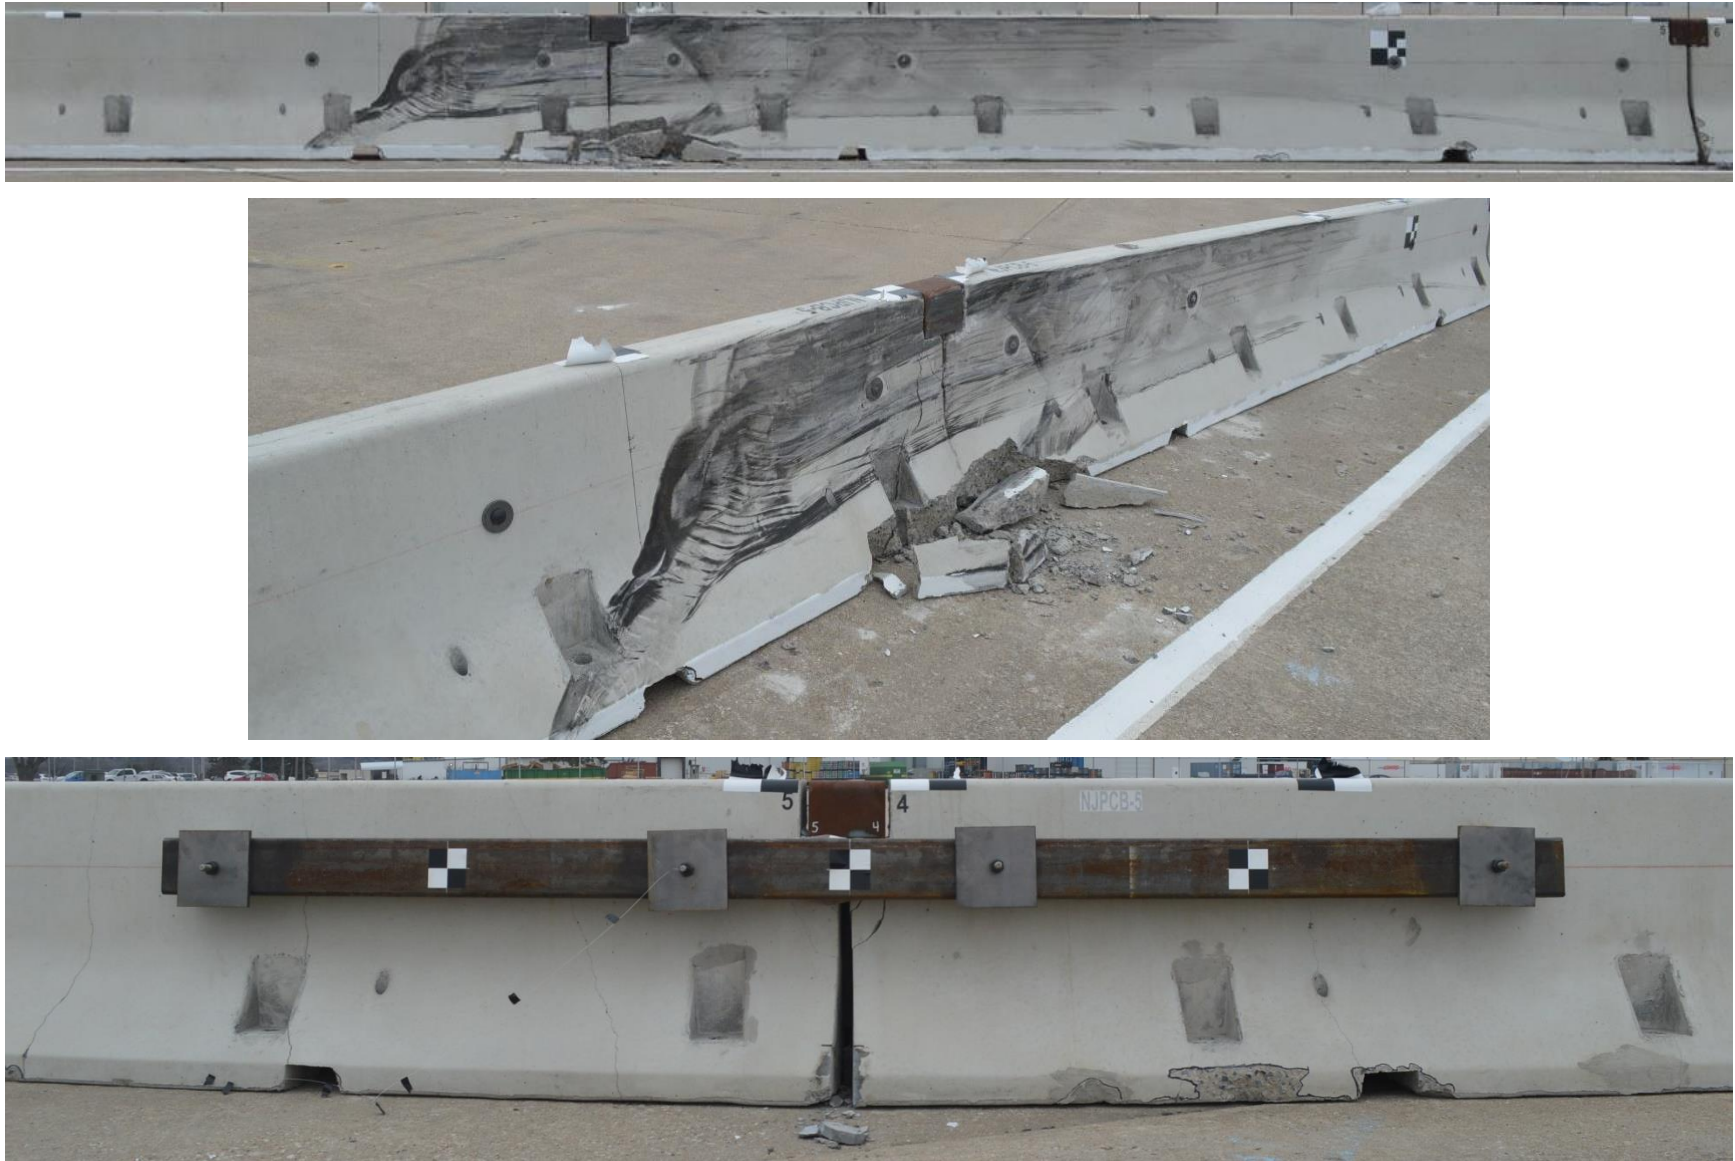
Figure 36. System Damage at Impact Location, Front and Back Side, Test No. NJPCB-5

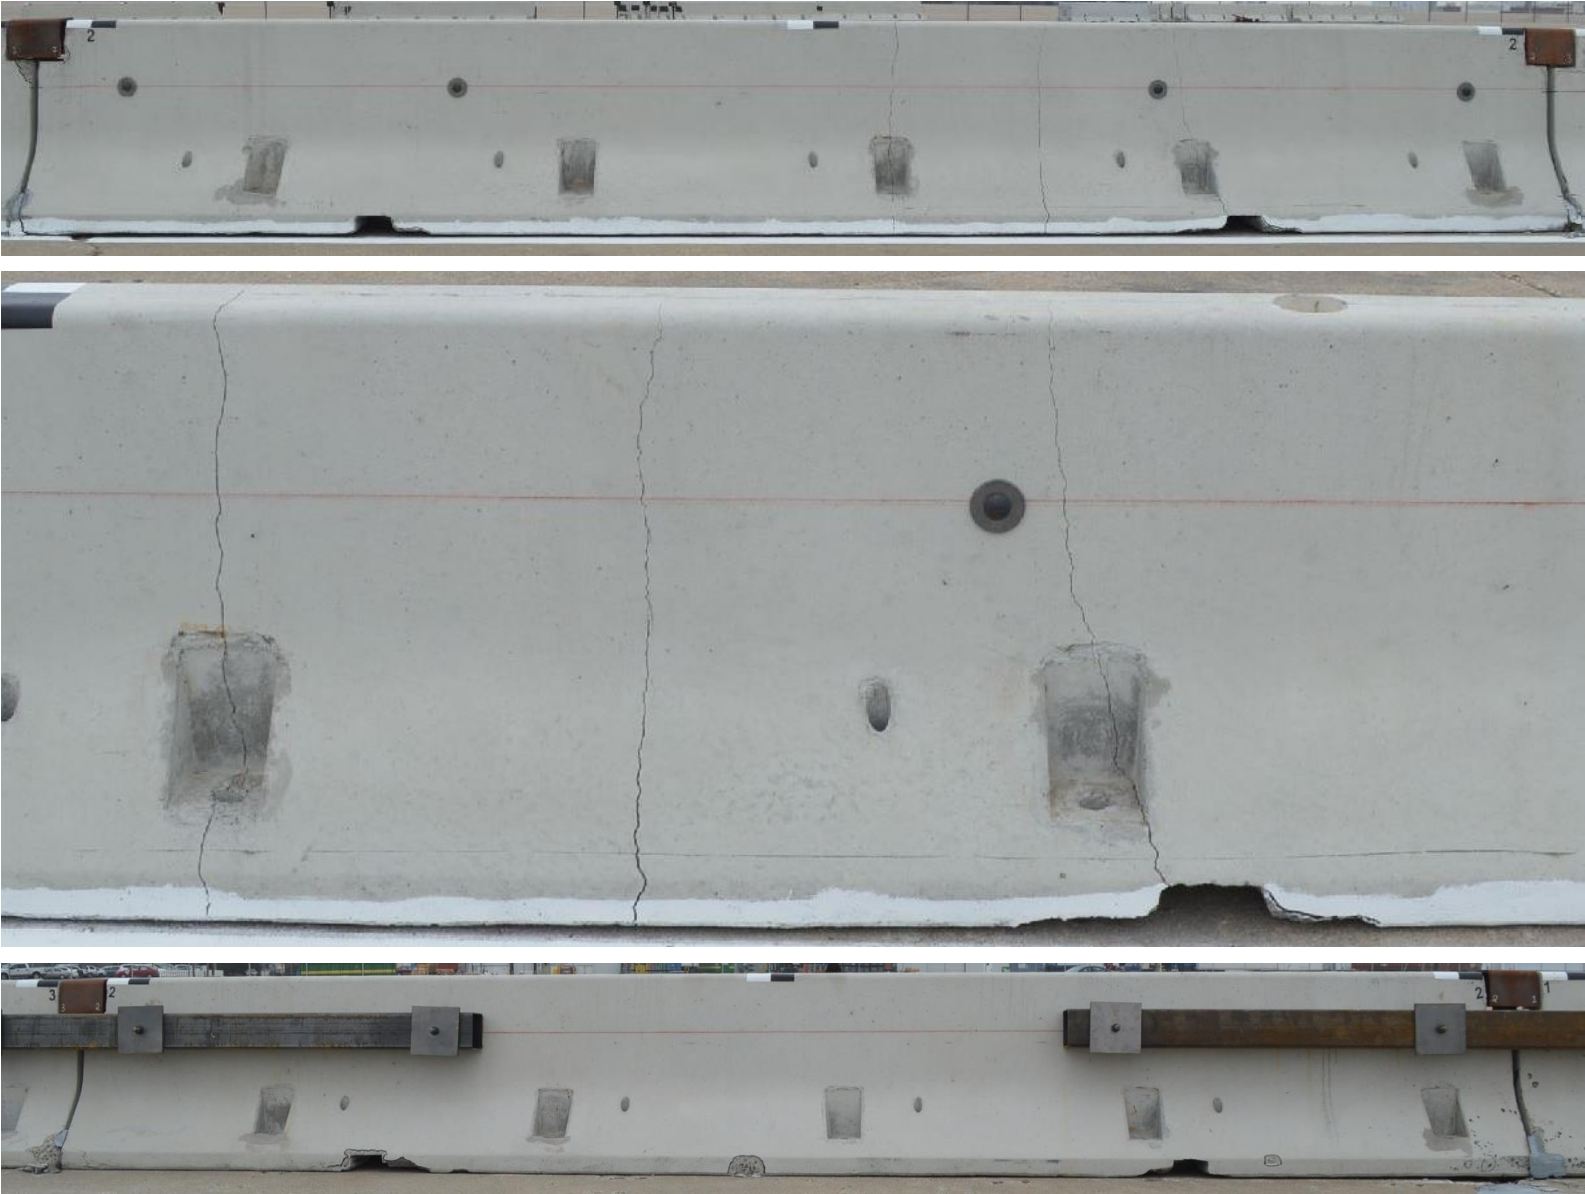
Figure 37. Barrier No. 2 – Traffic and Back Side Damage, Test No. NJPCB-5

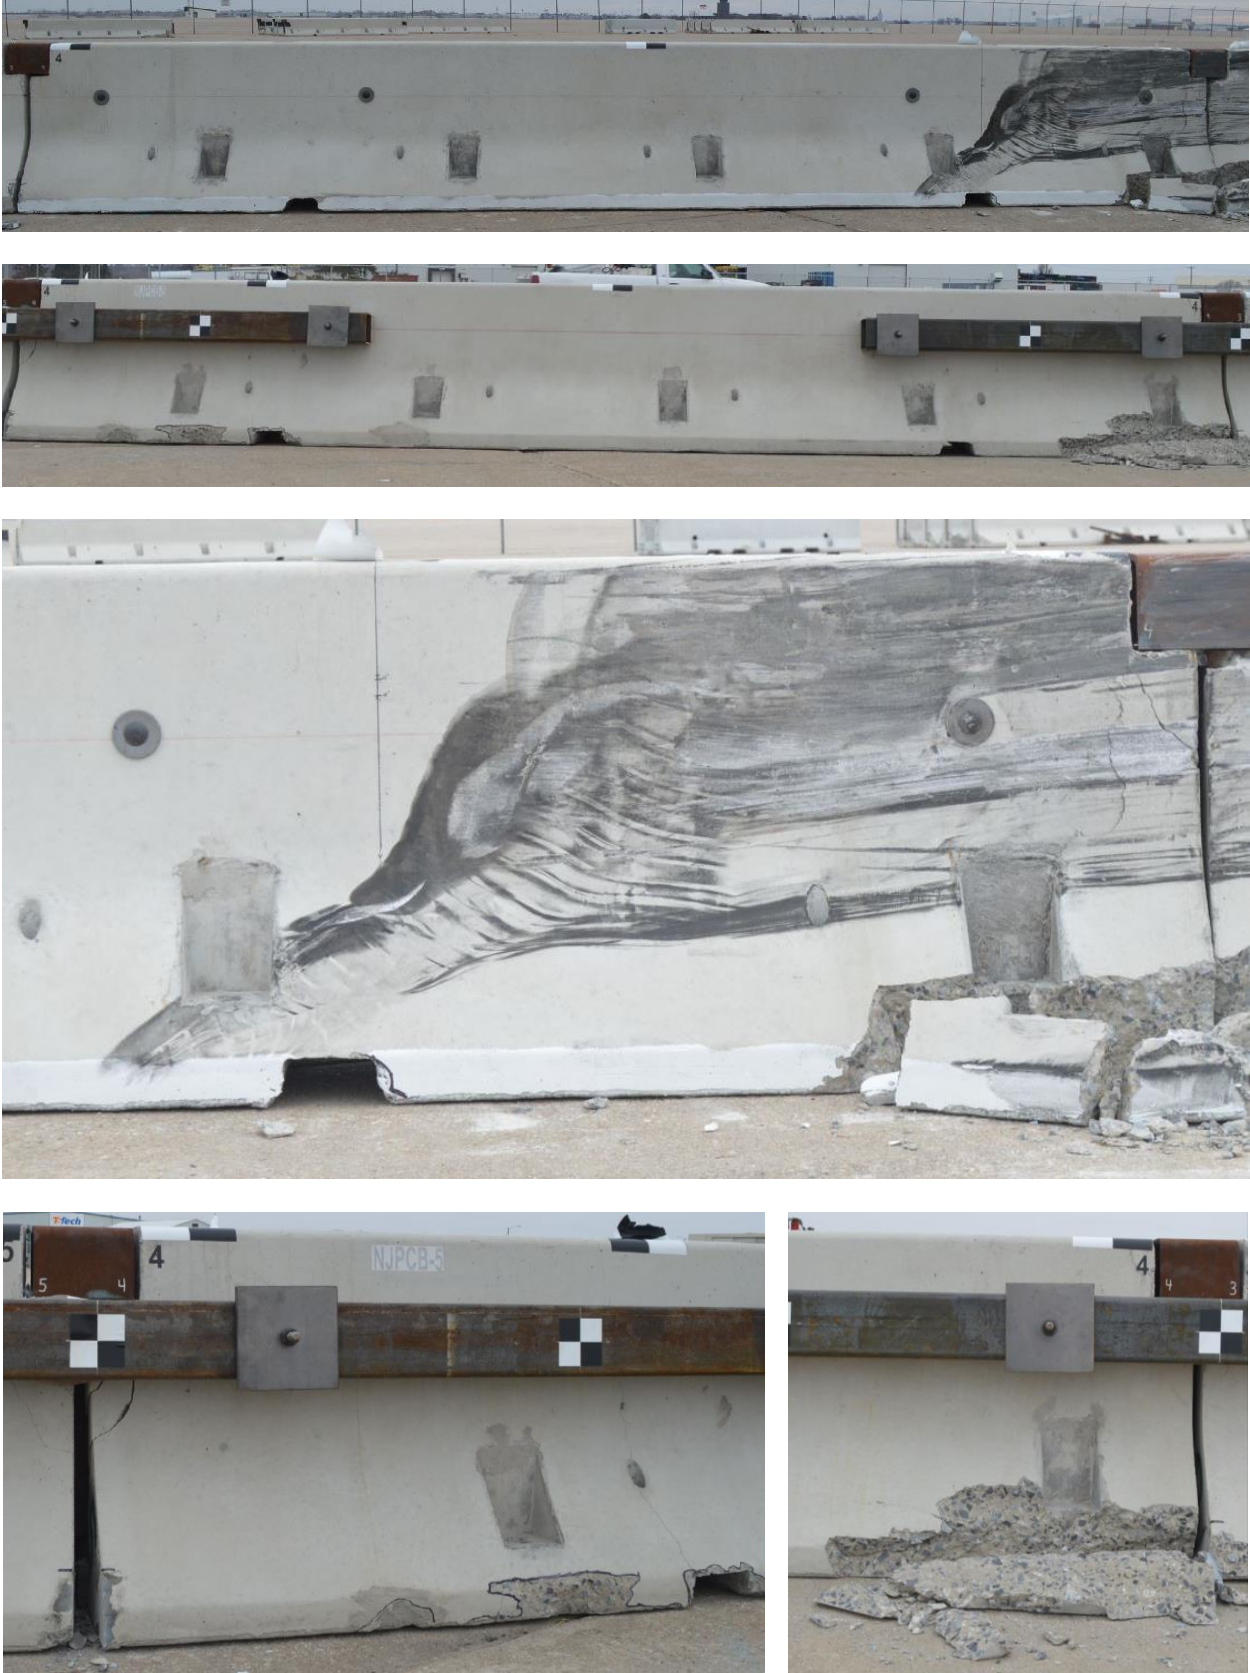
Figure 39. Barrier No. 4 – Traffic and Back Side Damage, Test No. NJPCB-5

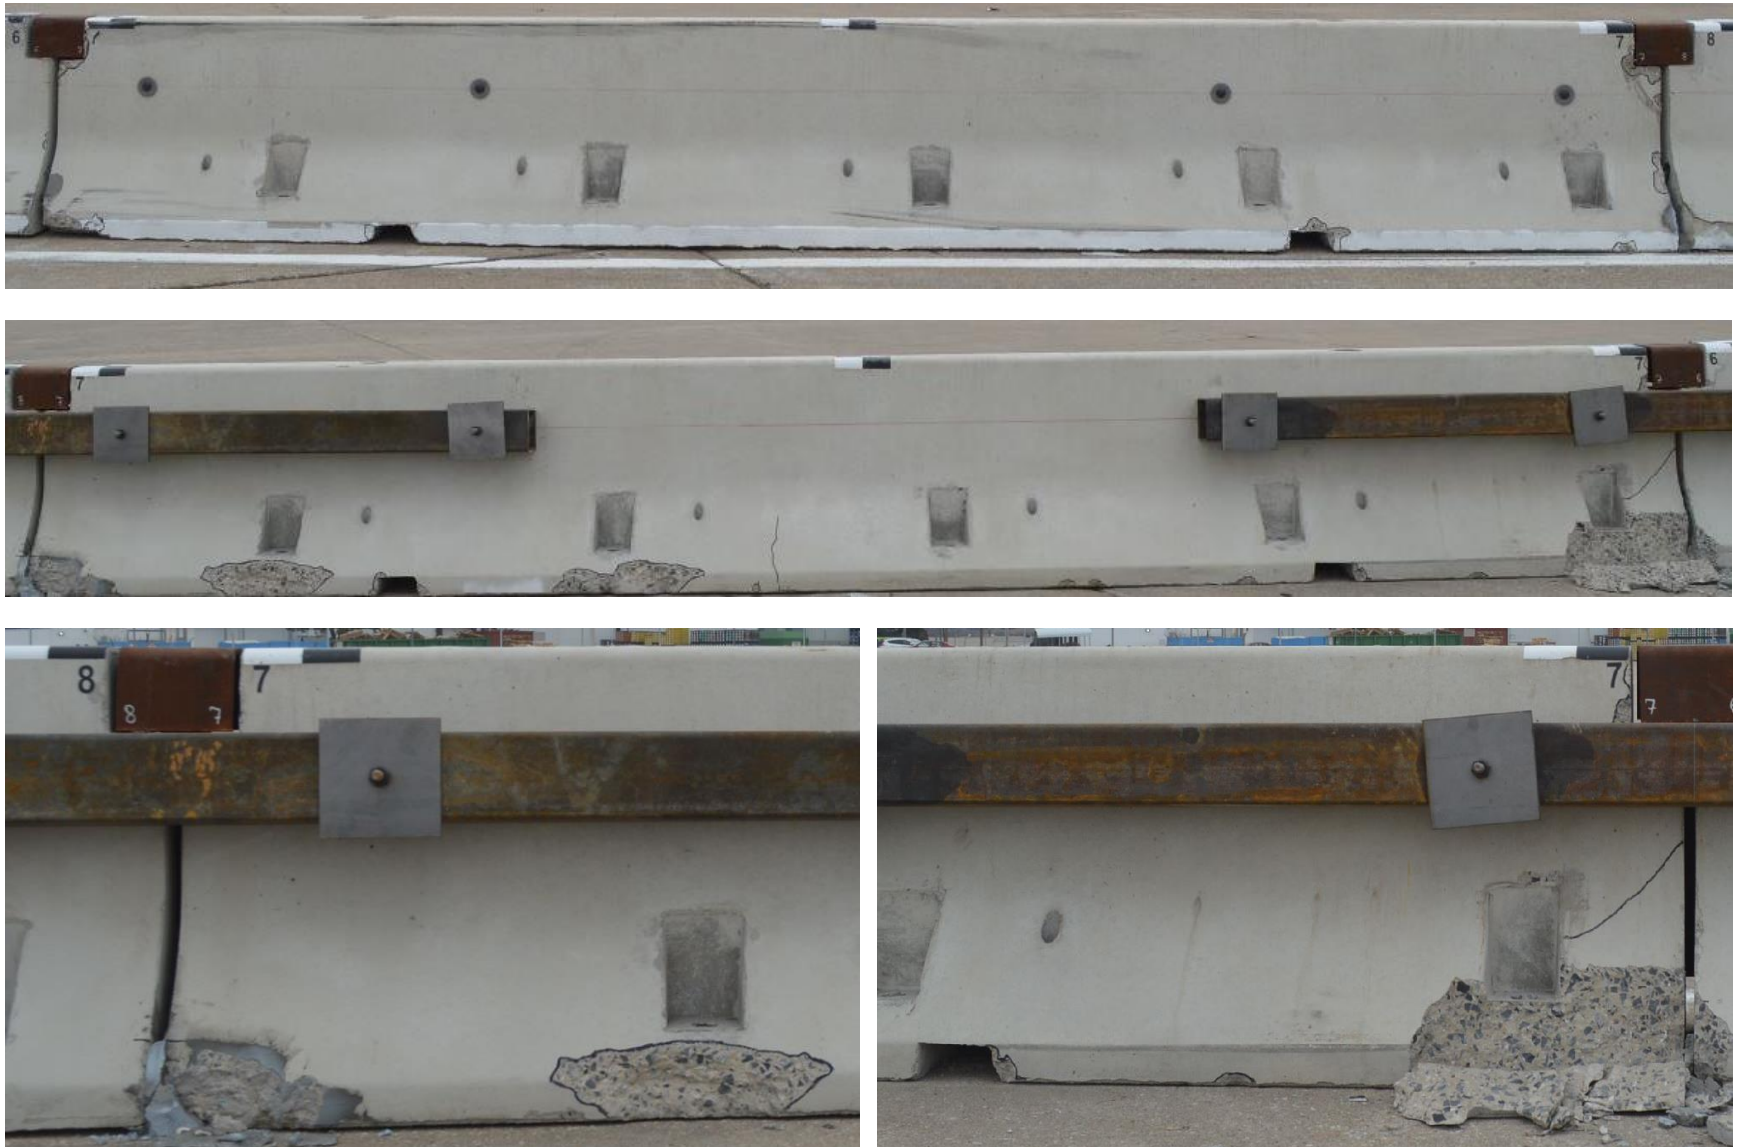
Figure 42. Barrier No. 7 – Traffic and Back Side Damage, Test No. NJPCB-5

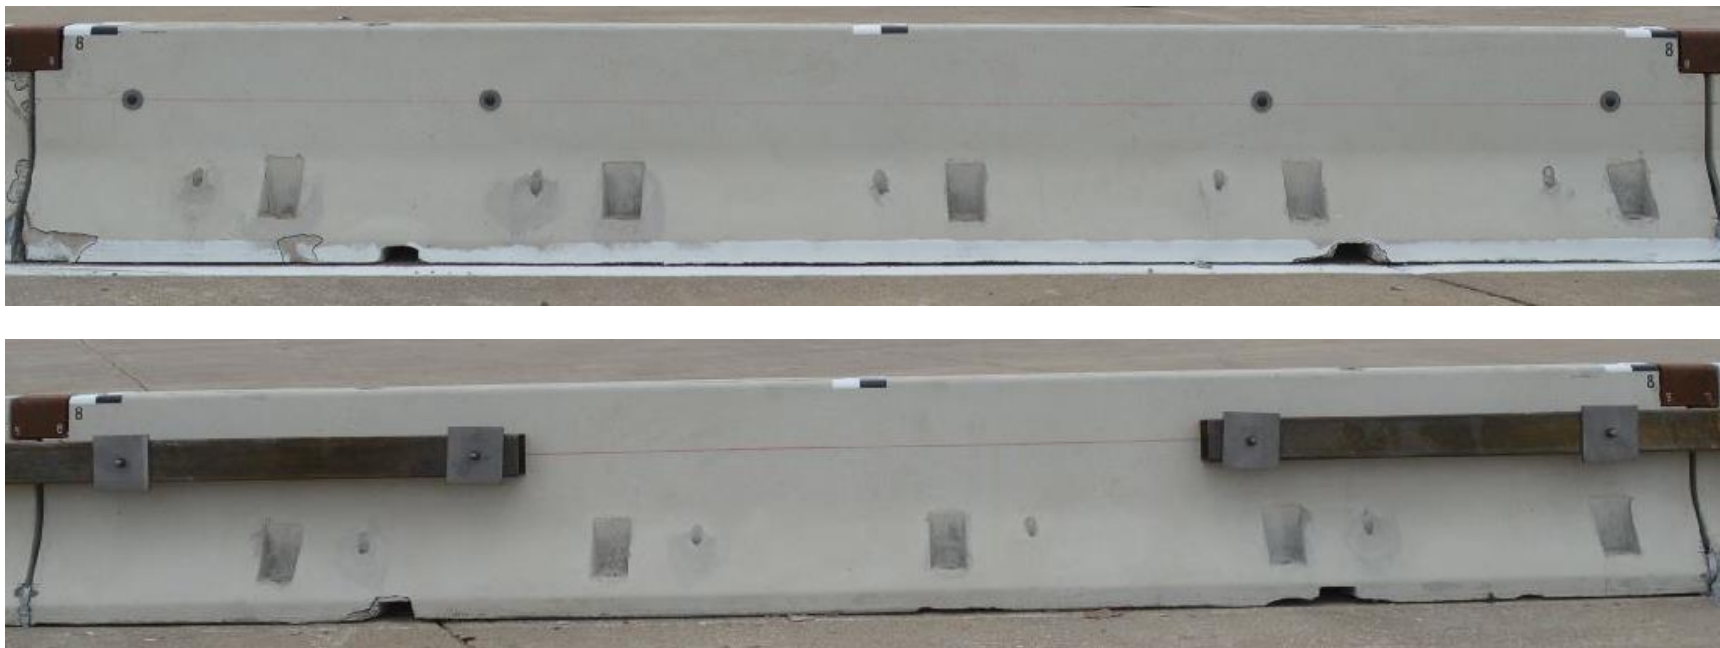
Figure 43. Barrier No. 8 – Traffic and Back Side Damage, Test No. NJPCB-5

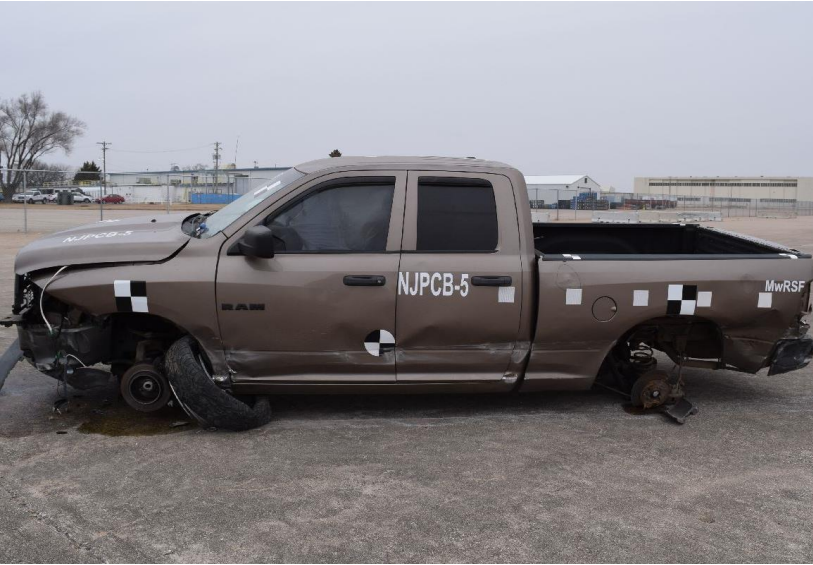
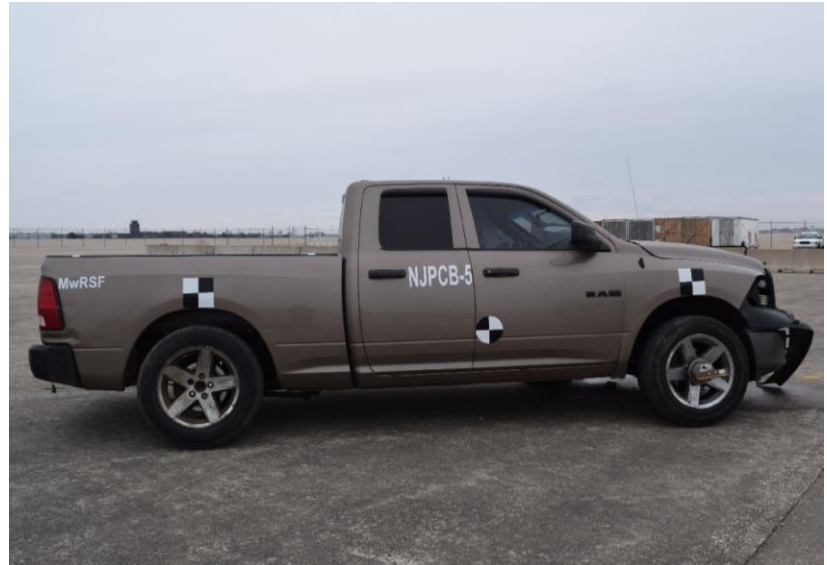
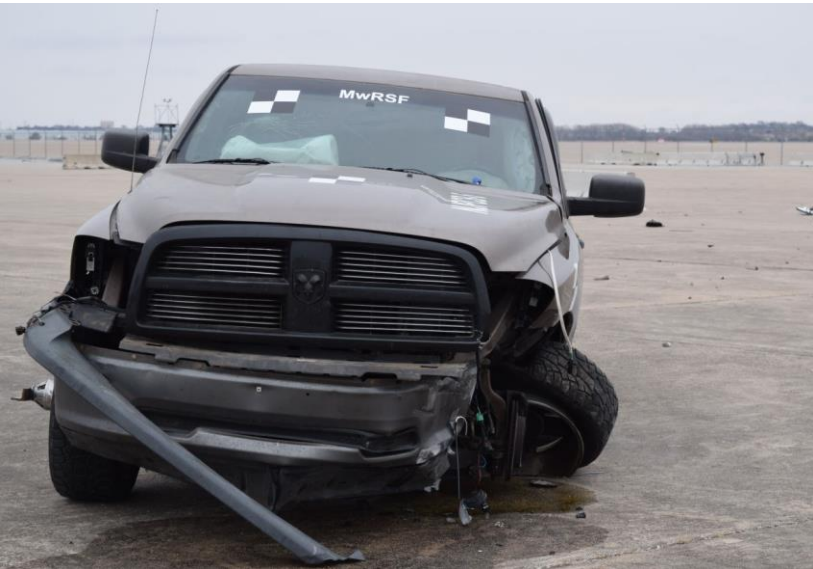
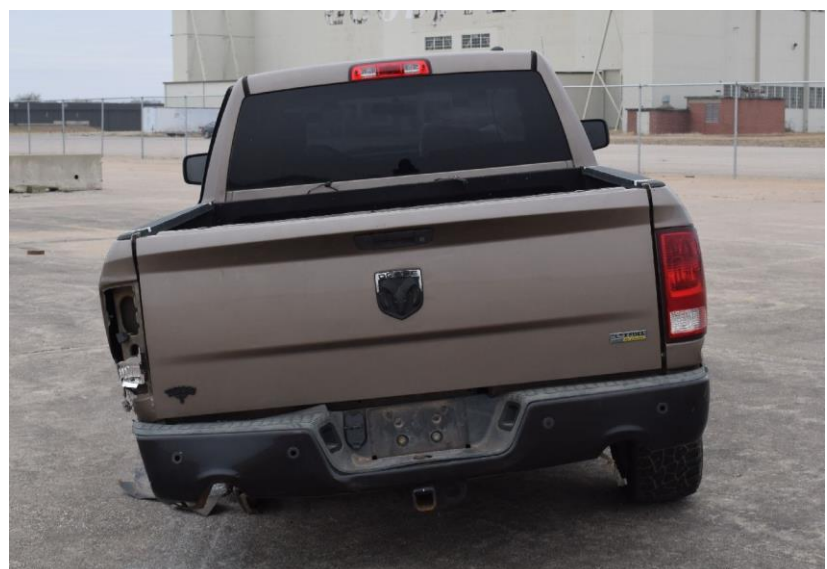
Figure 44. Vehicle Damage, Test No. NJPCB-5

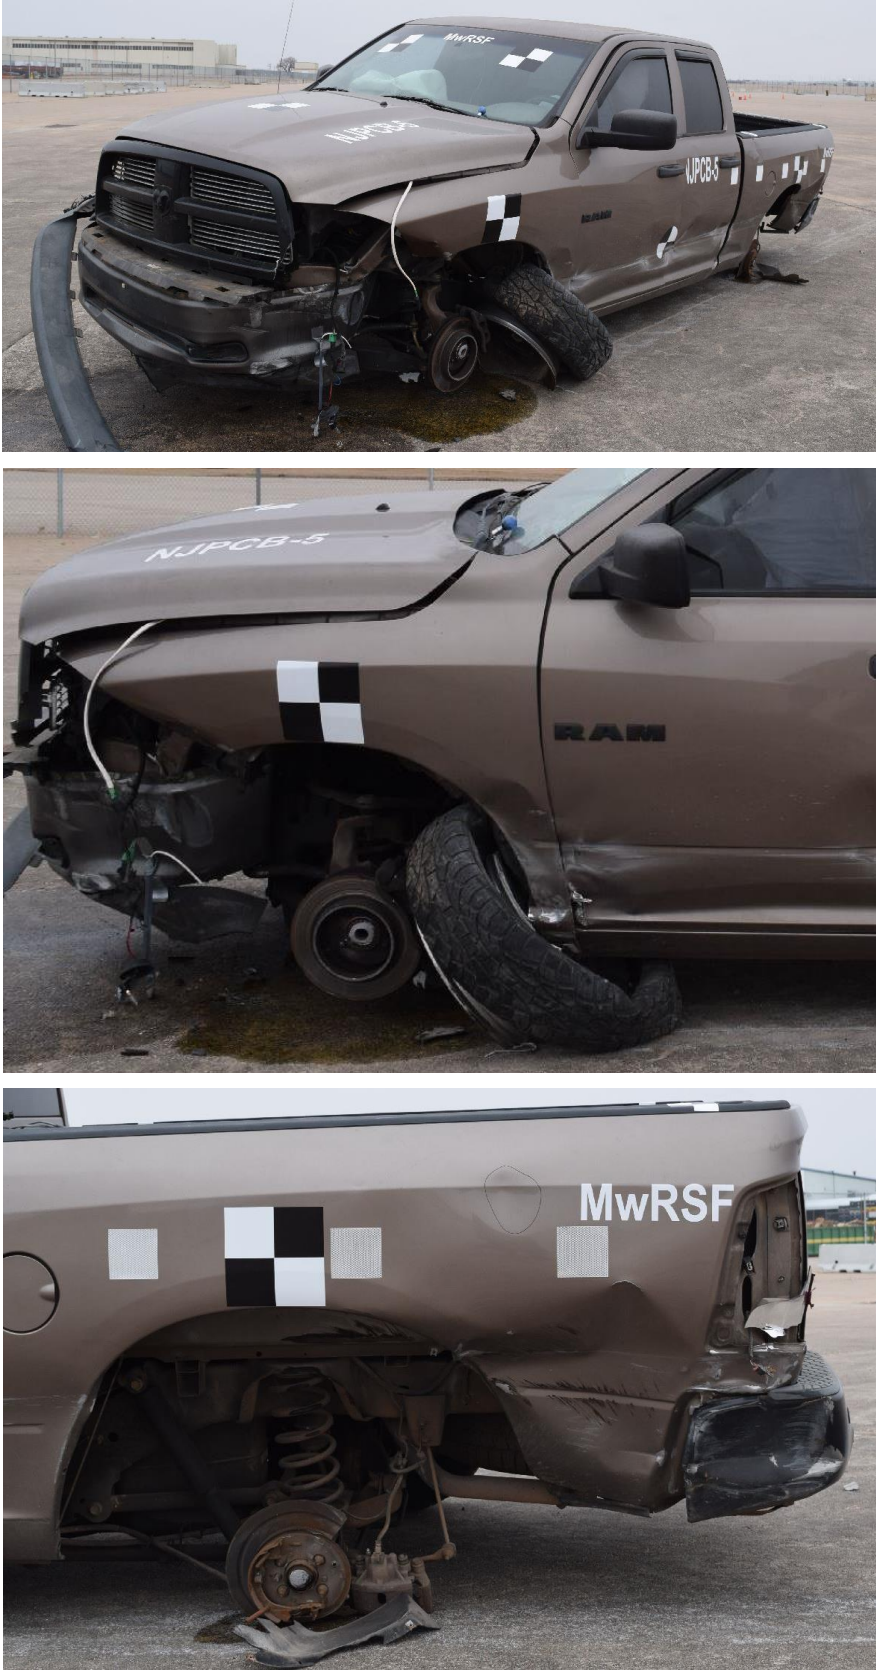
Figure 45. Vehicle Damage on Impact Side, Test No. NJPCB-5

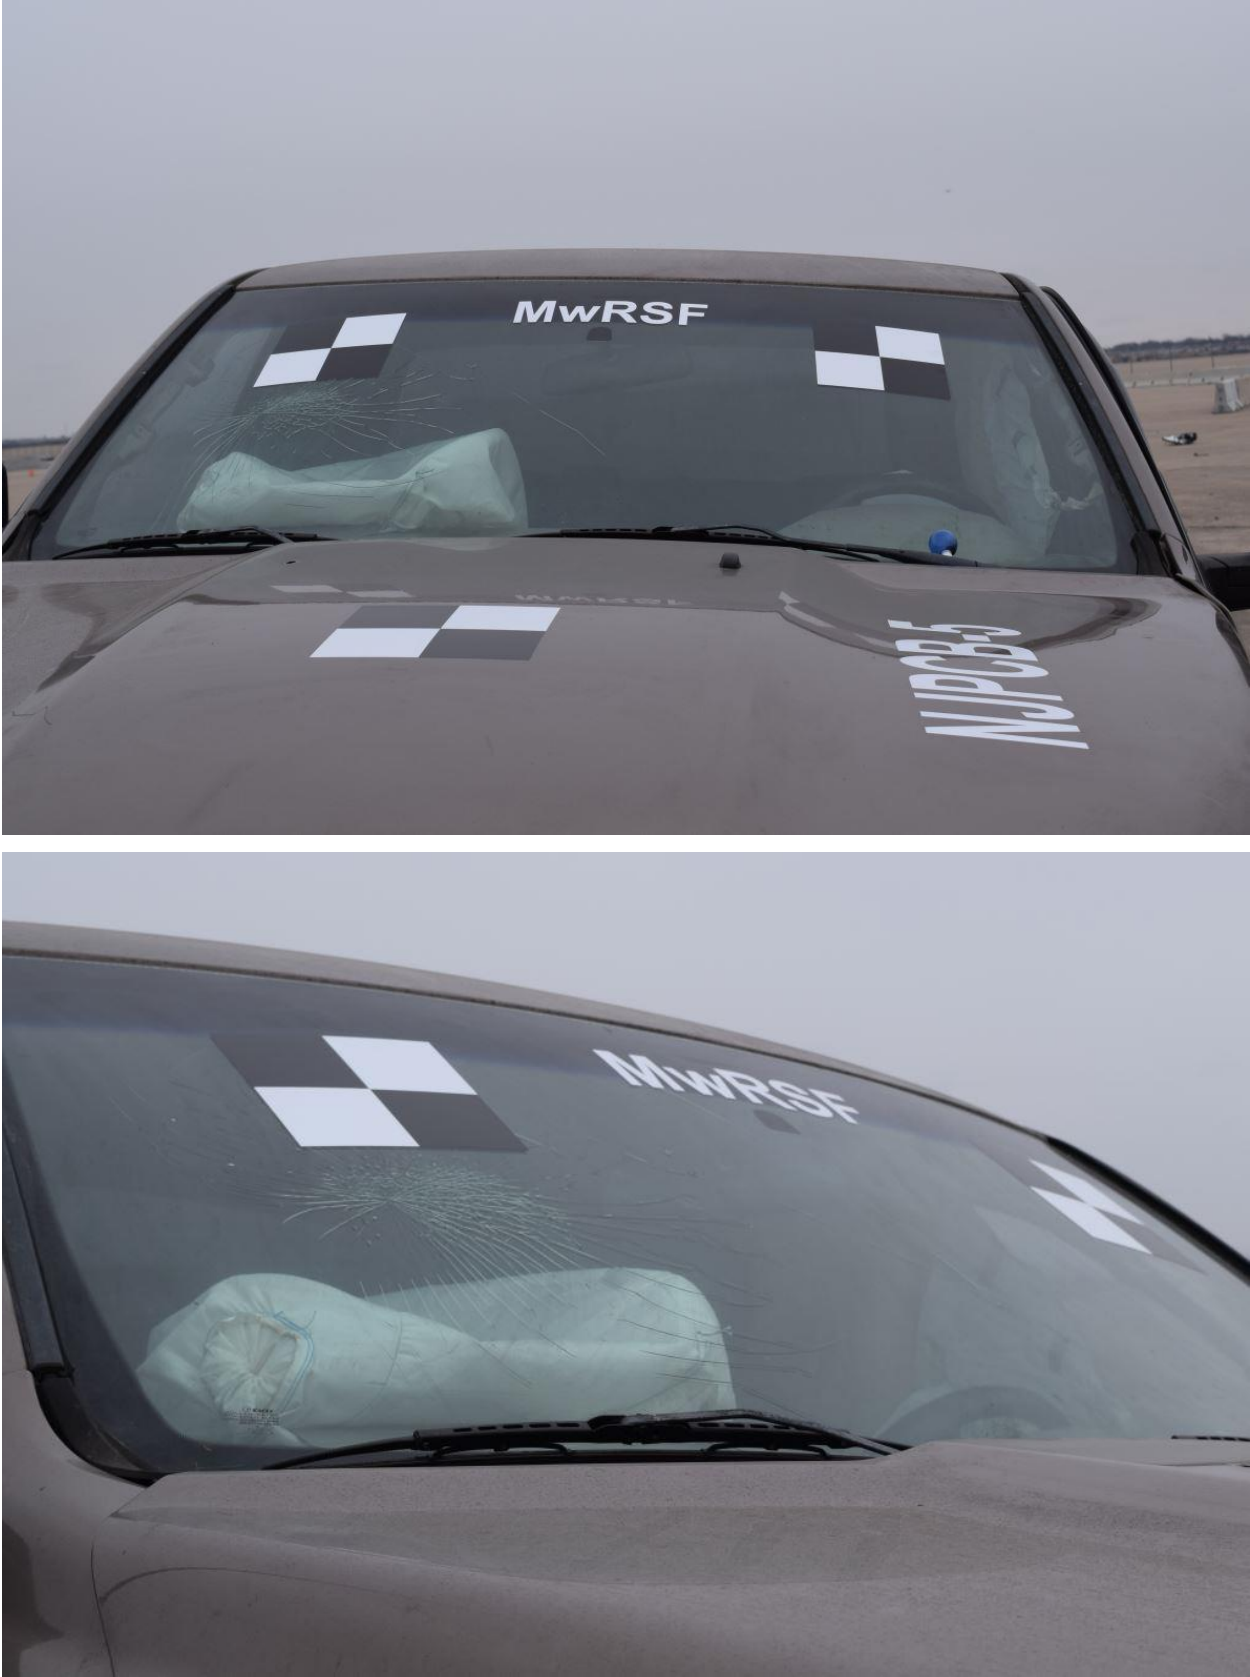
Figure 46. Vehicle Windshield Damage, Test No. NJPCB-5

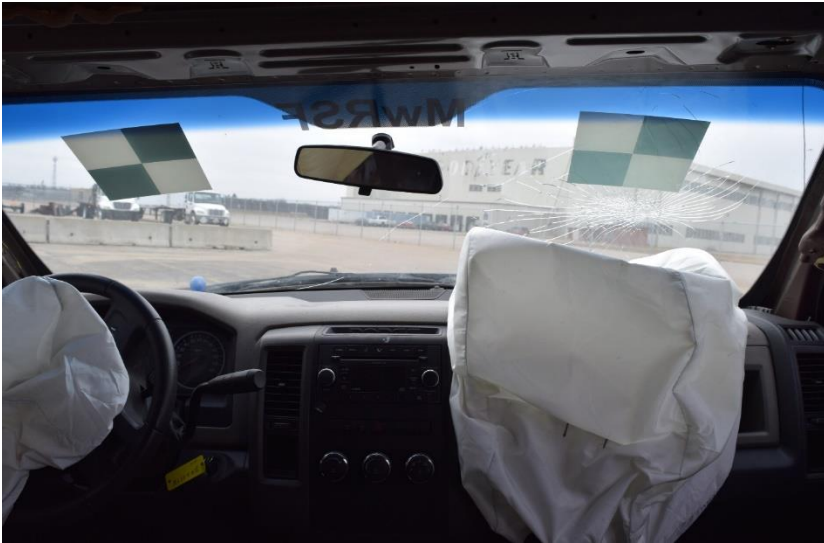
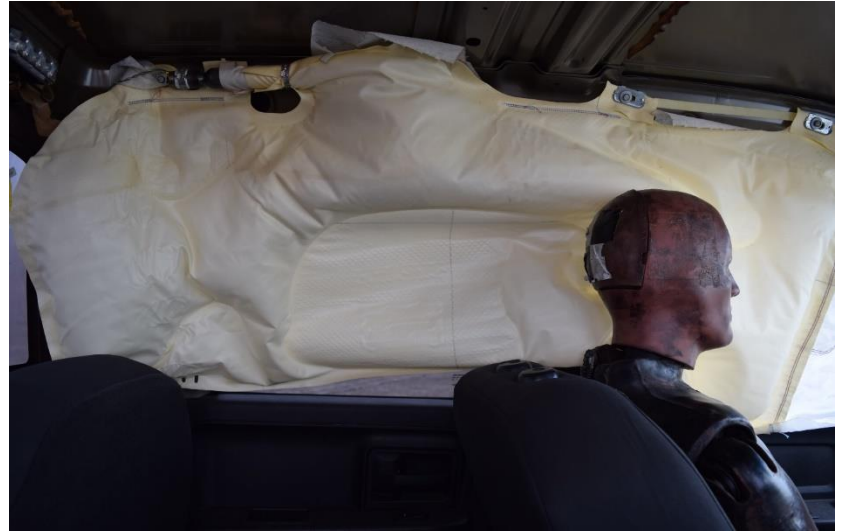
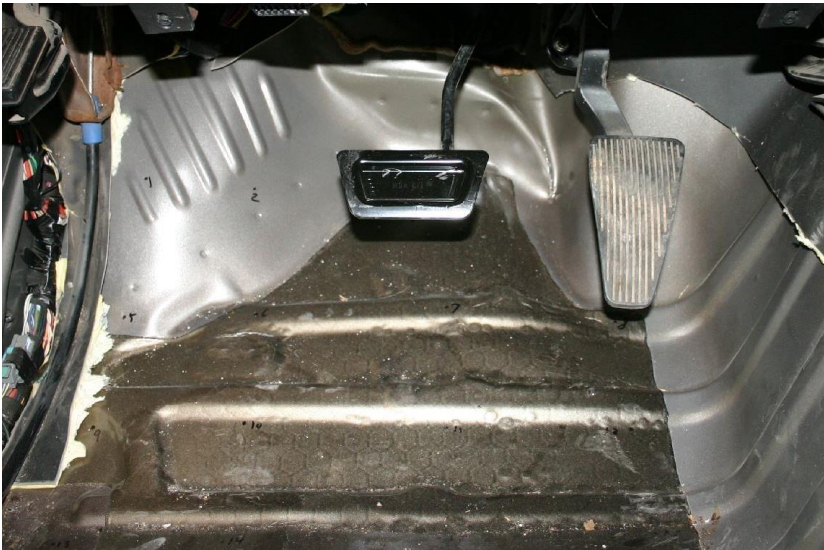
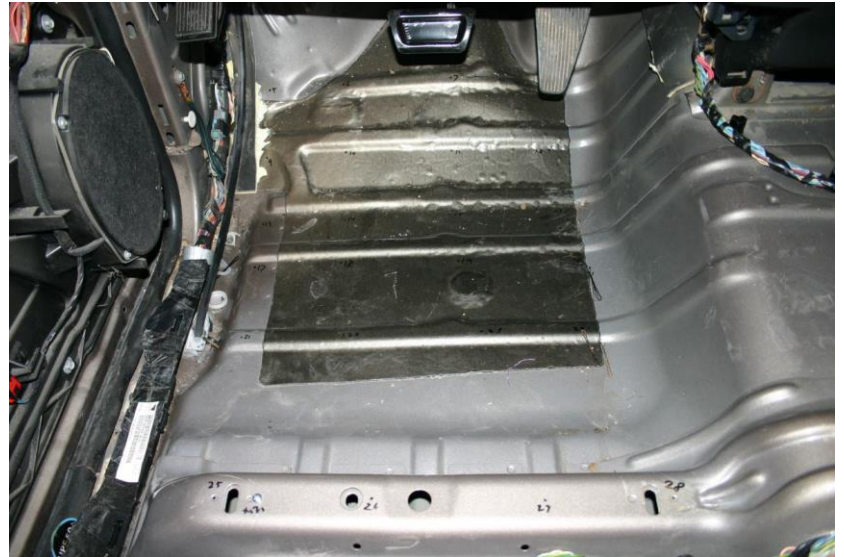
Figure 47. Occupant Compartment Deformation, Test No. NJPCB-5

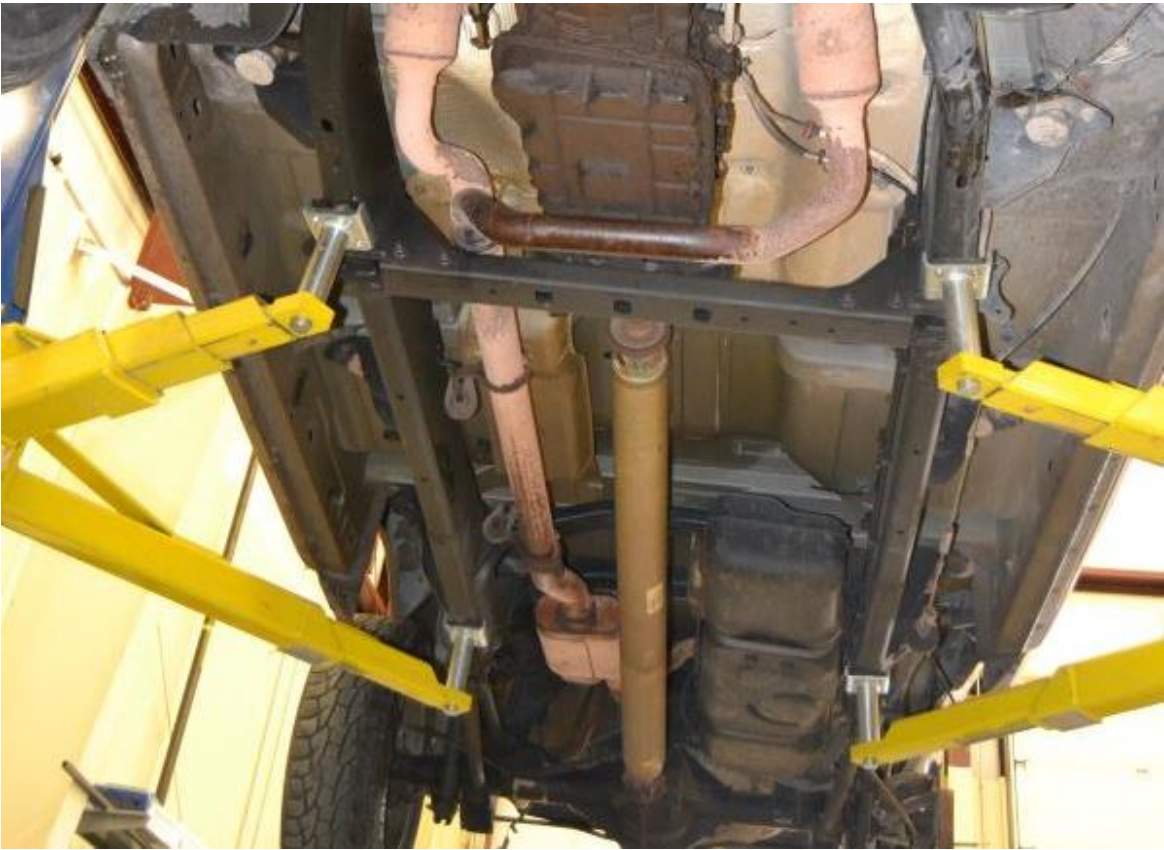
Figure 48. Undercarriage Damage, Test No. NJPCB-5

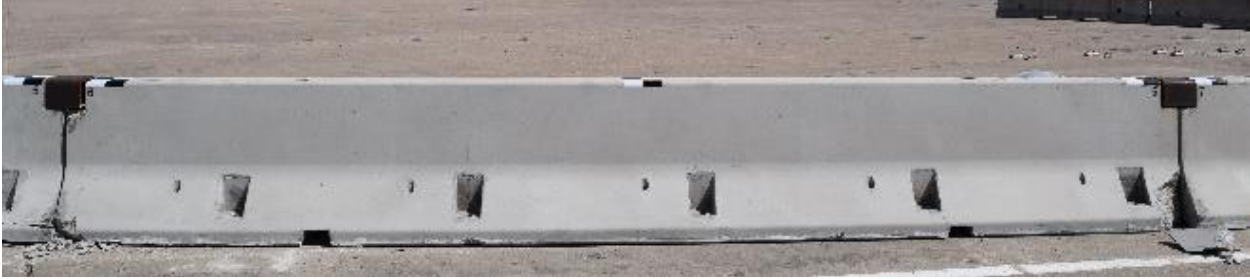
(a) Damage on 6th barrier

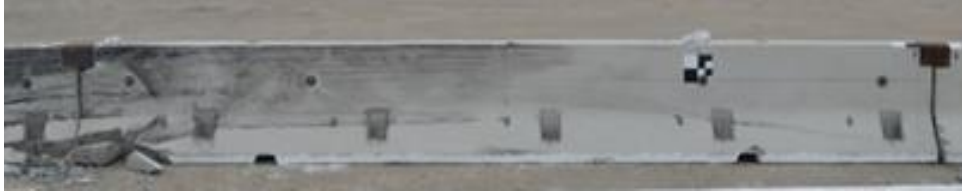
Figure 65. Barrier Segment Damage, Test No. NJPCB-5 and Simulation

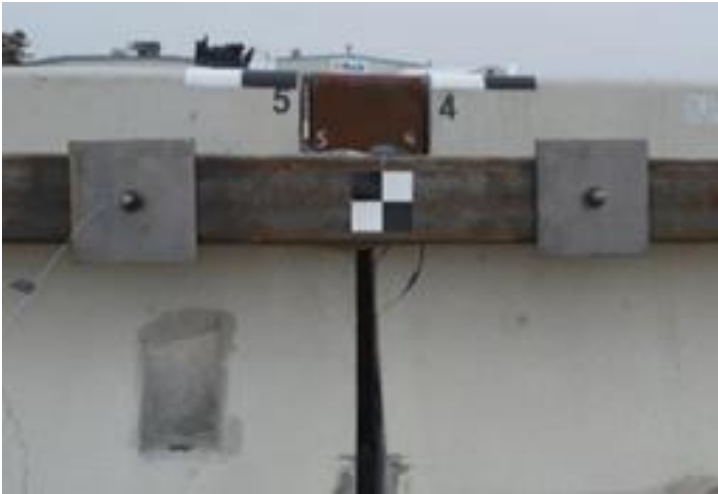
(c) Damage in tube between 4th and 5th barriers
