# **PERFORMANCE EVALUATION OF NEW JERSEY'S PORTABLE CONCRETE BARRIER WITH A BACK- SIDE PINNED CONFIGURATION AND GROUTED TOES – TEST NO. NJPCB-6**

## **MIDWEST ROADSIDE SAFETY FACILITY**

## **NEW JERSEY DEPARTMENT OF TRANSPORTATION**

MwRSF Research Report No. TRP-03-373-18

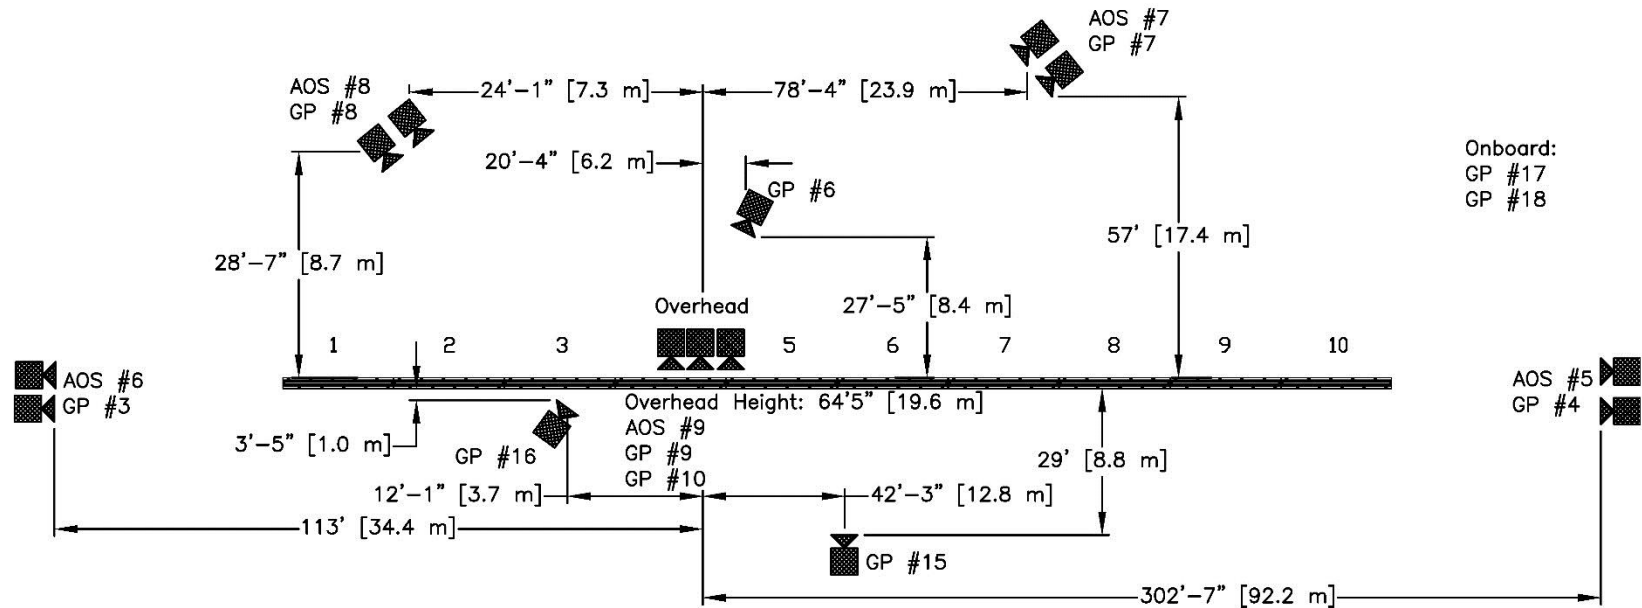
No.	Type	Operating Speed (frames/sec)	Lens	Lens Setting
AOS-5	AOS X-PRI Gigabit	500	VIVITAR 135mm Fixed	-
AOS-6	AOS X-PRI Gigabit	500	Fujinon 50mm Fixed	-
AOS-7	AOS X-PRI Gigabit	500	Fujinon 35mm Fixed	-
AOS-8	AOS S-VIT 1531	500	KOWA 25mm Fixed	-
AOS-9	AOS TRI-VIT 2236	500	KOWA 12mm Fixed	-
GP-3	GoPro Hero 3+	120		
GP-4	GoPro Hero 3+	120		
GP-6	GoPro Hero 3+	120		
GP-7	GoPro Hero 4	240		
GP-8	GoPro Hero 4	240		
GP-9	GoPro Hero 4	120		
GP-10	GoPro Hero 4	240		
GP-15	GoPro Hero 4	240		
GP-16	GoPro Hero 4	240		
GP-17	GoPro Hero 4	120		
GP-18	GoPro Hero 4	120

Five AOS high-speed digital video cameras and eleven GoPro digital video cameras were utilized to film test no. NJPCB-6. Camera details, camera operating speeds, lens information, and a schematic of the camera locations relative to the system are shown in Figure 23.

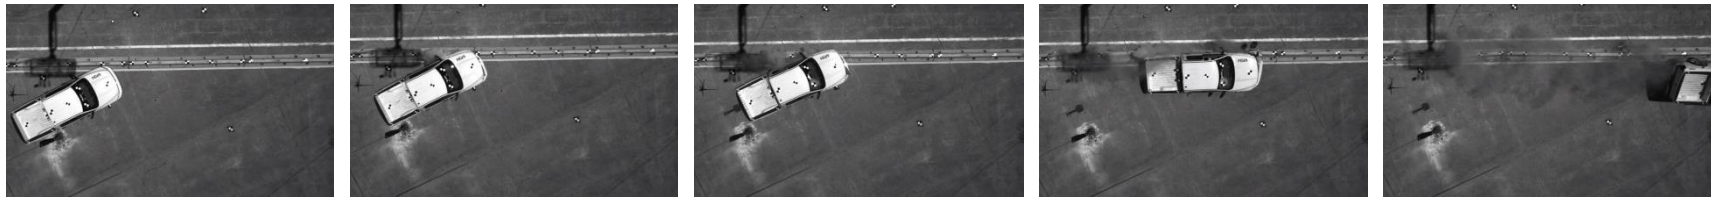
- Test Agency ..... MwRSF
- Test Number..... NJPCB-6
- Date ..... 6/02/2017
- MASH 2016 Test Designation ..... 3-11
- Test Article..... Back-Side Pinned NJDOT PCB with Grouted Toes, Connection Type C [2]

- Total Length ..... 200 ft (61.0 m)
- Key Component – NJDOT PCB
  - Length ..... 20 ft (6.1 m)
  - Width ..... 24 in. (610 mm)
  - Height ..... 32 in. (813 mm)

- Gross Static ..... 5,159 lb (2,340 kg)
- Impact Conditions
  - Speed ..... 62.9 mph (101.3 km/h)
  - Angle ..... 25.1 deg
  - Impact Location ..... 45<sup>11</sup>/<sub>16</sub> in. (1.2 m) upstream from joint 4-5

- Impact Severity ..... 119.0 kip-ft (161.3 kJ) > 105.6 kip-ft (143.1 kJ) limit in MASH 2016
- Exit Conditions
  - Speed ..... 46.9 mph (75.4 km/h)
  - Angle ..... 8.0 deg

- Vehicle Stability ..... Satisfactory
- Vehicle Stopping Distance ..... 205 ft – 3 in. (62.5 m) downstream  
21 ft – 2 in. (6.4 m) laterally behind
- Test Article Damage ..... Moderate
- Vehicle Damage ..... Moderate
  - VDS [14] ..... 11-LFQ-4
  - CDC [15] ..... 11-LYEW-4
  - Maximum Interior Deformation ..... 4<sup>3</sup>/<sub>8</sub> in. (117 mm)
- Maximum Test Article Deflections
  - Permanent Set ..... 3<sup>3</sup>/<sub>4</sub> in. (95 mm)
  - Dynamic ..... 15.2 in. (386 mm)
  - Working Width ..... 41.0 in. (1,041 mm)
- Transducer Data

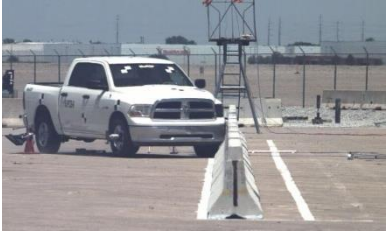
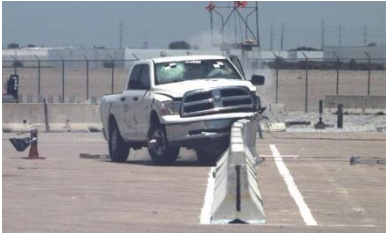
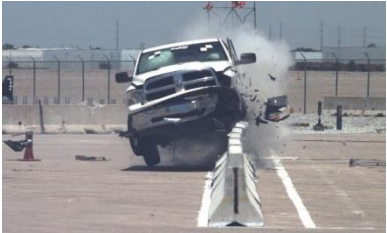
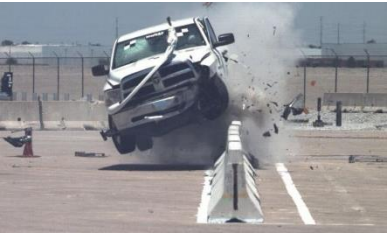
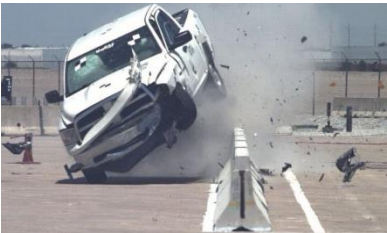
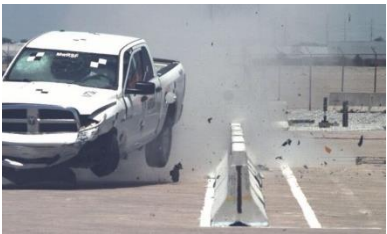
Figure 25. Summary of Test Results and Sequential Photographs, Test No. NJPCB-6

Evaluation Criteria		Transducer		MASH 2016 Limit
		SLICE-1	SLICE-2 (Primary)	
OIV ft/s (m/s)	Longitudinal	-17.74 (-5.41)	-17.30 (-5.27)	± 40 (12.2)
	Lateral	18.89 (5.76)	20.67 (6.30)	± 40 (12.2)
ORA g's	Longitudinal	-9.84	-9.73	± 20.49
	Lateral	9.87	8.43	± 20.49
MAX. ANGULAR DISPL. deg.	Roll	-28.2	28.9	± 75
	Pitch	-9.8	-12.2	± 75
	Yaw	40.1	39.5	not required
THIV ft/s (m/s)		25.95 (7.91)	27.00 (8.23)	not required
PHD g's		9.11	8.19	not required
ASI		1.14	1.26	not required

The 5,000-lb (2,268-kg) pickup truck impacted the NJDOT PCB, Type 4 (Alternative B) with a back-side pinned configuration and grouted toes, corresponding to connection type C in the 2015 NJDOT *Roadway Design Manual*, at a speed of 62.9 mph (101.3 km/h) and at an angle of 25.1 degrees. A summary of the test results and sequential photographs are shown in Figure 25. Additional sequential photographs are shown in Figures 26 and 27. Documentary photographs of the crash test are shown in Figure 28 through 31.

Initial vehicle impact was to occur 4 ft – 3<sup>3</sup>/<sub>16</sub> in. (1.3 m) upstream from the centerline of the joint between barrier nos. 4 and 5, as shown in Figure 32, which was selected using Table 2.7 of MASH 2016. The actual point of impact was 5½ in. (140 mm) downstream from the target location. A sequential description of the impact events is contained in Table 6. The vehicle came to rest 205 ft – 3 in. (62.5 m) downstream from the impact point and 21 ft – 2 in. (6.4 m) laterally behind the traffic side of the barrier, after brakes were applied. The vehicle trajectory and final position are shown in Figures 25 and 33.

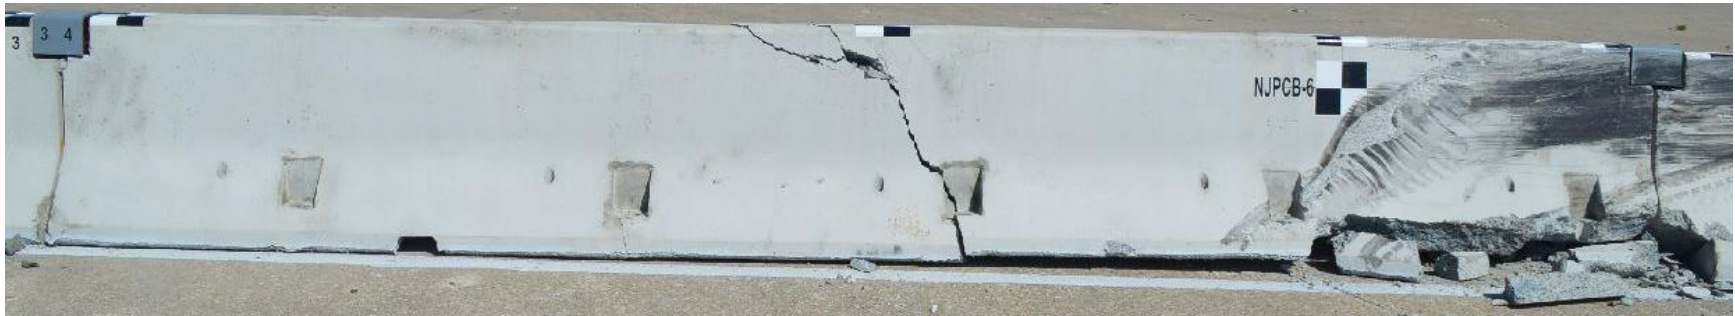
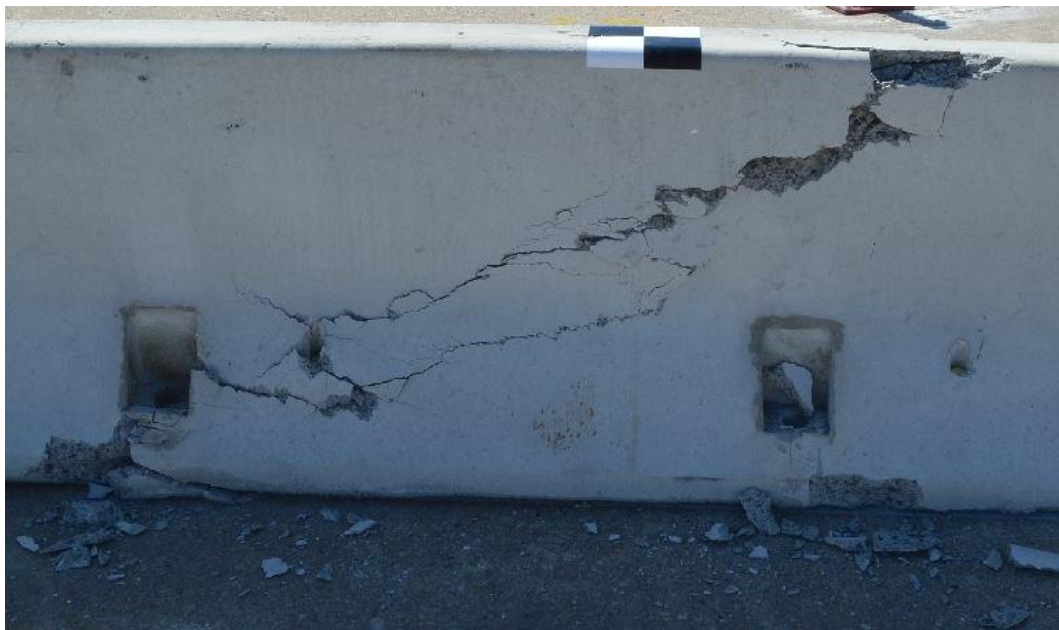
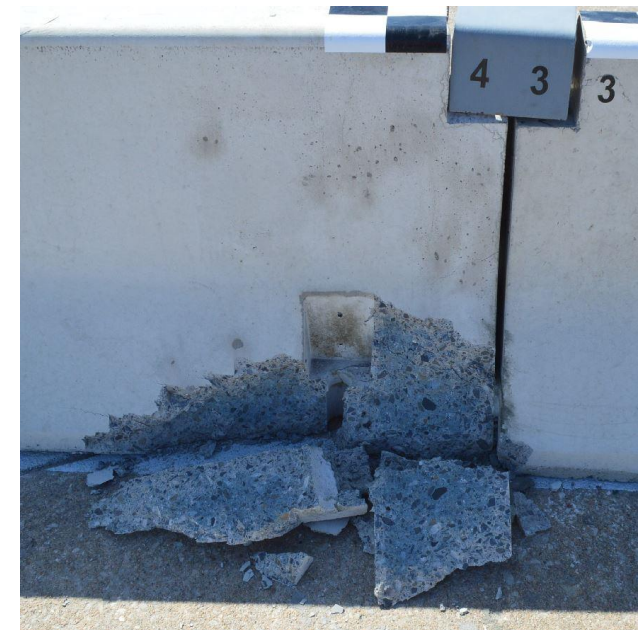
Figure 37. Barrier No. 4 – Traffic and Back Side Damage, Test No. NJPCB-6

Damage to the barrier was moderate, as shown in Figures 34 through 39. Barrier damage consisted of contact and gouge marks on the front face of PCB segments, spalling of the concrete, and concrete cracking and fracture. The length of vehicle contact along the barrier was approximately 23 ft – 10¼ in. (7.3 m), which spanned from 5 ft – 11¼ in. (1.8 m) upstream from the center of the joint between barrier nos. 4 and 5 through 17 ft – 9 in. (5.4 m) downstream from the center of the joint between barrier nos. 4 and 5.

The maximum permanent set deflection of the barrier system was 3¾ in. (95 mm) at the upstream end of barrier no. 5, as measured in the field. The maximum lateral dynamic barrier deflection, including tipping of the barrier along the top surface, was 15.2 in. (386 mm) at the upstream end of barrier no. 5, as determined from high-speed digital video analysis. The working width of the system was found to be 41.0 in. (1,041 mm), also determined from high-speed digital video analysis. A schematic of the permanent set, dynamic deflection, and working width is shown in Figure 25. In addition, NJDOT identifies the clear space behind the barrier, which is defined as the maximum deflection of the back of the barrier from its original position. For this test, the clear space behind the barrier was 15.2 in. (386 mm).
