*Research Project No. TPF-5(193) Supplement #103  
NDOT Sponsoring Agency Code RHE-17M*

## **34-IN. TALL THRIE BEAM TRANSITION TO CONCRETE BUTTRESS**

MwRSF Research Report No. TRP-03-367-19

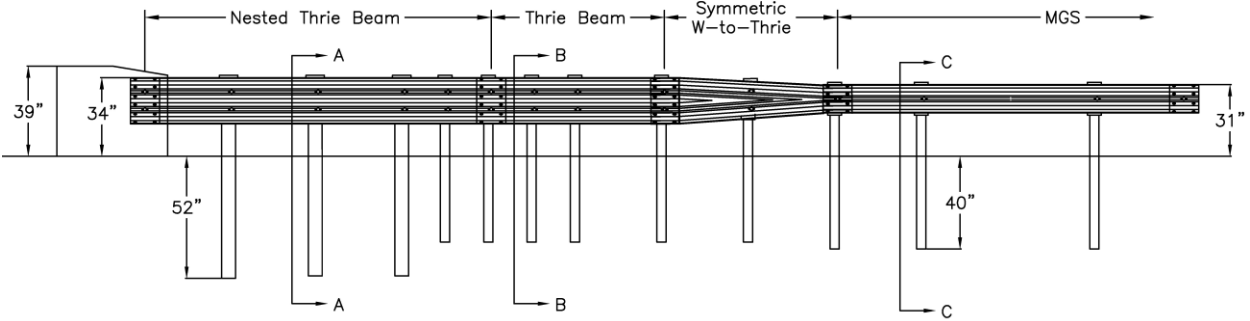
Figure 2. 34-in. (864-mm) Tall AGT Initial Installation, No Overlay

Second, the symmetric W-to-thrie transition segment would be replaced with an asymmetric rail segment, matching the original MGS stiffness transition design. Thus, by replacing only a single rail element and shifting the existing W-beam up 3 in. (76 mm), the entire transition system would be at its nominal 31-in. (787-mm) mounting height and would maintain its crashworthiness after a 3-in. (76-mm) roadway overlay. Drawings of the 34-in. (864-mm) AGT both before and after an overlay are shown in Figures 2 through 4.

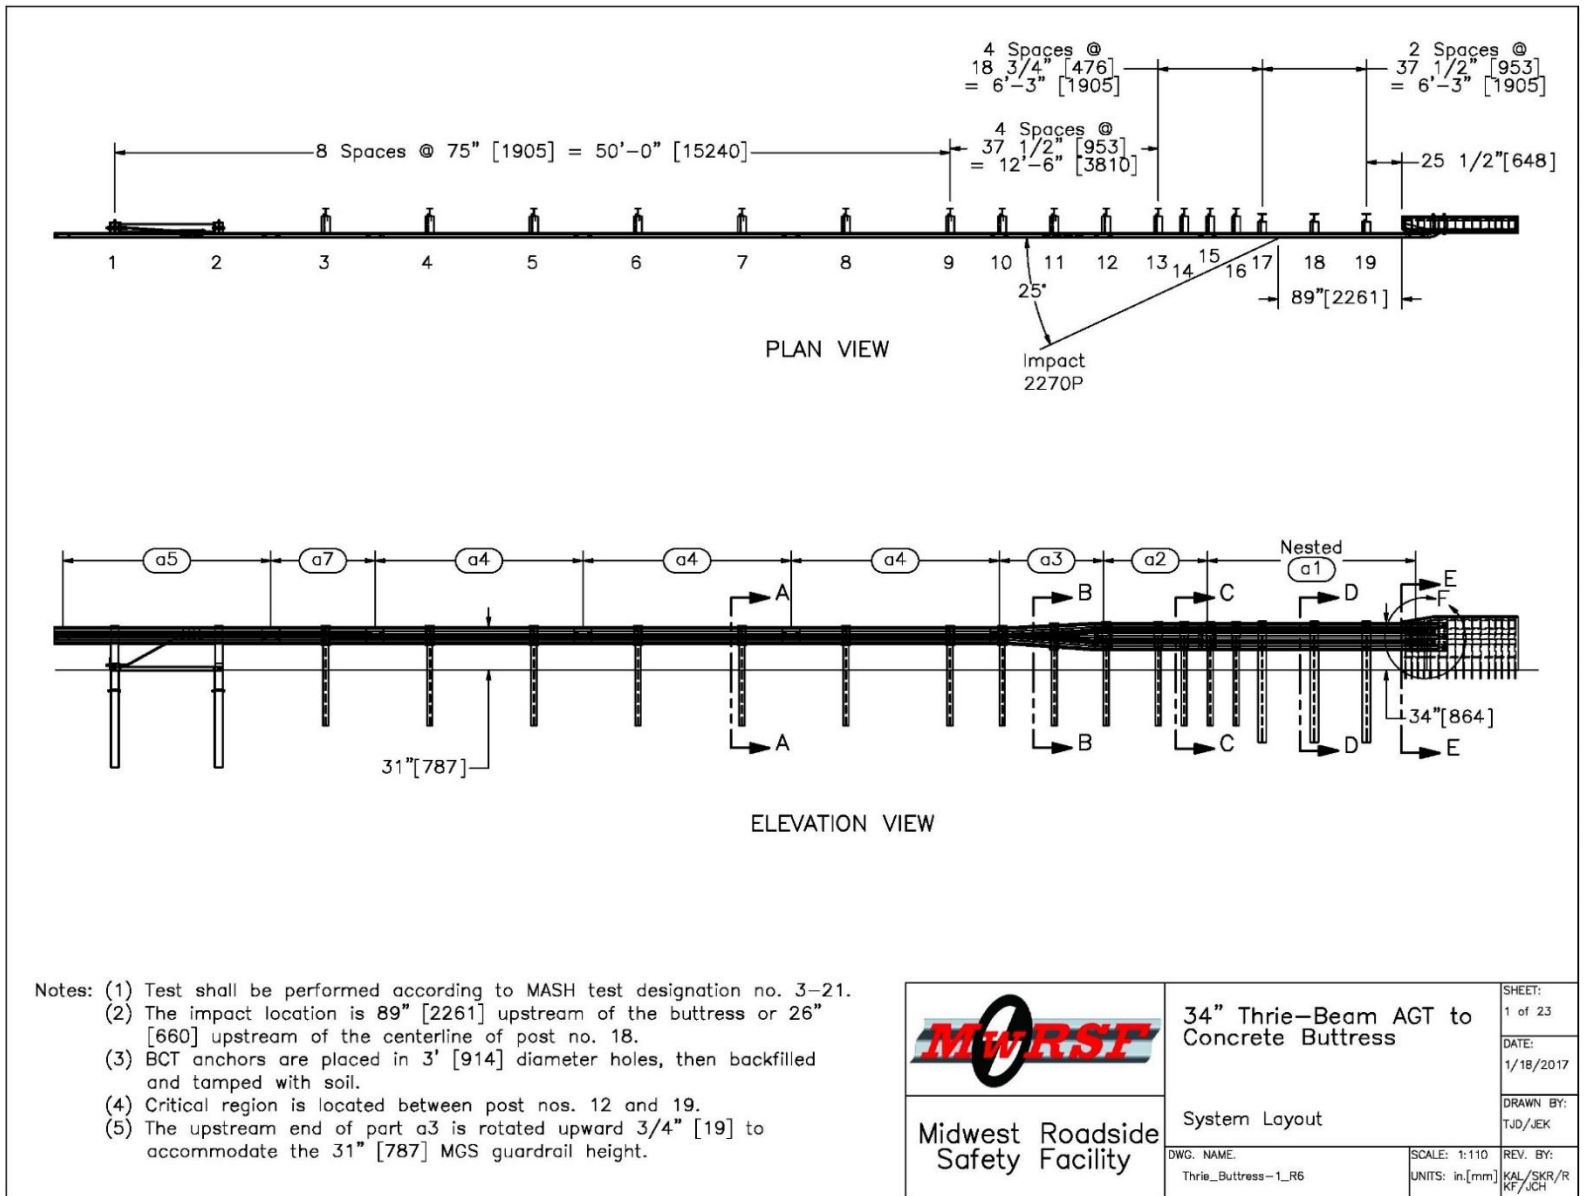
Figure 7. System Layout, Test No. 34AGT-1

As requested by NDOT, test nos. 34AGT-1 and 34AGT-2 featured two different configurations of the splice between the nested thrie beam and the thrie beam terminal connector. In test no. 34AGT-1, the terminal connector was placed behind both plies of the nested thrie beam, as shown in Figure 31, while in test no. 34AGT-2 the terminal connector was sandwiched between the two plies of the nested thrie beam, as shown in Figure 32. NDOT typically installs terminal connectors in the sandwiched configuration.

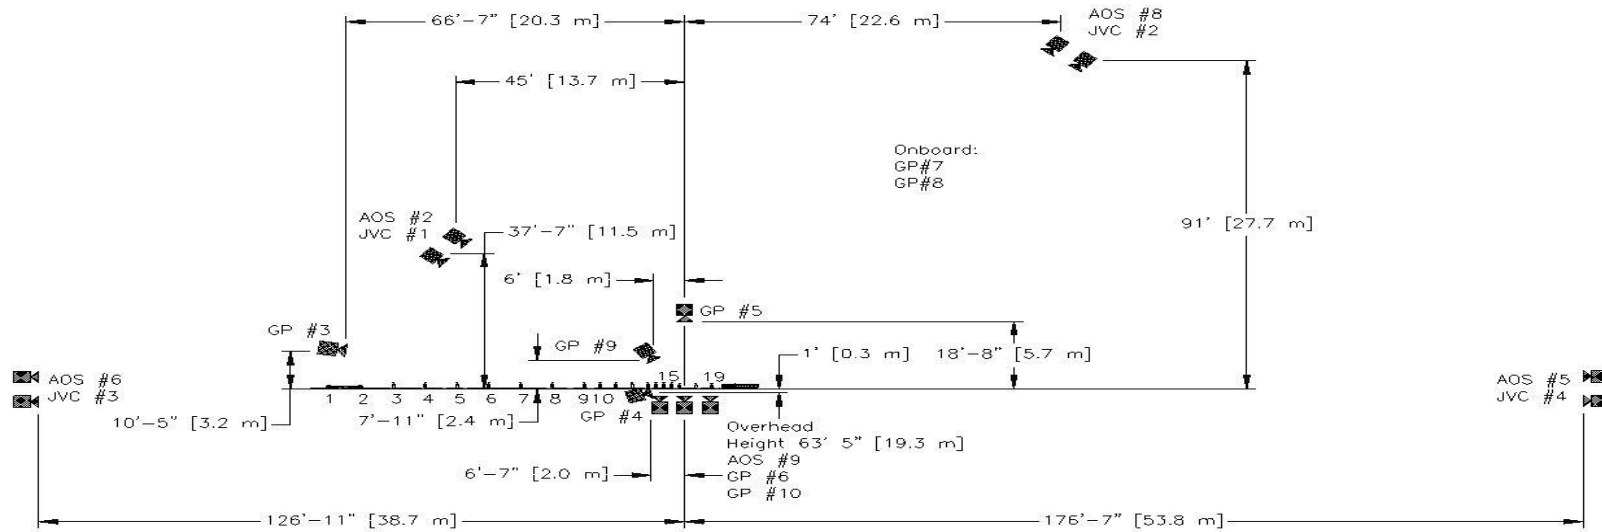
Figure 39. Camera Locations, Speeds, and Lens Settings, Test No. 34AGT-1

Five AOS high-speed digital video cameras, eight GoPro digital video cameras, and four JVC digital video cameras were utilized to film test no. 34AGT-1. Five AOS high-speed digital video cameras and twelve GoPro digital video cameras were utilized to film test no. 34AGT-2. Camera details, camera operating speeds, lens information, and a schematic of the camera locations relative to the system are shown in Figures 39 and 40.

No.	Type	Operating Speed (frames/sec)	Lens	Lens Setting
AOS-2	AOS Vitcam CTM	500	Fujinon 35 mm Fixed	-
AOS-5	AOS X-PRI Gigabit	500	Vivitar 135 mm Fixed	-
AOS-6	AOS X-PRI Gigabit	500	Fujinon 50 mm Fixed	-
AOS-8	AOS S-VIT 1531	500	Sigma 28-70 DG	70
AOS-9	AOS TRI-VIT 2236	500	Kowa 12 mm Fixed	-
GP-3	GoPro Hero 3+	120		
GP-4	GoPro Hero 3+	120		
GP-5	GoPro Hero 3+	120		
GP-6	GoPro Hero 3+	120		
GP-7	GoPro Hero 4	120		
GP-8	GoPro Hero 4	120		
GP-9	GoPro Hero 4	240		
GP-10	GoPro Hero 4	240		
JVC-1	JVC – GZ-MC500 (Everio)	29.97		
JVC-2	JVC – GZ-MG27u (Everio)	29.97		
JVC-3	JVC – GZ-MG27u (Everio)	29.97		
JVC-4	JVC – GZ-MG27u (Everio)	29.97

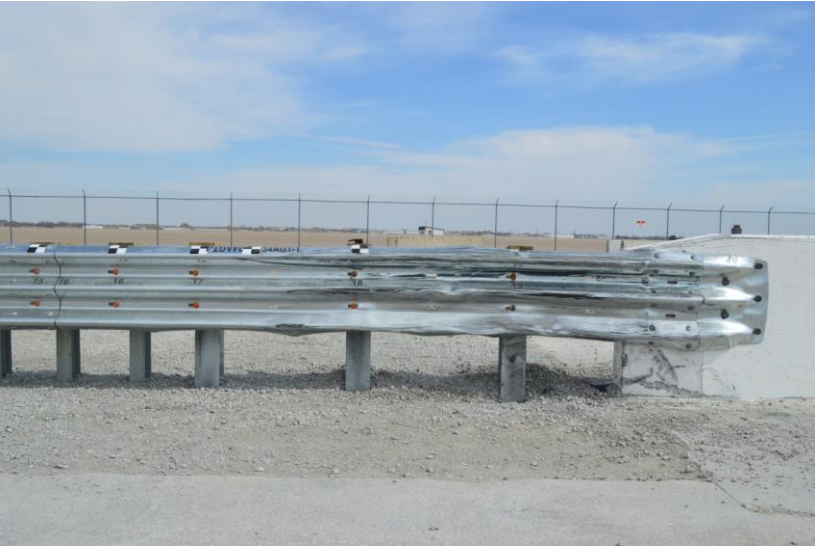
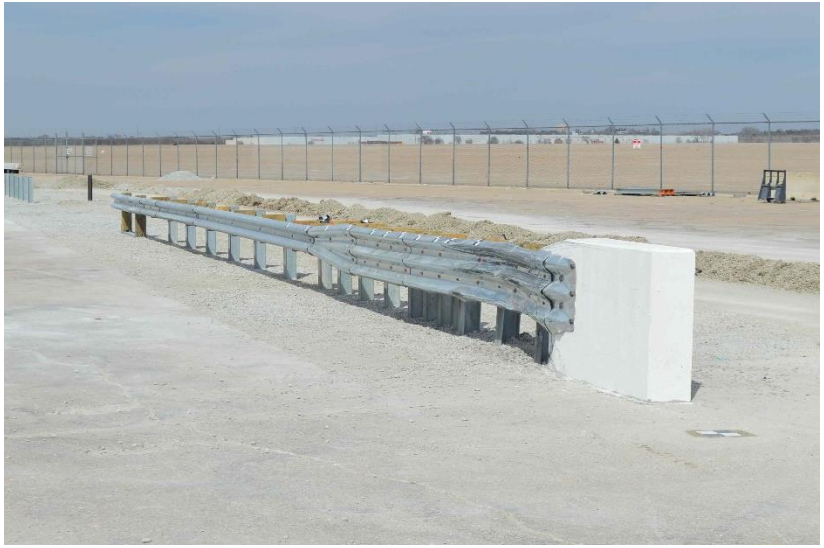
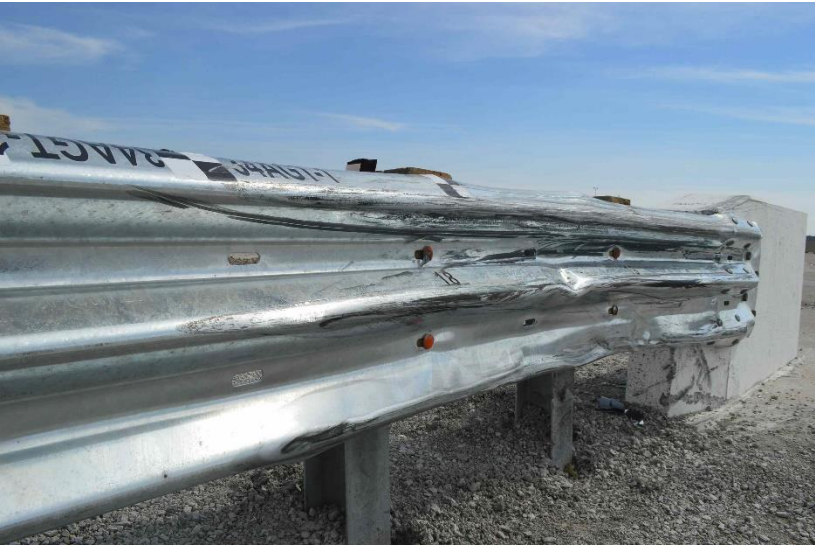
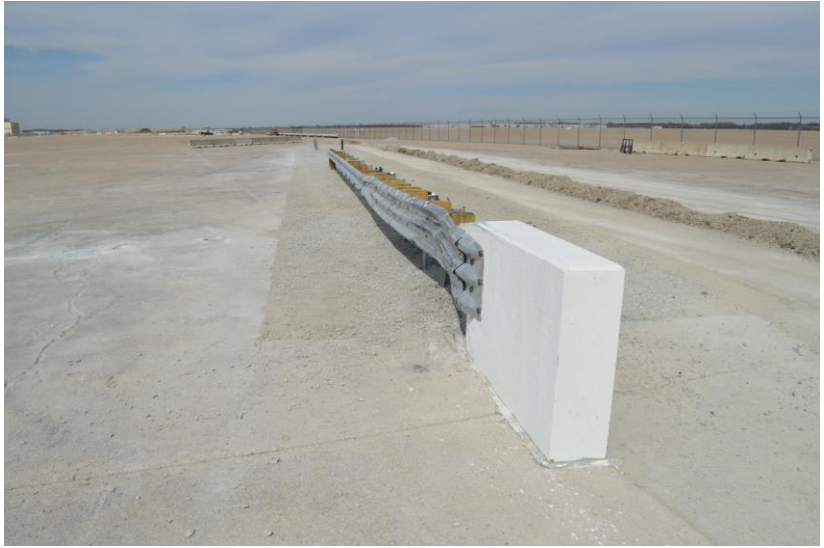
Figure 46. System Damage, Test No. 34AGT-1

Damage to the barrier was moderate, as shown in Figures 46 through 49. Barrier damage consisted of rail and post deformation, contact marks on the top and front face of the concrete buttress, concrete gouging, and concrete cracking. The length of vehicle contact along the barrier was approximately 12 ft – 2½ in. (3.7 m) which spanned from 10 in. (254 mm) downstream from post no. 17 to 28 in. (711 mm) from the downstream end of the concrete buttress.

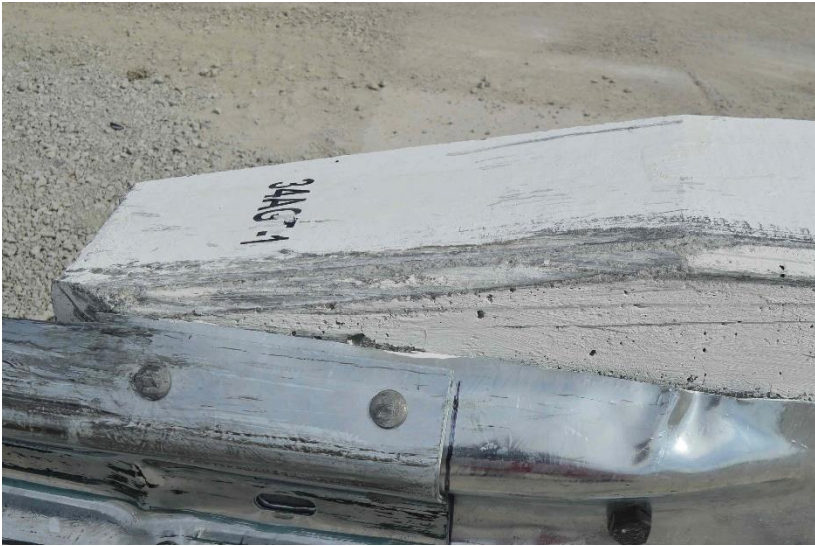
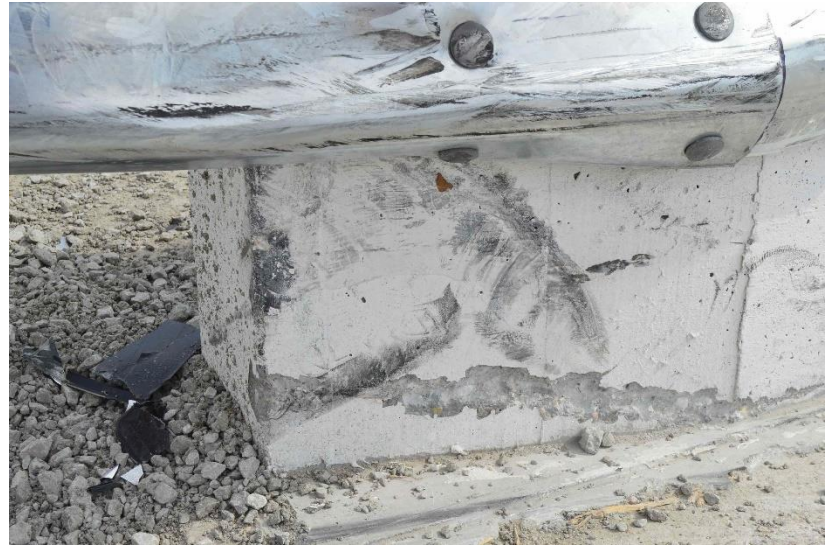
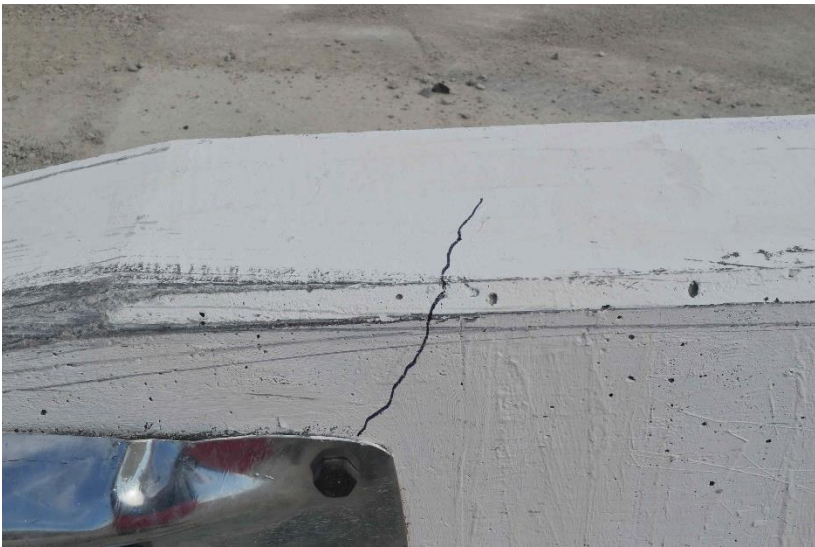
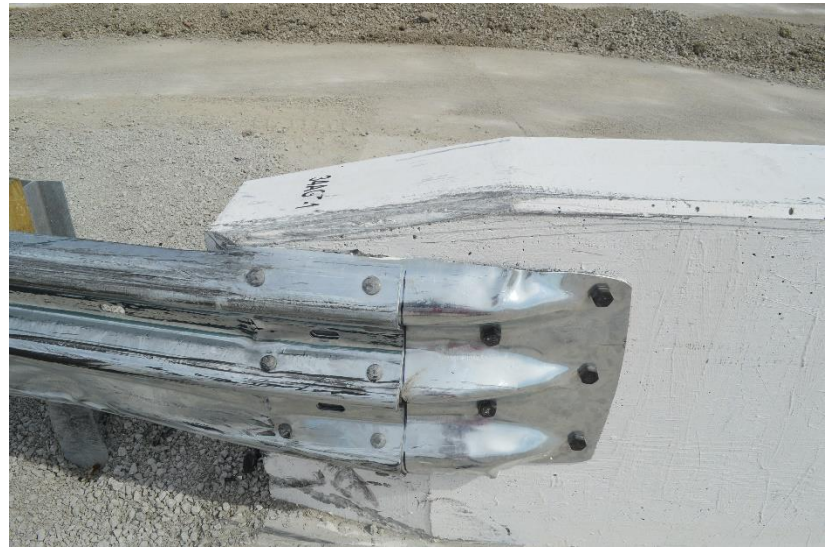
Figure 49. Buttress Damage, Test No. 34AGT-1

Tire marks were visible on the front face of the concrete buttress and on the lower chamfer of the buttress. Concrete gouging was observed along the entire length of the lower chamfer of the buttress and extended an additional 3 in. (76 mm) onto the front face of the buttress. The gouging was 3 in. (76 mm) from the bottom, and gradually sloped down to the bottom edge over its duration. Contact marks were found on the top and front face of the buttress beginning at the upstream end and extended to 28 in. (711 mm) from the downstream end. A hairline crack was found on the front face of the concrete buttress, extending upward and downstream at approximately a 45-degree angle from the top bolt hole of the thrie beam terminal connector to the top surface of the buttress.

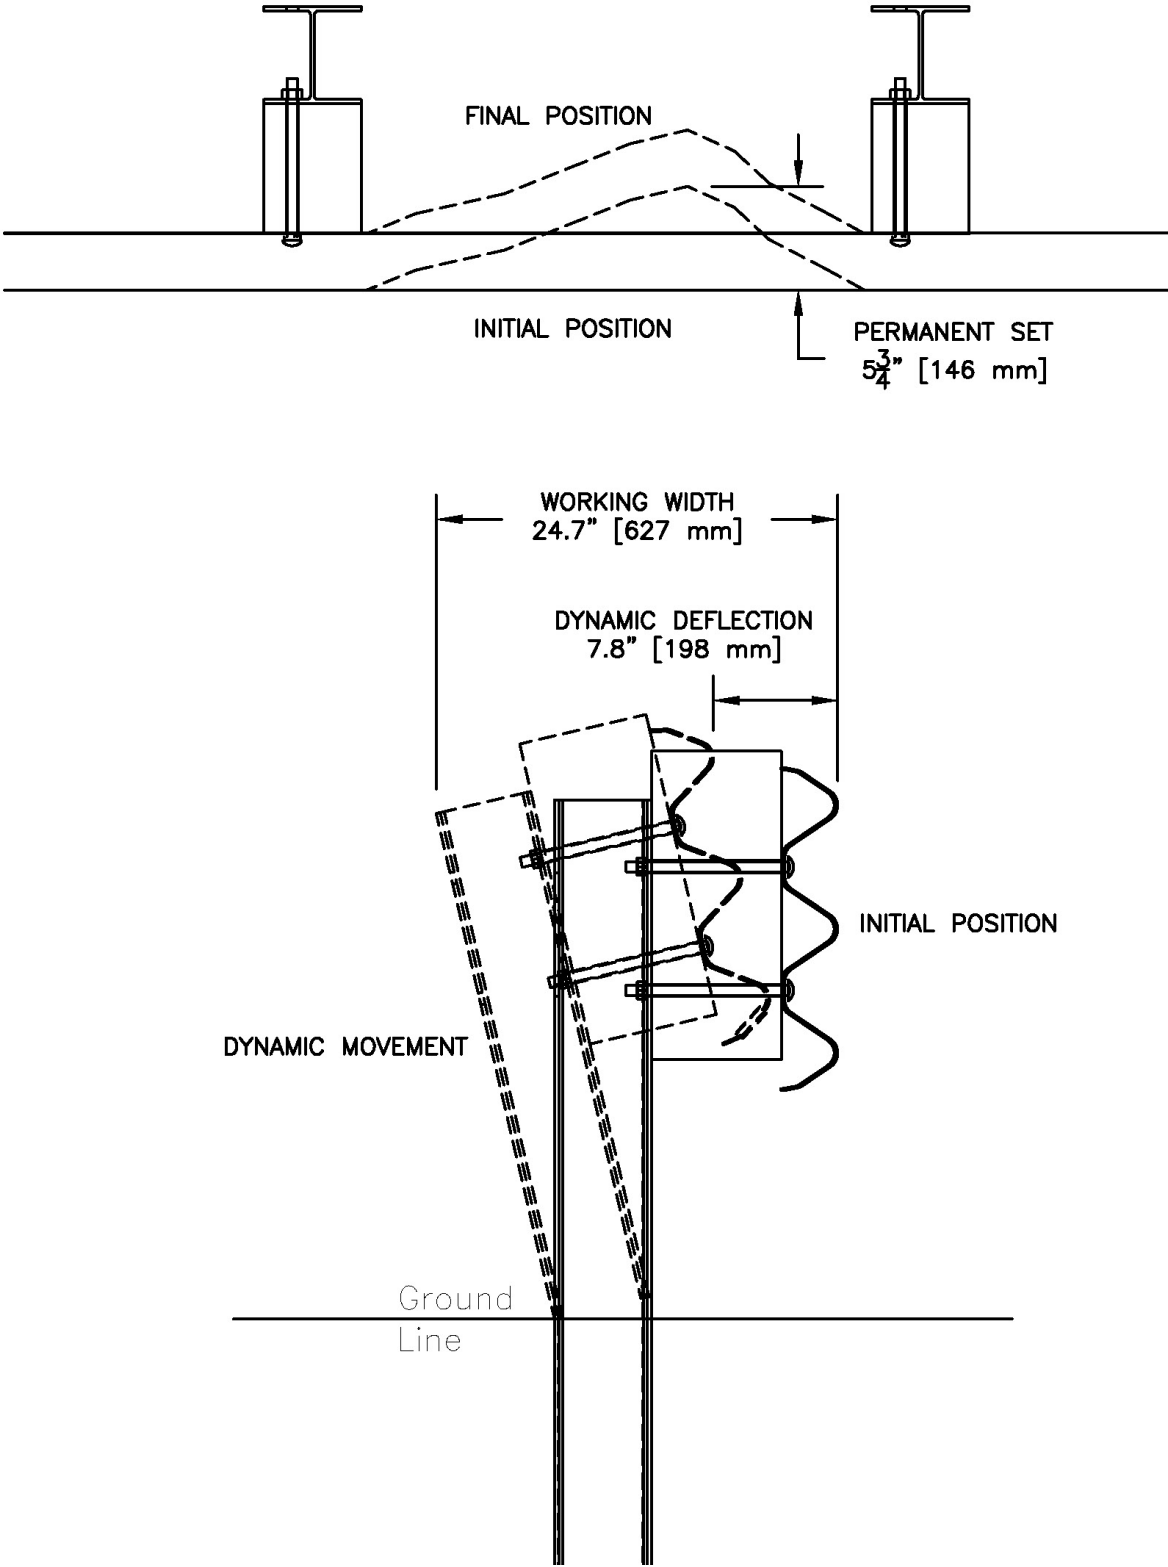
Figure 50. Permanent Set, Dynamic Deflection, and Working Width, Test No. 34AGT-1

The maximum lateral permanent set deflections of the rail and posts for the transition barrier system was 5¾ in. (146 mm) at the mid-span between post nos. 18 and 19, and 4¾ in. (121 mm) at post no. 18, respectively, as measured in the field. The maximum lateral dynamic barrier deflection of the rail and posts for the transition barrier system was 7.8 in. (198 mm) at post no. 18 and 7.4 in. (188 mm) at post no. 18, respectively, as determined from high-speed digital video analysis. The working width of the system was established by the deflection of post no. 18 and was found to be 24.7 in. (627 mm), also determined from high-speed digital video analysis. A schematic of the permanent set deflection, dynamic deflection, and working width is shown in Figure 50.

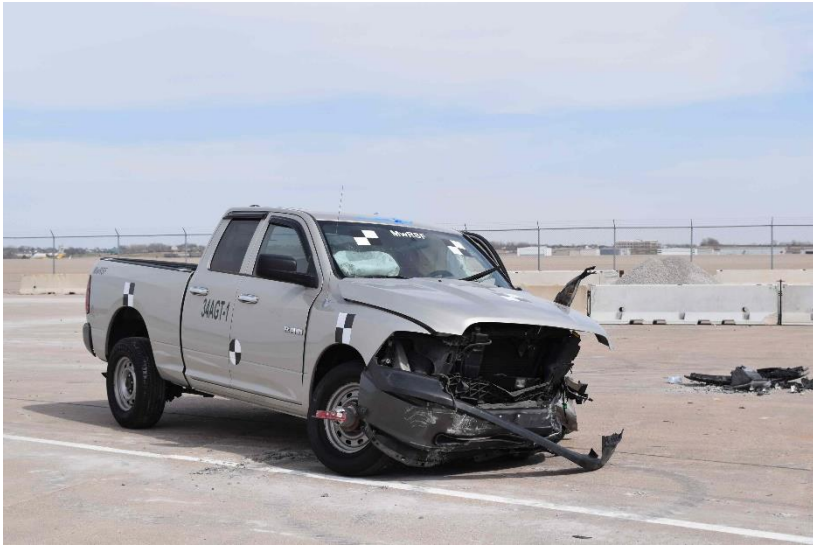
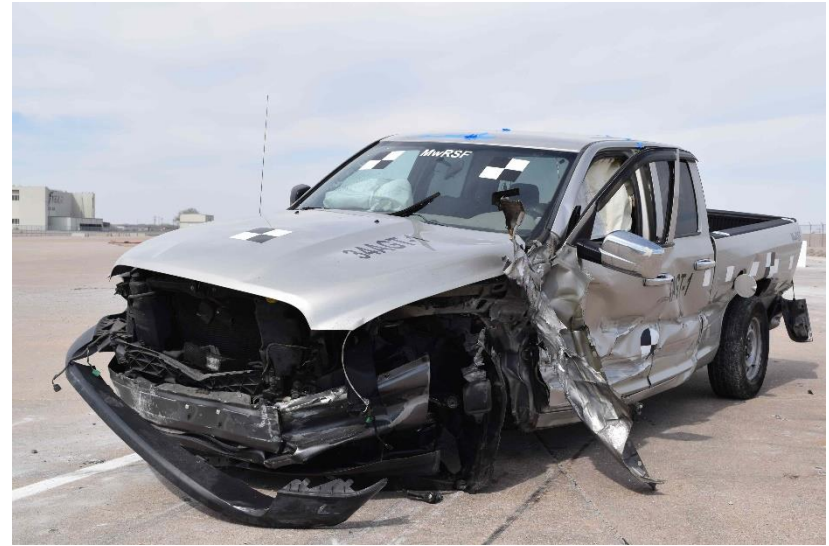
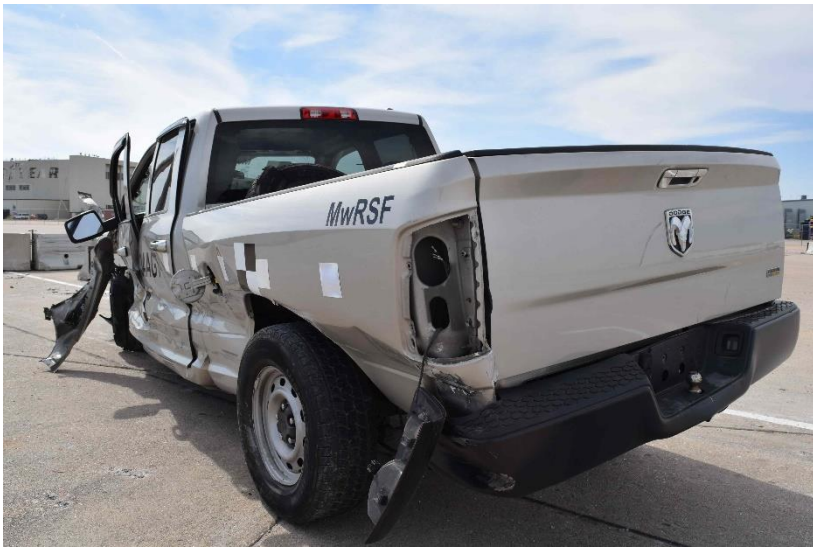
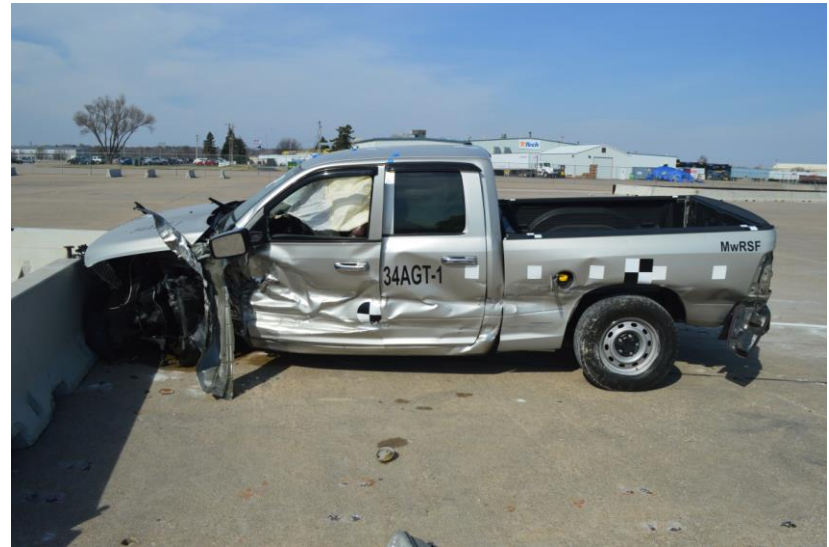
Figure 51. Vehicle Damage, Test No. 34AGT-1

The damage to the vehicle was moderate, as shown in Figures 51 through 53. The majority of damage was concentrated on the left-front corner and left side of the vehicle where the impact occurred. The left side of the front bumper was crushed inward and back. The left-front fender was pushed upward near the door panel and was dented and torn behind the left-front wheel. Both headlights and the grille were disengaged from the vehicle. The left side of the radiator was pushed backward. Denting and scraping was observed on the entire left side of the pickup truck. The bottom of the left-front door was crushed inward, and the top of the door was ajar. The left-rear door was dented. The left taillight was out of socket, but remained attached. The left side of the rear bumper was dented, scuffed, and partially disengaged.

The left-front wheel was disengaged from the vehicle, and the steel rim was deformed with tears and significant crushing. The left-front tire was torn and deflated. The left upper control arm was fractured. The left-front steering knuckle and ball joints were disengaged, and the upper control arm was bent toward the engine. The left-rear wheel assembly was deformed inward, the steel rim was dented, and scuff marks were found on the tire.

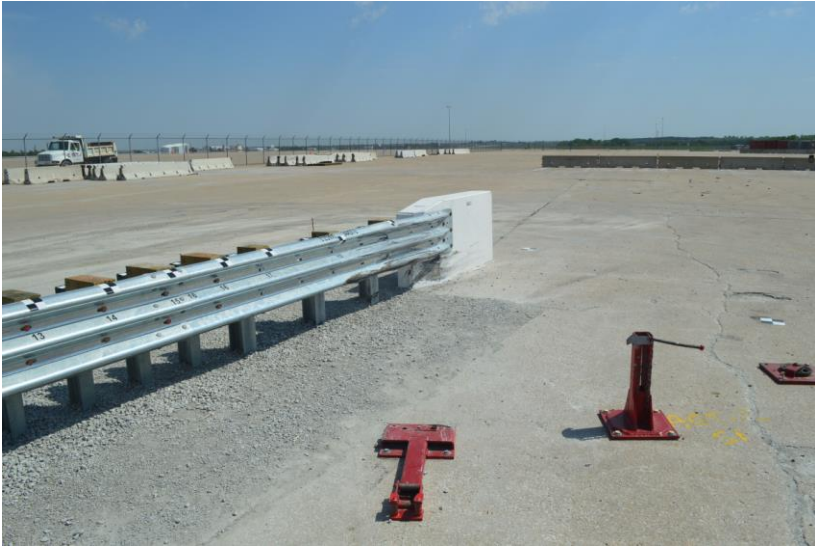
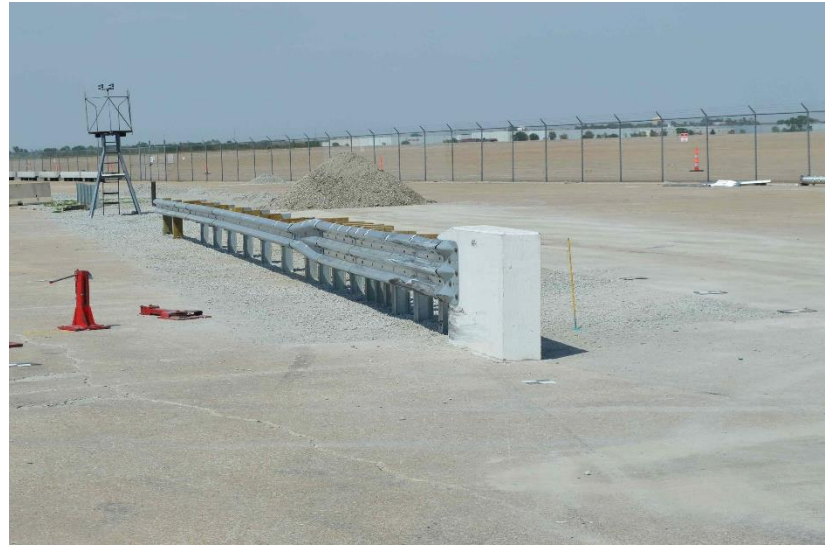
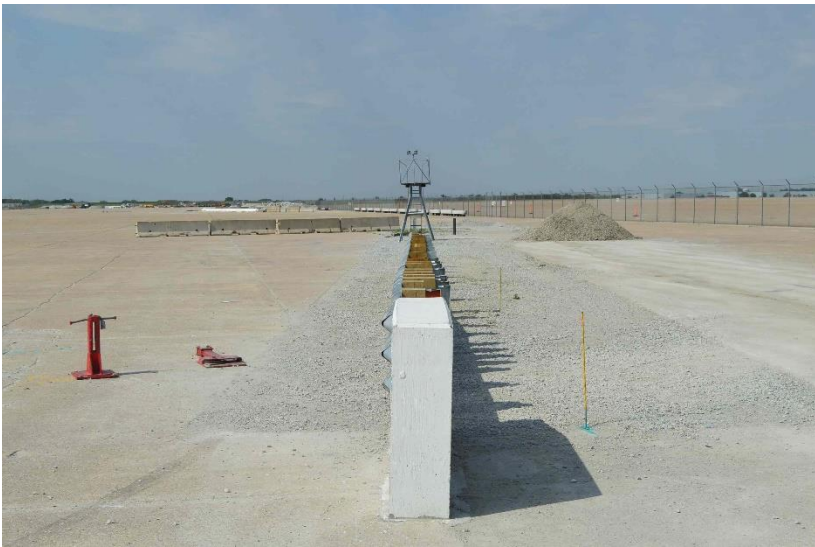
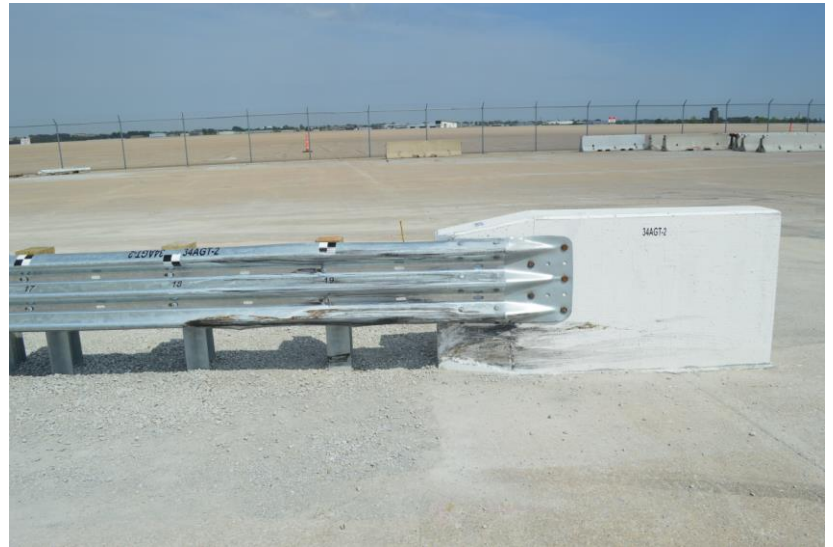
Figure 60. System Damage, Test No. 34AGT-2

Damage to the barrier was minimal, as shown in Figures 60 through 62. Barrier damage consisted of rail and post deformation, contact marks on the upstream and traffic faces of the concrete buttress, and concrete gouging. The length of vehicle contact along the barrier was approximately 12 ft – 1 in. (3.7 m) which spanned from 2 in. (51 mm) upstream from the centerline of post no. 18 to 4 in. (102 mm) from the downstream end of the concrete buttress.

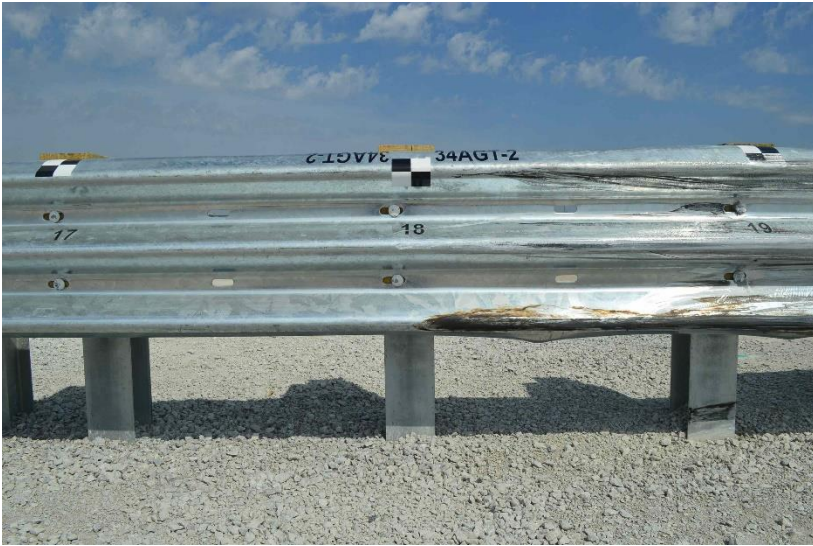
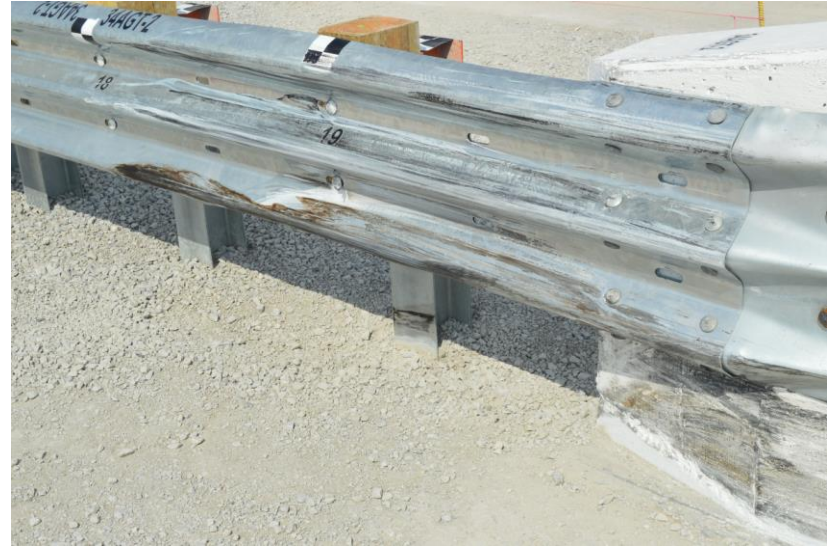
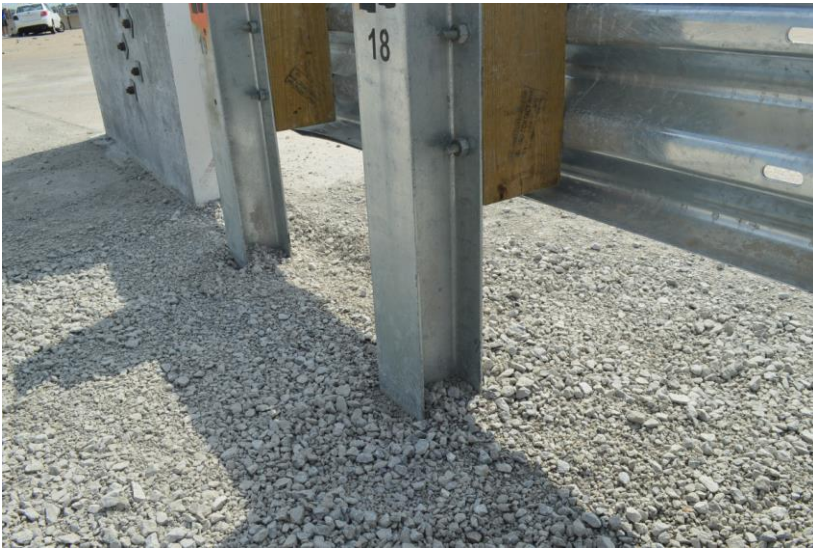
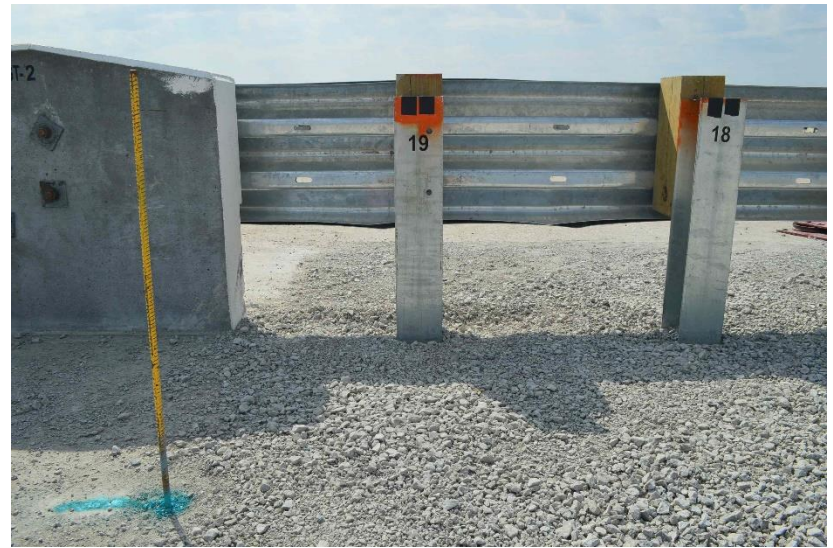
Figure 61. System Damage, Post Nos. 18 and 19, Test No. 34AGT-2

Tire marks were visible on the bottom corrugation of the thrie beam starting at the centerline of post no. 18 and extending 8½ in. (216 mm) onto the terminal connector. General contact marks and minor deformations were found on the upper half of the thrie beam between post no. 18 and the concrete buttress. A kink occurred in the bottom of the thrie beam, 13 in. (330 mm) downstream from the centerline of post no. 18. Approximately 4 ft (1.2 m) of the thrie beam's bottom corrugation was flattened at the downstream end. Tire marks were also found on the front flange of post no. 19 just above the ground line. Post nos. 18 and 19 were each deflected backward less than 1 in. (25 mm).
